VersaLink[®] C500/C600 Printer and C505/C605 Multifunction Printer Service Manual

Xerox VersaLink C605F Family Printer Service Manual

705P01395

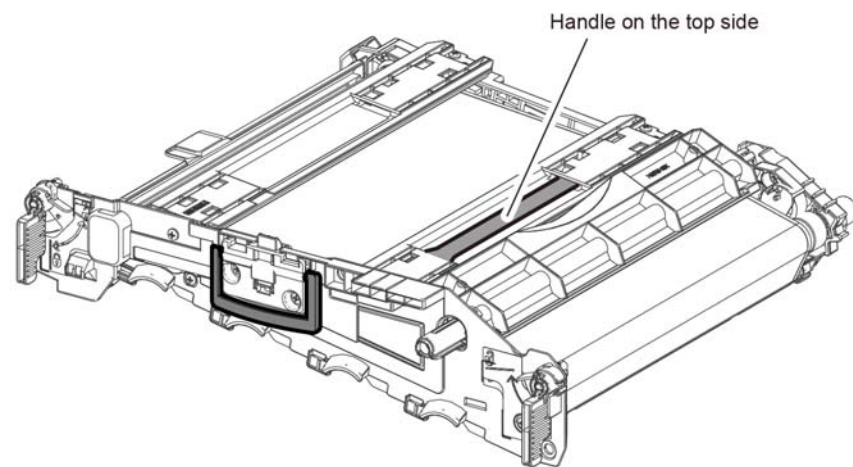
Figure 1 Handle Locations on the Transfer Belt Unit

NOTE: In the following step, do not grasp the foam on Transfer Belt Unit Cover when replacing the Transfer Unit. Grasp the Transfer Belt Unit Handles (see [Figure 1](#)).

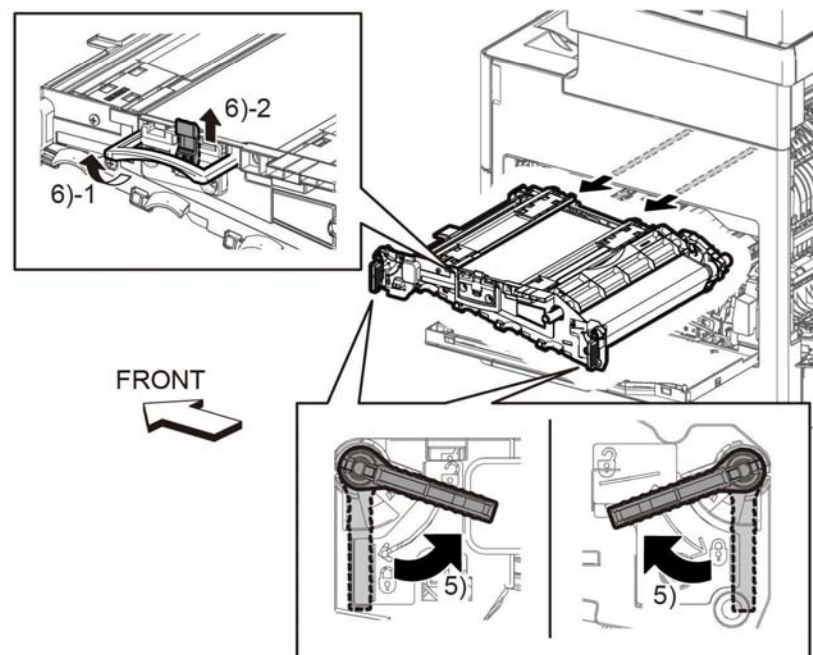
5. Refer to [Figure 1](#) to remove the four screws attaching the Transfer Belt Unit, [PL 6.1 Item 1](#) and remove the Transfer Belt Unit from the rails. Remove only the screws seated against the metal frame as shown in the figure.

Figure 2 Remove the Transfer Belt Unit

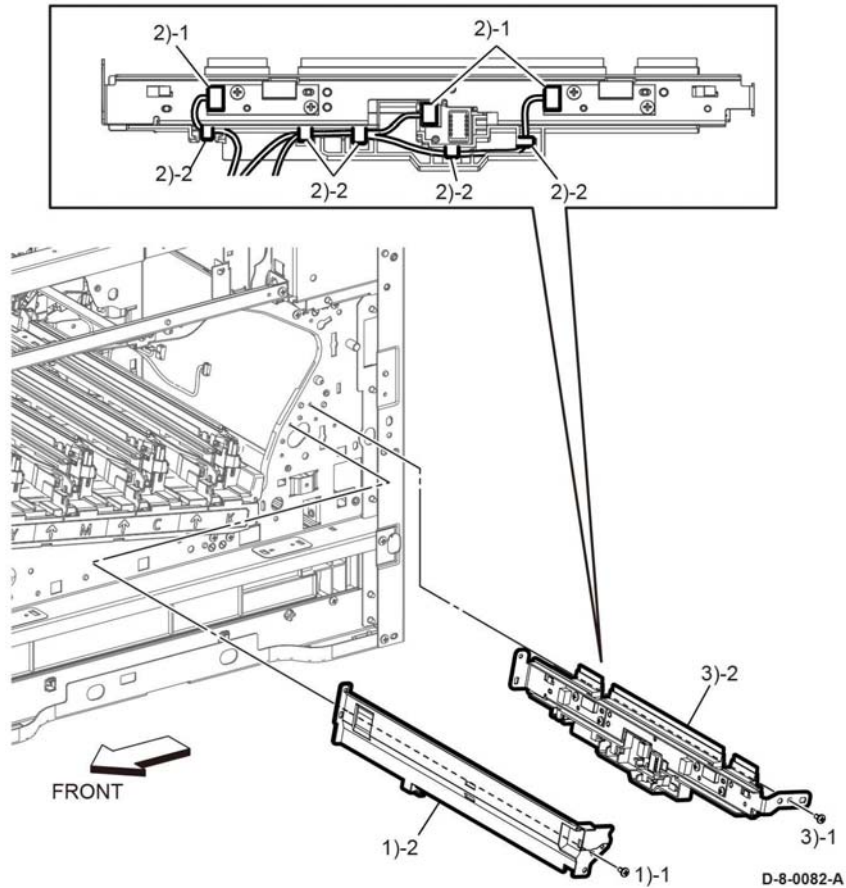
1. Remove the Registration Chute Feeder Assembly, REP 15.3.
2. Refer to Figure 1 to remove the one screw (silver, M3x6mm) attaching the Sensor Cover and remove the cover.

4. Refer to Figure 2 to remove the one screw (silver, M3x6mm) attaching the CTD Sensor Assembly, and remove the sensor.

Figure 1 Remove the CTD Sensor Assembly

3. Refer to Figure 2 to unplug the three sensor connectors (P/J142, P/J143, P/J145) and release the cable.

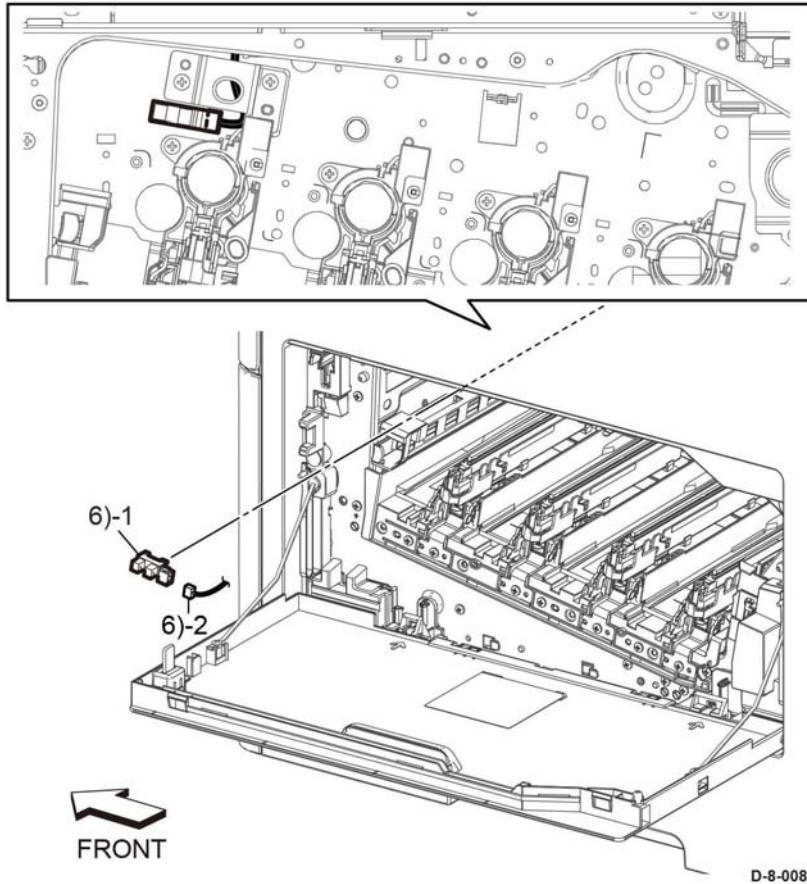
1. Remove the Transfer Belt Unit, [REP 6.1](#).
2. Remove the Drum Cartridge, [PL 8.1 Item 1](#).
3. Refer to [Figure 1](#) to remove the Photo Sensor.
4. Unplug the connector ([P/J466](#)) from the Photo Sensor.

Figure 1 Remove the Photo Sensor

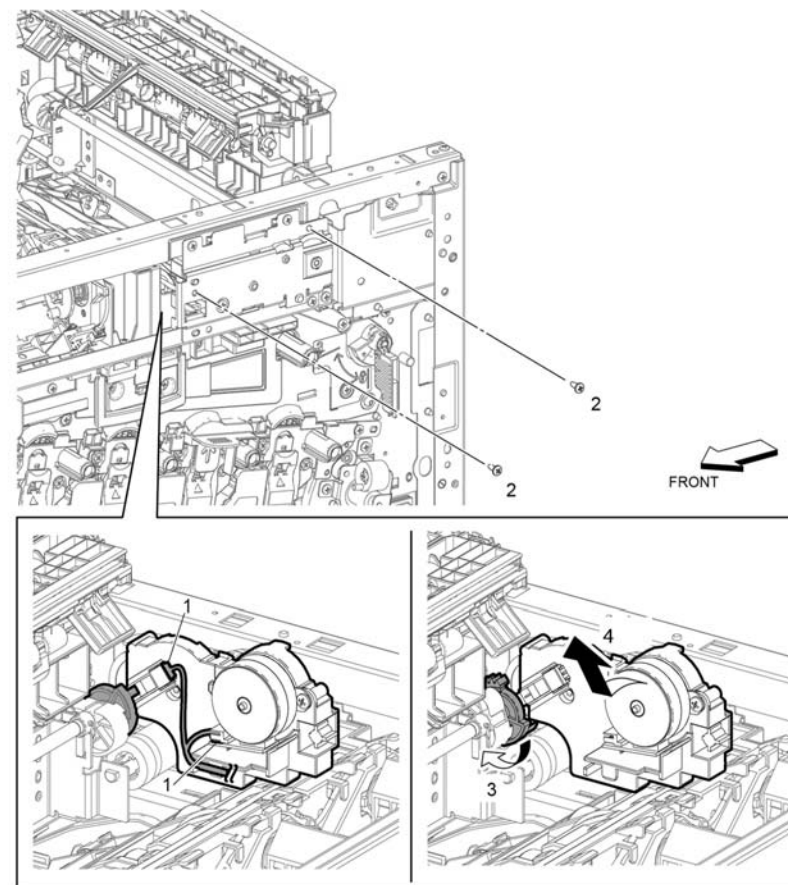
- a. Disengage two connectors (1), ([P/J171](#), [P/J172](#)).
 - b. Remove two screws (2).
 - c. Rotate the retract shaft (3), [PL 7.1 Item 6](#), to release the projection of the cam from the envelope mode sensor, [PL 7.1 Item 5](#), then remove the nip retract drive assembly (4).

Figure 1 Nip retract drive assembly removal

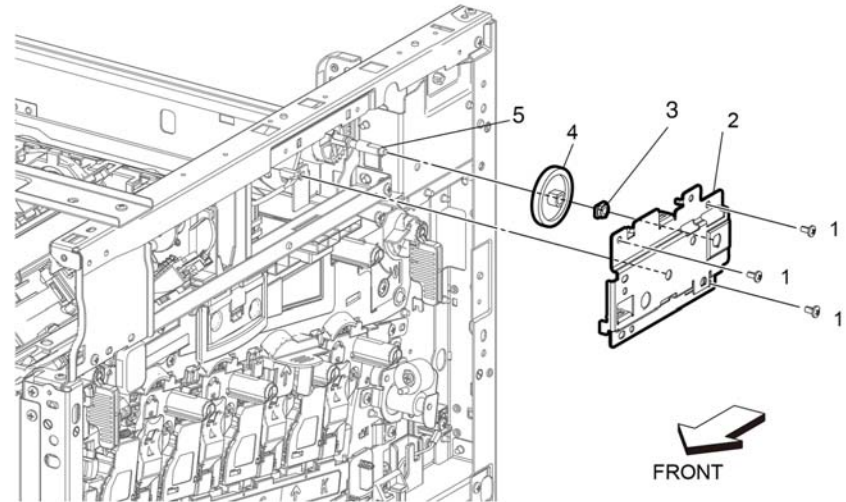
23. Remove the nip retract shaft assembly, [Figure 1](#):
 - a. Remove three screws (1), the nip retract bracket (2) and bearing (3).
 - b. Pull out the retraction shaft gear (4) from the retract shaft (5).

Figure 1 Nip retract shaft assembly removal

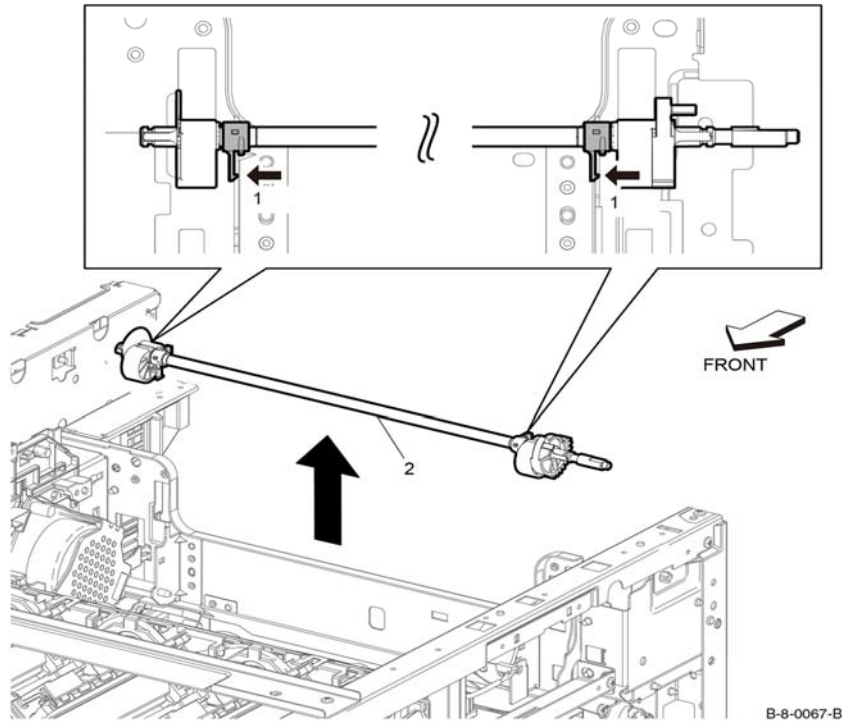
24. Release the levers (1) to remove the shaft (2), [Figure 2](#).

Figure 2 Nip retract shaft removal

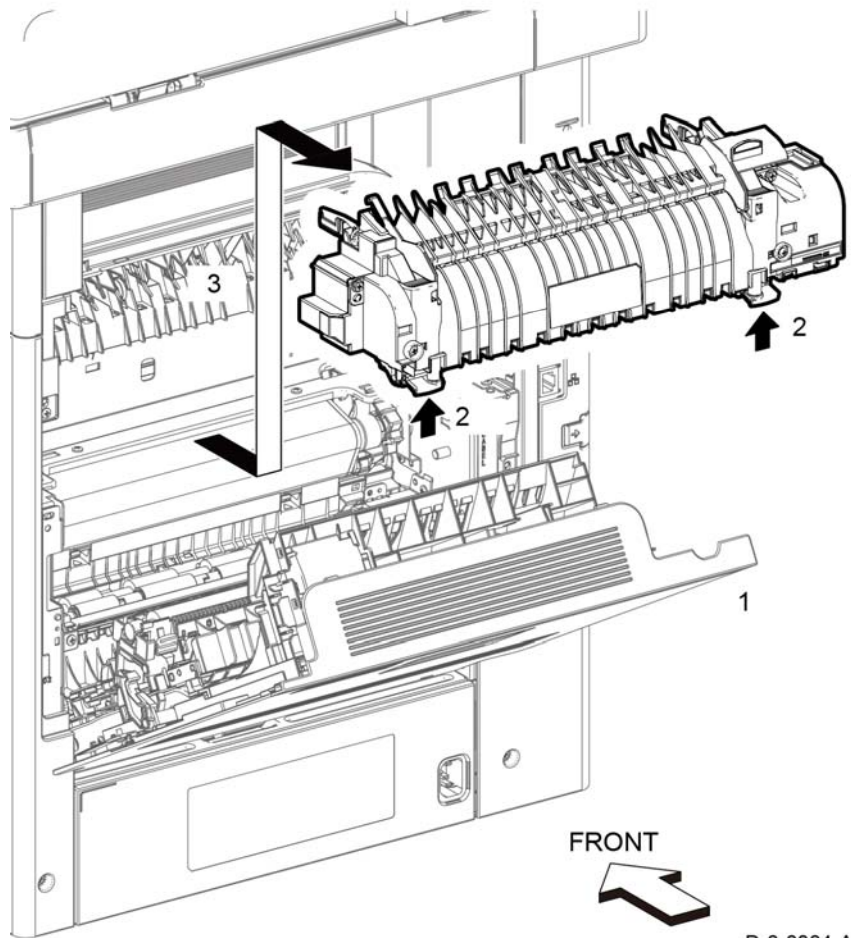
1. Open the rear door (1).
2. Release the two latches (2), then remove the fuser (3), [Figure 1](#).

Figure 1 Fuser removal

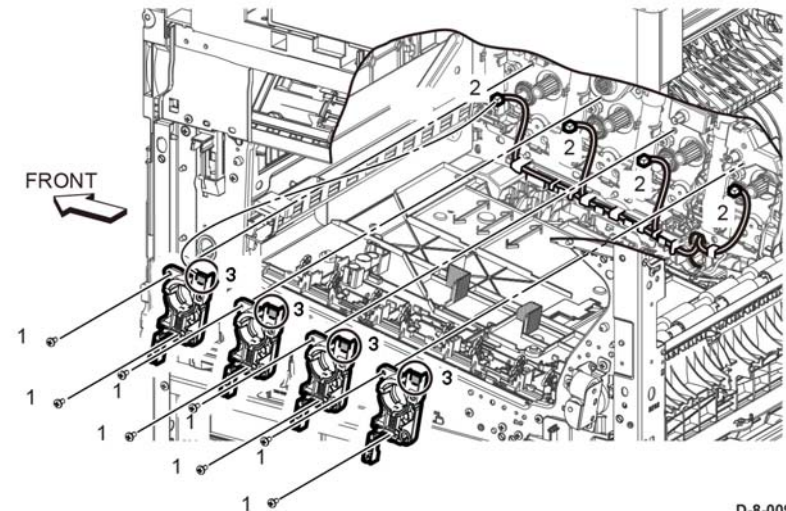
1. Remove the XERO DEVE CRU assembly and Y/M/C/K guide cover assembly, [REP 8.3](#).
2. Remove the IBT unit, [REP 6.1](#).
3. Remove the LPH color head assembly, [REP 2.1](#).
4. Remove the LPH CRUM FFC, [REP 2.3](#).
5. Remove the erase lamp assembly, [Figure 1](#):
 - a. Remove two screws (1) of each XERO holder assembly (2).
 - b. Disconnect the connectors (P/J201, P/J202, P/J203, P/J204).
 - c. Remove the XERO holder assembly (2) while releasing the erase-CF harness assembly (3) from the XERO holder assembly (2).

Figure 1 Erase lamp assembly removal

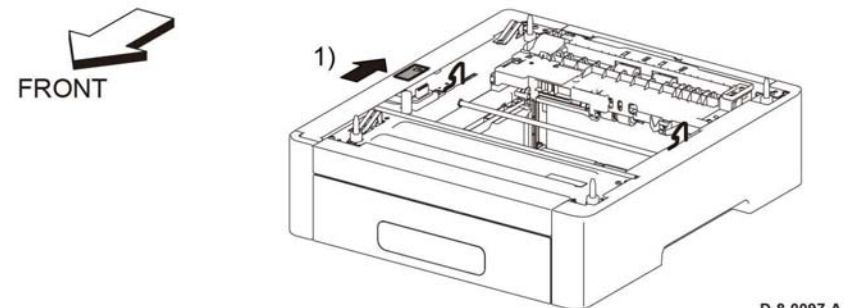
DANGER: Conformez-vous aux procédures de manipulation de sécurité pour le retrait du module. Reportez-vous à. Le module est lourd.

AVISO: No trabaje en un espacio reducido. Se necesita 1 metro de espacio para trabajar con seguridad.

Use safe handling procedures when removing the module. Refer to **GP 16**. The module is heavy.

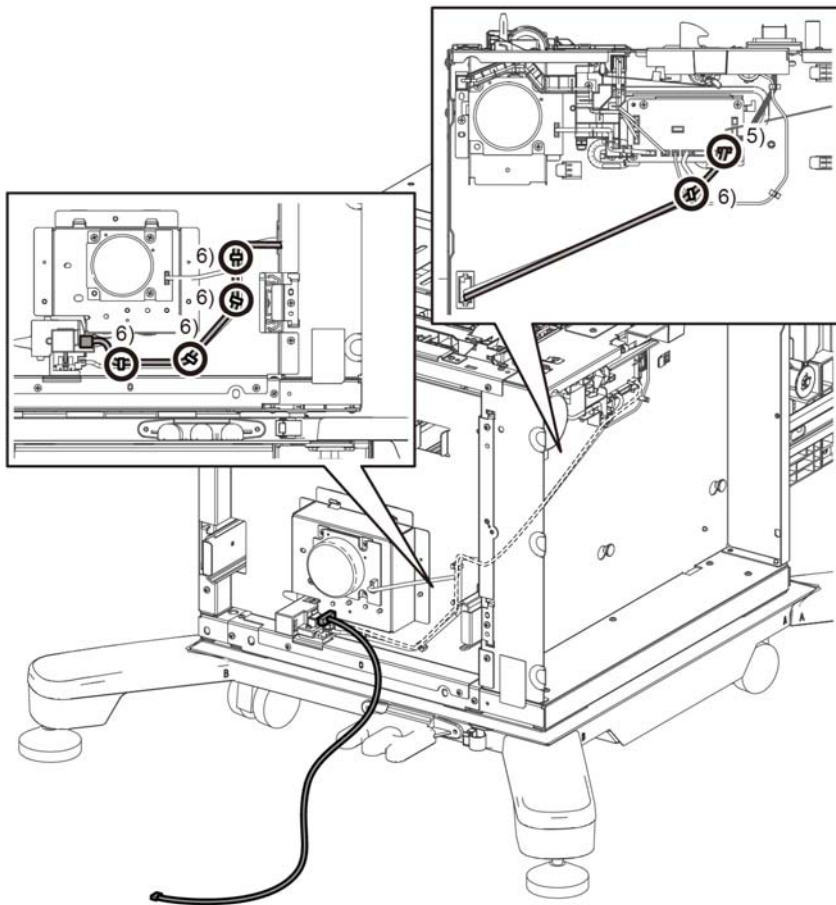
Ensure that the electricity to the machine is switched off while performing tasks that do not need electricity. Refer to **GP 4**. Disconnect the power cord. Electricity can cause death or injury. Moving parts can cause injury.

WARNING

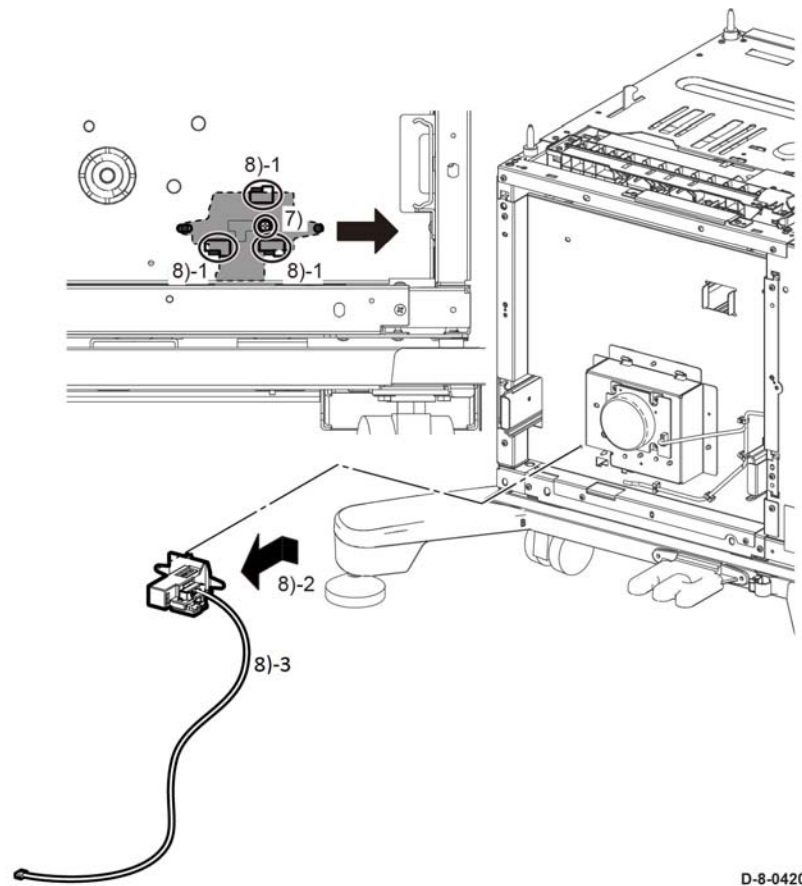
Figure 2 Rear interlock switch removal

7. Remove one screw, ST20, [Figure 2](#).
8. Perform the steps that follow, [Figure 2](#):
 - 8-1. Move the rear interlock switch in the direction shown to release three hooks.
 - 8-2. Remove the rear interlock switch.
 - 8-3. Disconnect the harness from the rear interlock switch.

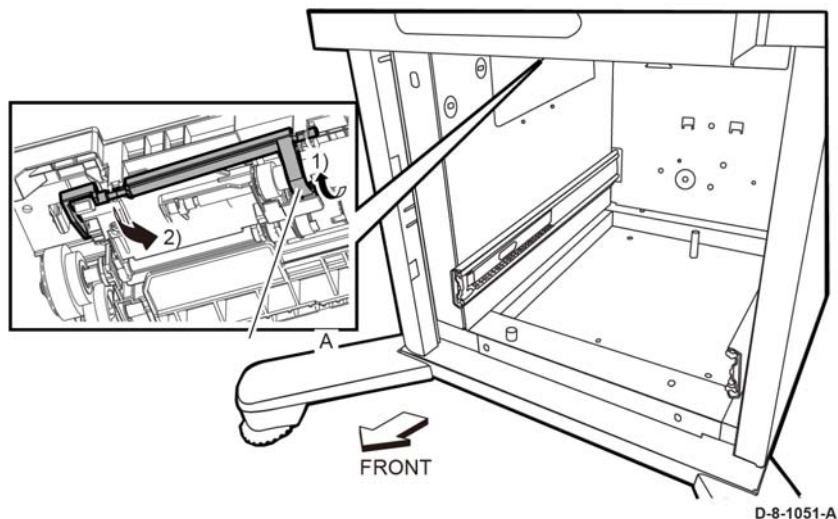
Figure 1 Releasing the feeder drawer

1. Pull the HCF feeder drawer out until it stops.
2. Push in the spring-loaded hatch one on each side, to remove the HCF feeder drawer, [Figure 1](#).

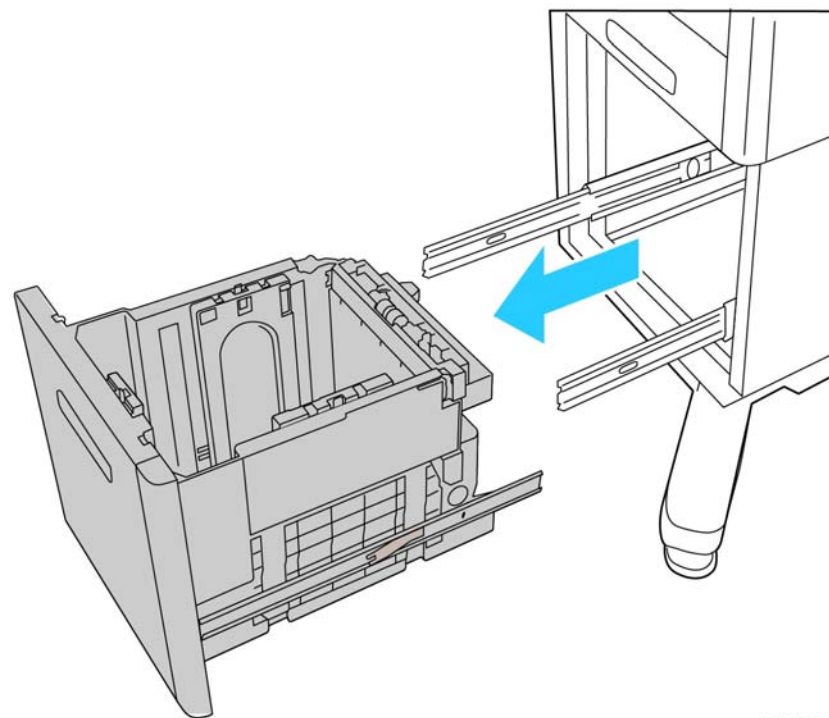
Figure 2 Installing the HCF feeder drawer

1. Push both slide rails all the way into the cabinet, [Figure 2](#).
2. Align the side rails, on the rear of the HCF feeder drawer, with the slide rails in the cabinet.
3. Push the HCF feeder drawer into place.

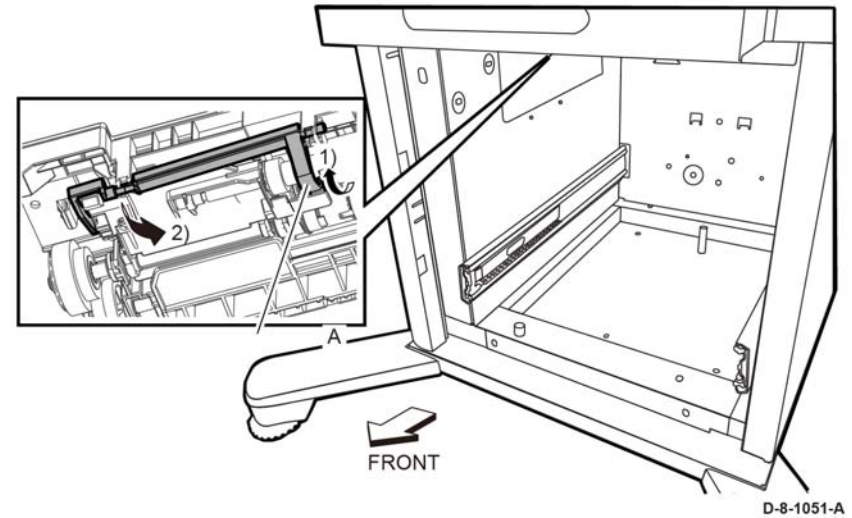
Figure 2 Removing the no paper actuator

3. Pull and lift the HCF feeder drawer off the side-rails to remove the HCF feeder drawer.
4. Release tab A of the no paper sensor in the direction of the arrow, then fully rotate the actuator, [Figure 2](#).

5. While fully rotated out of its home position, remove the no paper actuator by pulling the actuator out of the post.

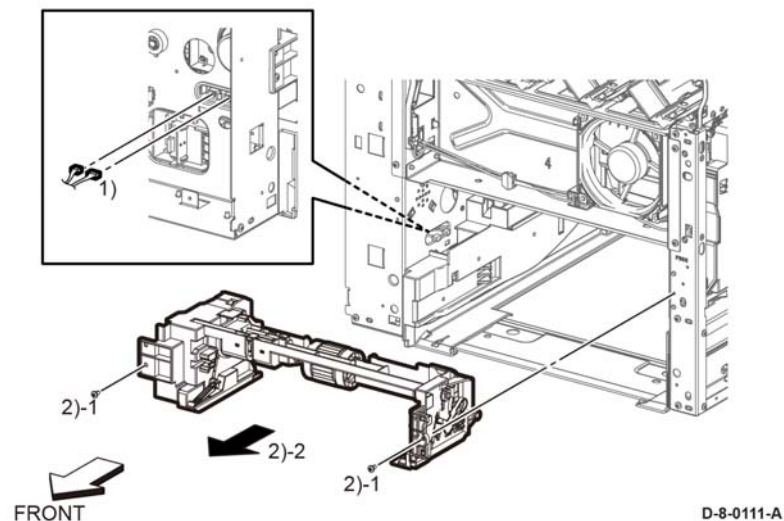
Figure 1 Frame assembly removal

1. Disconnect two connectors, P/J482, P/J483.
2. Remove the items that follow:
 - 2-1 Two screws, SM 18.
 - 2-2 Bypass tray frame assembly.

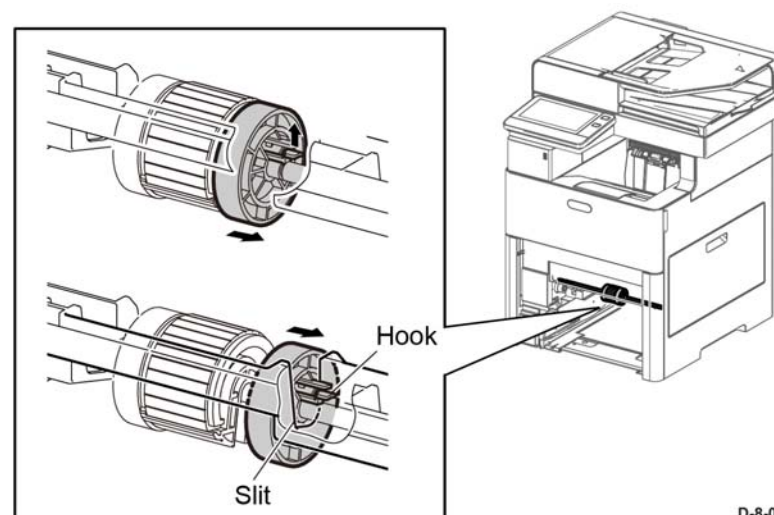
Figure 1 Release the bypass tray feed roller hook

1. Remove the bypass tray assembly, [REP 13.5](#).
2. Release the hook on the bypass core roll, [Figure 1](#).

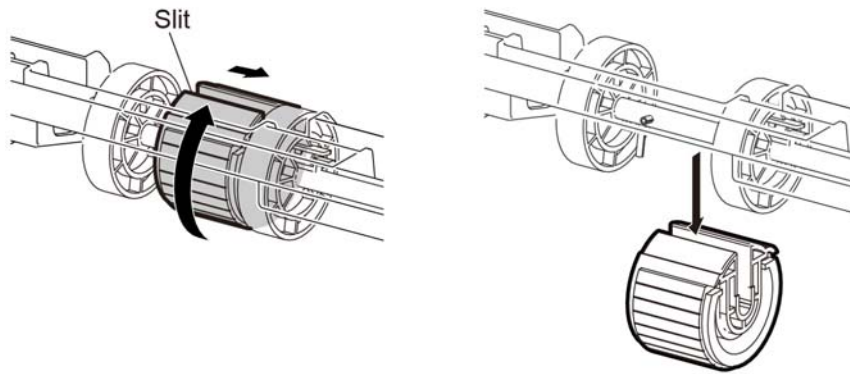
Figure 2 Remove the bypass tray feed roller

3. Rotate the bypass core roll and move it in the direction of the arrow until the core roll slides completely against the bypass frame housing, [Figure 2](#).
4. Slide and rotate the feed roller in the direction of the arrows until it releases from the shaft, [Figure 2](#).
5. Remove the bypass tray feed roller, [Figure 2](#).

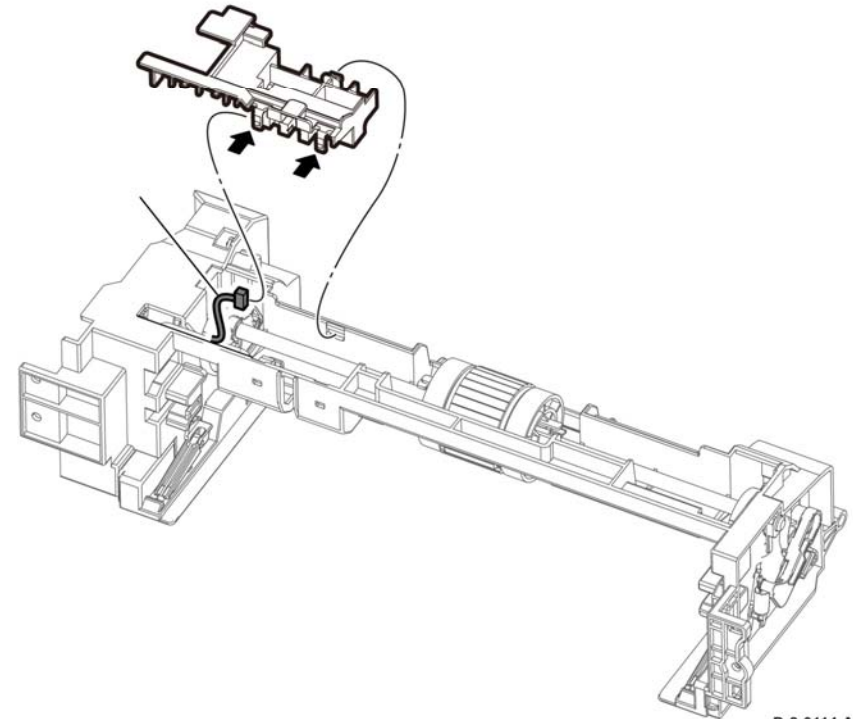
Figure 1 Remove the Bypass Tray No Paper Bracket

1. Remove the bypass tray frame assembly, [REP 13.1](#).
2. Release the two hooks and the boss, and lift up the bypass no paper bracket (with the no paper sensor) from the bypass tray frame assembly, [Figure 1](#).
3. Unplug the connector and release the harness, [Figure 1](#).

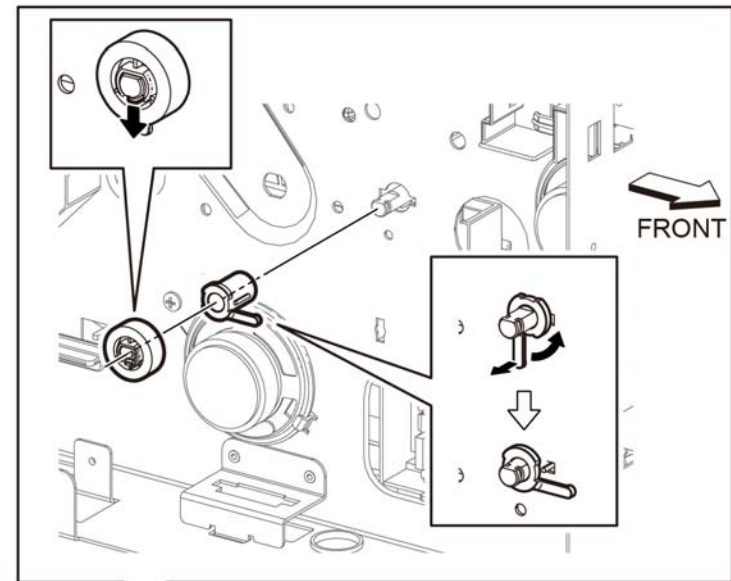
Figure 1 Remove the turn gear and left TA bearing

In the following step, avoid breaking the bearing tab by lifting the tab gently during bearing removal.

3. Unlock the left TA bearing by lifting the tab, then rotate and remove it, [Figure 1](#).

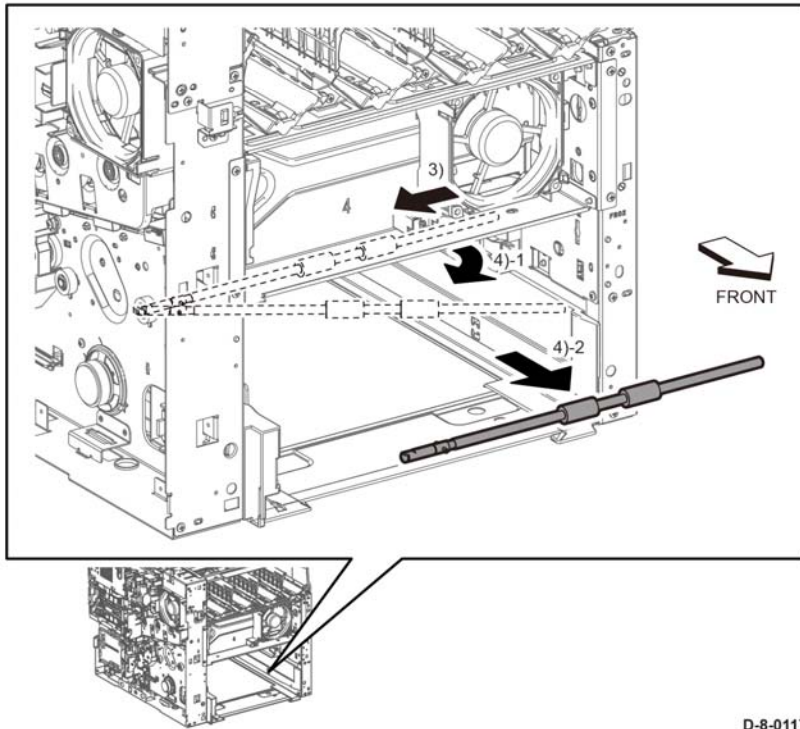
Figure 2 Remove the bypass tray TA1 roller assembly

4. Slide the TA1 roller assembly in the direction of the arrow, [Figure 2](#).
5. Remove the TA1 roller assembly in the direction of the arrow, [Figure 2](#).

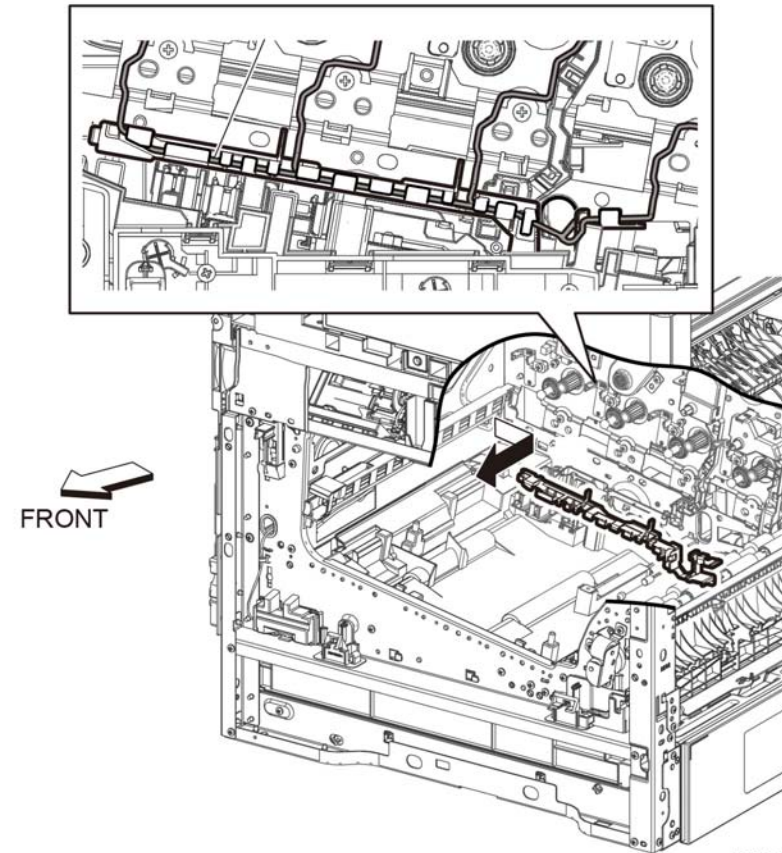
Figure 3 Remove the erase-CF harness

1. Remove the main drive assembly, [REP 3.8](#).
2. Release the erase-CF harness assembly from the harness guide and slide the harness in the direction of the arrow to remove the harness, [Figure 3](#).

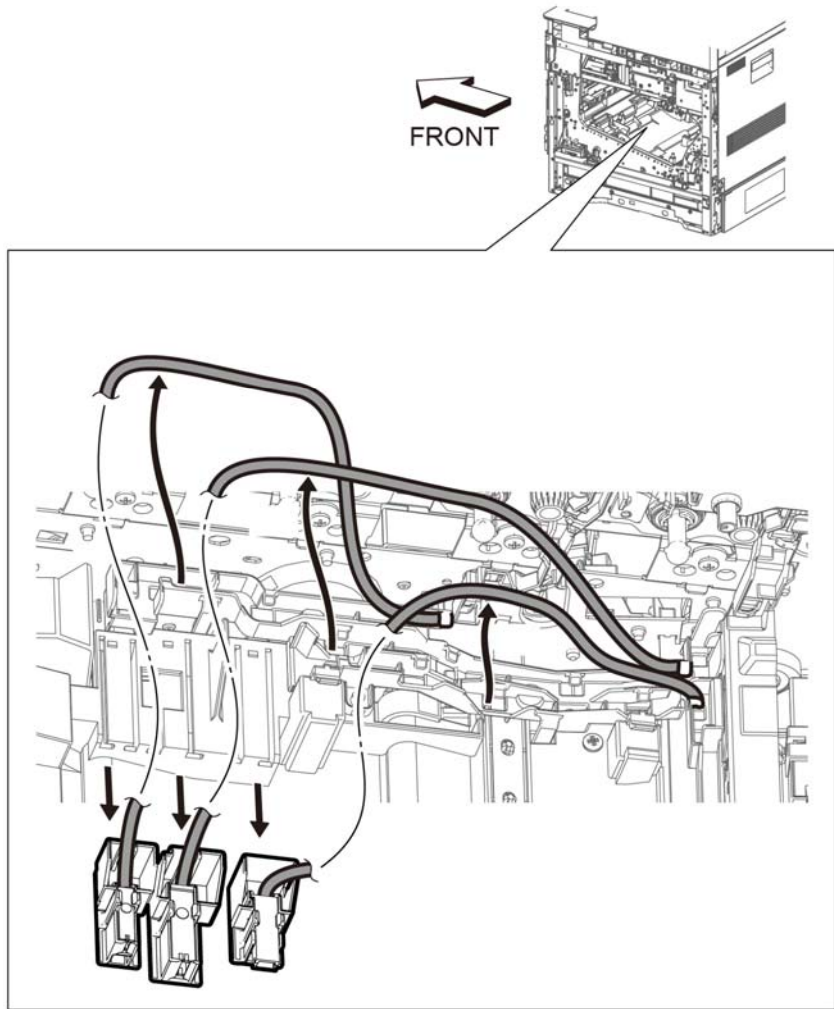
Figure 4 Release the harnesses

3. Release the three harnesses from the harness guide and remove the holder assembly, [Figure 4](#).

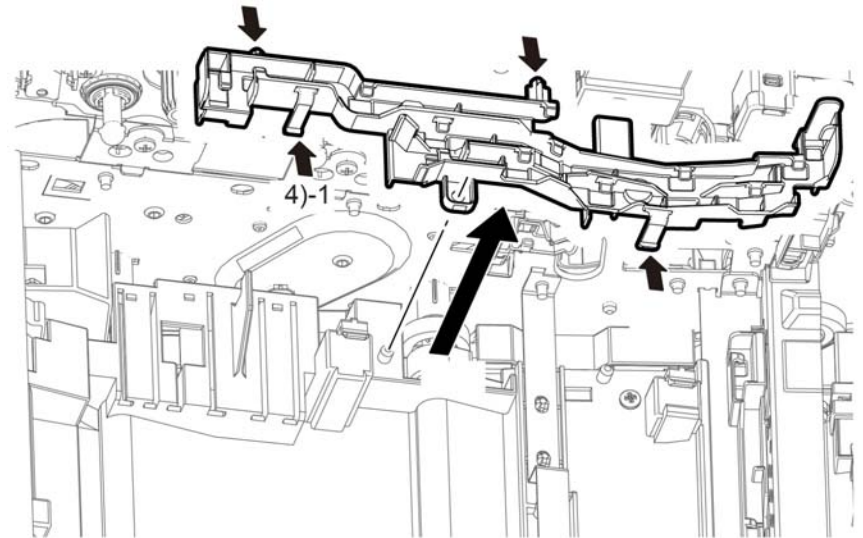
Figure 5 Remove the harness guide

4. Release the two hooks and the three bosses, then remove the harness guide, [Figure 5](#).

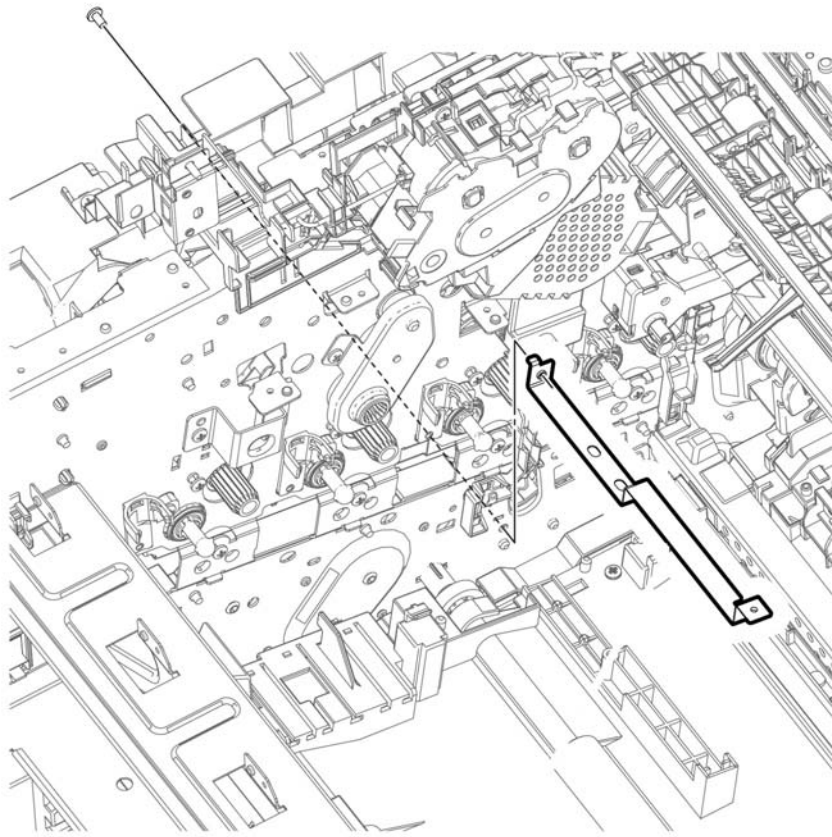
Figure 6 Remove the plate

5. Remove the one screw (SM18) attaching the plate and remove the plate, [Figure 6](#).

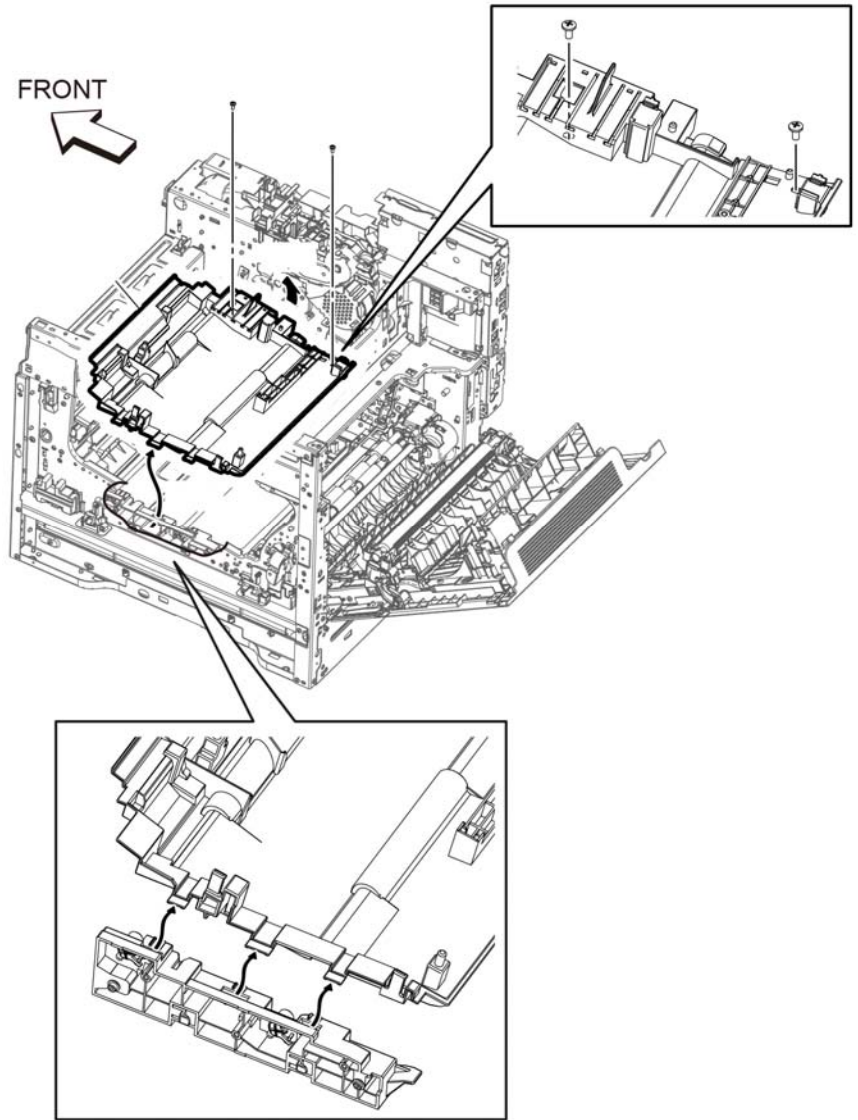
Figure 7 Remove the MSI upper chute

6. Remove the two screws (ST20) attaching the MSI upper chute and lift up the MSI upper chute, [Figure 7](#).

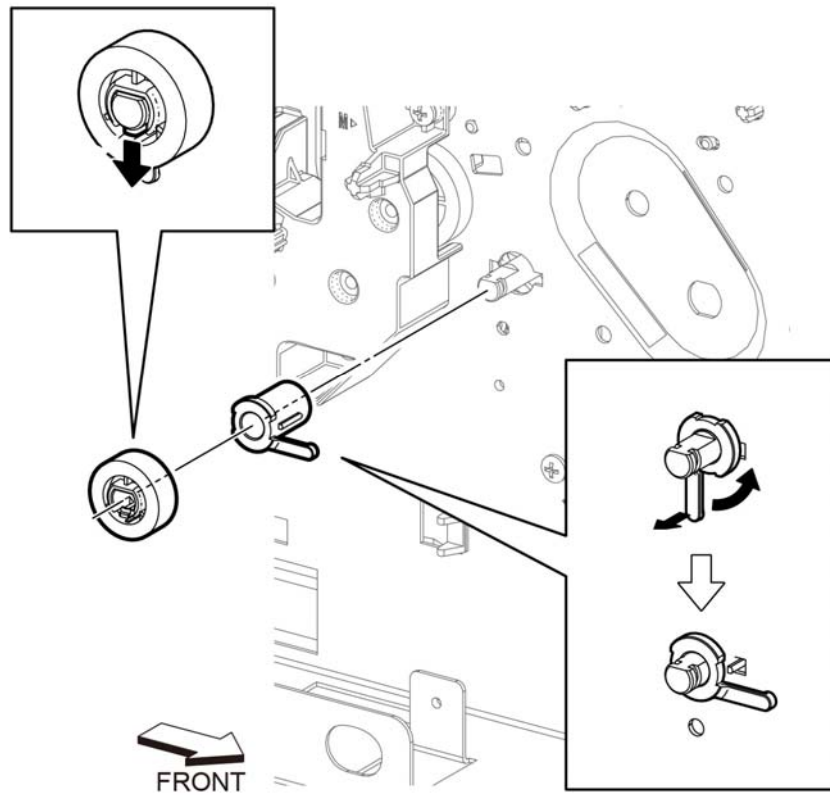
Figure 8 Remove the turn gear and left TA bearing

In the following step, avoid breaking the bearing tab by lifting the tab gently during bearing removal.

8. Unlock the left TA bearing by lifting the tab, then rotate and remove it, Figure 9.

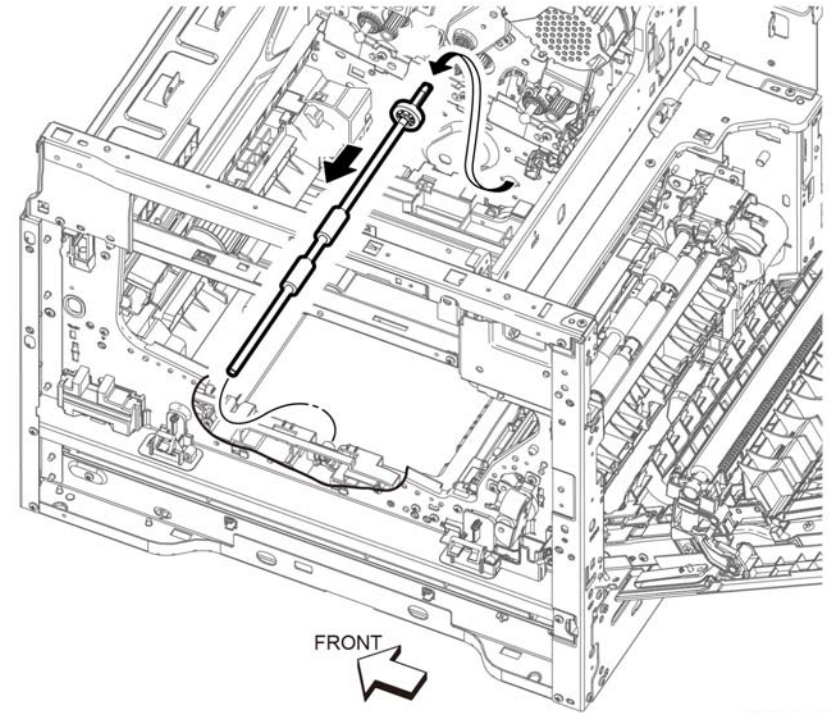
Figure 9 Remove the bypass tray TA2 roller assembly

9. Slide the bypass tray TA2 roller assembly, then remove the TA2 roller in the direction of the arrows, Figure 9.

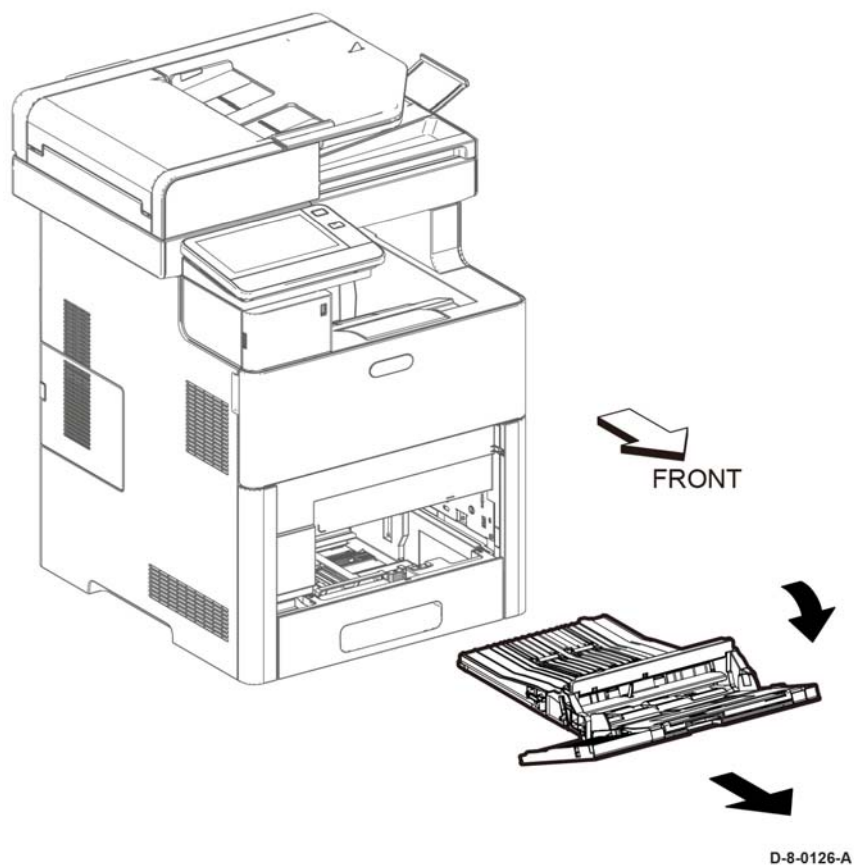
Figure 1 MSI main tray removal

1. Open the MSI bypass tray assembly, [Figure 1](#).
2. Remove the MSI bypass tray assembly, [Figure 1](#).

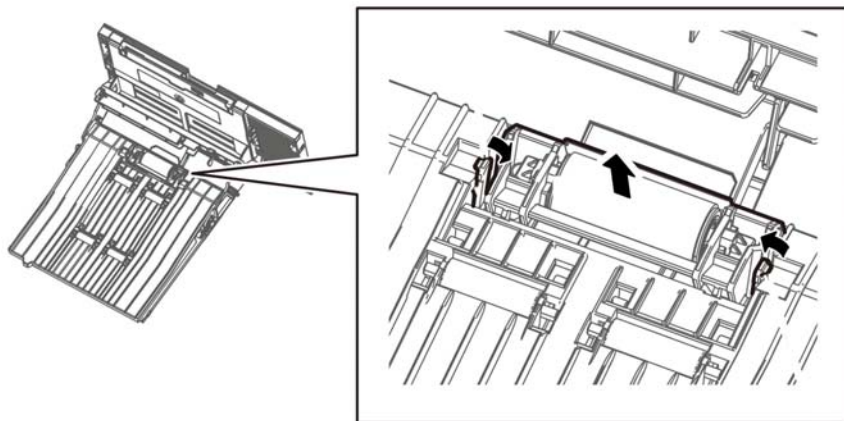
Figure 1 Remove the Bypass Tray Separator Holder Assembly

1. Remove the MSI main bypass tray assembly, [REP 13.5](#).
2. Release the hook of the bypass tray separator holder assembly and remove the bypass tray separator holder from the main bypass tray, [Figure 1](#).

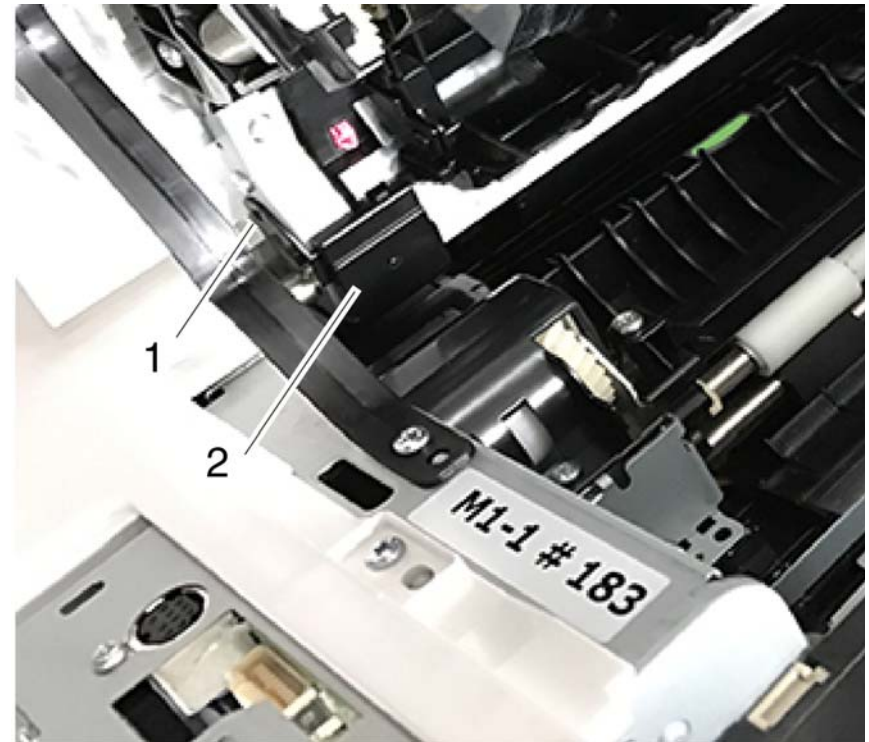
Figure 1 Duplex relay cover removal

1. Open the rear door.
2. Gently pry the arm of the duplex relay cover over the pin (1) to release.
3. Remove the duplex relay cover (2).

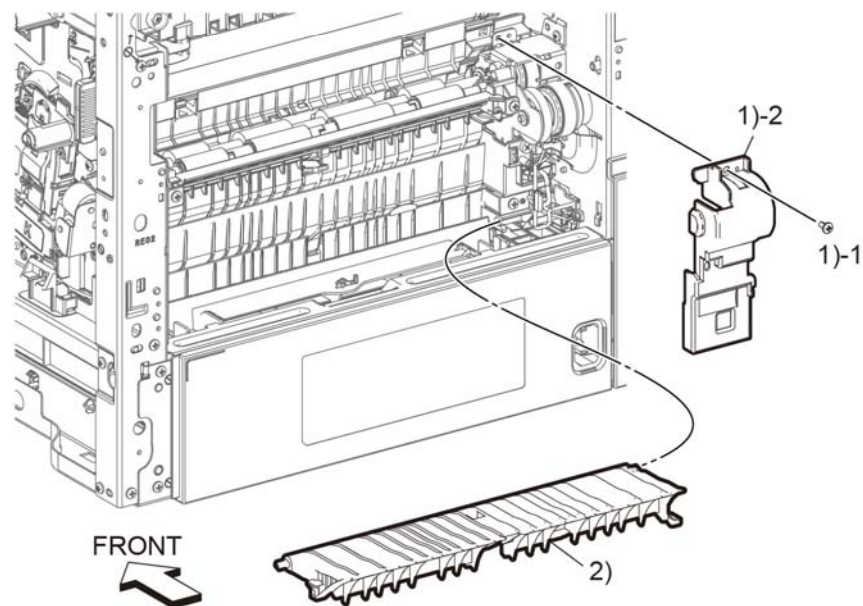
Figure 1 Remove the Lower Duplex Chute

1. Remove the rear cover assembly; [REP 19.12](#).
2. Refer to [Figure 1](#) to remove the Lower Duplex Chute.

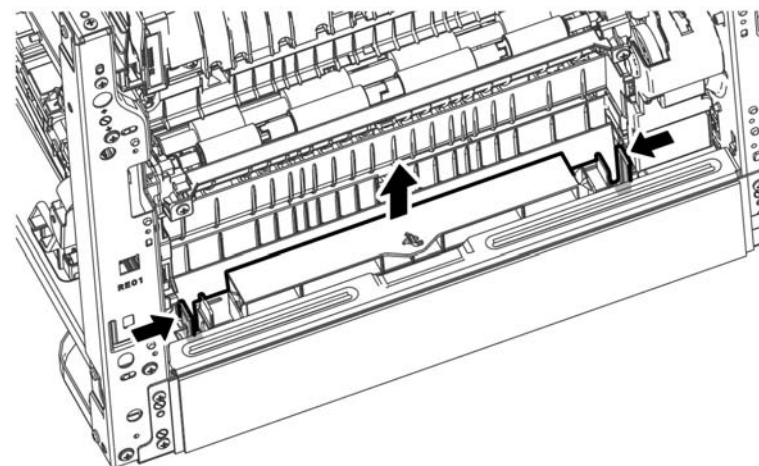
Figure 2 Remove the Option Registration Chute

3. Refer to [Figure 1](#) to release two hooks and remove the Option Registration Chute.

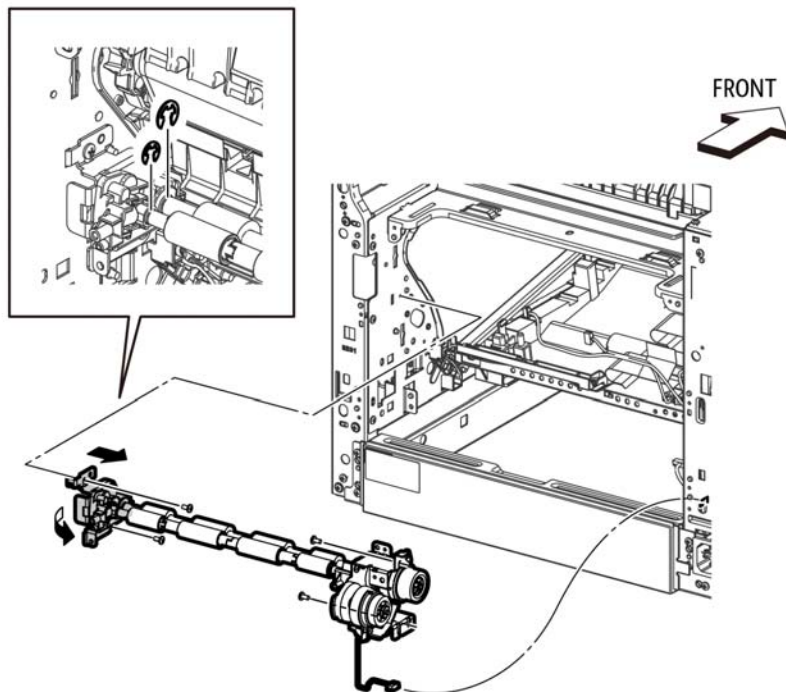
Figure 1 Remove the Duplex Registration Roller Assembly

1. Remove the Registration Chute Feeder Assembly, [REP 15.2](#).
2. Refer to [Figure 1](#) to unplug the connector [P/J541](#).

NOTE: When removing the Duplex Roller Registration Assembly, bearings and gears will move out of their seated positions. For easier replacement later, carefully observe the placement and orientation of bearings and gears at both ends of the roller assembly before removing it.

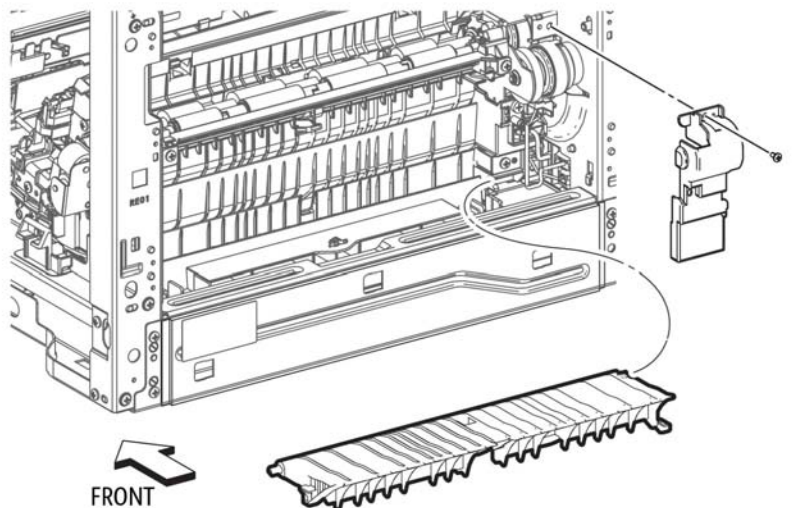
Figure 1 Remove the Rear Duplex Cover and Lower Duplex Chute

1. Remove the rear cover assembly; [REP 19.18](#).
2. Refer to [Figure 1](#) to remove the one screw (silver, M3x6mm) attaching the Rear Duplex Cover and remove the cover.

3. Refer to [Figure 1](#) to rotate the Lower Duplex Chute 90 degrees toward the rear, and remove the Lower Duplex Chute.
4. Remove the 550Option Registration Chute, [REP 15.1](#).
5. Refer to [Figure 2](#) to remove the two screws (silver, tapping, M3x8mm) attaching the Upper Duplex Chute and remove the chute.

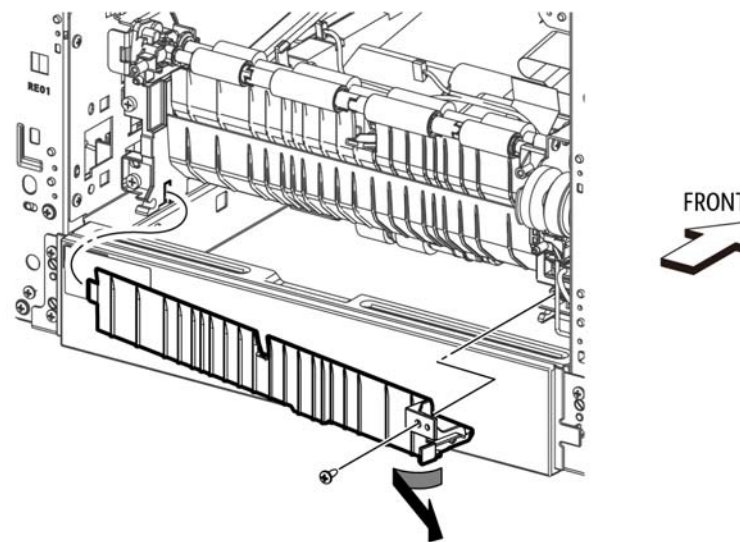
Figure 3 Remove the Feeder Chute

6. Remove the Second Bias Transfer Housing Kit; [REP 18.10](#).
7. Refer to [Figure 3](#) to remove the screw (silver, tapping, M3x8mm) attaching the Feeder Chute and pull out the chute in the direction of the arrow.

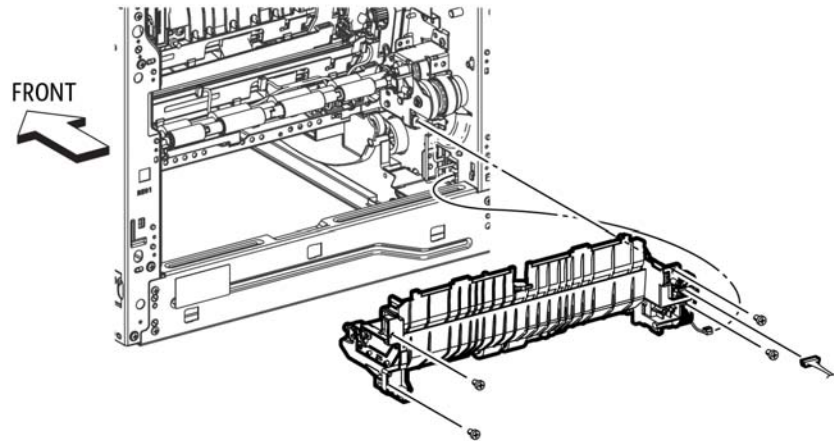
Figure 4 Remove the Registration Chute Feeder

8. Refer to [Figure 4](#) to unplug the two connectors (P/J544, P/J545).
