VersaLink[®] C500/C600 Printer and C505/C605 Multifunction Printer Service Manual

Xerox VersaLink C605F Family Printer Service Manual

705P01395

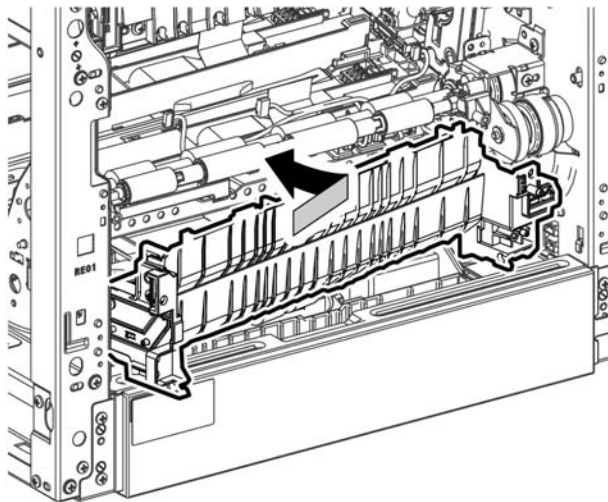
Figure 5 Observe Angle When Installing Feeder

9. Refer to [Figure 5](#) to remove the four screws (silver, M4x6mm) attaching the Registration Chute Feeder Assembly and remove the feeder.

When installing the Registration Chute Feeder, install it at the angle shown in [Figure 4](#).

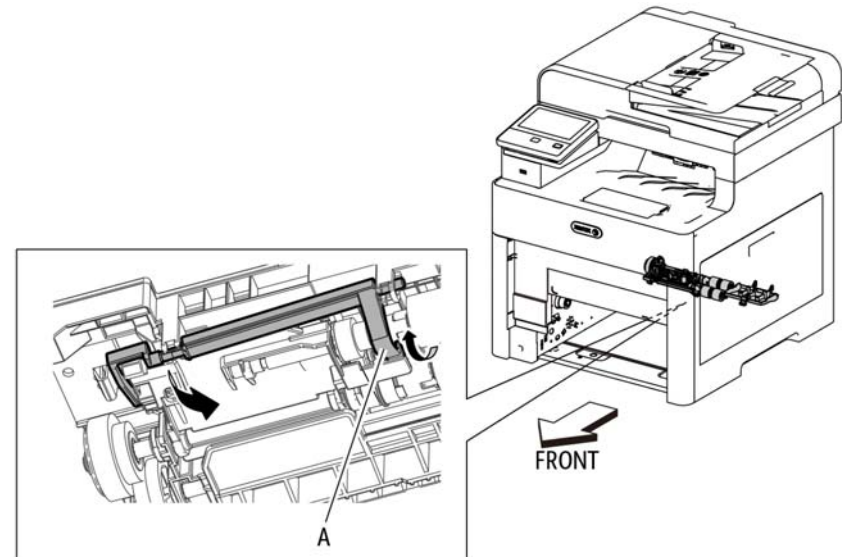
Figure 1 Remove the No Paper Actuator

1. Remove the 550 Cassette Assembly; [REP 9.1](#).
2. Remove the Main Bypass Tray Assembly; [REP 13.5](#).
3. Refer to [Figure 1](#) to release the No Paper Actuator in the direction of the arrow and fully rotate the actuator.

4. While fully rotated out of its home position, remove the No Paper Actuator by pulling the actuator out of the retaining post.

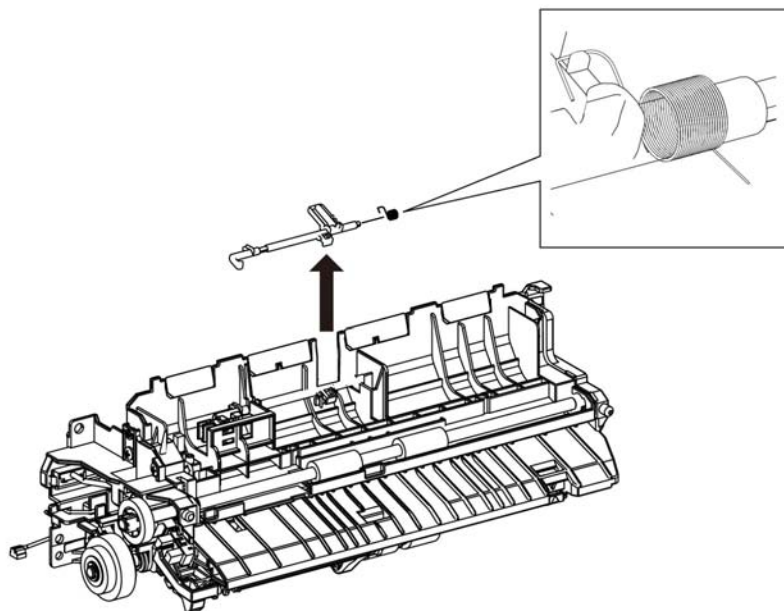
Figure 1 Remove the Registration Actuator

In the following step, avoid losing the spring from the end of the Registration Actuator when removing the actuator.

2. Refer to [Figure 1](#), use a flat-blade tool to release the left end of the Registration Actuator, then release the right end and remove the Registration Actuator from the Registration Chute Feeder Assembly.

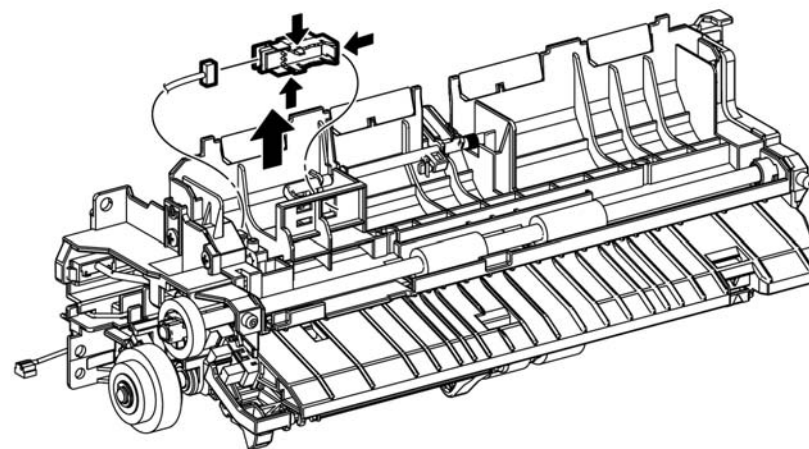
Figure 1 Remove the Registration Photo Sensor

1. Remove the Registration Chute Feeder Assembly; [REP 15.3](#).
2. Refer to [Figure 1](#) to release the double hooks, then remove the Registration Photo Sensor from the Registration Chute Feeder Assembly.

3. Refer to [Figure 1](#) to unplug the Photo Sensor Harness connector (P/J272) from the Registration Photo Sensor.

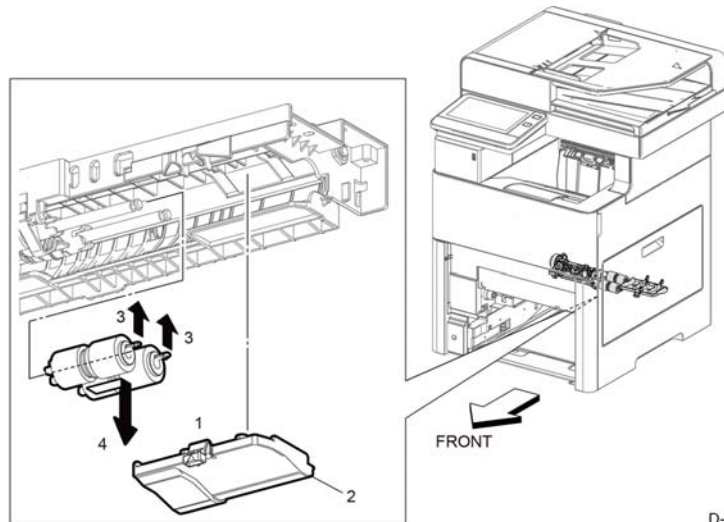
Figure 1 Feed roll removal

1. Remove the paper tray.
2. Remove the bypass tray.
3. Release the tab (1) on the upper feed chute (2), then remove the upper feed chute.
4. Release two hooks (3), then remove the feed rolls (4).

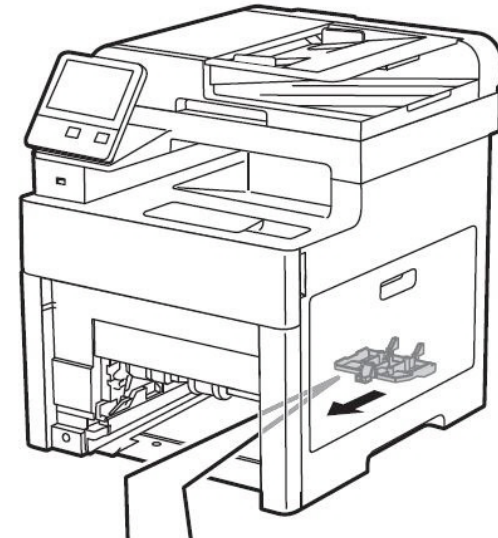
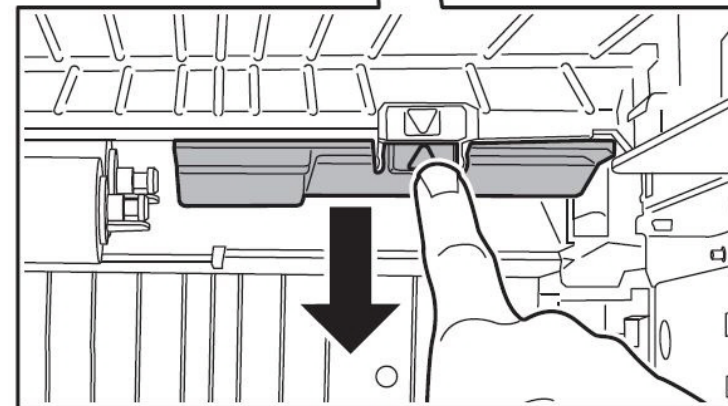
Figure 1 Remove the Upper Feed Chute

1. Remove the 550 Cassette Assembly; [REP 9.1](#).
2. Remove the Main Bypass Tray Assembly; [REP 13.5](#).
3. Refer to [Figure 1](#) to remove the Upper Feed Chute.

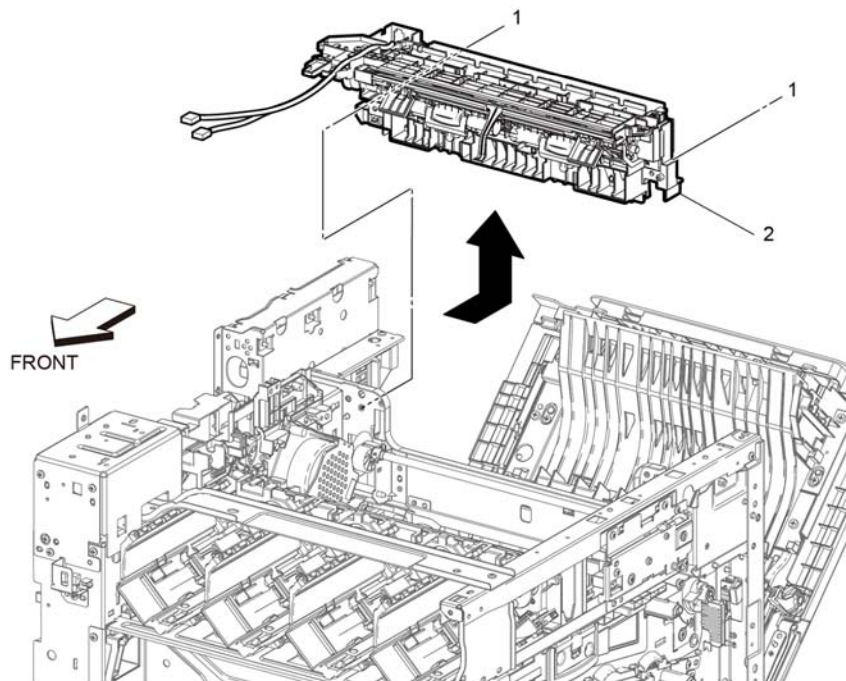
Figure 1 Remove the Exit Chute Assembly

1. Remove the main H exit drive assembly, [REP 17.3](#).
2. Remove the two screws (1), then remove the exit chute assembly (2), [Figure 1](#).

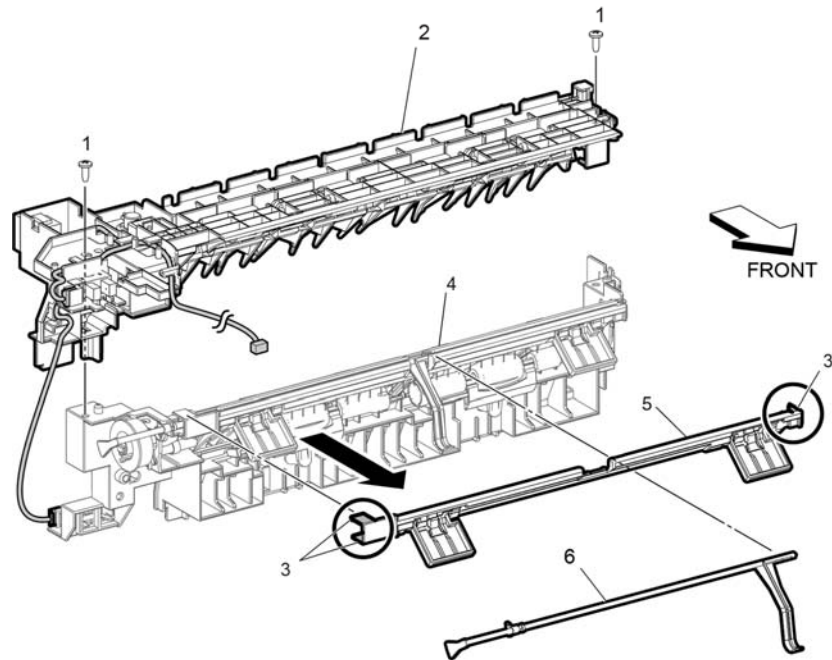
Figure 1 Full stack actuator removal

1. Remove the full stack sensor, [REP 17.3](#).
2. Remove the full stack actuator, [Figure 1](#):
 - a. Remove two screws (1), then release the upper side of the exit chute assembly (2).
 - b. Release three hooks (3), remove the lower exit top cover (4) with the exit chute flappers (5), then remove the full stack actuator (6).

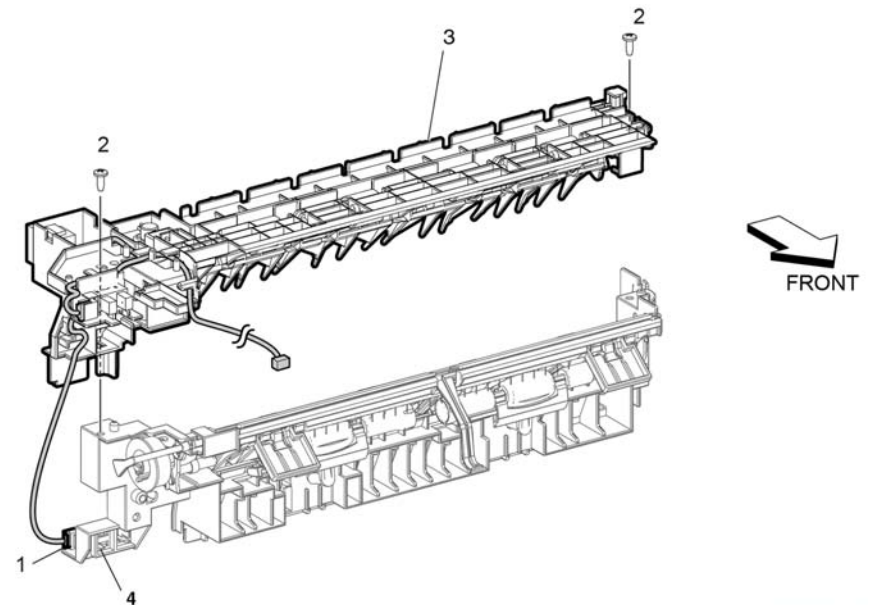
Figure 1 Full stack actuator removal

1. Remove the exit chute assembly, [REP 17.1](#).
2. Remove the exit sensor, [Figure 1](#):
 - a. Disconnect P/J469 (1).
 - b. Remove two screws (2), then release the upper side on the exit chute assembly (3).
 - c. Remove the exit sensor (4).

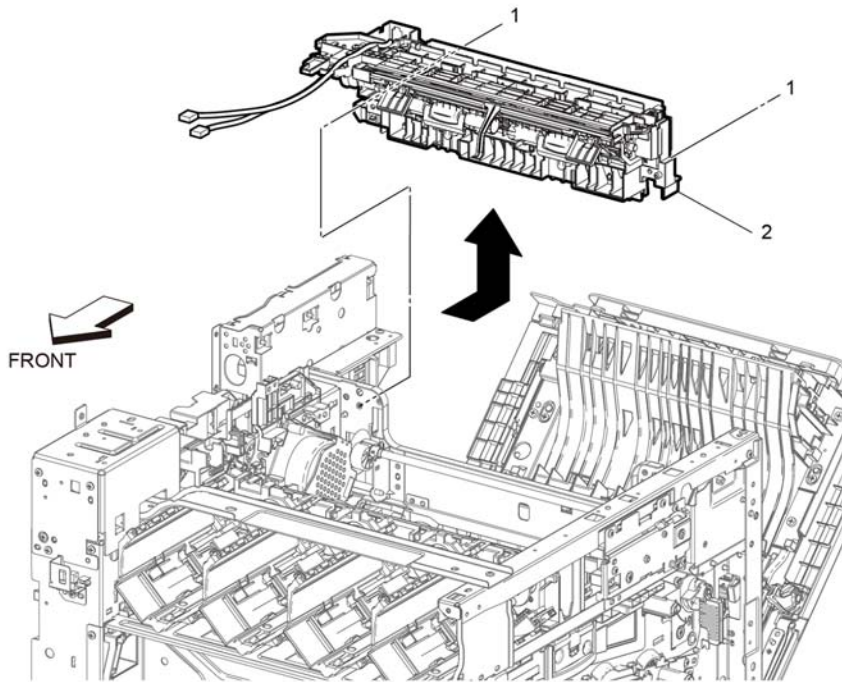
Figure 1 Remove the exit chute assembly

1. Remove the fuser, [REP 7.3](#).
2. Remove the main M exit drive assembly, [REP 17.7](#).
3. Remove two screws (1), then remove the exit chute assembly (2), [Figure 1](#).

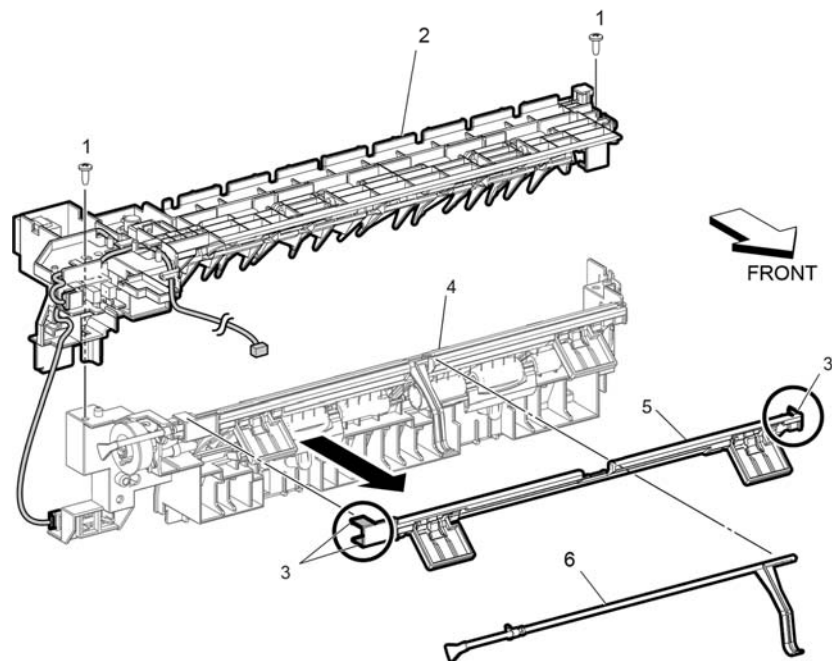
Figure 1 Full stack actuator removal

1. Remove the full stack sensor, [REP 17.8](#).
2. Remove the full stack actuator, [Figure 1](#):
 - a. Remove two screws (1), then release the upper side of the exit chute assembly (2).
 - b. Release three hooks (3), remove the lower exit top cover (4) with the exit chute flappers (5), then remove the full stack actuator (6).

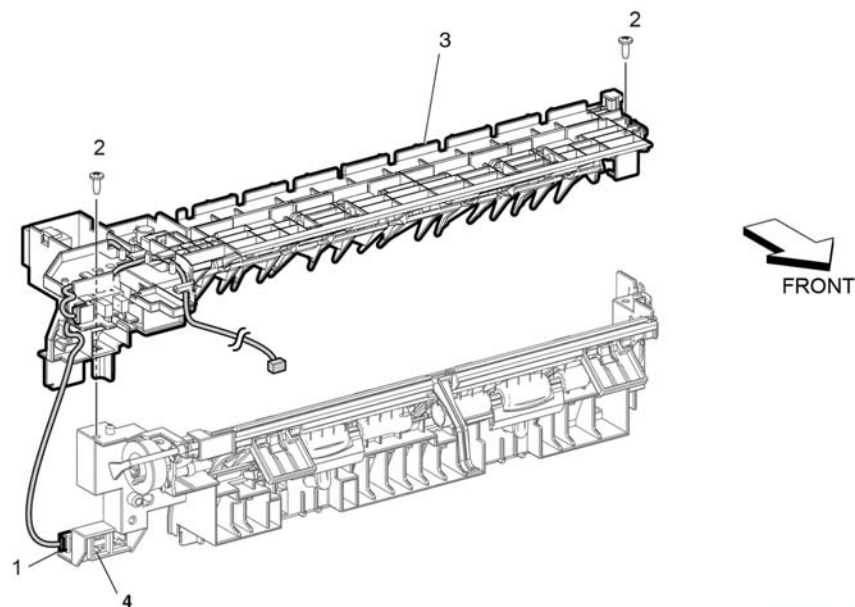
Figure 1 Full stack actuator removal

1. Remove the exit chute assembly, [REP 17.6](#).
2. Remove the exit sensor, [Figure 1](#):
 - a. Disconnect P/J469 (1).
 - b. Remove two screws (2), then release the upper side on the exit chute assembly (3).
 - c. Remove the exit sensor (4).

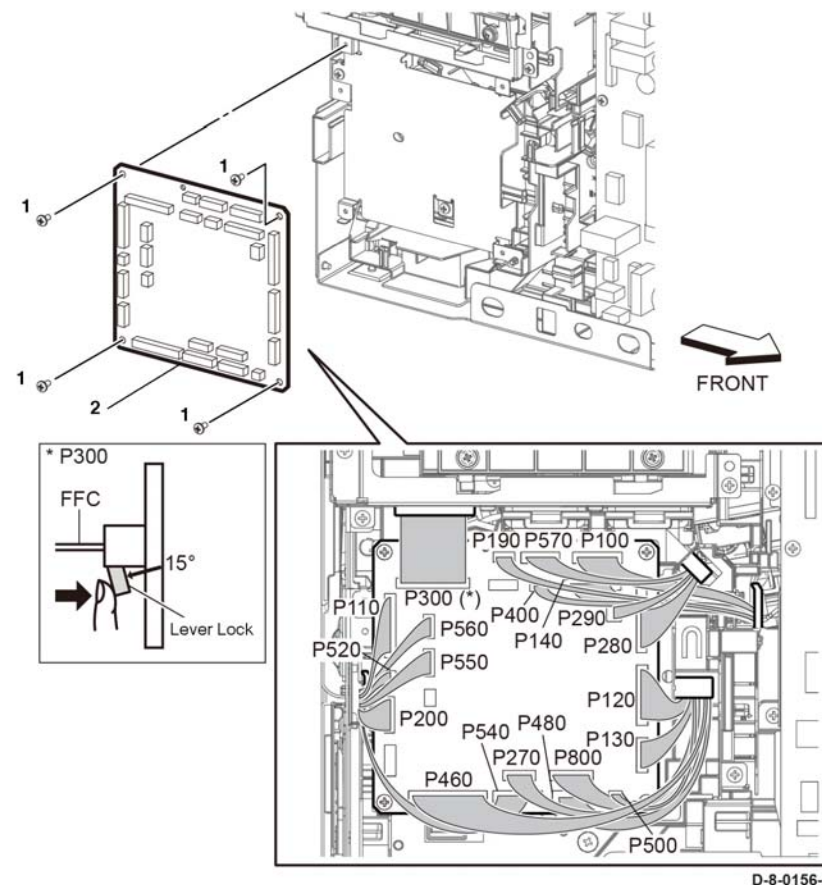
Figure 1 Remove the MCU PWB

1. Remove the MCU PWB, [Figure 1](#):
 - a. Remove the left side cover, [REP 19.14](#) or [REP 19.36](#).
 - b. Disconnect connectors (P/J100, P/J110, P/J120, P/J130, P/J140, P/J190, P/J200, P/J270, P/J280, P/J290, P/J400, P/J460, P/J480, P/J500, P/J520, P/J540, P/J550, P/J560, P/J570, P/J800) and the FFC (P/J300). Refer to, [GP 44](#) for proper FFC cable removal.
 - c. Remove four screws (1) securing MCU PWB (2), then remove the MCU PWB.

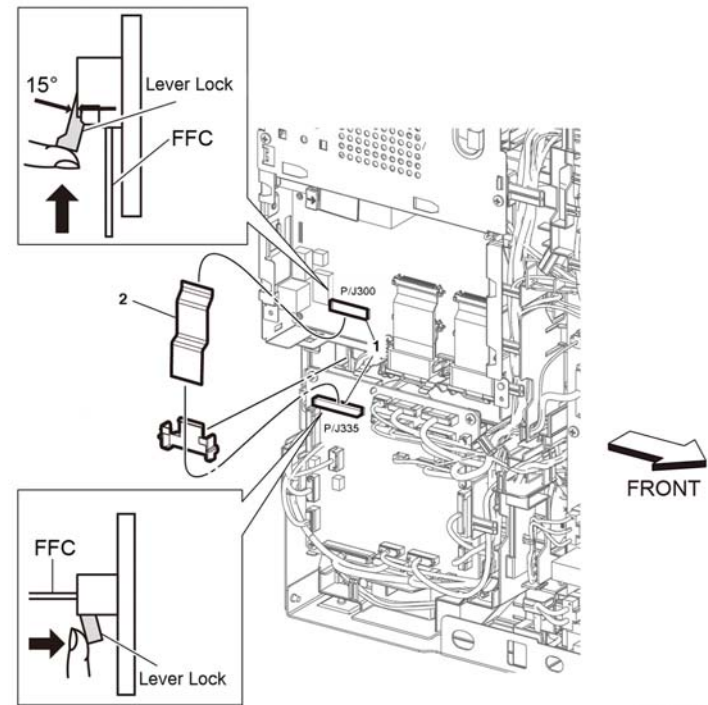
Figure 1 Remove the ESS MCU FFC.

1. Remove the MCU ESS FFC, [Figure 1](#):
 - a. Remove the left side cover, [REP 19.7](#) or [REP 19.36](#).
 - b. Remove the HDD assembly, [PL 18.1 Item 27](#) or [PL 18.5 Item 27](#).
 - c. Remove the ESS lower plate and HDD bracket, [REP 18.2.1](#).
 - d. Unlock connectors [P/J300](#) and [P/J335](#) (1), then remove the ESS MCU FFC (2), Refer to [GP 44](#).

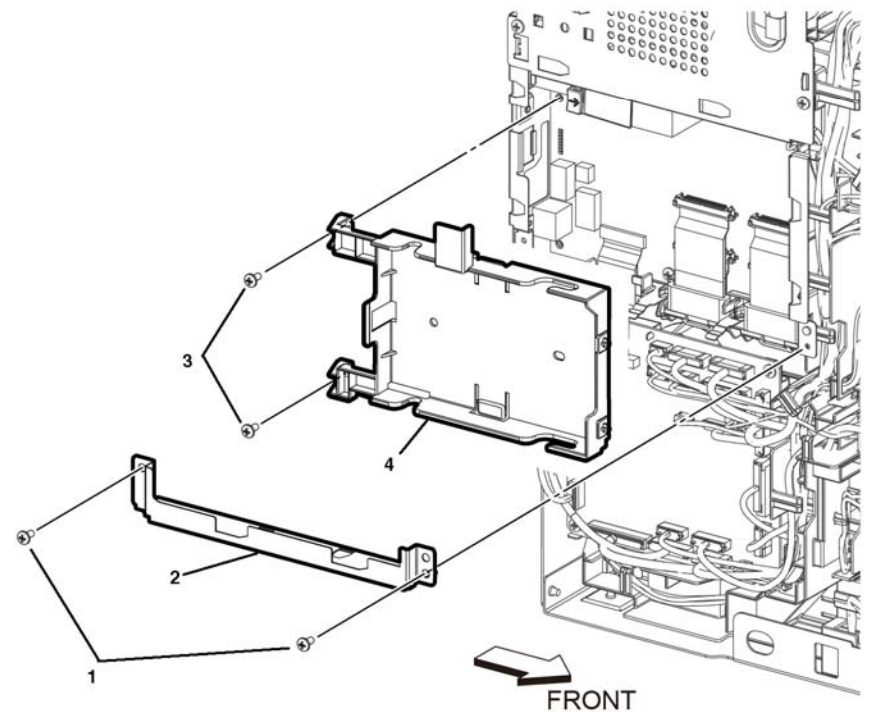
Figure 1 Remove the HDD bracket (C505/C605/C605_Tall)

1. Remove the left side cover, [REP 19.7](#) and [REP 19.36](#).
2. Remove the HDD assembly, [PL 18.1 Item 27](#) and [PL 18.5 Item 27](#).
3. Remove the ESS lower plate and HDD bracket, [Figure 1](#):
 - a. Remove two screws (1), then remove the ESS lower plate (2).
 - b. Remove two screws (3), then remove HDD bracket (4).

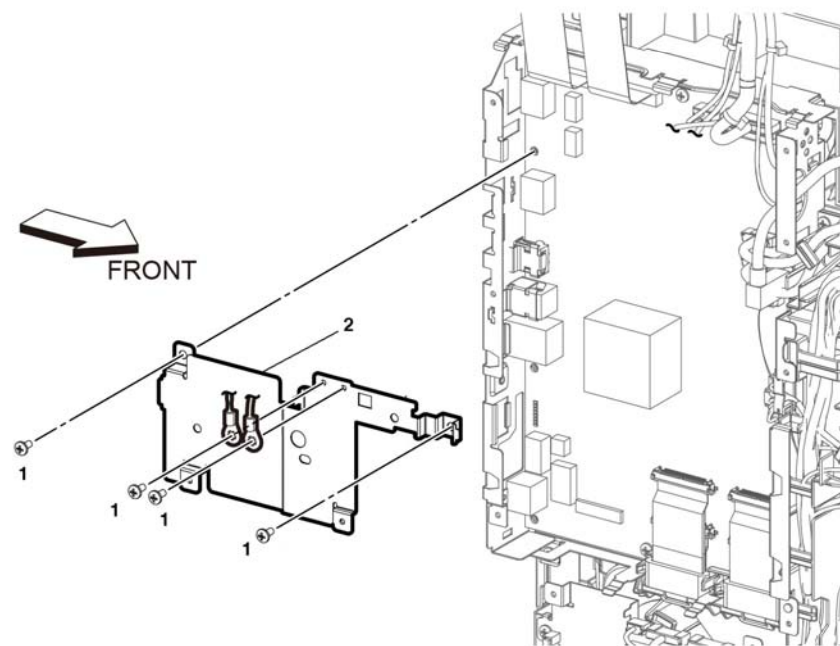
Figure 1 Remove the FAX plate (C505/C605/C605_Tall)

1. Remove the FAX plate, [Figure 1](#):
 - a. Remove the FAX PWB, [REP 18.4](#).
 - b. Remove the guide color FFC MCU, [PL 18.1 Item 7](#) or [PL 18.5 Item 7](#).
 - c. Remove four screws (1), then remove the FAX plate (2).

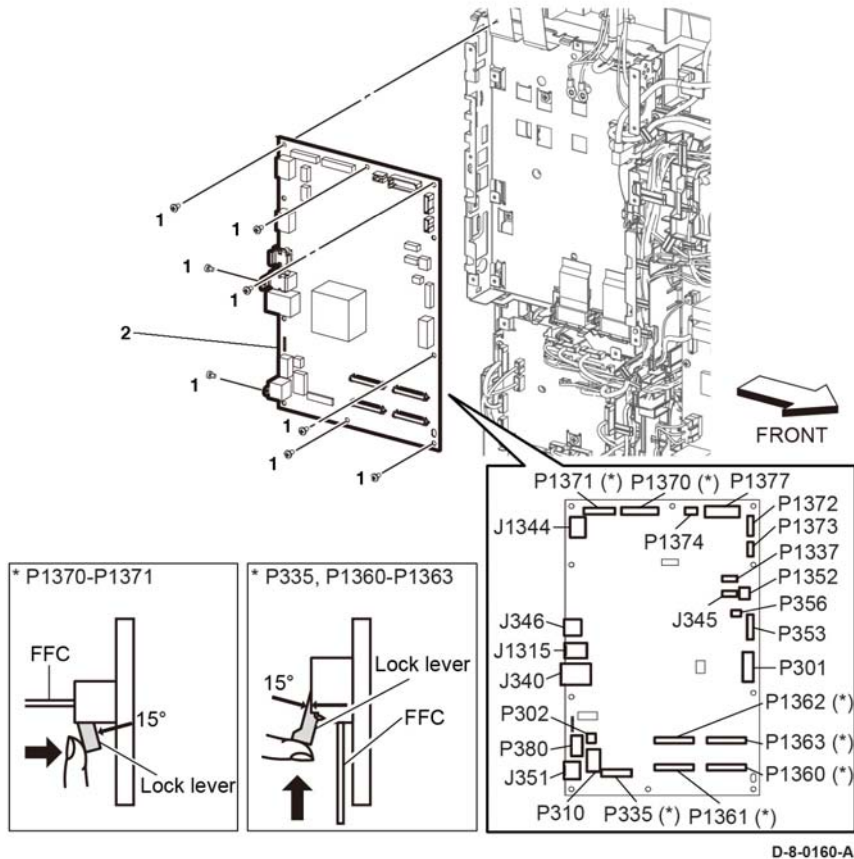
Figure 2 Remove the PWB ESS.

2. Remove the ESS PWB, [Figure 2](#):
 - a. Disconnect connectors (P/J301, P/J345, P/J356, P/J1337, P/J1352, P/J1372, P/J1373, P/J1374, P/J1377) and the FFCs (P/J1360, P/J1361, P/J1362, P/J1363, P/J1370, P/J1371, P/J335). Refer to [GP 44](#) for proper FFC cable removal.
 - b. Remove eight screws (1), then remove the ESS PWB (2).

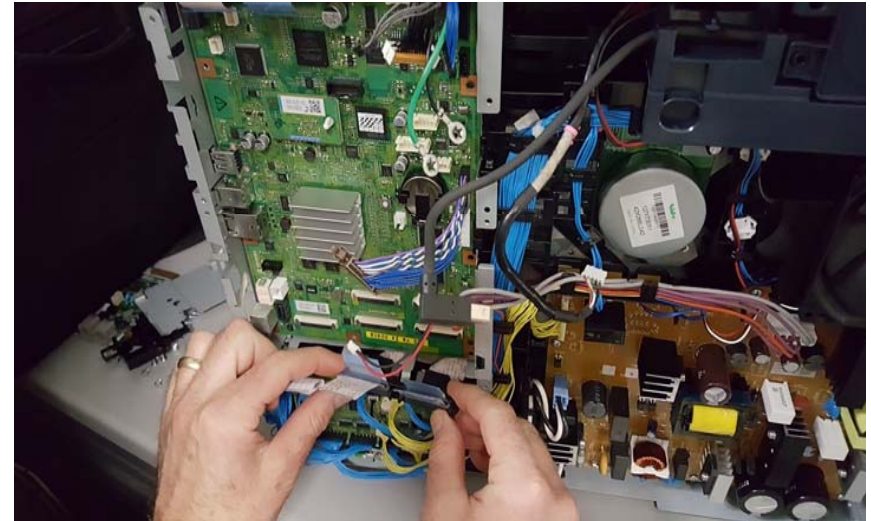
Figure 3 Disconnect all Cables

3. ESS PWB removal process:
 - a. Disconnect all Cables, carefully move the harnesses out of the way and remove the ESS PWB from the frame leaving all harnesses and guides in-place, [Figure 3](#).

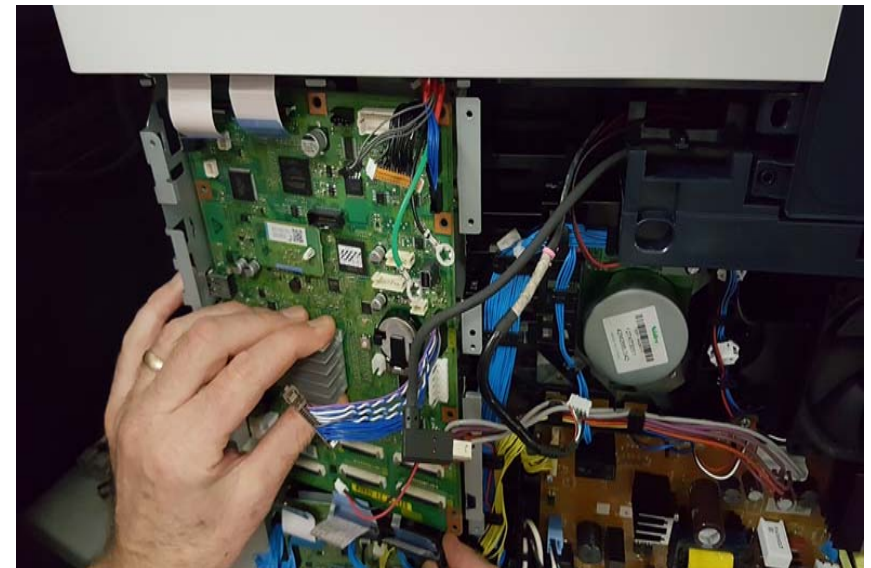
Figure 4 Lift the Bottom Right Corner

- b. Lift the bottom right corner of the ESS PWB from the ESS frame, [Figure 4](#).

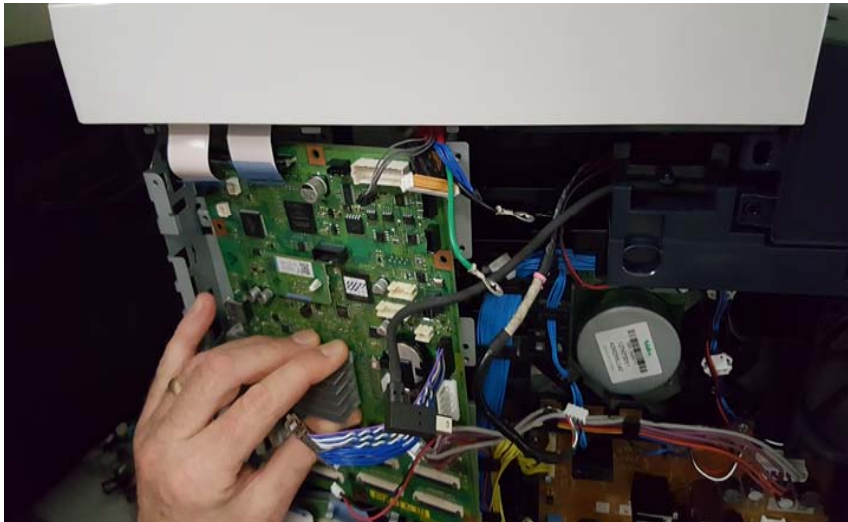
Figure 5 Slide the ESS PWB

- c. Carefully ease the ESS PWB out of the ESS frame, [Figure 5](#).

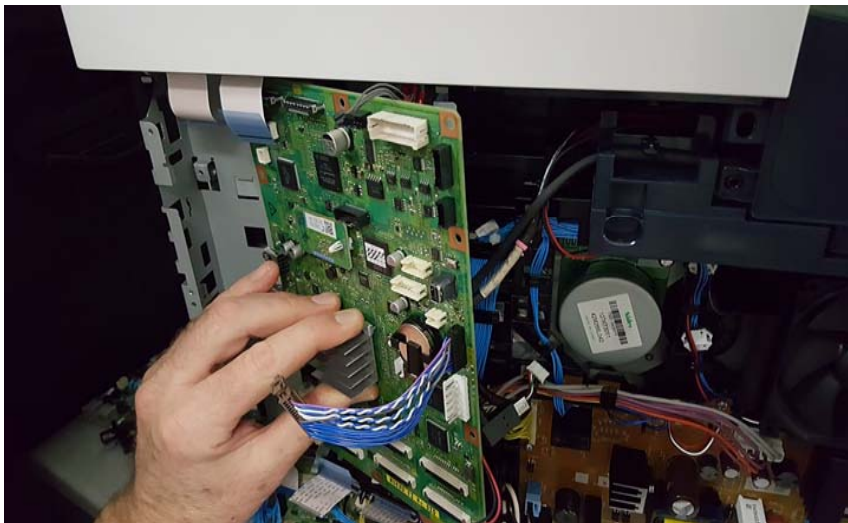
Figure 6 Remove the ESS PWB

- d. Remove the ESS PWB from the ESS frame entirely, [Figure 6](#).

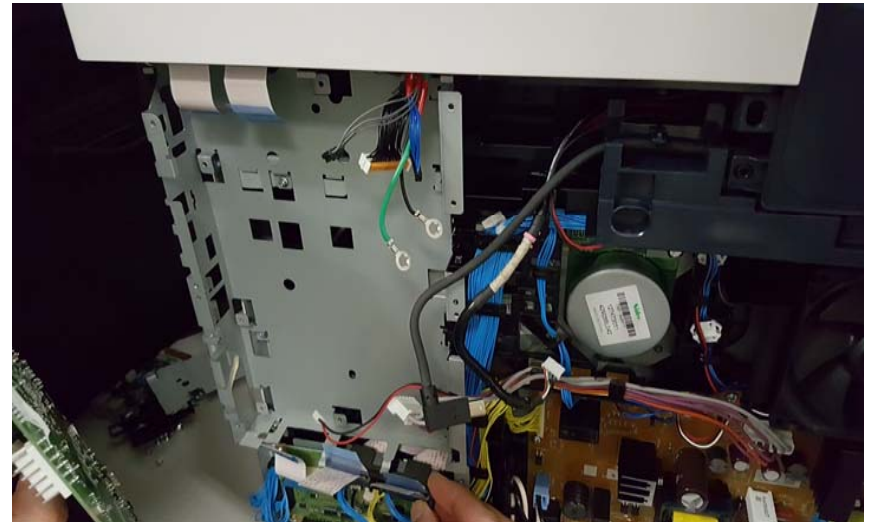
Figure 7 Removal Complete

- e. The ESS PWB removal is complete, [Figure 7](#).

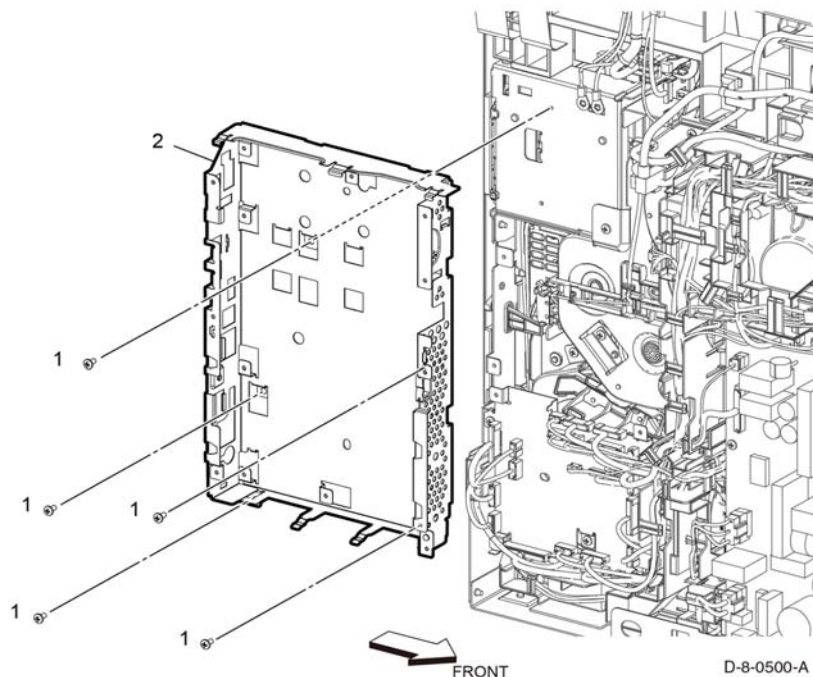
Figure 1 AIO ESS box removal

1. Remove the MCU PWB, [REP 18.1](#).
2. Remove the ESS PWB, [REP 18.3](#).
3. Remove five screws (1), then remove the AIO ESS box (2), [Figure 1](#).

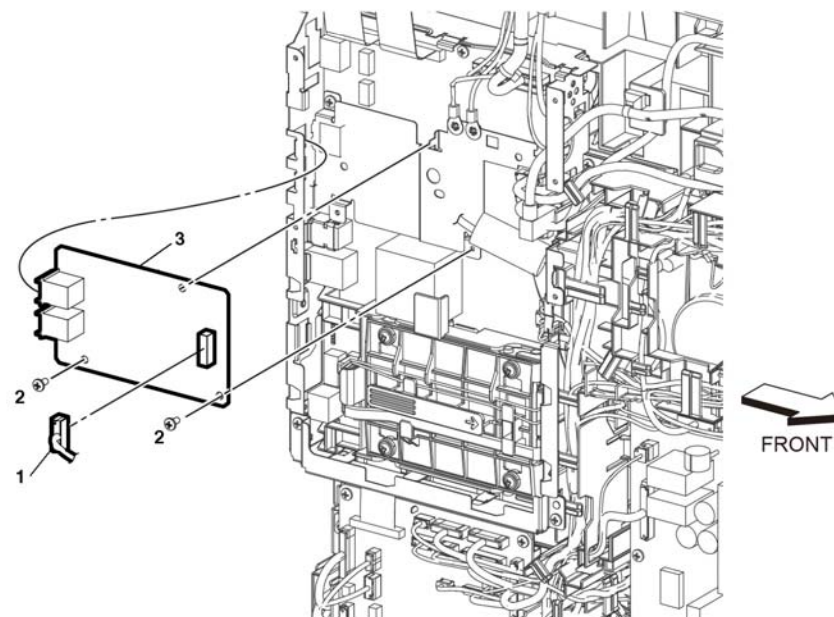
Figure 1 Remove the FAX PWB (C505/C605/C605_Tall)

1. Remove the left side cover, [PL 19.2 Item 2](#).
2. Remove the ESS Top plate, [PL 18.1 Item 18](#).
3. Disconnect [P/J1350](#) (1) from the FAX PWB (2).
4. Refer to [Figure 1](#) remove two screws (3) attaching the FAX PWB.

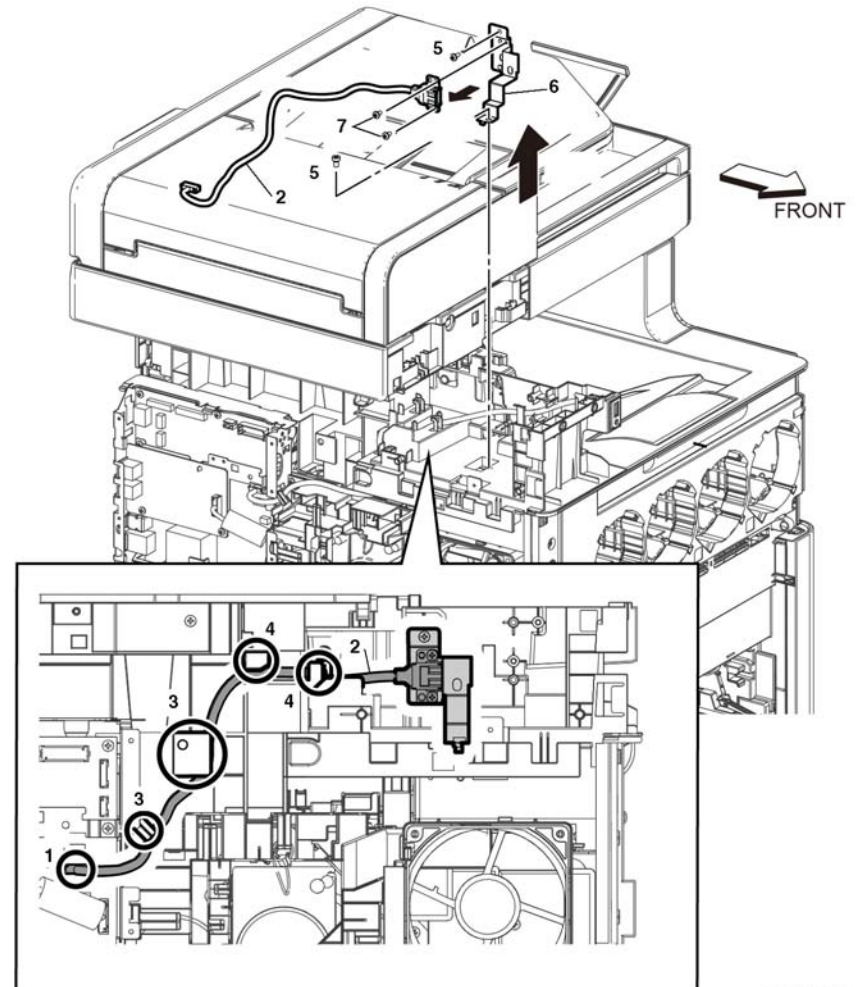
Figure 1 Remove the USB ICCR harness assembly

1. Remove the IOT 550 tray, [REP 9.1](#).
2. Remove the toner cover, [REP 19.11](#).
3. Remove the left cover, [REP 19.7](#).
4. Remove the left front cover, [REP 19.10](#).
5. Remove the ESS top plate, [REP 18.16](#).
6. Remove the UI console assembly, [REP 1.1](#).
7. Remove the UI inner cover, [REP 1.2](#).
8. Remove the UI frame cover, [REP 1.3](#).
9. Remove the ICCR USB harness assembly, [Figure 1](#):
 - a. Disconnect connector [P/J345](#) (1).
 - b. Release the ICCR USB harness assembly (2), from the DC harness guide (3), and the guides on the top cover (4).
 - c. Remove two screws (5), then remove the ICCR USB harness assembly (2), and the USB ICCR bracket (6), from the top cover (4).
 - d. Remove two screws (7) to remove the ICCR USB harness assembly (2) from the ICCR USB bracket (6).

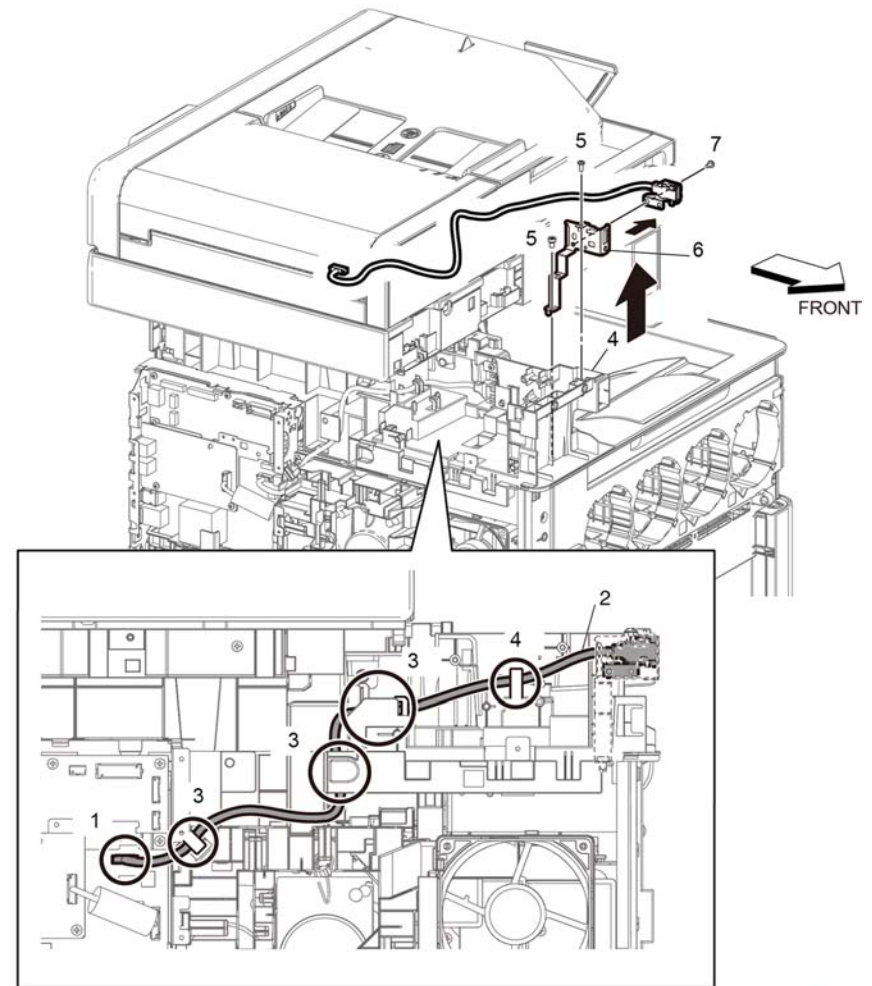
Figure 1 Remove the USB ICCR harness assembly (C505/C605/C605_Tall)

1. Remove the IOT 550 tray, [REP 9.1](#).
2. Remove the toner cover, [REP 19.11](#).
3. Remove the left cover, [REP 19.7](#).
4. Remove the left front cover, [REP 19.10](#).
5. Remove the ESS top plate, [PL 18.1 Item 18](#).
6. Remove the UI console assembly, [REP 1.1](#).
7. Remove the UI inner cover, [REP 1.2](#).
8. Remove the UI frame cover, [REP 1.3](#).
9. Remove the front USB harness assembly, [Figure 1](#):
 - a. Disconnect connector [P/J1337](#) (1).
 - b. Release the front USB harness assembly (2), from the DC harness guide (3), and the guides on the top cover (4).
 - c. Remove two screws (5), then remove the front USB harness assembly (2), and the front USB bracket (6), from the top cover (4).
 - d. Remove the screw (7) to remove the front USB harness assembly (2) from the front USB bracket (6).

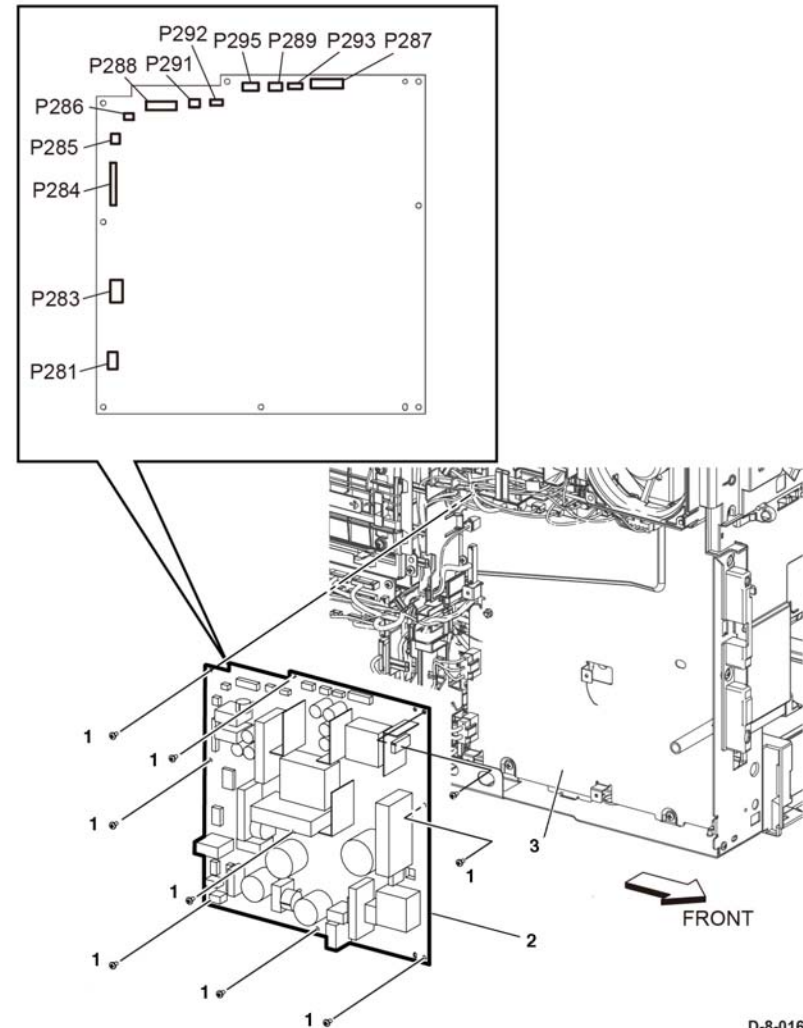
Figure 1 LVPS PWB removal

1. Remove the IOT 550 tray, [REP 9.1](#).
2. Remove the toner cover, [REP 19.11](#).
3. Remove the left cover, [REP 19.7](#).
4. Remove the LVPS PWB, [Figure 1](#):
 - a. Disconnect connectors ([P/J281](#), [P/J283](#), [P/J284](#), [P/J285](#), [P/J287](#), [P/J288](#), [P/J289](#), [P/J291](#), [P/J292](#), [P/J293](#), [P/J295](#)) from the LVPS PWB.
 - b. Remove eight screws (1) attaching the LVPS PWB (2) to the LVPS plate (3) then remove the LVPS PWB.

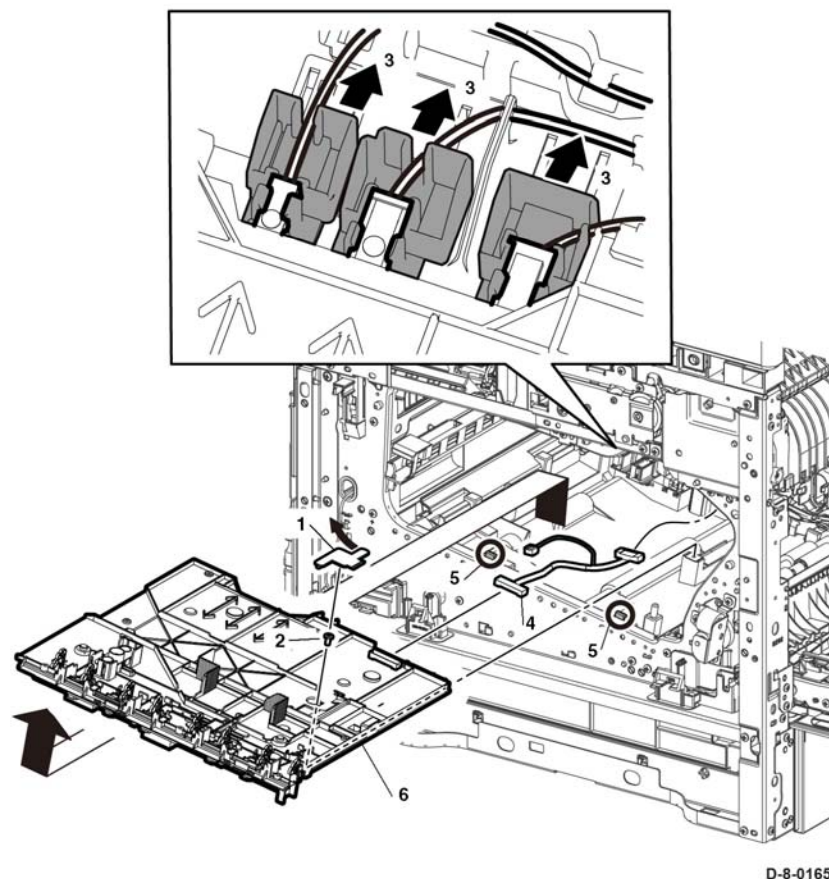
Figure 1 HVPS guide assembly removal

- iii. Push the faston holders in the direction of the arrows to remove the faston terminals ([P/J501](#), [P/J502](#), [P/JT601](#)) (3).
 - iv. Disconnect connector, [P/J100](#) (4).

- v. Release two hooks (5), then remove the HVPS guide assembly (6) in the direction of the arrow.

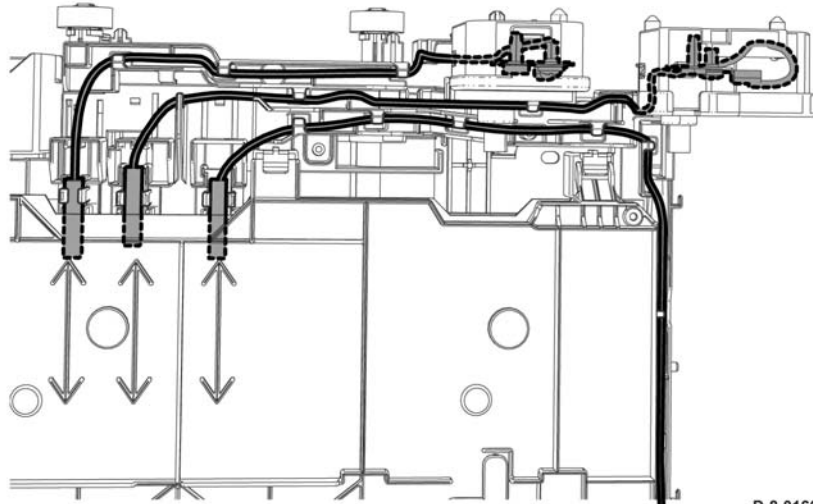
Figure 2 Re-attaching HVPS guide harnesses

NOTE: Make sure to attach the faston connectors (**P/J501**, **P/J502**, **P/JT601**), the 1st K supply harness assembly, **PL 18.2 Item 7**, the 1st YMC supply harness assembly, **PL 18.2 Item 6**, and the transfer supply harness assembly, **PL 18.2 Item 8**, at the initial position as shown in **Figure 2**.

1. Connect the connector **P/J100**.
2. Place the HVPS guide assembly into its installed position making sure to insert the alignment tabs at the left edge of the board into their slots.
3. Slide the faston connector holders towards the board to reconnect the plugs.

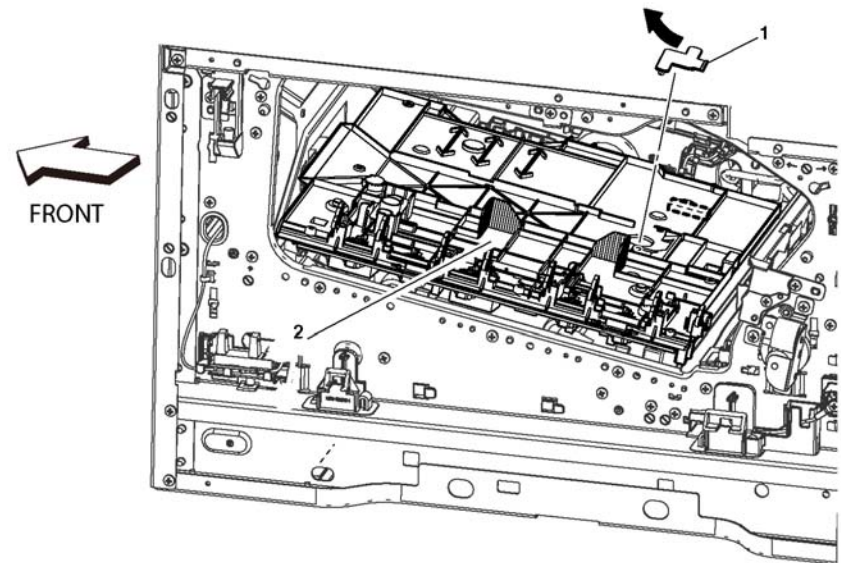
Figure 1 HVPS toner cover removal

1. Remove the IOT 550 tray, **REP 9.1**.
2. Remove the toner cover, **REP 19.11**.
3. Remove the right side cover, **REP 19.12**.
4. Remove the right side front cover, **REP 19.2**.
5. Remove the XERO DEVE CRU assemblies (YMCK), **PL 8.1**.
6. Remove the HVPS toner cover (1), **PL 18.2 Item 3** or **PL 18.7 Item 3**, from the HVPS guide assembly (2).

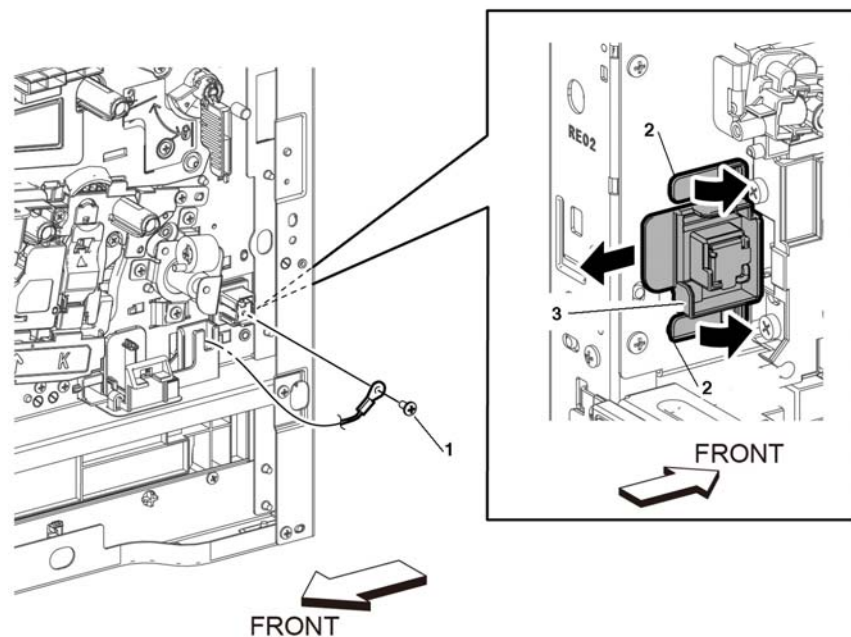
Figure 1 2nd bias transfer housing removal

1. Remove the right side cover, [REP 19.12](#).
2. Remove the right side front cover, [REP 19.2](#).
3. Open the rear door, [PL 19.2 Item 99](#).
4. Remove the 2nd bias transfer housing, [Figure 1](#):
 - a. Remove the screw (1) attaching the high voltage harness.
 - b. Release the two hooks (2), then remove the 2nd bias transfer housing (3).

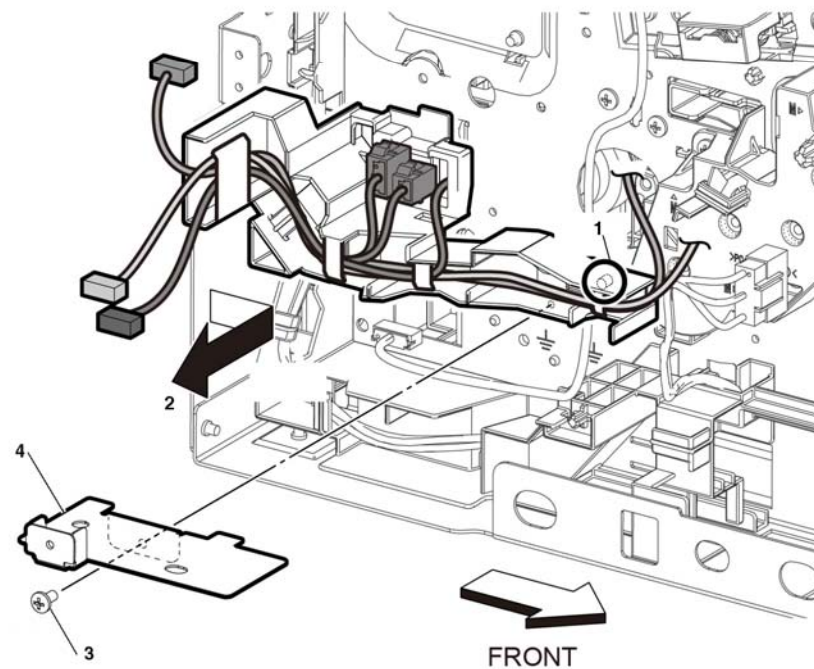
Figure 1 AC fusing harness guide plate removal

1. Remove the exit chute assembly, [REP 17.1](#).
2. Remove the AC fusing harness guide plate, [Figure 1](#):
 - a. Release one boss of the harness guide (1), then release the harness guide (2) with the harnesses in the direction of the arrow.
 - b. Remove one screw (3) to remove the plate (4).

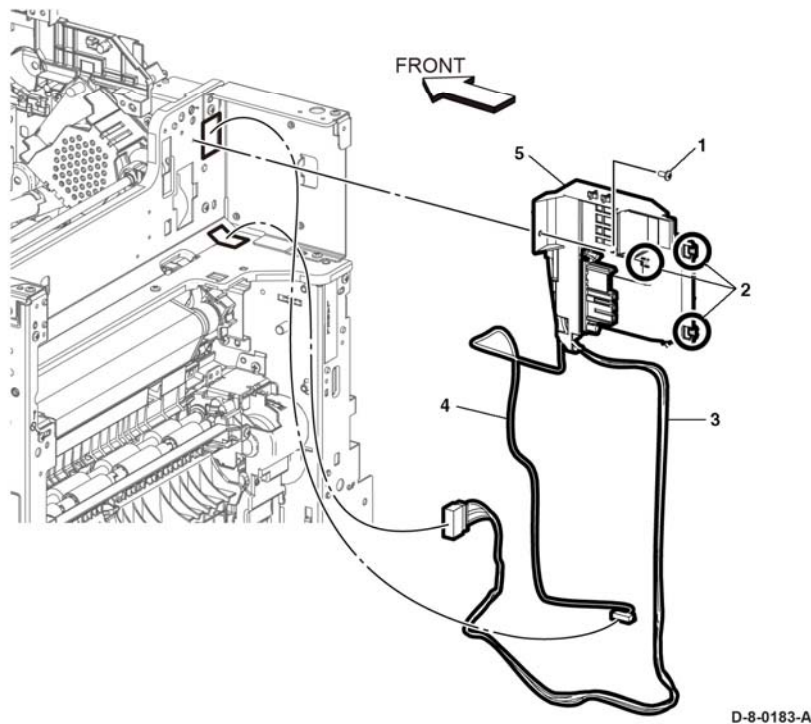
Figure 2 AC 100V/200V-CF fusing harness assembly removal

3. Release the AC 100V/200V-CF fusing harness assembly from the harness guides, [IOT diagram 12](#).
4. Remove one screw (1), release three hooks (2), then remove the AC fusing harness assembly (3), the DC-CF fusing harness assembly (4) and the fusing harness guide (5), [Figure 2](#).

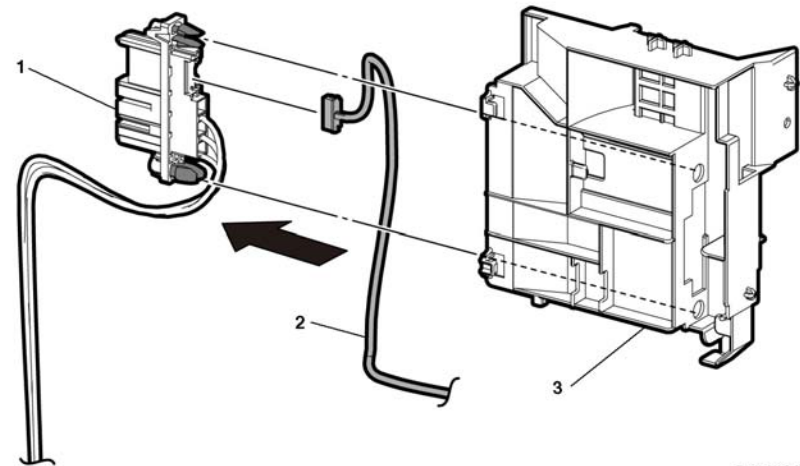
Figure 3 Harness assemblies separation

5. Remove the DC-CF fusing harness assembly (1) and AC fusing harness assembly (2) from the fusing harness guide (3), then remove the DC-CF fusing harness assembly from the AC fusing harness assembly, [Figure 3](#).

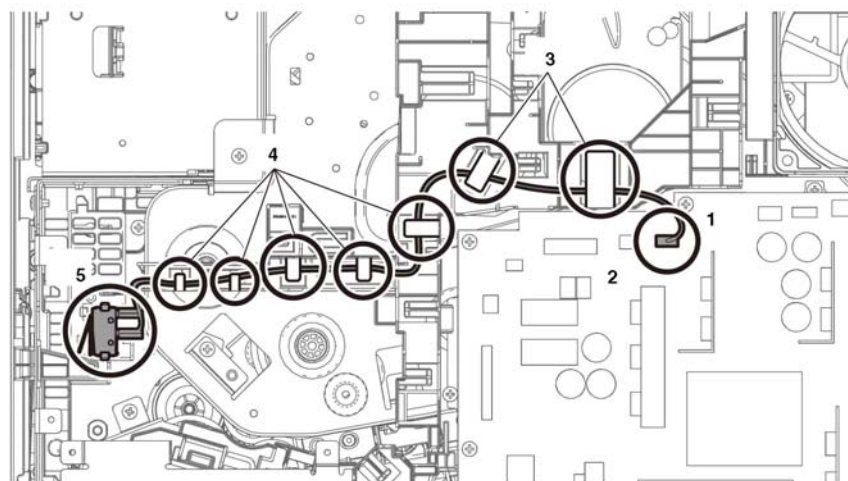
Figure 1 Rear interlock harness

1. Remove the AIO ESS Box, [REP 18.3.1](#).
2. Remove the rear I/L harness assembly, [Figure 1](#):
 - a. Disconnect connector [P/J292](#) (1) from the LVPS PWB (2), then release the rear I/L harness from the harness guide.
 - b. Release the rear I/L harness assembly from the DC harness guide (3) and the rear I/L harness guide (4).
 - c. Release the two hooks (5), then remove the rear I/L harness assembly.

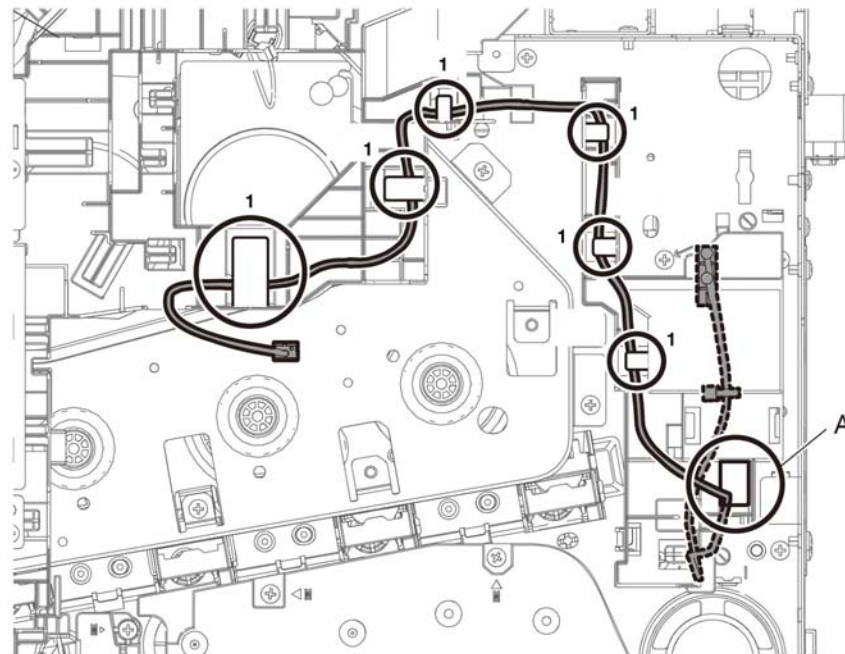
Figure 1 Side interlock harness

1. Remove the LVPS PWB, [REP 18.7](#).
2. Remove the LVPS plate, [PL 18.1 Item 13](#).
3. Remove the side I/L harness assembly, [Figure 1](#):
 - a. Release the side I/L harness assembly from the DC harness guide (1) and the duct harness guide (2).
 - b. Pull the side I/L harness assembly through hole (A).
