VersaLink[®] C500/C600 Printer and C505/C605 Multifunction Printer Service Manual

Xerox VersaLink C605F Family Printer Service Manual

705P01395

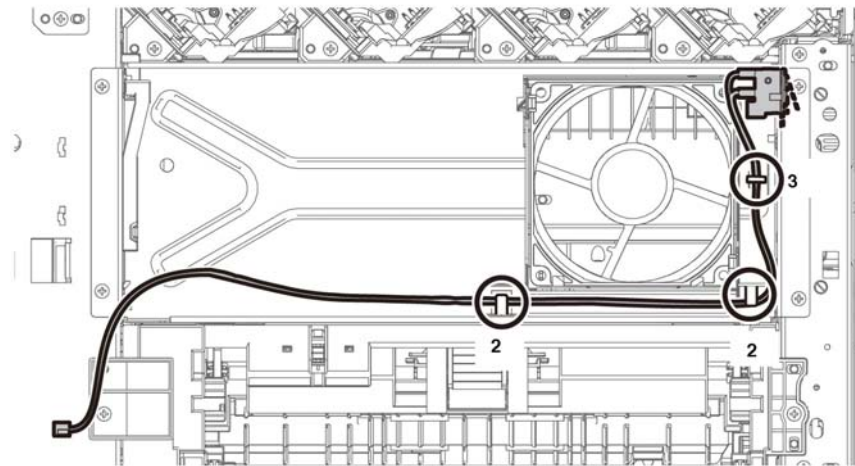
Figure 2 Side interlock harness

- c. Release the side I/L harness assembly from the sub fan duct (2), then remove the side I/L harness assembly from one push-tie (3) of the sub fan duct, [Figure 2](#).

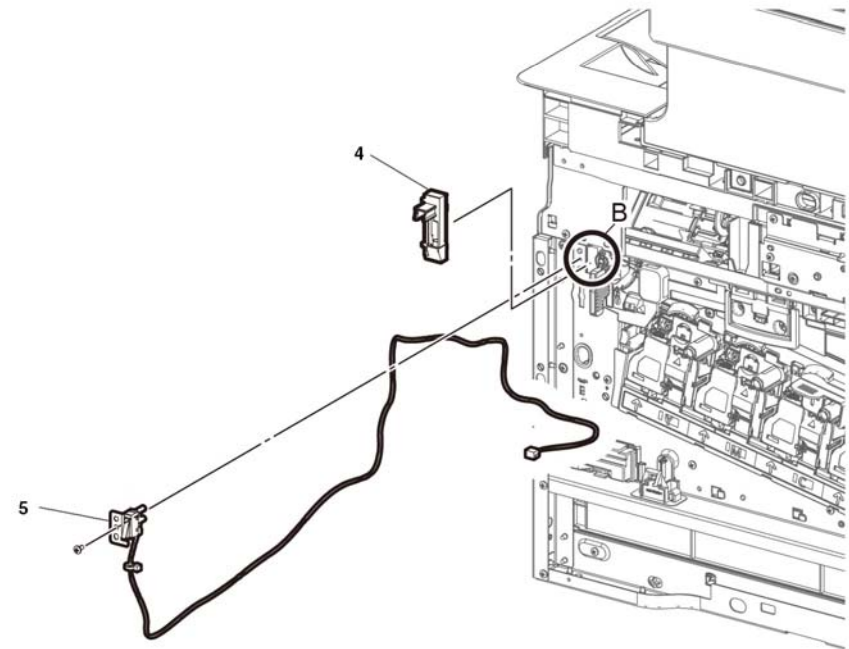
Figure 3 Pull out from the hole B.

- d. Remove the waste link and the waste link spring (4), remove one screw (5), then pull out the side I/L harness assembly through hole (B) to remove.

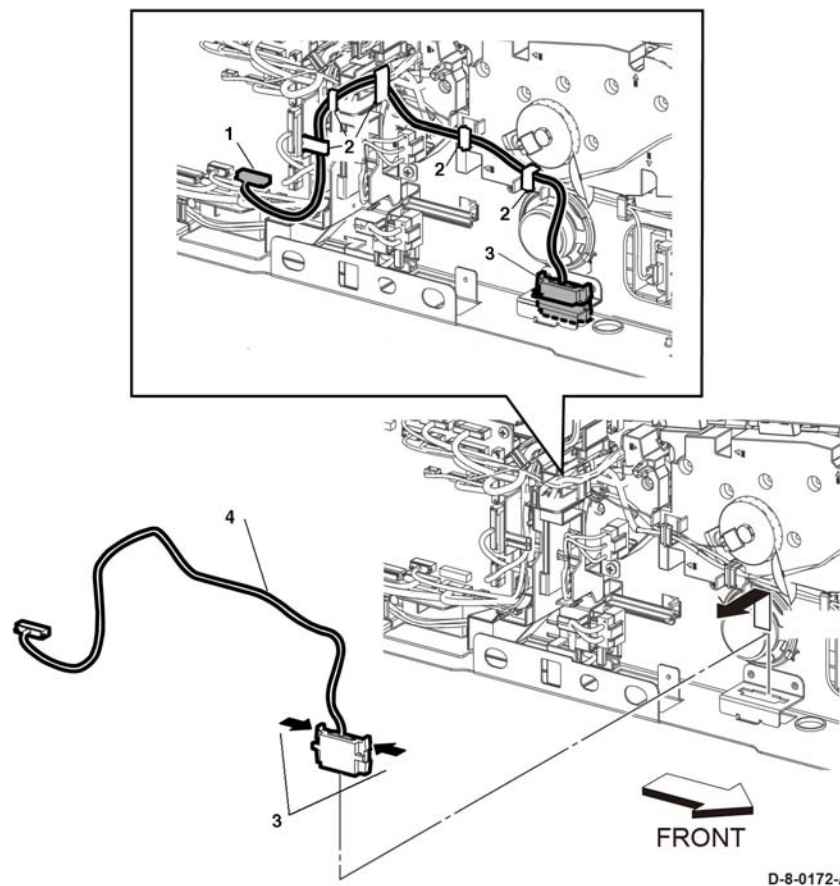
Figure 1 OPF harness assembly

- a. Disconnect connector [P/J800](#) (1), then release the OPF-CF harness assembly from five hooks (2) of the harness guide.
- b. Press two hooks and remove [P/J801](#) (3) from the harness bracket, then remove the OPF-CF harness assembly (4).

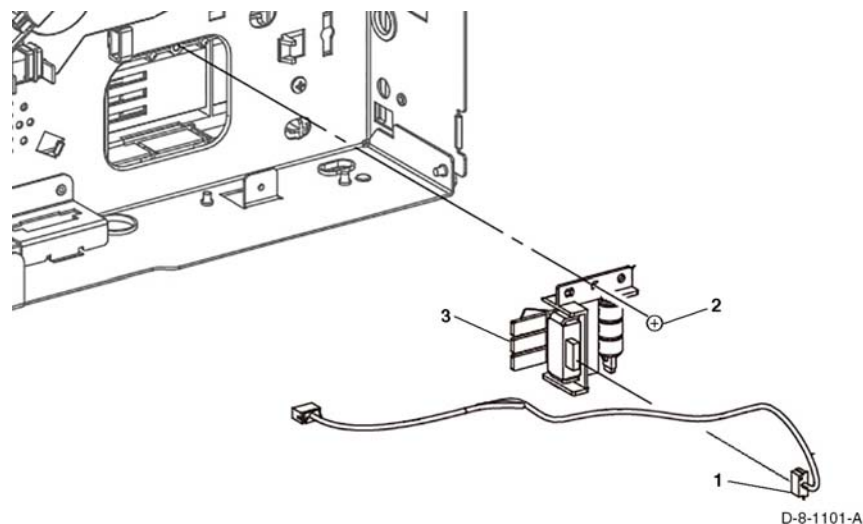
Figure 1 Size switch assembly removal

- a. Disconnect connector, [P/J191](#) (1).
- b. Remove one screw (2), then remove the size switch assembly (3).

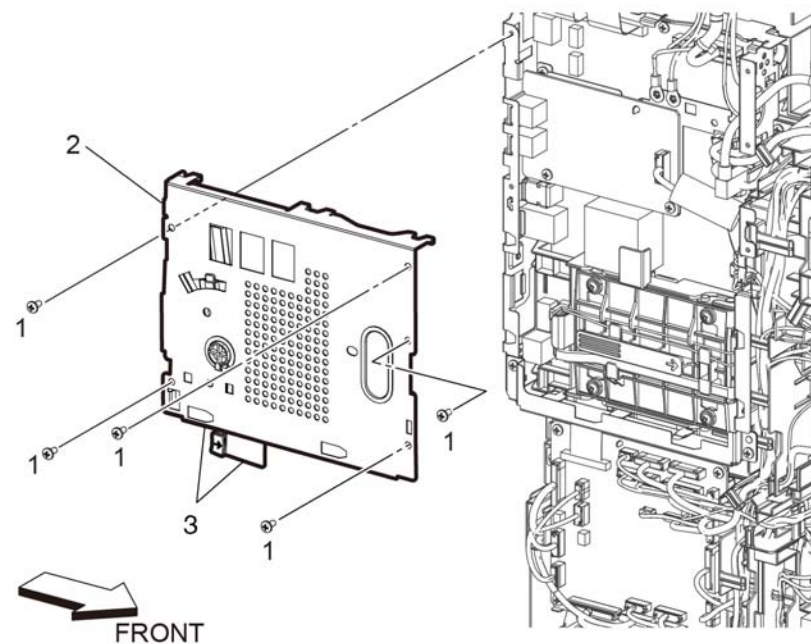
Figure 1 ESS top plate removal

1. Remove the left side cover, [REP 19.7](#) or [REP 19.36](#).
2. Remove five screws (1), then remove the ESS top plate (2) with the WiFi link (3), [Figure 1](#).

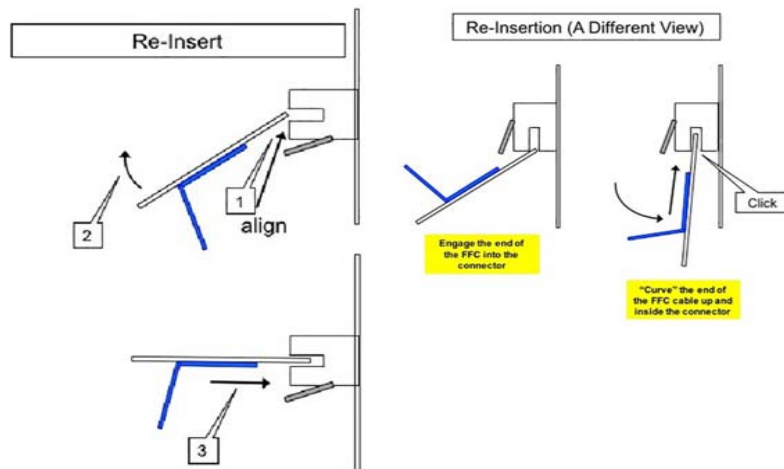
1. Slip the core down the FFC cable.
2. To ease installation and ensure proper alignment of the FFC cable, bend the blue “grip tab” 90 degrees perpendicular to the FFC.
3. Referring to [Figure 2](#), grasp the grip tab of the FFC cable placing the back, or non-conductive Side, of the FFC cable against the edge of the connector and centered to the connector.

4. Using the grip tab bent at 90 degrees, firmly push the FFC cable into the connector until fully seated. The latch of the connector will “click” when fully seated, locking the FFC in-place.

NOTE: To ensure integrity of the FFC connected at the ESS PWB, the following steps are to be observed. Do not attempt to engage the release lever to insert the FFC cable, the FFC connector will allow insertion and lock on its own.

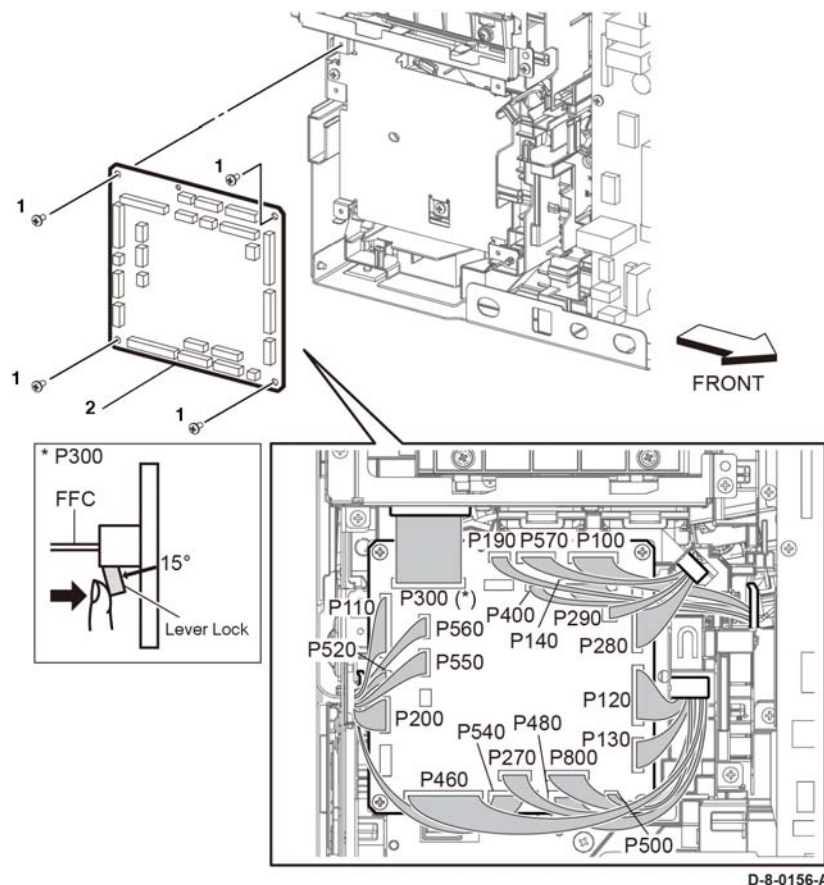
Figure 1 MCU PWB removal

1. Remove the MCU PWB, [Figure 1](#):
 - a. Remove the left side cover, [REP 19.51](#).
 - b. Disconnect connectors ([P/J100](#), [P/J110](#), [P/J120](#), [P/J130](#), [P/J140](#), [P/J190](#), [P/J200](#), [P/J270](#), [P/J280](#), [P/J290](#), [P/J400](#), [P/J460](#), [P/J480](#), [P/J500](#), [P/J520](#), [P/J540](#), [P/J550](#), [P/J560](#), [P/J570](#), [P/J800](#)) and the FFC ([P/J300](#)). Refer to, [GP 44](#) for proper FFC cable removal.
 - c. Remove four screws (1) securing MCU PWB (2), then remove the MCU PWB.

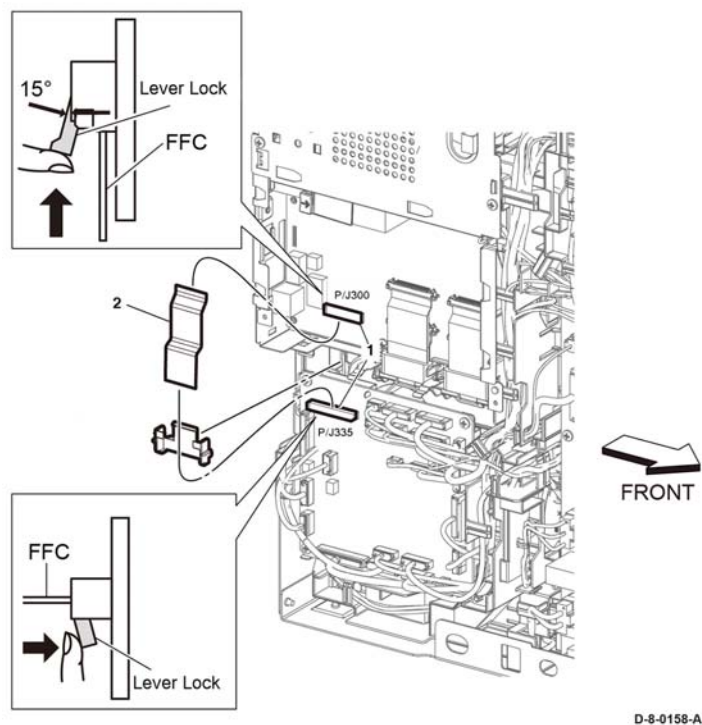
Figure 1 Remove the ESS MCU FFC.

1. Remove the MCU ESS FFC, [Figure 1](#):
 - a. Remove the left side cover, [REP 19.51](#).
 - b. Remove the HDD assembly, [PL 18.9 Item 27](#).
 - c. Remove the ESS lower plate and HDD bracket, [REP 18.2.1](#).
 - d. Unlock connectors [P/J300](#) and [P/J335](#) (1), then remove the ESS MCU FFC (2), Refer to [GP 44](#).

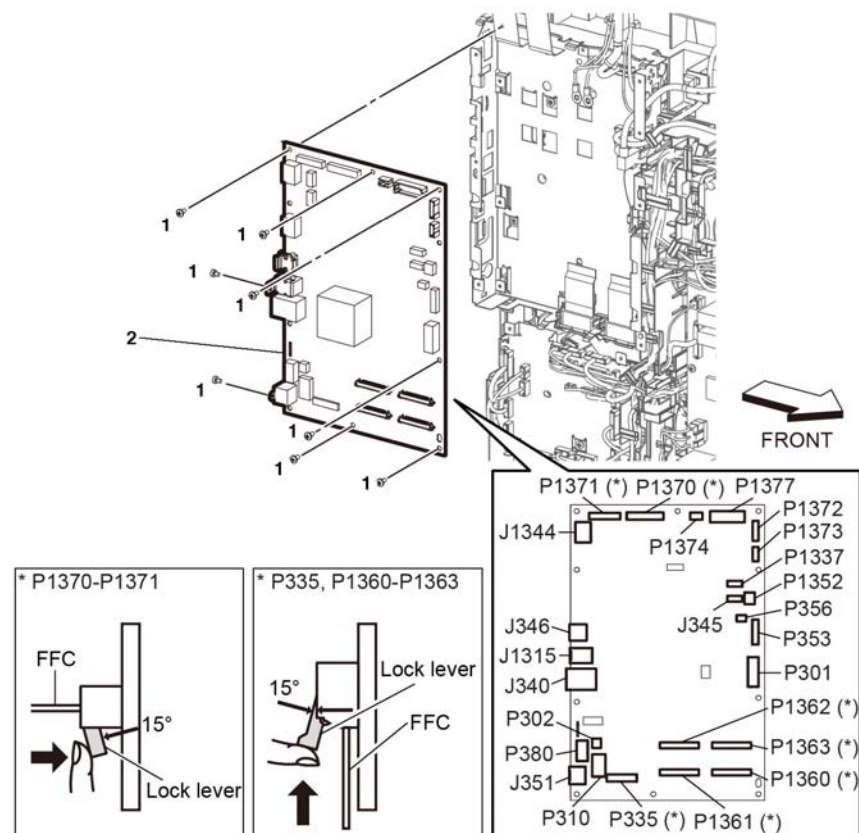
Figure 1 ESS PWB removal

5. Remove the ESS PWB, [Figure 1](#):
 - a. Remove two screws (1), then remove the ESS lower plate (2).
 - b. Remove two screws (3), then remove HDD bracket (4).

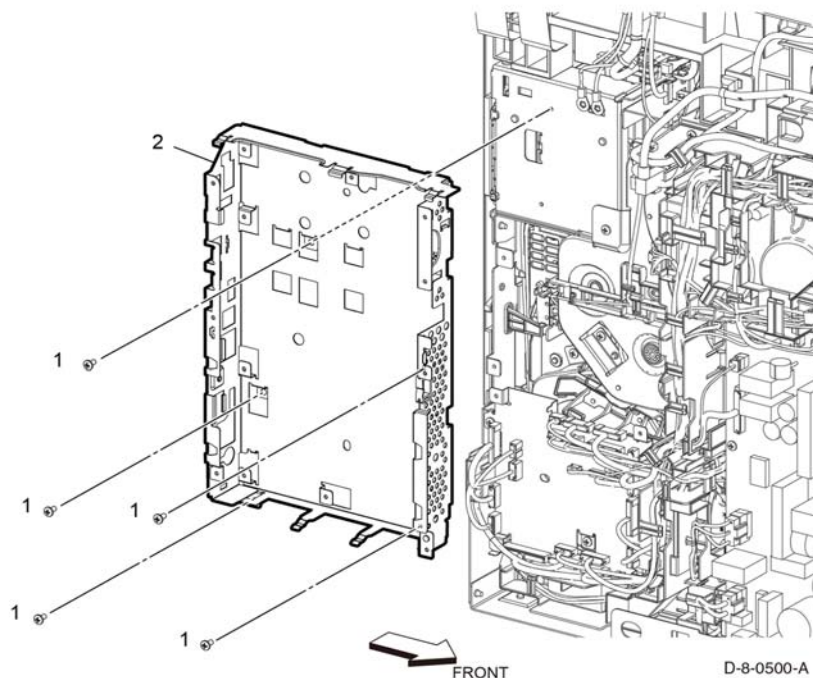
Figure 1 ESS box removal

1. Remove the MCU PWB, [REP 18.31](#).
2. Remove the ESS PWB, [REP 18.33](#).
3. Remove five screws (1), then remove the ESS box (2), [Figure 1](#).

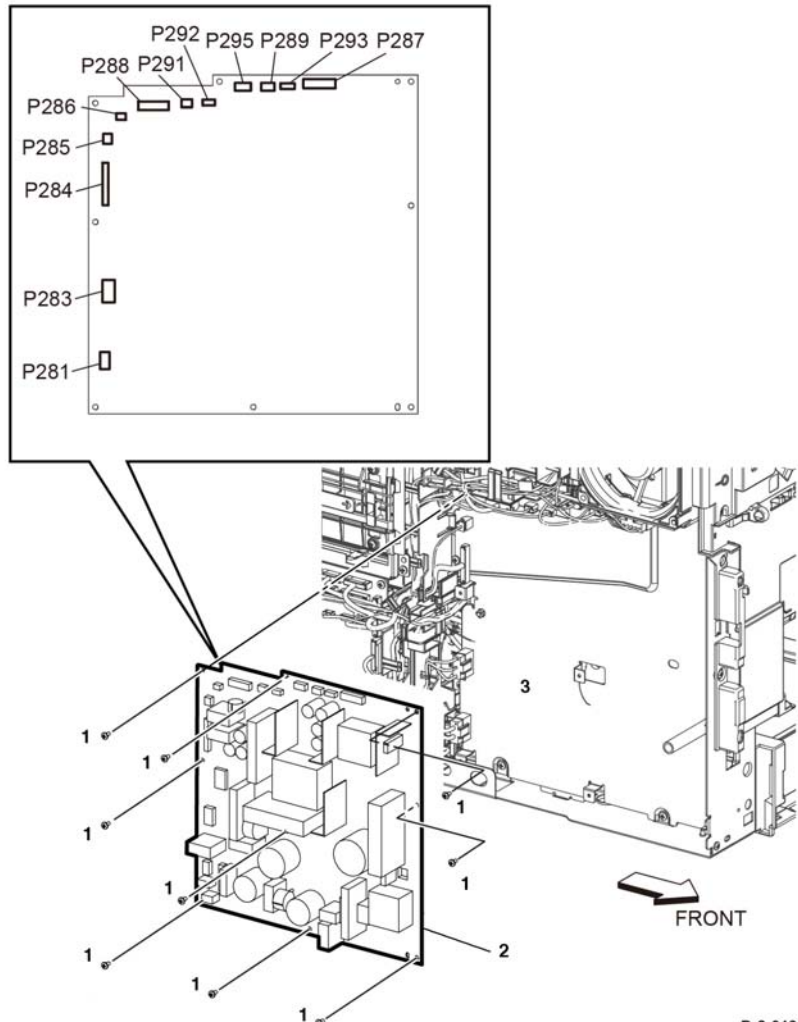
Figure 1 LVPS PWB

2. Disconnect connectors ([P/J281](#), [P/J283](#), [P/J284](#), [P/J285](#), [P/J286](#), [P/J287](#), [P/J288](#), [P/J289](#), [P/J291](#), [P/J292](#), [P/J293](#), [P/J295](#)) from the LVPS PWB (2), [Figure 1](#).
3. Remove nine screws (1) attaching the LVPS PWB (2) to the LVPS plate (3), then remove the LVPS PWB, [Figure 1](#).

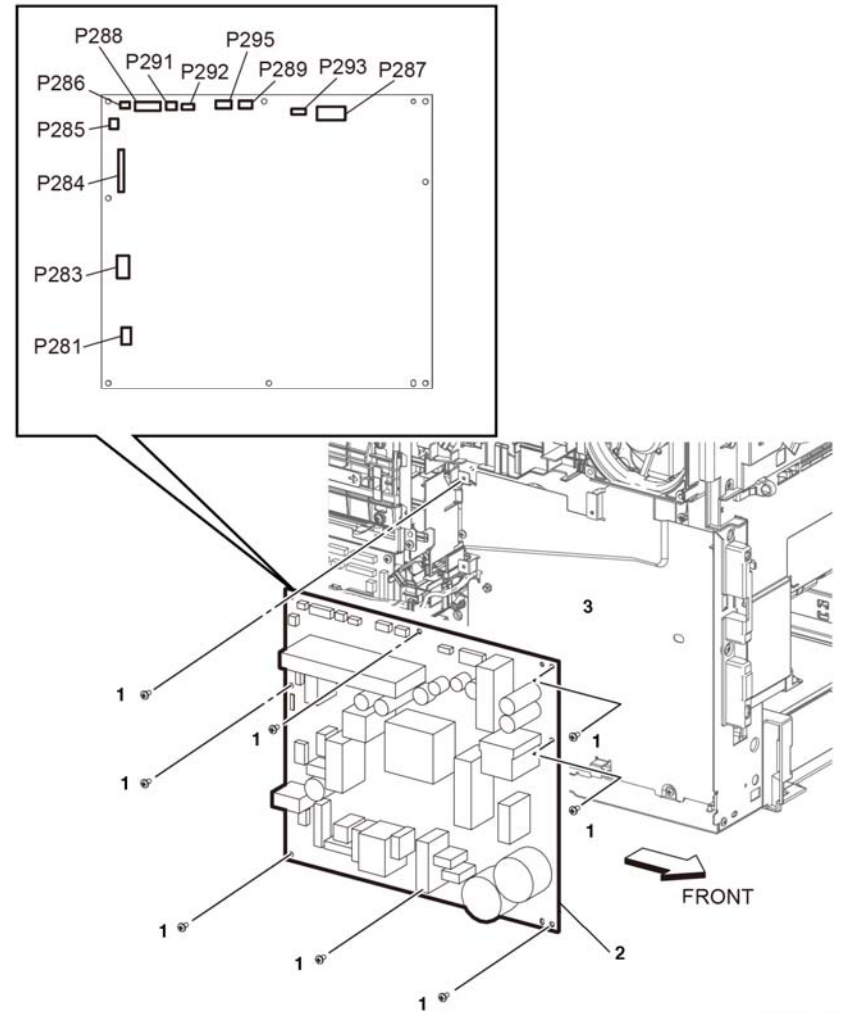
Figure 2 C500 LVPS PWB removal

1. Disconnect connectors (P/J281, P/J283, P/J284, P/J285, P/J286, P/J287, P/J288, P/J289, P/J291, P/J292, P/J293, P/J295) from the LVPS PWB (2).
2. Remove eight screws (1) attaching the LVPS PWB (2) to the LVPS plate (3), then remove the LVPS PWB.

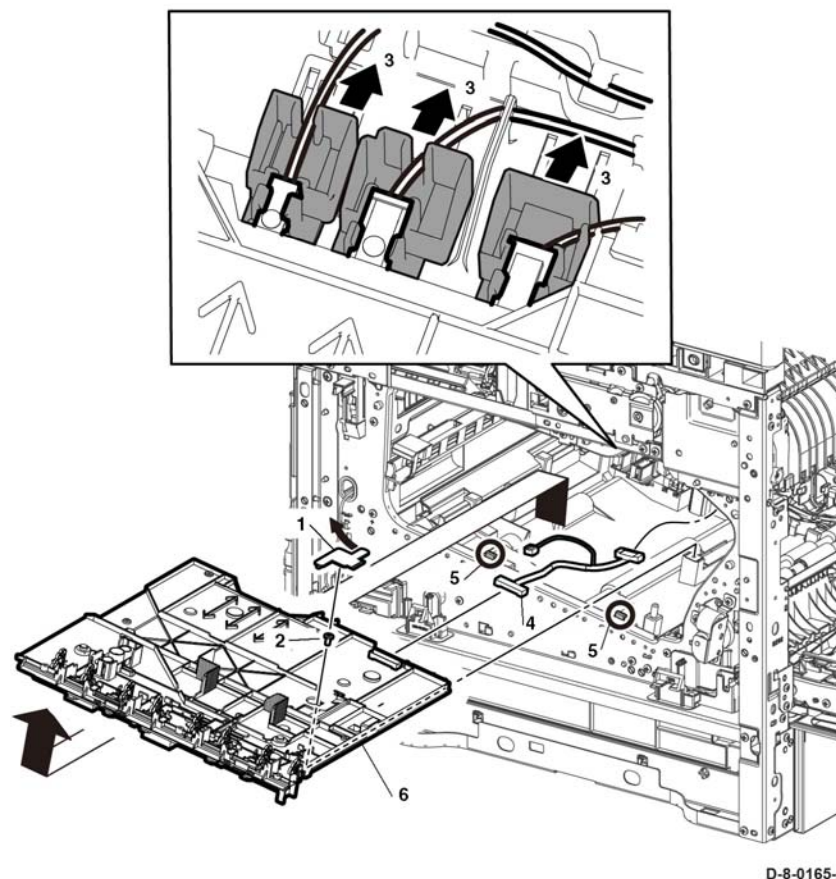
Figure 1 HVPS guide assembly removal

- iii. Push the faston holders in the direction of the arrows to remove the faston terminals ([P/J501](#), [P/J502](#), [P/JT601](#)) (3).
 - iv. Disconnect connector, [P/J100](#) (4).

- v. Release two hooks (5), then remove the HVPS guide assembly (6) in the direction of the arrow.

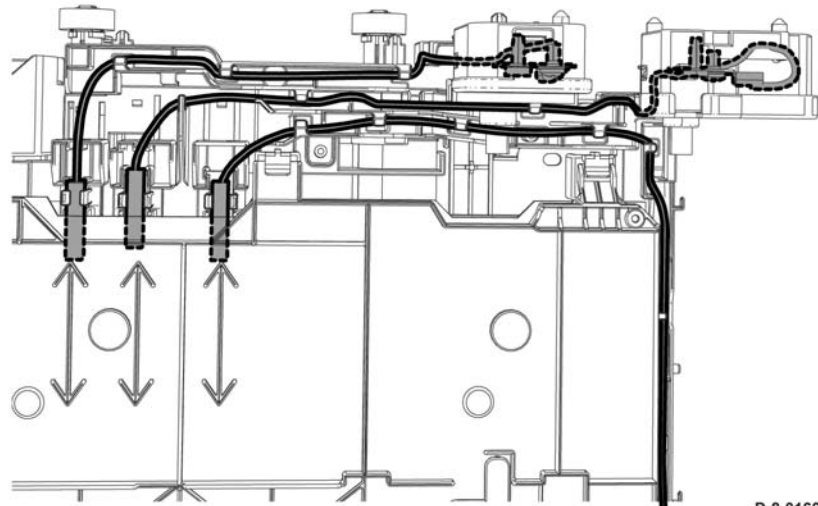
Figure 2 Re-attaching HVPS guide harnesses

NOTE: Make sure to attach the faston connectors ([P/J501](#), [P/J502](#), [P/JT601](#)), the 1st K supply harness assembly, [PL 18.10 Item 7](#), the 1st YMC supply harness assembly, [PL 18.10 Item 6](#), and the transfer supply harness assembly, [PL 18.10 Item 8](#), at the initial position as shown in [Figure 2](#).

1. Connect the connector [P/J100](#).
2. Place the HVPS guide assembly into its installed position making sure to insert the alignment tabs at the left edge of the board into their slots.
3. Slide the faston connector holders towards the board to reconnect the plugs.

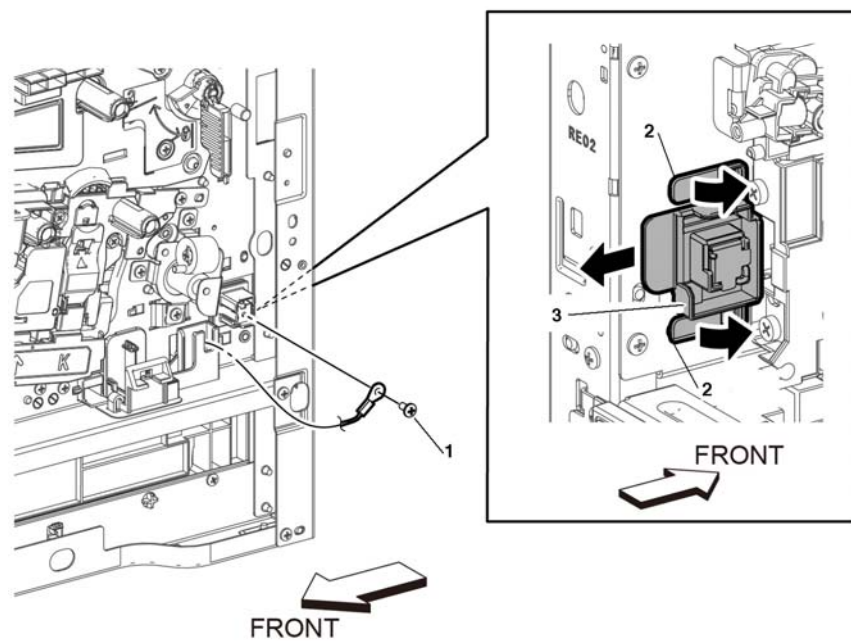
Figure 1 2nd bias transfer housing kit removal

1. Remove the right side cover, [REP 19.49](#).
2. Remove the right side front cover, [REP 19.45](#).
3. Open the rear door, [PL 19.2 Item 99](#).
4. Remove the 2nd bias transfer housing, [Figure 1](#):
 - a. Remove the screw (1) attaching the high voltage harness.
 - b. Release the two hooks (2), then remove the 2nd bias transfer housing (3).

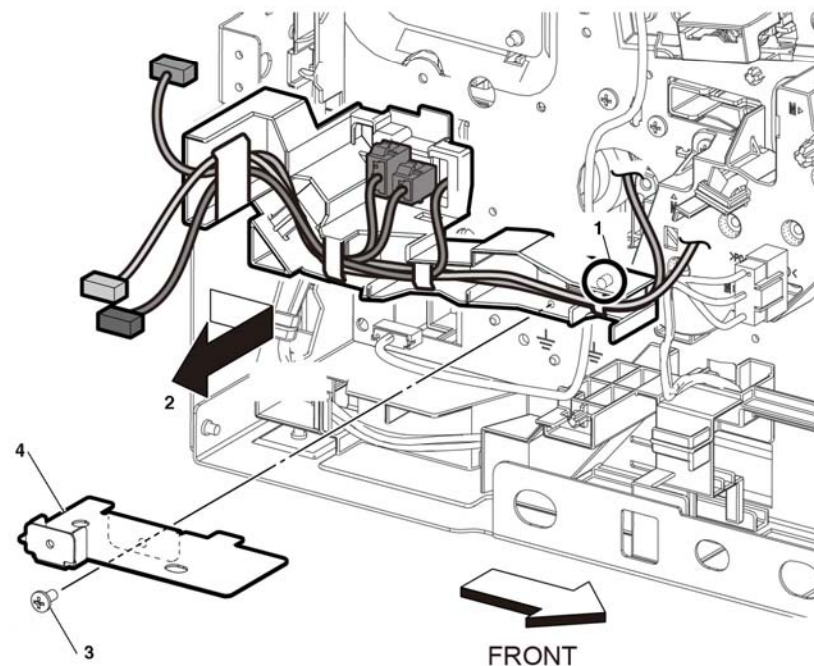
Figure 1 AC fusing harness guide plate removal

1. Remove the exit chute assembly, [REP 17.1](#).
2. Remove the AC fusing harness guide plate, [Figure 1](#):
 - a. Release one boss of the harness guide (1), then release the harness guide (2) with the harnesses in the direction of the arrow.
 - b. Remove one screw (3) to remove the plate (4).

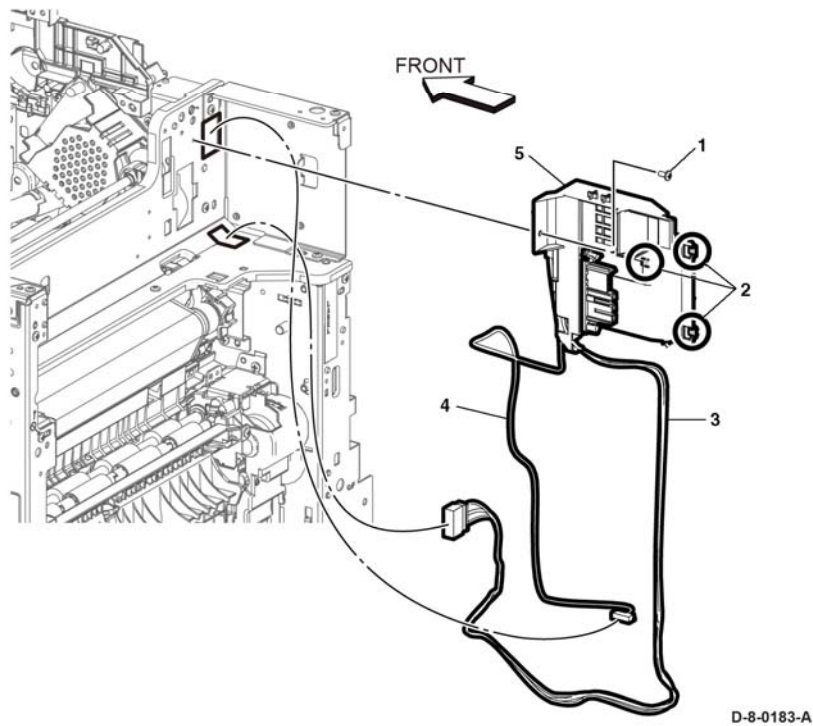
Figure 2 AC 100V/200V-CF fusing harness assembly removal

3. Release the AC 100V/200V-CF fusing harness assembly from the harness guides, [IOT diagram 12](#).
4. Remove one screw (1), release three hooks (2), then remove the AC fusing harness assembly (3), the DC-CF fusing harness assembly (4) and the fusing harness guide (5), [Figure 2](#).

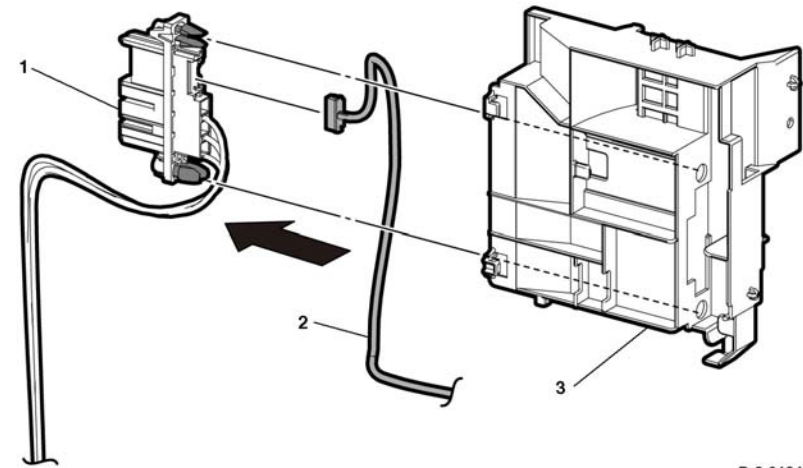
Figure 3 Harness assemblies separation

5. Remove the DC-CF fusing harness assembly (1) and AC fusing harness assembly (2) from the fusing harness guide (3), then remove the DC-CF fusing harness assembly from the AC fusing harness assembly, [Figure 3](#).

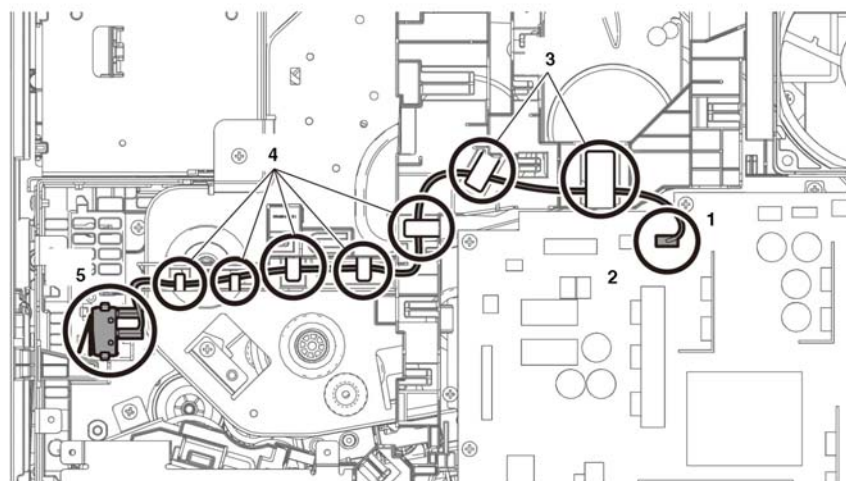
Figure 1 Rear interlock harness

1. Remove the ESS Box, [REP 18.33.1](#).
2. Remove the rear I/L harness assembly, [Figure 1](#):
 - a. Disconnect connector [P/J292](#) (1) from the LVPS PWB (2), then release the rear I/L harness from the harness guide.
 - b. Release the rear I/L harness assembly from the DC harness guide (3) and the rear I/L harness guide (4).
 - c. Release the two hooks (5), then remove the rear I/L harness assembly.

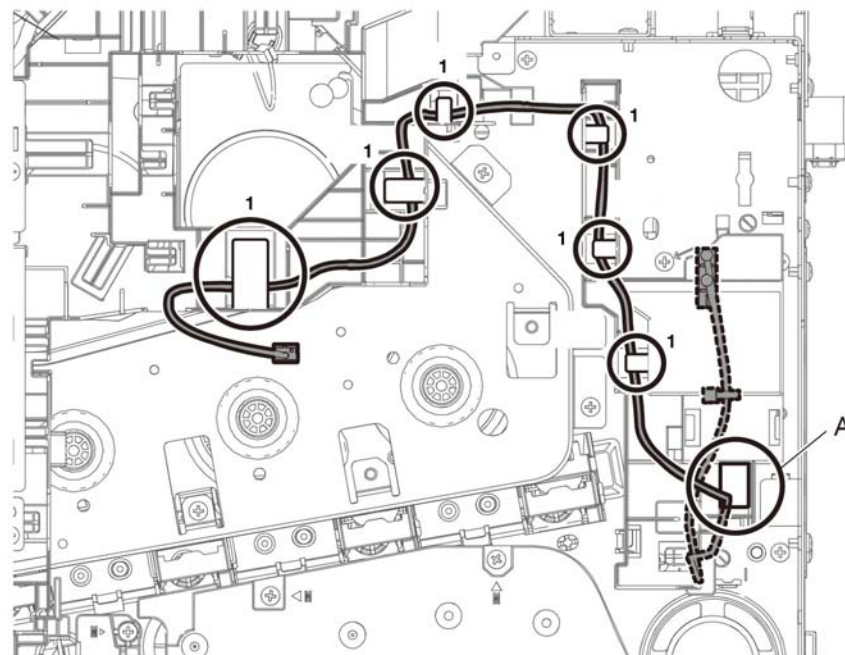
Figure 1 Side interlock harness release

1. Remove the LVPS PWB, [REP 18.35](#).
2. Remove the LVPS plate, [PL 18.9 Item 20](#).
3. Release the side-CF IL harness assembly from the three hooks (1), then pull the side-CF I/L harness assembly through hole (A).

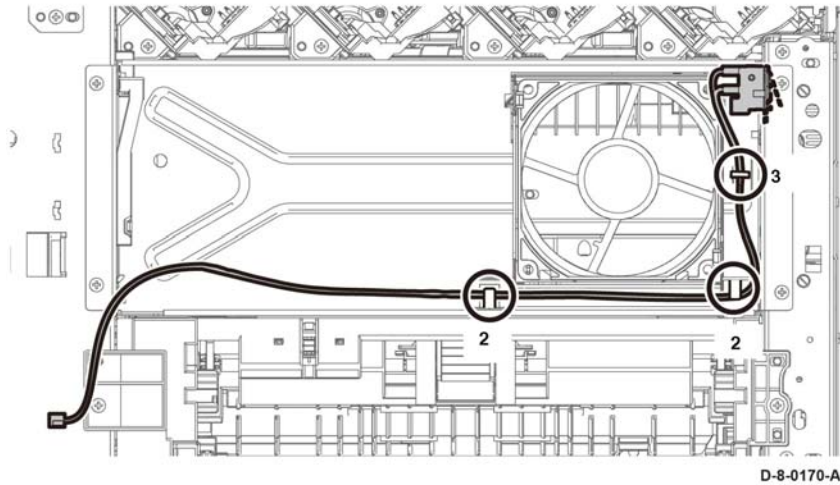
Figure 2 Sub fan duct harness release

4. Release the side-CF I/L harness assembly from the sub fan duct (2), then disconnect the push tie (3), [PL 4.1 Item 4](#).

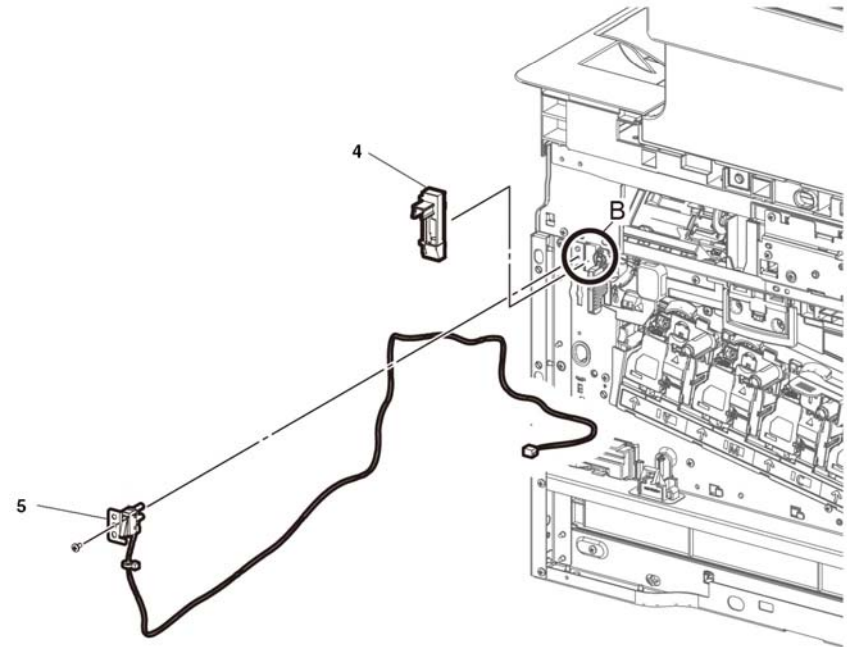
Figure 3 Pull through hole B.

- d. Remove the waste link and the waste link spring (4), remove one screw (5), then pull out the side I/L harness assembly through hole (B) to remove.

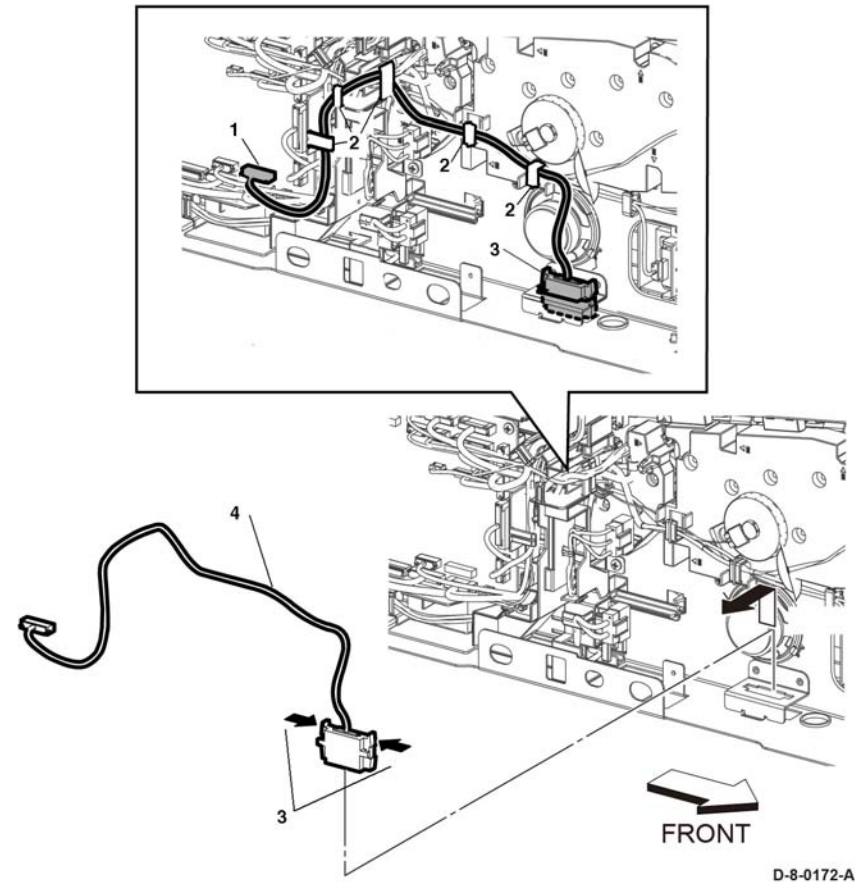
Figure 1 OPF harness assembly

- a. Disconnect connector [P/J800](#) (1), then release the OPF-CF harness assembly from five hooks (2) of the harness guide.
- b. Press two hooks and remove [P/J801](#) (3) from the harness bracket, then remove the OPF-CF harness assembly (4).

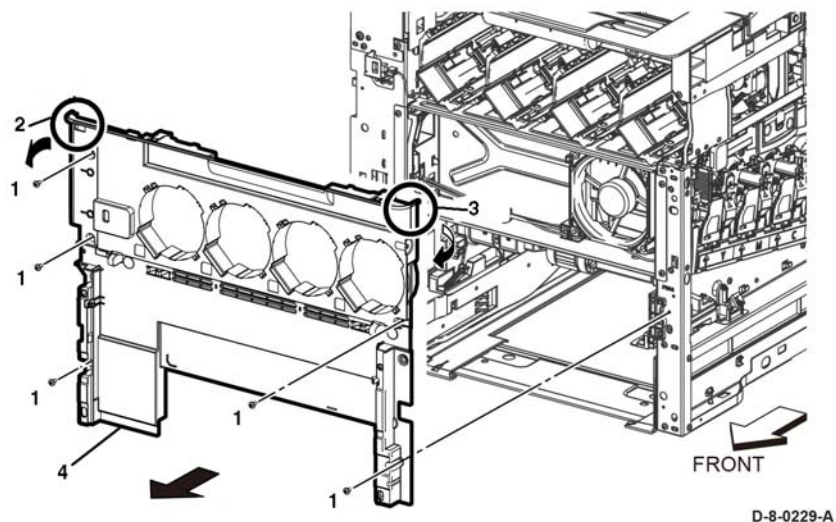
Figure 1 Remove the front inner cover

1. Remove the finisher or mailbox if necessary.
2. Remove the toner cover, [REP 19.11](#).
3. Remove the front inner cover, [Figure 1](#):
 - a. Remove five screws (1).
 - b. Release the hook (2) on the left side.
 - c. Release the hook (3) on the right side.
 - d. Remove the front inner cover (4).

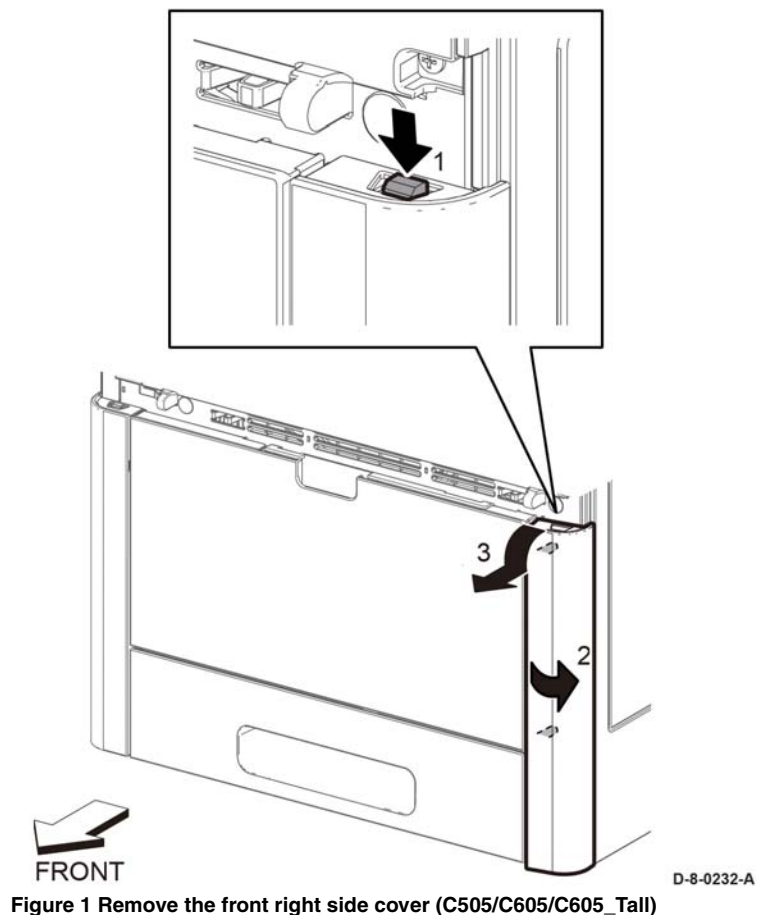
1. Remove the right side cover, [PL 19.1 Item 97](#)
2. Remove the right front cover, [Figure 1](#):
 - a. Press the button (1) to release the hook.
 - b. Rotate the right front (2) cover as shown.
 - c. Remove the right front cover (3)

Figure 1 Remove the front right side cover (C505/C605/C605_Tall)

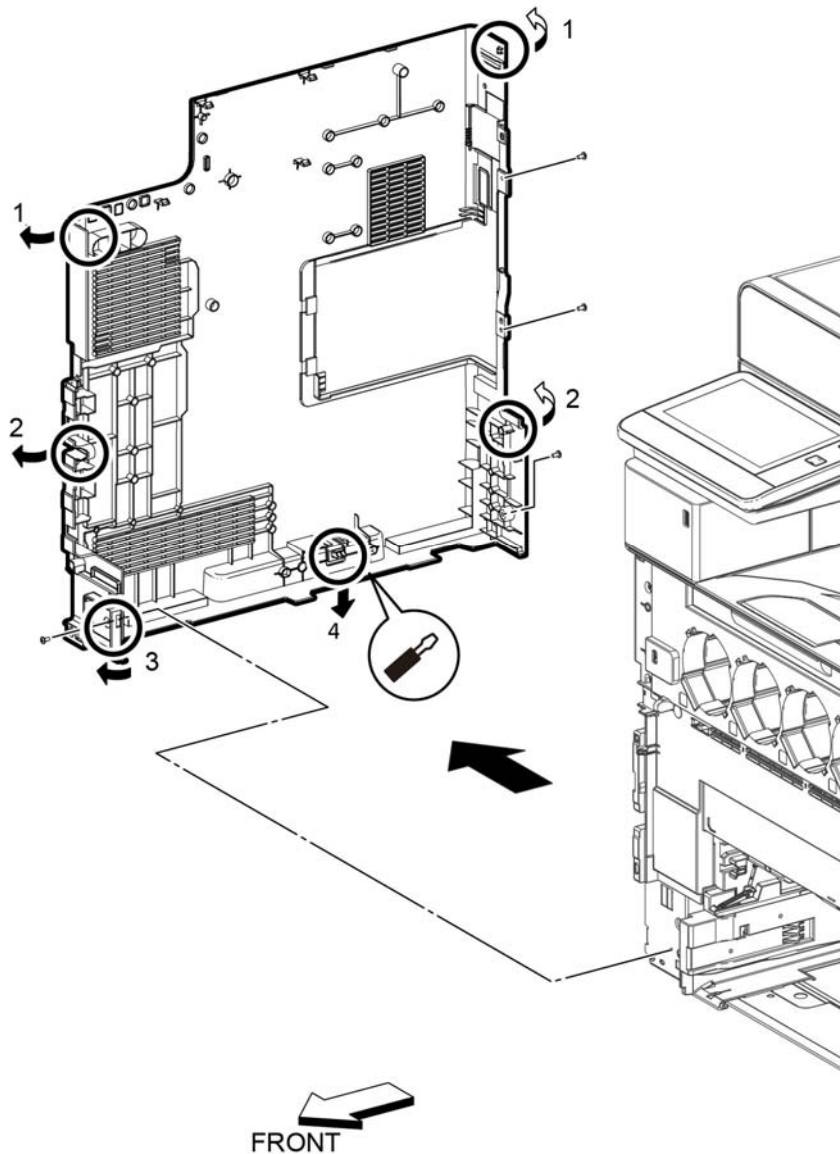
D-8-0225- b

9. Position the left side of the printer to overhang the edge of the workbench.
10. Following the sequence shown in [Figure 1](#), release the hooks and bosses of the left side cover assembly, and remove the cover.

Figure 1 Remove the Left Side Cover (C505/C605/C605_Tall)

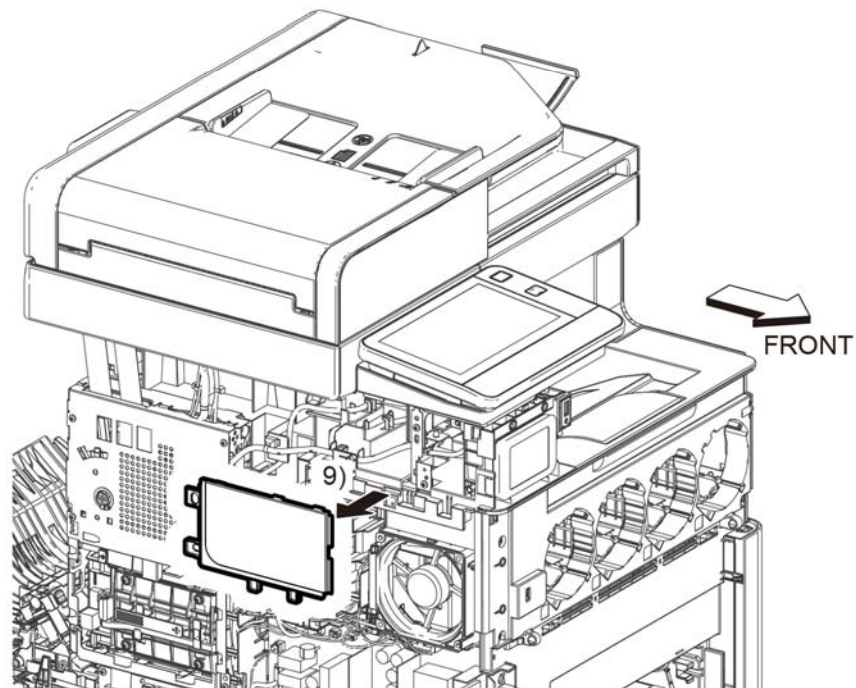
D-8-0239-A

1. Remove the ICCR cover, [REP 19.6](#).
2. Refer to [Figure 1](#), remove the left side IIT cover in the direction of the arrow

Figure 1 Remove the Left Side IIT Cover (C505/C605/C605_Tall)

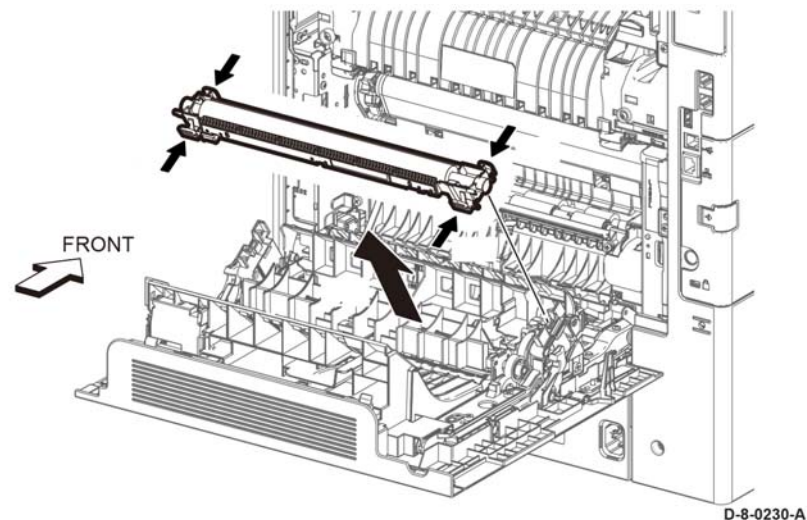
D-8-0230-A

1. Open the rear door.
2. Refer to [Figure 1](#), push the four latches and remove the 2nd BTR roll assembly.

Figure 1 Remove the Second Bias Transfer Roller Assembly (C505/C605/C605_Tall)

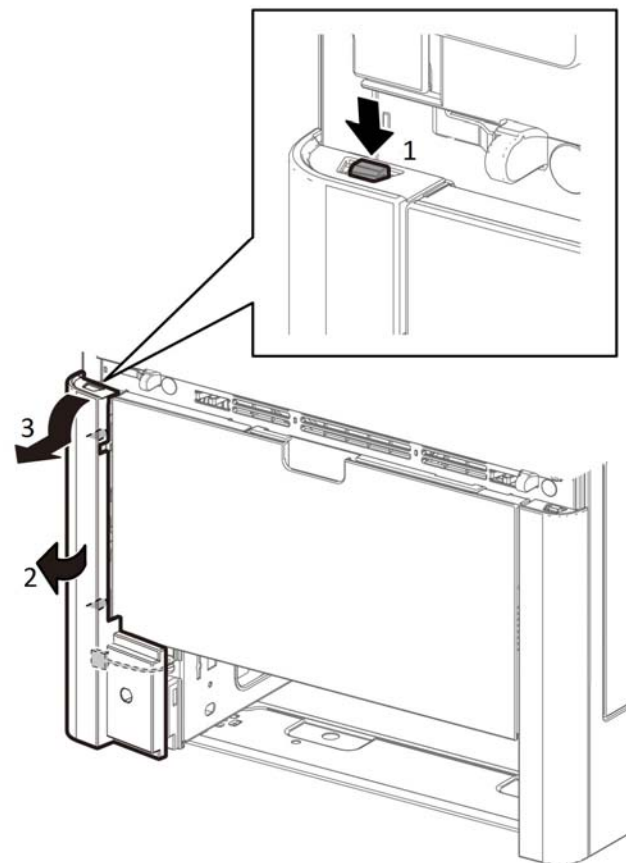
D-8-0231-B

1. Refer to [Figure 1](#), push down on the hook release button to release the top of the left front cover in the direction of the arrows.
2. Disconnect ([P/J521](#)) and remove the left front cover with the tray led PWB, and the tray shade cover, [REP 19.10](#).

Figure 1 Remove the left front cover

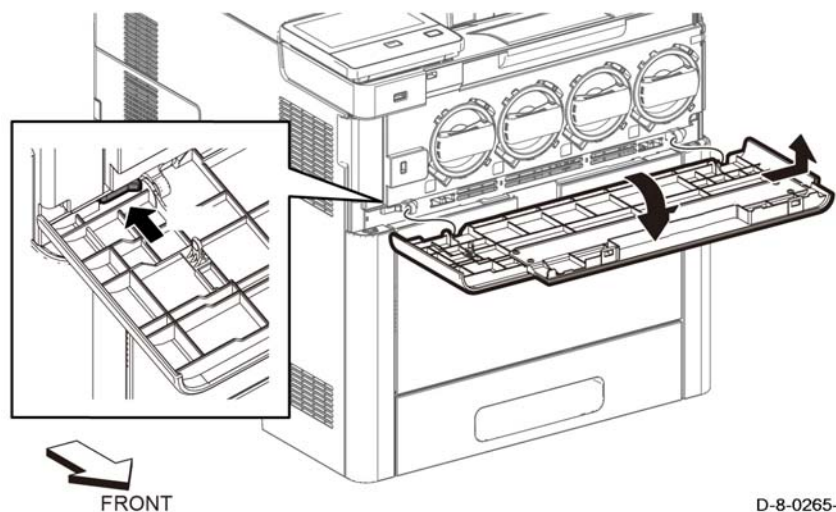
D-8-0265-B

1. Open the toner cover, [Figure 1](#).
2. Push the hook and remove the toner cover assembly in the direction of the arrow.

Figure 1 Toner cover assembly removal

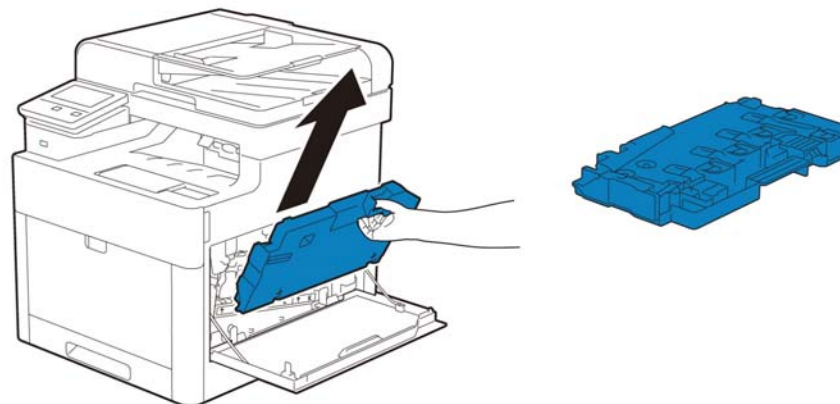
D-8-0462-A

1. Paper tray assembly, [REP 9.1](#).
2. Main MSI tray assembly, [REP 13.5](#).
3. Toner cover, [REP 19.11](#).
4. Right side front cover, [REP 19.2](#).
5. Open the rear door.
6. Refer to [Figure 1](#), open the waste box cover on the right side, press the tab and remove the waste box assembly.

Figure 1 Remove the toner waste box assembly

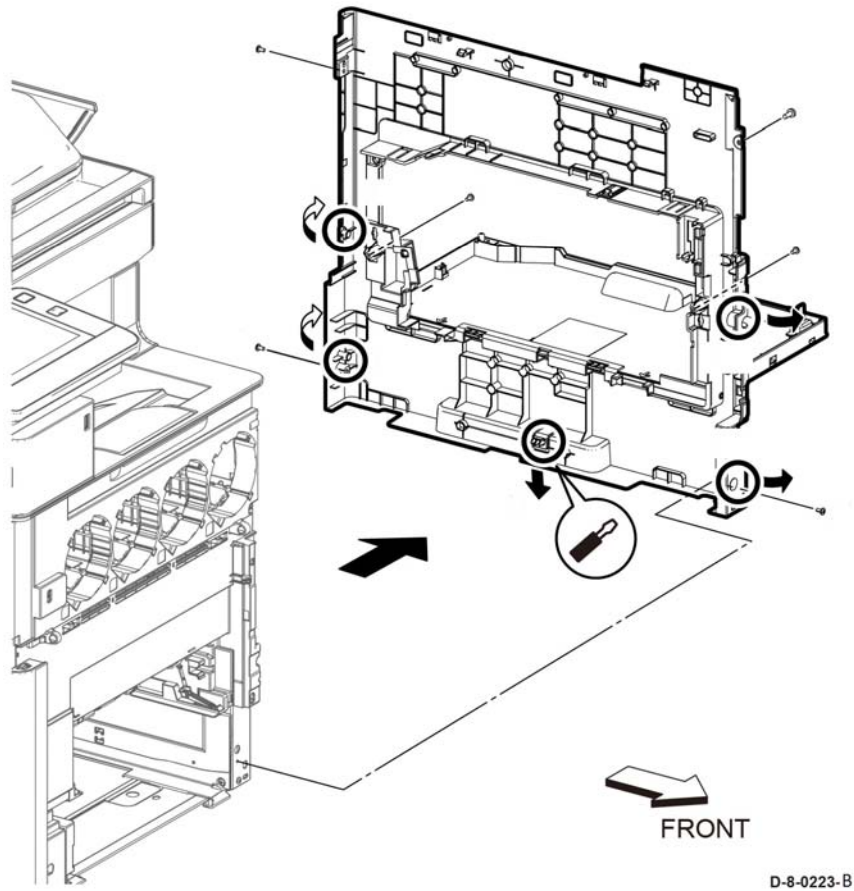
Figure 2 Remove the right side cover assembly (C505/C605/C605_Tall)

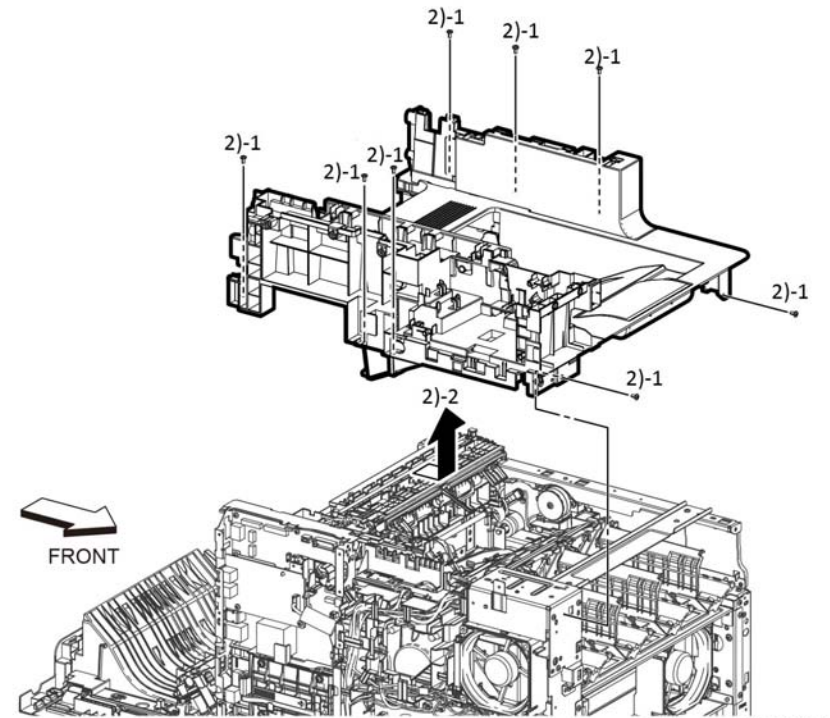
1. Open the rear cover assembly, [REP 19.18](#).
2. Perform the items that follow, [Figure 1](#):
 - 2-1 Remove eight screws ST18.
 - 2-2 Lift up and remove the top cover assembly.

NOTE: This includes the right IIT inner cover and left IIT inner cover.

Figure 1 Remove top cover assembly

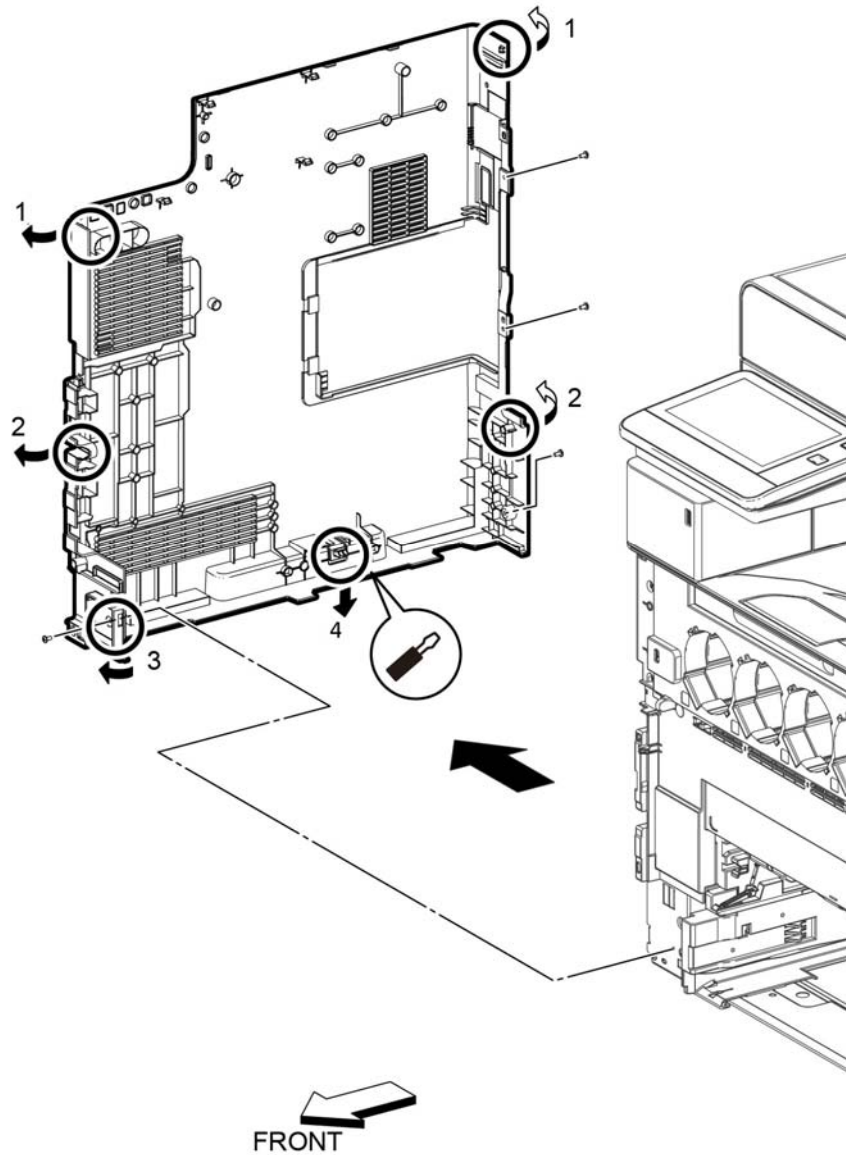
D-8-0225-b

Figure 1 Left side cover (C505/C605/C605_Tall) removal
