VersaLink[®] C500/C600 Printer and C505/C605 Multifunction Printer Service Manual

Xerox VersaLink C605F Family Printer Service Manual

705P01395

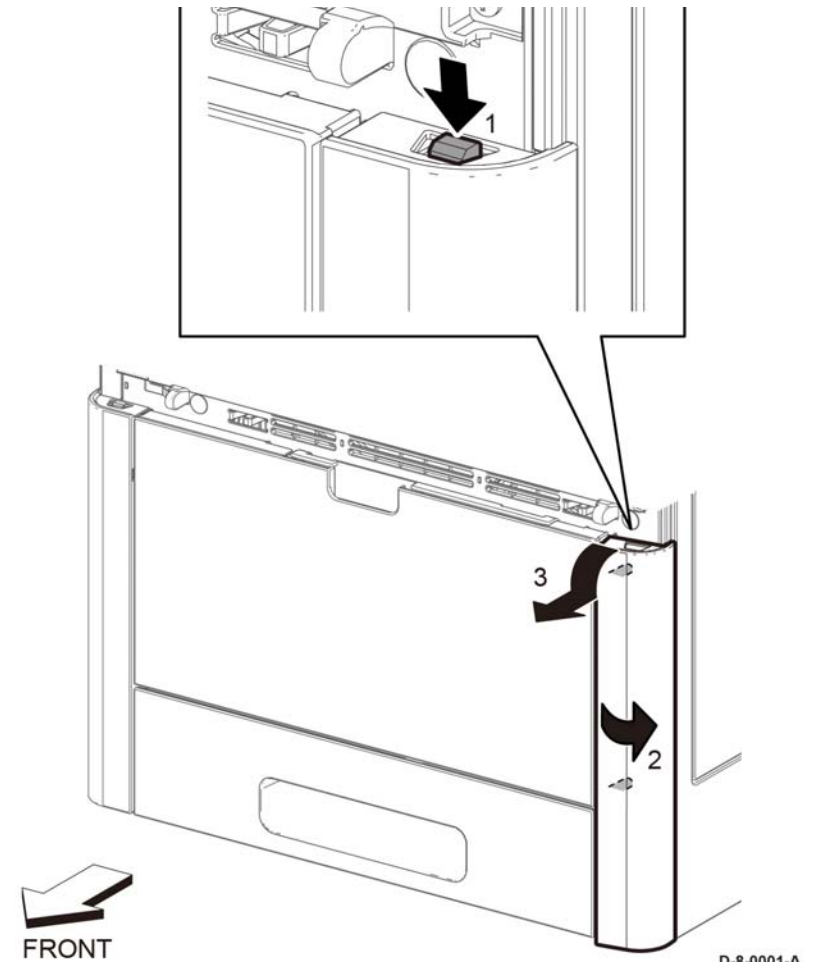
D-8-0001-A

1. Remove the toner cover, [REP 19.48](#).
2. Remove the MSI tray, [REP 13.5](#).
3. Remove the IOT paper tray, [REP 9.1](#).
4. Refer to [Figure 1](#), push and release button to release the hook at the top end of the right side front cover.
5. Press in at the two bosses and remove the right side front cover in the direction of the arrow.

Figure 1 Remove the Right Side Front cover (C500/C600)

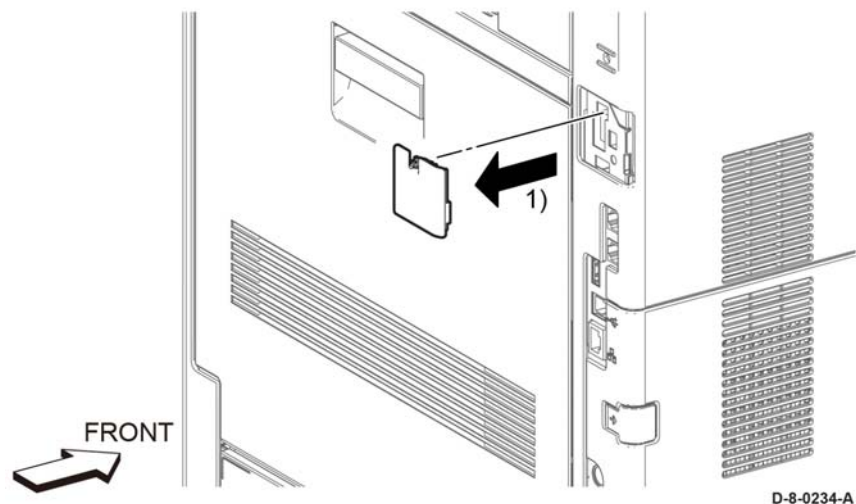
1. Release the hook and remove the WIFI cap, [Figure 1](#).

Figure 1 Remove the WIFI cap (C505/C605/C605_Tall)

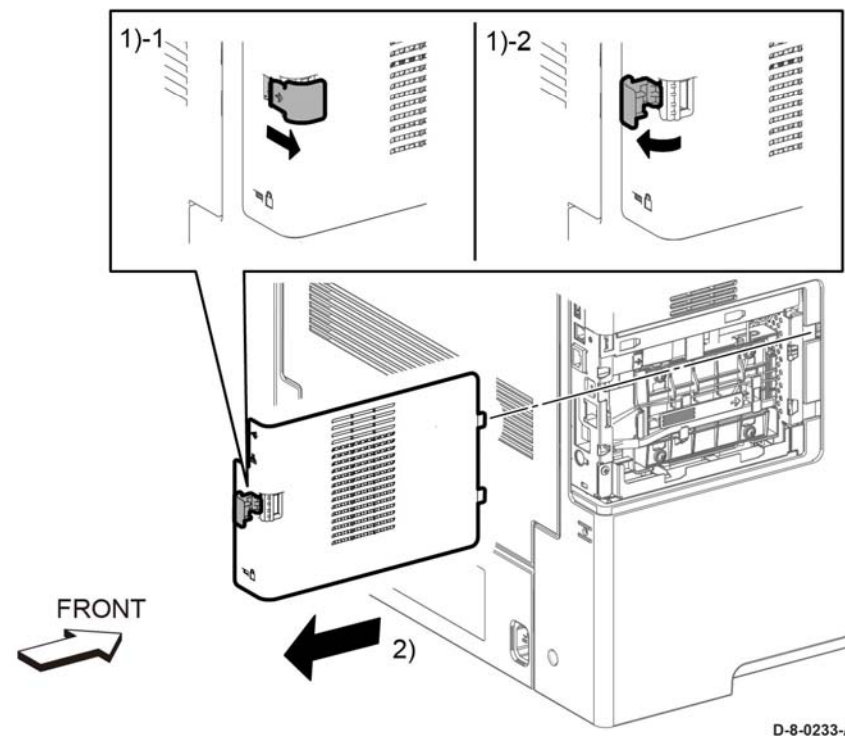
1. Perform the items that follow [Figure 1](#):
 - 1-1 Slide the lever as shown.
 - 1-2 rotate the lever as shown.
2. Remove the ESS window assembly.

Figure 1 Remove the ESS window assembly (C505/C605/C605_Tall)

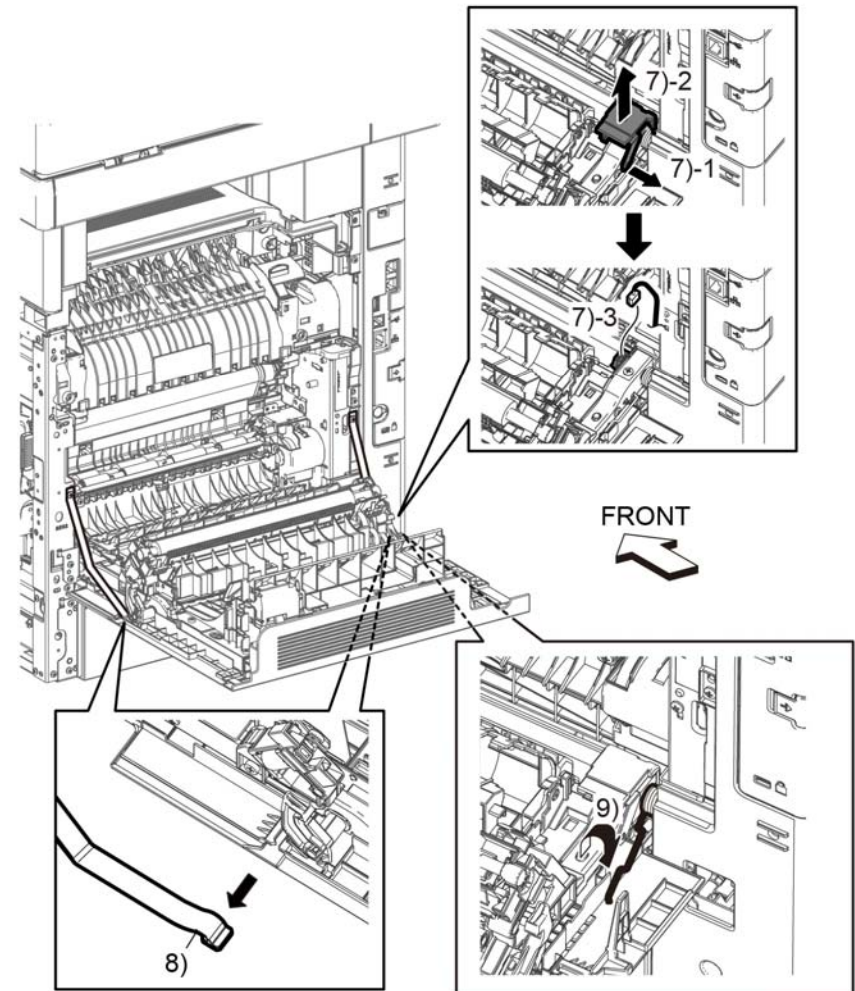
D-8-0227-A

1. Perform the items that follow, [Figure 1](#):
 - 1-1 Raise the lever.
 - 1-2 Remove the relay cover.
 - 1-3 Disconnect the connector, [P/J296](#).
2. Release two rear cover straps

Figure 1 Remove the rear cover assembly (C505/C605/C605_Tall)

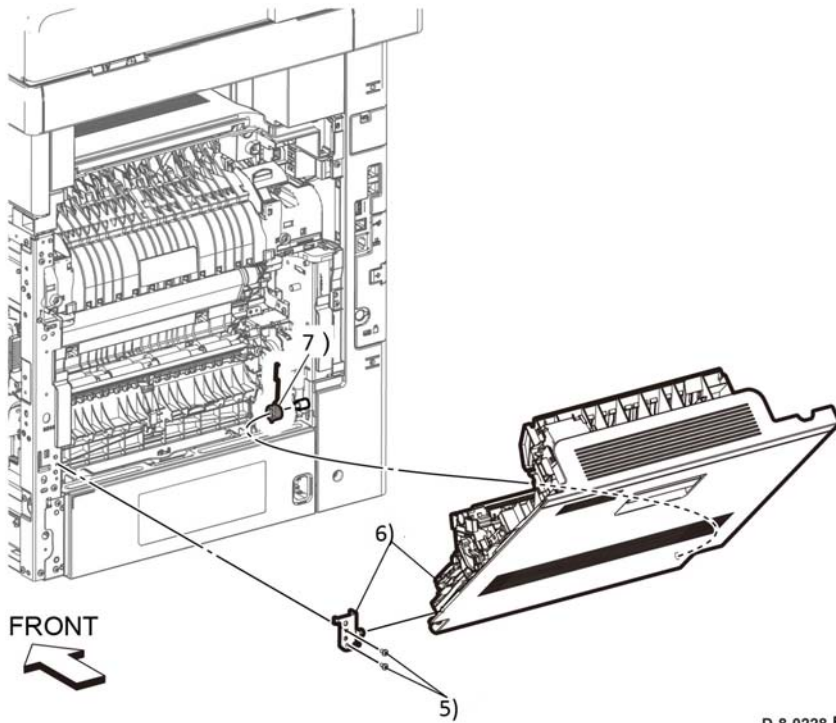
D-8-0228-B

Figure 2 Remove the rear cover assembly

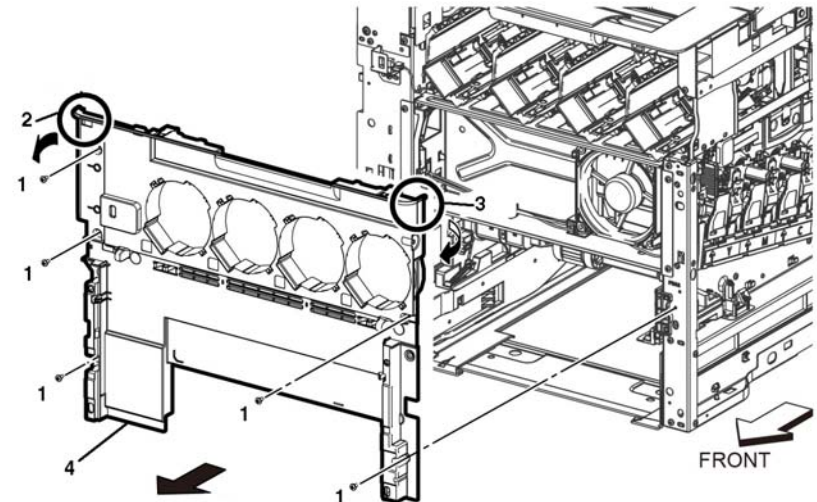
D-8-0229-A

1. Remove the finisher or mailbox if necessary.
2. Remove five screws, SM18, [Figure 1](#).
3. Perform the items that follow, [Figure 1](#).
 - 3-1 Release the hook on the left side.
 - 3-2 Release the hook on the right side.
 - 3-3 Remove the front inner cover.

Figure 1 Remove the front inner cover

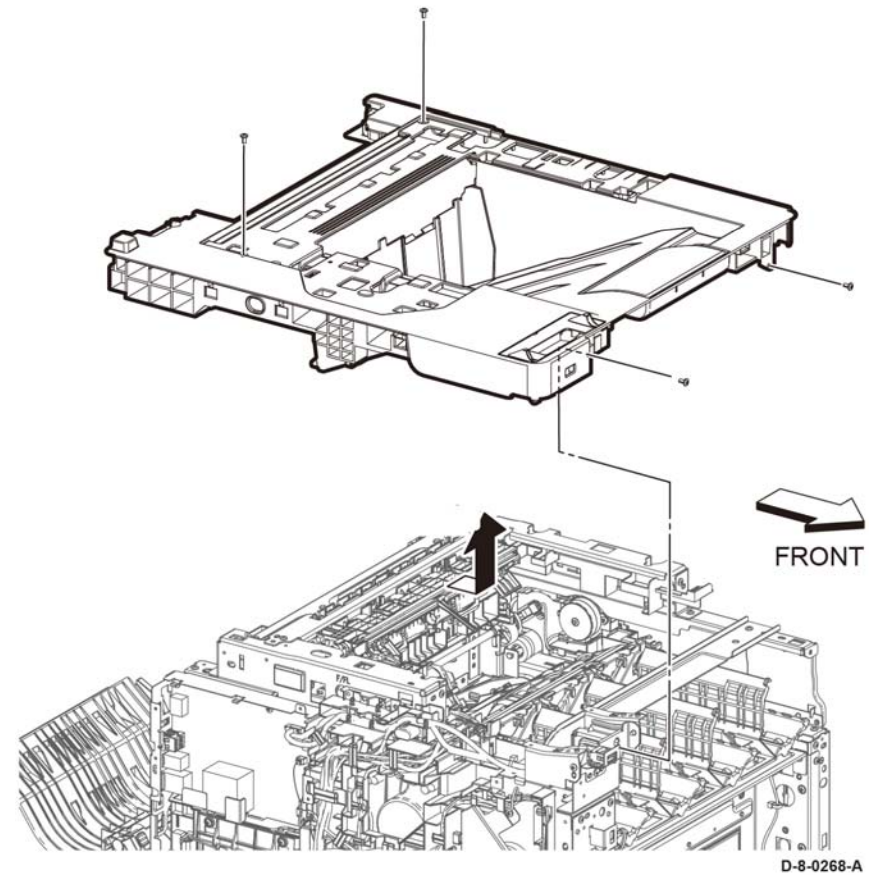
1. Remove the paper tray.
2. Remove the bypass tray assembly.
3. Remove the right side cover.
4. Remove the left side cover.
5. Remove the front inner cover.
6. Remove the left rear top cover.
7. Remove the right rear top cover.
8. Open the rear cover.
9. Remove the UI console.
10. Refer to [Figure 1](#), to remove the three screws (silver, M3x6mm) attaching the Top Cover Assembly, then lift up the cover.

Figure 1 Remove the Top Cover Assembly (C500/C600)

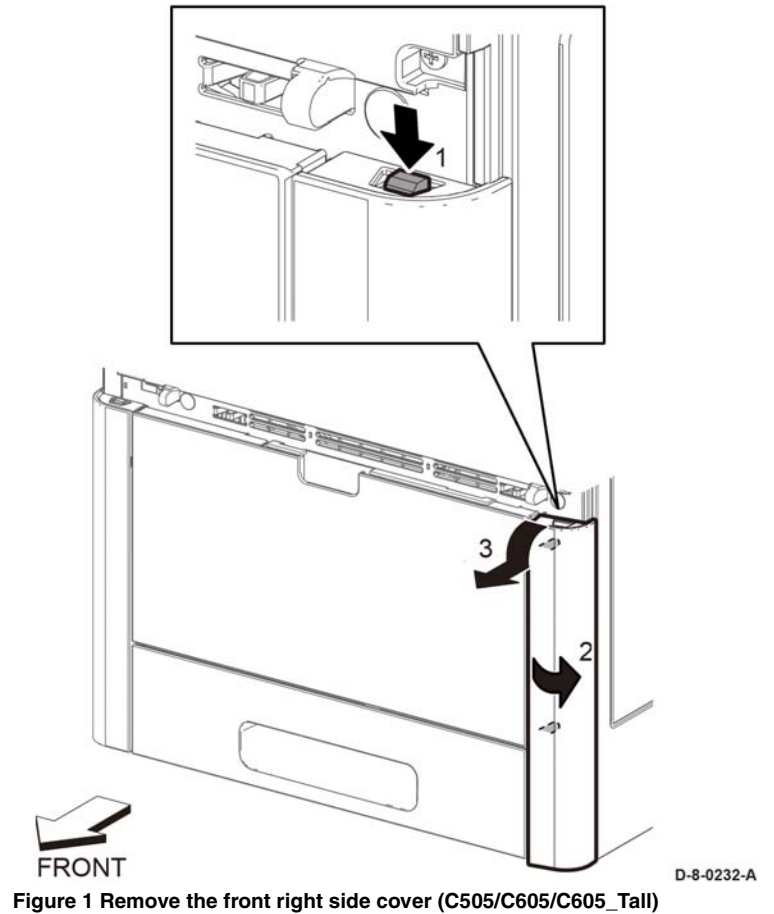
1. Remove the toner cover assembly, [REP 19.33](#).
2. Perform the steps that follow, [Figure 1](#):
 - 2-1 Press the hook.
 - 2-2 Rotate the right front cover as shown.
 - 2-3 Remove the right front cover.

Figure 1 Remove the front right side cover (C505/C605/C605_Tall)

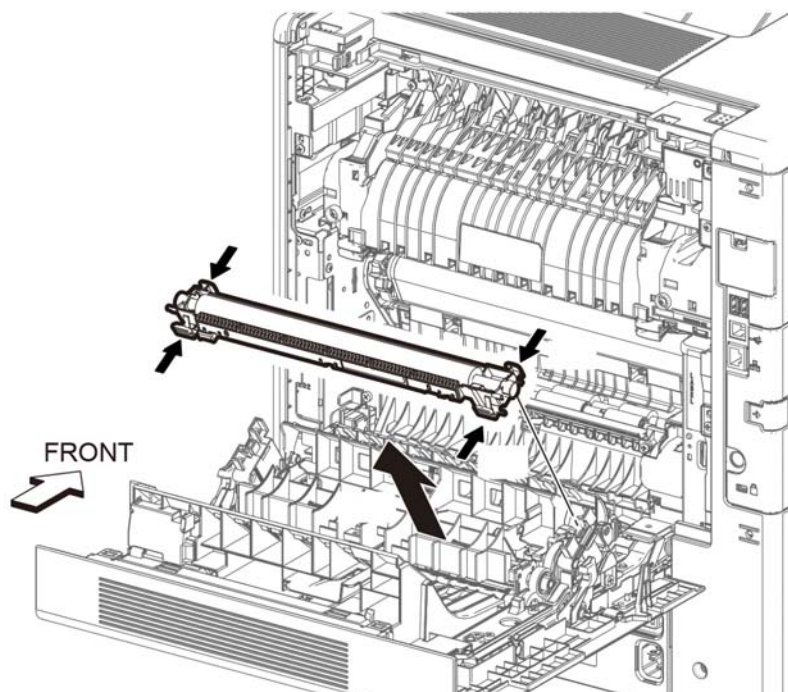
1. Open the Rear Cover, [REP 19.56](#).
2. Refer to [Figure 1](#), to release the four latches attaching the Second Bias Transfer Roller and remove the roller assembly.

Figure 1 Remove the Second Bias Transfer Roller Assembly (C500/C600)

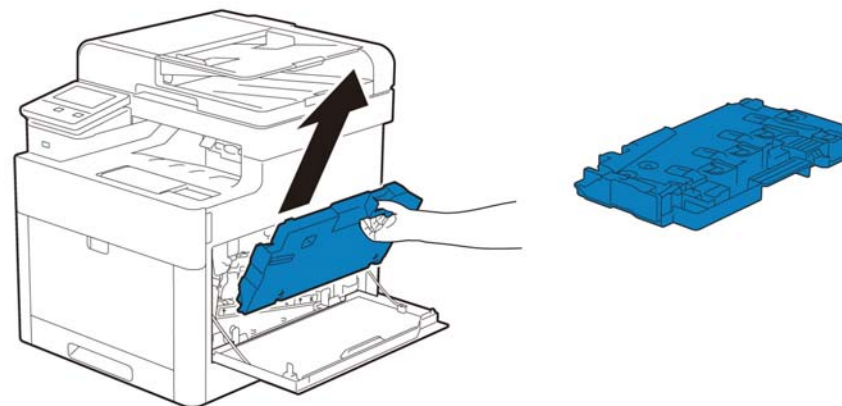
D-8-0462-A

1. Open the waste box cover on the right side, press the tab and remove the waste toner assembly, [Figure 1](#).

Figure 1 Remove the toner waste box assembly

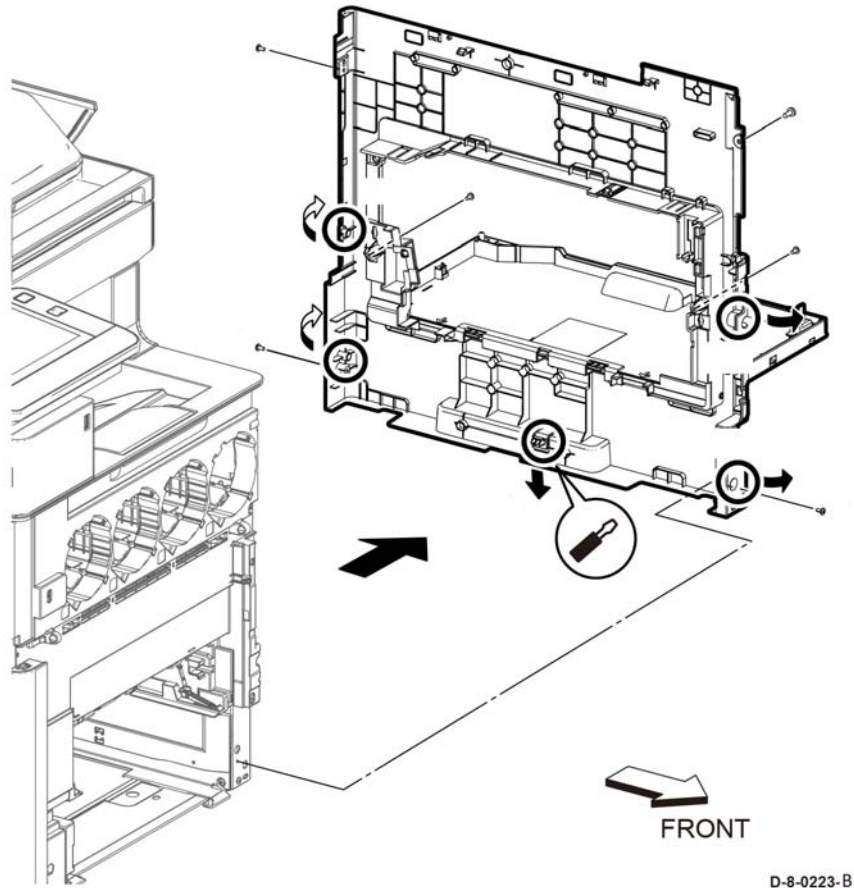
D-8-0223-B

3. Remove the items that follow, [Figure 2](#):
 - One screw ST6.
 - Five screws ST18.
4. Perform the items that follow, [Figure 1](#):
 - 4-1 Release one hook.
 - 4-2 Release one boss.
5. Release one hook at the bottom of the right side cover assembly, [Figure 2](#).

6. Perform the items that follow, **Figure 2**:
 - 6-1 Release one boss in the middle edge.
 - 6-2 Release one boss on the bottom edge.
 - 6-3 Remove the right side cover assembly.

Figure 2 Remove the right side cover assembly (C505/C605/C605_Tall-tall)

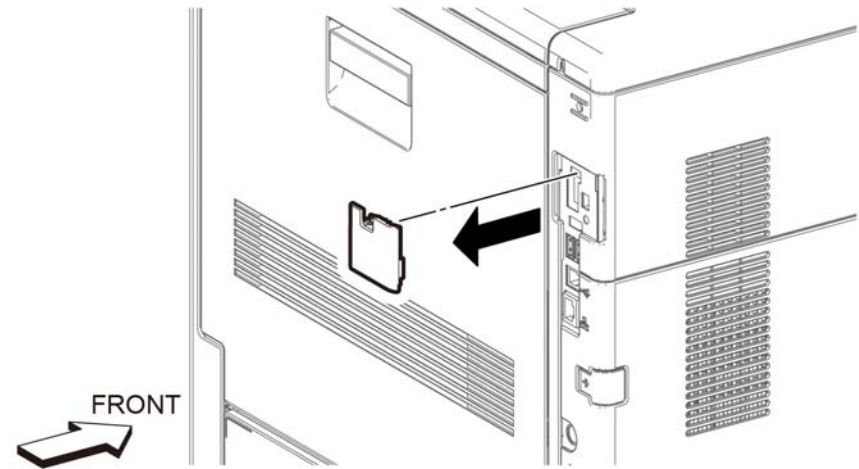
D-8-0278-A

1. Refer to **Figure 1**, to release the lever in the direction of the arrow.

Figure 1 Remove the ESS Window Assembly (C500/C600)

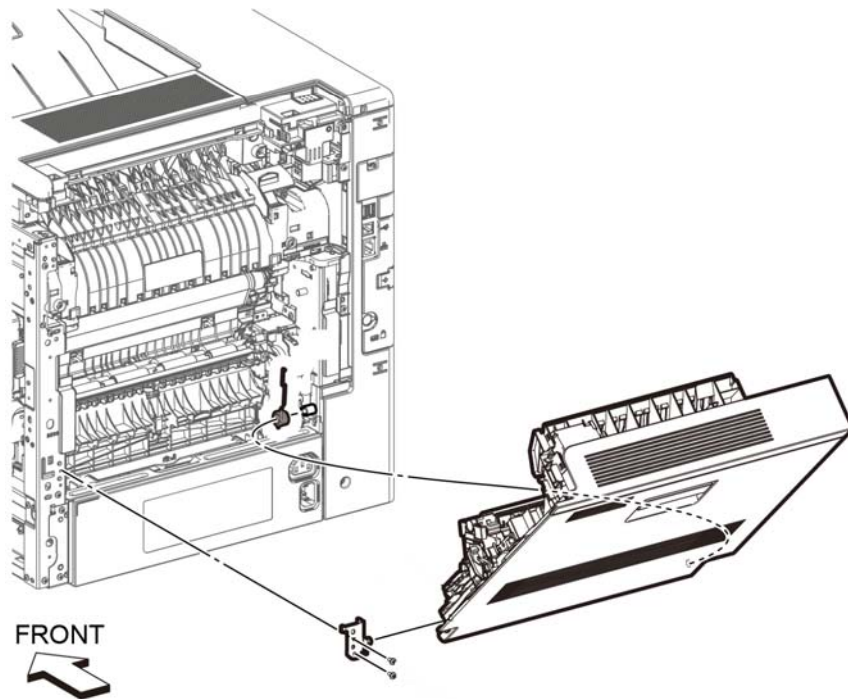
D-8-0272-A

1. Remove the right side cover.
2. Open the Rear Cover.;
3. Refer to [Figure 1](#), to remove the ends of the two rear cover straps from the rear cover.
4. close the rear cover.
5. Refer to [Figure 1](#), to remove the two screws (silver, M3x6mm) attaching the right rear hinge.

Figure 1 Remove the Rear Cover Assembly (C500/C600)

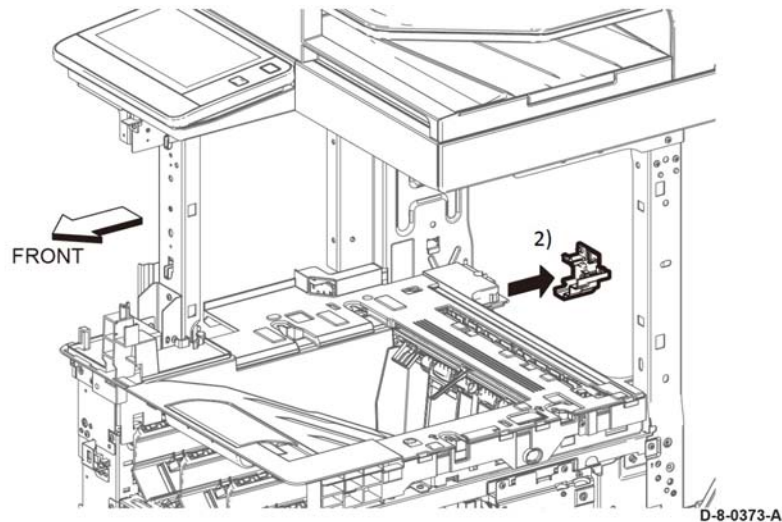
1. Open the rear cover assembly, [PL 19.2 Item 99](#).
2. Remove the OPT blind cover, [Figure 1](#):

Figure 1 Remove the OPT blind cover

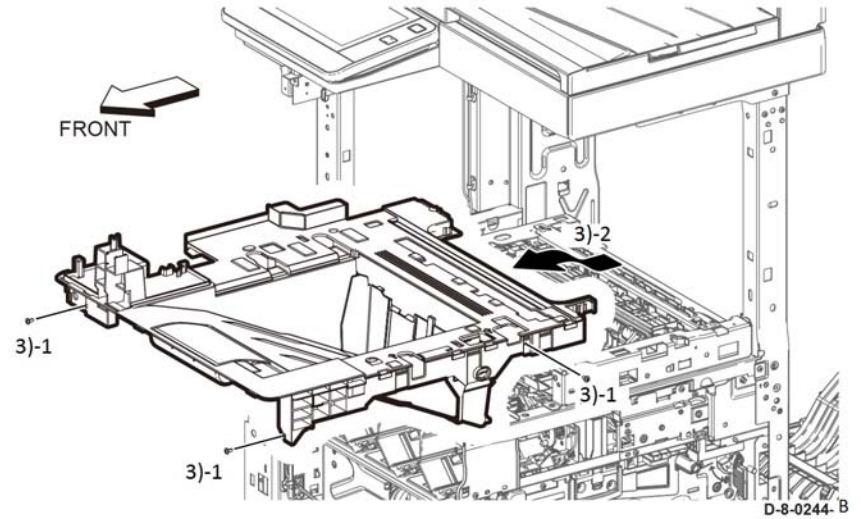
3. Perform the items that follow:
 - 3-1 Remove three screws SM18.
 - 3-2 Remove the top cover assembly.

Figure 2 Remove top cover

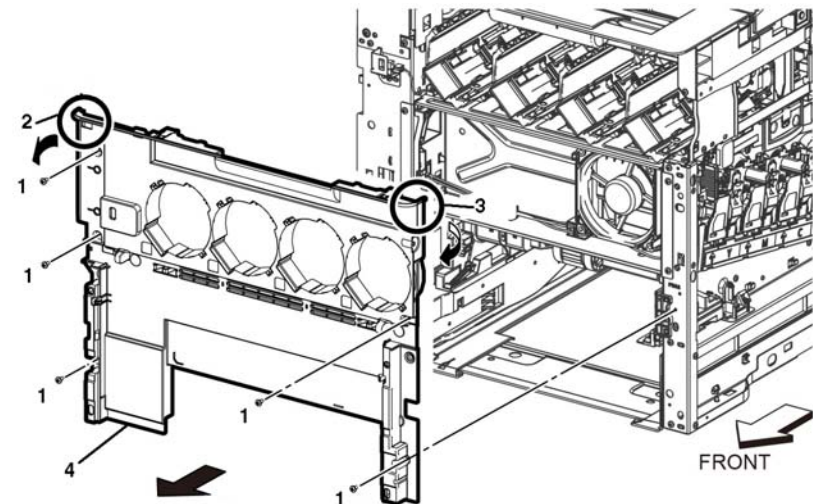
D-8-0229-A

1. Remove the finisher or mailbox as necessary.
2. Remove five screws, SM18, [Figure 1](#).
3. Perform the items that follow, [Figure 1](#).
 - 3-1 Release the hook on the left side.
 - 3-2 Release the hook on the right side.
 - 3-3 Remove the front inner cover.

Figure 1 Remove the front inner cover

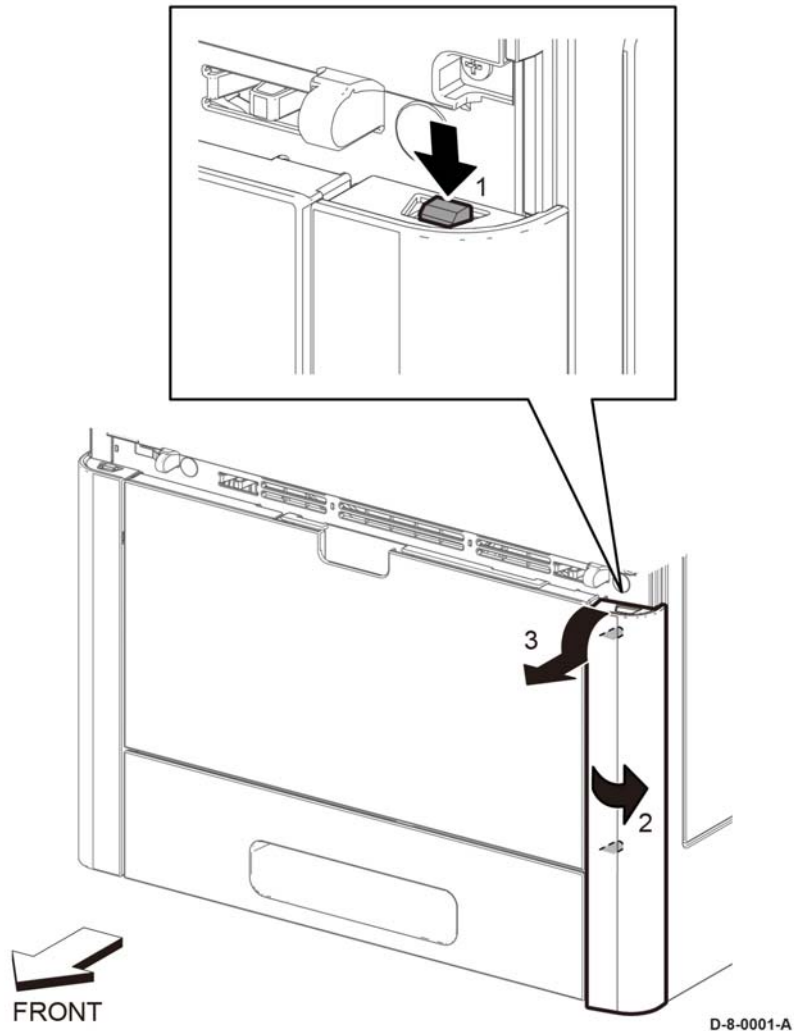
Figure 1 Remove the front right side cover (C500/C600)

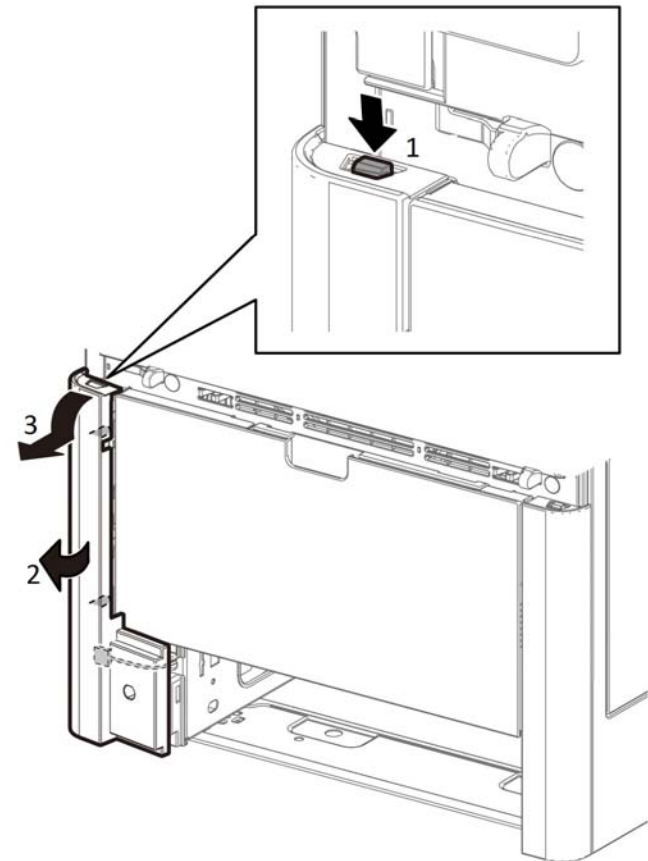
D-8-0231-B

- 1-3 Remove the left front cover.
2. Refer Disconnect the connector, [P/J521](#).

Figure 1 Remove the left side front cover

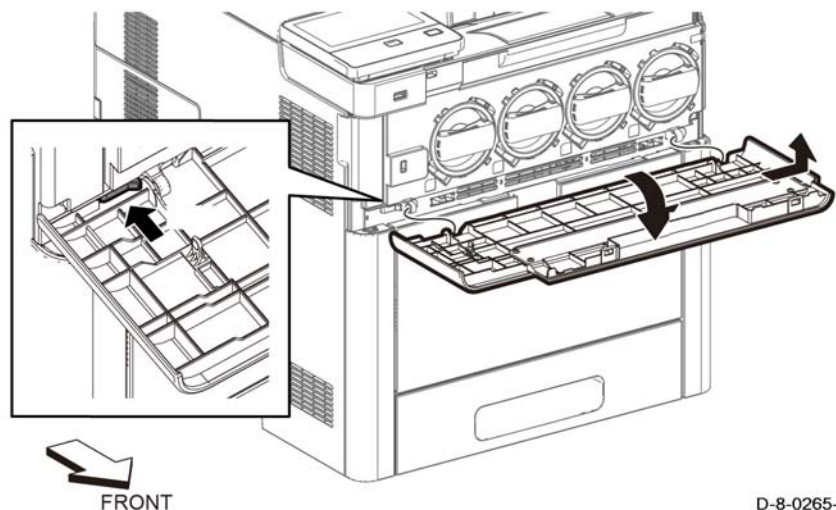
1. Open the Toner Cover Assembly, [Figure 1](#).
2. Perform the items that follow:
 - 2-1 Push the hook as shown.
 - 2-2 Remove the toner cover assembly.

Figure 1 Toner cover assembly removal

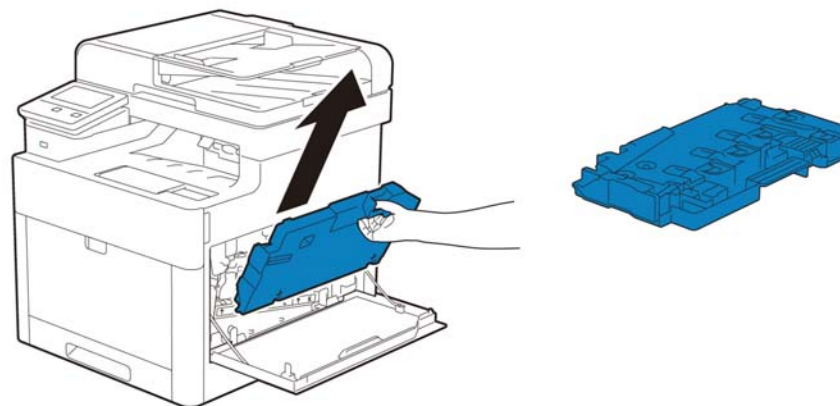
1. Open the waste box cover on the right side, press the tab and remove the waste toner assembly, [Figure 1](#).

Figure 1 Remove the toner waste box assembly

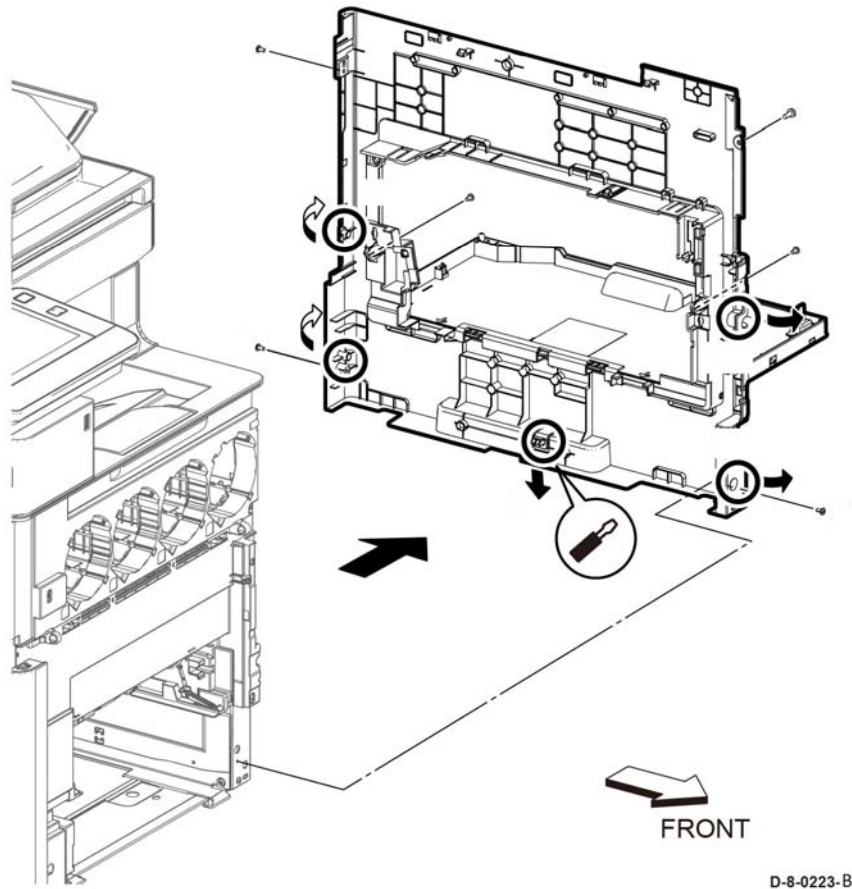
Figure 2 Remove the right side cover assembly (C500/C600)

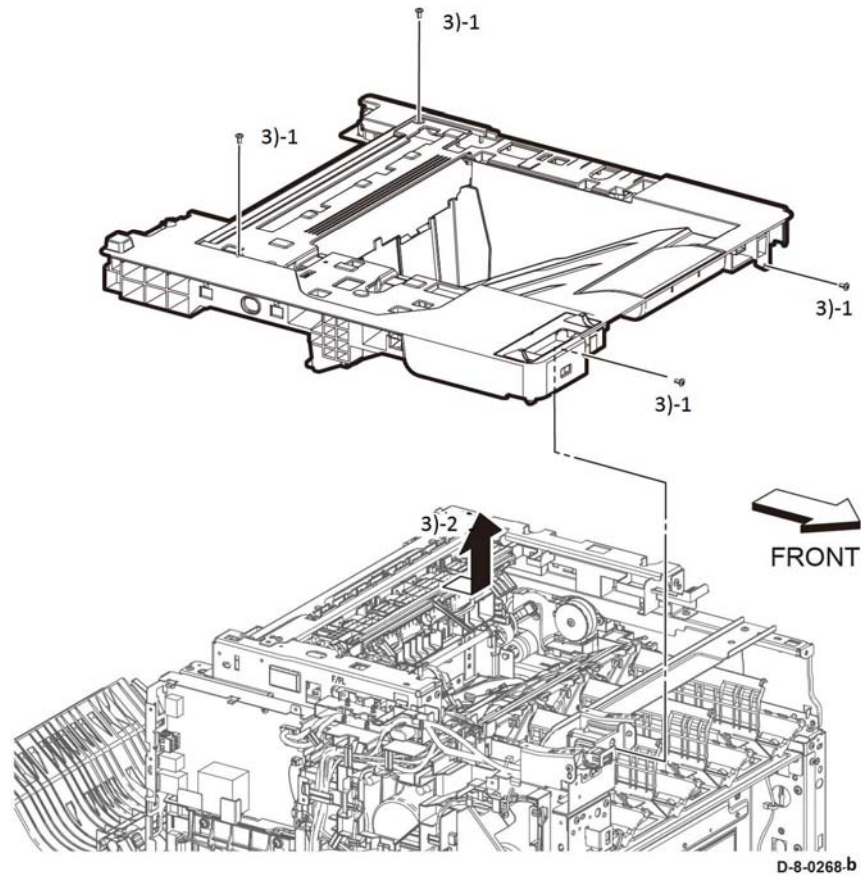
Figure 2 Remove top cover

3. Perform the items that follow:
 - 3-1 Remove four screws SM18.

3-2 Remove the top cover assembly.

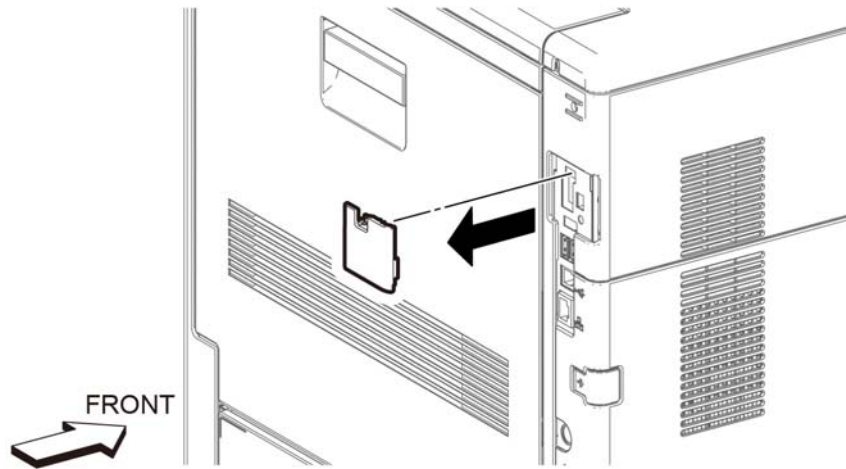
Figure 1 WIFI cap (C500/C600) removal

1. Release the hook and remove the WIFI cap, [Figure 1](#).

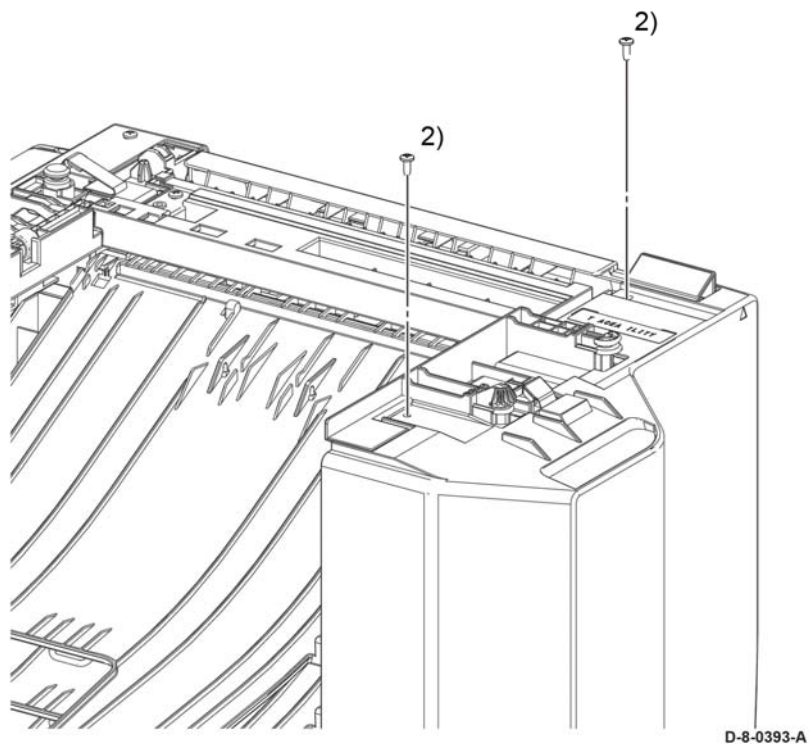
Figure 1 Removing bottom screws

1. Remove the mailbox from the IOT, then turn the mailbox upside down.
2. Remove two screws SM20, [Figure 1](#).

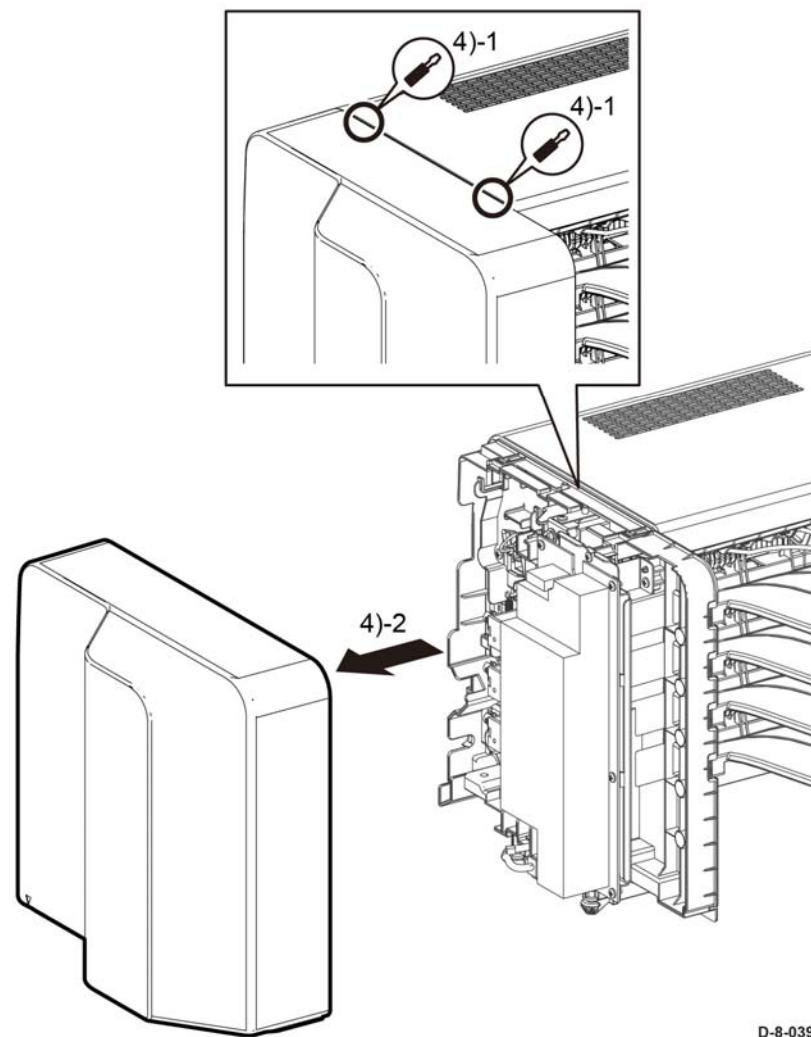
Figure 2 Left cover removal

4-2 Remove the cover LH C.

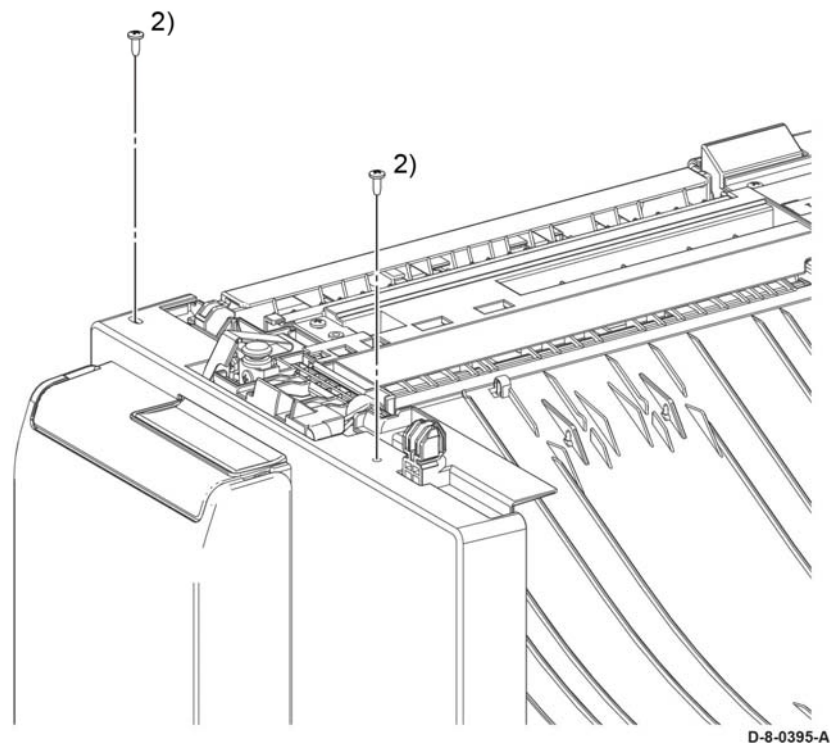
Figure 1 right hand cover bottom screws

1. Remove the mailbox from the IOT, then turn the mailbox upside down.
2. Remove two screws SM20, [Figure 1](#).

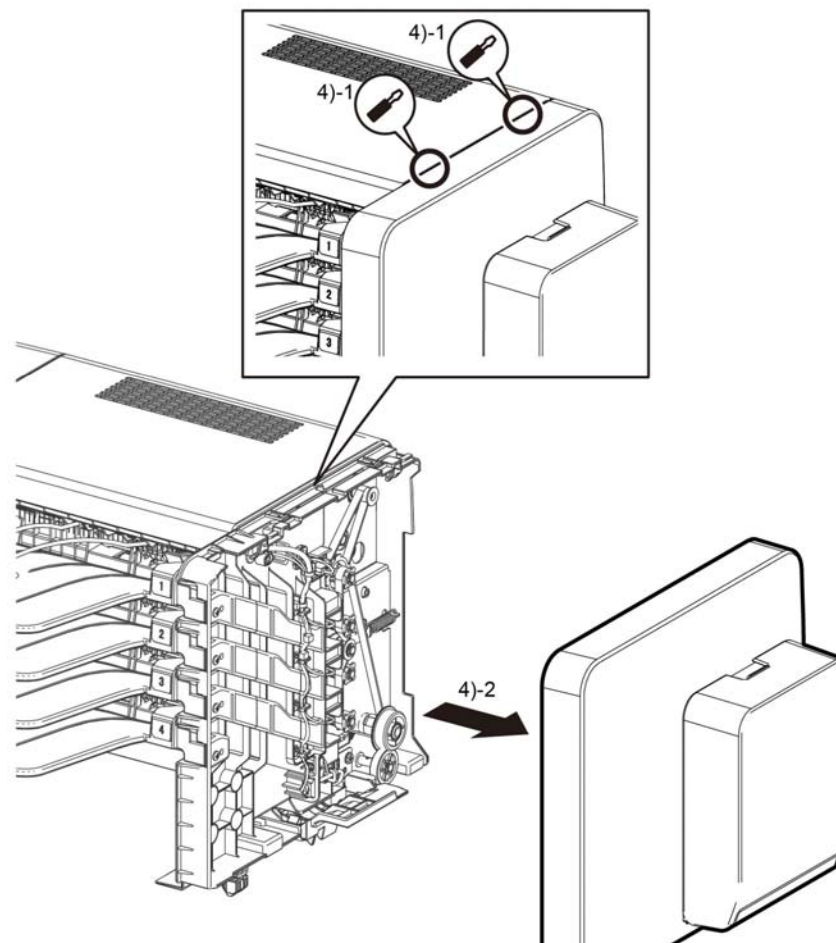
Figure 2 Right cover removal

3. Turn the mailbox right side up.
4. Perform the items that follow, [Figure 2](#):
 - 4-1 Release the two tabs.

4-2 Remove the cover RH C.

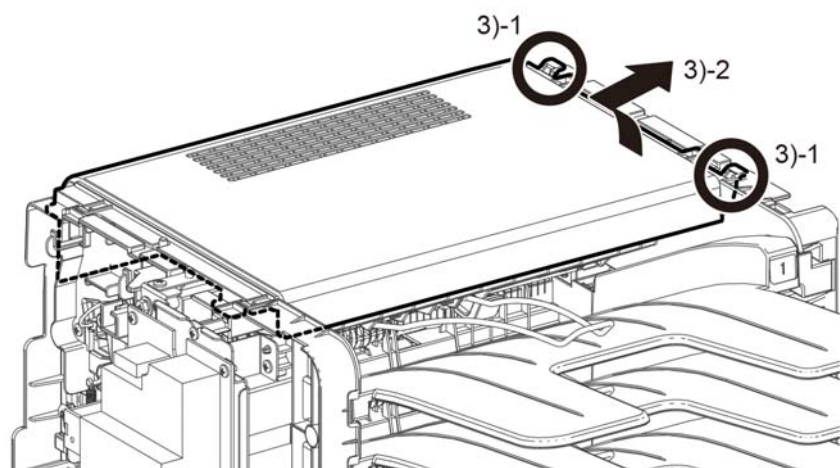
Figure 1 Top cover removal

1. Remove the cover LH C, [REP 20.1](#).
2. Remove the cover RH C/cover assembly staple, [REP 20.2](#).
3. Perform the items that follow, [Figure 1](#):
 - 3-1 Use a flat blade screwdriver and release the two tabs.
 - 3-2 Remove the cover top C.

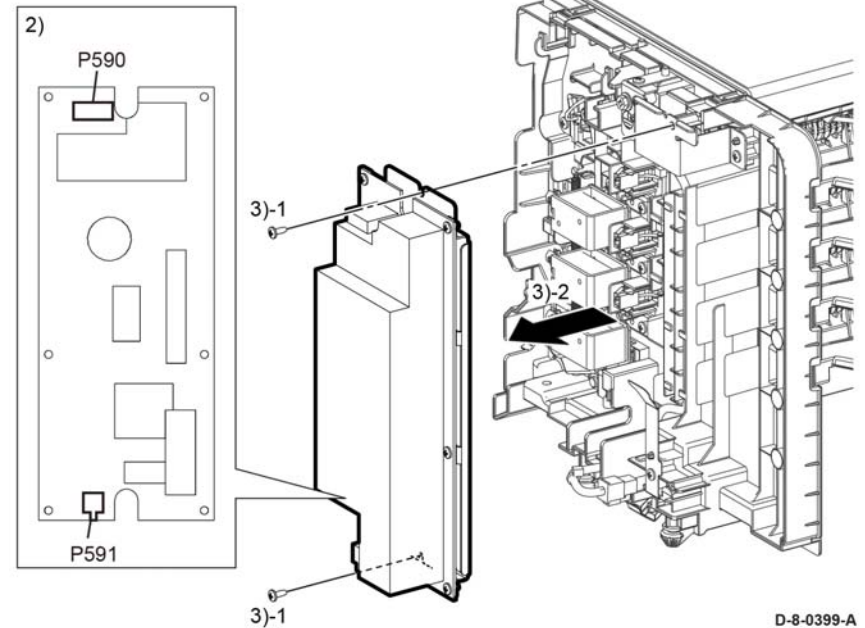
Figure 1 LVPS PWB removal

1. Remove the cover LH C, [REP 20.1](#).
2. Disconnect two connectors, [P/J590](#), [P/J591](#), [Figure 1](#).
3. Remove the components that follow, [Figure 1](#):
 - 3-1 Two screws, ST20.
 - 3-2 Remove the LVPS PWB.

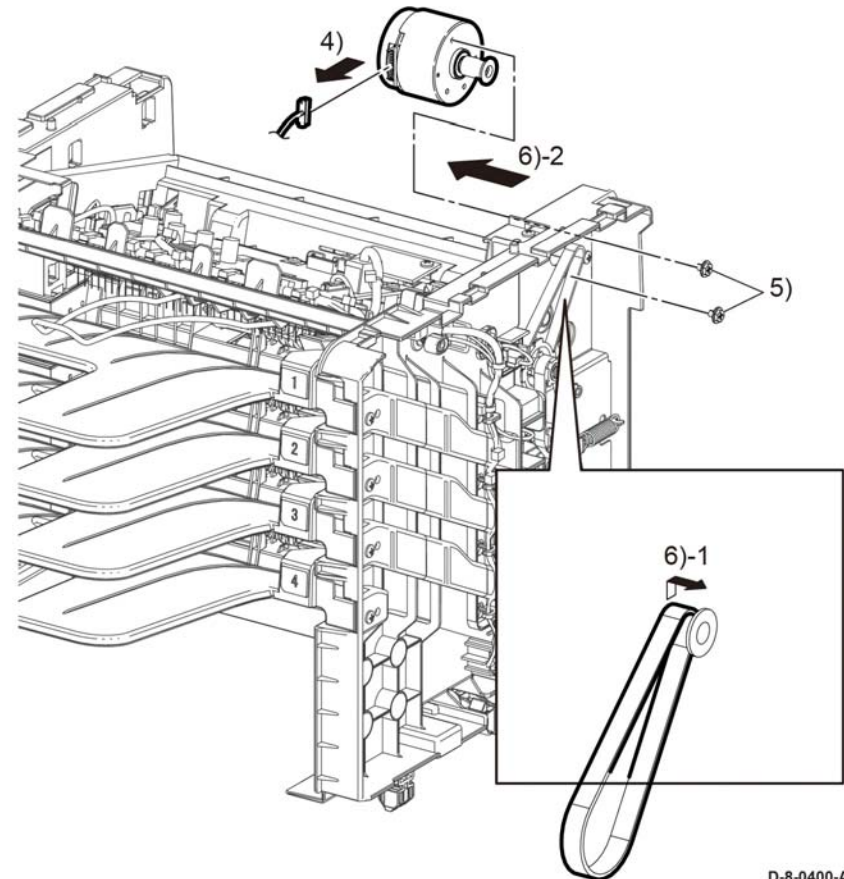
Figure 1 Motor assembly removal

1. Remove the cover LH C, [REP 20.1](#).
2. Remove the cover RH C/cover assembly staple, [REP 20.2](#).
3. Remove the cover top C, [REP 20.3](#).
4. Disconnect the connector, [P/J8910](#), [Figure 1](#).
5. Remove two screws, SM25.
6. Remove the items that follow, [Figure 1](#):
 - 6-1 Belt.
 - 6-2 Motor

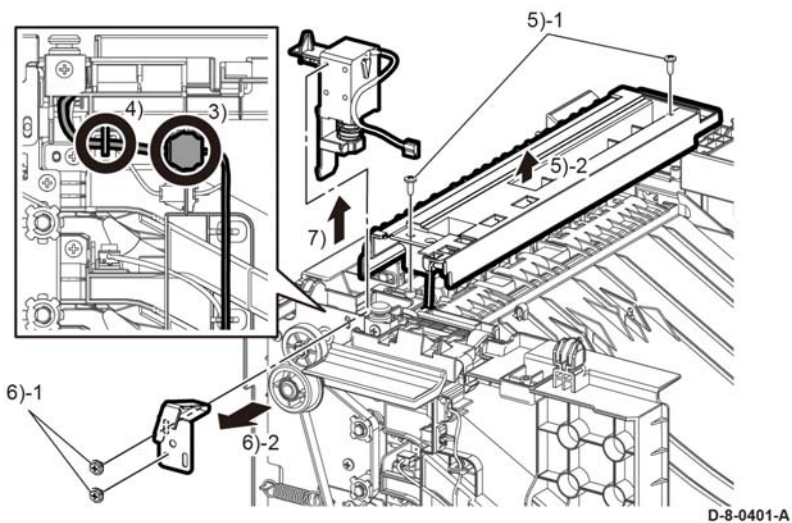
Figure 1 Gate solenoid removal

5. Remove the components that follow, [Figure 1](#):
 - 5-1 Two screws, ST20.
 - 5-2 Release the chute low mbx.
6. Remove the components that follow, [Figure 1](#):
 - 6-1 Two screws, SM25.
 - 6-2 Ground plate RH.
7. Remove the solenoid assembly gate while pulling out the harness through hole A.

When releasing the chute low MBX in the next step, be careful not to damage the harness assembly vertical LED, [PL 20.2.9](#).

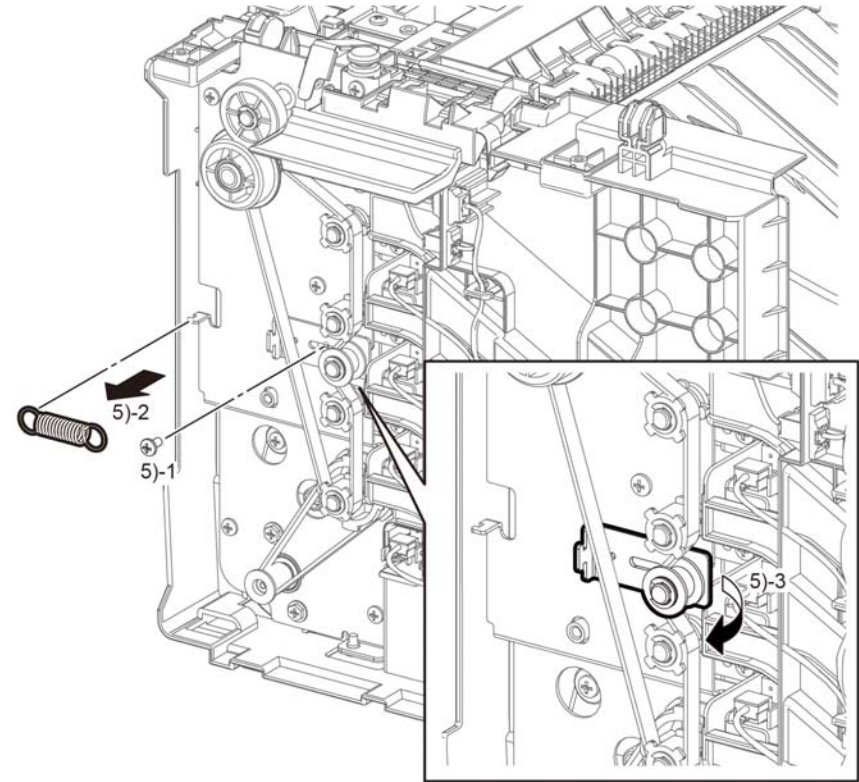
Figure 1 Tension pulley removal

1. Remove the cover LH C, [REP 20.1](#).
2. Remove the cover RH C/cover assembly staple, [REP 20.2](#).
3. Remove the tray assembly bottom, [REP 20.9](#).
4. Turn the mailbox up side down as shown in [Figure 1](#).
5. Remove the components that follow, [Figure 1](#):
 - 5-1 One screw, SM18.
 - 5-2 Spring tension, [PL 20.2 Item 16](#).
 - 5-3 Bracket assembly tension, [PL 20.2 Item 17](#).
 - 5-4 Pulley tension spring, [PL 20.2 Item 16](#).

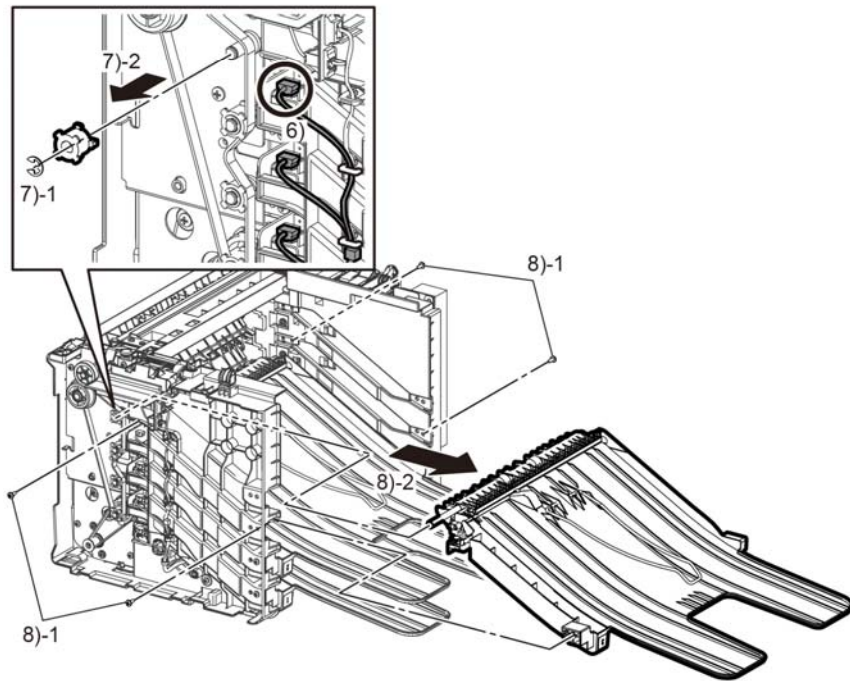
Figure 2 3rd tray assembly

6. Disconnect the connector [P/J8934](#), [Figure 2](#).
7. Remove the items that follow, [Figure 2](#):
 - 7-1 E-ring.
 - 7-2 Pulley. T20 MBX and Bushing while releasing the belt.
8. Remove the items that follow, [Figure 2](#):
 - 8-1 Four screws, ST20.
 - 8-2 3rd tray assembly, [PL 20.1 Item 2](#).

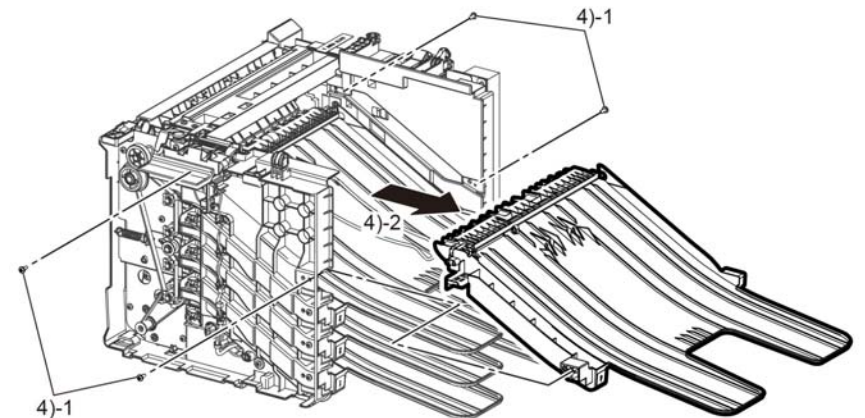
Figure 1 Bottom tray assembly removal

1. Remove the cover LH C, [REP 20.1](#).
2. Remove the cover RH c/cover assembly staple, [REP 20.2](#).
3. Turn the mailbox upside down as shown in [Figure 1](#).
4. Remove the items that follow, [Figure 1](#):
 - 4-1 Four screws, ST20.
 - 4-2 Tray assembly bottom, [PL 20.1 Item 3](#).

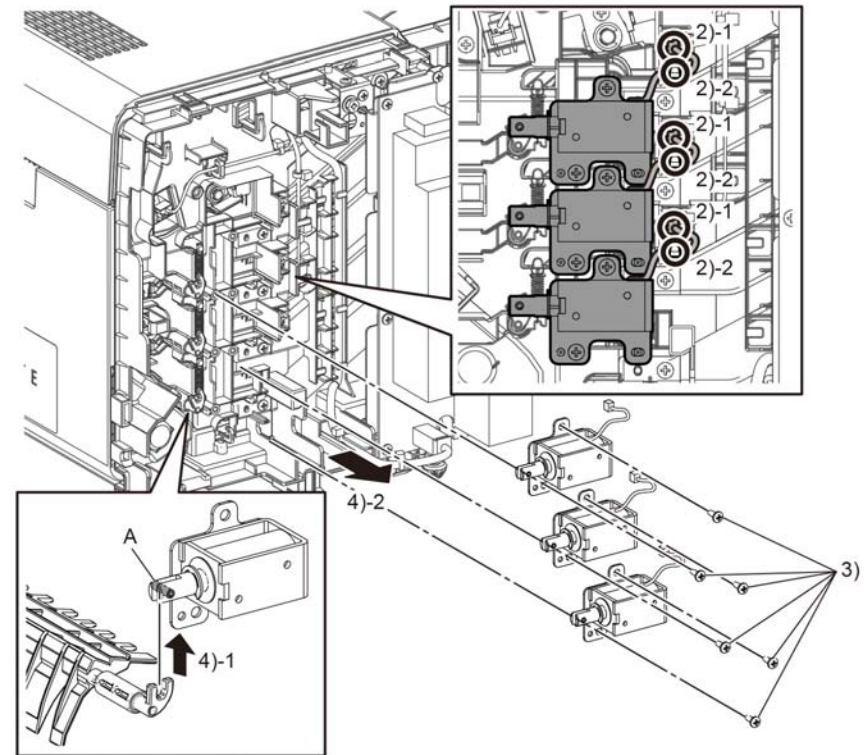
Figure 1 Bin gate solenoid removal

1. Remove the cover LH C, [REP 20.1](#).
2. Perform the items that follow, [Figure 1](#):
 - 2-1 Remove the connector from defective bin gate solenoid [P/J8940](#), or [P/J8941](#), or [P/J8942](#).
 - 2-2 Release the harness from the harness guides
3. Remove two screws, ST20, from the defective bin gate solenoid.
4. Perform the items that follow, [Figure 1](#):
 - 4-1 Disengage the link arm from the defective bin gate solenoid.
 - 4-2 Remove bin assembly gate solenoids.
