VersaLink[®] C500/C600 Printer and C505/C605 Multifunction Printer Service Manual

Xerox VersaLink C605F Family Printer Service Manual

705P01395

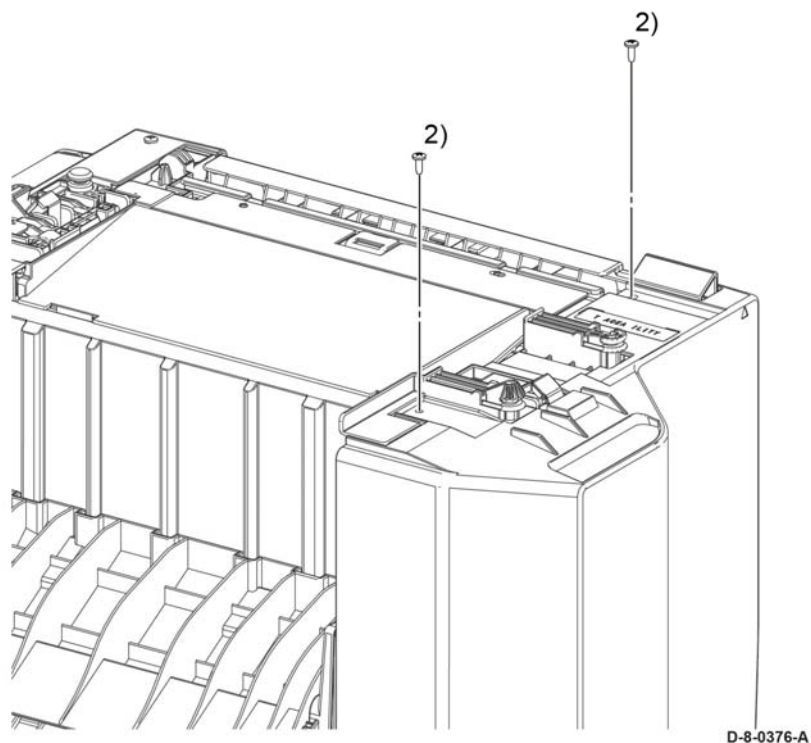
Figure 1 Removing bottom screws

2. Remove two screws, ST20, [Figure 1](#).

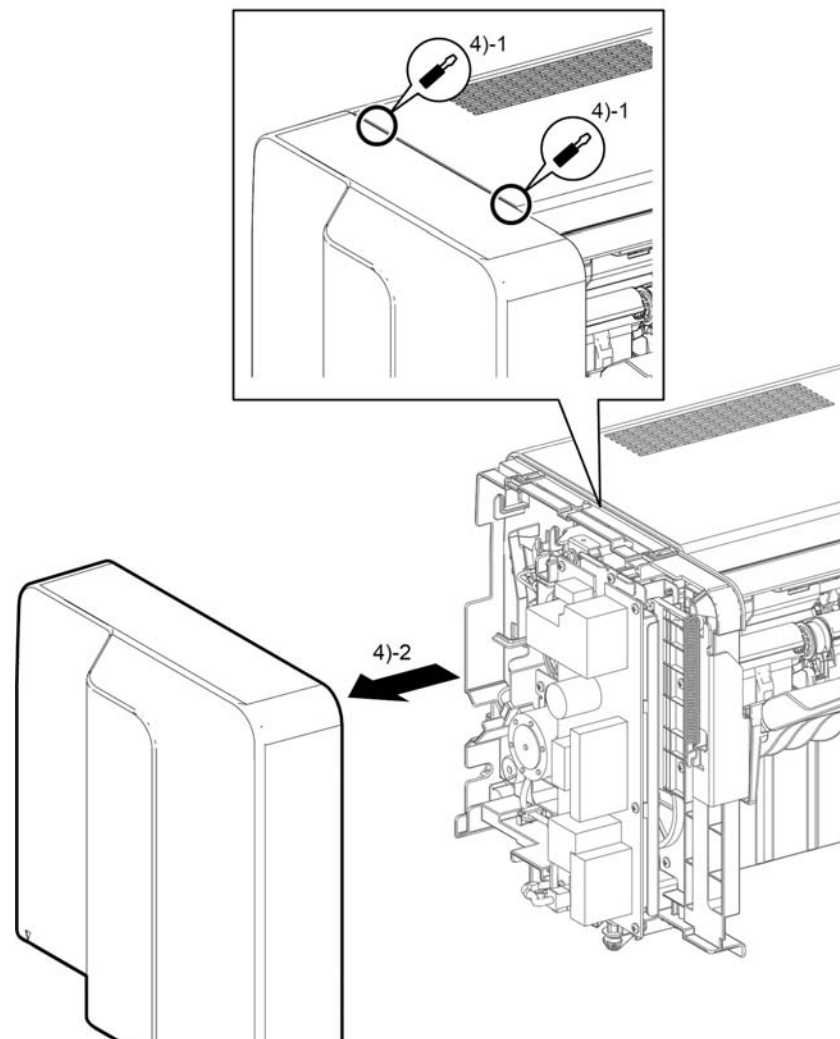
Figure 2 Left cover removal

3. Turn the finisher right side up.
4. Perform the steps that follow, [Figure 2](#):
 - 4-1. Use a flat blade screwdriver to release the two tabs.
 - 4-2. Remove the cover LH C.

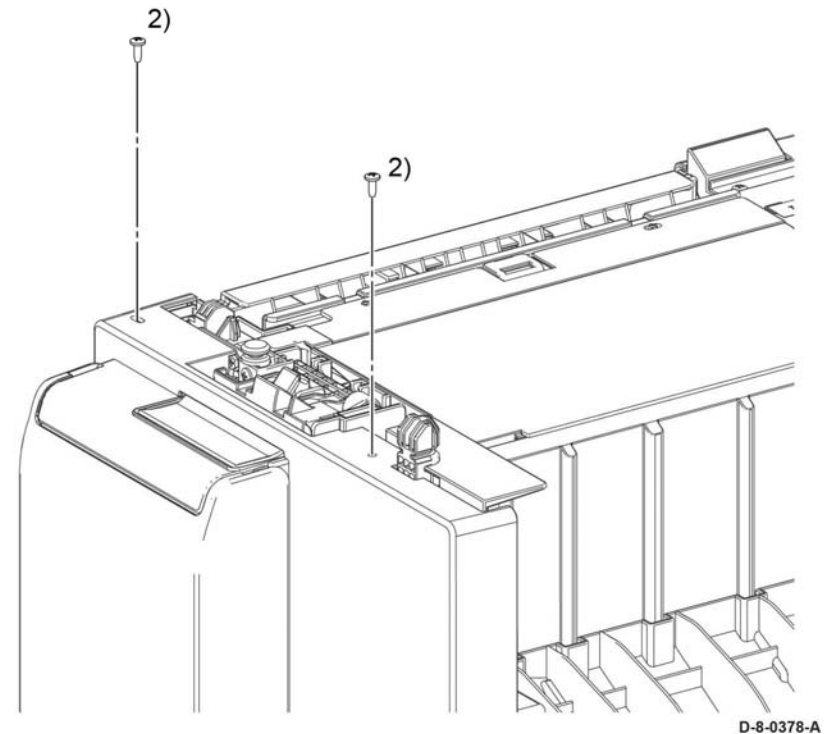
Figure 1 Right hand cover bottom screws

1. Perform the steps that follow:
 - Remove the finisher.
 - Turn the finisher upside down.
2. Remove two screws, ST20, [Figure 1](#).

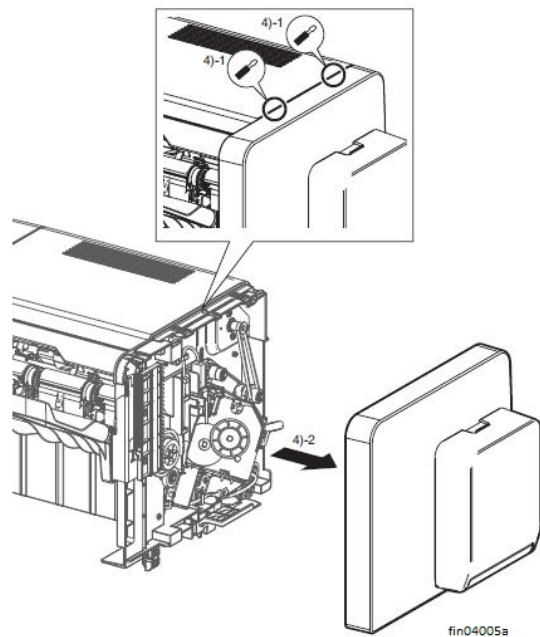
Figure 2 Right cover removal

4. Perform the steps that follow, [Figure 2](#).
 - 4-1 Insert a flat blade screwdriver to release the two tabs.
 - 4.2 Remove the cover RH C.

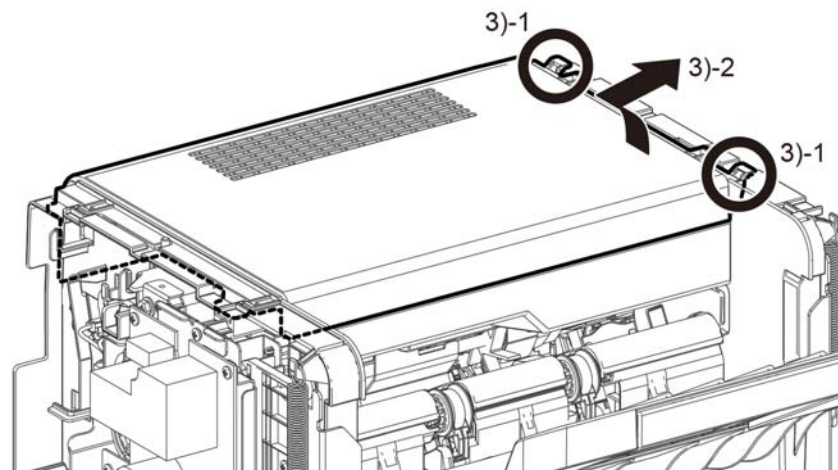
Figure 1 Top cover removal

1. Remove the cover LH C, [REP 21.1](#).
2. Remove the cover RH C, [REP 21.2](#).
3. Perform the items that follow, [Figure 1](#):
 - 3-1 Release two tabs.
 - 3-2 Remove the top cover C.

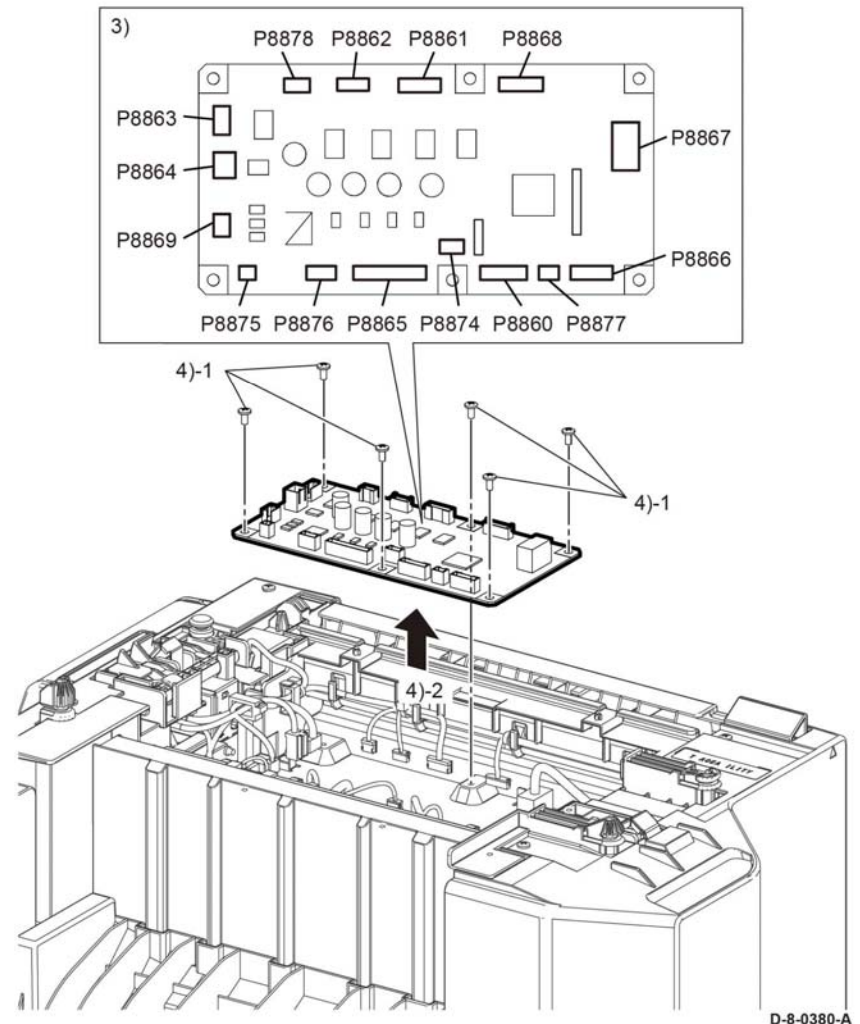
Figure 1 Finisher PWB removal

1. Remove the cover lower C, [REP 21.8](#).
2. Turn the finisher upside down.
3. Disconnect all connectors, [Figure 1](#).
4. Remove the components that follow:
 - 4-1 Six screws, SM18.
 - 4-2 Finisher PWB.

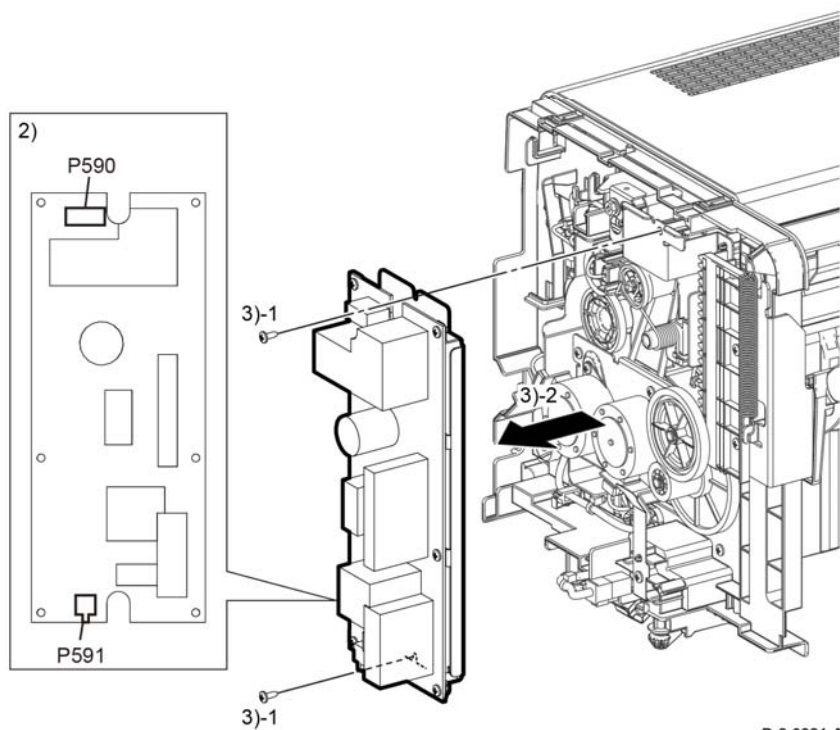
Figure 1 LVPS PWB removal

1. Remove the cover LH C, [REP 21.1](#).
2. Disconnect two connectors, [P/J590](#), [P/J591](#), [Figure 1](#).
3. Remove the components that follow:
 - 3-1 Two screws, ST20.
 - 3-2 LVPS PWB.

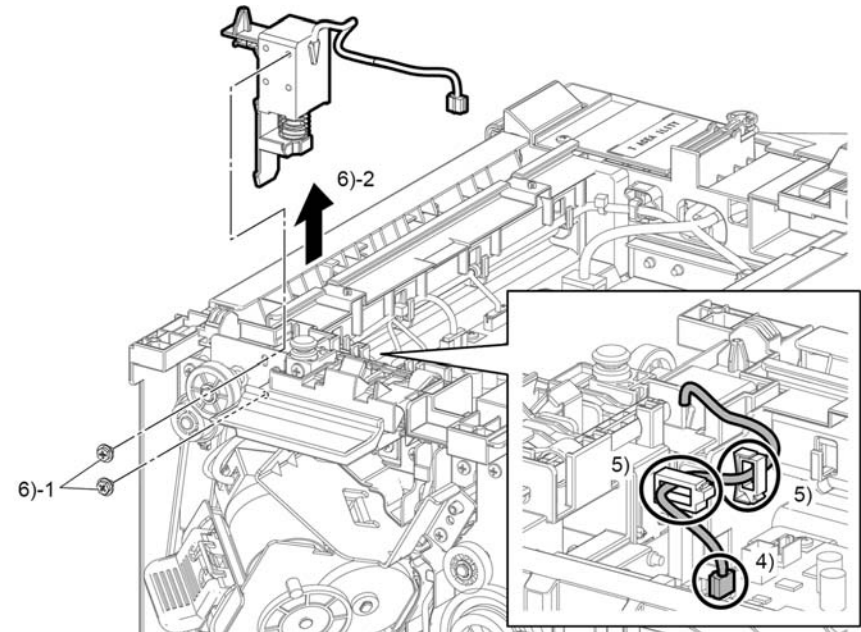
Figure 1 Solenoid gate assembly removal

1. Remove the cover RH C, [REP 21.2](#).
2. Remove the Cover lower C, [REP 21.8](#).
3. Turn the finisher upside down as shown in [Figure 1](#).
4. Disconnect the connector [P/J8869](#).
5. Release the solenoid assembly gate harness from the two clamps, [Figure 1](#).
6. Remove the components that follow, [Figure 1](#):
 - 6-1 Two screws, SM25.
 - 6-2 Gate solenoid assembly.

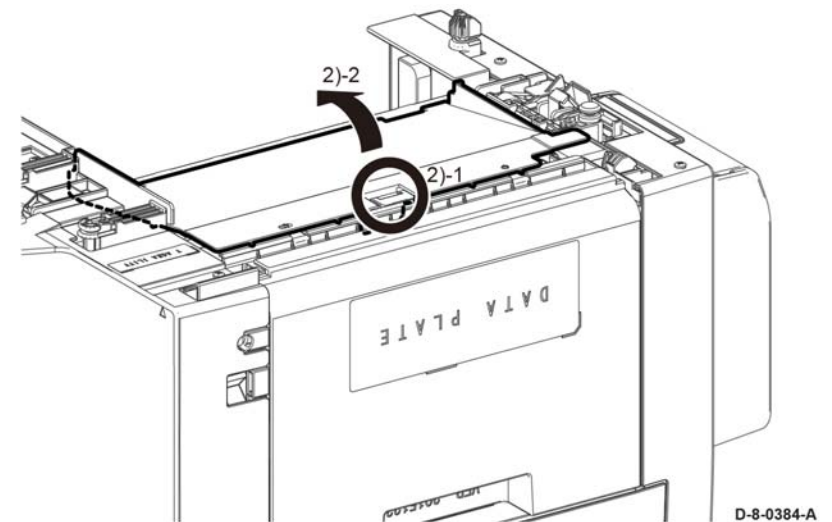
Figure 1 Lower cover removal

1. Remove the finisher, REP TBD. Turn the finisher upside down.
2. Perform the items that follow, [Figure 1](#):
 - 2-1 Press the release lever.
 - 2-2 Remove the finisher lower cover.

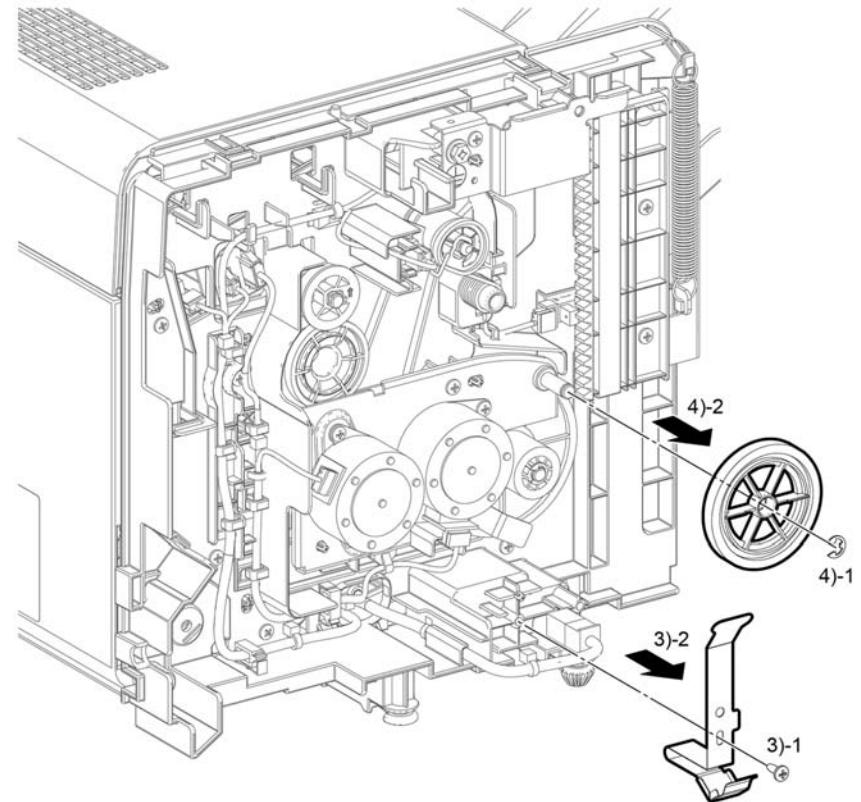
Figure 1 Motor gear and bracket removal

1. Remove the cover LH C, [REP 21.1](#).
2. Remove the LVPS, [REP 21.8](#).
3. Remove the components that follow, [Figure 1](#):
 - 3-1 One screw, ST20.
 - 3-2 Plate ground LH bracket.
4. Remove the components that follow, [Figure 1](#):
 - 4-1 One E-ring.
 - 4-2 Gear.

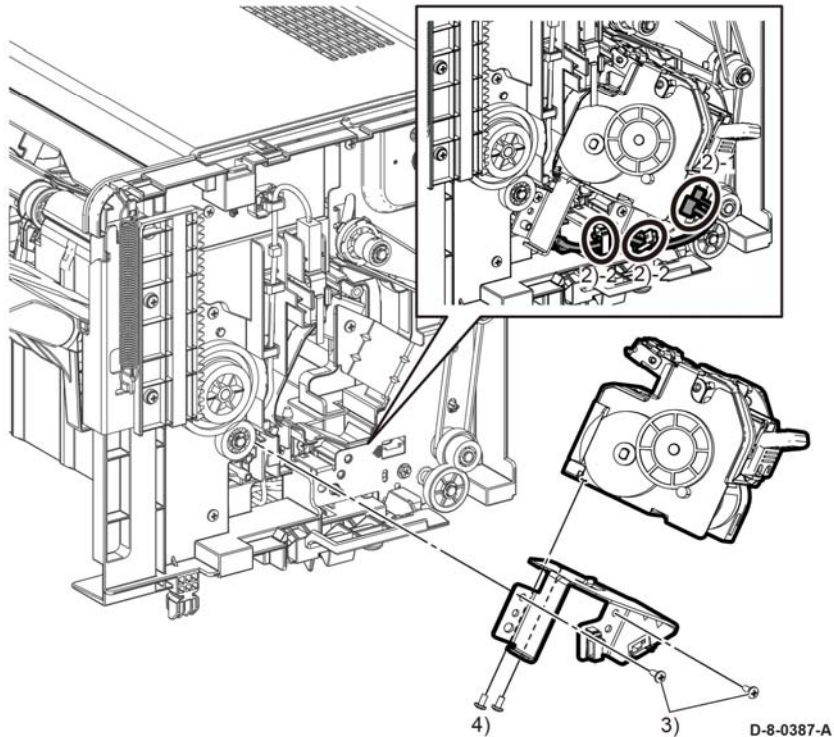
Figure 1 Stapler and bracket removal

1. Remove the Cover RH C, [REP 21.2](#).
2. Perform the steps that follow, [Figure 1](#):
 - 2-1 Disconnect connectors [P/J8897](#), [P/J8908](#).
 - 2-2 Release the harness from the clamps.
3. Remove the components that follow, [Figure 1](#):
 - 3-1 Two screws, ST20, harness Kit.
 - 3-2 Stapler assembly with the bracket assembly.
4. Remove the components that follow, [Figure 1](#):
 - 4-1 Two screws SM4.
 - 4-2 Bracket from the stapler assembly.

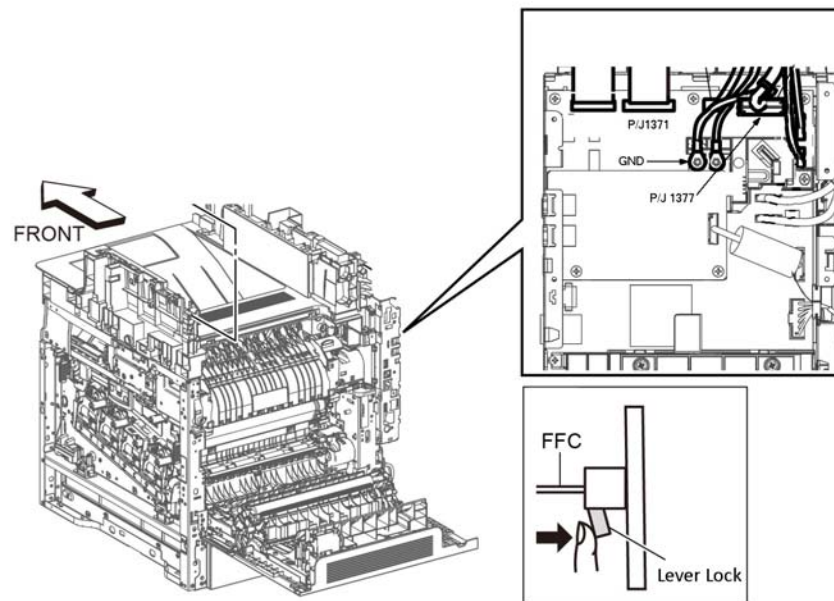
Figure 1 Disconnect the DADF harness and FFC (C600/C605)

NOTE: When engaging the release lever on the FFC connector, slightly press open the release lever no more than 15 degrees. Hold the lever while gently removing the FFC from the connector as shown in the inset of [Figure 1](#), Disconnect the DADF harness and FFC.

1. Refer to [Figure 1](#), following the caution above, release the FFC ([P/J1371](#)) coming from the DADF, disconnect ([P/J1377](#)), and the ground wire from the ESS PWB, [PL 18.1 Item 3](#).

In the following step, engage the lever enough to release the FFC only. Over-engagement of the release lever will break the lever destroying the lock mechanism forcing replacement of the PWB.

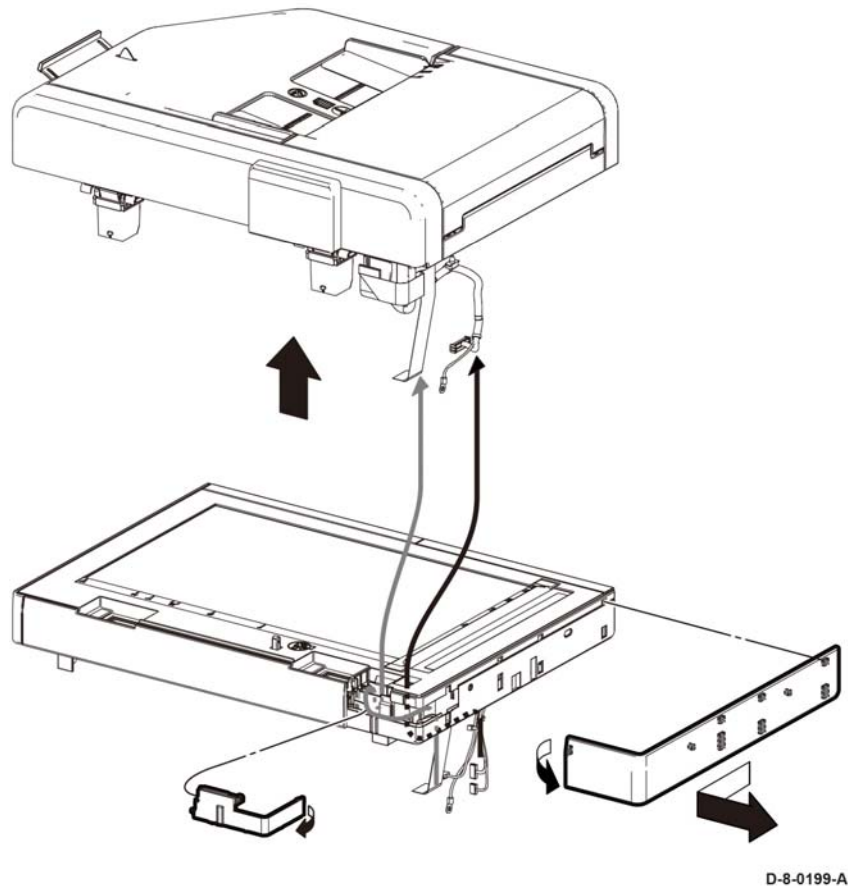
Figure 2 Separate the DADF Assembly from the IIT

2. Refer to [Figure 2](#), release the hook and remove the FFC Cover from the IIT Assembly.
3. Refer to [Figure 2](#), remove the DADF harness out of its harness guide and up through the IIT Assembly.
 - a. Fold the DADF harness connector up against the wires.
 - b. Orient the harness connector to face the front of the printer.
 - c. Pass the harness up through the IIT Assembly.
4. Refer to [Figure 2](#), lift the DADF assembly straight up from the IIT assembly in the direction of the arrow.

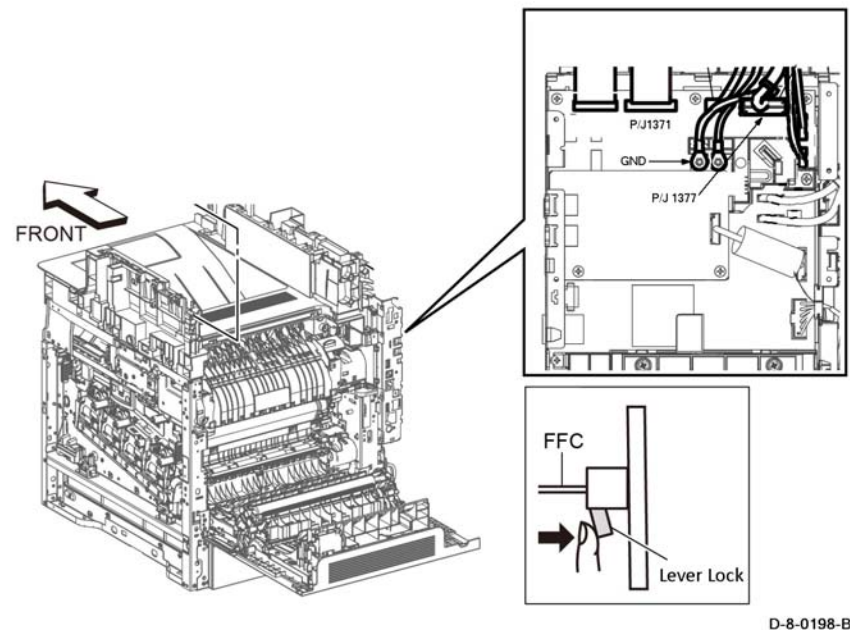
Figure 3 Disconnect the DADF harness and FFC (C605_Tall)

NOTE: When engaging the release lever on the FFC connector, slightly press open the release lever no more than 15 degrees. Hold the lever while gently removing the FFC from the connector as shown in the inset of Figure 3, Disconnect the DADF harness and FFC.

1. Refer to Figure 3, following the caution above, release the FFC (P/J1371) coming from the DADF, disconnect (P/J1377), and the ground wire from the ESS PWB, PL 18.1 Item 3.

In the following step, engage the lever enough to release the FFC only. Over-engagement of the release lever will break the lever destroying the lock mechanism forcing replacement of the PWB.

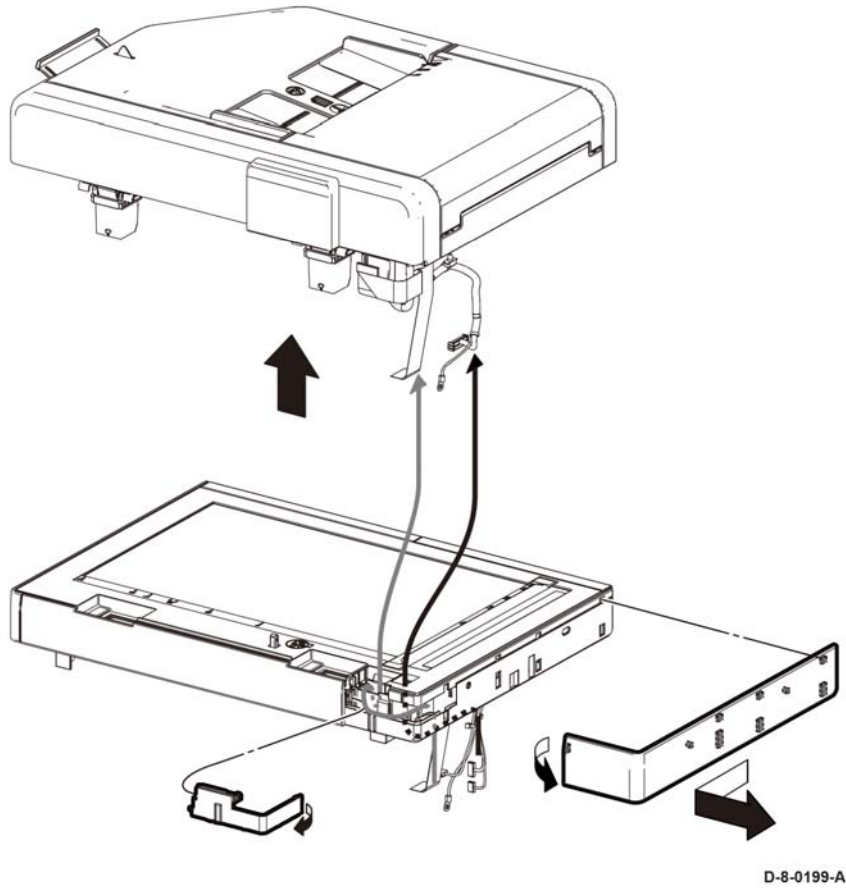
Figure 4 Separate the DADF Assembly from the IIT

2. Refer to Figure 4, release the hook and remove the FFC Cover from the IIT Assembly.
3. Refer to Figure 4, remove the DADF harness out of its harness guide and up through the IIT Assembly.
 - a. Fold the DADF harness connector up against the wires.
 - b. Orient the harness connector to face the front of the printer.

- c. Pass the harness up through the IIT Assembly.
- 4. Refer to [Figure 4](#), lift the DADF assembly straight up from the IIT assembly in the direction of the arrow.

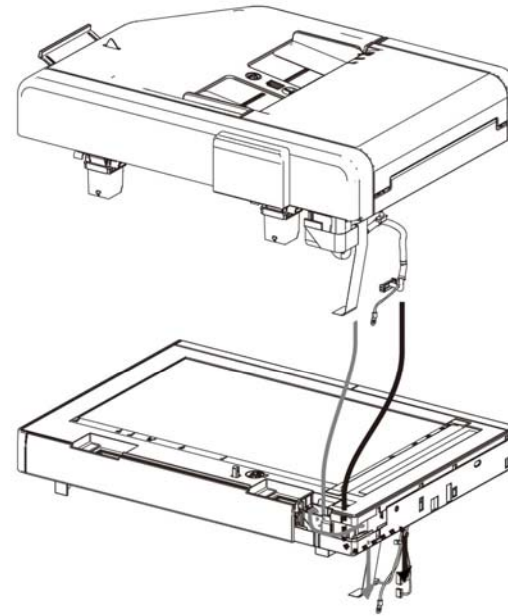
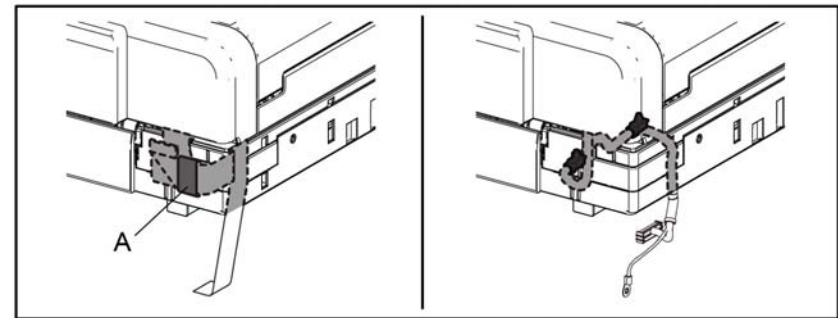
Figure 5 DADF Harness Routes

Avoid pinching wires when installing the DADF harness and FFC. Be sure to follow the harness routes as shown in [Figure 5](#).

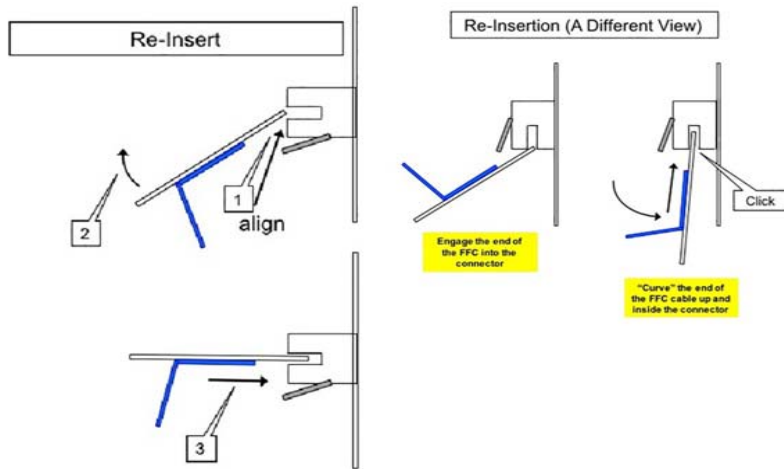
Figure 6 Proper FFC Cable Insertion.

NOTE: To ensure integrity of the FFC connected at the ESS PWB, the following steps are to be observed. Do not attempt to engage the release lever to insert the FFC cable, the FFC connector will allow insertion and lock on its own.

1. Slip the core down the FFC cable.
2. To ease installation and ensure proper alignment of the FFC cable, bend the blue “grip tab” 90 degrees perpendicular to the FFC.
3. Referring to **Figure 6**, grasp the grip tab of the FFC cable placing the back, or non-conductive Side, of the FFC cable against the edge of the connector and centered to the connector.

4. Using the grip tab bent at 90 degrees, firmly push the FFC cable into the connector until fully seated. The latch of the connector will “click” when fully seated, locking the FFC in-place.

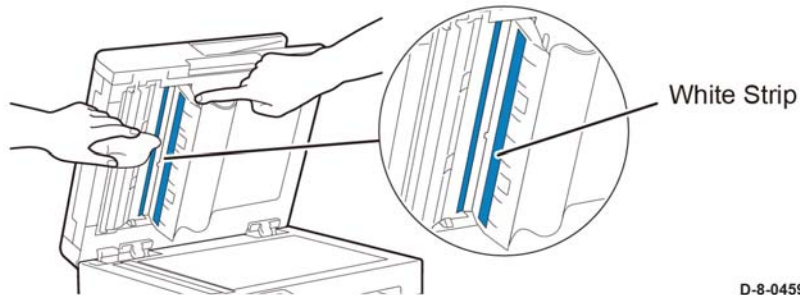
Procedure

Complete the following, if a fault is identified, return to [SCP 4 Fault Analysis](#):

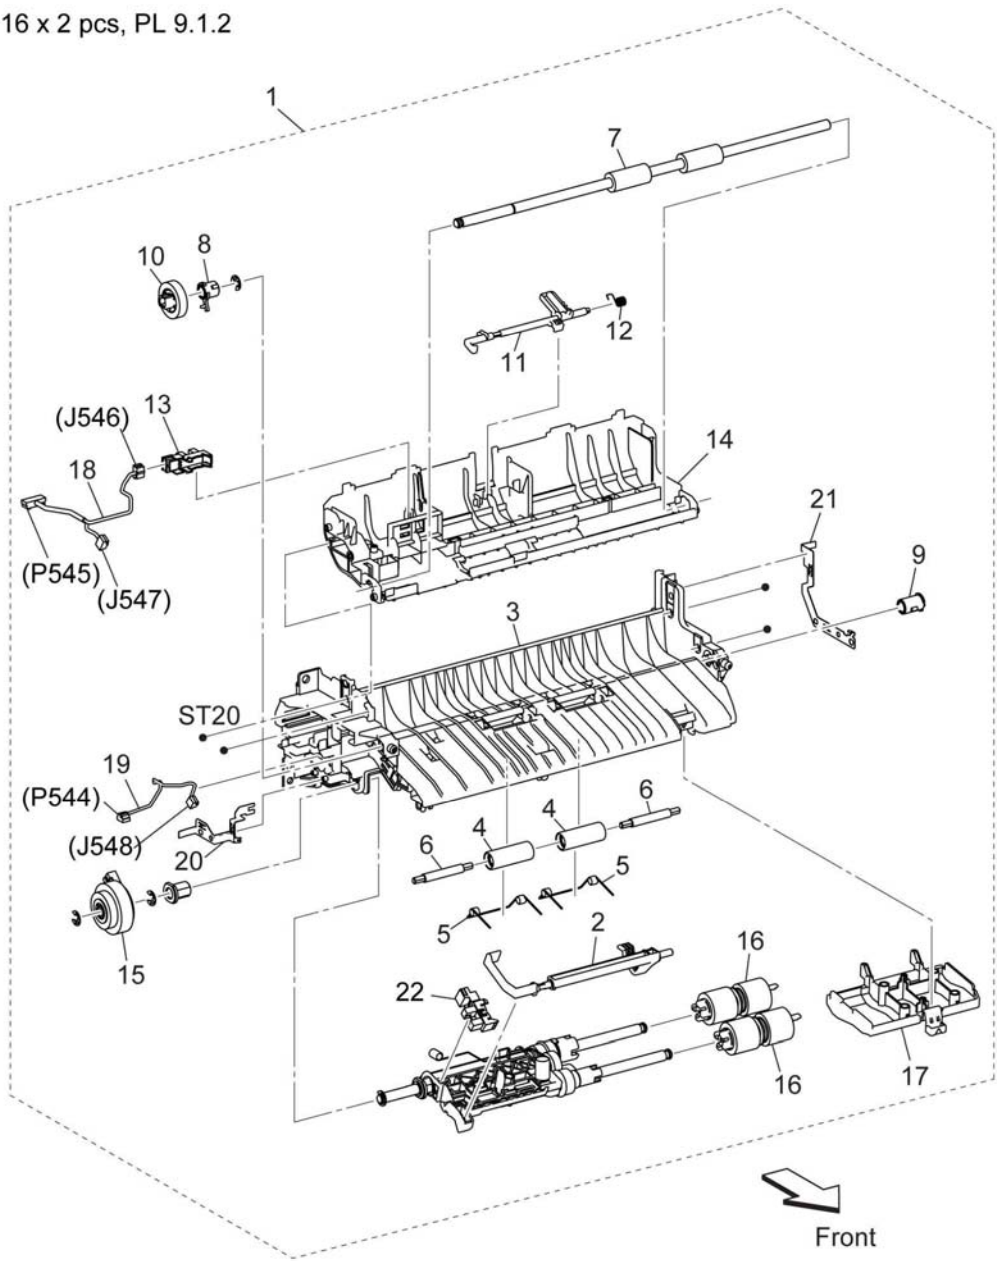
PL 17.1 Exit (C505/C605/C605_Tall)

Item	Part	Description
1	054K58741	Chute assembly exit C505/C605 (with 2-3, 6-7, 10-11) (REP 17.1)
-	054K58711	Chute assembly exit (with 2-3, 6-7, 10-11) C605_Tall (REP 17.1)
2	-	Roll pinch (P/O PL 17.1 Item 1)
3	-	Cover pinch (P/O PL 17.1 Item 1)
4	007K22120	Drive assembly exit main H (REP 17.2)
5	-	Not used
6	930W00123	Full stack sensor and exit sensor (REP 17.3, REP 17.5)
7	120E35590	Actuator full stack C605 (REP 17.4)
-	120E38230	Actuator full stack C600/C605_Tall (REP 17.4)
8	-	Harness assembly exit (Not Spared)
9	-	Harness assembly deve-CF (Not Spared)
10	-	Harness assembly finisher-CF (P/O PL 17.1 Item 1)

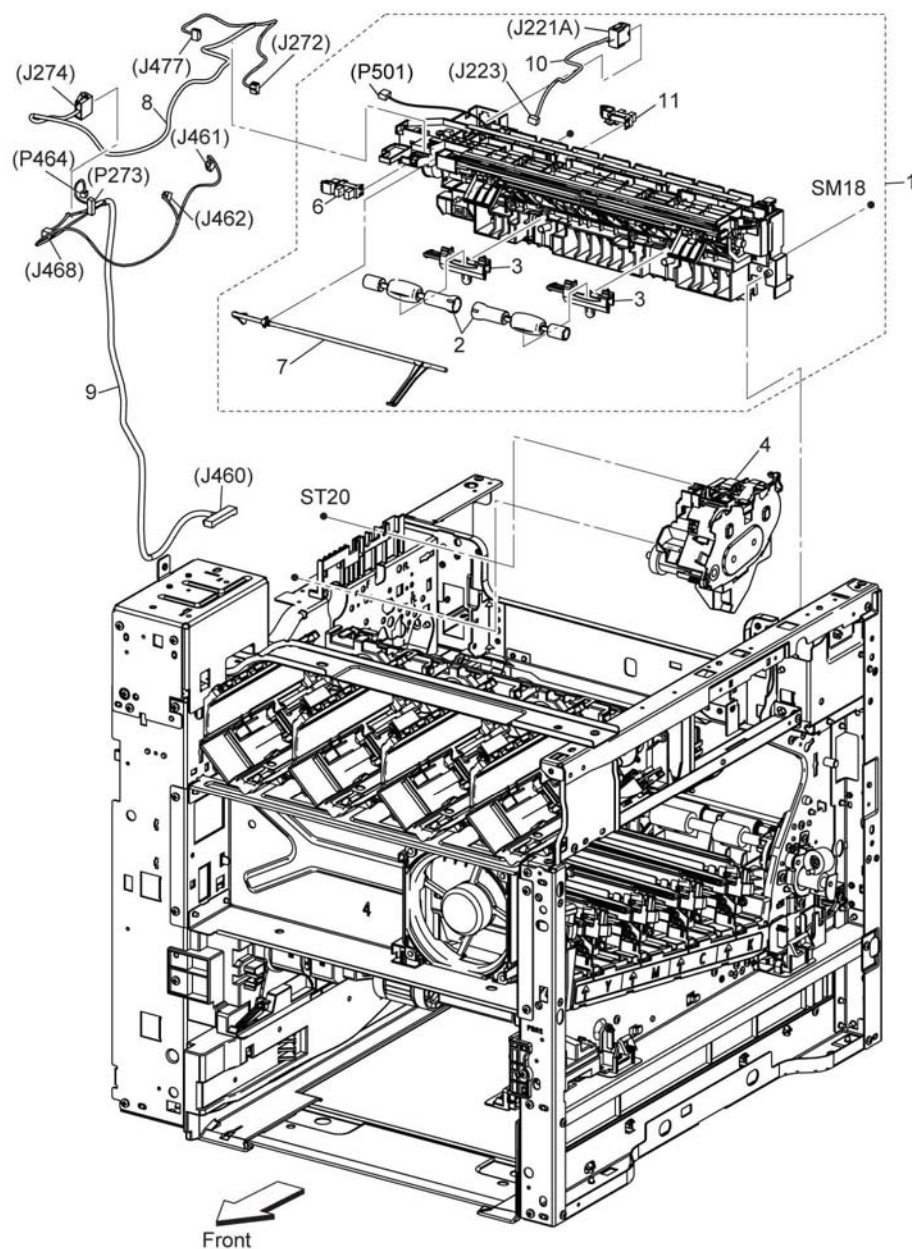
PL 17.2 Exit (C500/C505)

Item	Part	Description
1	054K58841	Chute assembly exit (with 2-3, 6-7, 10-11) C500 (REP 17.6)
-	054K58741	Chute assembly exit (with 2-3, 6-7, 10-11) C505/C605 (REP 17.6)
2	-	Roll pinch (P/O PL 17.2 Item 1)
3	-	Cover pinch (P/O PL 17.2 Item 1)
4	007K22150	Drive assembly exit main M (REP 17.7)
5	-	Gear assembly idle exit (Not Spared)
6	930W00123	Full stack sensor and exit sensor (REP 17.8)
7	120E35590	Actuator full stack C600 (REP 17.9)
-	120E38230	Actuator full stack C505 (REP 17.9)
8	-	Harness assembly exit T (Not Spared)
9	-	Harness assembly deve-CF (Not Spared)
10	-	Harness assembly finisher-CF (Not Spared)

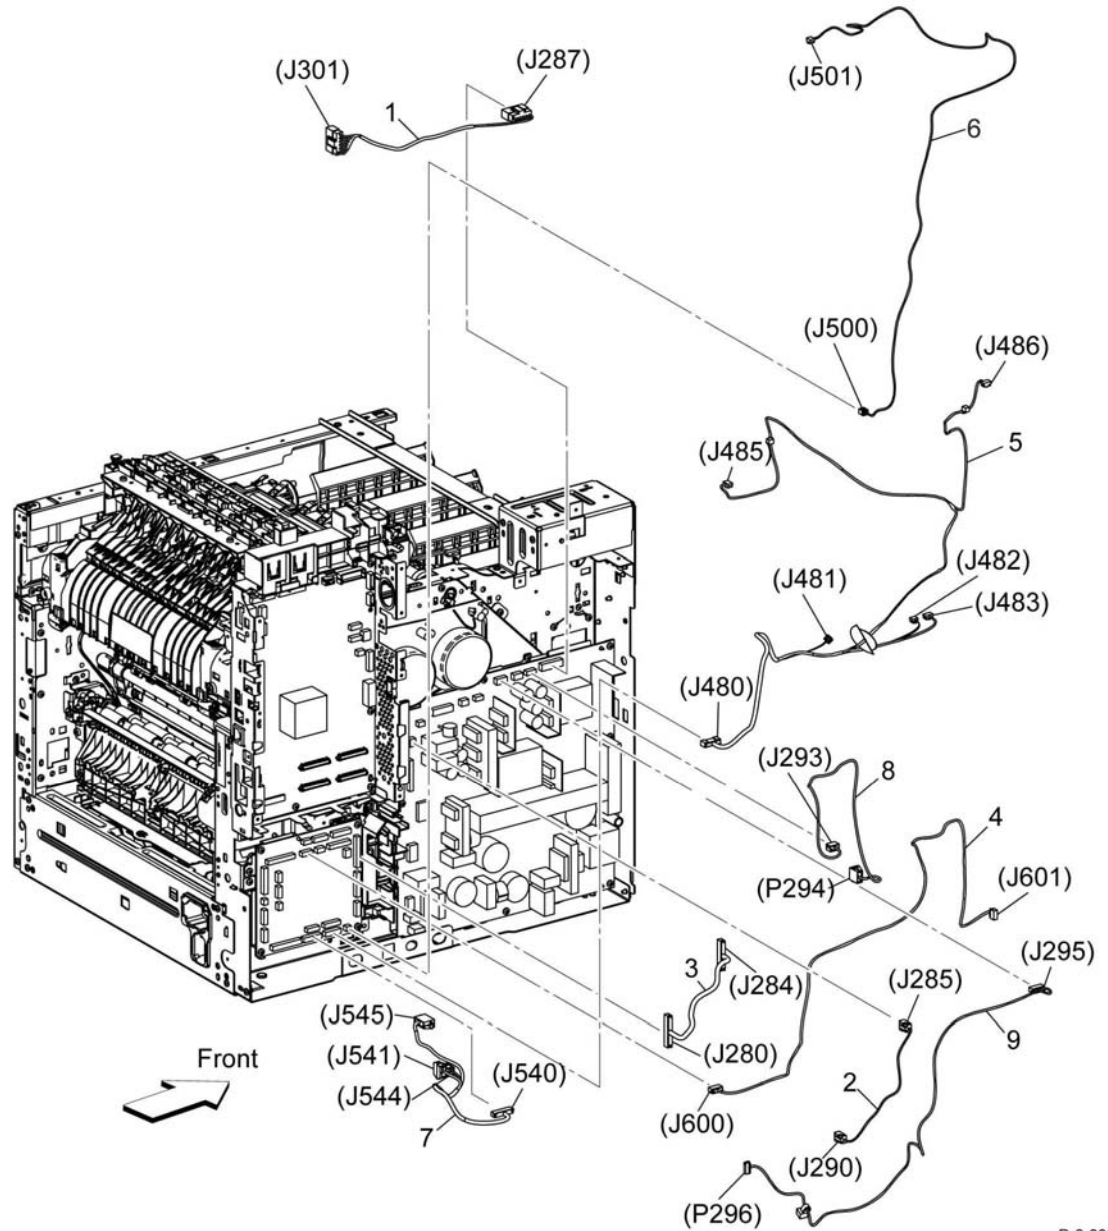
PL 18.5 Electrical (C605_Tall) (1/4)

Item	Part	Description
1	960K79930	PWBA MCU (REP 18.1)
2	952K22010	FFC MCU ESS (REP 18.2)
3	-	Guide FFC color MCU (Not Spared)
4	-	Core MCU (Not Spared)
5	960K89970	PWBA ESS tall (REP 18.3)
6	-	Plate FAX (Not Spared)
7	-	Guide FFC color R LPH (Not Spared)
8	-	Plate ESS lower (Not Spared) (REP 18.2.1)
9	960K80761	PWBA FAX (REP 18.4)
10	-	Harness assembly FAX (Not Spared)
11	-	Wireless module (Not Spared)
12	-	Not used
13	952K40010	Harness assembly ICCR USB (REP 18.5)
14	952K40000	Harness assembly Front USB (REP 18.6)
15	-	Speaker assembly A4 FAX
16	105K32780	PWBA LVPS 110V (REP 18.7)
17	-	PWBA LVPS 220V (Not Spared)
18	-	Plate ESS top (Not Spared) (REP 18.16)
19	-	Box ESS AIO (Not Spared) (REP 18.3.1)
20	-	Plate LVPS (Not Spared)
21	-	Plate MCU (Not Spared)
22	-	Not used
23	-	Guide harness ESS (Not Spared)
24	-	Not used
25	-	Core FAX (Not Spared)
26	-	Link WIFI (Not Spared)
27	101K73410	HDD assembly (REP 18.16)
28	-	Bracket HDD (Not Spared) (REP 18.2.1)

29	-	Speaker main (Not Spared)
30	-	EMMC card (Not Spared)
31	-	Not used
32	-	Bracket USB (Not Spared)
33	-	Guide harness MCU (Not Spared)
34	-	Shaft support LVPS (Not Spared)

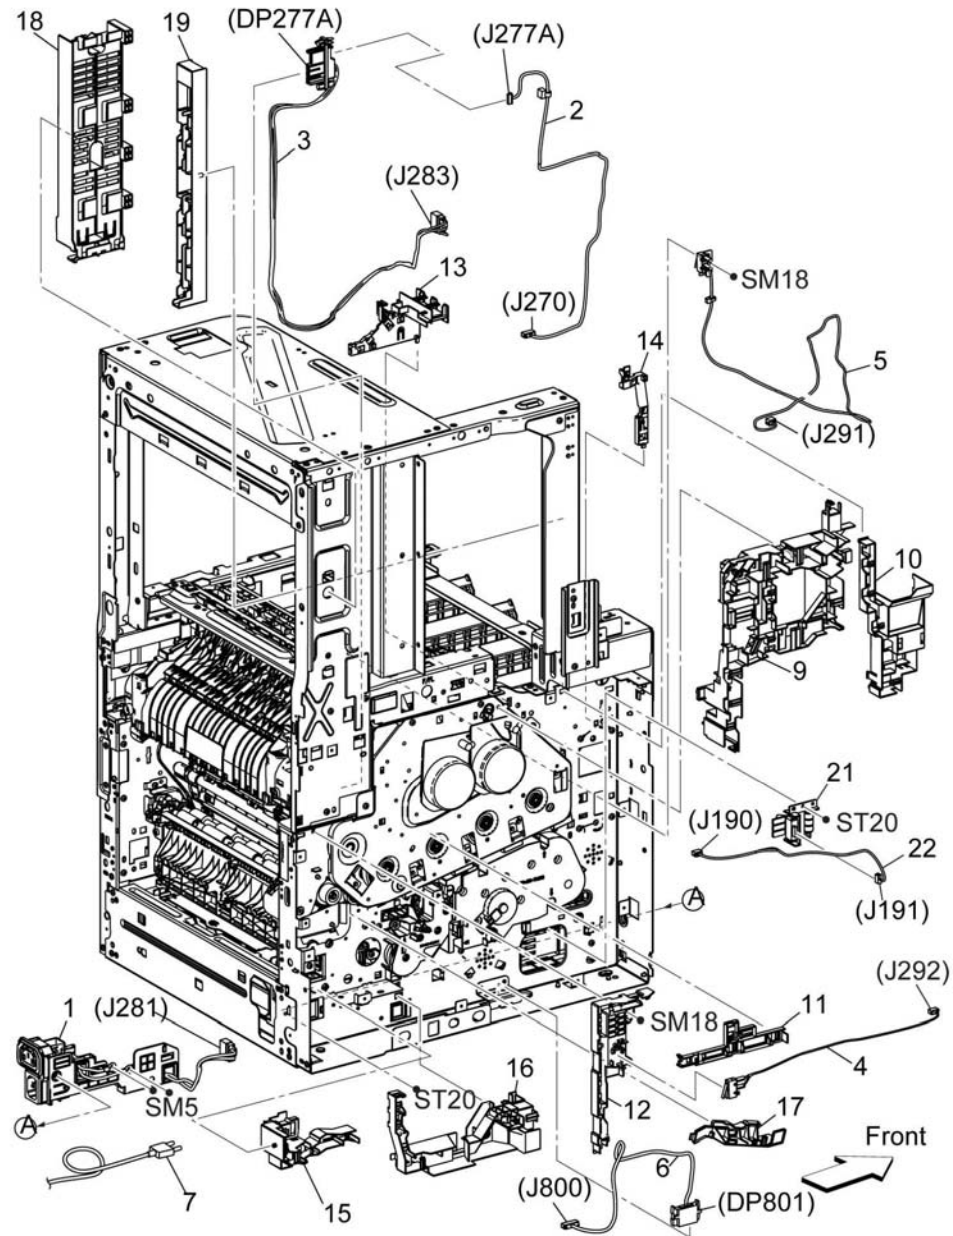
PL 18.8 Electrical (C605_Tall) (4/4)

Item	Part	Description
1	-	Harness assembly ESS-PWR-CF (Not Spared)
2	-	Harness assembly 24V-MCU-CF (Not Spared)
3	-	Harness assembly LV-MCU-CF (Not Spared)
4	-	Harness assembly XPRO-CF (Not Spared)
5	-	Harness assembly MSI CL (Not Spared)
6	-	Harness assembly gate SOL-CF (Not Spared)
7	-	Harness assembly REGI-CF (Not Spared)
8	-	Harness assembly sub fan-CF (Not Spared)
9	-	Harness assembly rear Fan2-CF (Not Spared)
10	-	Harness assembly FIN-MCU-CF (Not Spared)

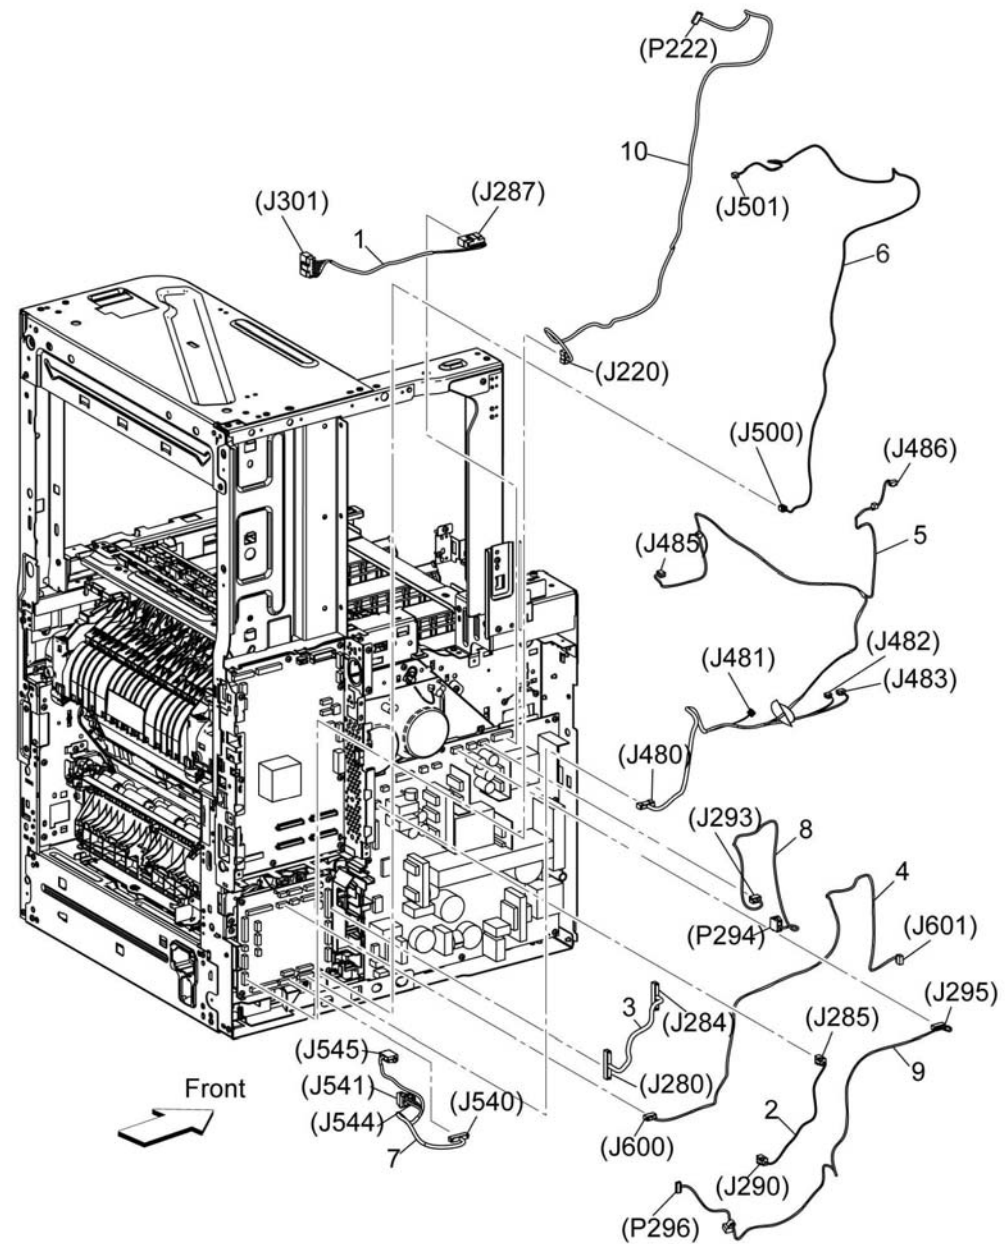
PL 18.9 Electrical (C500/C600) (1/4)

Item	Part	Description
1	960K79920	PWBA MCU C500 (REP 18.31)
-	960K79930	PWBA MCU C600 (REP 18.31)
2	952K22010	FFC MCU ESS (REP 18.32)
3	-	Guide FFC color MCU (Not Spared)
4	-	Core MCU (Not Spared)
5	960K89980	PWBA ESS SFP (REP 18.33)
6	-	Not used
7	-	Guide FFC color LPH (Not Spared)
8	-	Plate ESS lower (Not Spared) (REP 18.2.1)
9	-	Not used
10	-	Not used
11	-	Wireless module (Not Spared)
12	-	Not used
13	-	Not used
14	952K39980	Harness assembly front USB (REP 18.33)
15	-	Not used
16	105K32780	PWBA LVPS C600/C605/C605_Tall (REP 18.34)

-	105K33352	PWBA LVPS 220V C500 (220V) (REP 18.34)
-	105K33341	PWBA LVPS 110V C500 (110V) (REP 18.34)
18	-	Plate ESS top (Not Spared) (REP 18.44)
19	-	Box ESS SFP (Not Spared) (REP 18.33.1)
20	-	Plate LVPS (Not Spared)
21	-	Plate MCU (Not Spared)
22	-	Not used
23	-	Not used
24	-	Not used
25	-	Not used
26	-	Link WIFI (Not Spared)
27	101K73410	HDD assembly
28	-	Bracket HDD (Not Spared) (REP 18.2.1)
29	-	Speaker main (Not Spared)
30	-	EMMC card (Not Spared)
31	-	Not used
32	-	Not used
33	-	Guide harness MCU (Not Spared)
34	-	Shaft support LVPS (Not Spared)

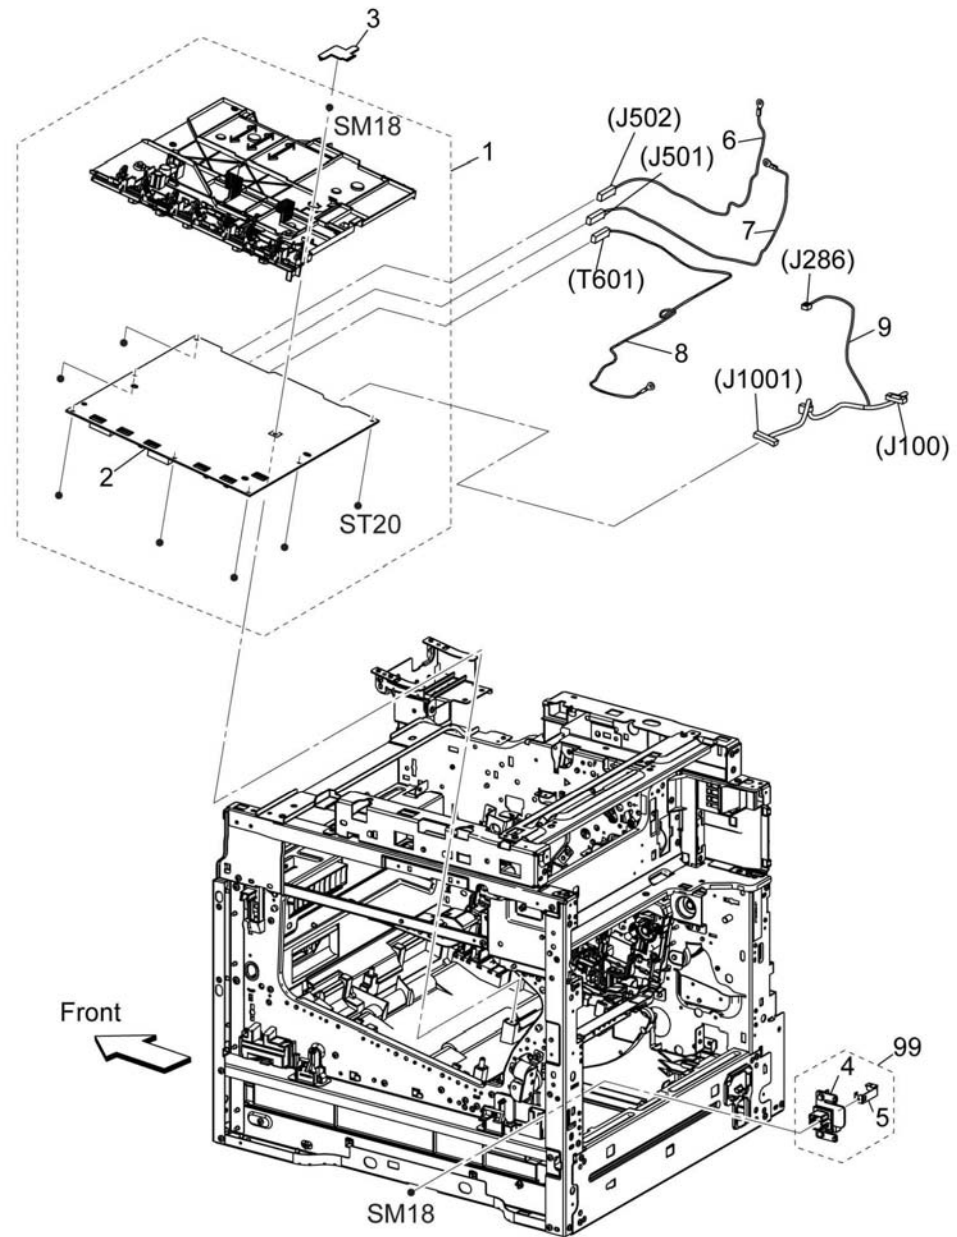
PL 18.10 Electrical (C500/C600) (2/4)

Item	Part	Description
1	032K09641	Guide assembly HVPS (with 2) (REP 18.36)
2	–	PWBA HVPS (P/O PL 18.10 Item 1)
3	822E21972	Cover toner HVPS (REP 18.37)
4	–	Housing 2nd BTR (P/O PL 18.10 Item 99)
5	–	Plate BIAS 2nd BTR (P/O PL 18.10 Item 99)
6	–	Harness assembly supply 1ST YMC (Not Spared)
7	–	Harness assembly supply 1ST K (Not Spared)
8	–	Harness assembly supply trans (Not Spared)
9	–	Harness assembly MCU-HVPS-CF (Not Spared)
99	604K97510	Kit housing 2nd BTR (with 4-5) (REP 18.38)

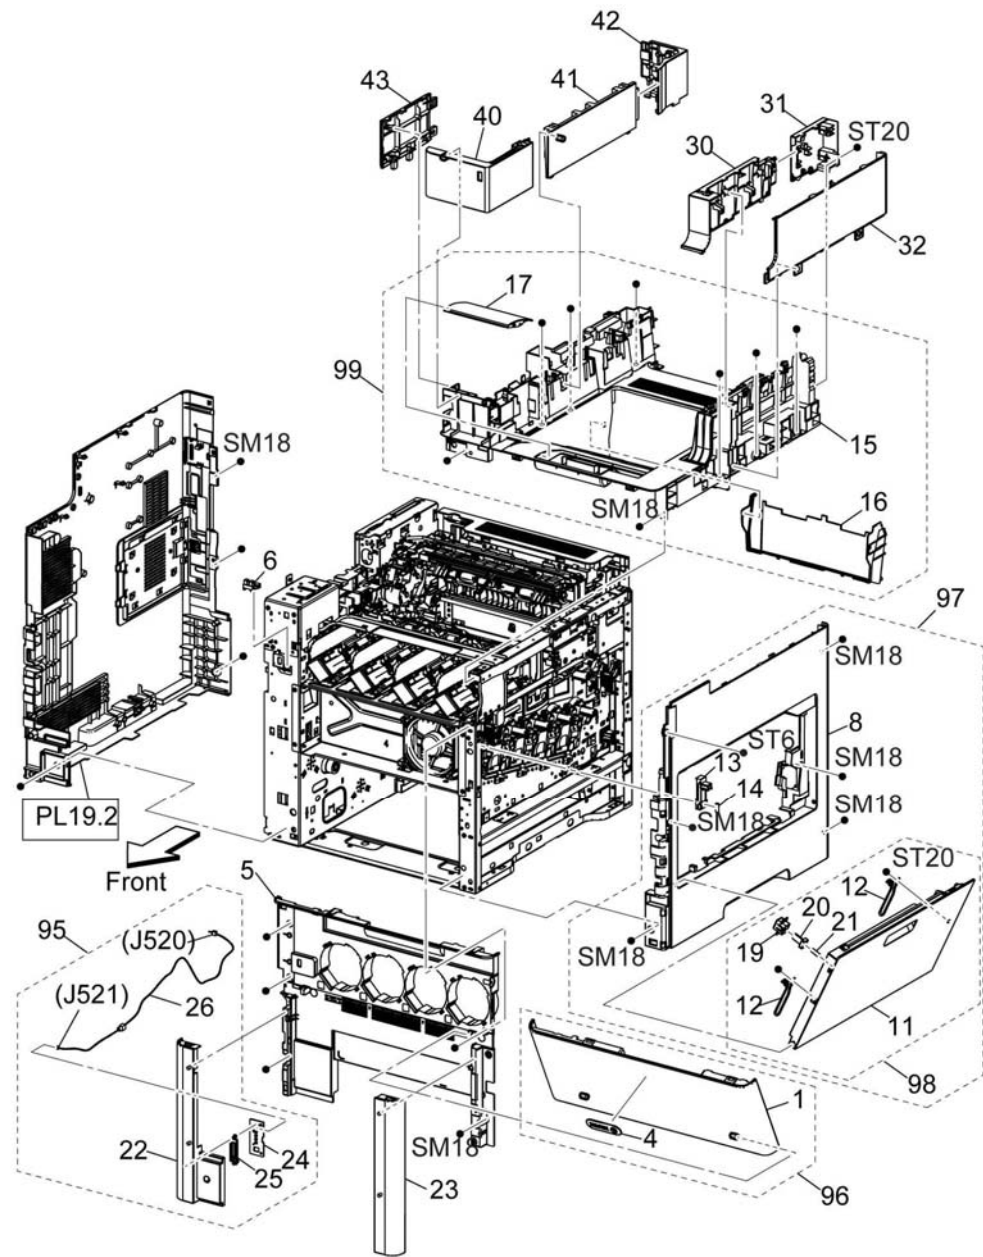
25.	-	Cover shade tray (P/O PL 19.1 Item 95)
26.	-	Harness assembly LED (P/O PL 19.1 Item 95)
30	822E32660	Cover IIT inner R (REP 19.3)
31	822E32700	Cover IIT inner R REAR (REP 19.4)
32	822E32741	Cover IIT side R (REP 19.5)
40	822E32623	Cover ICCR (REP 19.6)
41	822E32640	Cover IIT Inner L (REP 19.7)
42	822E32681	Cover IIT inner L rear (REP 19.8)
43	822E32783	Cover IIT side L (REP 19.9)
95	948K16080	Cover assembly front L (with 22, 24-26) (REP 19.10)
96	948K16131	Cover assembly toner (with 1, 4) (REP 19.11)
97	948K16141	Cover assembly side R (with 8, 13-14, 98) (REP 19.12)

98.	-	Cover assembly waste (with 11, 12x2, 19-21, label) (Not Spared)
99	948K16111	Cover assembly top (with 15-17) (REP 19.13)
