VersaLink[®] C500/C600 Printer and C505/C605 Multifunction Printer Service Manual

Xerox VersaLink C605F Family Printer Service Manual

705P01395

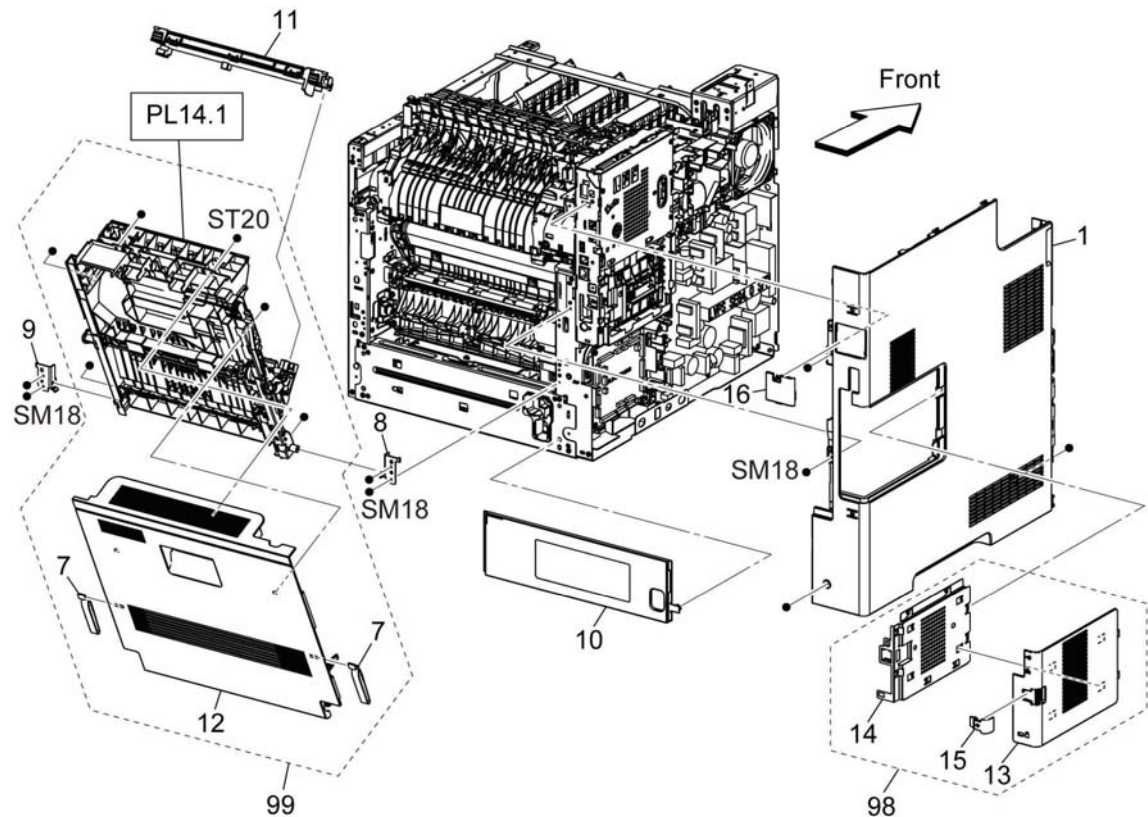
PL 19.2 Cover (C505/C605) (2/2)

Item	Part	Description
1.	822E46581	Cover side L (3in1) (REP 19.14)
–	822E33674	Cover side L (4in1) (REP 19.14)
2.	–	Not used
3.	–	Not used
4.	–	Not used
5.	–	Not used
6.	–	Not used
7.	–	Strap cover rear (P/O PL 19.2 Item 99)
8.	–	Hinge assembly rear L (Not Spared)
9.	–	Hinge assembly rear R (Not Spared)
10.	–	Cover rear bottom (Not Spared)
11.	859K00611	2nd BTR roll assembly (REP 19.15)
12.	–	Cover assembly rear AIO (P/O PL 19.2 Item 99)
13.	–	ESS window (P/O PL 19.2 Item 98)
14.	–	Plate ESS window (P/O PL 19.2 Item 98)
15.	–	Lever ESS window (P/O PL 19.2 Item 98)
16.	822E27572	WIFI cap (REP 19.16)
98.	815K21540	Kit ESS window assembly (with 13-15) (REP 19.17)
99.	607K04940	Kit cover assembly rear AIO (with 7x2, 12, PL14.1) (REP 19.18)

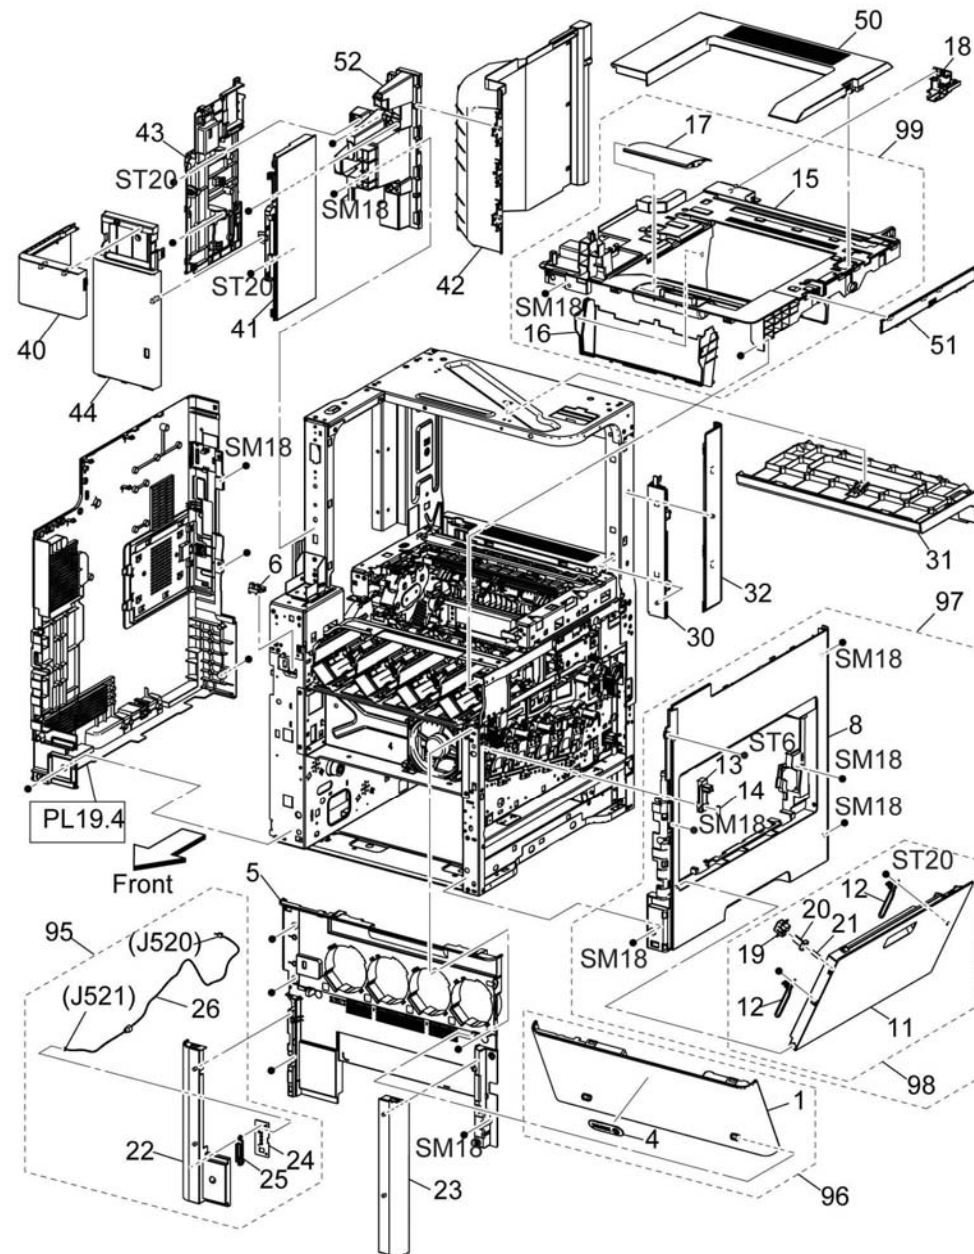
PL 19.3 Cover (C605_Tall) (1/2)

Item	Part	Description
1	–	Cover toner (P/O PL 19.3 Item 96)
4	–	Logo (P/O PL 19.3 Item 96)
5	822E33610	Cover front inner (REP 19.19)
6	–	Toner cover sensor (Not Spared)
8	–	Cover side R (P/O PL 19.3 Item 97)
11	–	Cover waste (P/O PL 19.3 Item 98)
12	–	Strap cover waste (P/O PL 19.3 Item 98)
13	–	Link waste (P/O PL 19.3 Item 97)
14	–	Spring link waste (P/O PL 19.3 Item 97)
15	–	Cover top (P/O PL 19.3 Item 99)
16	–	Cover exit (P/O PL 19.3 Item 99)
17	–	Tray extension (P/O PL 19.3 Item 99)
18	822E32391	OPT blind cover (REP 19.20)
19	–	Holder IL (P/O PL 19.3 Item 98)
20	–	Actuator IL (P/O PL 19.3 Item 98)
21	–	Spring IL (P/O PL 19.3 Item 98)
22	–	Cover front L (P/O PL 19.3 Item 95)
23	822E33131	Cover front R (REP 19.21)
24	–	Tray LED PWBA (P/O PL 19.3 Item 95)
25	–	Cover shade tray (P/O PL 19.3 Item 95)
26	–	Harness assembly LED (P/O PL 19.3 Item 95)
30	–	Cover fin inner R (Not Spared)
31	822E34823	Cover fin inner rear (REP 19.22)

32	822E32940	Cover fin side R (REP 19.23)
40	822E32843	Cover ICCR fin (REP 19.24)
41	822E32922	Cover fin inner L (REP 19.25)
42	822E34800	Cover fin inner side L (REP 19.26)
43	822E32901	Cover fin side L sub (REP 19.27)
44	822E32861	Cover fin front (REP 19.28)
50	822E34782	Cover fin top exit (REP 19.29)
51	822E37762	Cover fin side R cap (REP 19.30)
52	801E35940	Frame fin (REP 19.31)
95	948K16080	Cover assembly front L (with 22, 24-26) (REP 19.32)
96	948K16131	Cover assembly toner (with 1, 4) (REP 19.33)
97	948K16140	Cover assembly side R (with 8, 13-14, 98) (REP 19.34)
98	–	Cover assembly waste (with 11, 12x2, 19-21, label)
99	948K04220	Cover assembly top (with 15-17) (REP 19.35)

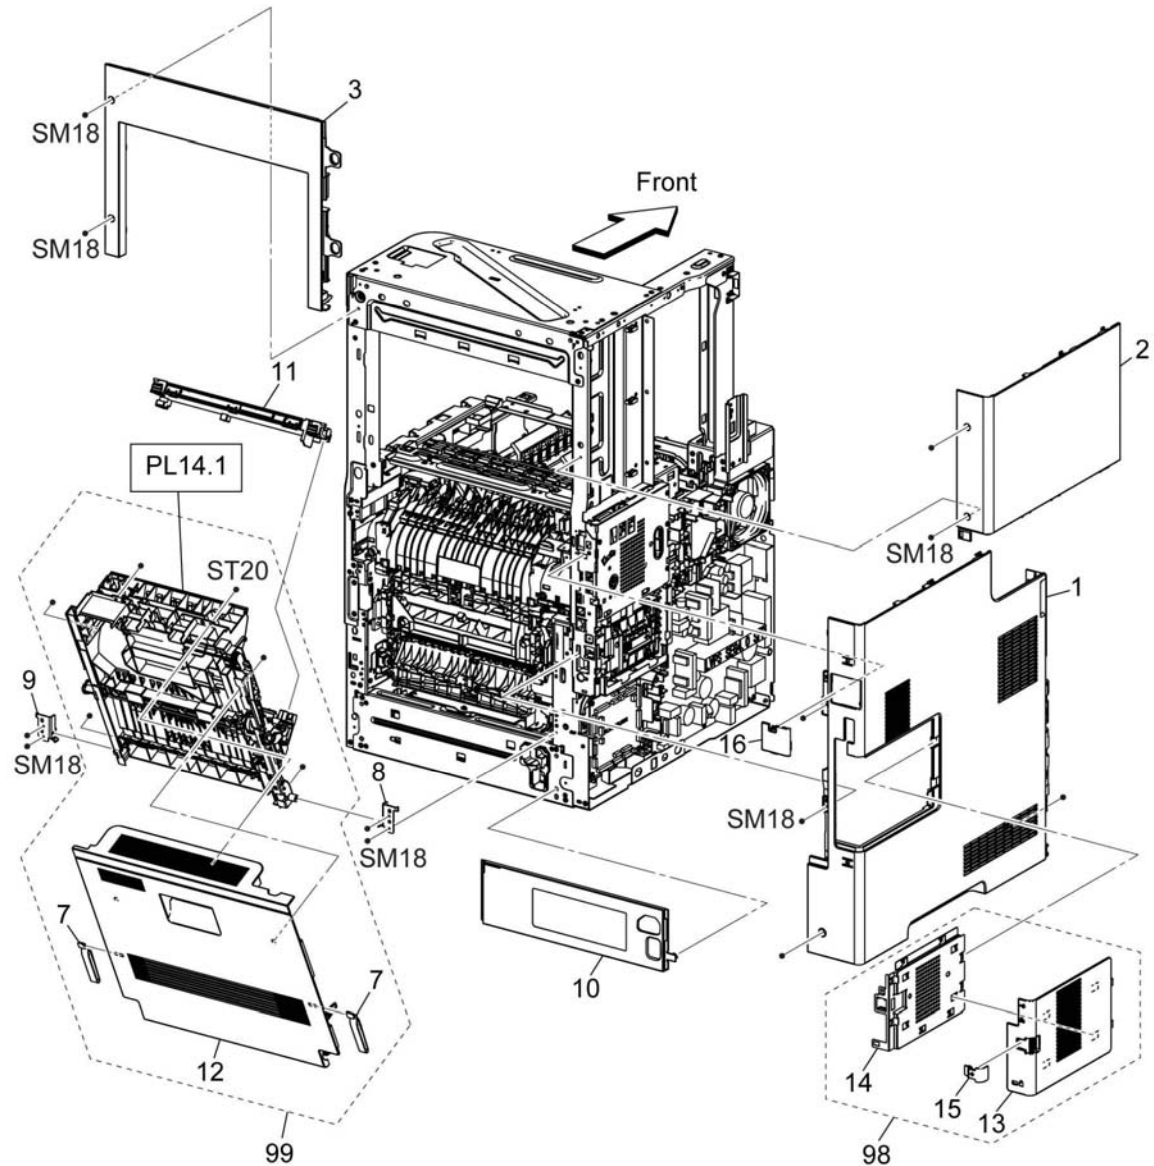
PL 19.4 Cover (C605_Tall) (2/2)

Item	Part	Description
1	822E33673	Cover side L (REP 19.36)
2	822E32882	Cover fin side L (REP 19.37)
3	822E33001	Cover fin rear (REP 19.38)
4	-	Not used
5	-	Not used
6	-	Not used
7	-	Strap cover rear (P/O PL 19.4 Item 99)
8	-	Hinge assembly rear L (Not Spared)
9	-	Hinge assembly rear R (Not Spared)
10	-	Cover rear bottom (Not Spared)
11	859K00610	2nd BTR roll assembly (REP 19.39)
12	-	Cover assembly rear AIO (P/O PL 19.4 Item 99)
13	-	ESS window (P/O PL 19.4 Item 98)
14	-	Plate ESS window (P/O PL 19.4 Item 98)
15	-	Lever ESS window (P/O PL 19.4 Item 98)
16	822E27572	WiFi cap (REP 19.40)
98	815K21540	Kit ESS window assembly (with 13-15) (REP 19.41)
99	607K04940	Kit cover assembly rear AIO (with 7x2, 12, PL14.1) (REP 19.42)

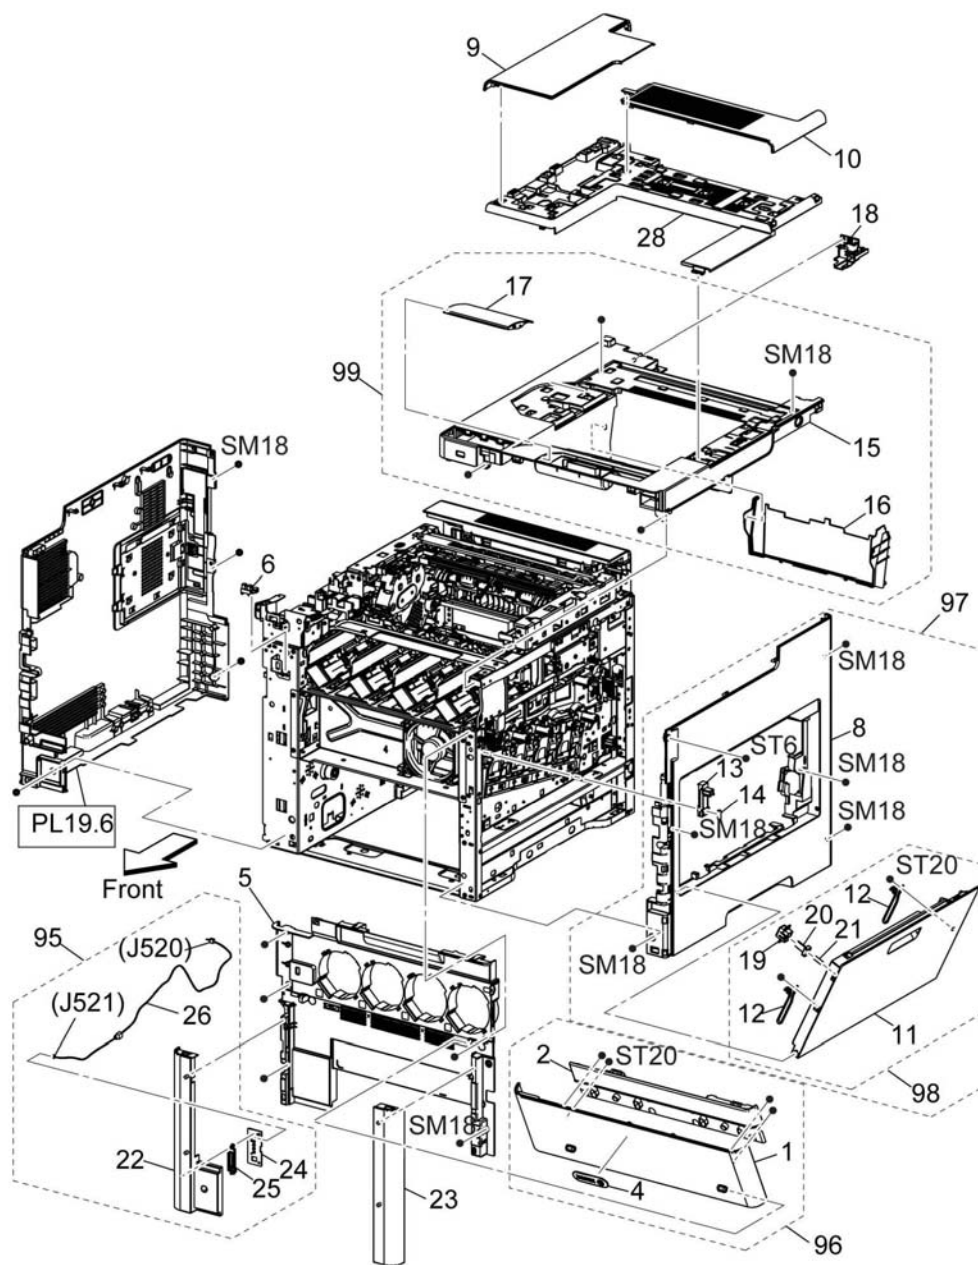
27.	-	Not used
28.	822E32353	Cover top exit (REP 19.46)
95.	948K16080	Cover assembly front L (with 22, 24-26) (REP 19.47)
96.	948K16051	Cover assembly toner (with 1, 2, 4) (REP 19.48)

97.	948K16061	Cover assembly side R (with 8, 13-14, 98) (REP 19.49)
98.	-	Cover assembly waste (with 11, 12x2, 19-21, label) (P/O PL 19.5 Item 97)
99.	948K04203	Cover assembly top C500/C600 (with 15-17) (REP 19.50)

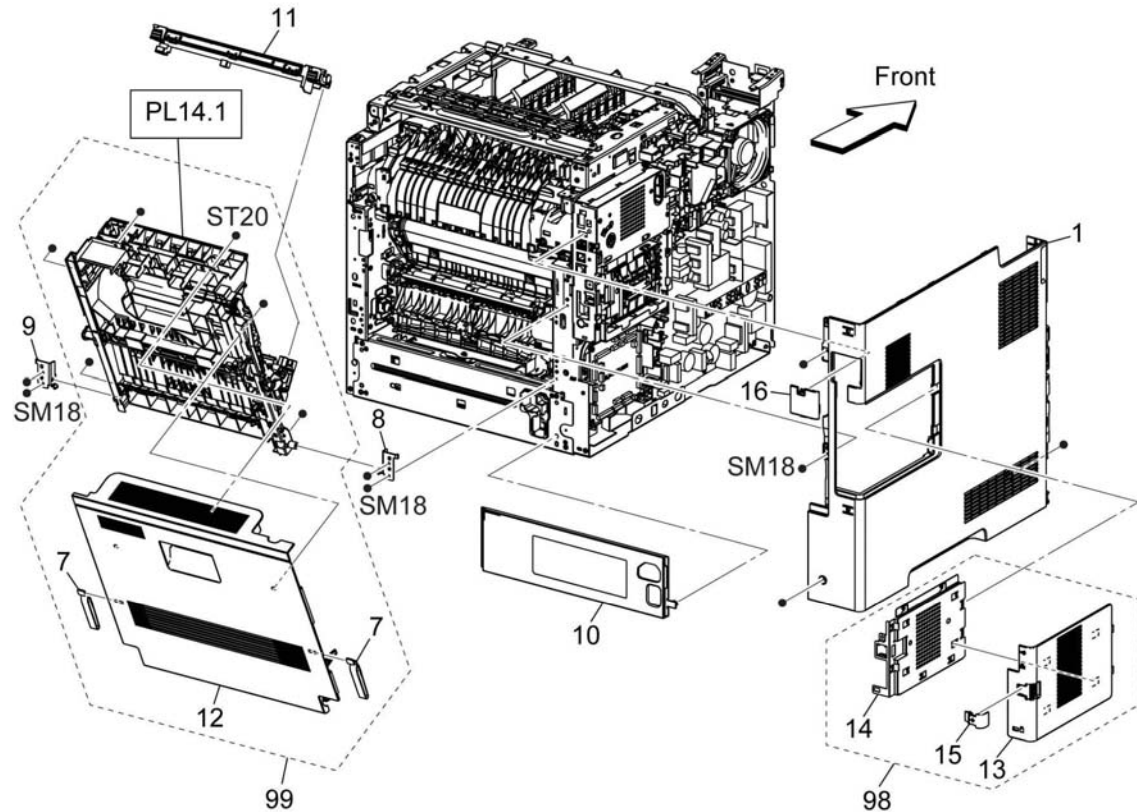
PL 19.6 Cover (C500/C600) (2/2)

Item	Part	Description
1	822E33545	Cover side L (REP 19.51)
2	–	Not used
3	–	Not used
4	–	Not used
5	822E32391	OPT blind cover (REP 19.52)
6	–	Not used
7	–	Strap cover rear (P/O PL 19.6 Item 99)
8	–	Hinge assembly rear L (Not Spared)
9	–	Hinge assembly rear R (Not Spared)
10	–	Cover rear bottom (Not Spared)
11	859K00610	2nd BTR roll assembly (REP 19.53)
12	–	Cover assembly rear C500/C600 (P/O PL 19.6 Item 99)
13	–	ESS window (P/O PL 19.6 Item 98)
14	–	Plate ESS window (P/O PL 19.6 Item 98)
15	–	Lever ESS window (P/O PL 19.6 Item 98)
16	822E27572	WiFi cap (REP 19.54)
98	815K21540	Kit ESS window assembly (with 13-15) (REP 19.55)
99	607K04950	Kit cover assembly rear C500/C600 (with 7x2, 12, PL14.1) (REP 19.56)

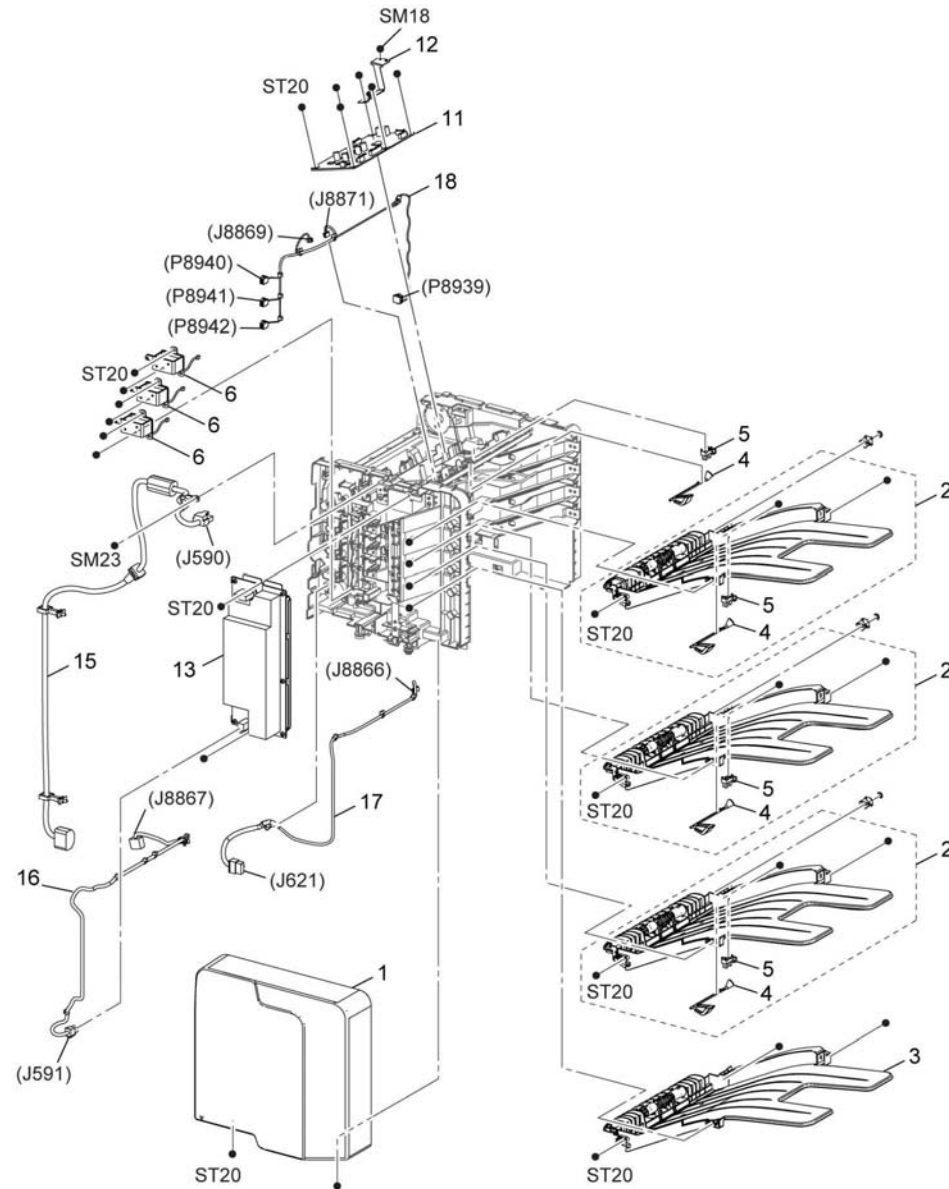
PL 20.1 Mailbox

Item	Part	Description
1.		-Cover LH C (Not Spared) (REP 20.1)
2.	607K05020	Tray assembly (with label) (with 4, 5) (REP 20.8)
3.	607K05030	Tray assembly bottom (with label) (REP 20.9)
4.		-Actuator tray full (P/O PL 20.1 Item 2)
5.		-1/2/3/4-Bin full paper sensor (P/O PL 20.1 Item 2)
6.	049K34930	Bracket assembly gate sol (REP 20.10)
7.	-	Not used
8.	-	Not used
9.	-	Not used
10.	-	Not used
11.	960K90041	PWBA GPF A4MBX (REP 20.4)
12.	-	Bracket earth RH (Not Spared)
13.		-LVPS W/I bracket (Not Spared) (REP 20.5)
14.	-	Not used
15.	-	Harness assembly MBX AC (Not Spared)
16.	-	Harness assembly MBX DC (Not Spared)
17.	-	Harness assembly MBX IF (Not Spared)
18.	-	Harness assembly trans S (Not Spared)

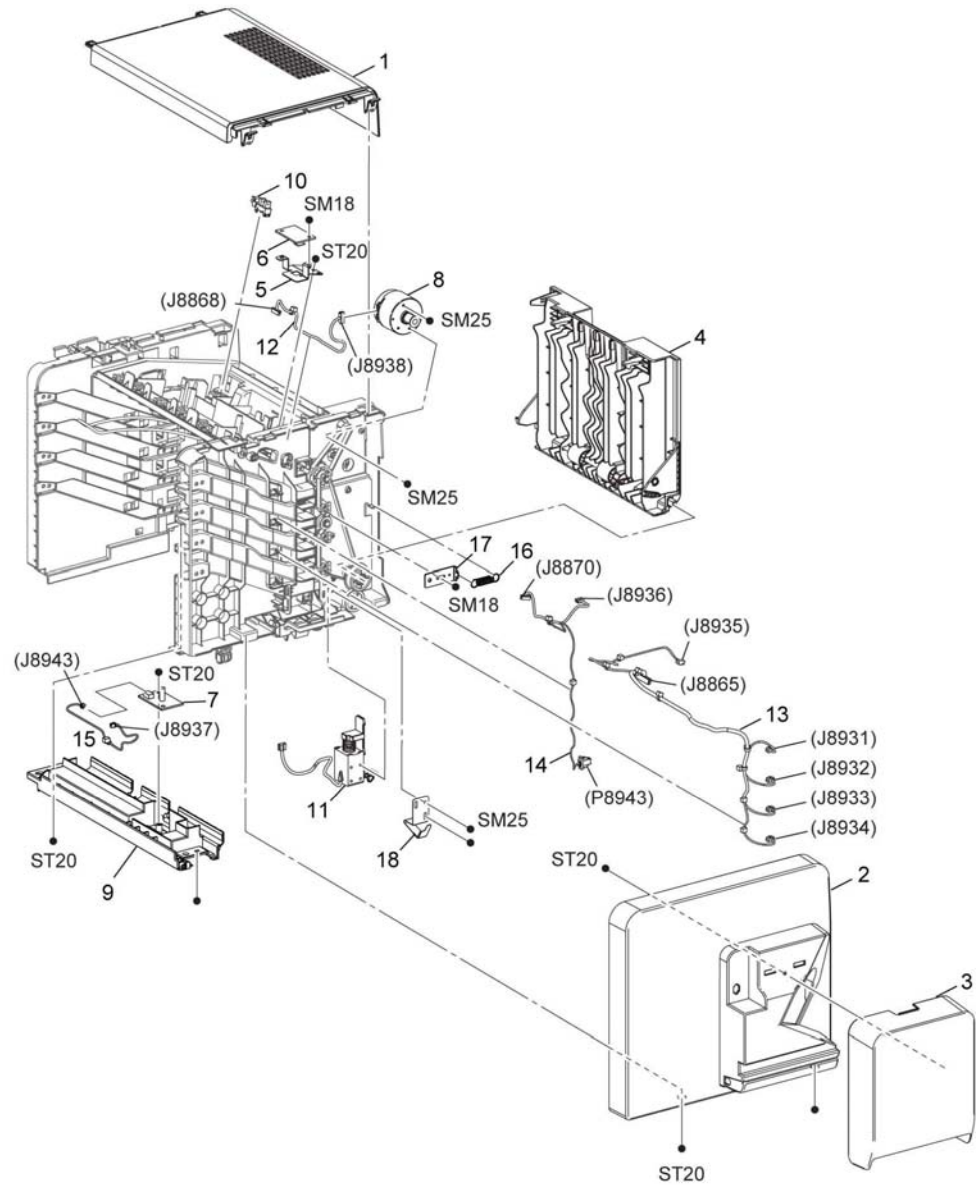
PL 20.2 Mailbox

Item	Part	Description
1.	-	Cover Top C (Not Spared) (REP 20.3)
2.	-	Cover RH C (Not Spared) (REP 20.2)
3.	-	Cover assembly staple (Not Spared)
4.	-	Cover assembly rear (Not Spared)
5.	-	Bracket vertical sensor MBX (Not Spared)
6.	-	PWBA vertical sensor rev (Not Spared)
7.	-	PWBA vertical sensor LED (Not Spared)
8.	127K72241	Motor assembly (REP 20.6)
9.	-	Chute low MBX (Not Spared)
10.	-	Rear cover interlock sensor (Not Spared)
11.	121K58300	Solenoid assembly gate (REP 20.7)
12.	-	Harness assembly MBX trans M (Not Spared)
13.	-	Harness assembly Mbx sensor (Not Spared)
14.	-	Harness assembly vertical sensor (Not Spared)
15.	-	Harness assembly vertical LED (Not Spared)
16.	-	Spring tension (Not Spared)
17.	-	Bracket tension (Not Spared)
18.	-	Plate ground RH (Not Spared)

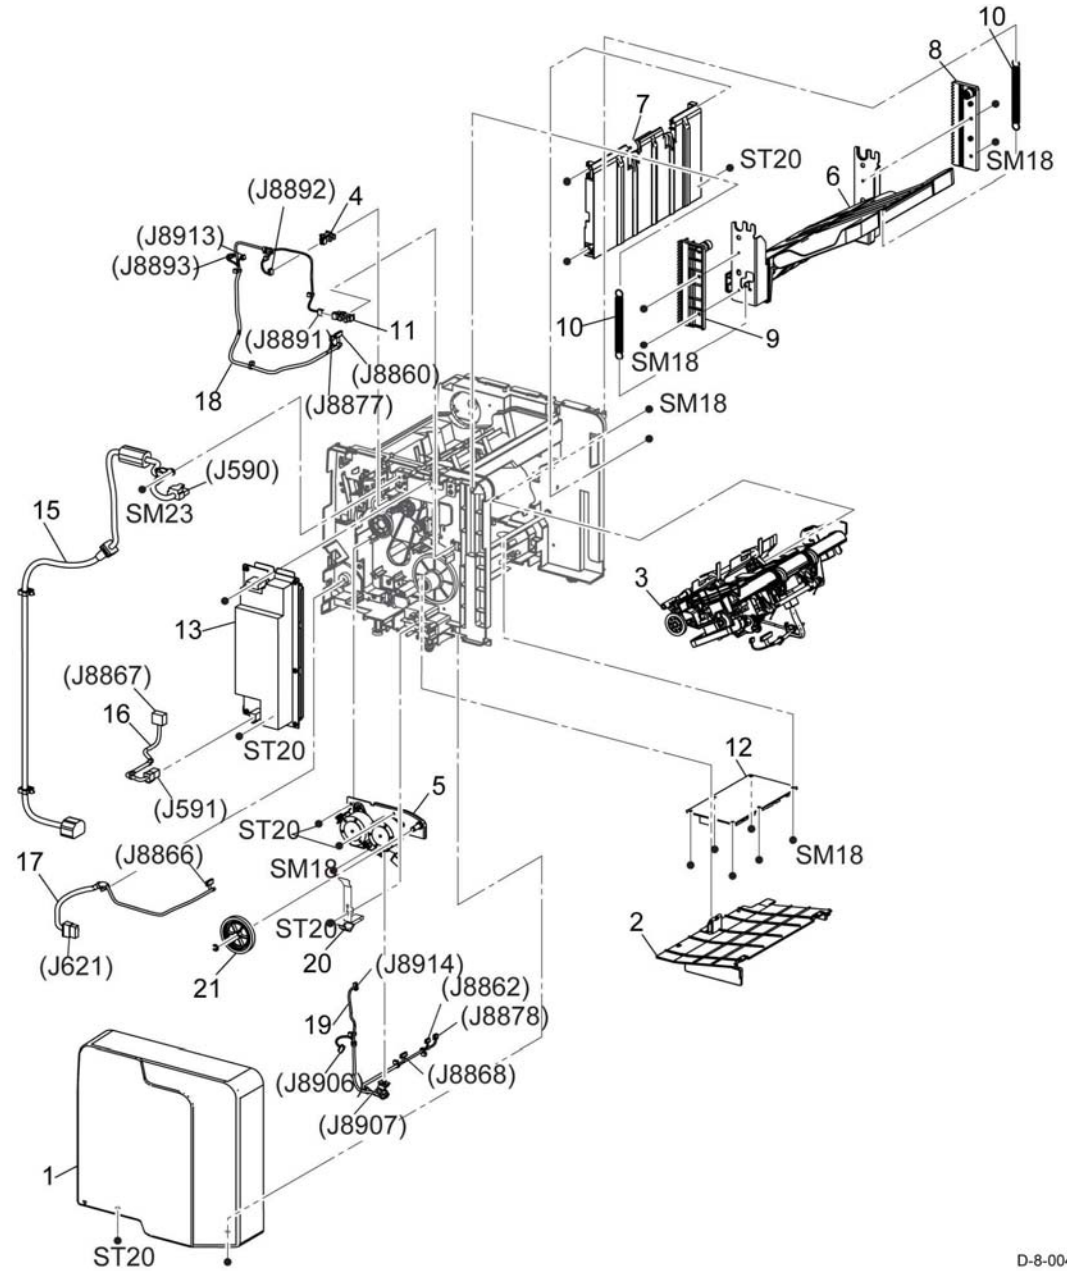
PL 21.1 Finisher

Item	Part	Description
1.	-	Cover LH C (Not Spared) (REP 21.1)
2.	-	Cover lower C (Not Spared) (REP 21.8)
3.	-	Tray assembly compile (Not Spared)
4.	-	Sub paddle home sensor (Not Spared)
5.	049K34570	Motor assembly stepping (REP 21.9)
6.	050K75450	Tray assembly base (REP 21.11)
7.	-	Tray guide C (Not Spared)
8.	-	Gear assembly rack R (Not Spared)
9.	-	Gear assembly rack L (Not Spared)
10.	-	Spring - lift (Not Spared)
11.	-	Stacker tray no-paper & full sensor (Not Spared)
12.	960K90036	PWBA GPF A4Fin (REP 21.4)
13.	105E22590	LVPS (REP 21.5)
14.	-	Not used
15.	-	Harn assembly AC (Not Spared)
16.	-	Harness assembly fin DC (Not Spared)
17.	-	Harness assembly fin IF (Not Spared)
18.	-	Harness assembly fin SNR1 (Not Spared)
19.	-	Harness assembly fin mot (Not Spared)
20.	-	Plate ground LH (Not Spared)
21.	-	Gear-Z50 Z20 (Not Spared)

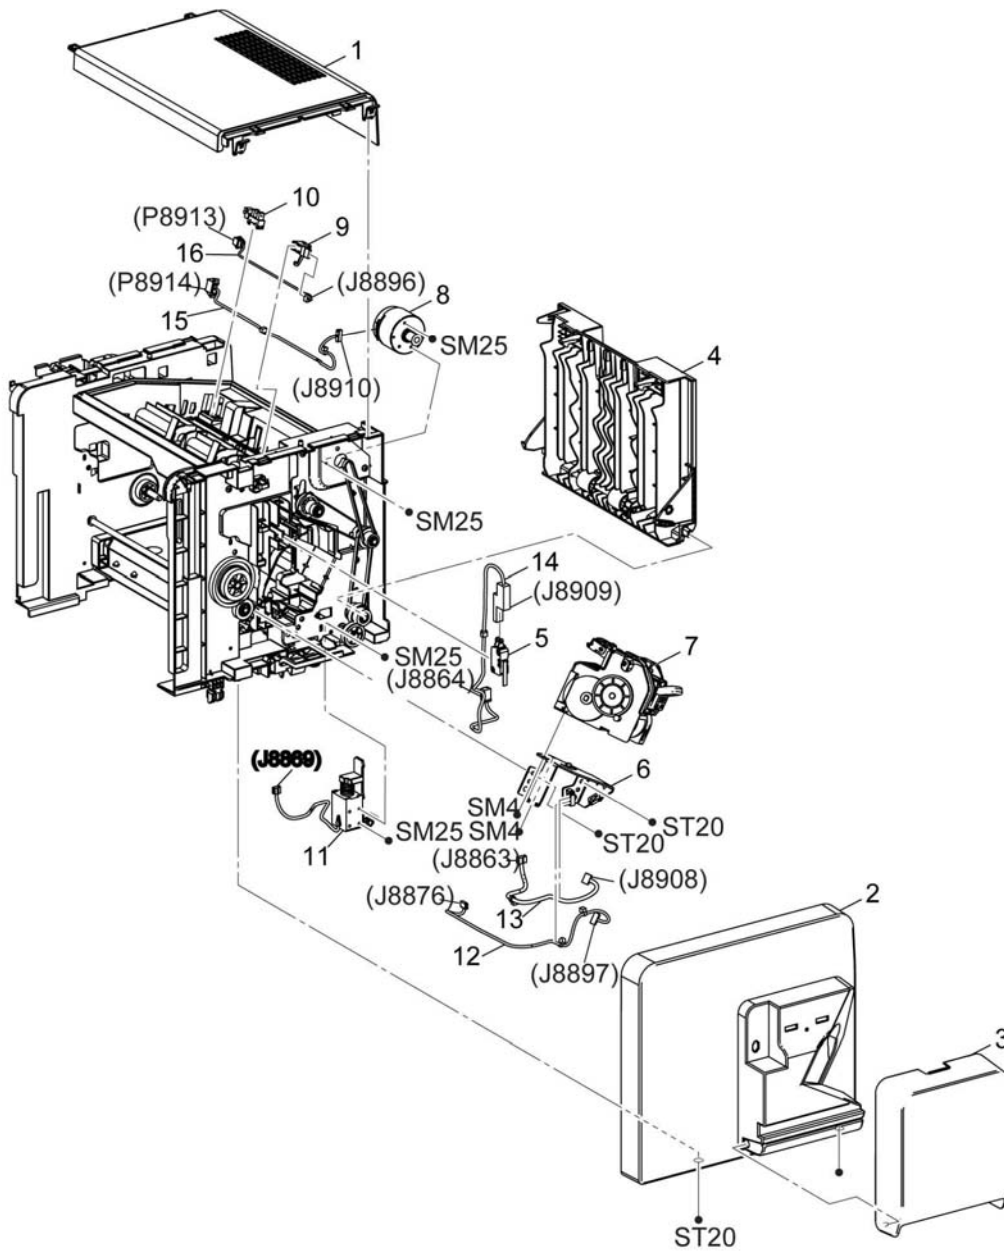
PL 21.2 Finisher

Item	Part	Description
1.	–	Cover Top C (Not Spared) (REP 21.3)
2.	–	Cover RH C (Not Spared)
3.	948K04650	Cover assembly staple
4.	–	Cover assembly rear (Not Spared)
5.	–	Switch safety L (Not Spared)
6.	–	Bracket stapler (Not Spared)
7.	029K93260	Stapler assembly (REP 21.10)
8.	127K72241	Motor assembly (REP 21.6)
9.	–	Compile exit sensor (Not Spared)
10.	–	Rear cover interlock sensor (Not Spared)
11.	121K58300	Solenoid assembly gate (REP 21.7)
12.	–	Harness assembly staple unit (Not Spared)
13.	–	Harness assembly stapler M (Not Spared)
14.	–	Harness assembly fin IL (Not Spared)
15.	–	Harness assembly fin trans M1 (Not Spared)
16.	–	Harness assembly fin compile sensor (Not Spared)

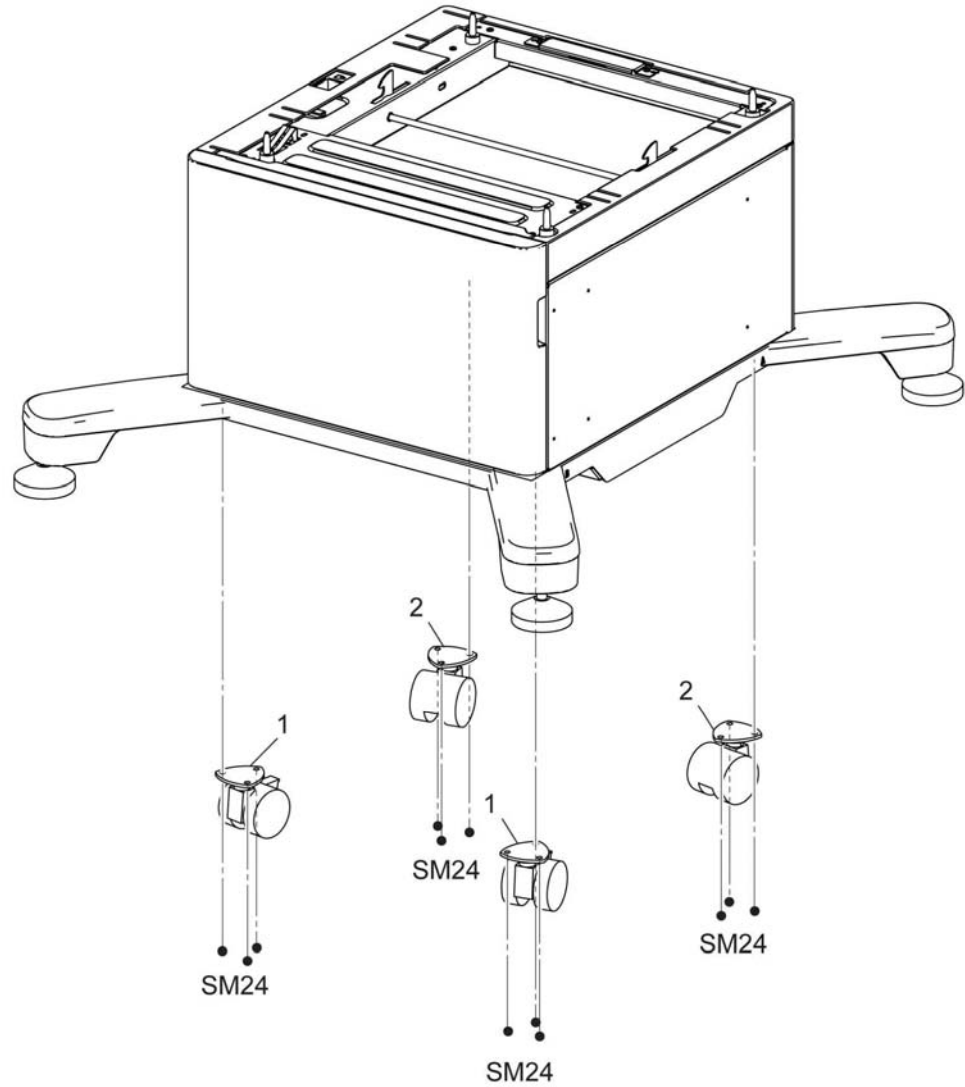
PL 30.1 Cabinet

Item	Part	Description
1	-	Caster (with lock) (Not Spared)
2	-	Caster (without lock) (Not Spared)

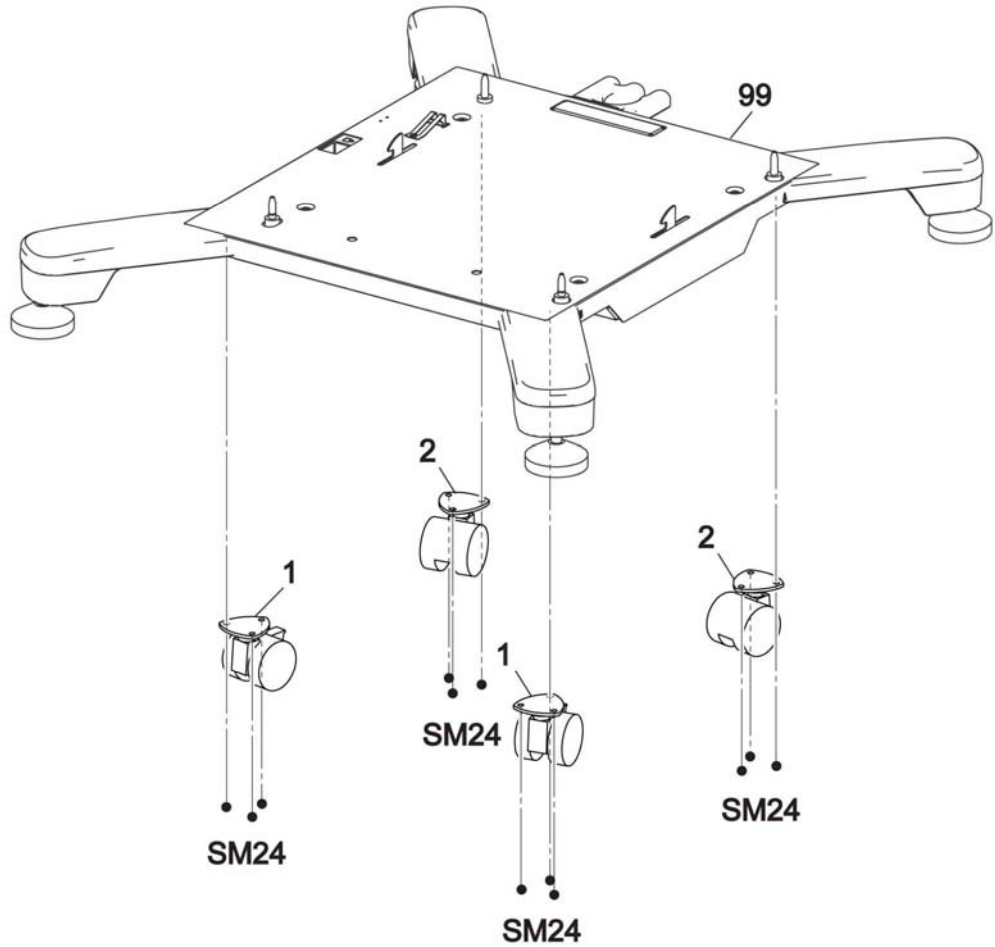
PL 30.2 Caster

Item	Part	Description
1	-	Caster (with lock) (Not Spared)
2	-	Caster (without lock) (Not Spared)

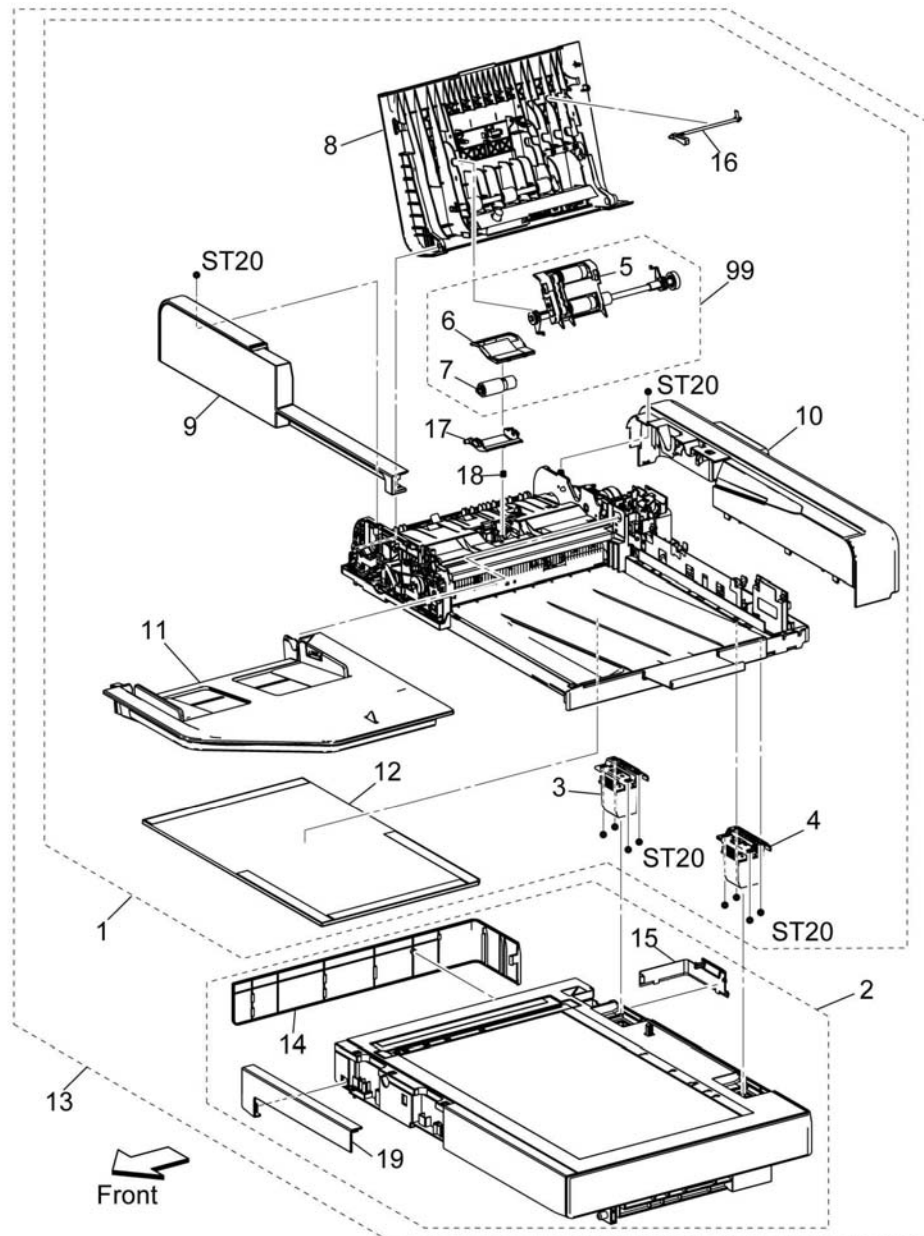
PL 50.1 Scanner (C505/C605/ C605_Tall only)

-	607K04861	IIT assembly C605/C605_Tall (with 14-15, 19) (REP 50.2)
-	607K04871	IIT assembly C605_Tall (with 14-15, 19) (REP 50.2)
3	036K92351	Counterbalance assembly L (REP 50.3)
4	036K92331	Counterbalance assembly R (REP 50.3)
5	-	Feeder roll DADF (P/O PL 50.1 Item 99)
6	-	Cover assembly separator (P/O PL 50.1 Item 99)
7	-	Roll assembly separator DADF (P/O PL 50.1 Item 99)
8	-	Feeder assembly upper (P/O PL 50.1 Item 1)
9	-	Cover DADF front (P/O PL 50.1 Item 1)
10	-	Cover DADF rear (P/O PL 50.1 Item 1)
11	-	Tray assembly DADF (P/O PL 50.1 Item 1)
12	004K03660	Cushon assembly platen (REP 50.4)
13	-	Scanner assembly (with 1-2)
14	822E35271	Cover IIT left (REP 50.5)
15	822E35341	Cover IIT left cap (REP 50.6)
16	120E35681	DADF actuator (REP 50.7)
17	-	Holder separator DADF (P/O PL 50.1 Item 1)
18	-	Spring separator DADF (Not Spared)
19	822E35311	Cover front IIT (REP 50.8)
99	-	Kit DADF feed roll (with 5-7) (P/O PL 50.1 Item 1)

NOTE: #99 - Kit DADF feed roll is available as Scanner Maintenance Kit (DADF), p/n 108R01490 in GP 40 Supplies and Accessories.

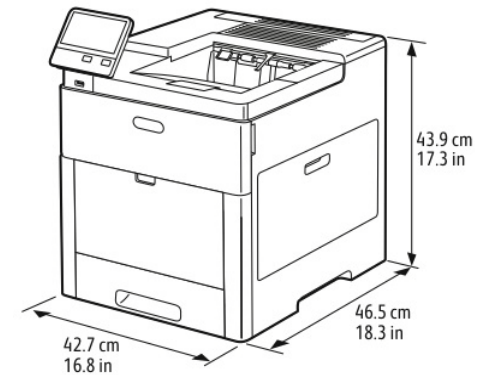
Figure 1 Standard configuration

Refer to [Figure 1](#) and [Table 3](#) for the weight and dimensions for standard C500 and C600 printers.

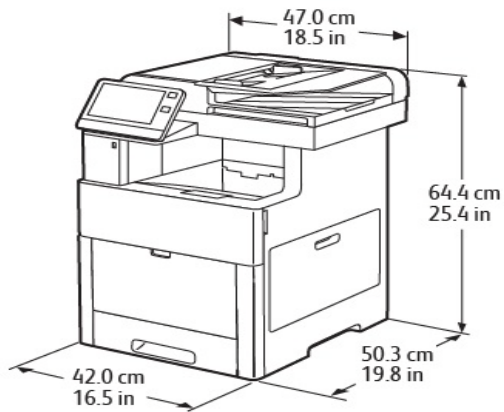
Figure 2 C505/C605

Width	470mm (18.5 in.)
Depth	505mm (19.9 in.)
Height	644mm (25.4 in.)
Weight (C505)	36.1kg (79.6 lb.)
Weight (C605)	36.1kg (79.6 lb.)

- C505/C605: [Figure 2](#) and [Table 6](#)

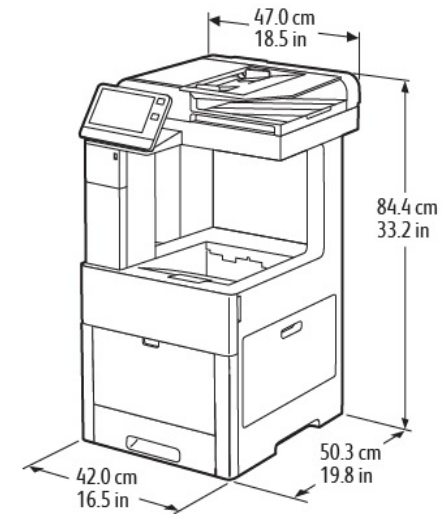
Figure 3 C605_Tall

- C605_Tall: [Figure 3](#) and [Table 7](#)

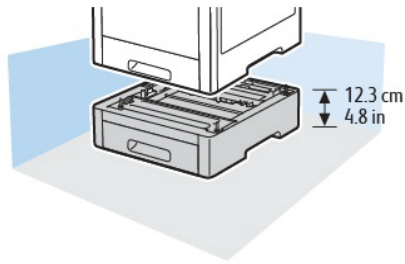
Figure 4 Optional 550 sheet feeder

Width	420mm (16.5 in.)
Depth	464.5mm (18.3 in.)
Height	123.5mm (4.8 in.)
Weight	6.6kg (14.6 lb.)

- [Figure 4, Table 8](#): Optional 550 sheet feeder
- [Figure 5, Table 9](#): Caster base with cabinet
- [Figure 6, Table 10](#): Caster stand with HCF
- [Figure 7, Table 11](#), Finisher (C600 and C605_Tall)
- [Figure 8, Table 12](#), Mailbox (C600 and C05_Tall)

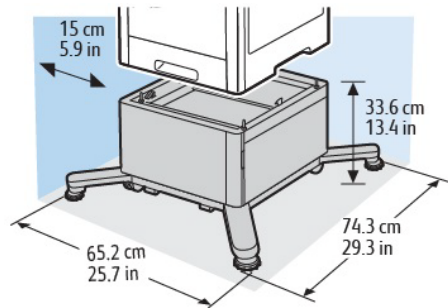
Figure 5 Caster base with cabinet

Depth	743mm (29.3 in.)
Height	336mm (13.4 in.)
Weight (cabinet)	16.6kg (36.6 lb.)
Weight caster base	8.5kg (18.8 lb.)

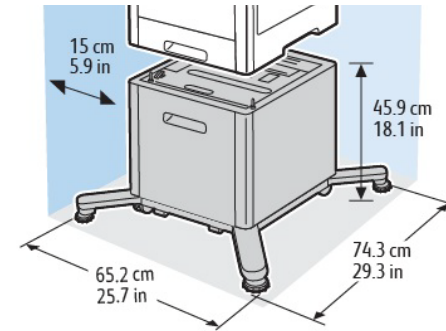
Figure 6 Caster base with HCF

Width (min.)	652mm (25.7 in.)
Width (max.)	802mm (31.6 in.)
Depth	743mm (29.3 in.)
Height	459mm (18.1 in.)
Weight (HCF)	19.7kg (43.4 lb.)
Weight (caster base)	8.5kg (18.8 lb.)

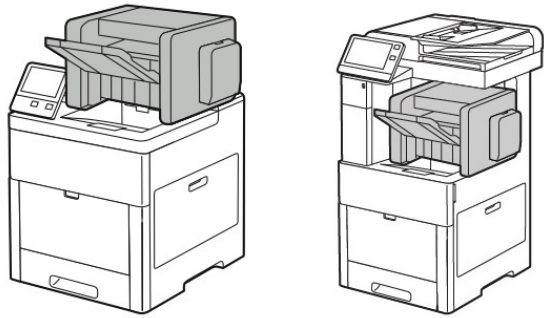
Figure 7 Finisher (C600 C500/C600 and C605_Tall)

Width	477mm (18.8 in.)
Depth	450mm (17.7 in.)
Height	248mm (9.8 in.)
Weight	6.8kg (15 lb.)

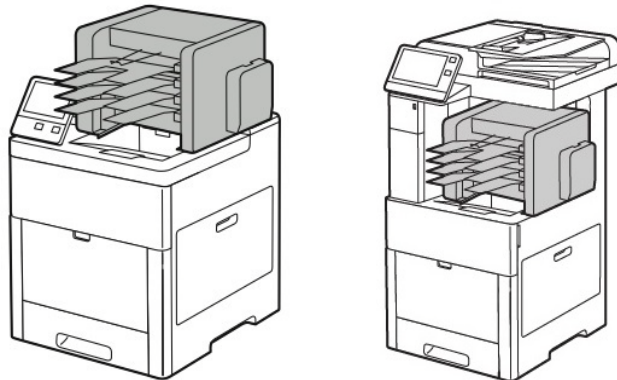
Figure 8 Mailbox (C600 C500/C600 and C605_Tall)

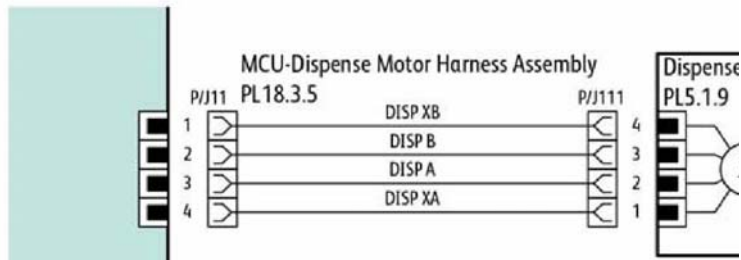
1. Refer to [Figure 1](#) as an example. Disconnect PJ111. Check the +24VDC supply and the phase pulses to GND when the component control code for the motor is entered. If the supply and pulses are present, install a new motor.
2. Check the connectors and wiring to the motor. Repair or install new wiring, as necessary.
3. Disconnect PJ11. Check the +24VDC. If +24VDC is not present, check the power to the PWB. If the power is good, install a new PWB. Check the phase pulses at the PWB. If the phase pulses are not present at the PWB, install a new PWB.

Figure 1 Motor wiring diagram

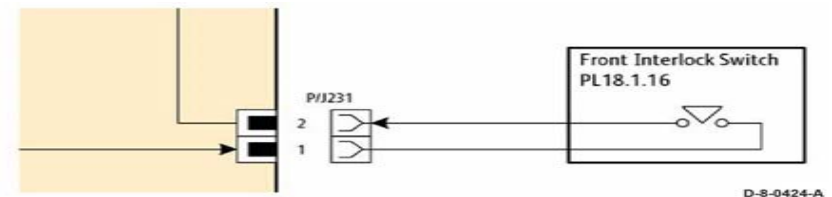
1. Enter dc330 diagnostics and enable the component control code for the switch to test. Actuate the switch. If the display changes, the switch operates correctly. If the display does not change, perform the following steps.
2. Inspect the mechanism intended to actuate the switch. Adjust, repair or install a new part as needed if it is not actuating the switch.
3. Disconnect the switch and measure the resistance between the two connector pins. If it does not change from infinite to 0 ohms as the switch is actuated, install a new switch. If the resistance changes correctly, go to the next step.
4. Check the continuity of the wire harness between the switch and its control PWB. If open, repair or install a new harness.
5. If the switch and wire harness have tested good, install a new PWB that the switch is connected to.

Figure 1 Switch wiring diagram

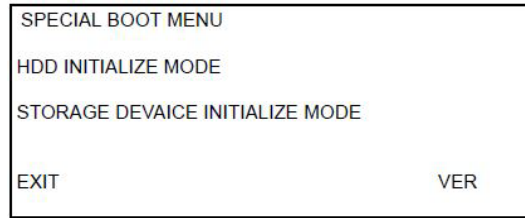
1. Switch Off the machine GP 4.
2. Simultaneously press then hold down the **Home** and **Power** buttons until the device powers On and SPECIAL BOOT MENU appears. Figure 1.

Figure 1 Special boot menu

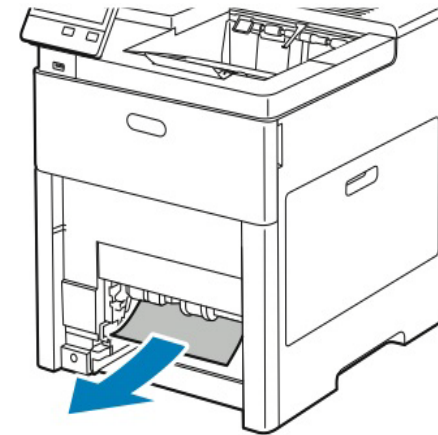
Figure 1 Clear the media path and output tray (C500/C600)

- Refer to the following figures to clear the media path and output trays.
 - Figure 1 C500/C600
 - Figure 2 C505/C605
 - Figure 3 C505/C605 with optional 550 sheet feeder
 - Figure 4 Remove the optional feeder from the printer

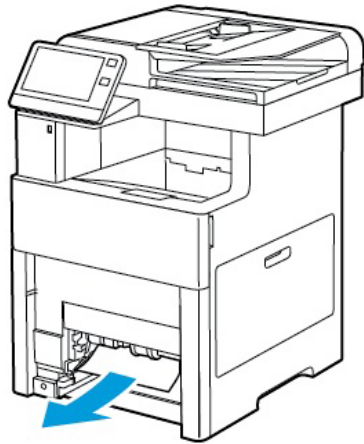
Figure 2 Clear the media path and output tray (C505/C605)

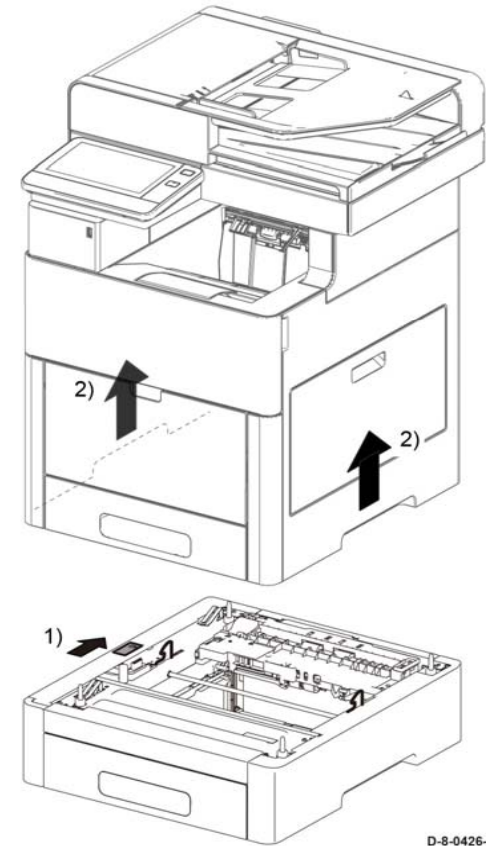
2. Refer to [Figure 4](#) to locate and toggle the slider switch to the unlocked position before separating the printer and optional trays.

Figure 4 Separate optional feeder assembly from the printer

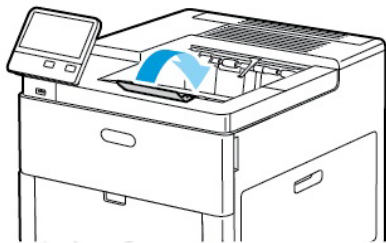
4. Turn off the printer and disconnect the power cord and other cables from the back of the printer.
5. Remove any paper or other media from the output tray. If the output tray extension is extended, close it, [Figure 1](#).

Figure 1 Close the Output Tray Extension

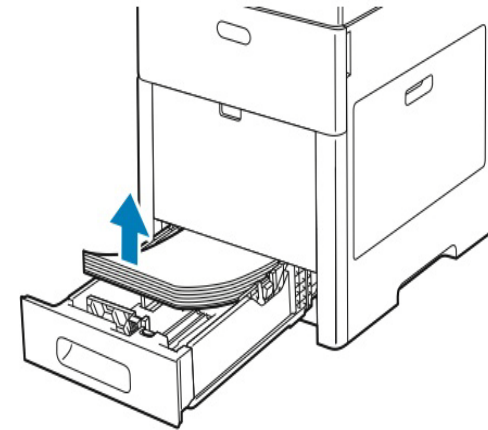
6. Remove the paper from the paper tray, [Figure 2](#). Keep the paper wrapped and away from humidity and dirt.

Figure 2 Remove Paper from the Paper Tray

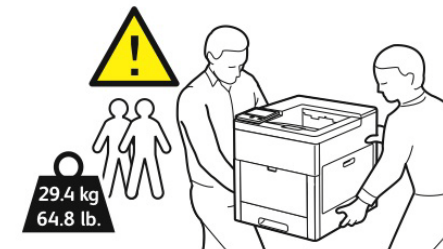
Figure 3 Printer Lifting Technique (C500/C600)

7. Lift and carry the printer as shown in [Figure 3](#) and [Figure 4](#).

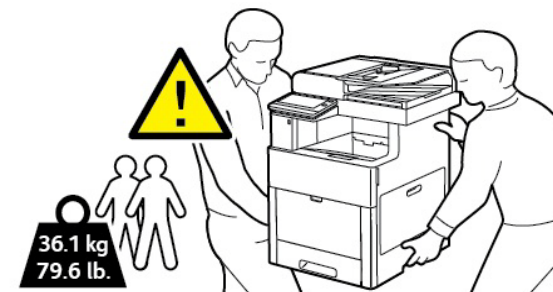
Figure 4 Printer Lifting Technique (C505/C605/C605_Tall)

- When moving the printer, do not tilt it more than 10 degrees to the front, back, left, or right. Tilting the printer more than 10 degrees can cause toner spillage.

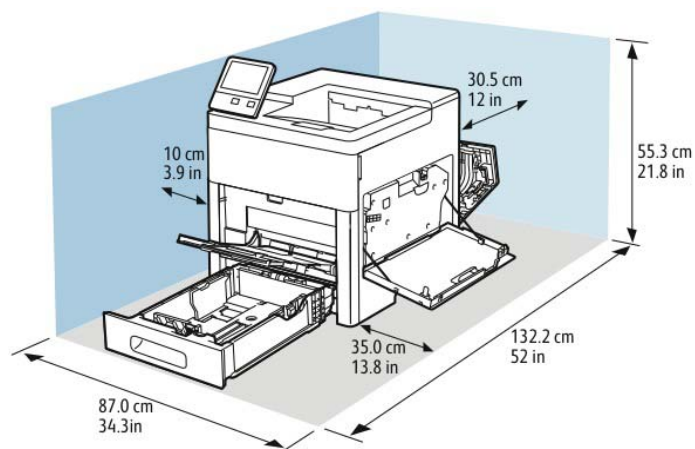
C500/C600 Standard
Width	870mm (34.3 in.)
Depth	1322mm (52 in.)
Height	553mm (21.8 in.)

Figure 1 C500/C600 standard

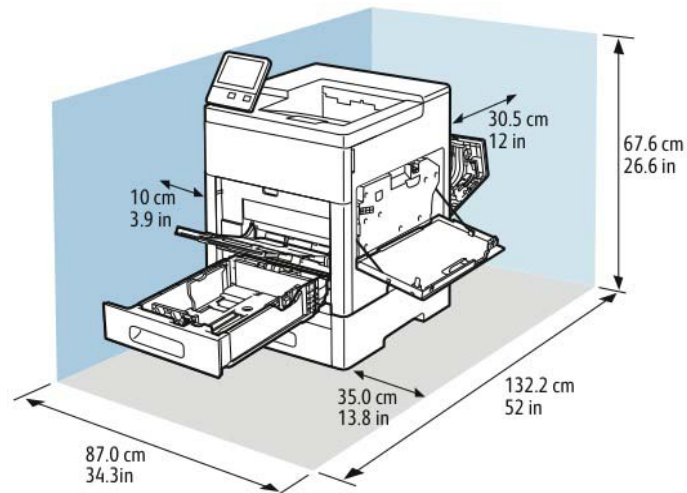
Figure 2 C500/C600 with optional 550 sheet feeder

Width	870mm (34.3 in.)
Depth	1322mm (49.8 in.)
Height	676mm (26.6 in.)

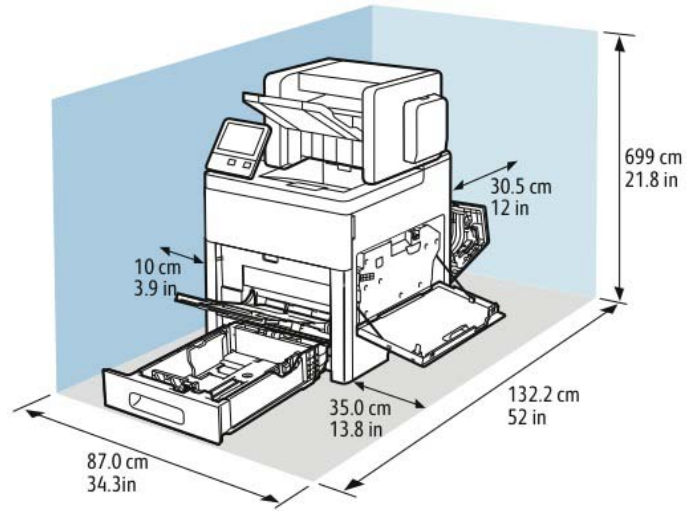
Figure 3 C600 C500/C600 with optional finisher

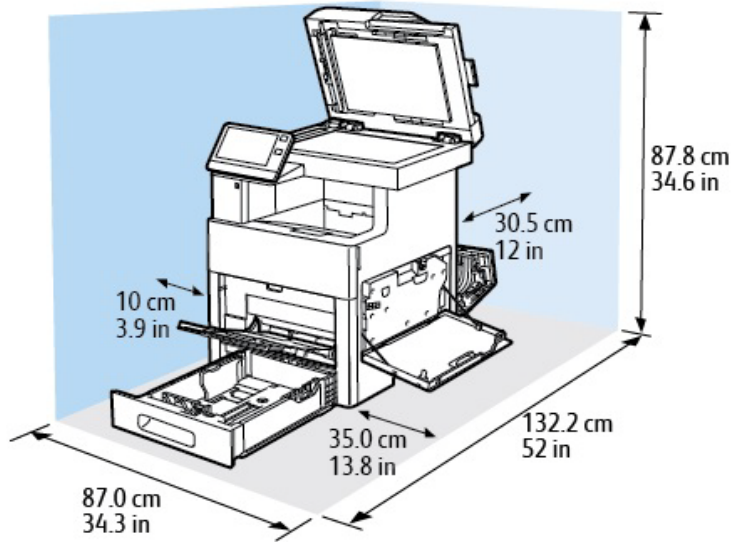
Figure 4 C505/C605

See the following illustrations and tables for the space requirements for the VersaLink multi-function printers. Refer to [Figure 4](#) and [Table 4](#) for C505. [Figure 4](#) and [Table 5](#) for C605 and [Figure 5](#) and [Table 6](#) for C605_Tall total space requirements. Refer to [Figure 6](#) and [Table 7](#) for the 550-sheet feeder and to [Figure 7](#) and [Table 8](#) for the caster stand with HCF,

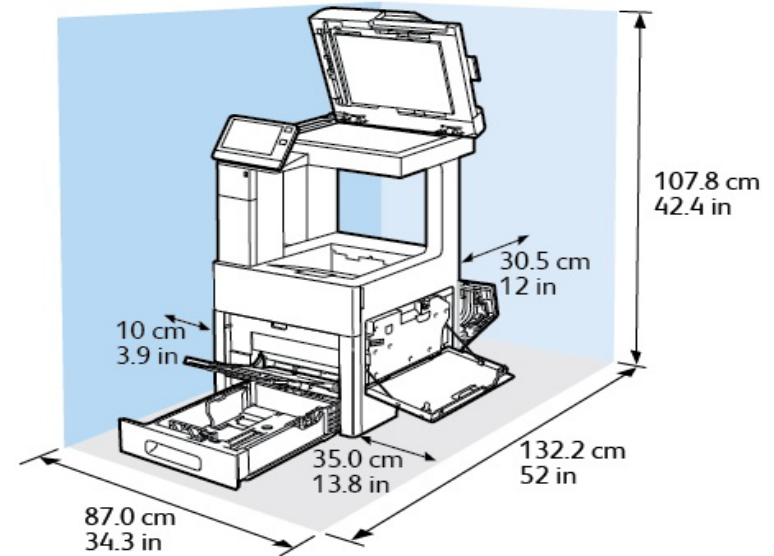
Figure 5 C605_Tall

Refer to [Table 6](#) for total space required for clearance.

C605_Tall	Configurations without the Optional 550-Sheet Feeder	Optional 550-Sheet Feeder Dimensions
Width	870mm (34.3 in.)	420mm (16.5 in.)
Depth	1322mm (52 in.)	465mm (18.3 in.)
Height	1078mm (34.3 in.)	148mm (5.8 in.)

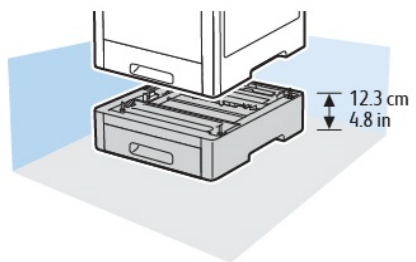
Figure 6 Optional 550 sheet feeder

Width	420mm (16.5 in.)
Depth	464.5mm (18.3 in.)
Height	123mm (4.8 in.)
Weight	6.6kg (14.6 lb.)
