VersaLink[®] C500/C600 Printer and C505/C605 Multifunction Printer Service Manual

Xerox VersaLink C605F Family Printer Service Manual

705P01395

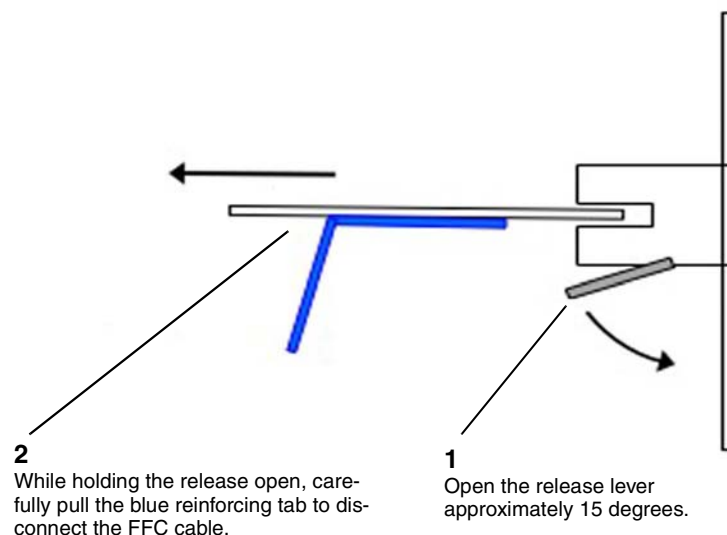
Figure 1 FFC cable disconnect

Take care not to break the FFC release lever when disconnecting the FFC cable. Open the lever just far enough (approximately 15 degrees) to release the FFC cable. Opening the lever too far will break the lock mechanism. A new PWB will be required if the lock mechanism breaks.

1. Disconnect the FFC cable, [Figure 1](#).

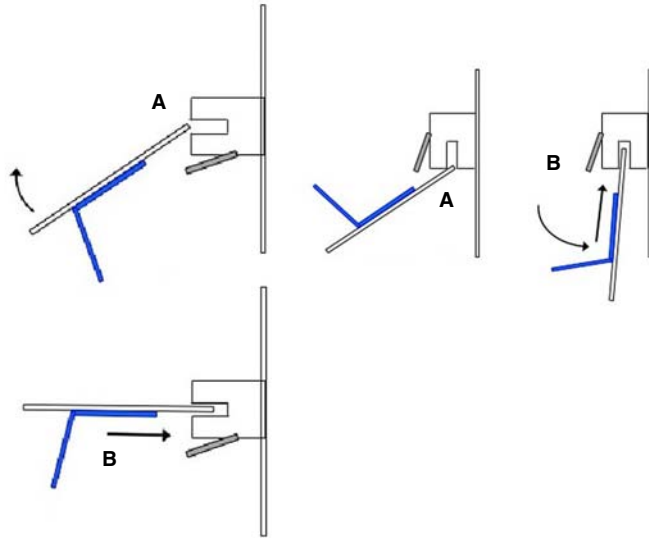
Figure 2 FFC cable connect

3. Use the blue reinforcing tab to very carefully connect the FFC cable, [Figure 2](#):
 - a. Position the FFC cable at an angle (A), then centrally (B) in the slot of the connector.
 - b. While aligning the FFC cable with the slot, firmly push the FFC cable into the connector (B). The release lever will close and a click will be heard when the FFC cable is fully inserted.

NOTE: Two types of surface mounted connectors are shown in [Figure 2](#).

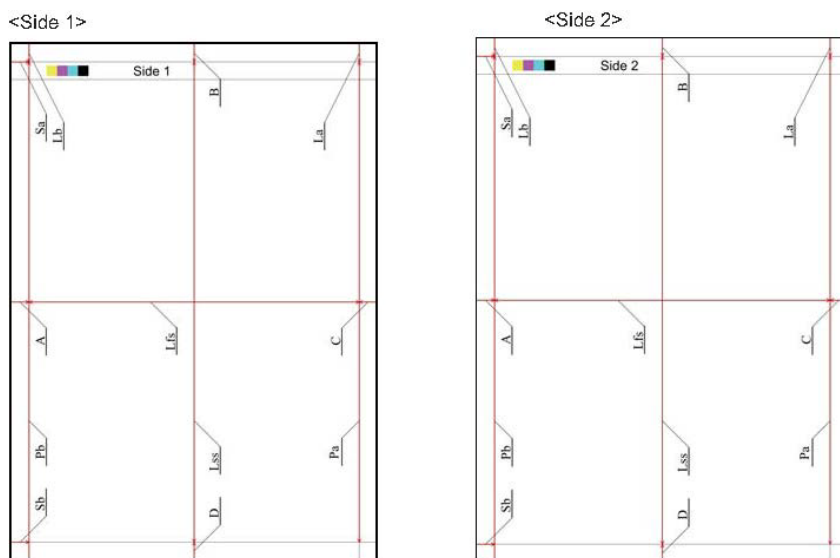
Figure 1 DC126 System registration adjustment test pattern

1. Enter Diagnostics, **GP 1**.
2. Touch **DC126 System Registration Adjustment**.
The System Registration Adjustment screen is displayed.
3. Select **Paper Supply**, then choose the adjusting tray.
4. Select **Printout Settings**, then touch **Print**. to print the test pattern (Figure 1).

NOTE: The A, B, C and D locations marked on the test pattern indicate the distance from the test pattern image to the paper's edge.

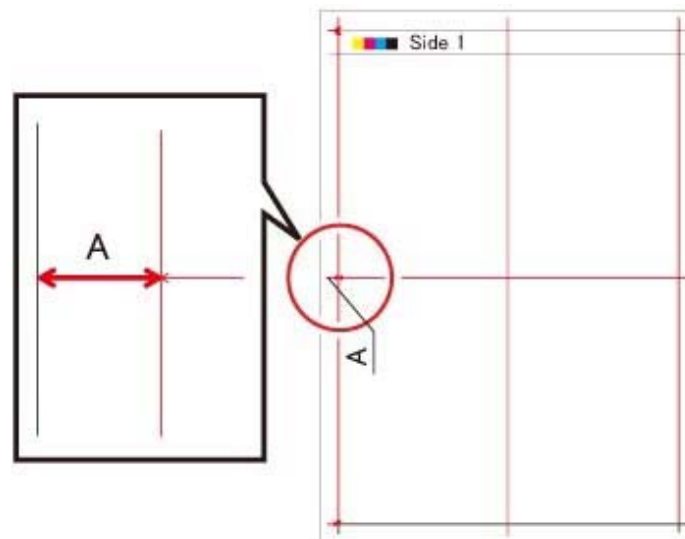
1. Using the test pattern chart which was output from the tray requiring adjustment, measure the length (in millimeters) of "A" on the printed test pattern Side 1.

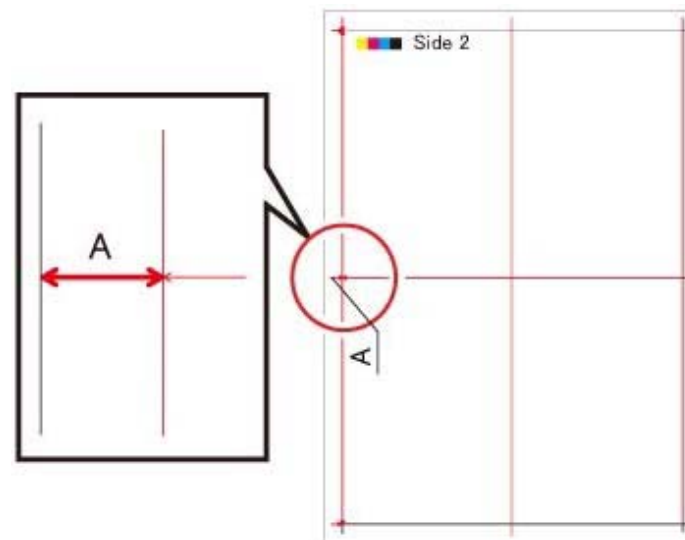
2. Measure the length (in millimeters) of "A" on the printed test pattern Side 2.

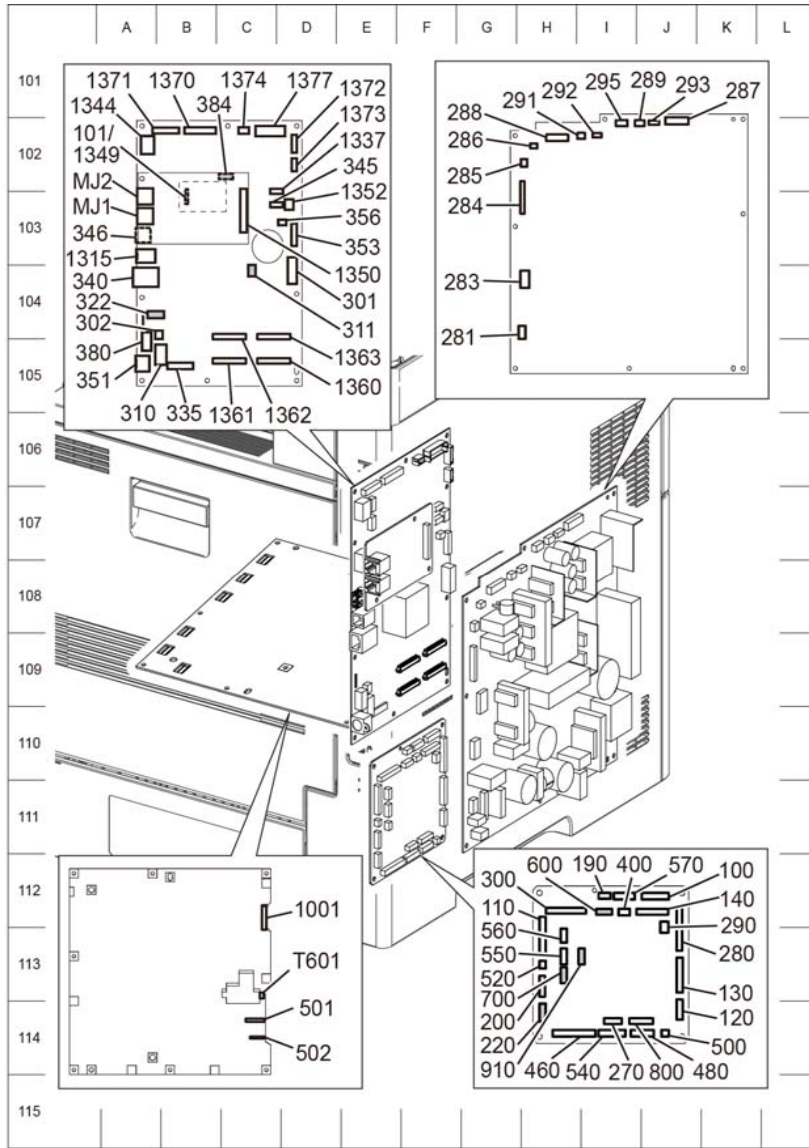
Figure 1 C505/C605 (1 of 8)

P/J	Map	Coordinates	Connection
P/J1370	Figure 1	B-102	C505/C605 ESS PWB and DADF/ITT harness assembly
P/J1371	Figure 1	B-102	C505/C605 ESS PWB and DADF/ITT harness assembly
P/J1372	Figure 1	D-102	C505/C605 ESS PWB and DADF/ITT harness assembly
P/J1373	Figure 1	D-102	C505/C605 ESS PWB and DADF/ITT harness assembly
P/J1374	Figure 1	C-102	C505/C605 ESS PWB and DADF/ITT harness assembly
P/J1377	Figure 1	C-102	C505/C605 ESS PWB and DADF/ITT harness assembly
P/JMJ1	Figure 1	F-108	Network port (line)
P/JMJ2	Figure 1	F-108	Network port (phone)
P/JT601	Figure 1	D-113	HVPS PWB and Trans supply harness assembly

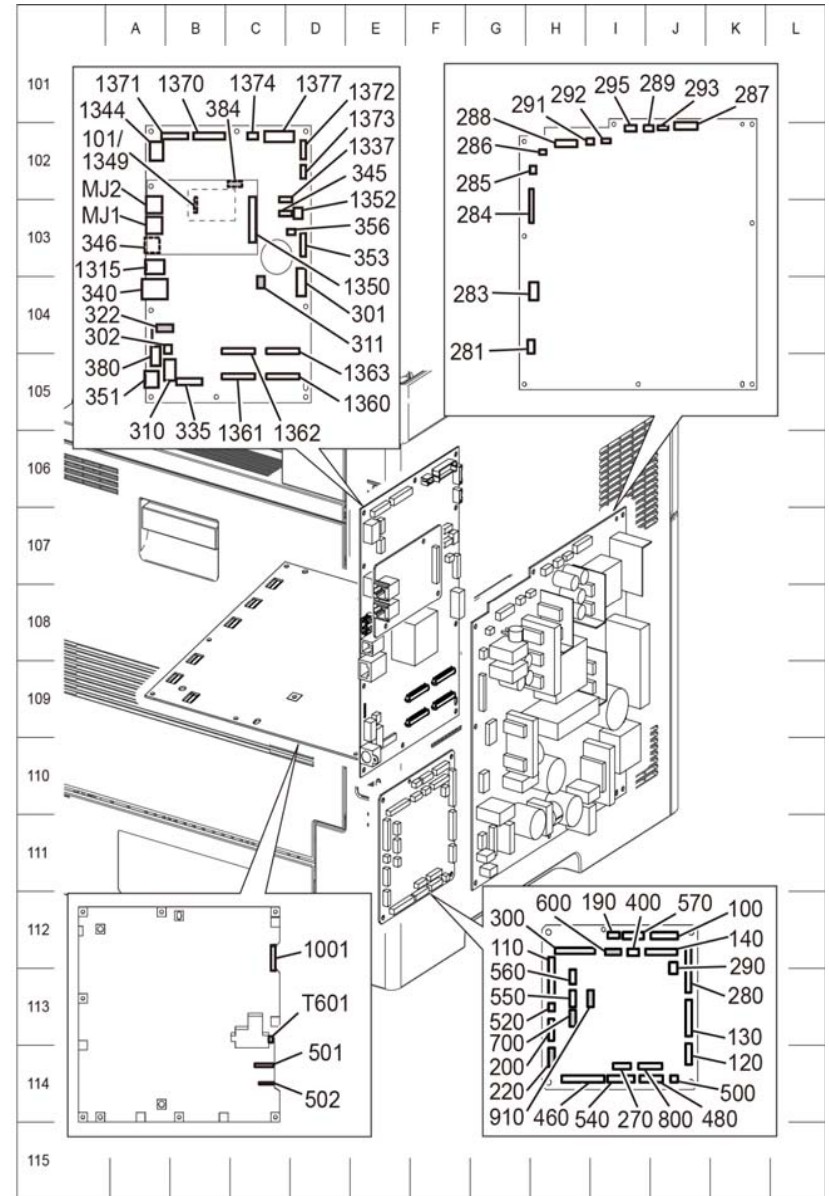
Figure 1 C605_Tall (1 of 6)

P/J	Map	Coordinates	Connection
P/J816	Figure 7	H-107	Succeeding optional feeder and FDR drawer harness assembly
P/J910	Figure 1	I-113	Not connected
P/J1001	Figure 1	C-112	HVPS PWB and MCU-HVPS-CF harness assembly
P/J1315	Figure 1	A-103	USB 3.0 type B port
P/J1337	Figure 1	E-103	ICCR USB harness assembly and C505/C605 ESS PWB
P/J1344	Figure 1	A-102	C505/C605 ESS PWB and Wireless module
P/J1349	Figure 1	B-103	C505/C605 ESS PWB and EMMC card
P/J1350	Figure 1	C-103	FAX PWB and FAX harness assembly
P/J1352	Figure 1	D-103	C505/C605 ESS PWB and UI harness
P/J1360	Figure 1	C-105	C505/C605 ESS PWB and LPH color (Y) head assembly
P/J1361	Figure 1	C-105	C505/C605 ESS PWB and LPH color (M) head assembly
P/J1362	Figure 1	C-105	C505/C605 ESS PWB and LPH color (C) head assembly
P/J1363	Figure 1	C-105	C505/C605 ESS PWB and LPH color (K) head assembly
P/J1370	Figure 1	B-102	C505/C605 ESS PWB and DADF/ITT harness assembly

P/J1371	Figure 1	B-102	C505/C605 ESS PWB and DADF/ITT harness assembly
P/J1372	Figure 1	D-102	C505/C605 ESS PWB and DADF/ITT harness assembly
P/J1373	Figure 1	D-102	C505/C605 ESS PWB and DADF/ITT harness assembly
P/J1374	Figure 1	C-102	C505/C605 ESS PWB and DADF/ITT harness assembly
P/J1377	Figure 1	D-102	C505/C605 ESS PWB and DADF/ITT harness assembly
P/JMJ1	Figure 1	A-103	Network port (line)
P/JMJ2	Figure 1	A-103	Network port (phone)
P/JT601	Figure 1	D-113	HVPS PWB and Trans supply harness assembly

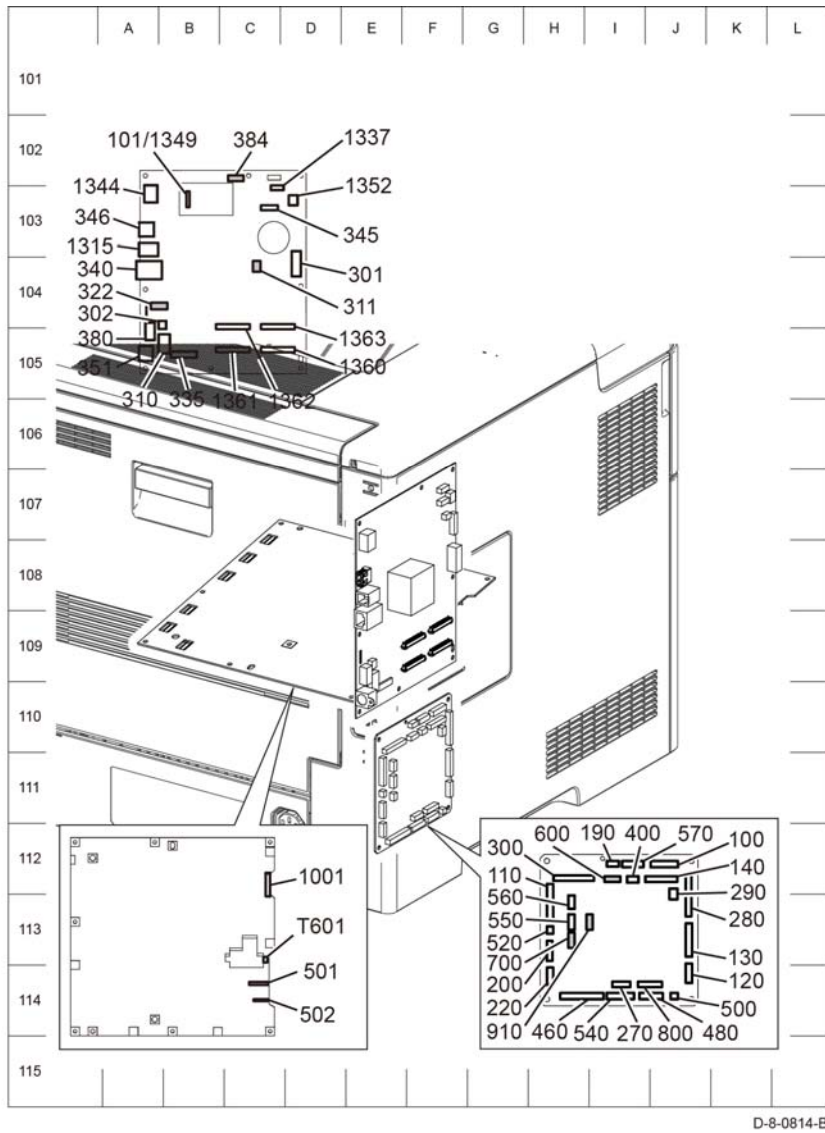
Figure 1 SPF (1 of 9)

P/J	Map	Coordinates	Connection
P/J808	Figure 10	F-112	OPF 550 PWB and turn harness assembly
P/J809	Figure 10	D-106	OPT take away clutch and turn harness assembly
P/J810	Figure 10	D-106	OPT paper path sensor and turn harness assembly
P/J811	Figure 10	H-112	OPF 550 PWB and size harness assembly
P/J812	Figure 10	I-107	OPF 550 switch assembly and size harness assembly
P/J813	Figure 10	J-111	OPF 550 PWB and OPF LED harness assembly
P/J814	Figure 10	K-106	OPF LED tray and OPF LED harness assembly
P/J815	Figure 10	I-112	OPF 550 PWB and FDR drawer harness assembly
P/J816	Figure 10	H-107	Succeeding optional feeder and FDR drawer harness assembly
P/J910	Figure 1	I-113	Not connected
P/J1001	Figure 1	C-112	HVPS PWB and MCU-HVPS-CF harness assembly
P/J1315	Figure 1	A-103	USB type B port
P/J1337	Figure 1	C-103	ESS C505/C605 PWB and Front USB harness assembly
P/J1344	Figure 1	A-102	ESS C505/C605 PWB and wireless module

P/J1349	Figure 1	B-103	ESS C505/C605 PWB and EMMC Card
P/J1352	Figure 1	D-103	ESS C505/C605 PWB and UI harness assembly
P/J1360	Figure 1	C-105	ESS C505/C605 PWB and LPH color (Y) head assembly
P/J1361	Figure 1	C-105	ESS C505/C605 PWB and LPH Color (M) head assembly
P/J1362	Figure 1	C-104	ESS C505/C605 PWB and LPH Color (C) head assembly
P/J1363	Figure 1	C-105	ESS C505/C605 PWB and LPH Color (K) head assembly
P/JT601	Figure 1	C-113	HVPS PWB and trans supply harness assembly

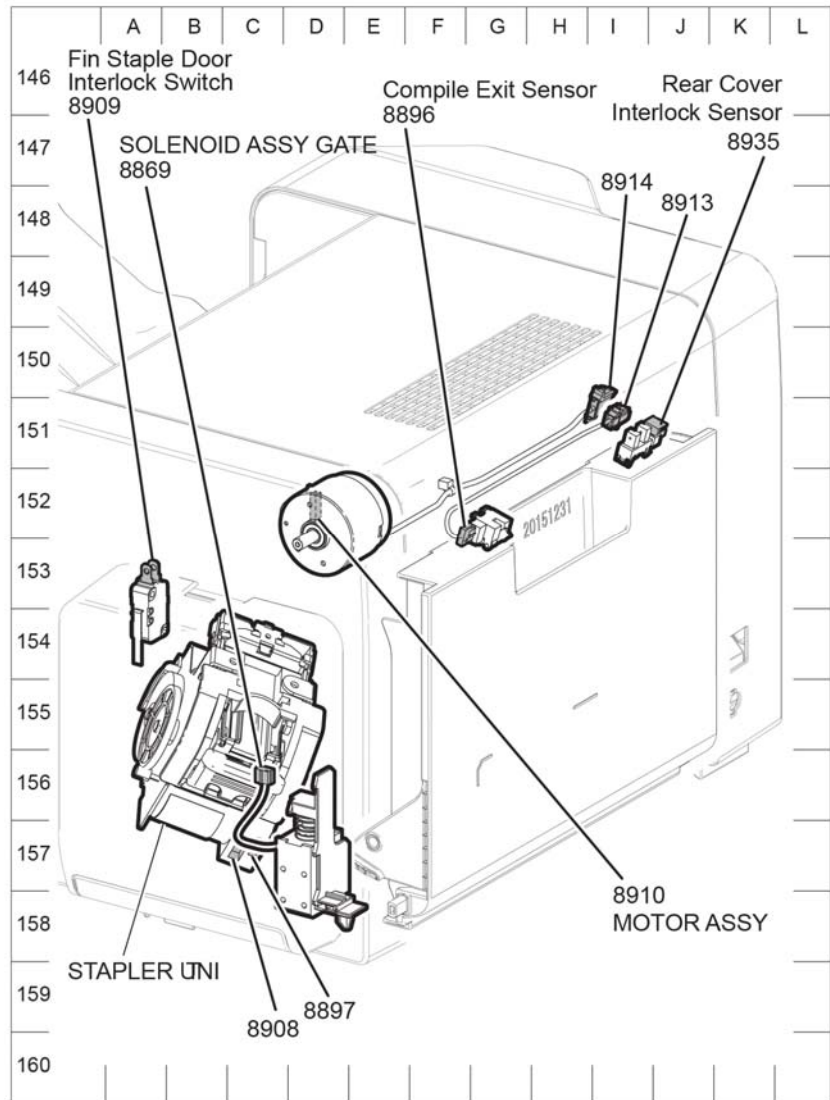
Figure 3 Connector locations, sensors and motors (2/4)

P/J8909	Figure 3, B-153	Connects harness assembly FIN IL and switch safety L
P/J8910	Figure 3, D-152	Connects harness assembly FIN TRANS M1 and motor assembly
P/J8912	Figure 4, H-154	Connects harness assembly compile tamper MOT, clutch and set clump clutch
P/J8913	Figure 3, I-151	Connects harness assembly FIN SNR1 and harness assembly FIN compile sensor
P/J8914	Figure 3, I-150	Connects harness assembly FIN MOT and harness assembly FIN TRANS M1
P/J8935	Figure 3, I-151	Rear Cover Interlock Sensor

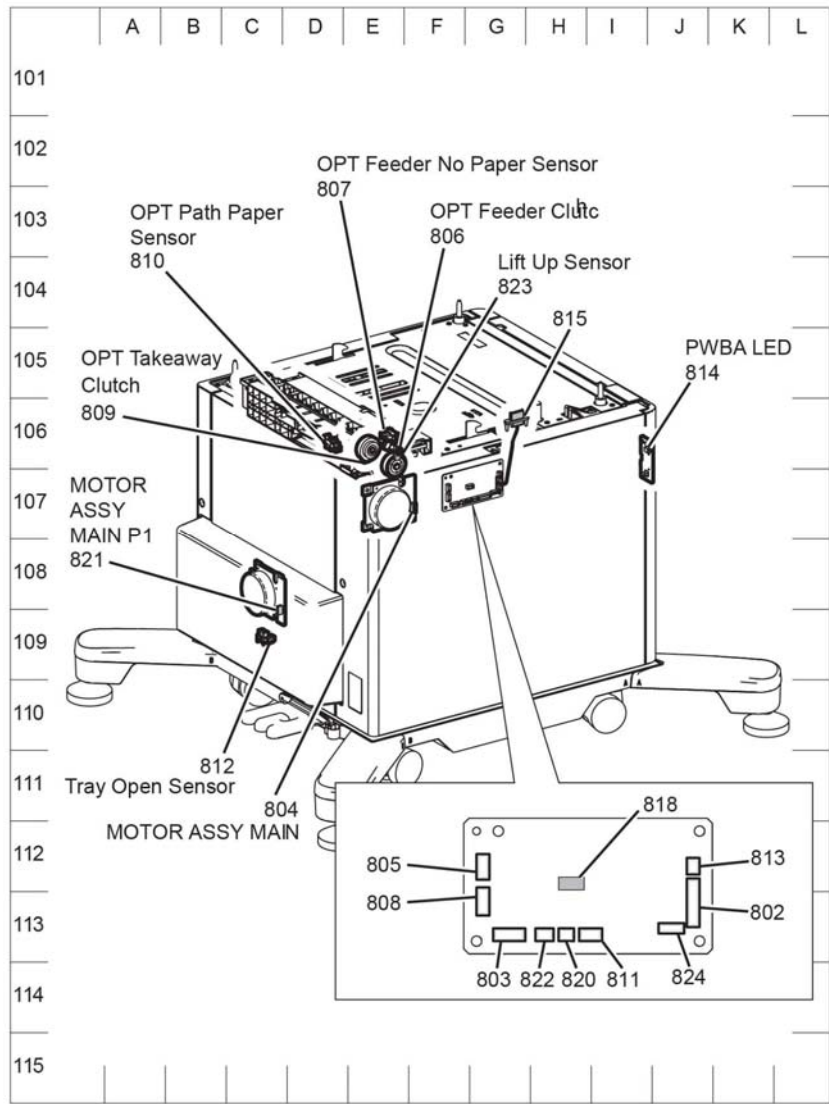
Figure 1 HCF P/J locations

P/J814	Figure 1, I-107	Connects Tray LED assembly and harness assembly OPF LED
P/J815	Figure 1, G-106	Connects PWBA assembly OPF 550 and harness assembly FDR Drawer 2
P/J818	Figure 1, H-112	Connects harness assembly OPF2-C and harness assembly FDR Drawer 2
P/J820	Figure 1, H-114	Connects PWBA OPF and harness assembly lift motor I/L
P/J821	Figure 1, C-108	Connects harness assembly T-Open/Lift motor and main motor assembly P1
P/J822	Figure 1, H-113	Connects PWBA OPF and harness assembly lift up sensor
P/J823	Figure 1, F-107	Connects harness assembly lift up sensor and lift up sensor
P/J824	Figure 1, J-113	Connects PWBA OPF and rear cover interlock switch

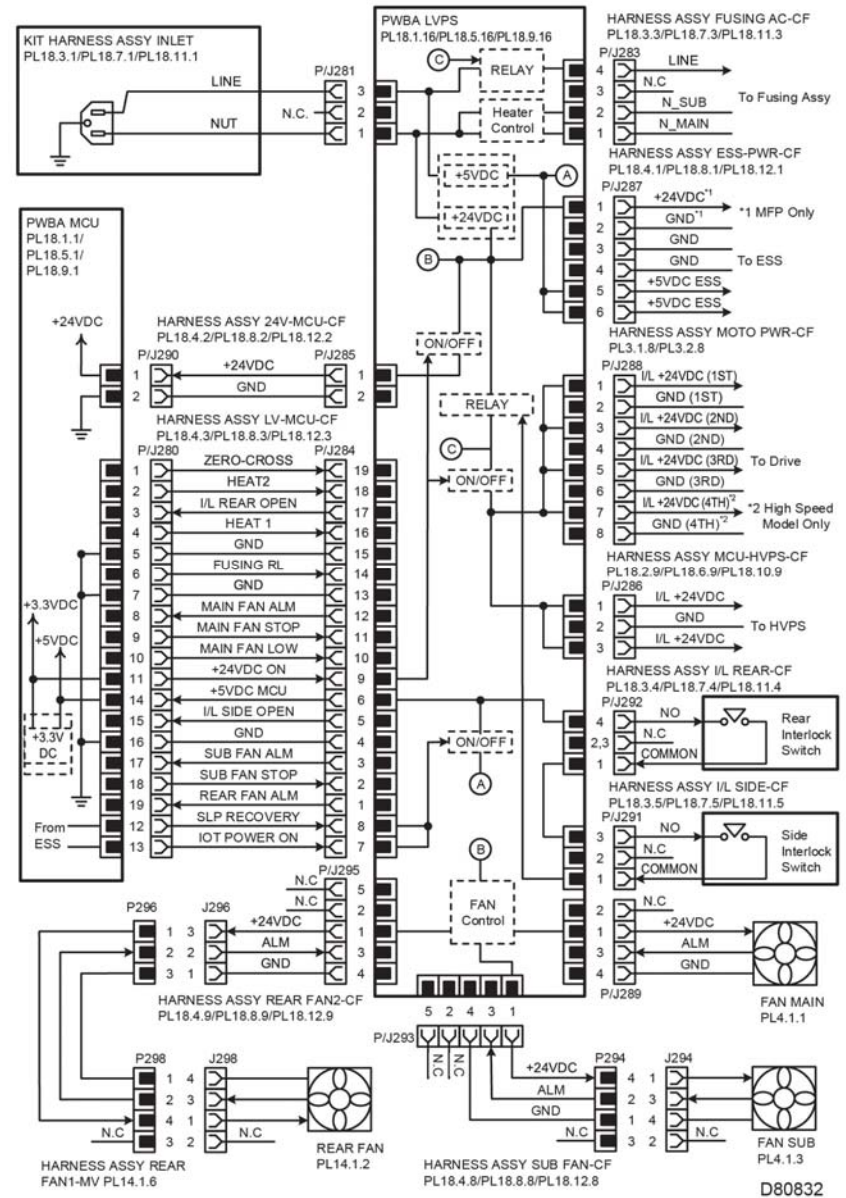
Figure 1 Power connection diagram

- Each output (+24VDC, +5VDC) of LVPS stops all outputs if there is overvoltage.
- The operating voltage of the overvoltage protection of each output is as following:
 - +24VDC: 27 VDC~36 VDC
 - +5VDC: 7 VDC

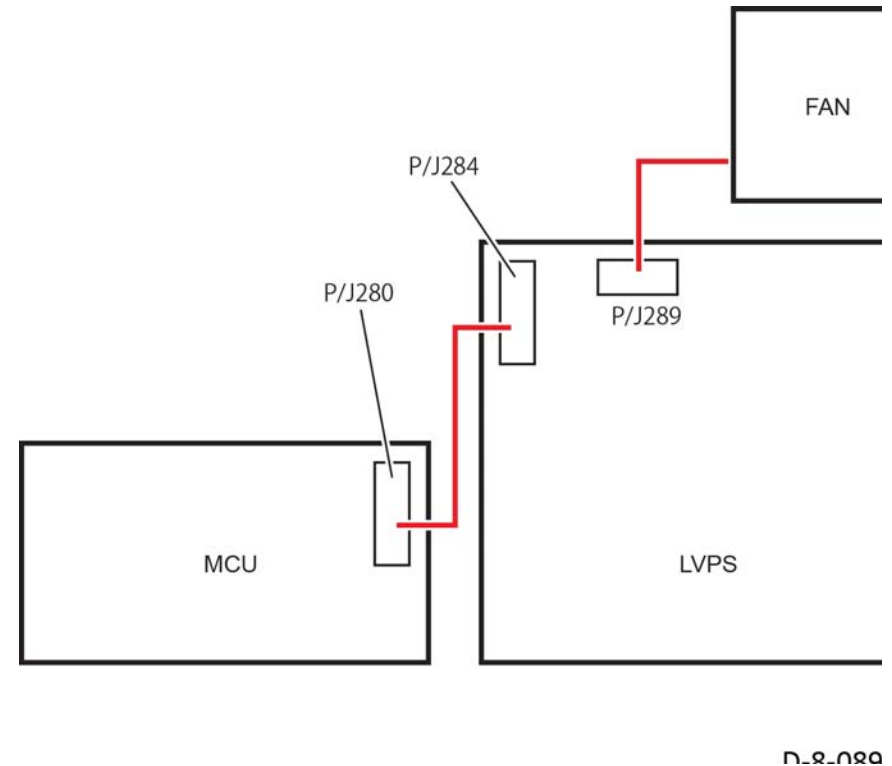
Figure 1 MCU, LVPS, fan

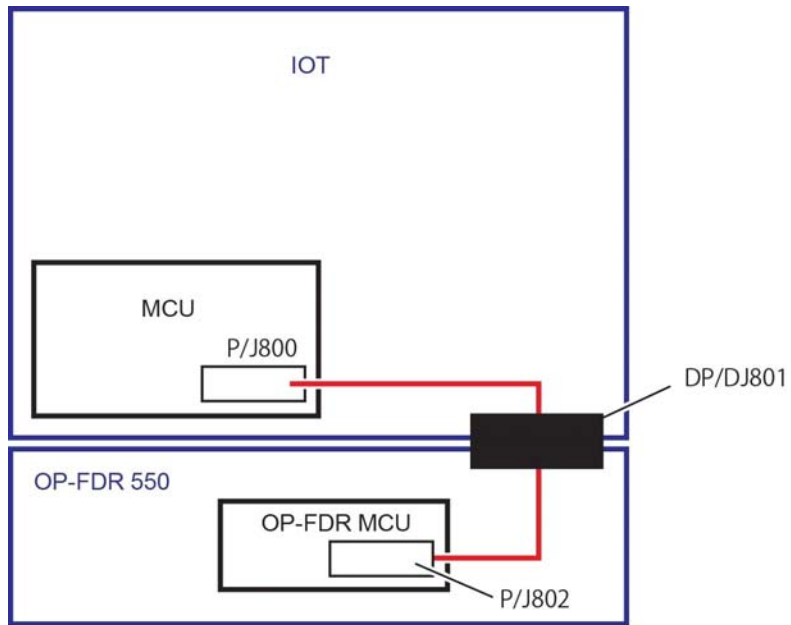
D-8-0894-A

Figure 2 MCU, OP-FDR 550

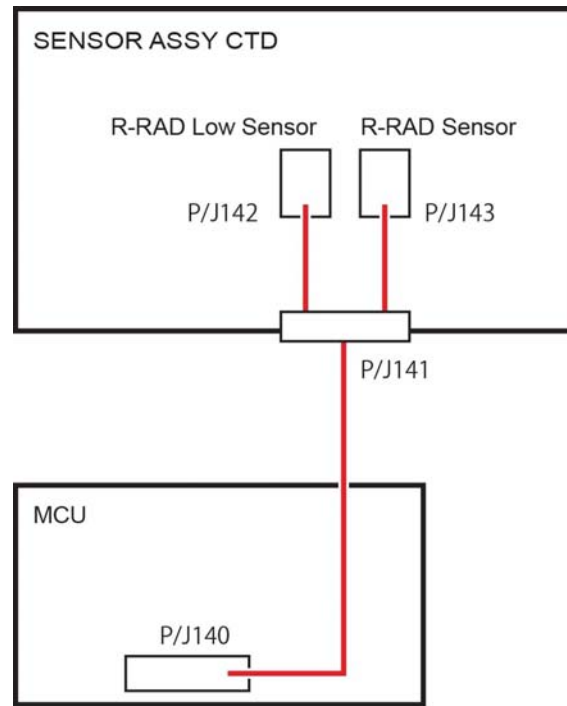
D-8-0895-A

Figure 3 R-RAD sensor

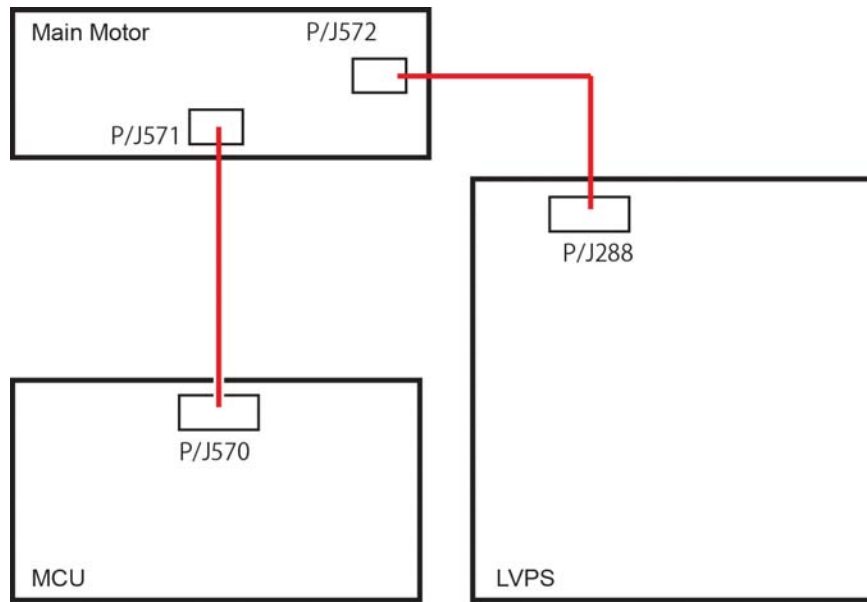
Figure 4 Main motor

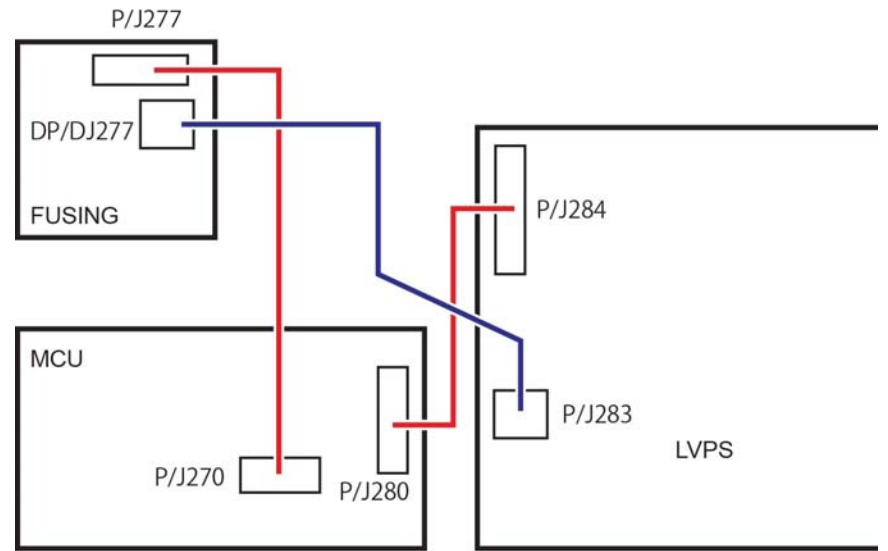
Figure 5 Fusing

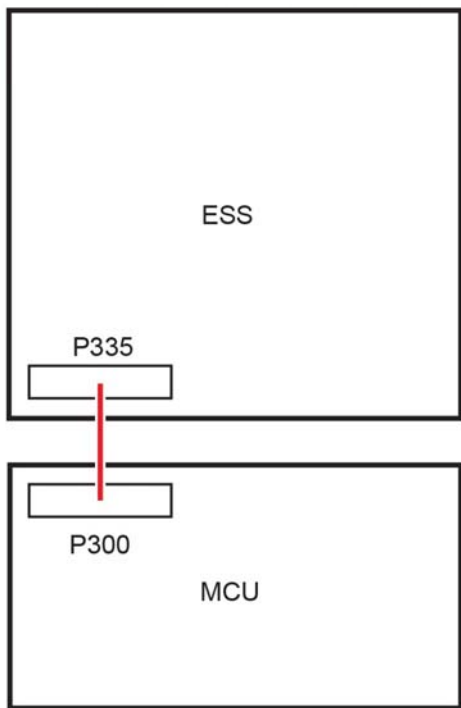
D80898

Figure 6 ESS

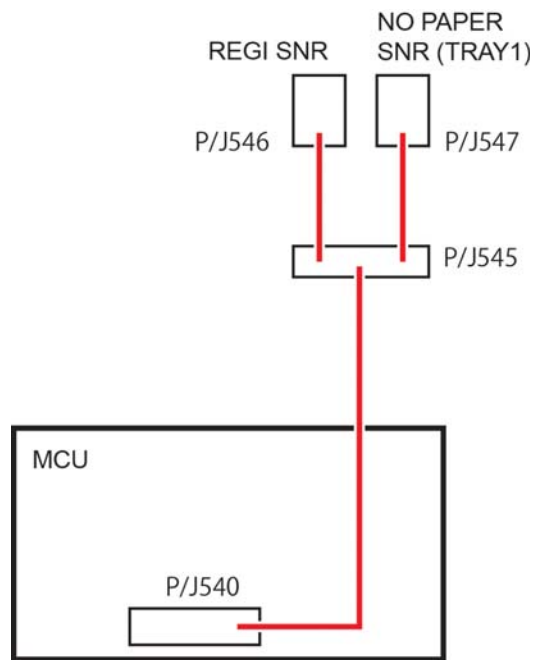
D-8-0899-A

Figure 7 REGI

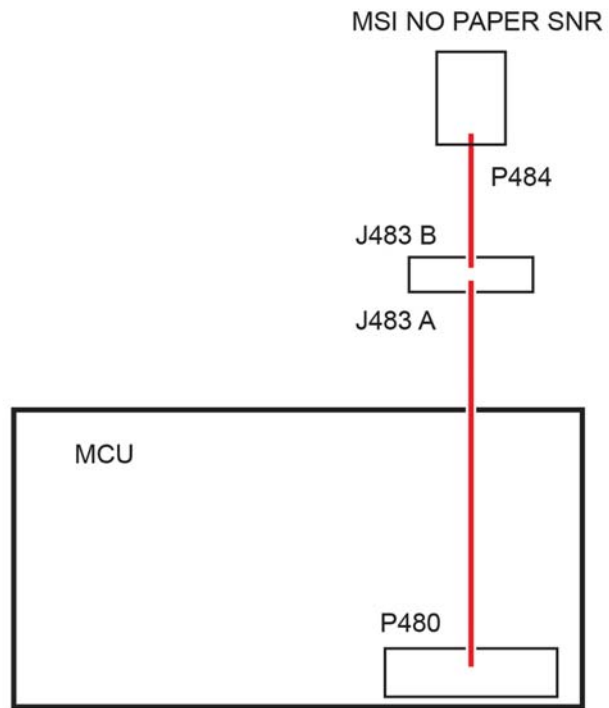
D80900

Figure 8 MSI no paper sensor

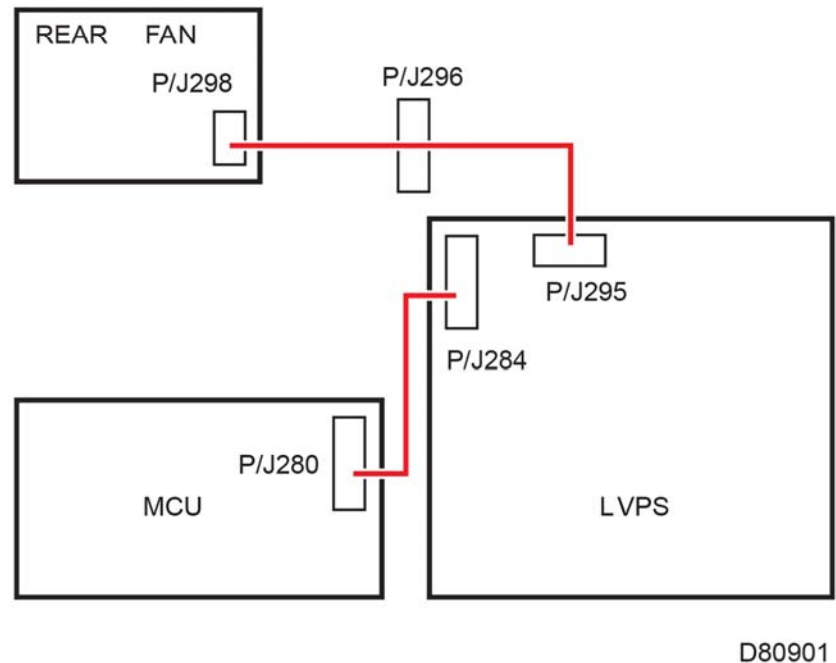
D80901

Figure 9 Supply Rear fan

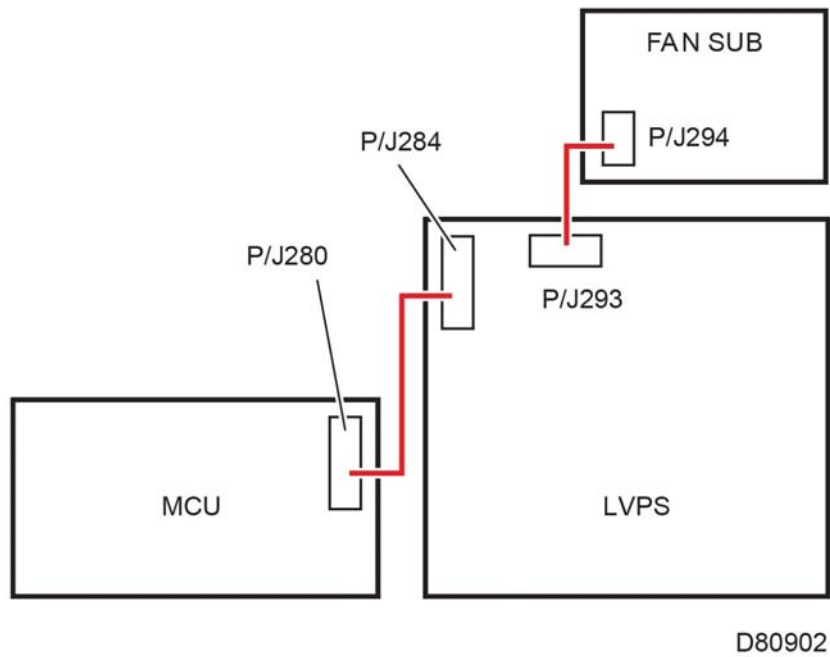
Figure 10 Sub fan

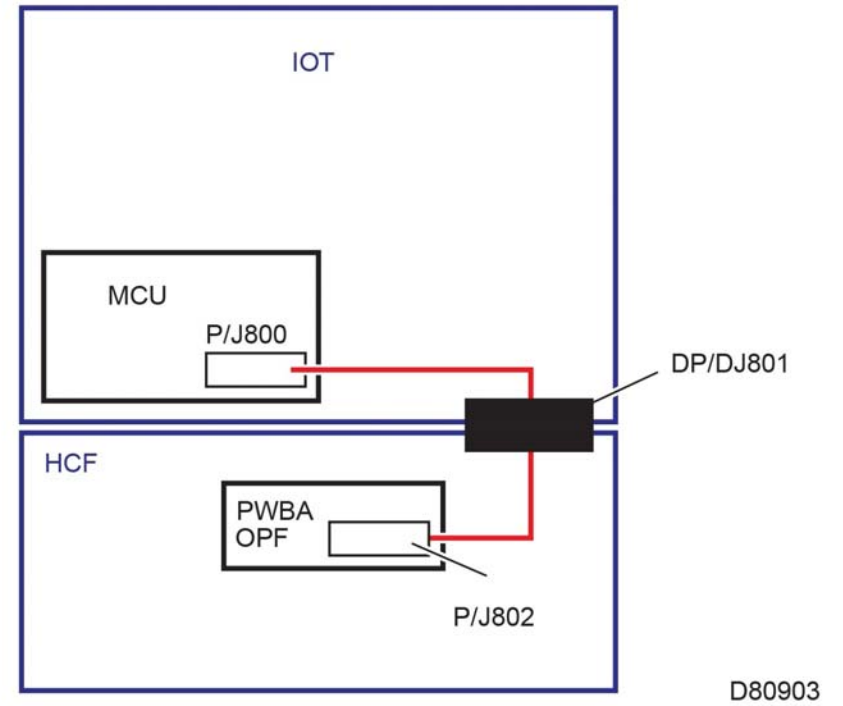
Figure 11 IOT and HCF

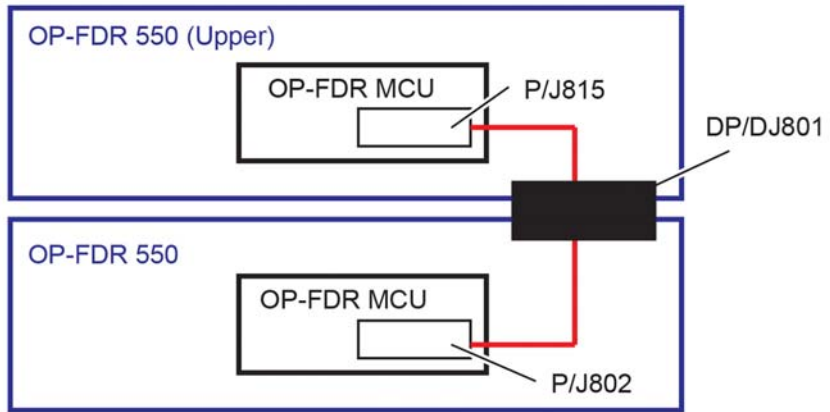
D80904

Figure 12 Optional feeder

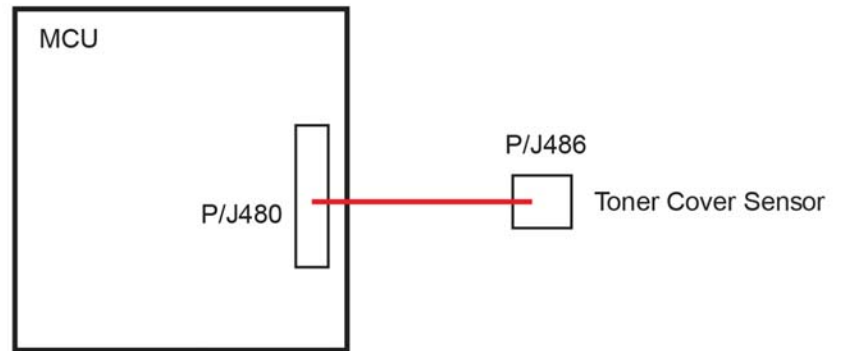
D80906

Figure 13 Toner cover sensor

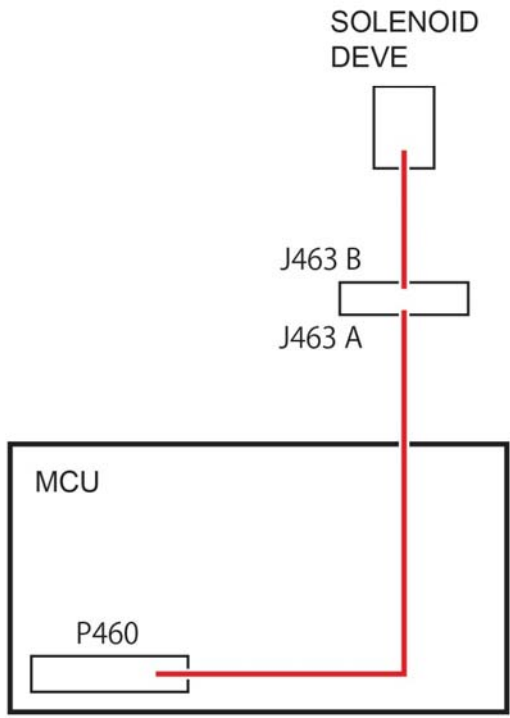
D80907

Figure 14 Solenoid drive

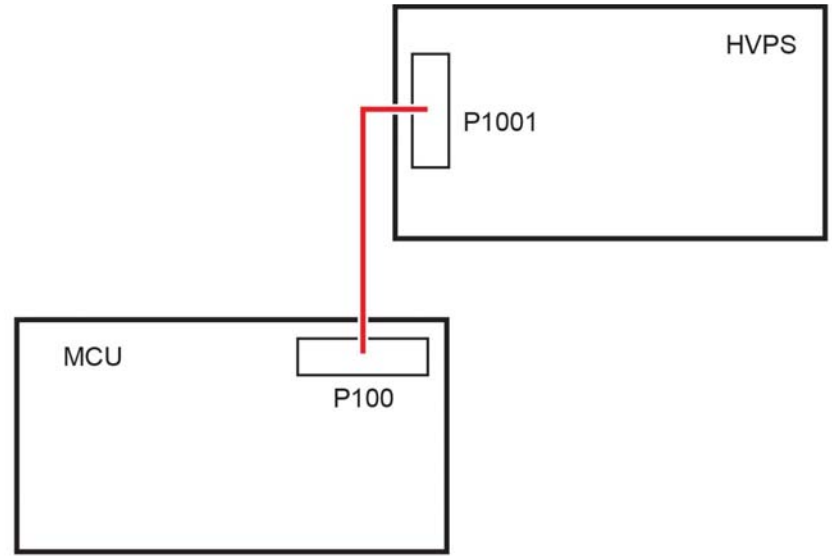
D80908

Figure 15 MCU and HVPS

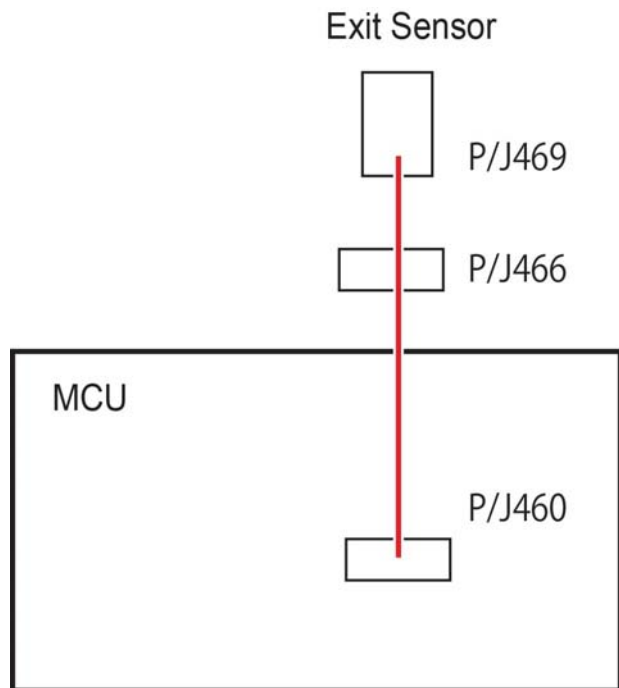
Figure 16 Exit sensor

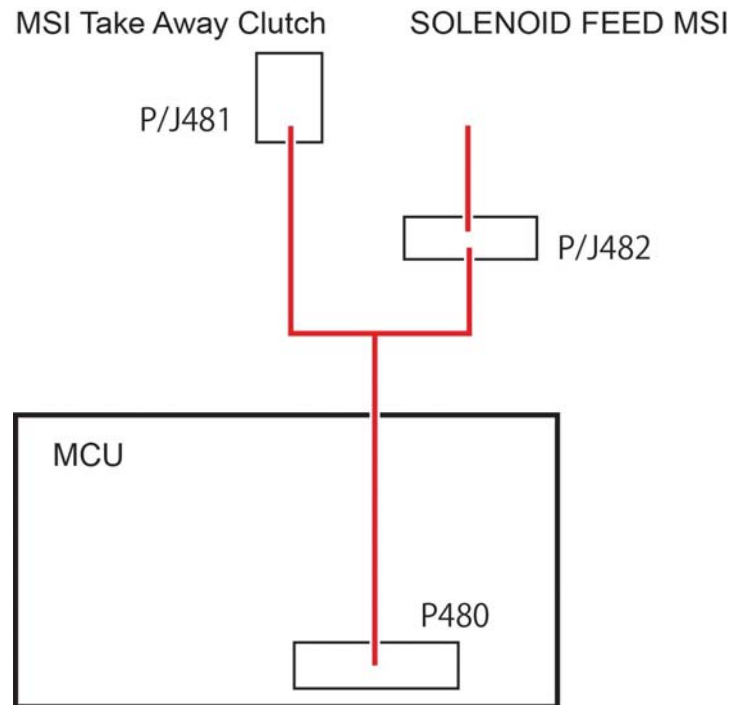
Figure 17 TCLT and MSI solenoid

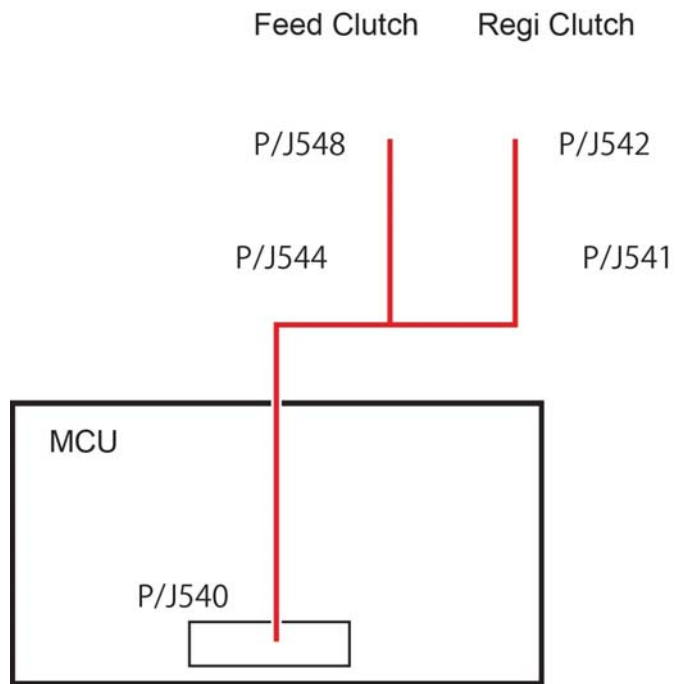
D-8-0911-A

Figure 18 Feed and REGI clutch

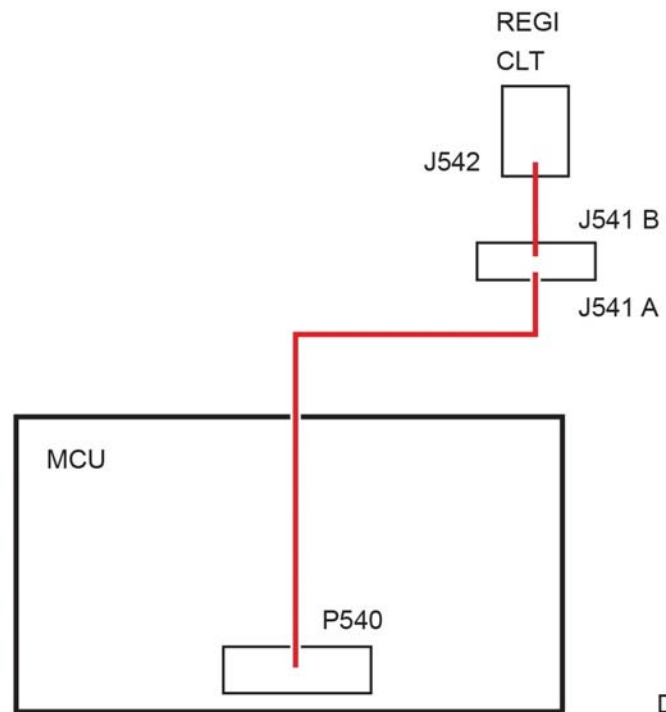
D80912

Figure 19 REGI clutch

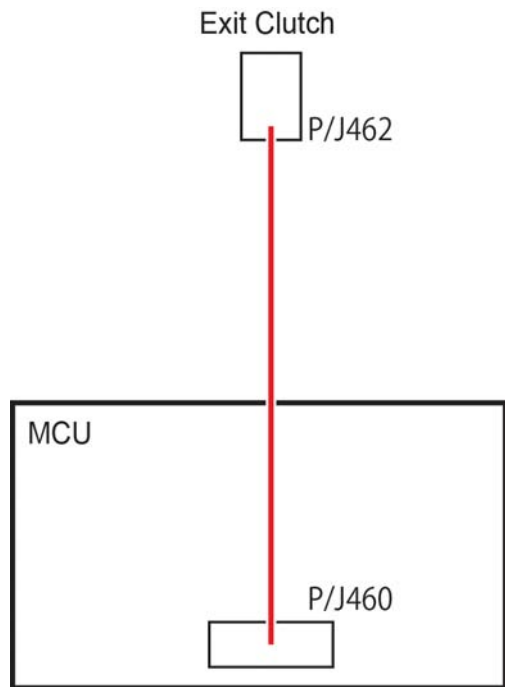
D-8-0913-A

Figure 20 Exit clutch, REGI clutch

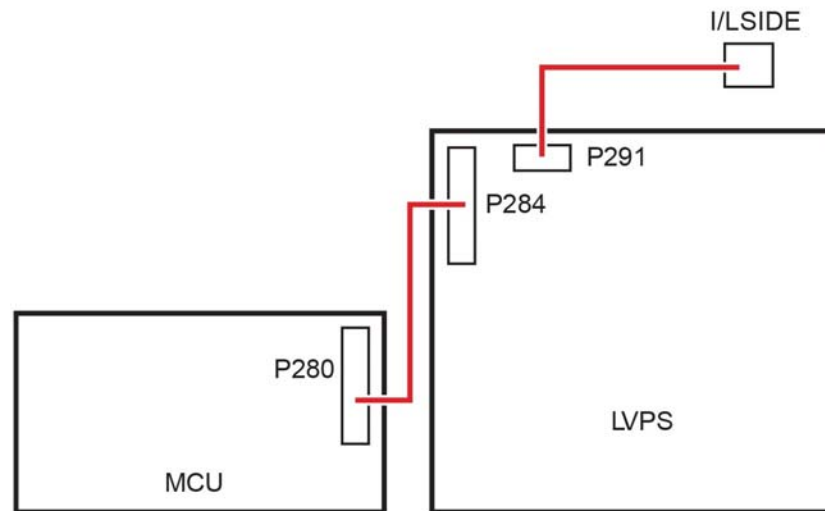
D80914

Figure 21 I/L side, MCU, LVPS

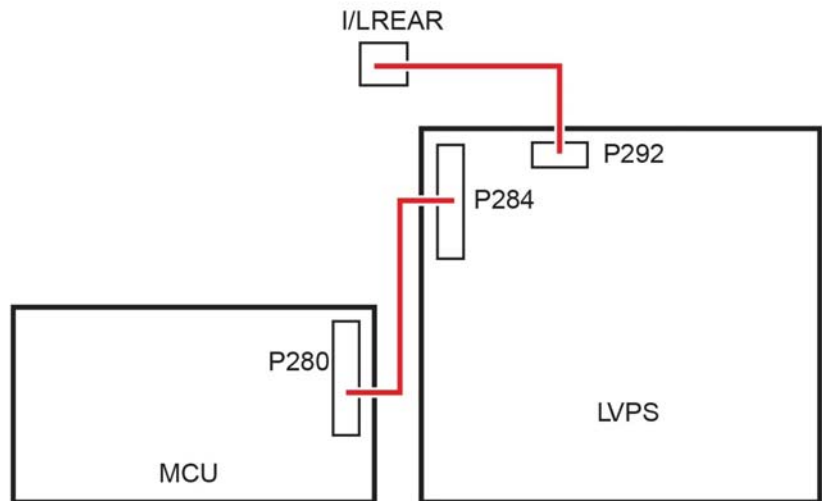
D80915

Figure 22 I/L rear, MCU, LVPS

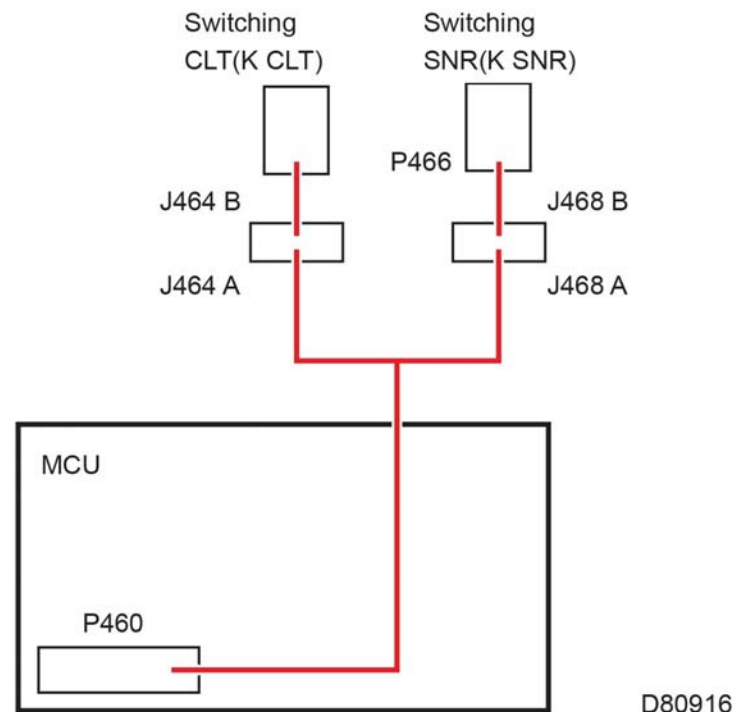
D80916

Figure 23 Switching CLT(K CLT), switching SNR(KSNR), MCU

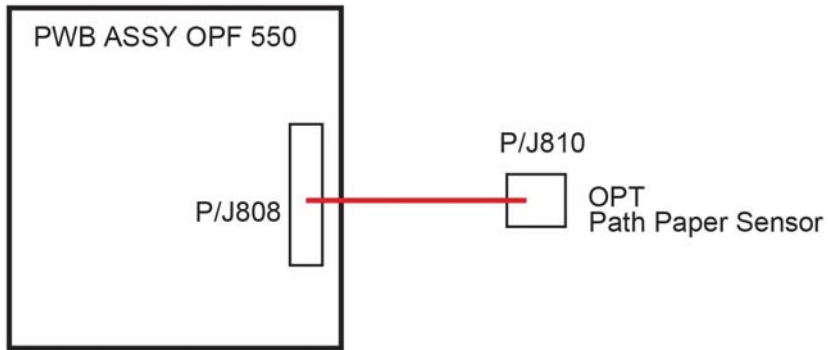
D80917

Figure 24 550 OPF PWB, OPT paper path SNR

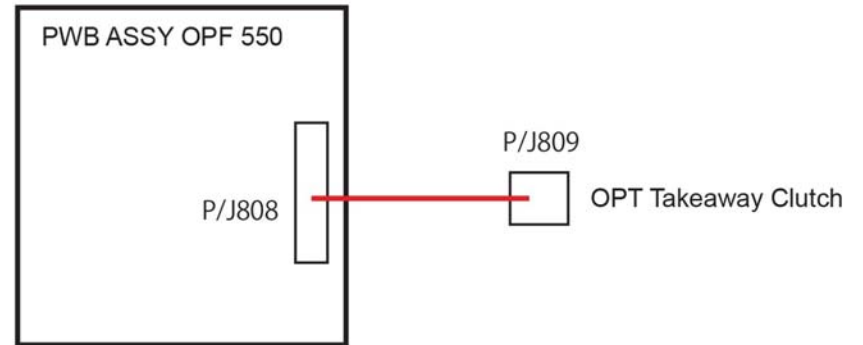
D80919

Figure 26 550 OPF PWB, OPF take away clutch

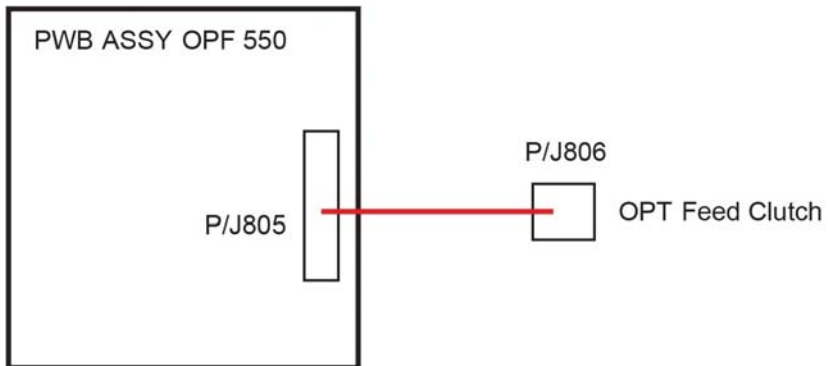
D80918

Figure 25 550 OPF PWB, optional feed clutch

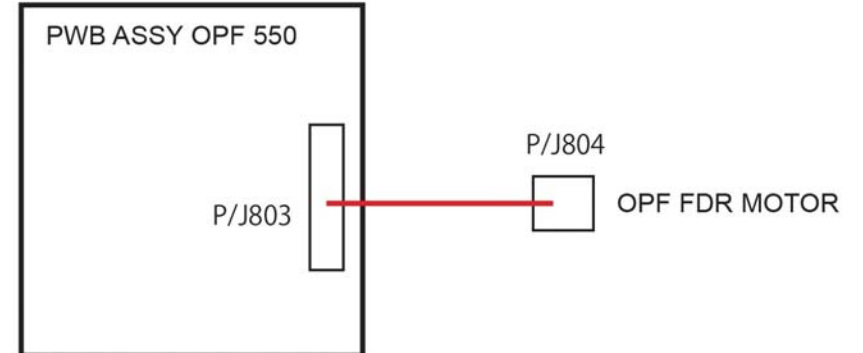
D80920

Figure 27 550 OPF PWB, OPF forward motor

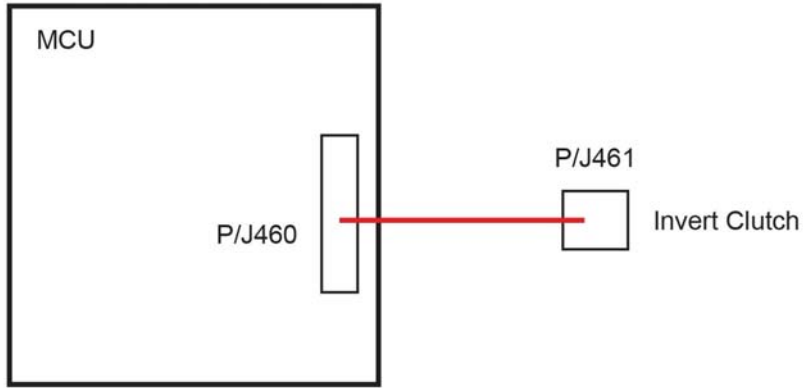
D80921

Figure 28 MCU, inverter clutch

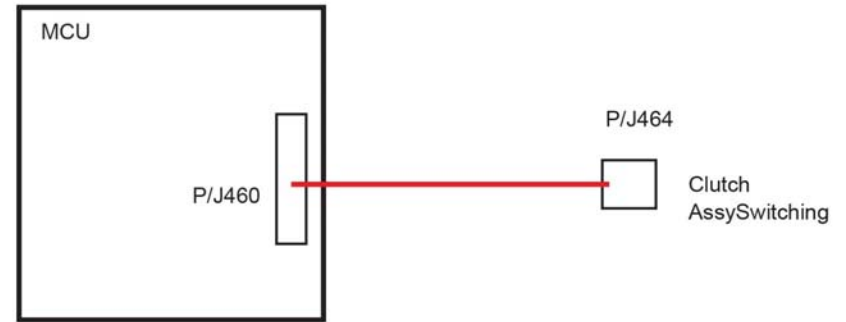
D80923

Figure 30 MCU, switching clutch assembly

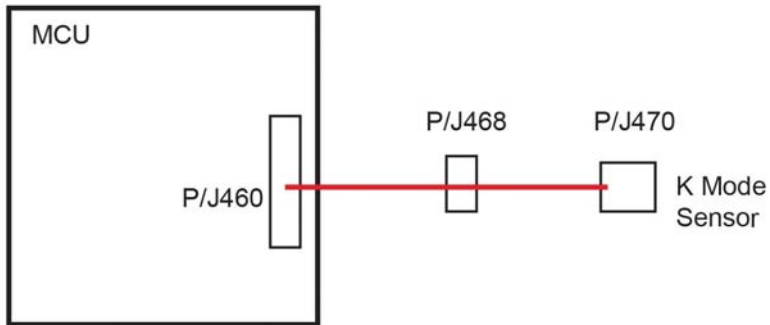
D80922

Figure 29 MCU, K module sensor

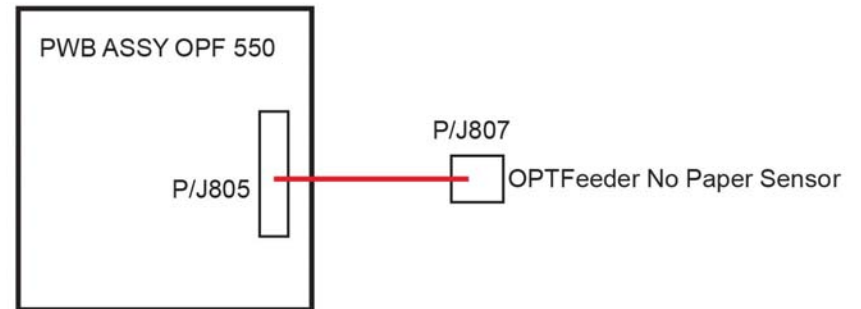
D80924

Figure 31 OPF 550 PWB, OPF feeder no paper sensor

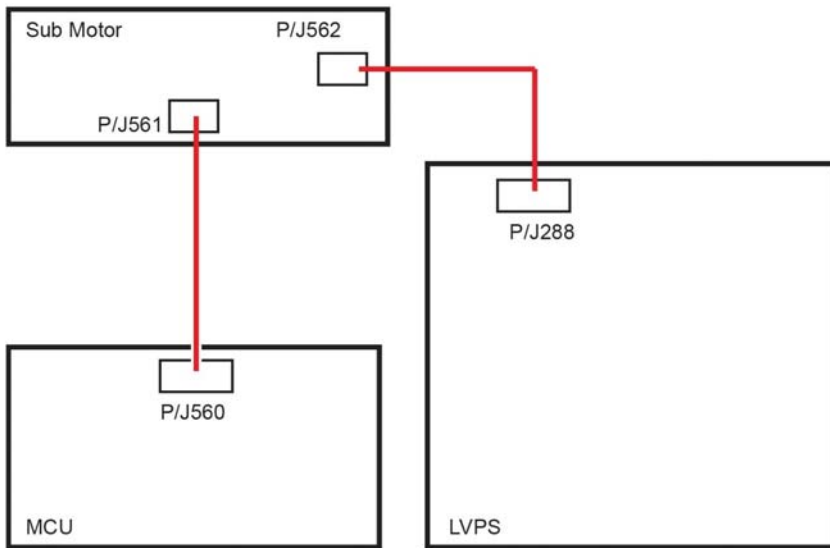
D80925

Figure 32 Sub motor, MCU, LVPS
