VersaLink[®] C500/C600 Printer and C505/C605 Multifunction Printer Service Manual

Xerox VersaLink C605F Family Printer Service Manual

705P01395

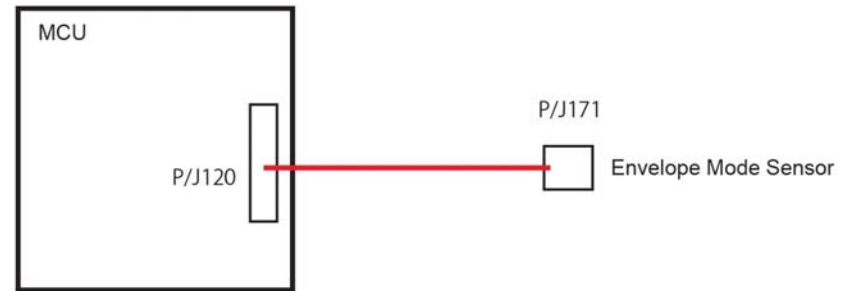
D80926

Figure 33 MCU, envelope mode sensor

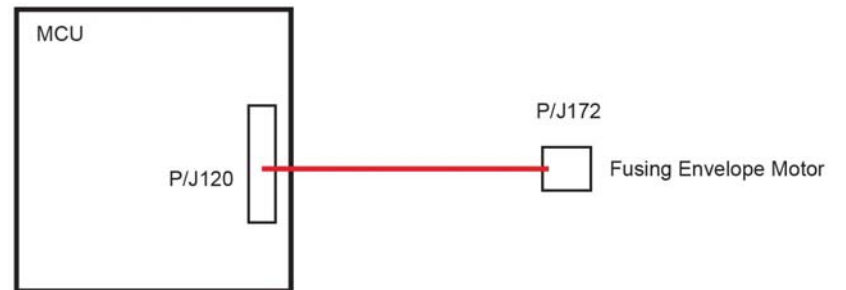
D80927

Figure 34 MCU, fusing envelope motor

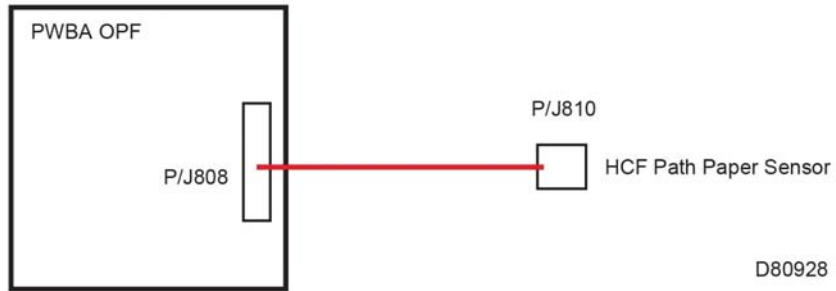
D80928

Figure 35 OPF PWB, HCF paper path sensor

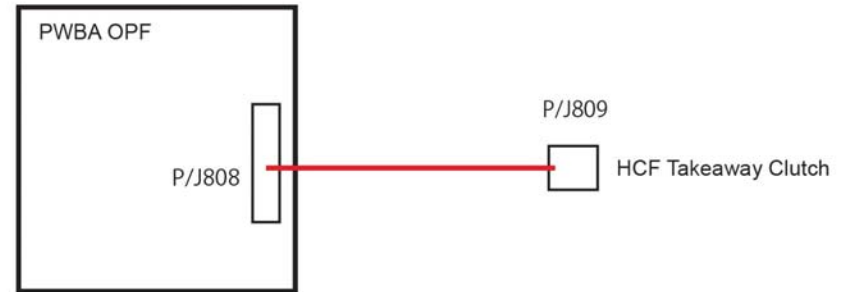
D80930

Figure 37 OPF PWB, HCF take away clutch

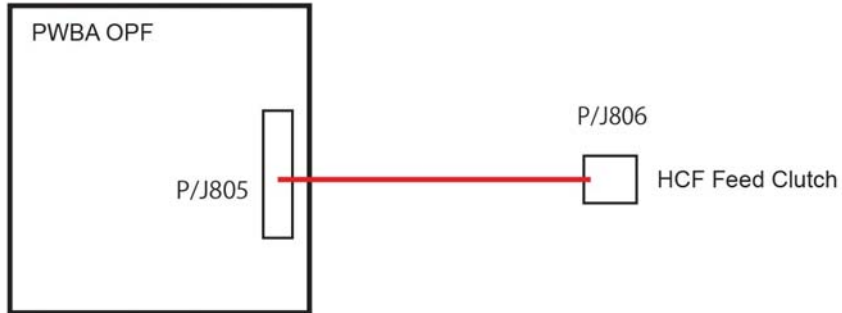
D80929

Figure 36 OPF PWB, HCF feed clutch

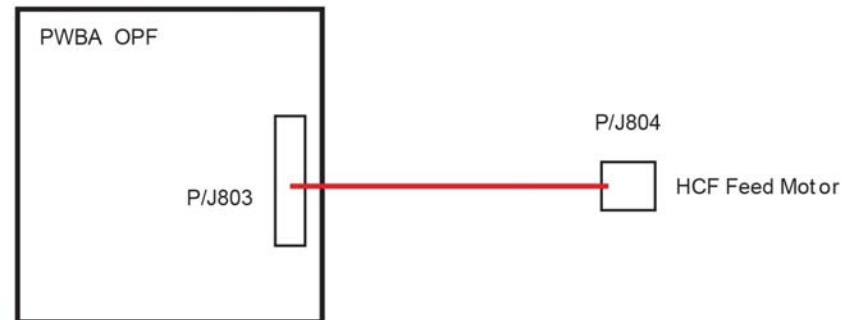
D80931

Figure 38 OPF PWB, HCF feed motor

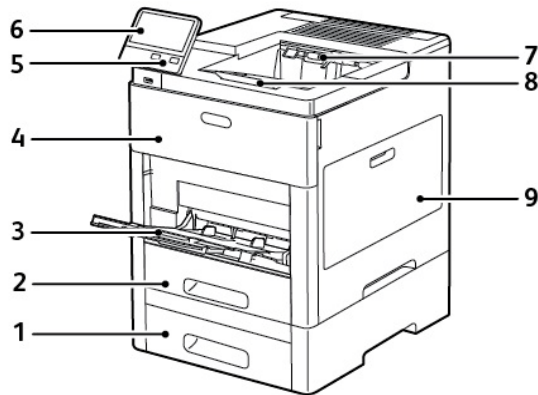
Figure 1 VersaLink® C500 and C600 front and right side views shows the printer's front and right side views with parts identified in Table 1.

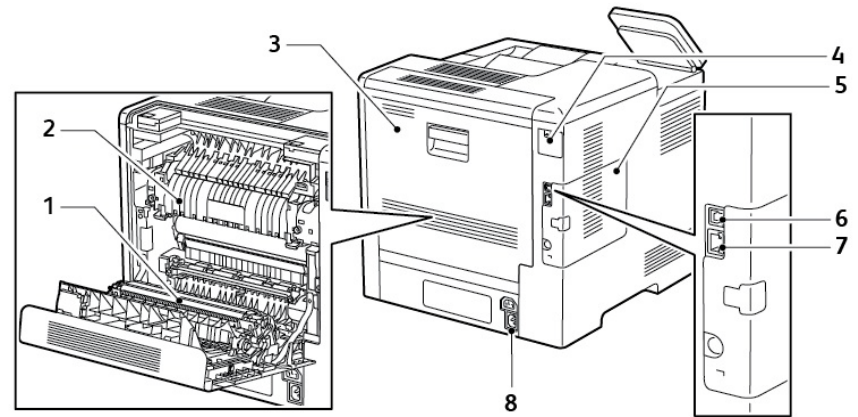
Figure 2 VersaLink® C500 and C600 rear and left side views

Figure 2 VersaLink® C500 and C600 Rear and left side views shows the printer's rear and left side views with parts identified in Table 2 Rear and left side parts identification.

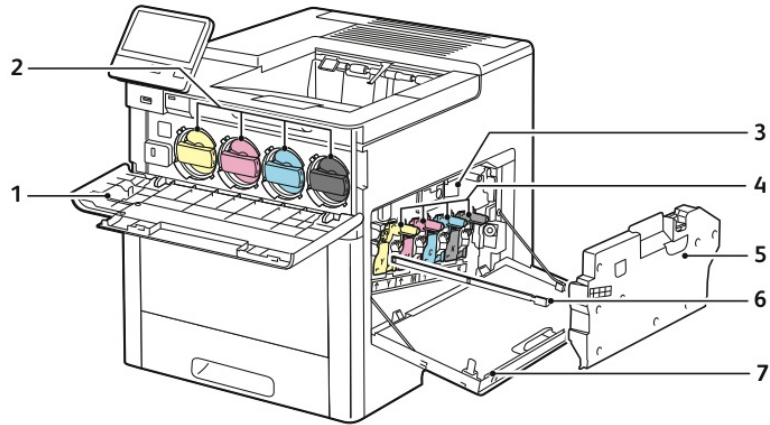
Figure 3 VersaLink® C500 and C600 internal parts shows the printer's front and right side internal views with parts identified in Table 3 Internal parts identification.

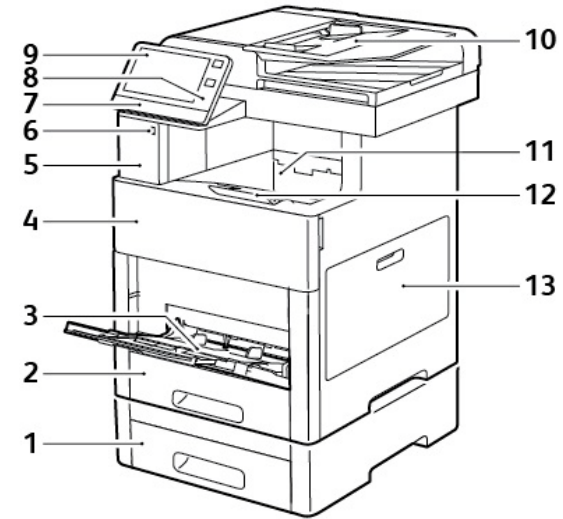
Figure 4 VersaLink® C505/C605 and C605_Tall version front and right side views

Figure 4 shows the printer's front and right side views with parts identified in Table 4.

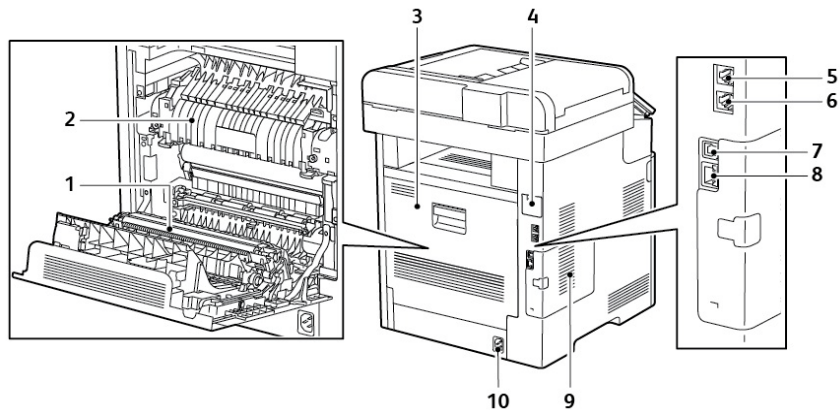
Figure 5 VersaLink® C505 and C605 rear and left side views

Figure 5 shows the printer's rear and left side views with parts identified in Table 5.

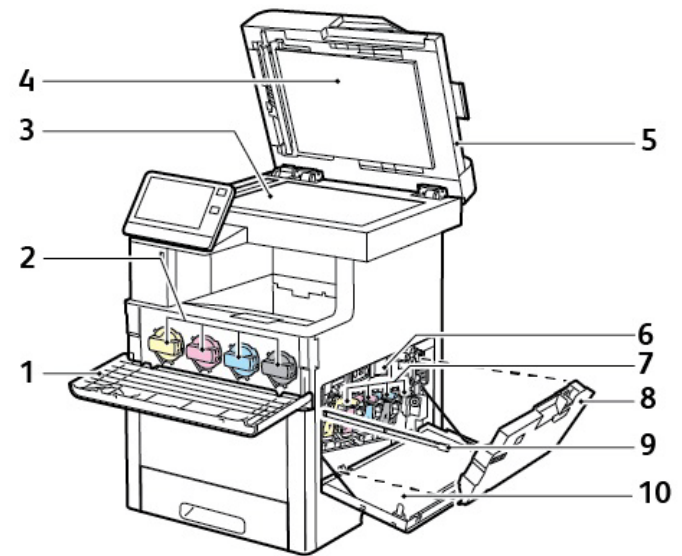
Figure 6 VersaLink® C505/C605 and C605_Tall version internal parts

Figure 6 shows the printer's front and right side views with internal parts identified in Table 6.

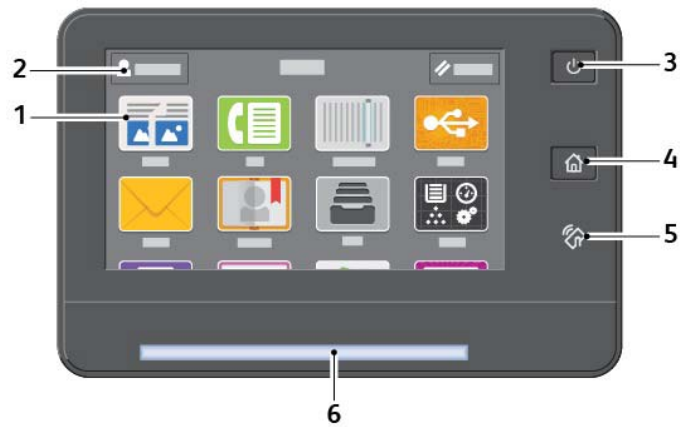
Figure 7 VersaLink® C505/C605 and C605_Tall version control panel

The VersaLink® C505/C605 and C605_Tall Version Control panel shown in Figure 7, consists of a touchscreen, a keypad, and several buttons. These buttons are used to navigate the menu system, perform functions, and select operational modes. Table 7 lists the function of each control.

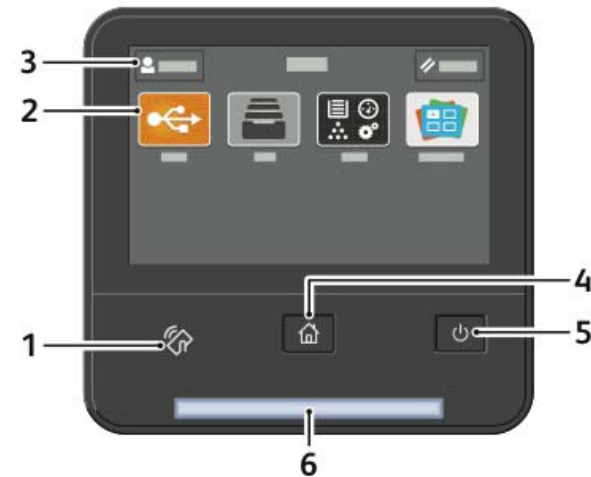
Figure 8 VersaLink® C500 and C600 control panel

The VersaLink® C500 and C600 control panel shown in Figure 8, consists of a touch screen, a keypad, and several buttons. These buttons are used to navigate the menu system, perform functions, and select operational modes. Table 8 lists the function of each control.

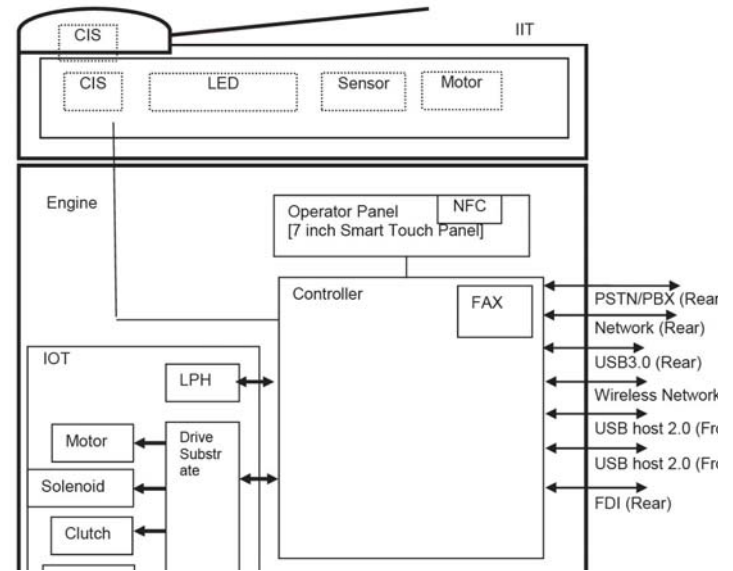
Figure 10 C505/C605/C605_Tall functional configuration

The functional configuration for this printer is shown in [Figure 10](#).

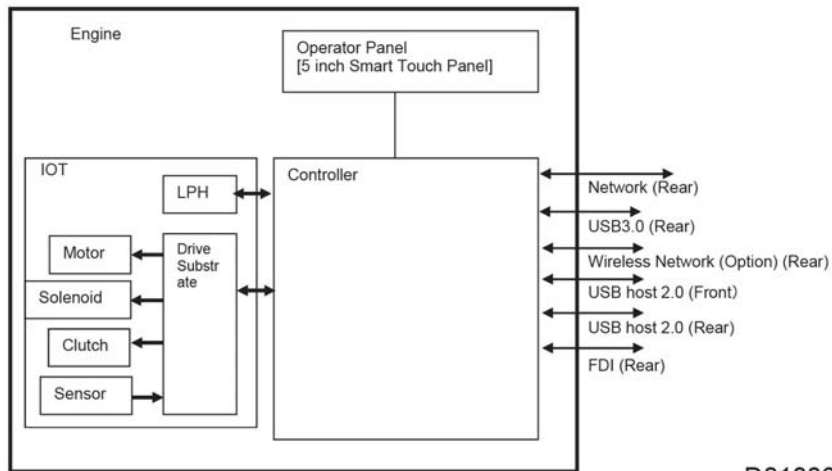
Figure 11 C500/C600 functional configuration

The functional configuration for the C500/C600 printer is shown in Figure 11.

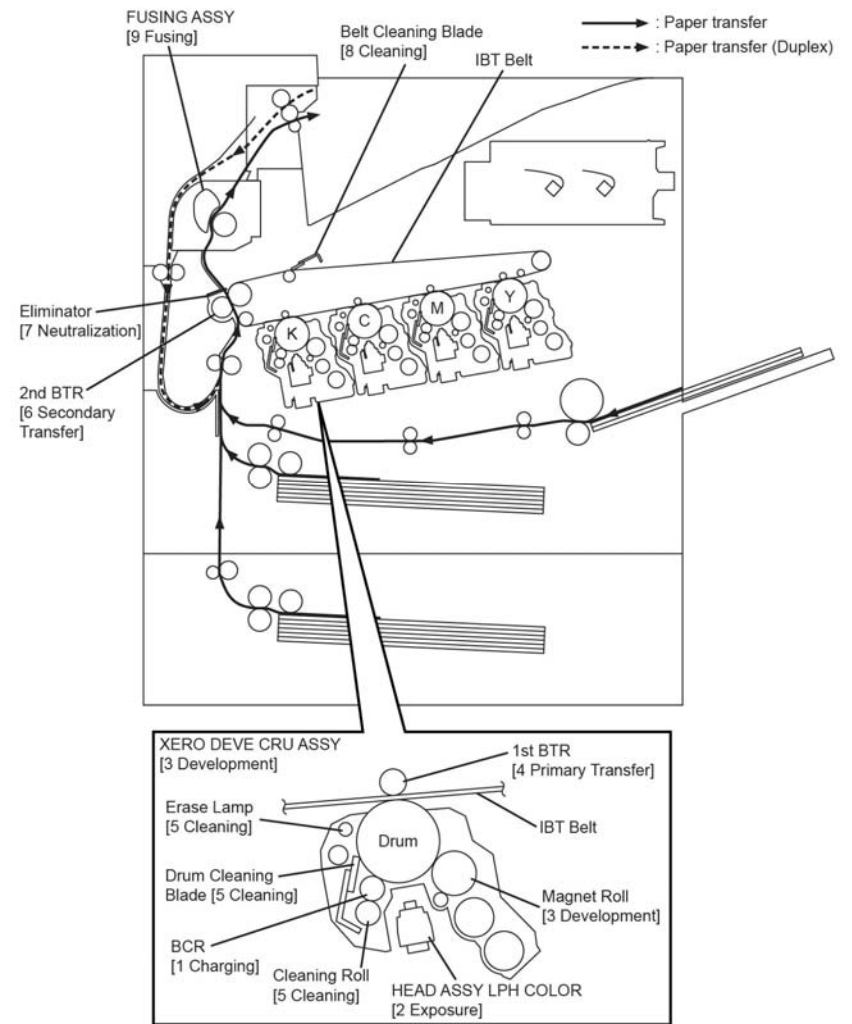
Figure 2 Printing process functions

Figure 2 shows the printing process outline.

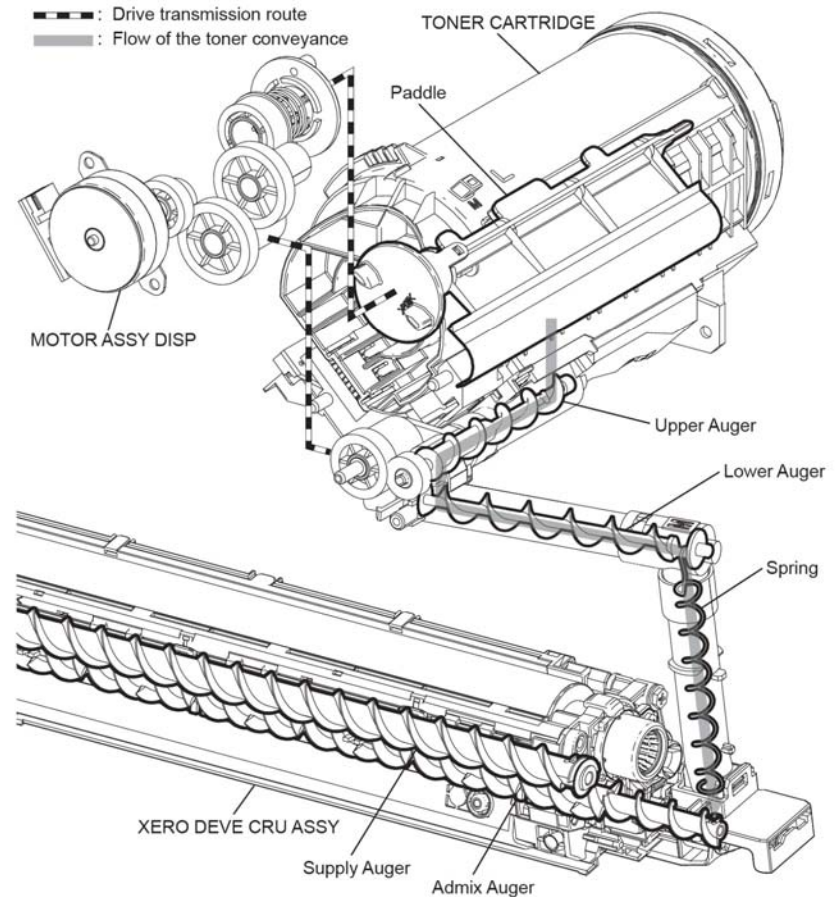
Figure 3 Toner dispensing during development

The toner in the toner cartridge is fed into the drum cartridge by the upper auger and the Lower Auger driven by the motor assembly DISP as shown in Figure 3. The toner supplied from the toner cartridges fed toward the drum cartridge by the upper auger and the lower auger in the DISP assembly and the paddle in the toner cartridge driven by the motor assembly disp.

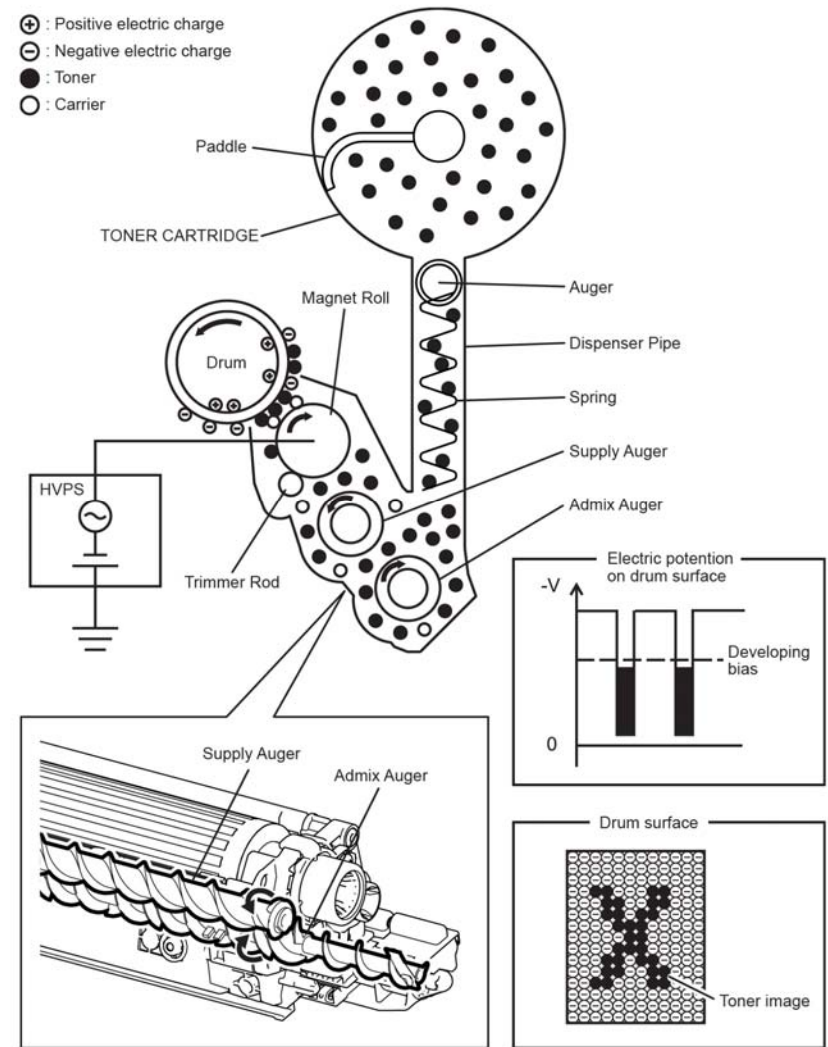
Figure 4 Development process

In the developer section, the incoming toner is mixed with the existing developer (toner/carrier mixture) by the admix auger and the supply auger, and then supplied to the magnet roll located near the drum surface as shown in Figure 4. The toner and carrier are charged by friction due to agitation (toner in negative, carrier in positive), and they attract each other electrically. The carrier, due to its magnetic properties, is attracted to the magnet roll, and then uniformly leveled by the trimmer rod.

The magnet roll is covered by a thin semi-conductive sleeve all over the surface. The DB (Developing Bias) voltage is supplied to this semiconductor sleeve from the High Voltage Power Supply (HVPS). The DB voltage is negative DC voltage combined with AC voltage. The DC voltage keeps the Magnet roll at a constant negative voltage against the photoreceptor layer of the drum. Therefore, at the area where the negative electric charge on the drum surface does not decrease, the potential is lower than that of the Magnet roll, while the potential is higher than that of the Magnet roll at the area where the negative charge on the drum surface decreases. The AC voltage shakes the developer on the surface of the Magnet roll so that the toner easily flies to the drum. Thus, only the portions of the drum surface where the negative charge has decreased below that of the Magnet roll (electrostatic latent image) attract the toner to form an image on the drum. Once the toner is deposited on the drum, the potential and the toner-attracting force of the corresponding portion decreases because the increase of negative charge lowers the potential at that portion.

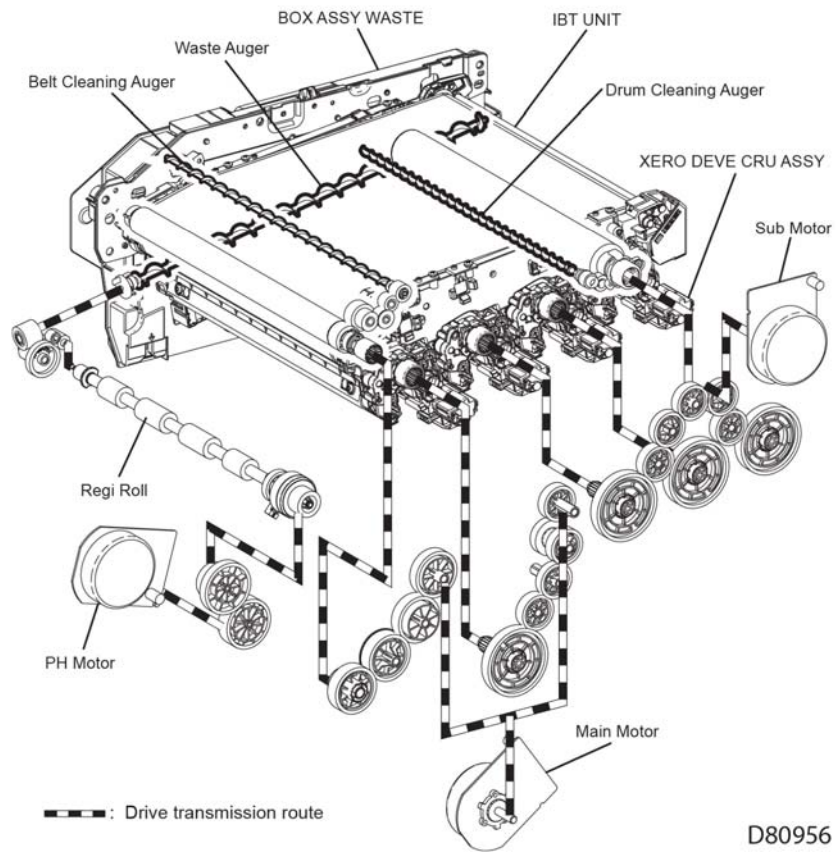
Figure 5 C505/C605/C605_Tall waste toner collection

The excess toner fed to the waste cartridges is collected into the cartridge by the waste auger in the waste cartridge.

The waste auger in the waste cartridge is driven by the main motor via the regi roll.

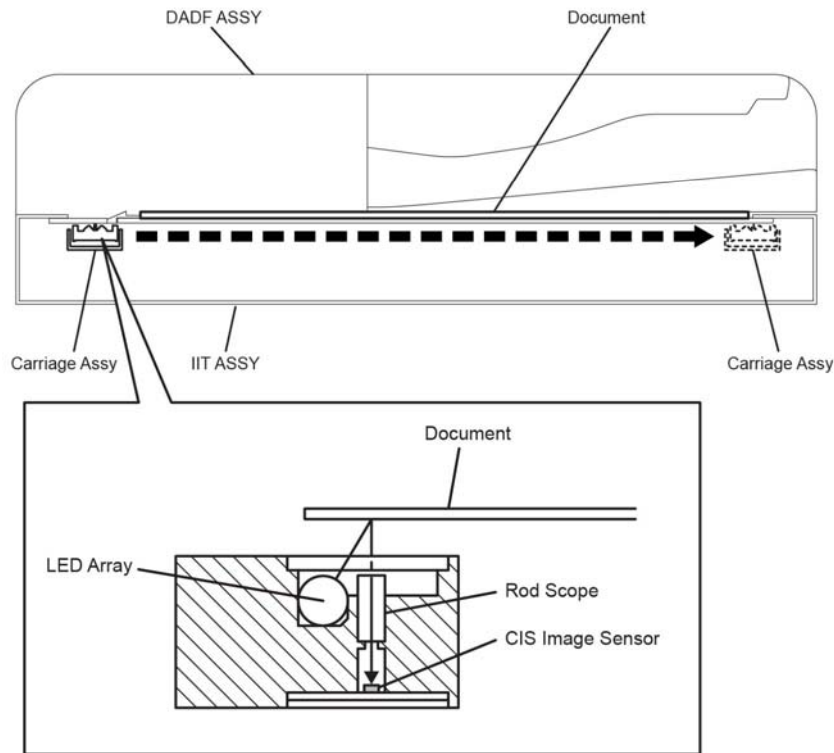
Figure 1 Scanning at platen (IIT) assembly

The Scanner assembly shown in Figure 1 consists of the Image Input Terminal (IIT) and the Duplex Automatic Document feeder (DADF). The CIS assembly in the Image Input Terminal scans the front side of the document and the CIS assembly in the Duplex Automatic Document feeder scans the back side of the document.

The Carriage assembly consists of components such as the CIS Image sensor for converting image to data, the LED Array for illuminating the original, and the Rod Scope for converting the original image to a full-size erect image.

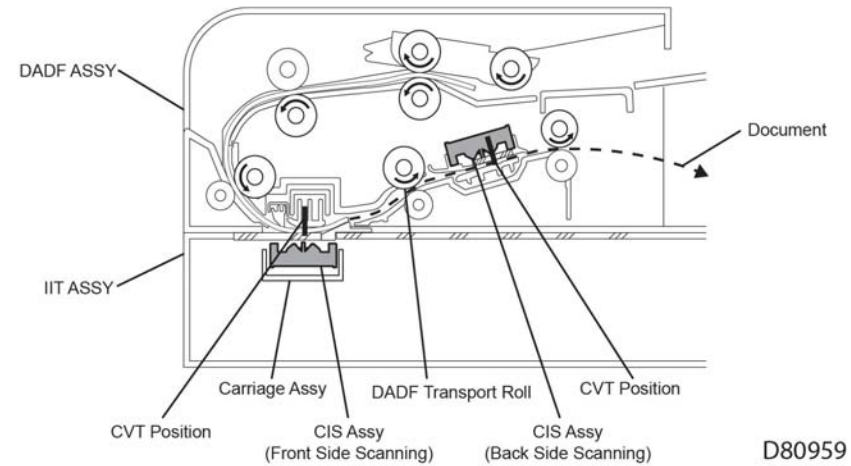
Figure 2 Scanning at DADF assembly

This DADF, shown in Figure 2, has a different system from the conventional document feeder, being capable of scanning both the front and back sides of the document during the one-pass conveyance. The CIS Array assembly on the IIT assembly reads the front side of the document, and the CIS Array assembly on the DADF assembly reads the back side of the document. These two scanning parts are arranged so as to interpose the paper path from both sides, and this allows both sides of the document to be scanned without rotation.

When the document being fed by the torque from the DADF motor at the speed corresponding to the set magnification passes the scanner home position (CVT: Constant Velocity Transport) of the Carriage assembly in the IIT assembly, allowing the reflected image to be read by the CCD Image sensor.

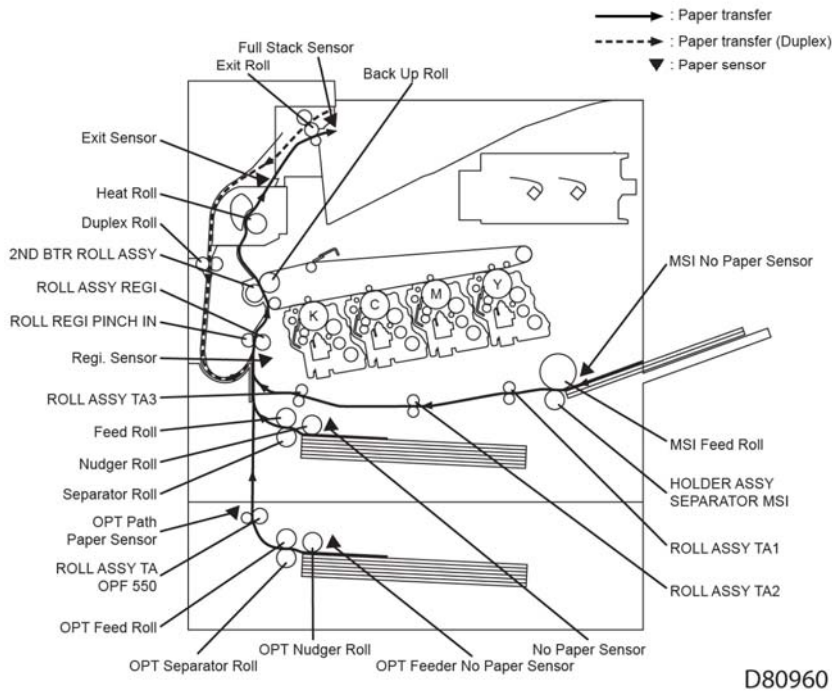
Figure 1 Paper path layout

Figure 1 shows the paper feed layout when the tray module is installed, and the components relevant to paper feed.

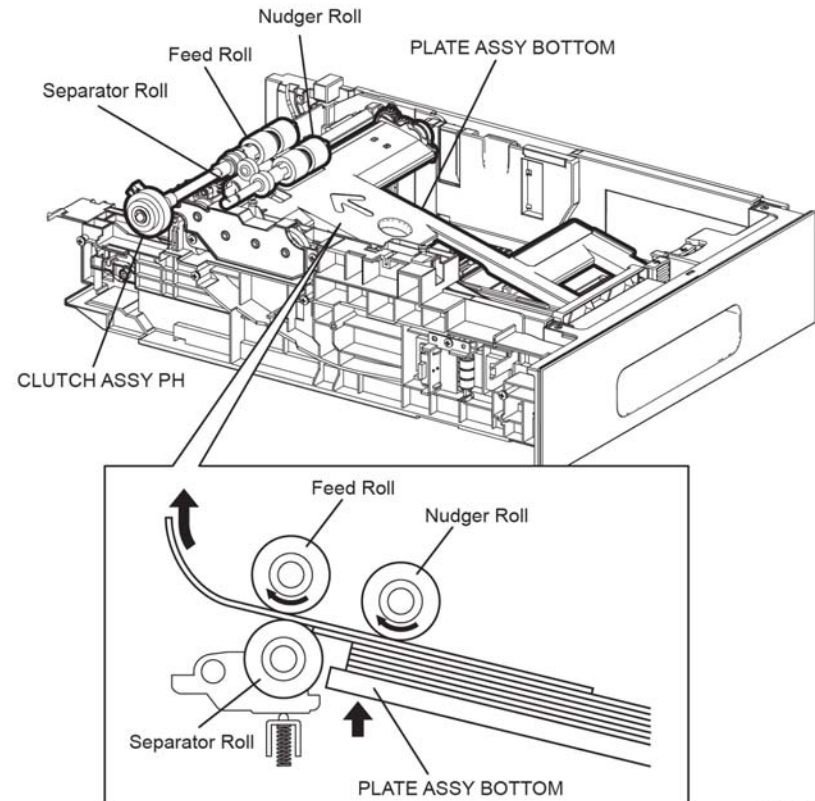
Figure 2 Feeding from paper cassette

- The nudger roll and the feed roll are rotated by the main motor via the clutch assembly PH.
- The separator roll, pressed from underneath by the spring pressure and forced against the feed roll, fans a sheet by the rotation friction.

- When the sheet is lapped over, the break force of the torque limiter combined with the Separator roll separates and feeds only the top sheet.
- The plate assembly bottom is the mechanism driven with the gear located on the side of the paper cassette.
- Unless the interlock gear is unlocked, the plate assembly bottom keeps the state that it is not lowered or elevated from the arbitrary position. The sheet is fed at this position.
- As paper is fed and the stack of paper decreases by several sheets, the Nudger roll lowers down and the lever unlocks the gear, which elevates the plate assembly bottom.

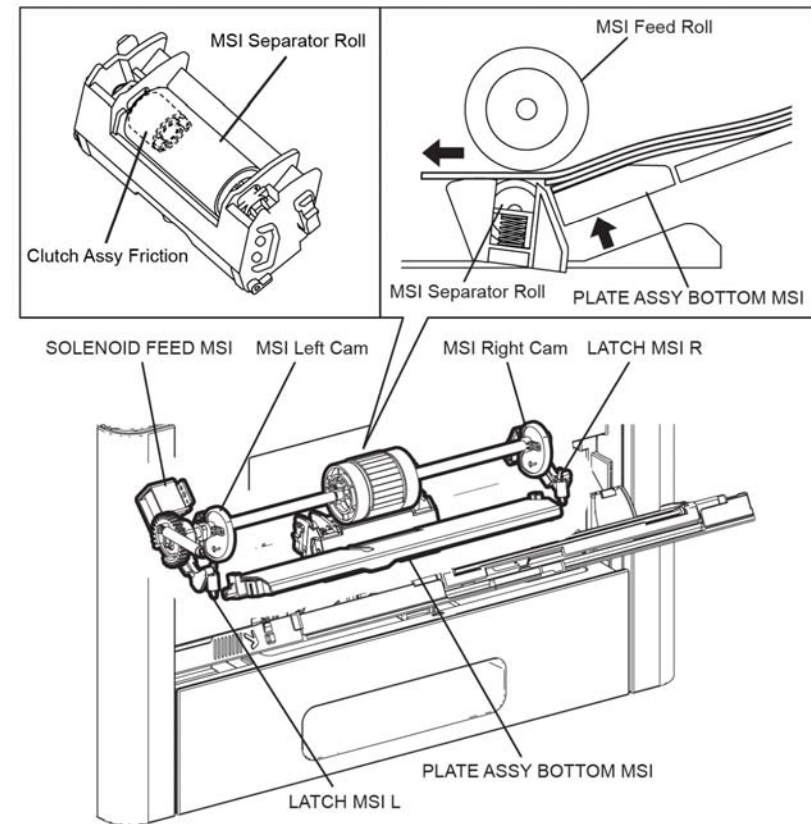
Figure 3 Feeding from the bypass tray

Normally, when only one sheet is fed, both the MSI feed roll and MSI separator roll rotate to allow the sheet to pass. However, when two sheets are fed concurrently, only the MSI feed roll rotates and the MSI separator roll is locked. This allows the upper sheet to pass by being separated from the lower sheet that is stopped by the friction with the MSI Separator roll at rest.

The MSI separator roll is pushed toward the MSI feed roll by spring pressure, and controlled by the torque limiter (clutch assembly friction) with which it is coupled.

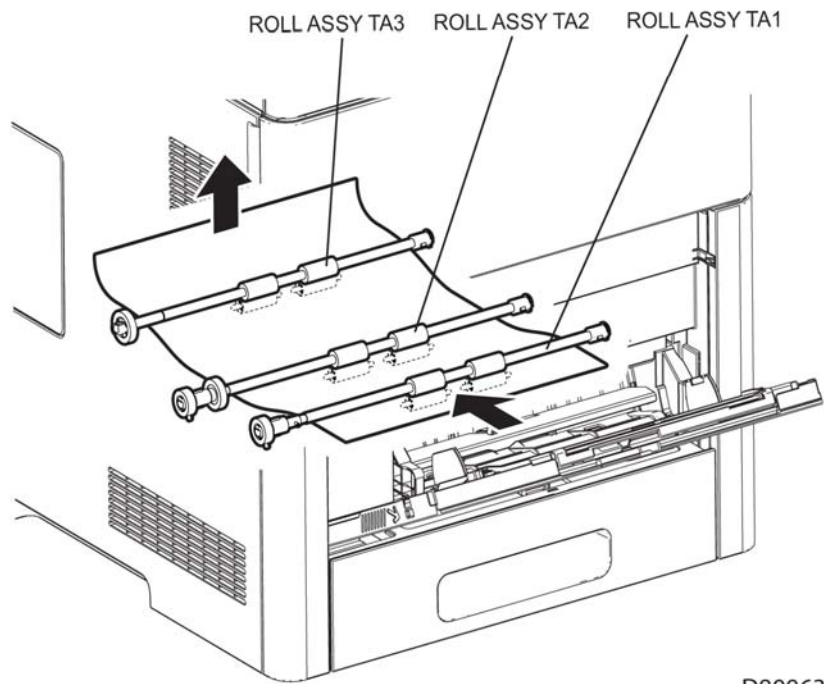
Figure 4 Feeding through the takeaway rolls

The sheet fed from the MSI is fed to the registration section by the ROLL assembly TA1, roll assembly TA2, and roll assembly TA3 driven by the main motor. See [Figure 4](#).

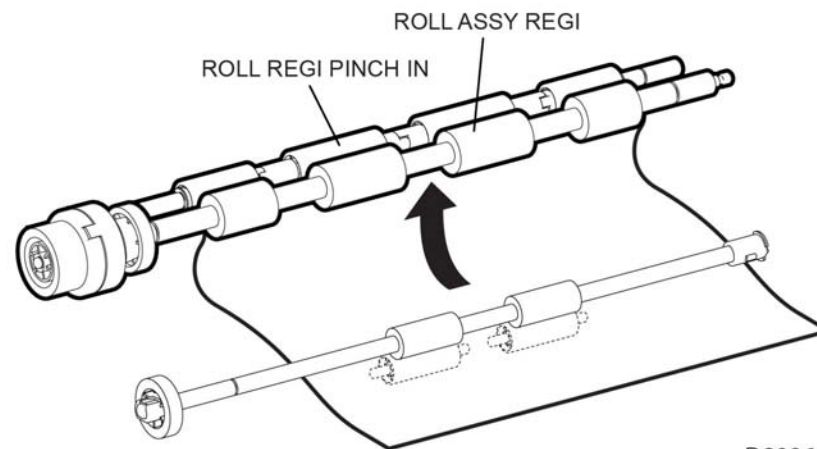
Figure 5 Feeding to the registration section

The sheet fed from the paper cassette is passed through the chute directly and fed to the registration section. See [Figure 5](#).

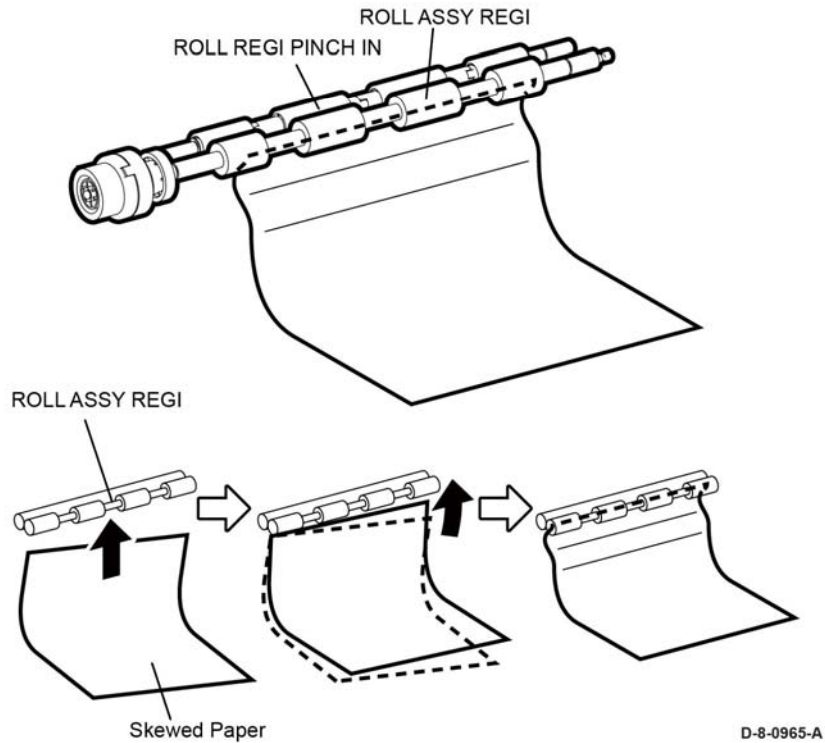
Figure 6 Sheet leading edge position correction

By thrusting the edge of the sheet fed out of the MSI or tray against the locked roll assembly regi, the sheet's lead edge position is corrected. See [Figure 6](#).

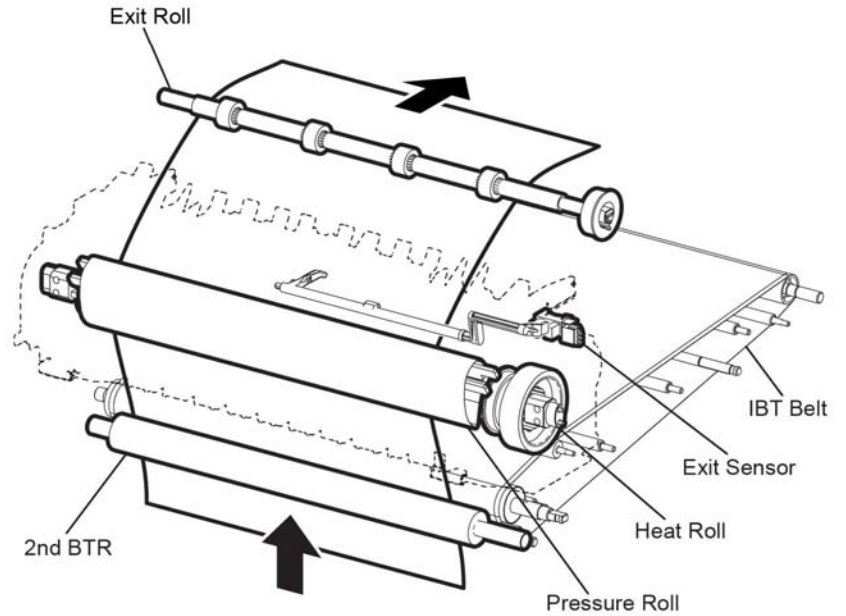
Figure 7 Feeding through the transfer/fusing/exit

On the sheet passed through the registration section, the toner image on the transfer belt and the 2nd transfer roller rotated by the Main Motor drive. Then, the sheet is fed to the exit section while its toner image is being fused by the Heat roll rotated by the main motor. See Figure 7. Also, the main motor drive is transmitted to the Exit clutch, and the exit roll is rotated in the sheet exit direction. The printed sheet is ejected from the printer. The exit sensor detects when the sheet completely exits the printer. See Figure 8 for feeding through the envelope mode.

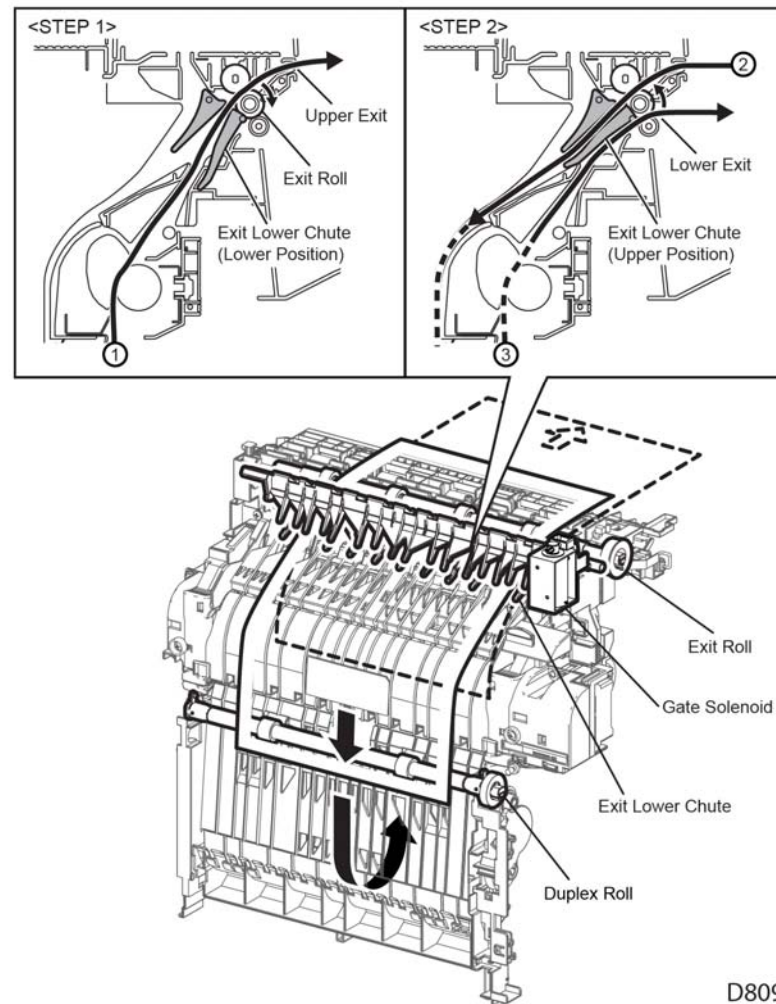
Figure 9 Feeding through the duplexer

After the sheet is passed through the Heat roll and side 1 printing is completed, the rotation direction of the exit roll is changed to the duplex feed direction at the proper timing, and the sheet is nipped in the Duplex assembly. See Figure 9. When the main motor drive is transferred to the exit clutch 2, the exit roll is rotated in the duplex direction. Also, the duplex roll is rotated by the main motor drive, and the sheet is fed to the registration position.

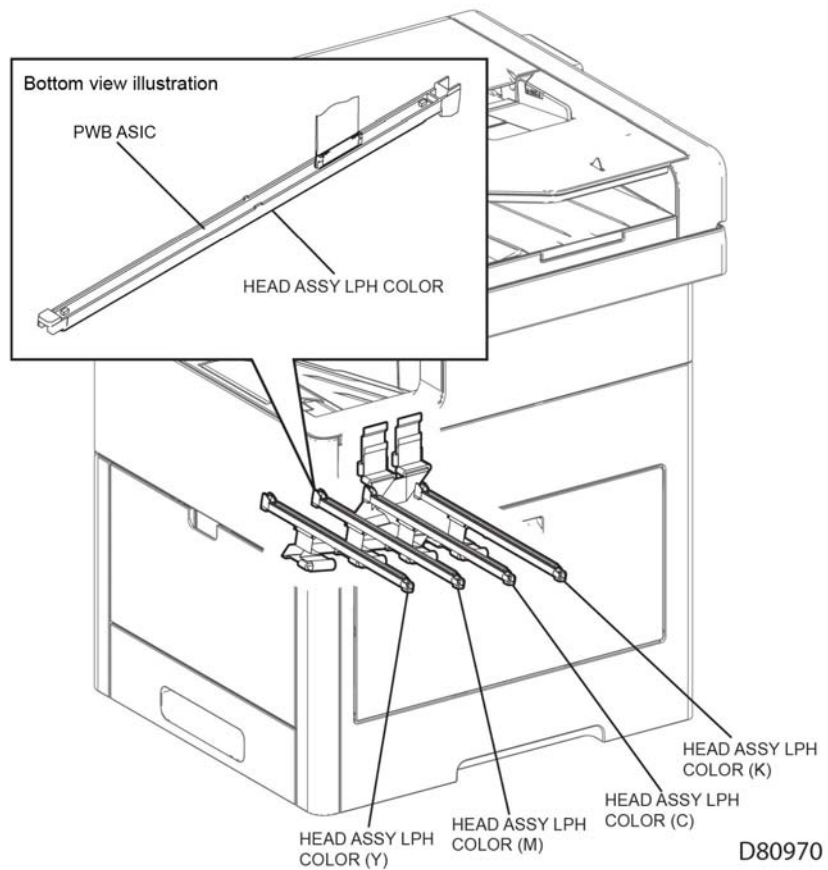
Figure 1 LPH Function

An exposure device for creating an electrostatic latent image on the drum surface. One unit is provided for each color: yellow, magenta, cyan, and black.

The head assembly LPH color mainly consists of the following part:

- PWB ASIC
A board that bridges between the PWBA ESS C505/C605/C605_Tall/PWBA ESS C500/C600 and the head assembly LPH COLOR.

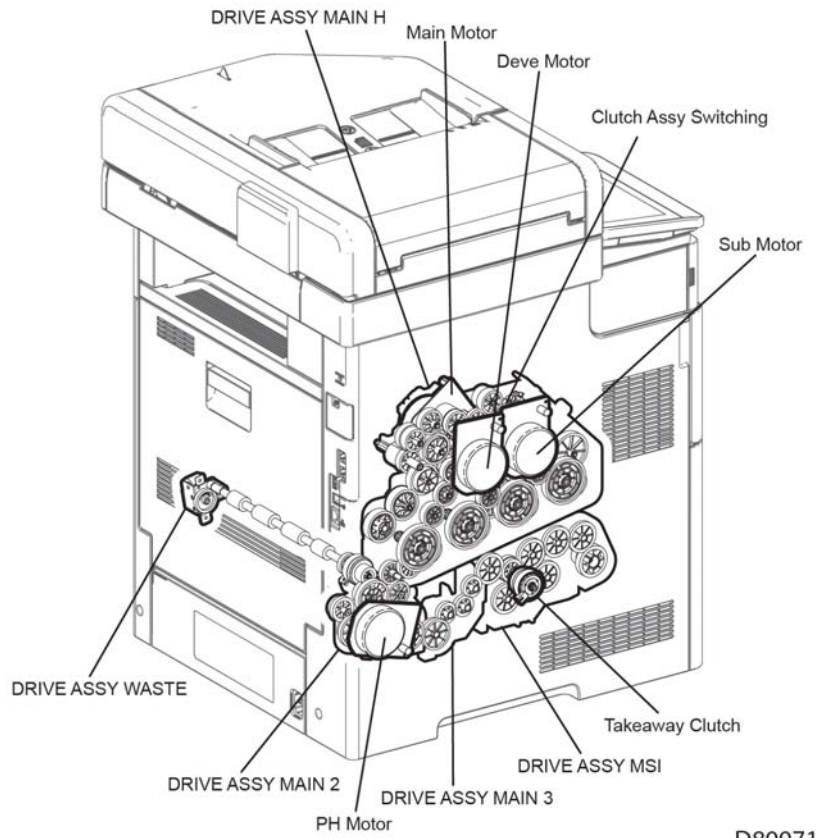
D80971

- Sub motor
The DC motor that drives the drum and magnet roll in the drum cartridge (Y/M/C) (Yellow/Magenta/Cyan).
- Development coupling clutch assembly
transfers the drive from the sub motor to the drum and magnet roll in the drum cartridge (Y/M/C) (Yellow/Magenta/Cyan). This clutch is controlled by the solenoid deve and deve zero sensor.

- switching clutch assembly (K clutch)
transfers the drive from the main motor to the switching camshaft in the transfer belt unit and switches the contact/retract of the 1st transfer roller.

Figure 2 C505/C605/C605_Tall drive function

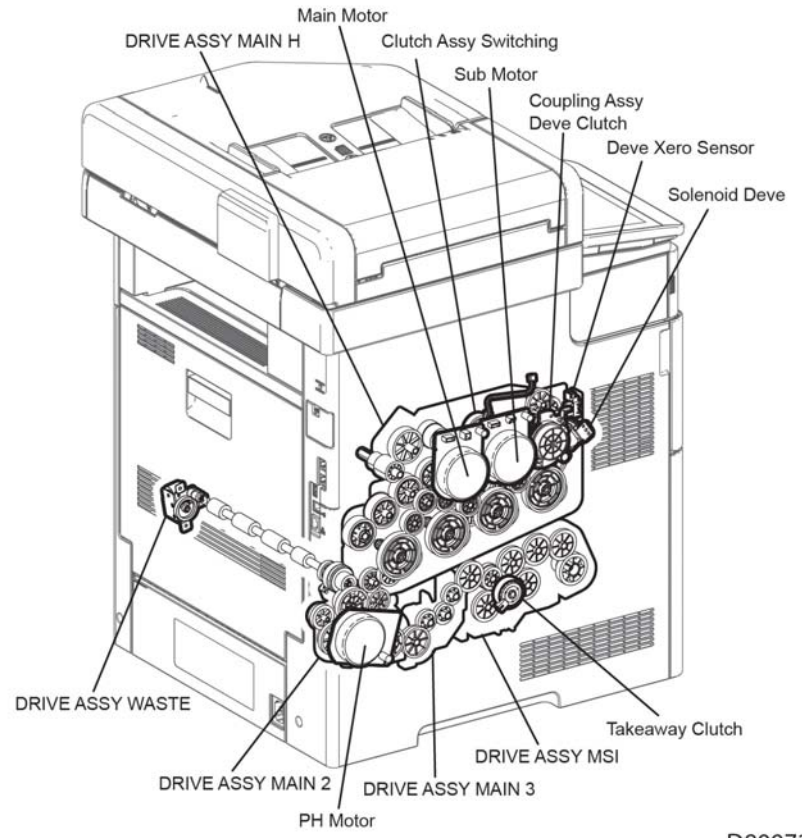
D80972

Figure 3 C500/C600 drive function

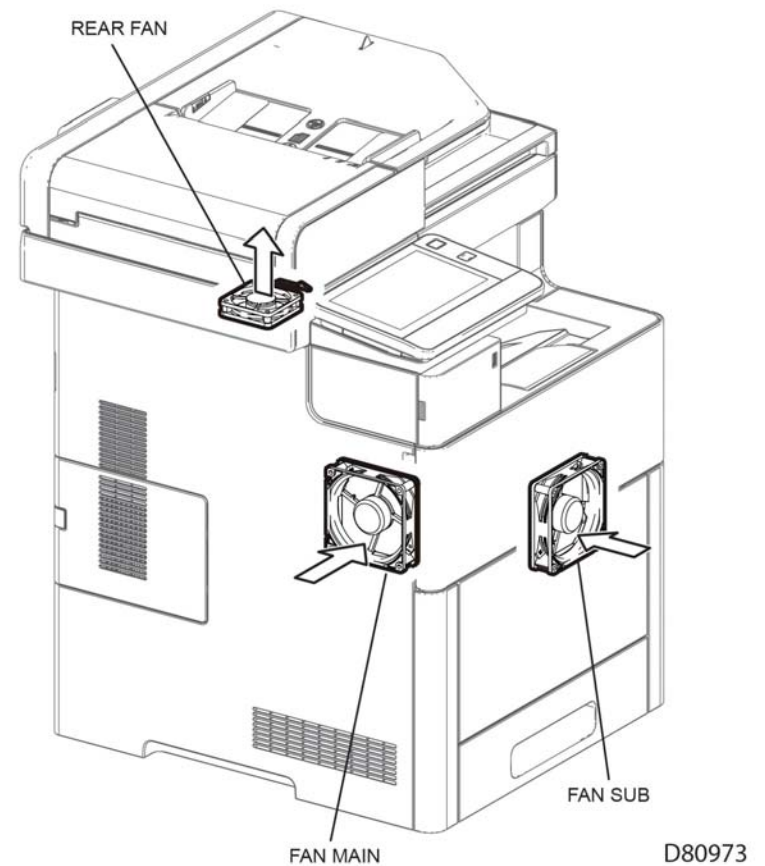
Main Fan (Figure 4)

Takes air in from outside the machine, and prevents temperature rise inside the machine.

Figure 4 Air flow

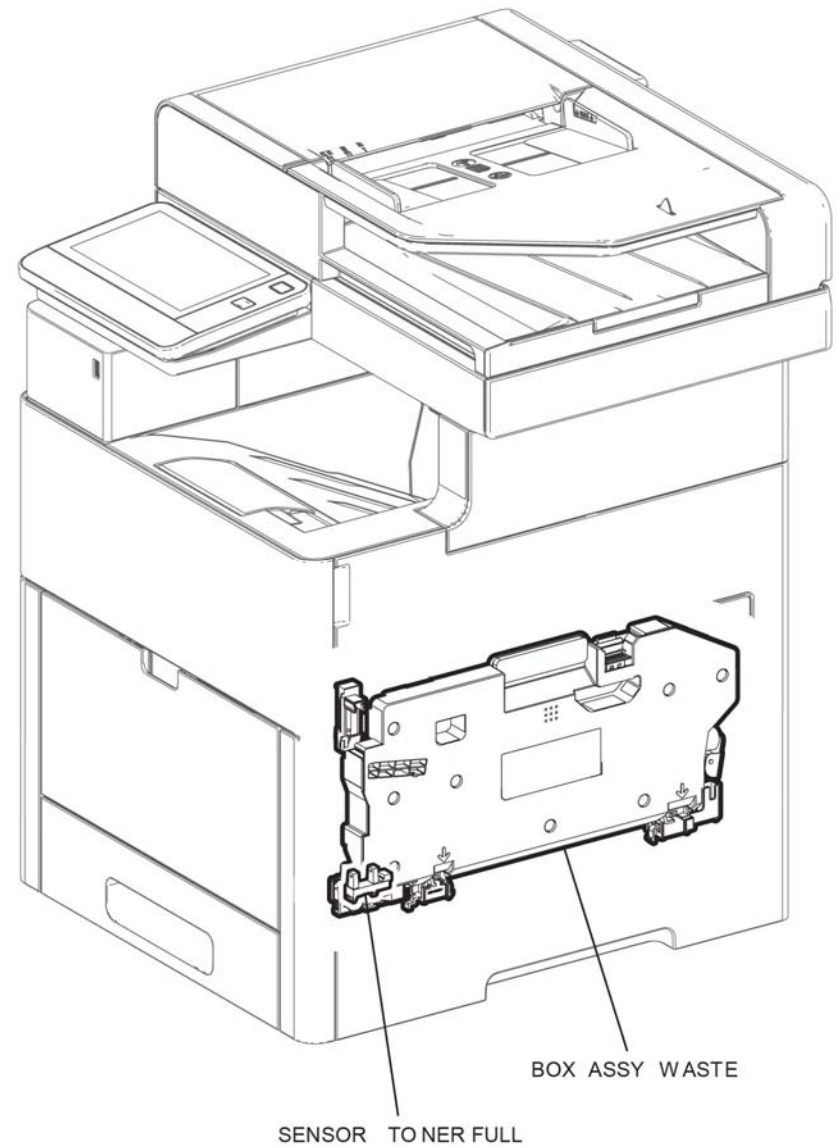
D80974

Waste Cartridge (Figure 5)

Stores the waste toner conveyed from the transfer belt and the drum cartridge (Y/M/C/K) via the belt cleaning auger and the drum cleaning auger.

Figure 5 Waste toner function

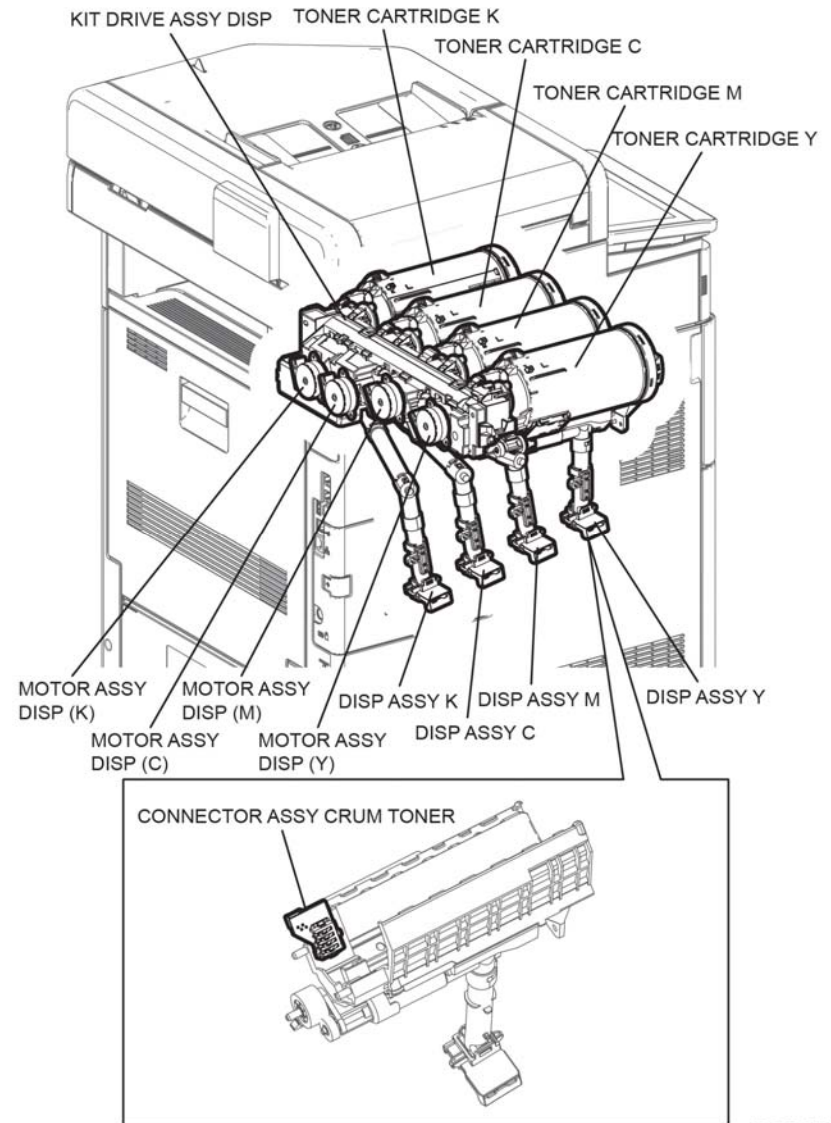
D80975

Feeds toner in the toner cartridge to the drum Cartridge and mainly consists of the following parts:

- Connector assembly crum toner: (detects whether the toner cartridge being connected is a regular part.)

Figure 6 Toner dispensing function

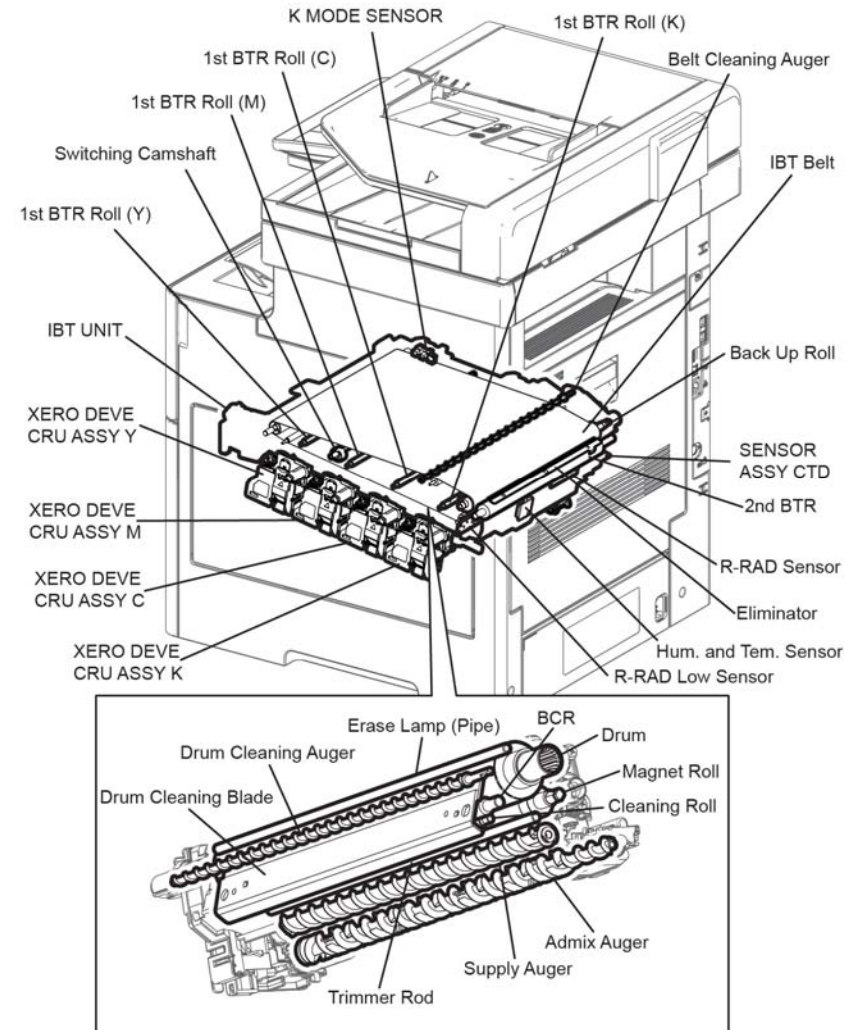
D80977

A unit that consists of the drum to form the static latent image and toner image, and the developer to develop toner to the drum. Placed in yellow, magenta, cyan, and black color each.

- Drum
Forms the static latent image and the toner image.
- BCR
Charges the drum.
- Cleaning roll
Cleans toner on the BCR surface.
- Drum cleaning blade
Cleans the remaining toner in the drum after the toner image is transferred on the sheet.
- Magnet roll
Contacts with the drum and forms the toner image on the drum.
- Admix auger, supply auger -stirs toner.
- Trimmer rod
Equalizes toner and carriers on the magnet roll.

Figure 7 Xerographics function
