VersaLink[®] C500/C600 Printer and C505/C605 Multifunction Printer Service Manual

Xerox VersaLink C605F Family Printer Service Manual

705P01395

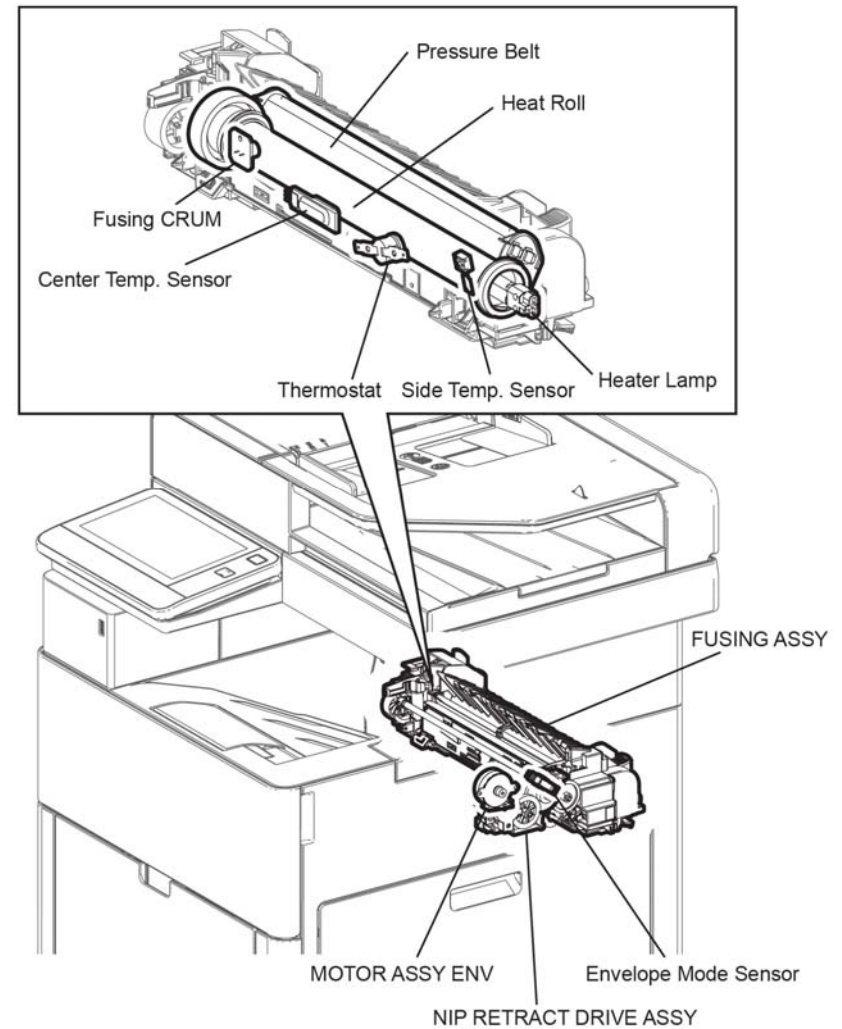
D80979

- Thermostat
Located in series with the heater lamp's power source. A secondary device to prevent excessive temperature in the heat roll if the temp. sensors fail.

- Nip retract drive and motor assembly envelope
Reduces the fuser belt pressure on the heat roller to reduce wrinkle when printing envelopes.
- Envelope mode sensor
Detects whether or not the envelope nip is retracted.

Figure 9 Fuser function

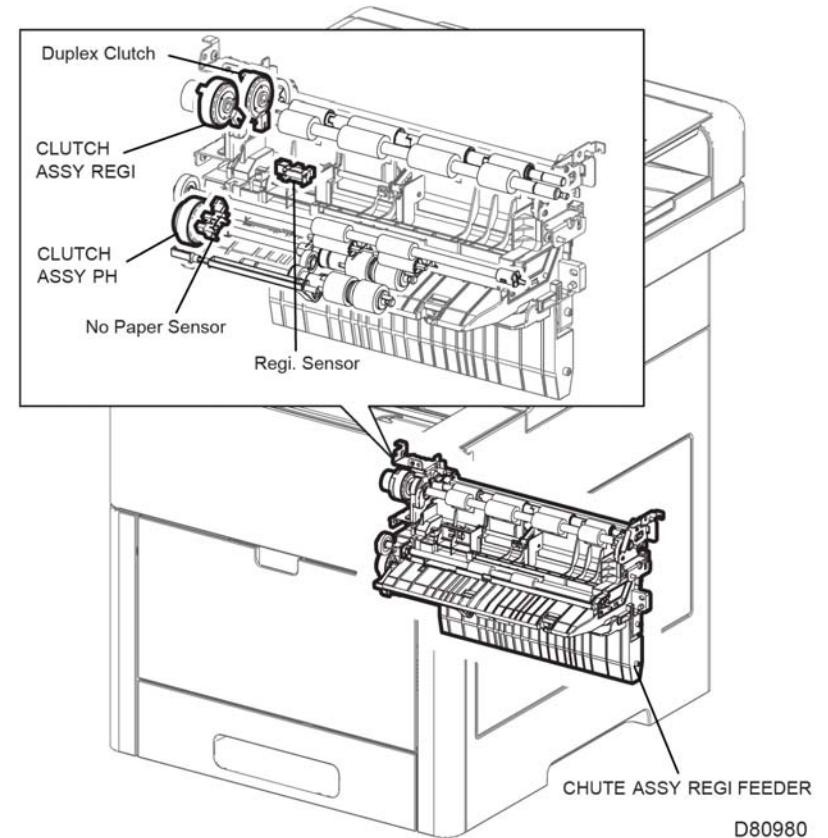
Duplex clutch

transfers the Main Motor drive to the duplex roll inside the duplex assembly.

Figure 10 Paper transport function

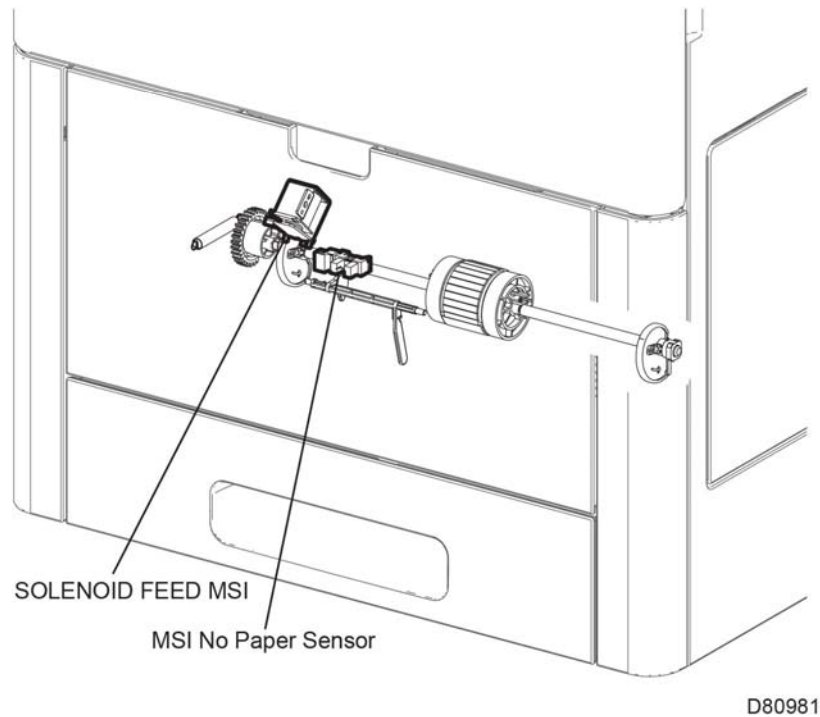
Solenoid Feed MSI (Figure 11)

Transfers the main motor drive to the MSI feed roll.

Figure 11 Bypass function

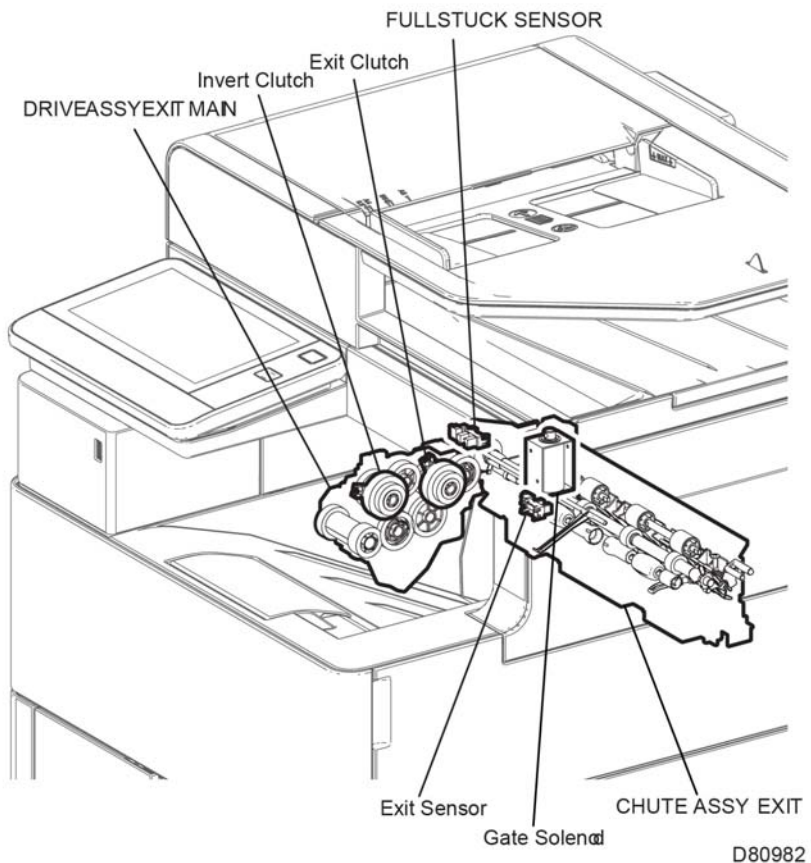
DRIVE assembly exit main (Figure 12)

Gear assembly idle exit (Figure 12)

Contains the gears that transmit the Main Motor drive to the gears in the drive assembly exit main.

Figure 12 Exit Function

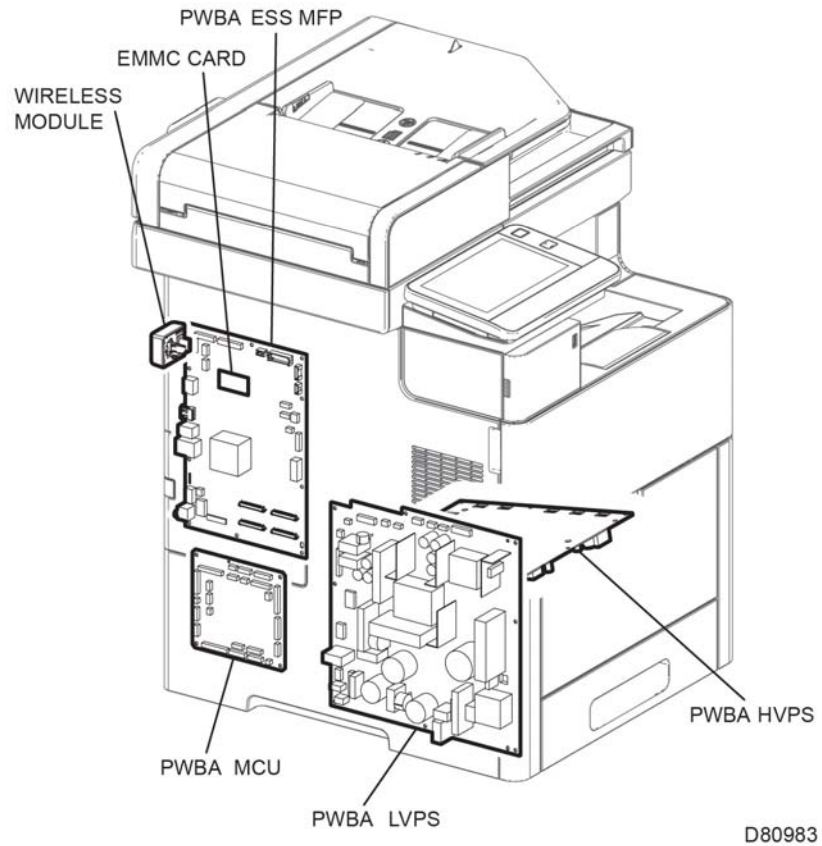
EMMC BOARD (Figure 13)

Non-volatile memory that stores the machine information.

Figure 13 Electrical function

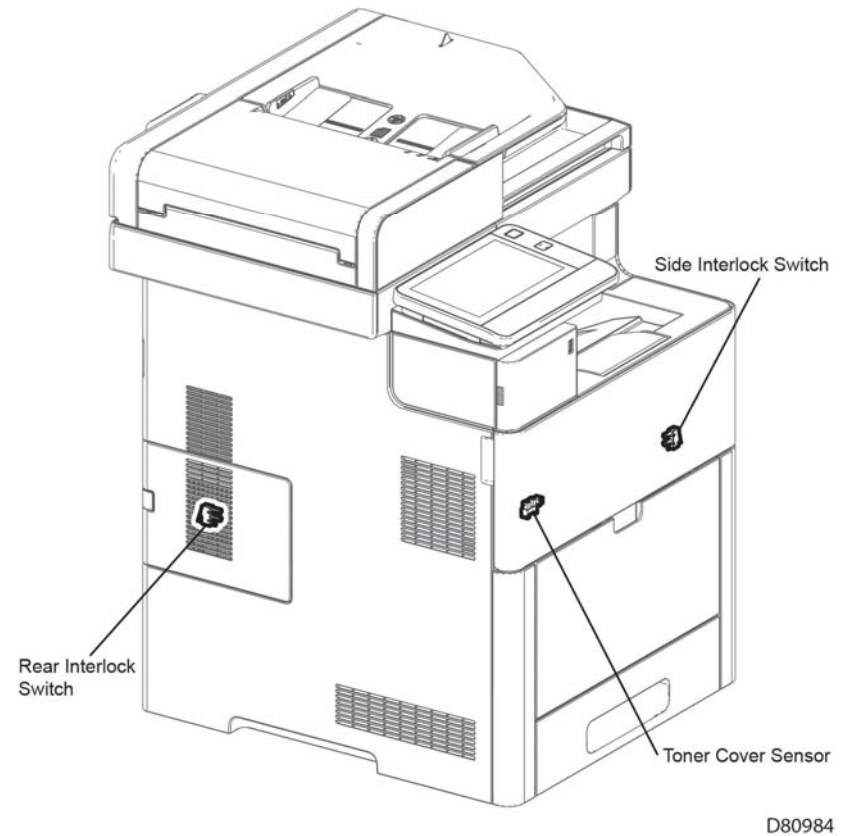
Rear Interlock switch **Figure 14.**

Side Interlock switch **Figure 14.**

Detects the opening/closing of the side cover.

Figure 14 Interlock function

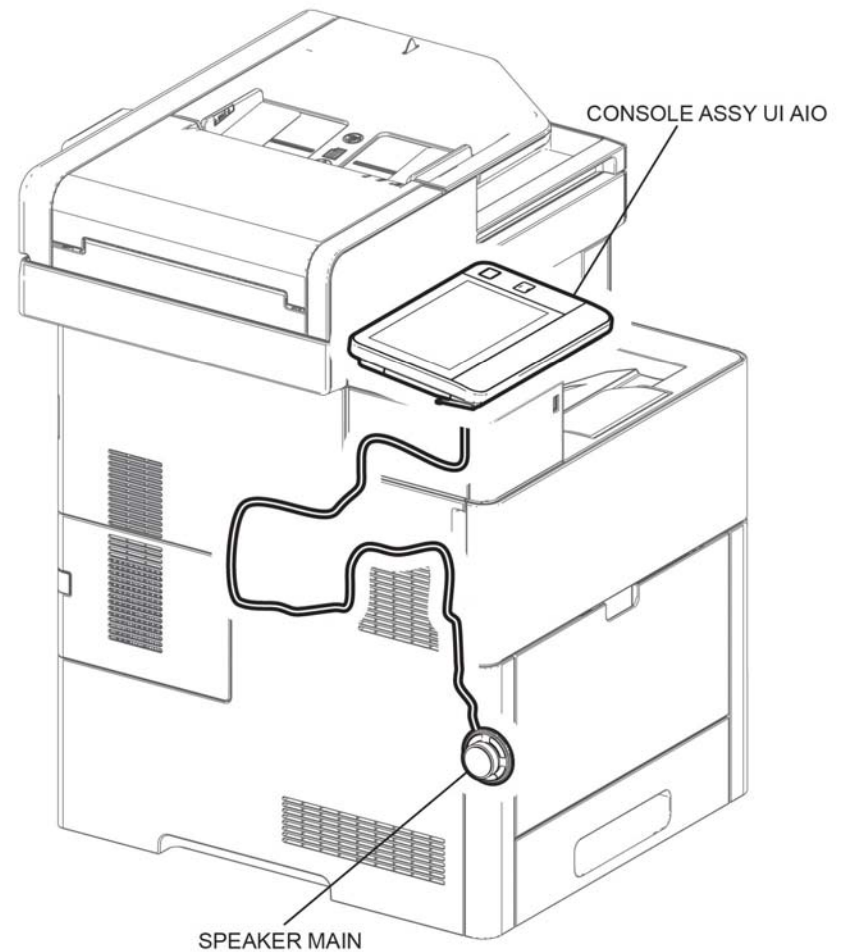
D80985

Speaker Main (Figure 15)

Console Assembly UI AIO (Figure 15)

The board for controlling the fax signal. (See Figure 13 for the UI board.)

Figure 15 UI and Fax function (C505/C605)

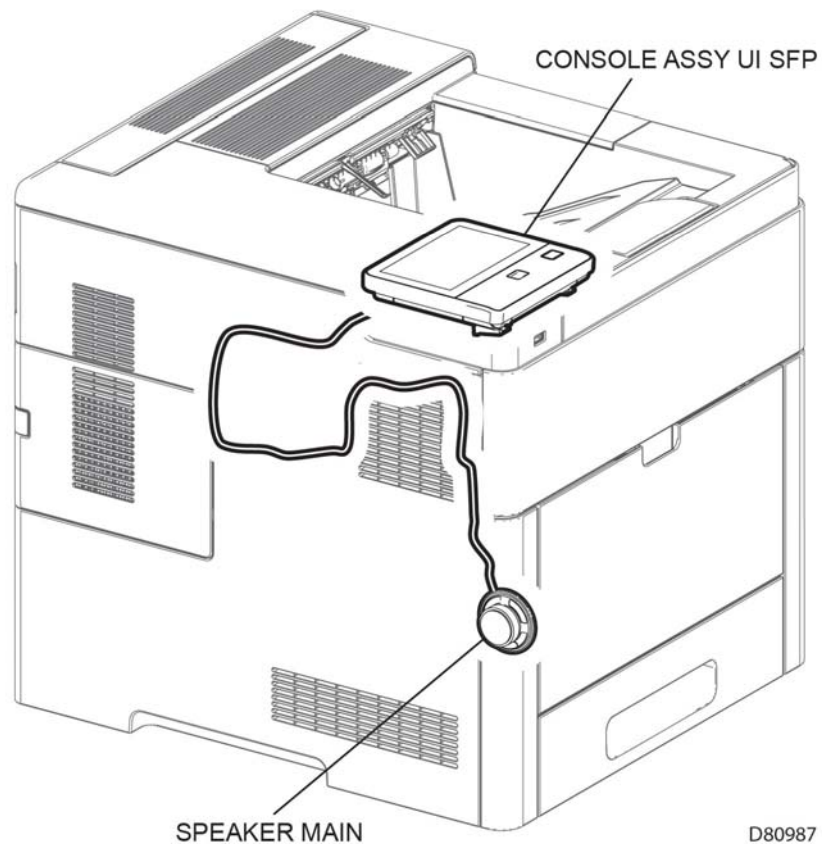
Speaker Main (Figure 16)

Console Assembly (Figure 16)

Figure 16 UI function (C500/C600)

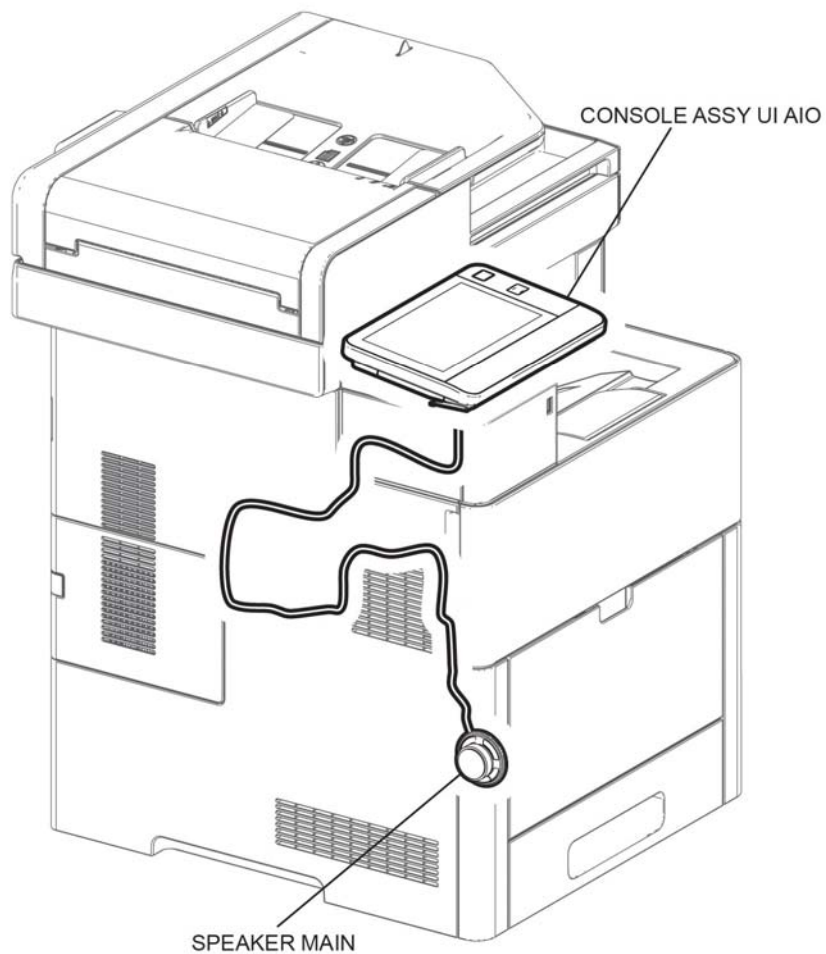
Speaker Main Figure 17

Console assembly UI (C500/C600) Figure 17

Figure 17 UI and fax function (C505/C605)

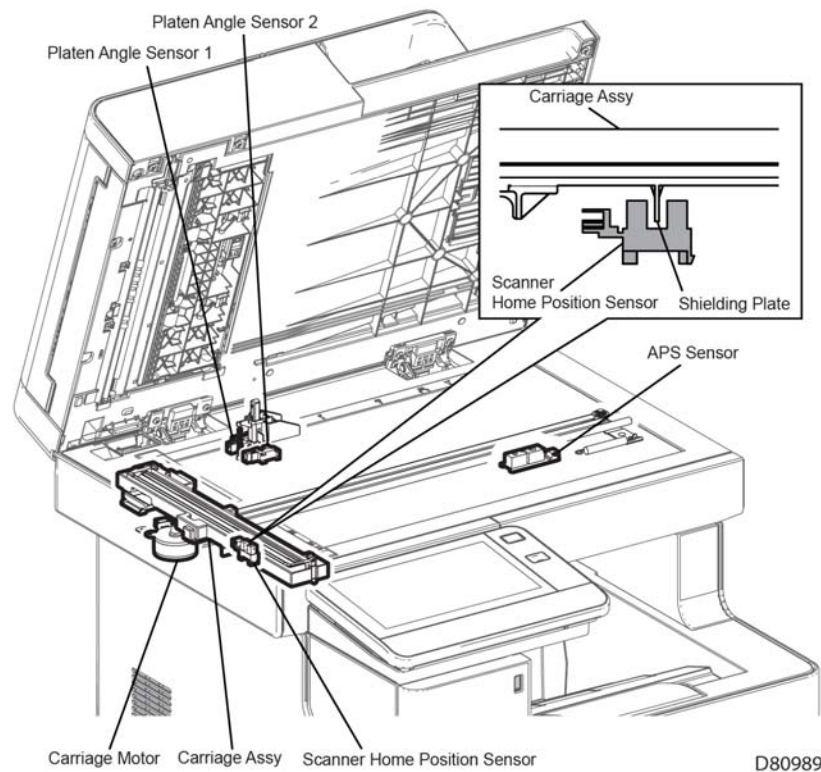
IIT assembly Figure 18

- Carriage motor (scanner motor)
The stepping motor that drives the carriage assembly.
- Scanner home position sensor (CVT position)
As part of the rear side of the carriage assembly frame, the sensor functions as an actuator and blocks the light on the scanner home position sensor, thus detecting the registration position. This sensor detects the home position of the carriage assembly. When the carriage assembly is in the home position, the light is shielded, and when not in the home position, the light is unshielded.
- Platen angle sensor
Detects when the platen is open/closed.

Figure 18 Scanner IIT function (C505/C605/C605_Tall)

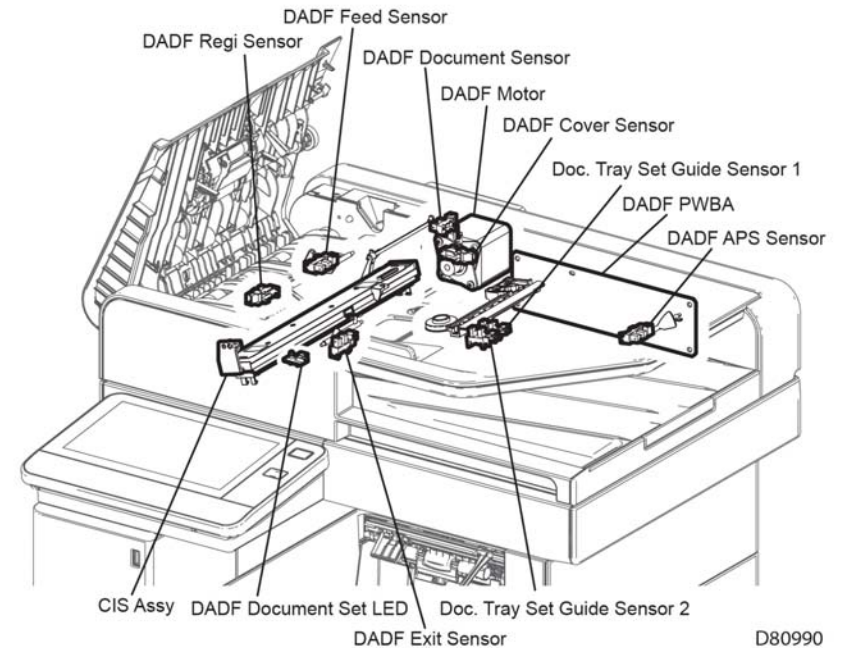
DADF assembly (Figure 19)

- DADF Motor
The DADF motor rotates the DADF nudger roll, DADF feed roll, DADF takeaway roll, DADF regi roll, DADF transport roll, and DADF exit roll.
- CIS array assembly
Scans the image on the back side of the document in the duplex mode.

- DADF Board
Controls the whole DADF system.

Figure 19 Scanner DADF function

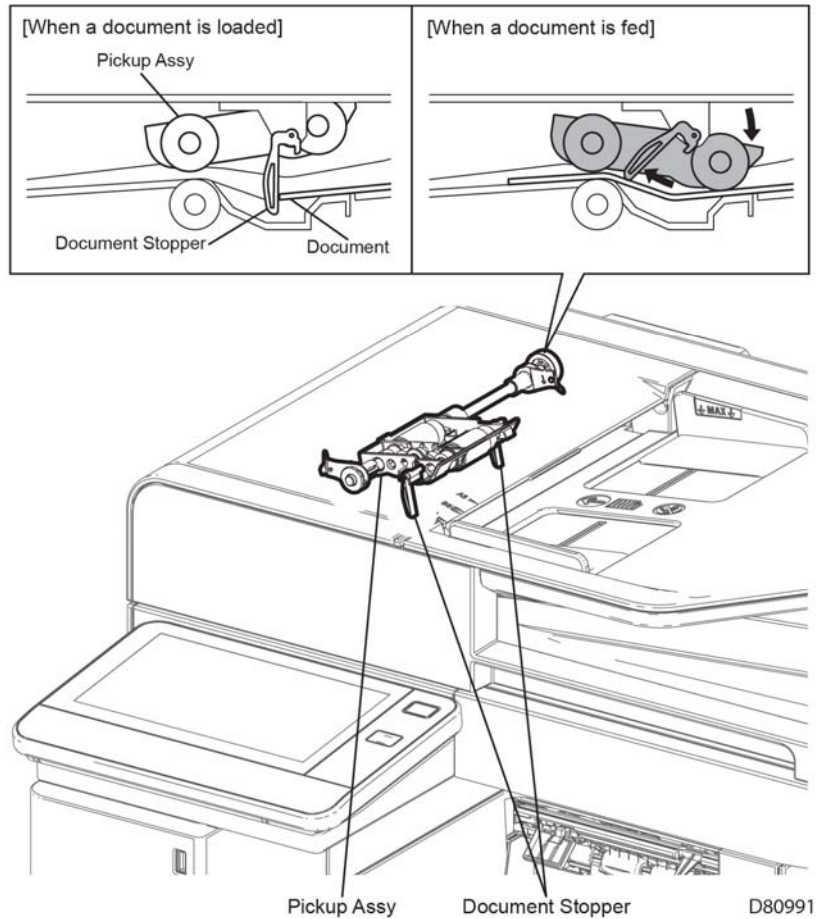
- Document stopper [Figure 20](#)
When a document is loaded in the DADF, the document stopper is locked to prevent the document from being moved forward.
When the DADF starts feeding, the front portion of the pickup assembly is lowered. This unlocks the document stopper that blocks the document. When the document stopper is pressed by the lead edge of the document in the feed direction, the document is fed. When the paper feed is completed, the pickup assembly returns to its original position.

Figure 20 Document stopper function

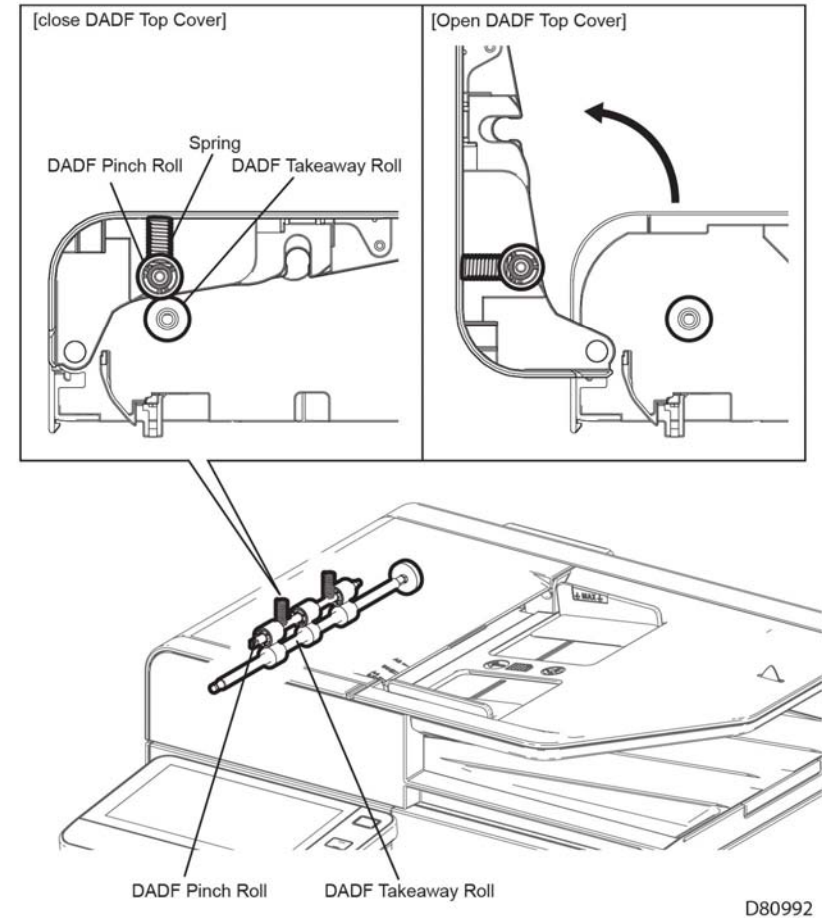
- DADF pinch roll ([Figure 21](#))
The DADF pinch roll is normally pressed against the direction of the DADF takeaway roll by the spring pressure.
Documents are fed between the DADF pinch roll and the DADF takeaway roll to the CVT Window by the rotation of the DADF takeaway roll.
If a jam occurs between the DADF pinch roll and the DADF takeaway roll, it is hard to retrieve documents due to the high spring pressure of DADF pinch roll.
To retrieve jammed documents, open the DADF top cover to release the spring pressure, and make enough clearance between the DADF pinch roll and the DADF takeaway roll.

Figure 21 DADF Pinch roll function

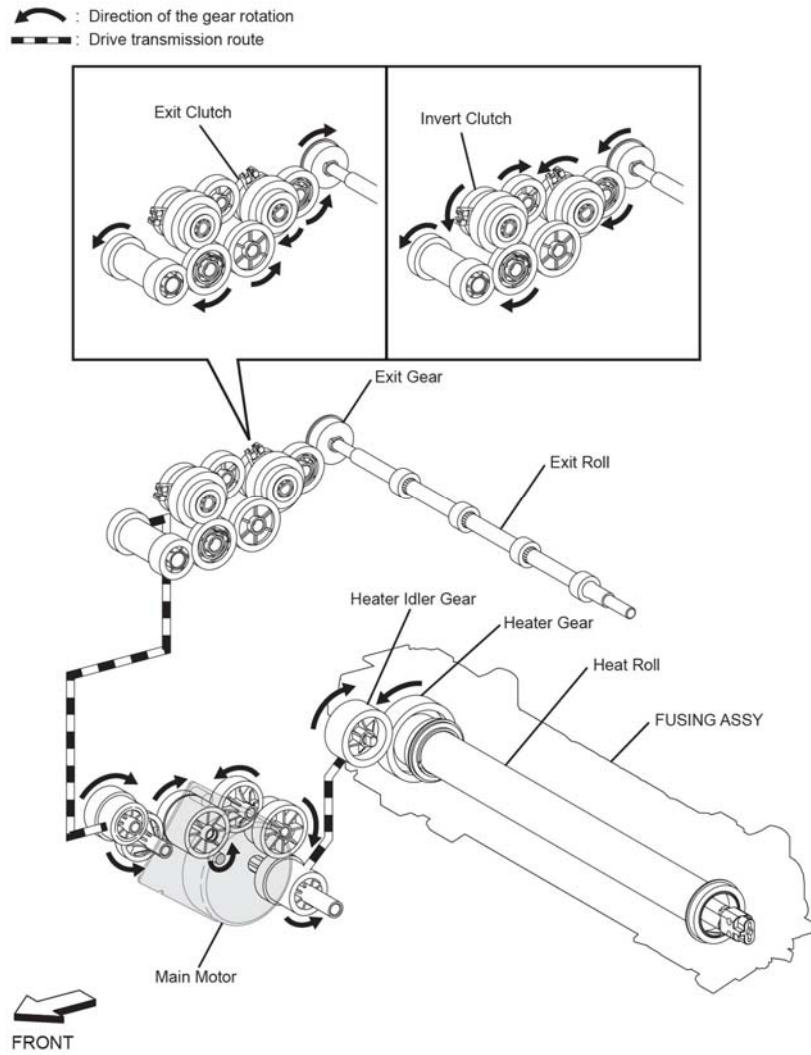
D80997

Figure 2 shows the drive transmission from the fuser section to the exit section where the rolls and gears are driven by the main motor.

Figure 2 Paper feed (fuser to exit)

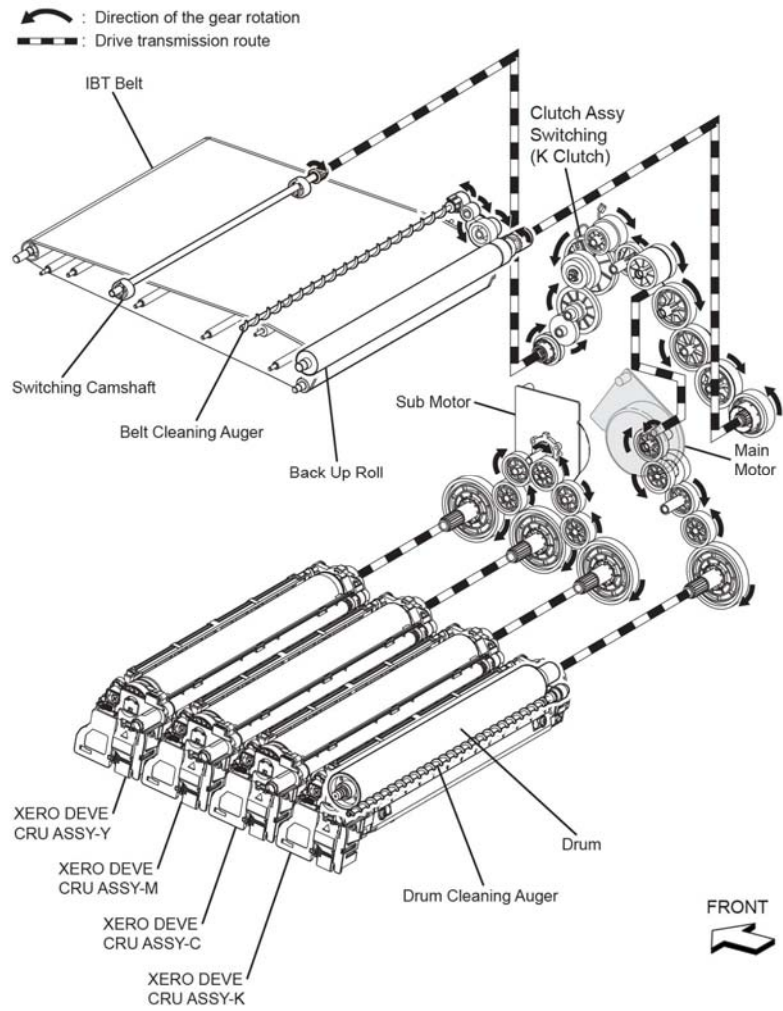
D80999

Figure 3 shows the drive transmission of the drum and the transfer belt. The main motor drives the rolls and gears of the drum (K) and the transfer belt. The sub motor drives the rolls and gears of the drums (Y/M/C).

Figure 3 Drum and transfer belt feed

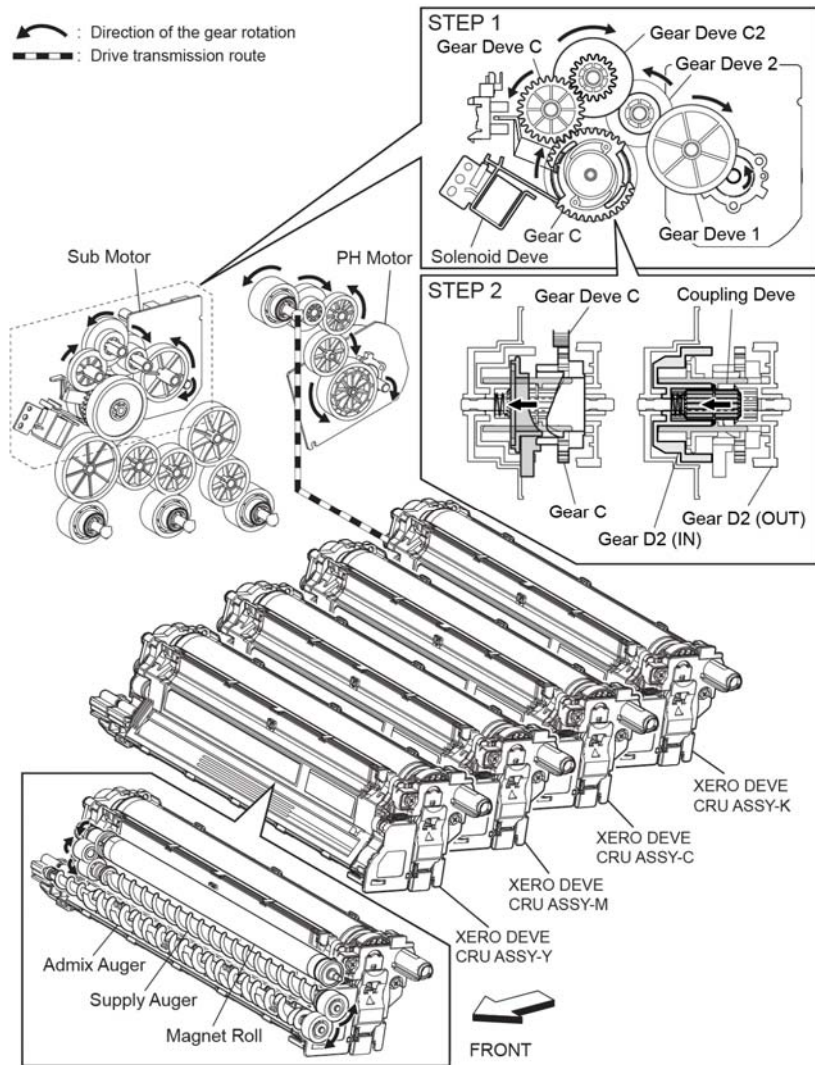
Figure 4 and Figure 5 show the development feed components. The main motor drives the rolls and gears of the development components (K). The sub motor drives the rolls and gears of the development components (Y/M/C)

Figure 4 Development feed

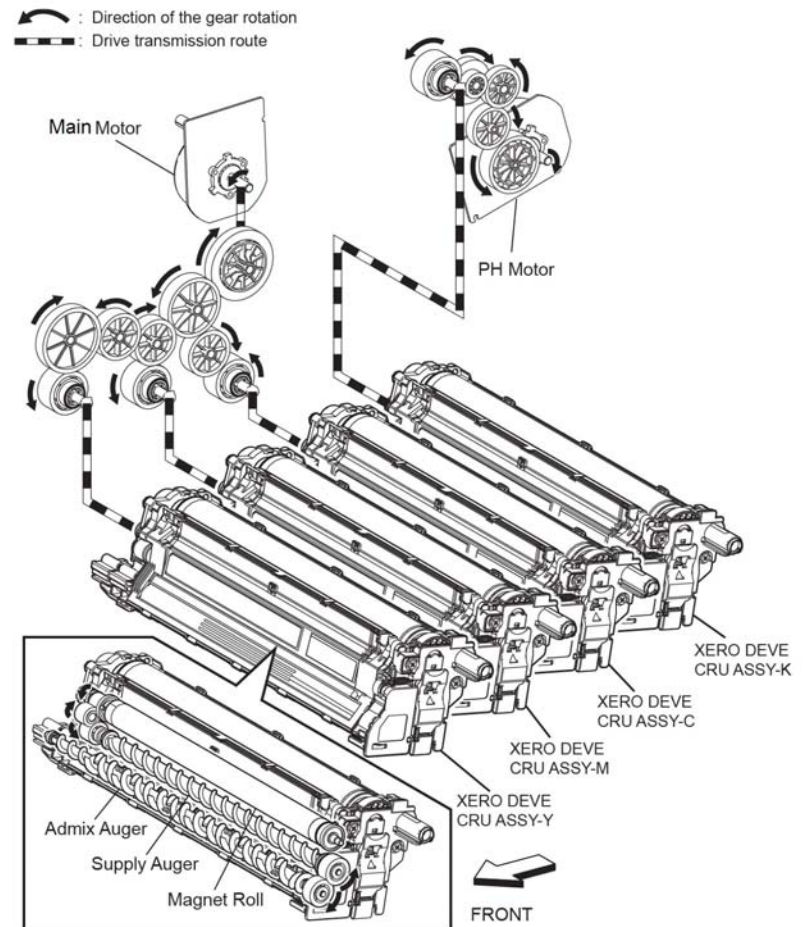
Figure 5 Development feed (Sub Motor)

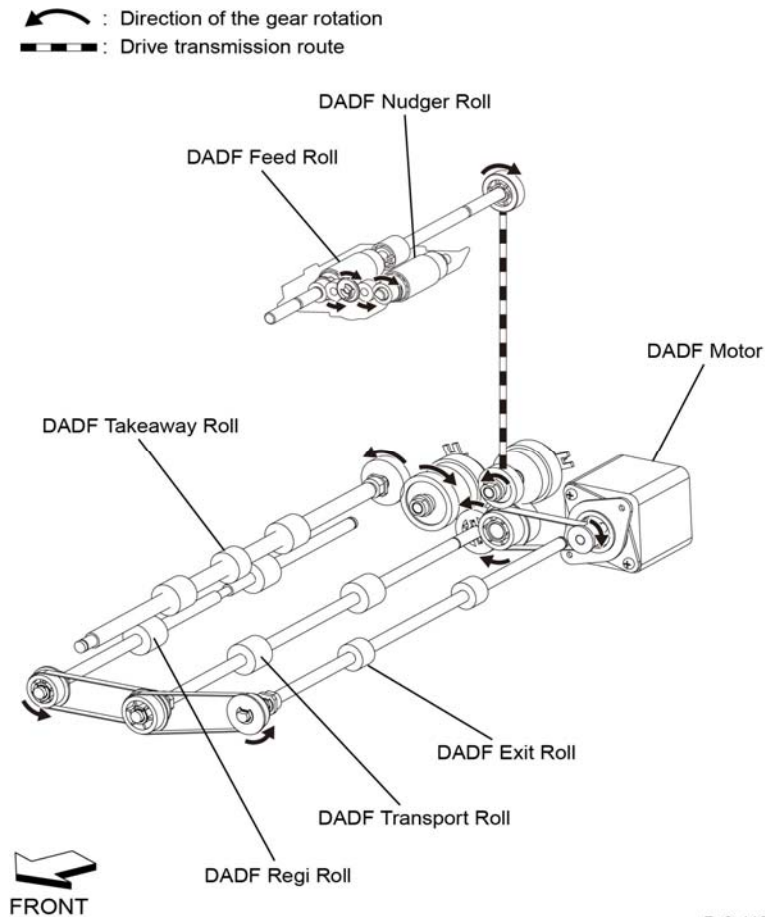
D-8-1103-A

Figure 6 shows the drive transmission route from the DADF motor to each roller.

Figure 6 DADF motor

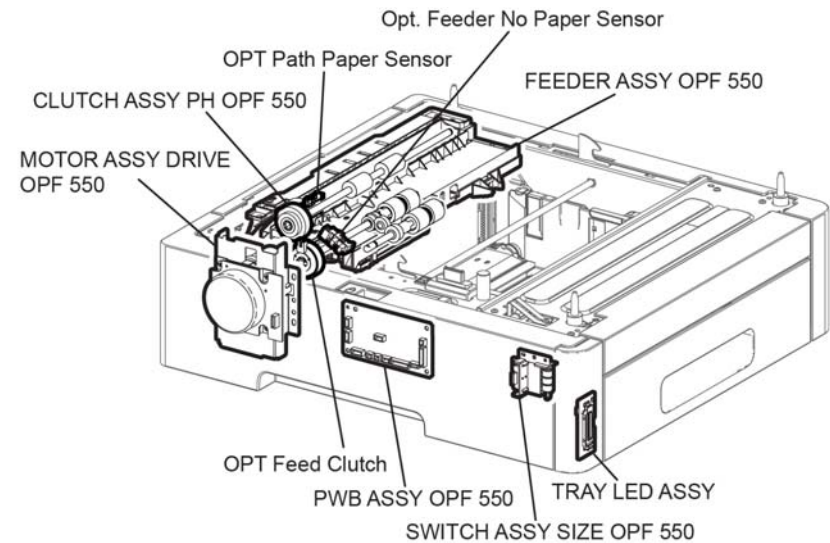
D80993

The options are documented in their respective installation instructions. Refer to Figure 1 for the option feeder functions.

Figure 1 Option feeder functions

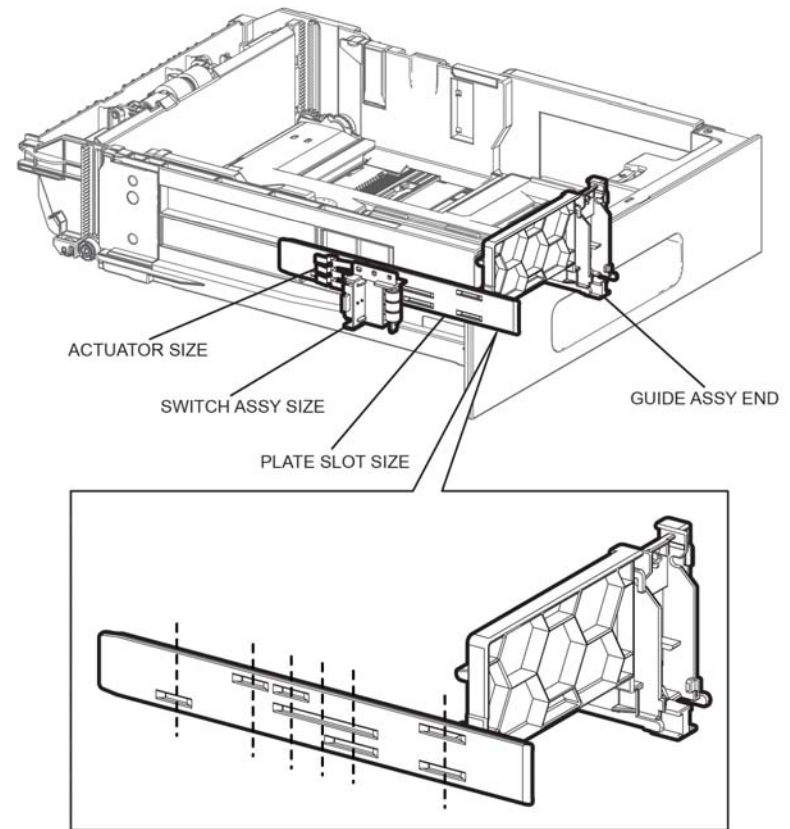
D80994

The option feeder size switch (Figure 2) detects paper size, and presence or absence of paper in the 550 paper cassette.

Load paper in the paper cassette, and adjust the left guide assembly, right guide assembly, and End guide assembly to the paper size. Linked with the end guide assembly, the position of the size slot plate is changed, and the three size actuators on the side of the cassette depress the size switch assembly. The detected paper size corresponds to the combination of actuators depressing the size switch.

Figure 2 Option feeder size switch
