Xerox® VersaLink® C7000 Color Printer & C7030 Family Color Multifunction Printer Service Manual

Service Documentation

708P91463

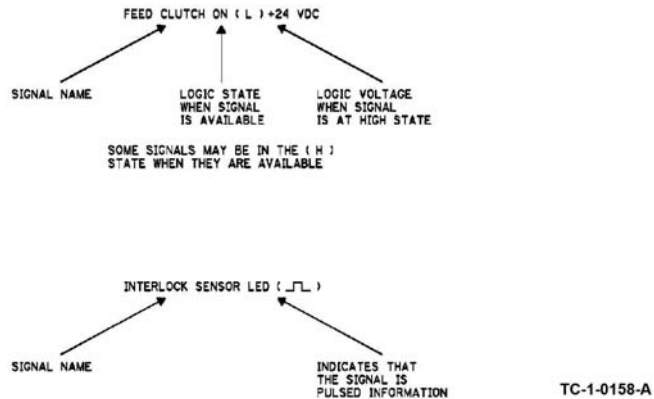
Figure 1 shows the signal nomenclature used in the BSDs.

Figure 1 Signal Nomenclature

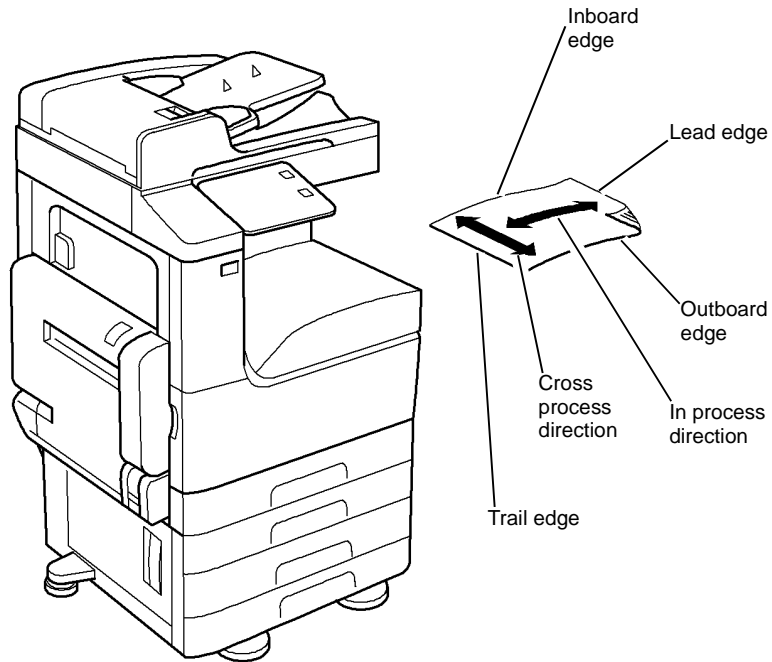
C-1-0431-A

Figure 1 Print/copy definitions

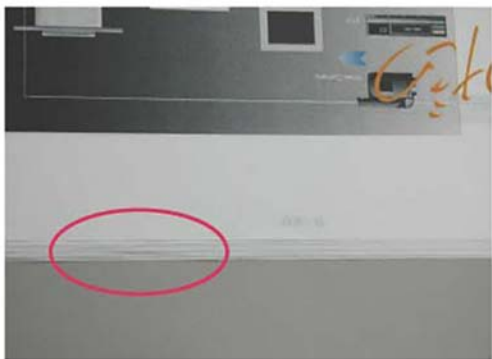
C-1-0662-A

- Lead Edge: Paper lead edge contacts the belt when it is transported from registration to Transfer.
- Trail Edge: The tail edge of paper that loops between the transfer-fusing sections, at the release of the secondary transfer nip, moves opposite to the feed direction and contacts the BTR surface, or bounds up and contacts the belt

Figure 1 Example

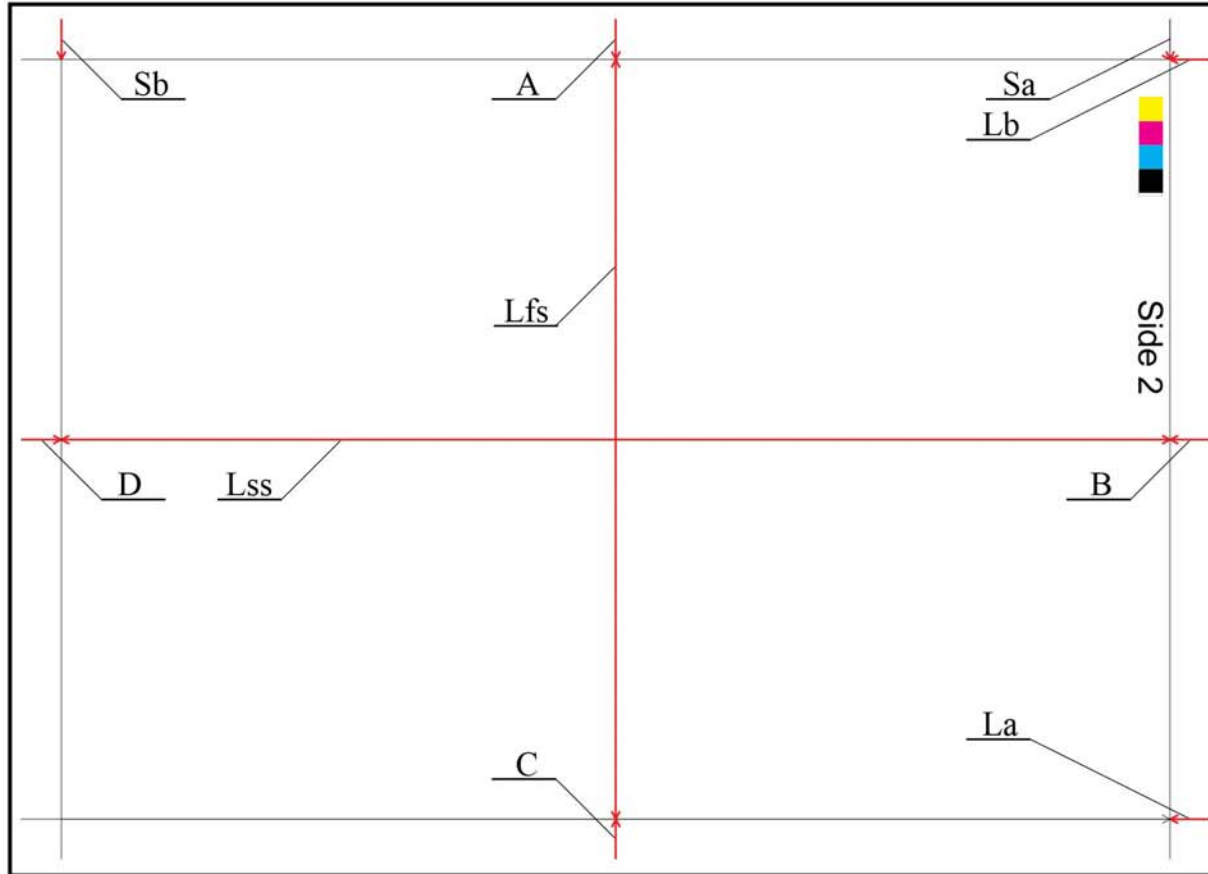
C-1-0685-A

Figure 2 Test pattern side 2

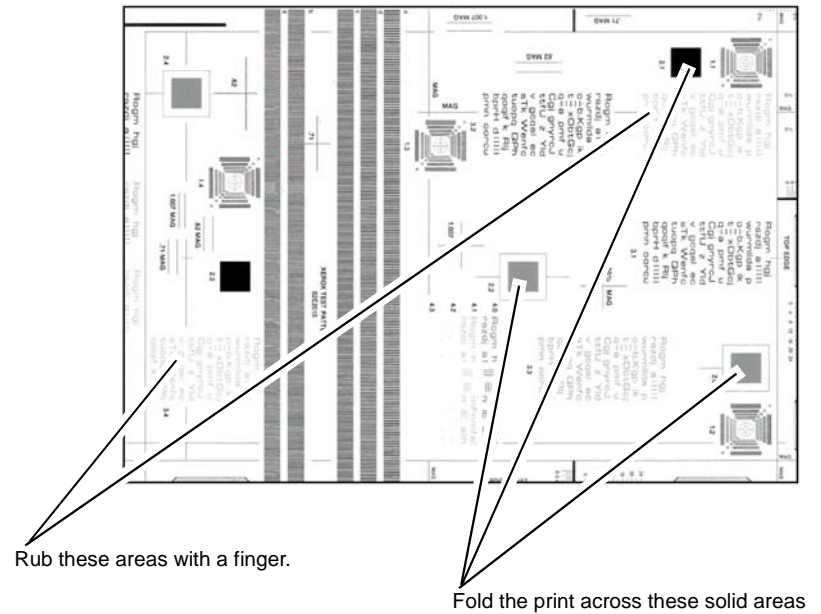
C-1-0686-A

Figure 1 Test pattern

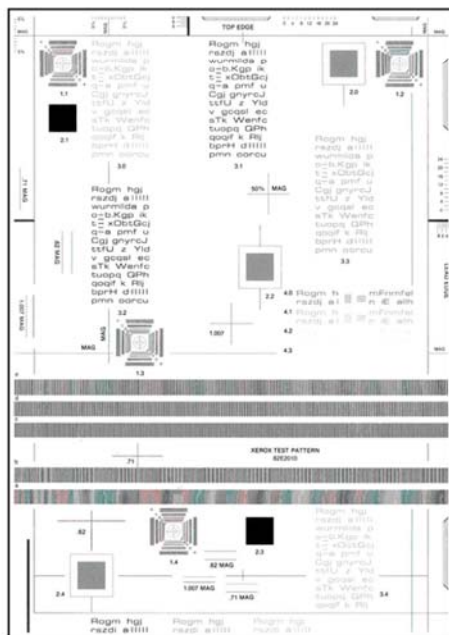
Figure 1 Test pattern

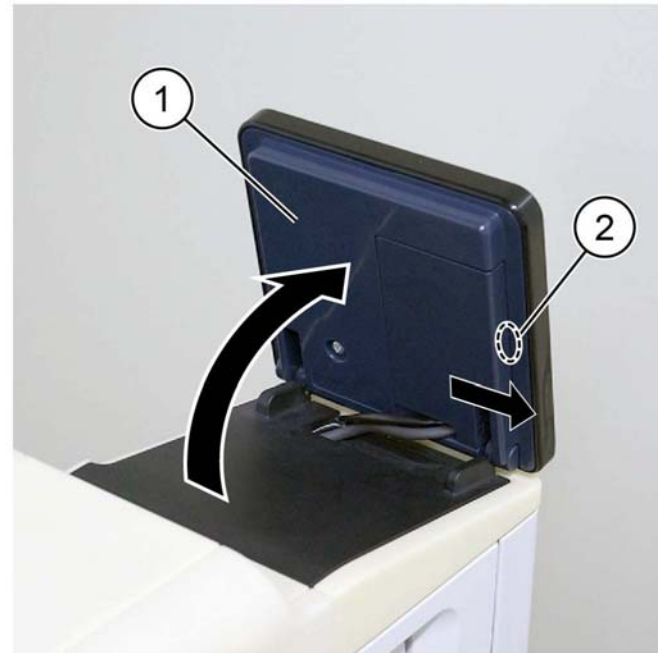
1. If possible, record the current software level by either:
 - Printing the configuration report, [GP 14](#).
 - From the user interface Home screen, touch Device, then About. Scroll down to view the Software Version.
2. Remove the UI rear cover, [Figure 1](#).
 - a. Lift the UI assembly (1) in the direction of arrow.
 - b. Insert a flat screwdriver in the gap between the UI rear cover and the UI assembly (2).

Figure 1 User interface rear cover

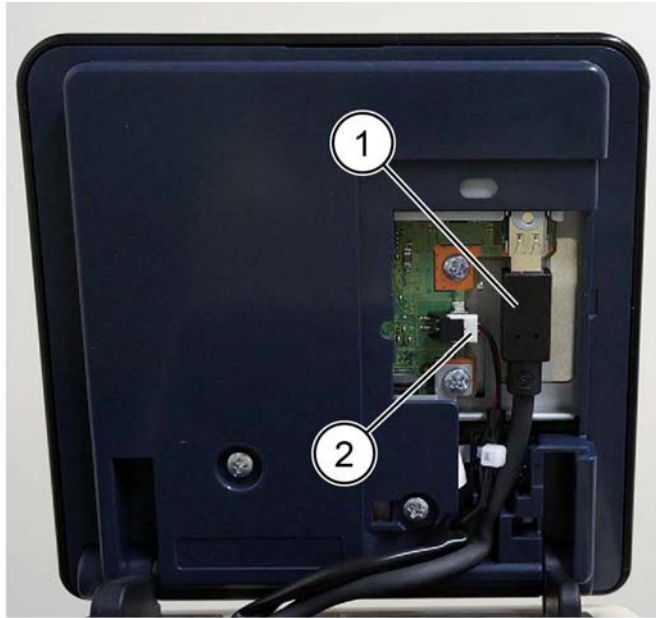
3. Disconnect two connectors, [Figure 2](#).

Figure 2 User interface connectors

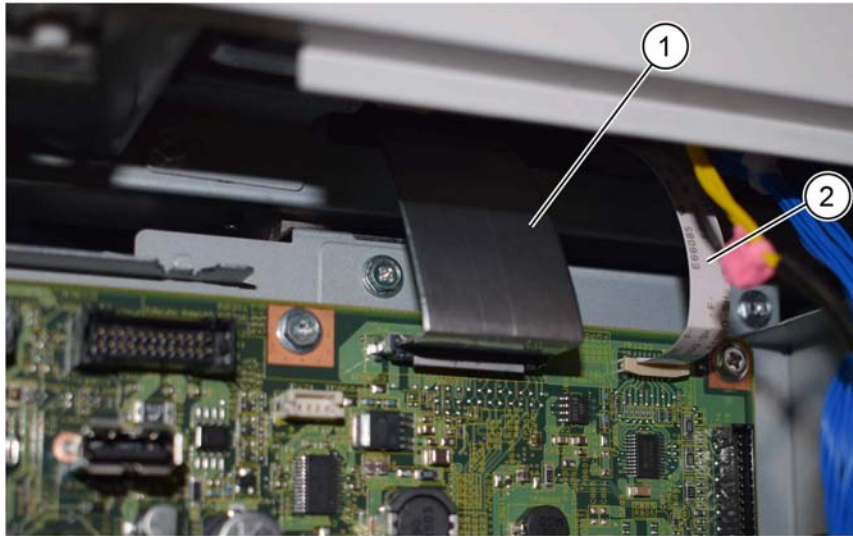
The FFC LED cable is secured by a clamp. Carefully lift both ends of the cable clamp simultaneously to release the cable.

13. **(C7030F only)**. Carefully disconnect the CCD ribbon cable (1) and the FFC LED cable (2), Figure 10.

Figure 10 Cables

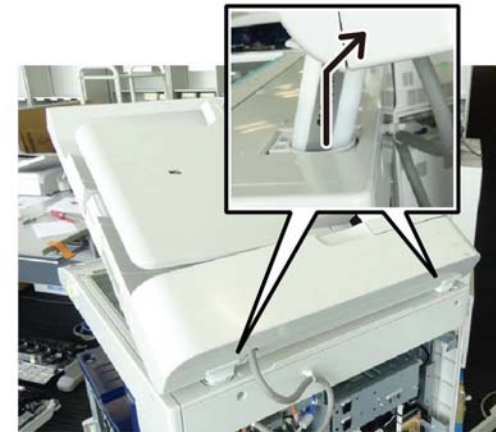
4. Remove the DADF, [Figure 2](#).

Figure 2 DADF removal

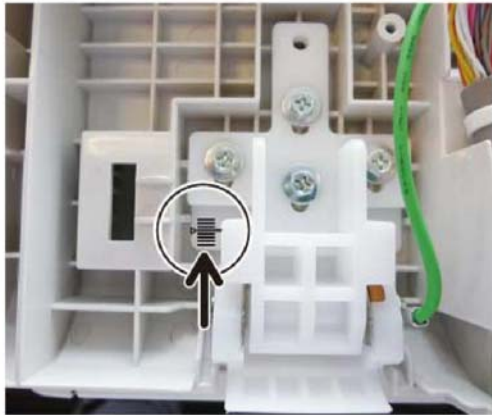
1. Remove the DADF rear cover, [REP 5.4](#).
2. Remove the DADF, [REP 5.1](#).
3. Record the position of right counter balance, [Figure 1](#).

Figure 1 Position

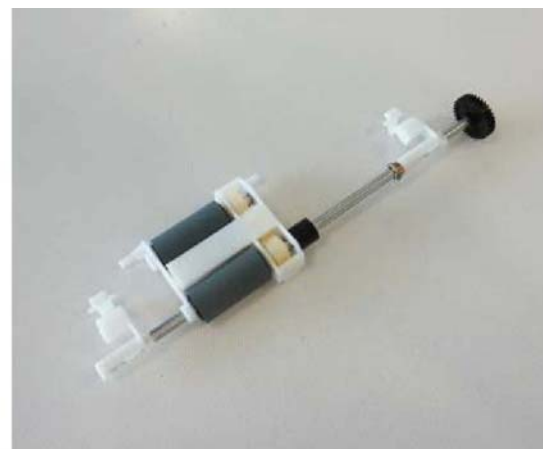
C-1-0053-A

NOTE: The removed feed/nudger roll assembly is shown in [Figure 2](#).

Figure 2 Removed feed/nudger roll assembly

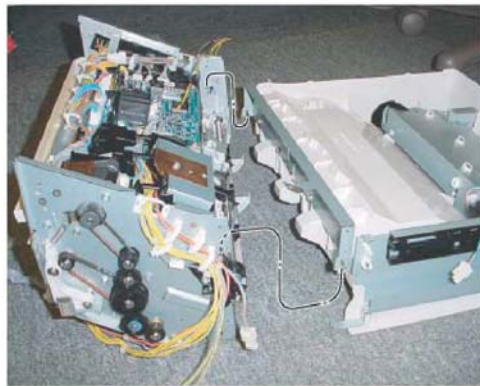
C-1-0285-A

1. The replacement is the reverse of the removal procedure.
2. Install the stacker tray assembly and integrated office finisher as shown in Figure 5.

Figure 5 Stacker tray assembly installation

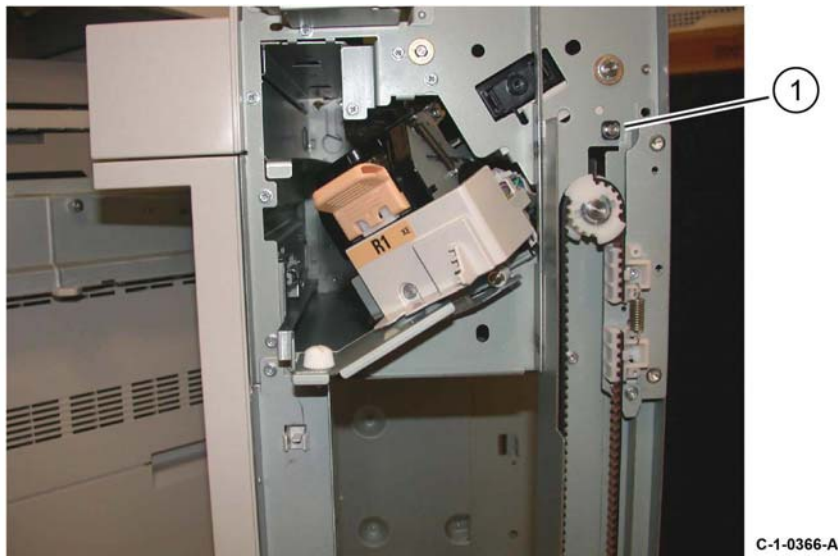
Figure 5 Front E-ring removal

13. Remove the front E-ring and the bushing (1) from the set clamp shaft assembly, [Figure 5](#).

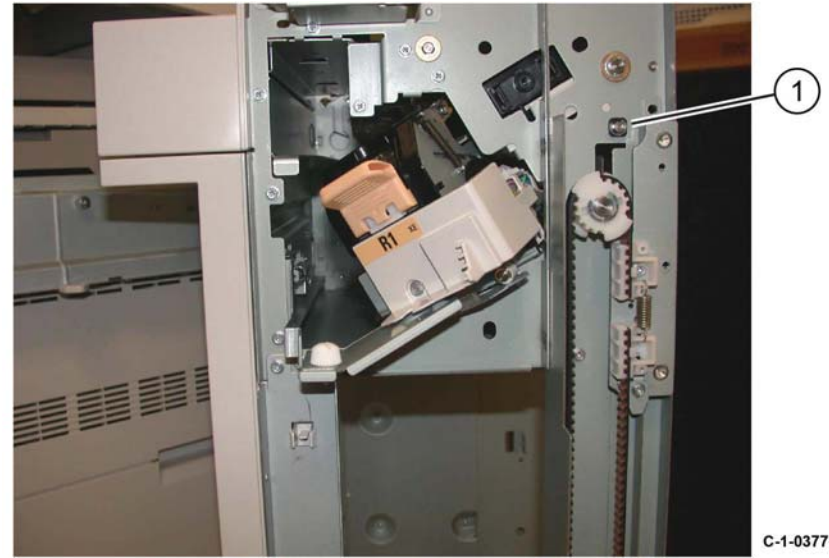
Figure 16 Bushing and E-ring

9. Install the bushing onto the front end of the set clamp shaft, then install the E-ring (1), [Figure 16](#).

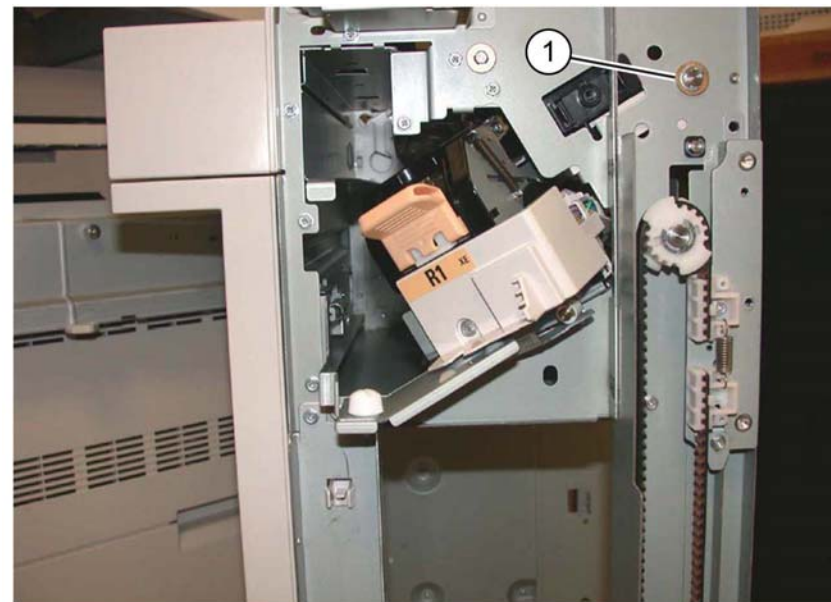
Figure 20 Eject roll shaft front components

13. Install the brass bearing and E-ring onto the front of the eject roll shaft (1), [Figure 20](#).
14. Perform the remainder of the replacement procedure in reverse of the removal procedure.

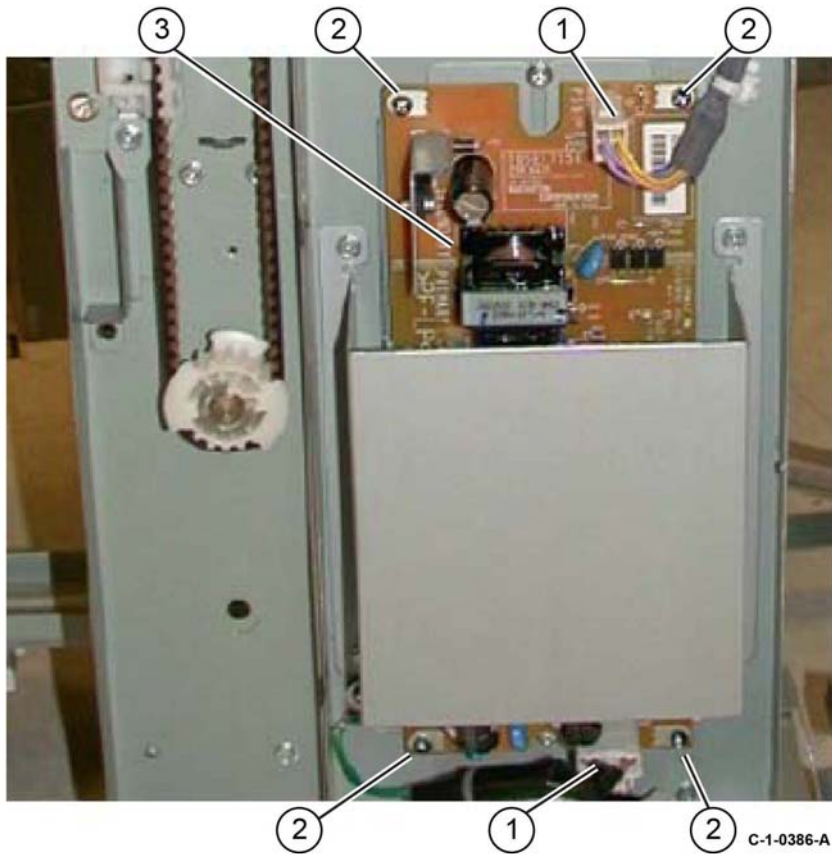
Figure 1 Finisher LVPS removal

1. Remove the rear lower cover, [REP 13.8](#).
2. Remove the finisher LVPS, [Figure 1](#):
 - a. Disconnect both Connectors (1).
 - b. Remove four screws (2).
 - c. Remove the finisher LVPS (3).

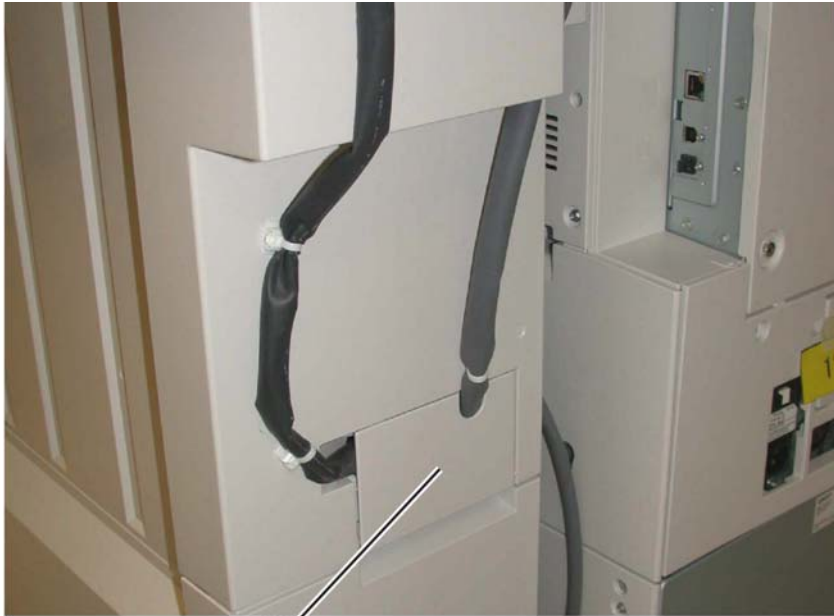
Figure 2 Connector cover

2. Remove the connector cover (1), [Figure 2](#).

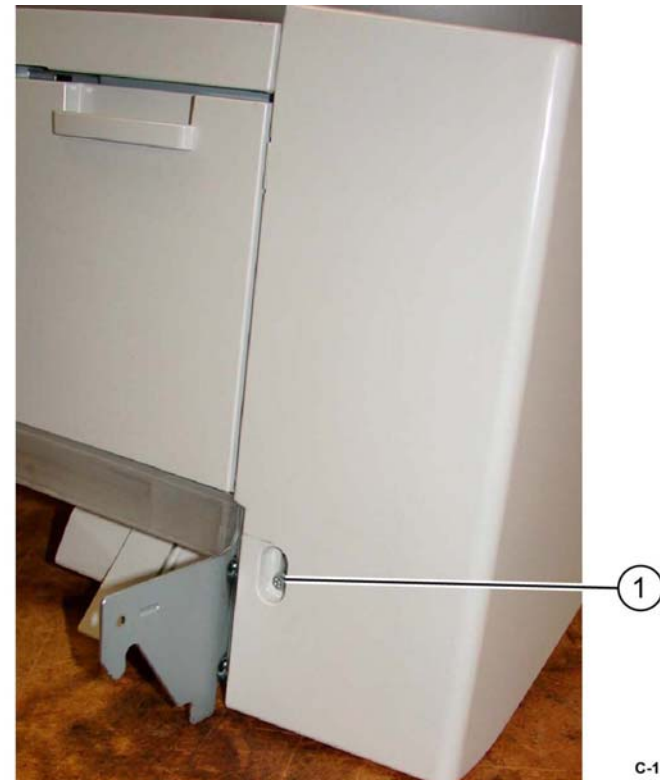
Figure 1 Screw removal

1. Remove the booklet maker assembly from the finisher, [REP 13.31](#).
2. Remove the screw (1), [Figure 1](#).

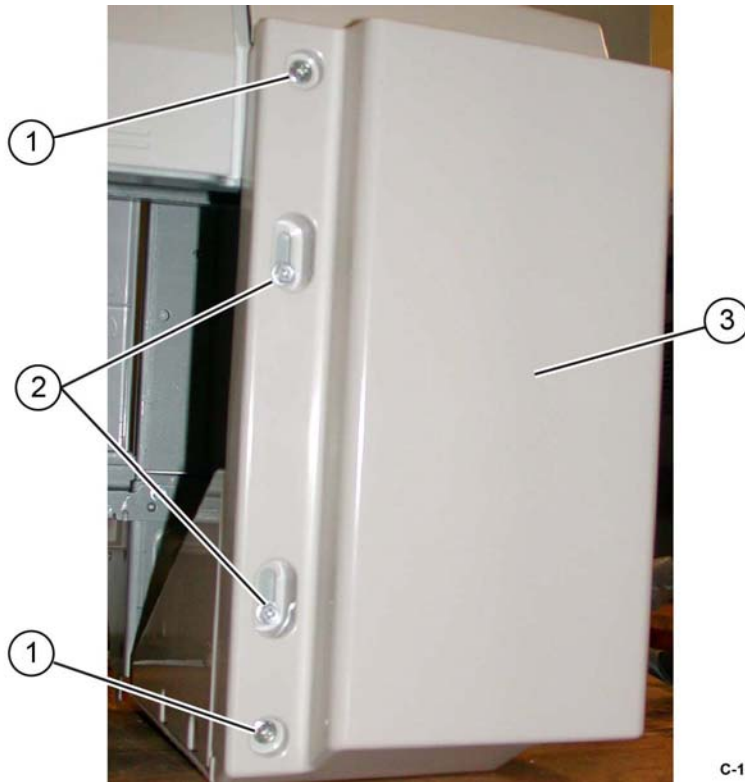
1. Remove the booklet PWB cover, [Figure 1](#):
 - a. Remove both self-tapping screws (1).
 - b. Remove both screws (2).
 - c. Remove the booklet PWB cover (3).

Figure 1 Booklet PWB cover removal

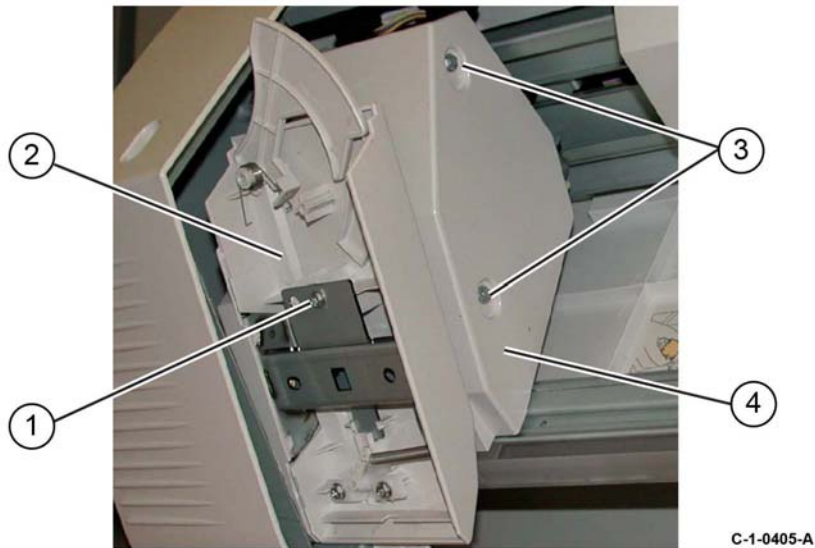
C-1-0405-A

4. Prepare to remove the stapler, [Figure 3](#):
 - a. Remove the screw (1).
 - b. Remove the chute (2).
 - c. Remove both screws (3).
 - d. Remove the stapler rear cover (4).

Figure 3 Preparation

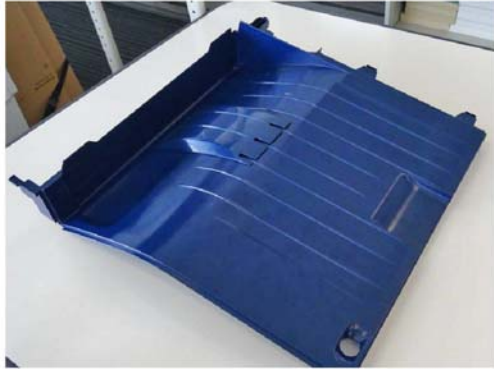
C-1-0111-A

NOTE: The removed top cover is shown in [Figure 2](#).

Figure 2 Removed top cover

1. The replacement is the reverse of the removal procedure.
2. When installing the top cover, align the bosses on the rear of the top cover with the mounting holes.

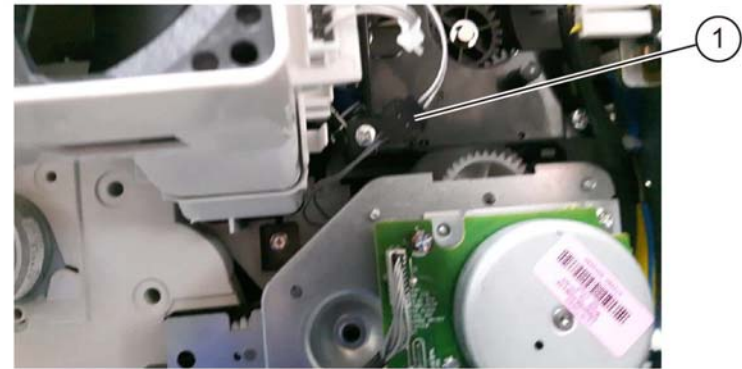
9. Pull out the four drum units.
10. Disconnect the drive assembly connector (1), [Figure 2](#).

Figure 2 Drive assembly connector

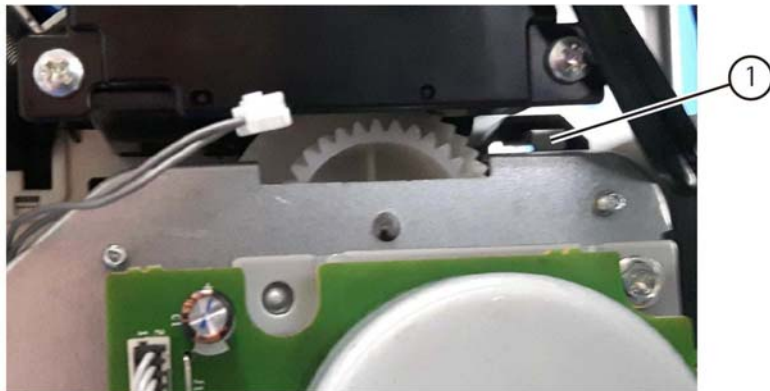
C-1-0635-A

13. Release the hook (1), carefully move the drive assembly down and remove the drive assembly, [Figure 5](#).

Figure 5 Drive assembly removal

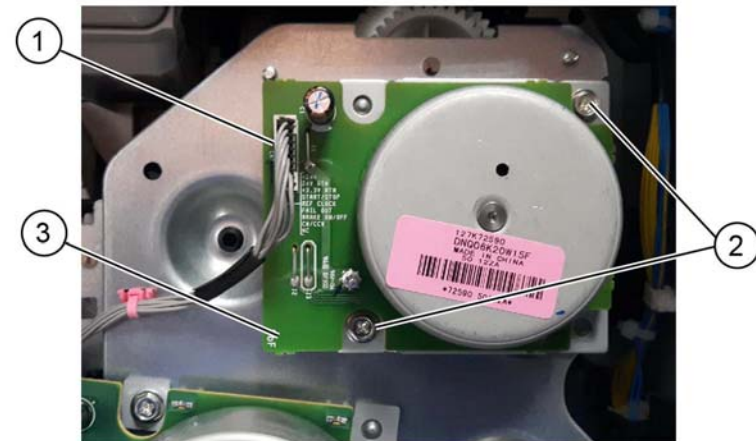
C-1-0642-A

1. Remove the upper rear cover, **REP 28.5**.
2. Remove the lower rear cover, **REP 28.6**.
3. Remove the LVPS assembly, **REP 1.4**.
4. Remove the fusing unit drive motor PWB, **Figure 1**.
 - a. Remove the connector (1).
 - b. Remove two screws (2).
 - c. Remove the fusing unit drive motor PWB (3).

Figure 1 Fusing unit drive removal

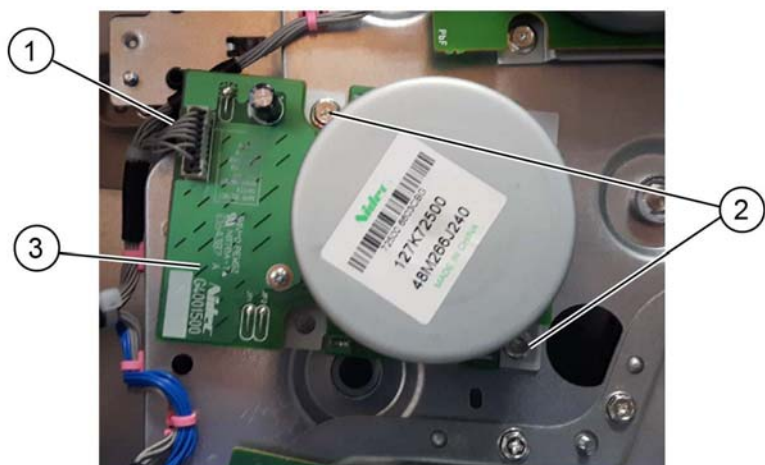
C-1-0643-A

1. Remove the upper rear cover, [REP 28.5](#).
2. Remove the lower rear cover, [REP 28.6](#).
3. Remove the LVPS assembly, [REP 1.4](#).
4. Remove the main motor PWB, [Figure 1](#).
 - a. Remove the connector (1).
 - b. Remove two screws (2).
 - c. Remove the main motor PWB (3).

Figure 1 Main motor PWB removal

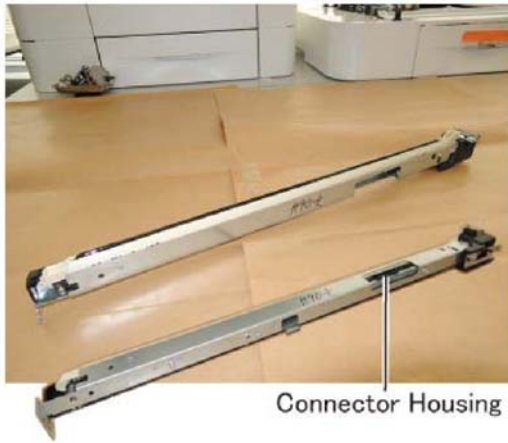
Figure 6 Removed LPH

13. Remove the LPH (K), [Figure 6](#).

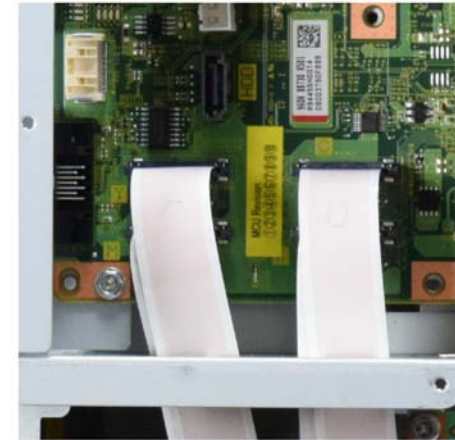
Figure 4 FFC cables

5. Disconnect the four FFC cables, [Figure 4](#):
 - a. Carefully disconnect the FFC cables (1) by releasing the side clips.
 - b. Pull down the FFC cables through the ESS chassis.

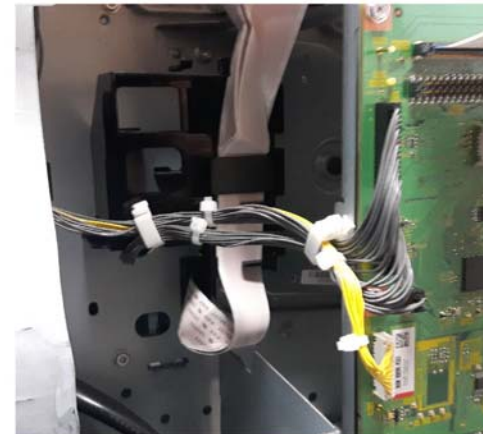
Figure 5 Wire harness removal

6. Disconnect cables (1) from drive PWB, remove the harness clips (2), and remove the harness from FFC guide, [Figure 5](#).

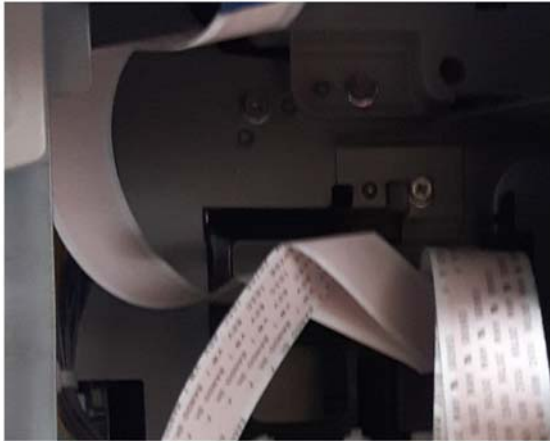
Figure 6 FFC guide removal

7. Disengage the hook (1), and remove the FFC guide (2), [Figure 6](#).

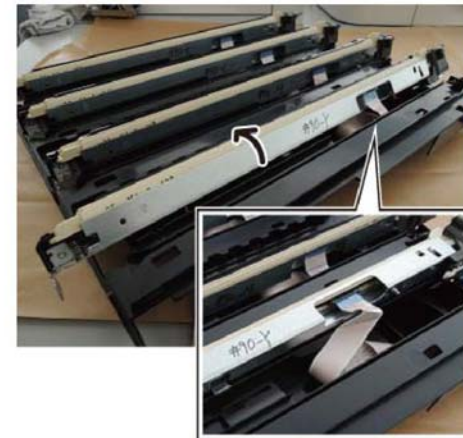
Figure 13 Alignment

23. Push the LPH (Y) towards the direction of the arrow, and place it so the right side of LPH (Y) is on the top, [Figure 13](#).

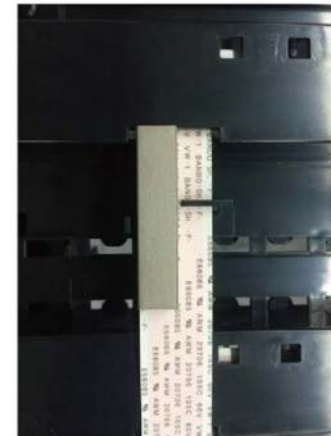
Figure 16 FFC cable

1. The replacement is the reverse of the removal procedure.
2. When replacing the K FFC cable, insert the cable in the correct position of the gasket within the marking guide, [Figure 16](#).

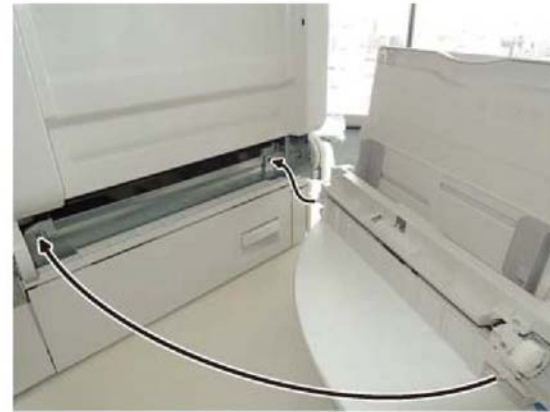
Figure 4 Replacement

1. The replacement is the reverse of the removal procedure.
2. When installing the bypass tray, insert the two bypass tray bosses into the holes in the frame, [Figure 4](#).

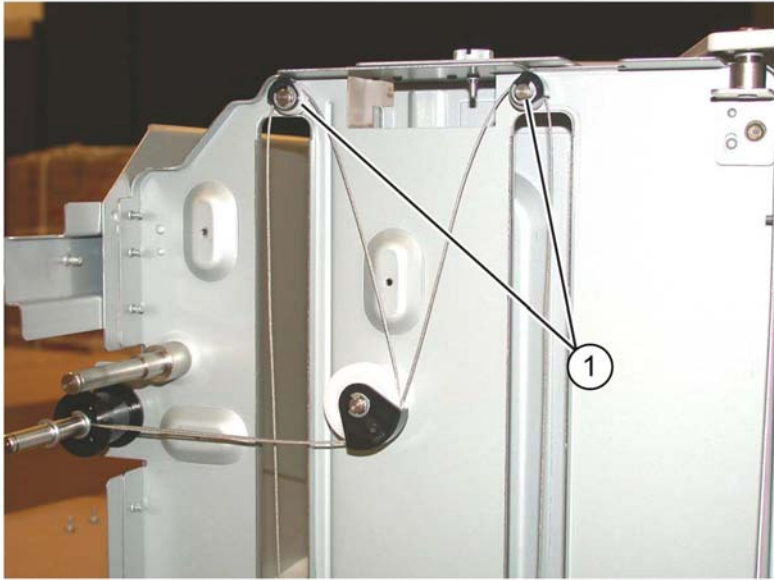
4. Prepare to remove the tray rear cables. Remove two E-rings, wire guides and pulleys (1), [Figure 3](#).

Figure 3 Preparation

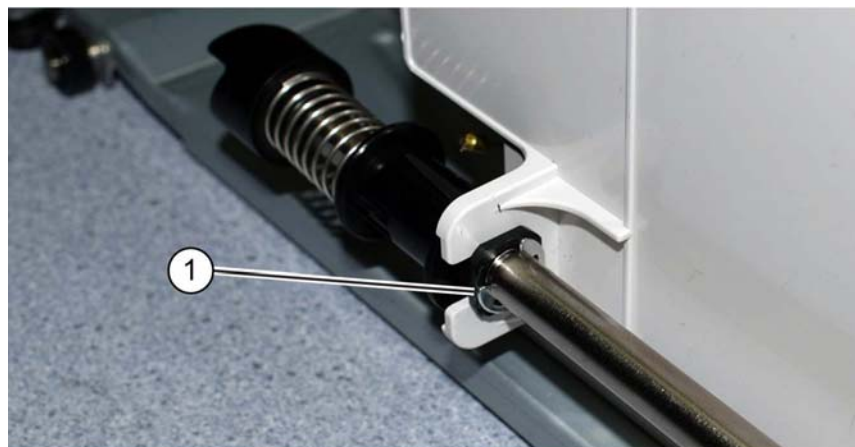
6. Remove the E-clip (1), Figure 3:

Figure 3 Rear E-clip

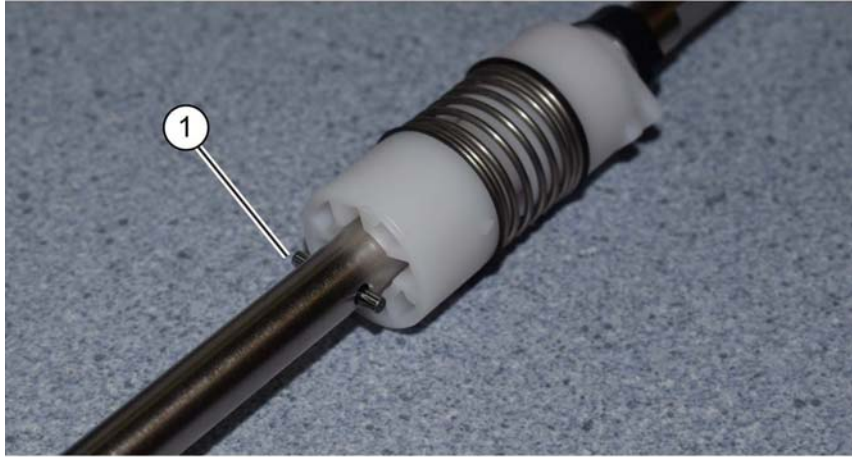
NOTE: The thick E-clips secure the bearings, the thinner E-clips secure the pulleys.
2. Ensure the brake securing pin (1) is installed correctly, Figure 5.

Figure 5 Pin

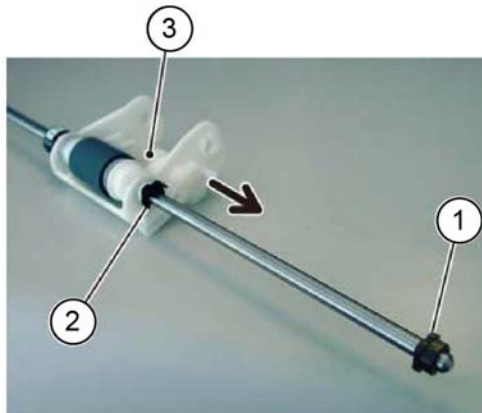
Figure 7 Shaft

8. Move the housing, [Figure 7](#):
 - a. Remove the bearing (1).
 - b. Remove the E-clip (2).
 - c. Move the housing, in the direction of the arrow, to the end of the shaft.

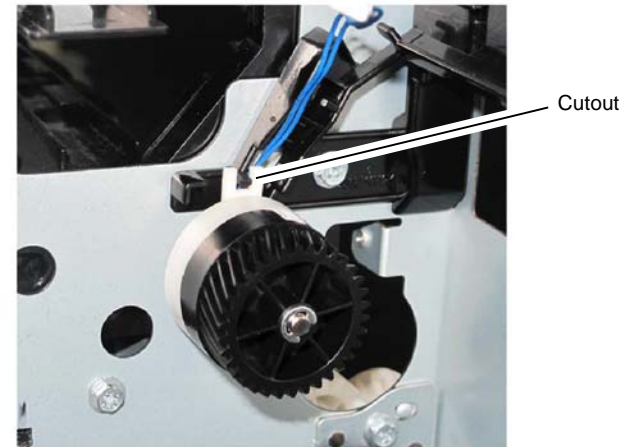
Figure 5 Alignment

1. The replacement is the reverse of the removal procedure.
2. When installing the registration clutch assembly, align the cutout with the harness guide tab, [Figure 5](#).

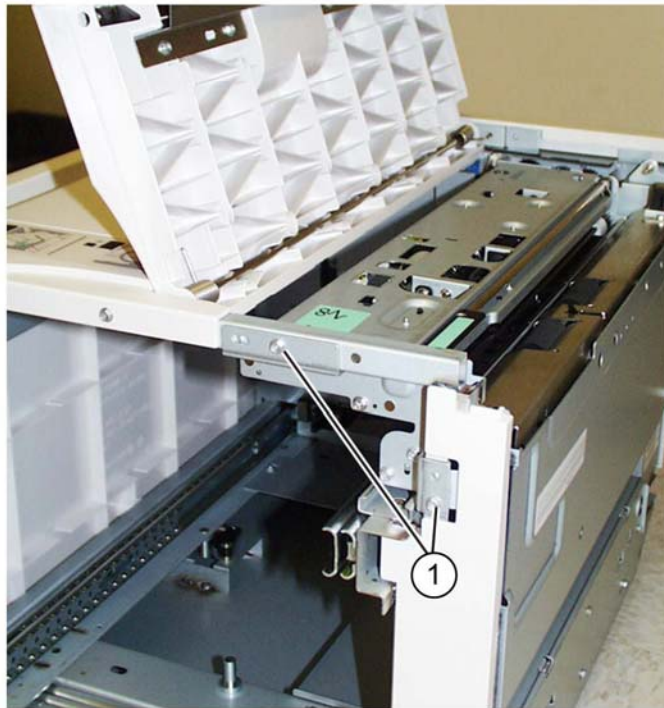
Figure 1 Feeder securing screws

1. Move the HCF away from the machine.
2. Open the feeder top cover, [PL 70.55 Item 7](#).
3. Remove two screws (1) that secure the HCF feeder to the rail, [Figure 1](#).

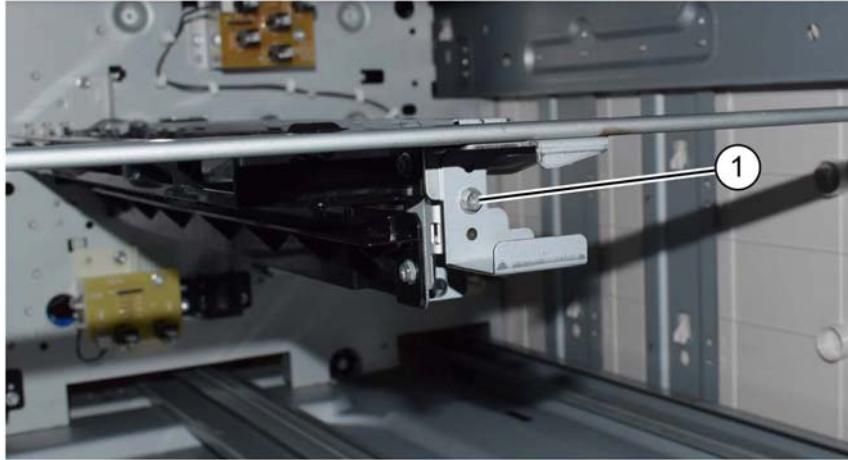
Figure 1 Support bracket removal

1. Pull out tray 2, 3 and 4. Remove the paper.
2. Lift out tray 3 and 4. Remove tray 2.
3. Remove the support bracket (1), [Figure 1](#).

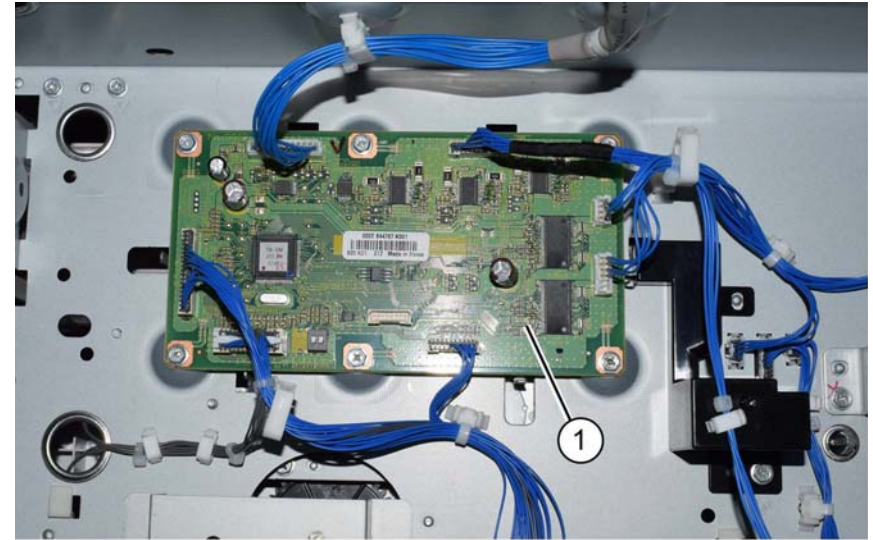
C-1-0514-A

1. Remove the TTM rear cover, [PL 70.95 Item 8](#).
2. Remove the TTM PWB, [Figure 2](#):
 - a. Disconnect seven connectors.
 - b. Remove six screws.
 - c. Remove the TTM PWB (1). [Figure 2](#).

Figure 2 TTM PWB removal

1. The replacement is the reverse of the removal procedure.
2. If a new TTM PWB is installed, enter [dC131](#). Change the value of NVM ID 742-205 to '2'.

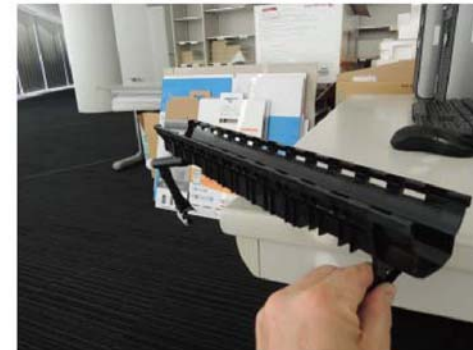
C-1-0549-A

Figure 3 Dispenser K after removal

NOTE: Figure 3 shows the removed dispenser (K).

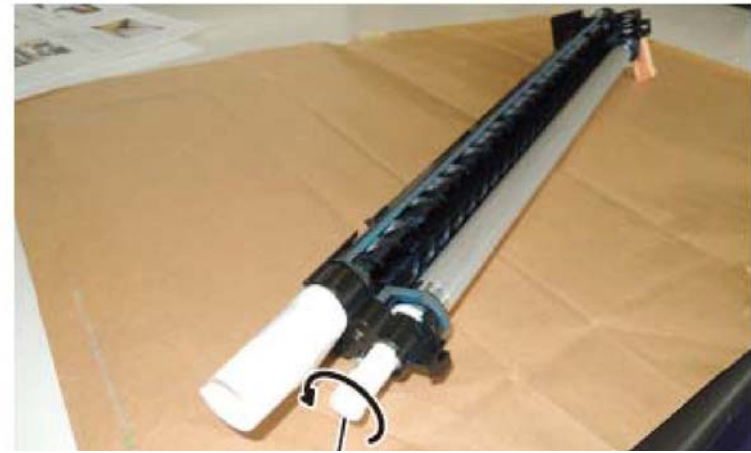
Figure 7 Coupling rotation

11. Uniform the developer, [Figure 7](#).
 - a. Rotate the coupling in the direction of the arrow.

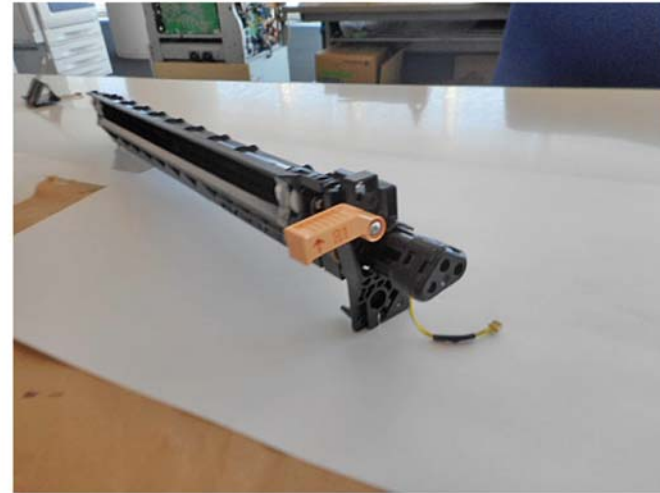
C-1-0564-A

1. Install the developer front cover, [Figure 11](#).

Figure 11 Developer front cover

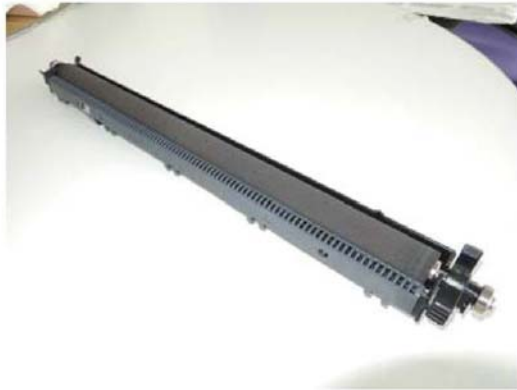
Figure 2 Removed BTR roll

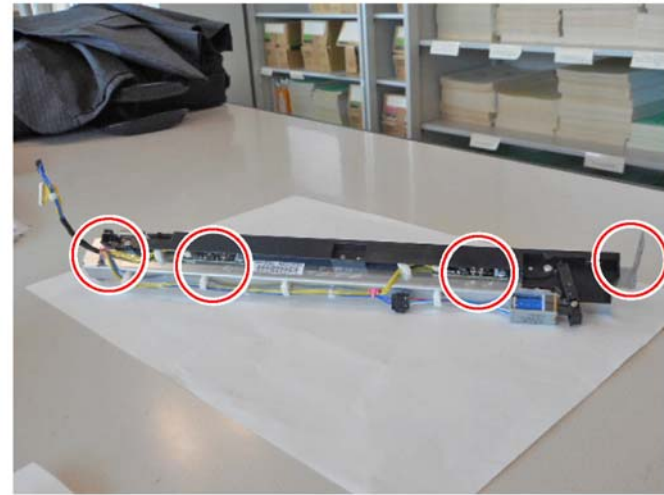
C-1-0576-A

Figure 3 Sensor unit and bracket positioning sections

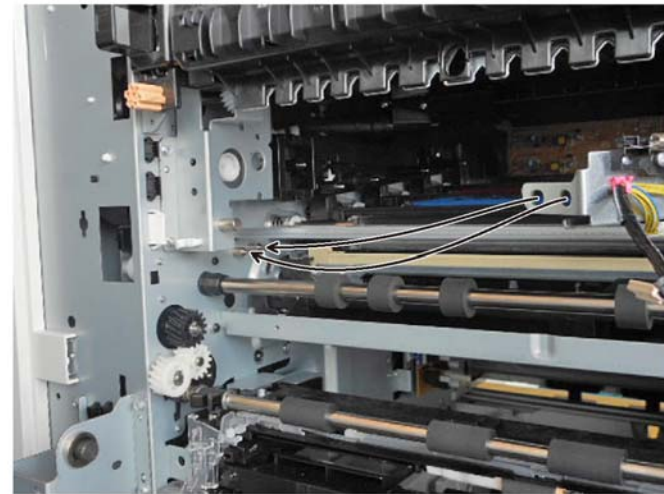
C-1-0577-A

2. When installing the MOB ADC assembly, insert the boss (x2) of the rear frame into the installation holes of the MOB ADC assembly, Figure 4.

Figure 4 MOB ADC assembly install

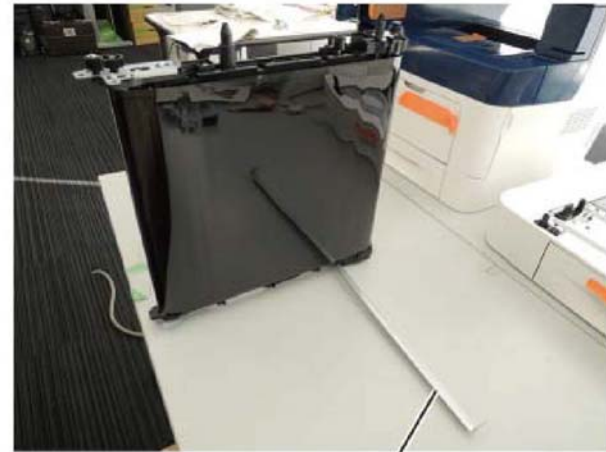
C-1-0588-A

Figure 8 IBT belt unit

11. Place the rear of the IBT belt unit facing Up, [Figure 8](#).
13. Remove the rear holder and the tension roll, [Figure 10](#).

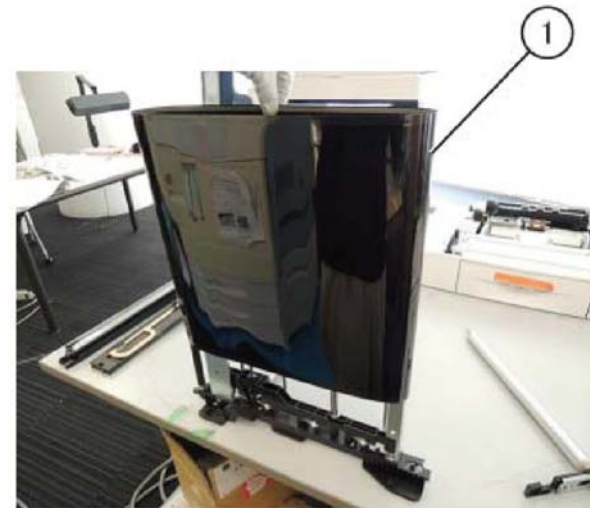
C-1-0592-A

Figure 12 IBT belt unit replacement

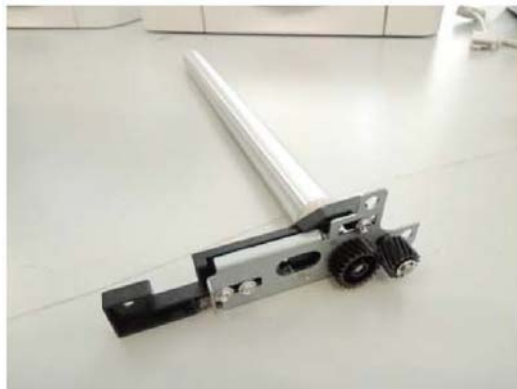
C-1-0591-A

Reference: This shows the removed rear holder and tension roll, [Figure 11](#).

Figure 11 Rear holder and tension roll

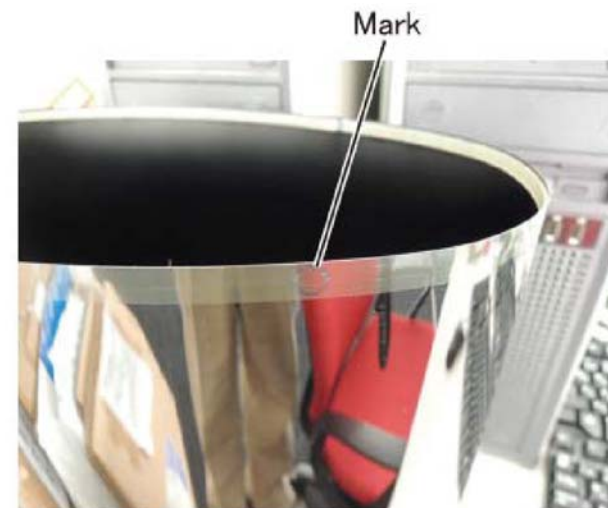
C-1-0593-A

1. The replacement is the reverse of the removal procedure.
2. Install so the IBT belt mark is on the rear side, [Figure 13](#).

NOTE: Assemble so the mark is facing up when assembling the IBT belt.

Figure 13 IBT belt mark

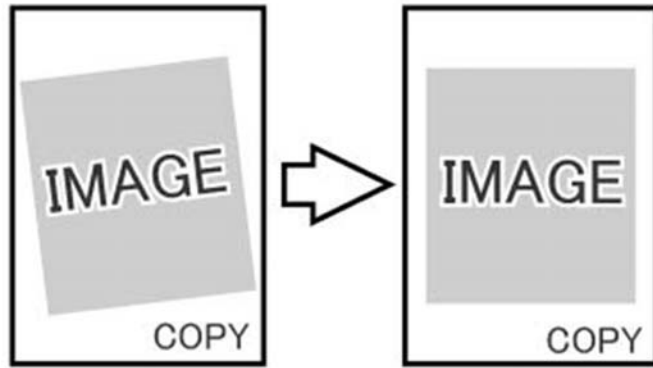
TC-1-0175-A

Figure 3 Direction B

1. Remove the DADF rear cover, [REP 5.4](#).
2. Adjust the position of the DADF by moving the DADF in direction A or B, [Figure 1](#):
 - a. Loosen four screws (1).
 - b. Move the DADF in direction A or B (2):
 - DADF moved in direction A (clockwise) is shown in [Figure 2](#).
 - DADF moved in direction B (counter-clockwise) is shown in [Figure 3](#).
 - c. Tighten four screws (3).

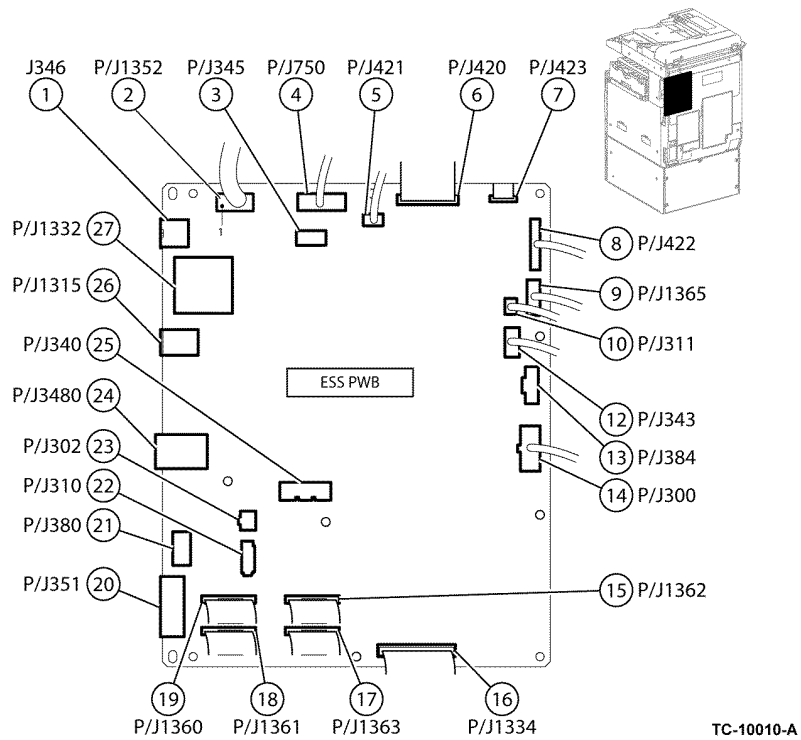
Location: PL 3.10

Figure 10 ESS PWB

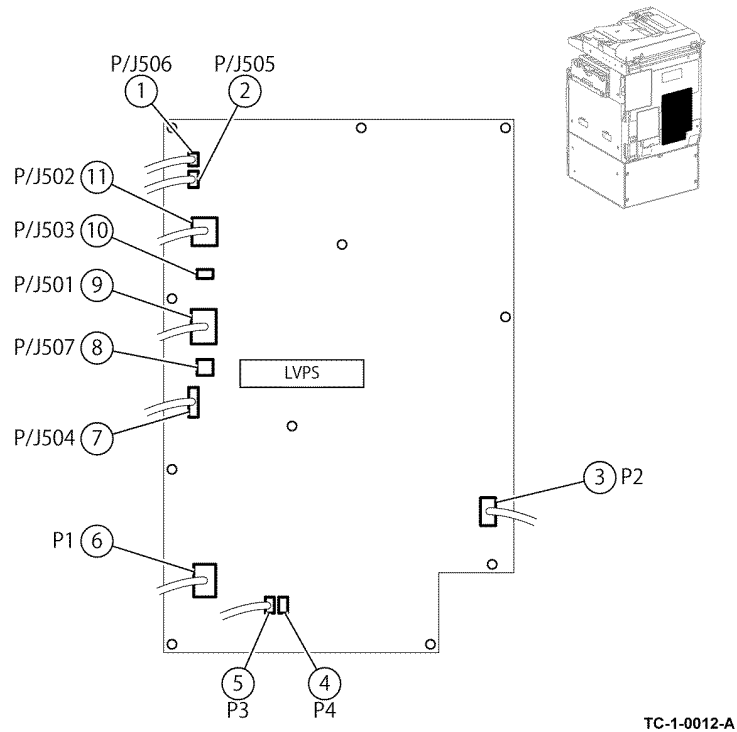
Location: PL 1.10

Figure 12 LVPS

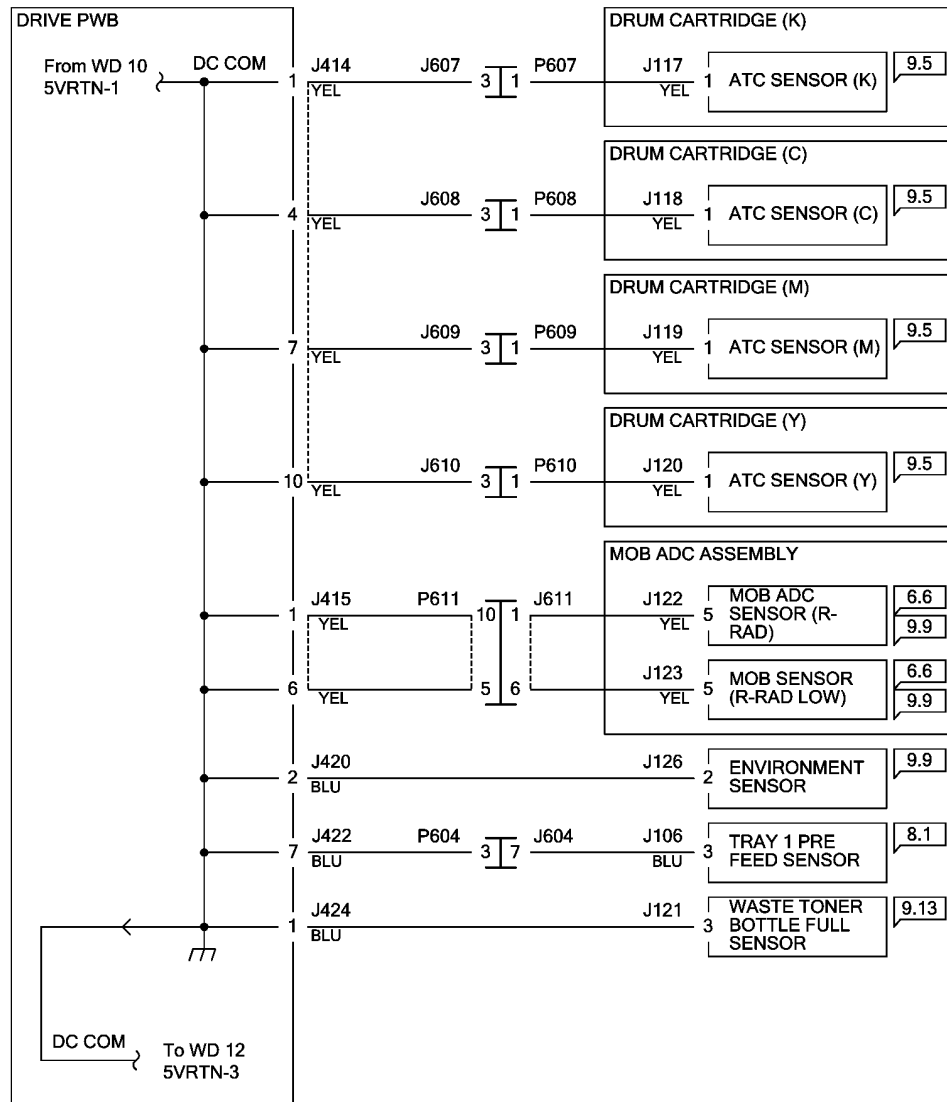
Figure 11 Wiring diagram 11

Wiring Diagram 11 IOT/IIT +5V RTN (2 of 3)
