Xerox® VersaLink® C7000 Color Printer & C7030 Family Color Multifunction Printer Service Manual

Service Documentation

708P91463

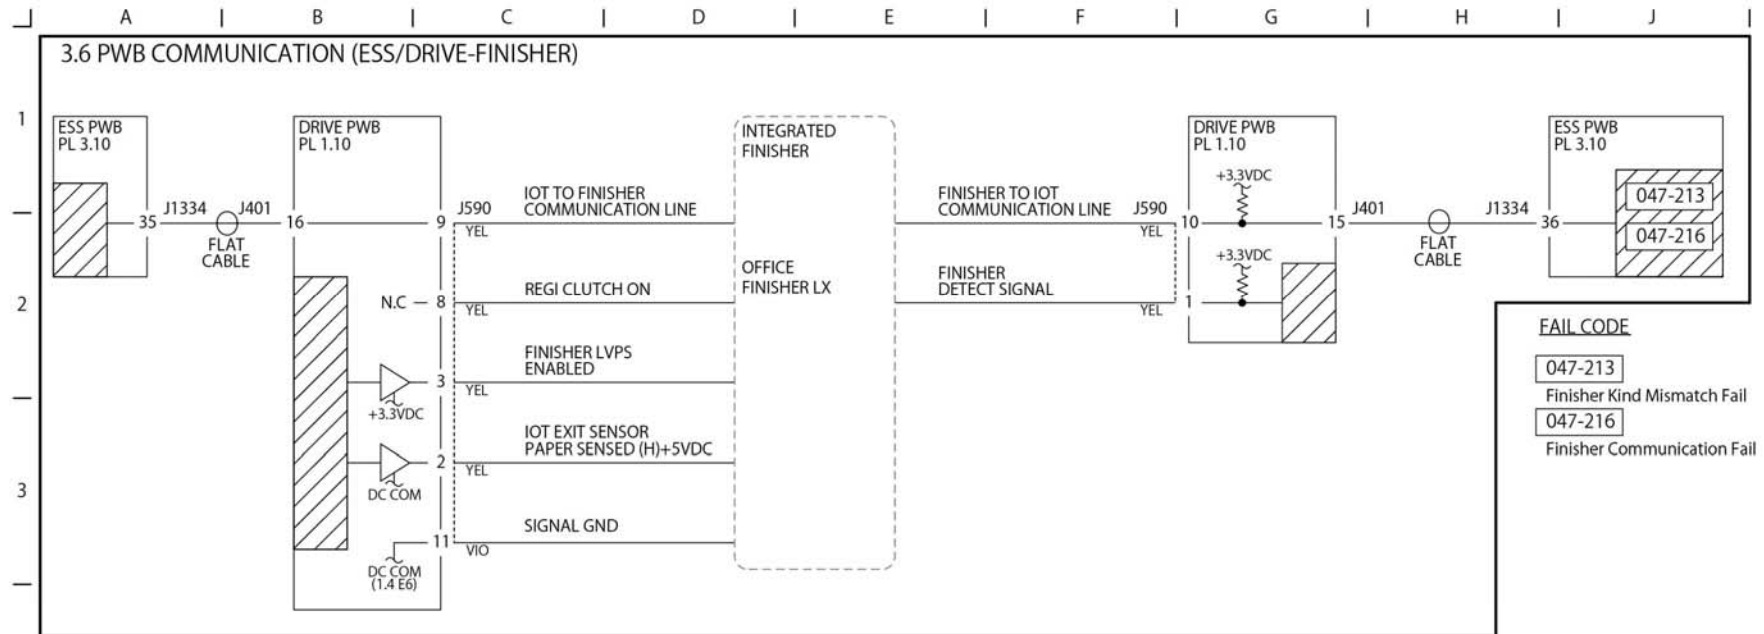
Figure 19 BSD 3.6

BSD 3.6 PWB Communications (ESS PWB/Drive PWB to Finisher)

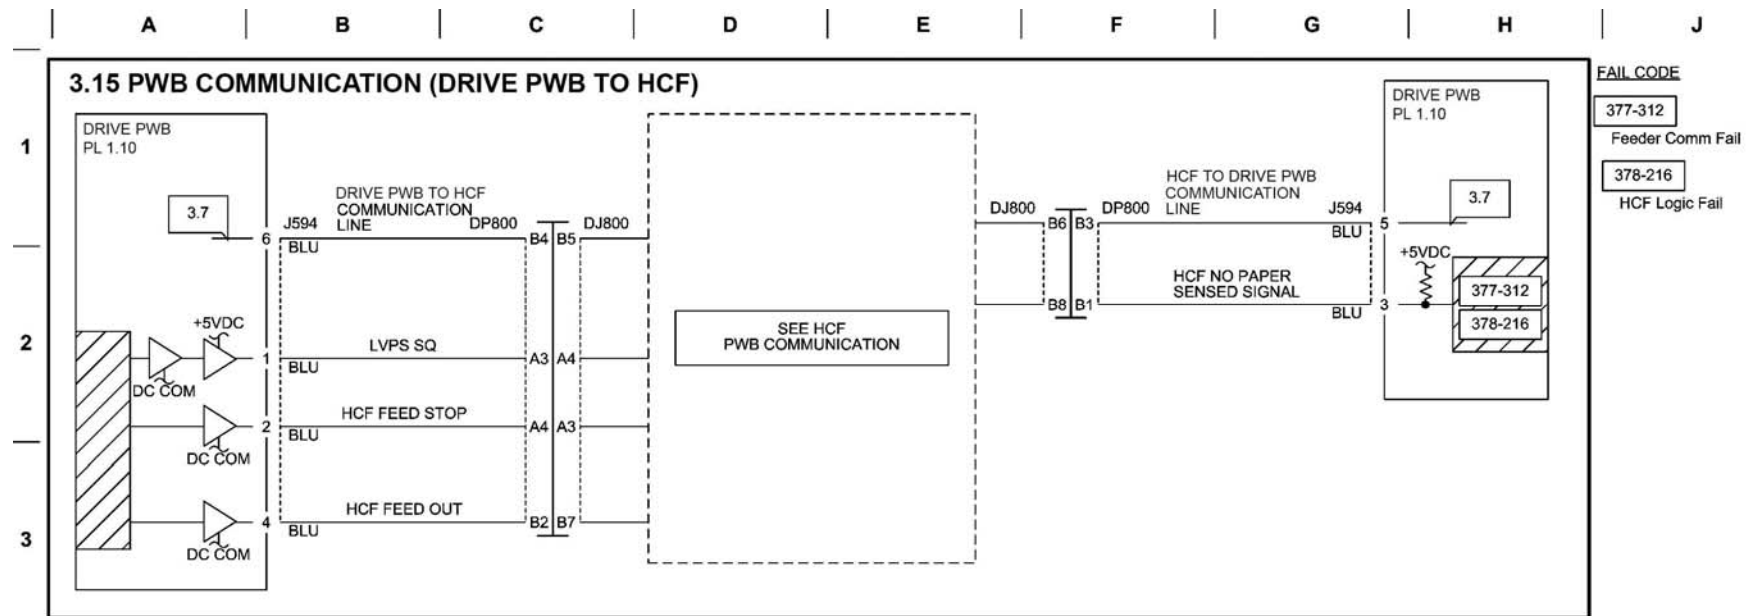
BSD 3.15 PWB Communications (ESS PWB to HCF)

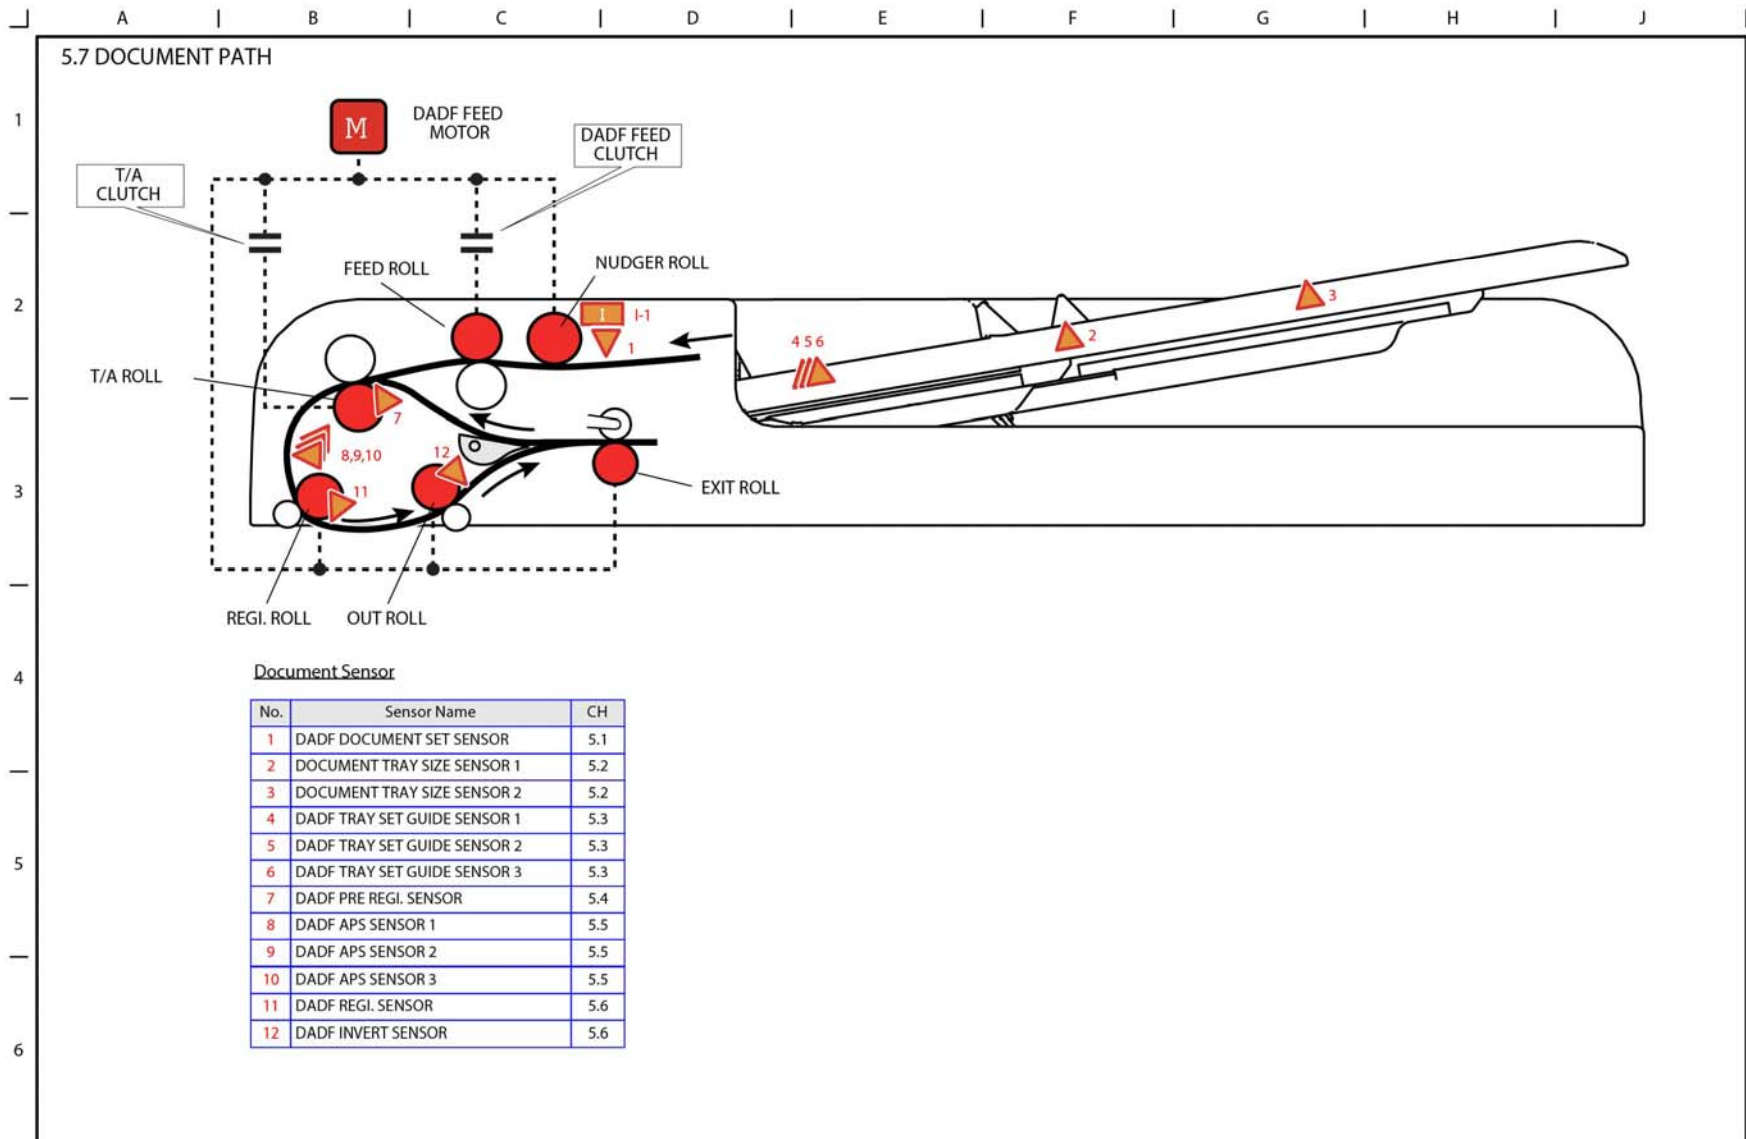
Figure 37 BSD 5.7

BSD 5.7 Document Path

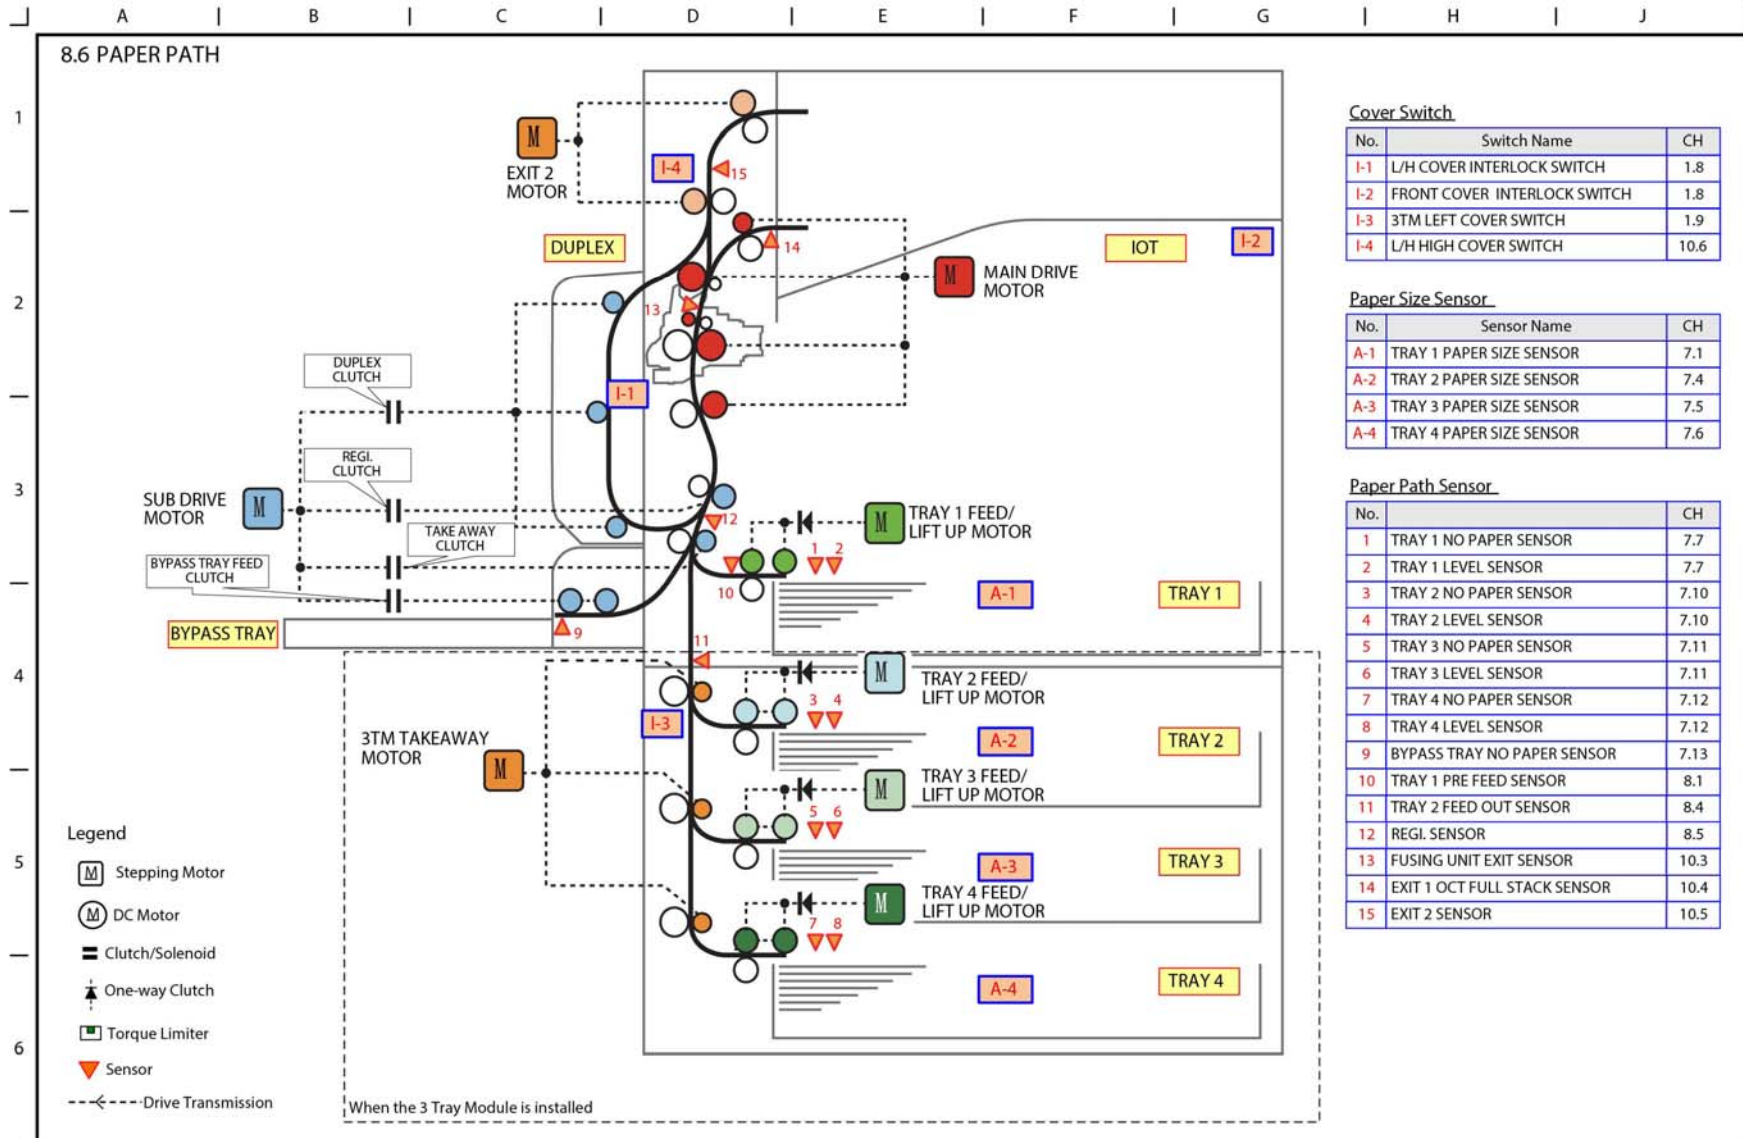
Figure 71 BSD 8.6

BSD 8.6 Paper Path

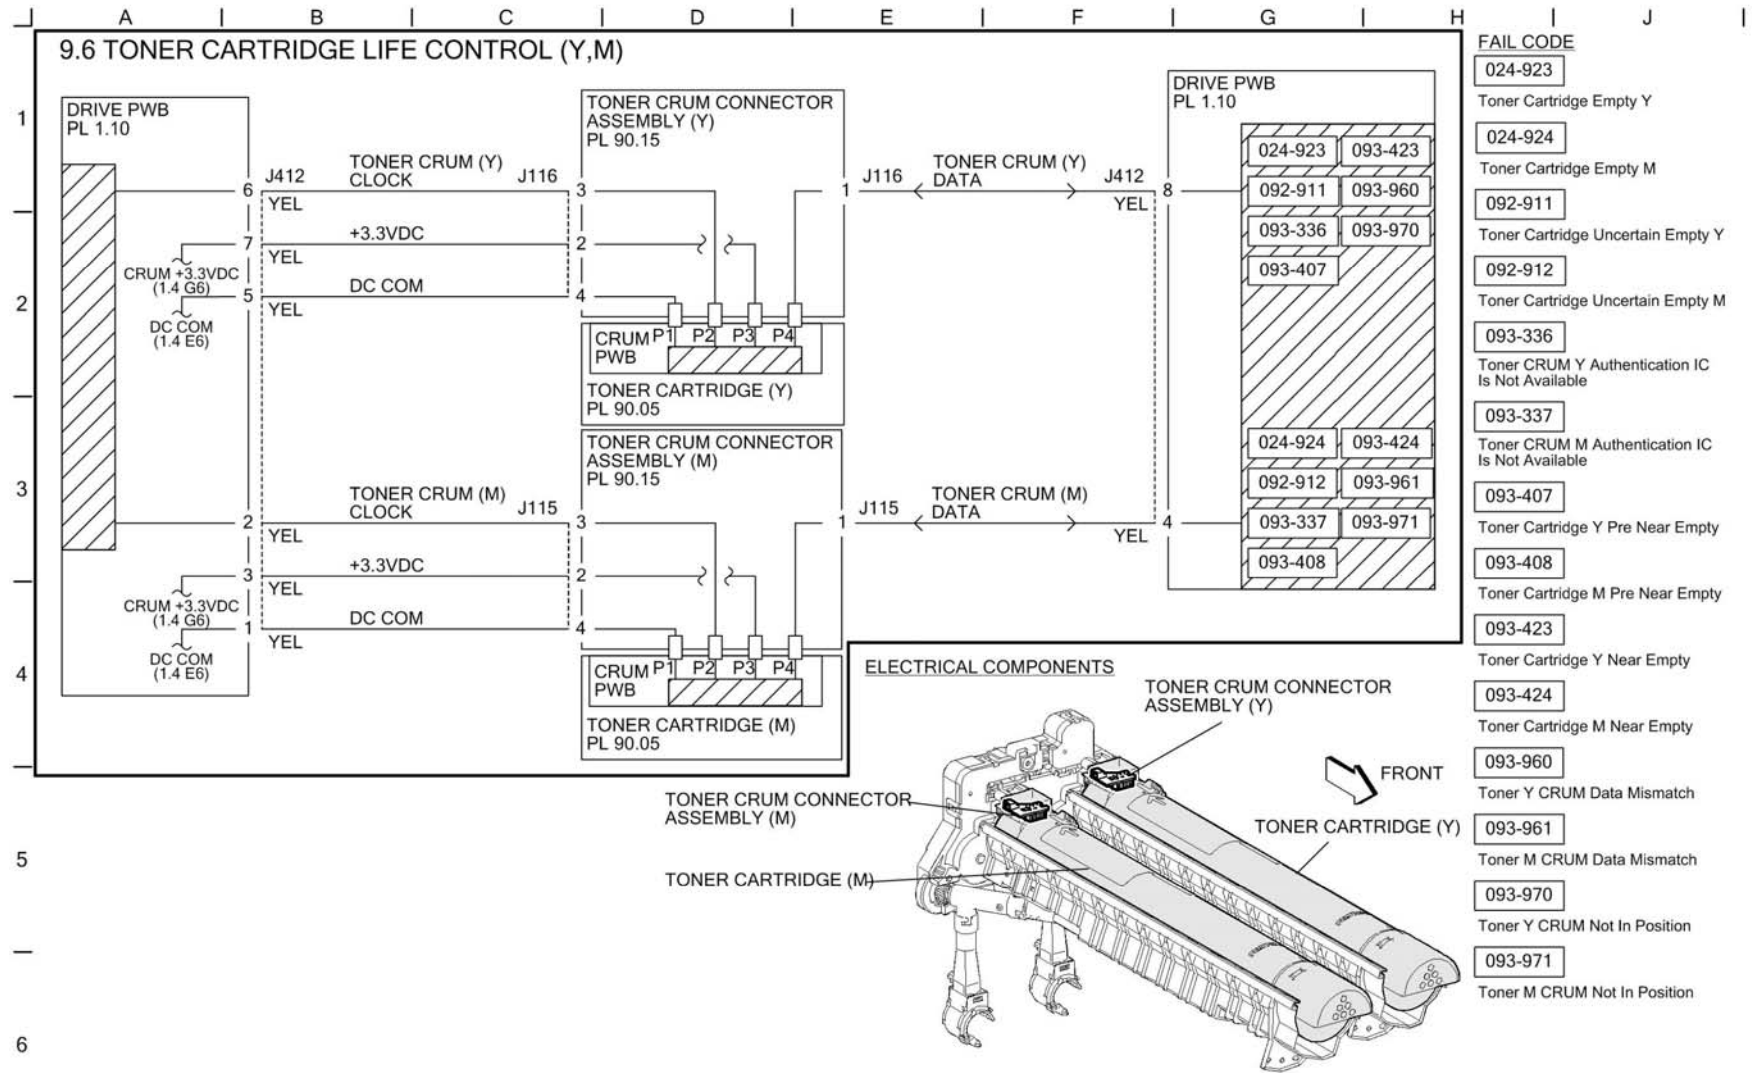
Figure 81 BSD 9.6

BSD 9.6 Toner Cartridge Life Control (Y, M)

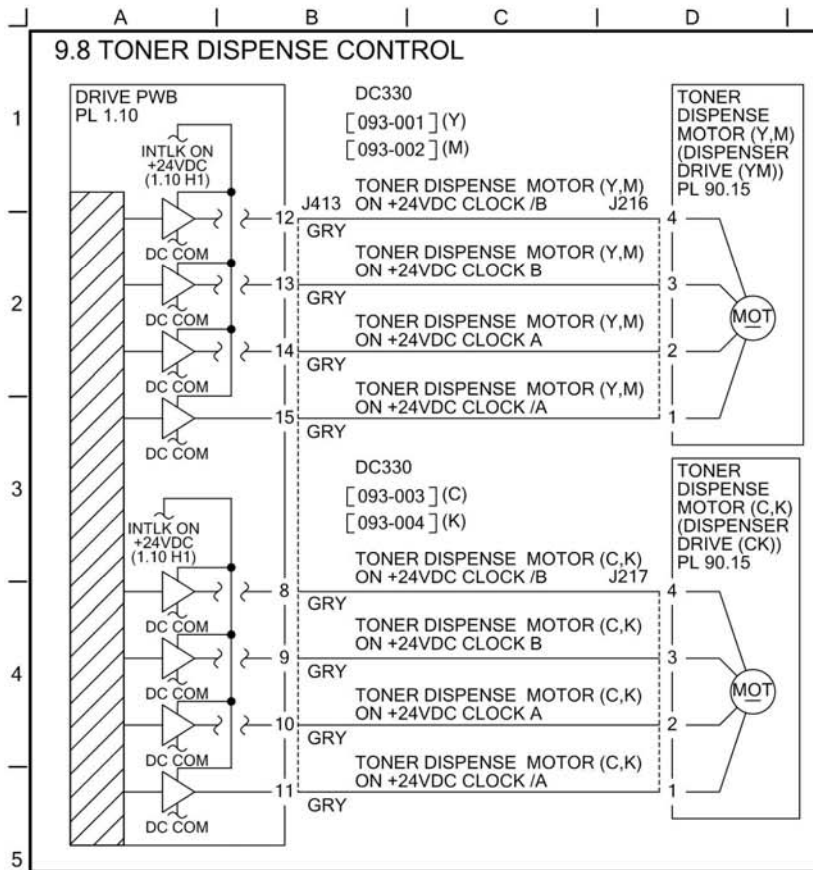
Figure 83 BSD 9.8

BSD 9.8 Toner Dispense Control

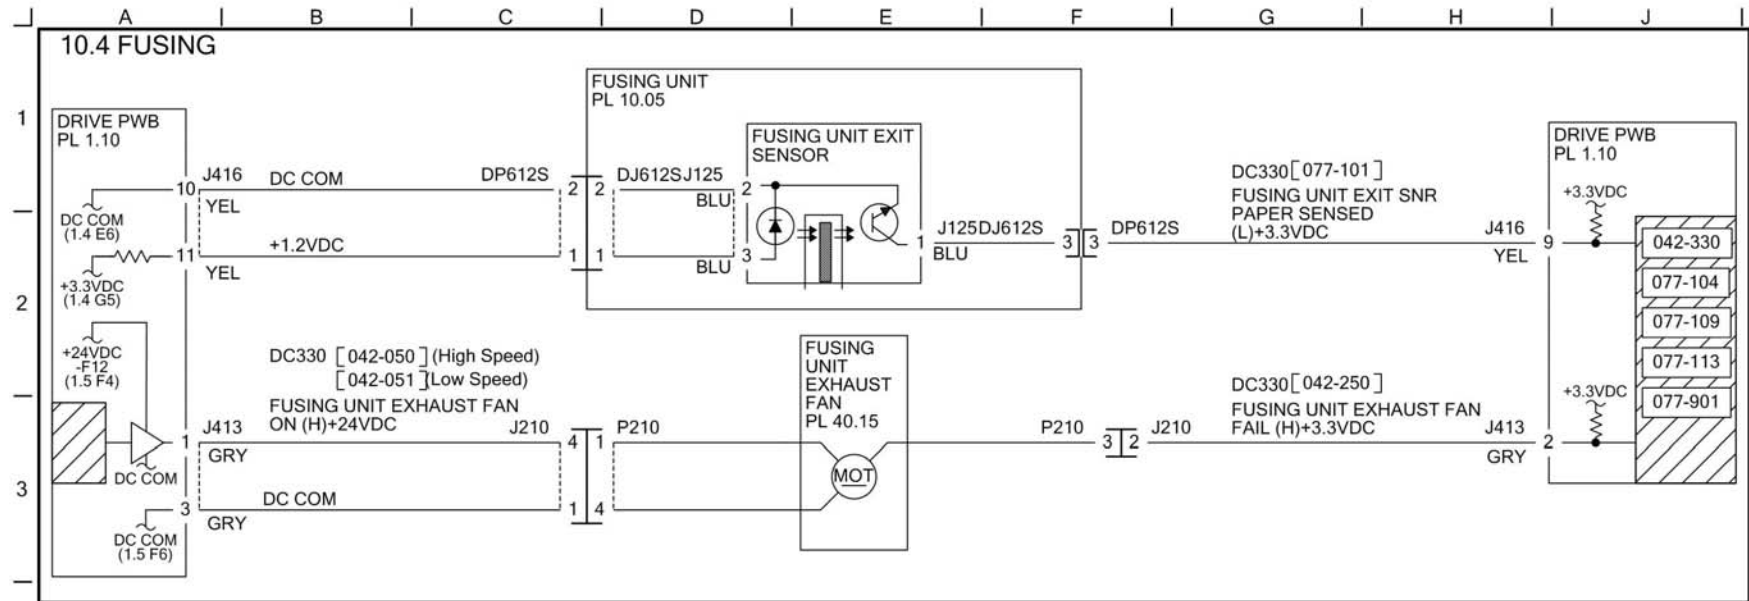
BSD 10.4 Fusing

- 042-330**
Fusing Unit Exhaust Fan Fail
- 077-104**
Fusing Unit Exit Sensor Off Jam (Short)
- 077-109**
Fusing Unit Exit Sensor On Jam
- 077-113**
Fusing Unit Exit Sensor Off Jam (Long)
- 077-901**
Fusing Unit Exit Sensor Static Jam

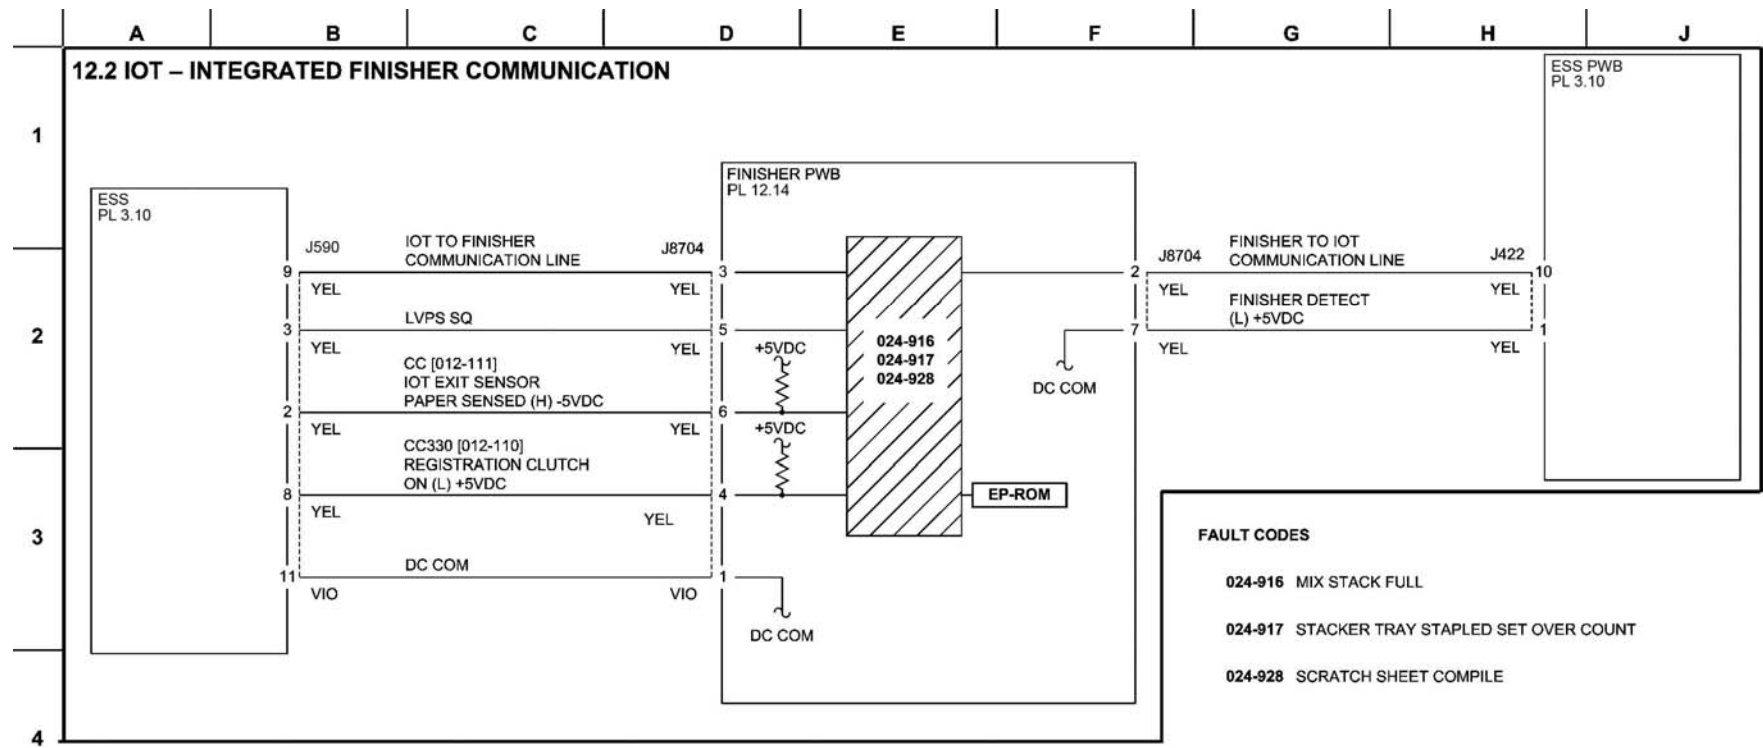
Figure 98 BSD 12.2

BSD 12.2 IOT to Integrated Office Finisher Communication

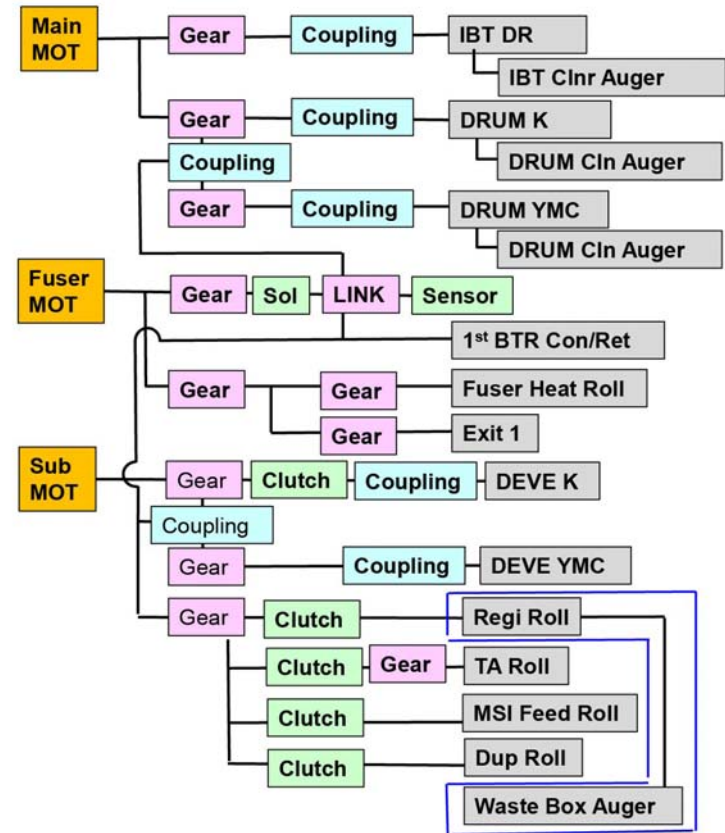
TC-5-0211-A

The drive trains for the main and sub motors are show in the schematic in Figure 4.

Figure 4 Drive schematic

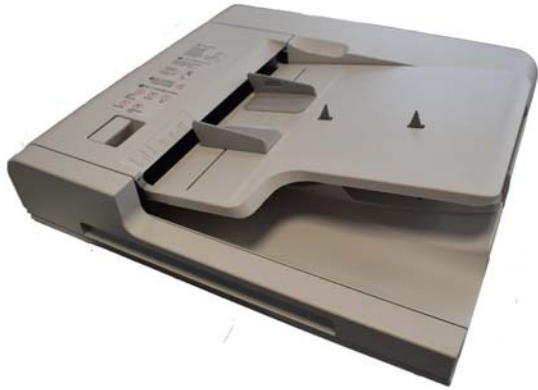
C-5-0100-A

The DADF can invert a document to scan images on both sides, and it employs a constant velocity transport (CVT) system. With the CVT system, the lamp carriage of the IIT is fixed at a specified position (the scan position) where images are scanned as documents feed across the platen at a constant speed. Refer to [Figure 1](#).

Figure 1 DADF

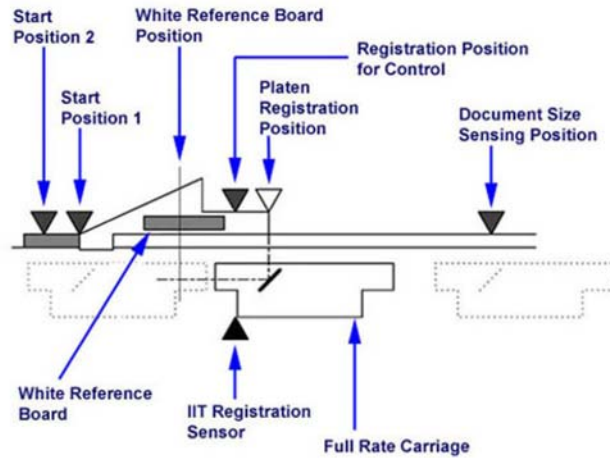
TC-5-0112-A

The scan speed varies according to the reduction or enlargement ratio that has been selected. A slow scan produces an enlarged image and a fast scan produces a small image. Electronic processing is used to change the image size in the front- to-back (fast scan) direction when reduction or enlargement is selected. Refer to [Figure 5](#).

Figure 5 Scanning overview

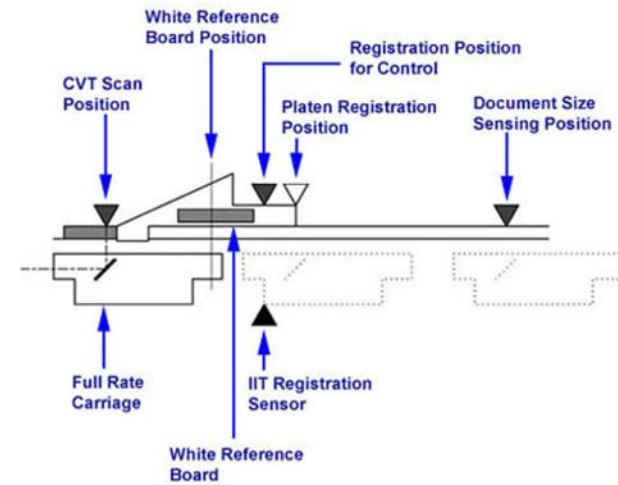
TC-5-0113-A

The stationary half rate and full rate mirrors are used in the usual way to reflect the image through the lens to the CCD.

In all copy modes, the document is only scanned once regardless of the number of copies required. Refer to [Figure 6](#).

Full Rate Carriage position for DADF scanning

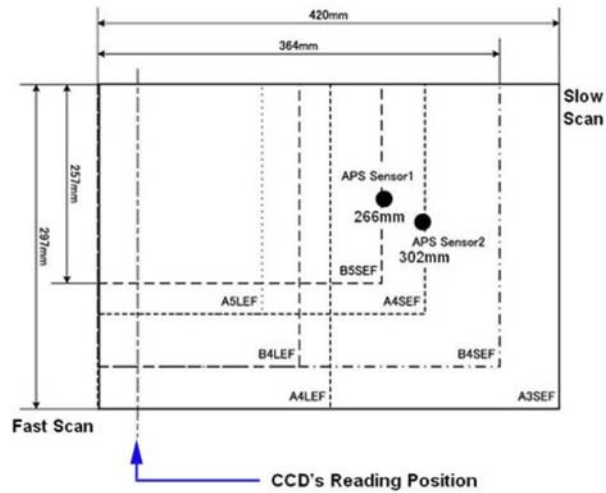
TC-5-0116-A

The IIT has two APS sensors which enable it to distinguish between 8.5x11 inch SEF, 8.5x13 inch SEF, and 8.5x14 inch SEF. Refer to [Figure 9](#).

Figure 9 Document size sensing

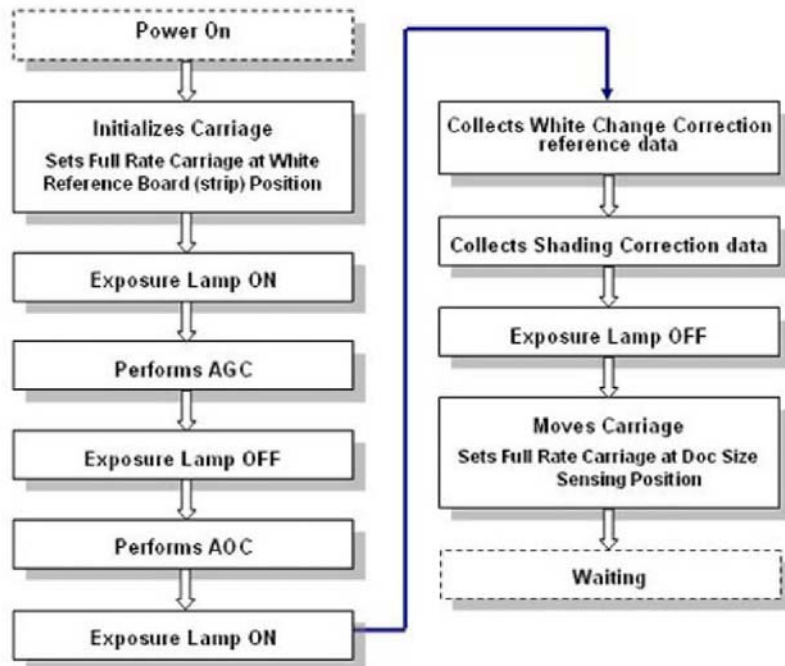
TC-5-0117-A

The carriage position initializes after the machine is powered on or has recovered from power save mode. Refer to [Figure 10](#).

Figure 10 Scanner initialization

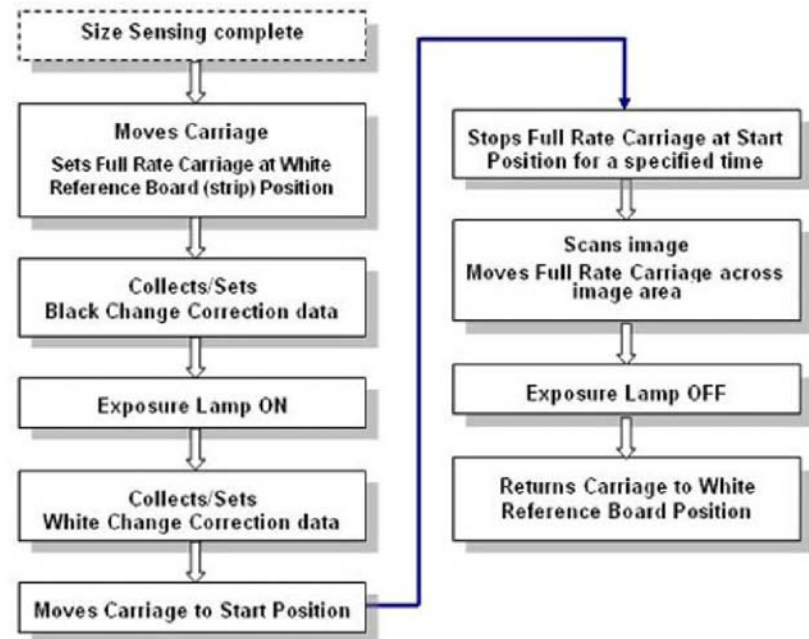
TC-5-0118-A

The full rate carriage now moves to the start position, where it waits a specified time. When the wait time elapses, the full rate carriage moves across the image area.

The exposure lamp turns off at the end of the scan, and the full rate carriage returns to the white reference strip position. Refer to [Figure 11](#).

Figure 11 Platen scanning operation

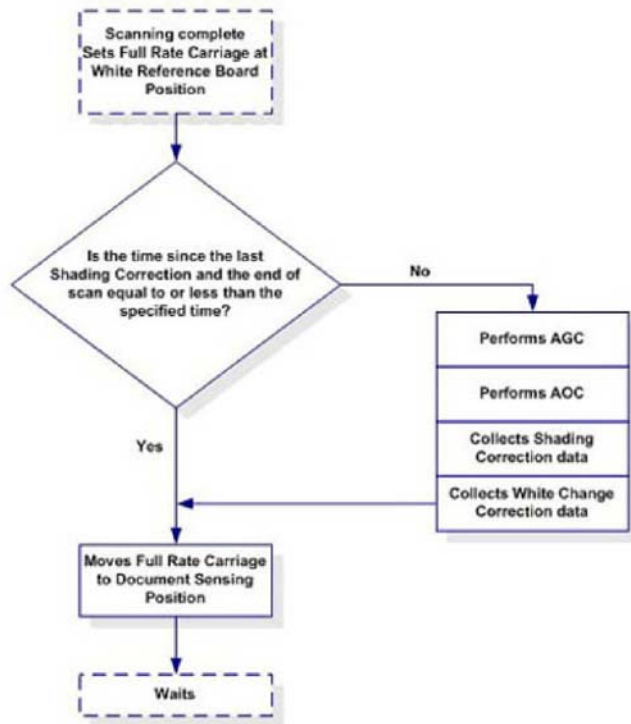
TC-5-0119-A

If the elapsed time is greater than a specified value, the IIT performs auto gain control and auto offset control, and collects shading correction data and white change correction data.

It then moves the full rate carriage to the document sensing position, where it waits for the next customer job. Refer to [Figure 12](#).

Figure 12 End of platen scanning

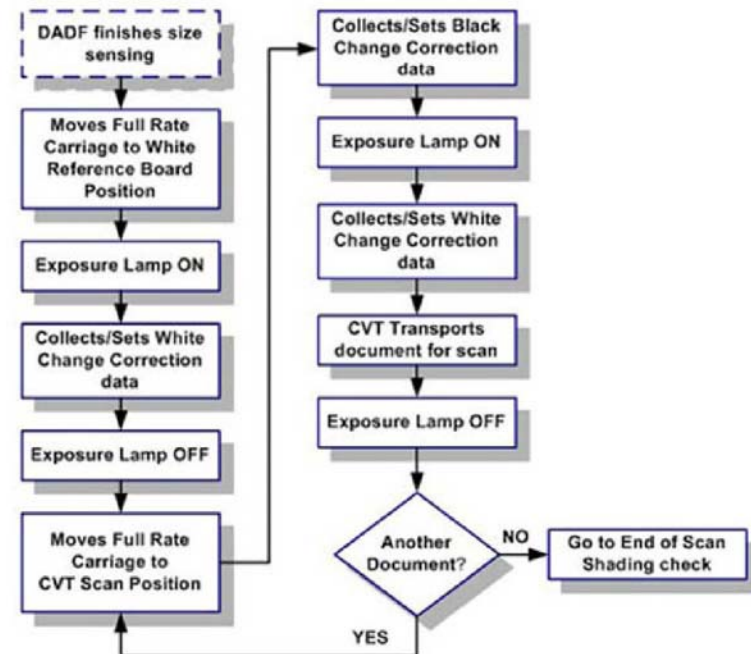
TC-5-0120-A

Next the exposure lamp turns off and the full rate carriage moves to the CVT scan position. First it collects and applies black change correction data, then it turns on the exposure lamp and collects white change correction data, setting the white and black levels.

The IIT scans the document as it is transported by the CVT. If there are multiple documents, the full rate carriage stays at the CVT scan position. Refer to [Figure 13](#).

Figure 13 DADF scanning operation

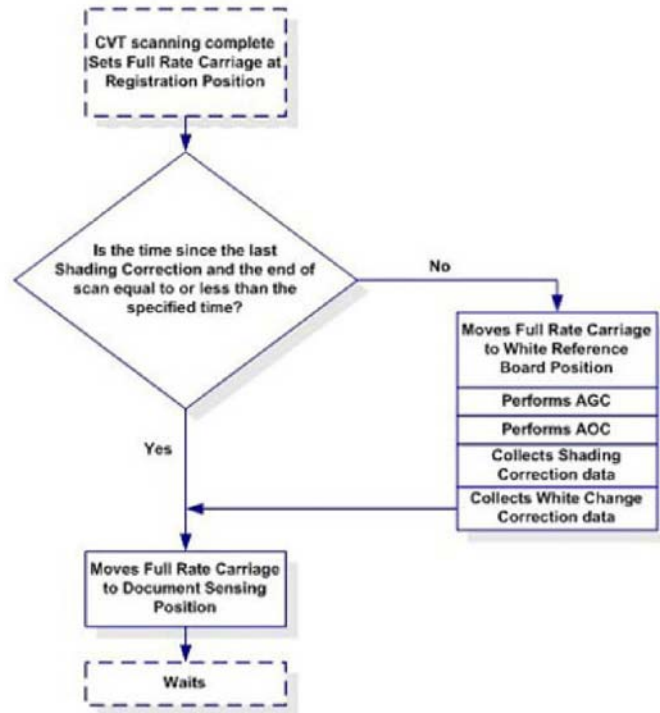
TC-5-0121-A

If the elapsed time is greater than a specified value, the IIT moves the full rate carriage to the white reference strip position and performs AGC and AOC, and collects shading correction data and white change correction data.

It then moves the full rate carriage to the document sensing position, where it waits for the next customer job. Refer to [Figure 14](#).

Figure 14 End of DADF scan

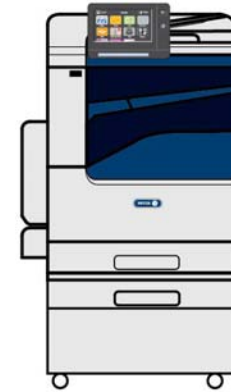
C7020/C7025/C7030 with tray 1 and 1TM

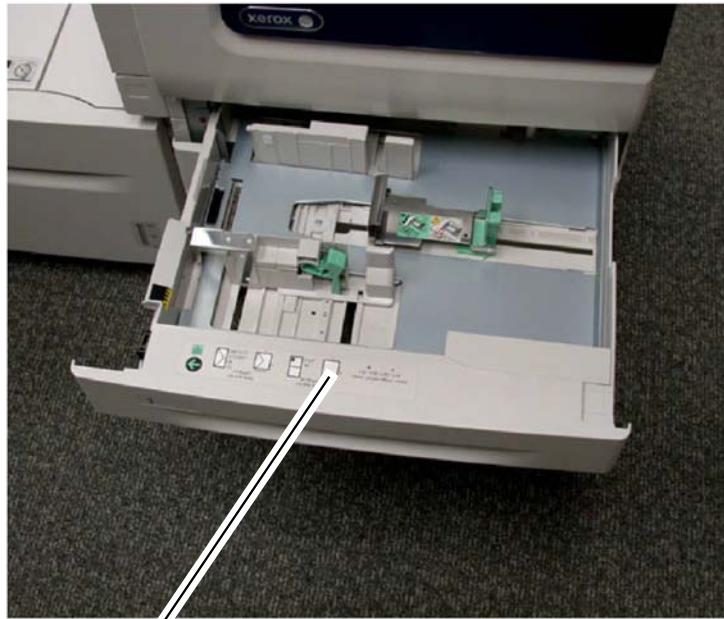
C-5-0128-A

An optional envelope tray is available, [PL 70.100 Item 1](#). The envelope tray is installed by the customer in the tray 1 position. Refer to [Figure 5](#).

Envelope tray

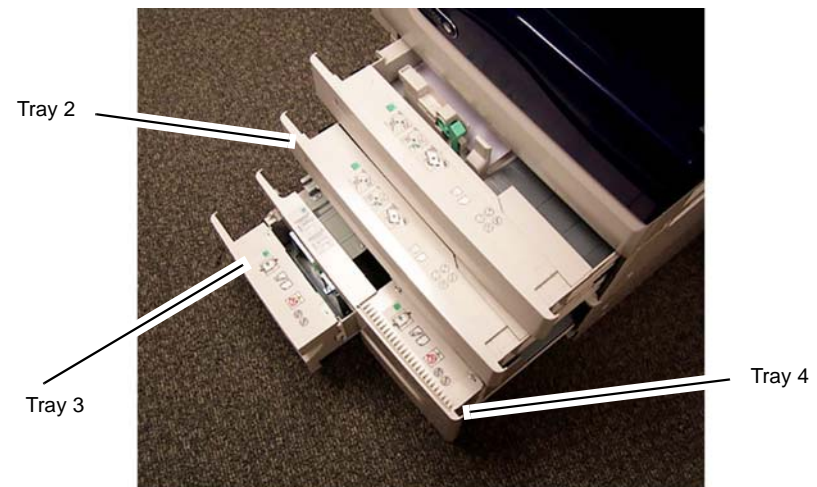
C-5-0103-A

Figure 12 TTM tray 3 and tray 4

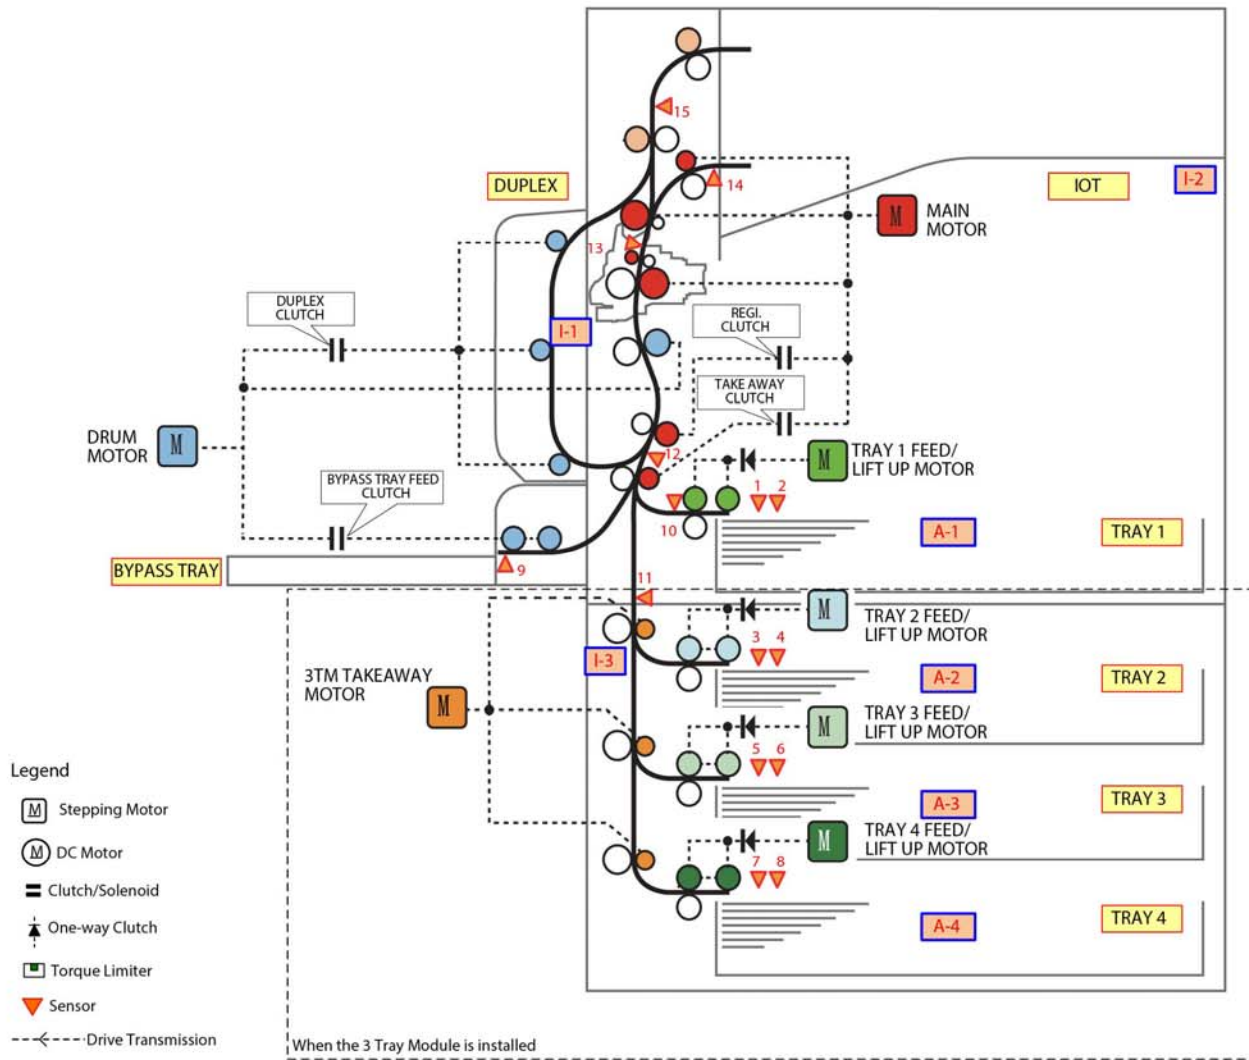
[Figure 1](#) shows the paper path, drive components and sensors of the Xerox® VersaLink® C7020/B7025/C7030 and C7000 machine, configured with a 3 tray module (3TM).

Cover Switch

No.	Switch Name	CH
I-1	L/H COVER INTERLOCK SWITCH	1.8
I-2	FRONT COVER INTERLOCK SWITCH	1.8
I-3	3TM LEFT COVER SWITCH	1.9

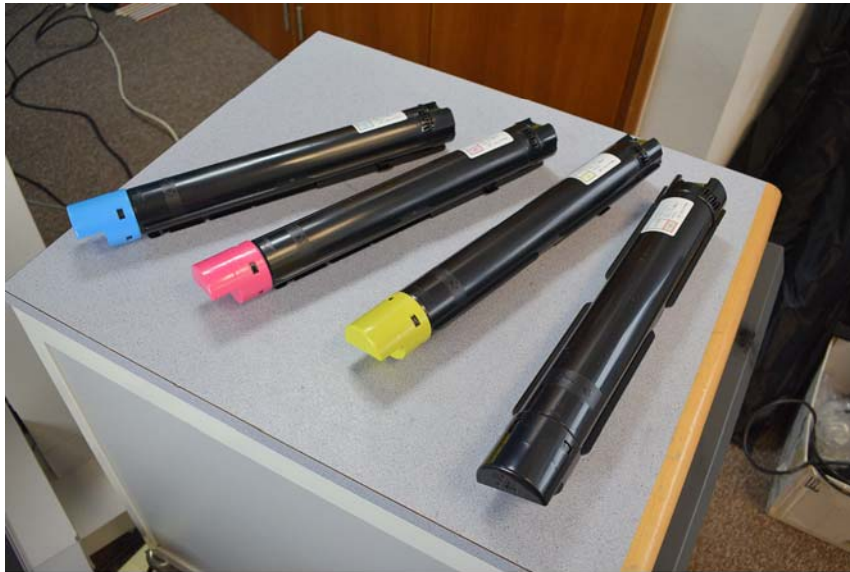
The toner cartridges, PL 26.05 are customer replaceable units (CRU). The larger black toner cartridge carries a higher capacity of toner than the yellow, cyan and magenta cartridges due to the expected higher use of black toner. Refer to [Figure 2](#).

- Pre-Near End-of-Life: the toner cartridge is approximately 25% full
- Near End-of-Life: the dispense motor is on but the ATC sensor detects no increase in toner in the drum cartridge.
- End-of-Life: the ATC sensor detects no toner in the drum cartridge. The machine hard stops at this point.

Figure 2 Toner Cartridges

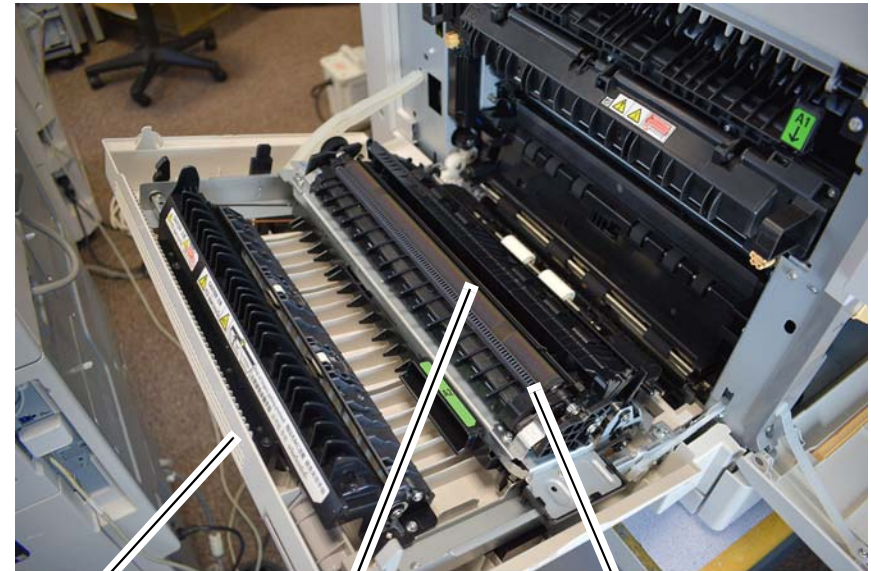
The paper is released from the transfer belt by the detack saw. A voltage is applied to the detack saw to eliminate the charge on the paper. Refer to [Figure 21](#).

NOTE: The detack saw is part of the 2nd roll assembly, [PL 90.40 Item 5](#).

L/H cover

2nd Bias transfer roll

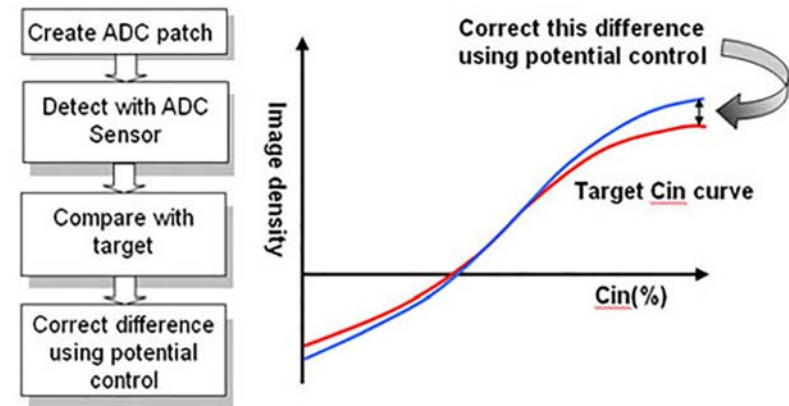
The ADC Patch is generated at specified times, such as at Power ON, at recovery from Sleep Mode, at the start, during, and at the end of a job. If the measured density of the ADC patch is lighter than the target, the machine controls the drum charging potential, developer bias, and LPH light quantity to bring the density closer to the ADC target.

Figure 29 Automatic density control

Image density control uses the Automatic Density Control (ADC) and Marks On Belt (MOB) sensors, [Figure 28](#), to read the density of ADC patches that are developed on the transfer belt. Process control then compensates for the difference between the reading and an ADC Target Value by controlling the electrical potentials, [Figure 29](#).

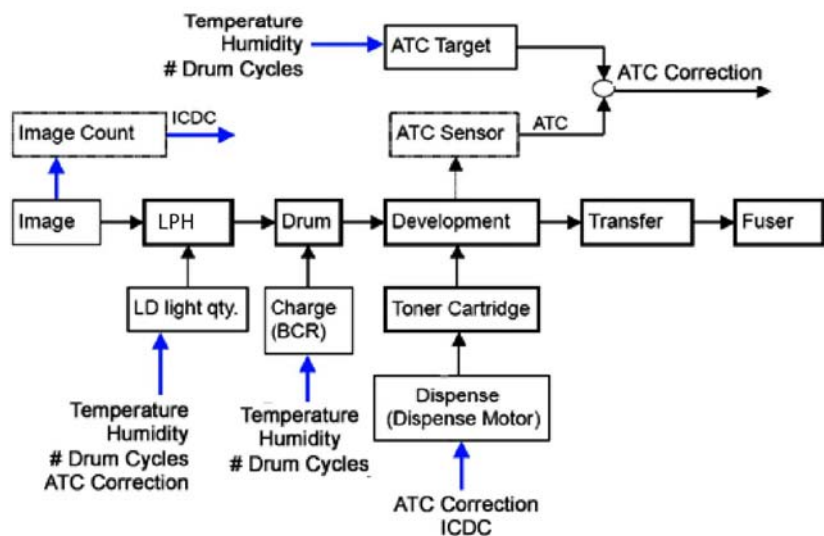
NOTE: Toner dispense may be set in the NVMs to timed dispense, ICDC dispense, or dispense based on ATC control. When either timed or ICDC dispense is selected, ATC s will not be reported but TC will be out of control. The preferred (default) setting allows Toner Control to manage dispense.

Figure 30 Toner dispensing control

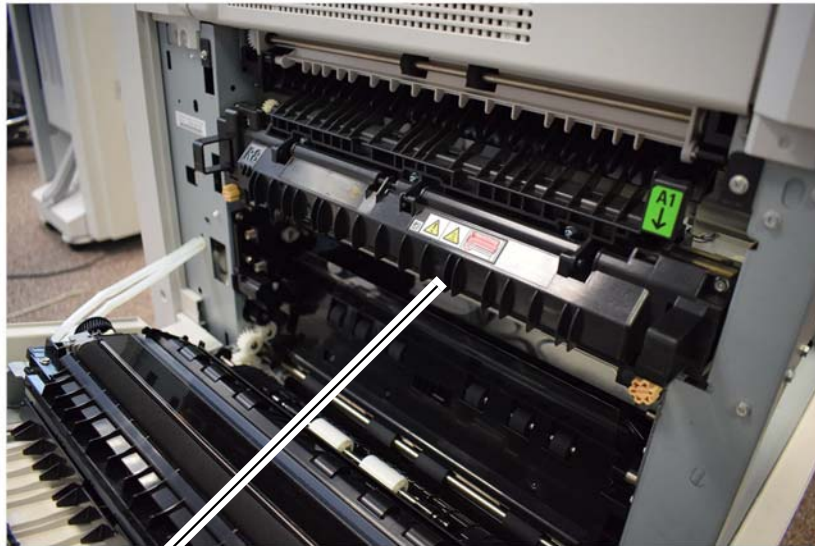
NOTE: There are no spare parts in the fuser assembly. The fuser is replaced as an assembly.

Fuser

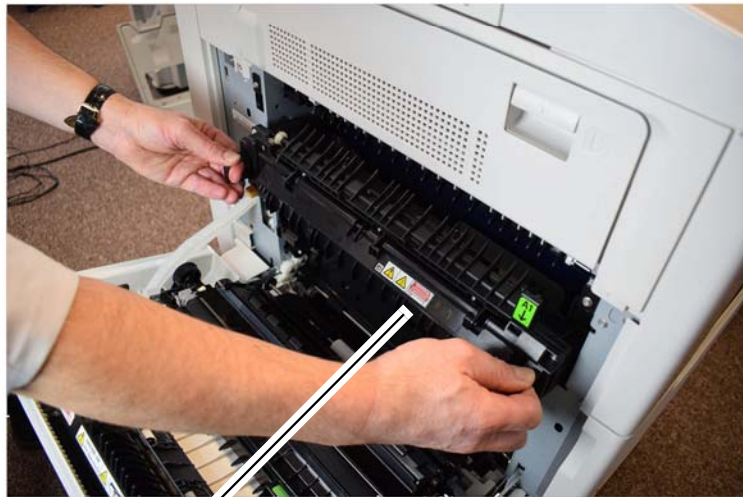
After installing a new fuser, the HFSI counters are reset automatically. Refer to [Figure 6](#).

Fuser

Figure 6 Fuser replacement

Each A4 LEF fed sheet is counted as 10 HFSI counts. When the HFSI counter (chain-link 954-850) reaches a value of 1,000,000 (100,000 x 10), the CSE will be notified on the HFSI counter UI diagnostics screen that the fuser should be replaced. Note that the machine and fuser will continue to run if the fuser is not replaced at this time.

The fuser assembly will also age/degrade due to extended usage time. The ON time HFSI counter (chain-link 954-851) keeps track of machine ON time in seconds. When this HFSI reaches a count of 18,000,000 seconds (approximately 208 days), the CSE will be notified on the HFSI counter UI diagnostics screen that the fuser should be replaced. Note that the machine and fuser will continue to run if the fuser is not replaced at this time.

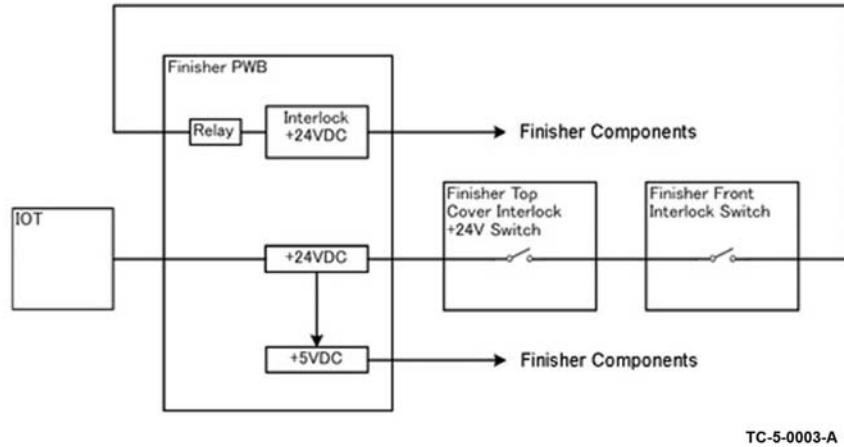
The finisher does not have its own power supply. It receives +24VDC from the IOT and controls power supply in the finisher as shown.

+24VDC output from the IOT is supplied to the finisher PWB. The finisher PWB generates +5VDC from +24VDC and it supplies +5VDC to various finisher components. In addition, +24VDC from the finisher PWB goes through the finisher top cover Interlock +24V switch and the finisher front Interlock switch, then returns to a relay on the finisher. When these interlock switches are both ON, the relay is energized and +24VDC is supplied to various finisher components. Refer to [Figure 3](#).

Figure 3 Power, control and interlocks
