Xerox® VersaLink® C7000 Color Printer & C7030 Family Color Multifunction Printer Service Manual

Service Documentation

708P91463

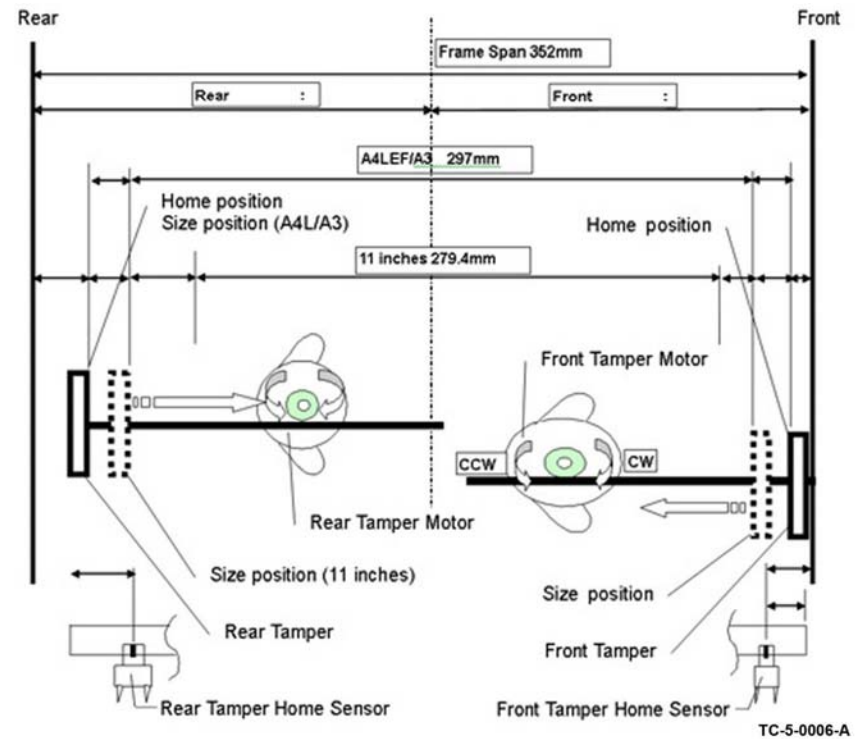
During the tamping operation the tampers are moved, thereby aligning sheets of paper transported into the compile tray into a registered set. During the offset operation the paper sets are shifted, front and rear. The tampers also hold the paper set during the stapling operation.

[Figure 6](#) shows the tamper positions when the width of the output paper is 182mm or more.

Figure 6 Tamper operation

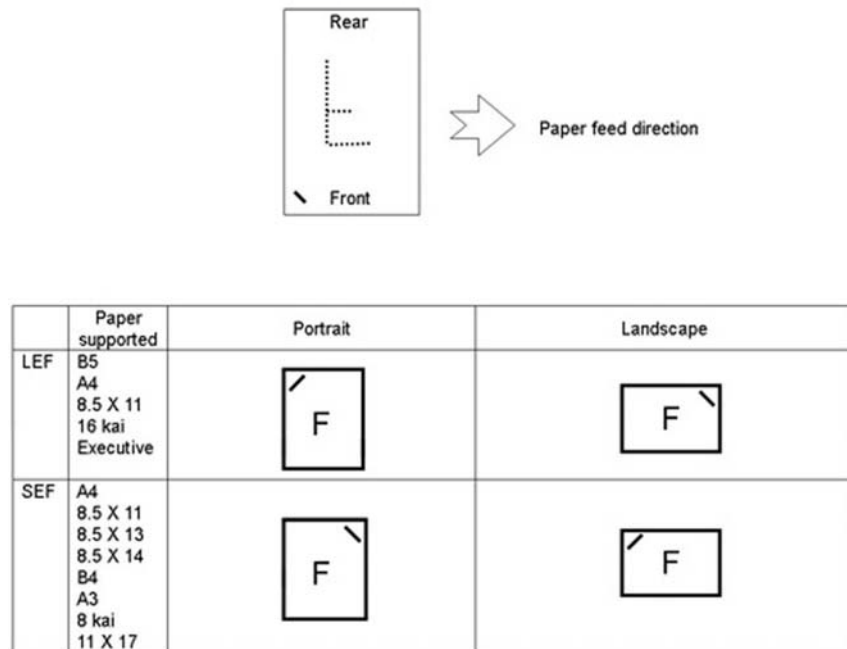
TC-5-0015-A

Sheets of paper in the compile tray are stapled with only a single staple on the front corner.

Stapling positions relative to a page placed in the document handler or placed on the platen glass are different for LEF paper and SEF paper, as shown. Refer to Figure 15.

Figure 15 Stapling positions

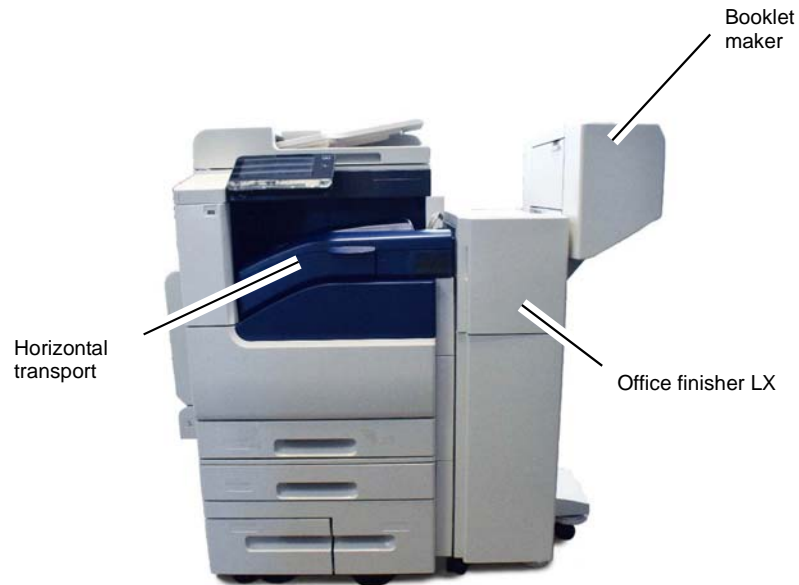
C-5-0021-A

- **Horizontal Transport Assembly** - feeds the sheets exiting from the IOT to the finisher.
- **Finisher** - squares up the edges of sheets in the compiler tray to create sets and ejects/offsets the sets into the stacker tray.
- **Compiler Stapler** - Staples sets as specified.
- **Hole Punch Assembly** - Punches 2, 3 or 4 holes depending on the market. If ordered by the customer, the punch unit is in the horizontal transport.
- **Stacker Tray** - Collects the sets ejected from the finisher.
- **Booklet Maker** - (optional) saddle stitches and creases booklets

Figure 1 Overview

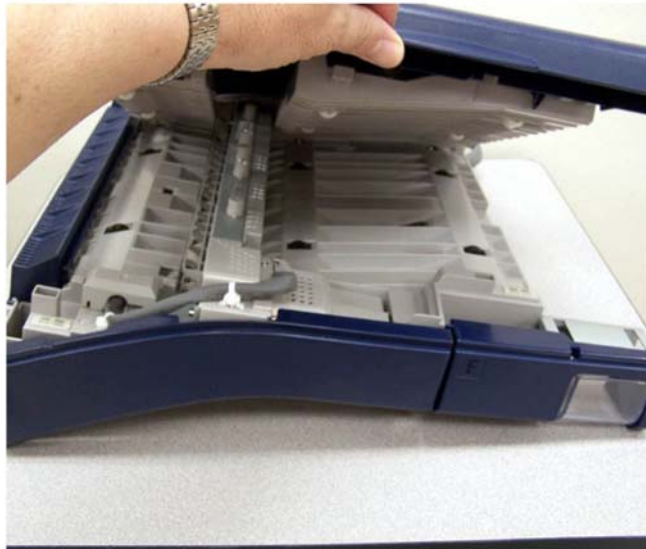
C-5-0022-A

The top cover can be opened for jam clearance. Refer to [Figure 4](#).

NOTE: If a booklet maker also is installed, the hole punch is installed in the horizontal transport.

Figure 4 Horizontal transport assembly

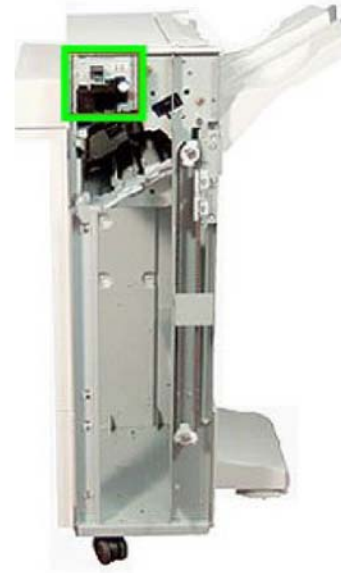
C-5-0028-A

Figure 11 Front door interlock

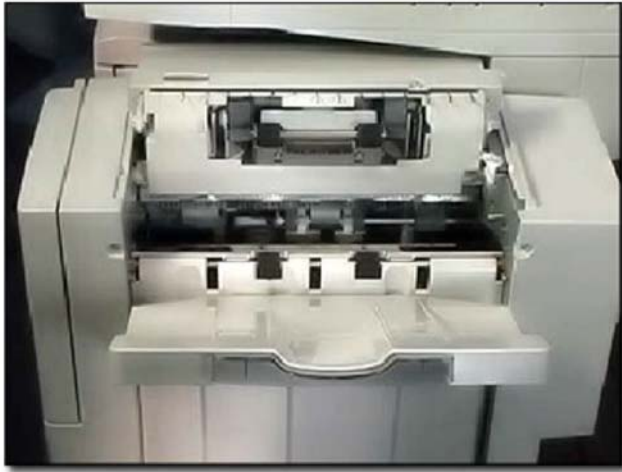
C-5-0038-A

The rotation of the sub paddles actively drives the paper against the compiler backstops where the paper is tamped, stapled (if required), and ejected.

Figure 20 Sub paddle assembly

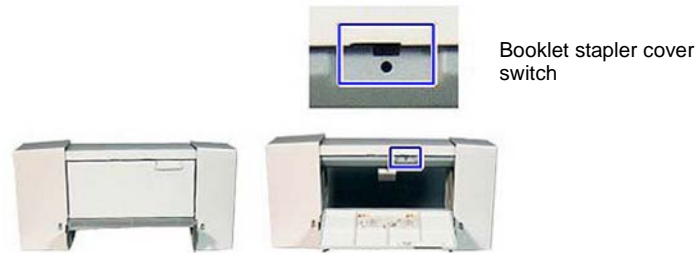
C-5-0050-A

The booklet stapler cover switch is actuated when the side cover is opened. When actuated, all + 24V supplies are removed from the booklet maker. Refer to [Figure 32](#).

Figure 32 Booklet stapler cover switch

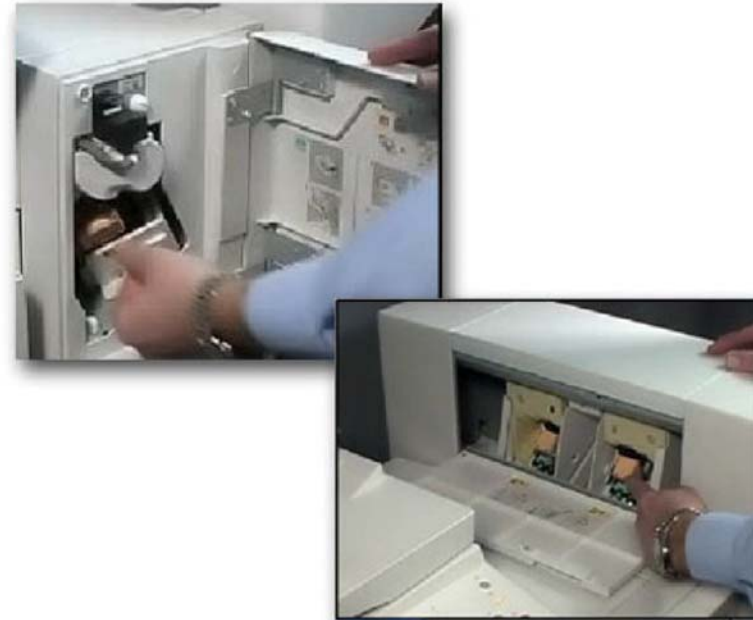
C-5-0068-A

Refer to [Figure 49](#). The only customer replaceable units (CRUs) for the LX finisher are:

- The 5,000 stitch staple cartridge and
- The two staple cassettes for the booklet maker. Each of the staple cassettes holds 2,000 staples.

Figure 49 Customer replaceable units
