708P90841
November 2014

Xerox® WorkCentre® 5790 Family Multifunctional Printer Service Manual

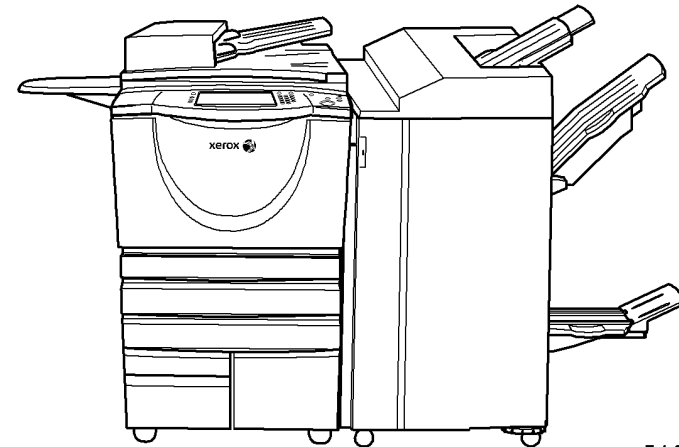
T-1-0008-A

Figure 6 WC5790 with DADH, work shelf and HVF BM

- [Figure 1](#) WC5735 with stand, document cover and OCT.
- [Figure 2](#) WC5740 with DADH, HCF, work shelf and OCT.
- [Figure 3](#) WC5745 with DADH, HCF, work shelf and 1K LCSS.
- [Figure 4](#) WC5755 with DADH, HCF, work shelf and 2K LCSS.
- [Figure 5](#) WC5775 with DADH, HCF, work shelf and HVF.
- [Figure 6](#) WC5790 with DADH, HCF, work shelf and HVF BM.

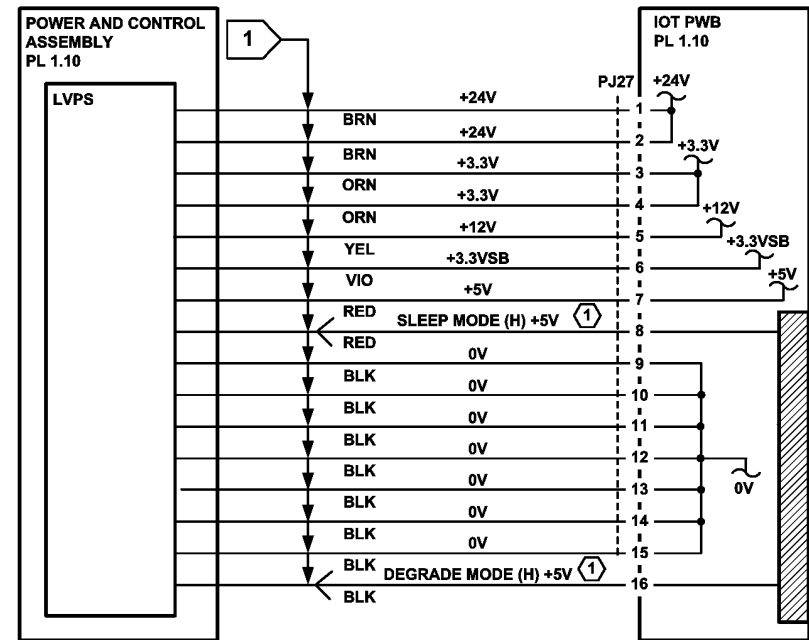
1 THESE LINES ARE HELD LOW DURING NORMAL OPERATION BY WATCHDOG ACTIVITY. FAILURE OF THIS ACTIVITY ALLOWS MACHINE TO ENTER SLEEP OR DEGRADE MODE

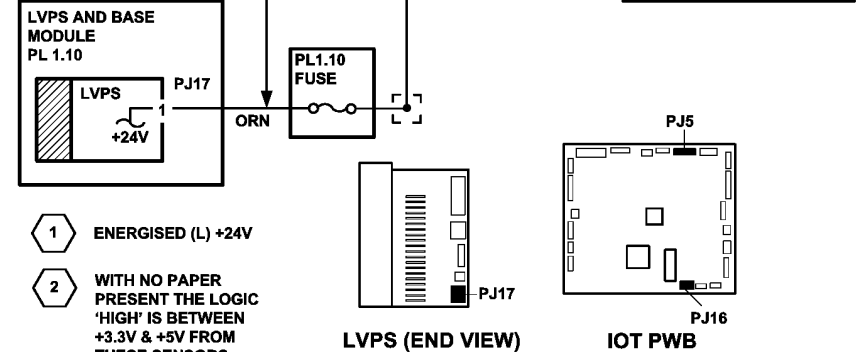
- 1 ENERGISED (L) +24V
- 2 WITH NO PAPER PRESENT THE LOGIC 'HIGH' IS BETWEEN +3.3V & +5V FROM THESE SENSORS

LVPS (END VIEW)

- Check the registration transport rolls and registration rolls, (65-90 ppm) [PL 8.17 Item 1, GP 7](#).
- Check the drives plate on the registration clutch for damage and contamination. Refer to the replacement procedure in [REP 8.5](#). If necessary, install a new registration clutch, [PL 8.17 Item 7](#).
- Check the tray 1 and 2 transport motor, [PL 8.25 Item 5](#). Ensure that the motor runs correctly.
- Check the tray 1 and 2 transport roll assemblies, transport drive belt and pulleys, [PL 8.26 Item 1, GP 7](#). Install new components as necessary.
- Install a new tray 1 and 2 control PWB, [PL 7.10 Item 2](#).
- Refer to [Figure 2](#). Make sure PJ44 is securely connected.

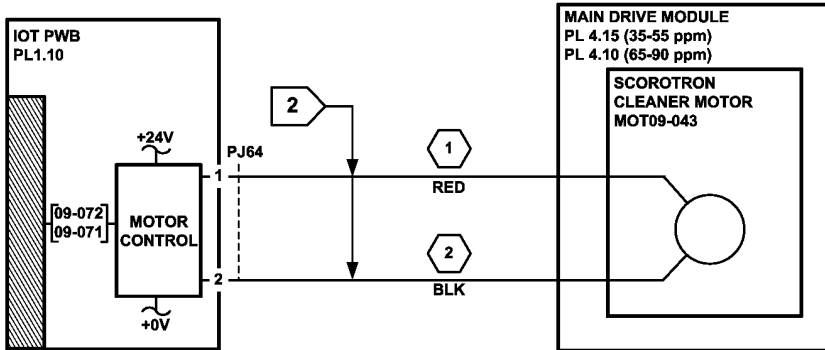
- 1** +24V WHEN 09-072 IS RUN
0V WHEN 09-071 IS RUN
- 2** 0V WHEN 09-072 IS RUN
+24V WHEN 09-071 IS RUN

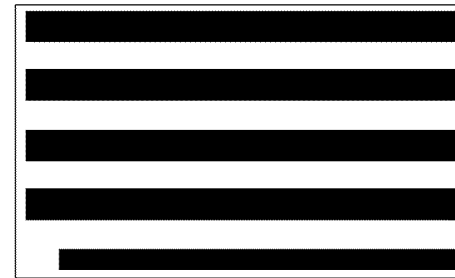
Figure 2 Internal test pattern 12

If the solid area density specification is not met, then go to the [IQ1](#) Image Quality Entry RAP.

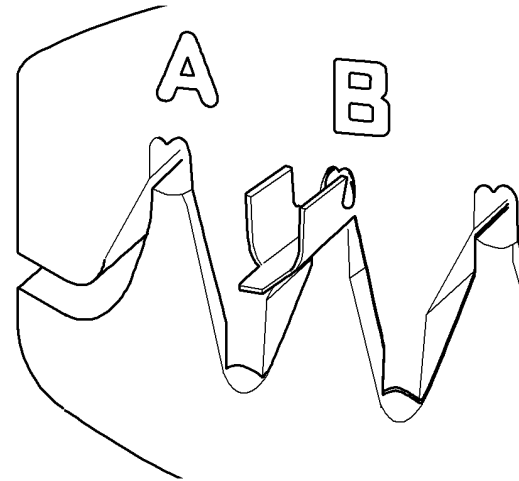
T-1-0335-A

1. Select the correct replacement terminal, and identify the appropriate crimp positions for the terminal.
2. **Figure 3.** Insert a male or female terminal into the appropriate position of the crimp tool, then close the tool just enough to hold the terminal.

Figure 3 Crimping the terminal.

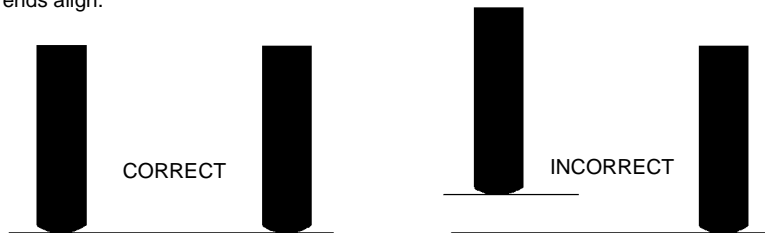
NOTE: Set the front and rear support fingers so that their ends are aligned when extended. Refer to [Figure 4](#).

- With the pressing plate installed, set the front and rear support finger alignment, [Figure 4](#). If the fingers are not aligned, the compiler output will be uneven and cause exit jams.

- 3 Rotate the encoder wheel until the finger ends align.
 - 2 Remove the clip and disengage the gear.
 - 1 Remove the rear pressing plate finger
- Encoder Wheel

- 4 Re-engage the gear and refit the circlip

- 5 Replace rear pressing plate finger

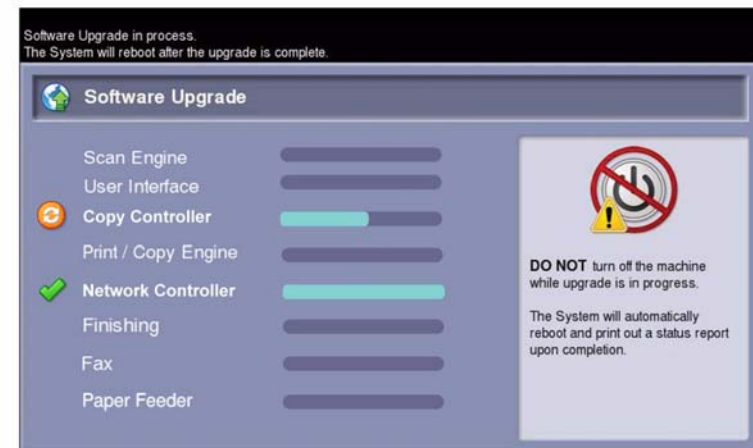
Figure 1 Software upgrade in progress

During the software loading procedure, a progress screen is displayed on the UI, Figure 1. The display has the following features:

- A progress bar is assigned to each of the hardware modules.
- For the upgrade of each hardware module to be successful, the progress bar must reach 100% for each module being upgraded. During upgrading, the symbol to the left of the progress bar indicates one of the following conditions:
 - Orange circle with white arrows, an upgrade is in progress.
 - Green tick, an upgrade has completed.
 - Red circle with white cross, a module has failed to be upgraded.
- The upgrade is completed when all the progress bars are 100%.

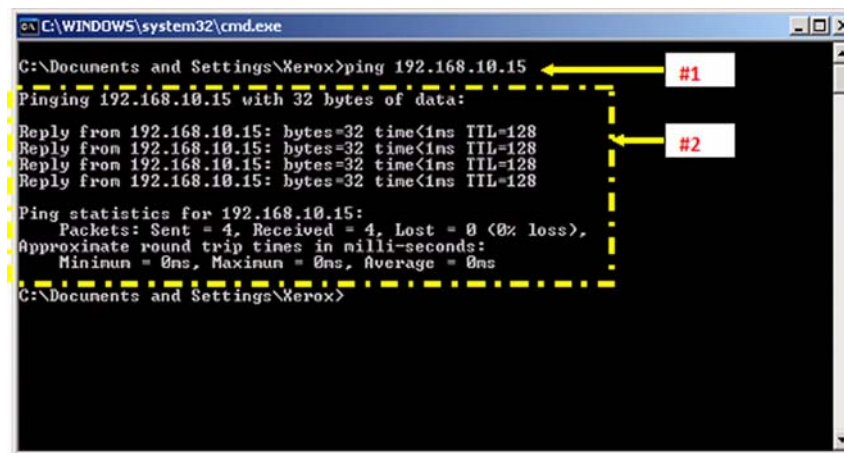
Figure 1 Successful ping command

1. Set the IP address of the PWS one digit higher or lower than the device to be pinged. For example, if the IP address of the device is 192.168.10.15, set the PWS to 192.168.10.14 or 192.168.10.16. To set the IP address of the PWS, refer to [GP 34](#).
2. Set the subnet mask of the PWS the same as the device to be pinged.
3. On the PWS, Select Start, then Run.
4. In the Run dialog box, type cmd.
5. Select OK. A command window will open.
6. In the command window, type ping and the address of the device. Refer to number 1 in [Figure 1](#).
7. If the ping command is successful, a reply from the device will be received. Refer to number 2 in [Figure 1](#).

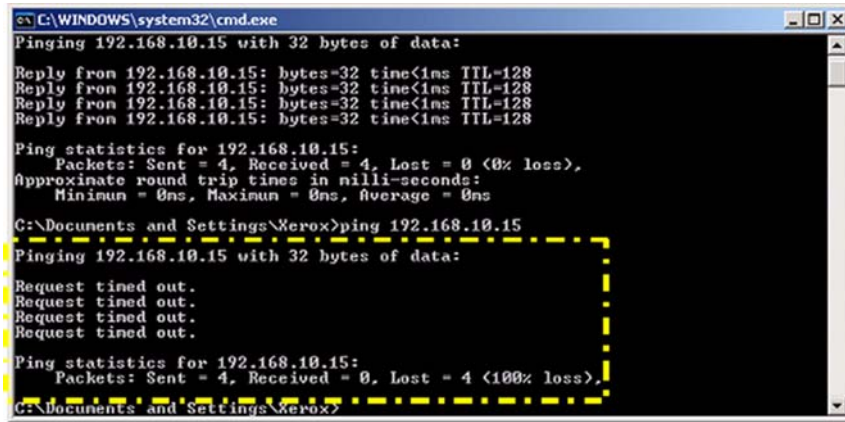
8. If the ping command is unsuccessful, a timed out message will be received, [Figure 2](#).

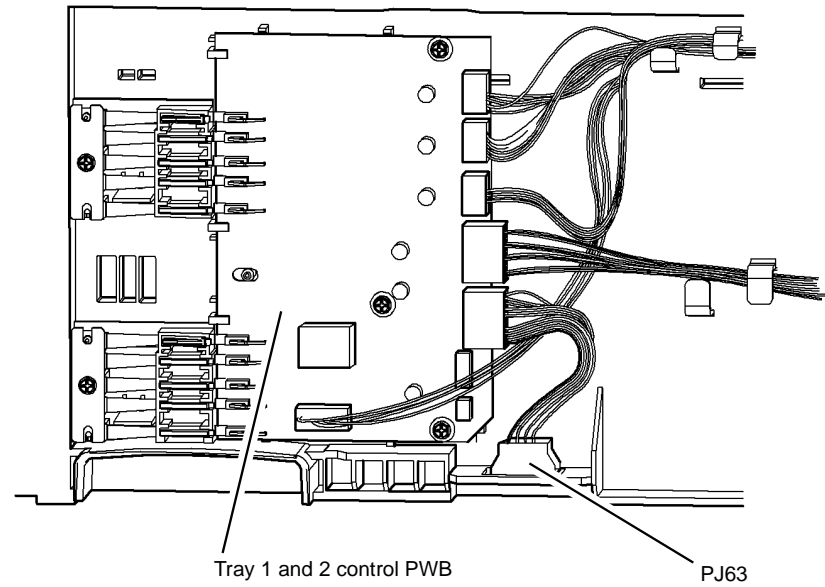
Figure 14 PJ63

Location: [PL 7.10](#)

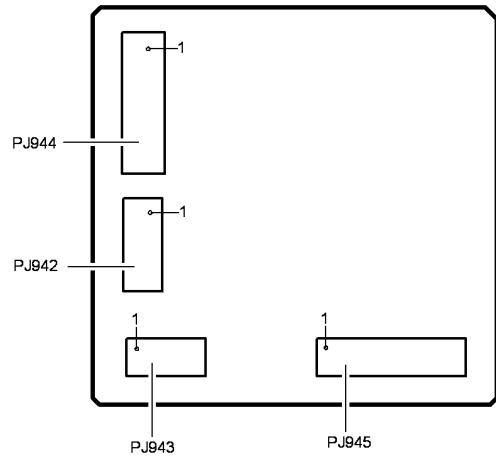
Location: **PL 2.10**

921	Figure 11	Scanner PWB (W/TAG 150)	WD 16
922	Figure 11	Scanner PWB (W/TAG 150)	WD 16
923	Figure 11	Scanner PWB (W/TAG 150)	WD 17
924	Figure 11	Scanner PWB (W/TAG 150)	WD 17
926	Figure 11	Scanner PWB (W/TAG 150)	WD 17
927	Figure 11	Scanner PWB (W/TAG 150)	WD 17
929	Figure 11	Scanner PWB (W/TAG 150)	WD 17
930	Figure 11	Scanner PWB (W/TAG 150)	WD 18
931	Figure 11	Scanner PWB (W/TAG 150)	WD 18
932	Figure 11	Scanner PWB (W/TAG 150)	WD 18
942	Figure 41	UI LCD PWB	WD 45
943	Figure 41	UI LCD PWB	WD 45
944	Figure 41	UI LCD PWB	WD 45
945	Figure 41	UI LCD PWB	WD 45
998	Figure 2	Tray 1 and 2 control PWB	-
998	-	Hard Disk	WD 4
999	-	Hard Disk	WD 4
