708P91139
February 2016

Xerox® WorkCentre® 5945 Family Multifunction Printer Service Manual

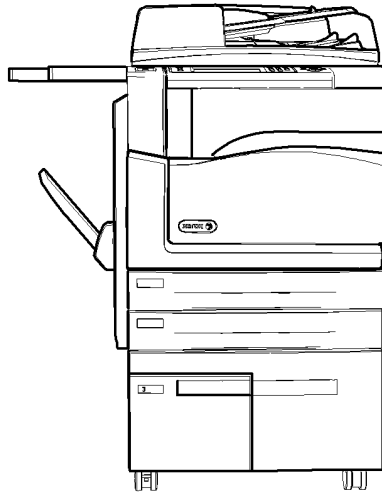
W-1-0899-A

Figure 1 WorkCentre 5945 with centre output tray

- **Figure 1** WorkCentre 5945 with trays 3 and 4, centre output tray and workshelf.
- **Figure 2** WorkCentre 5955 with trays 3 and 4, workshelf and 2K LCSS.
- **Figure 3** WorkCentre 5955 with trays 3 and 4, workshelf and LVF BM.

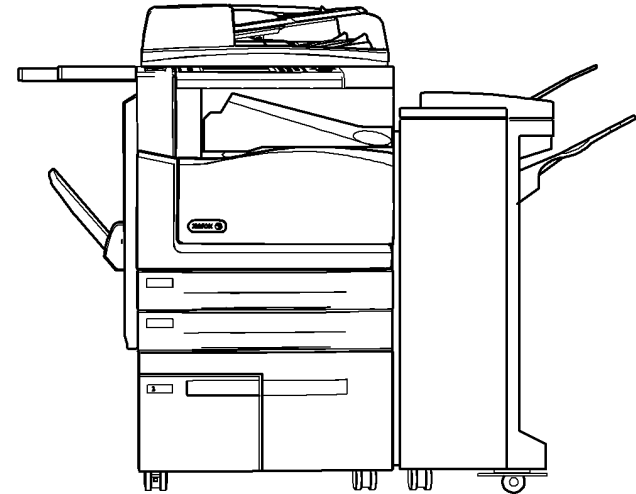
W-1-0900-A

Figure 2 WorkCentre 5955 with 2K LCSS

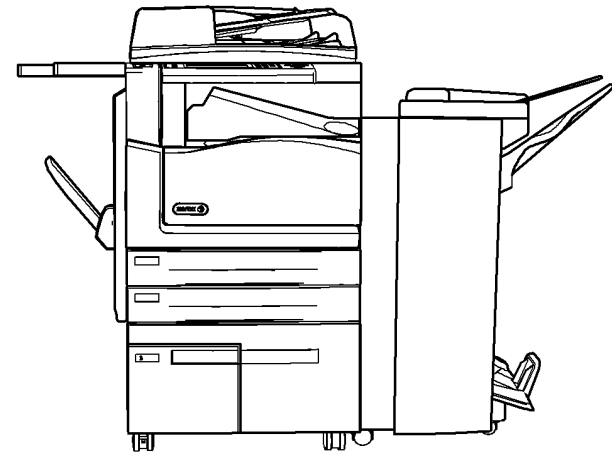
W-1-0901-A

Figure 3 WorkCentre 5955 with LVF BM

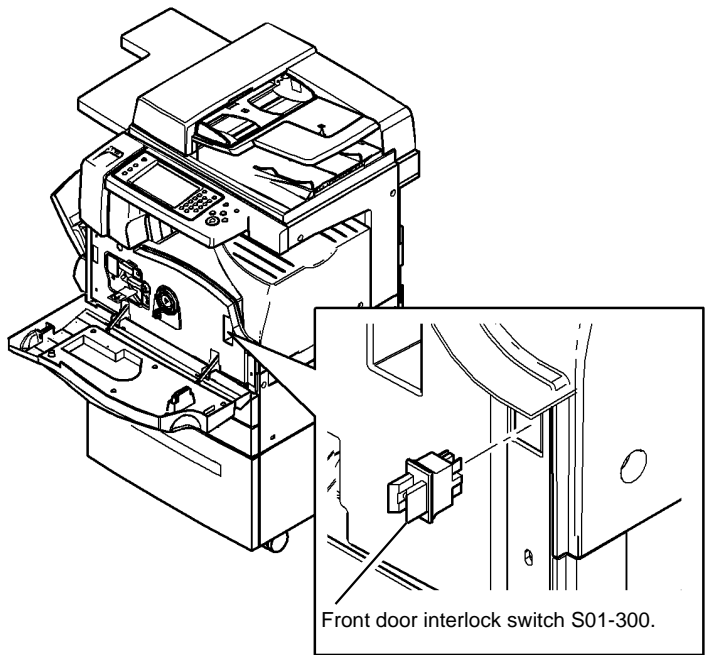
W-1-0988-A

Front door interlock switch S01-300.

Figure 1 Component location

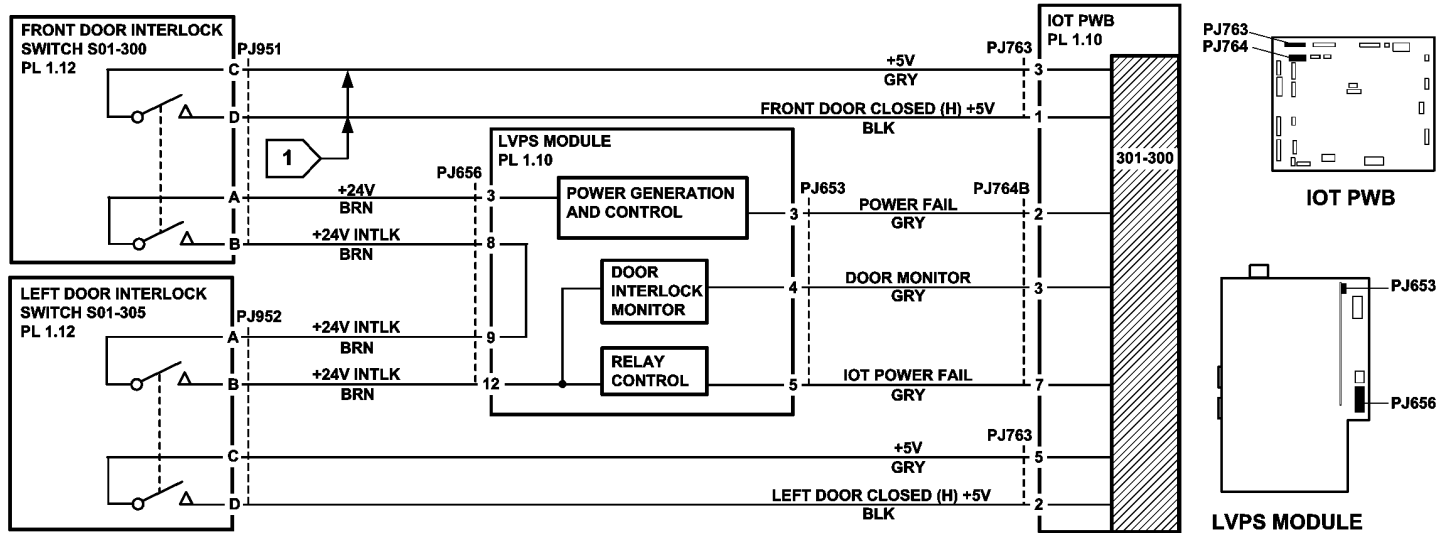
TW-1-0250-A

Figure 2 Circuit diagram

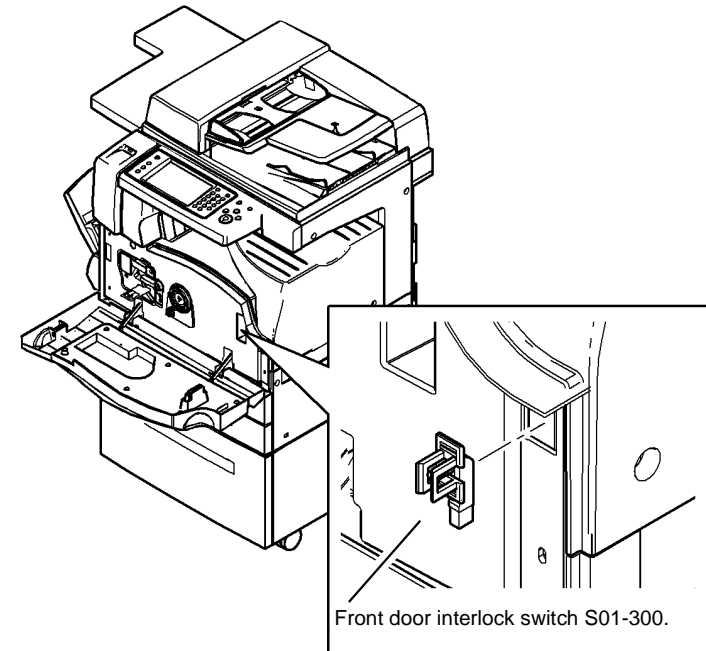
W-1-1432-A

Figure 1 Component location

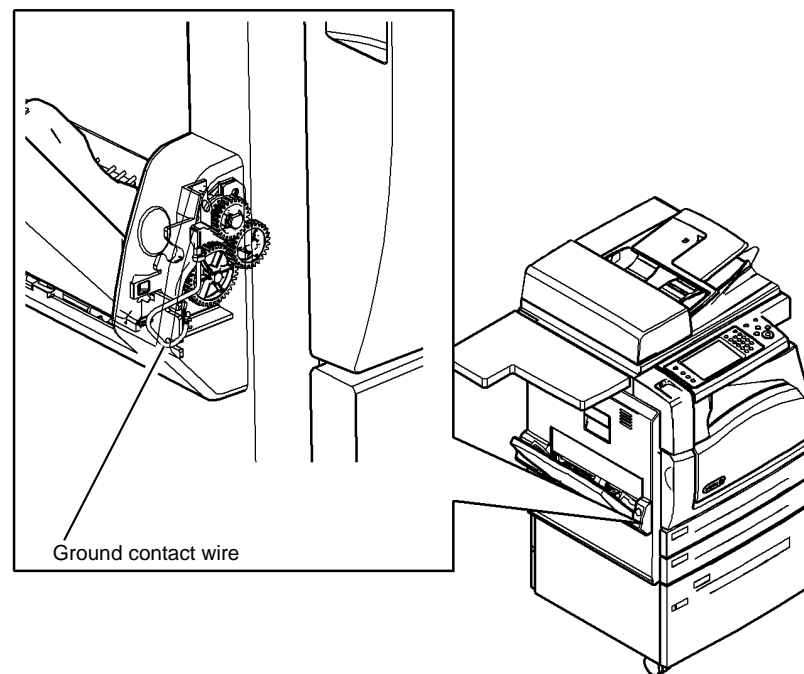
W-1-0995-A

1. Remove the feed roll assembly, REP 80.15.
2. Remove the ground wire, Figure 1 and clean the terminals at both ends of the wire.
3. Clean the bearings, PL 70.35 Item 10 and the parts of the feed roll shaft where the bearings locate.
4. Reassemble the bypass tray assembly

Figure 1 Bypass ground connections

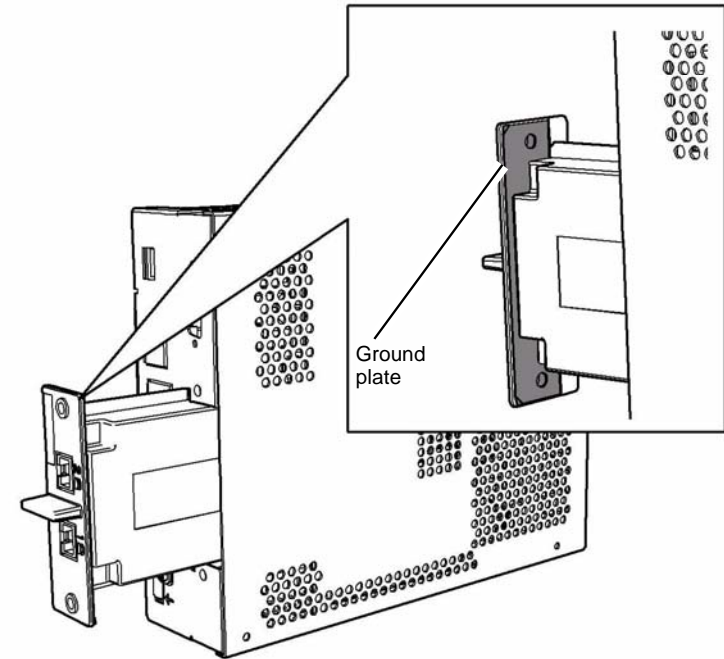
Refer to [Figure 3](#). Ensure the face of the Fax module ground plate and the mounting area of the SBC cage are clean.

Figure 3 Fax module ground

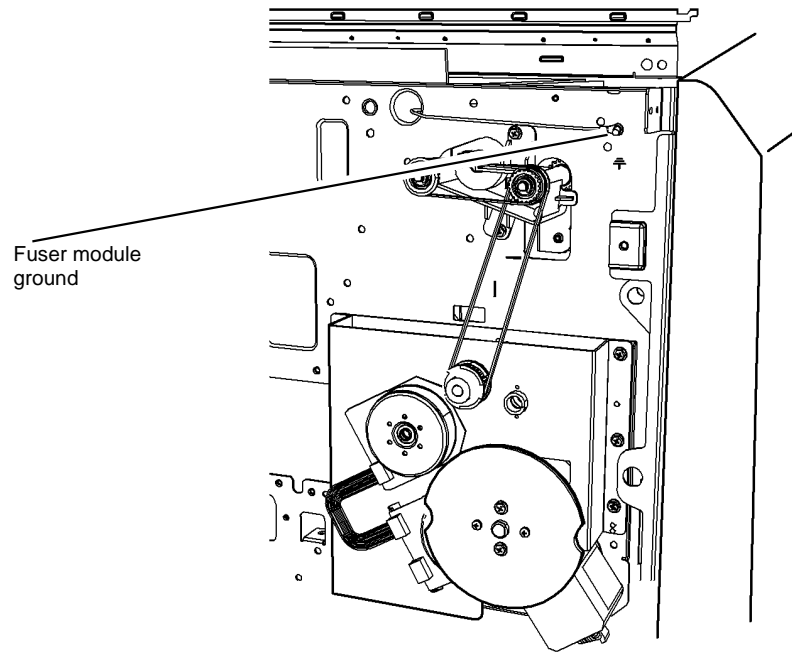
W-1-1005-A

Refer to [Figure 4](#). Perform the steps that follow:

- To improve continuity, disconnect the fuser module ground terminal, clean the contact faces and re-assemble.
- Remove the fuser. Check the drawer connector contacts are clean and undamaged. If necessary install new components.

Figure 4 Fuser module ground

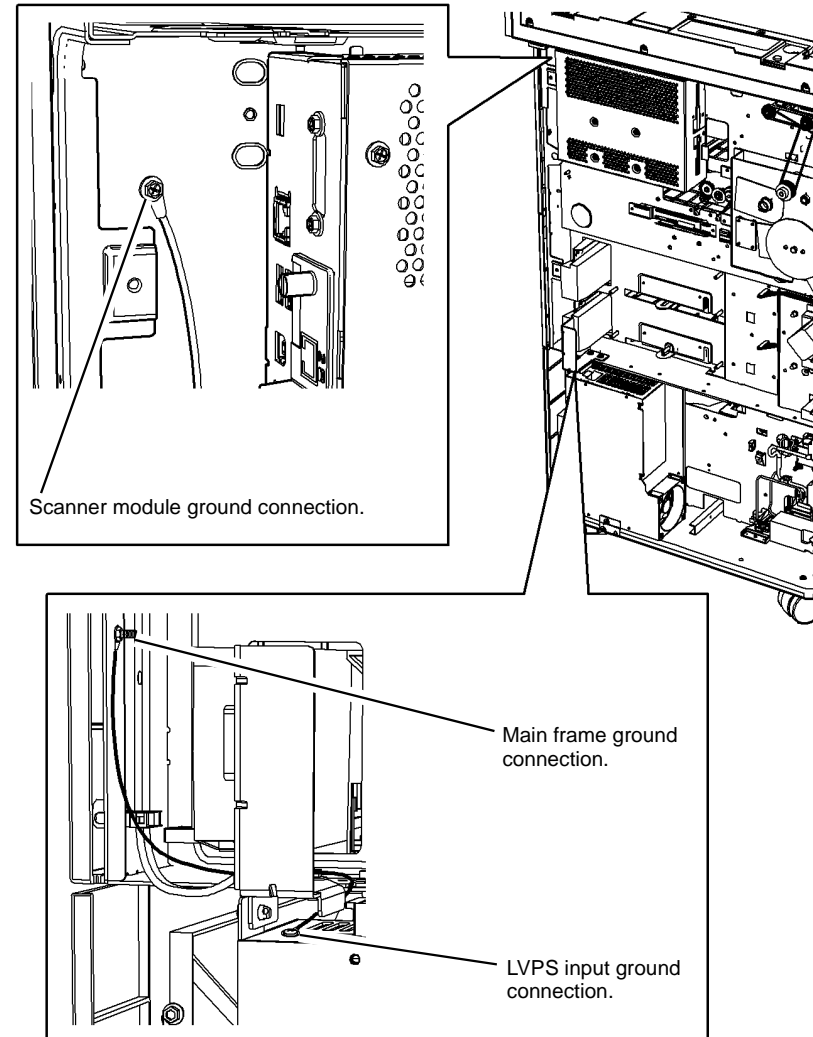
Refer to [Figure 5](#), check for continuity of less than 1 ohm between the LVPS input ground connection and the main frame ground. Also check for a continuity of less than 1 ohm between the scanner module ground connection and the main frame ground. Check that the hardware is tight and the harness crimping is good. To improve continuity, disconnect the terminals, clean the contact faces then re-assemble.

Figure 5 Component location

Refer to [Figure 8](#). Open the left door. Rotate the transport rolls by hand and check for continuity of less than 10k ohms between the tray 1 and tray 2 transport roll shafts and the main frame ground connection, [Figure 5](#). To improve continuity for the tray 1 and tray 2 transport roll shafts, remove, clean and re-install the shaft and bearings, [REP 80.10](#).

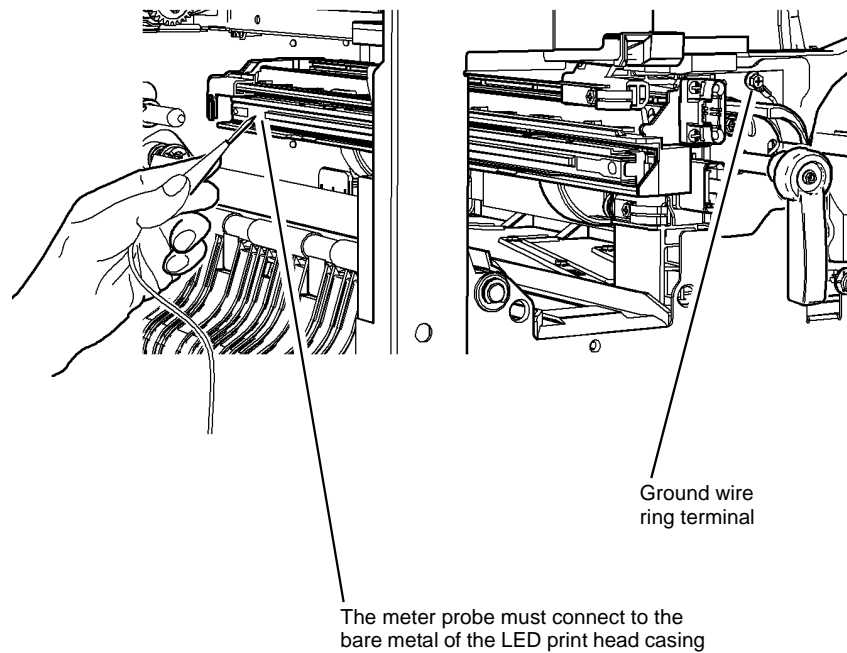
Check for continuity of less than 10 ohms between the LED print head casing, [Figure 6](#) and the main frame ground connection.

Figure 6 LPH ground connection

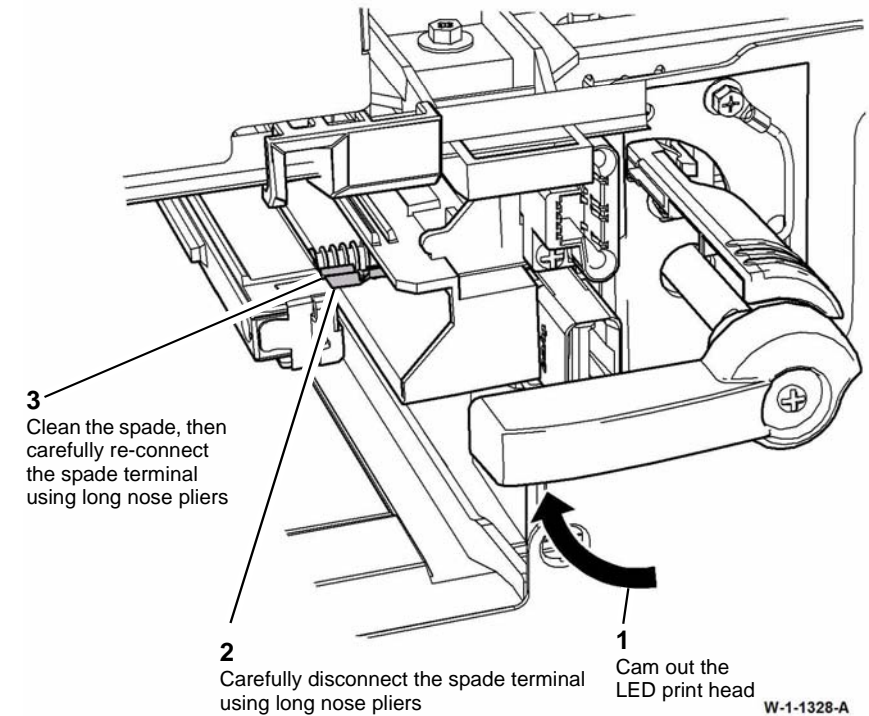
1. Remove the LED print head module, [REP 60.15](#).
2. Clean the contact faces of the ground wire ring terminal.
3. [Figure 7](#), clean the contact faces of the LPH ground spade connector.

Figure 7 LPH ground spade connection

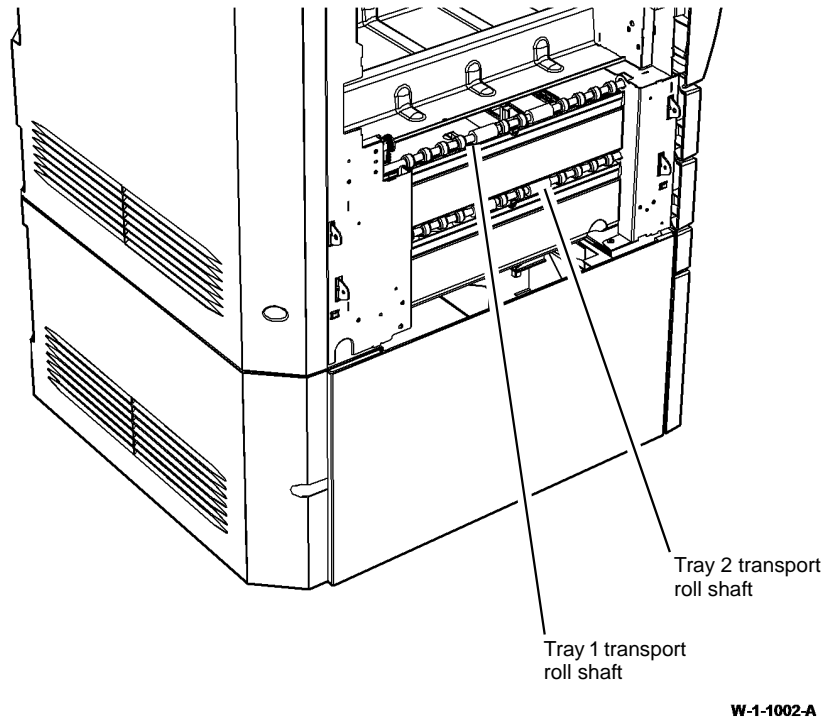
Figure 8 Paper transport rolls

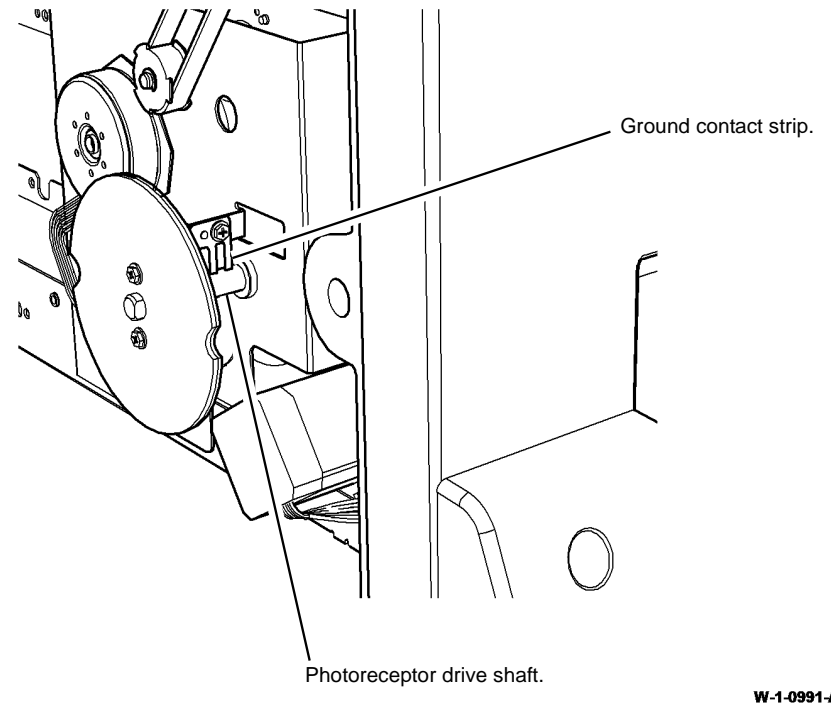
Refer to [Figure 9](#). Ensure the machine is switched off, [GP 14](#). Check for continuity of less than 10 ohms between the machine frame and photoreceptor drive shaft. To improve continuity, remove the ground contact strip, [Figure 9](#) and clean the contact areas of the strip, frame bracket and drive shaft, then re-assemble and test.

Figure 9 Print cartridge ground

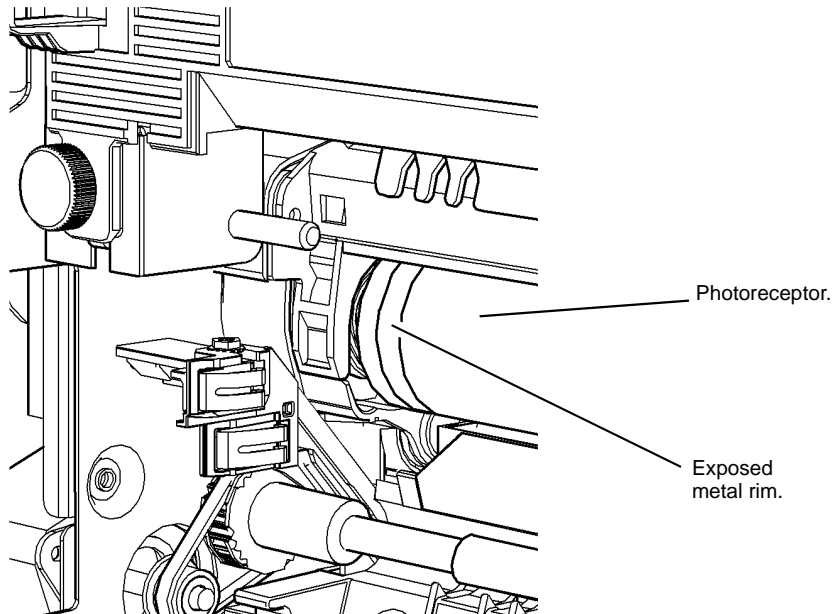
W-1-1403-A

Figure 10 Print cartridge ground

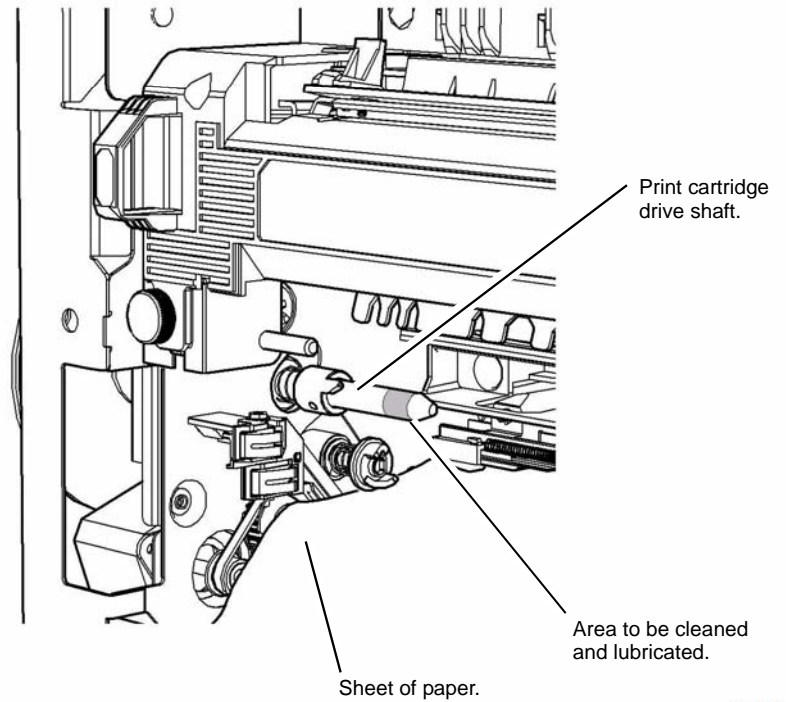
W-1-1402-A

1. Remove the print cartridge, [PL 90.17 Item 9](#).
2. Put a sheet of paper beneath the print cartridge drive shaft, [Figure 11](#).

Figure 11 Print cartridge drive shaft

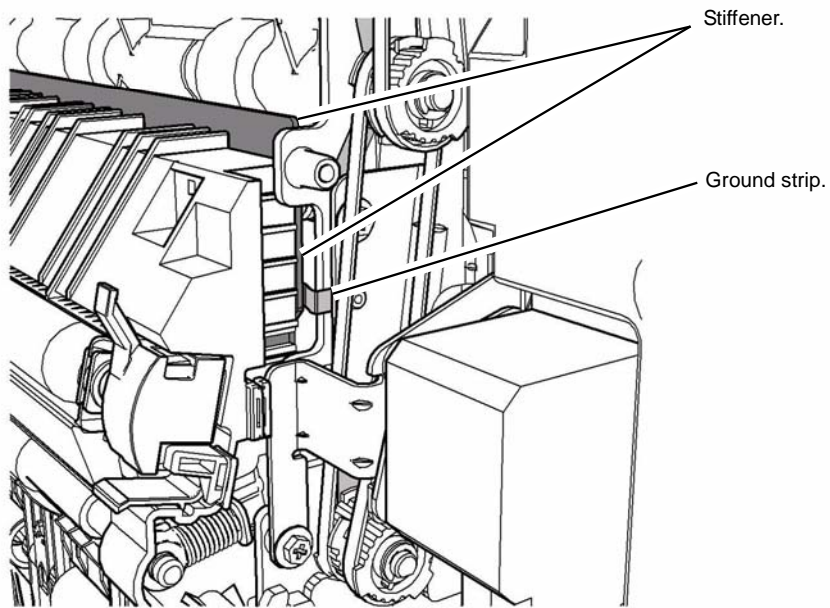
W-1-1251-A

Refer to [Figure 12](#). Check for continuity of less than 10 ohms between the stiffener and the ground strip, [PL 80.22 Item 18](#). If necessary remove the stiffener (4 screws), clean the contact faces and re-assemble, to improve continuity.

Figure 12 Stiffener ground

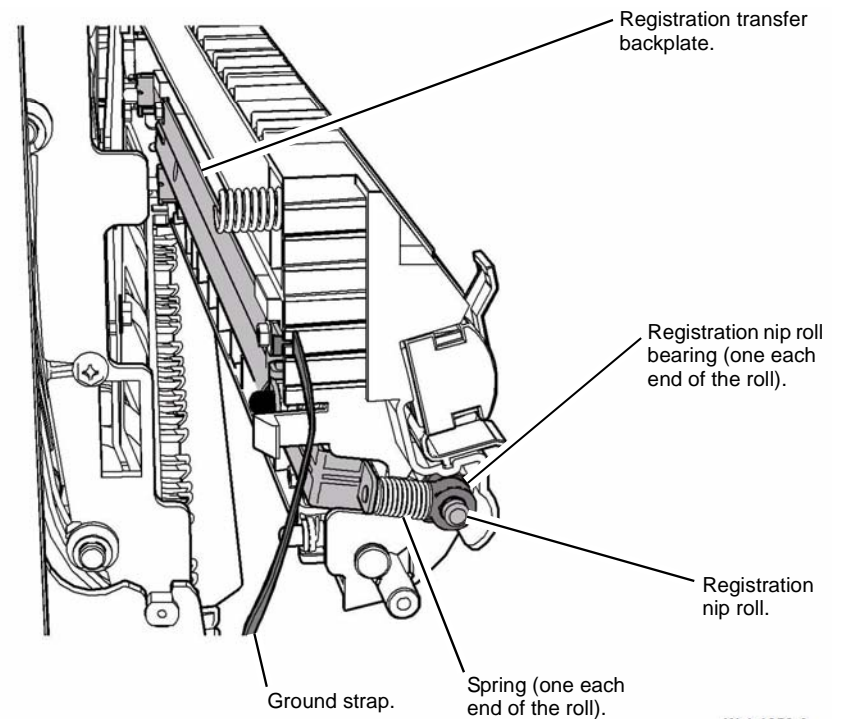
W-1-1252-A

Refer to [Figure 13](#). Check for continuity of less than 10 ohms between the registration transfer backplate and the springs, [PL 80.15 Item 10](#). If necessary remove the springs, clean the contact faces and re-assemble, to improve continuity.

Refer to [Figure 13](#). Check for continuity of less than 2k ohms between the springs and the registration nip roll, [PL 80.15 Item 4](#). If necessary remove the springs, registration nip roll and registration nip roll bearings. Clean the contact faces and re-assemble, to improve continuity.

Figure 13 Transfer ground

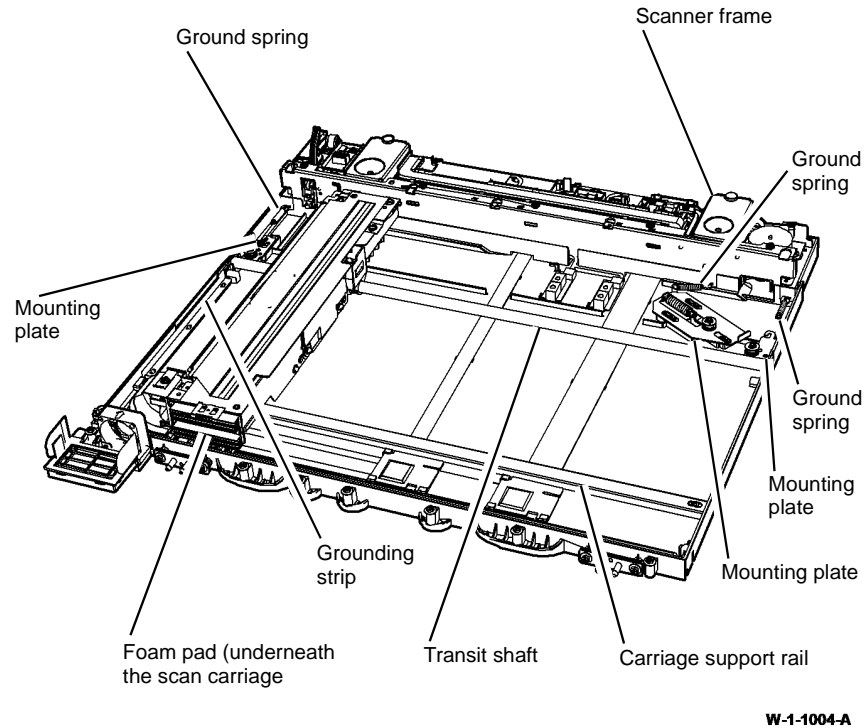
- For continuity of less than 10 ohms between the grounding strip and the carriage support rail. To improve continuity disassemble the parts, clean the contact faces and re-assemble.

- The cleanliness of the foam pad between the scan carriage and the carriage support rail. If necessary clean the pad using film remover, [PL 26.10 Item 4](#).

Figure 14 Scanner ground connections

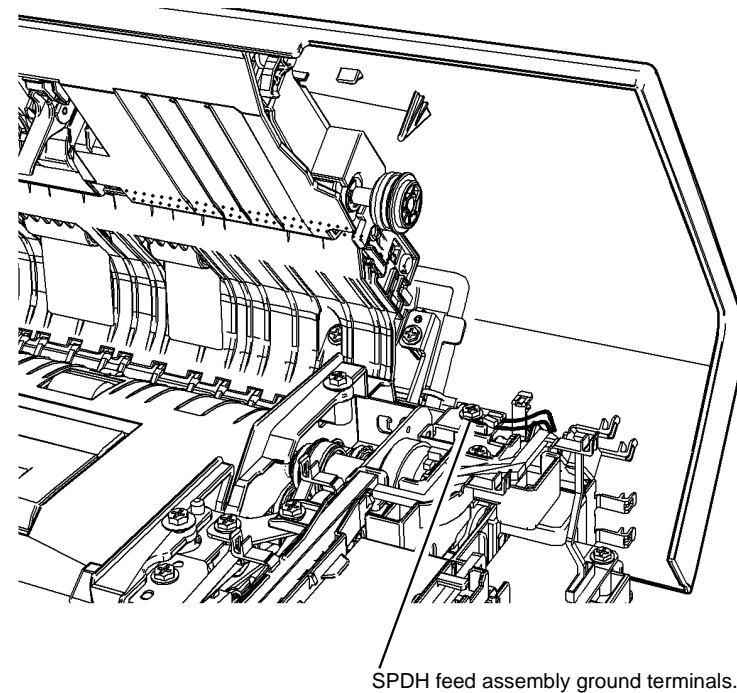
Figure 15 SPDH ground connections 1

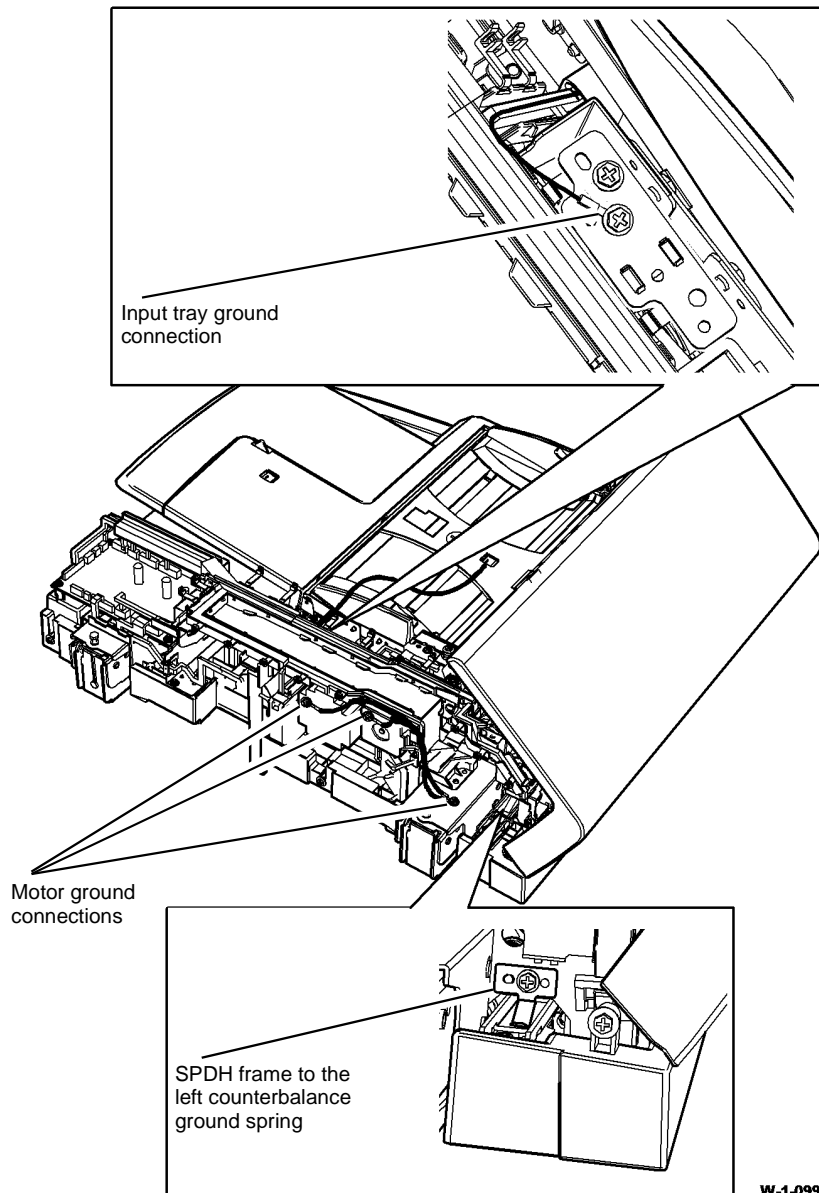
W-1-0994-A

- Check for continuity between the motor housings and the left counterbalance. To improve continuity disconnect, clean and reassemble the motor ground connections shown in [Figure 16](#).

- Remove the input tray assembly, [REP 5.4](#), but do not disconnect the harness. Check for continuity between the ground point at the end of the green wire next to the last sheet out sensor, [PL 5.30 Item 18](#) and the input tray ground connection indicated in [Figure 16](#). To improve continuity disconnect, clean and reassemble the connections.

Figure 16 SPDH ground connections 2

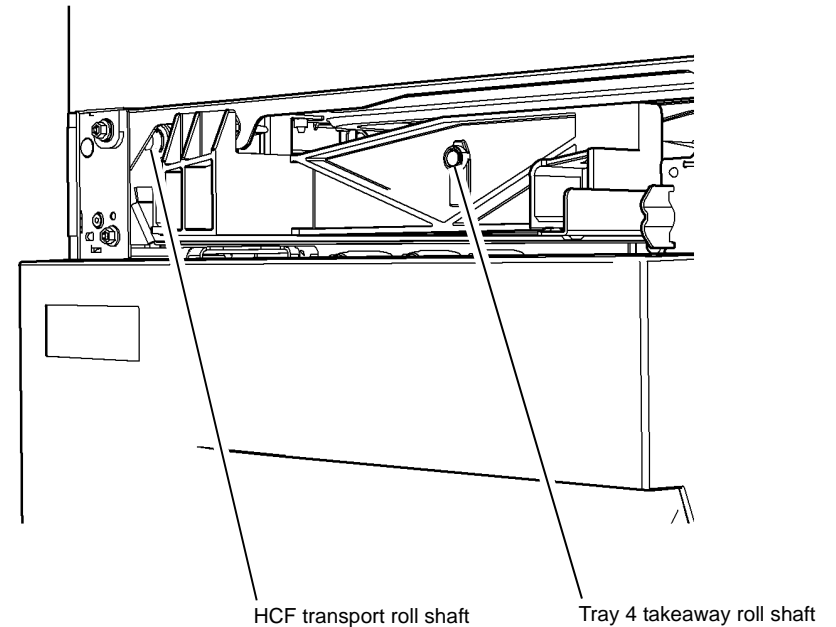
W-1-0997-A

Remove the tray 4 front cover, [PL 70.26 Item 5](#) (4 screws). Refer to [Figure 17](#). With tray 4 closed, check for continuity of less than 10k ohms between the tray 4 takeaway roll shaft and the main frame ground connection, also between the HCF transport roll shaft and the main frame ground connection.

Figure 17 Continuity check points

1. If necessary, open the tray then rotate the shafts. Close the tray and repeat the measurements.
2. To improve continuity, remove the tray 4 takeaway roll, [REP 80.26](#). Refer to [Figure 18](#). Clean the conductive plastic bearings and shaft. Then install the removed components.

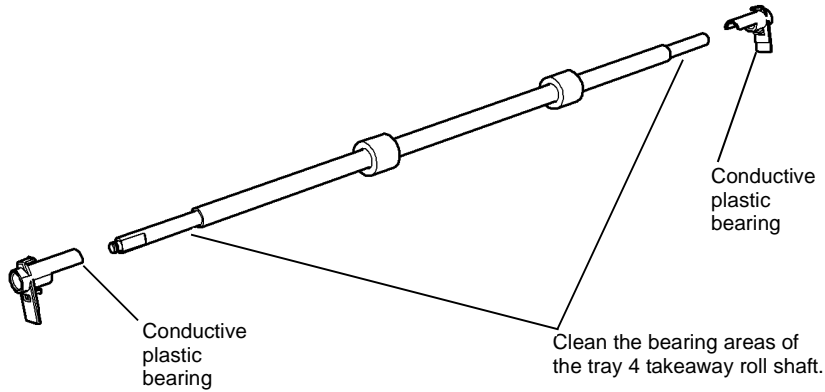
W-1-0998-A

Clean inside and outside of the conductive plastic bearings.

Figure 18 Component cleaning

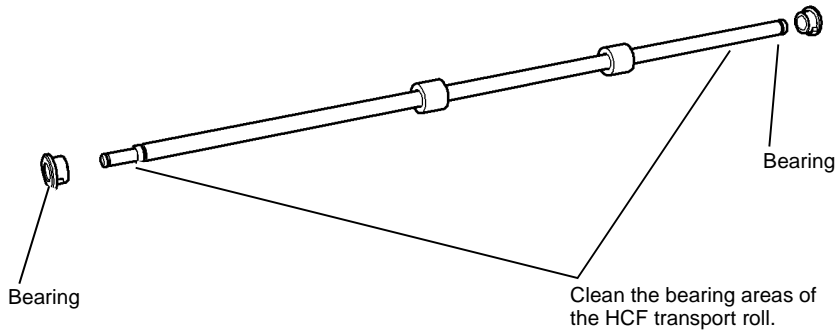
W-1-0999-A

3. To improve continuity, remove the HCF transport roll and bearings, REP 80.27. Refer to Figure 19. Clean the bearings and shaft. Then install the removed components.

Clean inside and outside of the conductive plastic bearings.

Figure 19 Component cleaning

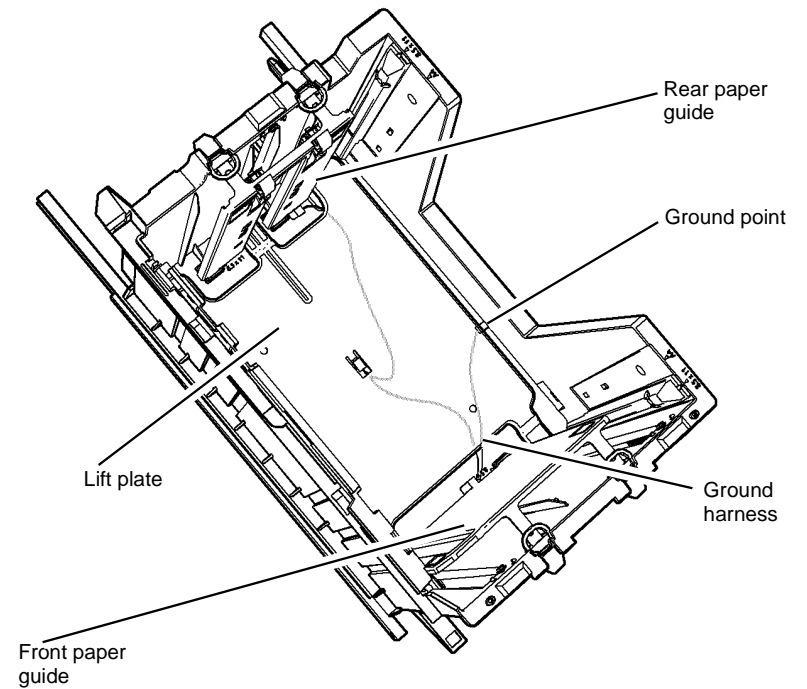
W-1-1000-A

4. Empty tray 4 of paper. Refer to Figure 20. Check for continuity of less than 10k ohms between the ground point and the points that follow:
 - Lift plate.

- Front paper guide
- Rear paper guide.

To improve continuity, disconnect and clean the ground harness connectors, then re-connect.

Figure 20 Tray 4 grounding

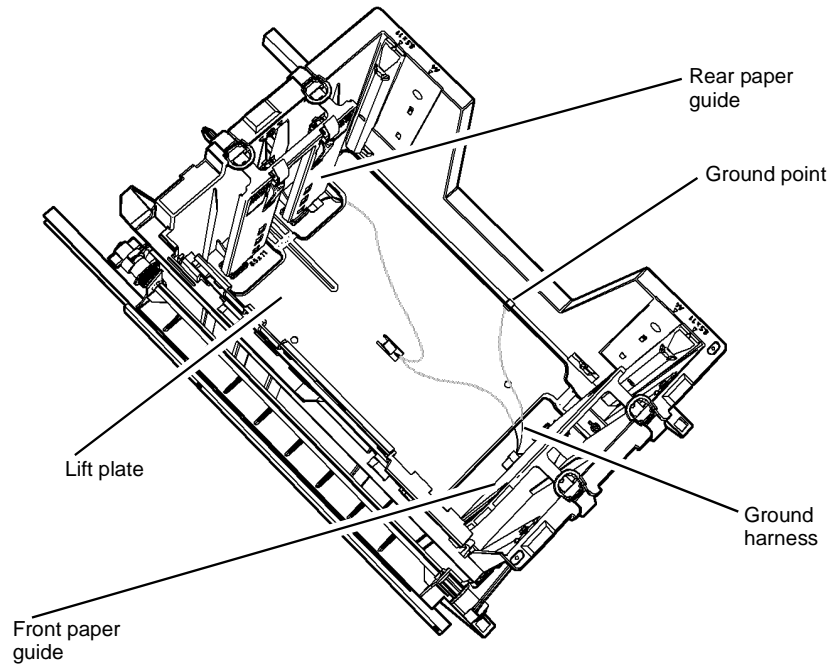
W-1-1001-A

5. Empty tray 3 of paper. Refer to Figure 21. Check for continuity of less than 10k ohms between the ground point and the points that follow:
 - Lift plate.
 - Front paper guide
 - Rear paper guide.

Figure 21 Tray 3 grounding

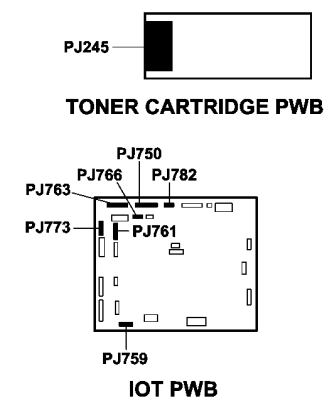
TW-1-0245-C

Figure 4 +5V return 3 of 4

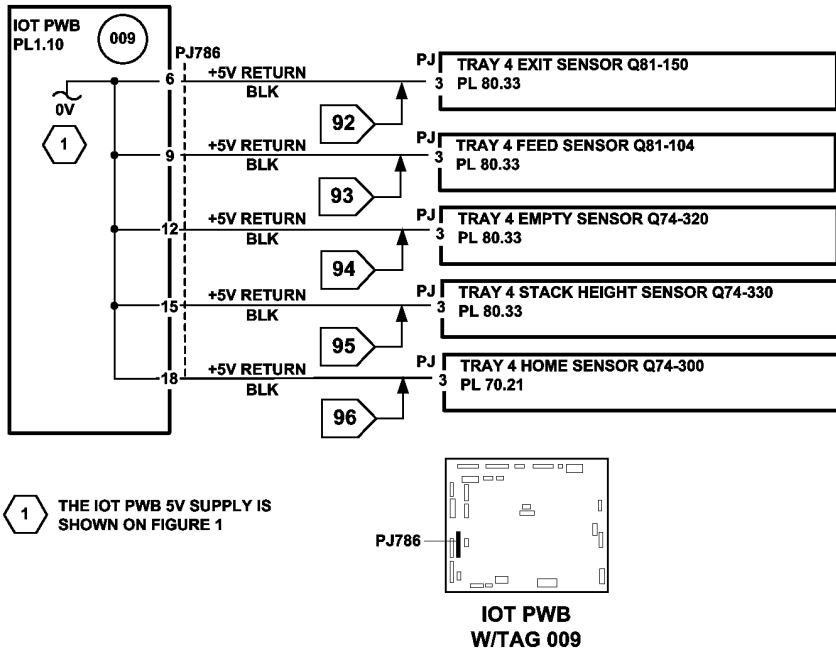
TW-1-0333-A

Figure 5 +5V return 4 of 4

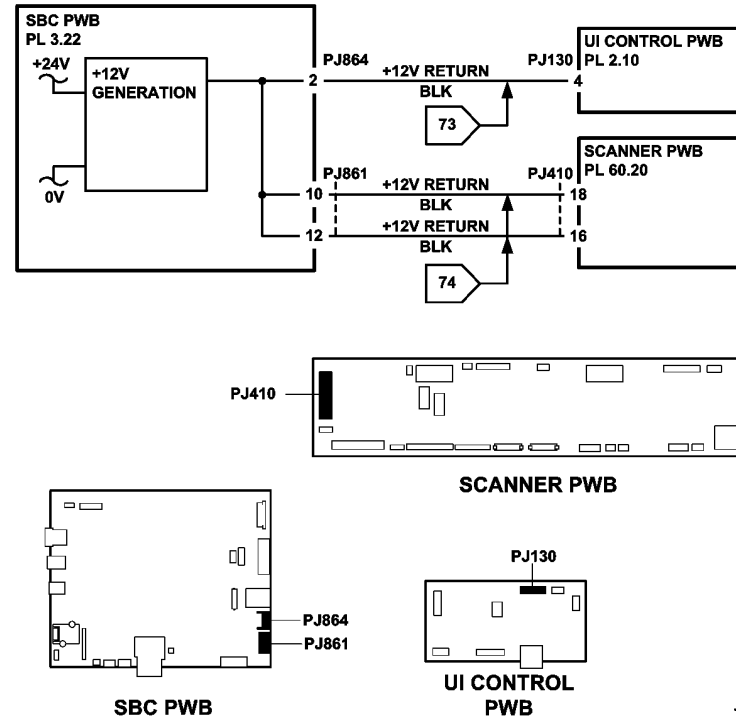
TW-1-0239-A

Figure 6 +12V Return

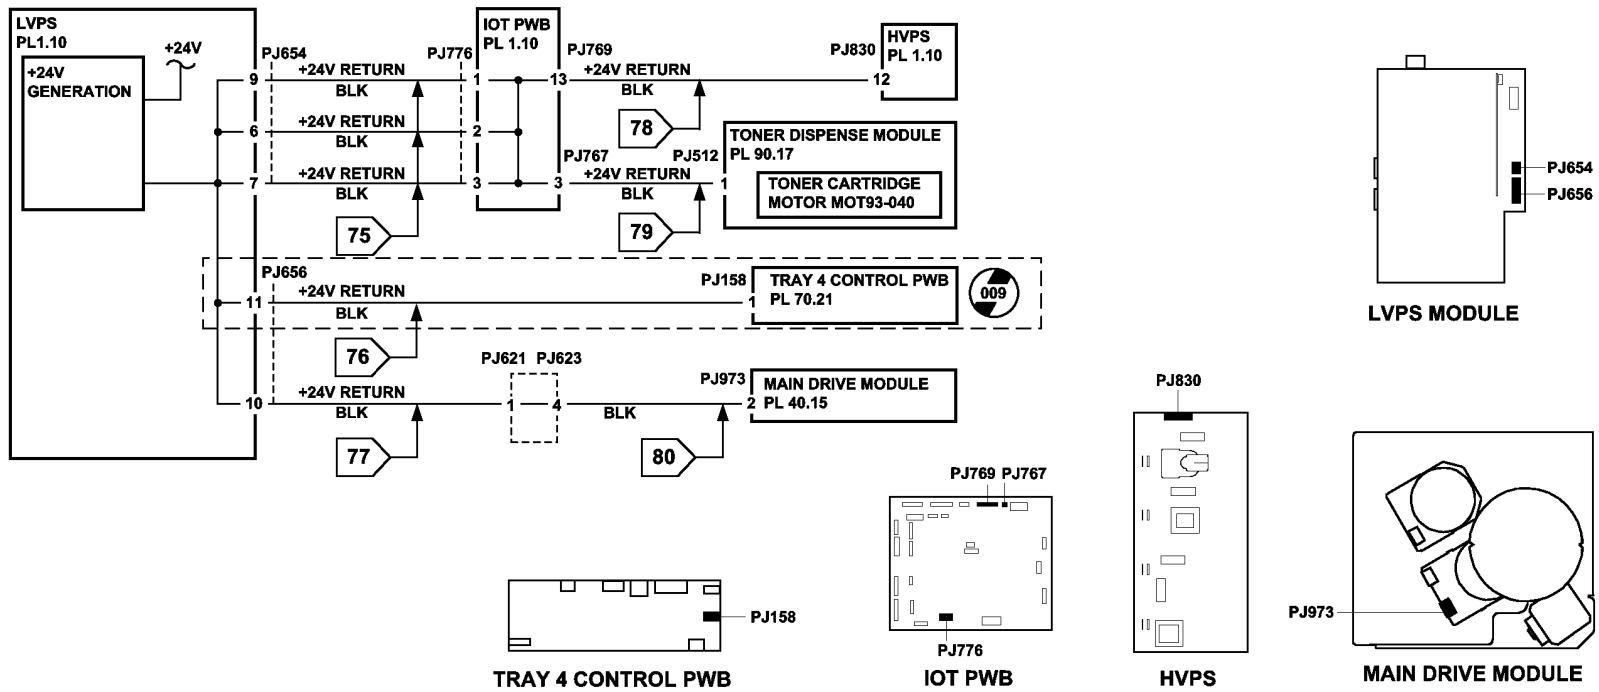
TW-1-0246-B

LVPS MODULE

Figure 7 +24V return 1 of 2

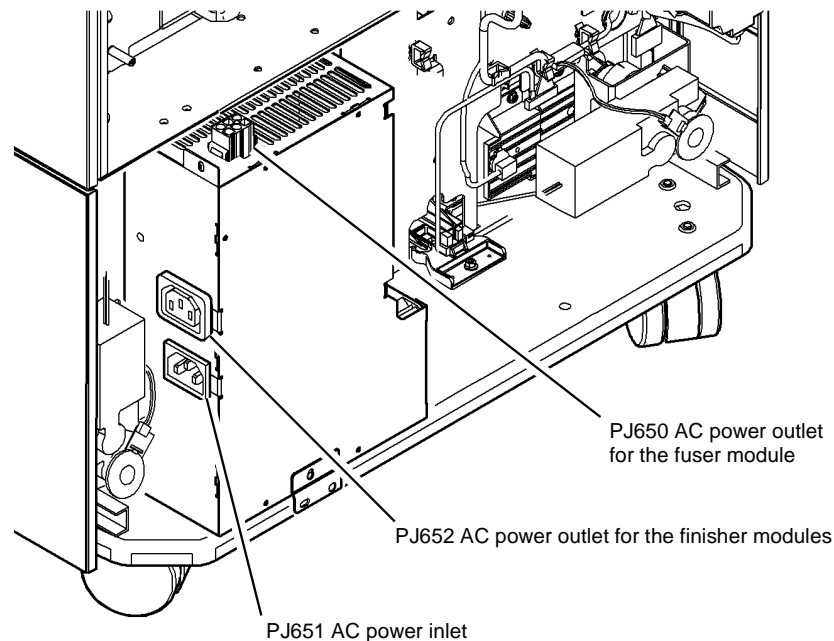
W-1-1006-A

Figure 1 AC input and output

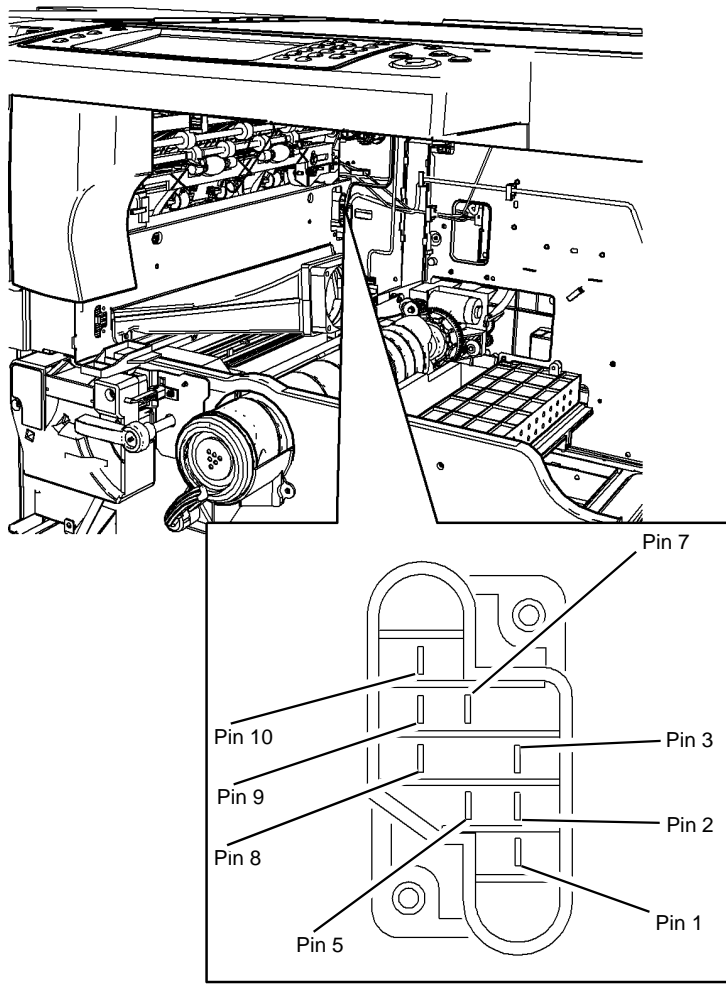
W-1-1007-B

Figure 2 Supply to the fuser module

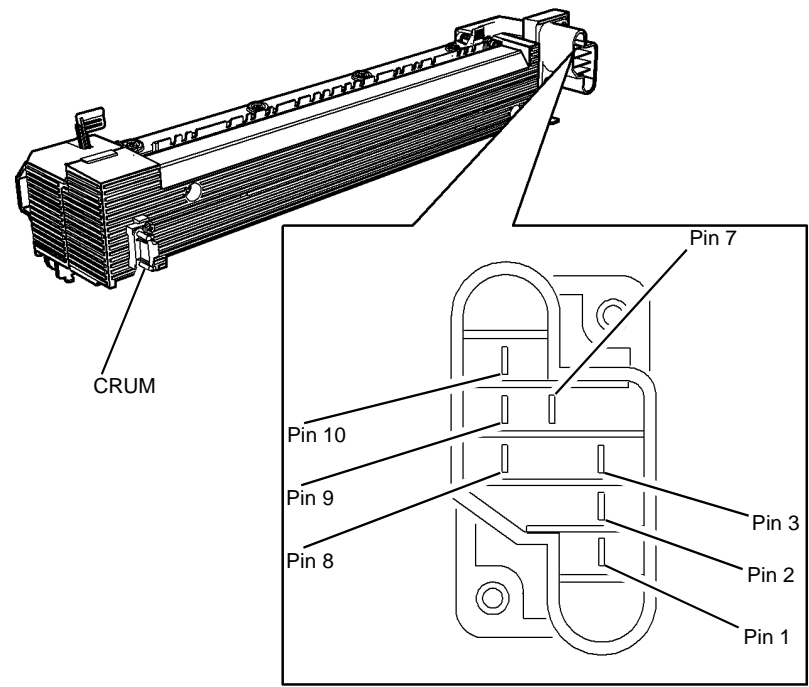
W-1-1008-B

Figure 3 Fuser module

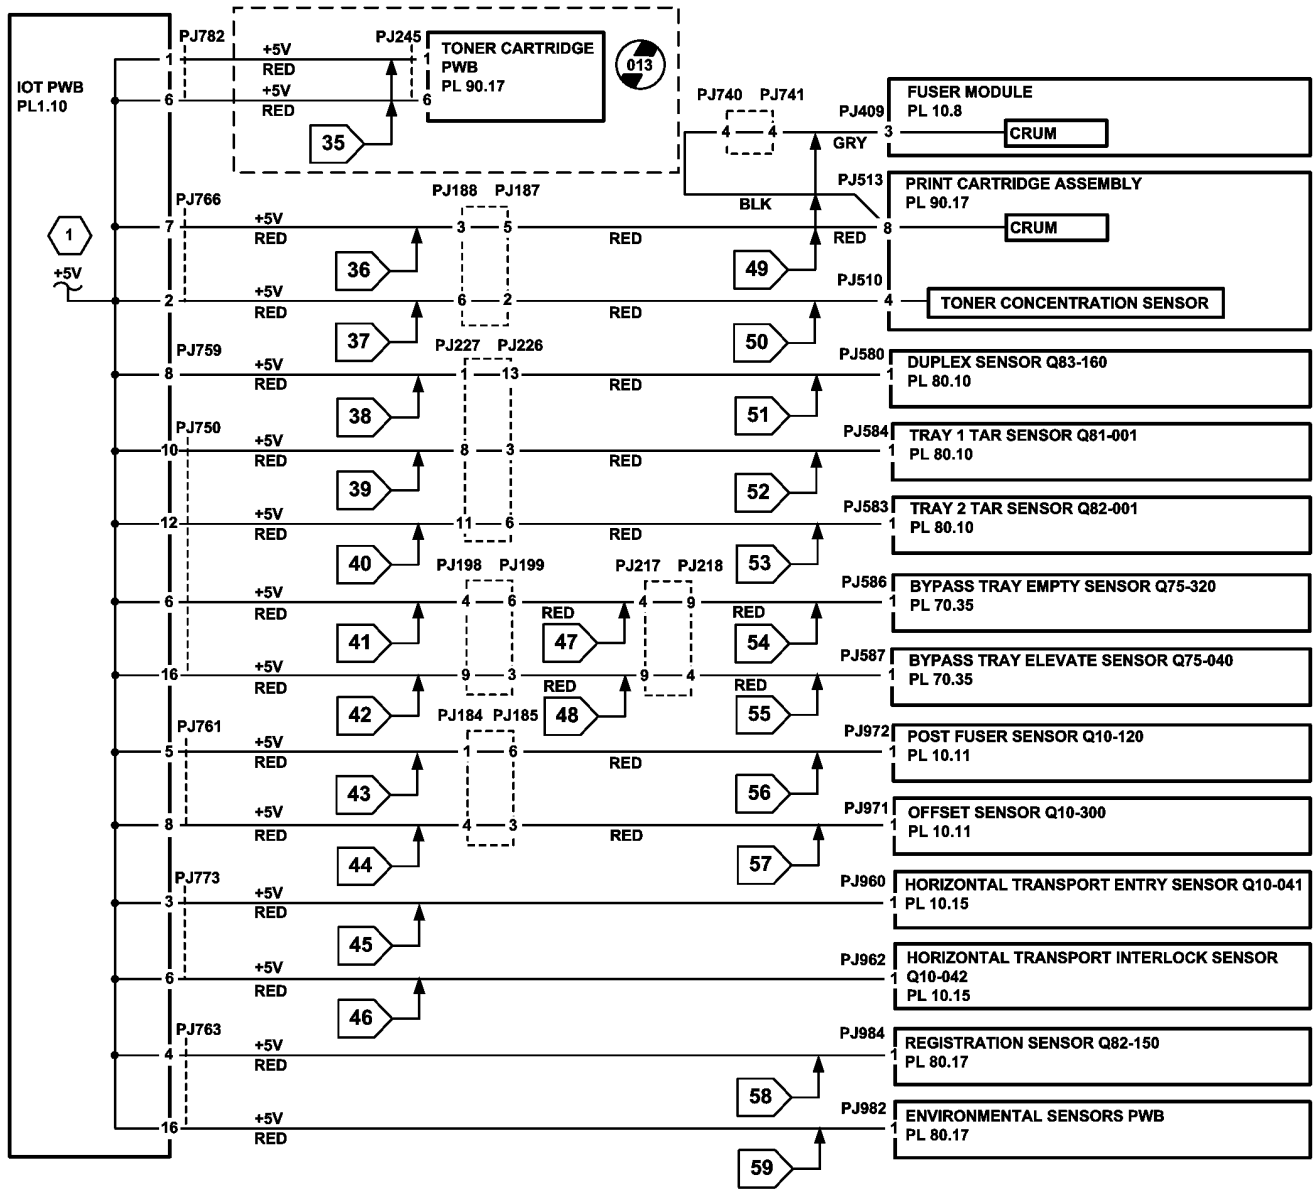
TW-1-0263-B

1 THE IOT PWB +5V SUPPLY IS SHOWN ON FIGURE 1

Figure 3 +5V distribution 3 of 4

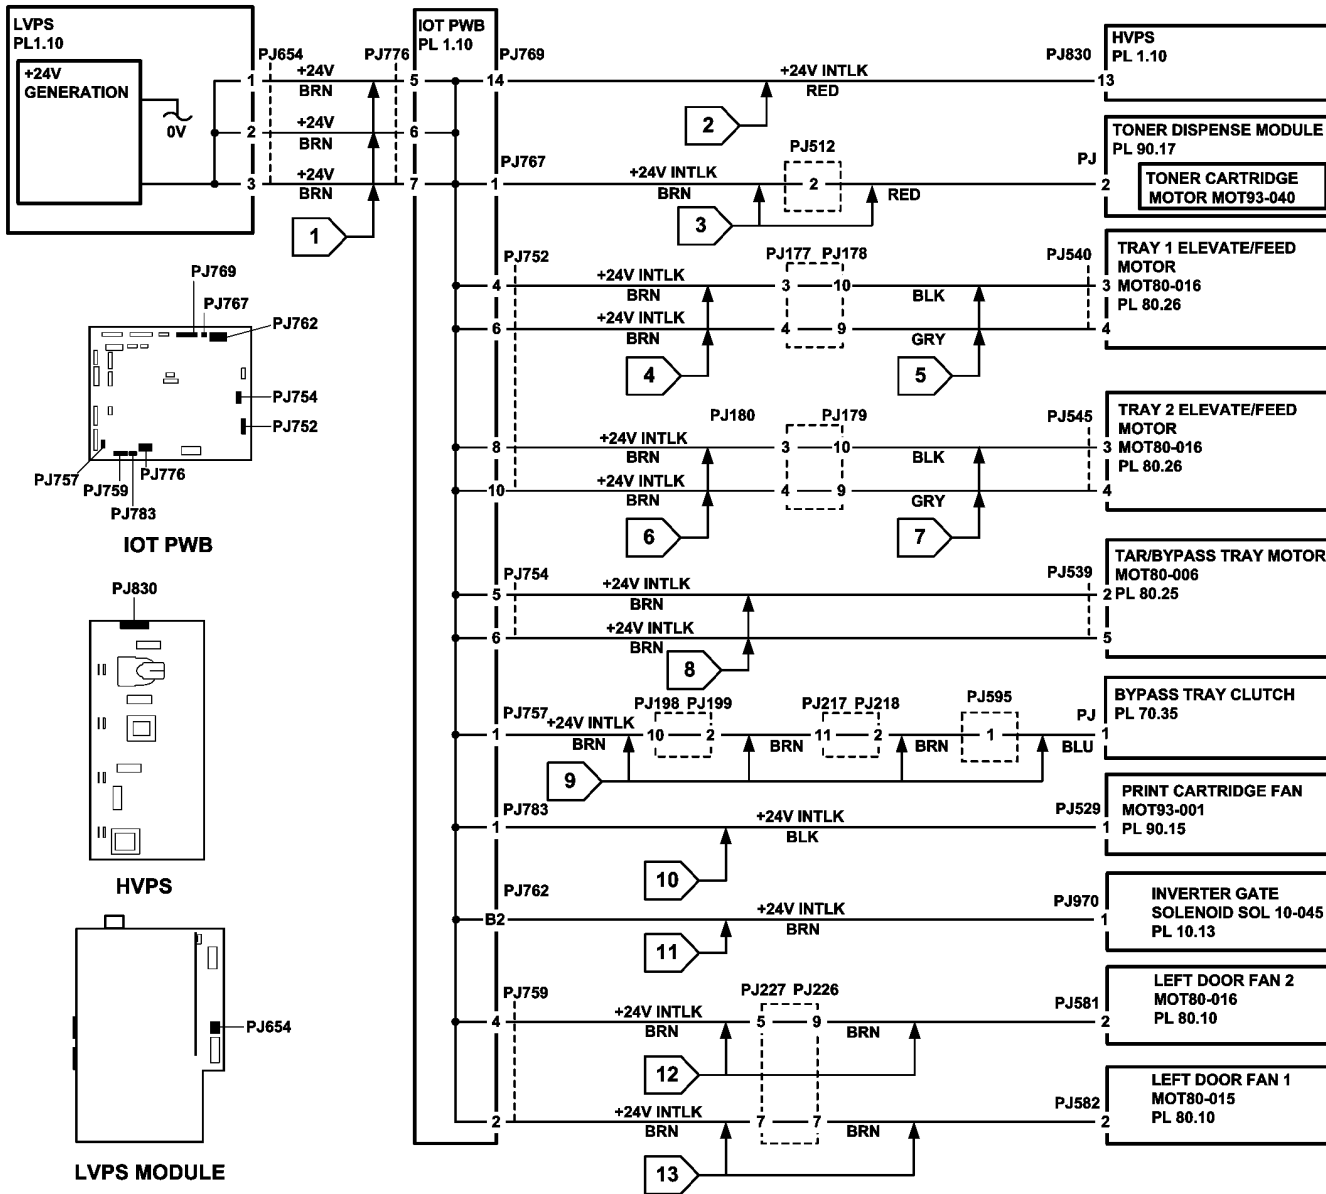
TW-1-0266-A

Figure 1 +24V Distribution 1 of 4
