708P91139
February 2016

Xerox® WorkCentre® 5945 Family Multifunction Printer Service Manual

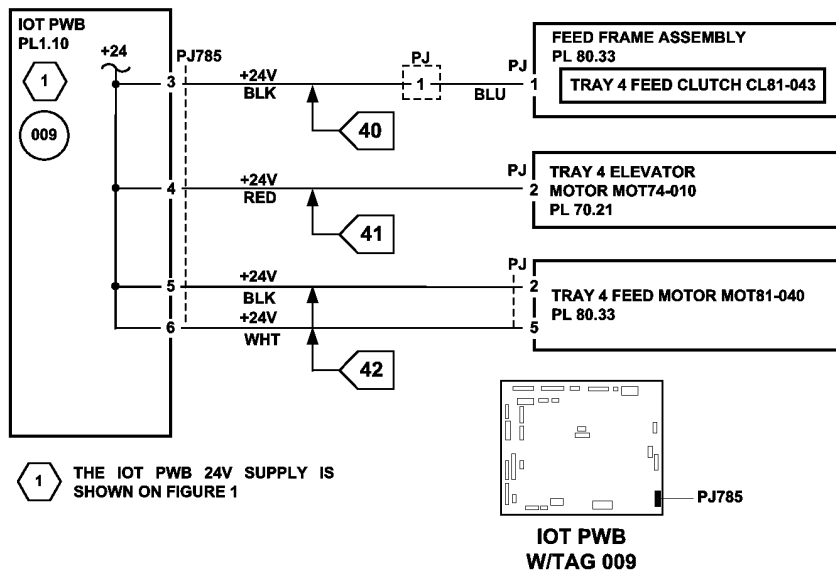
TW-1-0335-A

Figure 4 +24V Distribution 4 of 4

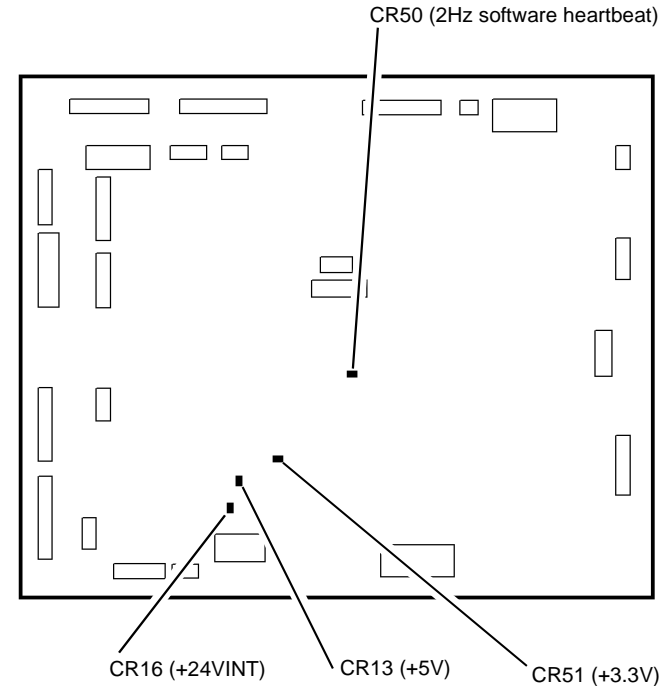
W-1-1082-A

Figure 1 IOT PWB LEDs

1. Go to [Flag 10](#). Disconnect [P/J751](#). If CR13 and CR16 are now illuminated, repair the short circuit in the wiring to the tray 1 and tray 2 paper sensors. Refer to [WD 5](#). If after 10 seconds the LEDs remain off, reconnect [P/J751](#) and continue at the next check.

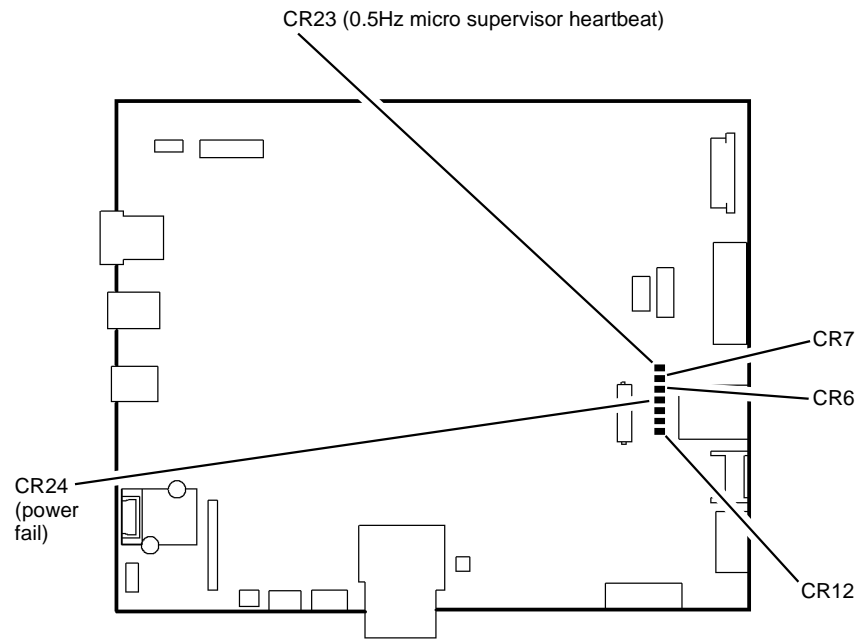
W-1-1083-A

Figure 2 SBC PWB LEDs

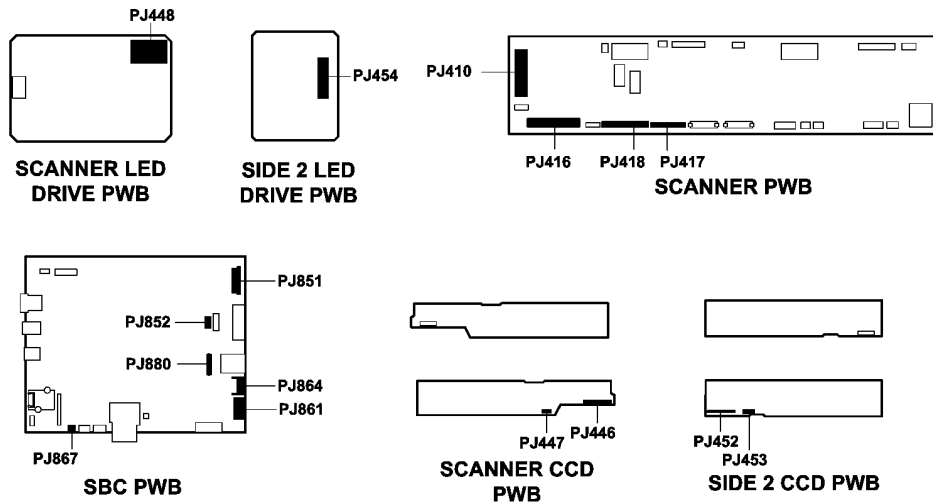
TW-1-0272-A

Figure 4 Low voltage distribution 2 of 2

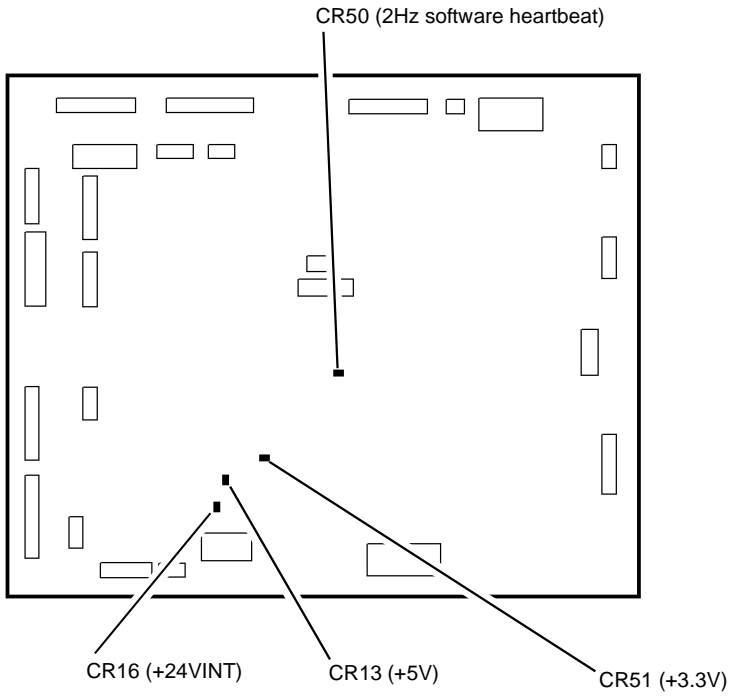
Figure 1 IOT PWB LEDs

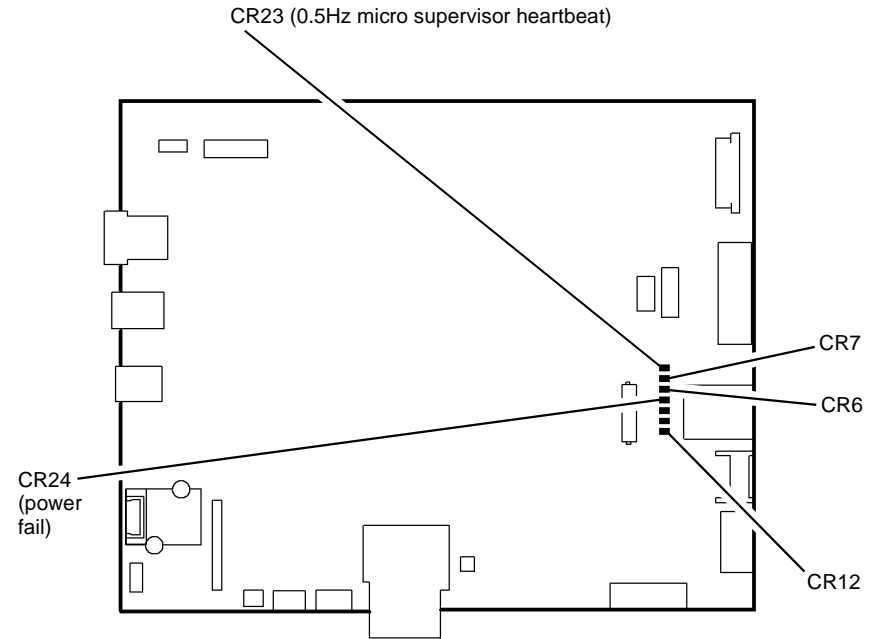
Figure 2 SBC PWB LEDs

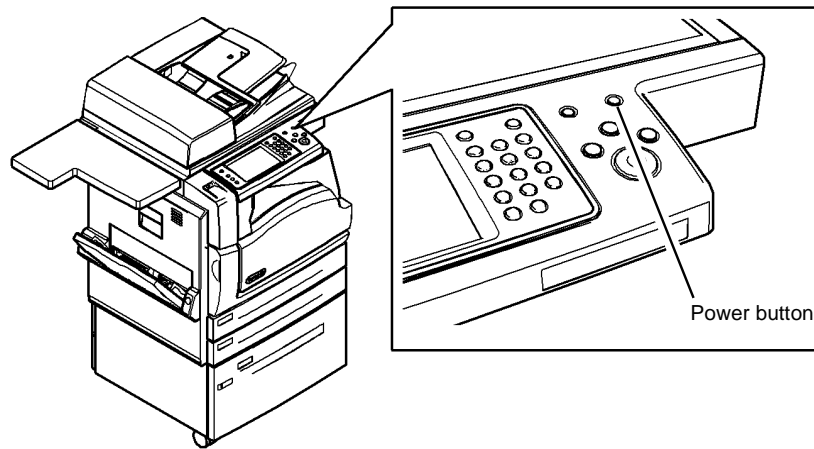
W-1-1086-A

Figure 1 Power button location

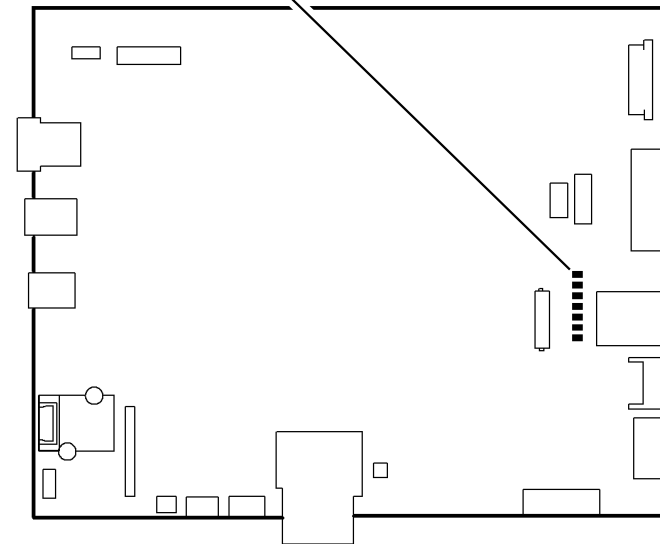
W-1-1087-A

CR23 (0.5Hz micro supervisor heartbeat)

Figure 2 Component location

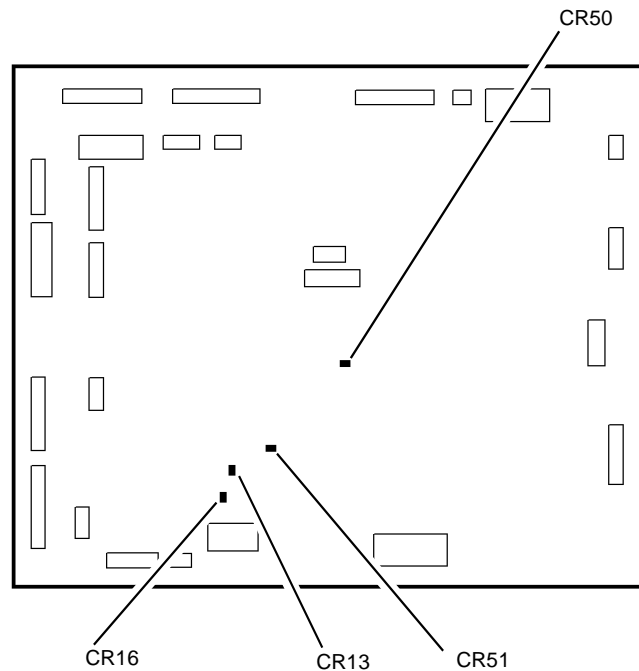
W-1-1314-A

- CR51 is illuminated yellow to indicate the presence of +3.3V (generated on the IOT PWB).

Figure 1 IOT PWB LED locations

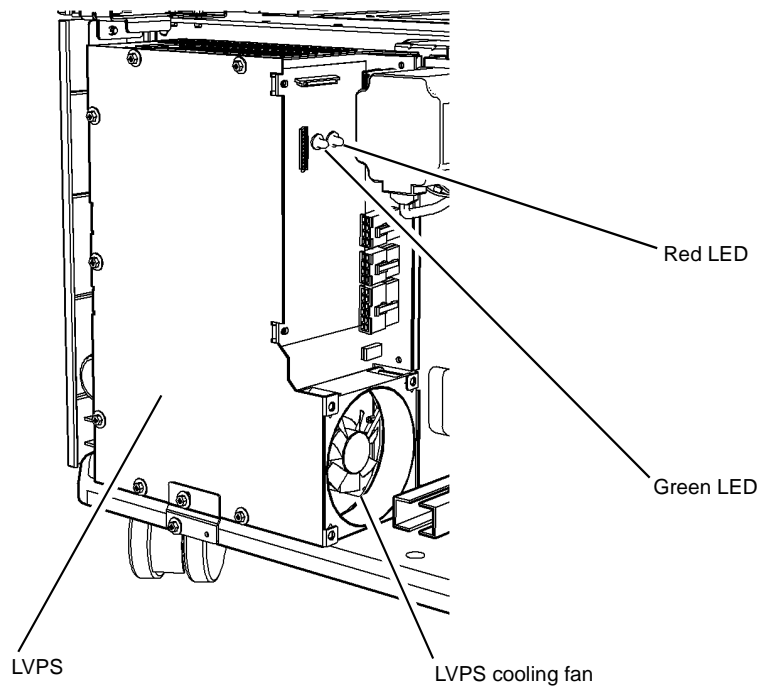
W-1-1307-A

Figure 3 Component location

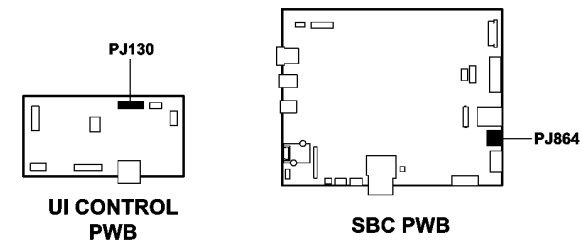
TW-1-0178-B

Figure 1 Circuit Diagram

1. Switch off, then switch on the machine, GP 14.
2. Go to Flag 1. Check the wiring between P/J130 on the UI control PWB and P/J864 on the SBC PWB. Repair the wiring, REP 1.2. Install new components as necessary:
 - SBC PWB to UI PWB harness, PL 3.22 Item 15.
 - UI control PWB, PL 2.10 Item 6.
3. If the fault persists, perform the 303D SBC PWB Diagnostics RAP.

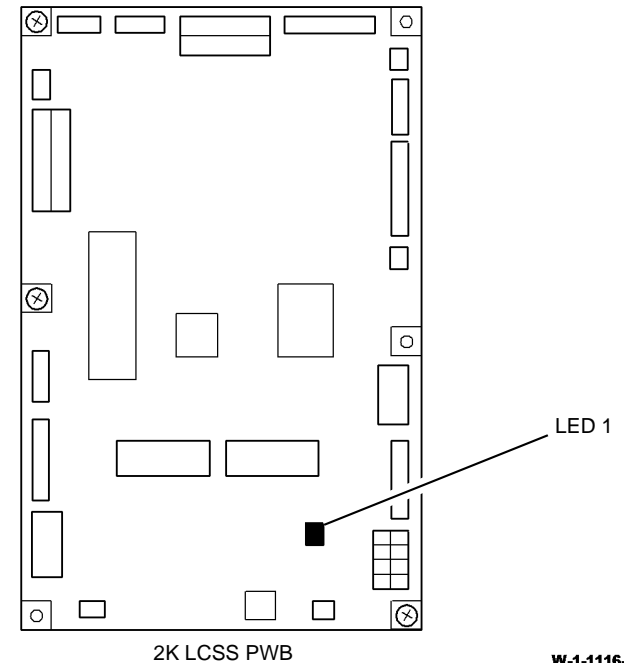
W-1-1116-A

Figure 1 2L LCSS component location

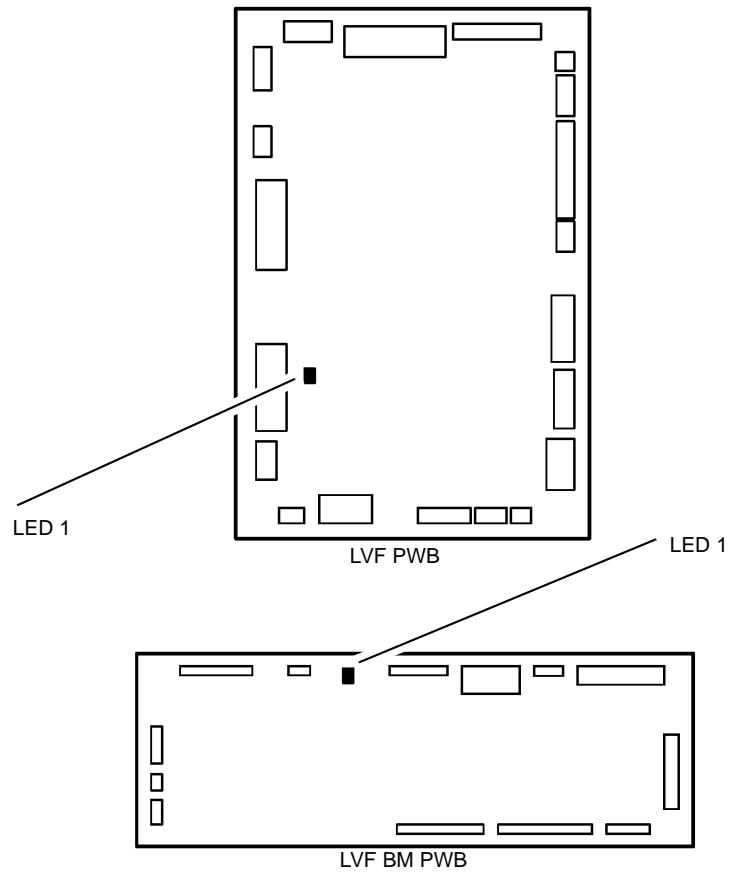
W-1-1066-A

Figure 2 LVF BM component location

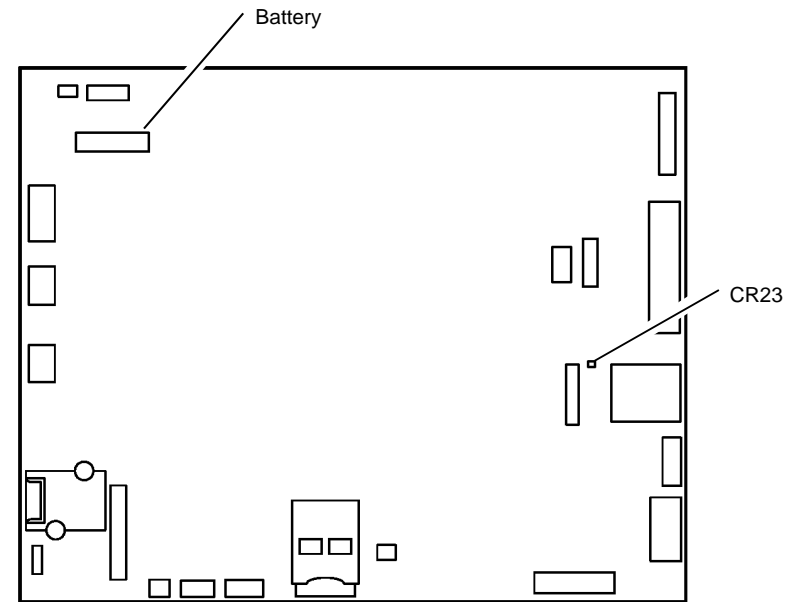
W-1-1070-A

Figure 2 SBC PWB

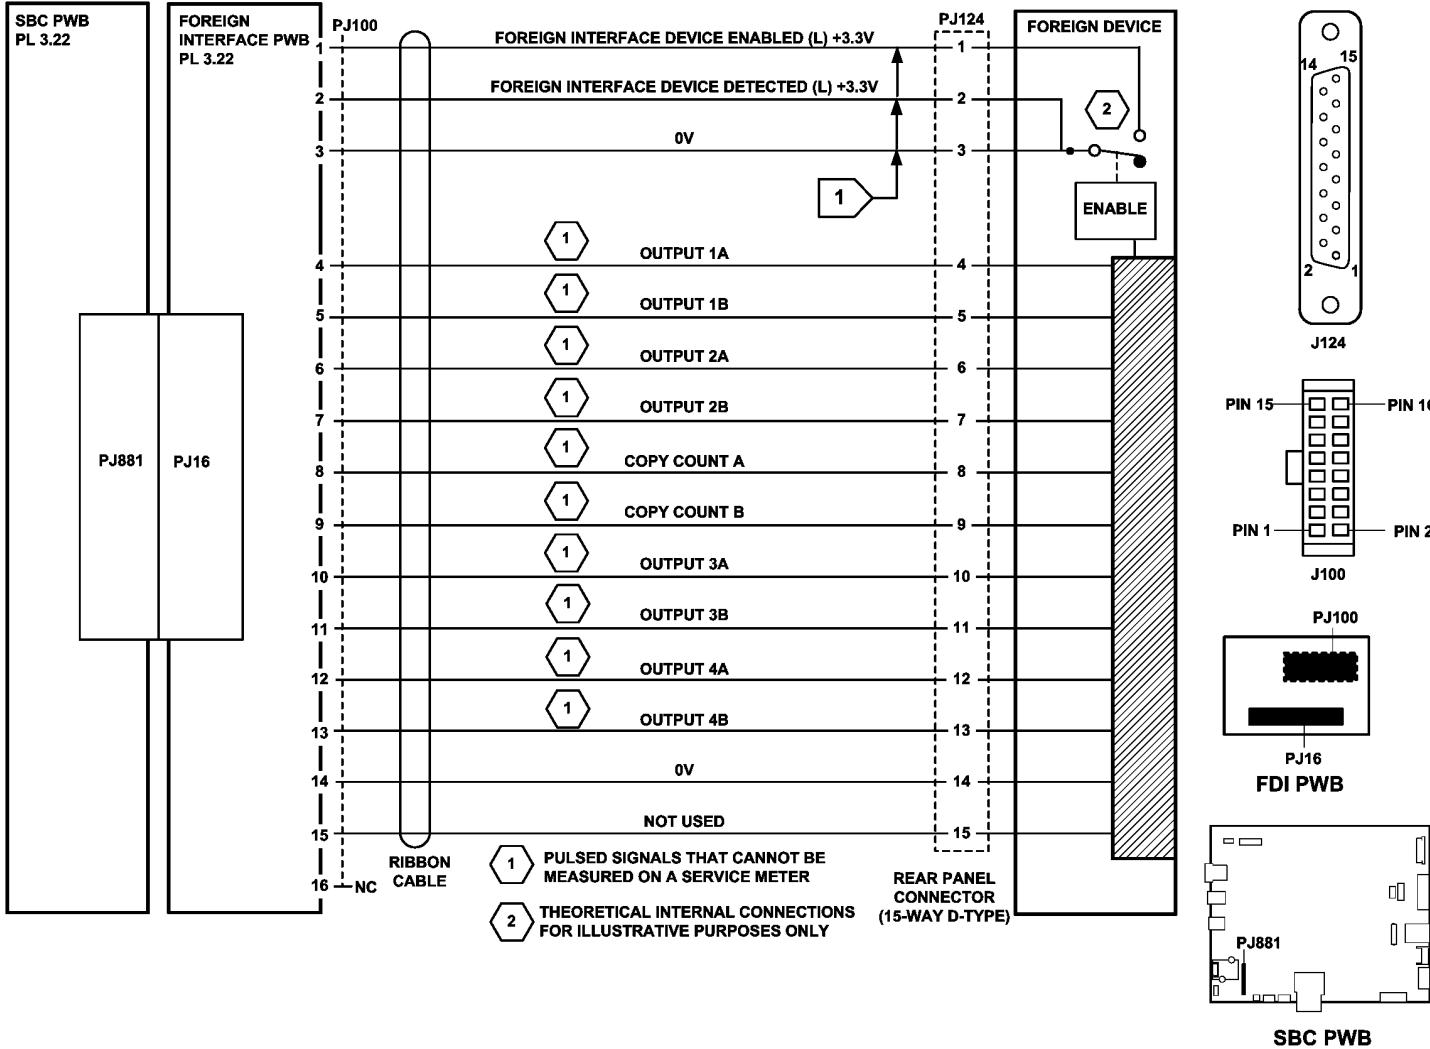
TW-1-0179-A

Figure 1 Circuit diagram

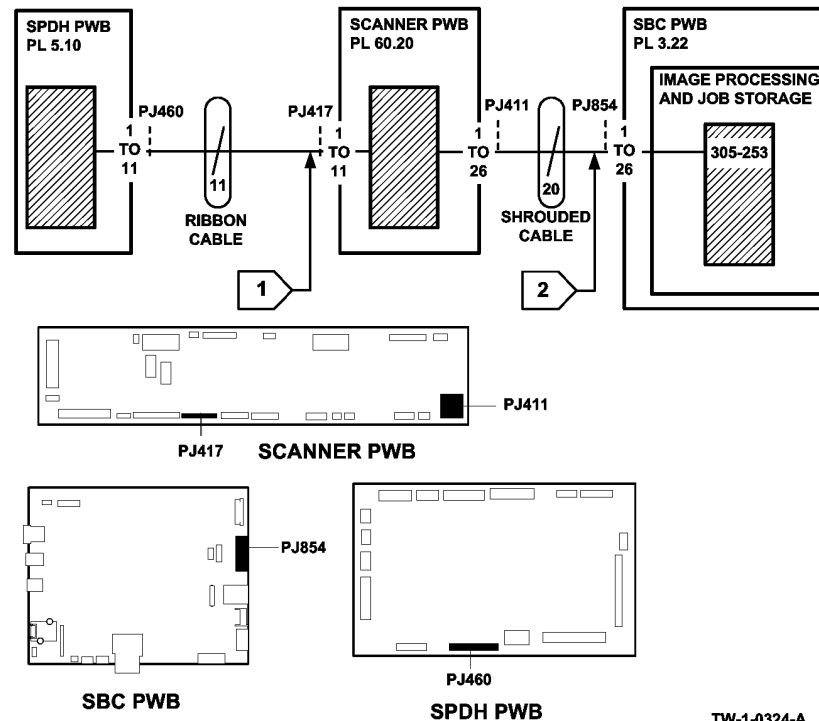
TW-1-0324-A

Figure 1 Circuit diagram

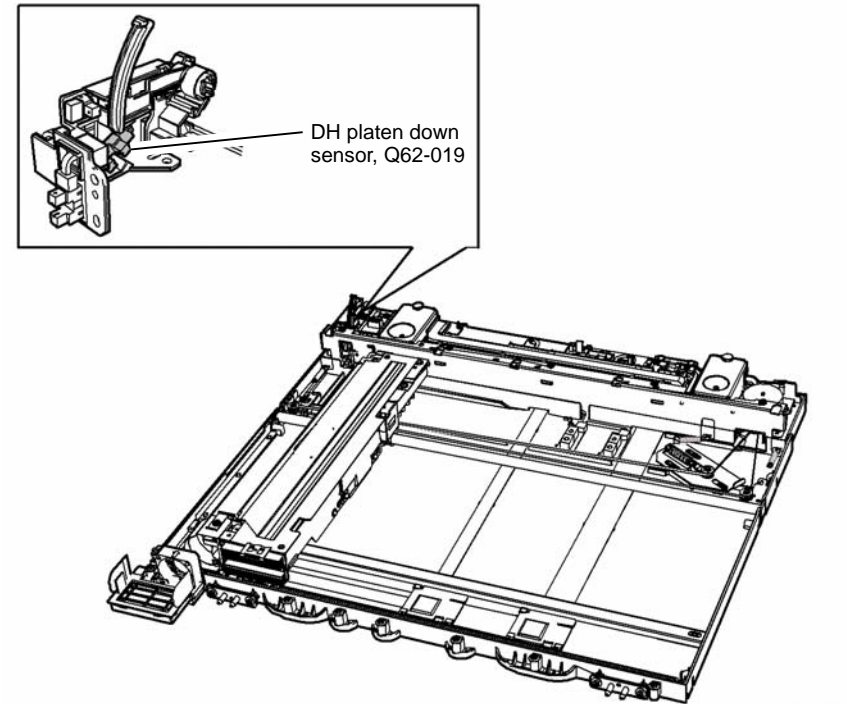
Check that Q62-019 is installed correctly.

Figure 1 Component location

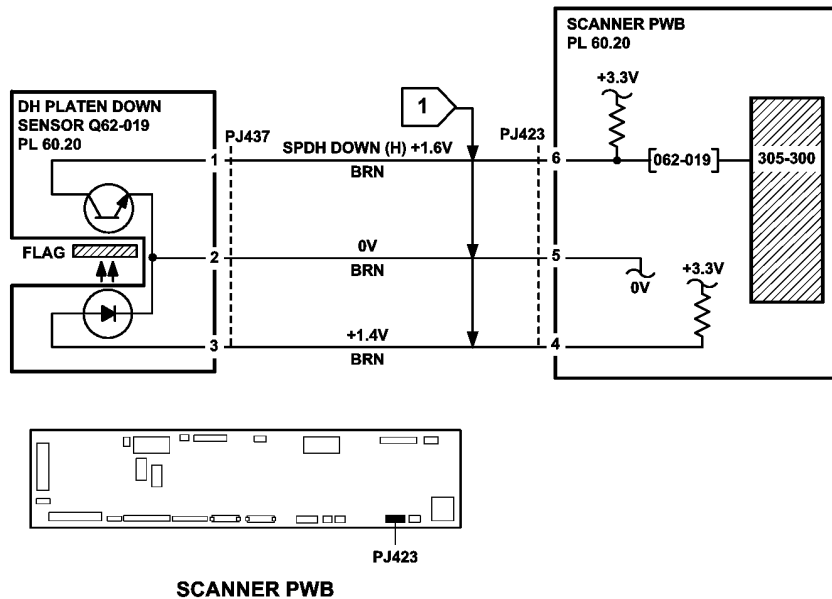
TW-1-0006-A

Figure 2 Circuit diagram

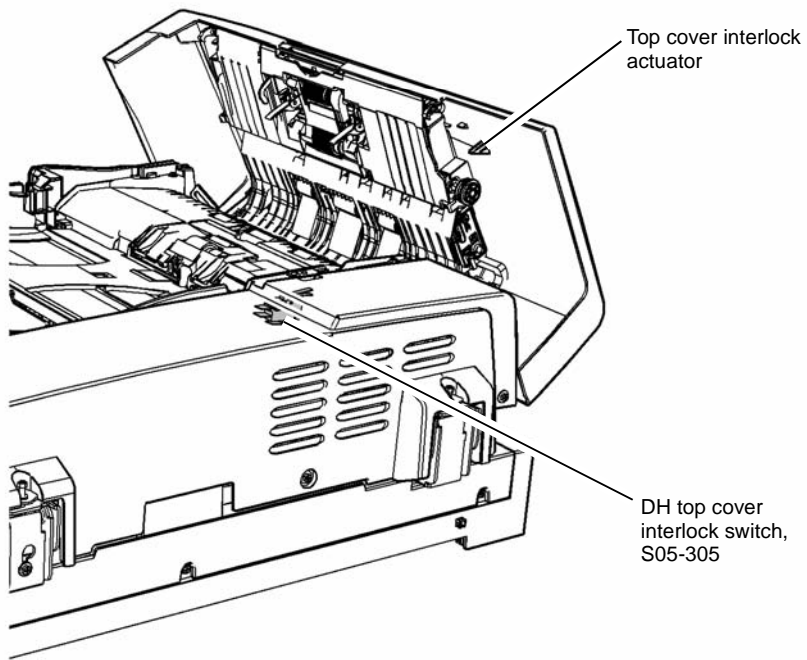
w-1-0005-A

Check that S05-305 is installed correctly and that the switch arm is not bent or damaged. The switch should be heard to click as it is actuated or de-actuated by closing and opening the top cover.

Figure 1 Component location

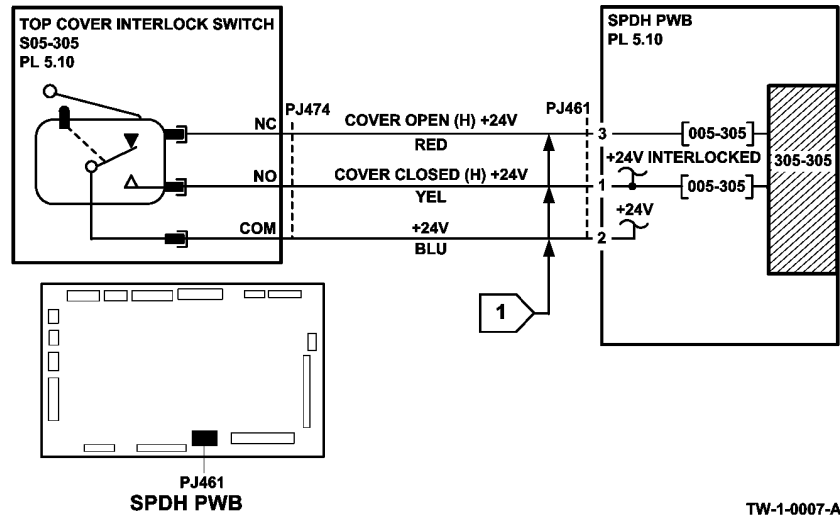
Figure 2 Circuit diagram

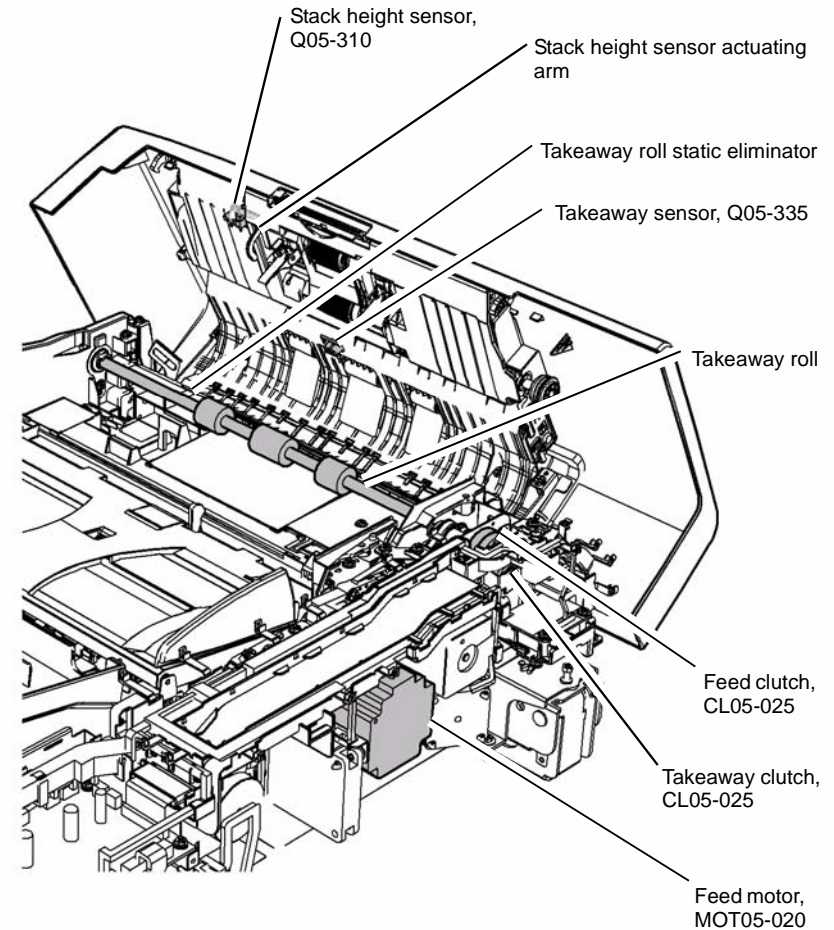
W-1-1006-B

Figure 1 Component location

- Check the takeaway roll static eliminator, [Figure 1](#).
- Ensure that the SPDH is connected to ground correctly. Refer to [301A](#) Ground Distribution RAP.
- Check the condition and operation of the items that follow. If necessary clean the items or install new components:
 - Feed roll, [PL 5.20 Item 6](#).
 - Nudger roll, [PL 5.20 Item 7](#).
 - Retard roll, [PL 5.25 Item 3](#).
- Check for a malfunction of the last sheet out sensor, Q05-308. Perform the [305B](#) Last Sheet Out Sensor Failure RAP.
- Check the correct location and mechanical operation of the stack height sensor, Q05-310 and the stack height sensor actuating arm, [Figure 1](#). Refer to [REP 5.8](#).

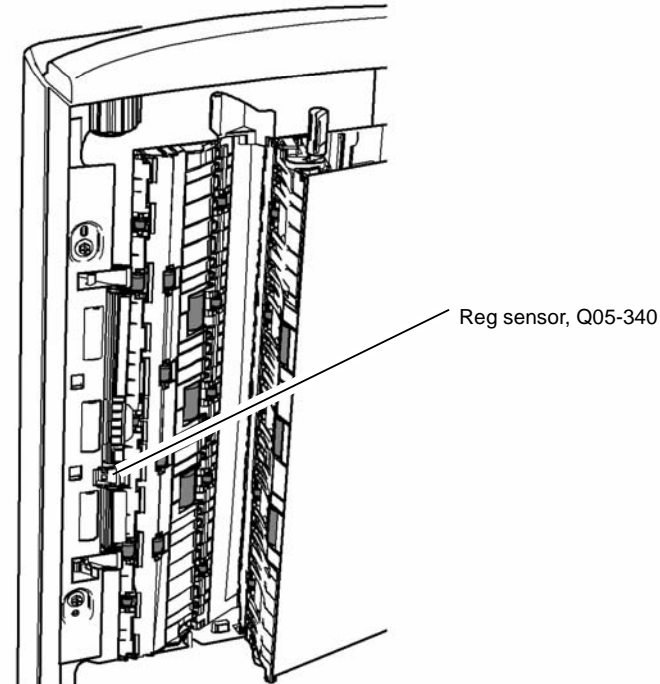
W-1-0904-A

Figure 1 Component location

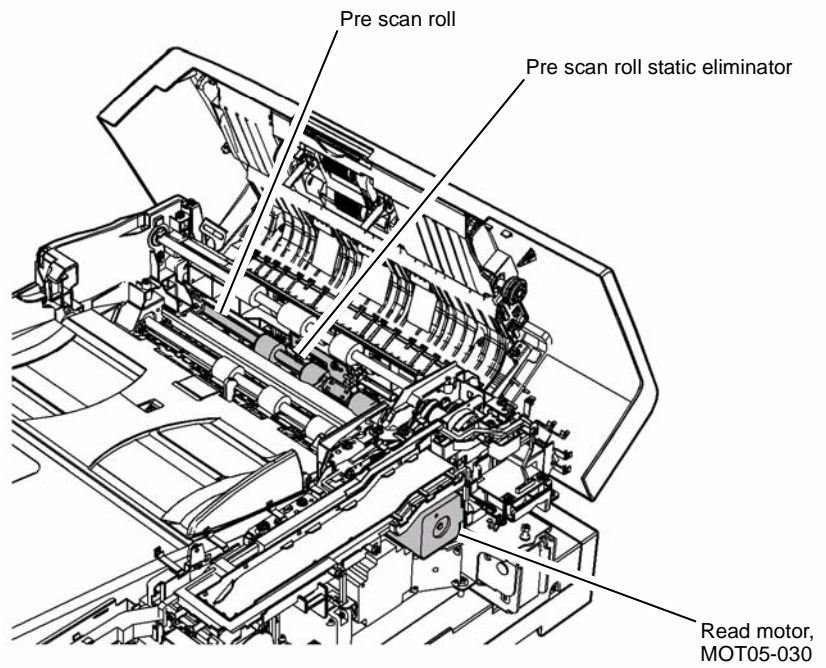
W-1-0007-A

Figure 2 Component location

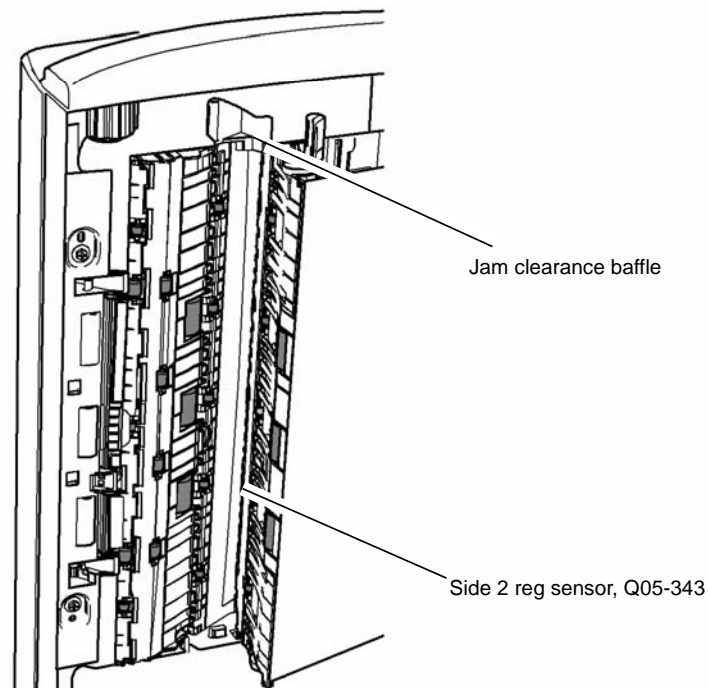
W-1-0009-A

Figure 1 Component location

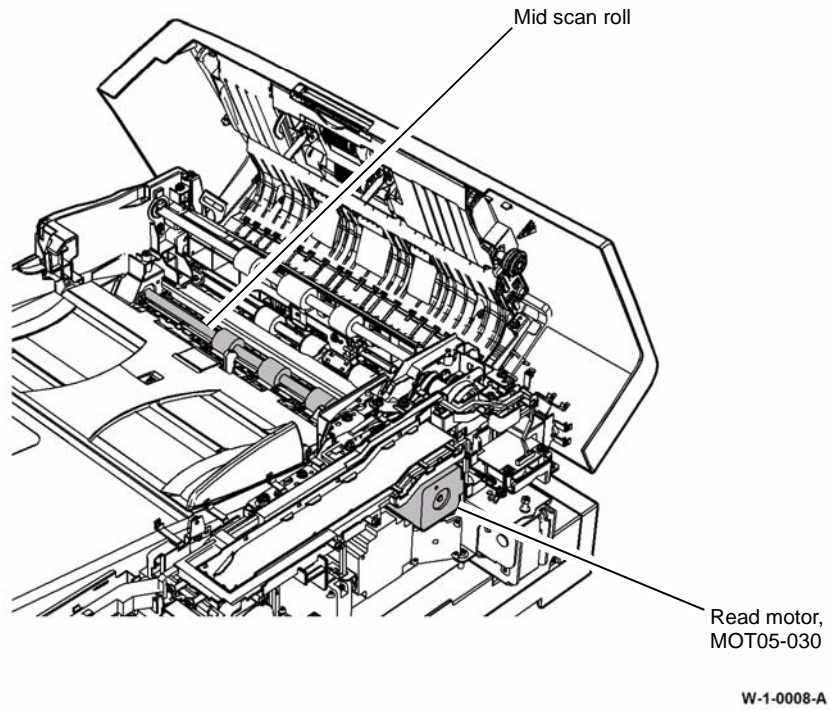
Figure 2 Component location

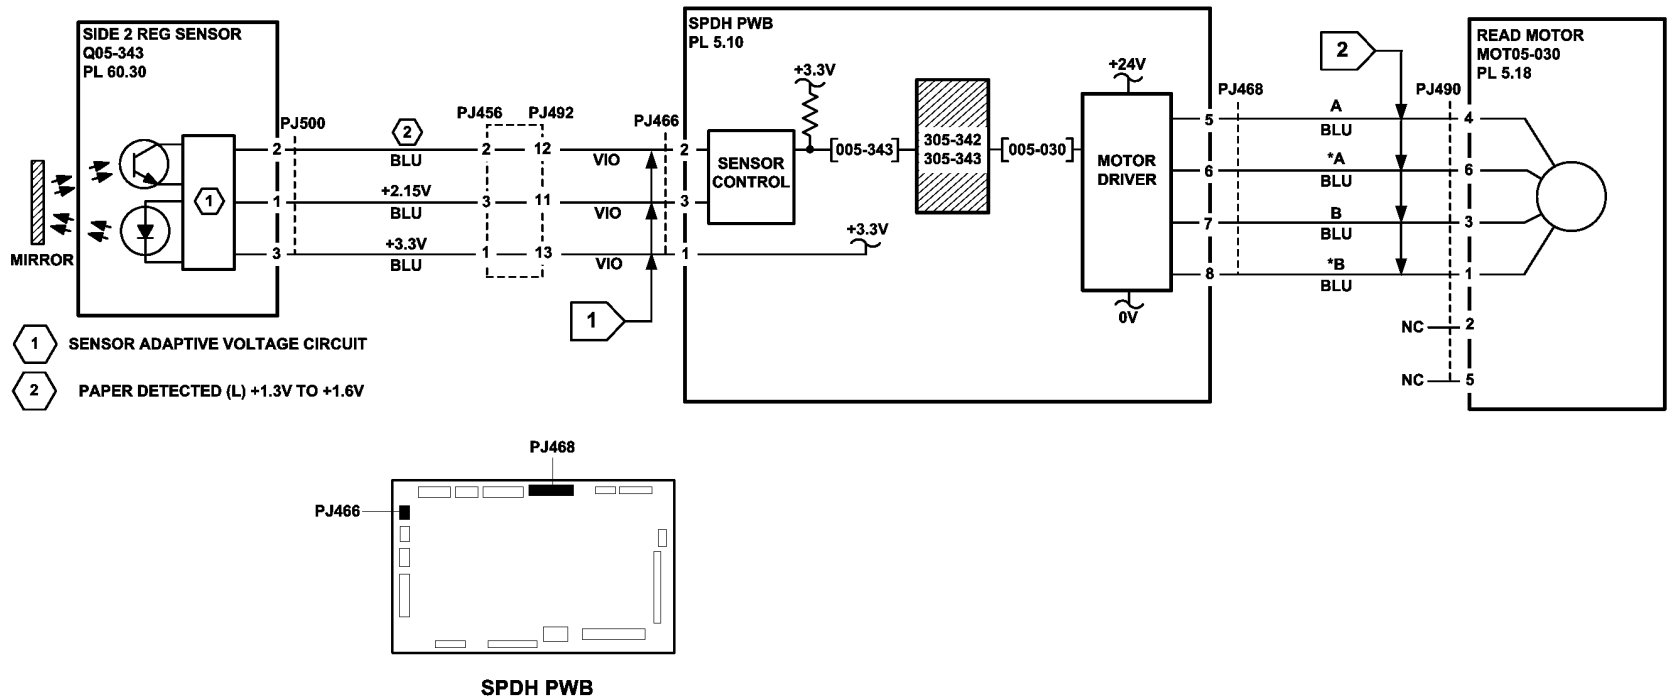
TW-1-0010-A

Figure 3 Circuit diagram

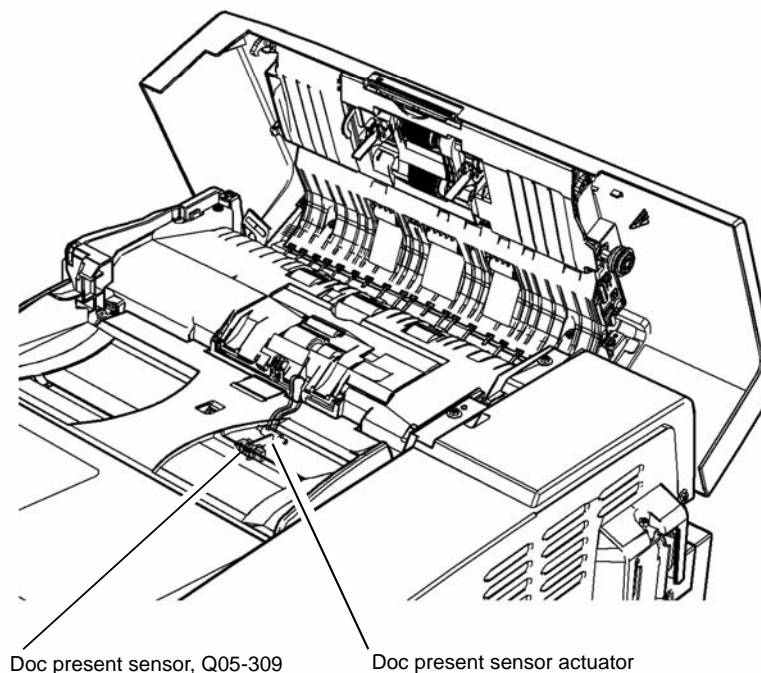
W-1-0010-A

Check that Q05-309, [PL 5.30 Item 5](#) and the doc present sensor actuator, [PL 5.30 Item 6](#) are correctly installed and undamaged.

Figure 1 Component location

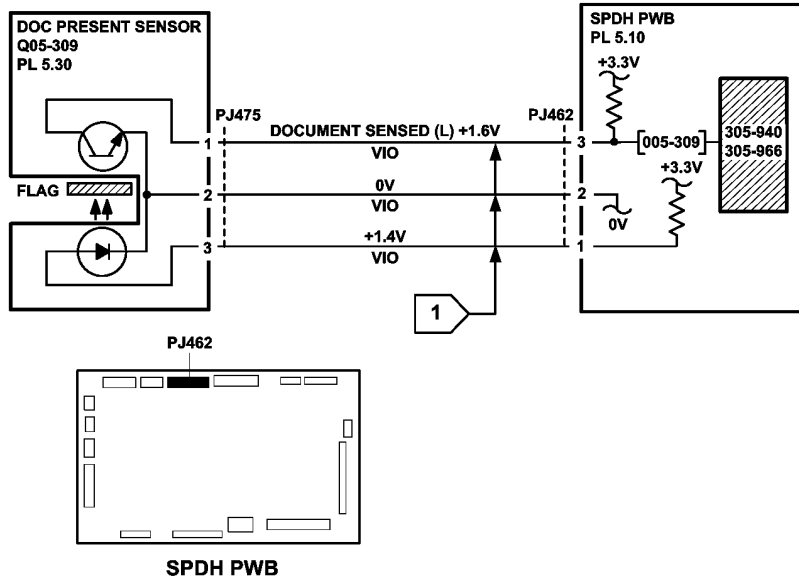
TW-1-0011-A

Figure 2 Circuit diagram

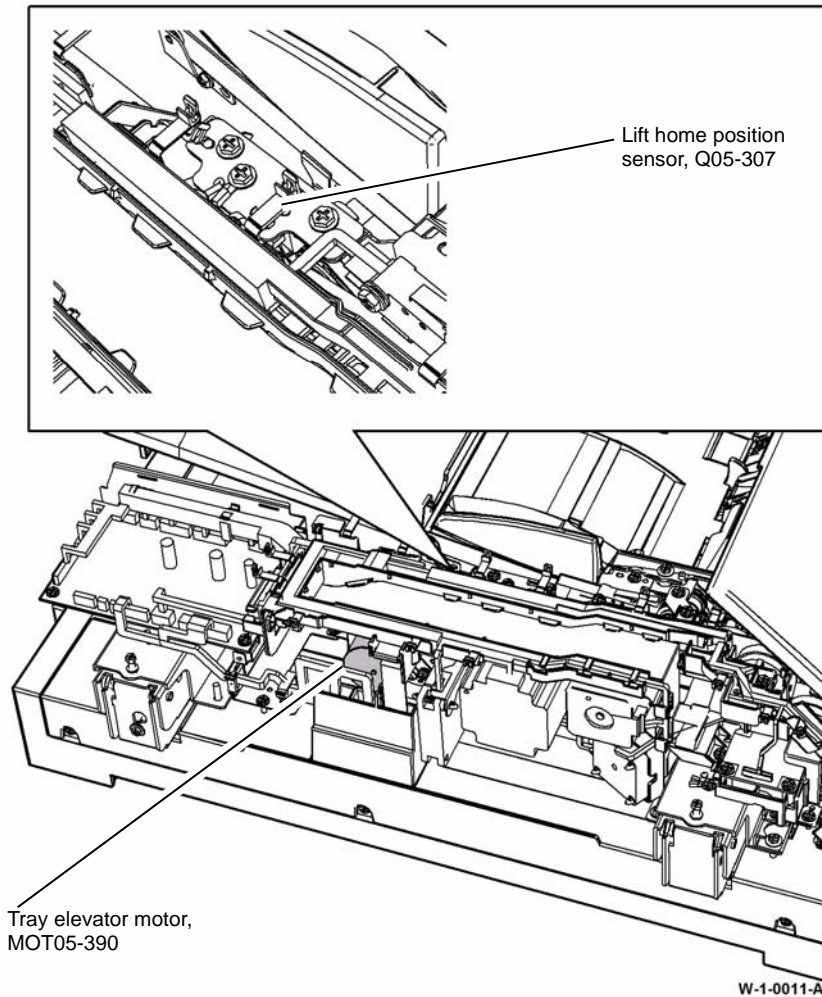
Figure 1 Component location

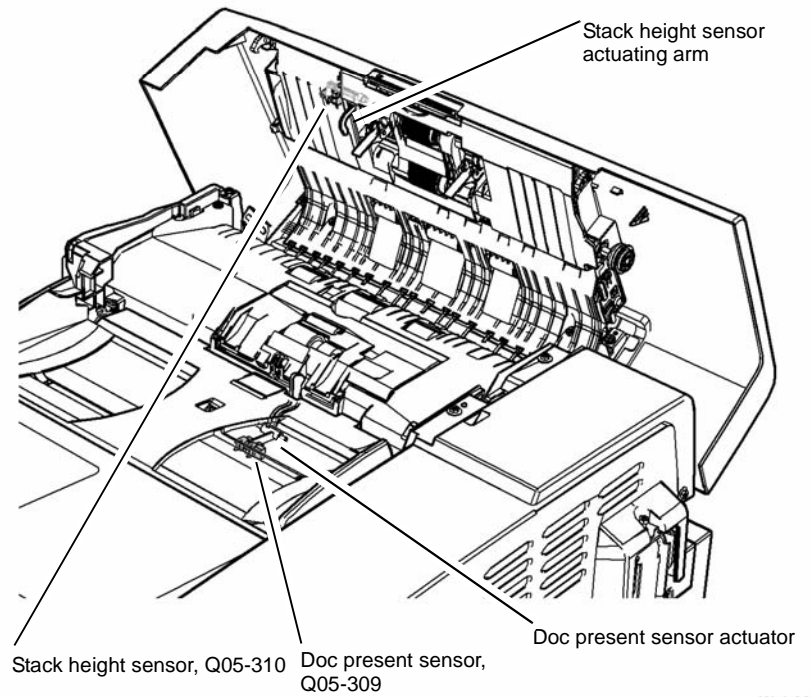
Figure 2 Component location

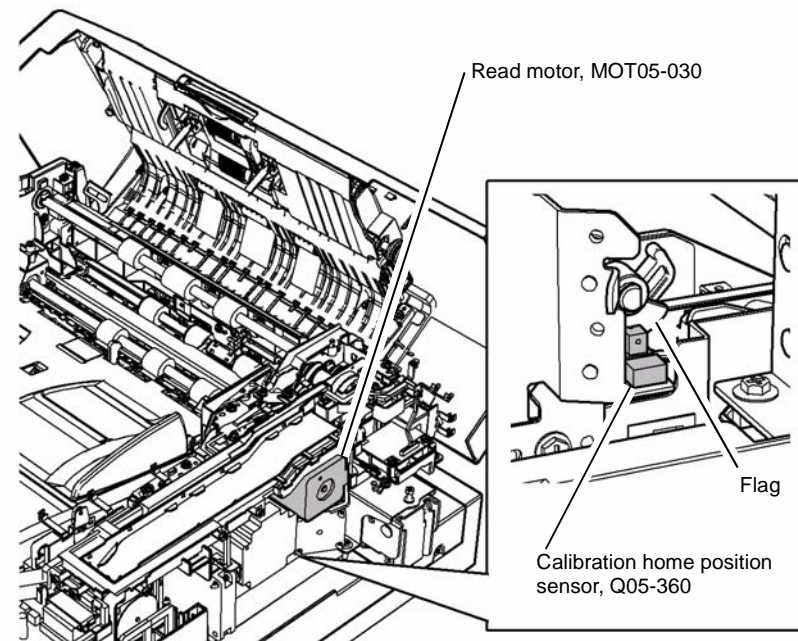
W-1-0014-A

Figure 1 Component location

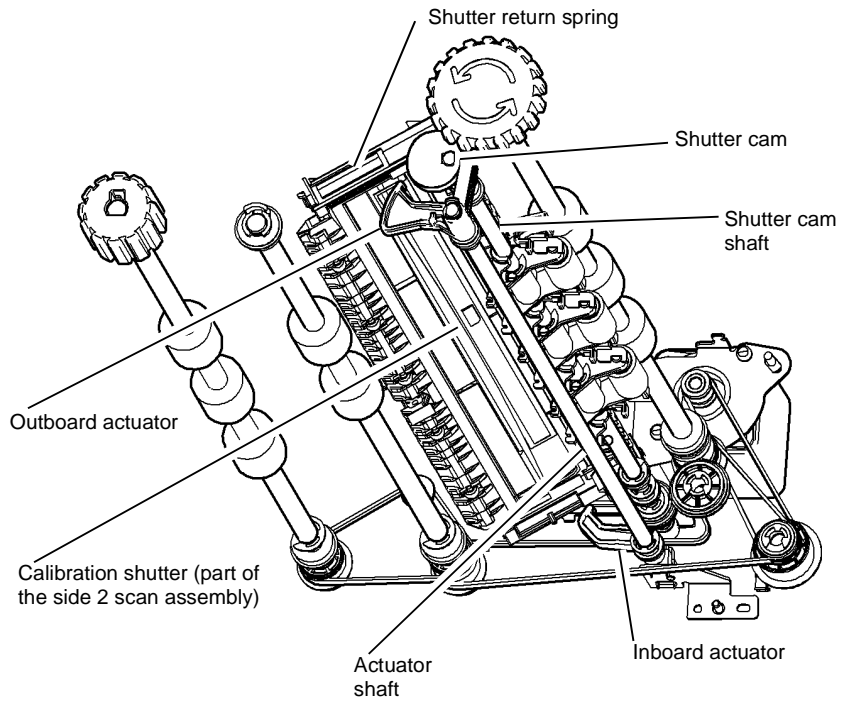
W-1-0015-A

Figure 2 Calibration shutter mechanism

Check the calibration shutter mechanism, [Figure 2](#). Repair any damaged components if possible. If necessary install a new SPDH, [PL 5.10 Item 9](#).

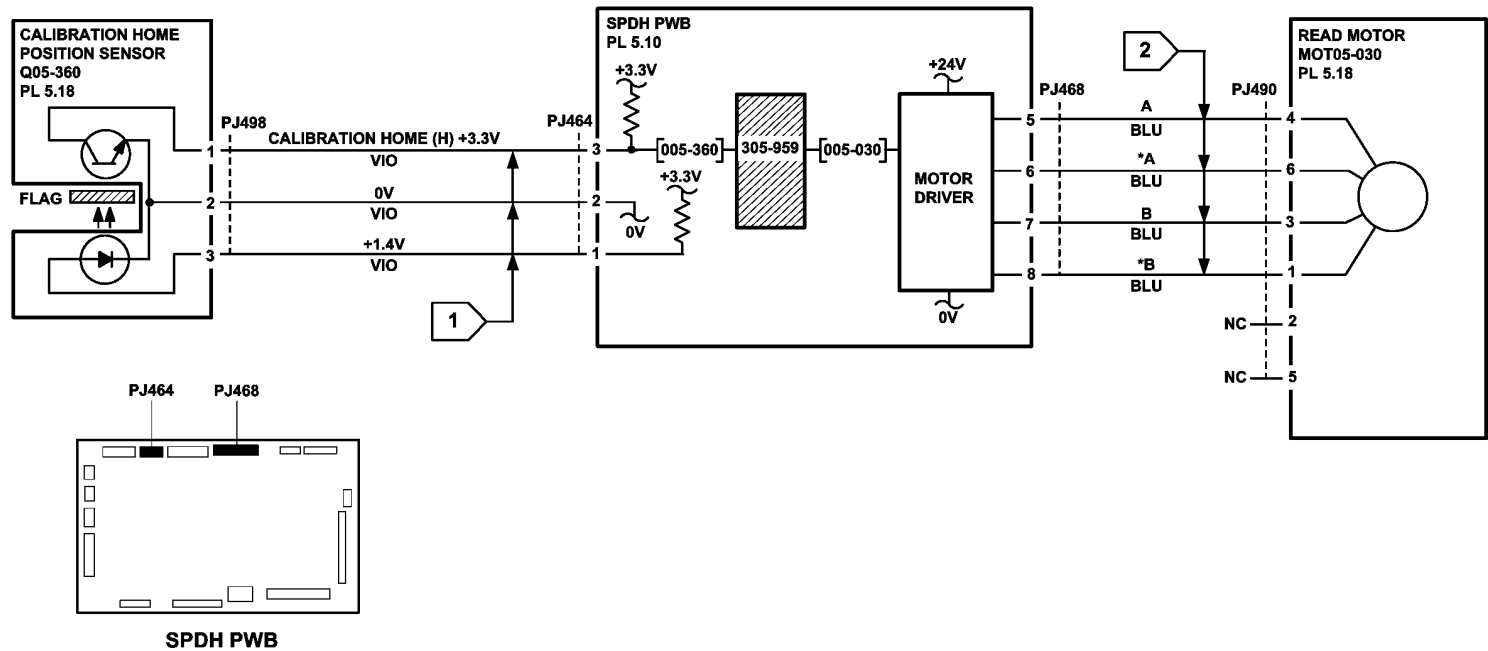
TW-1-0012-A

Figure 3 Circuit diagram

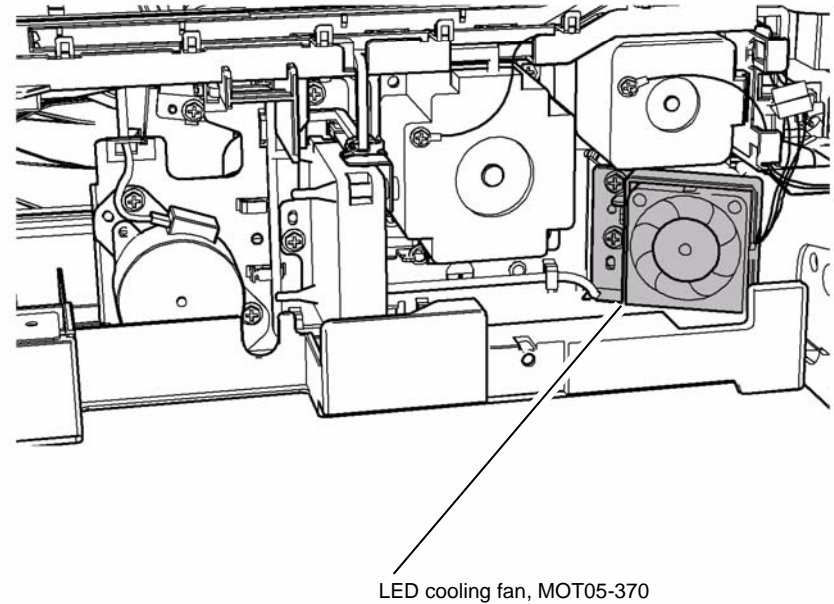
W-1-0016-A

Figure 1 Component location

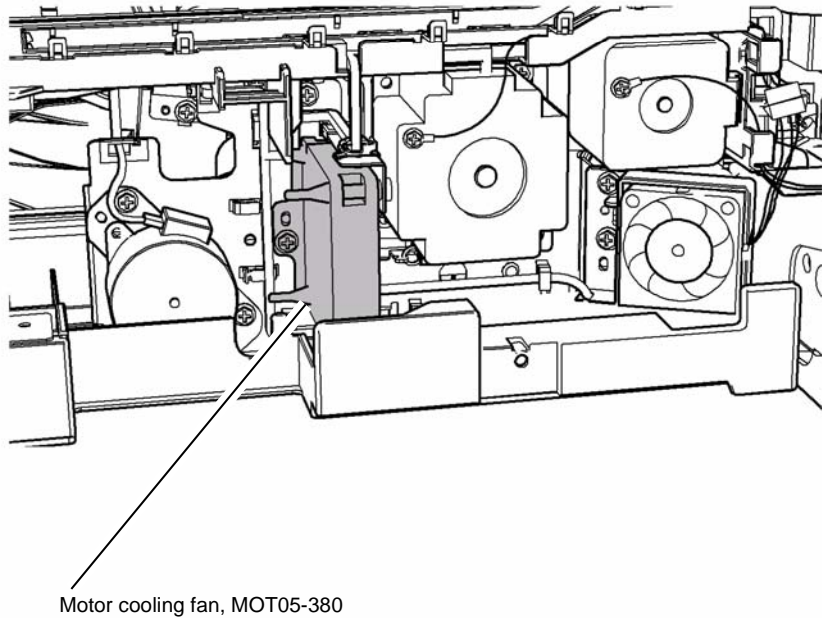
W-1-0017-A

Motor cooling fan, MOT05-380

Figure 1 Component location

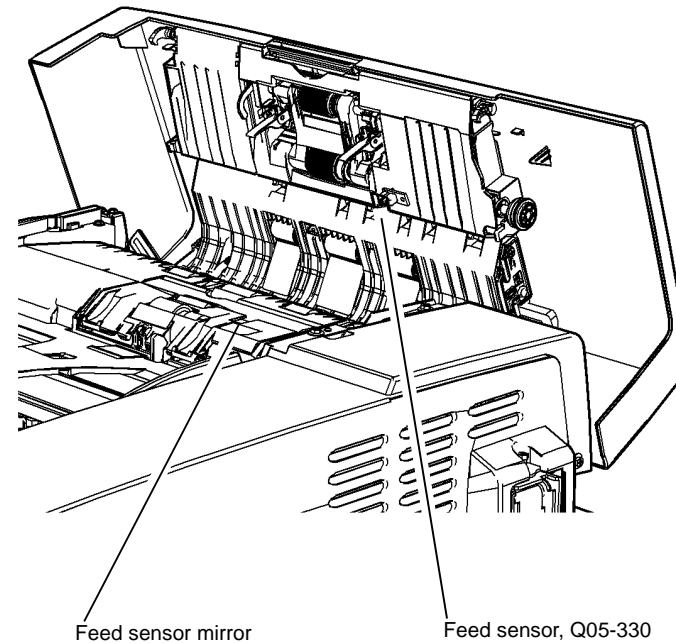
W-1-0018-A

Figure 1 Component location

Clean the feed sensor mirror, Figure 1. Switch off, then switch on the machine, GP 14. If the fault persists, install new components:

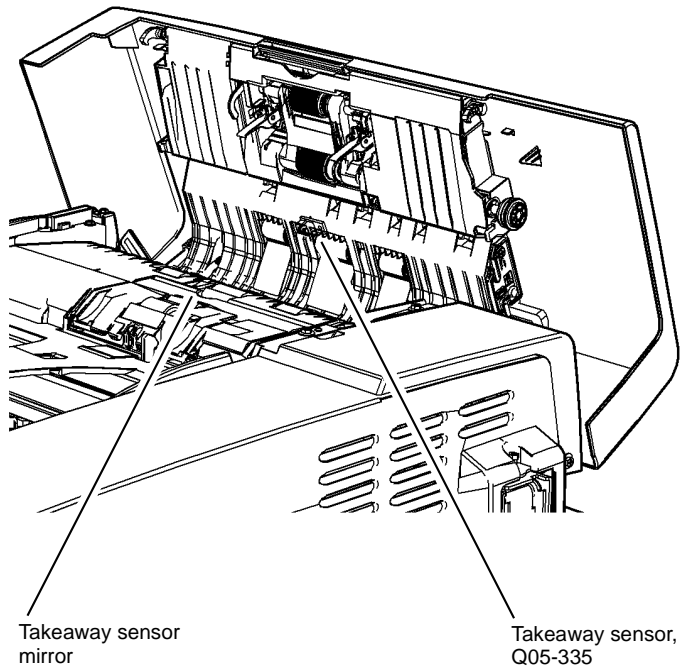
W-1-0019-A

Figure 1 Component location

Clean the takeaway sensor mirror, Figure 1. Switch off, then switch on the machine, GP 14. If the fault persists, install new components:

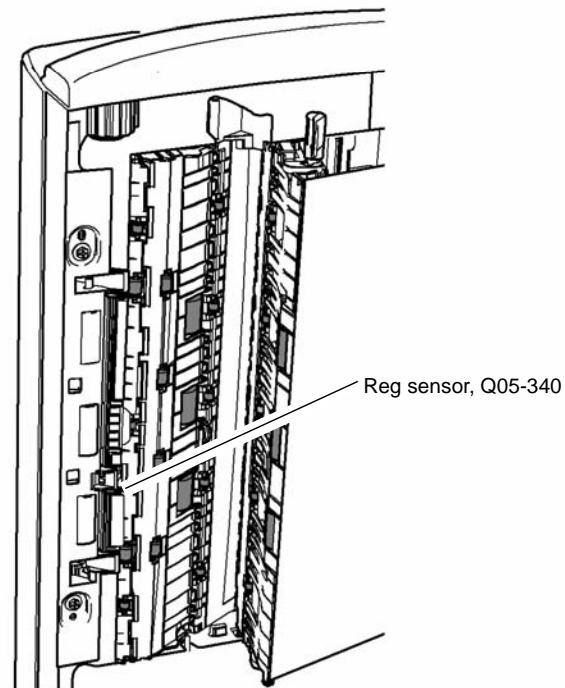
W-1-0020-A

Figure 1 Component location

Clean the reg sensor mirror, [Figure 1](#). Switch off, then switch on the machine, [GP 14](#). If the fault persists, install new components:

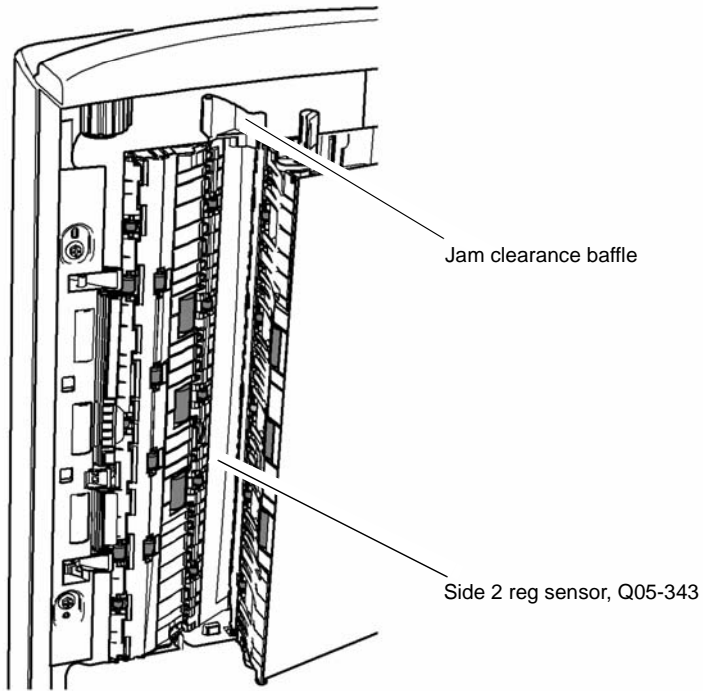
W-1-0021-A

Figure 1 Component location

Clean the side 2 reg sensor mirror, [Figure 1](#). Switch off, then switch on the machine, [GP 14](#). If the fault persists, install new components:
