708P91139
February 2016

Xerox® WorkCentre® 5945 Family Multifunction Printer Service Manual

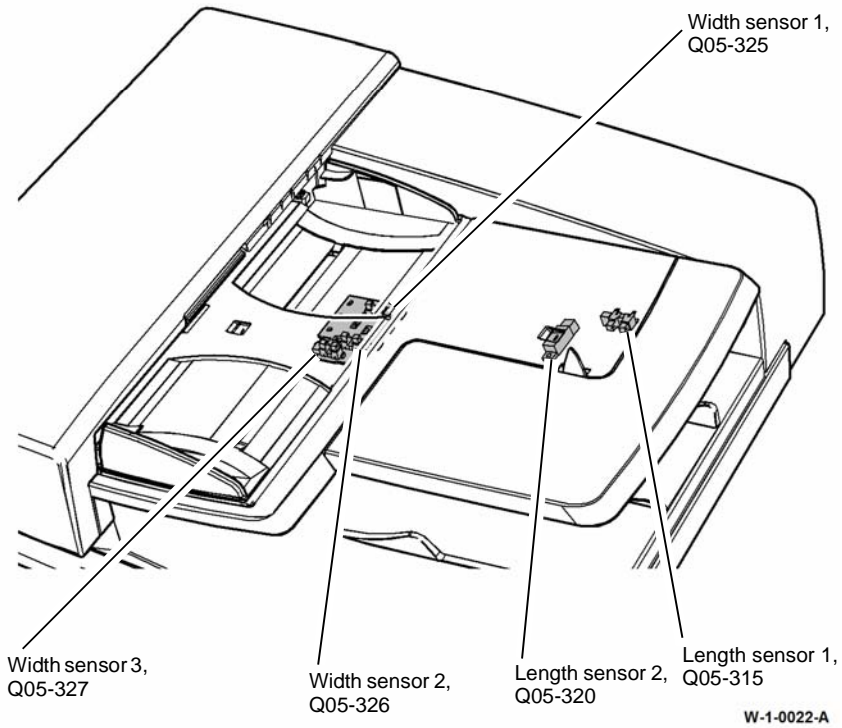
Figure 1 Component location

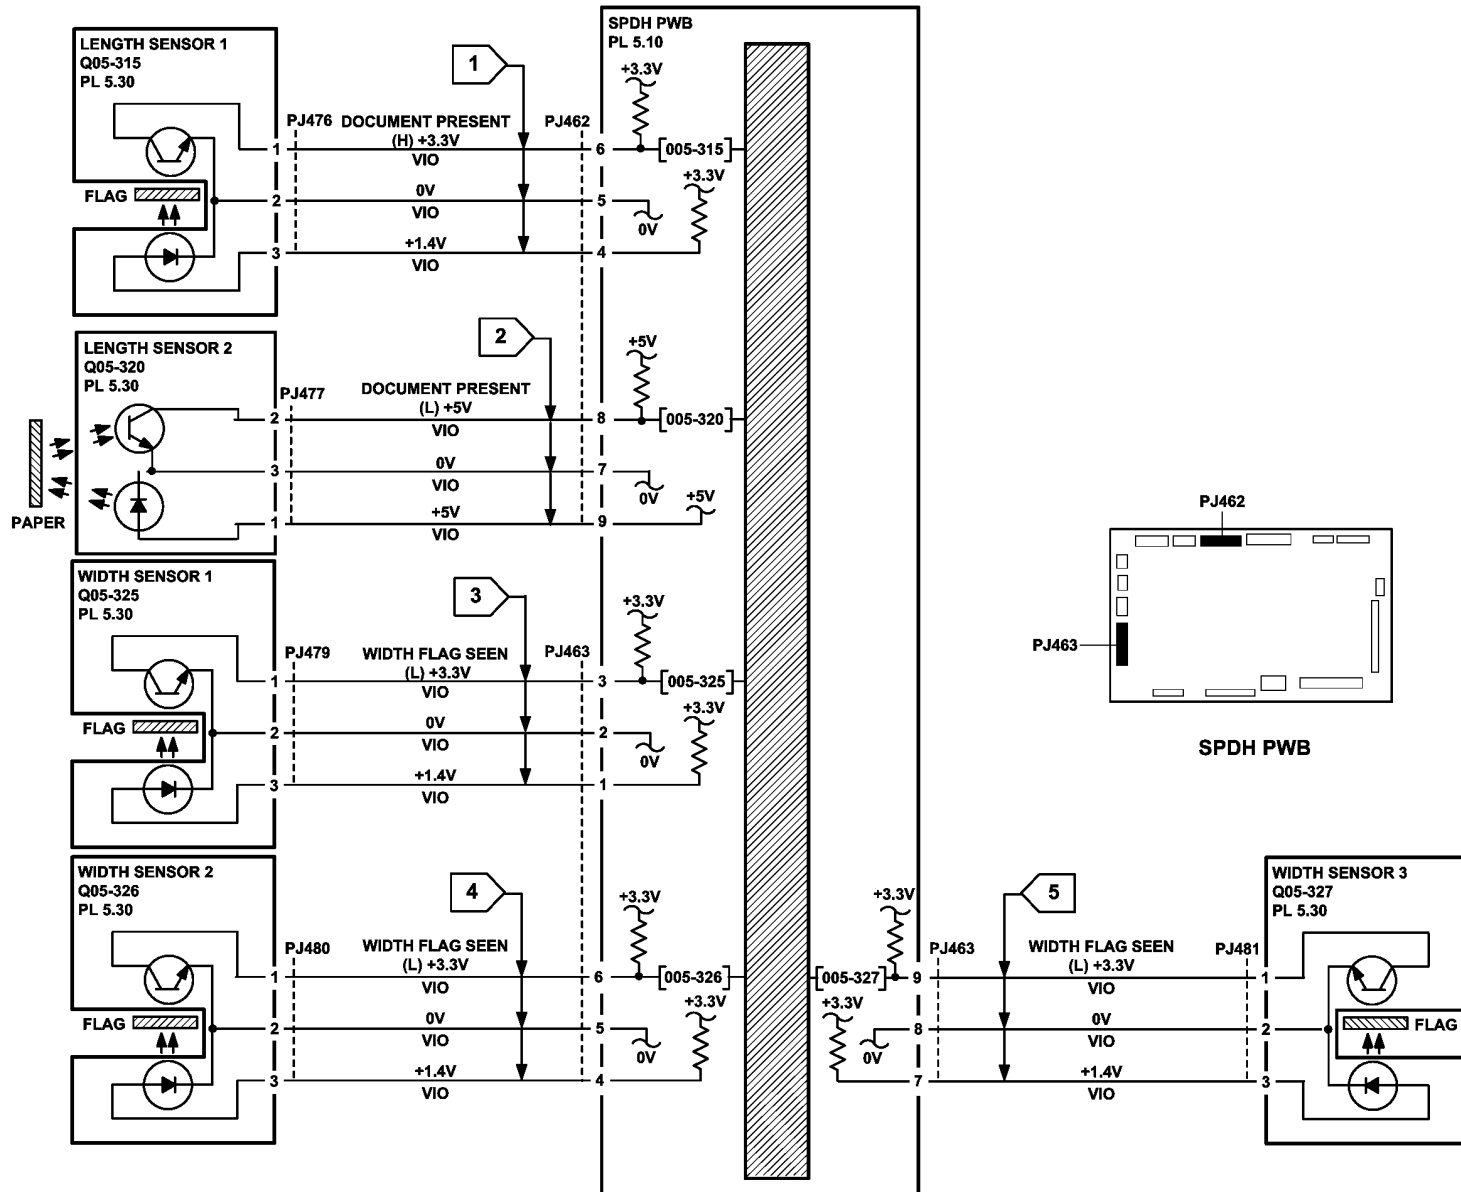
TW-1-0020-A

Figure 2 Circuit diagram

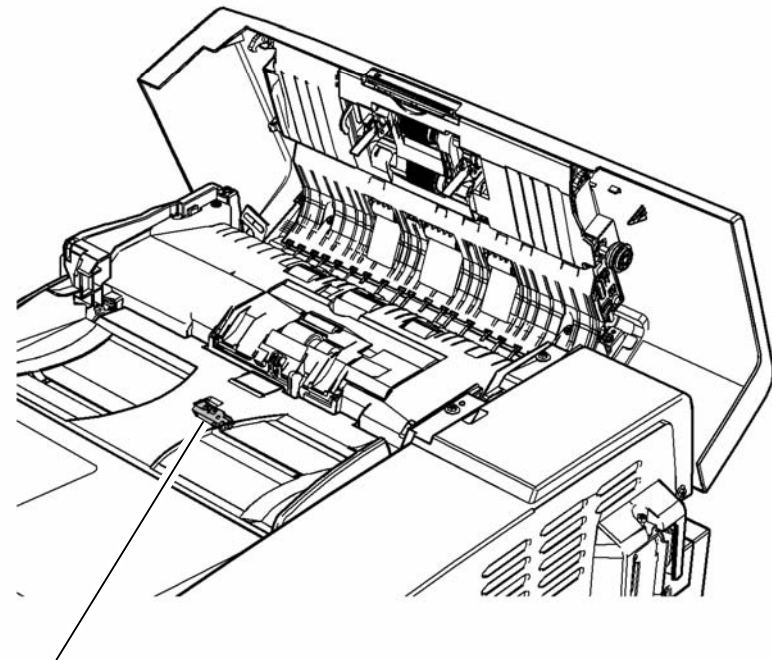
W-1-0023-A

Last sheet out sensor,
Q05-308

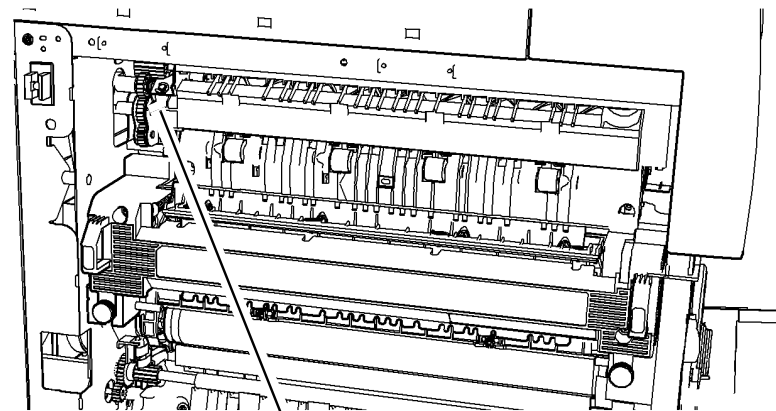
Figure 1 Component location

Exit drive gears

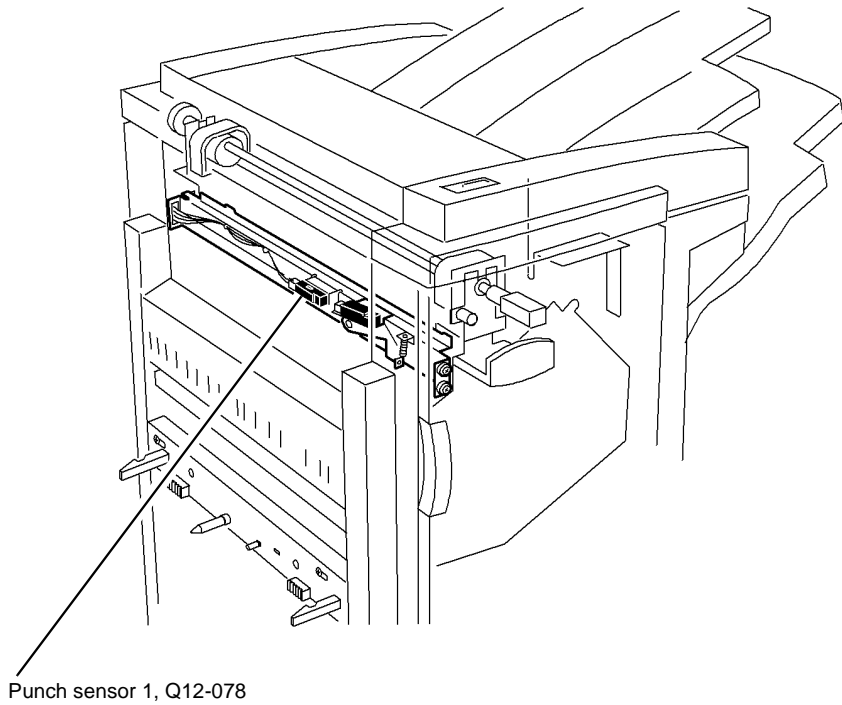
TW-1-0083-B

Figure 1 Component location

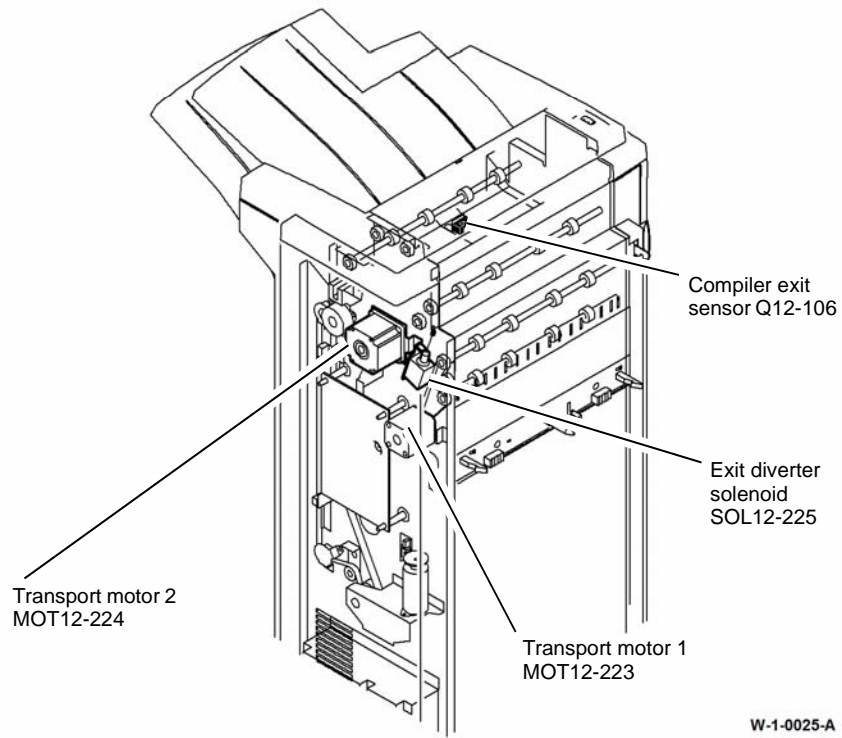
Figure 1 Component location

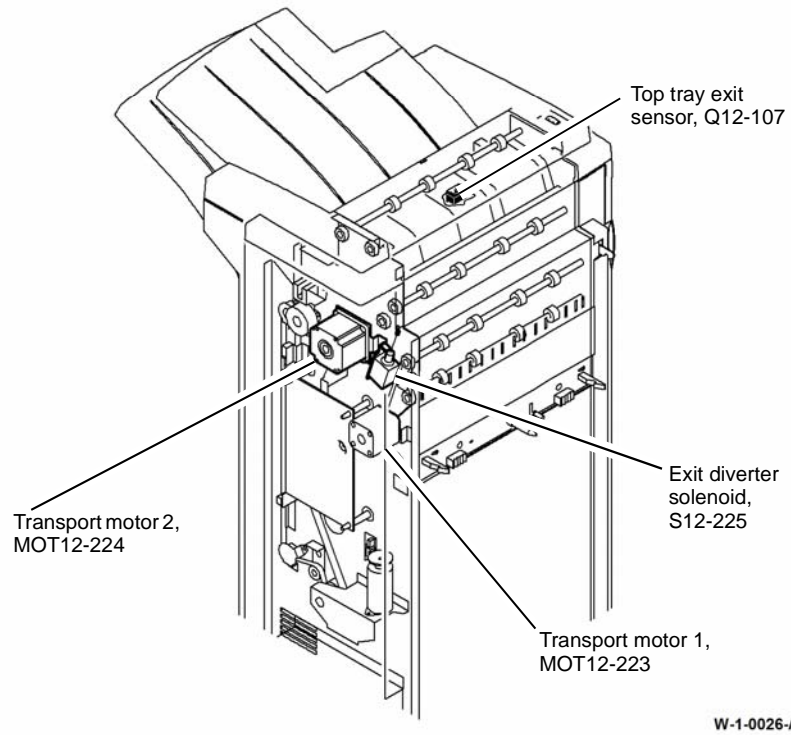
Figure 1 Component location

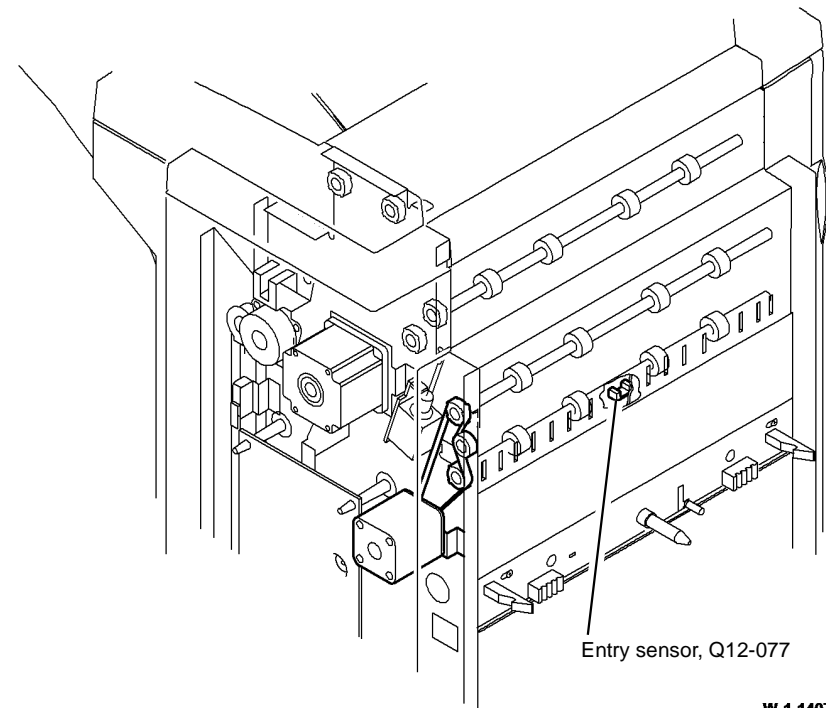
W-1-1407-A

Figure 1 Component location

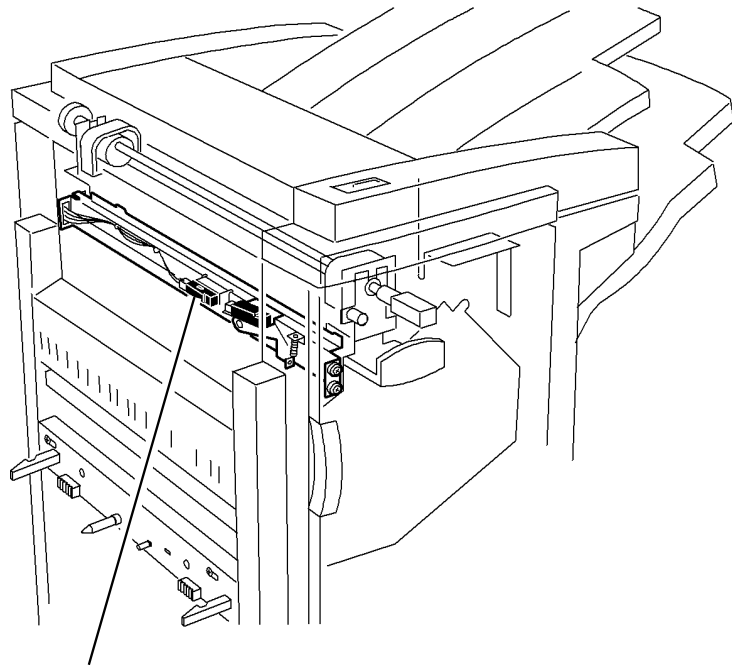
W-1-1408-A

Punch sensor 1, Q12-078

Figure 2 Component location

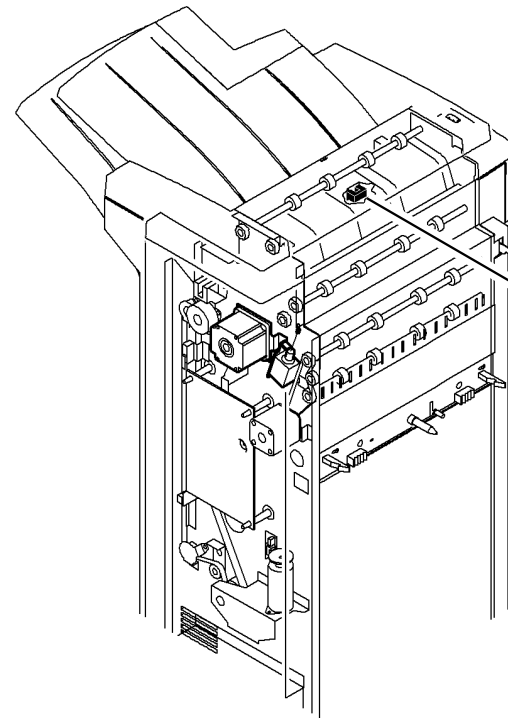
W-1-1409-A

Top tray exit
sensor, Q12-107

Figure 3 Component location

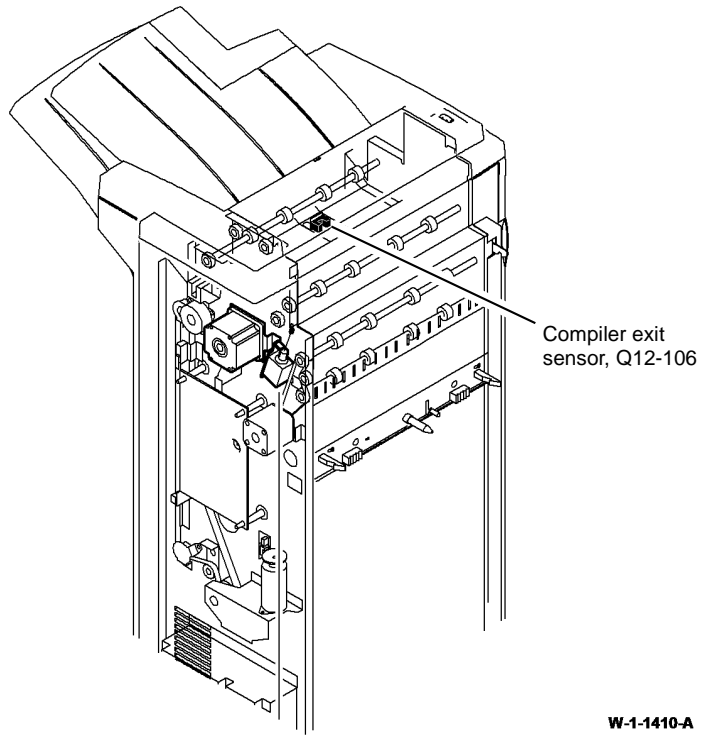
W-1-1410-A

Figure 4 Component location

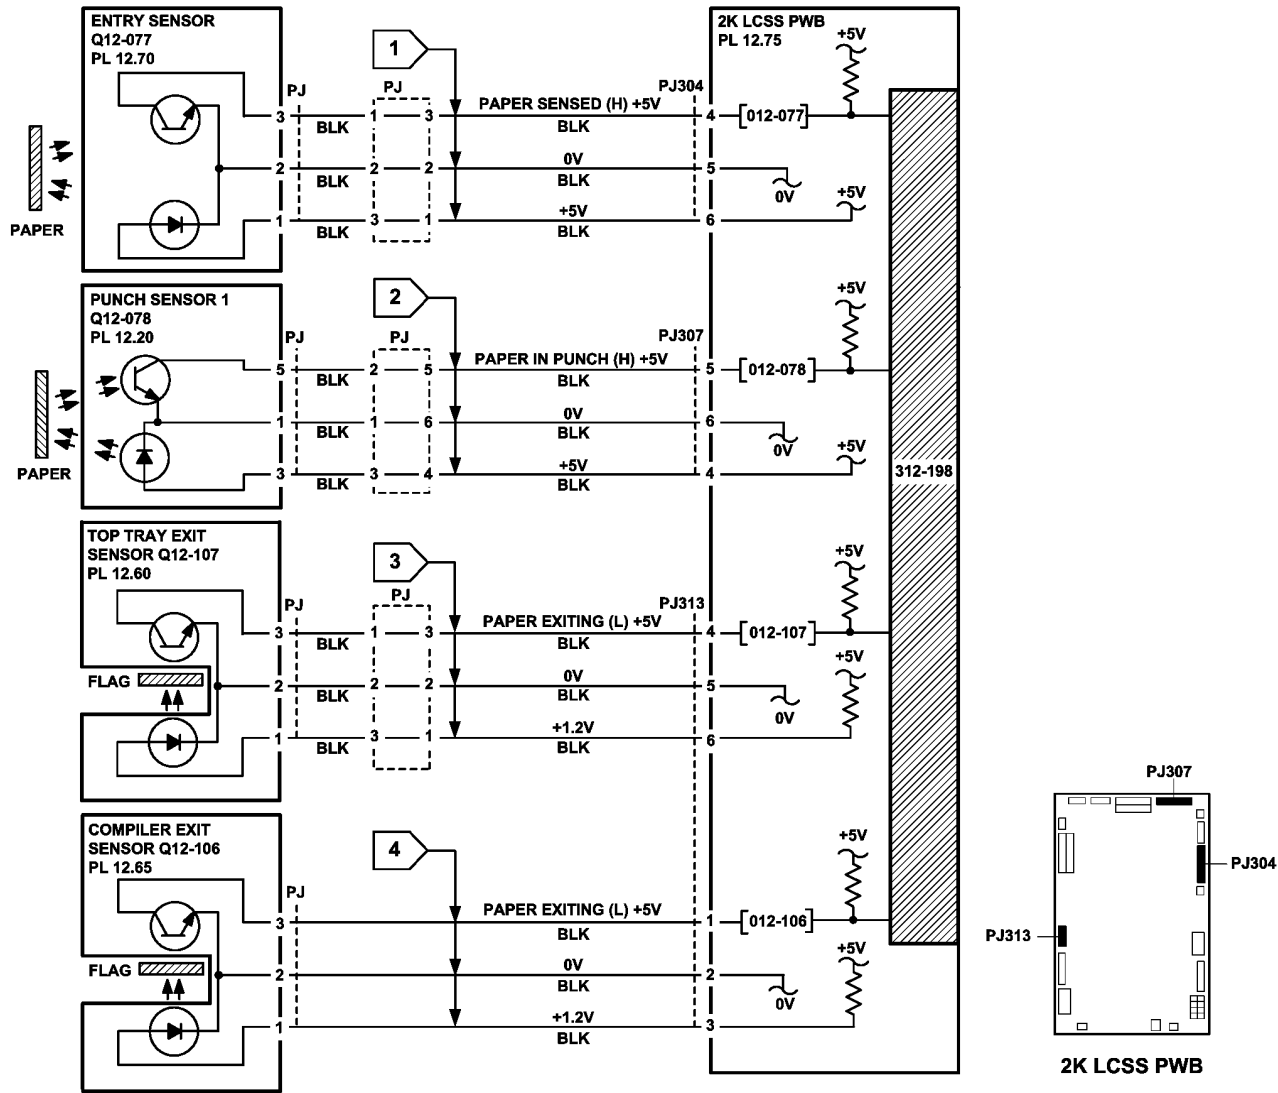
TW-1-0326-B

Figure 5 Circuit diagram

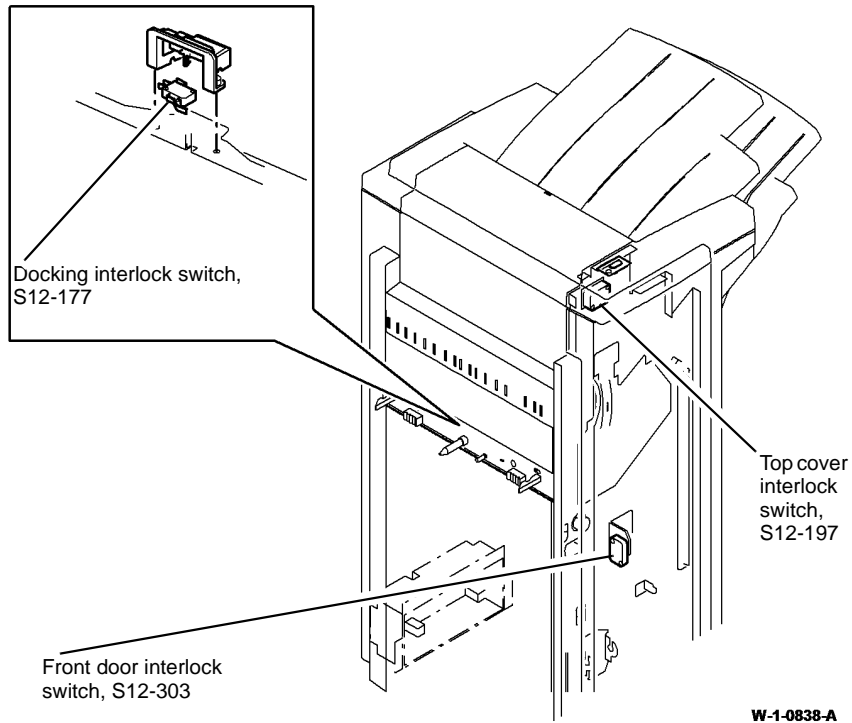
W-1-0838-A

Figure 1 Component location

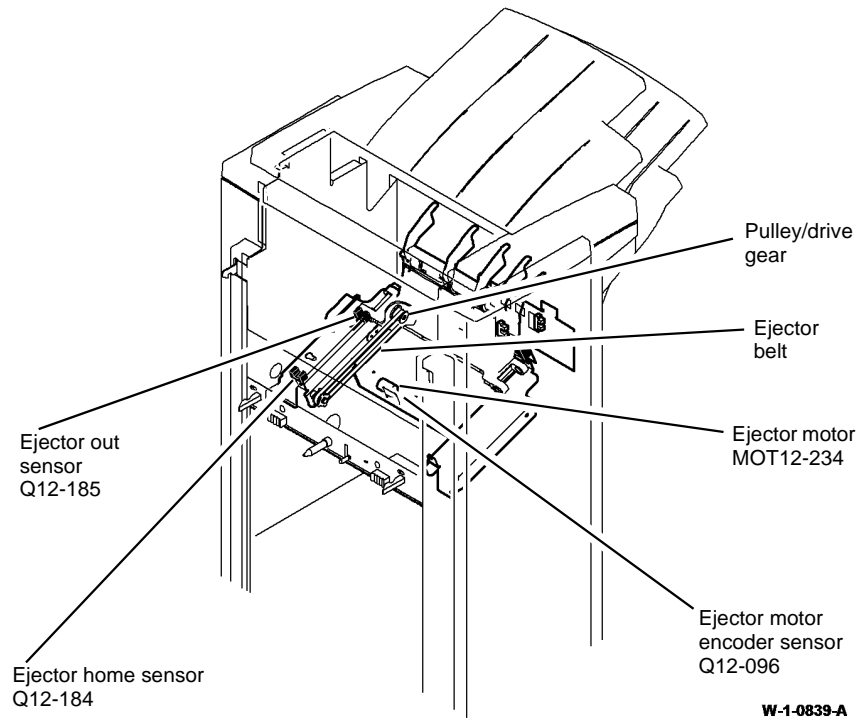
Figure 1 Component location

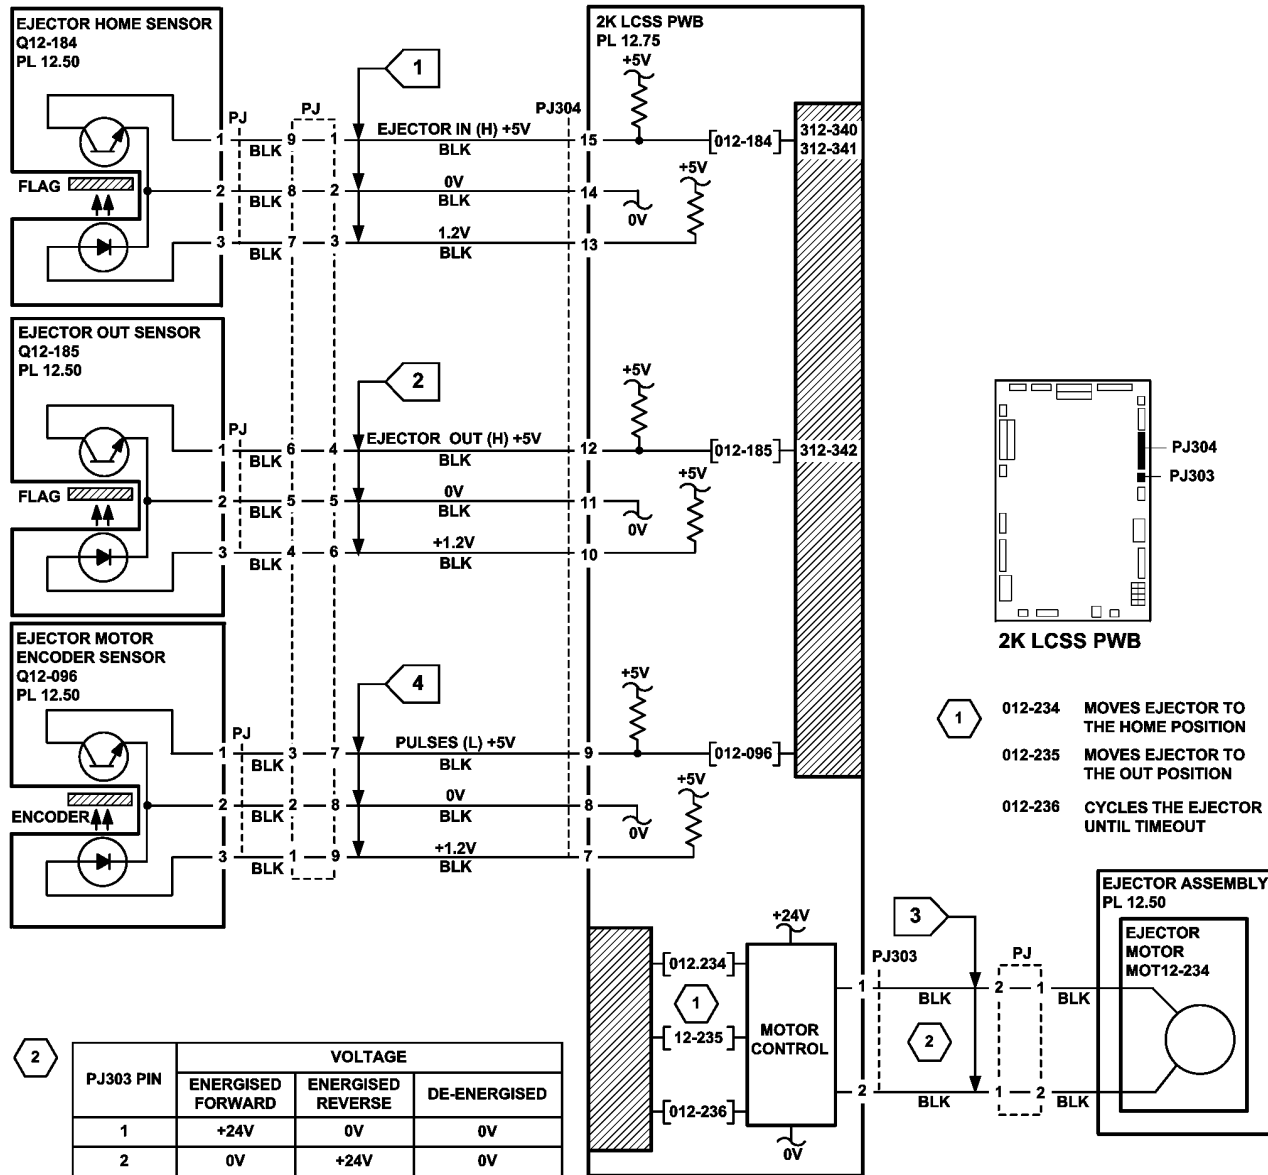
Figure 2 Circuit diagram

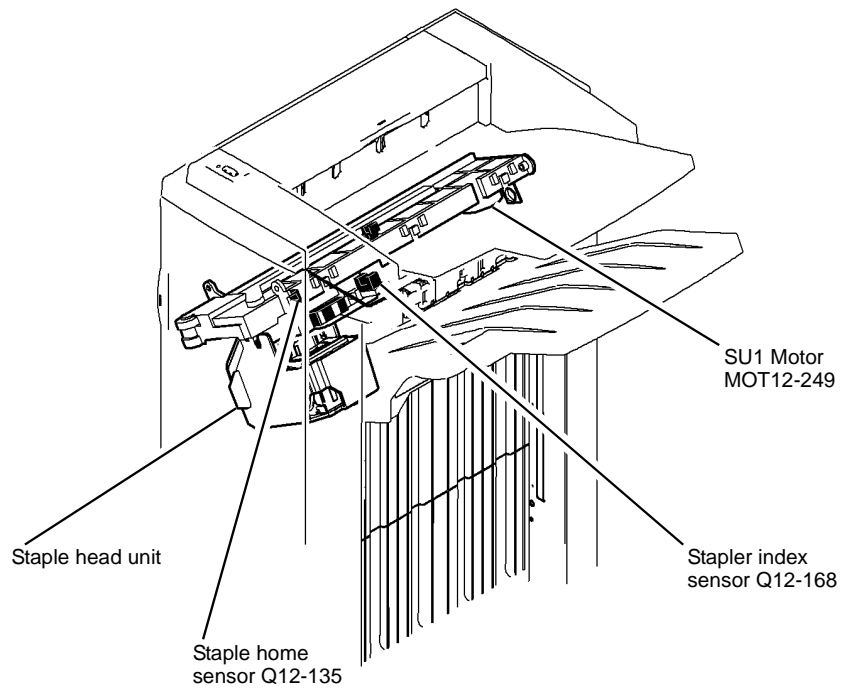
W-1-0027-A

Figure 1 Component location

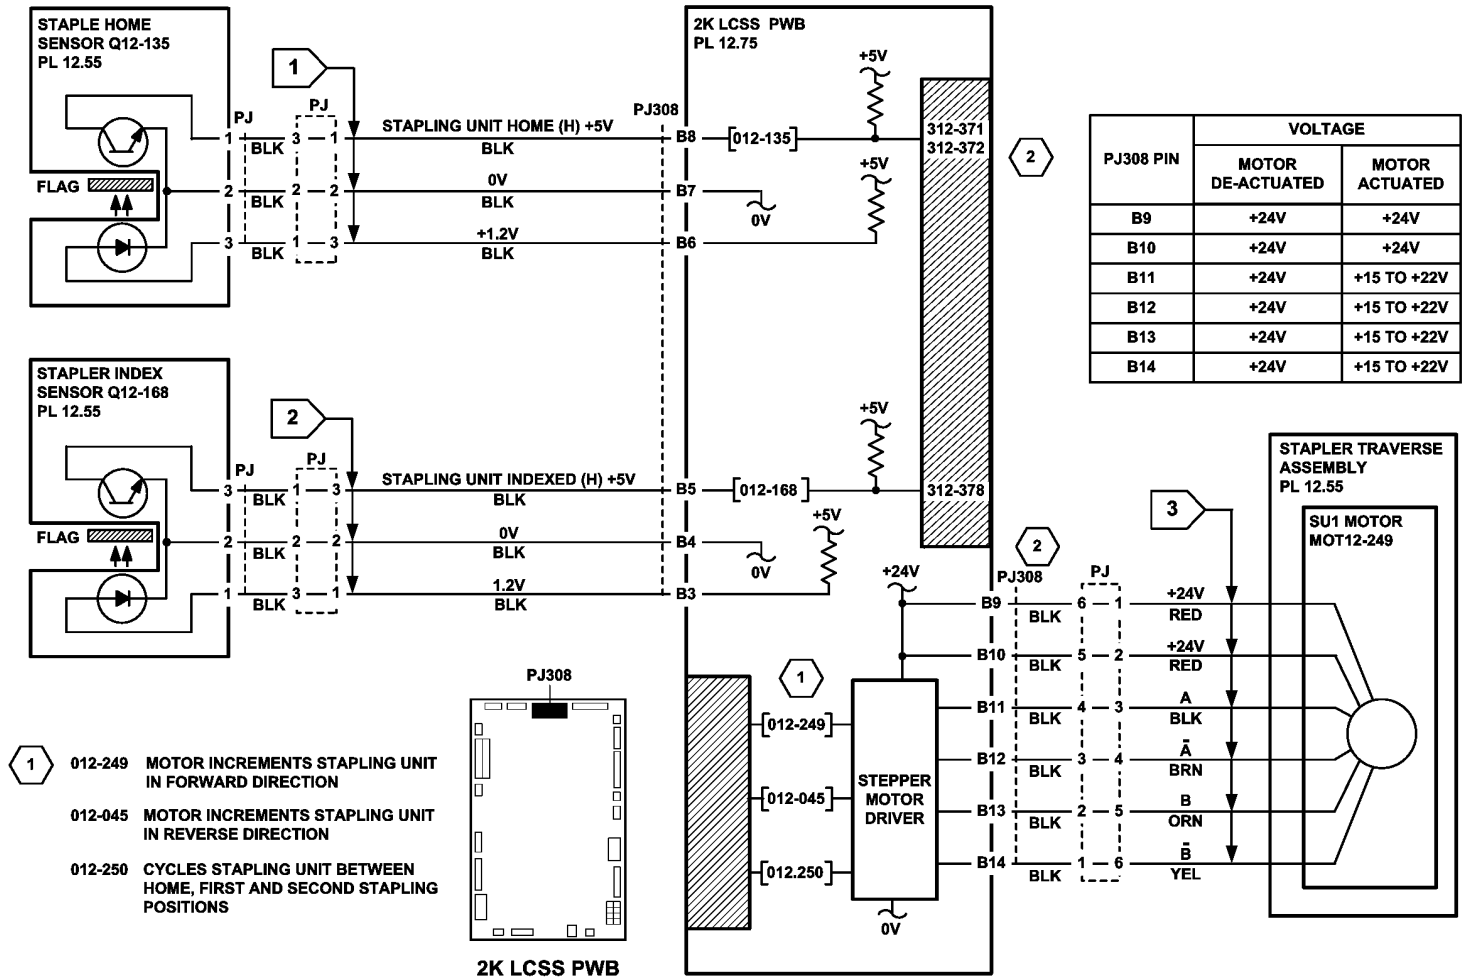
TW-1-0076-B

Figure 2 Circuit diagram

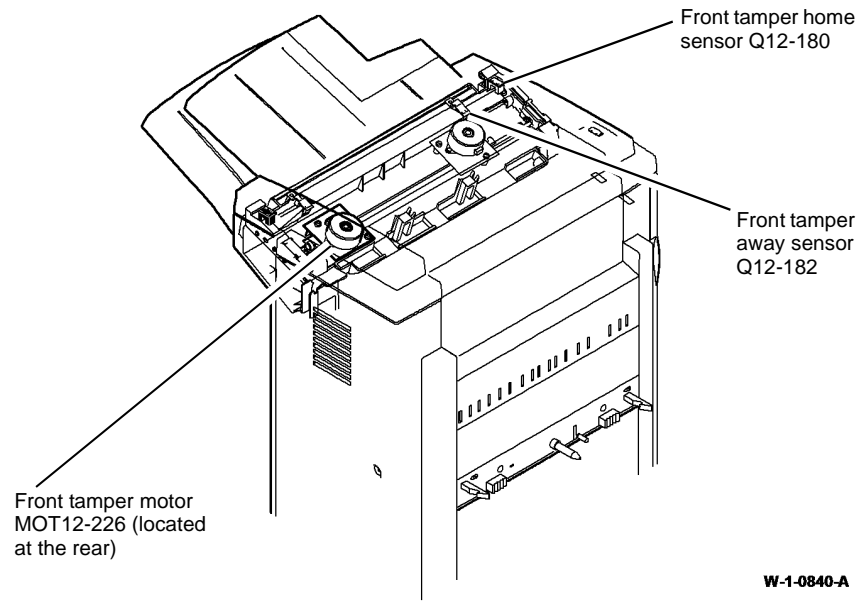
Figure 1 Component location

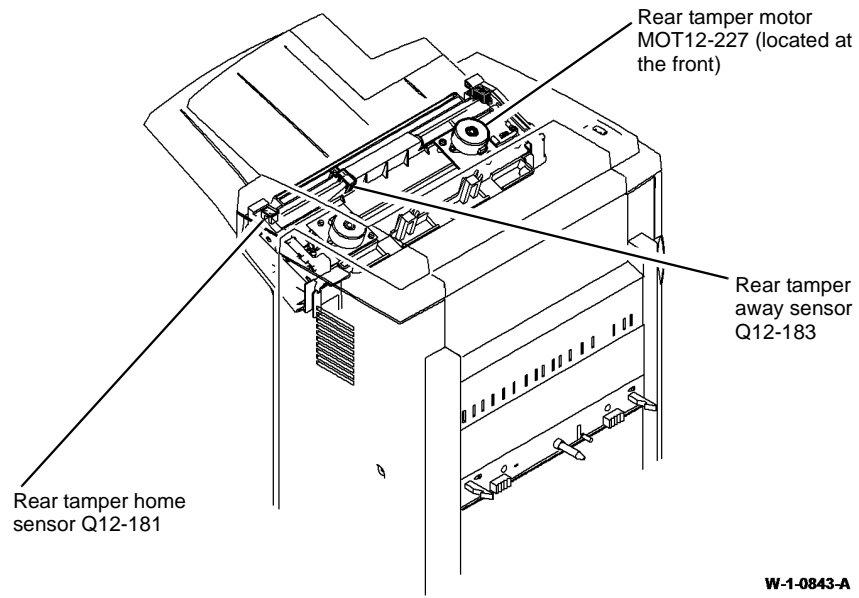
Figure 1 Component location

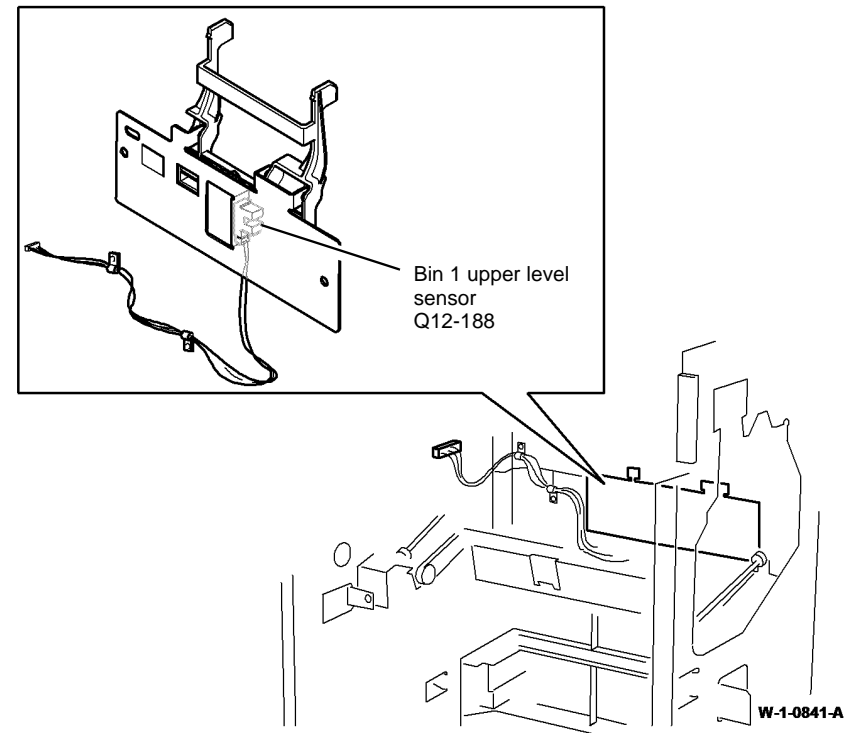
Figure 1 Component location

- Paper is delivered to the tray until the bin 1 upper level sensor, Q12-188 is actuated.
- The bin 1 elevator motor MOT12-241 lowers the tray until the bin 1 upper level sensor, Q12-188 is de-actuated.
- The Bin 1 elevator motor raises the tray until the top of the paper stack actuates the Bin 1 upper level sensor, then the Bin 1 elevator motor lowers the tray to continue the cycle.
- When the tray is emptied, the tray returns to the home position. The tray is elevated until the bin 1 upper level sensor, Q12-188 is made. The tray is then lowered until the bin 1 upper level sensor, Q12-188 is just cleared. In the home position the bin 1 upper limit switch, S12-190 is actuated.

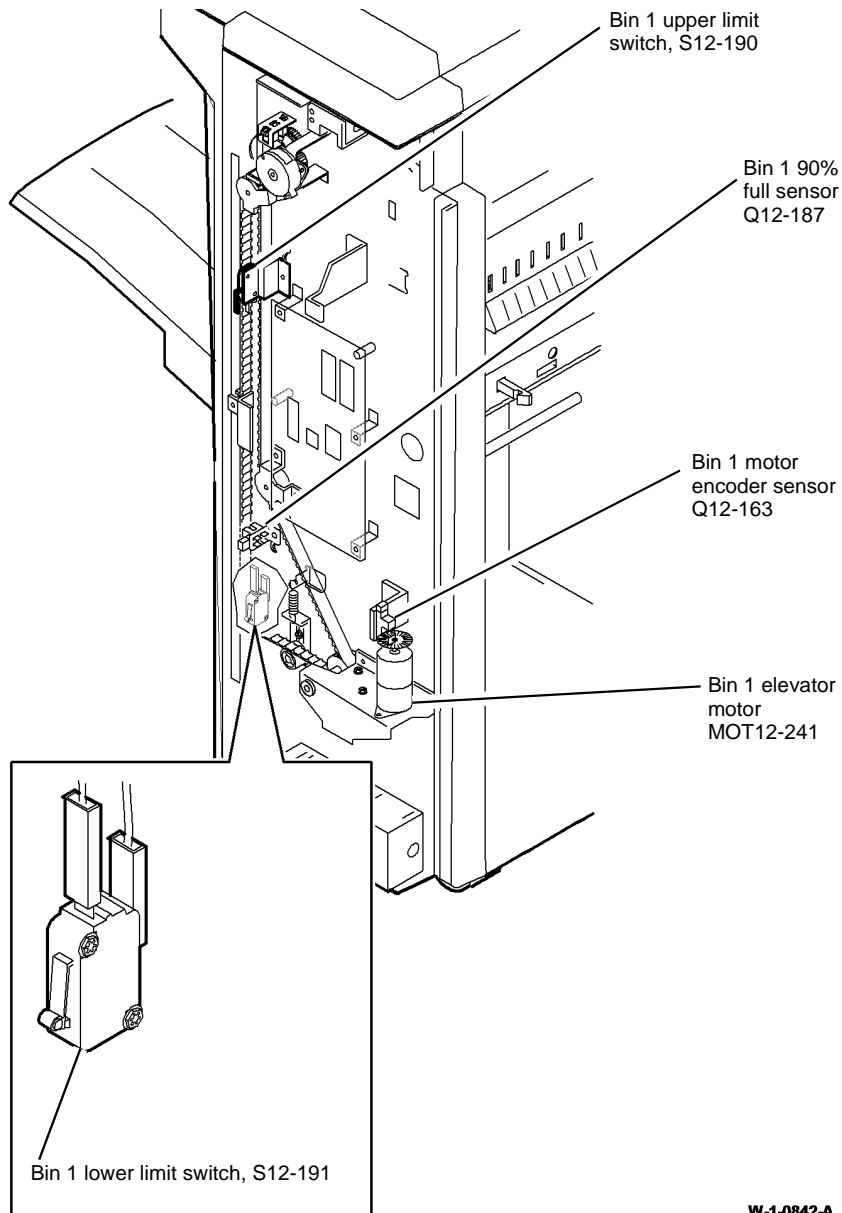
W-1-0842-A

Figure 2 Component location

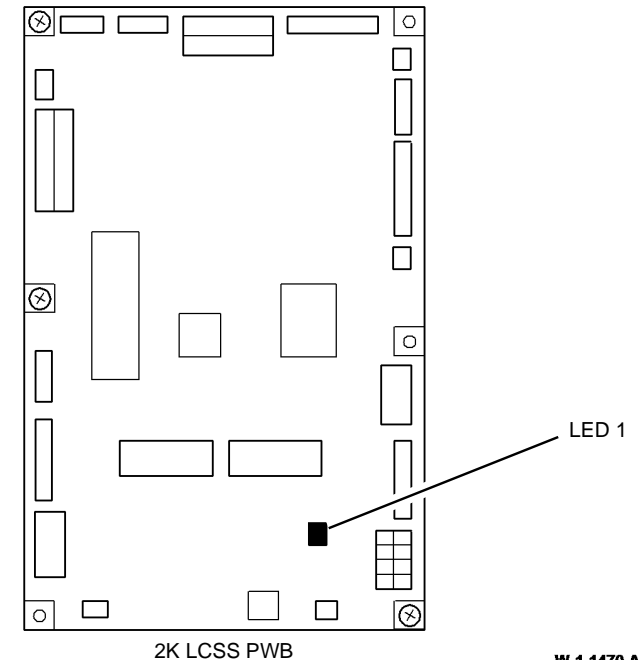
Figure 1 LCSS LED1 location

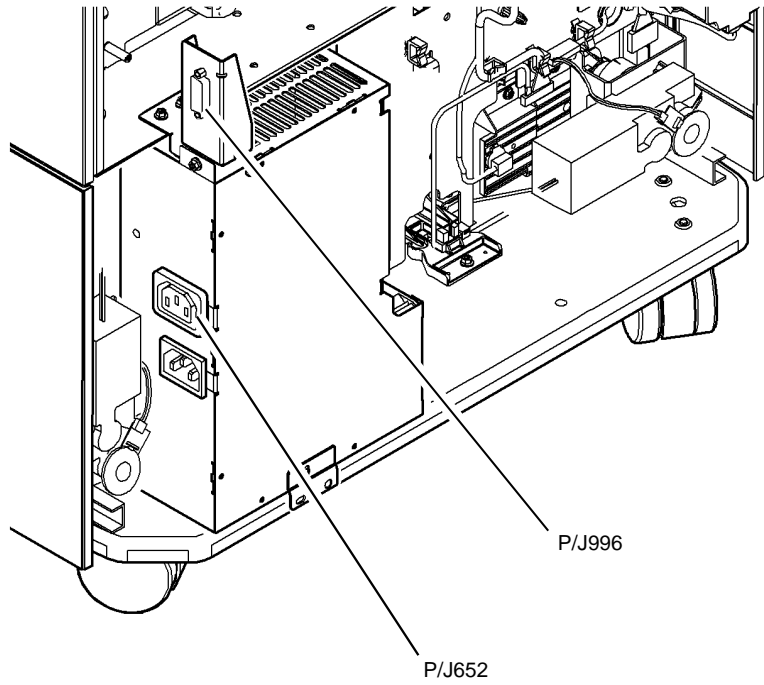
W-1-1306-A

Figure 2 PJ966 and PJ652 locations

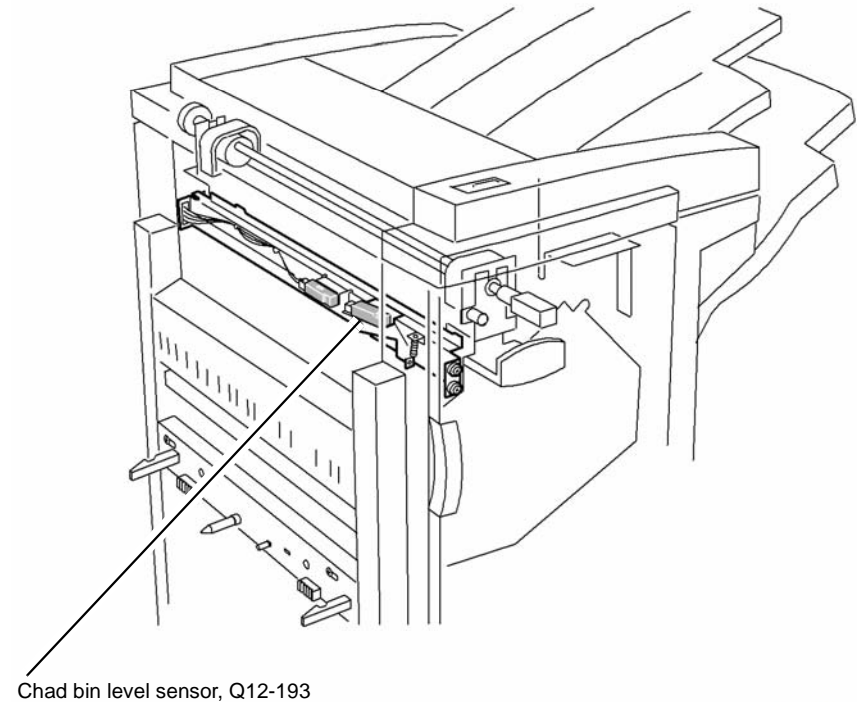
W-1-0903-A

Figure 1 Component location

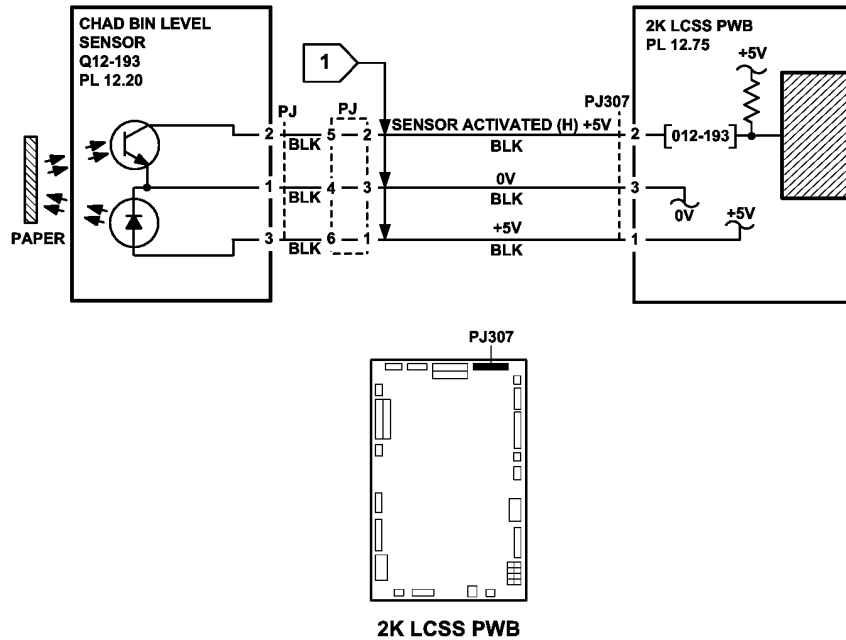
TW-1-0208-B

Figure 2 Circuit diagram

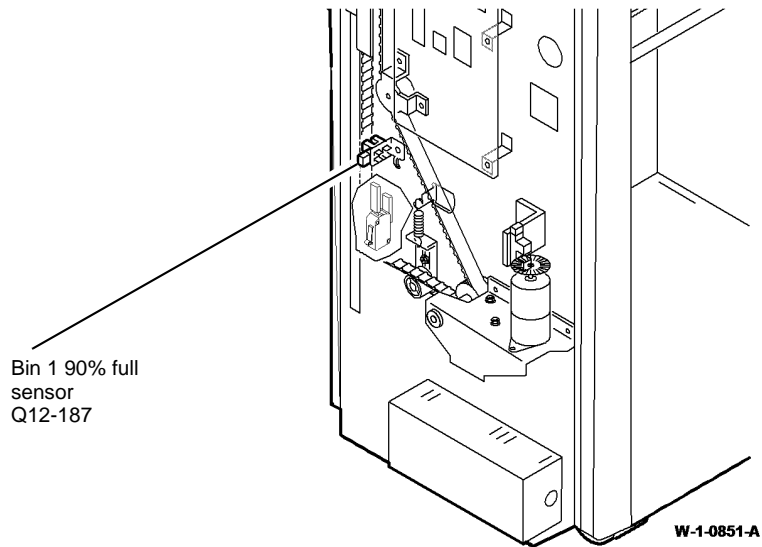
Figure 1 Component location

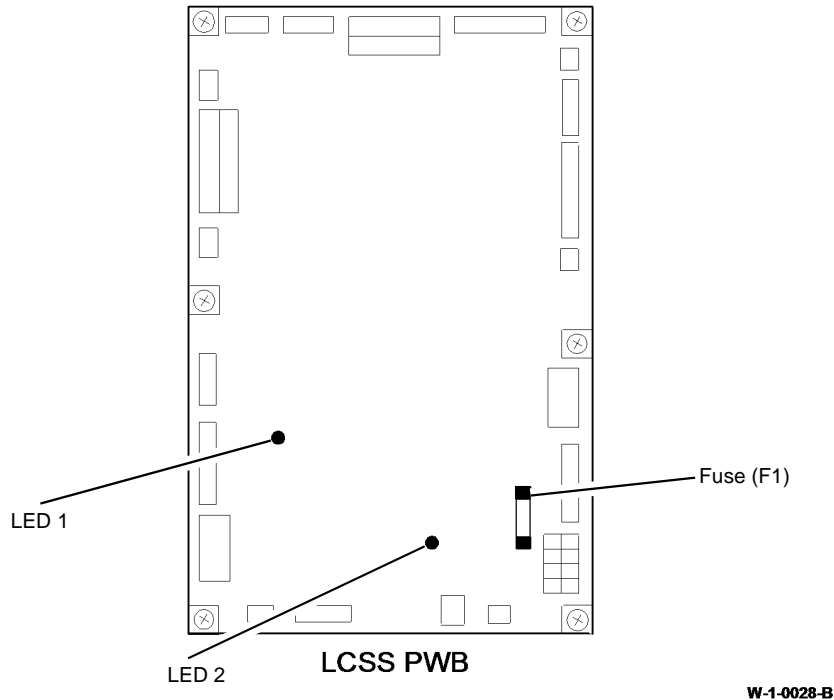
Figure 1 LED location

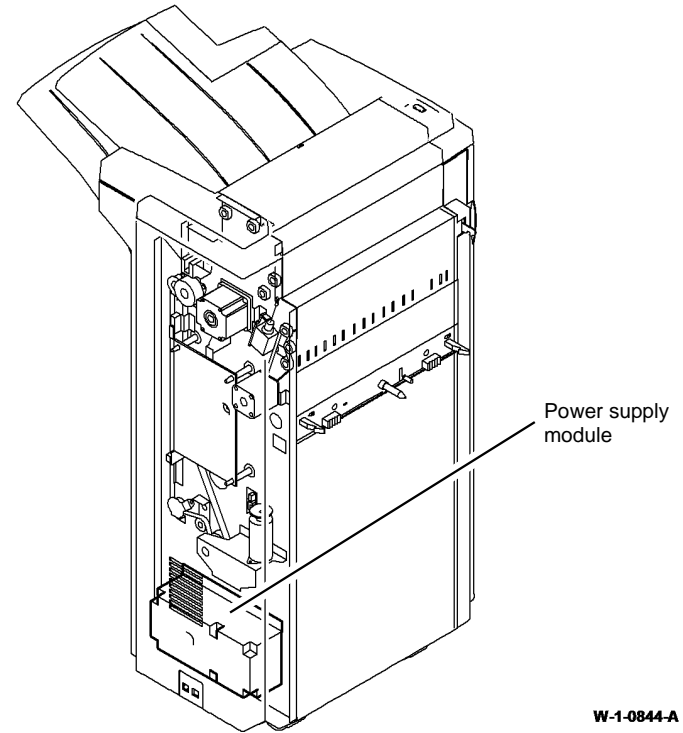
W-1-0844-A

Figure 1 Component location

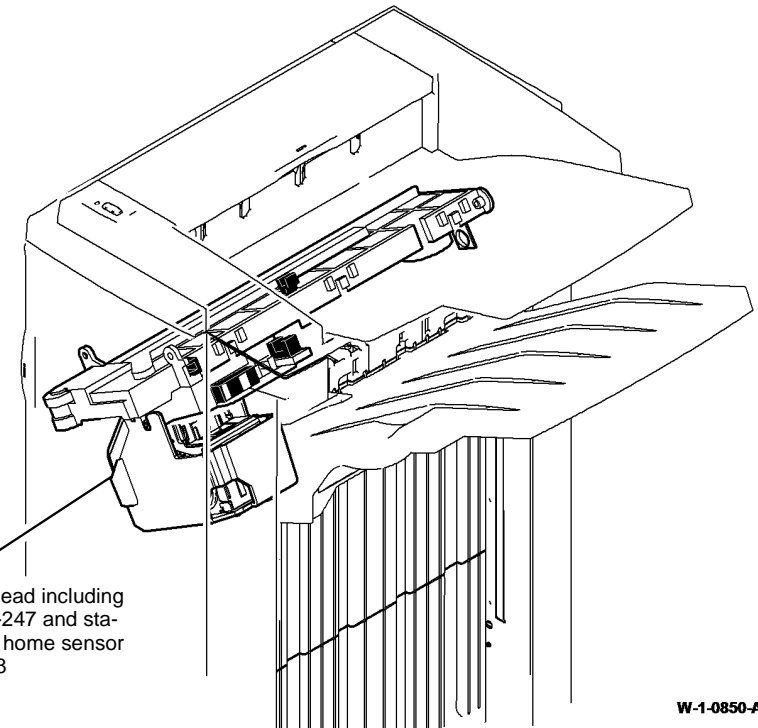
W-1-0850-A

Staple head including MOT12-247 and stapler jaw home sensor Q12-318

Figure 1 Component location

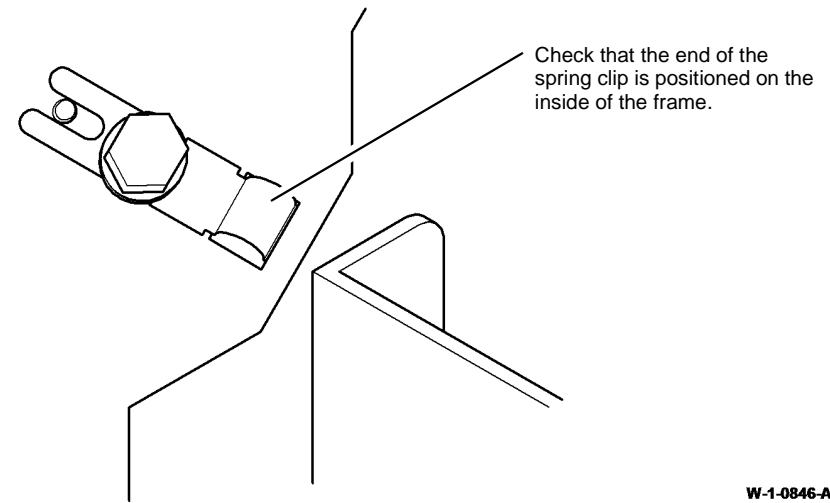
W-1-0846-A

Figure 1 Position of the spring clip

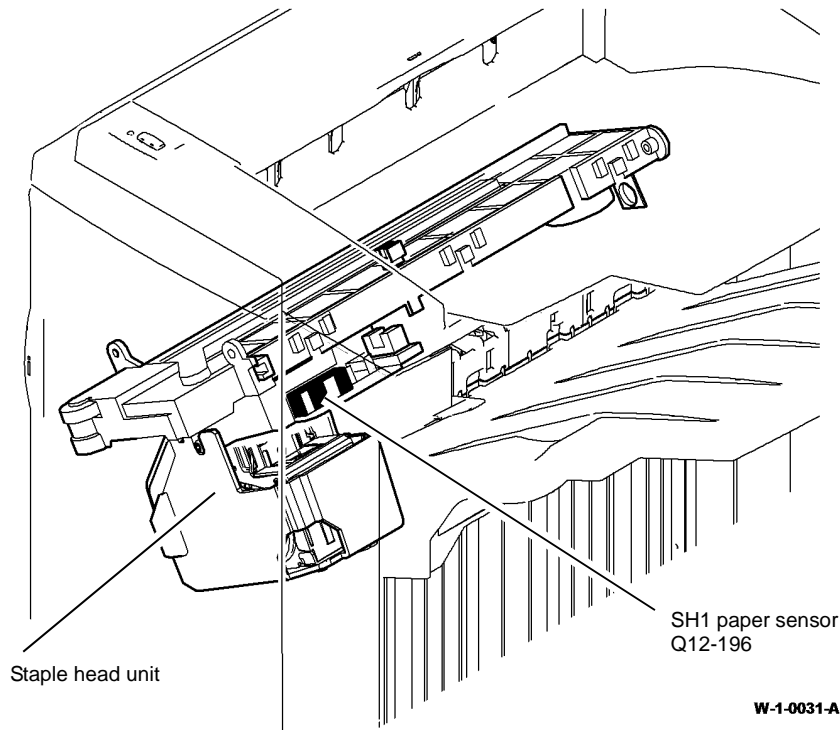
Figure 1 Component location

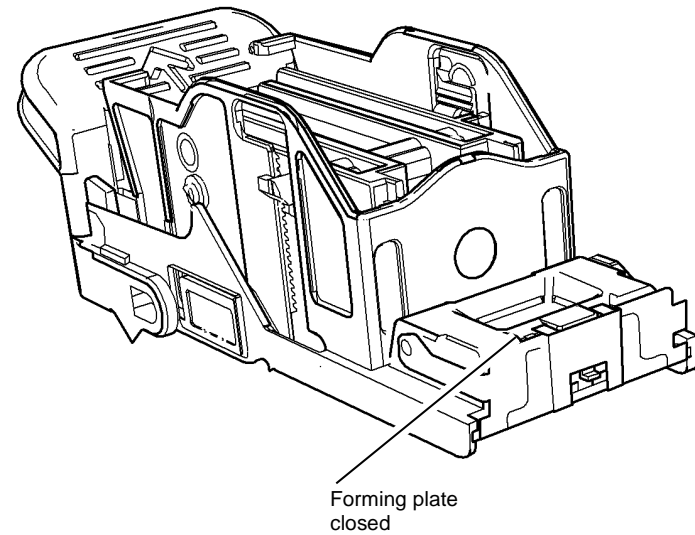
Figure 2 Staple cartridge closed

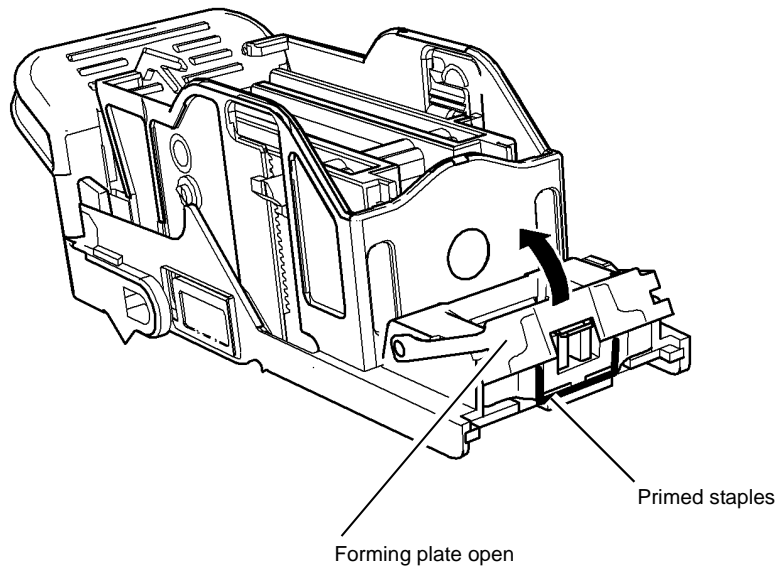
Figure 3 Staple cartridge open

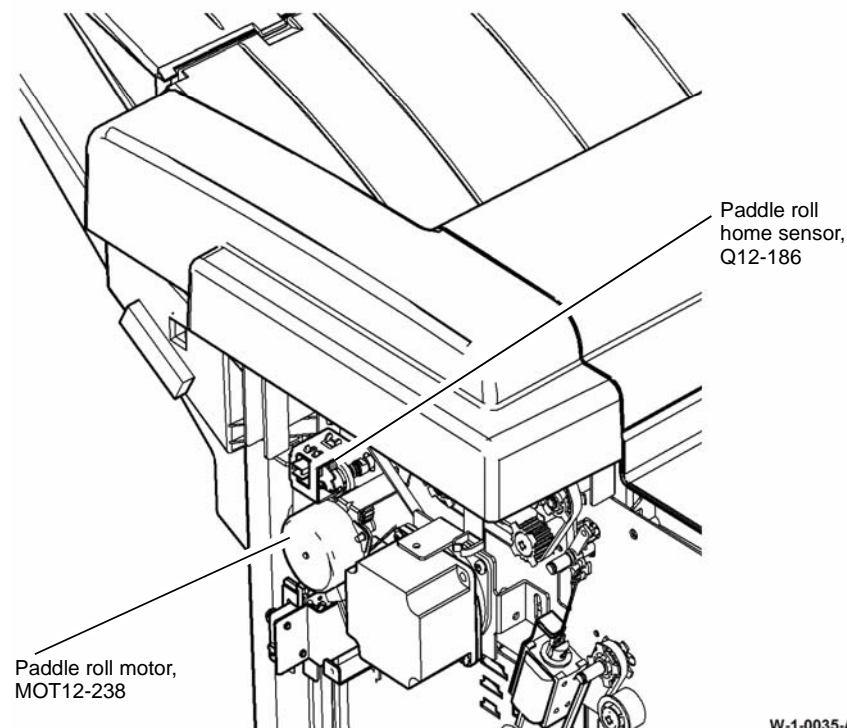
Figure 1 Component location

- [GP 11](#), How to Check a Sensor.
 - [Figure 1](#).
 - [P/J314](#), [LVF PWB](#).
 - [312D-150 LVF BM Power Distribution RAP](#).
- Repair or install new components as necessary:
- Paddle roll home sensor, [PL 12.335 Item 4](#).
 - LVF PWB, [PL 12.425 Item 8](#).
