708P91139
February 2016

Xerox® WorkCentre® 5945 Family Multifunction Printer Service Manual

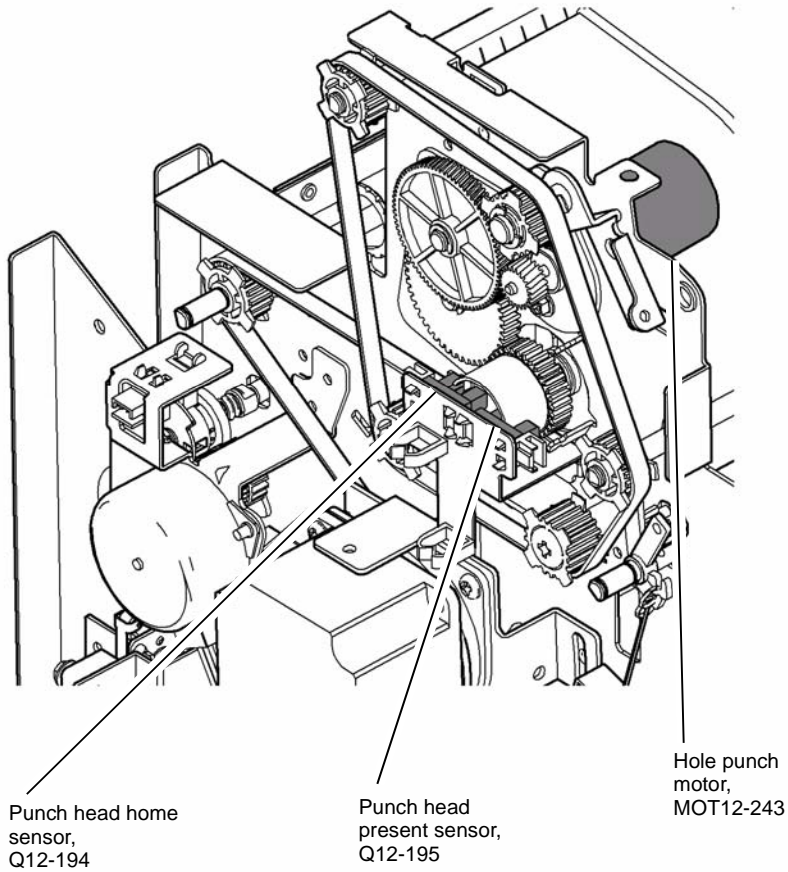
Figure 1 Component location

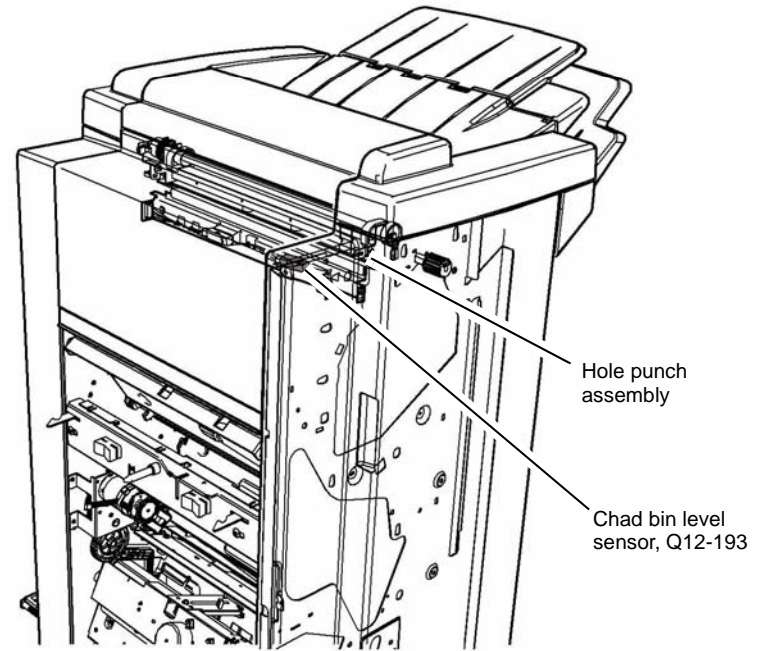
Figure 2 Component location

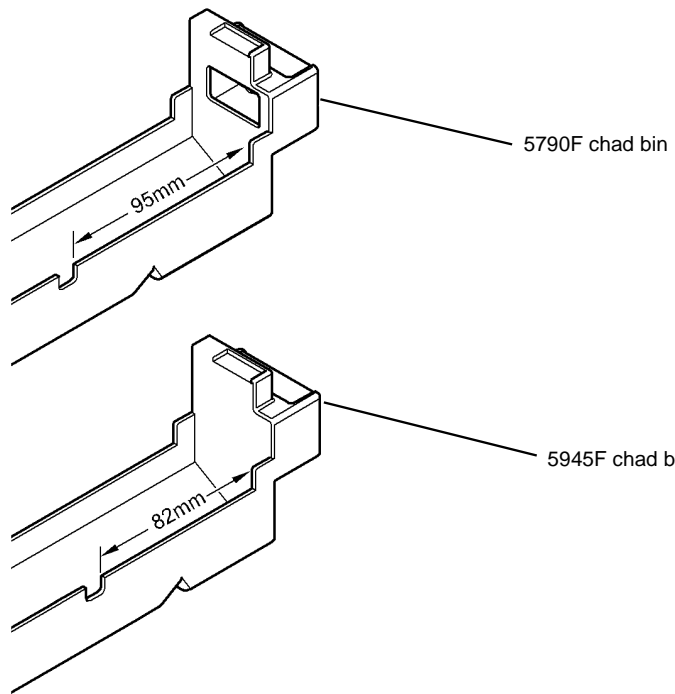
Figure 3 Chad bin differences

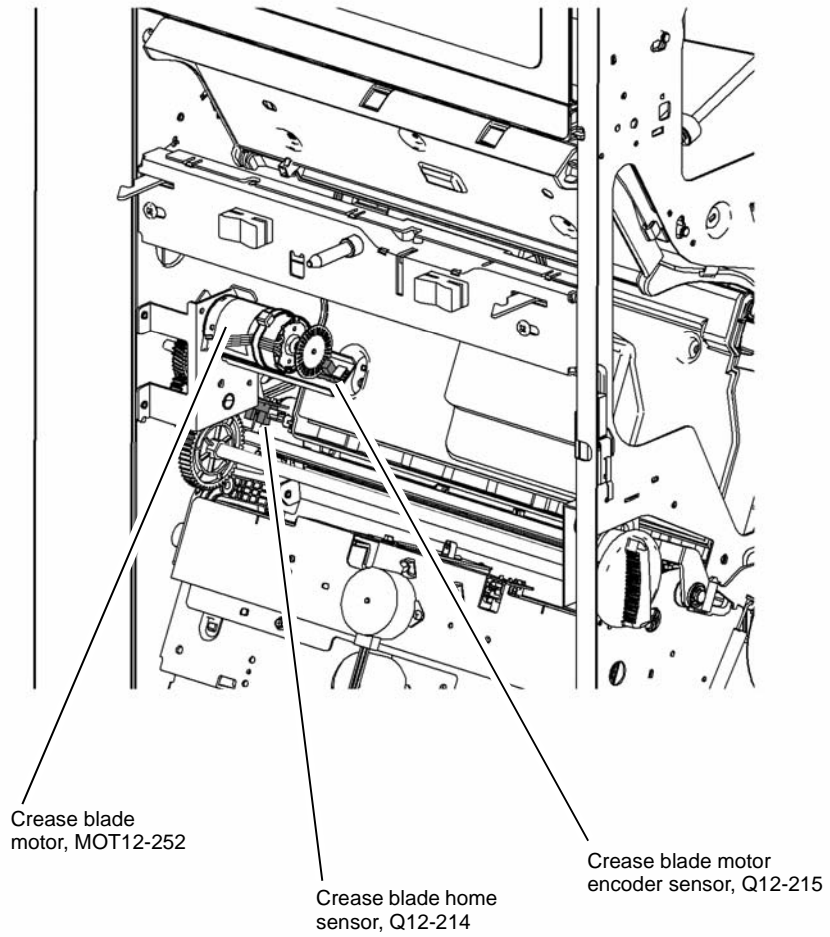
Figure 1 Component location

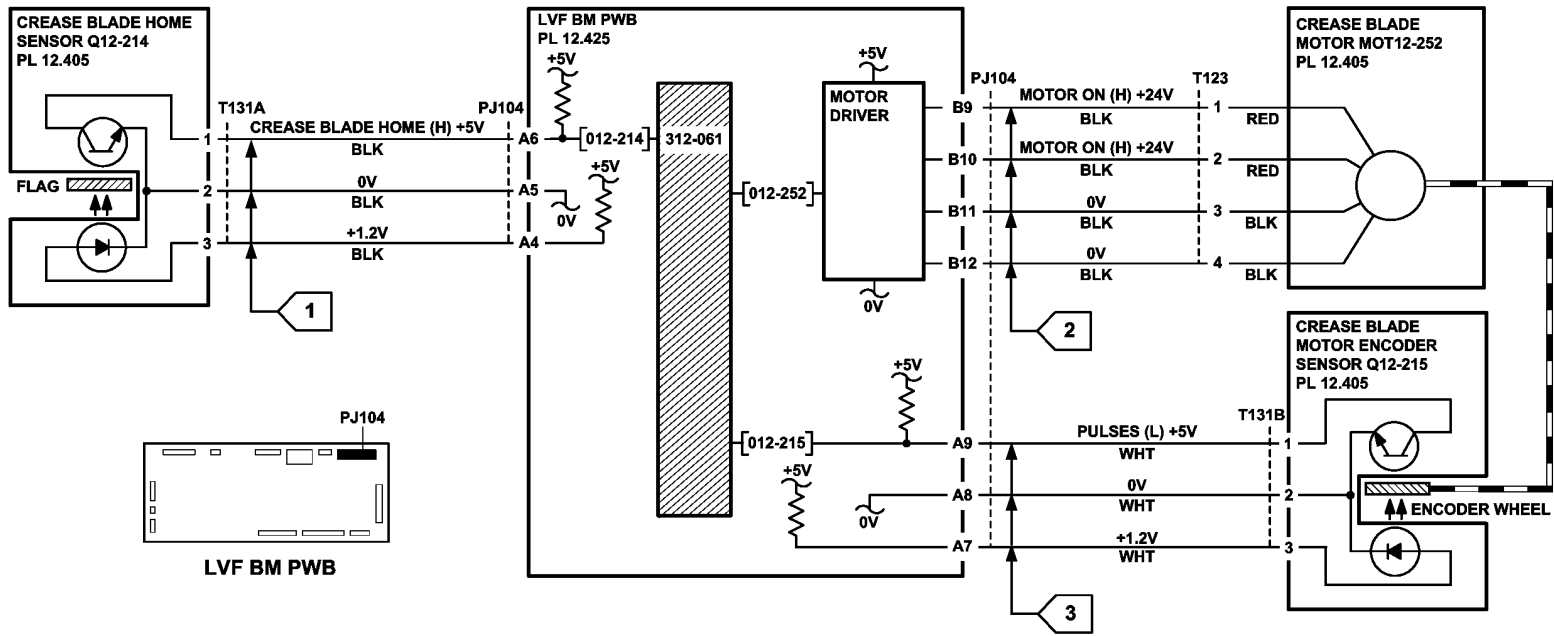
Figure 2 Circuit diagram

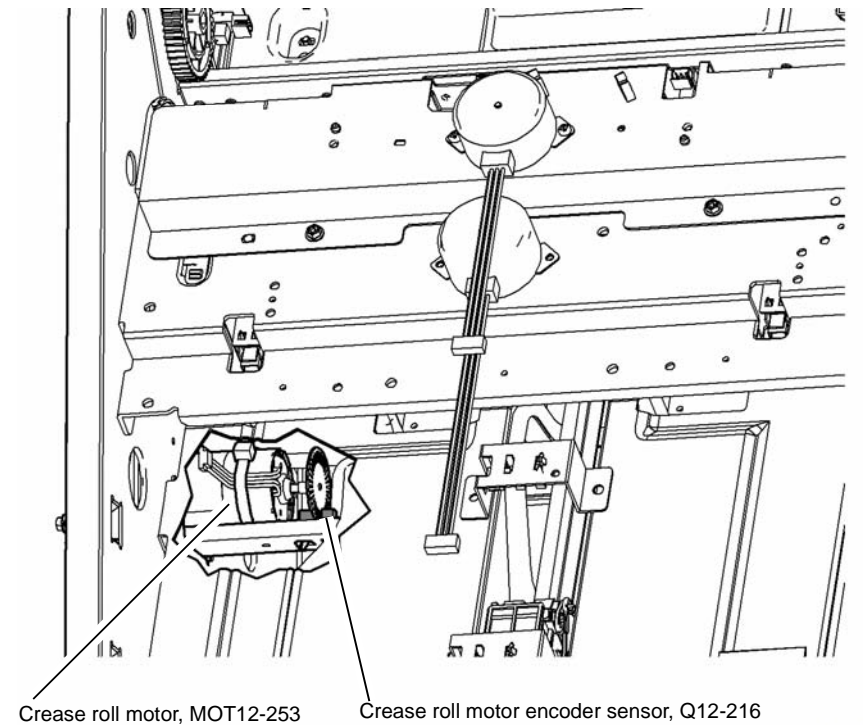
Figure 1 Component location

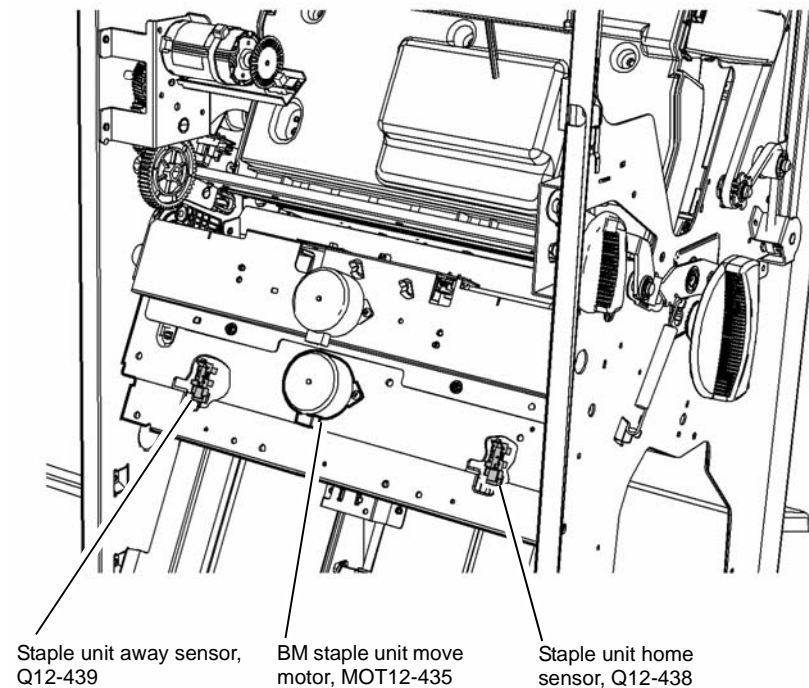
Figure 1 Component location

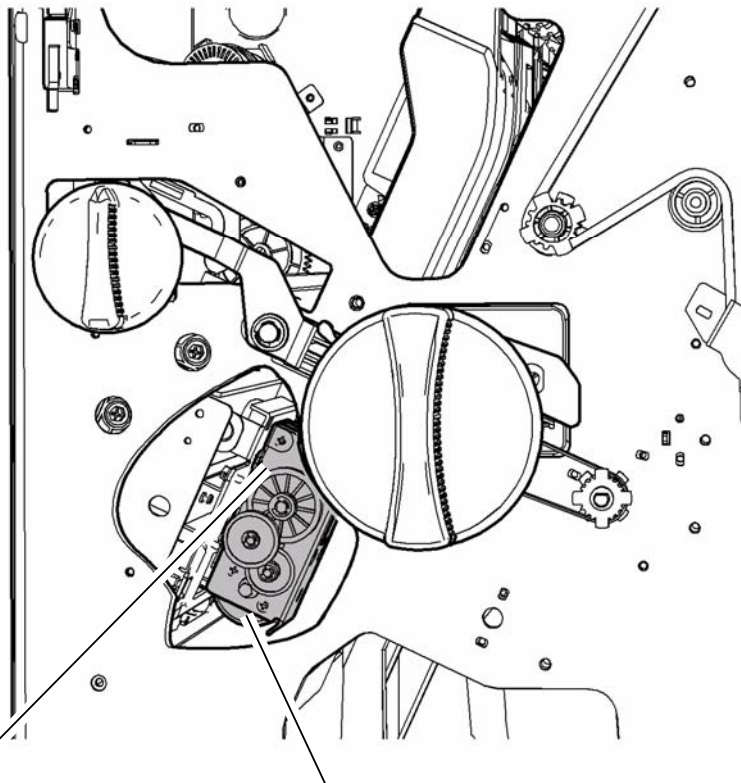
BM stapler jaw home sensor, Q12-411
(part of the BM staple head assembly)

BM stapler clinch motor, MOT12-437
(part of the BM staple head assembly)

Figure 2 Component location

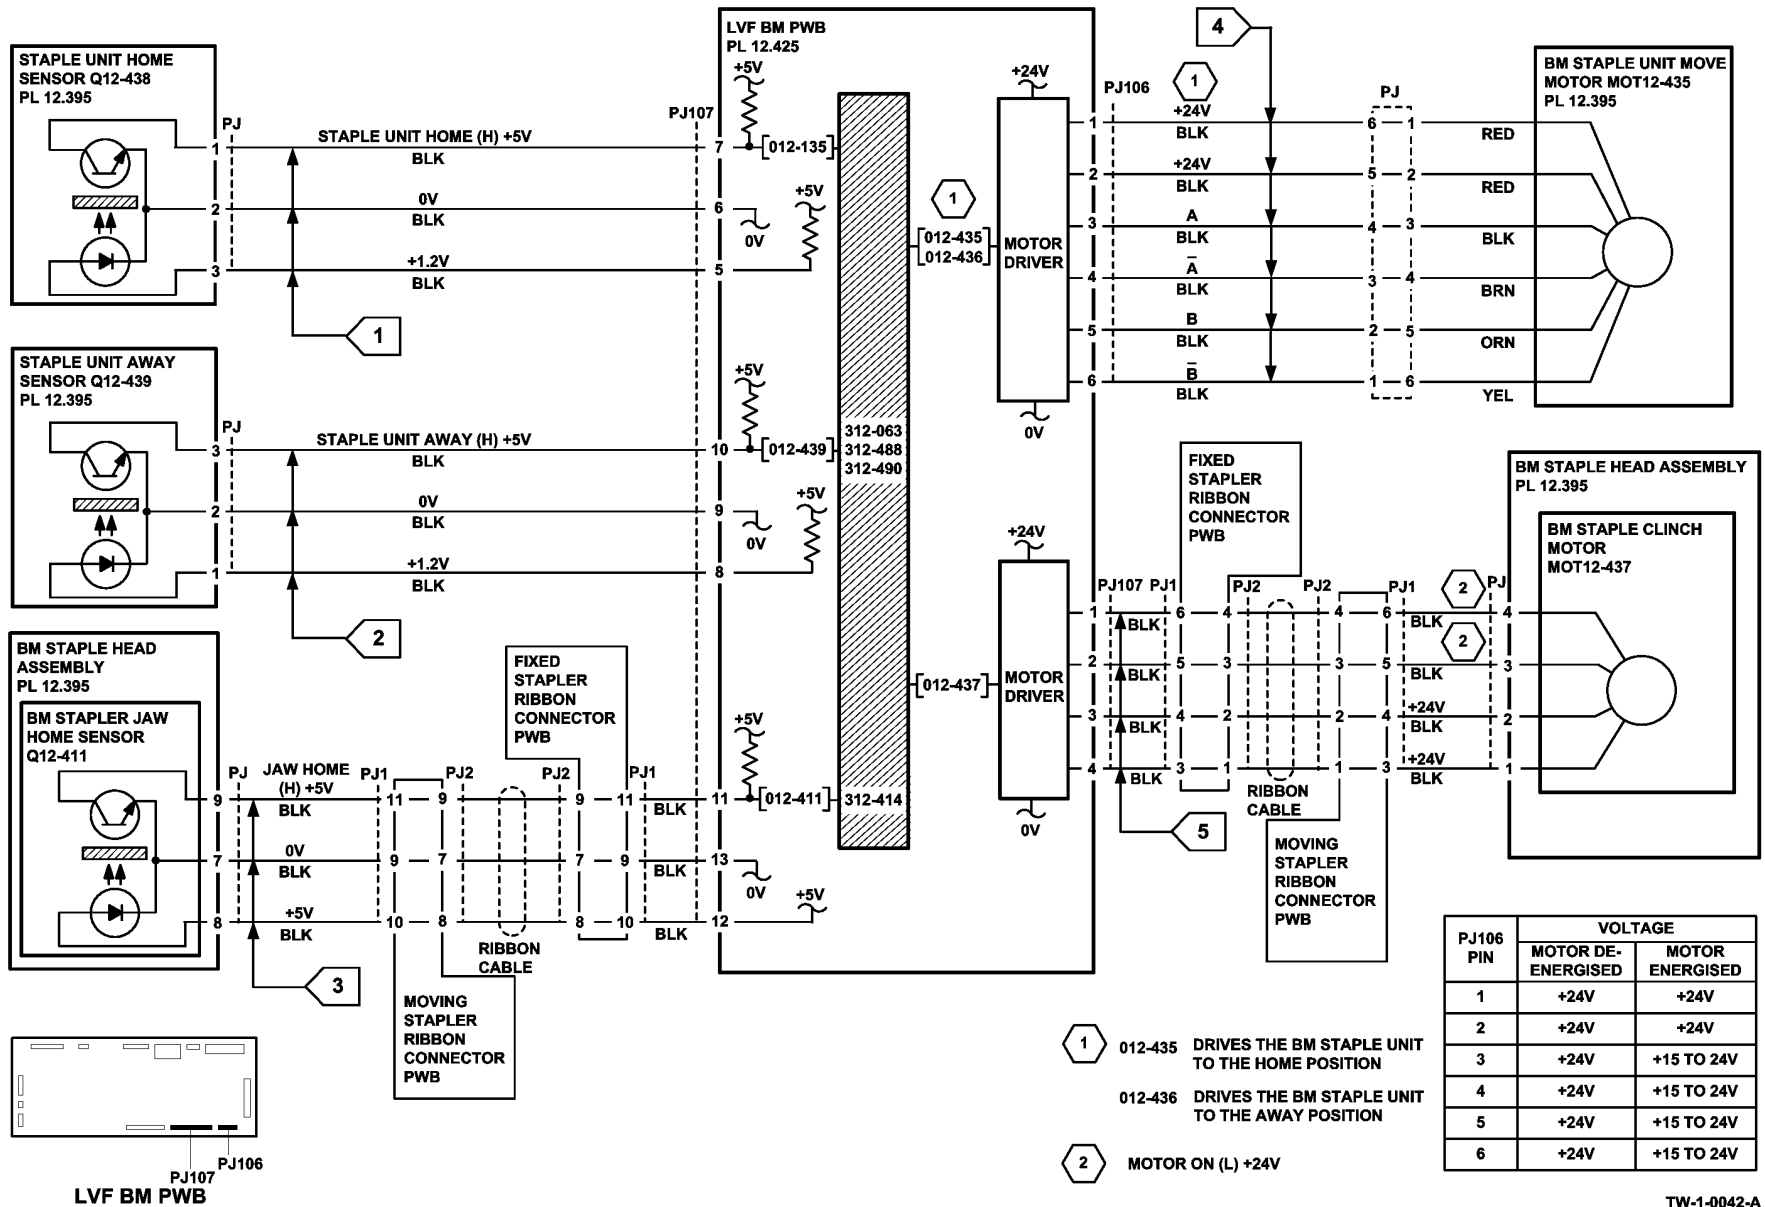
Figure 3 Circuit diagram

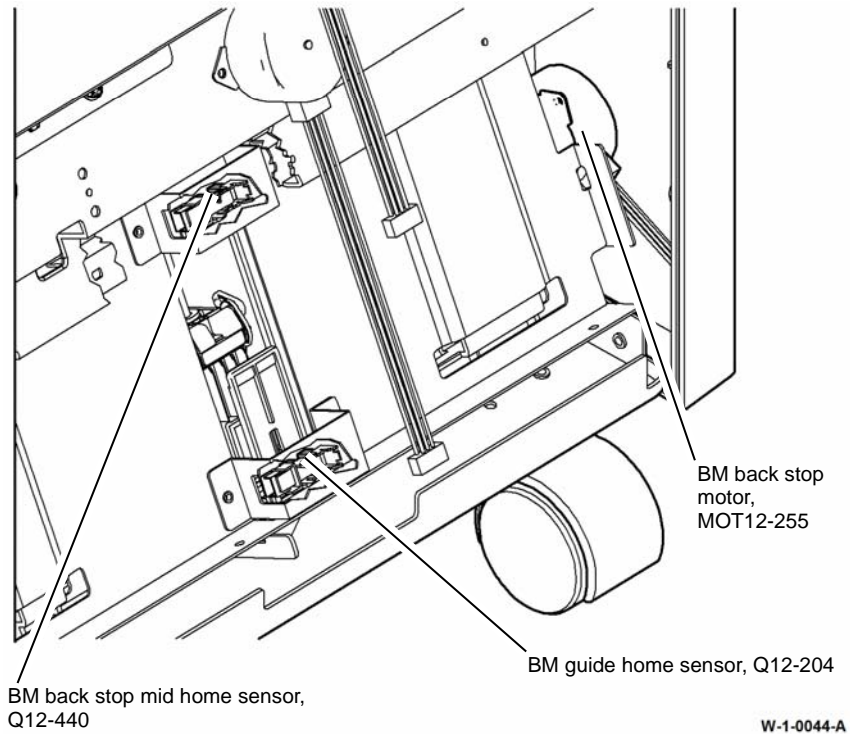
Figure 1 Component location

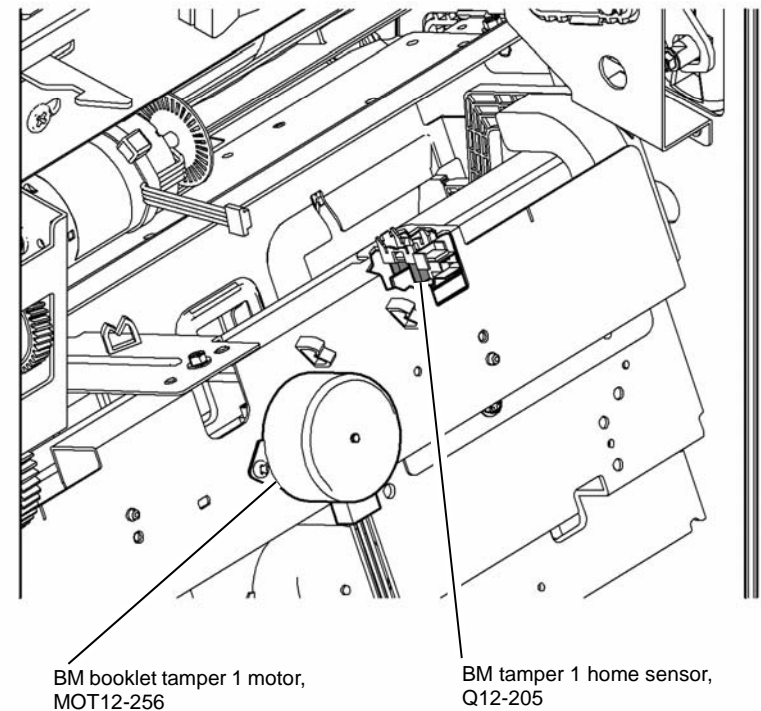
Figure 1 Component location

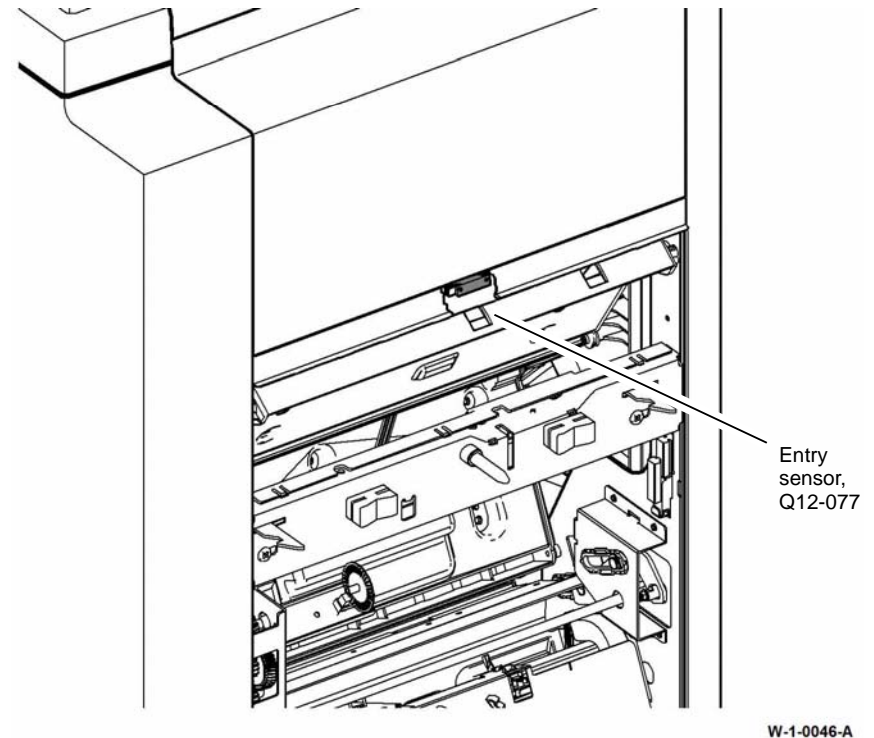
Figure 1 Component location

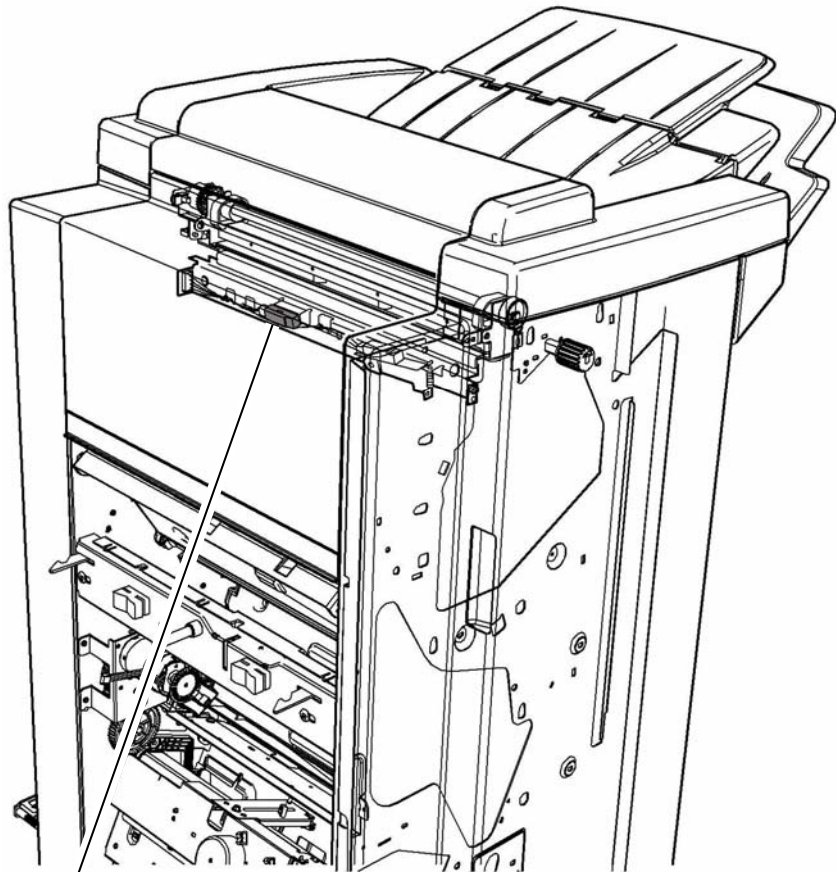
Punch sensor 1, Q12-078

Figure 1 Component location

- The LVF PWB DIP switch settings. Refer to 312F-150 LVF PWB and LVF BM PWB DIP Switch Settings RAP.
- That the paper tray guides are set to the correct position for the size of paper in the tray.
- For a paper jam at the entrance to the LVF BM. Check that there is no obstruction that would prevent a sheet from arriving in position for punching, refer to the 312H-150 Copy Damage in the LVF BM RAP.
- The punch sensor 1, Q12-078 for chad debris, Figure 1.

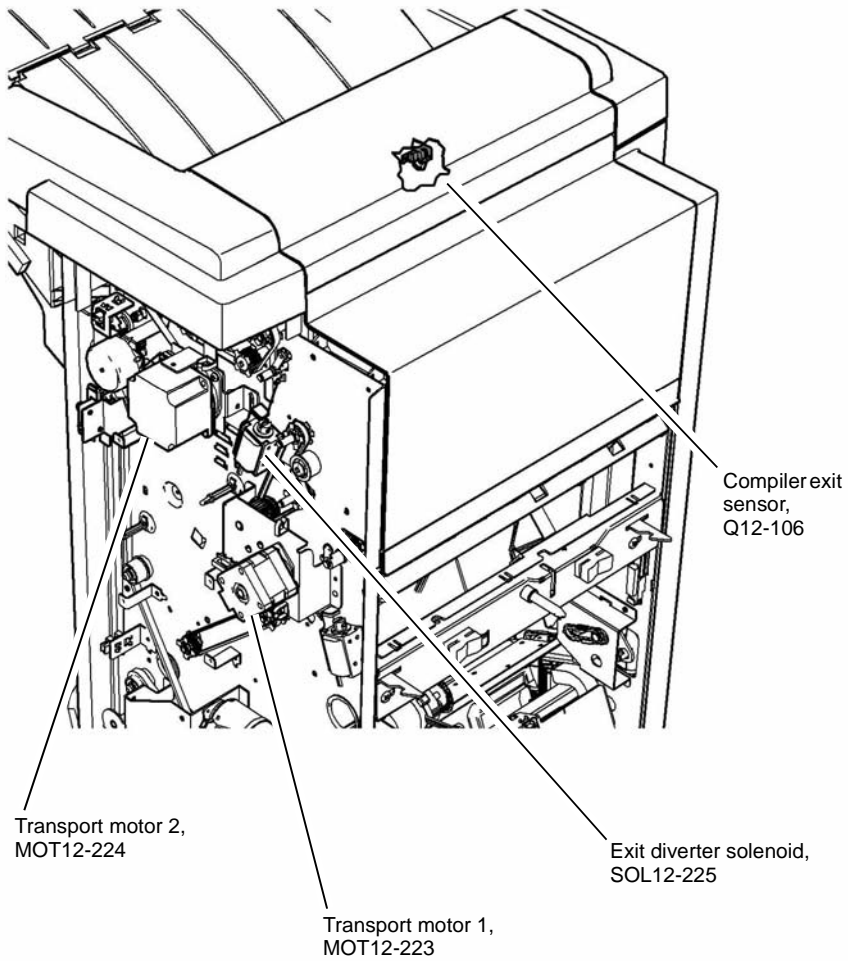
Figure 1 Component location

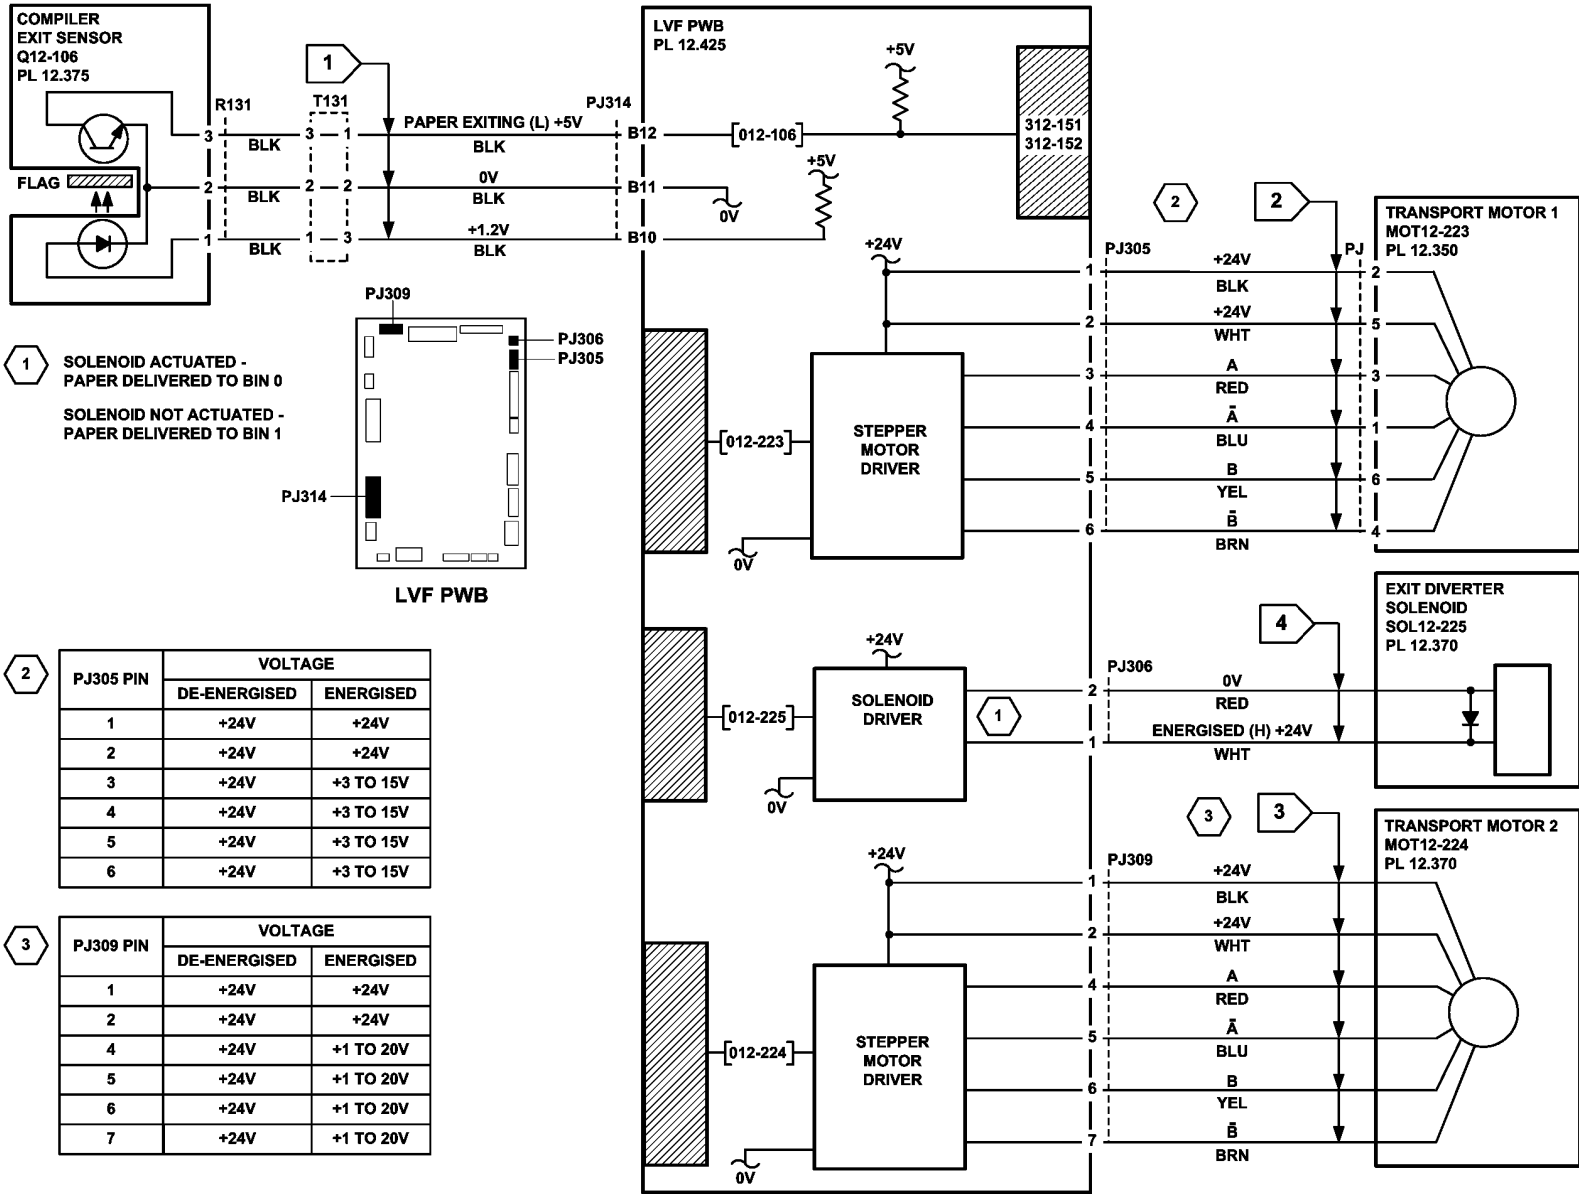
Figure 2 Circuit diagram

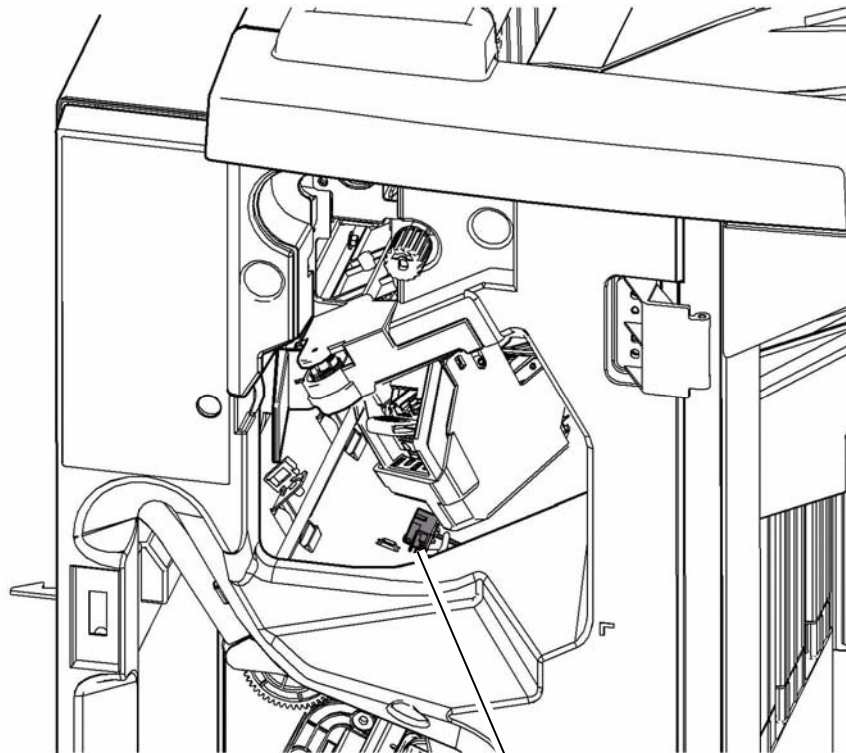
BM entry sensor, Q12-089

Figure 1 Component location

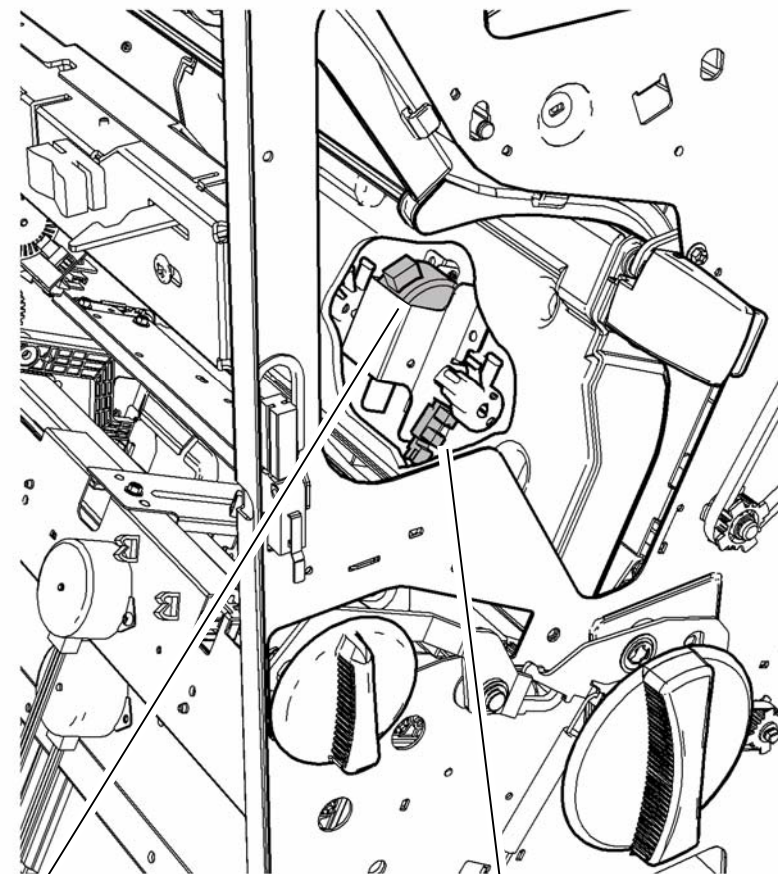
BM flapper motor,
MOT12-271

BM flapper home
sensor, Q12-207

Figure 2 Component location

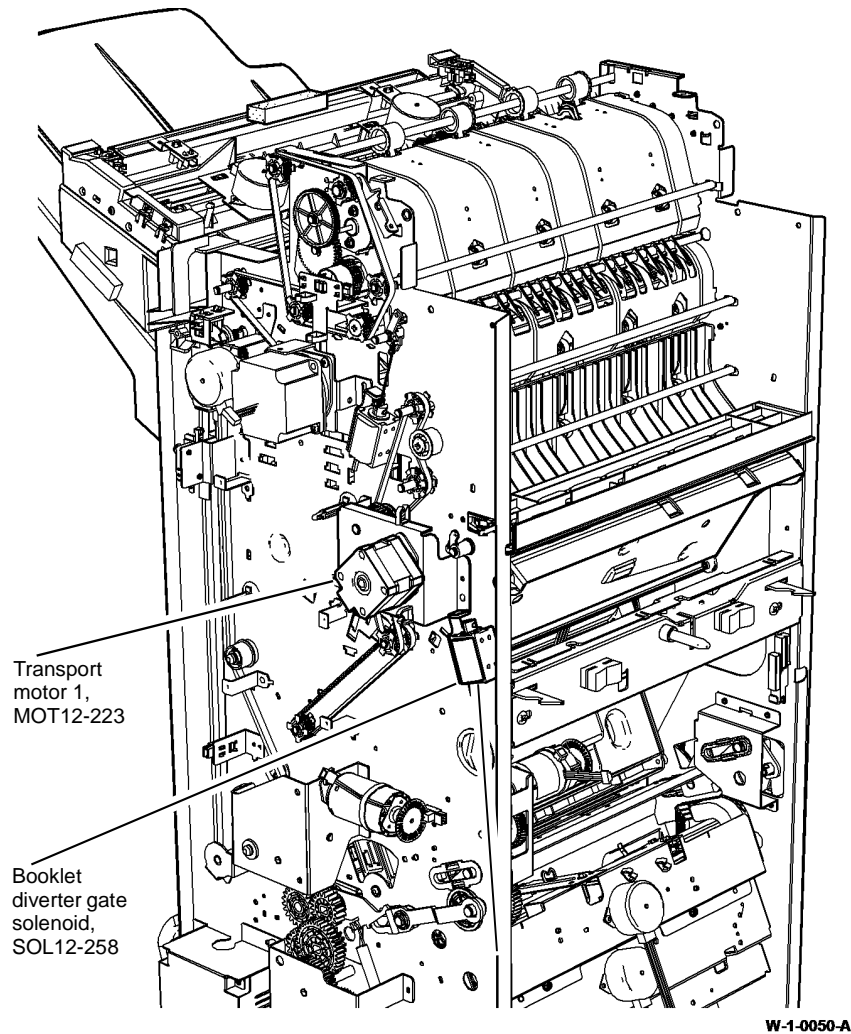
Figure 3 Component location

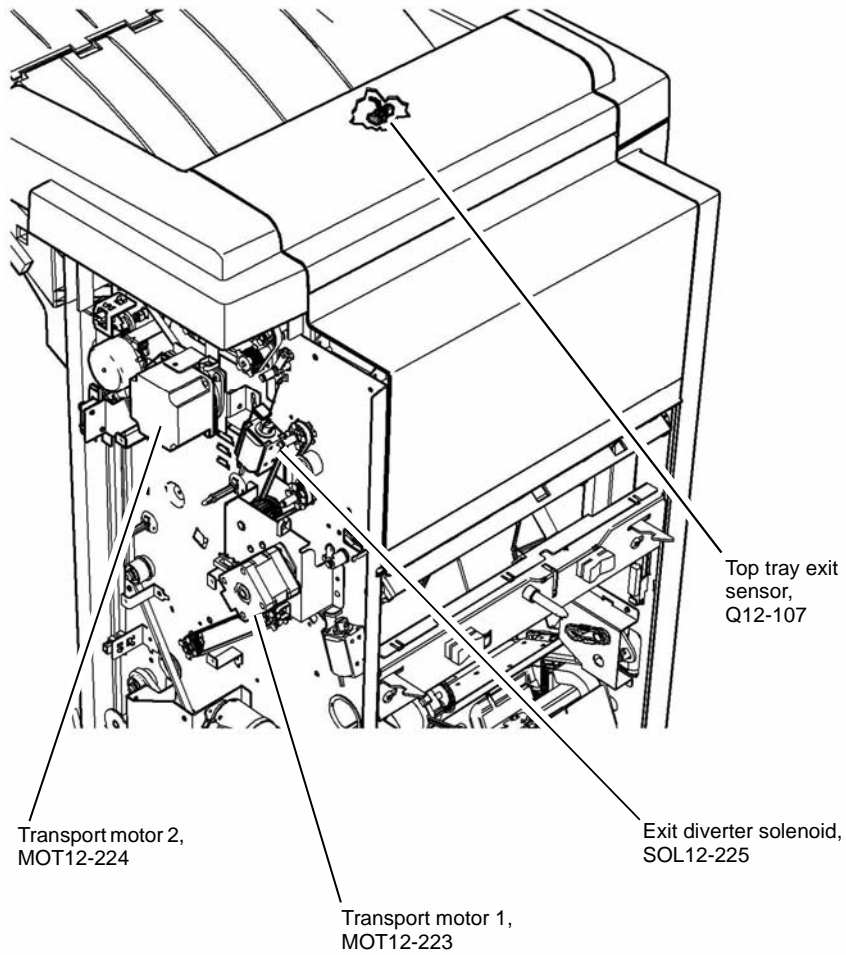
Figure 1 Component location

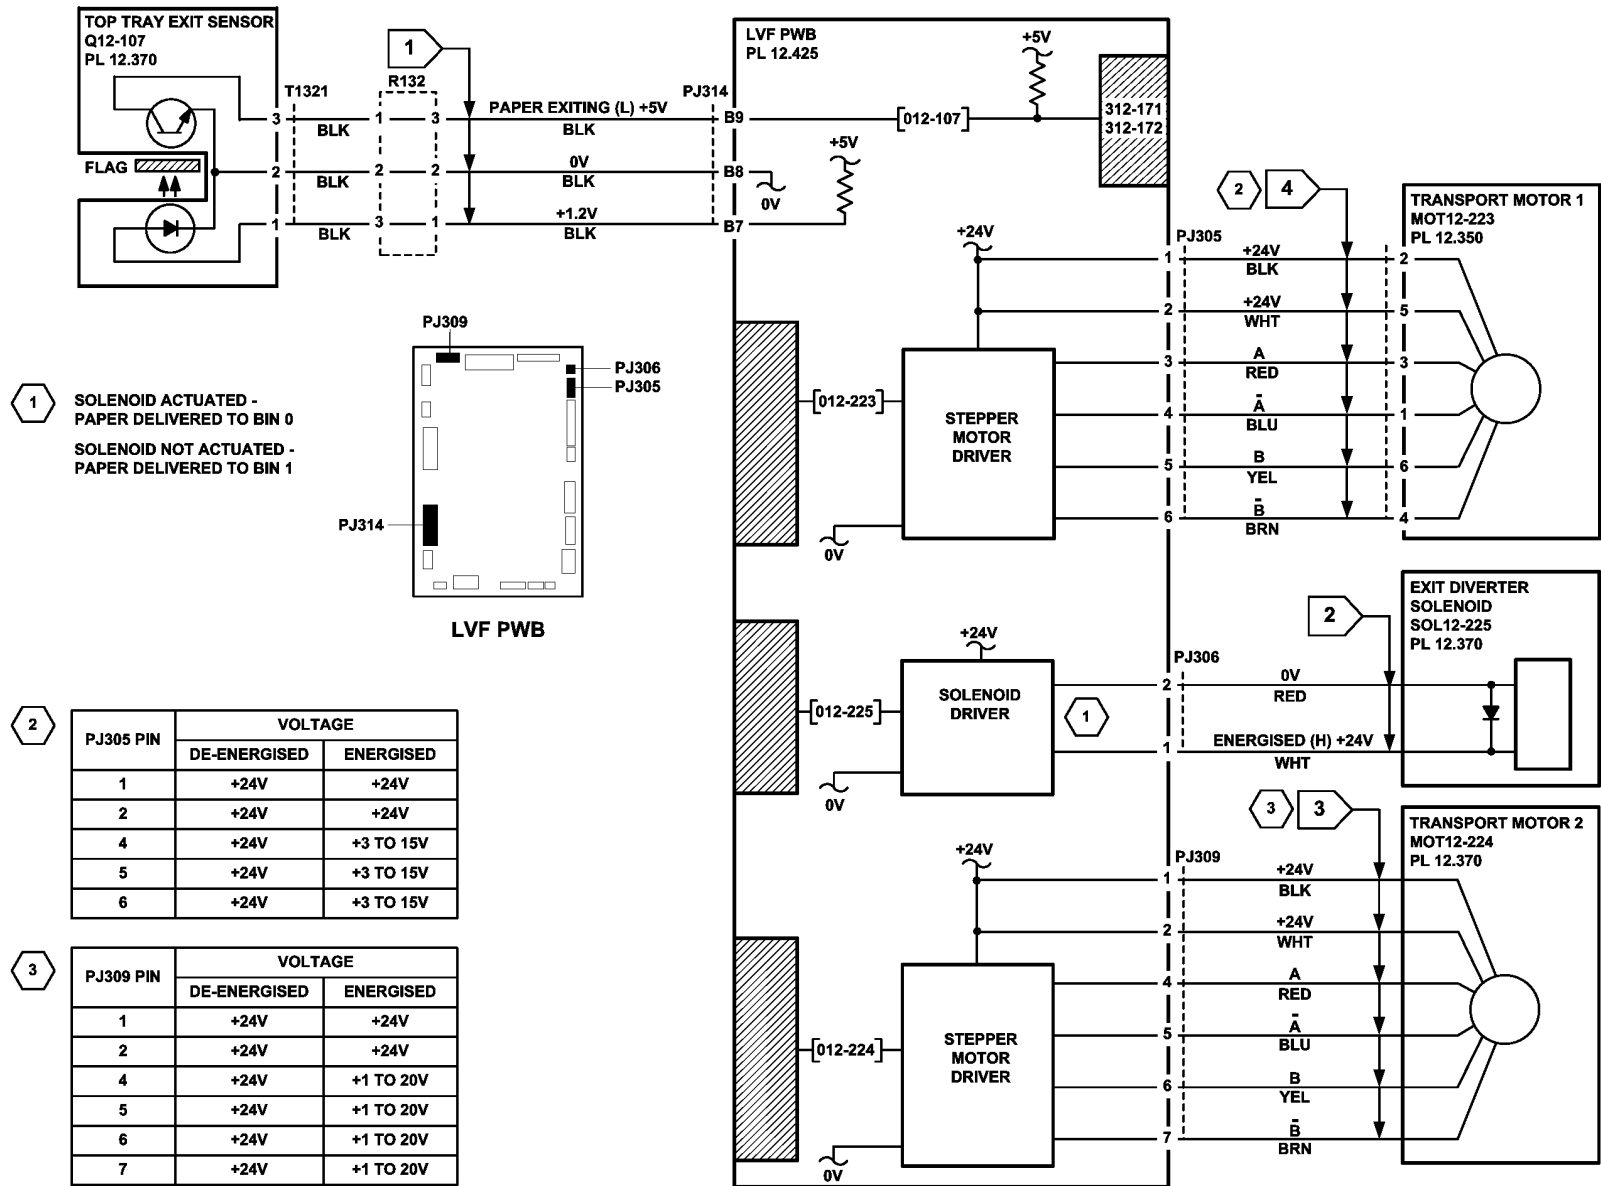
Figure 2 Circuit diagram

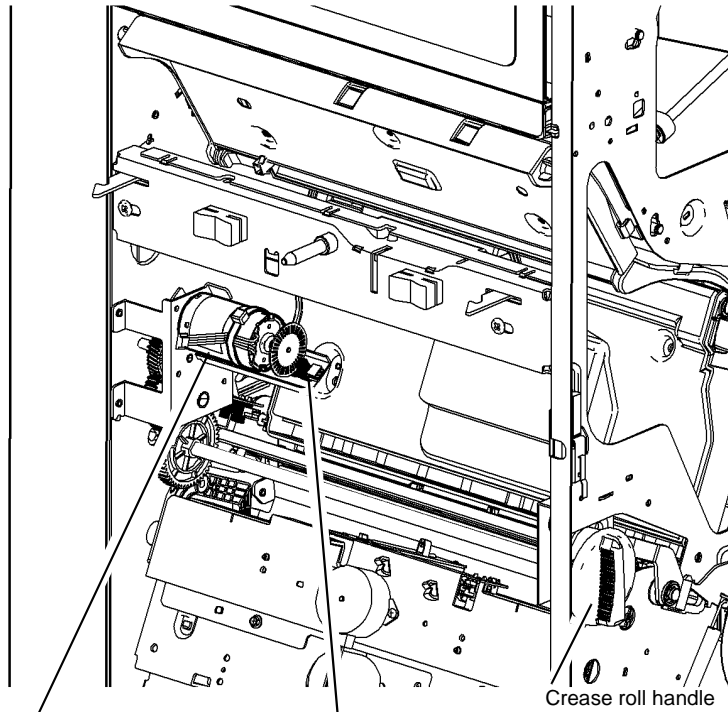
Crease blade motor,
MOT12-252

Crease blade motor encoder sensor,
Q12-215

Figure 1 Component location

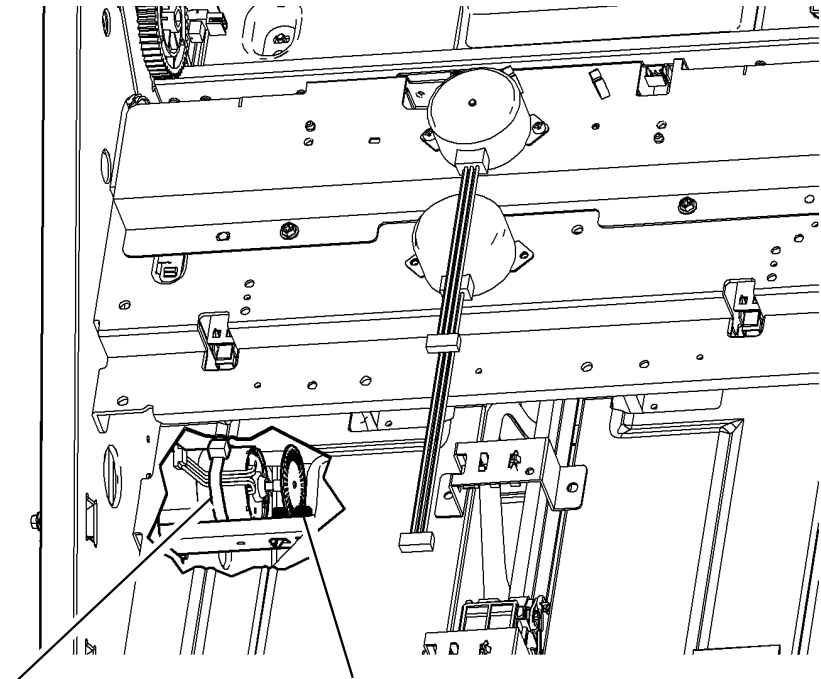
Crease roll motor, MOT12-253

Crease roll motor encoder sensor, Q12-216

Figure 2 Component location

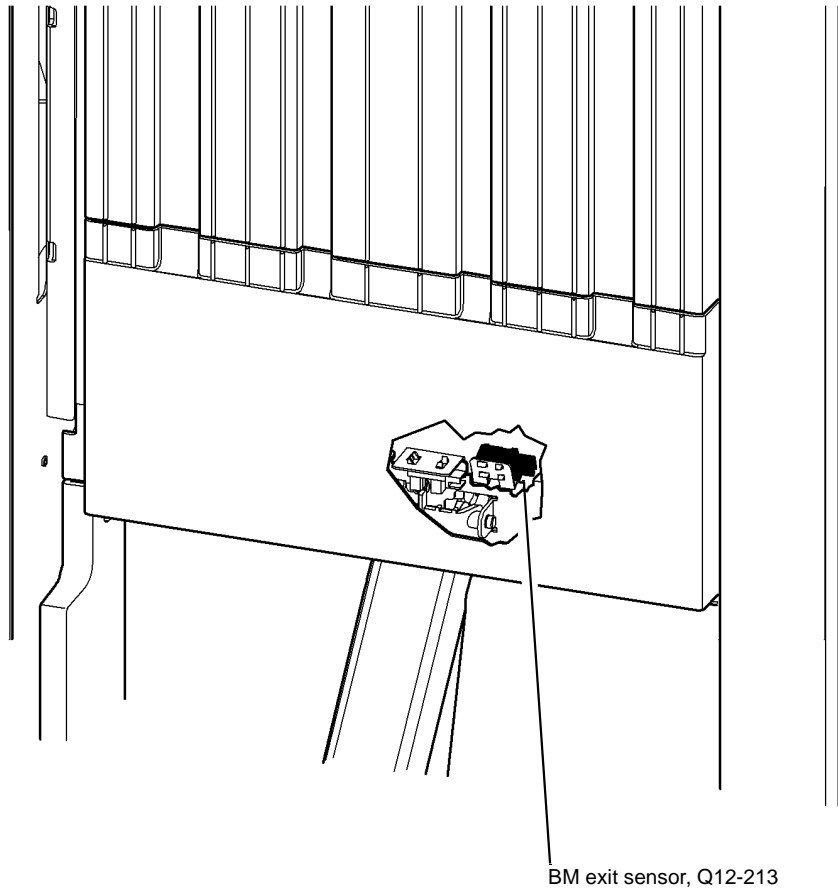
Figure 3 Component location

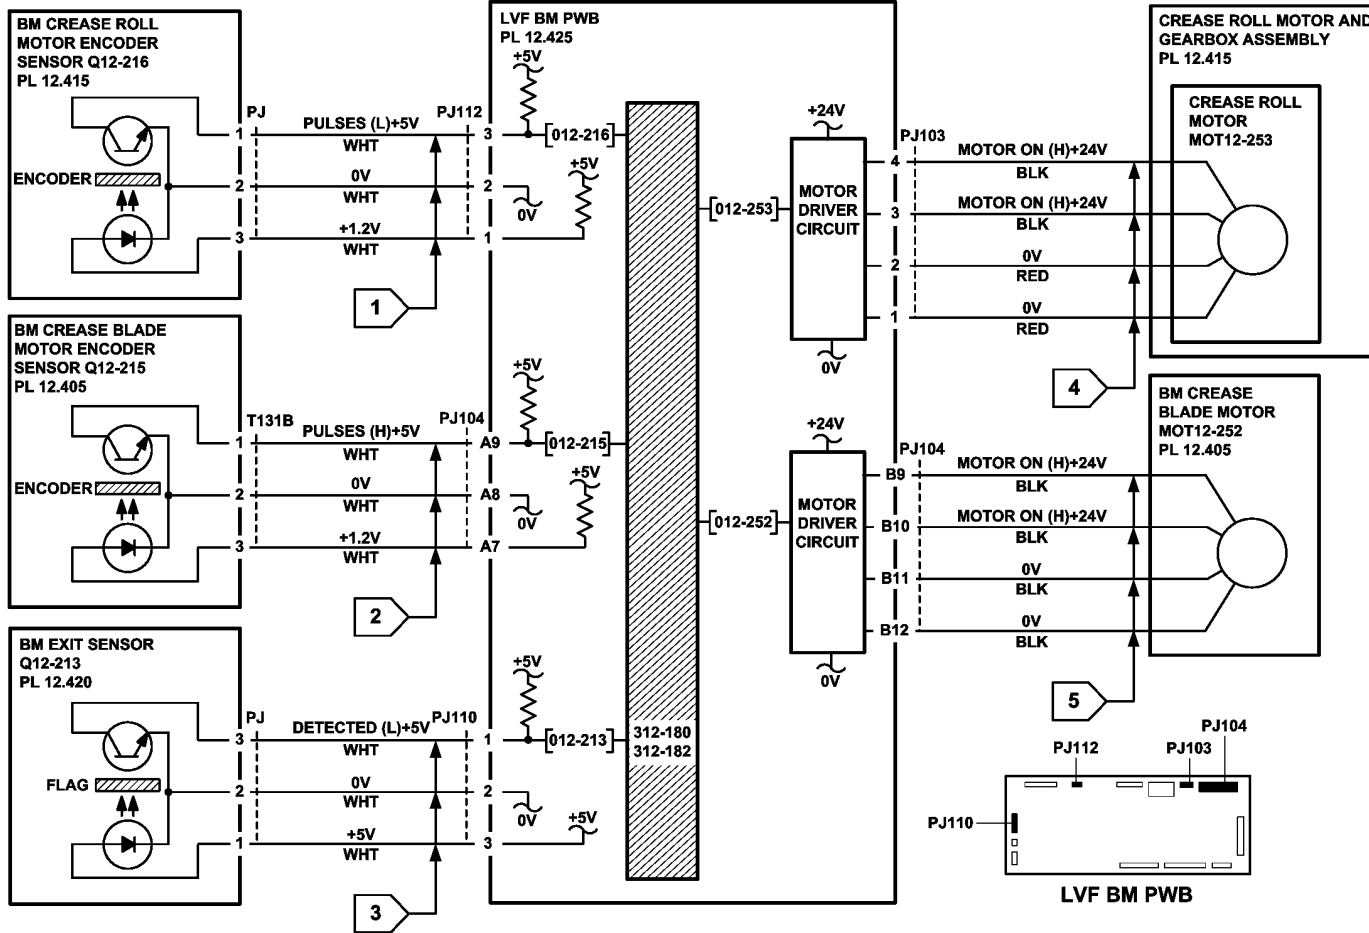
Figure 4 Circuit diagram

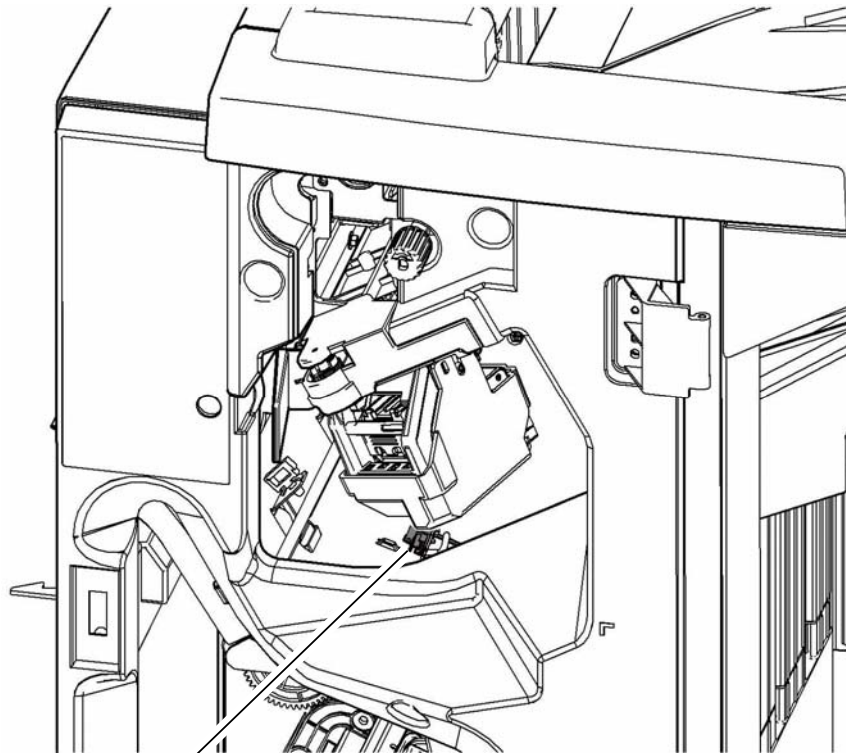
BM entry sensor,
Q12-089

Figure 1 Component location

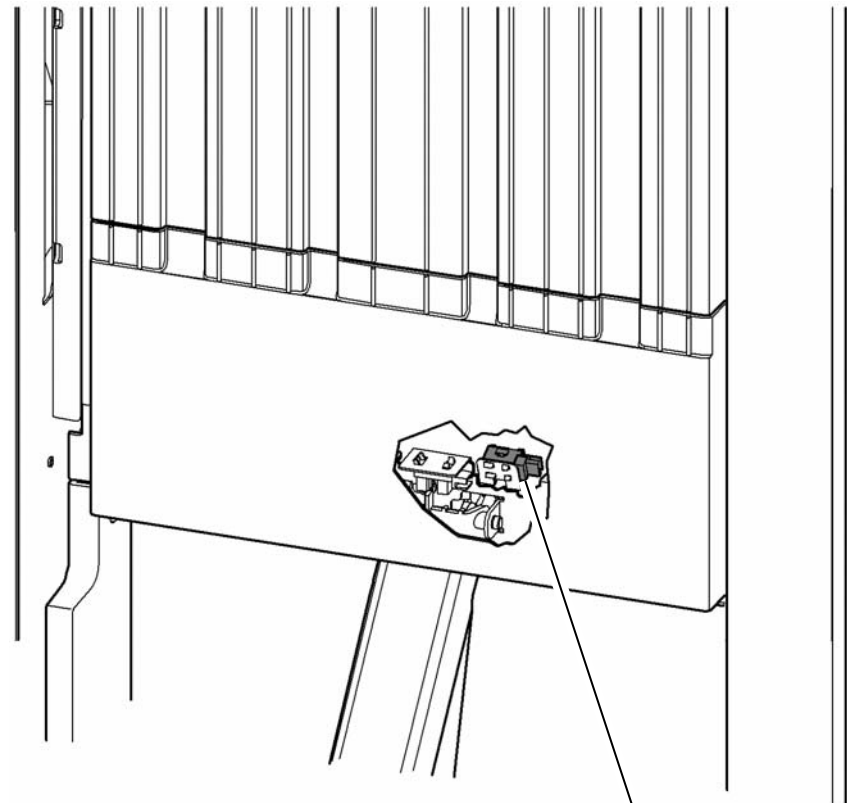
BM exit sensor,
Q12-213

Figure 2 Component location

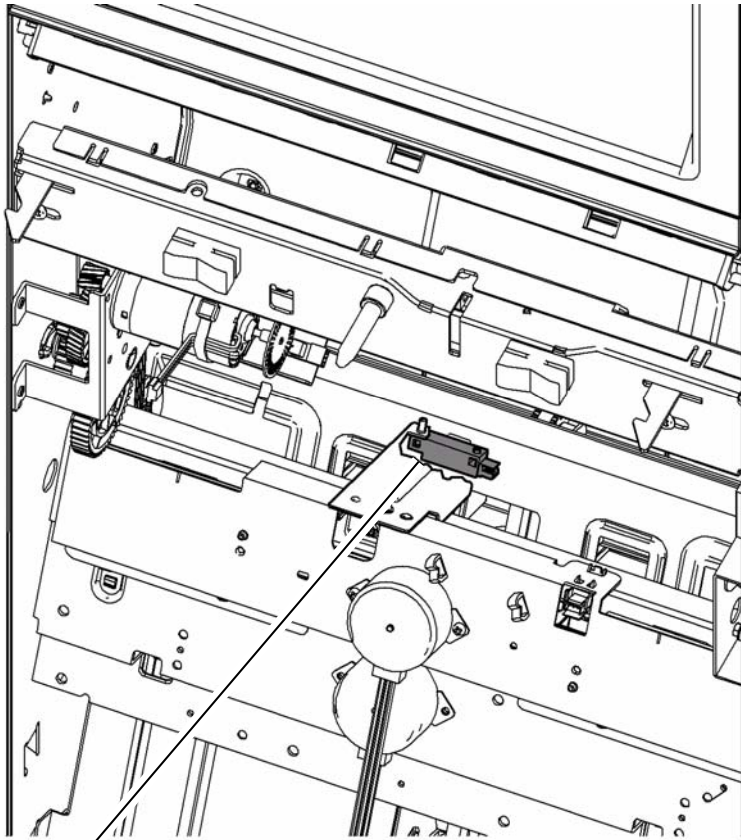
BM paper present sensor, Q12-170

Figure 3 Component location
