708P91139
February 2016

Xerox® WorkCentre® 5945 Family Multifunction Printer Service Manual

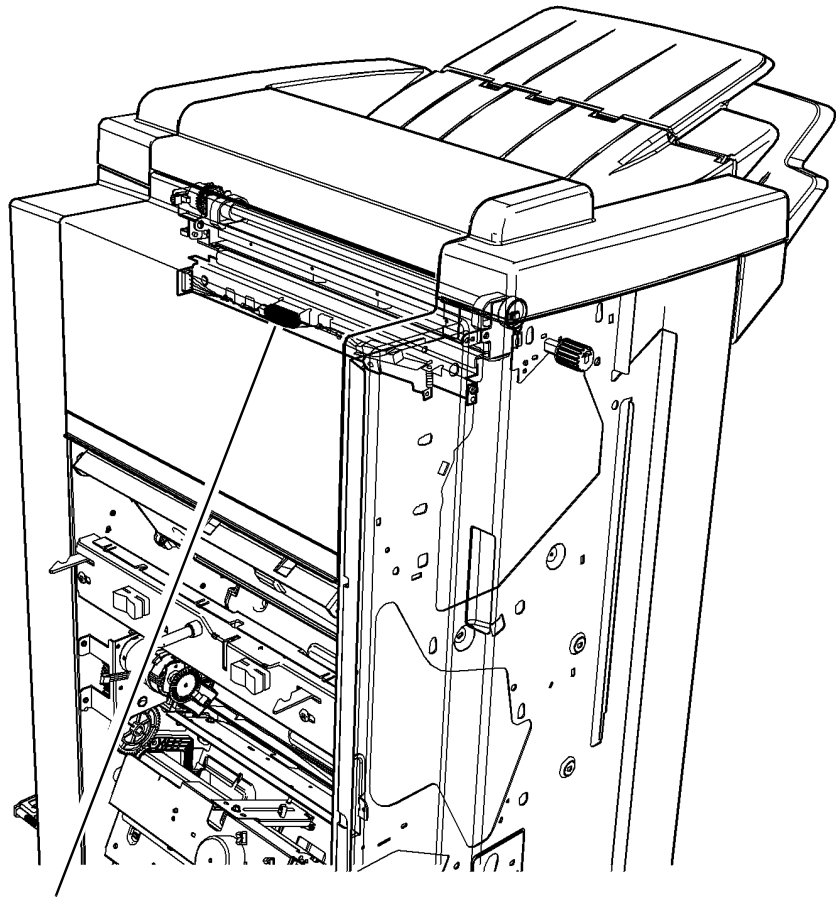
Figure 2 Component location

Punch sensor 1, Q12-078

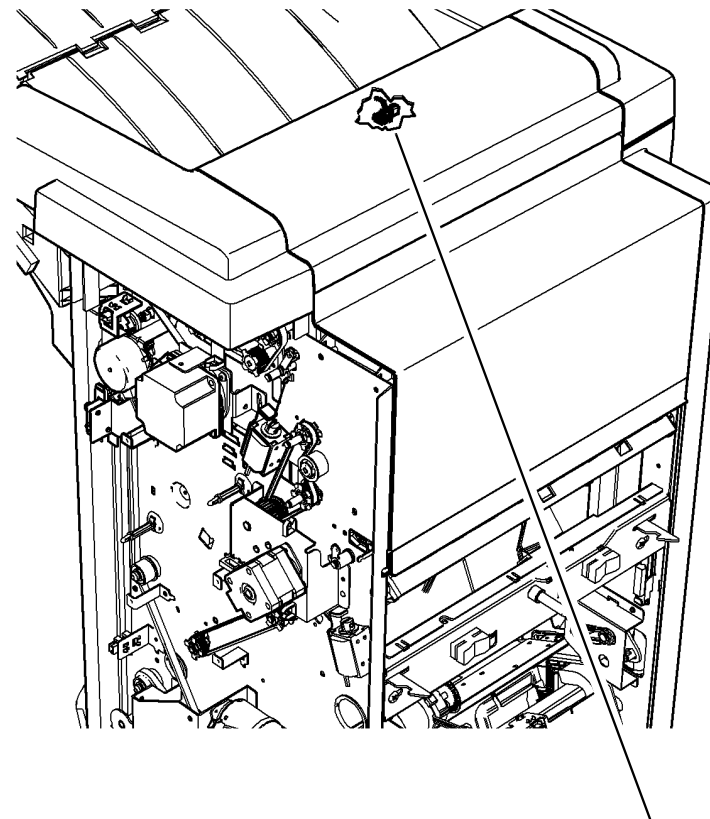
Figure 3 Component location

Top tray exit
sensor, Q12-107

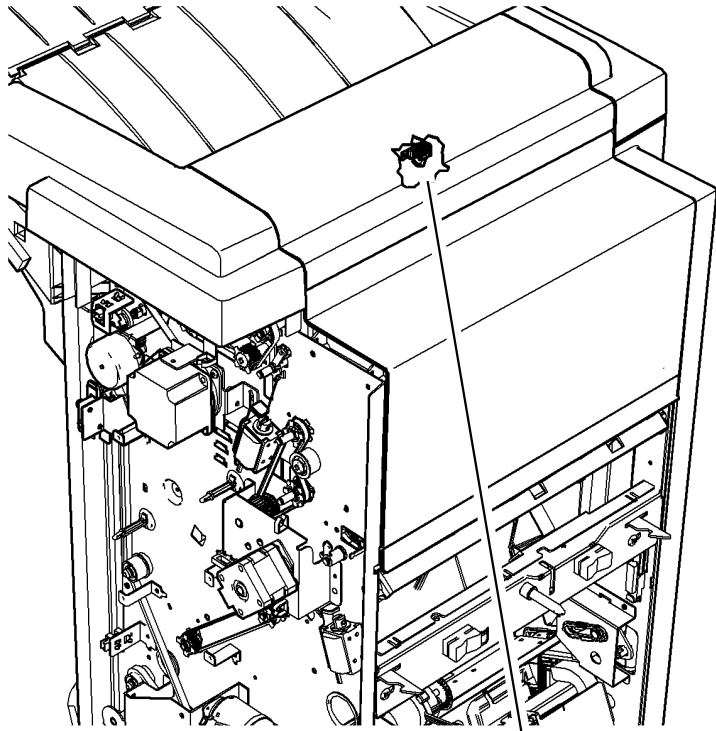
Figure 4 Component location

Compiler exit sensor,
Q12-106

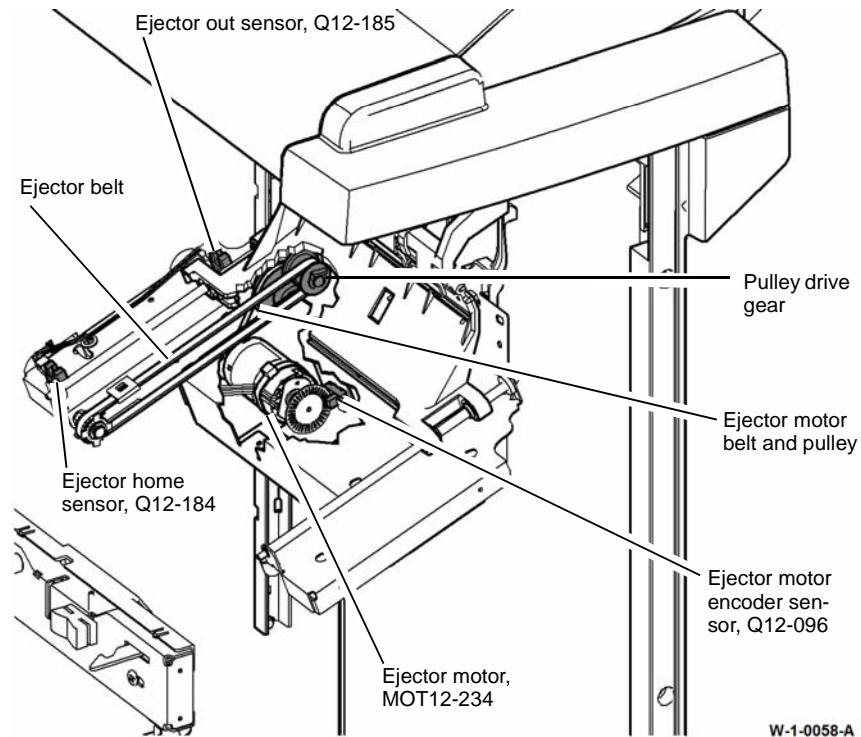
Figure 1 Component location

- 1 012-234 MOVES EJECTOR TO THE HOME POSITION
- 012-235 MOVES EJECTOR TO THE OUT POSITION
- 012-236 CYCLES THE EJECTOR UNTIL TIMEOUT

- Ejector motor encoder sensor, Q12-096, PL 12.360 Item 3.
- LVF PWB, PL 12.425 Item 8.

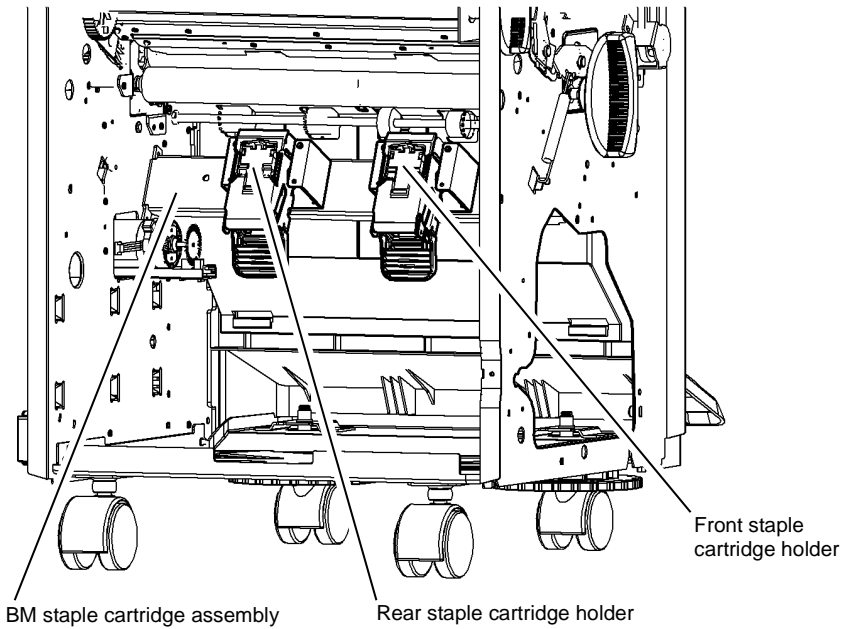
Figure 1 Component location

NOTE: The back stop assembly, BM stapler assembly and booklet tamper assembly have been removed for clarity.

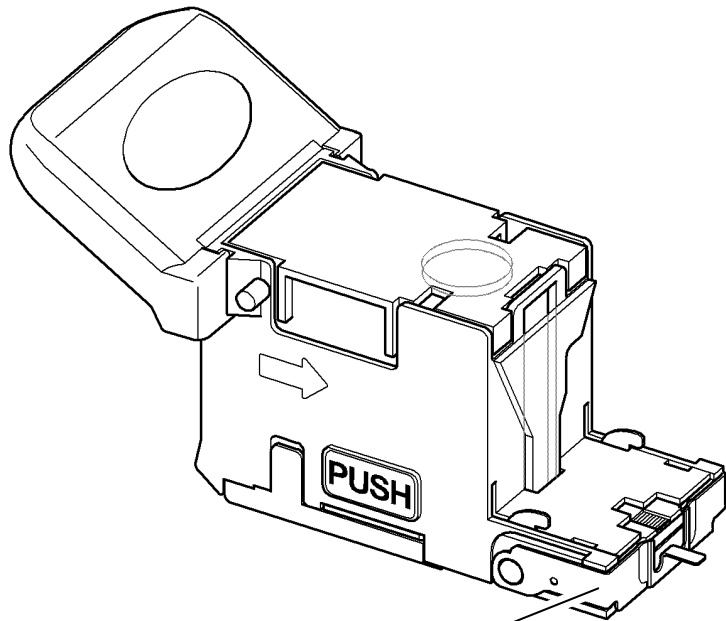
Figure 3 Staple cartridge closed

Forming plate fully closed

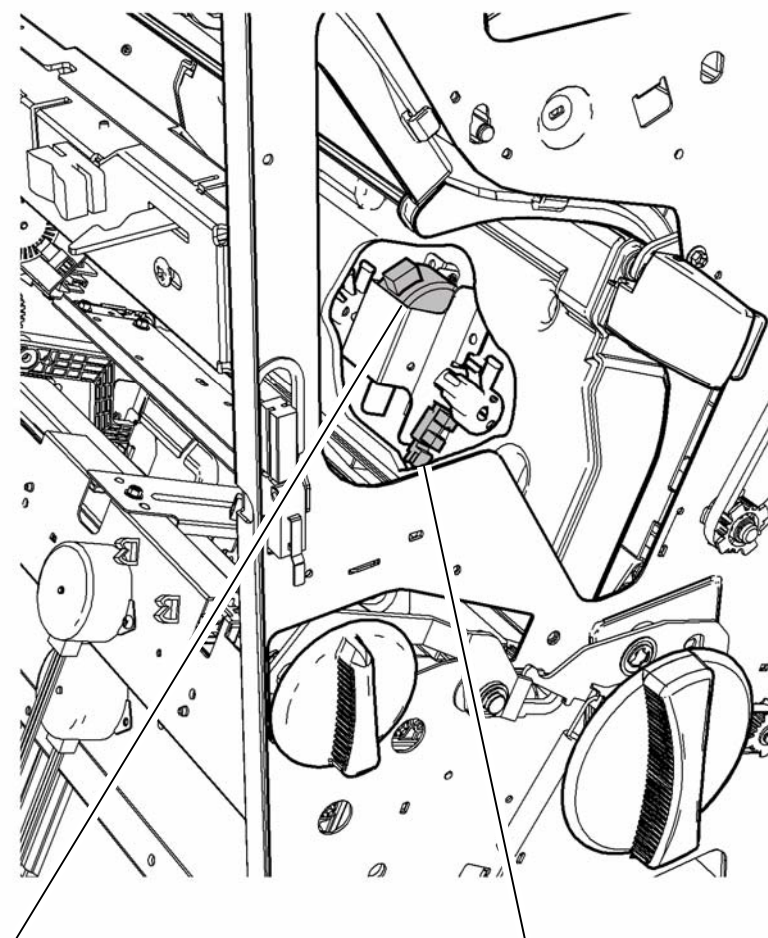
Figure 1 Component location

BM flapper motor,
MOT12-271

Flapper home
sensor, Q12-207

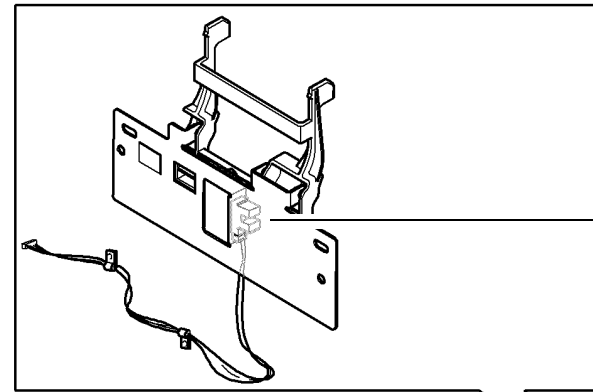
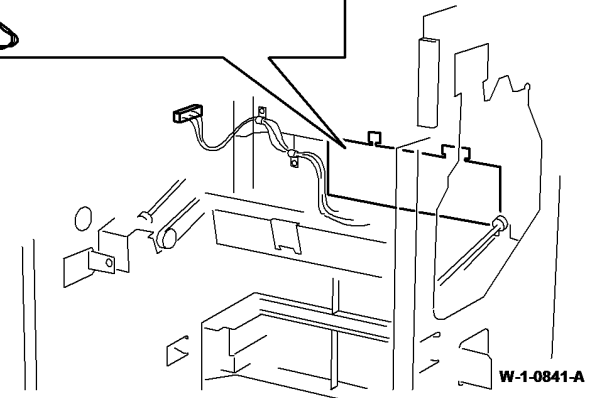
Figure 1 Component location

Bin 1 upper level sensor, Q12-188

1. Paper is delivered to the tray until the bin 1 upper level sensor, Q12-188 is actuated.
2. The bin 1 elevator motor, MOT12-241 lowers the tray until the bin 1 upper level sensor, Q12-188 is de-actuated.
3. The bin 1 elevator motor, MOT12-241 raises the tray until the paper stack height actuates the bin 1 upper level sensor, then MOT12-241 lowers the tray to continue the cycle.
4. When the tray is emptied, the tray returns to the home position. The tray is elevated until the bin 1 upper level sensor, Q12-188 is made. The tray is then lowered until Q12-188 is just cleared. In the home position the bin 1 upper limit switch, S12-190 is actuated.

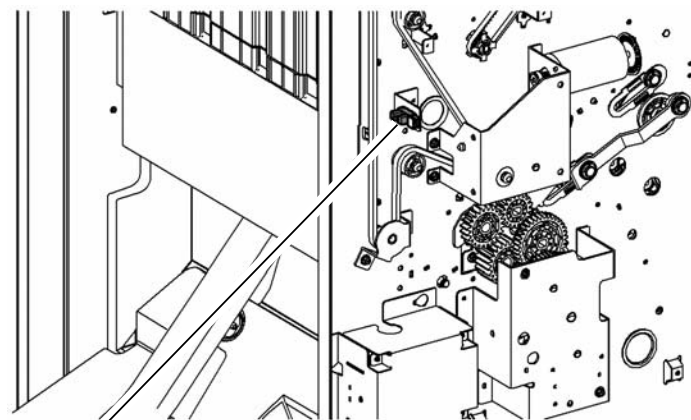
Figure 1 Component location

Bin 1 90% full sensor, Q12-187

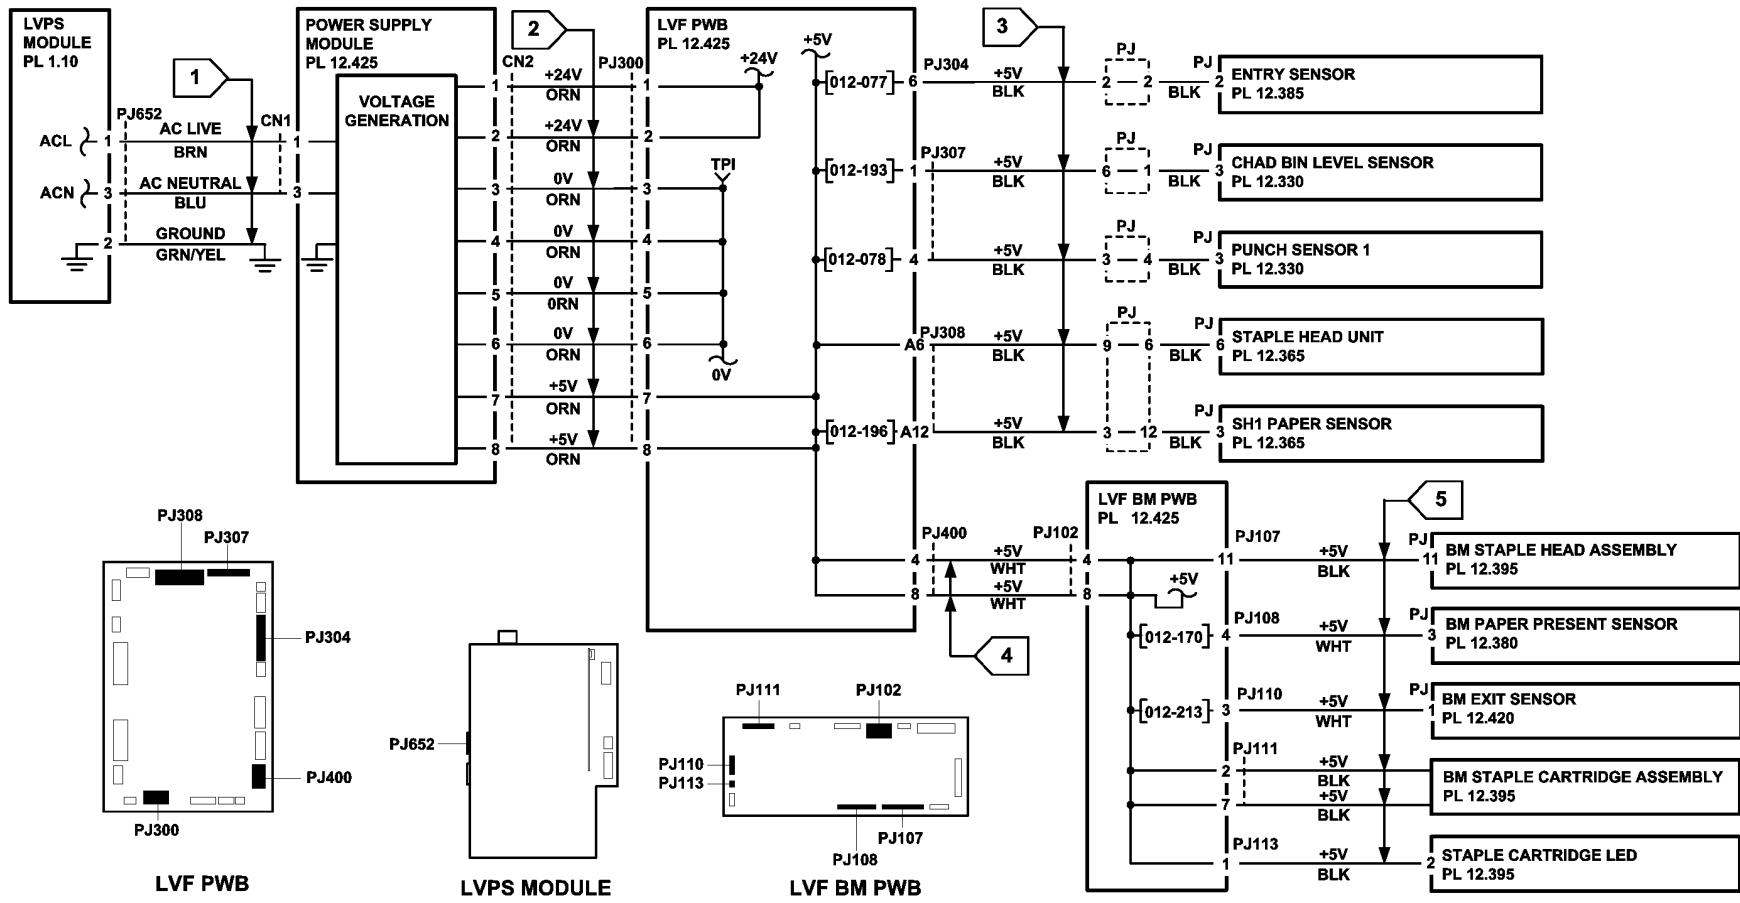
TW-1-0238-A

Figure 4 +5V circuit diagram

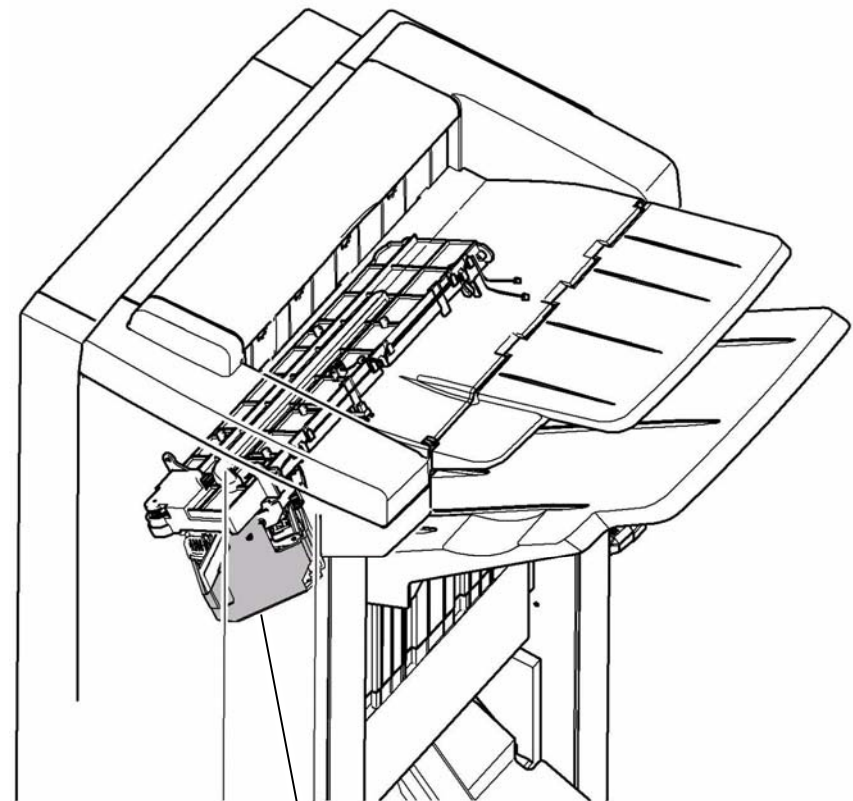
W-1-0040-A

Staple head including
MOT12-247 and stapler jaw
home sensor, Q12-318

Figure 1 Component location

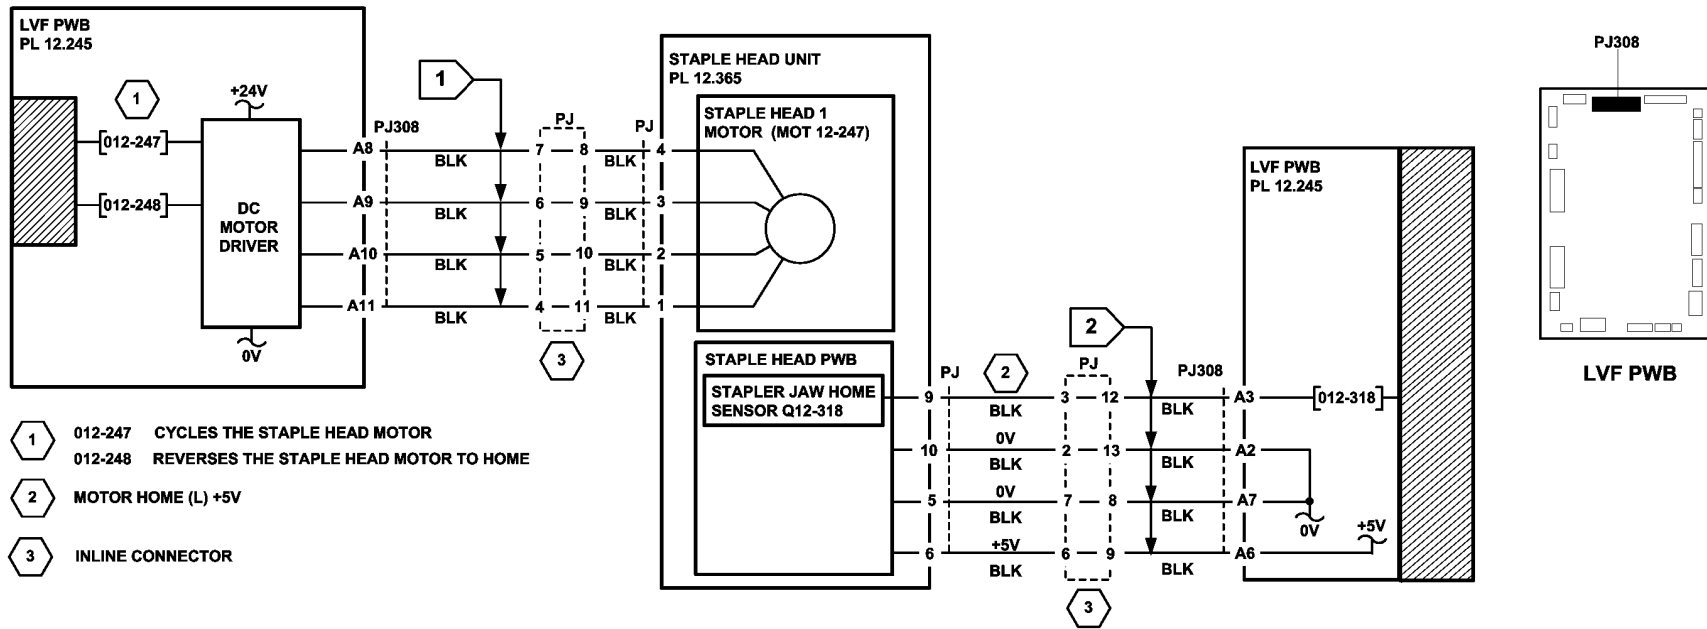
TW-1-0027-A

Figure 2 Circuit diagram

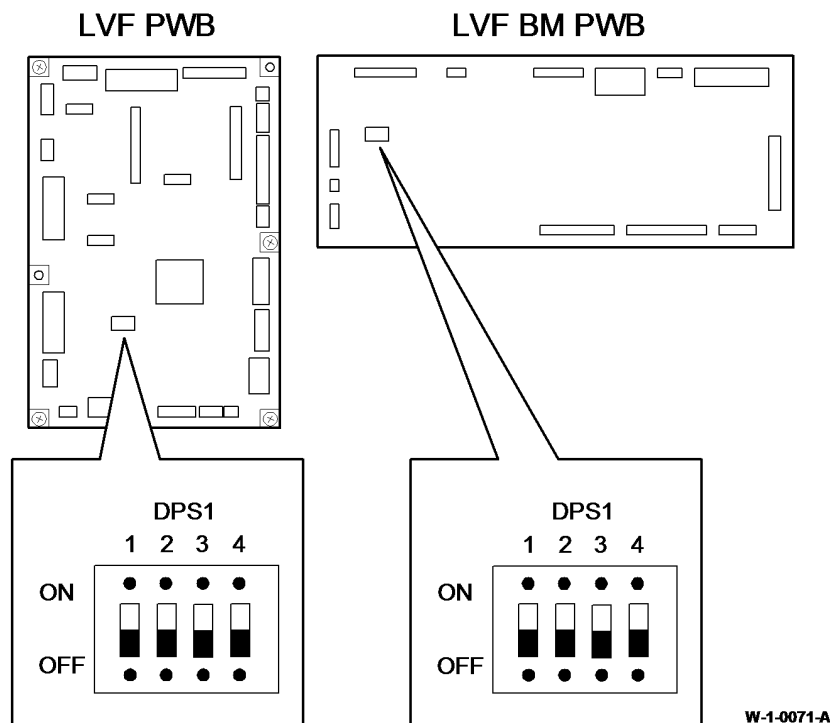
Figure 1 DIP switch settings

Check the DIP switch settings, [Figure 1](#). If necessary, switch off the machine, [GP 14](#). Correct the DIP switch settings, then switch on the machine, [GP 14](#).

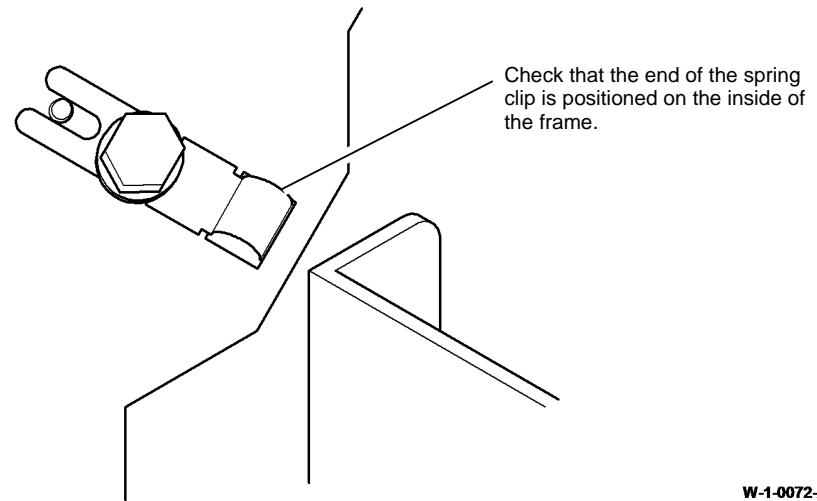
W-1-0072-A

Figure 1 Position of the spring clip

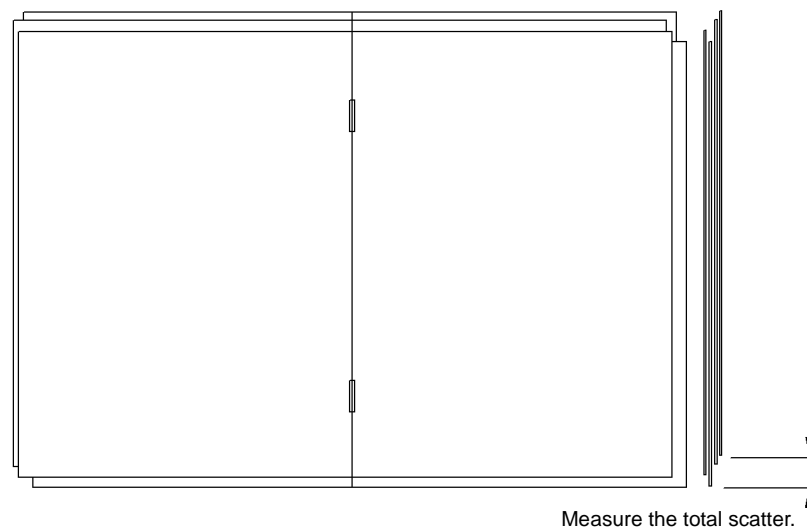
W-1-1345-A

Figure 1 Top and bottom alignment

Open out the booklet at the centre page and press it onto a flat surface. Measure the mis-alignment of the top and bottom edges of the booklet, Figure 1.

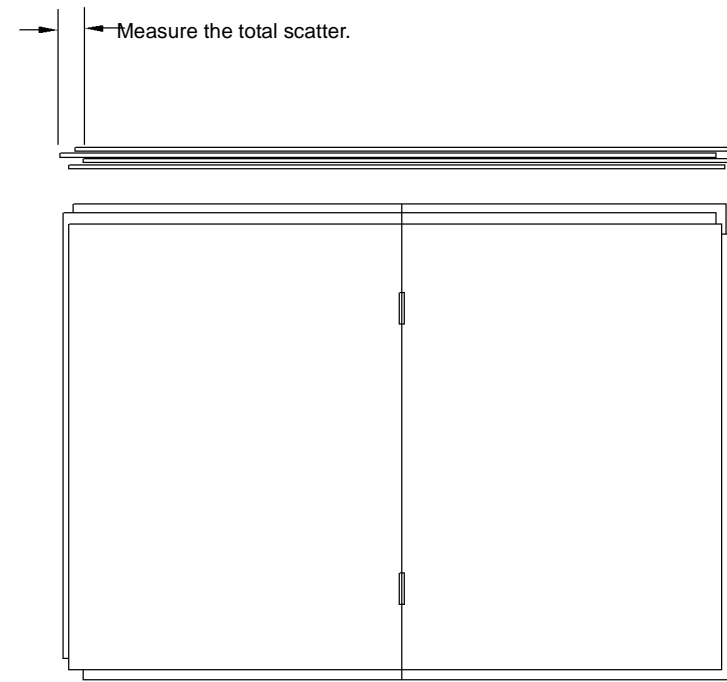
W-1-1346-A

Figure 2 Open side edge alignment

Open out the booklet at the centre page and press it onto a flat surface. Measure the mis-alignment of the open side edges of the booklet, [Figure 2](#).

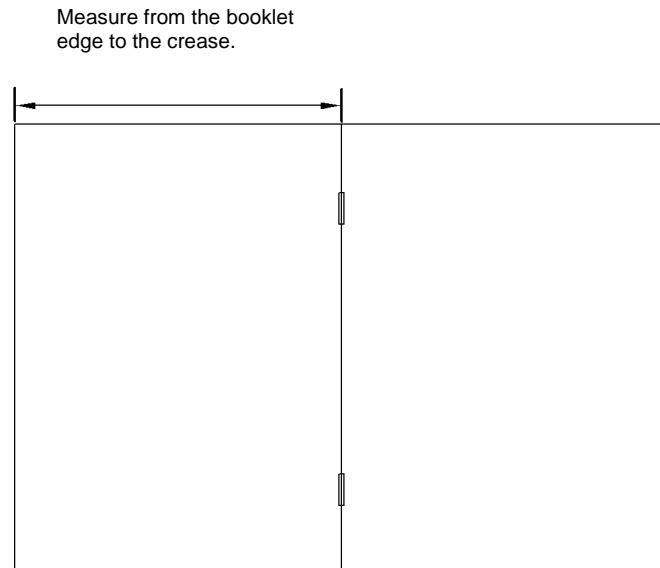
Figure 3 Booklet skew

Open out the booklet at the centre page and press it onto a flat surface. Measure the position of booklet crease, [Figure 3](#).

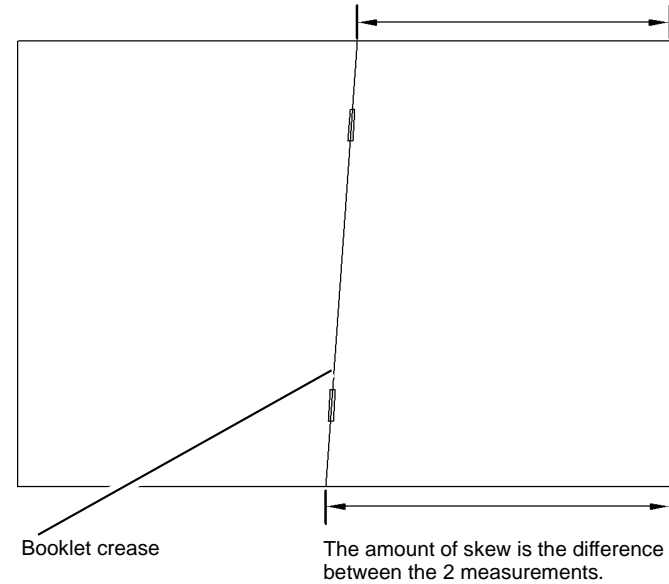
W-1-1347-A

Figure 4 Booklet crease skew

Open out the booklet at the centre page and press it onto a flat surface. Measure the mis-alignment of the open side edges of the booklet, [Figure 4](#).

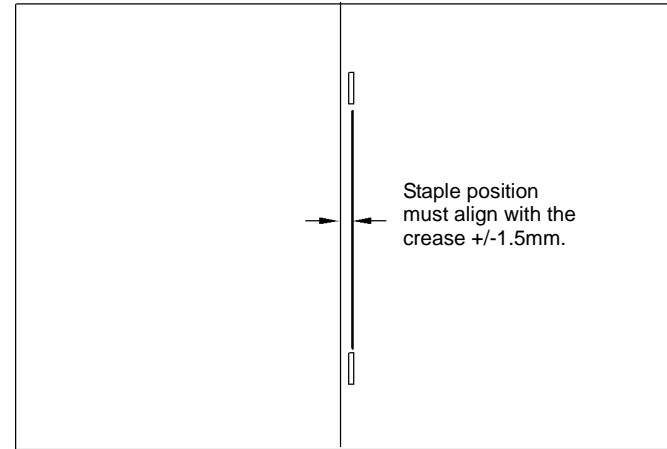
W-1-1349-A

Figure 5 Booklet staple position

Open out the booklet at the centre page and press it down onto a flat surface. Measure the position of the booklet staple from the crease line, [Figure 5](#).

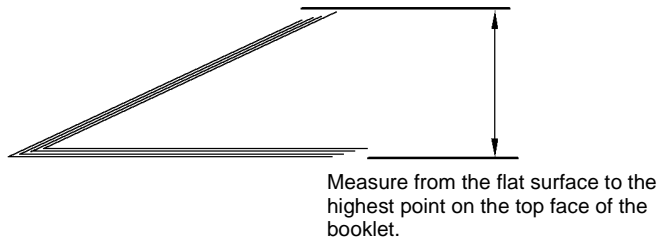
W-1-1350-A

Figure 6 Booklet creasing

Place the folded booklet onto a flat surface. Measure the maximum open dimension of the booklets within 20 seconds of being formed, [Figure 6](#).

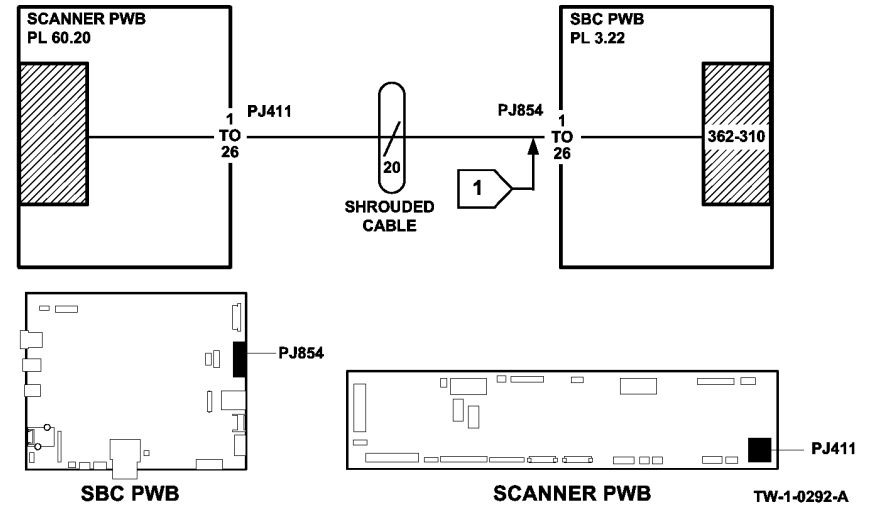
Figure 2 Circuit diagram

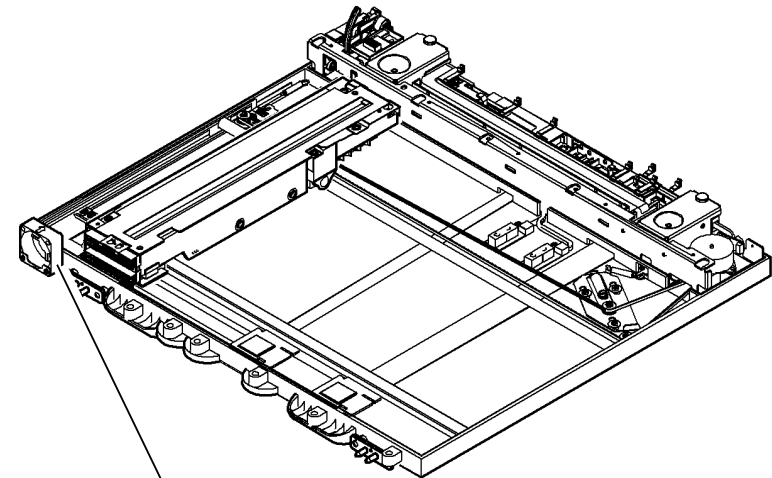
W-1-0912-A

Cooling fan, MOT62-029

Figure 1 Component location

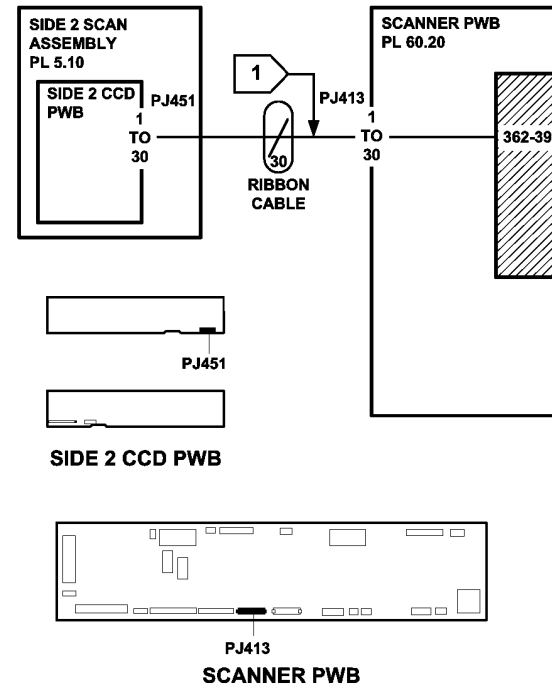
TW-1-0214-A

Figure 2 Circuit diagram

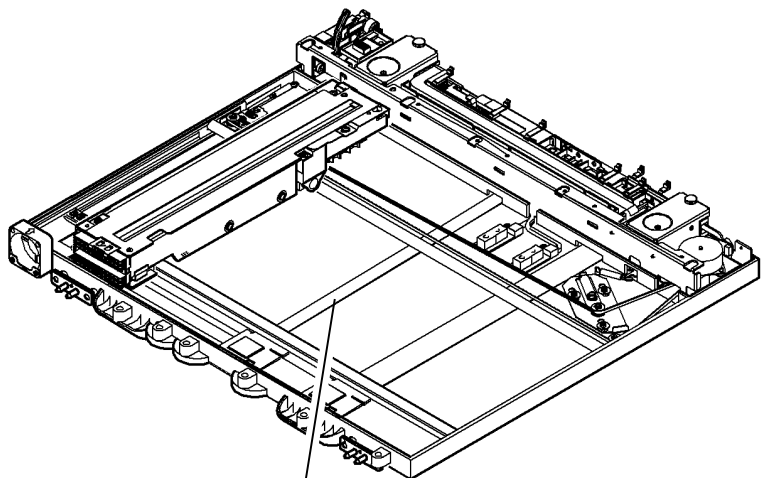
W-1-1159-A

Scan carriage data ribbon cable

Figure 2 Component location

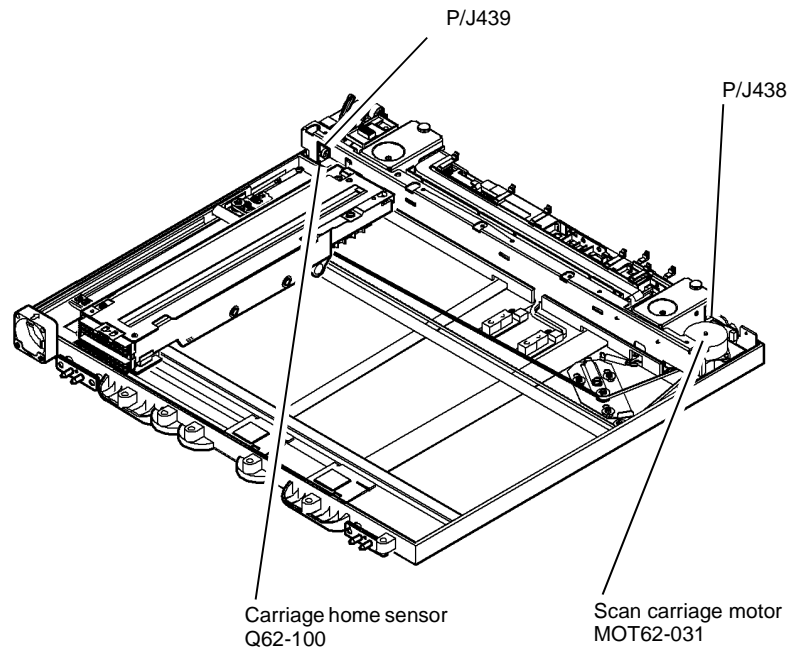
W-1-0909-A

Figure 1 Component location

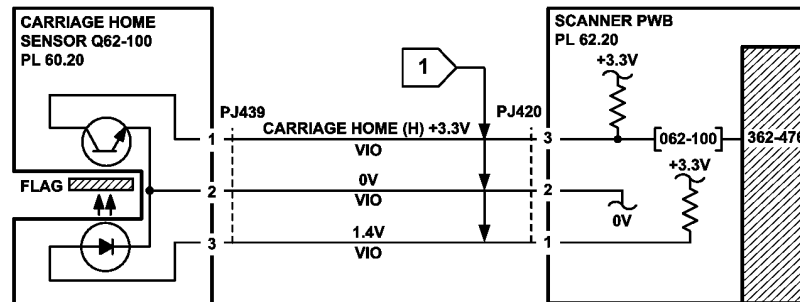
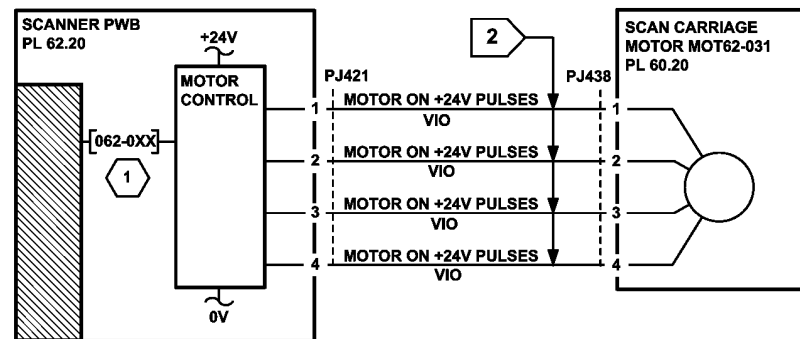
- 062-024 MOVES THE CARRIAGE TO THE DOCUMENT SIZE POSITION
- 062-025 MOVES THE CARRIAGE TO THE CVT POSITION
- 062-026 MOVES THE CARRIAGE TO THE TEST A POSITION
- 062-027 MOVES THE CARRIAGE TO THE TEST B POSITION
- 062-028 MOVES THE CARRIAGE TO THE TEST C POSITION
- 062-030 MOVES THE CARRIAGE TO THE CALIBRATION STRIP POSITION
- 062-031 MOVES THE CARRIAGE TO THE HOME POSITION

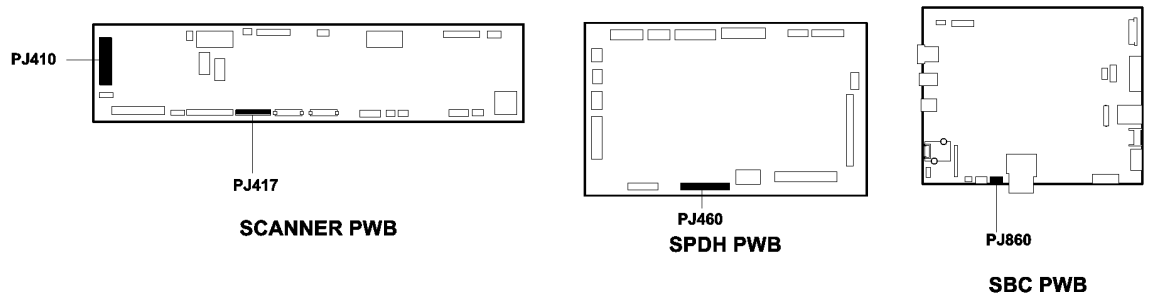
TW-1-0255-A

Figure 2 Circuit diagram

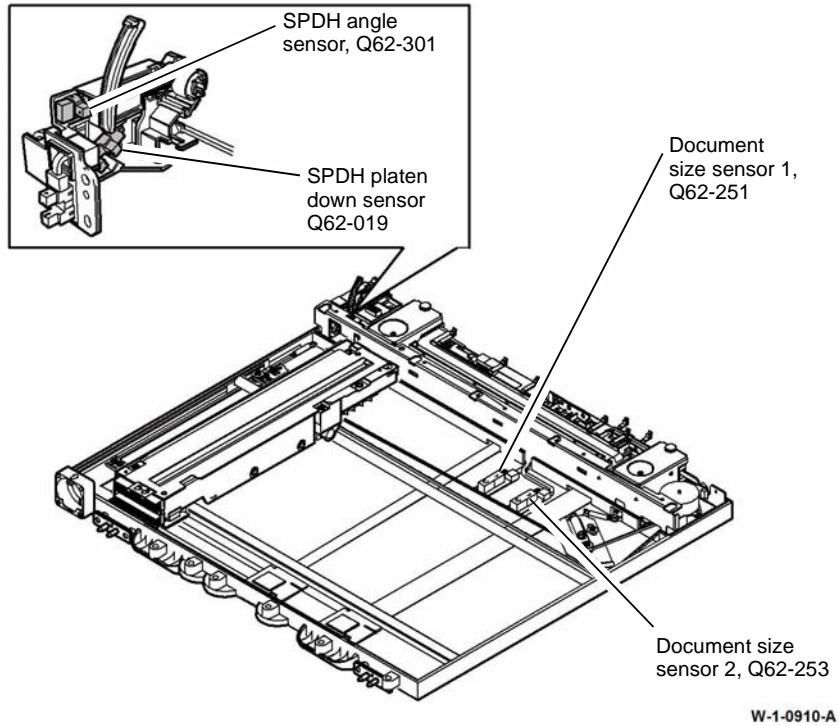
Figure 1 Component location

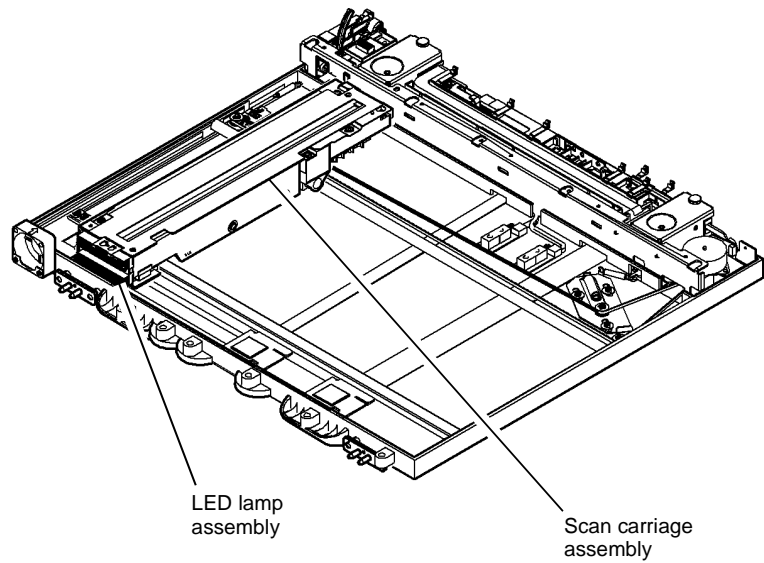
W-1-0911-A

Figure 1 Component location

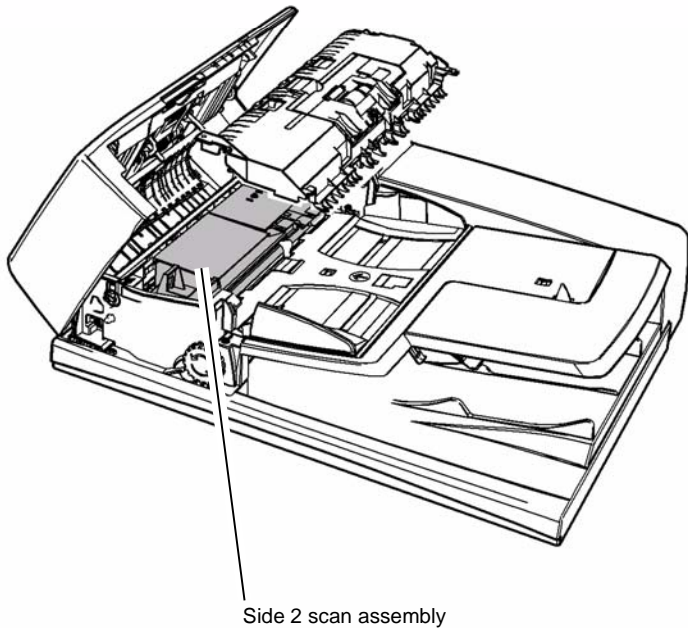
W-1-0913-A

Figure 2 Component location

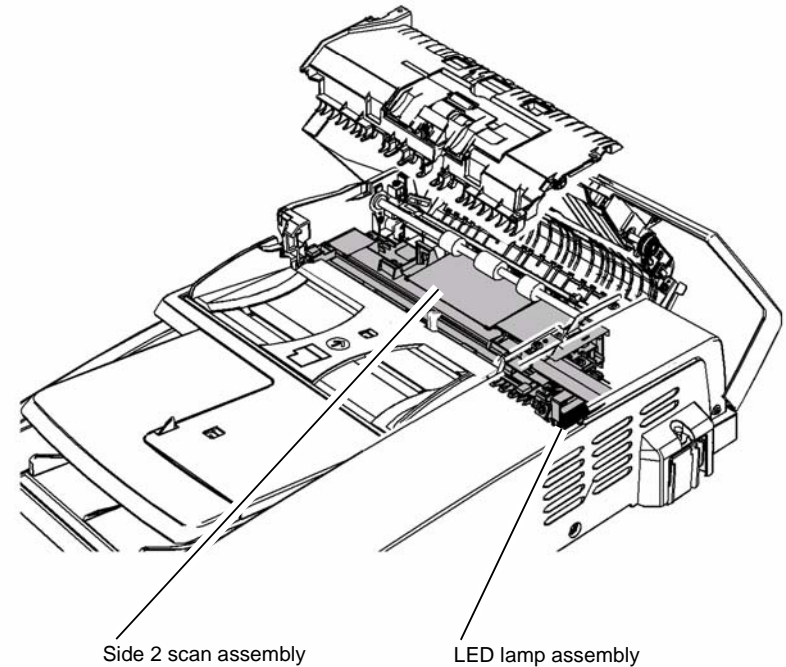
W-1-0914-A

Figure 1 Component location

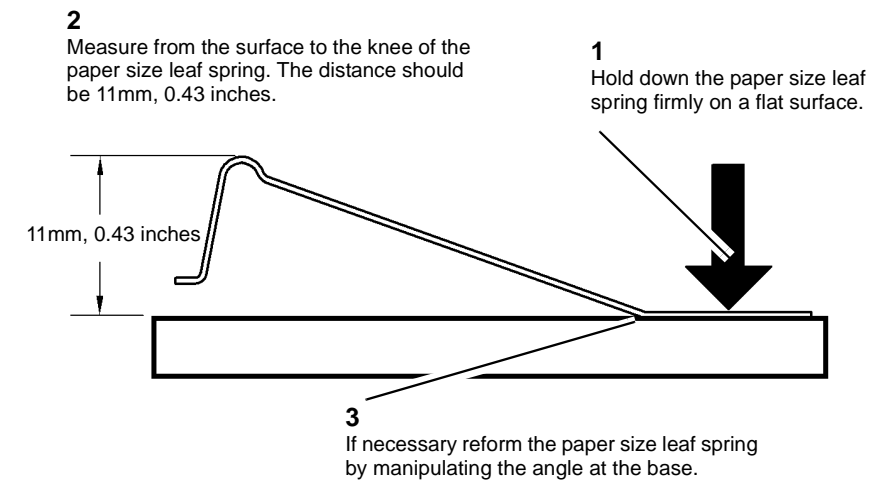
W-1-1450-A

Figure 1 Contact measurement

1. Remove paper tray 1 or tray 2, [REP 70.1](#).
2. Remove the paper size leaf springs, [PL 70.10 Item 23](#).
3. Check the contact measurement of the paper size leaf springs, [Figure 1](#).

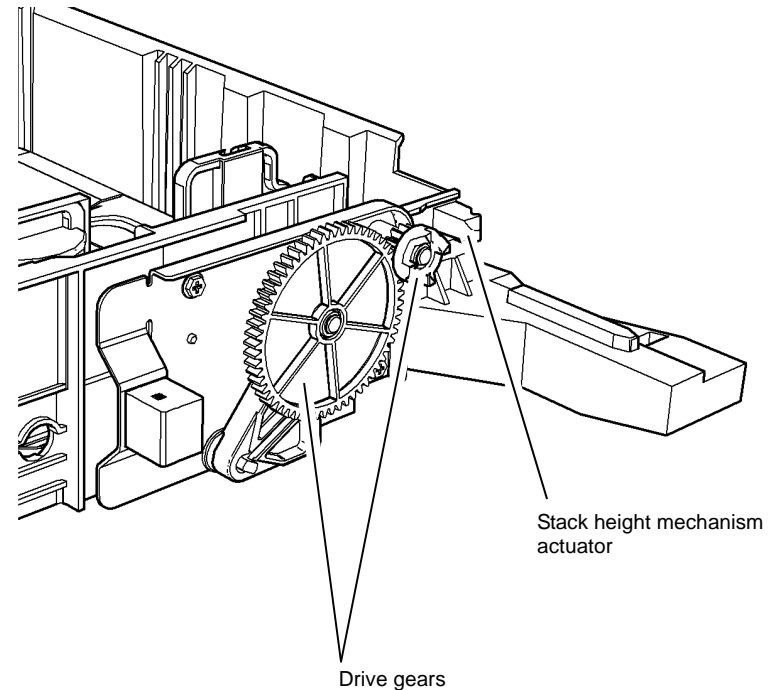
W-1-0964-A

Figure 1 Component location

- Elevator motor drive gears, **Figure 1**.
- Tray 1 stack height mechanism on the feeder assembly.

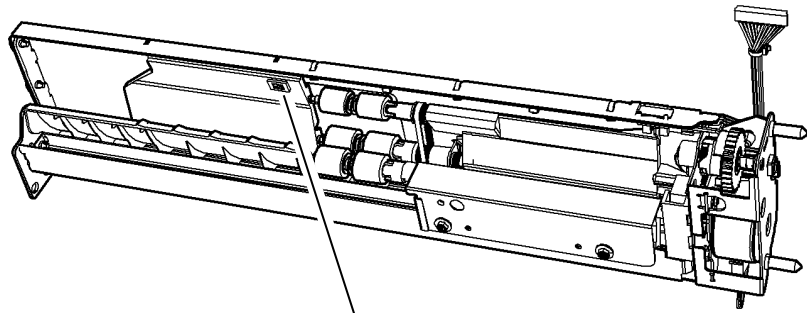
Figure 1 Component location

Tray 1 empty sensor, Q71-320
Tray 2 empty sensor, Q72-320

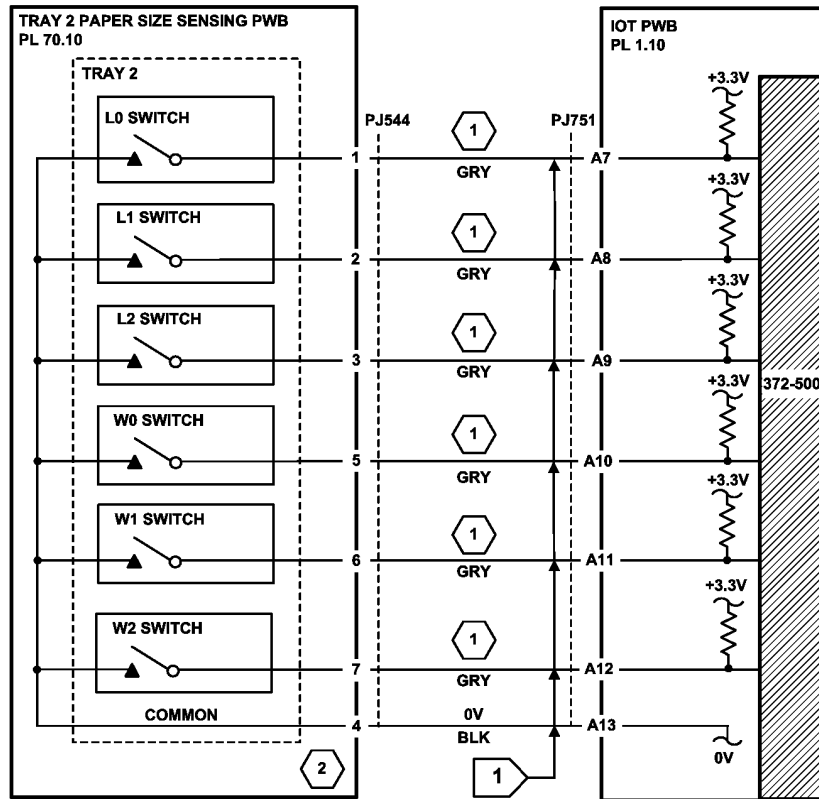
1 SWITCH OPEN +3.3V. CHECK THE VOLTAGE AT THE PJ ON THE PWB. TRAY CLOSED DETECTED IF ONE OR MORE SWITCHES ARE CLOSED.

2 LOGICAL REPRESENTATION OF SIZE SENSING SWITCHING. CIRCUITS ARE COMPLETED BY CONTACT SPRINGS ON REAR OF TRAY 2.

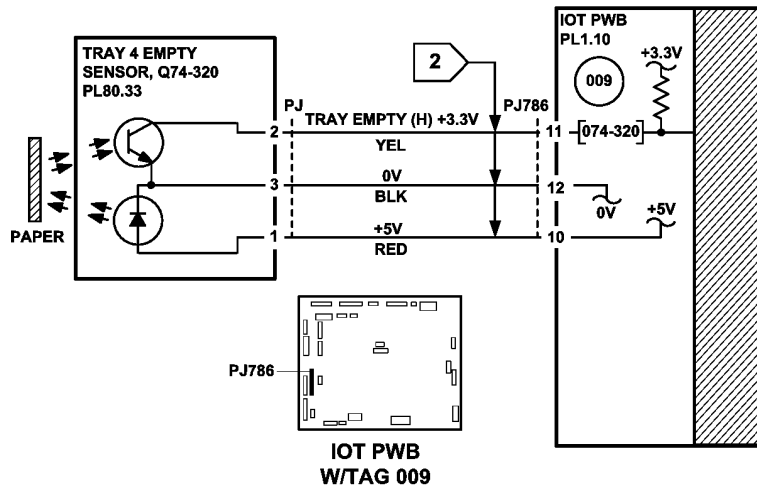
Figure 4 Circuit diagram W/TAG 009

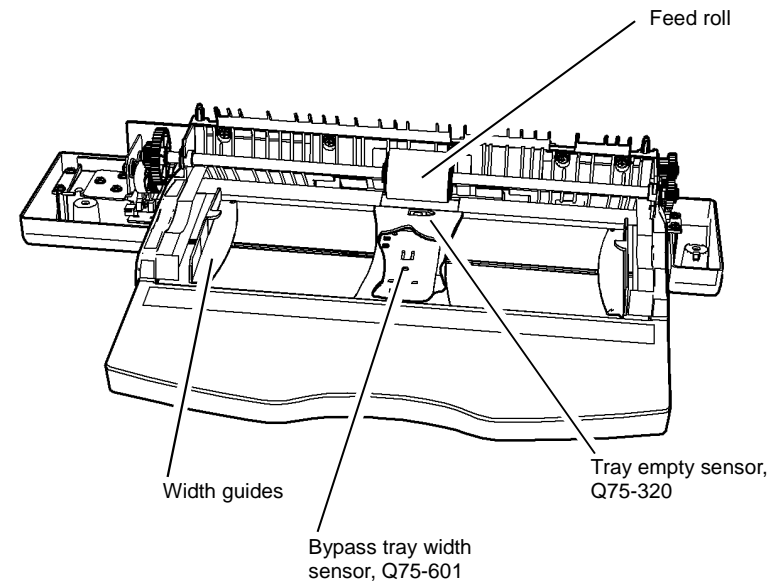
Figure 1 Component location

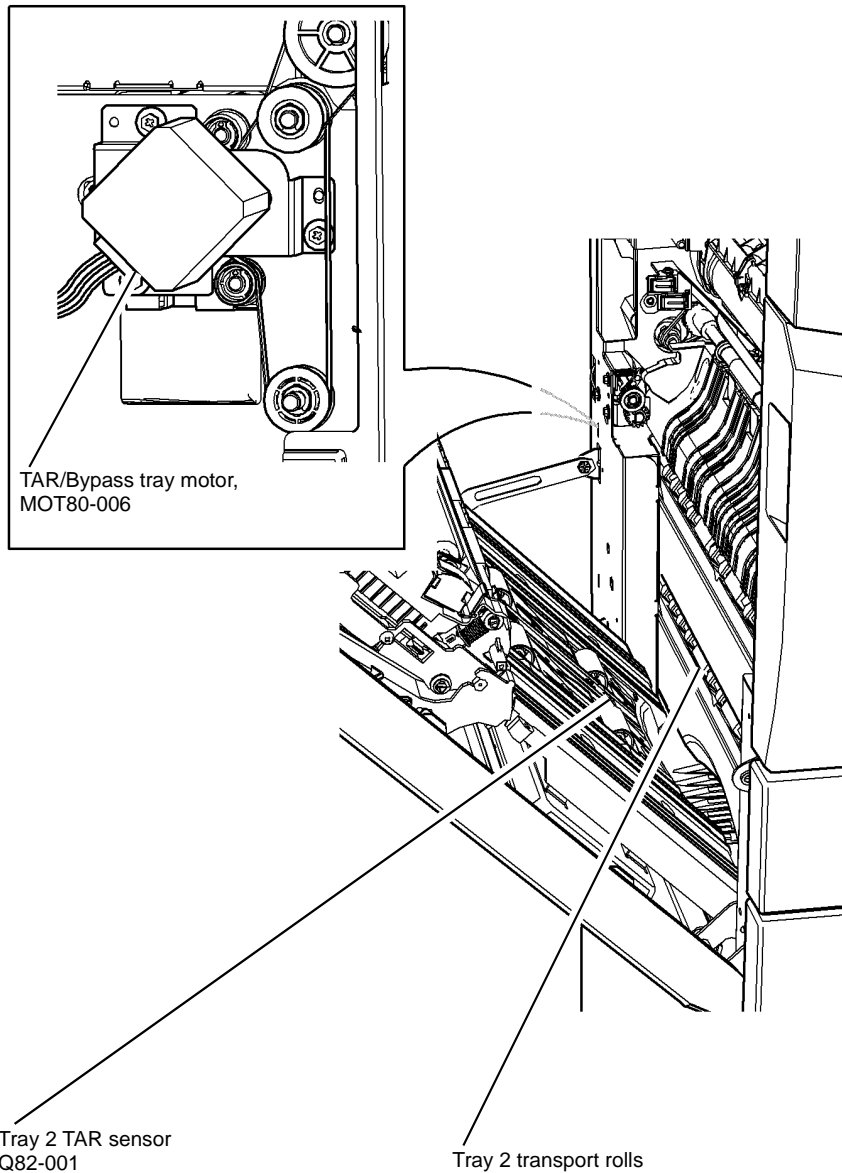
Figure 1 Component location

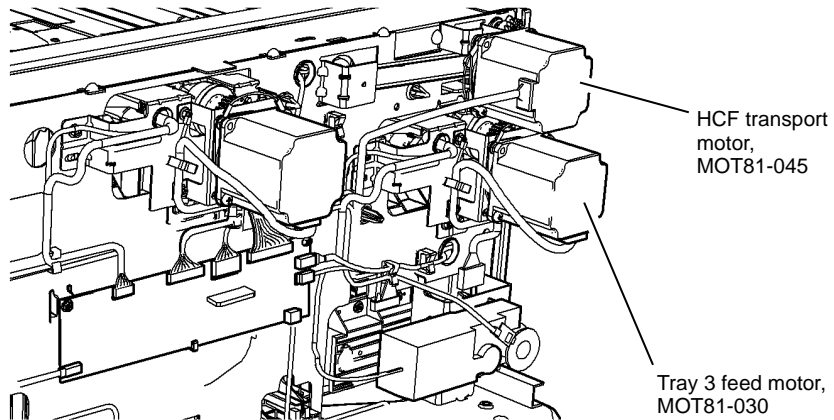
W-1-0159-A

Figure 1 Component location

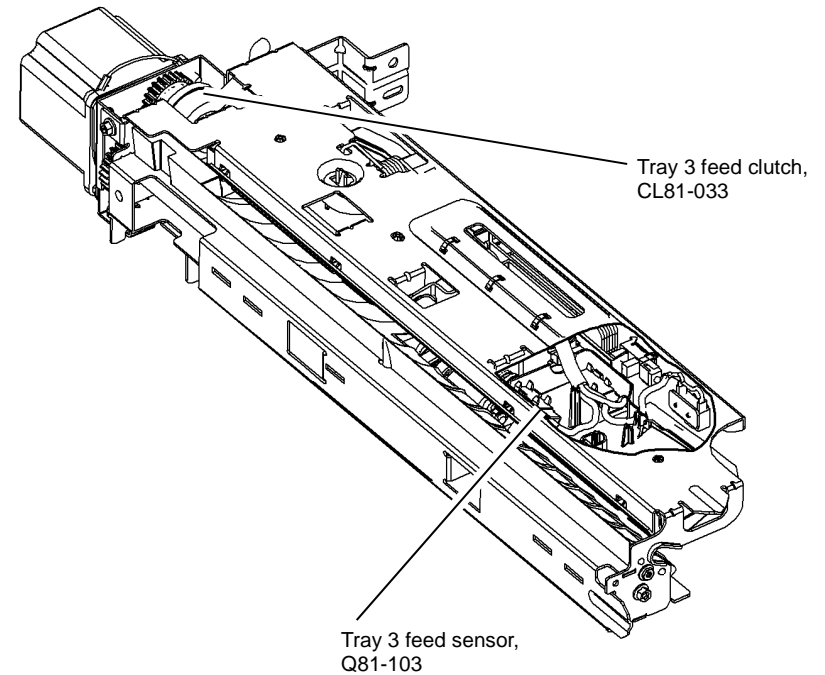
W-1-0160-A

Figure 2 Component location

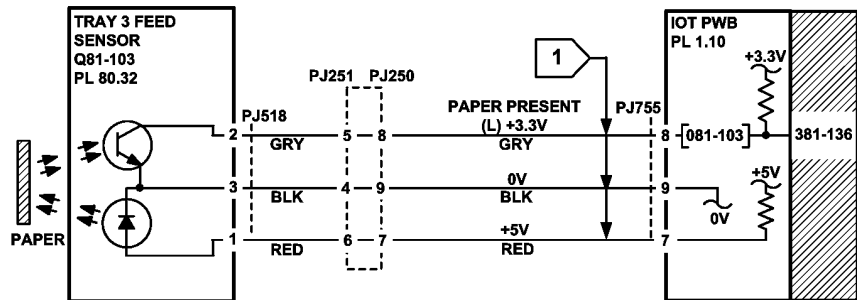
TW-1-0092-A

1 DATA LINES A AND B PULSE BETWEEN 0V AND +24V WHEN THE MOTOR IS RUNNING

Figure 3 Circuit diagram

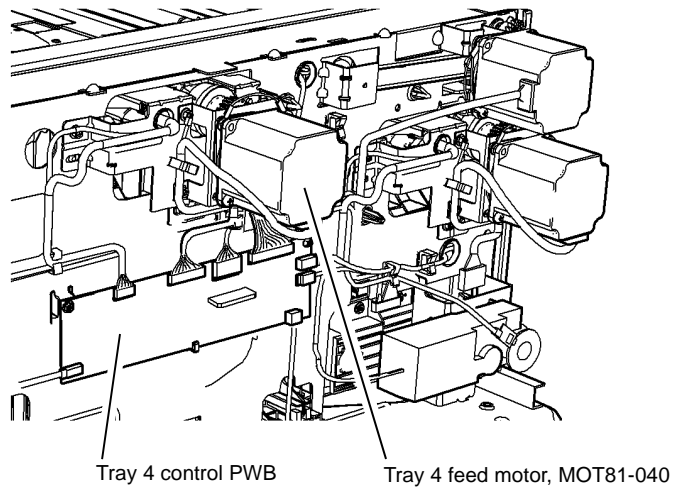
W-1-0157-A

Figure 1 Component location
