708P91139
February 2016

Xerox® WorkCentre® 5945 Family Multifunction Printer Service Manual

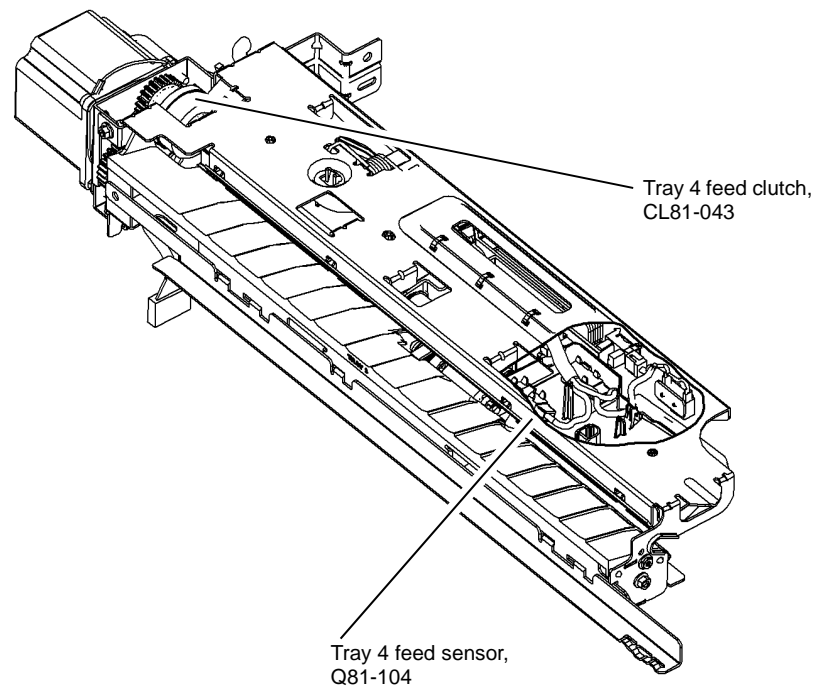
W-1-0158-A

Figure 2 Component location

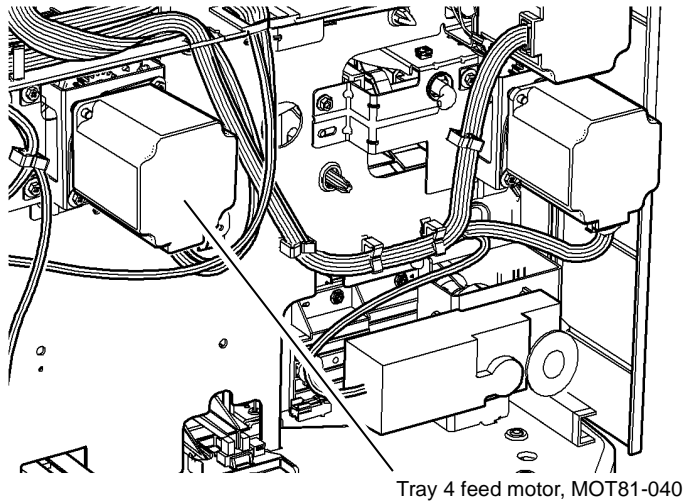
W-1-1437-A

Figure 1 Component location

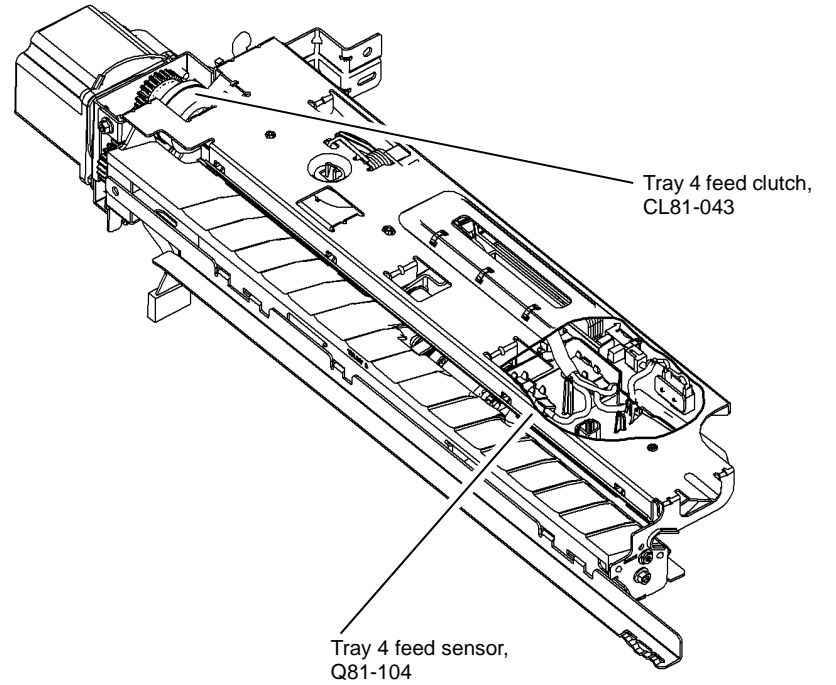
W-1-1438-A

Figure 2 Component location

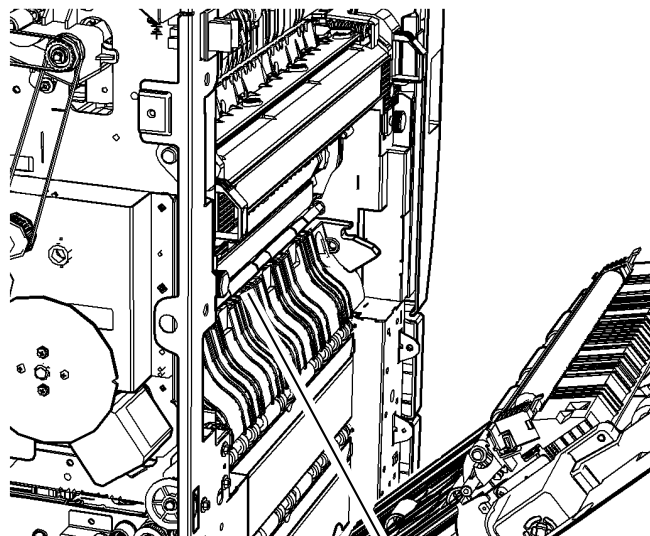
W-1-1212-A

Registration sensor, Q82-150

Figure 1 Component location

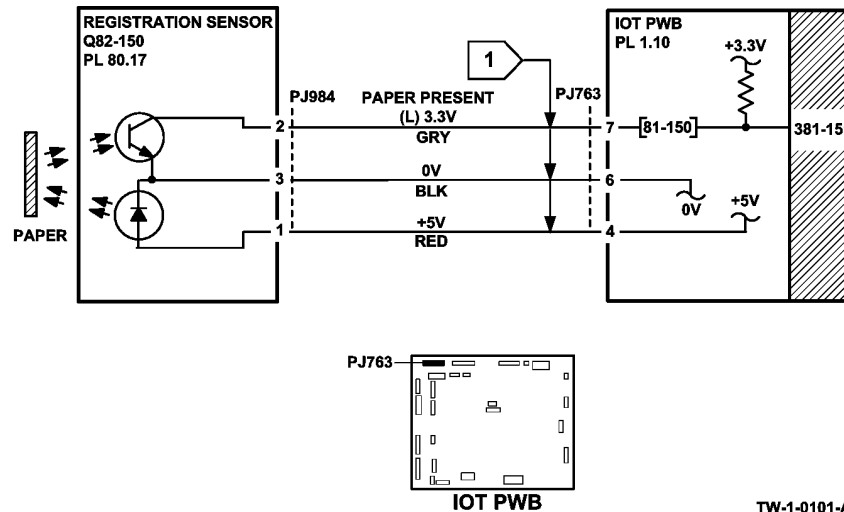
TW-1-0101-A

Figure 2 Circuit diagram

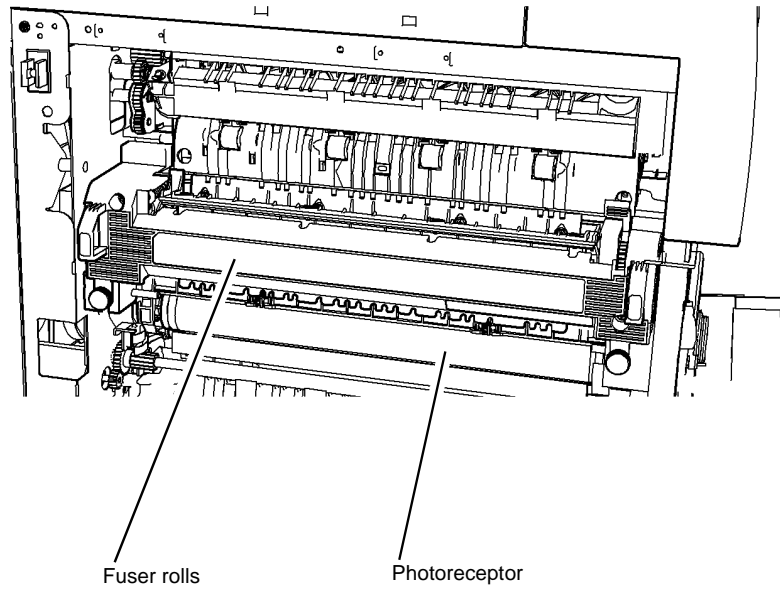
W-1-0166-A

Figure 1 Component location

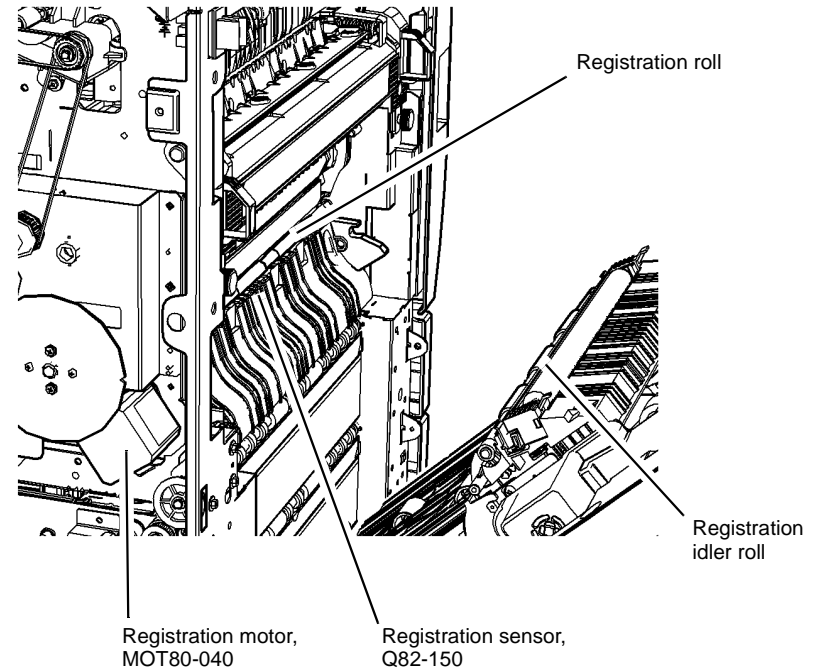
W-1-1213-A

Figure 2 Component location

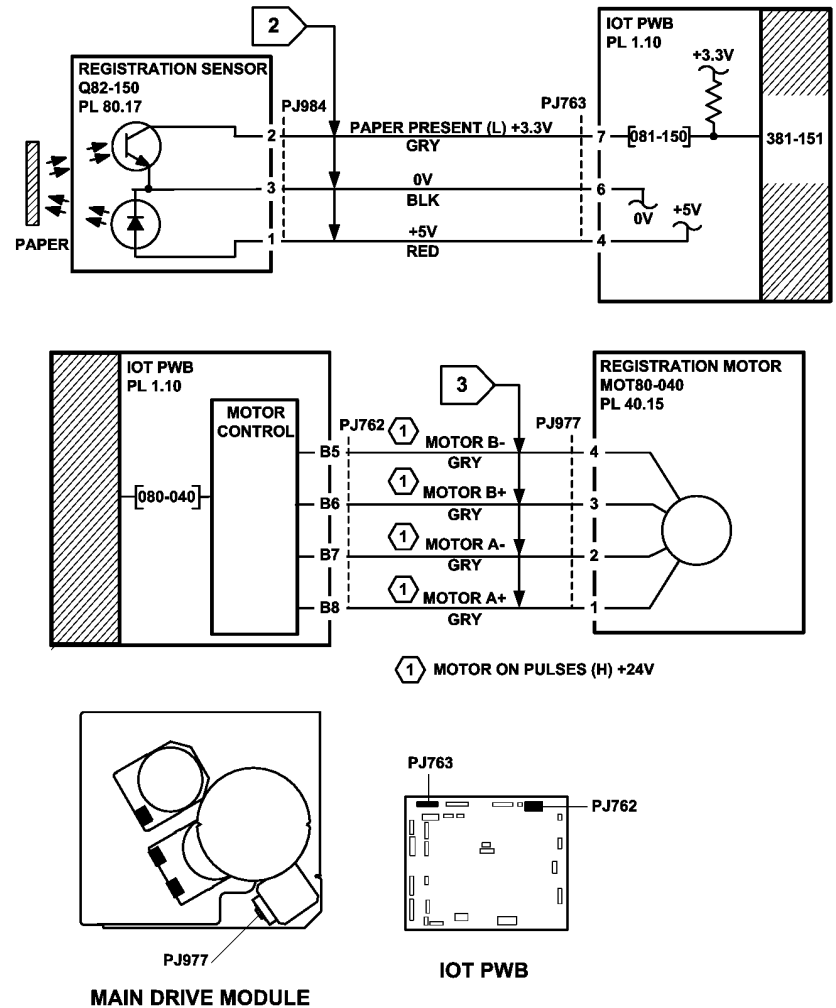
Figure 4 Circuit diagram

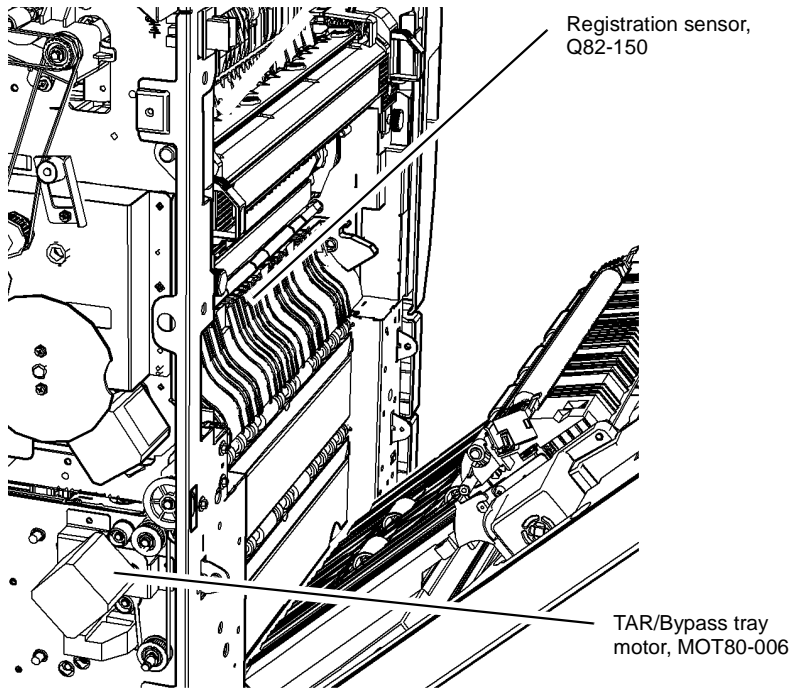
W-1-1215-A

Figure 1 Component location

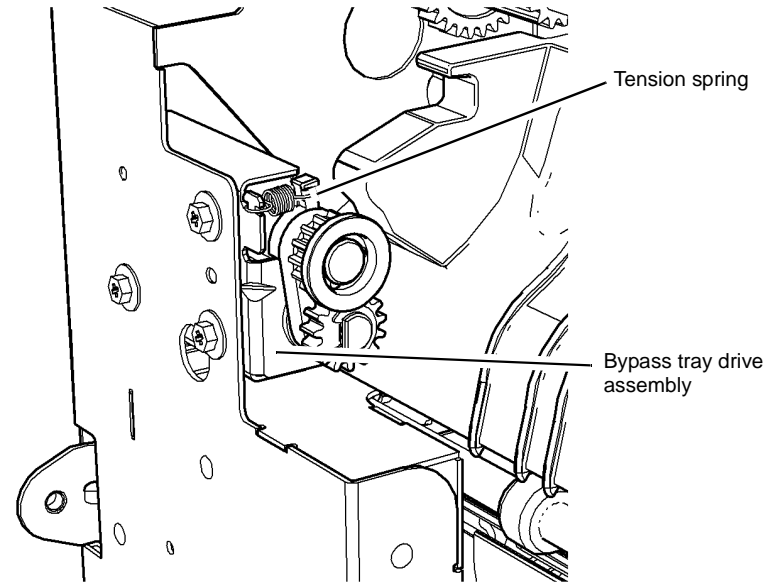
W-1-1214-A

Figure 2 Component location

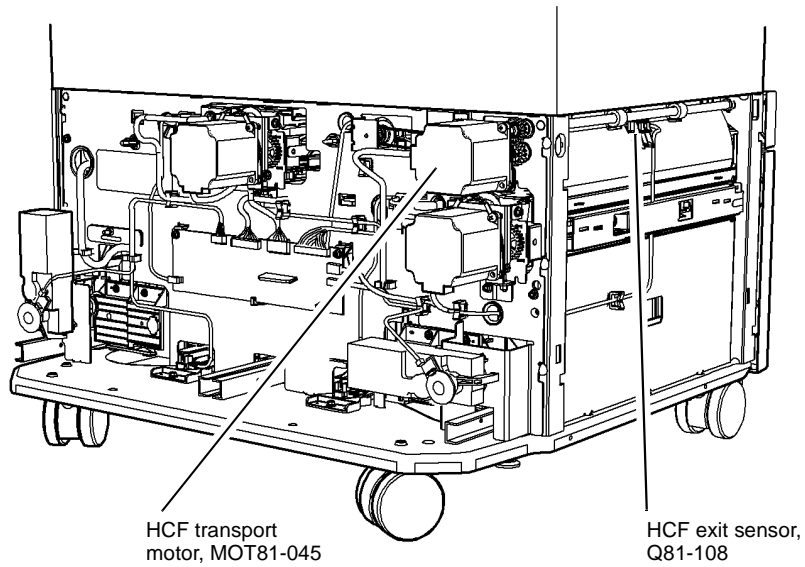
W-1-1253-A

Figure 1 Component location

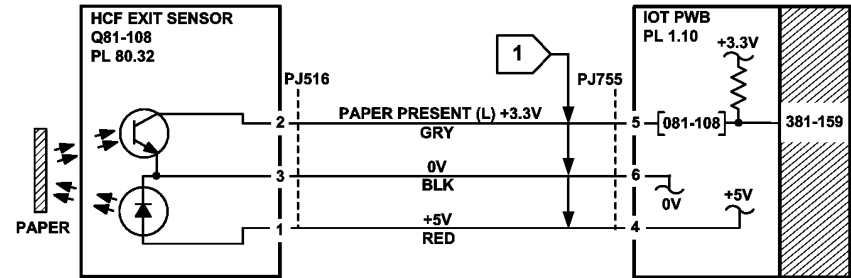
1 DATA LINES A AND B PULSE BETWEEN 0V AND 24V WHEN THE MOTOR IS RUNNING

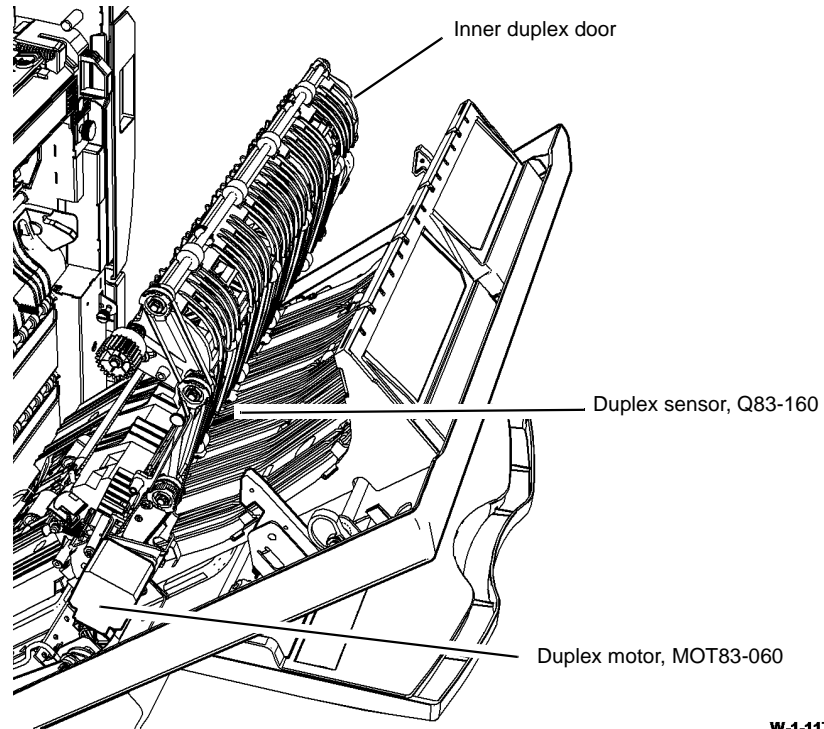
W-1-1173-A

Figure 1 Component location

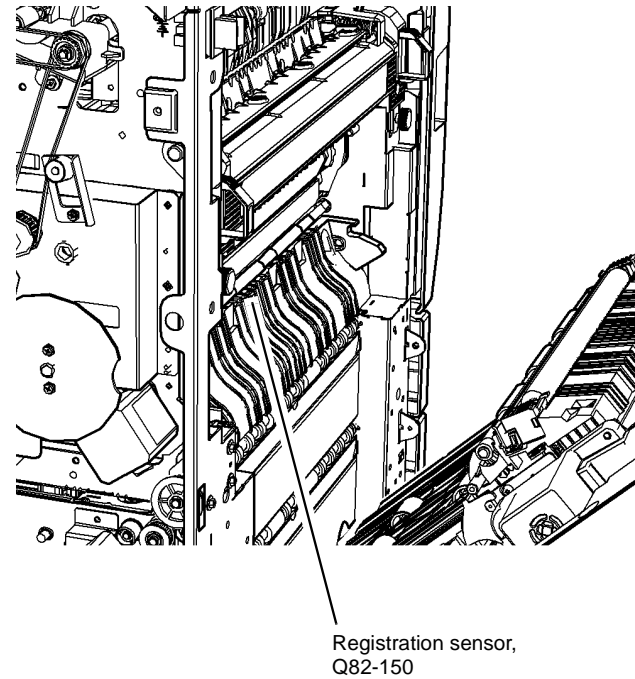
W-1-1217-A

Figure 2 Component location

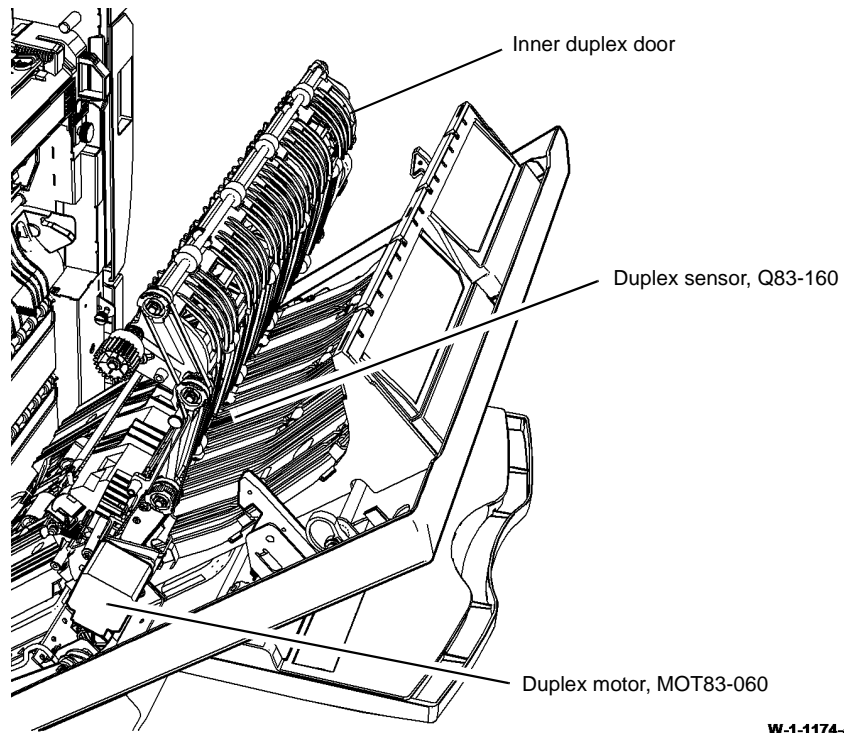
W-1-1174-A

Figure 1 Component location

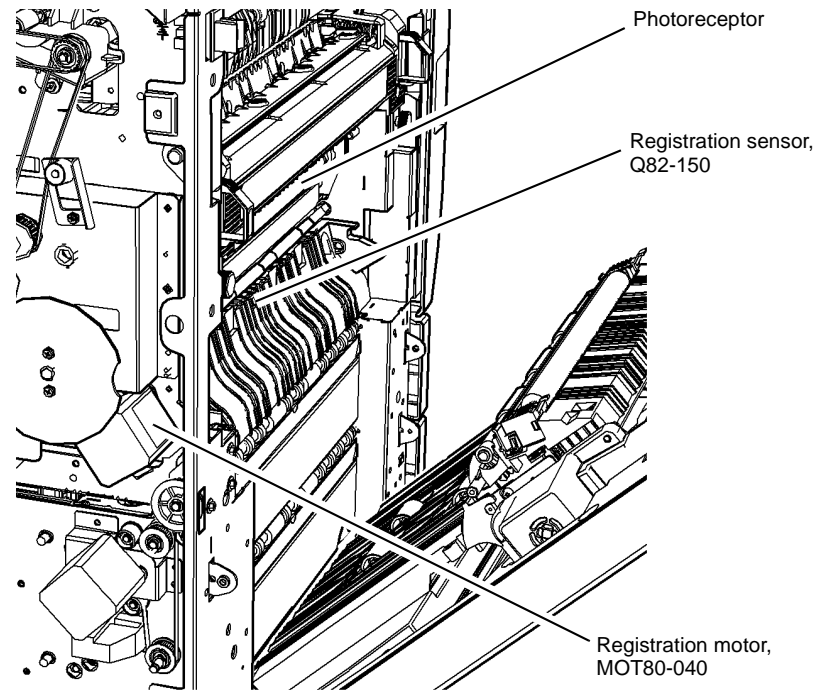
W-1-1216-A

Figure 2 Component location

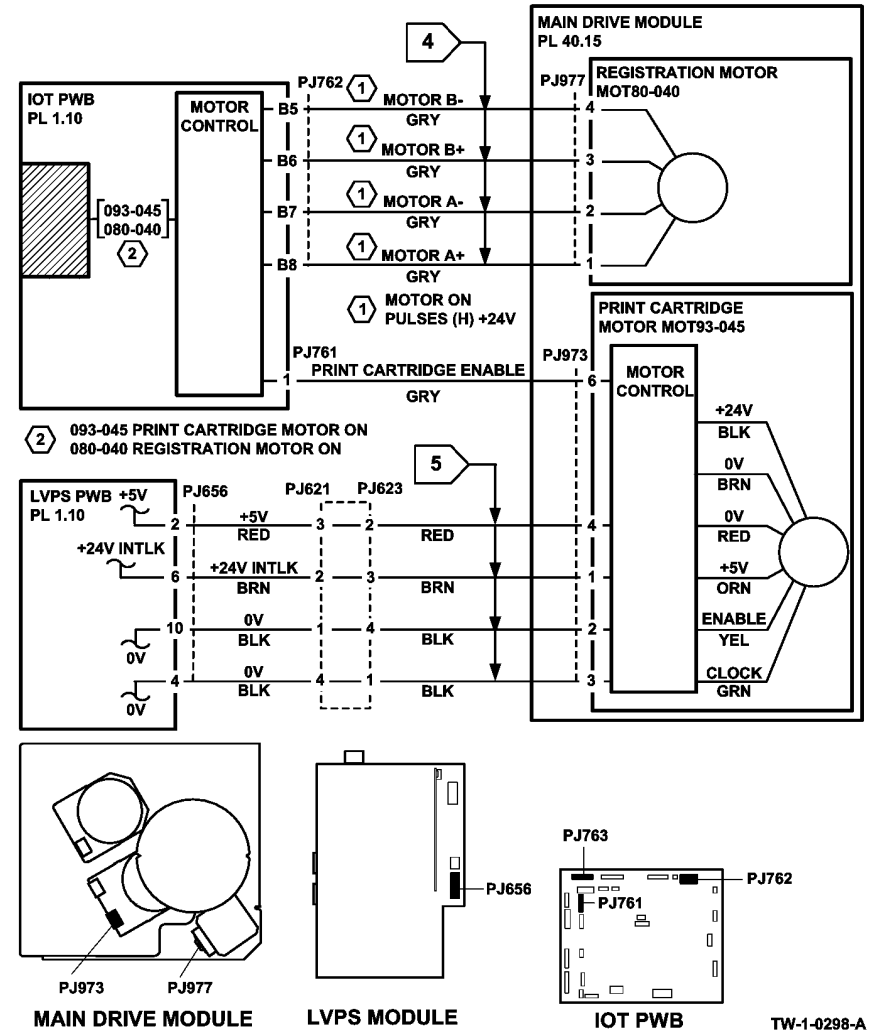
Figure 4 Circuit Diagram

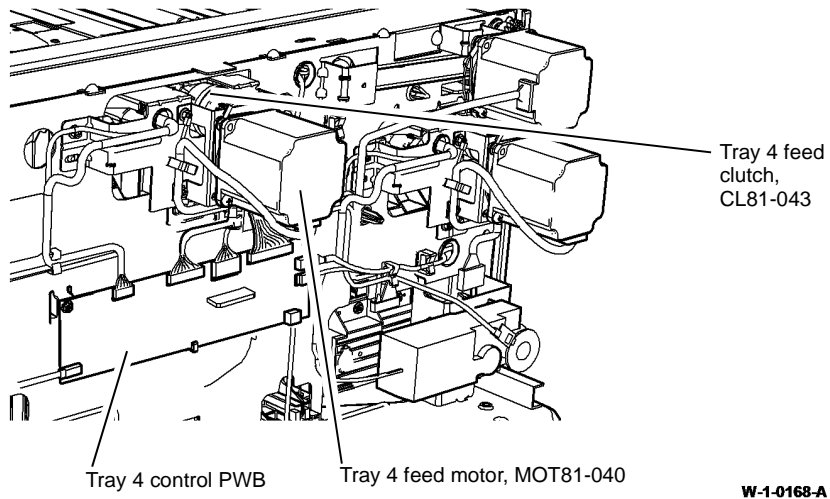
Figure 1 Component location

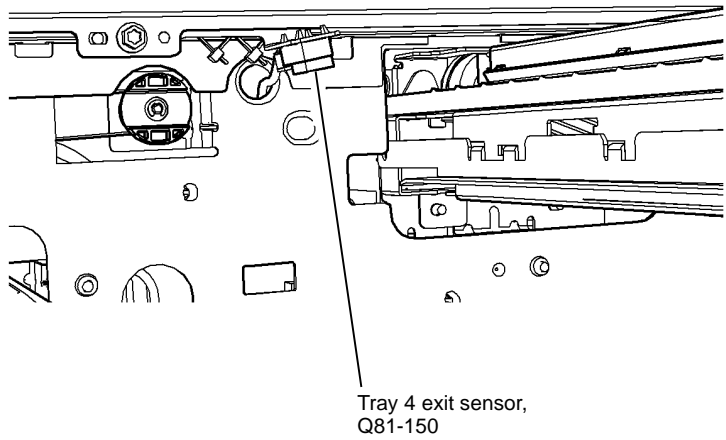
Figure 2 Component location

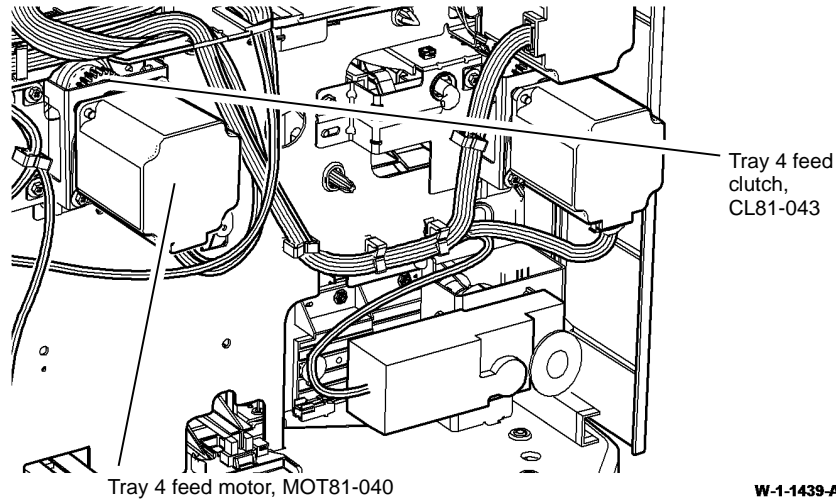
Figure 1 Component location

W-1-1439-A

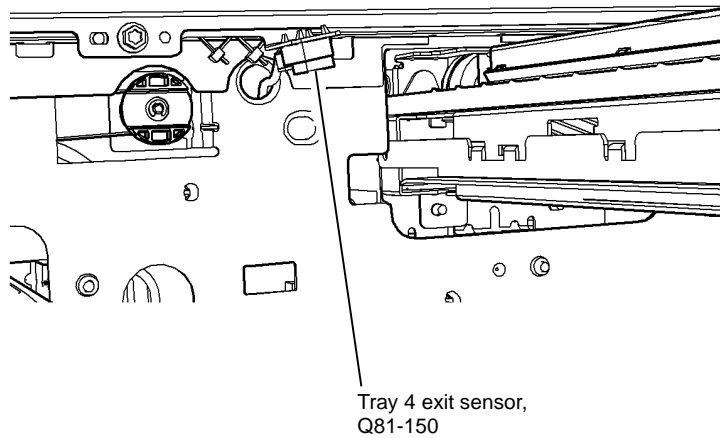
Figure 2 Component location

W-1-1440-A

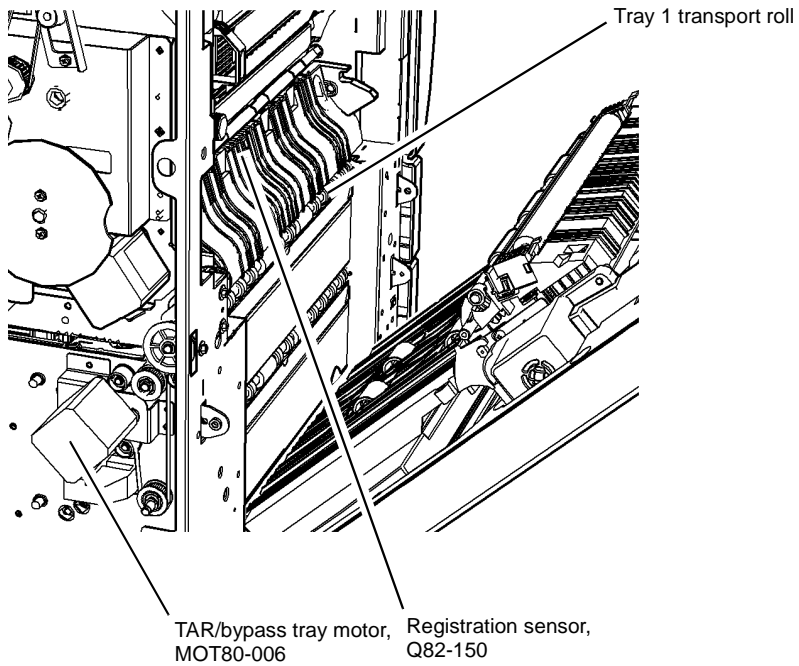
Figure 1 Component location

W-1-1256-A

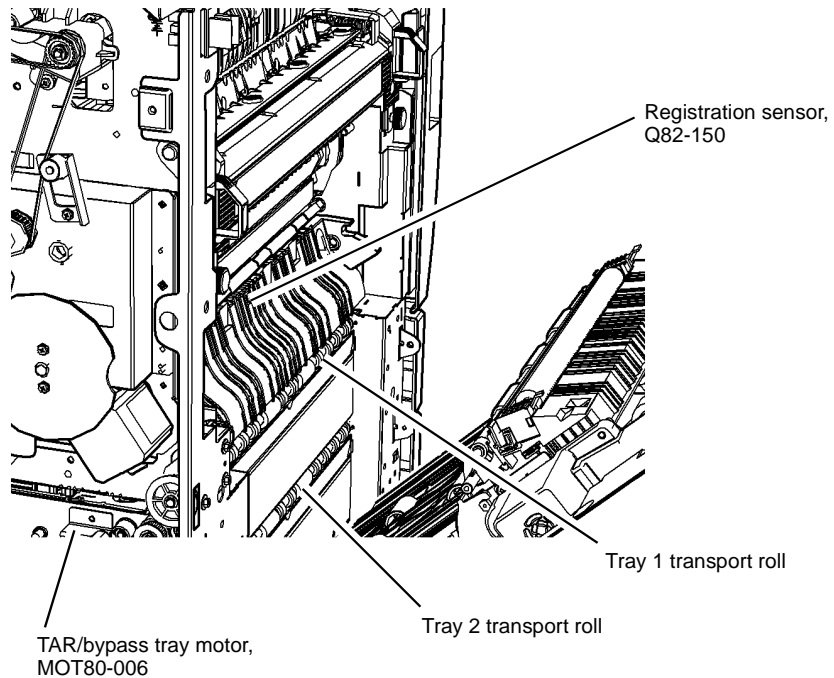
Figure 1 Component location

W-1-1257-A

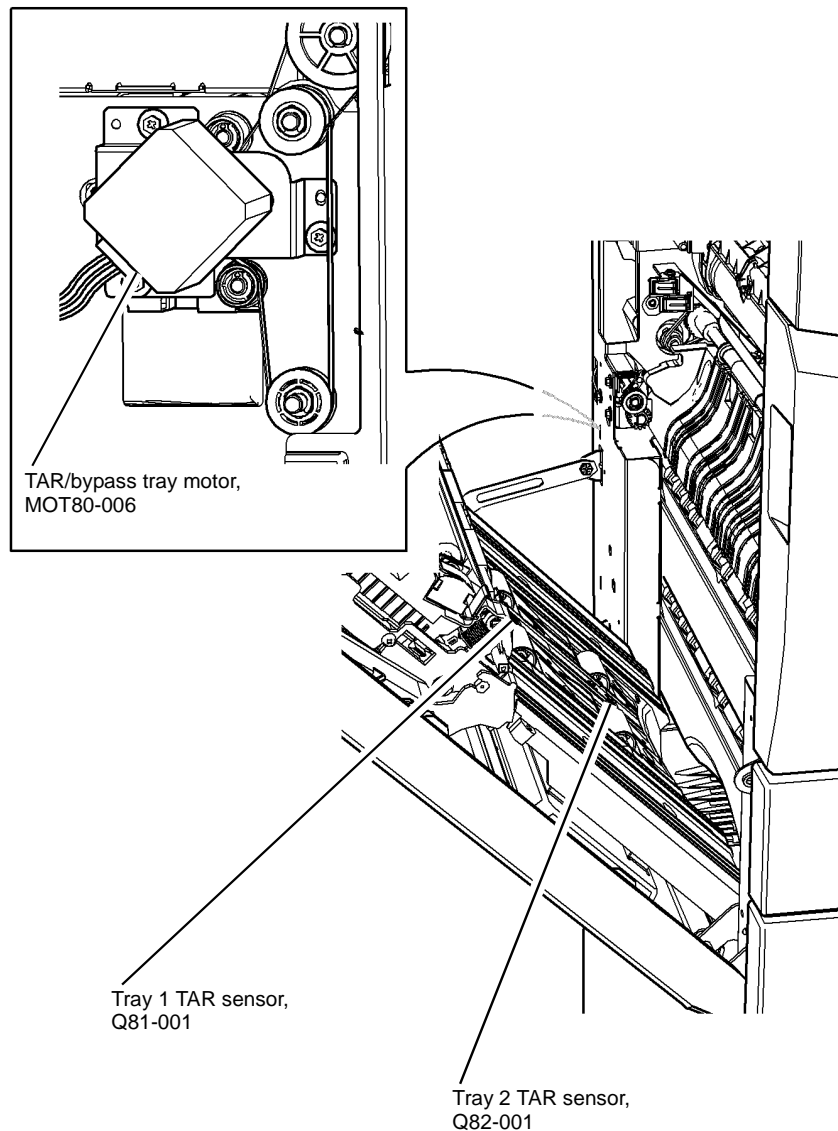
Figure 2 Component location

W-1-1266-A

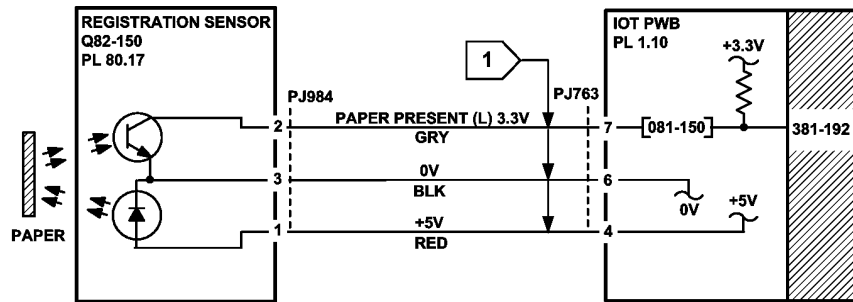
Figure 3 Circuit Diagram

TW-1-0311-A

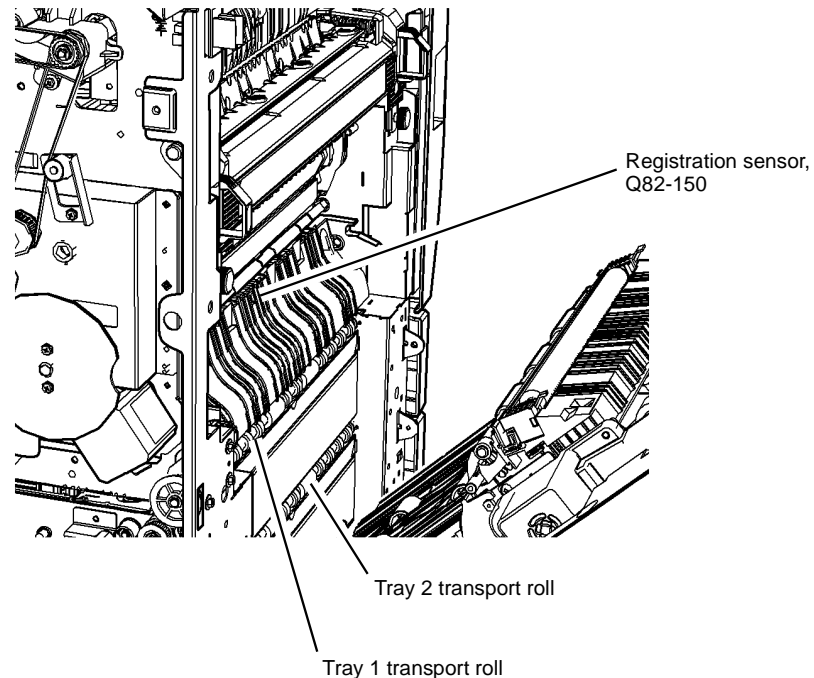
Figure 1 Component location

W-1-1267-A

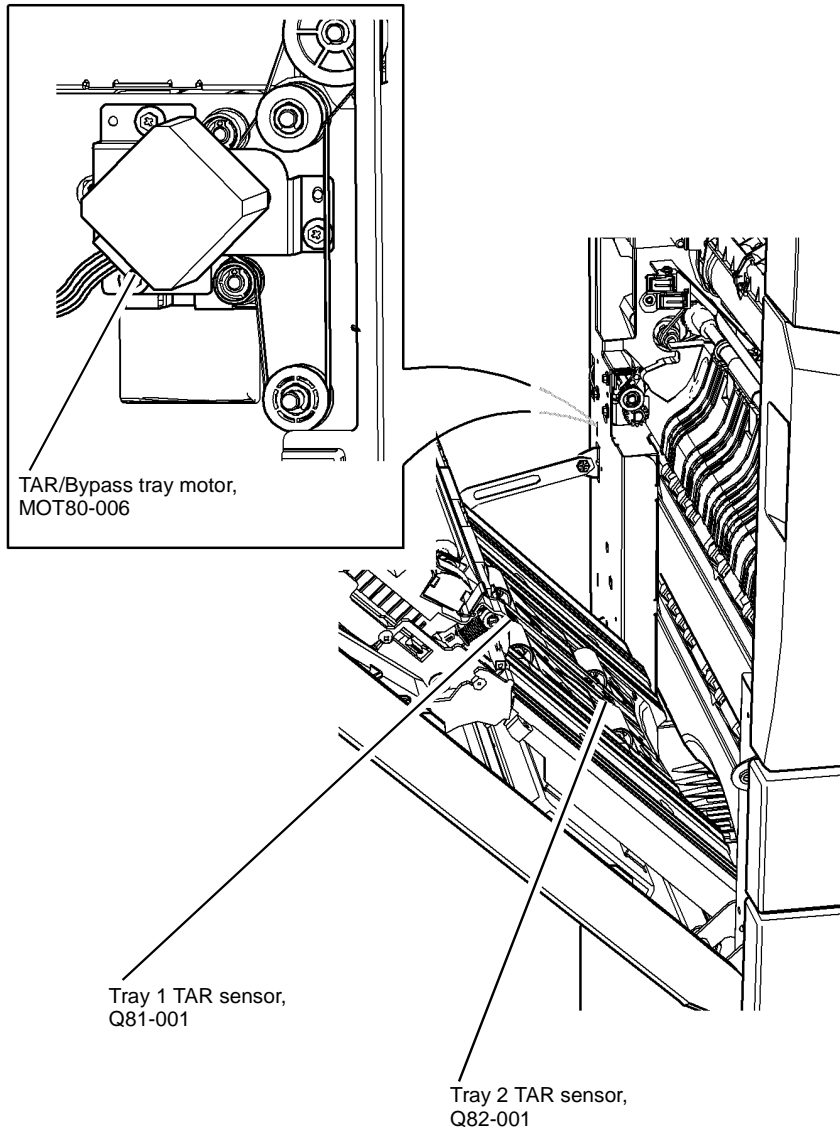
Figure 2 Component location

W-1-1268-A

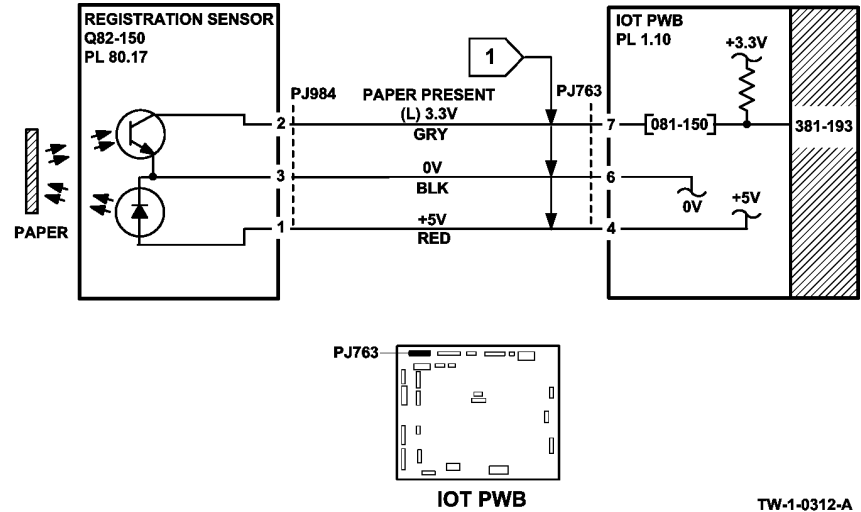
Figure 3 Circuit Diagram

TW-1-0312-A

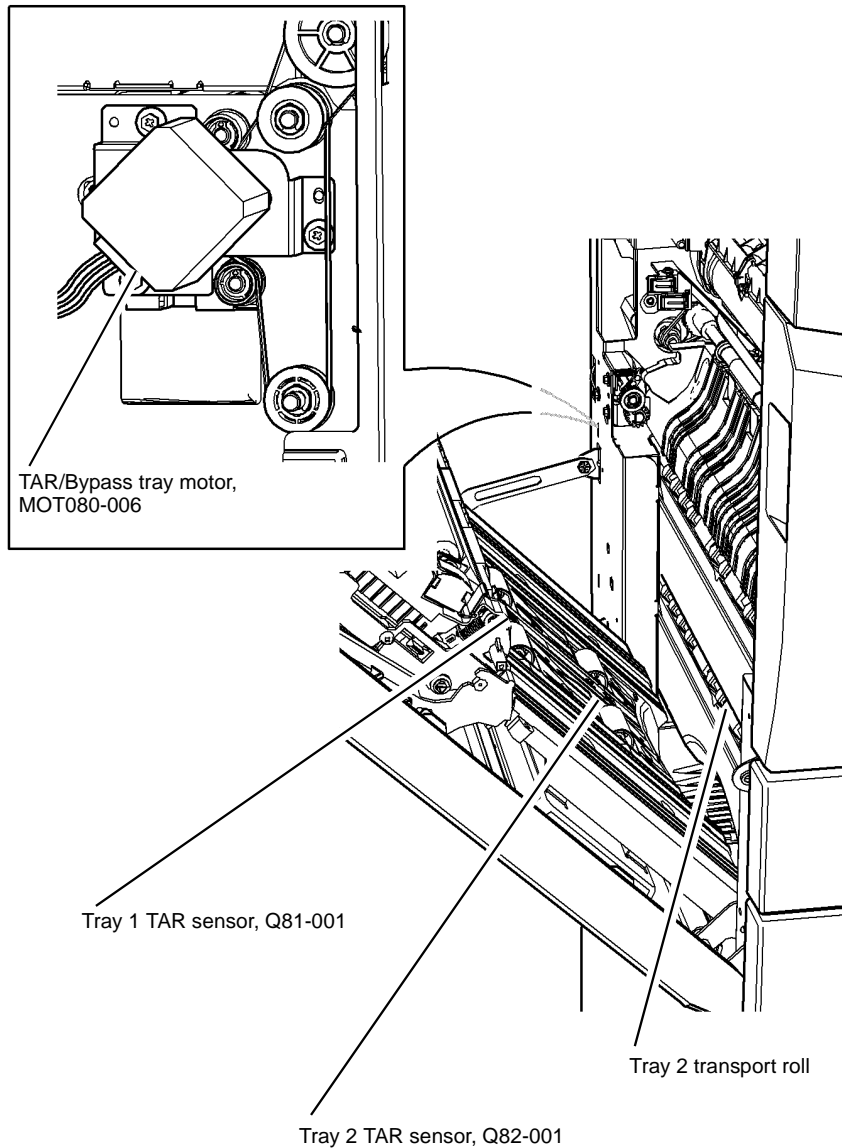
Figure 1 Component location

W-1-1269-A

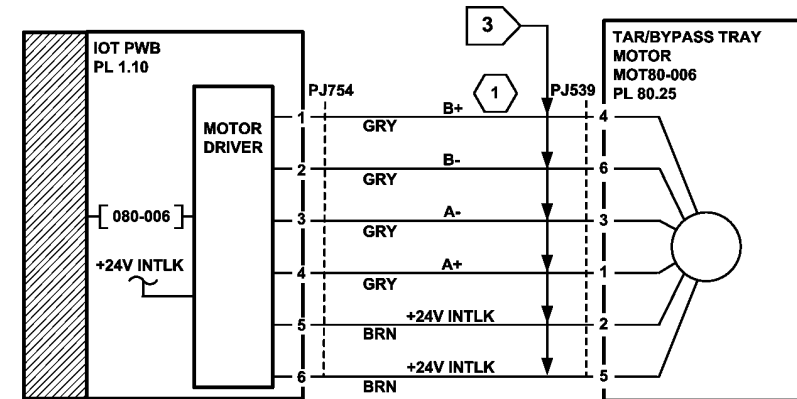
1 DATA LINES A AND B PULSE BETWEEN 0V AND +24V WHEN THE MOTOR IS RUNNING

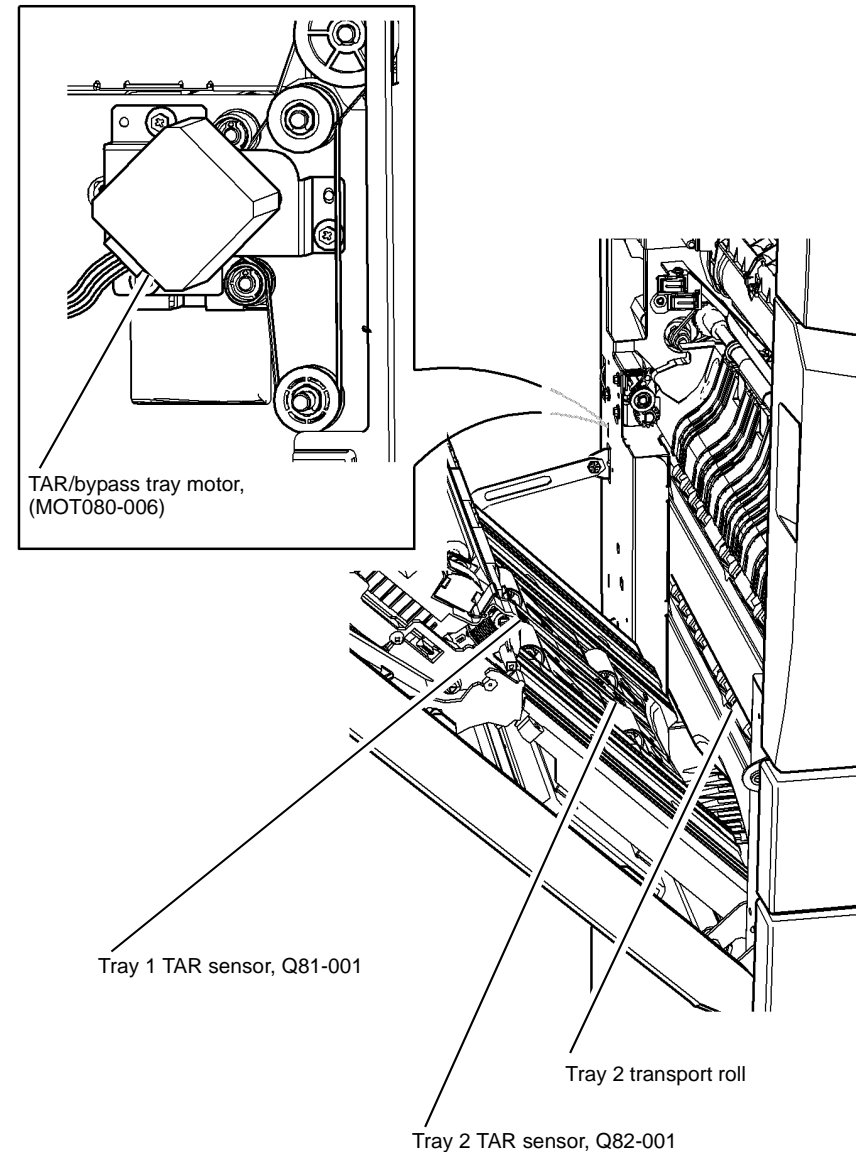
Figure 1 Component location

W-1-1270-A

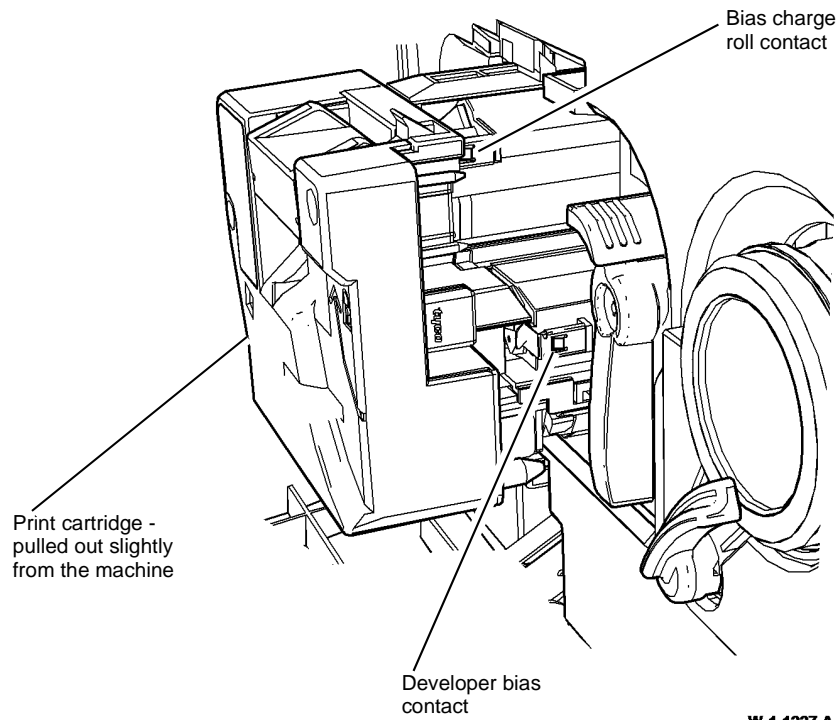
Figure 1 Component location

- Track (BCR) on the HVPS tray assembly for continuity, short circuits and damage. Ensure the contact area at each end is clean and undamaged.
- The BCR contact on the HVPS is clean and undamaged, Figure 3.
- The bias charge roll contact on the print cartridge is clean and undamaged, Figure 1.

- Track (DEV) on the HVPS tray assembly for continuity, short circuits and damage. Ensure the contact area at each end is clean and undamaged.
- The DB contact on the HVPS is clean and undamaged, Figure 3.
- The developer bias contact on the print cartridge is clean and undamaged, Figure 1.

- Track (BTR) on the HVPS tray assembly for continuity, short circuits and damage. Ensure the contact area at each end is clean and undamaged.
- The BTR contact on the HVPS is clean and undamaged, Figure 3.
- The bias transfer contact on the registration transfer housing is clean and undamaged, Figure 1.
- The condition of the bias transfer roll and bearings, Figure 2.

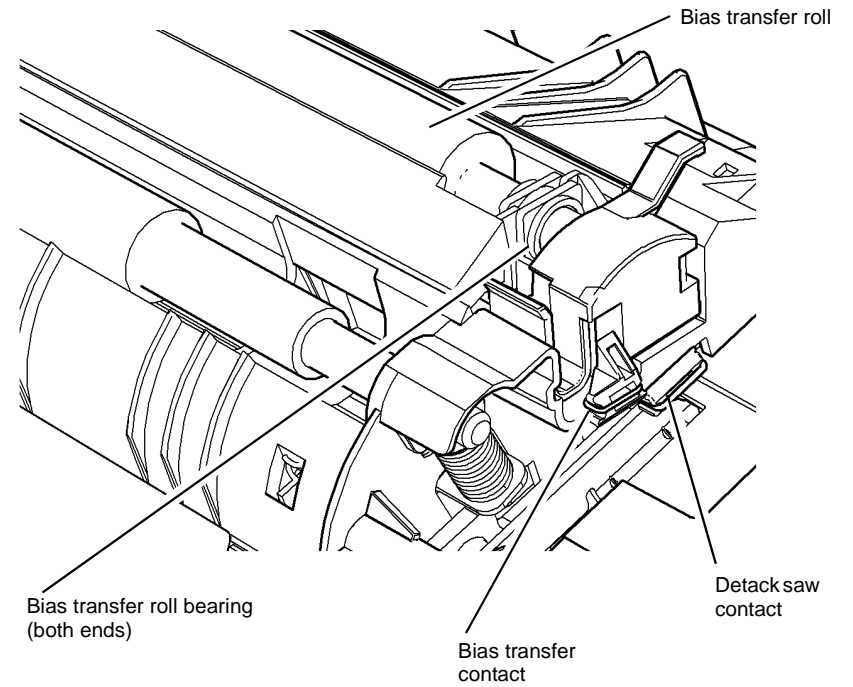
Figure 2 Component Location

- Track (DTS) on the HVPS tray assembly for continuity, short circuits and damage. Ensure the contact area at each end is clean and undamaged.
- The DTS contact on the HVPS is clean and undamaged, Figure 3.
- The detach saw contact on the registration transfer housing is clean and undamaged, Figure 2.

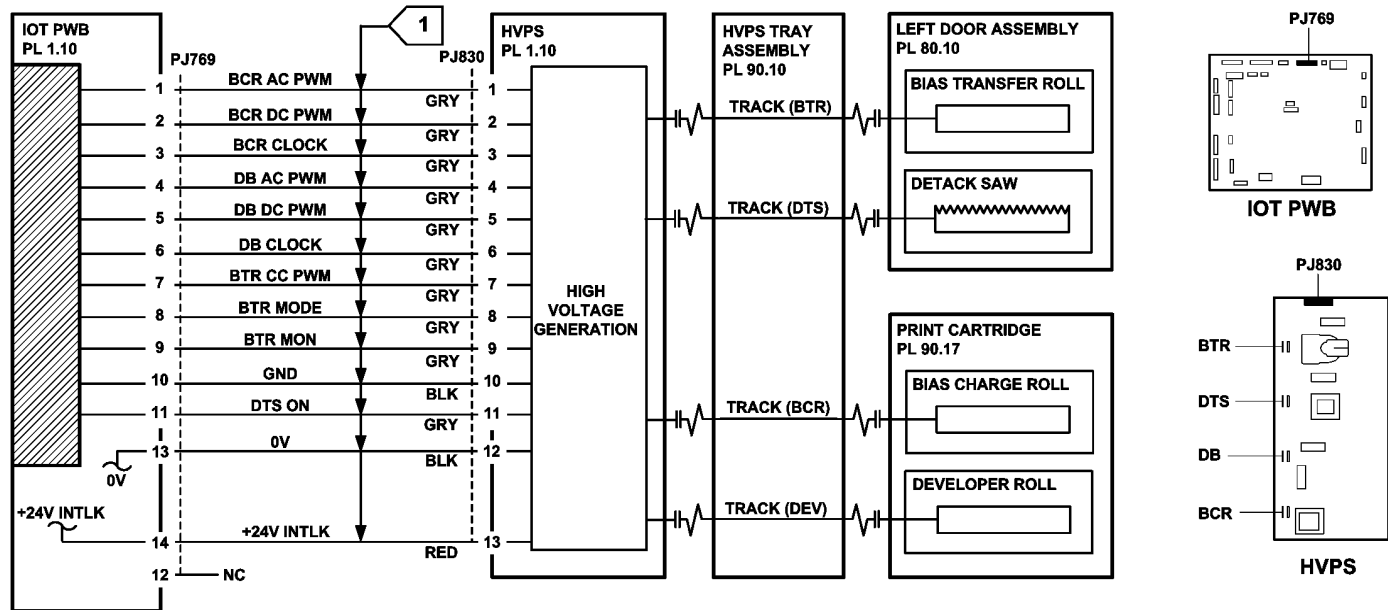
TW-1-0300-A

Figure 3 Circuit diagram

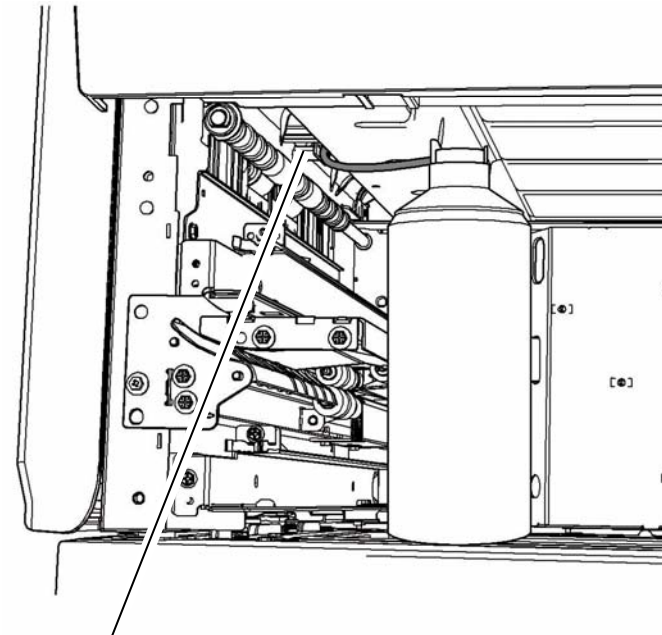
W-1-1354-A

Humidity sensor (Q91-601), part of the environmental sensors PWB.

Figure 1 Component location

Remove trays 1 and 2. Remove the tray 1 paper feed assembly, REP 80.1. Enter dC140 code 091-601, humidity sensor, Q91-601. Observe the displayed state of Q91-601. Use an air duster, PL 26.11 Item 1 directed onto the environmental sensors PWB to change the state of Q91-601, Figure 1. The displayed state changed.

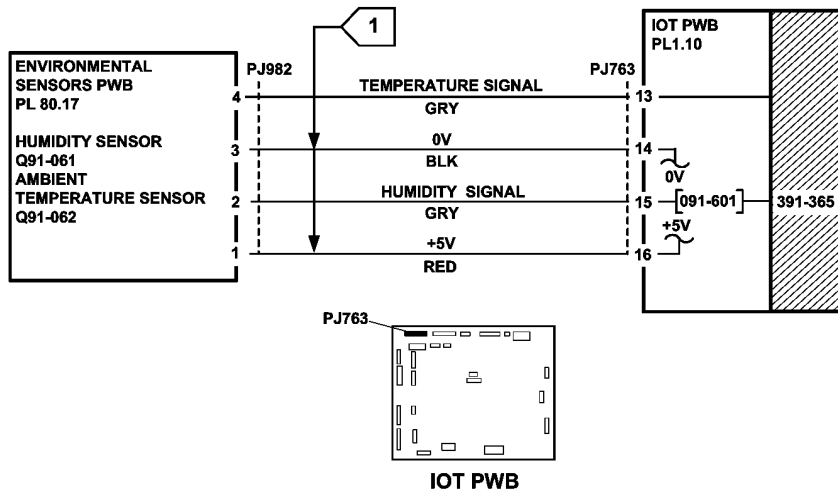
TW-1-0277-A

Figure 2 Circuit diagram

Y N
Check the wiring between P/J763 on the IOT PWB and PJ982. Repair the wiring as necessary, REP 1.2.

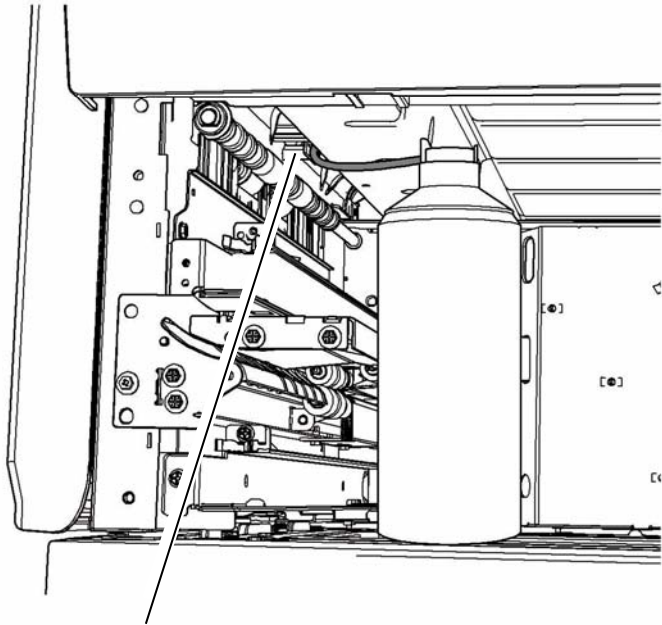
W-1-1355-A

Ambient temperature sensor (Q91-062),
part of the environmental sensors PWB.

Figure 1 Component location

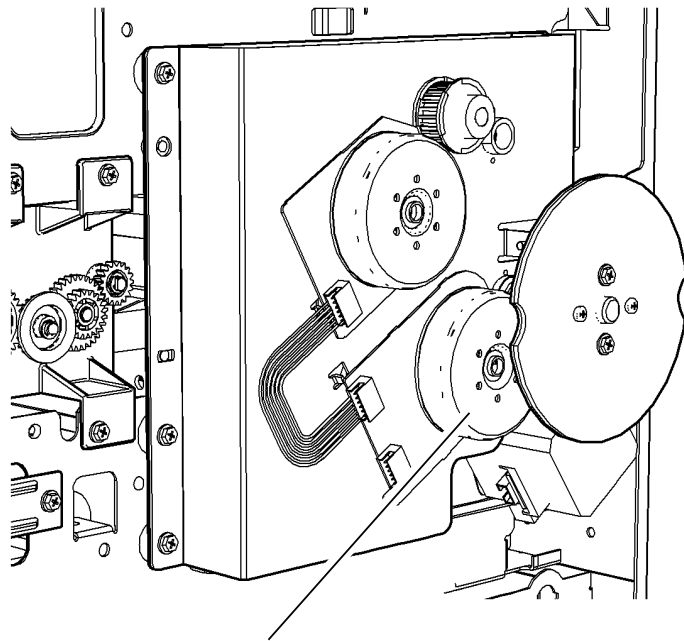
W-1-1164-A

Print cartridge
motor, MOT93-045

Figure 1 Component location

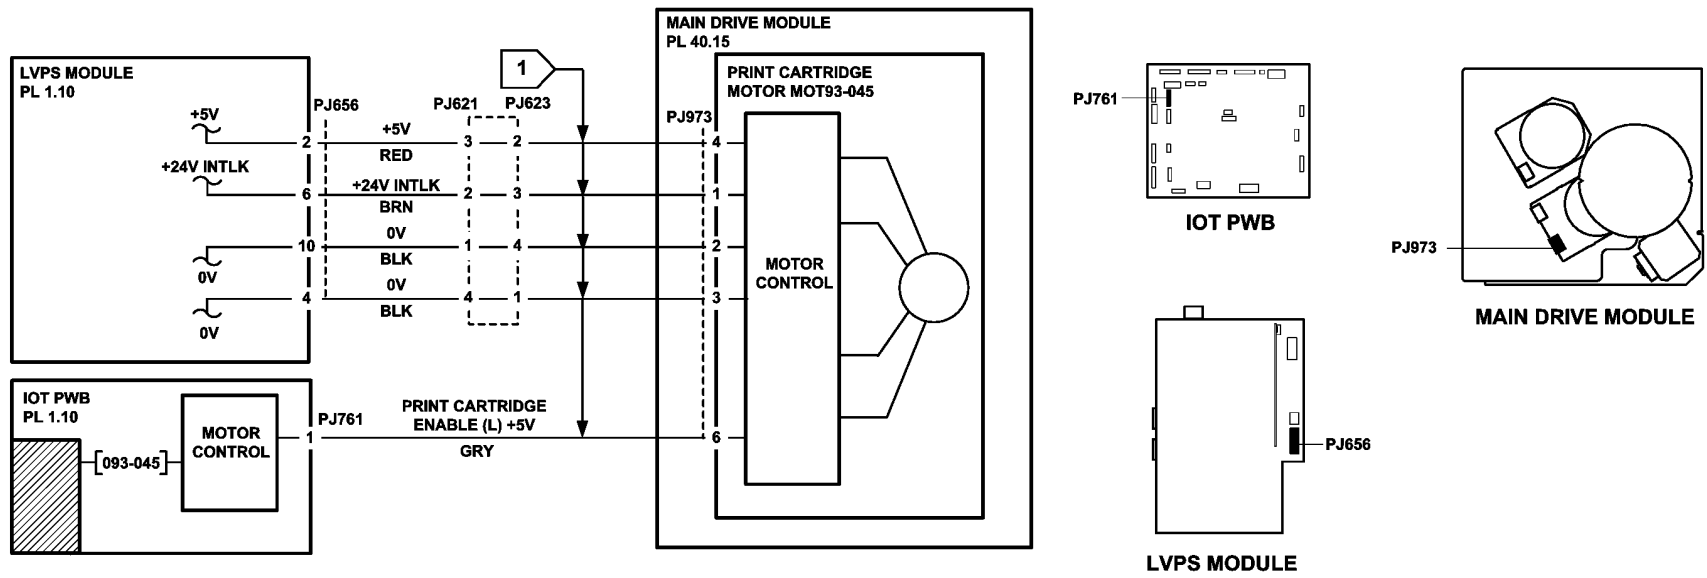
TW-1-0295-A

Figure 2 Circuit diagram
