708P91139
February 2016

Xerox® WorkCentre® 5945 Family Multifunction Printer Service Manual

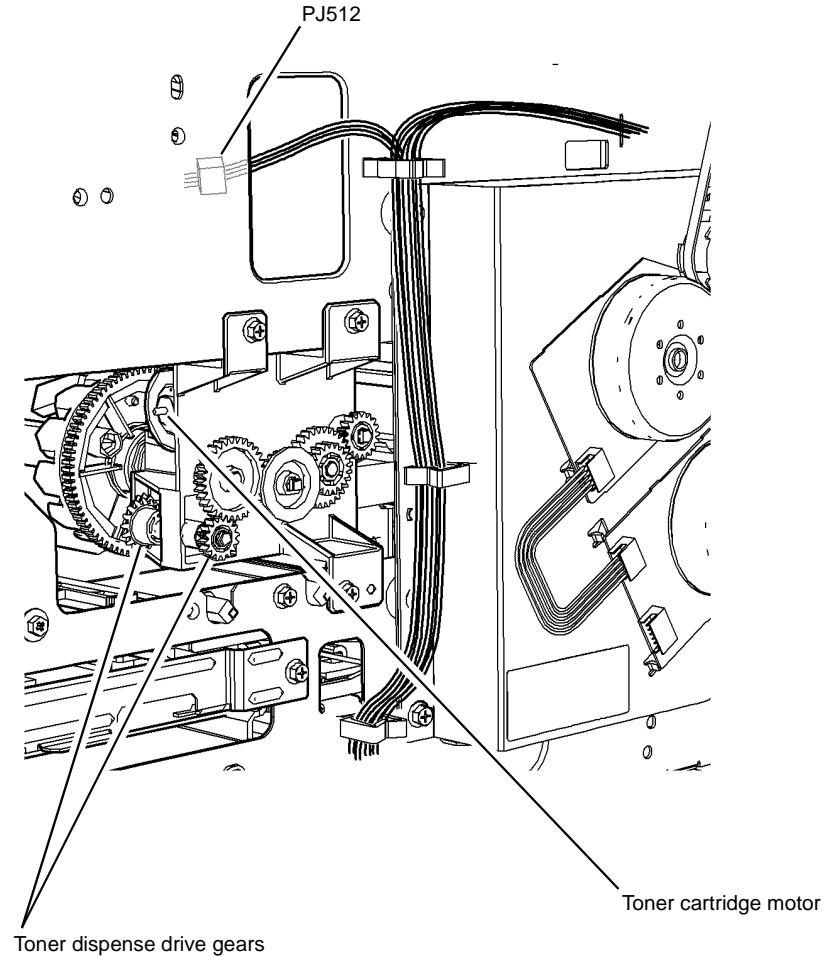
W-1-1098-A

Figure 1 Toner dispense module

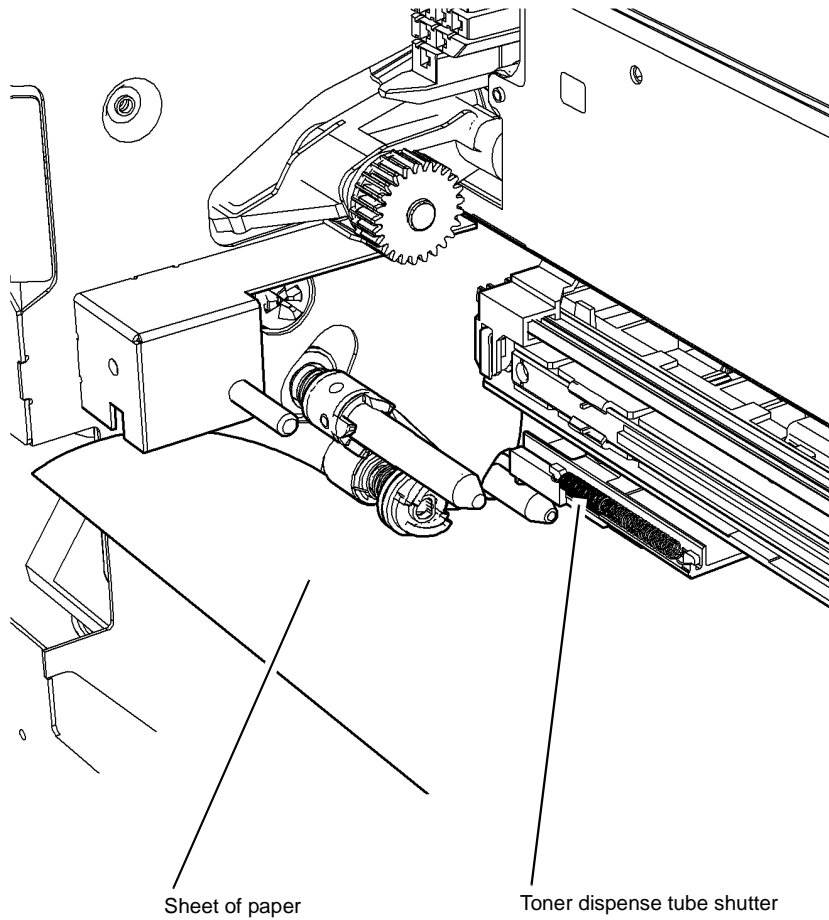
W-1-1099-A

Sheet of paper

Toner dispense tube shutter

Figure 2 Toner dispense tube

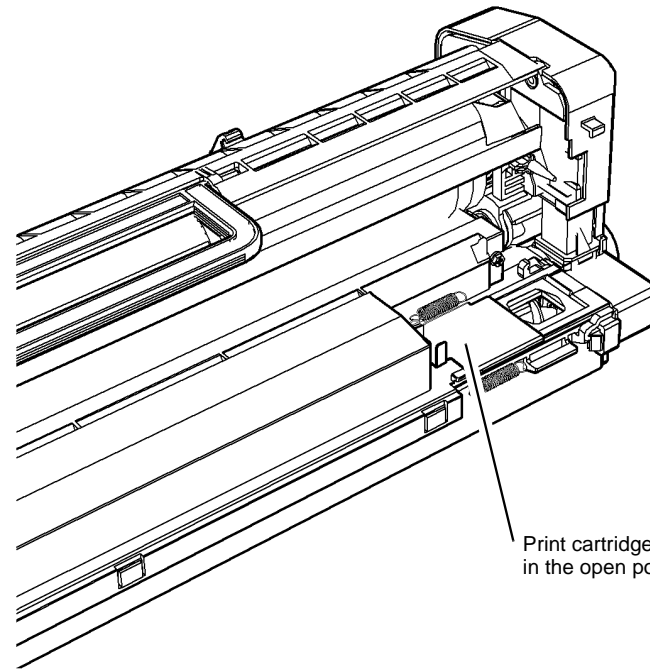
W-1-1100-A

Print cartridge shutter (shown in the open position)

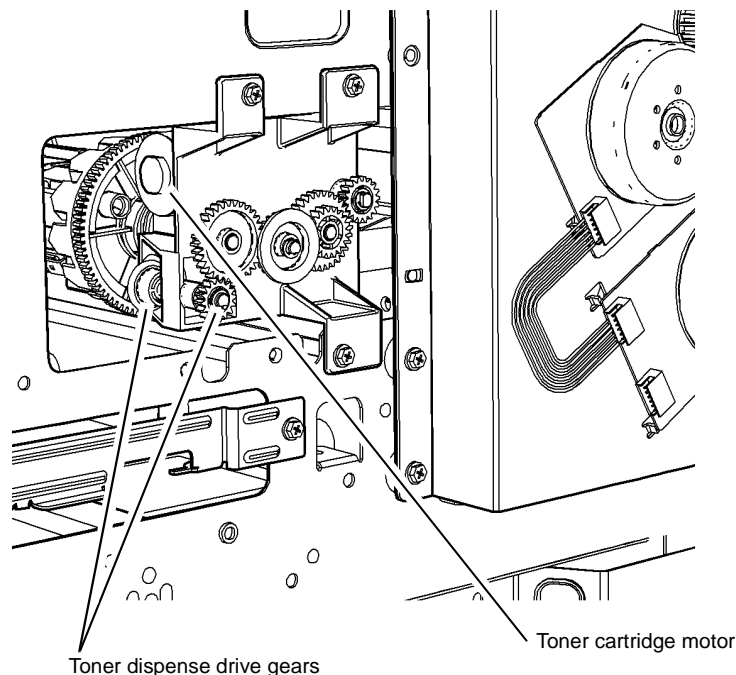
W-1-1101-A

Figure 1 Toner dispense module

Y N
Ensure the shutter on the toner dispense tube opens and closes correctly. If necessary, install a new toner dispense module, PL 90.17 Item 1. Install a new toner cartridge, PL 90.17 Item 2.

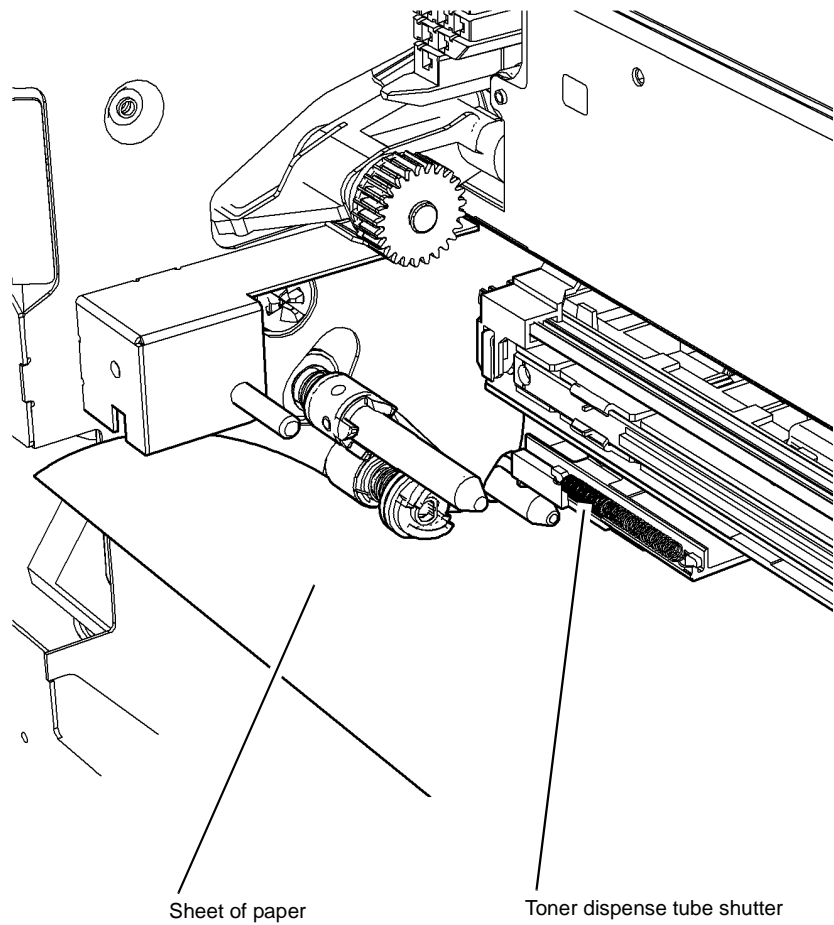
W-1-1102-A

Sheet of paper

Toner dispense tube shutter

Figure 2 Toner dispense tube

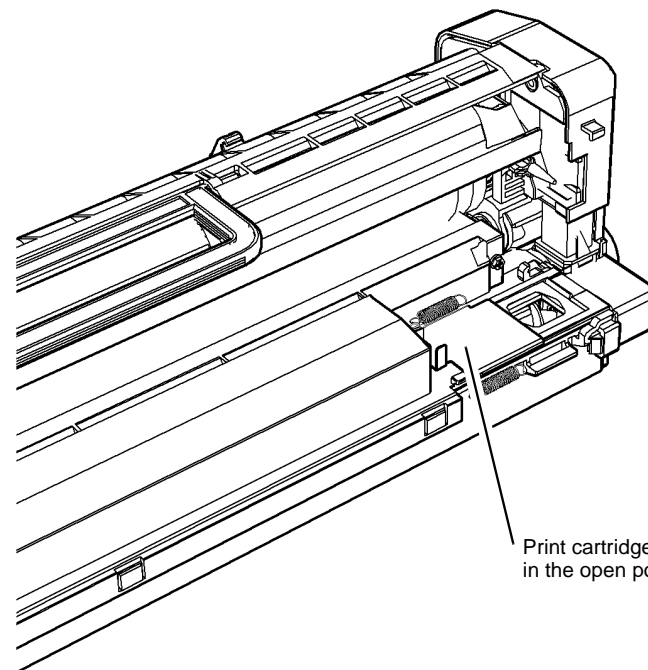
W-1-1103-A

Print cartridge shutter (shown in the open position)

Ensure the shutter on the print cartridge, Figure 3, opens and closes correctly. If necessary, install a new print cartridge, PL 90.17 Item 9. Install a new toner cartridge, PL 90.17 Item 2.

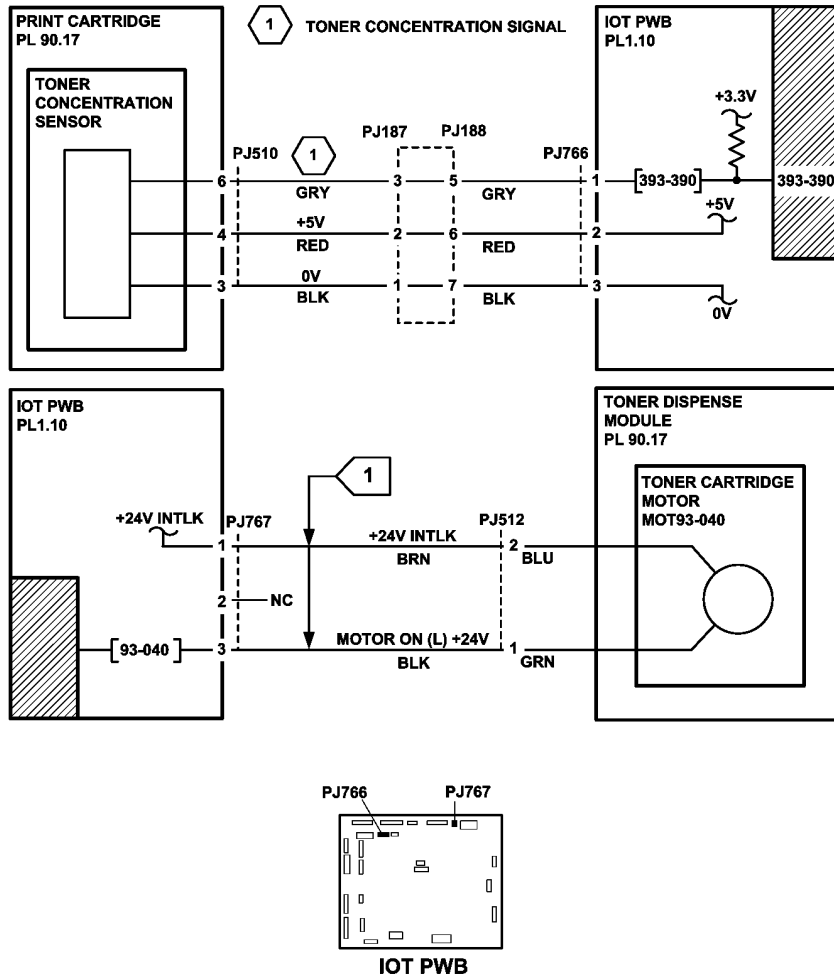
TW-1-0276-A

Figure 4 Circuit diagram

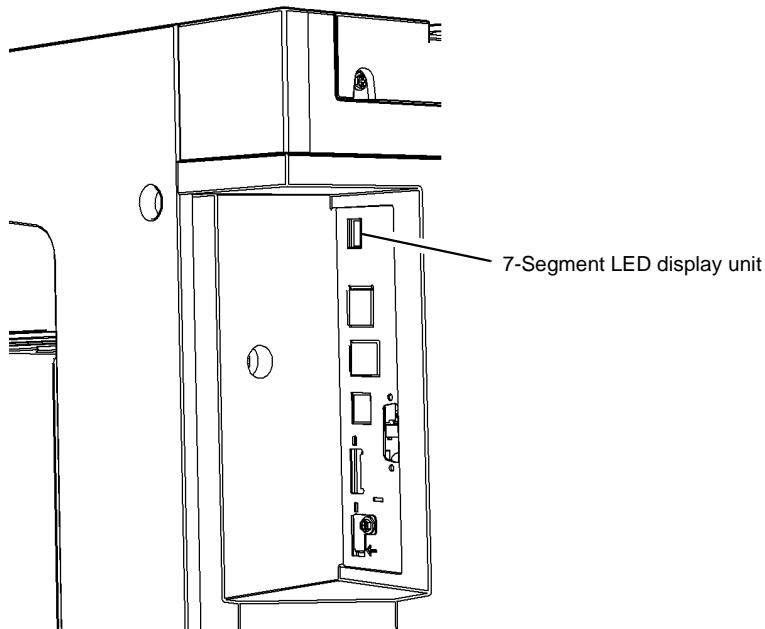
W-1-1051-A

Figure 1 SBC LED display unit

- POST is performed by the IOT PWB and the SBC PWB.
- The fault is communicated via a 7-Segment LED display unit on the rear of the machine attached to the SBC PWB, [Figure 1](#). This is to help diagnose common faults which prevent the machine from powering up correctly to the point where faults are displayed and service mode can be entered. The LED display should show just a pulsing decimal point when the machine boots correctly. The main codes are displayed for short periods of time during power up depending, on how long each test takes. If any code is left displayed during power up and the machine appears not to have powered on correctly, then this should indicate the problem component. Refer to [Table 1](#).

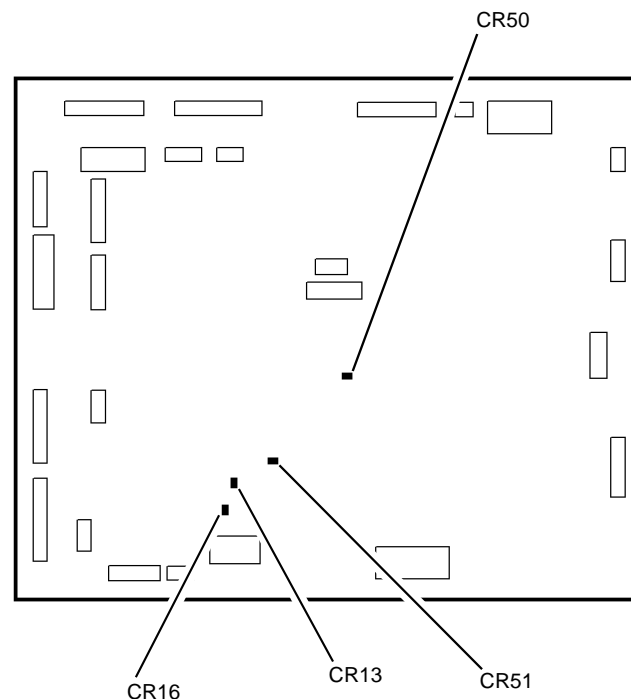
W-1-1089-A

Figure 1 IOT PWB LED locations

1. Switch off, then switch on the machine, GP 14. With the front door and left door closed, the LEDs that follow should be observed on the IOT PWB, Figure 1:
 - CR13 - on indicates the presence of +5V.
 - CR16 - on indicates the presence of +24V interlocked.
 - CR50 - flashing at about 2 Hz is the software heartbeat.
 - CR51 - on indicates the presence of +3.3V (generated on the IOT PWB).
2. If any of the above conditions still fail, then install a new IOT PWB, PL 1.10 Item 2.

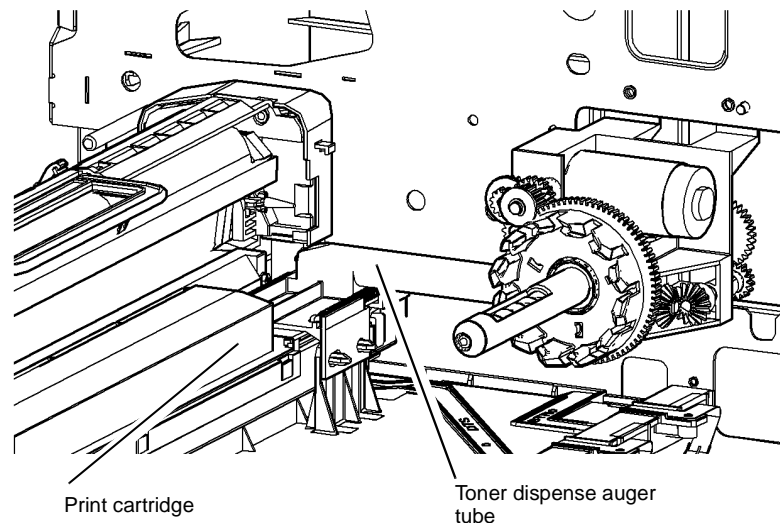
W-1-1230-A

Figure 1 Component location

- The toner cartridge, **PL 90.17 Item 2**, is undamaged, and that the toner cartridge seal is undamaged.
- The print cartridge, **PL 90.17 Item 9**, is undamaged.
- The dispense module, **PL 90.17 Item 1**, is undamaged.
- The toner dispense auger tube engages correctly with the print cartridge, **Figure 1**.
- The xerographic voltage tracks on the HVPS tray assembly, **PL 90.10 Item 1**. Refer to the **391A HVPS RAP**.
- The fault history file for any recent 391-XXX or 393-XXX fault codes. The contamination may be caused by a xerographic control fault. Perform the appropriate RAP.

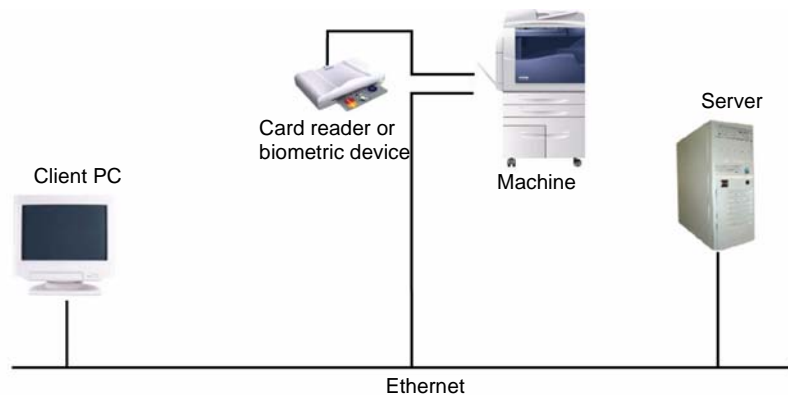
W-1-1079-A

Figure 1 Network Diagram

Xerox Secure Access uses an external device, such as a card reader or biometric device, to authorize access to the machine. The reader passes the information to the machine, which handles the authentication process, including which UI screens are displayed, accepting UI responses that define their content and order. The machine can gather user identities and passwords directly from an external server. All communication is via the machine's connection to the ethernet. Refer to Figure 1.

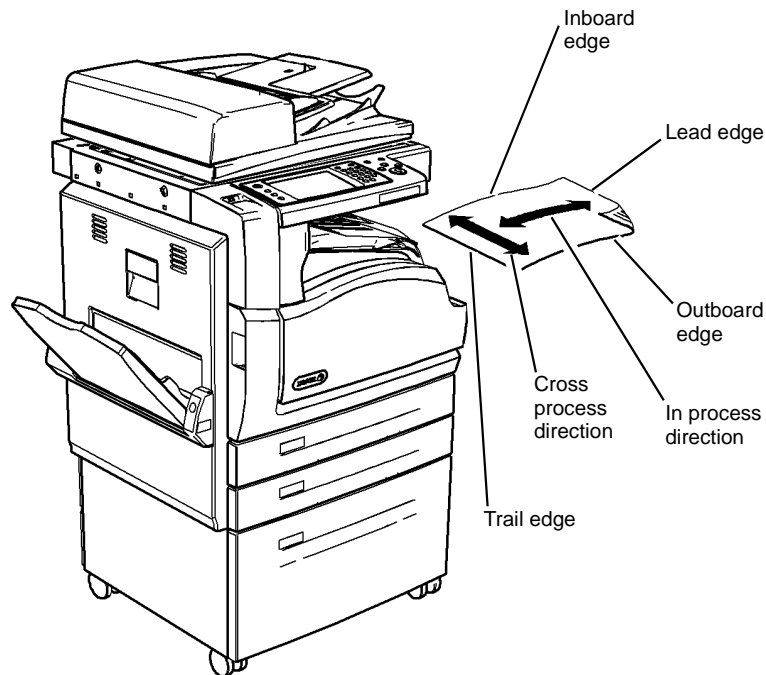
W-1-1229-A

Figure 1 Print/copy definitions

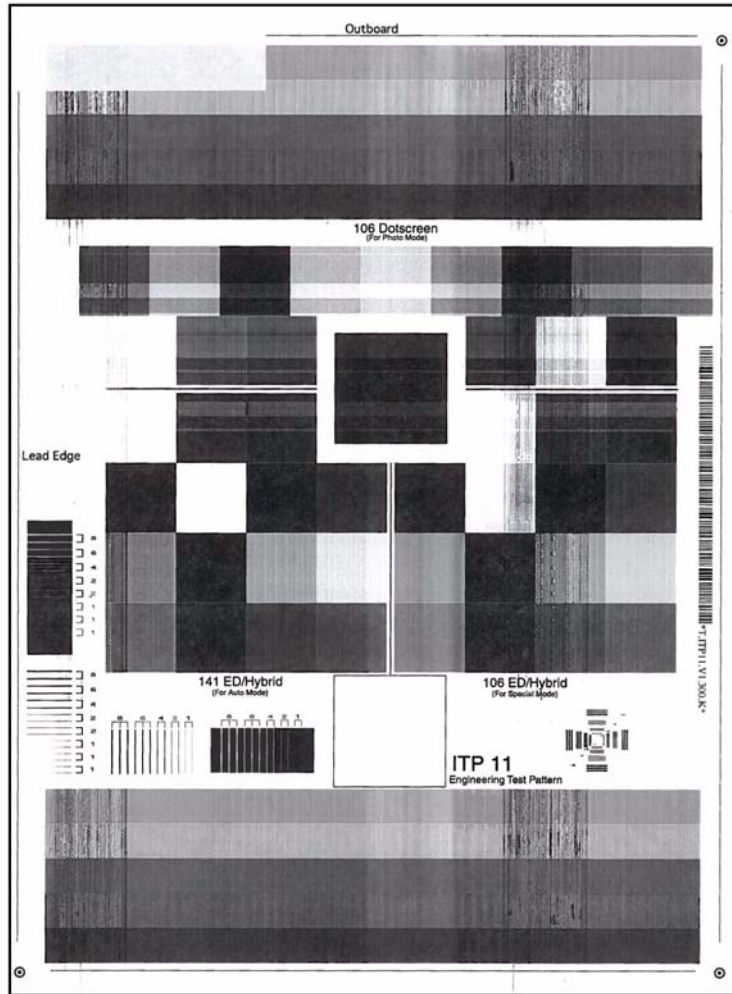
Figure 3 IQ defect sample

The defect shown in Figure 3 is a result of electrostatic discharge (ESD) affecting the LED print head, caused by a loss of grounding.

Toner contamination on the back of prints	Random black spots or marks.	2	Figure 3
Uneven density or non uniform image	Variation in image density across the print.	3 22	Figure 4 Figure 21
Unfused prints	The toner image on the finished print is not fused to the print medium.	7	Figure 8
White lines in the process direction	White lines in the dark or image areas of the print in the process direction.	2 3	Figure 3 Figure 4
White spots	White spots are areas visible on a half tone or solid area where the toner has failed to be deposited.	2 3 4 9	Figure 3 Figure 4 Figure 5 Figure 10

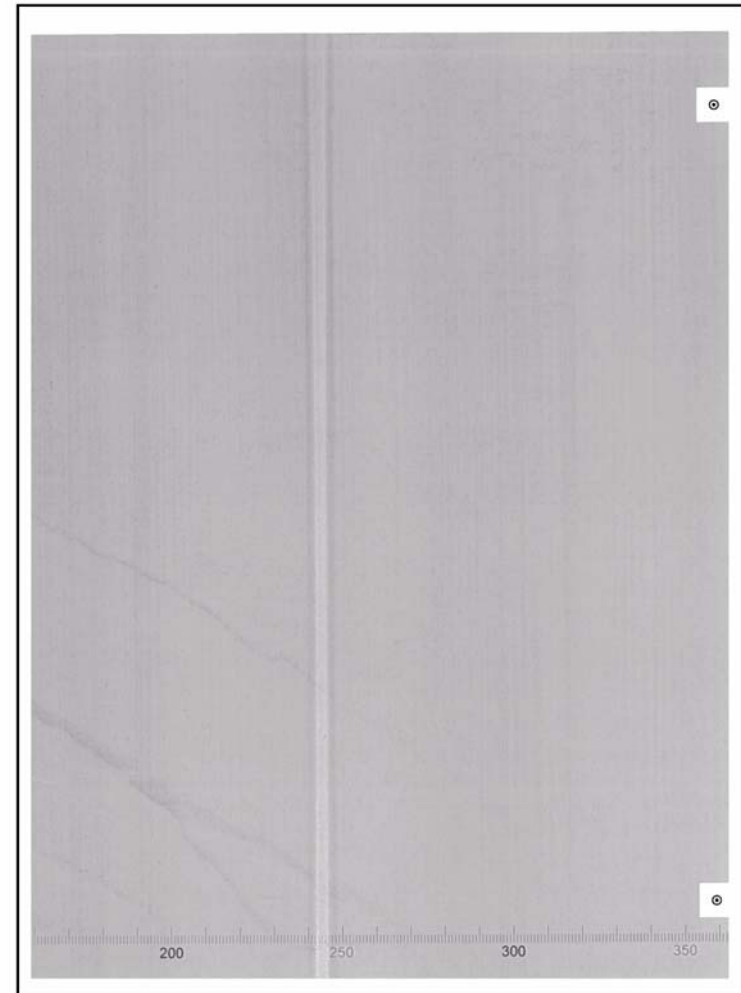
Figure 4 IQ defect sample

The defect shown in Figure 4 is the result of a light shocked photoreceptor caused by the LED print head being energized while the photoreceptor is stationary.

If the bands resemble [Figure 4](#), the bands may have been caused by the LED print head being energized while the photoreceptor was stationary. Perform the procedures that follow:

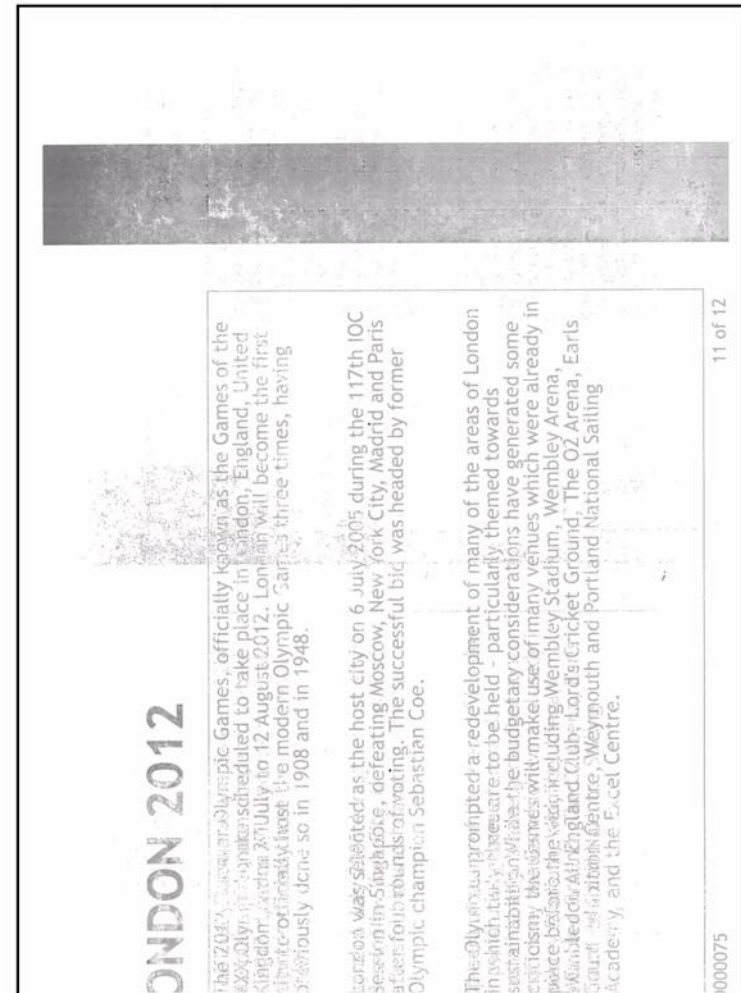
Figure 6 IQ defect sample

The defect shown in Figure 6 is a toner image that adheres to the fuser roll or pressure roll and transfers to another area of the print. The repeat interval for a fuser roll defect or a pressure roll defect is 94.3mm (3.71 inches).

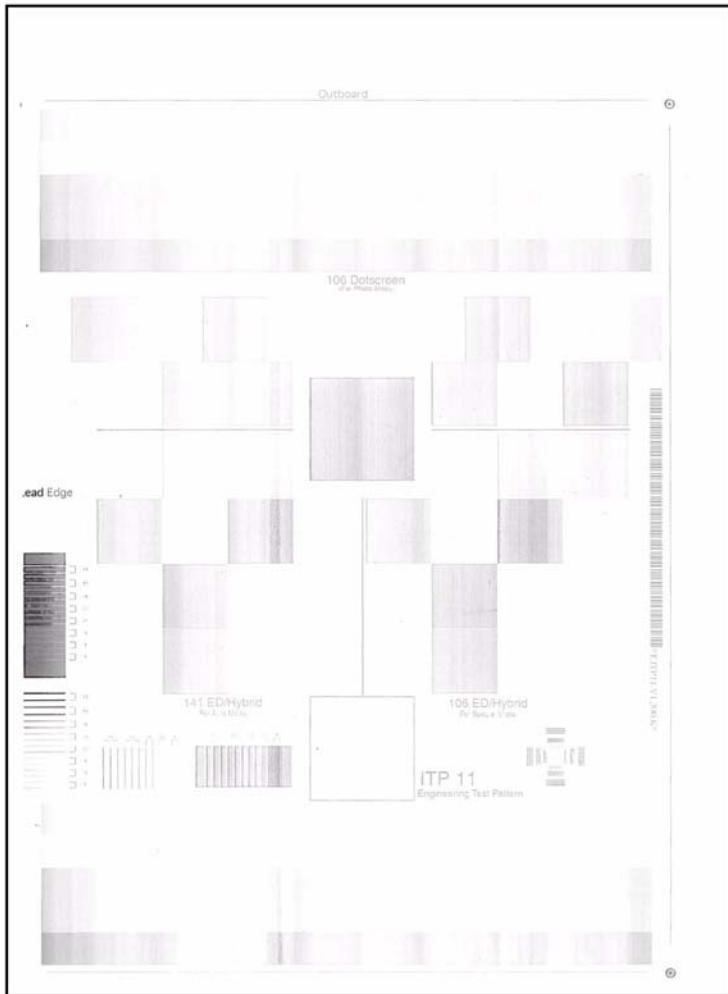
Figure 9 IQ defect sample

The defect shown in Figure 9 is a result of the loss of the developer bias DC voltage.

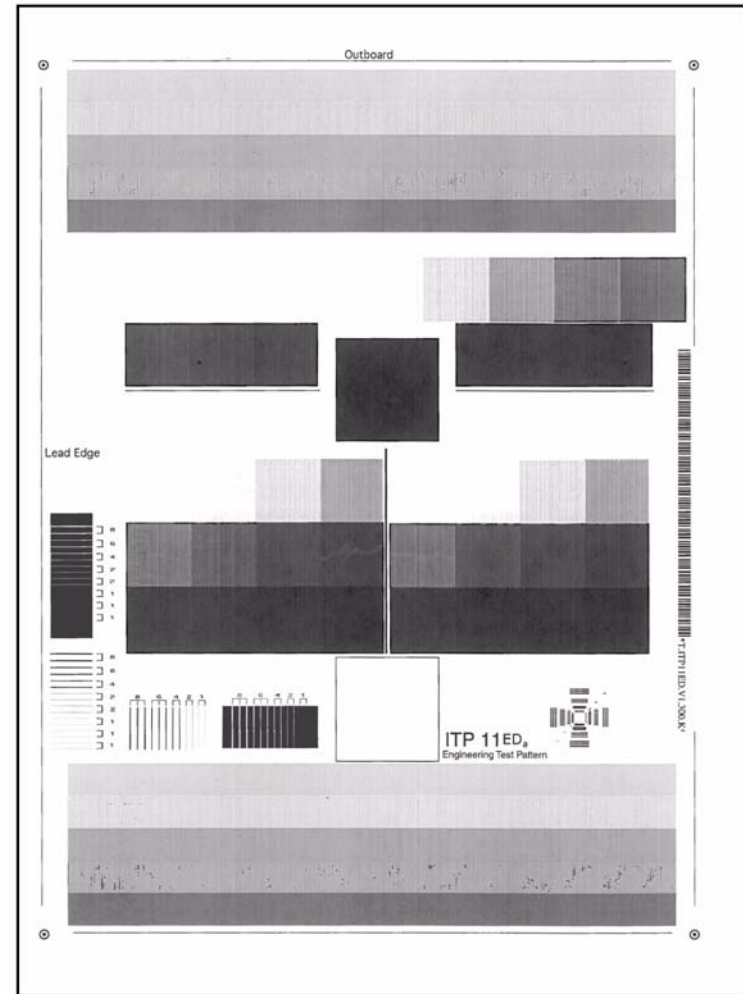
Figure 10 IQ defect sample

The defect shown in Figure 10 is the result of the distance between the LED print head and the photoreceptor being wrong, giving poor focus.

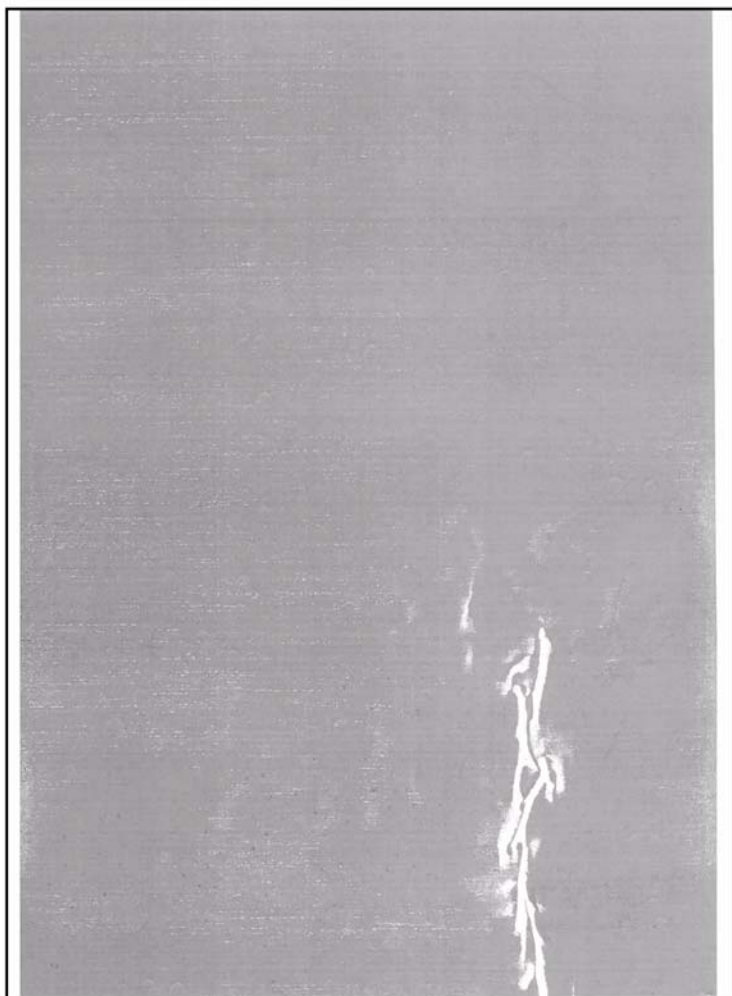
Figure 11 IQ defect sample

The defect shown in [Figure 11](#) is the result of wrinkled paper before transfer, resulting in image loss.

- If the deletions are small and align with the stripper fingers in the fuser module, clean the stripper fingers. If necessary install a new fuser module, [PL 10.8 Item 1](#).
- If the deletions resemble those shown in [Figure 11](#), go to [IQS 6 Copy / Print Defects](#) and perform the Paper Wrinkle corrective actions.
- Perform the [IQ3 Xerographic RAP](#).

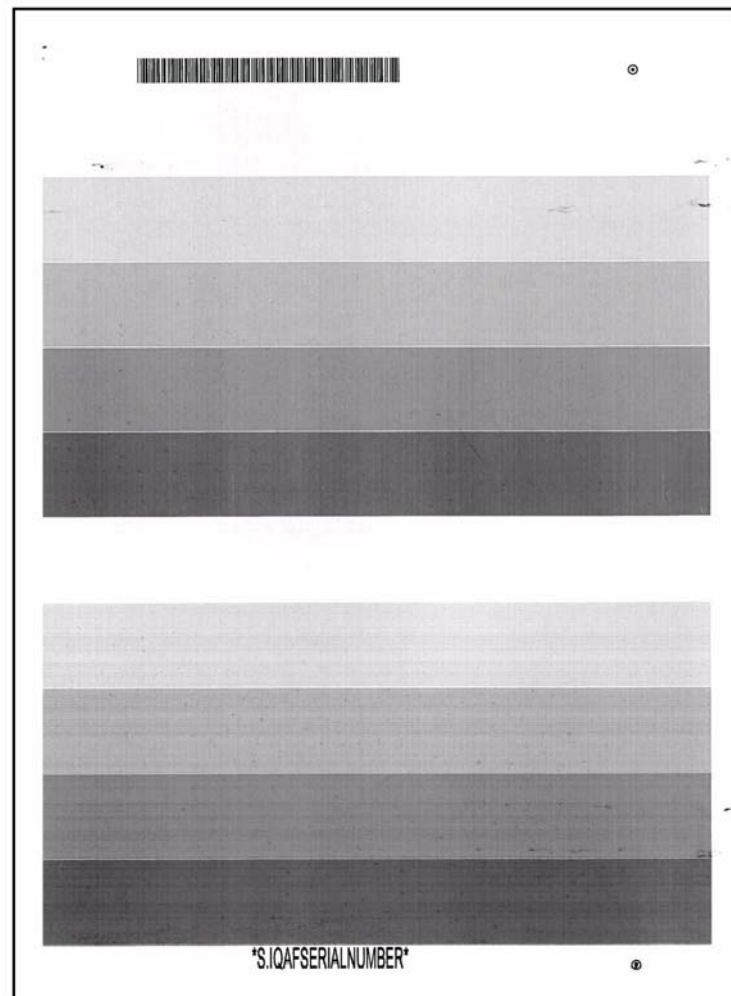
Figure 12 IQ defect sample

The defect shown in [Figure 12](#) is the result of contamination from the print cartridge. This can be seen as random contamination deposits over the entire area of the page.

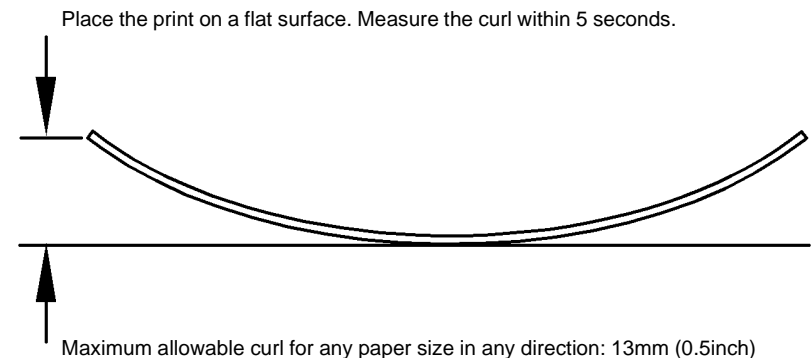
Figure 1 Curl height measurement

Make 5 simplex prints. Refer to [Figure 1](#). If the curl on the prints exceeds 13mm (0.5 inch), perform the steps that follow:

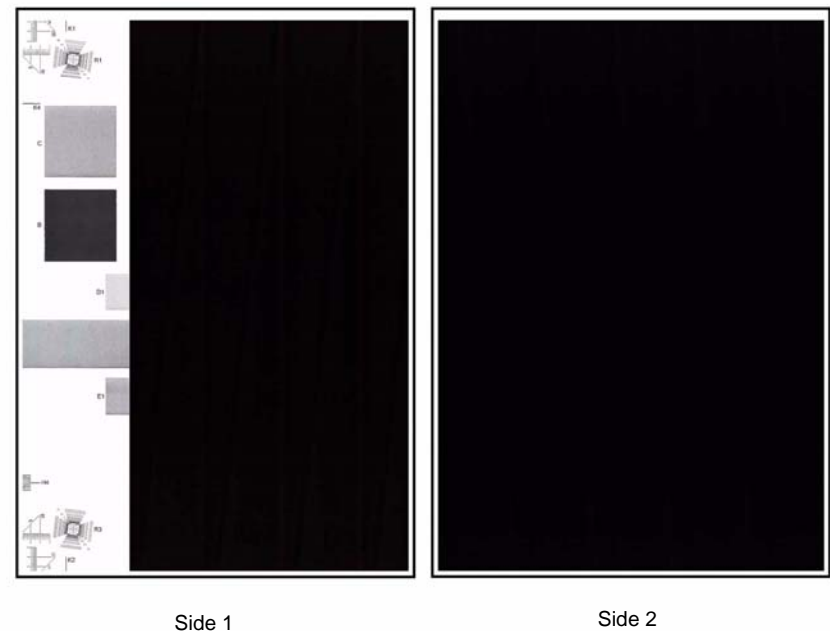
Figure 1 IQ sample

Refer to [Figure 1](#). A strip of the image next to the leading edge is good but the remainder of the page is black, with a sharp joint between the 2 parts that runs from inboard to outboard. If the output is duplex, side 2 of the copy/scan will have a larger proportion of black or may be completely black. The fault history may contain 362-960 codes.

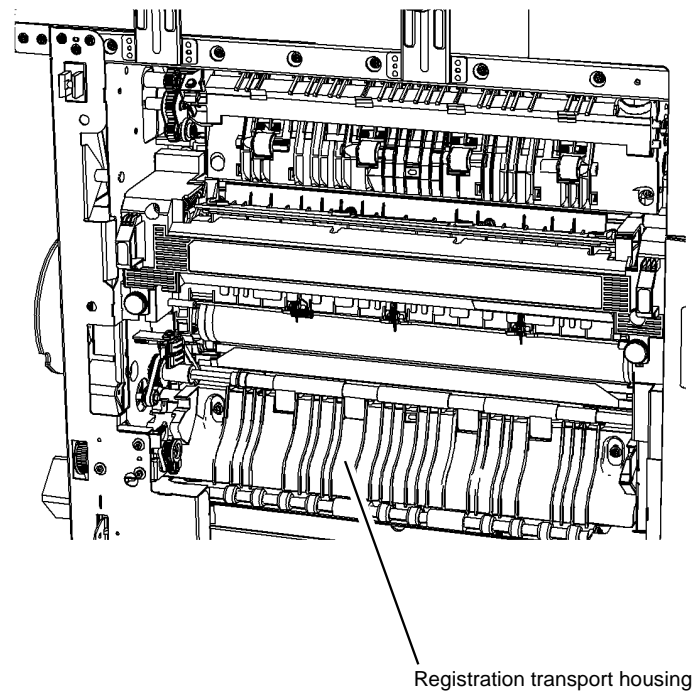
Figure 3 Registration transport

- Check the registration transport housing ribs for wear, damage and contamination, **Figure 3**. If necessary clean the housing or install a new registration transport housing, **PL 80.17** Item 1.

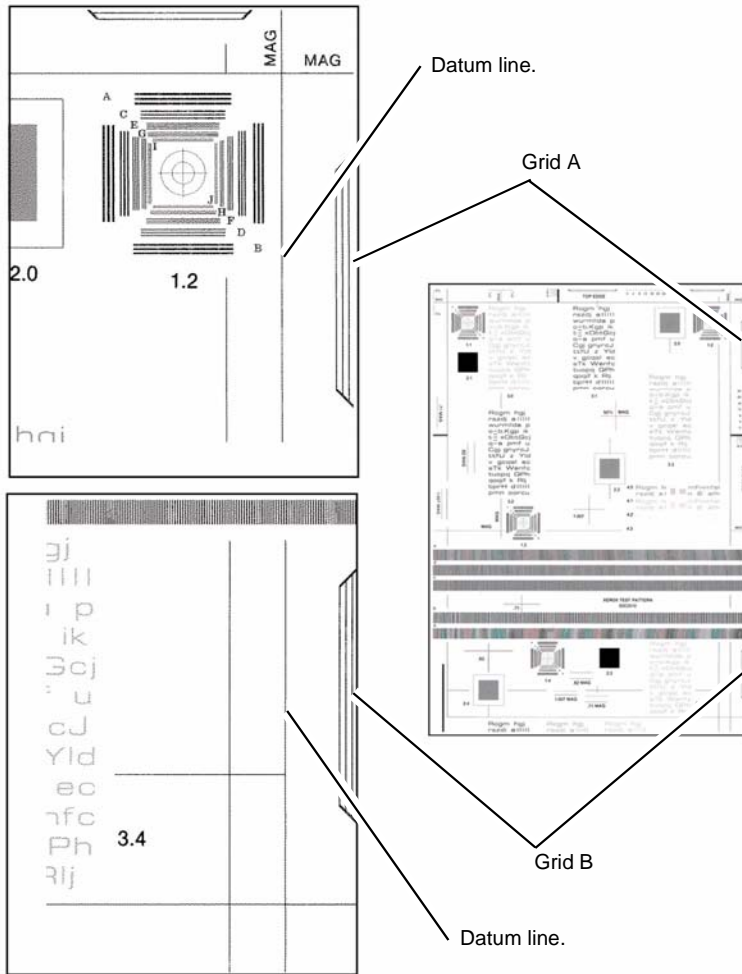
W-1-1240-A

Figure 3 Copy and scan skew measurement

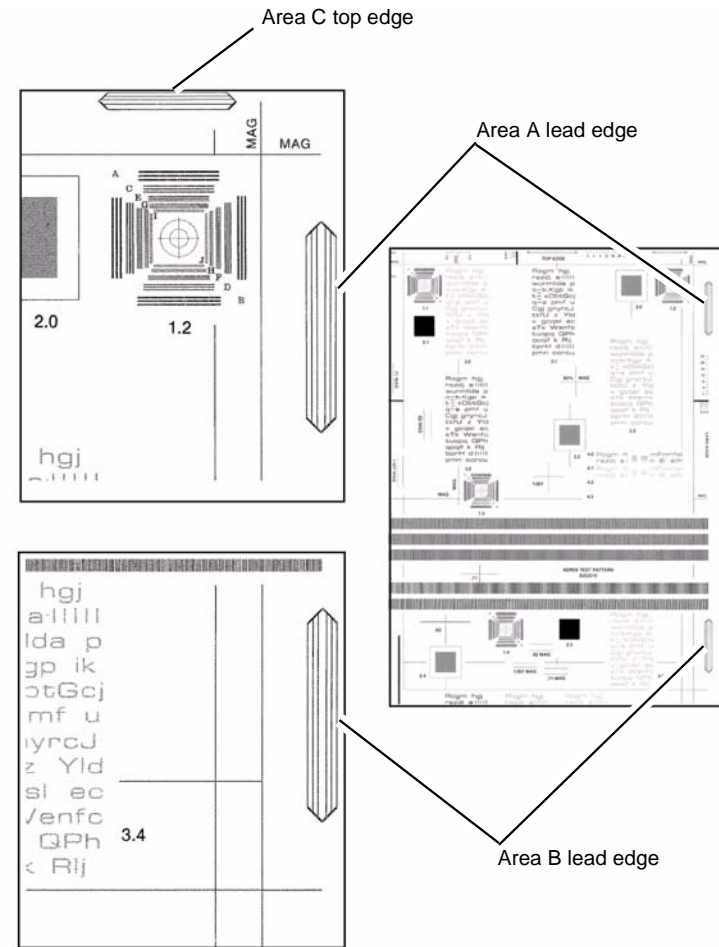
Figure 1 Registration measurement

Perform the **dC604** Registration Setup.

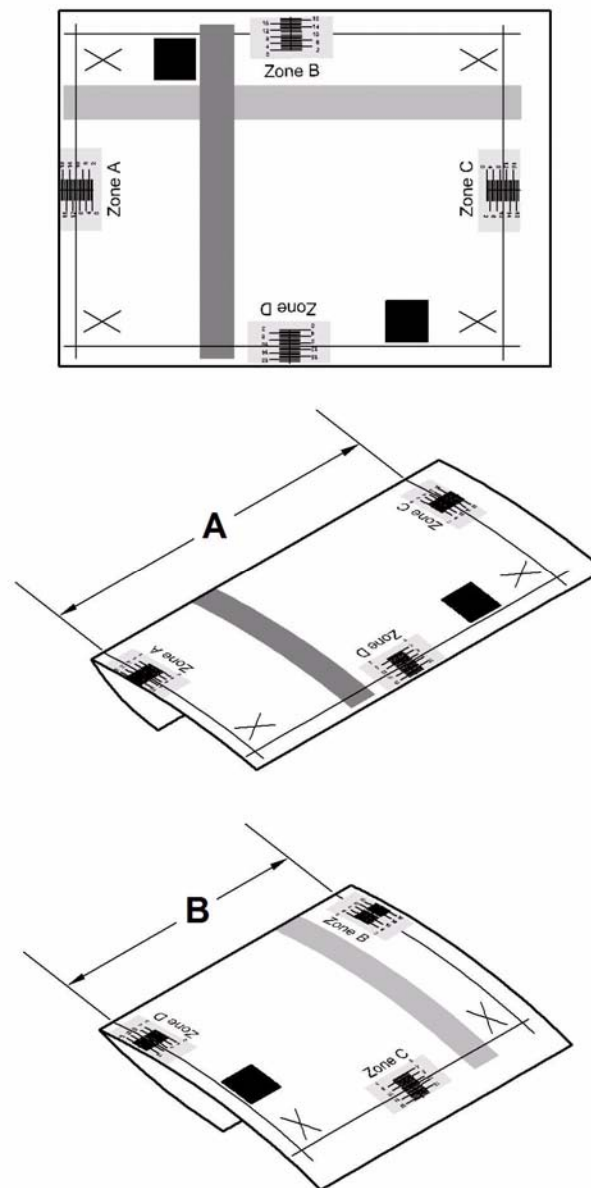
Figure 1 Magnification check

Perform [ADJ 60.3](#) IIT Registration, Magnification and Calibration.

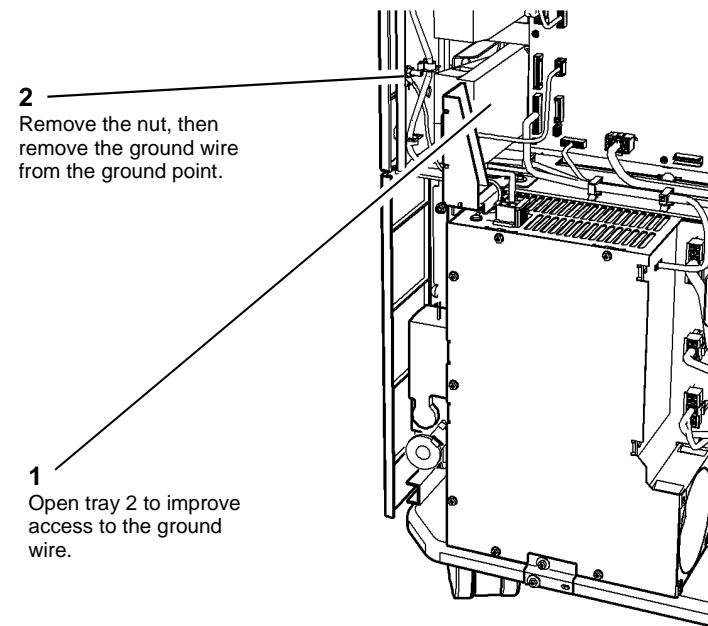
5. Disconnect the ground wire from the main frame ground point, [Figure 2](#).

Figure 2 Main frame ground point

1. The replacement is the reverse of the removal procedure.
2. Ensure that the nut on the main frame ground point is tightened to secure the ground terminal. Refer to [Figure 2](#).
3. Using a digital multimeter set to a resistance range, verify that there is continuity between the ground pin on PJ651 and the frame ground point of less than 10 ohms, [Figure 5](#).

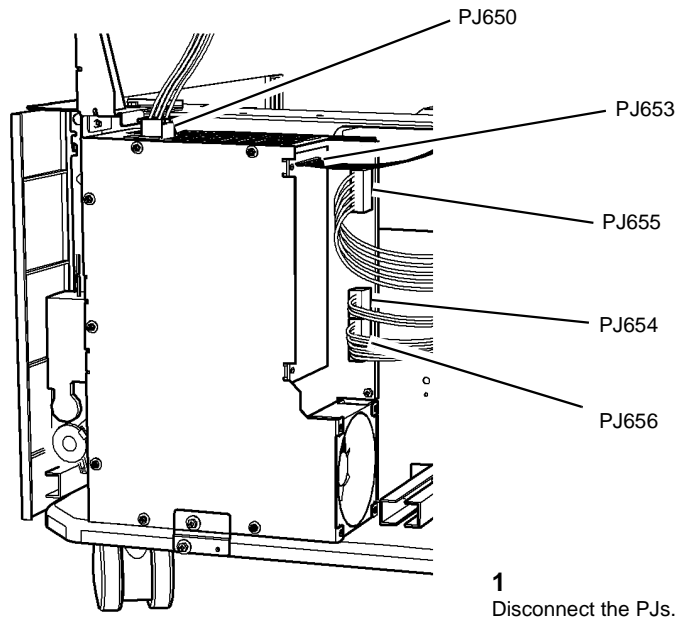
6. Disconnect the wiring to the LVPS, [Figure 3](#).

Figure 3 Wiring disconnection

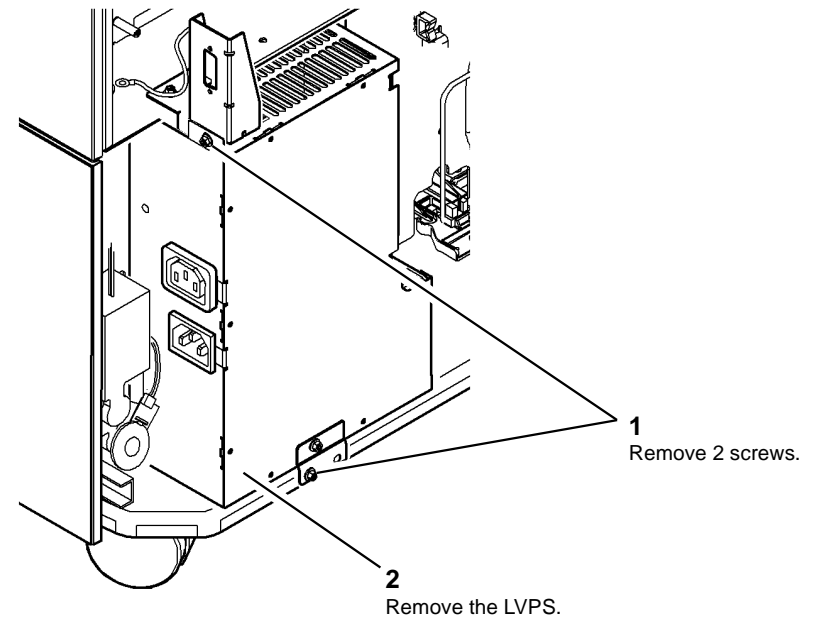
7. Remove the LVPS module, [Figure 4](#).

Figure 4 LVPS module removal

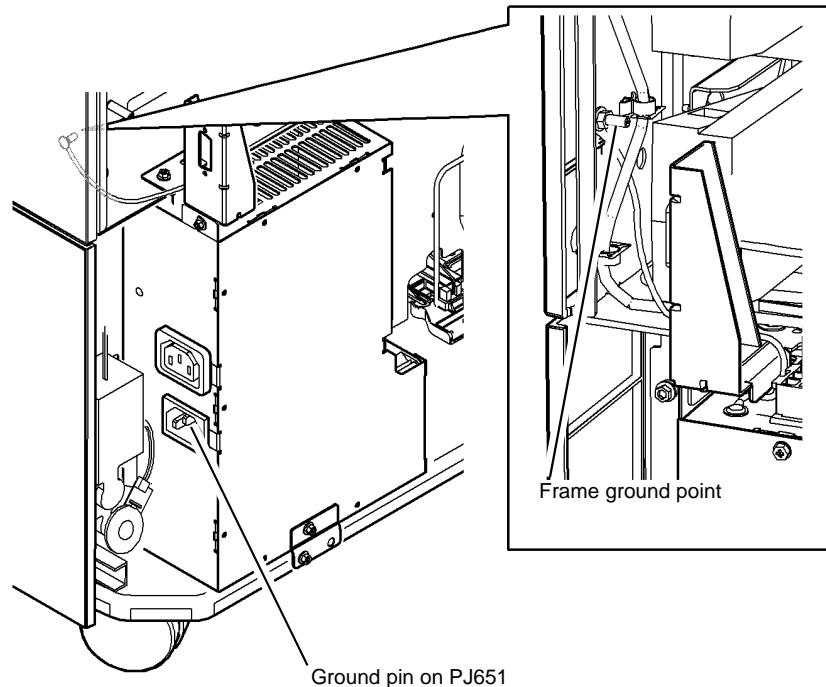
Figure 5 Ground check

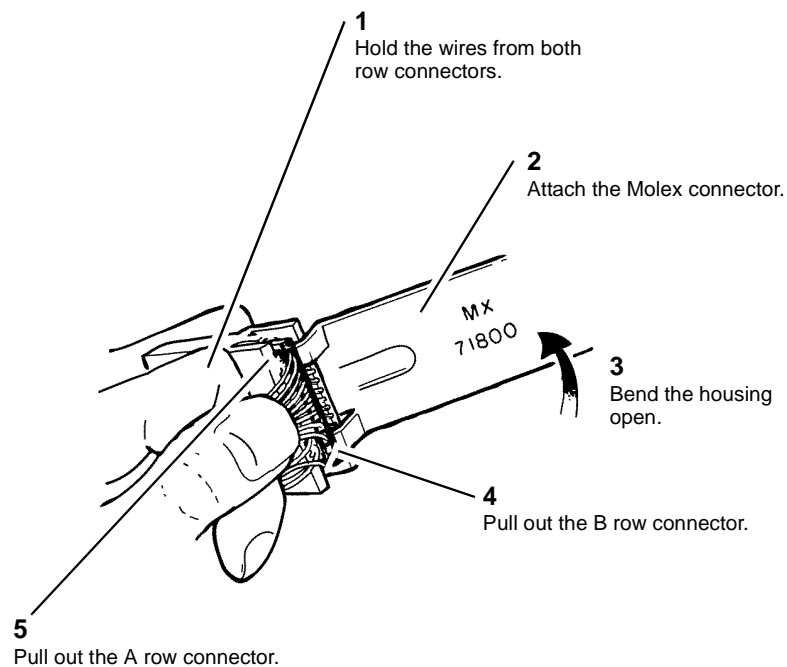
1. If the damaged connector is in the centre of a double row housing beneath the latching clip, the latching prong will not be accessible to release the connector from the housing. Therefore it will be necessary to disassemble the housing as shown in Figure 1.

Figure 1 Disassembling the connector

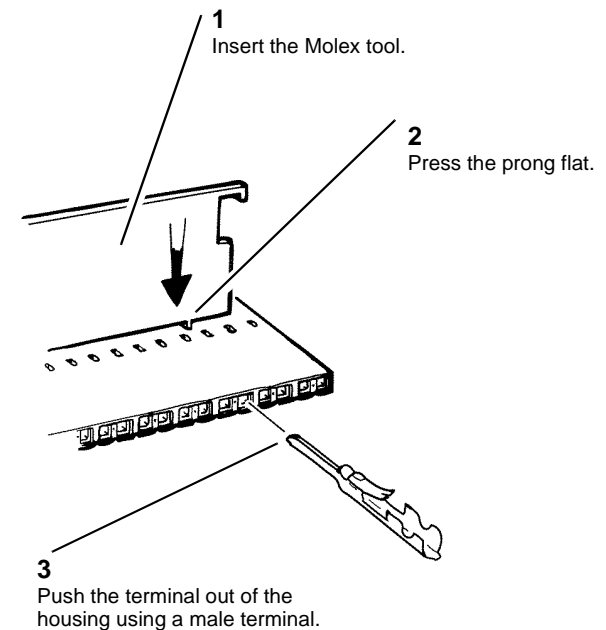
2. Remove the terminal from the connector housing using the Molex extractor tool, Figure 2.

Figure 2 Removing the terminal

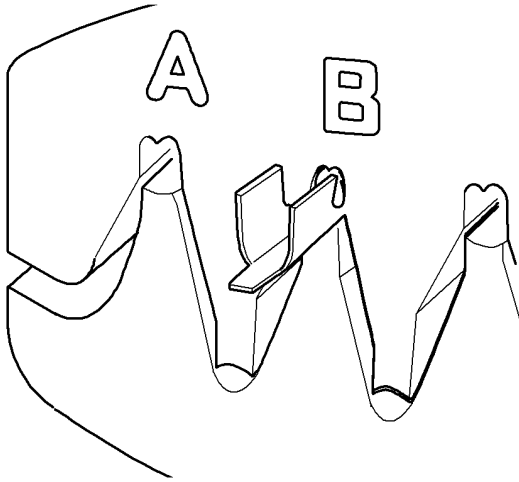
1. Select the correct replacement terminal, and identify the appropriate crimp positions for the terminal.
2. Insert a male or female terminal into the appropriate position of the crimp tool, then close the tool just enough to hold the terminal, Figure 3.

Figure 3 Crimping the terminal

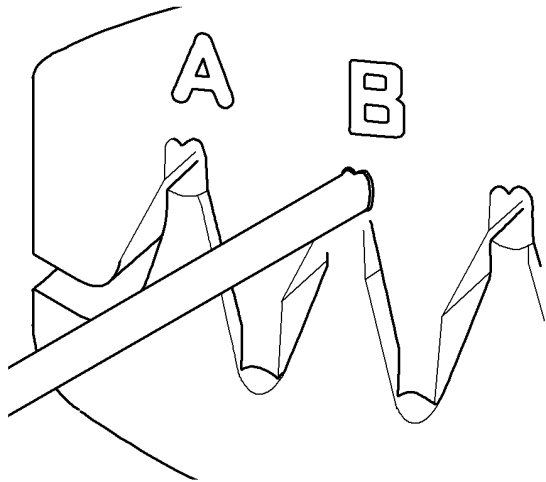
3. Insert the wire fully into the terminal so that the stripped portion of the wire is within the inner grip of the terminal. Close the crimp tool fully to make the crimp.
4. Insert the crimped terminal into the appropriate position of the crimp tool and close the crimp tool, to fasten the insulation of the wire in the outer grip of the terminal, Figure 4.

Figure 4 Crimping the insulation grip

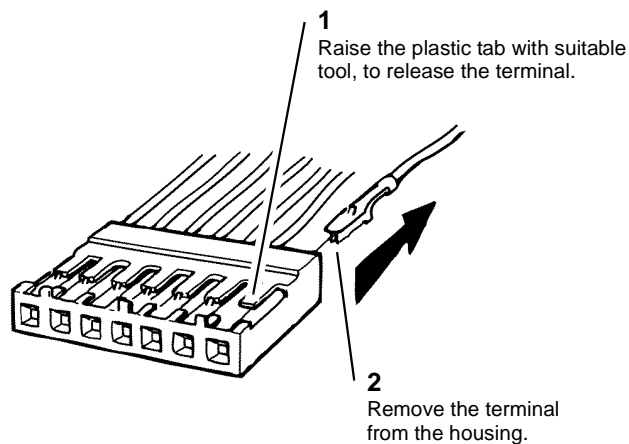
1. Remove the damaged terminal from the housing, Figure 1.

Figure 1 Remove the terminal

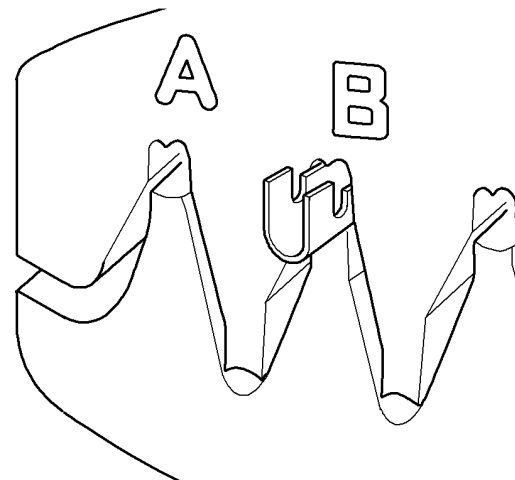
2. Insert the terminal into the appropriate position of the crimp tool and close the tool just enough to hold the terminal, Figure 2.

Figure 2 Crimping the terminal

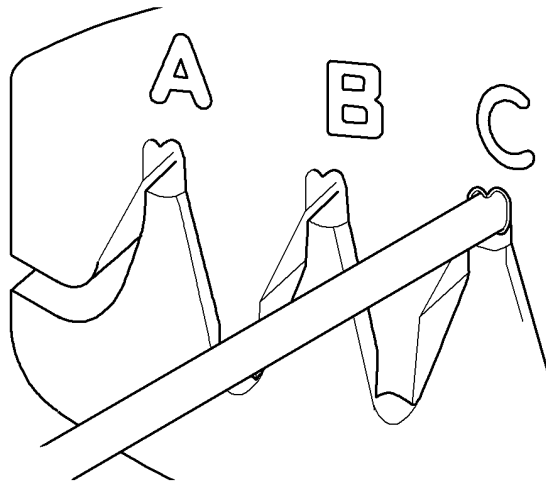
4. Insert the crimped terminal into the appropriate position of the crimp tool, then close the crimp tool to firmly fasten the insulation of the wire in the cable grip of the terminal, [Figure 3](#).

Figure 3 Crimping the insulation grip

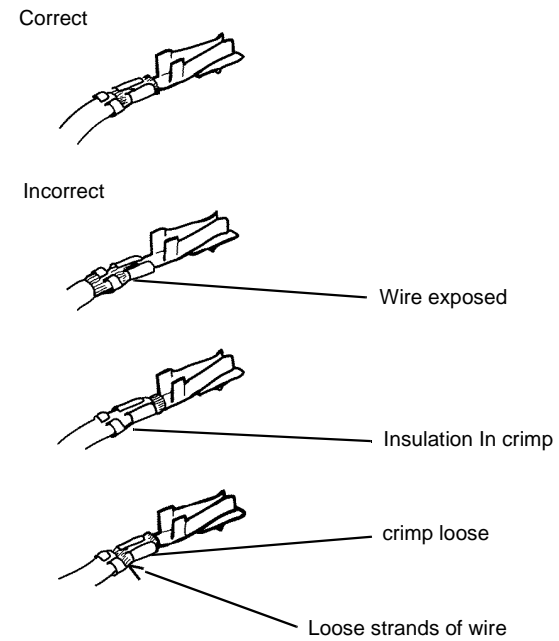
5. Check that the crimp is correctly made, [Figure 4](#).

Figure 4 Inspecting the finished crimp

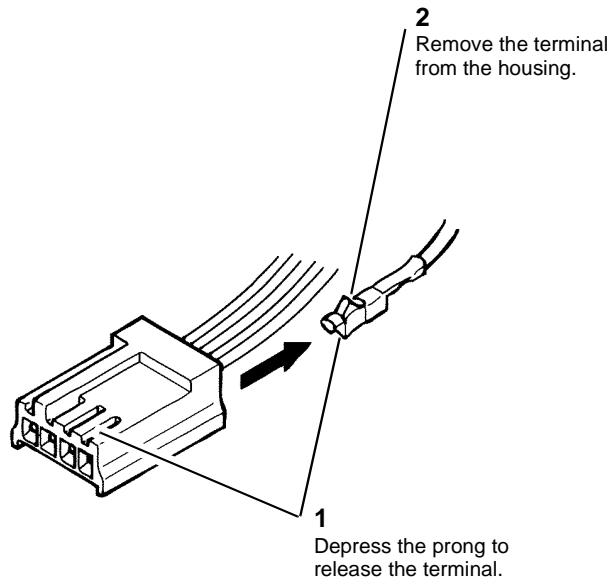
1. Use the extractor tool, to release the terminal from the housing. Refer to Figure 1 to identify the male housing and terminal type. Refer to Figure 2 to identify the female housing and the terminal type.

Figure 1 Terminal removal; male housing
