708P91139
February 2016

Xerox® WorkCentre® 5945 Family Multifunction Printer Service Manual

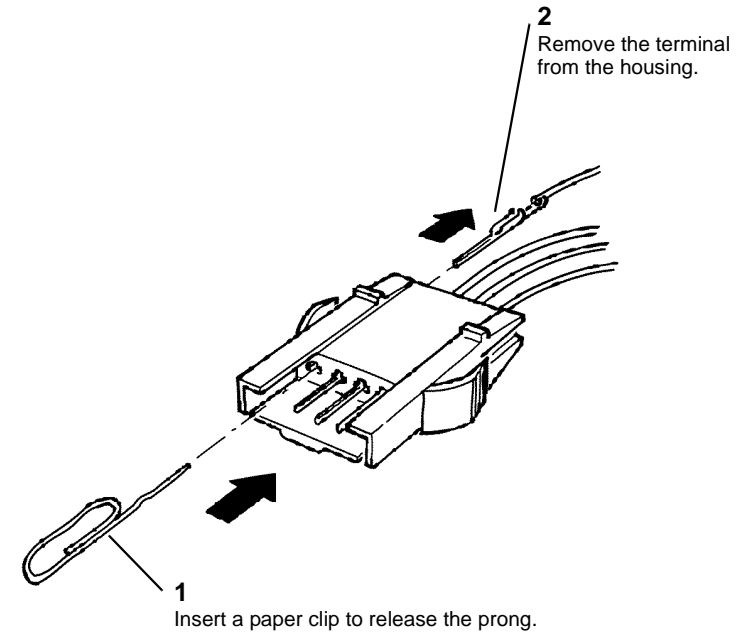
1. Use the extractor tool, to release the terminal from the housing. Refer to Figure 1 to identify the male housing and terminal type. Refer to Figure 2 to identify the female housing and the terminal type.

Figure 2 Terminal removal; female housing

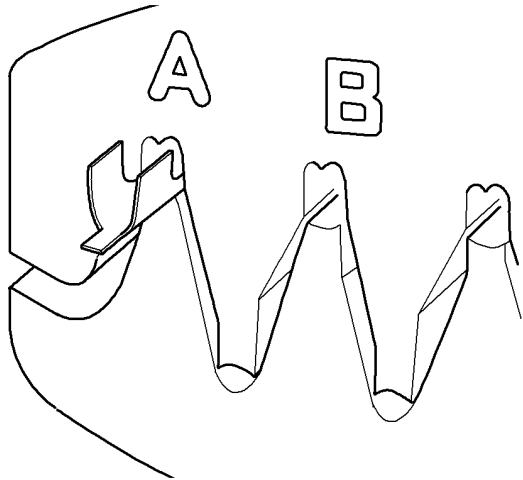
1. Select the correct replacement terminal and identify the appropriate crimp positions for the terminal.
2. Insert the terminal into the appropriate position of the crimp tool and close the tool enough to hold the terminal, [Figure 3](#).

Figure 3 Crimping the terminal

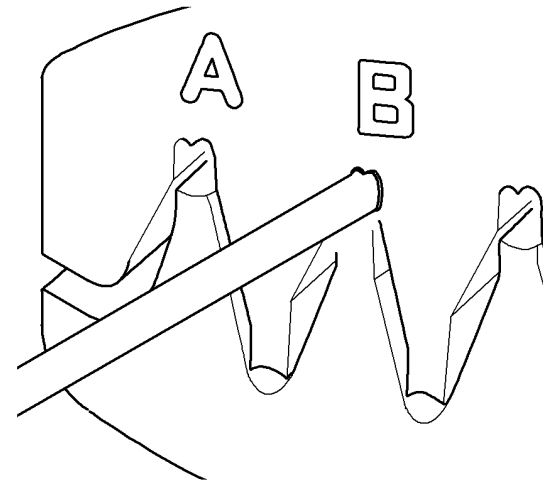
4. Insert the crimped terminal into the appropriate position of the crimp tool and close the crimp tool to firmly fasten the insulation of the wire in the cable grip of the terminal, [Figure 4](#).

Figure 4 Crimping the insulated grip

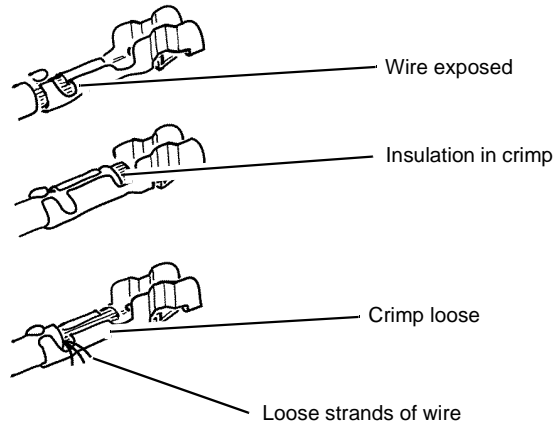
Figure 5 Inspect the finished crimp

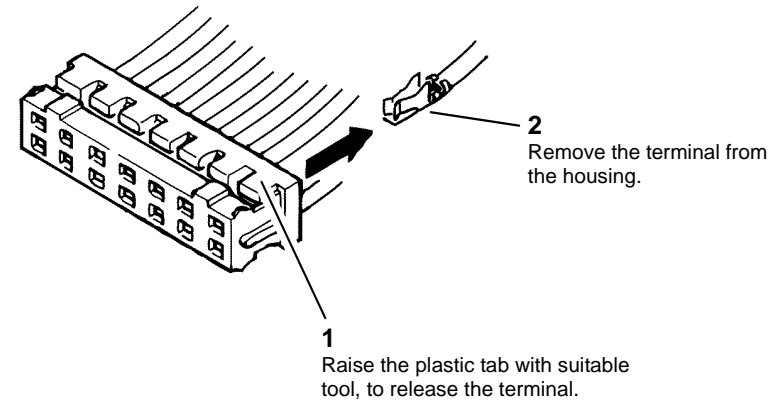
1. Remove the damaged terminal from the connector housing, [Figure 1](#).

Figure 1 Terminal removed

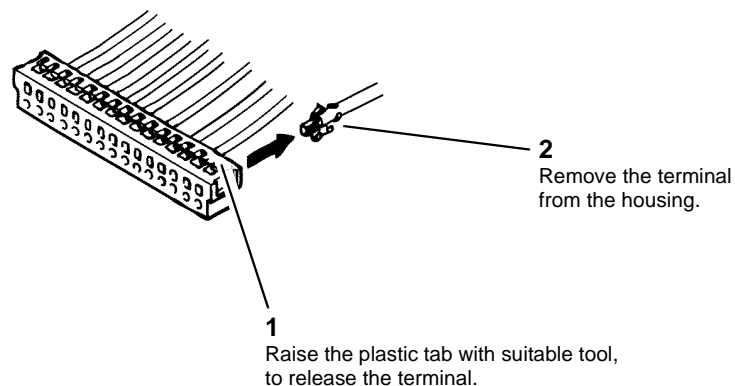
1. Identify the terminal type. Go to step 2 for a housing containing crimp terminals, or go to step 4 for a housing containing insulation displacement (IDC) terminals.
2. Remove the damaged crimp terminal from the connector housing, Figure 1.

Figure 1 Terminal removal

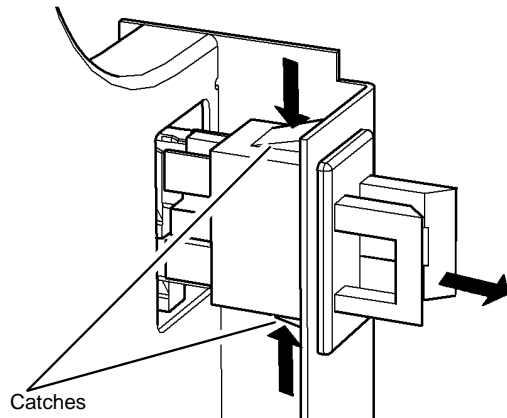
- 1 Squeeze the catches in whilst pulling the switch out of the frame.

Figure 1 Switch release

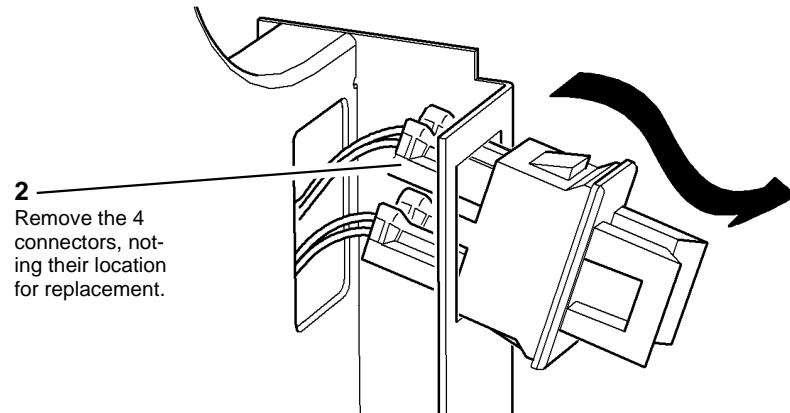
- 2 Remove the 4 connectors, noting their location for replacement.

Figure 2 Switch removal

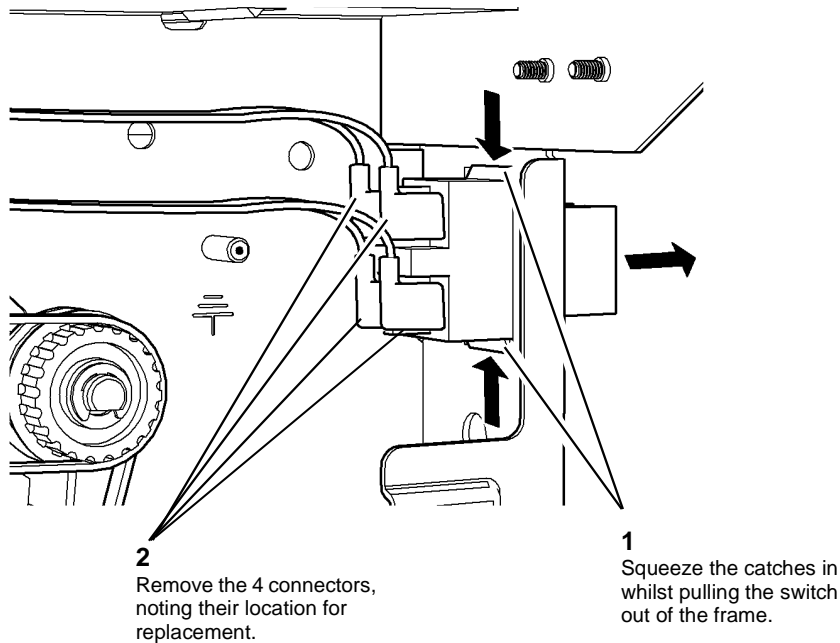
1. Remove the rear cover, [REP 28.2](#).
2. Open the left door.
3. Remove the left door interlock switch, [Figure 1](#).

Figure 1 Switch removal

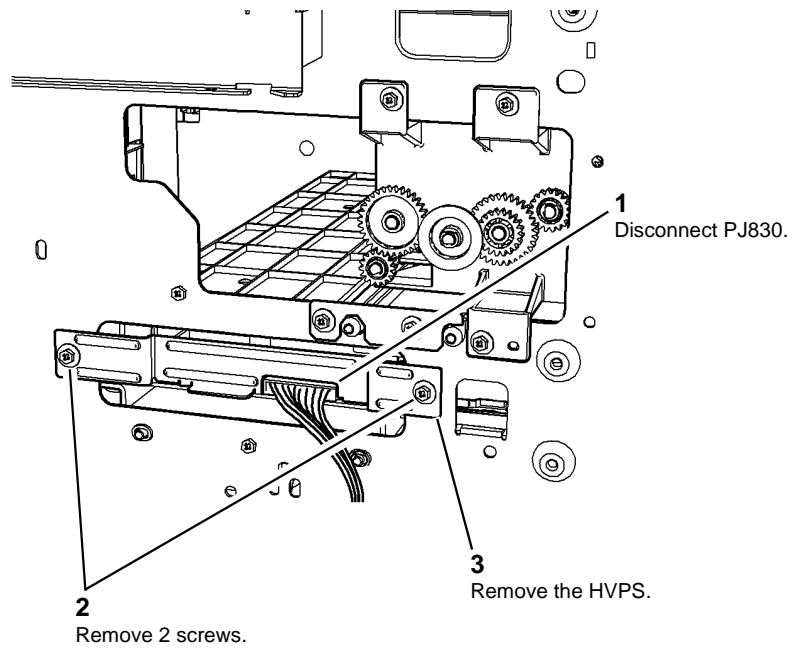
4. Remove the HVPS, [Figure 2](#).

Figure 2 HVPS removal

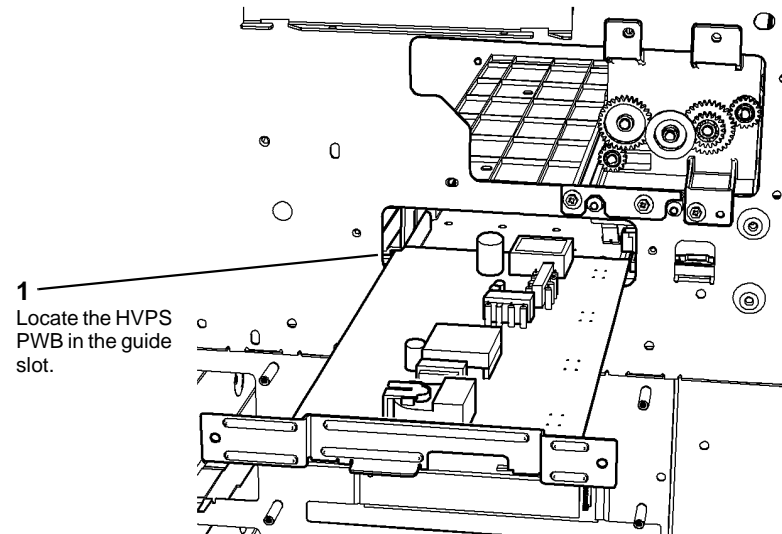
1. The replacement is the reverse of the removal procedure.
2. Align the left side of the HVPS PWB into the guide slot then push the HVPS into the machine, [Figure 3](#).

Figure 3 HVPS replacement

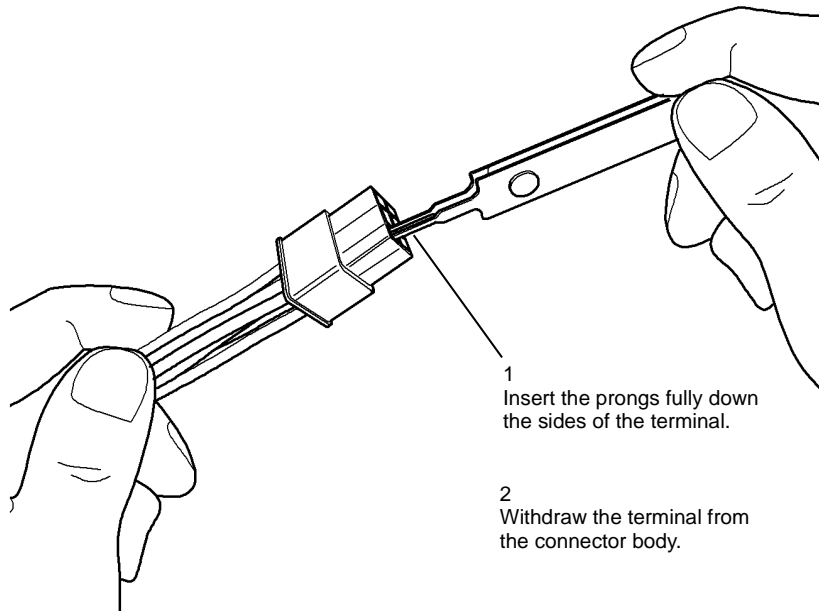
1. Remove the terminal from the housing, using the Molex, Mini-Fit extractor tool, Figure 1.

Figure 1 Removing the terminal

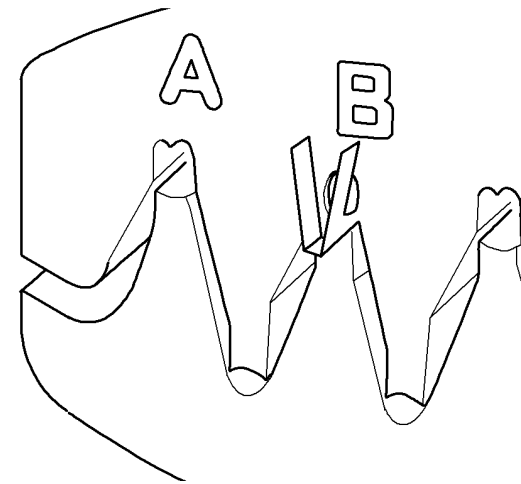
2. Insert the terminal into the appropriate position of the crimp tool and close the tool just enough to hold the terminal, Figure 2.

Figure 2 Crimping the terminal

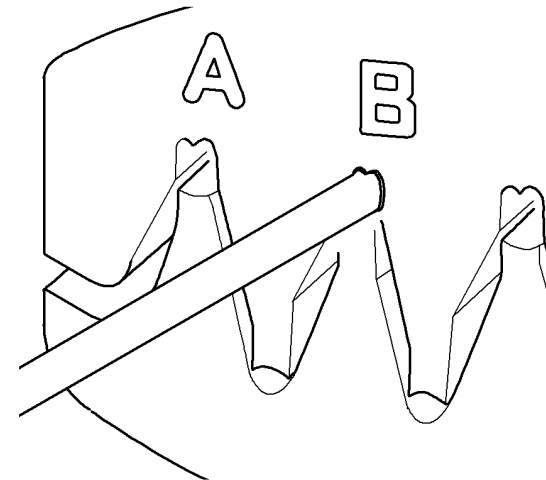
3. Insert the wire fully into the terminal so that the stripped portion is within the inner grip of the terminal. Close the crimp tool fully to make the crimp.
4. Insert the crimped terminal into the appropriate position of the crimp tool and close the crimp tool to fasten the wire insulation in the outer grip of the terminal, Figure 3.

Figure 3 Crimping the insulation grip

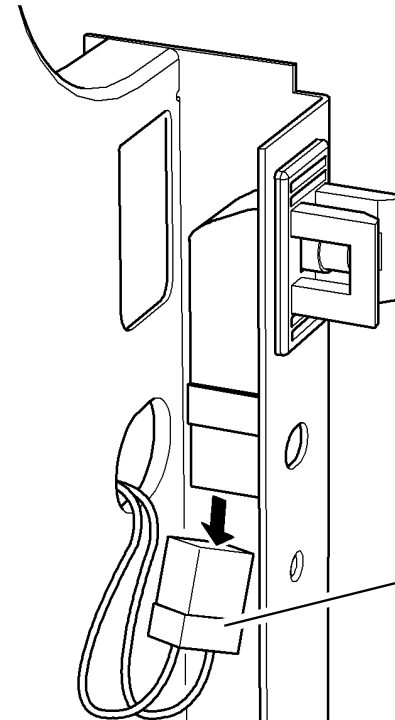
1
Release the latch, then
disconnect PJ951.

Figure 1 Switch connection

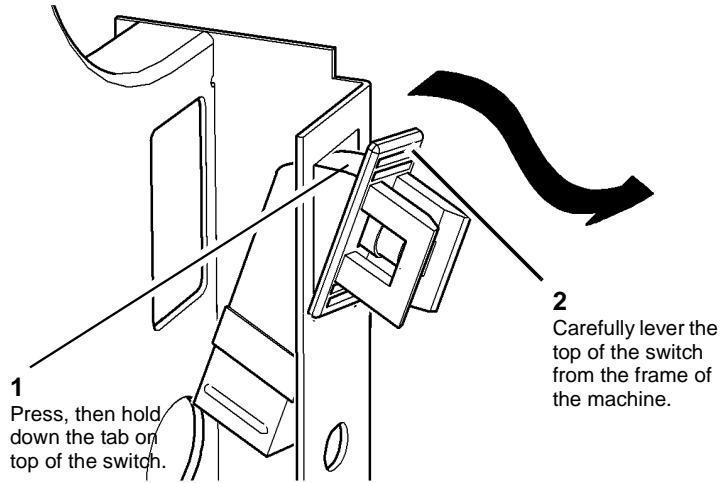
4. Remove the front door interlock switch, [Figure 2](#).

Figure 2 Switch removal

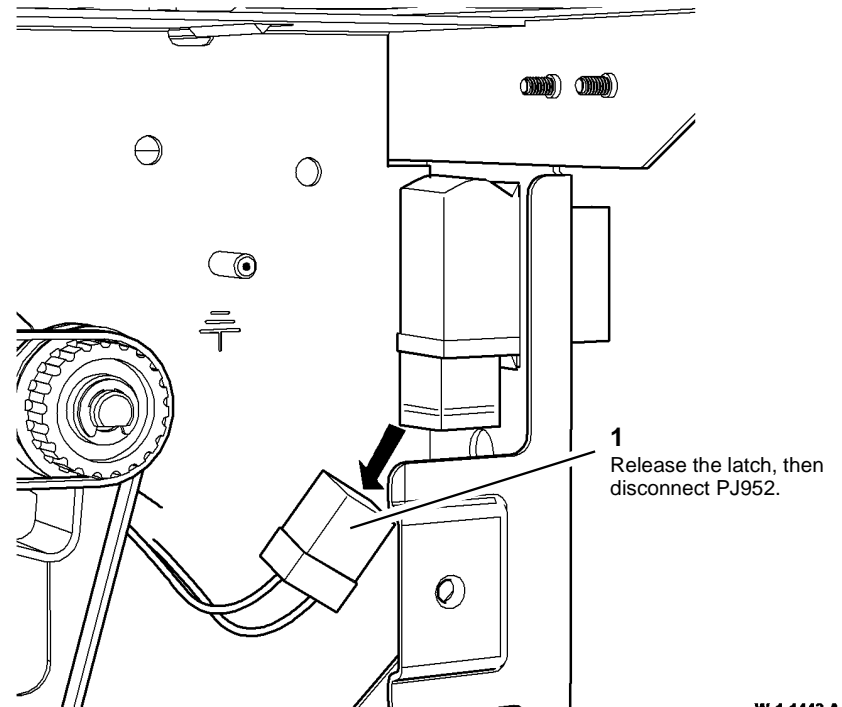
3. Disconnect the left door interlock switch, [Figure 1](#).

Figure 1 Switch connection

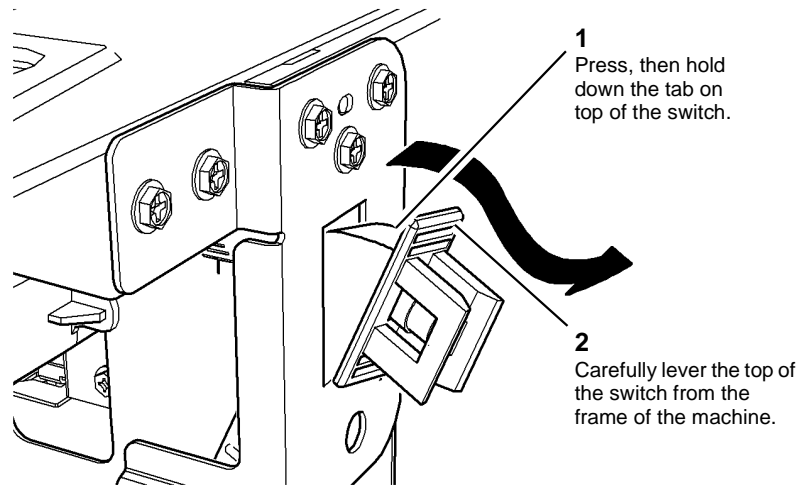
4. Remove the left door interlock switch, [Figure 2](#).

Figure 2 Switch removal

1. The replacement is the reverse of the removal procedure.
2. Engage the bottom of the switch with the machine frame ([Figure 2](#)), then pivot the switch backwards until it locks into position.
3. Install new tie-wraps to replace any removed during this procedure.

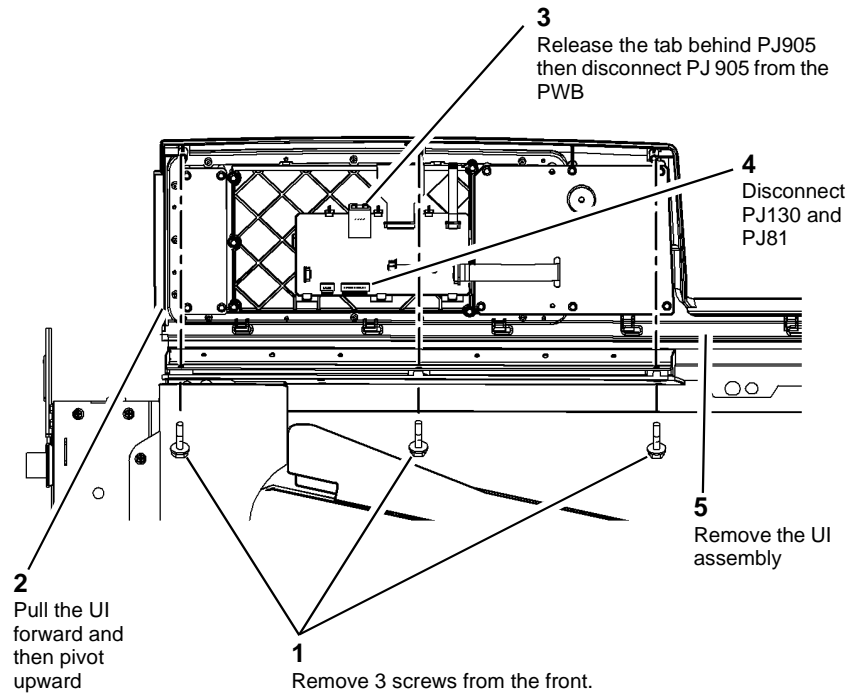
1. Open the front door assembly, [PL 28.11 Item 1](#).
2. Remove the left frame cover [REP 28.1](#).
3. Remove the UI assembly, [Figure 2](#).

Figure 2 UI assembly removal

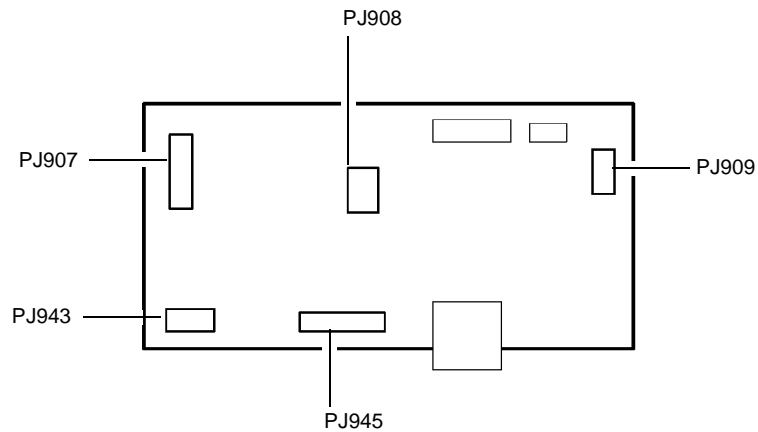
3. Disconnect PJ907, PJ908, PJ909 and PJ943 by pulling the clamp away from each connector. Disconnect PJ945 by lifting the clamp. Refer to [Figure 2](#).

Figure 2 UI control PWB

1. The replacement is the reverse of the removal procedure. Refer to [GP 6](#) before the screws are installed.
2. Ensure the ribbon cable to PJ908 is routed through the hole in the PWB.
3. The ribbon cable to PJ907 is positioned over the cable clamp, all other ribbon cables are positioned under the cable clamps.

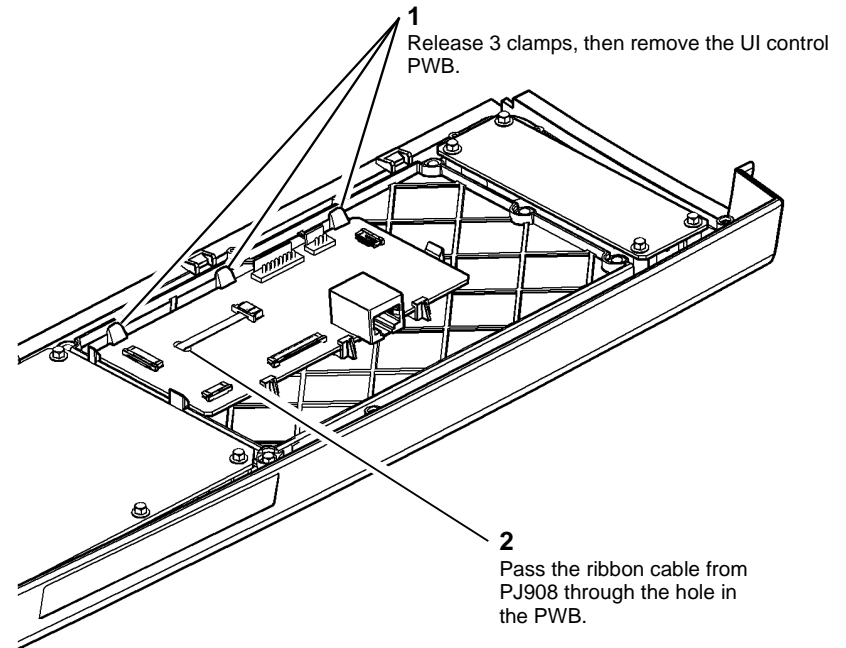
4. Remove the UI control PWB, [Figure 3](#).

Figure 3 UI control PWB removal

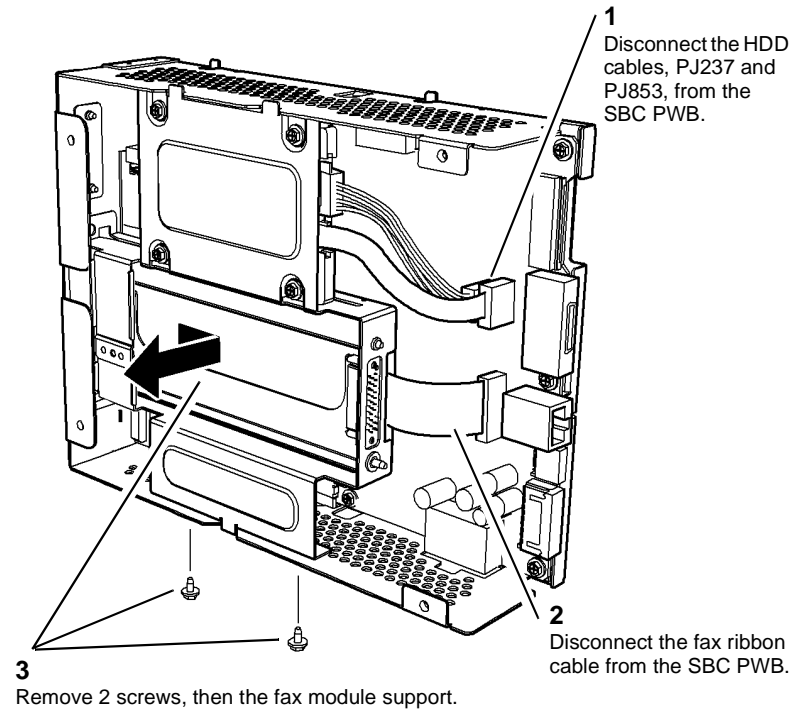
1. Remove the rear cover, [REP 28.2](#).
2. Remove the SBC cover, [PL 3.22 Item 9](#).
3. If installed, remove the fax module, [PL 20.05 Item 1](#).
4. Remove the fax module support, [Figure 2](#).

NOTE: If a foreign device interface is installed, carefully pull the FDI ribbon cable away from the fax module support before removing the fax module support.

Figure 2 Fax module support removal

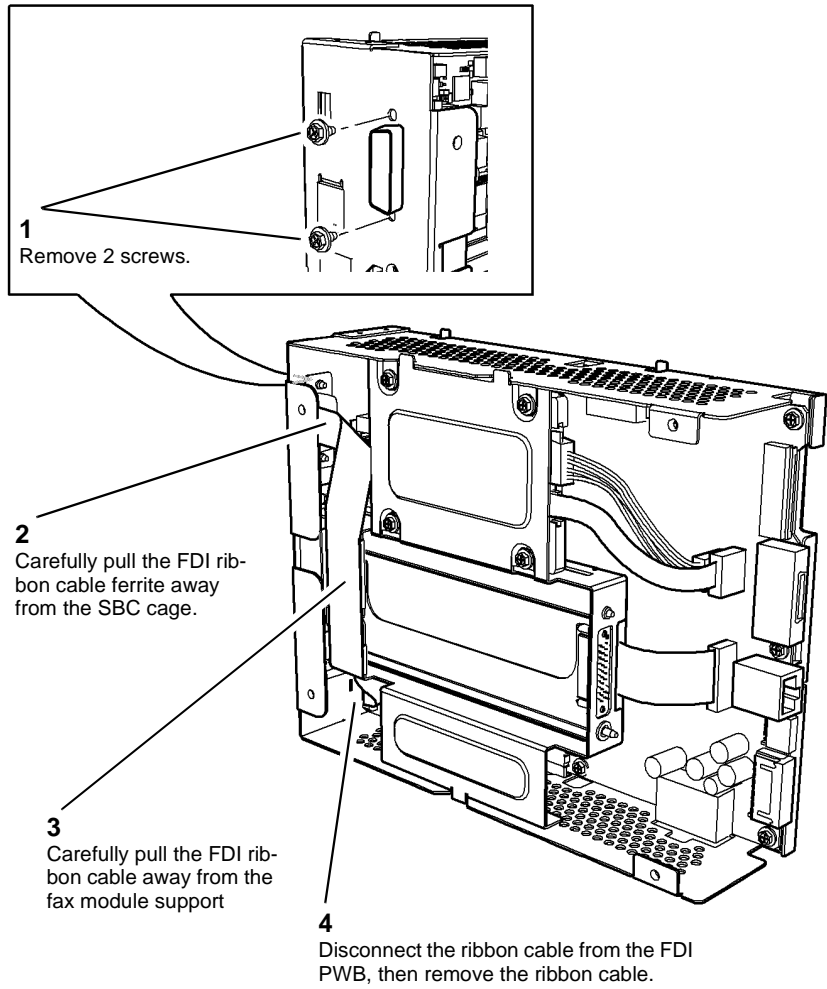
1. Remove the rear cover, [REP 28.2](#).
2. Remove the SBC cover, [PL 3.22 Item 9](#).
3. Remove the FDI ribbon cable from the SBC cage, [Figure 2](#).

Figure 2 FDI ribbon cable

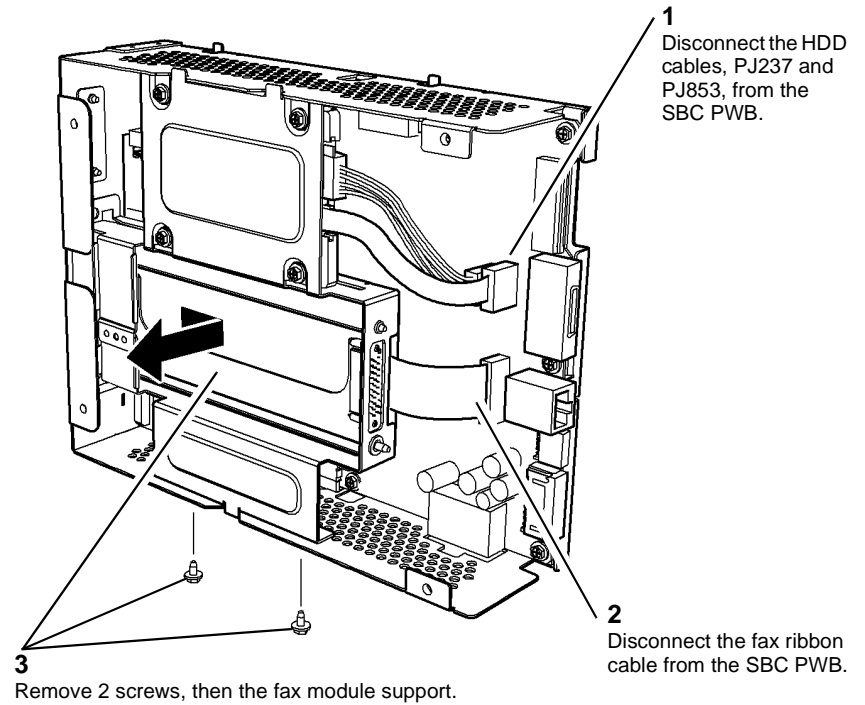
- Remove the fax module support, [Figure 3](#).

Figure 3 Fax module support removal

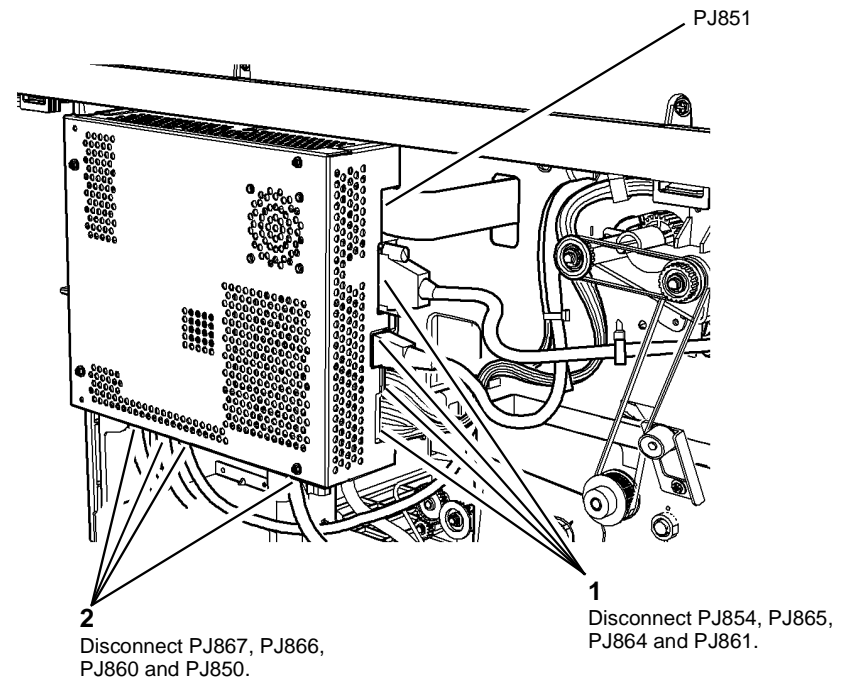
Figure 2 Preparation

3. Prepare to remove the SBC module, [Figure 2](#).

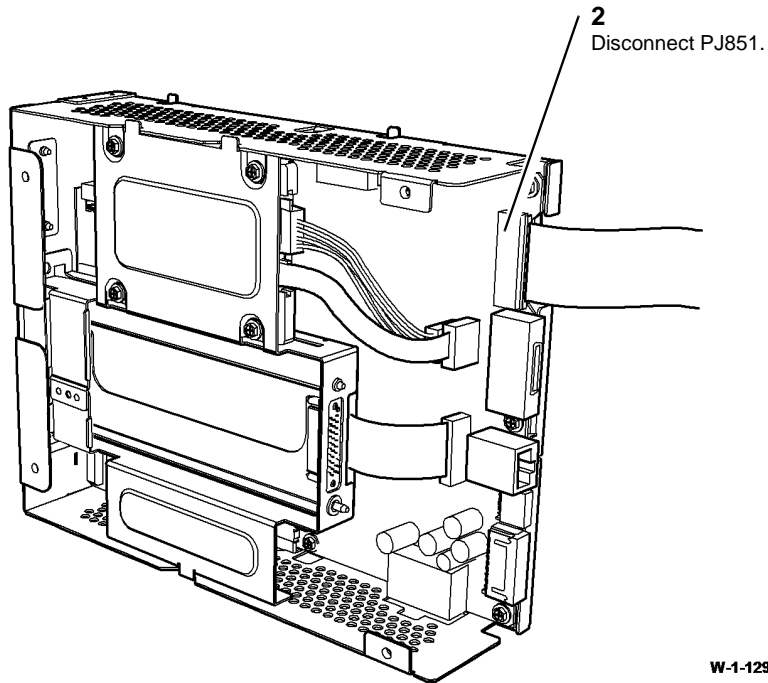
Figure 3 Disconnect PJ851

Disconnect PJ851 by carefully releasing the clamp. The cable clamp is very fragile and only needs to be moved slightly to release the ribbon cable.

5. Disconnect PJ851, Figure 3.

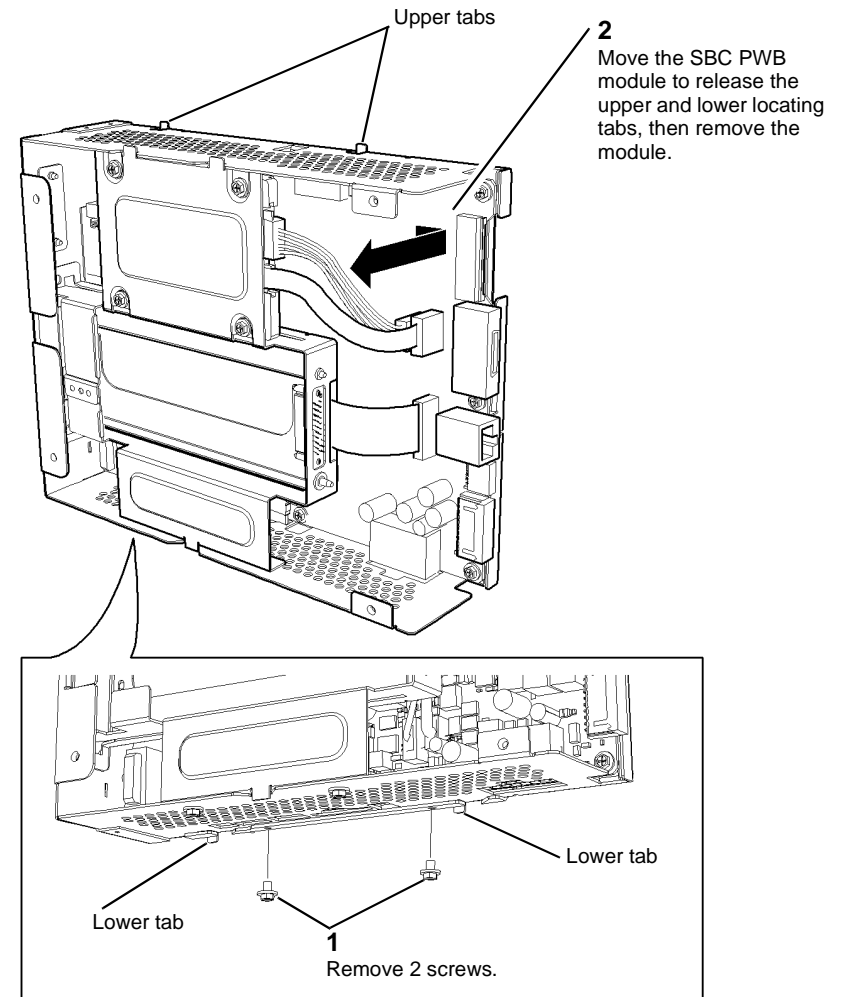
Figure 4 Removal

6. Remove the SBC PWB module, Figure 4.

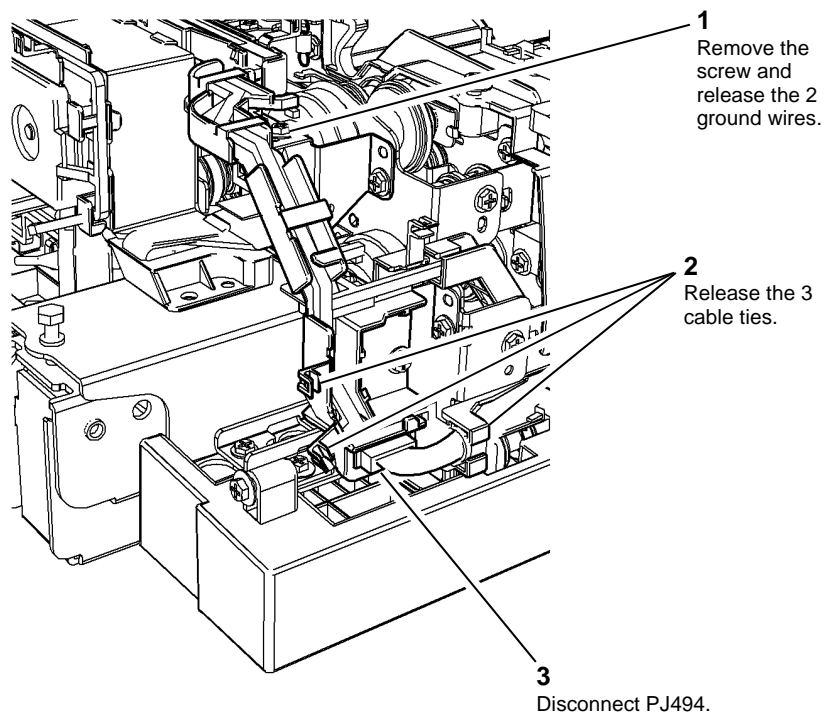
Figure 1 Preparation

1. Open the SPDH top cover assembly, [PL 5.20 Item 15](#).
2. Remove 5 screws then remove the rear cover, [PL 5.10 Item 1](#).
3. Prepare to remove the top cover assembly, [Figure 1](#).

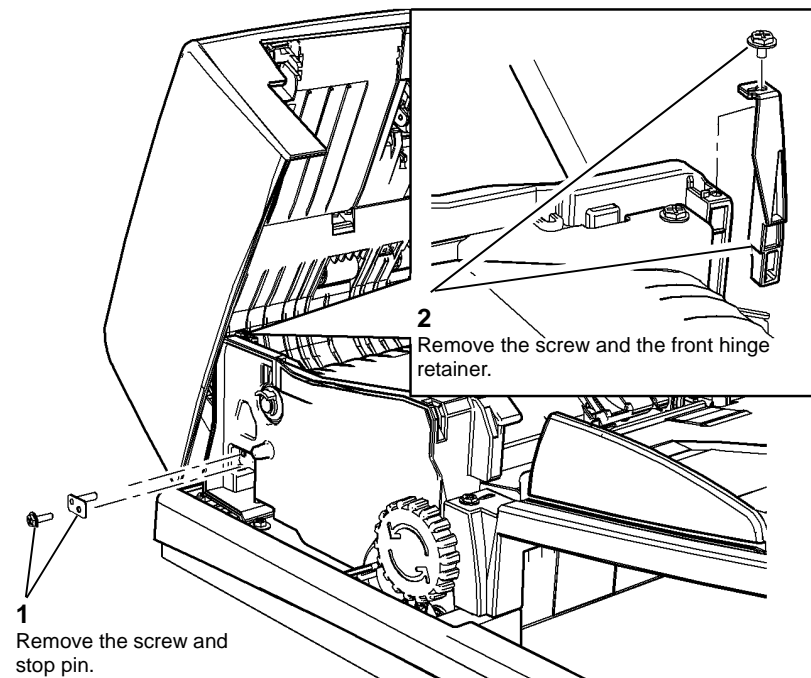
Figure 2 Front hinge release

4. Release the front hinge, [Figure 2](#).

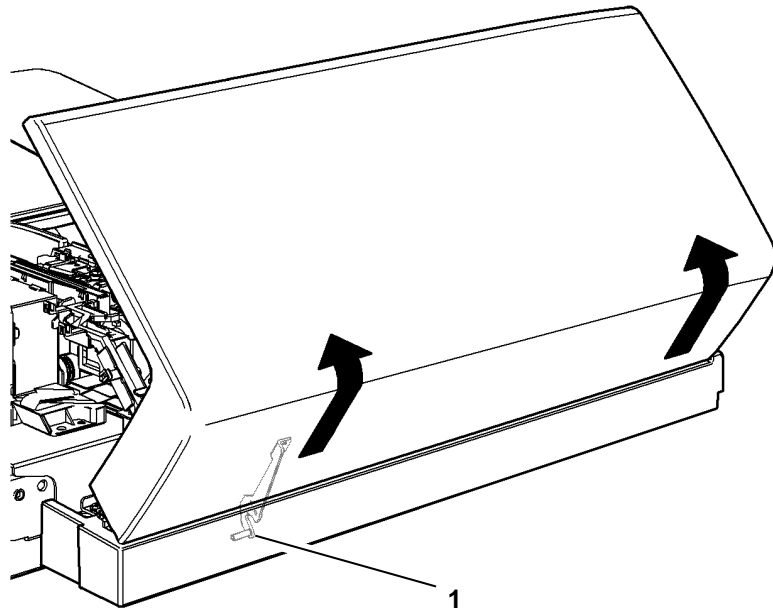
- Remove the top cover assembly, [Figure 3](#).

- Turn the top cover assembly to release the rear hinge.

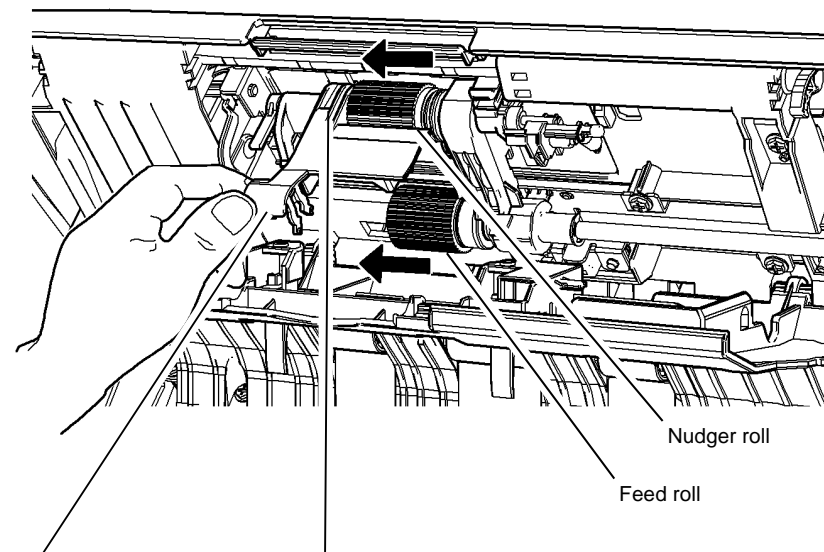
- Open the SPDH top cover assembly, [PL 5.20](#) Item 15.
- Pull open the lower cover [PL 5.20](#) Item 13.
- Remove the feed and nudger rolls, [Figure 1](#).

- Unclip the bottom fixing of the roll housing.
- Unclip the top fixing of the roll housing then remove the housing.
- Slide off the nudger roll and feed roll.

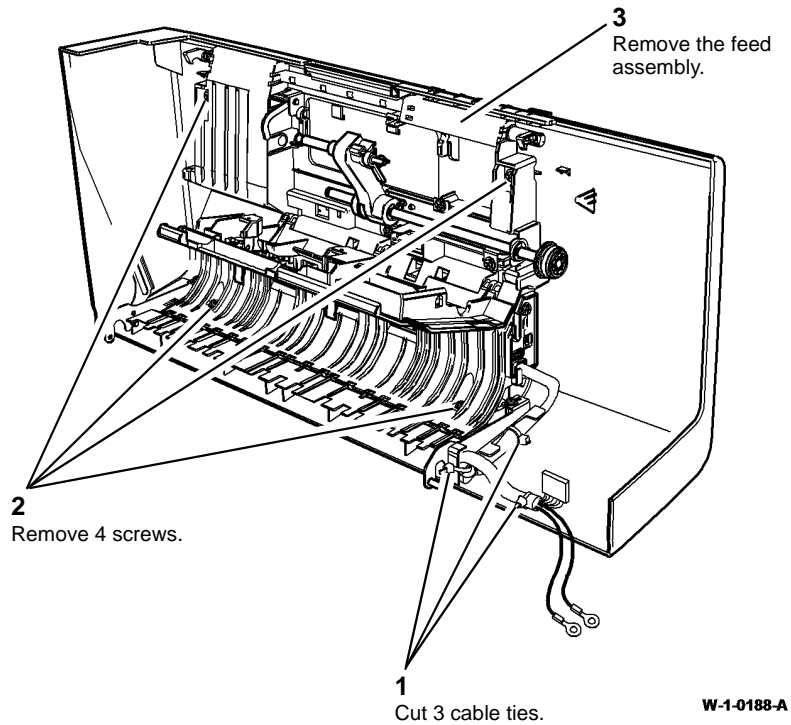
Figure 2 Feed assembly removal

- Remove the feed assembly, [Figure 2](#).

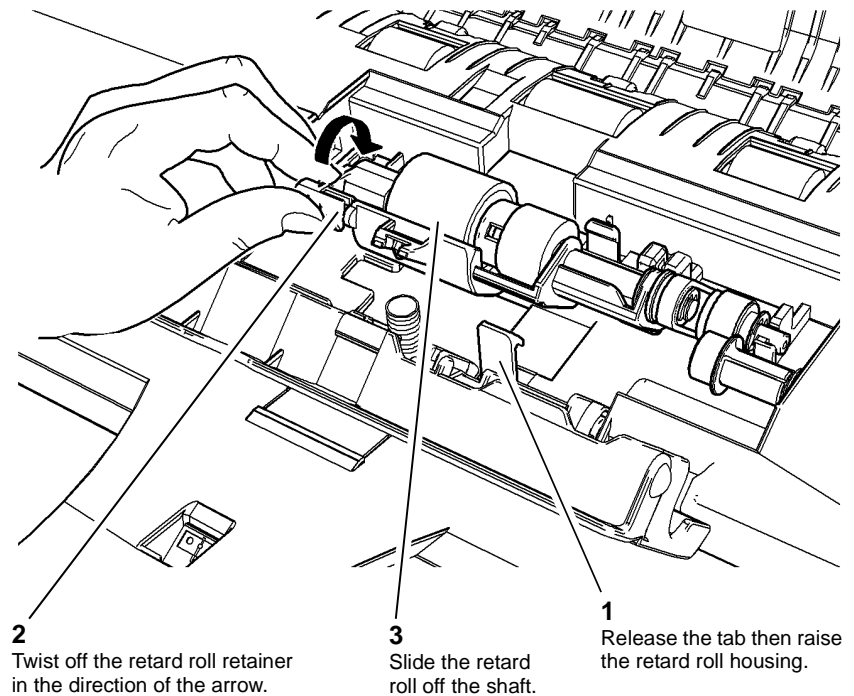
Figure 1 Retard roll removal

- Open the SPDH top cover assembly, [PL 5.20 Item 15](#).
- Pull open the retard roll cover, [PL 5.25 Item 2](#).
- Remove the retard roll, [Figure 1](#).

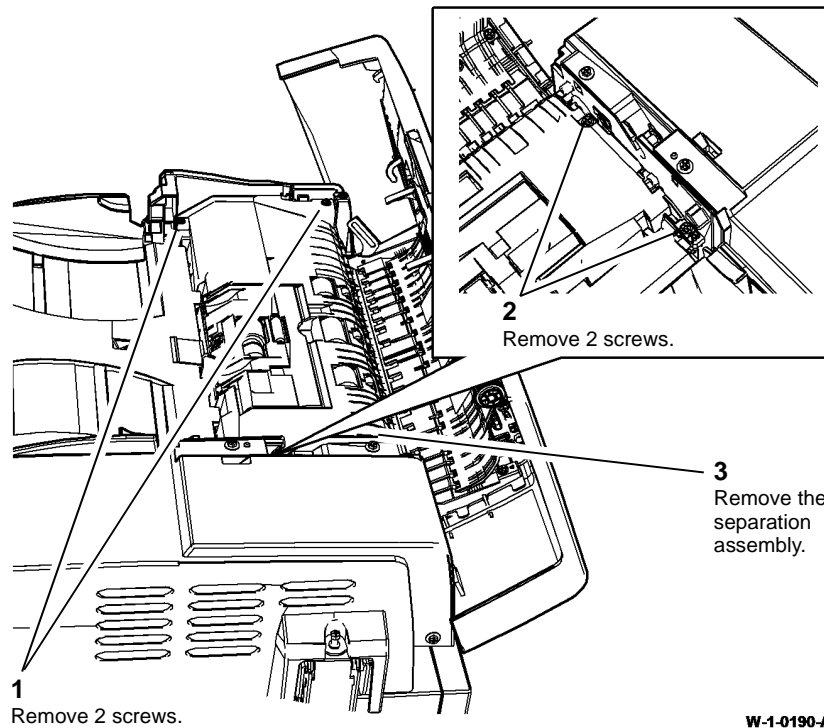
Figure 2 Separation assembly removal

4. Remove the separation assembly, [Figure 2](#).

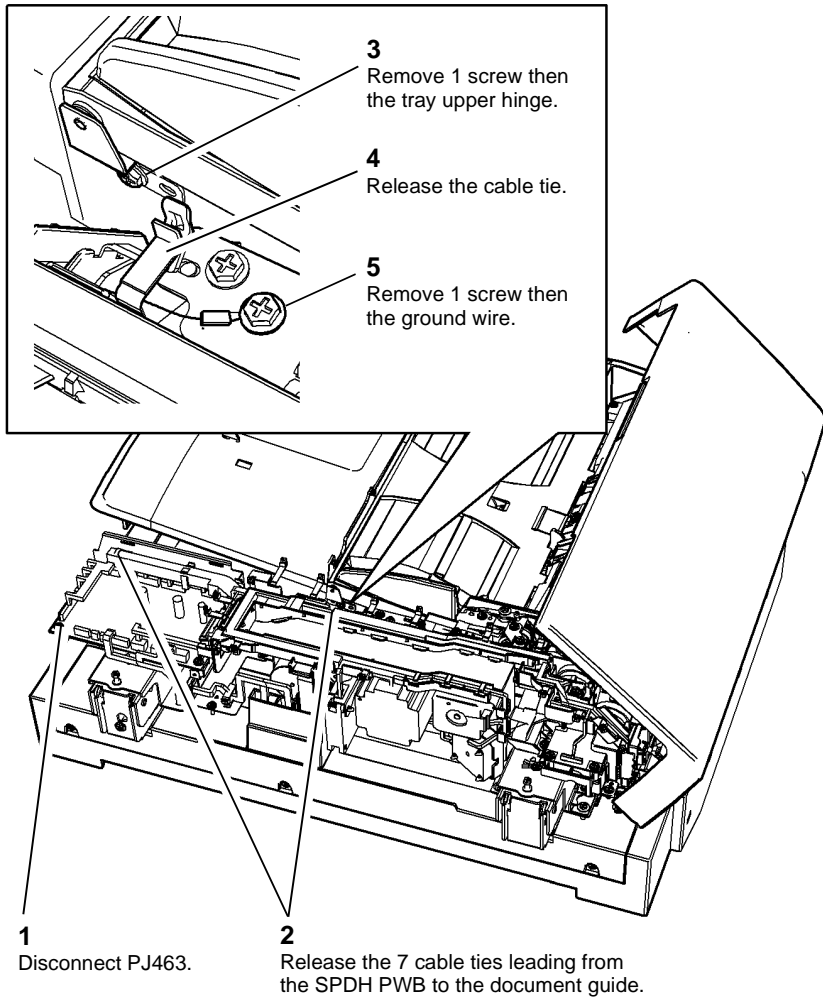
Figure 1 Preparation

1. Remove 5 screws then remove the rear cover, [PL 5.10 Item 1](#).
2. Prepare to remove the input tray upper assembly, [Figure 1](#).

NOTE: Machines W/OTAG D-003 will have two ground wires.

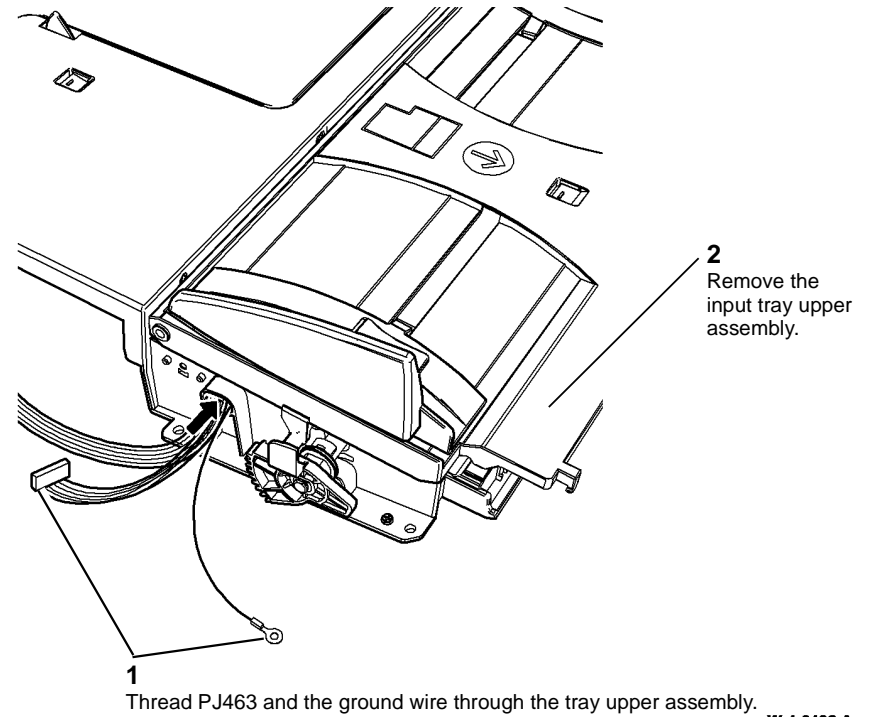
Figure 2 Upper assembly removal

3. Remove the input tray upper assembly, **Figure 2**.

NOTE: Machines W/OTAG D-003 will have two ground wires.

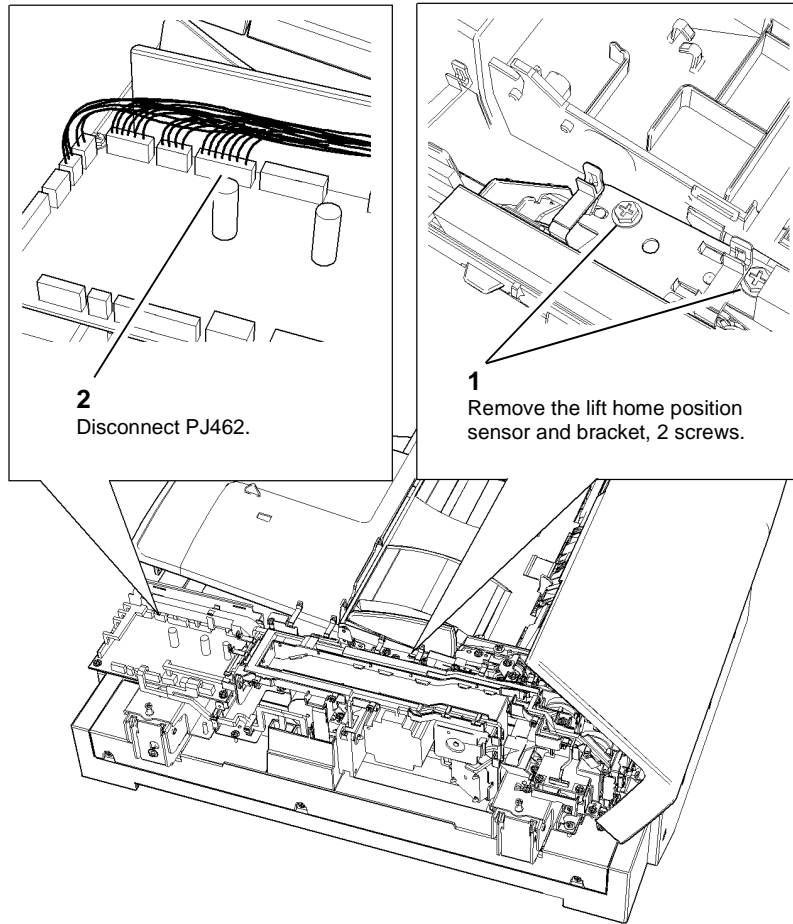
Figure 3 Preparation

4. Prepare to remove the input tray lower assembly, [Figure 3](#).

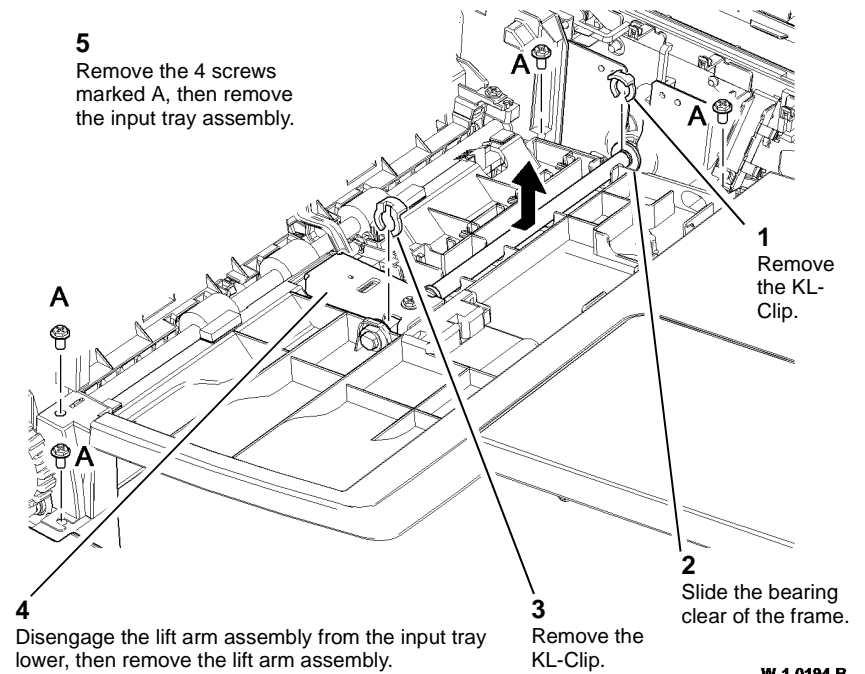
Figure 4 Input tray lower removal

5. Remove the input tray lower assembly, [Figure 4](#).

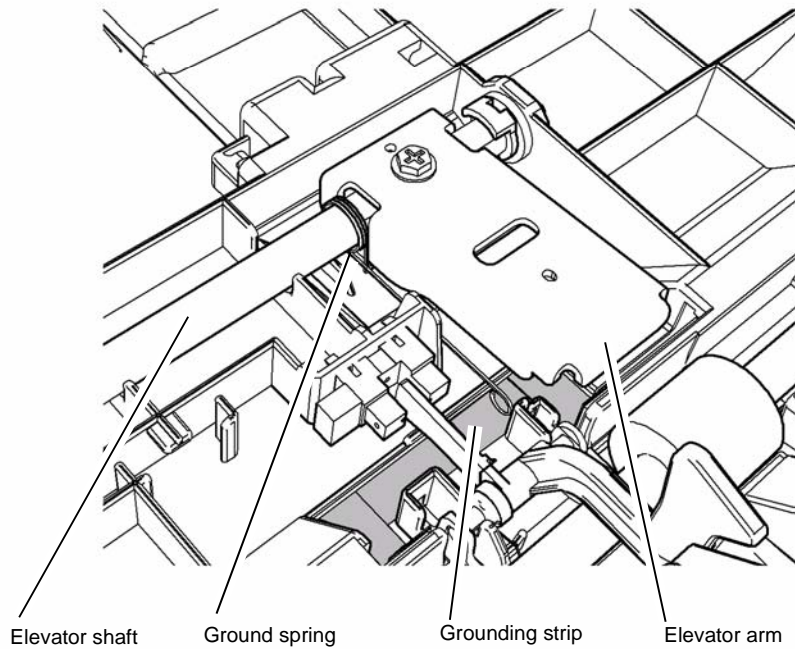
Figure 5 Ground spring position

2. Ensure that the ground spring is correctly positioned on the elevator shaft and under the elevator arm, [Figure 5](#).

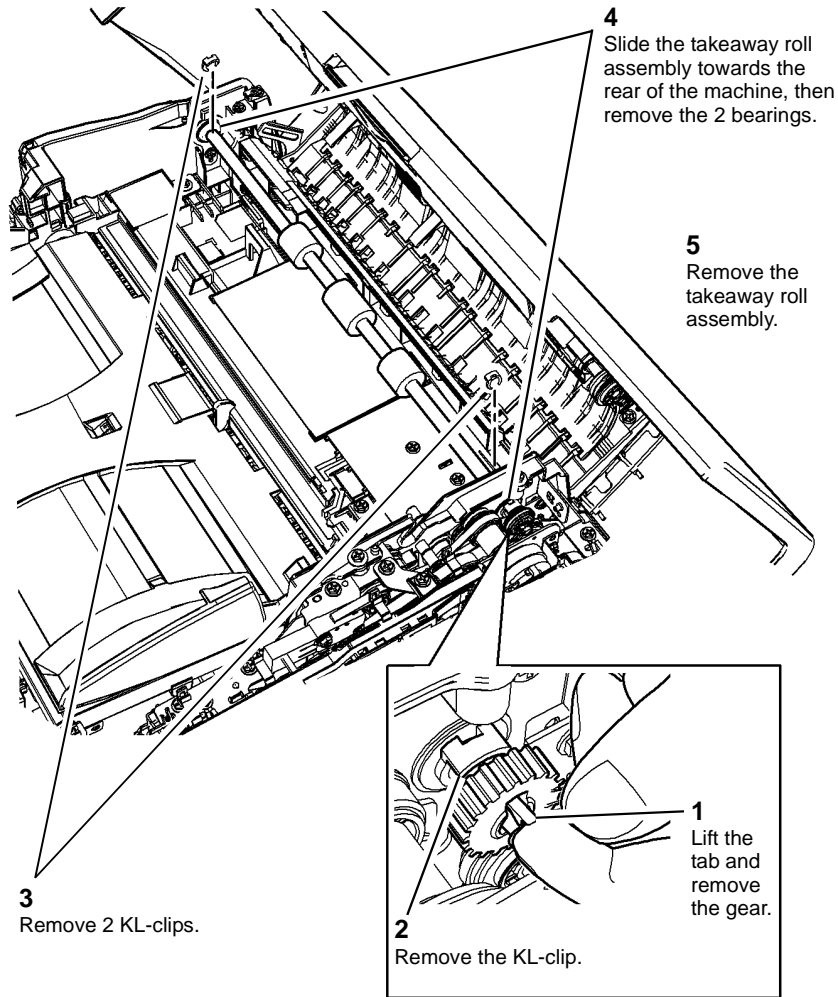
Figure 1 Takeaway roll removal

3. Remove the takeaway roll assembly, [Figure 1](#).

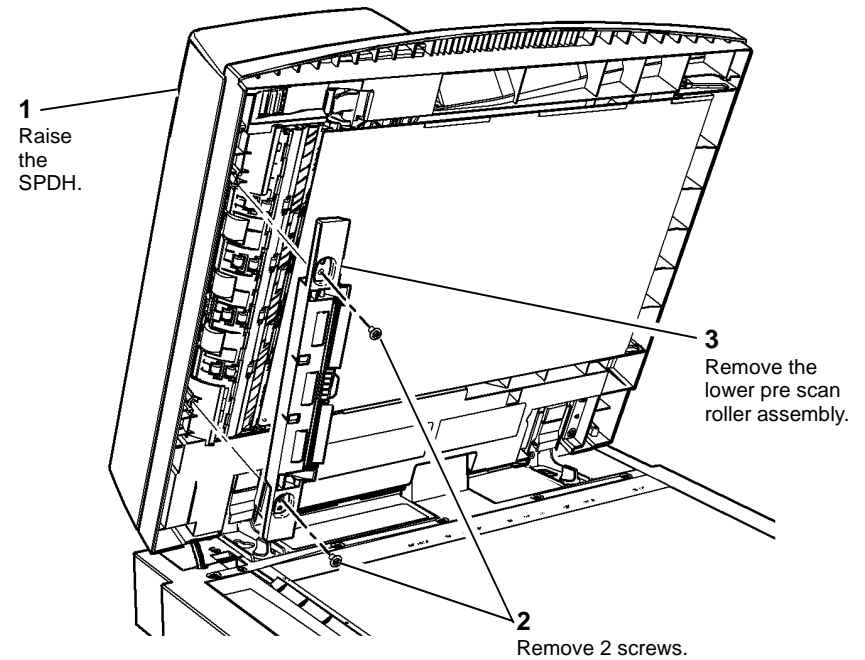
Figure 1 Lower Pre scan roller assembly

Handle the lower pre scan assembly with care. The lower pre scan assembly is loosely assembled and contains 2 springs under compression. The assembly can spring apart on removal.

1. Remove the lower pre scan roller assembly, [Figure 1](#).

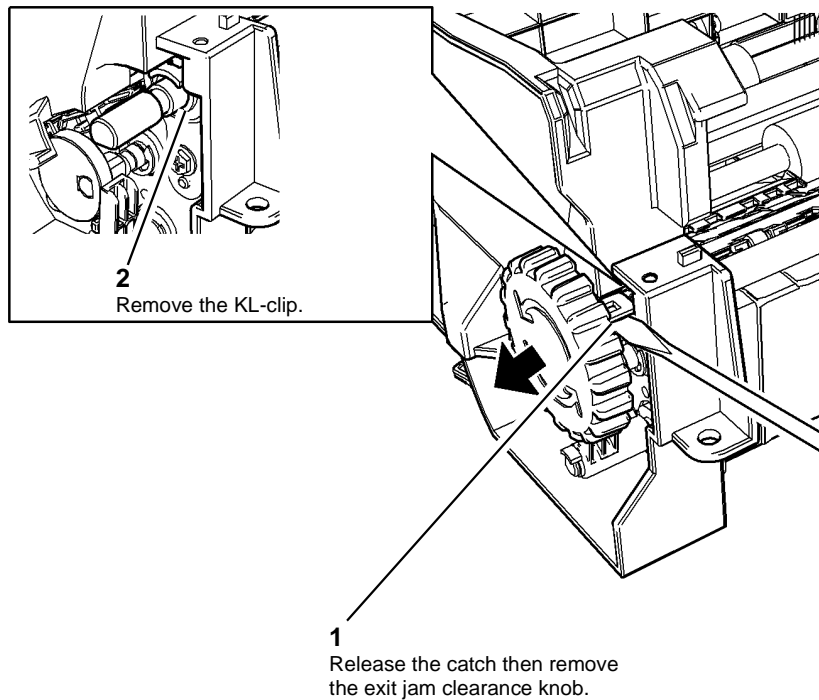
Figure 1 Front components removal

1. Remove the SPDH read assembly outer frame, by performing [REP 5.25](#) up to step 2.
2. Remove the front components, [Figure 1](#).
