708P91139
February 2016

Xerox® WorkCentre® 5945 Family Multifunction Printer Service Manual

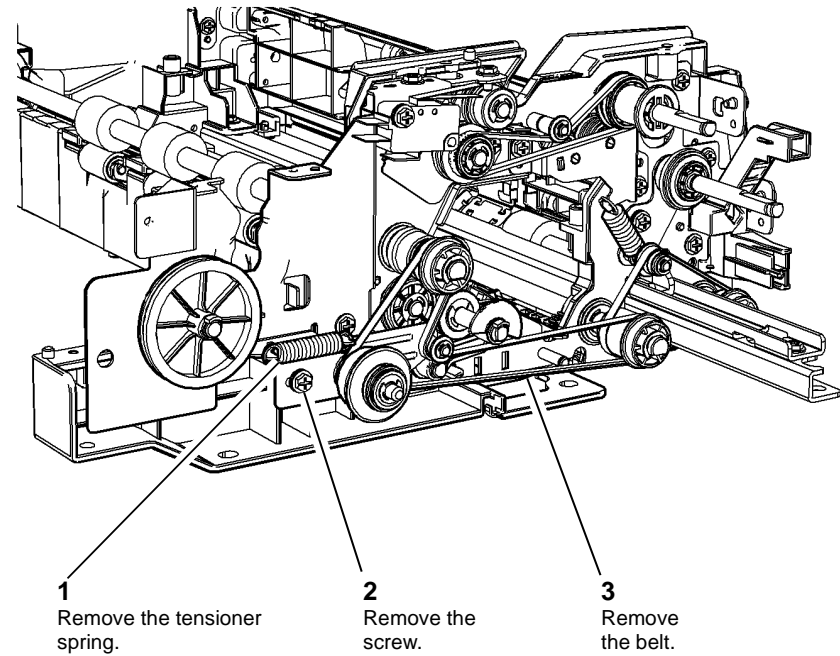
Figure 2 Preparation

3. Prepare to remove the exit roll assembly, [Figure 2](#).

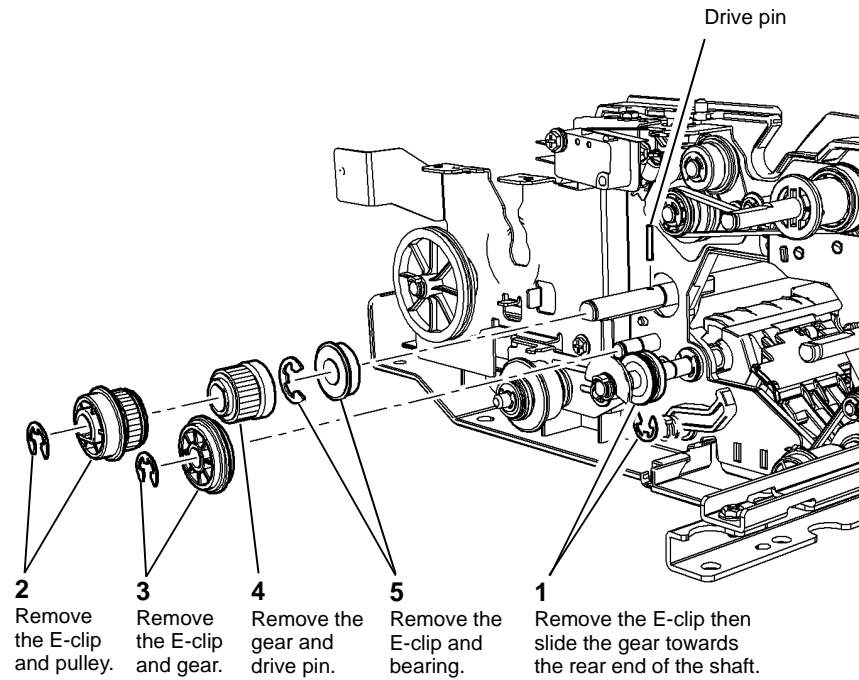
Figure 3 Rear components removal

4. Remove the rear components, [Figure 3](#).

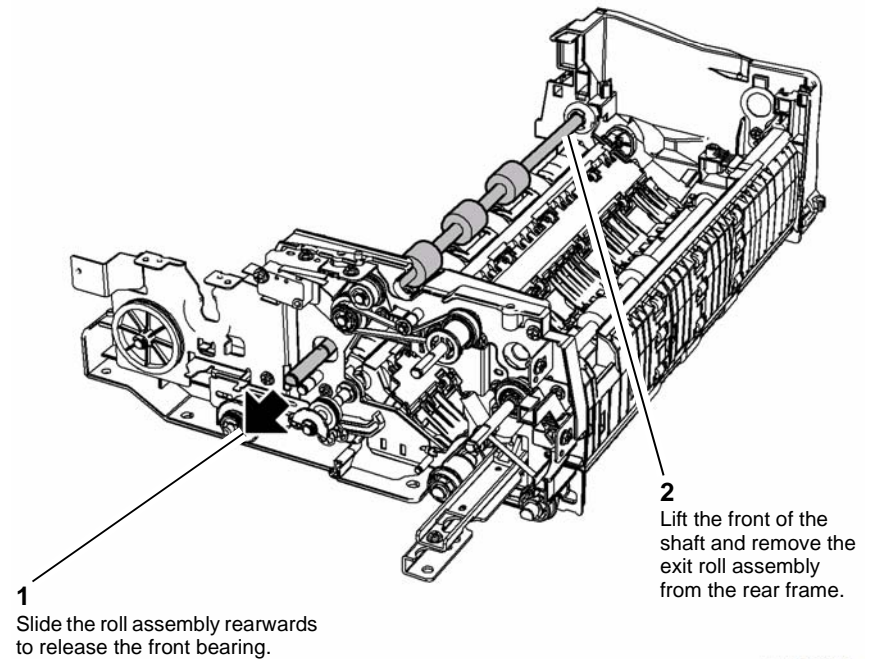
Figure 4 Exit roll assembly removal

5. Remove the exit roll assembly, [Figure 4](#).

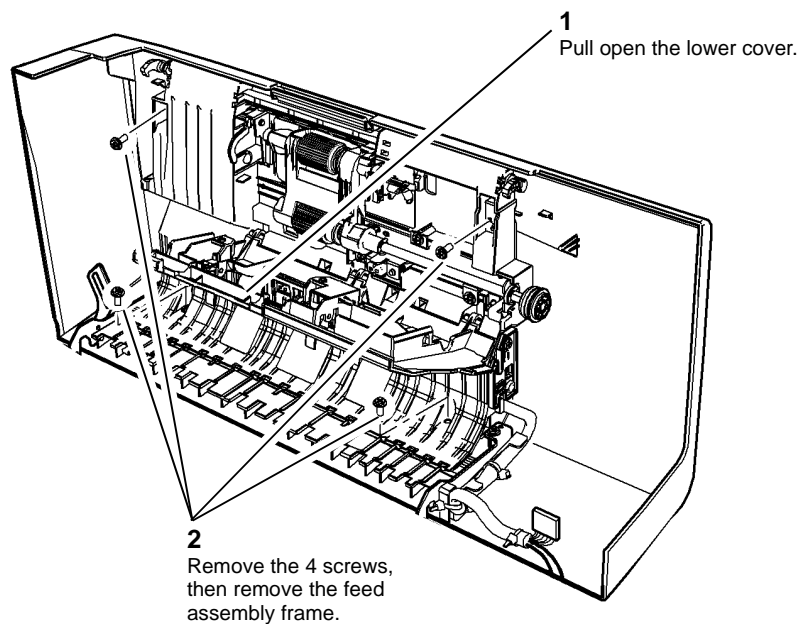
Figure 1 Frame removal

1. Open the SPDH top cover assembly, [PL 5.20 Item 1](#).
2. Remove the feed assembly frame, [Figure 1](#).

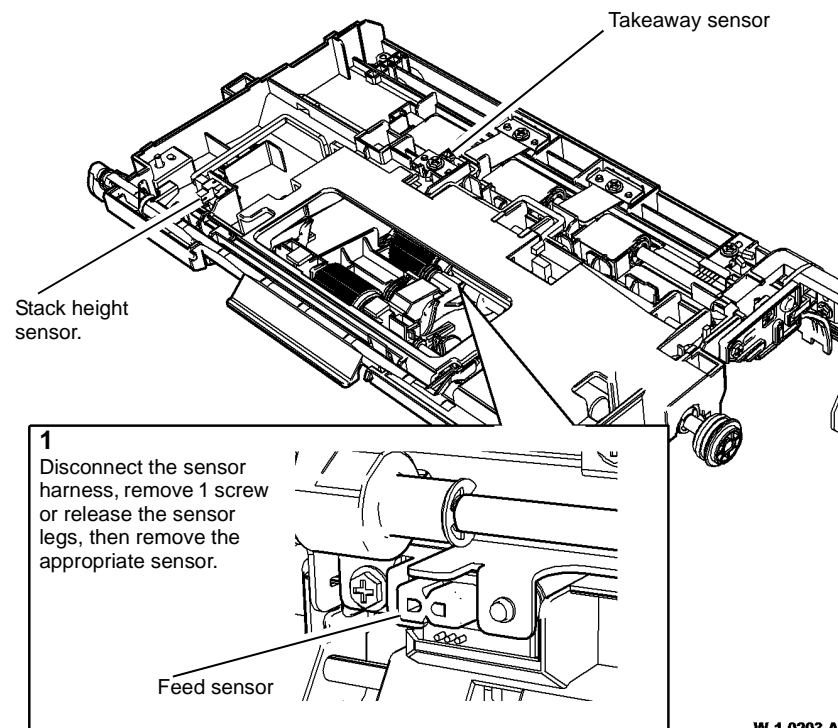
Figure 2 Sensor removal

3. Remove the appropriate sensor, [Figure 2](#).

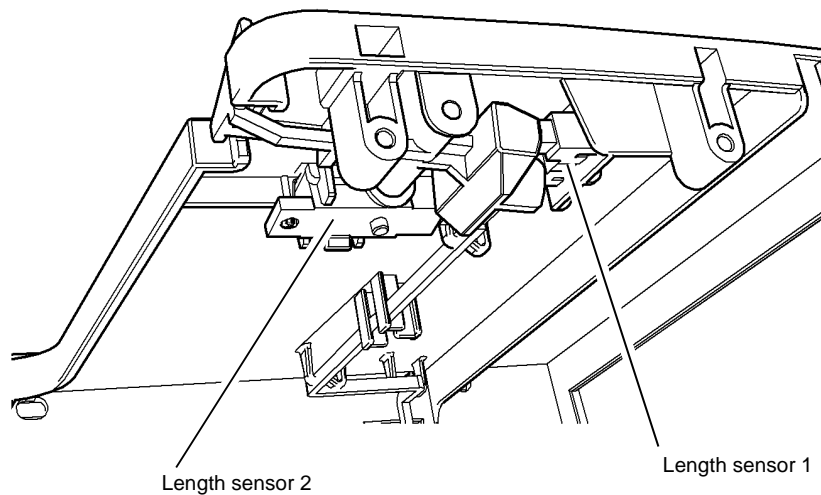
Disconnect the PJ, then remove the appropriate sensor.

NOTE: Removal of the sensor flag will improve access to length sensor 1.

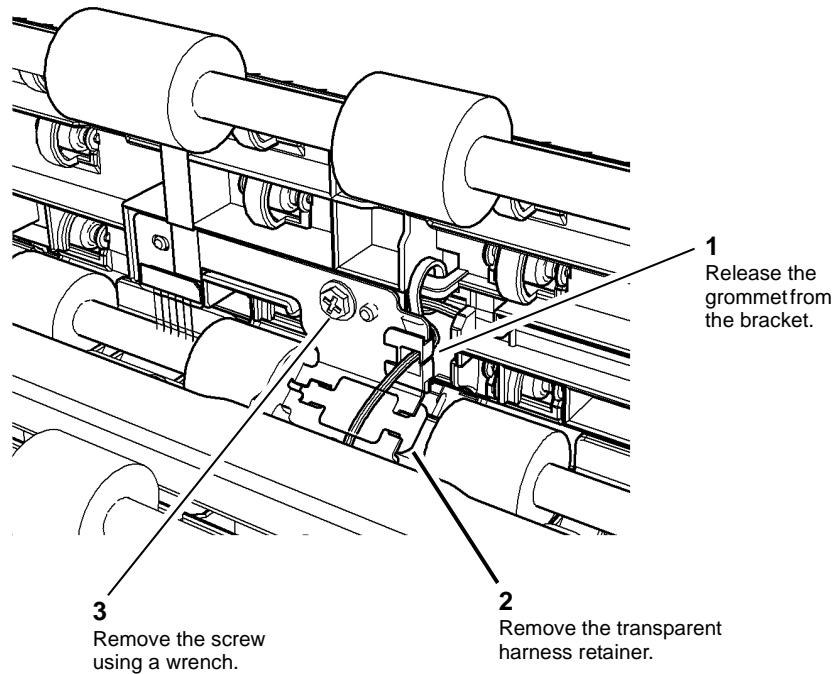
Figure 1 Preparation

1. Remove the side 2 scan assembly, [REP 60.6](#).
2. Prepare to remove the SPDH reg sensor, [Figure 1](#).

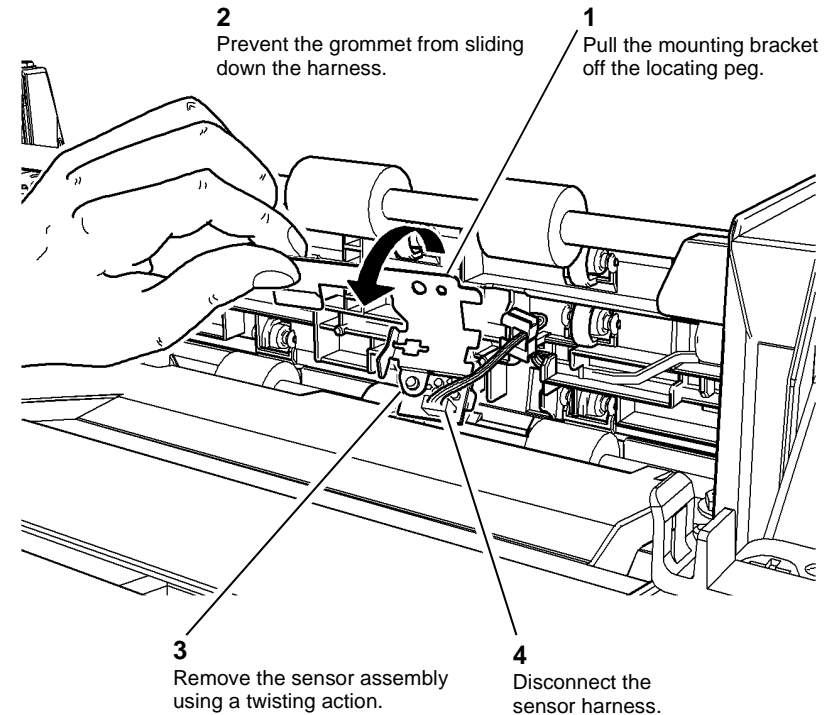
Figure 2 Sensor assembly removal

3. Remove the SPDH reg sensor and bracket assembly, [Figure 2](#).

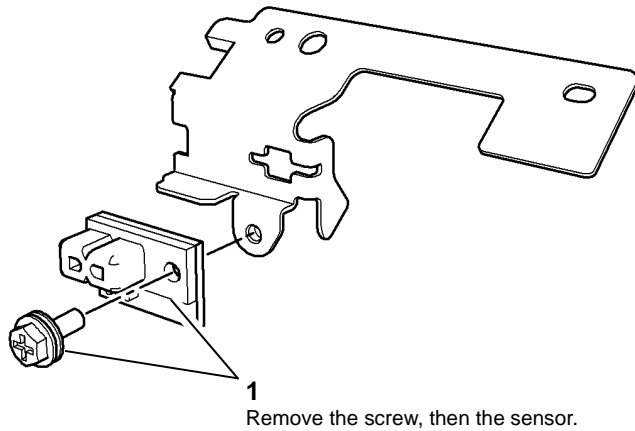
Figure 3 Sensor removal

4. Remove the sensor from the bracket, [Figure 3](#).

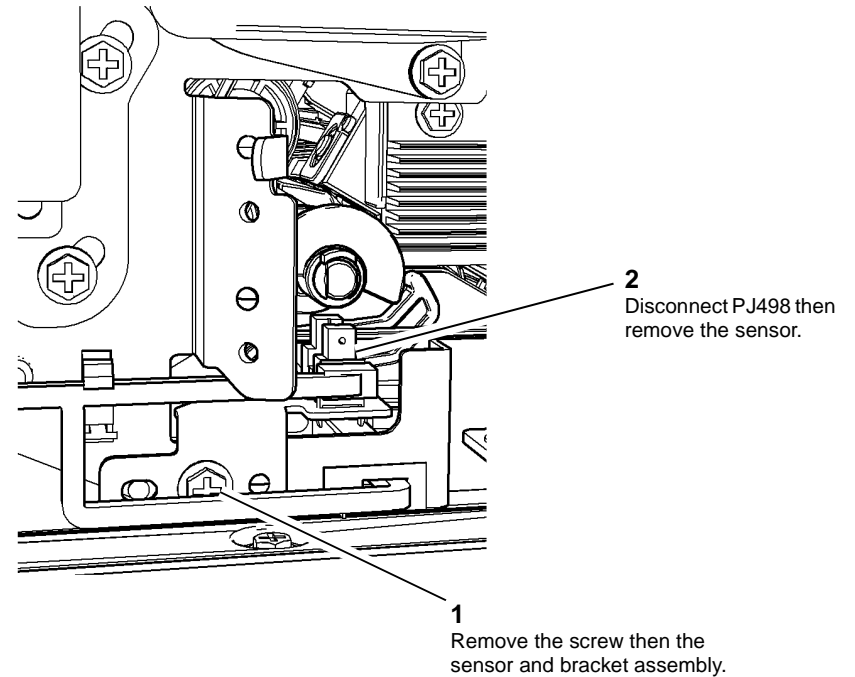
Figure 1 Sensor removal

1. Remove the LED cooling fan, [REP 5.21](#).
2. If necessary rotate the exit jam clearance knob, [PL 5.17 Item 5](#), so that the flag is not within the gap of the sensor.
3. Remove the calibration home position sensor, [Figure 1](#).

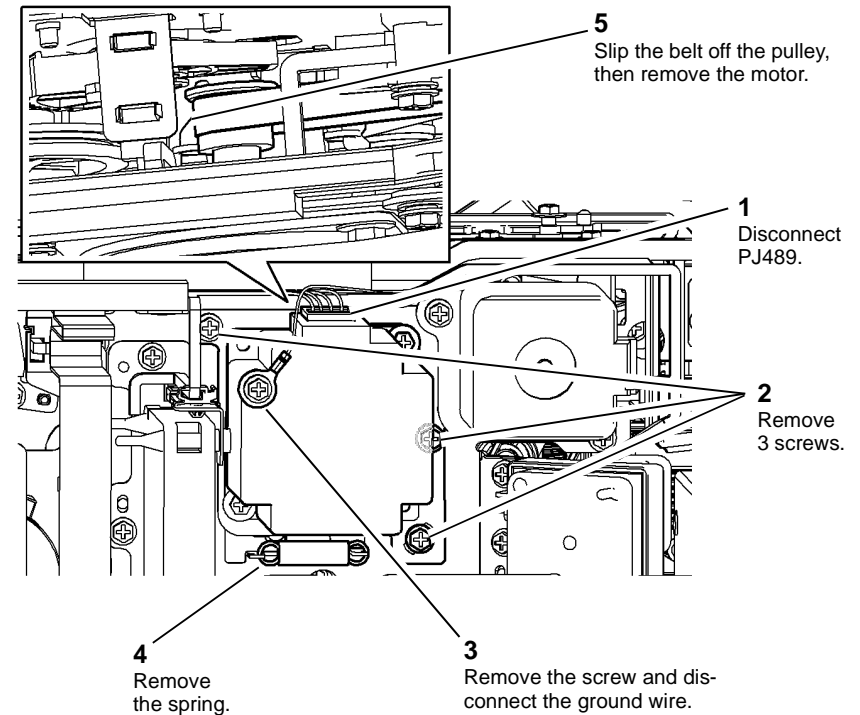
Figure 1 Feed motor removal

2. Remove the feed motor, [Figure 1](#).

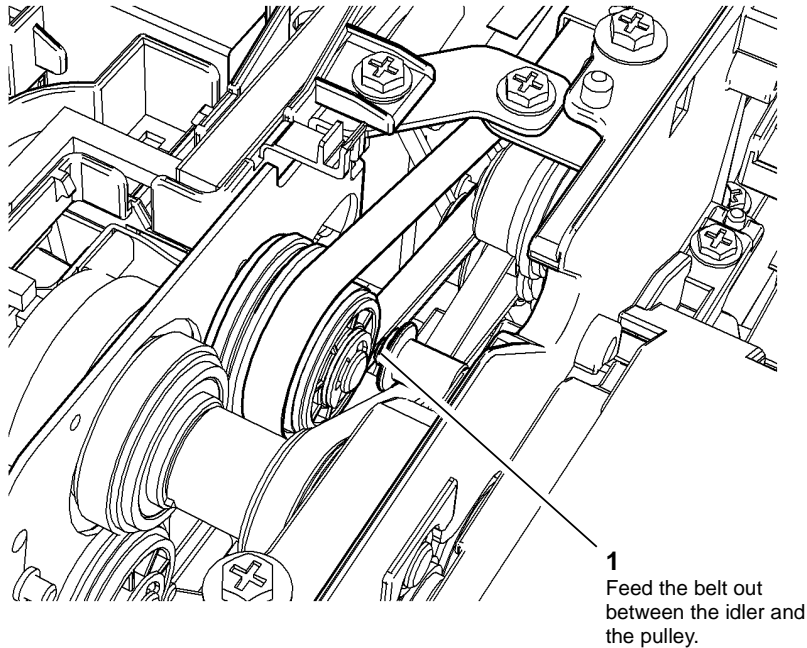
Figure 2 Feed motor belt removal

3. Remove the feed motor belt, [Figure 2](#).

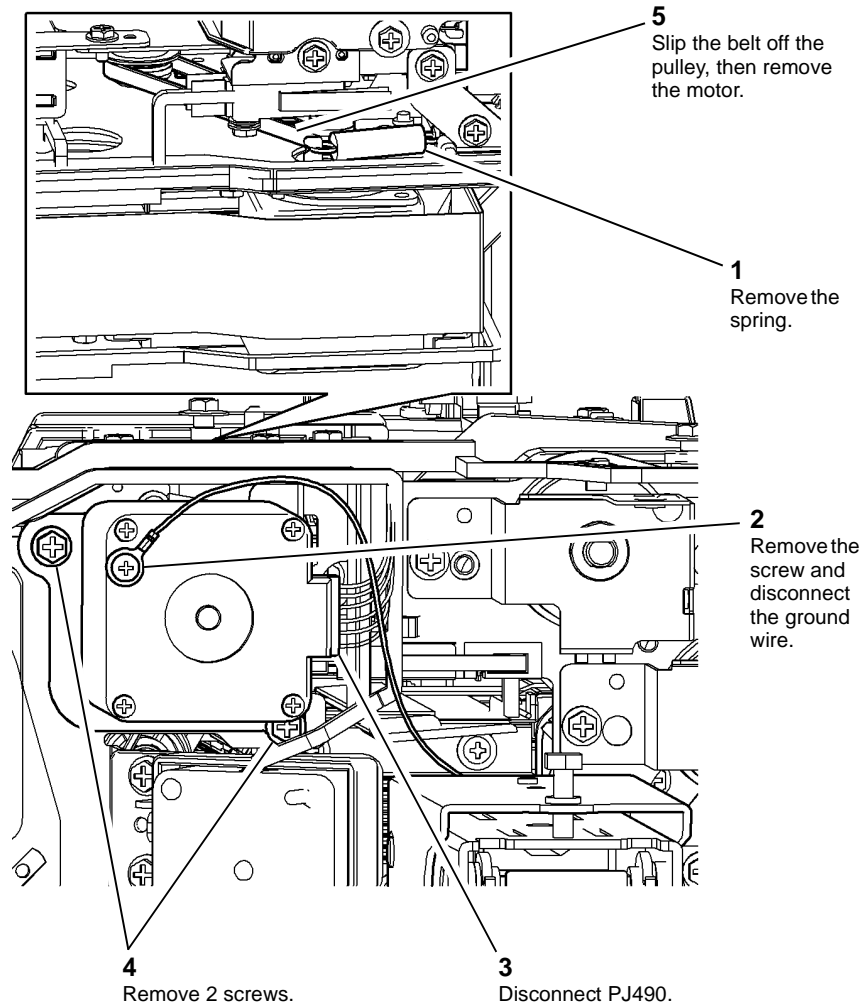
Figure 1 Read motor removal

1. Position the motor in the loop of the drive belt.
2. Insert but do not tighten the 2 screws.
3. Attach the spring to correctly tension the drive belt, then tighten the 2 screws.
4. The remainder of the replacement is the reverse of the removal procedure.

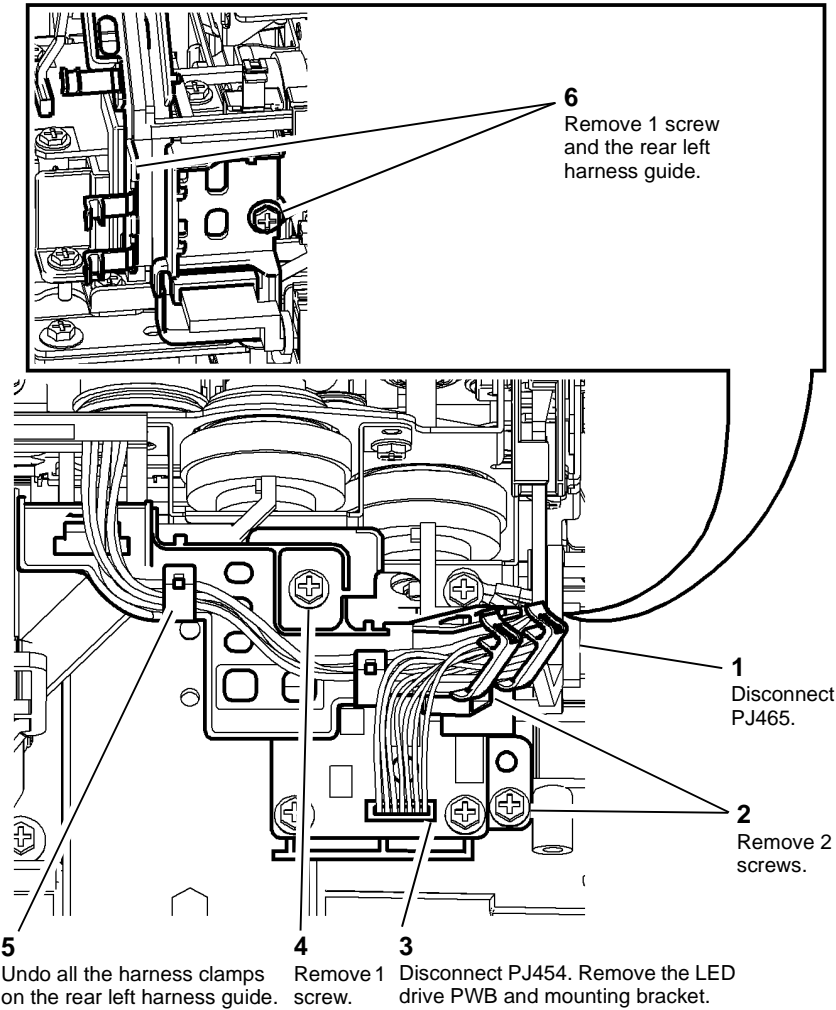
Figure 1 Preparation

3. Prepare to remove the feed clutch, **Figure 1**.

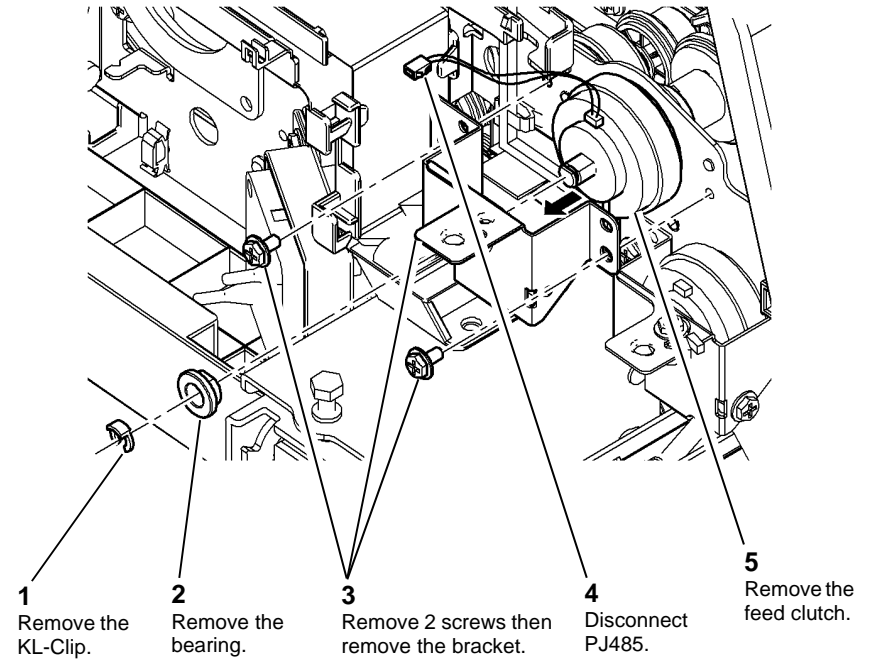
Figure 2 Feed clutch removal

4. Remove the feed clutch, **Figure 2**.

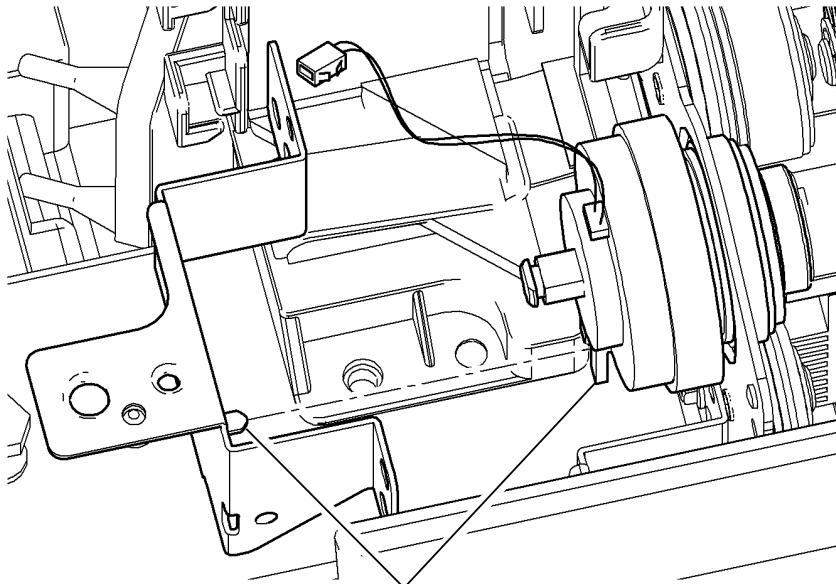
1. The replacement is the reverse of the removal procedure.
2. Ensure the feed clutch engages correctly with the bracket, [Figure 3](#).

- 1**
Ensure the two-fingered moulding on the feed clutch engages with the peg of the bracket.

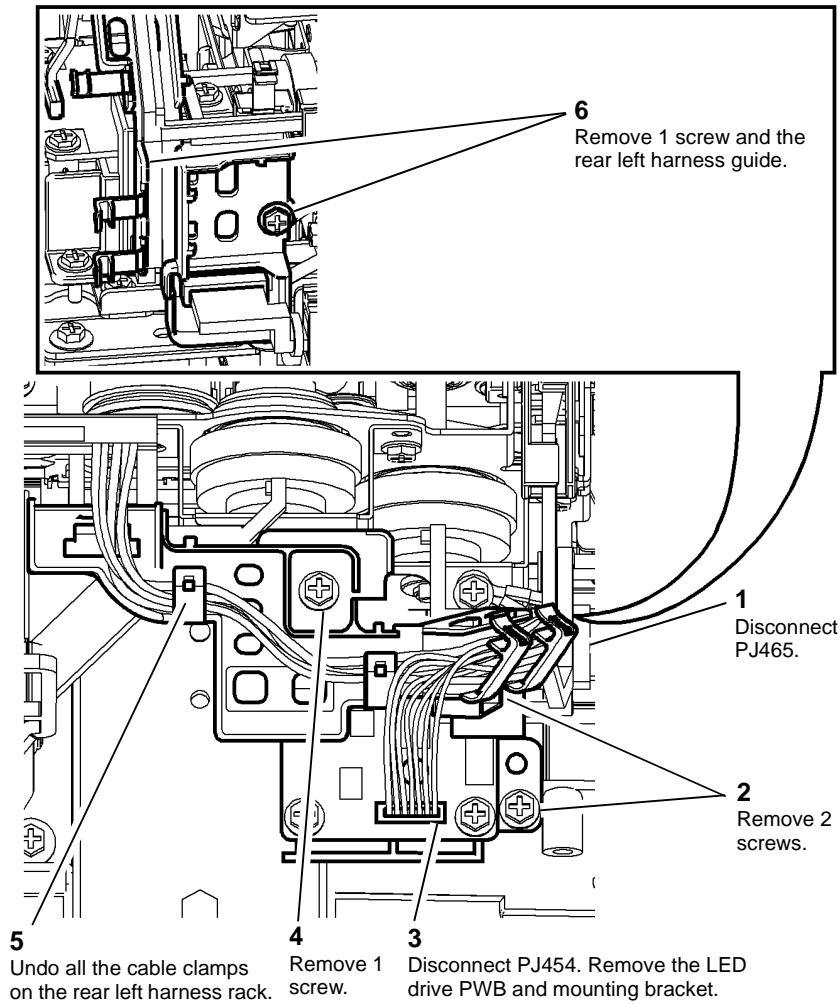
Figure 1 Preparation

3. Prepare to remove the takeaway clutch, **Figure 1**.

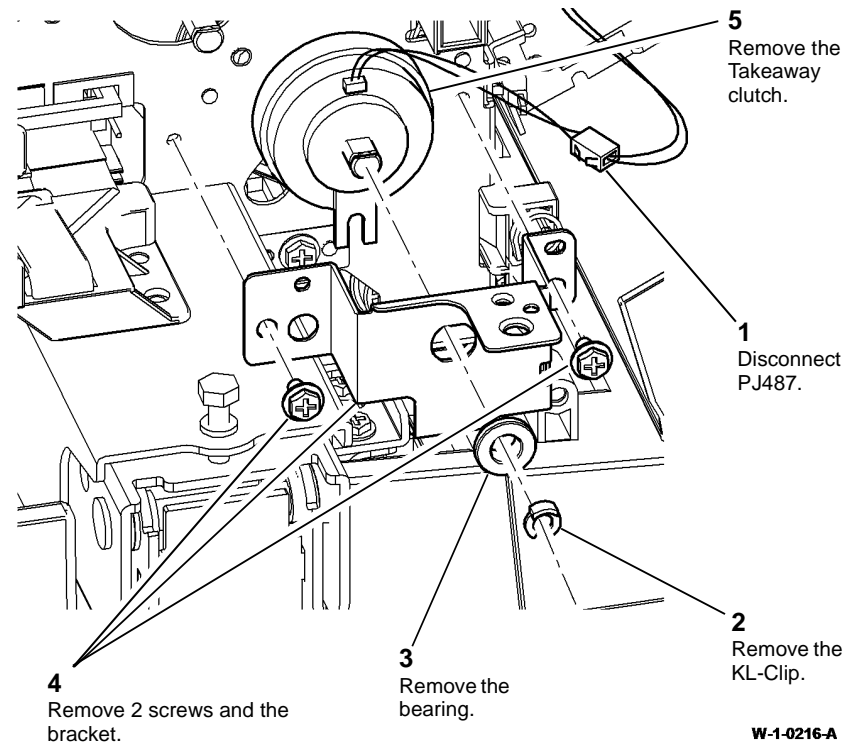
Figure 2 Takeaway clutch removal

4. Remove the Takeaway clutch, **Figure 2**.

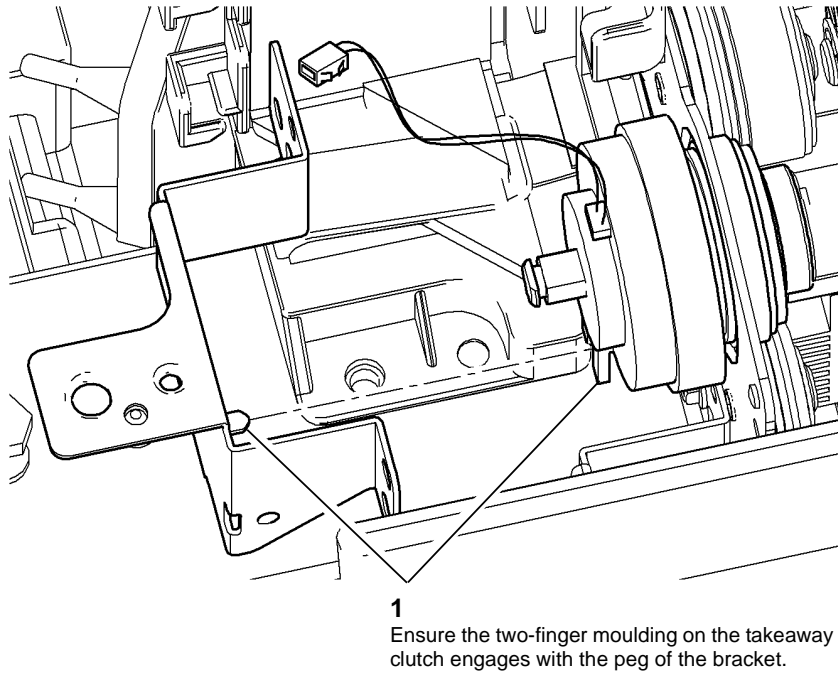
Figure 3 Clutch locator

1. The replacement is the reverse of the removal procedure.
2. Ensure the takeaway clutch engages correctly with the bracket, [Figure 3](#).

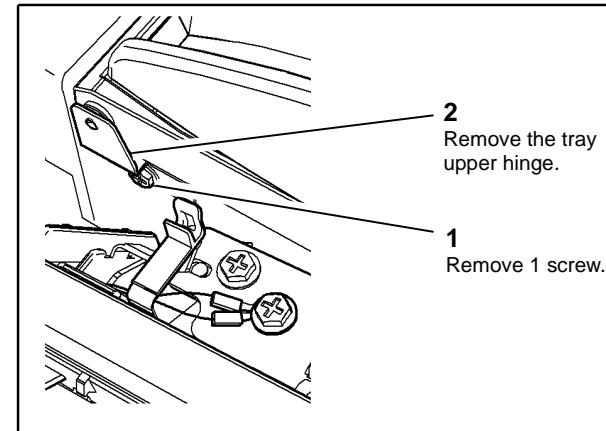
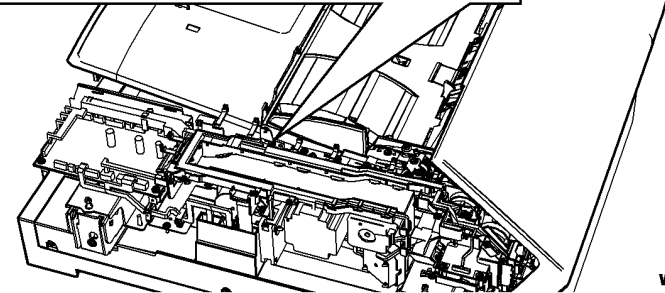
Figure 1 Hinge removal

1. Remove 5 screws then the rear cover, [PL 5.10 Item 1](#).
2. Remove the tray upper hinge, [Figure 1](#).

- 3
Lift up the tray upper assembly, taking care not to damage the sensor harnesses.

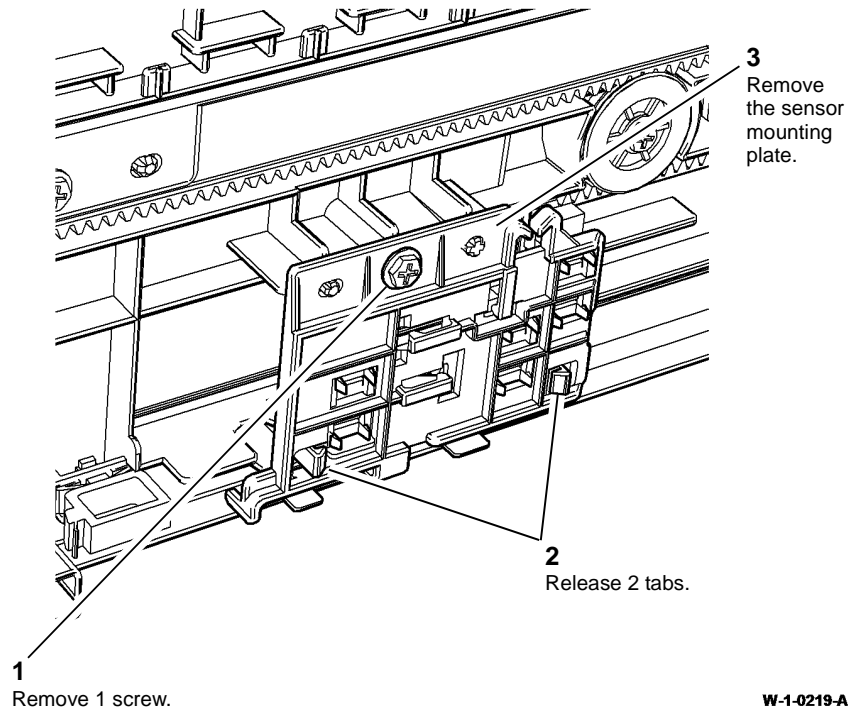
Figure 2 Mounting plate release

3. Release the sensor mounting plate, [Figure 2](#).

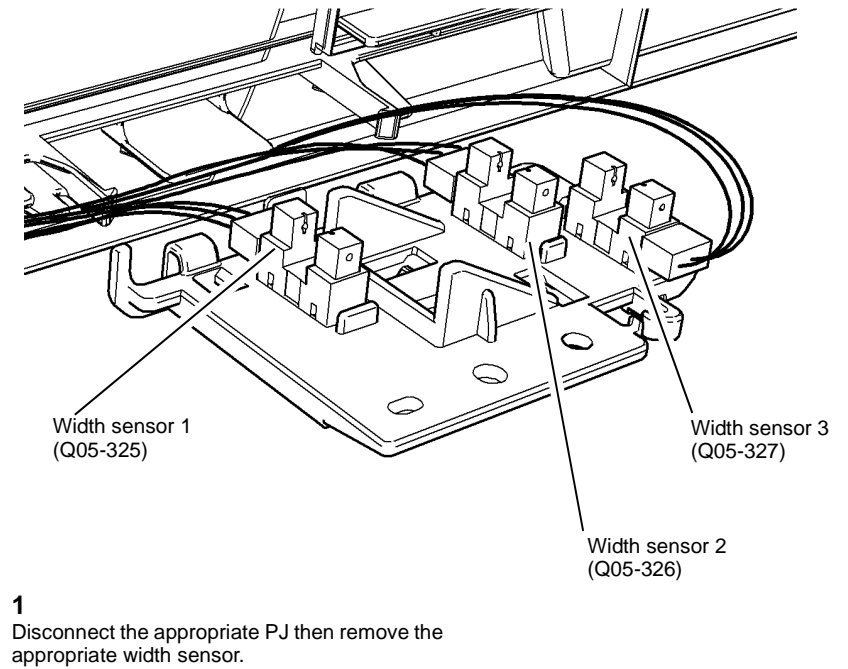
Figure 3 Width sensors removal

4. Remove the document width sensors, [Figure 3](#).

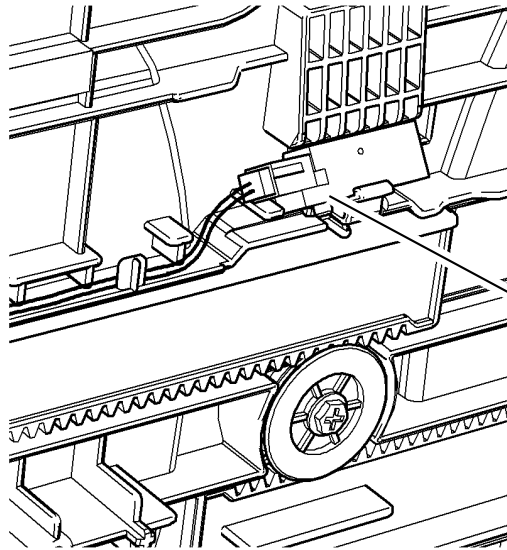
Figure 4 Last sheet out sensor removal

5. Remove the last sheet out sensor, [Figure 4](#).

1
Disconnect the PJ
then remove the last
sheet out sensor
(Q05-308).

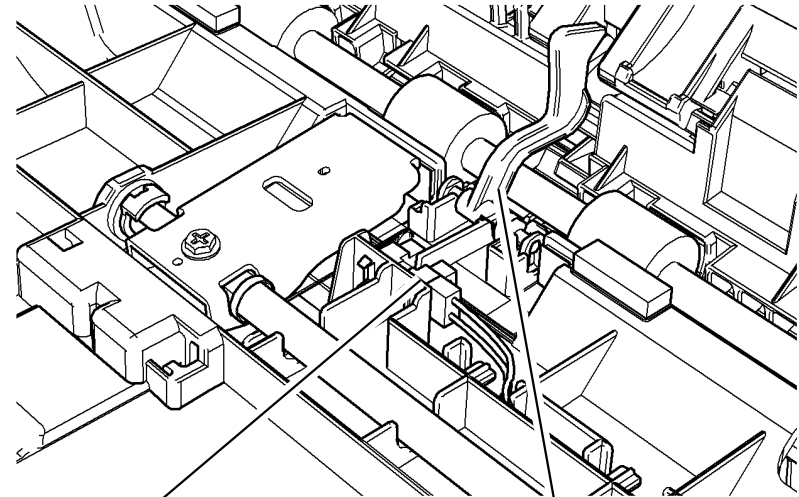
6. Remove the doc present sensor, [Figure 5](#).

1
Disconnect the PJ then remove
the doc present sensor (Q05-309).

2
If required, remove the doc
present sensor actuator.

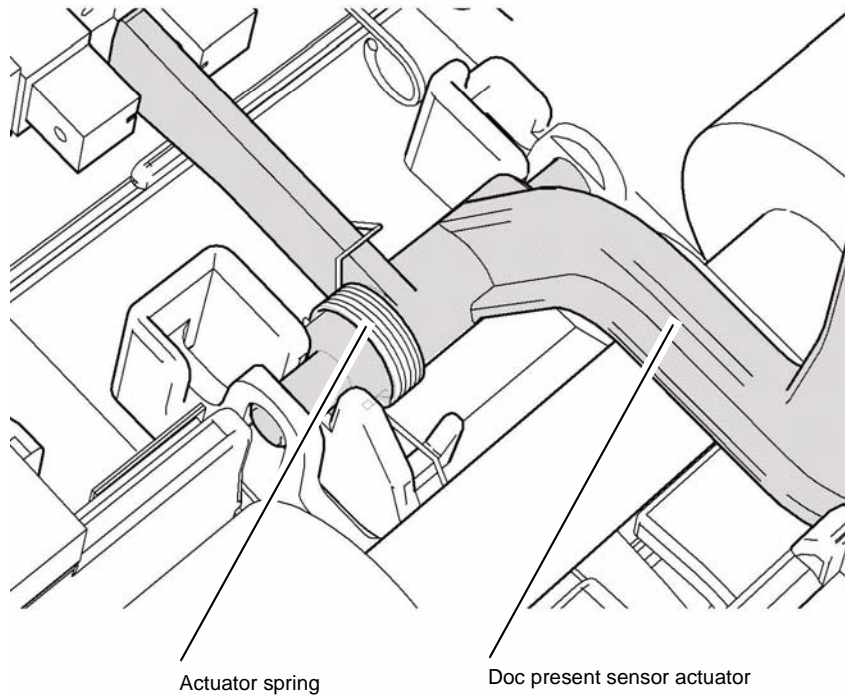
Figure 6 Spring position

1. The replacement is the reverse of the removal procedure.
2. Ensure the actuator spring is positioned correctly, [Figure 6](#).

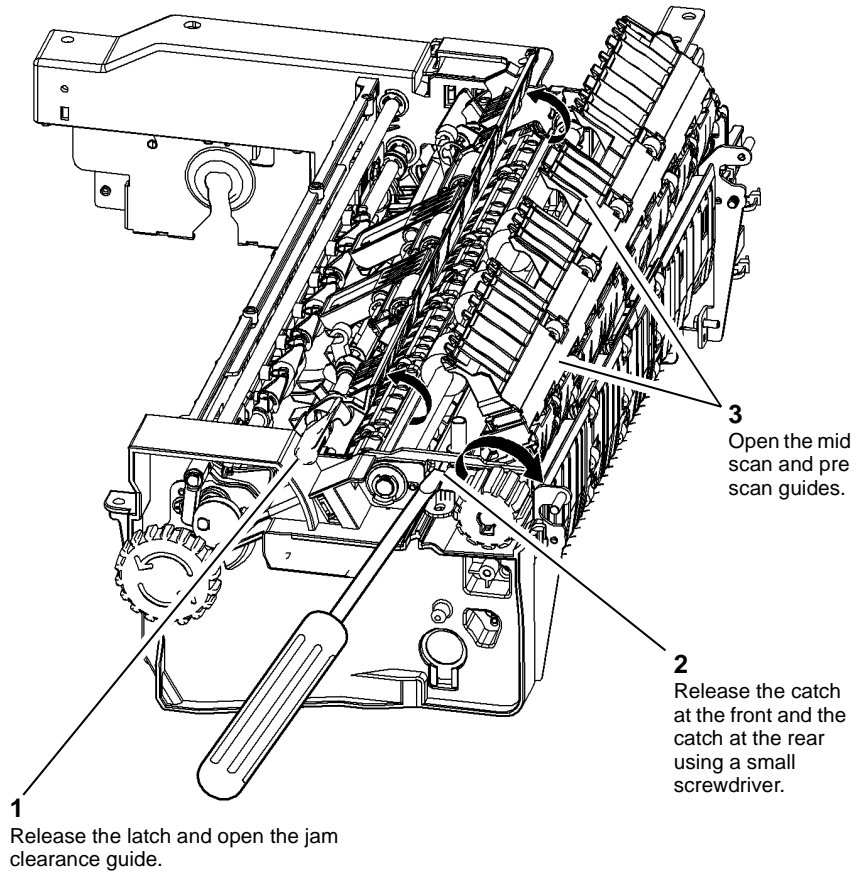
Figure 1 Preparation

3. Prepare to remove the mid scan document guide, [Figure 1](#).

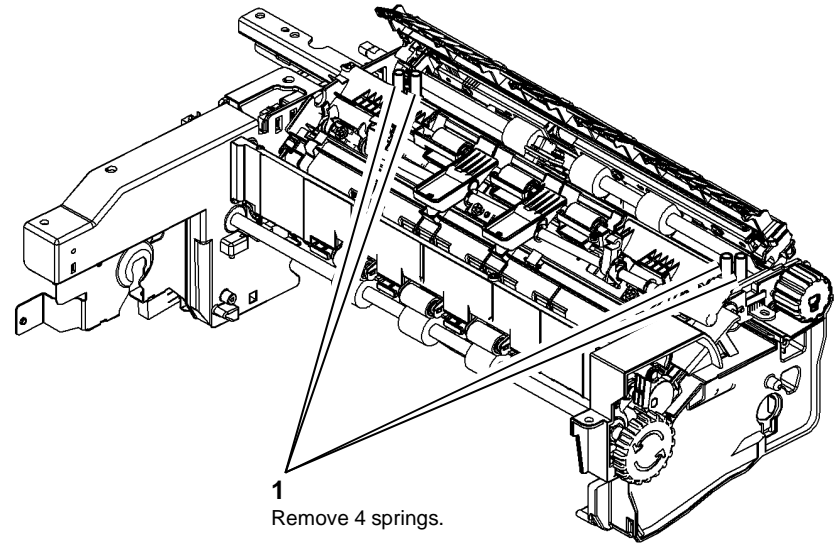
Figure 2 Springs removal

4. Remove 4 springs, [Figure 2](#).

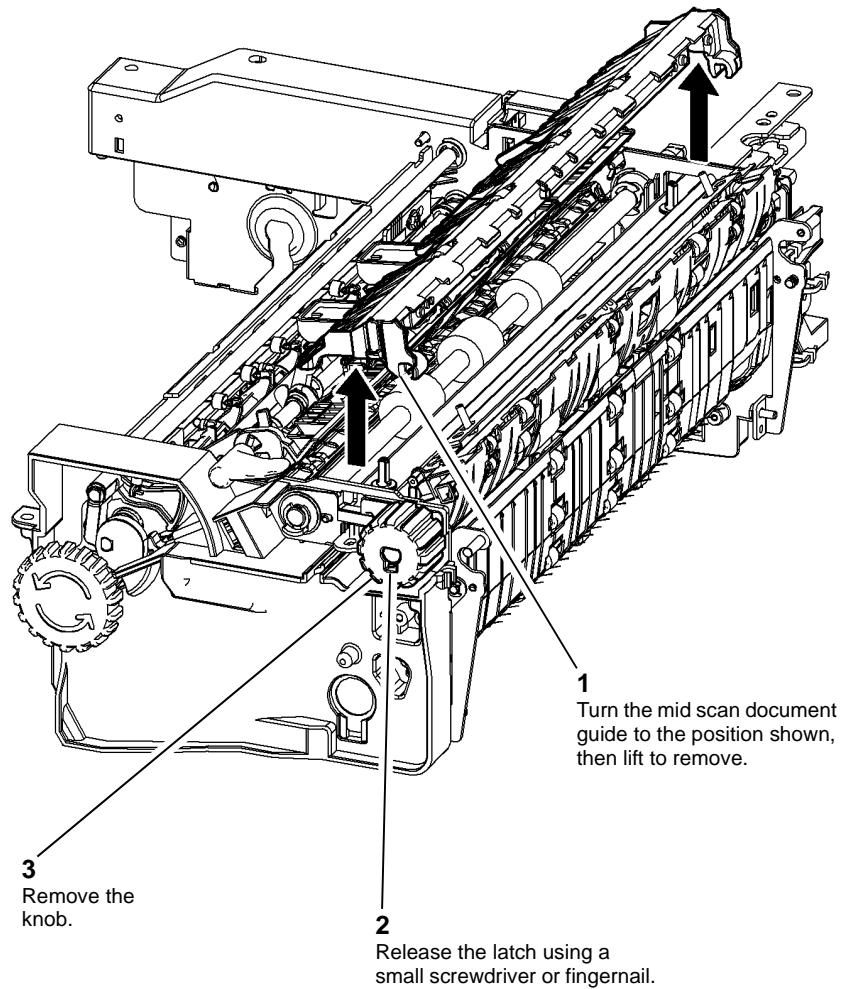
Figure 3 Guide and knob removal

5. Remove the mid scan document guide and pre scan clearance knob, **Figure 3**.

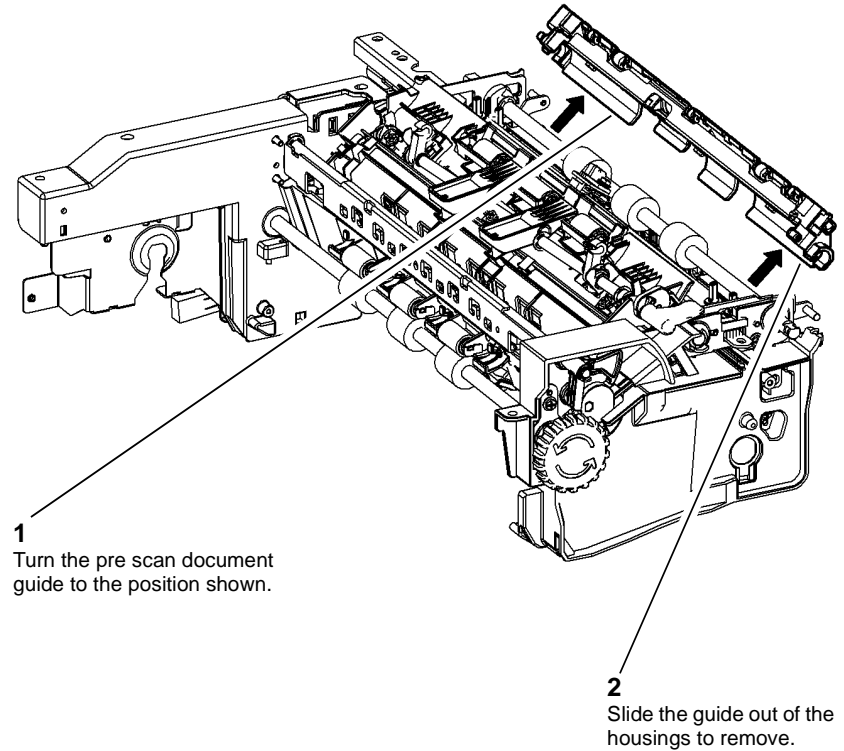
Figure 4 Pre scan guide removal

6. Remove the pre scan document guide, **Figure 4**.

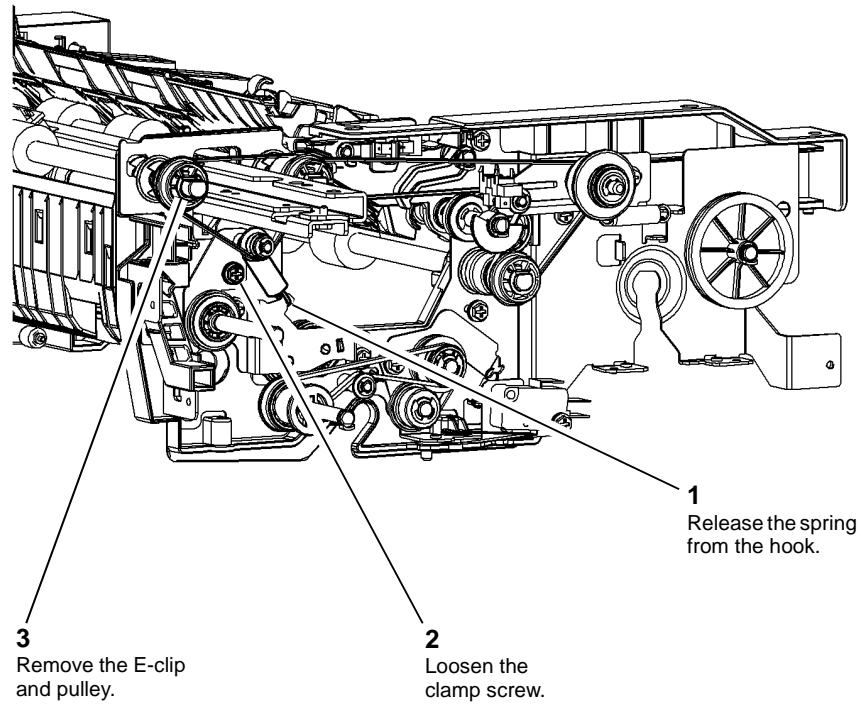
Figure 5 Preparation

7. Prepare to remove the pre scan roll assembly, [Figure 5](#).

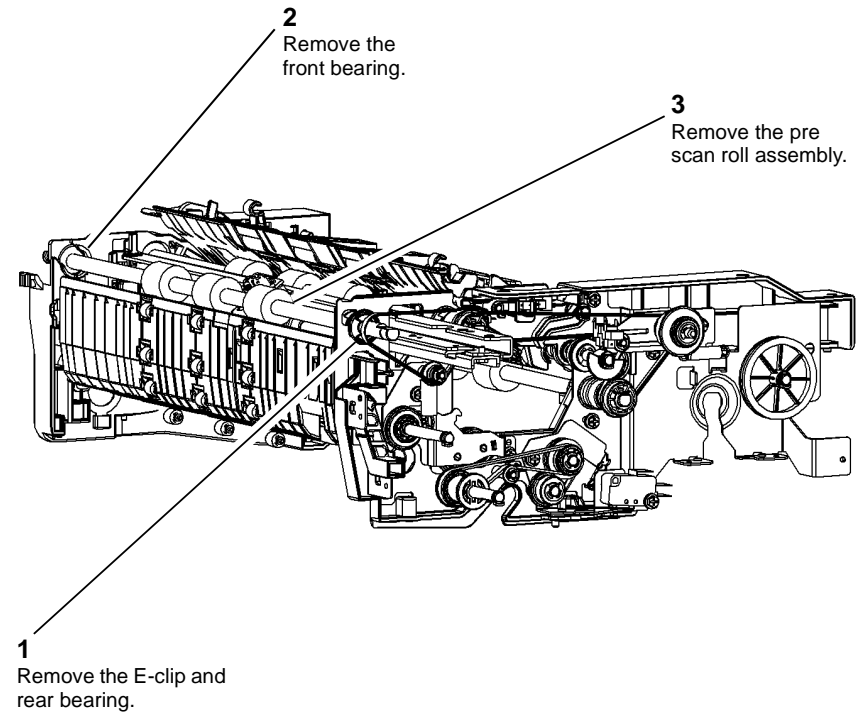
Figure 6 Pre scan roll removal

8. Remove the pre scan roll assembly, [Figure 6](#).

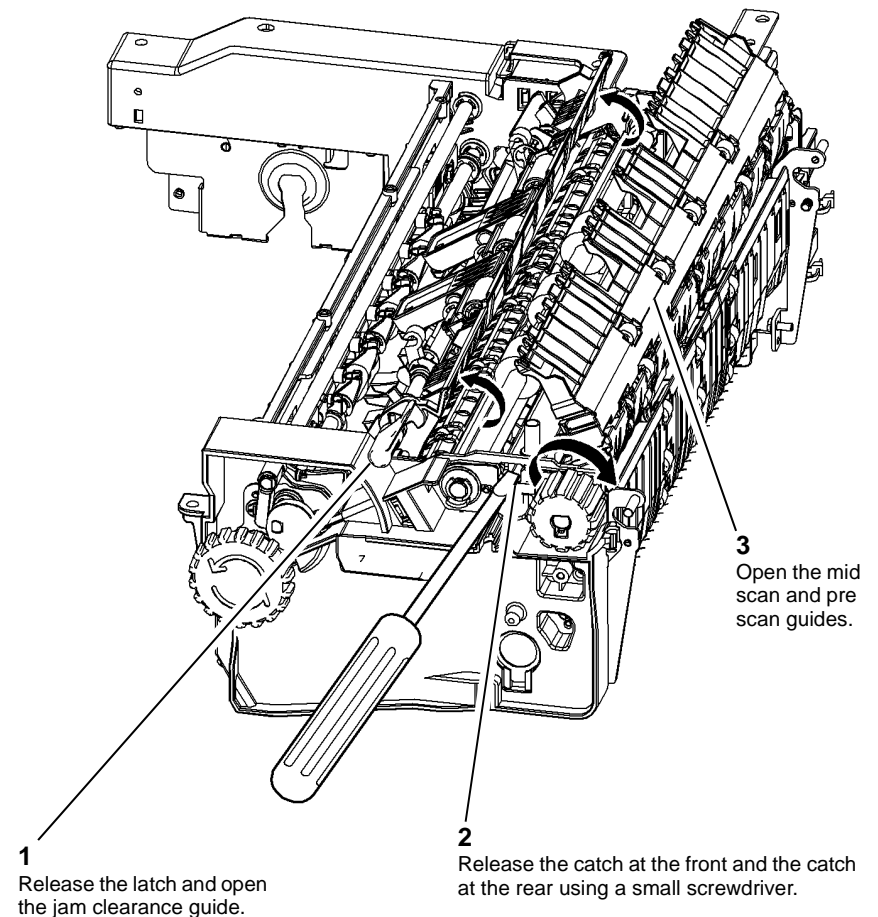
Figure 1 Guides opening

The mid scan and pre scan document guides are spring loaded, take care to not lose the springs when the guides are opened.

3. Open the mid scan document guide and pre scan document guide, [Figure 1](#).

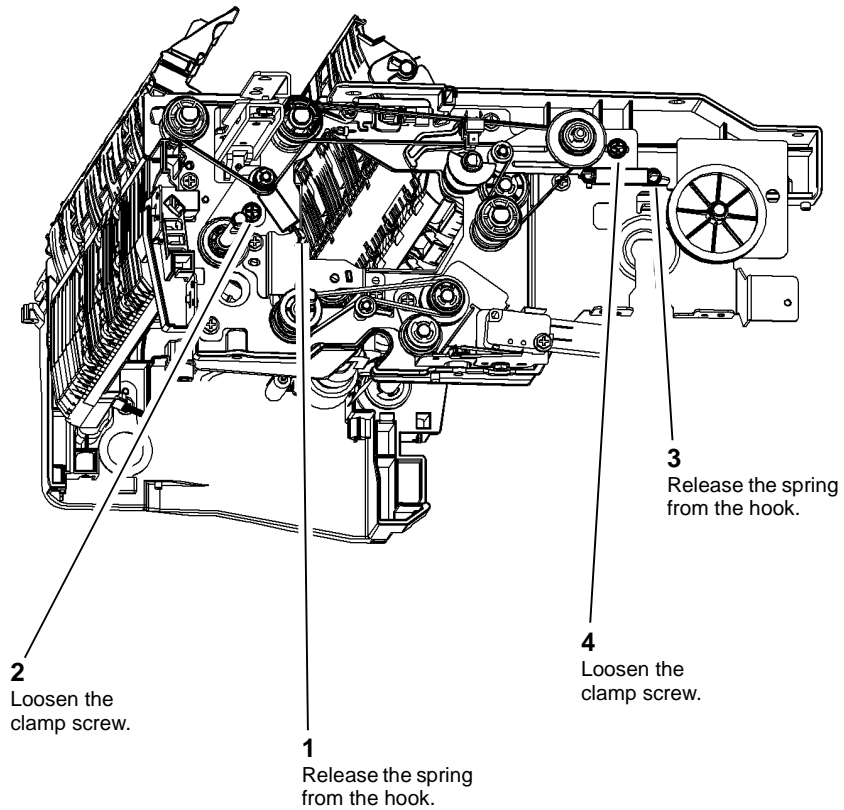
Figure 2 Belt tensions release

4. Release the belt tension in the 2 drive belts, [Figure 2](#).

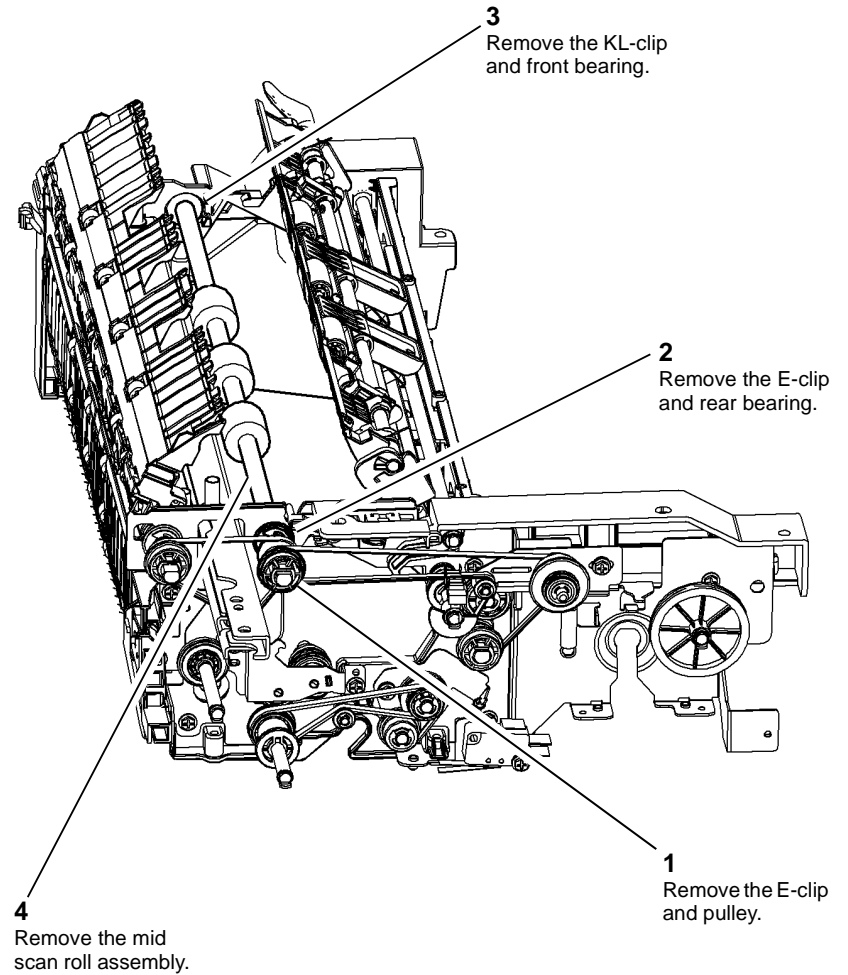
Figure 3 Mid scan roll removal

5. Remove the mid scan roll assembly, [Figure 3](#).

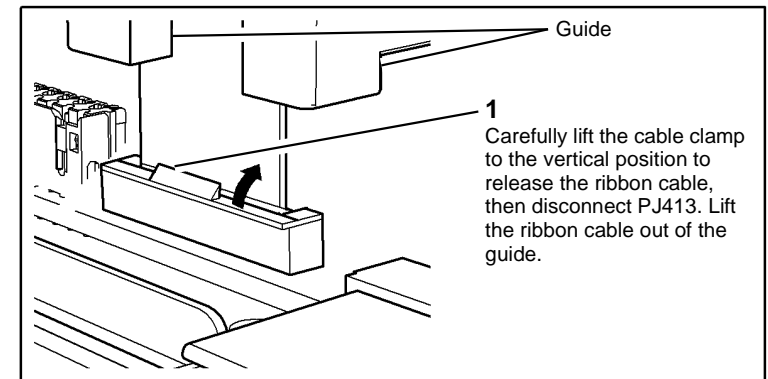
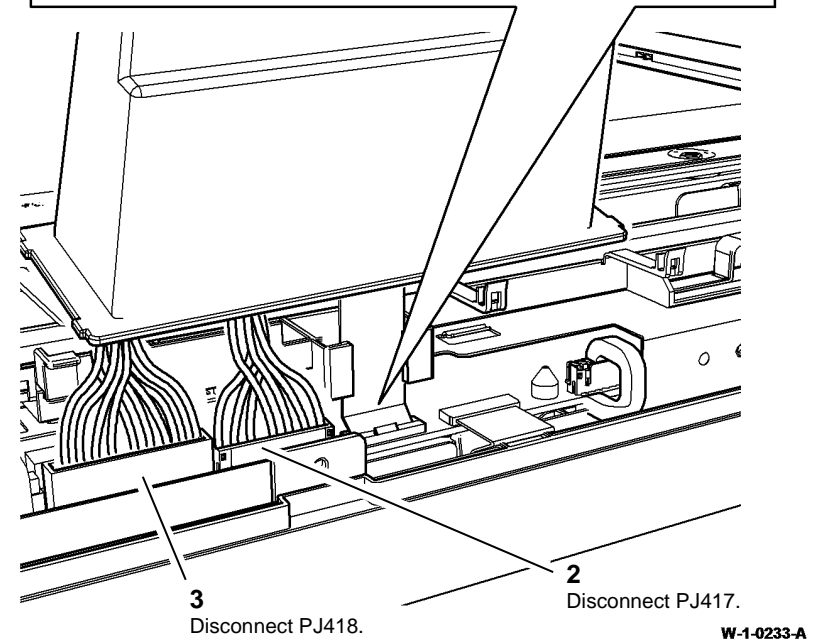
Figure 1 SPDH to Scanner Connections

1. Remove the scanner rear cover and faraday shield, [REP 60.1](#).
2. Disconnect the communication and power cables, [Figure 1](#).

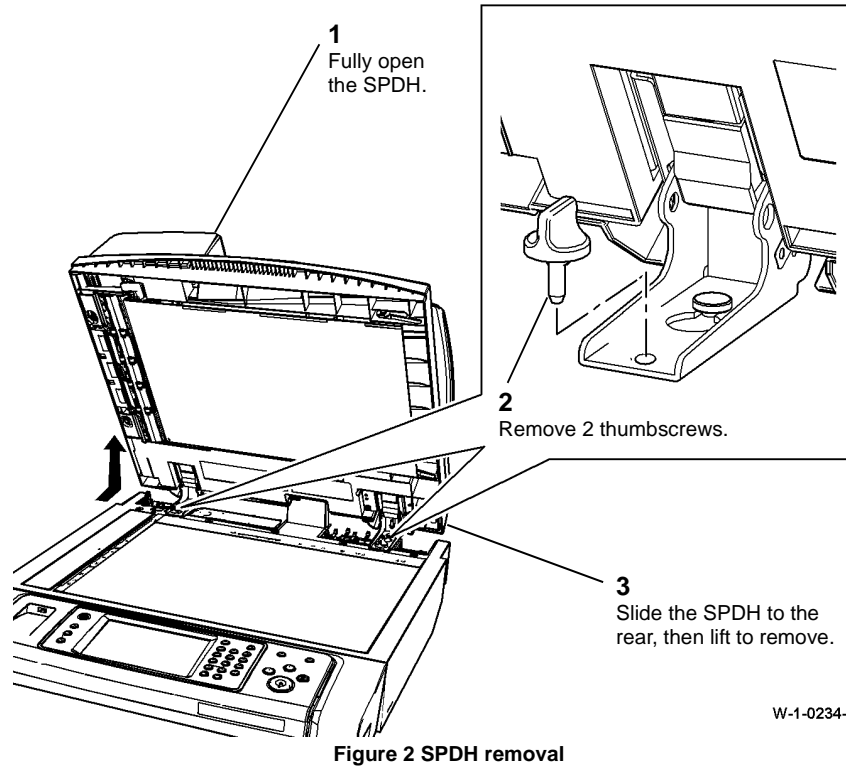
Figure 2 SPDH removal

NOTE: The SPDH weight is 11.5Kg (25.4lb).

3. Remove the SPDH from the rear of the machine, Figure 2.
