708P91139
February 2016

Xerox® WorkCentre® 5945 Family Multifunction Printer Service Manual

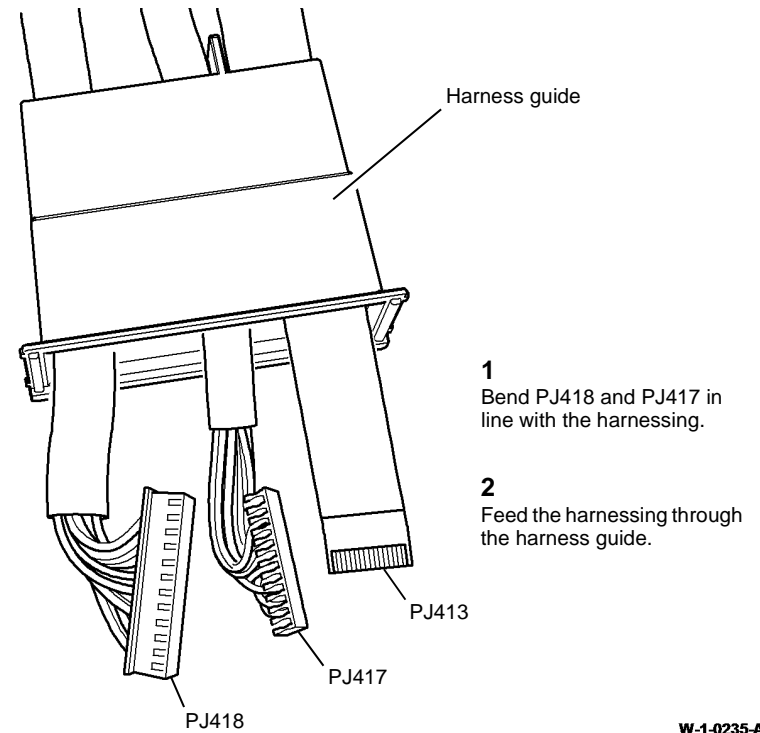
Figure 3 Harness guide removal

4. If necessary remove the SPDH harness guide, Figure 3.

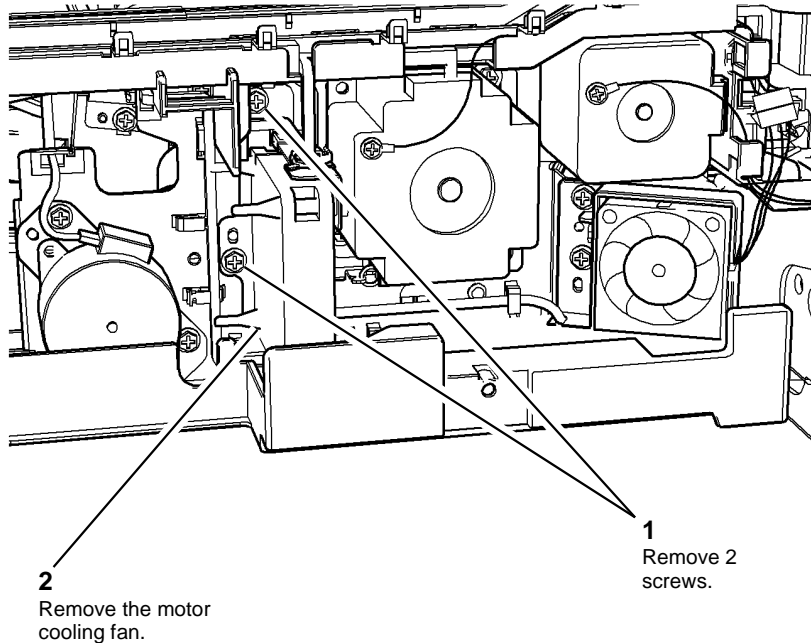
Figure 1 Motor cooling fan removal

1. Remove 5 screws then the rear cover, [PL 5.10 Item 1](#).
2. Disconnect PJ470 on the [SPDH PWB](#).
3. Release the 5 cable ties leading to the motor cooling fan from the SPDH PWB.
4. Remove the motor cooling fan, [Figure 1](#).

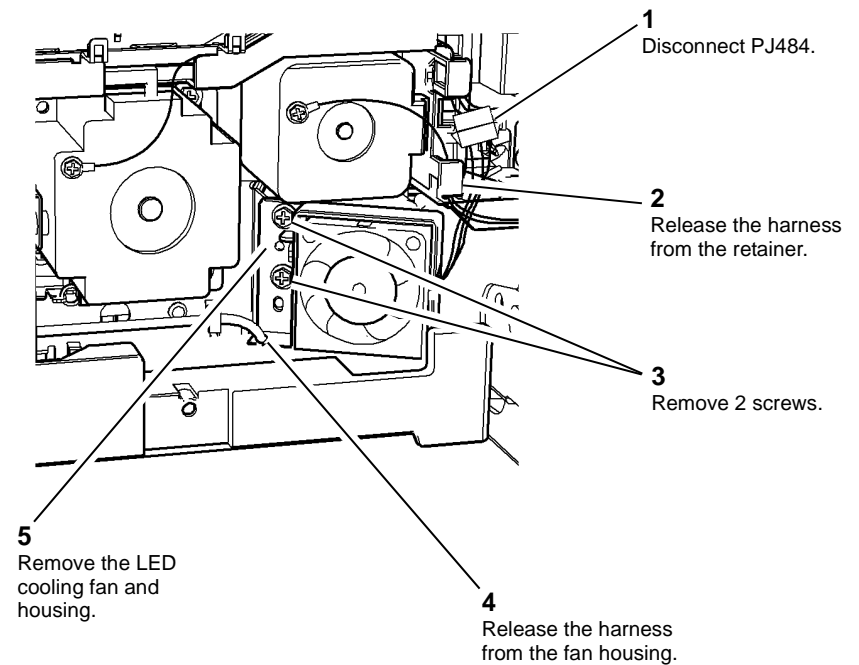
Figure 1 LED Cooling fan removal

1. Remove 5 screws then the rear cover, [PL 5.10 Item 1](#).
2. Remove the LED cooling fan, [Figure 1](#).

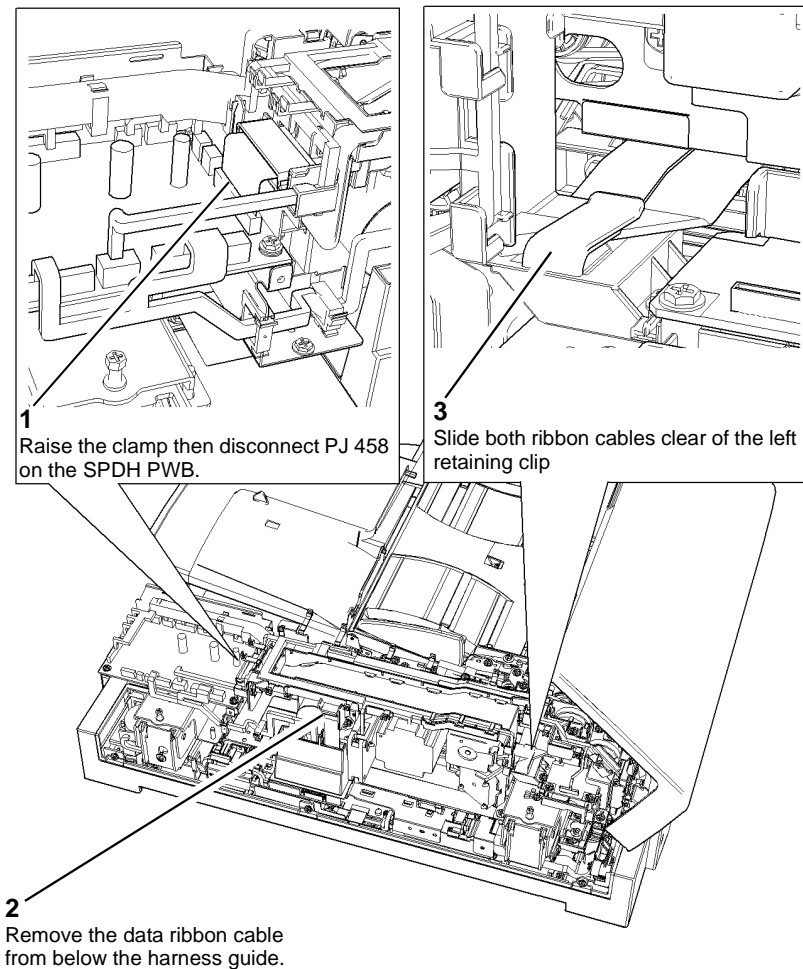
Figure 1 Preparation

1. Remove the scanner rear cover and faraday shield, [REP 60.1](#).
2. Refer to [REP 5.19](#). Disconnect PJ413 only, by following step 1 in figure 1.
3. Remove 5 screws, then remove the rear cover, [PL 5.10 Item 1](#).
4. Refer to [REP 5.3](#). Remove separation assembly. Do not remove the retard roll.
5. Refer to [REP 60.6](#). Disconnect the ribbon cables from PJ451 and PJ452. Do not disconnect PJ456. Do not remove the side 2 scanner
6. Prepare to remove the side 2 scan assembly data ribbon cable and power ribbon cable, [Figure 1](#).

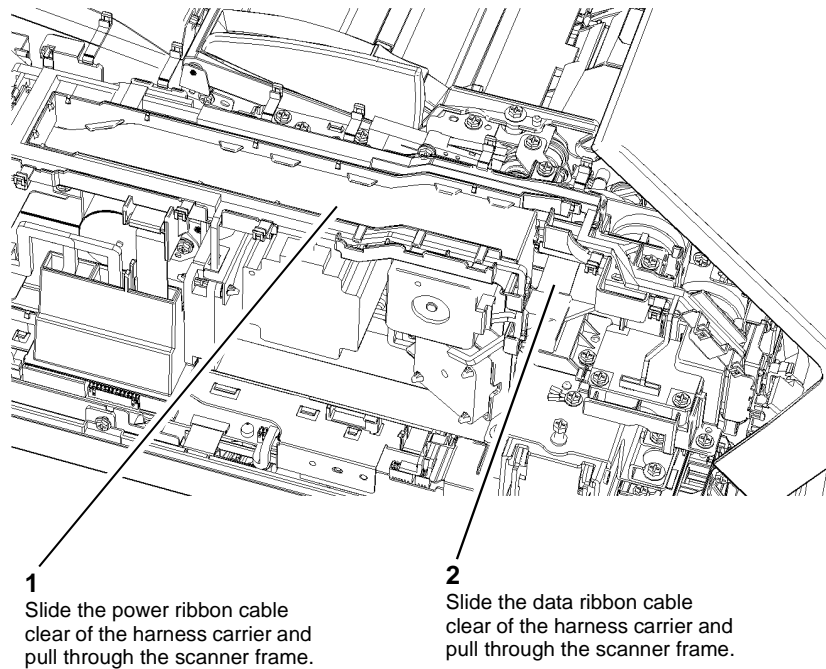
Figure 2 Ribbon cable removal

7. Remove the side 2 scan assembly data ribbon cable and power ribbon cable, [Figure 2](#).

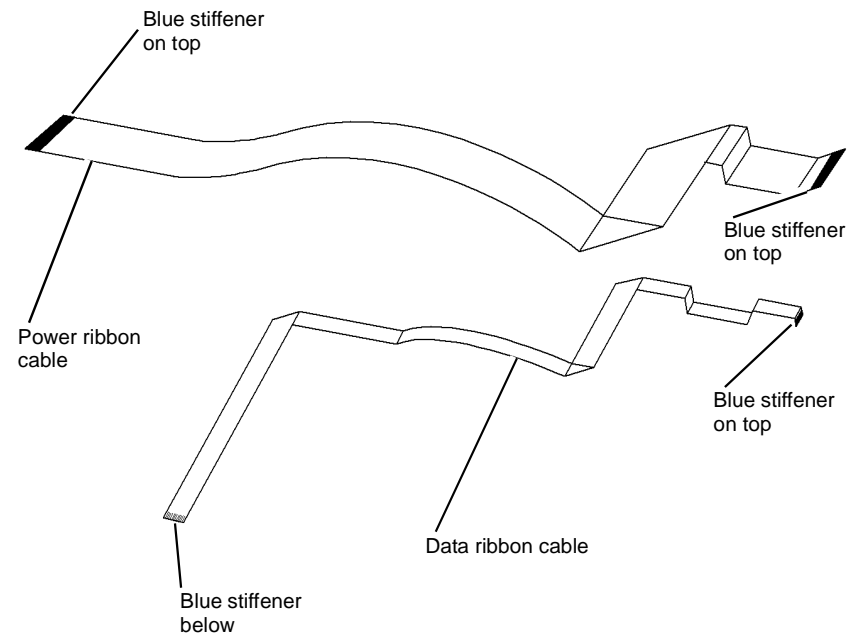
Figure 3 Ribbon cable folds

1. New ribbon cable are supplied pre-folded, refer to [Figure 3](#).

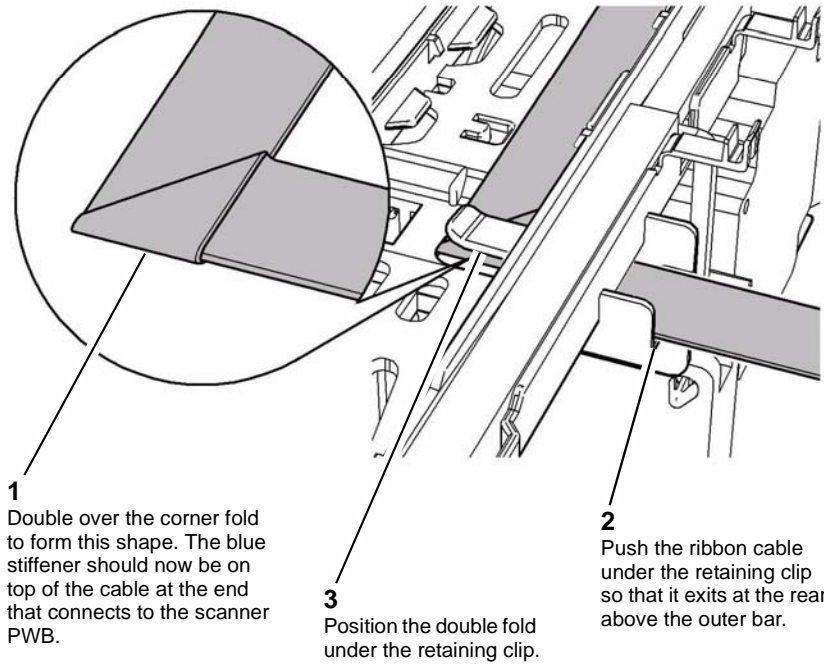
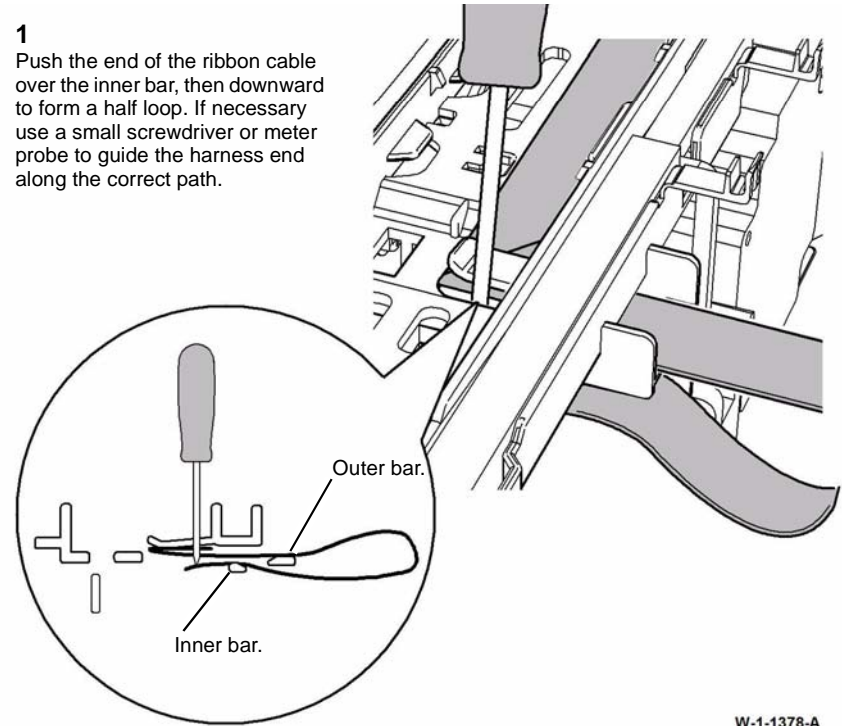
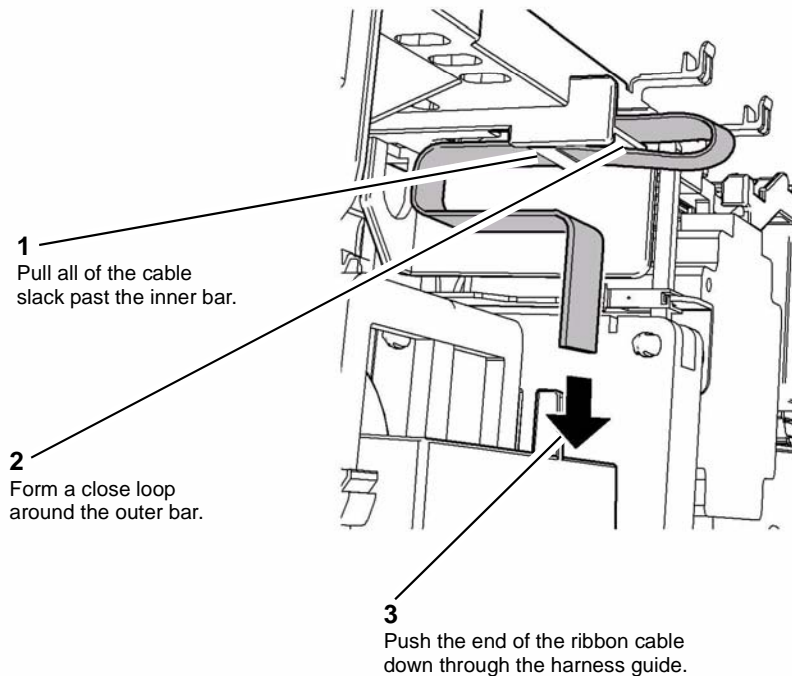
2. Install the data ribbon cable on the harness carrier, [Figure 4](#), [Figure 5](#) and [Figure 6](#).

- a. Ensure the cable clamp is facing to the left (open).
 - b. Place the ribbon cable fully into the connector. The blue stiffener at the scanner end of the cable should be on the same side as the cable clamp.
 - c. Close the cable clamp by folding it up against the cable.
9. The remainder of the replacement is the reverse of the removal procedure.

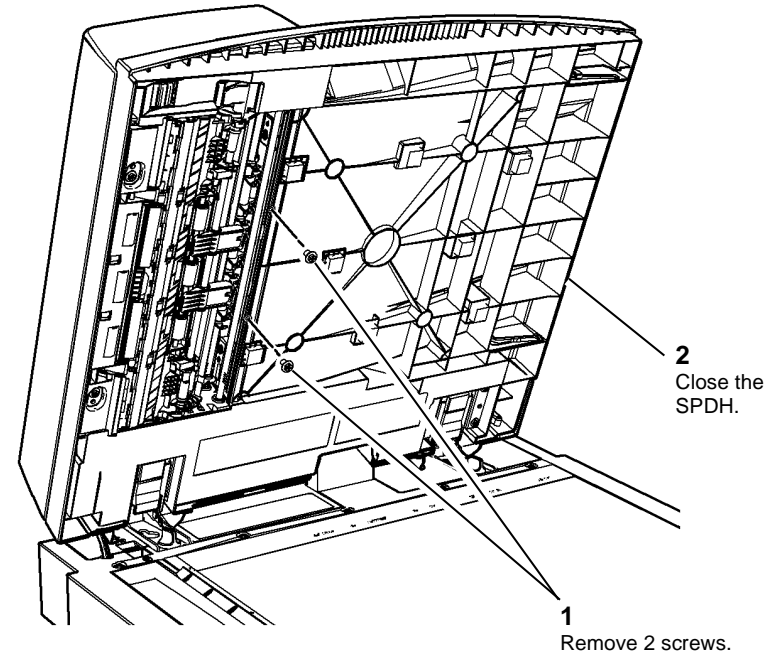
Figure 1 Lower fasteners removal

1. Remove the document pad, [PL 5.10 Item 3](#), by removing 2 K-L clips from the right side of the pad, then un-clip the 2 fasteners at the left side.
2. Remove the read assembly lower fasteners, [Figure 1](#).

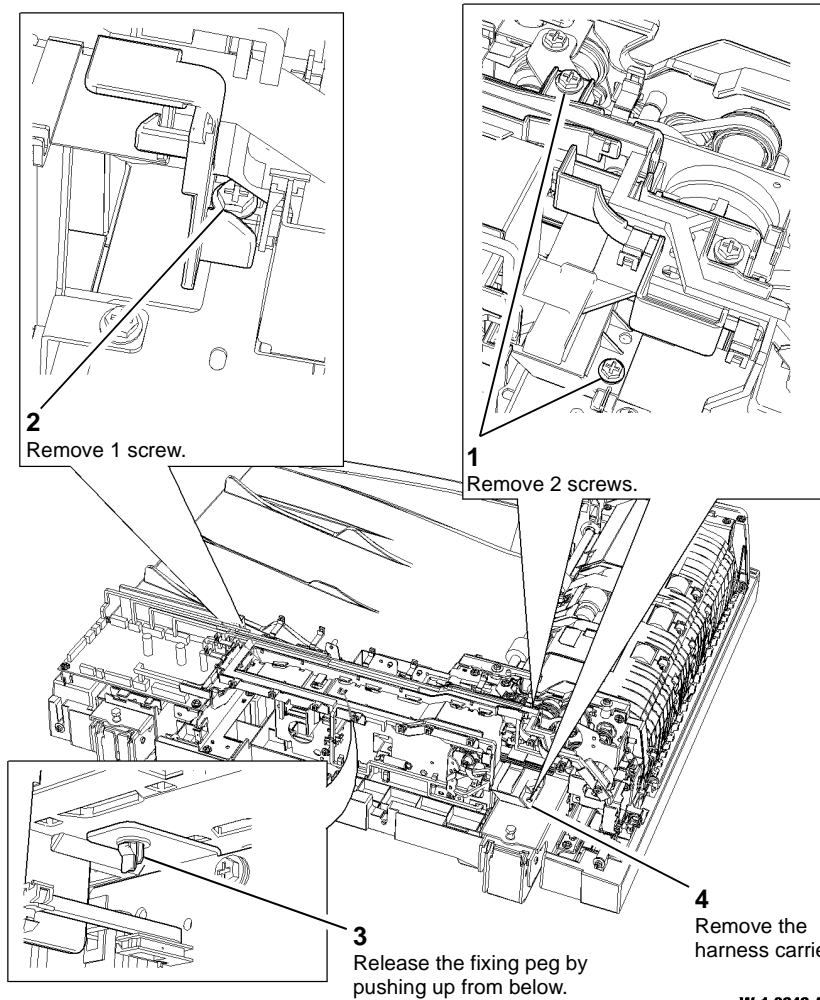
Figure 2 Harness carrier removal

18. Remove the harness carrier, [Figure 2](#).

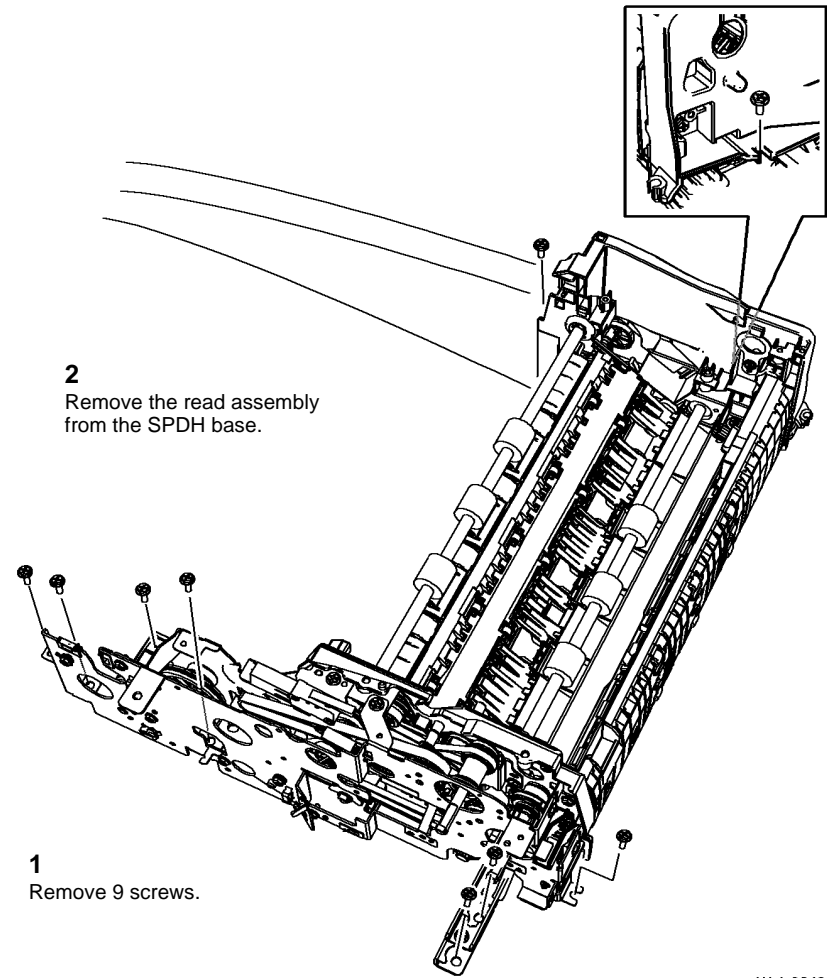
Figure 3 SPDH read assembly removal

19. Remove the SPDH read assembly, [Figure 3](#).

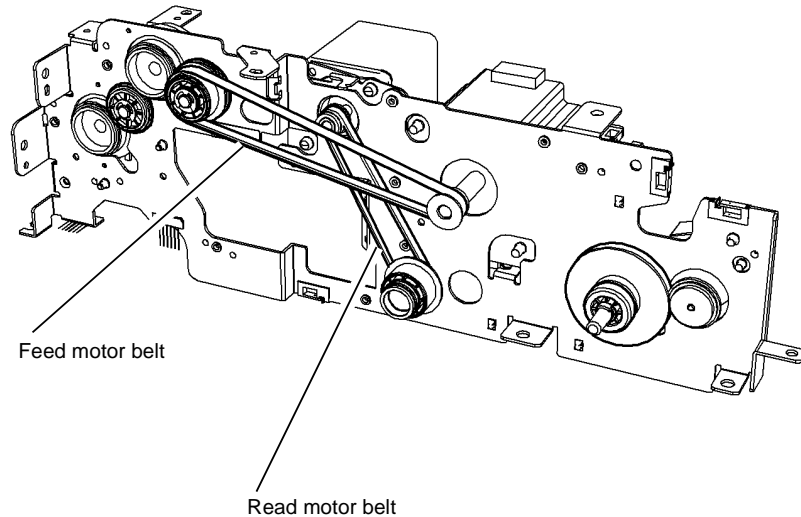
Figure 4 Drive belt routing

1. Replacement is the reverse of the removal procedure.
2. When installing the feed motor and read motor, refer to [Figure 4](#) for the drive belt routing.

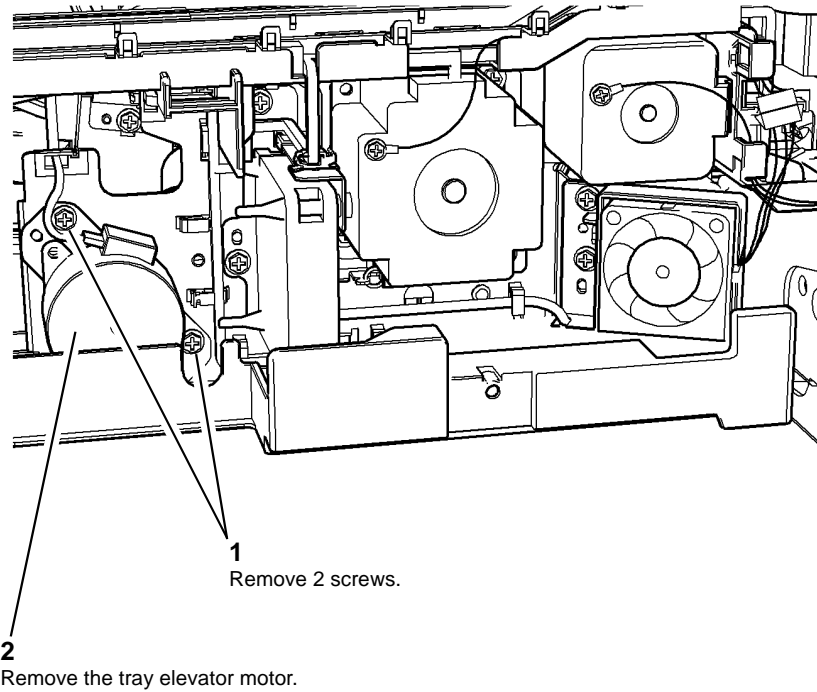
4. Remove the tray elevator motor, [Figure 1](#).

1
Remove 2 screws.

2
Remove the tray elevator motor.

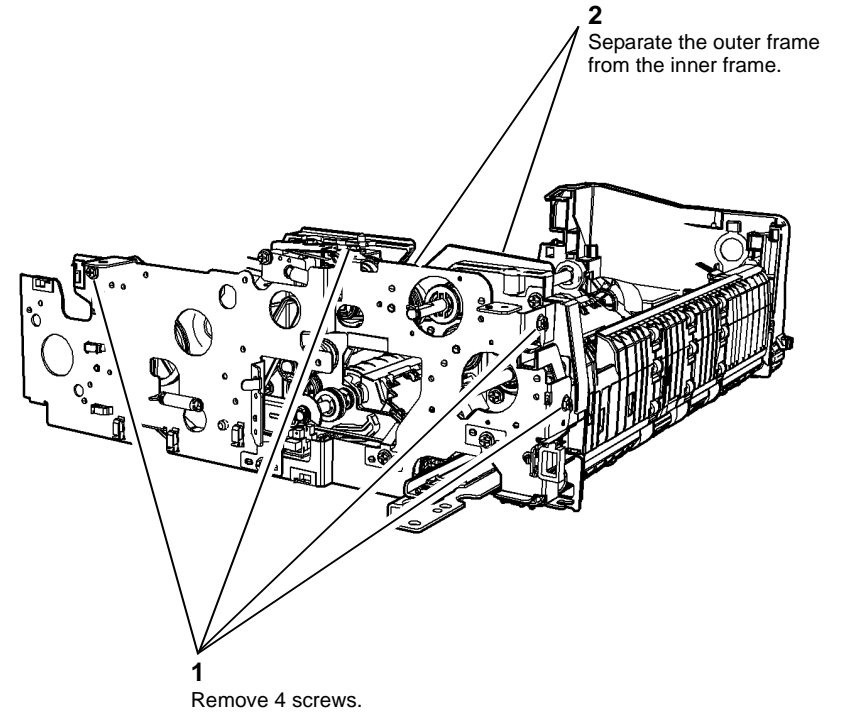
Figure 1 Outer frame removal

1. Remove the SPDH read assembly, [REP 5.23](#).
2. Remove the outer frame, [Figure 1](#).

1
Remove 4 screws.

2
Separate the outer frame
from the inner frame.

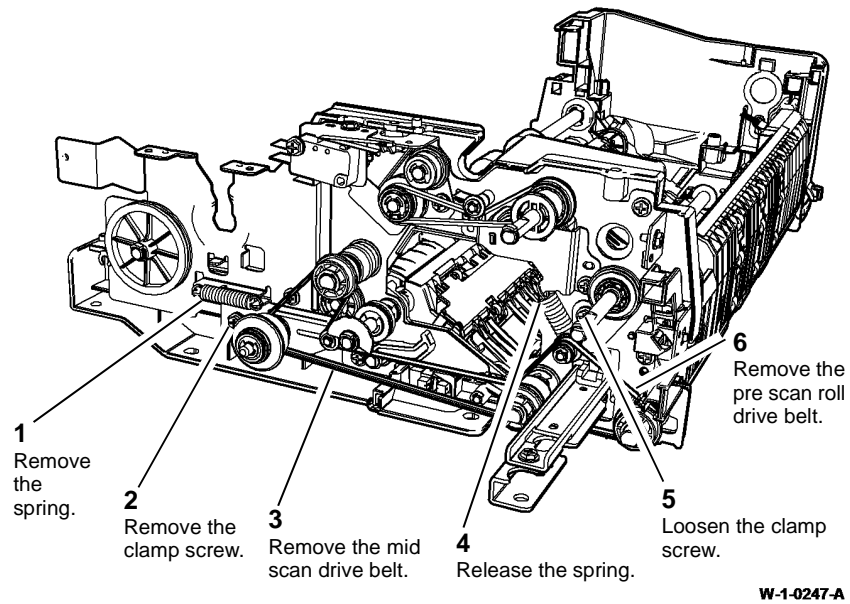
Figure 2 Drive belts removal

3. Remove the mid scan drive belt, [PL 5.19 Item 21](#) and the pre scan roll drive belt, [PL 5.19 Item 20, Figure 2.](#)
4. Remove the calibration shutter driven gear [PL 5.19 Item 8](#) and the bearing, [Figure 3.](#)

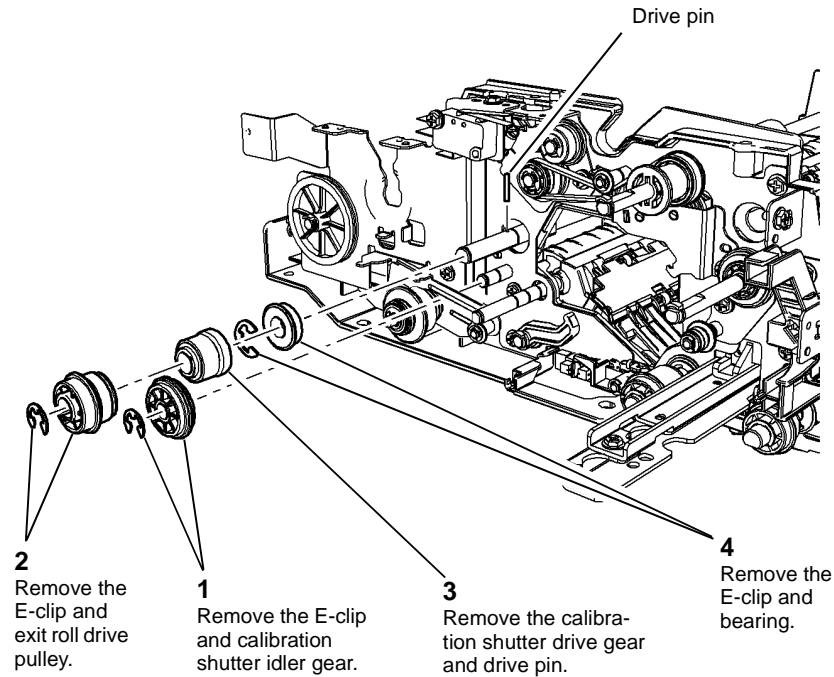
Figure 4 Exit roll components removal

- Remove the calibration shutter idler gear, PL 5.19 Item 7, the exit roll drive pulley, PL 5.19 Item 12 and the calibration shutter drive gear, PL 5.19 Item 10, Figure 4.

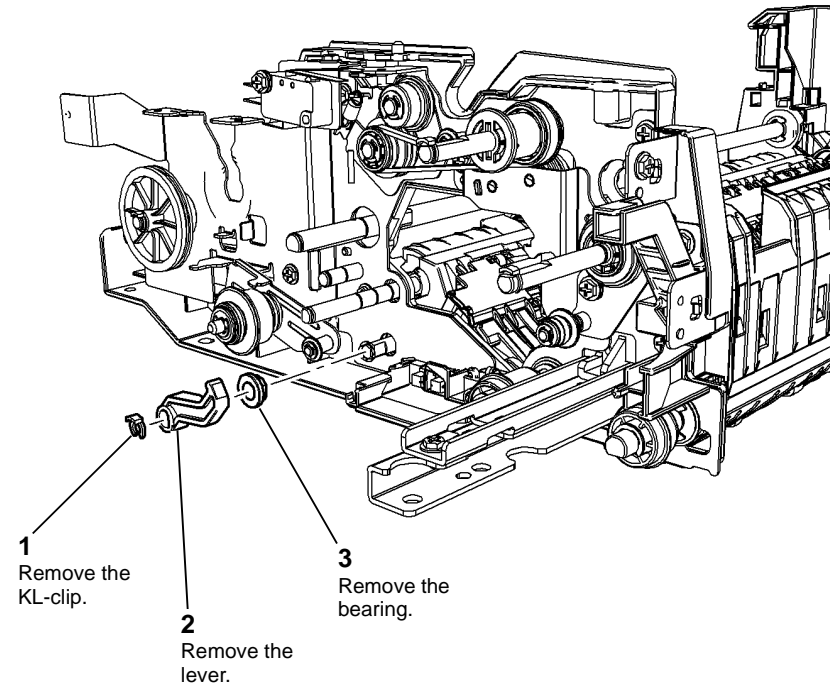
Figure 5 Shutter lever removal

- Remove the calibration shutter lever and bearing, Figure 5.

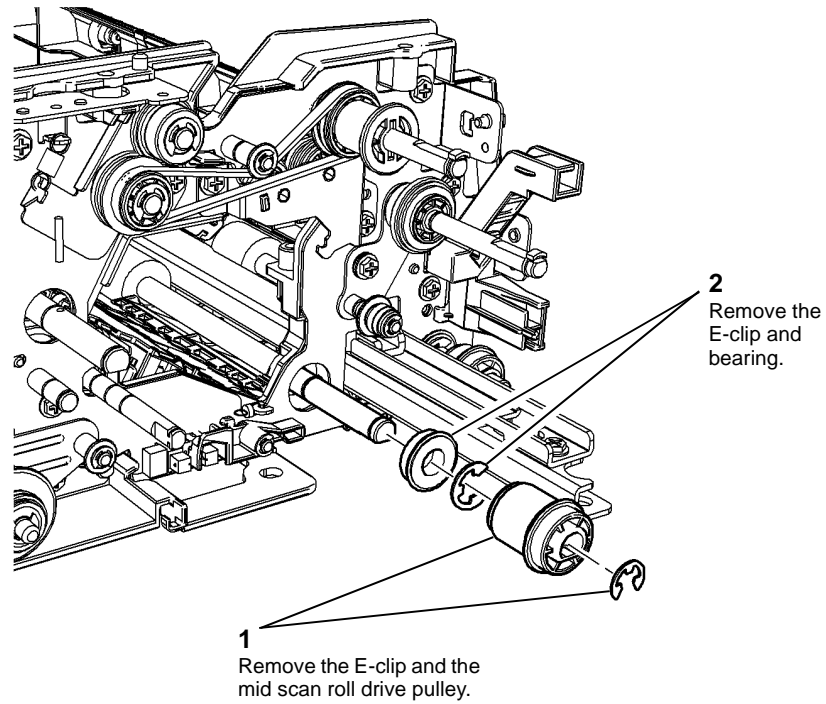
Figure 6 Mid scan pulley removal

8. Remove the mid scan roll drive pulley, PL 5.19 Item 13 and bearing, Figure 6.

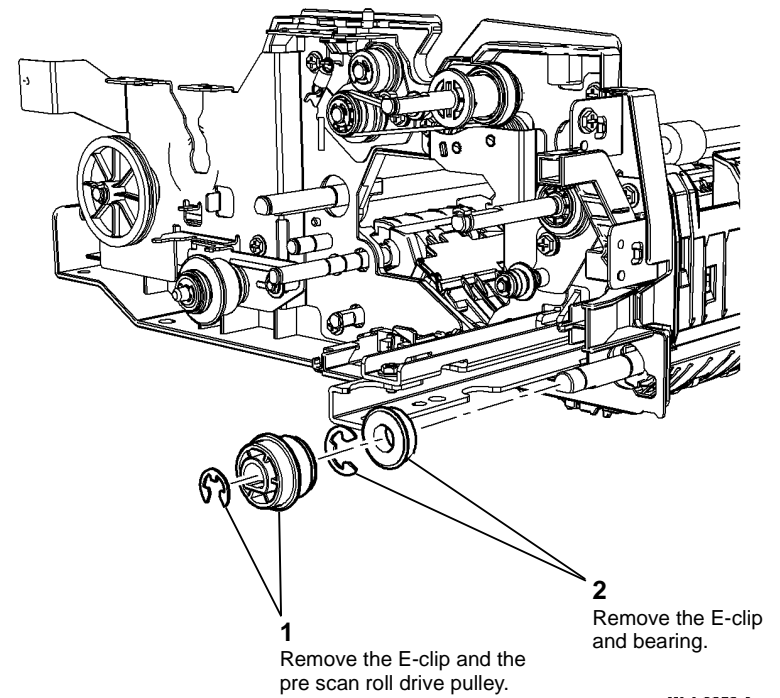
Figure 7 Pre scan roll pulley removal

9. Remove the pre scan roll drive pulley, PL 5.19 Item 12 and bearing, Figure 7.

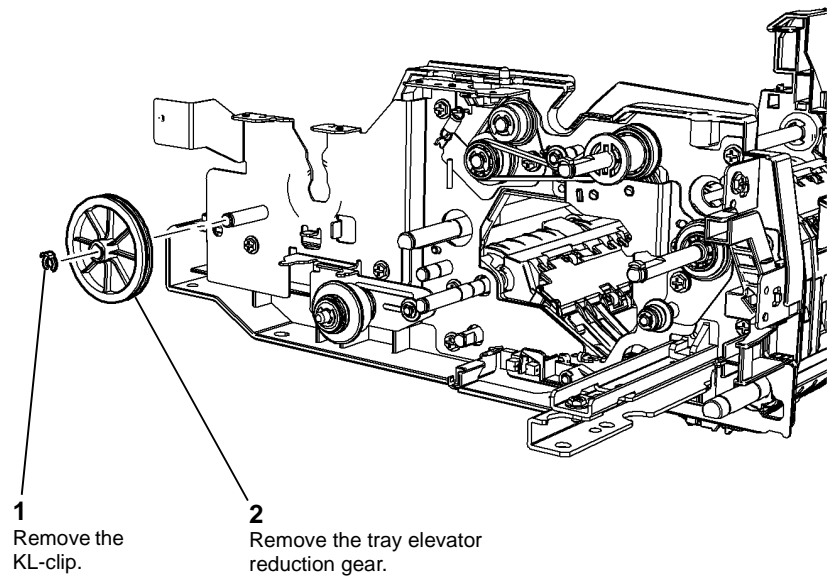
Figure 8 Reduction gear removal

10. Remove the tray elevator reduction gear, [Figure 8](#).

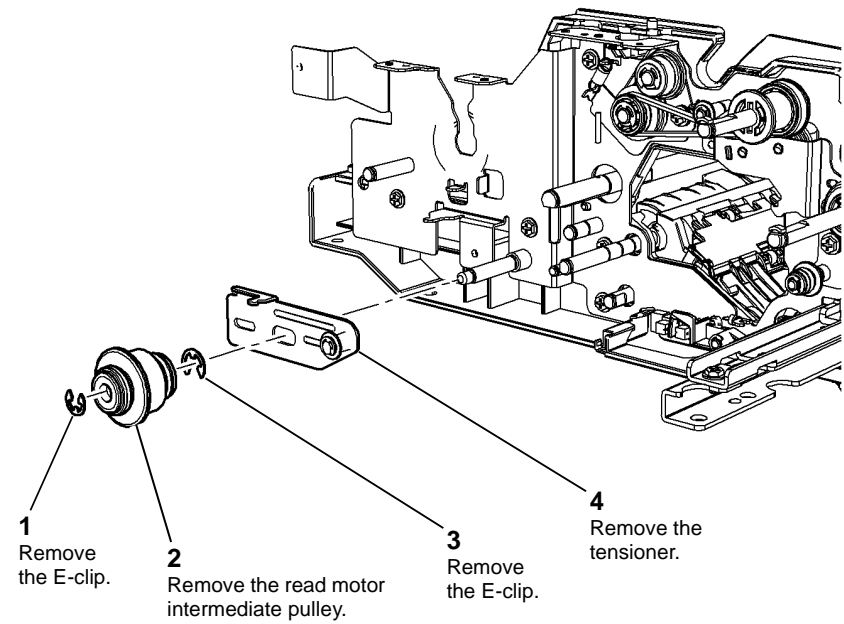
Figure 9 Intermediate pulley removal

11. Remove the read motor intermediate pulley, [PL 5.19 Item 15](#) and the belt tensioner, [Figure 9](#).

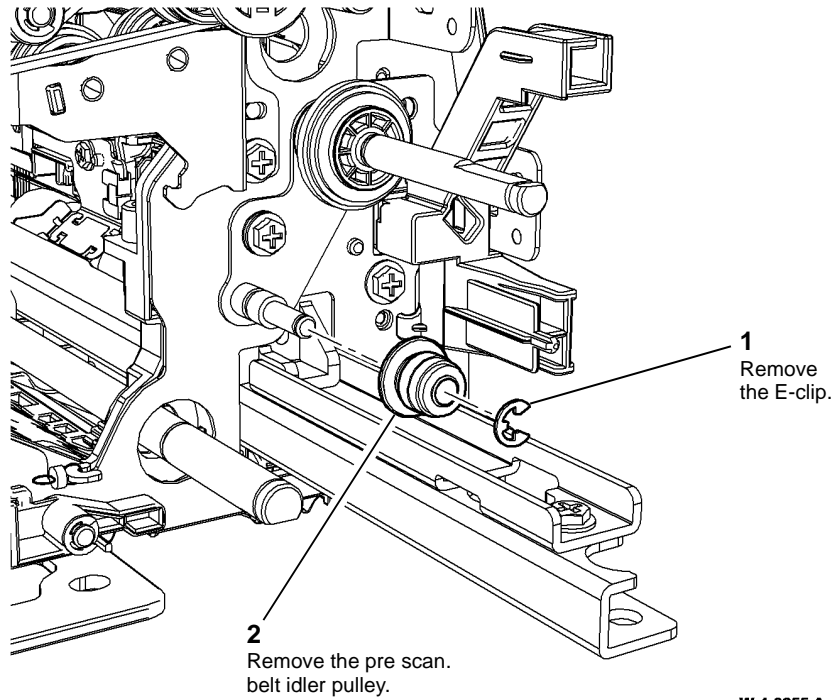
Figure 10 Idler pulley removal

12. Remove the pre scan belt idler pulley, PL 5.19 Item 14, Figure 10.

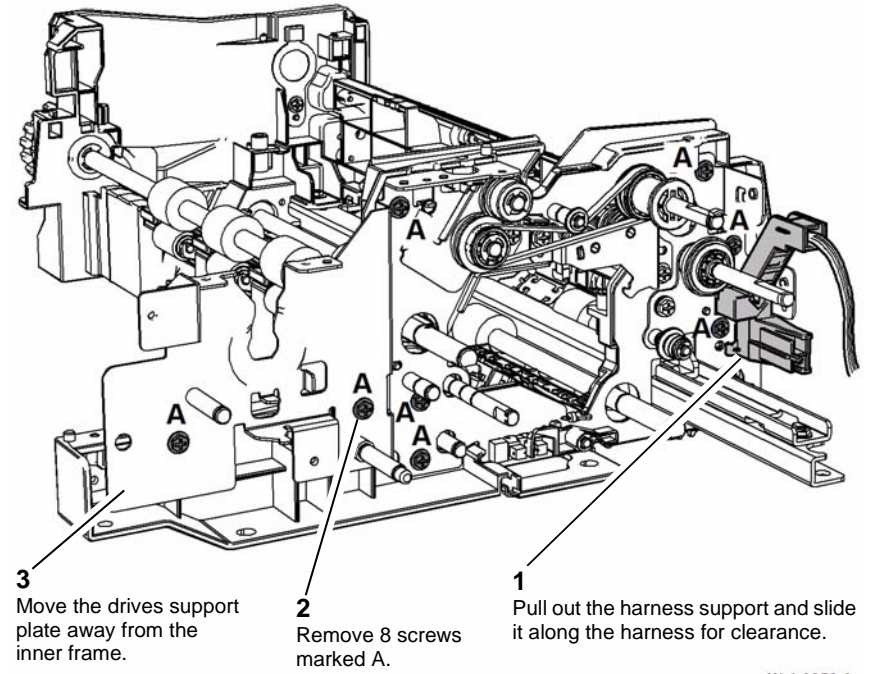
13. Remove the drives support plate, Figure 11.

Figure 11 Support plate removal

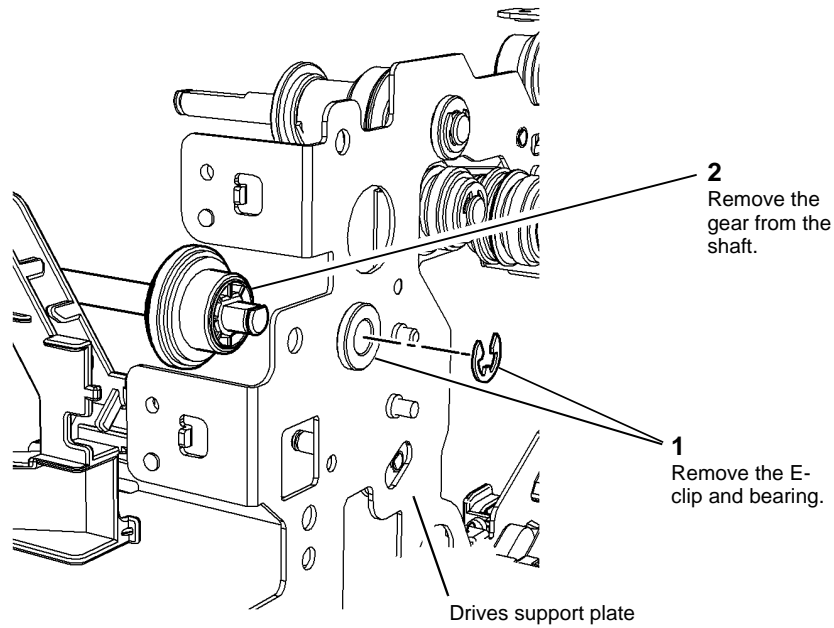
W-1-0257-A

14. Remove the takeaway roll drive gear, PL 5.19 Item 6, from the front face of the drives support plate, Figure 12.

Figure 12 Drive gear removal

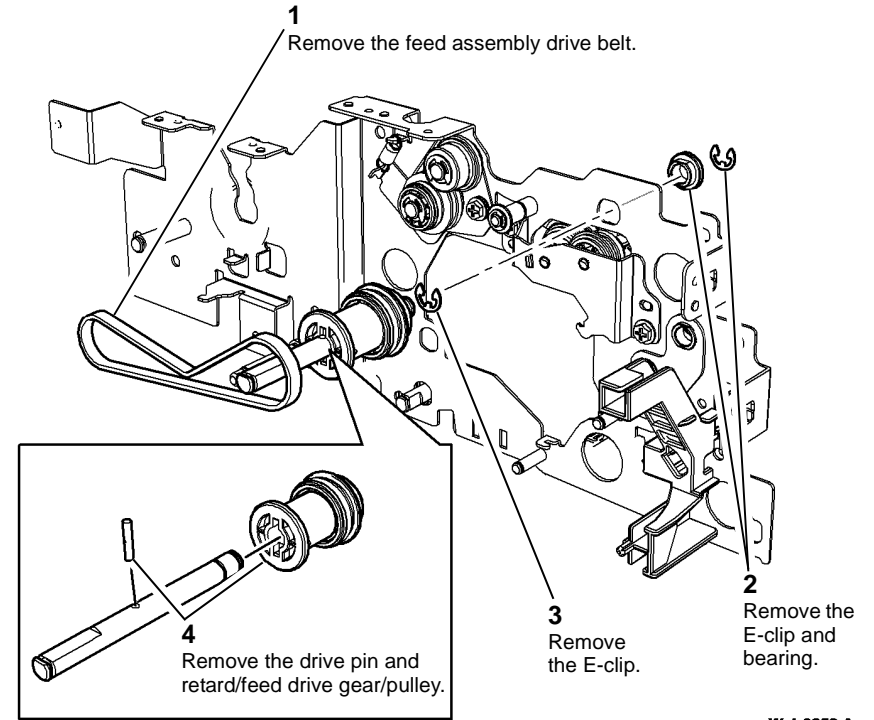
W-1-0258-A

15. Remove the retard/feed drive gear/pulley, PL 5.19 Item 22 and feed assembly drive belt, PL 5.19 Item 18, Figure 13.

Figure 13 Gear and belt removal

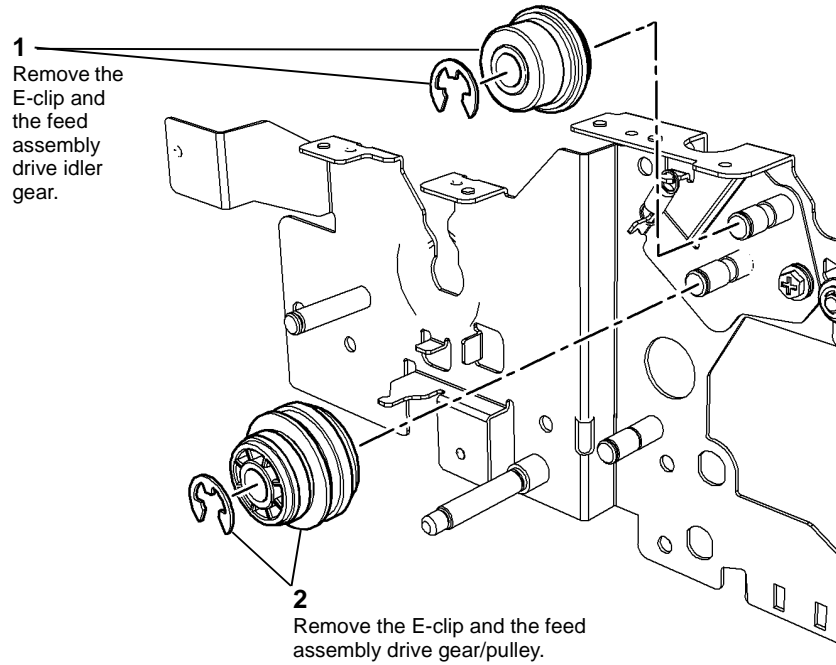
16. Remove the feed assembly drive idler gear, PL 5.19 Item 5 and the feed assembly drive gear/pulley, PL 5.19 Item 11, Figure 14.

Figure 14 Drive and idler gears removal

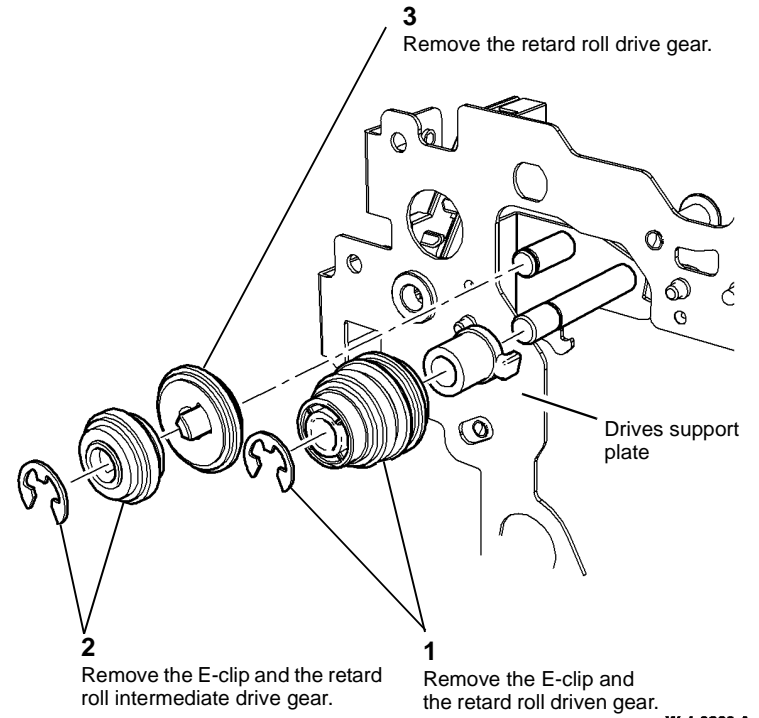
17. Remove the retard roll intermediate drive gear, PL 5.19 Item 1, the retard roll driven gear, PL 5.19 Item 2 and the retard roll drive gear, PL 5.19 Item 3, Figure 15.

Figure 15 Retard drive removal

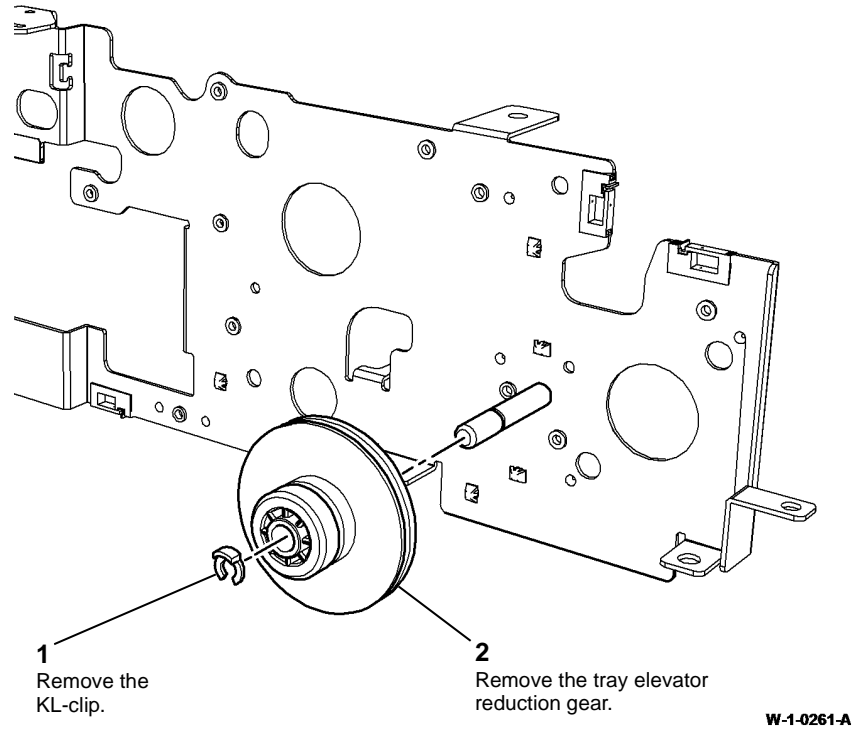
18. Remove the tray elevator reduction gear, [PL 5.19 Item 9](#), from the front face of the outer frame, [Figure 16](#).

Figure 16 Reduction gear removal

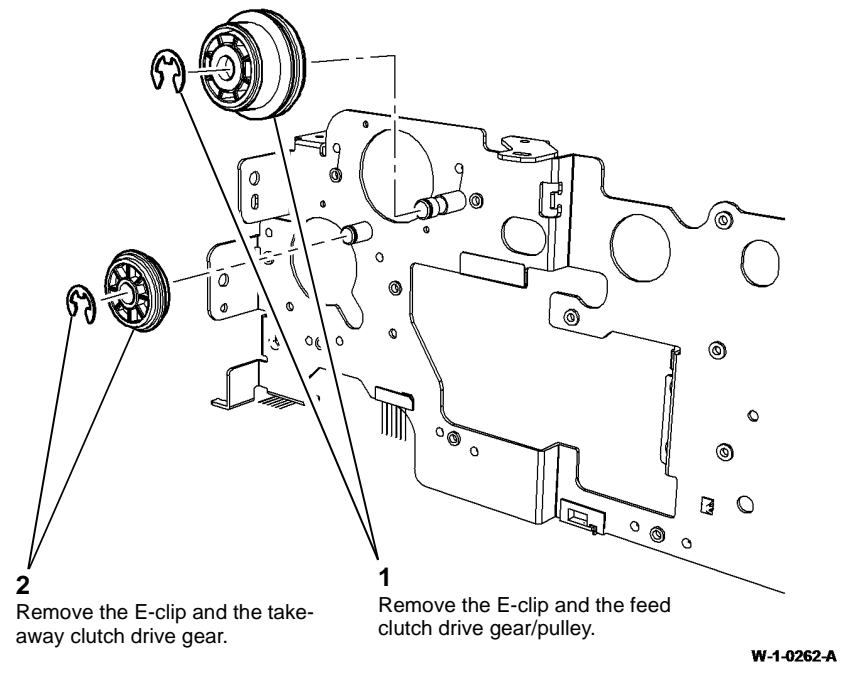
19. Remove the feed clutch drive gear/pulley, [PL 5.19 Item 4](#) and the takeaway clutch drive gear, [PL 5.19 Item 7](#), from the front face of the outer frame, [Figure 17](#).

Figure 17 Gears removal

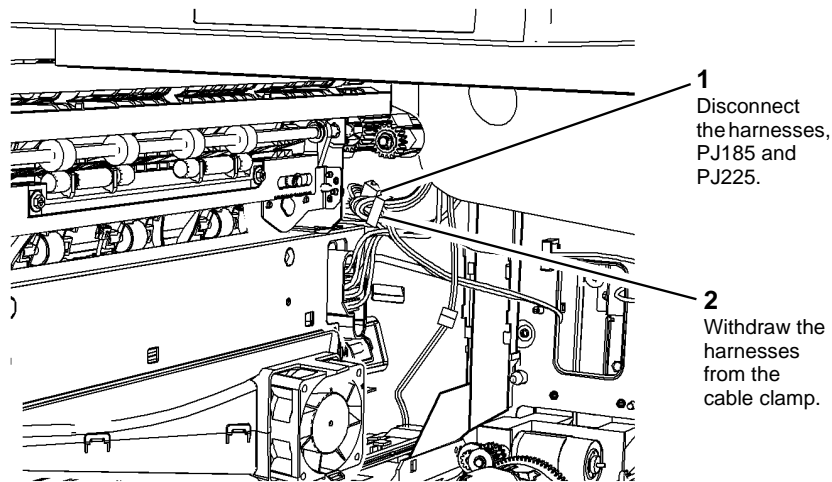
W-1-1149-A

1. Open the front door.
2. Open the left door.
3. Remove the print cartridge, [PL 90.17 Item 9](#), then place in a black bag.
4. Remove the horizontal transport, [REP 10.6](#).
5. Disconnect the harnesses to the inverter, [Figure 1](#).

Figure 1 Harness disconnection

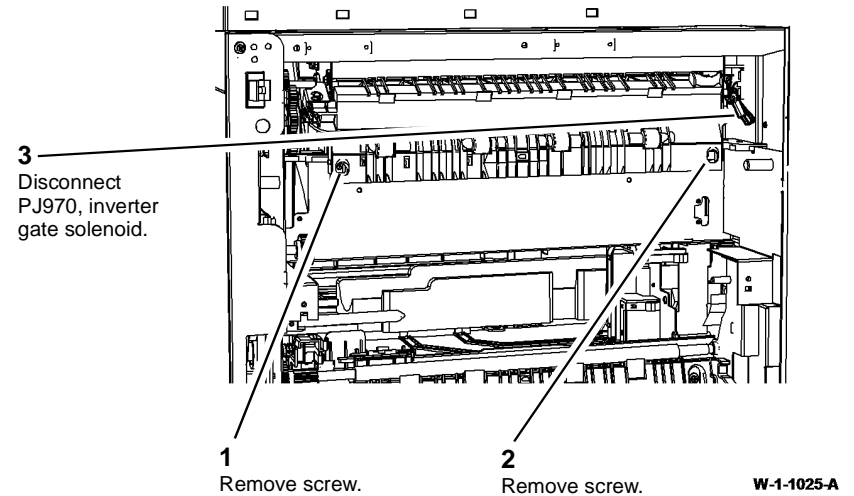
W-1-1025-A

6. Prepare to remove the inverter assembly, [Figure 2](#).

Figure 2 Inverter removal preparation

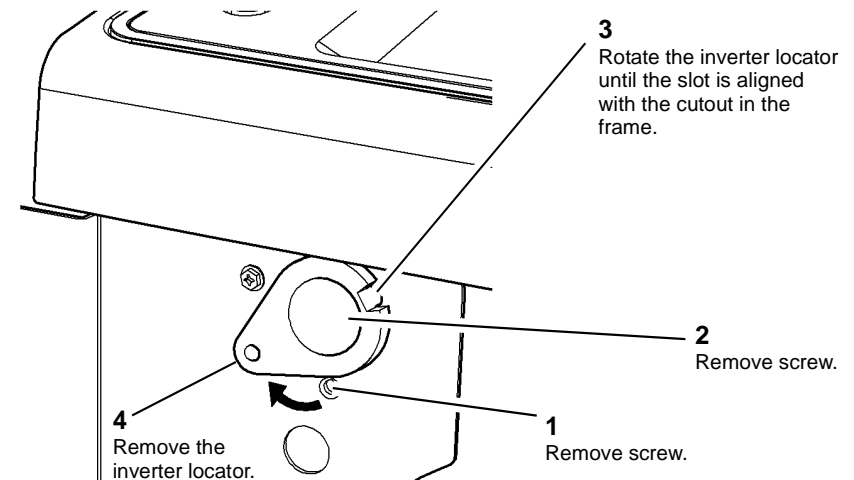
W-1-1024-A

7. Remove the exit drive assembly, [REP 10.2](#).
8. Remove the inverter locator, [Figure 3](#).

Figure 3 Inverter locator removal

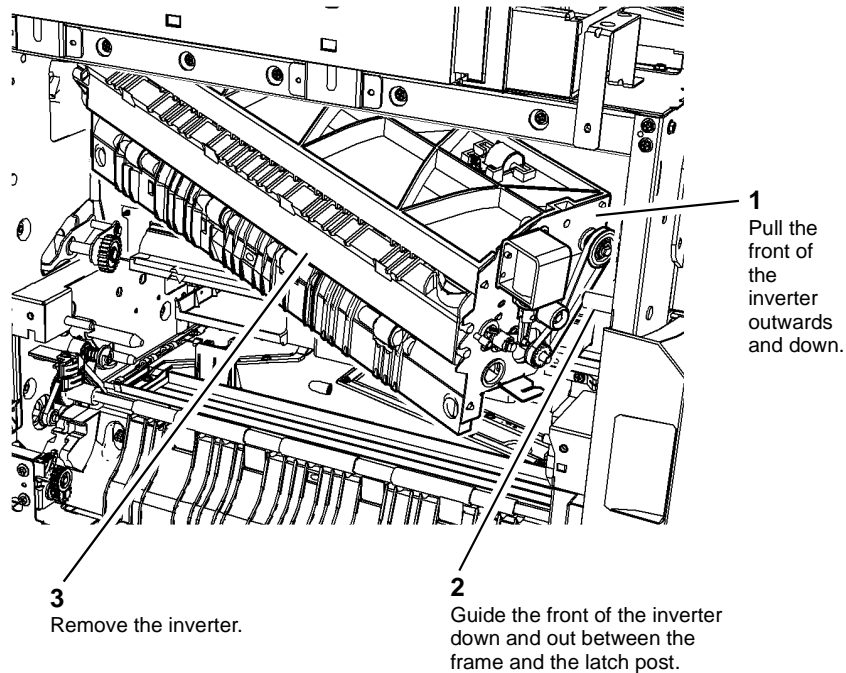
W-1-1026-A

- Remove the inverter assembly, [Figure 4](#).

Figure 4 Inverter removal

Screws must be replaced in the exact reverse of the removal order shown to ensure the optimum alignment of the inverter assembly.

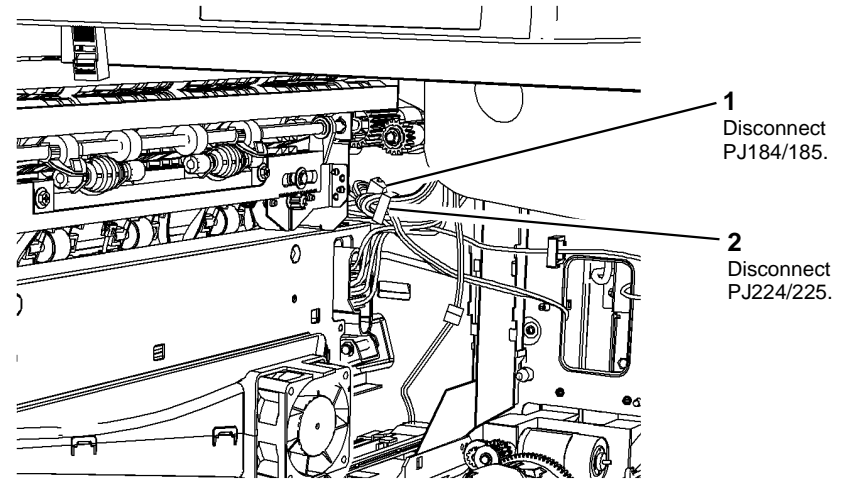
W-1-1027-A

- Disconnect the harnesses to the inverter, [Figure 1](#).

Figure 5 Harness disconnection

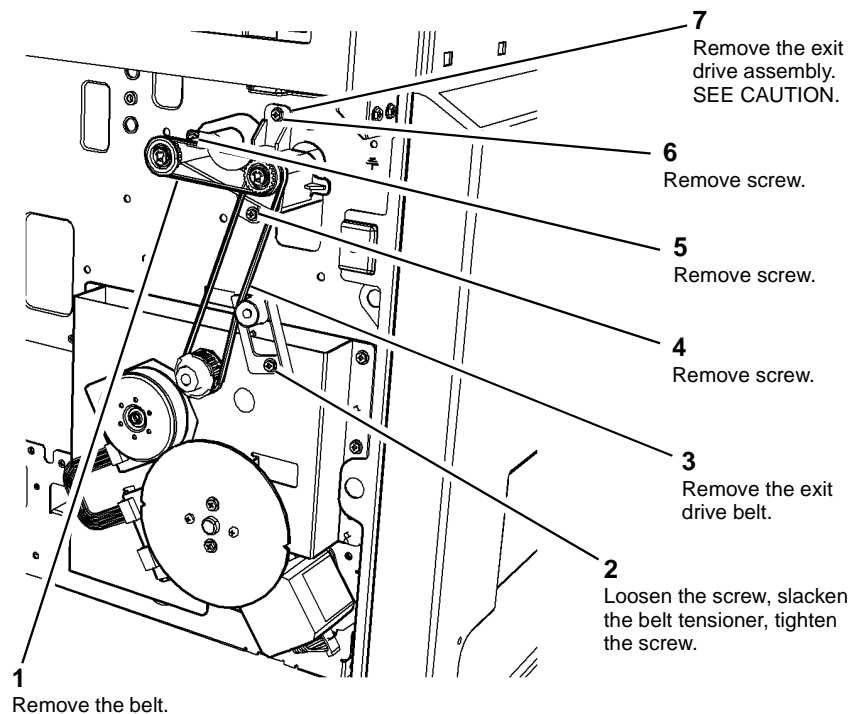
W-1-1028-A

Take care to not damage the wiring harness that passes over the top of the exit drive assembly, inside the rear frame.

2. Remove the exit drive assembly, [Figure 1](#).

Figure 1 Exit drive assembly removal

Screws must be replaced in the exact reverse of the removal order shown to ensure the optimum alignment of the exit drive assembly.

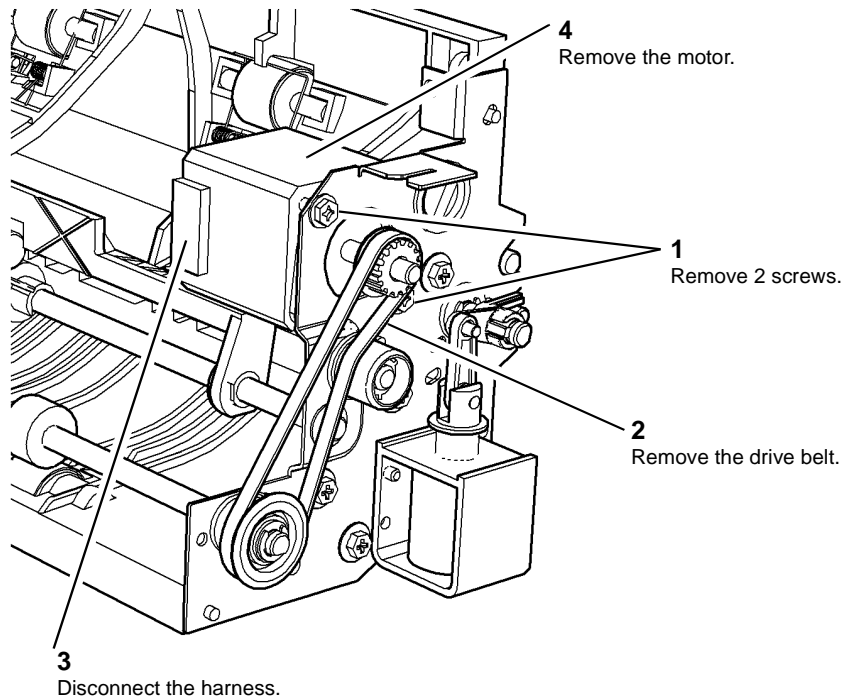
W-1-1030-A

1. Remove the inverter assembly, [REP 10.1](#).
2. Remove the inverter motor, [Figure 1](#).

Figure 1 Inverter motor removal

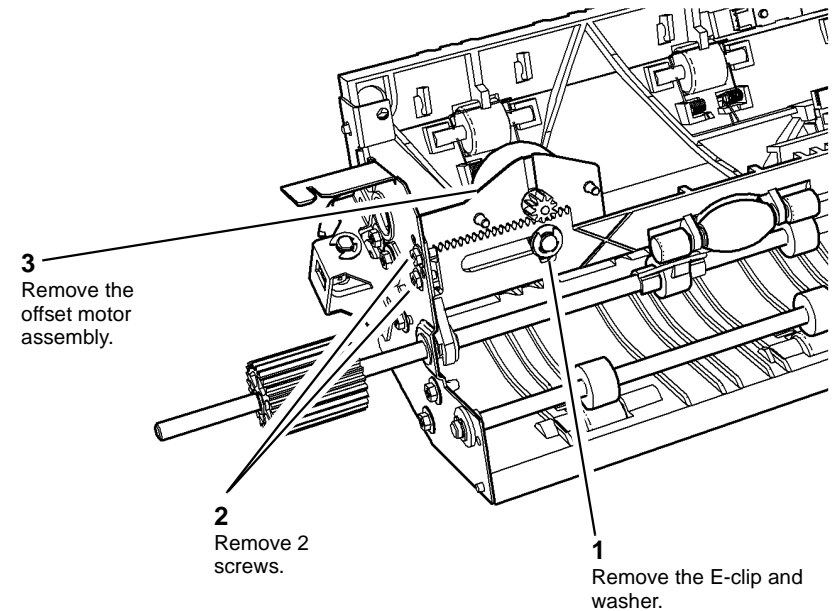
W-1-1031-A

1. Remove the inverter assembly, [REP 10.1](#).
2. Remove the offset motor assembly, [Figure 1](#).

Figure 1 Offset motor removal
