708P91139
February 2016

Xerox® WorkCentre® 5945 Family Multifunction Printer Service Manual

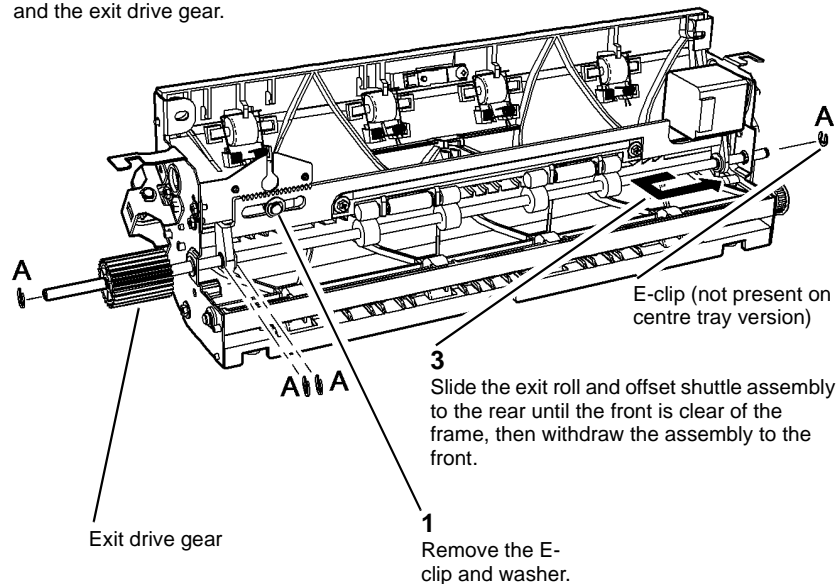
Remove 3 E-clips (centre tray) or 4 E-clips (horizontal transport) marked A, and the exit drive gear.

Figure 1 Shaft and shuttle removal

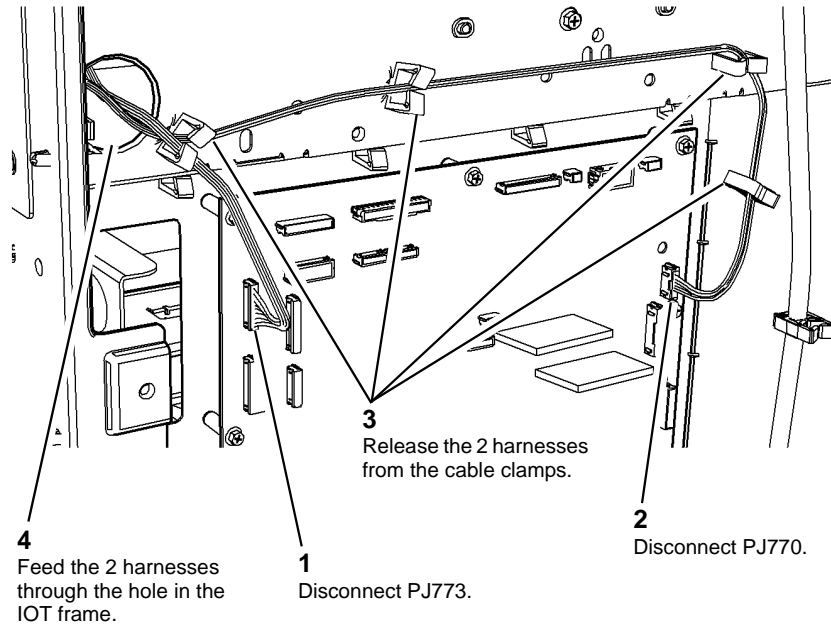
W-1-1356-A

3. Disconnect the harnesses to the horizontal transport assembly, [Figure 1](#).

Figure 1 Harness disconnection

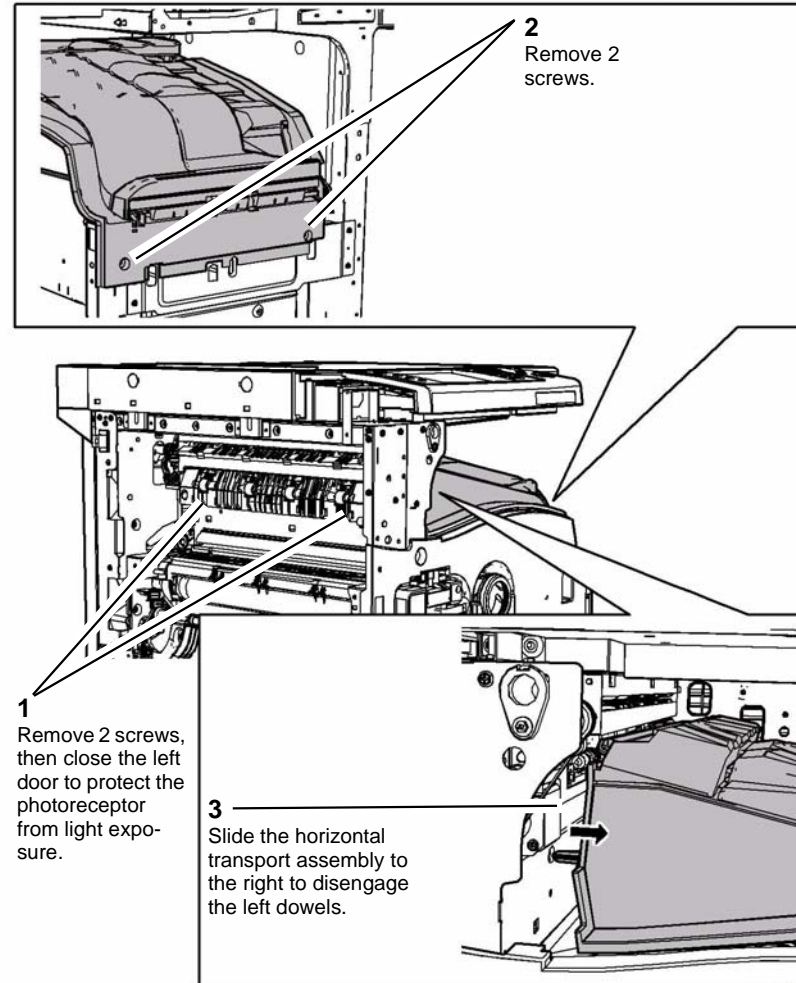
W-1-1095-A

8. Prepare to remove the horizontal transport assembly, [Figure 2](#).

Figure 2 Horizontal transport preparation

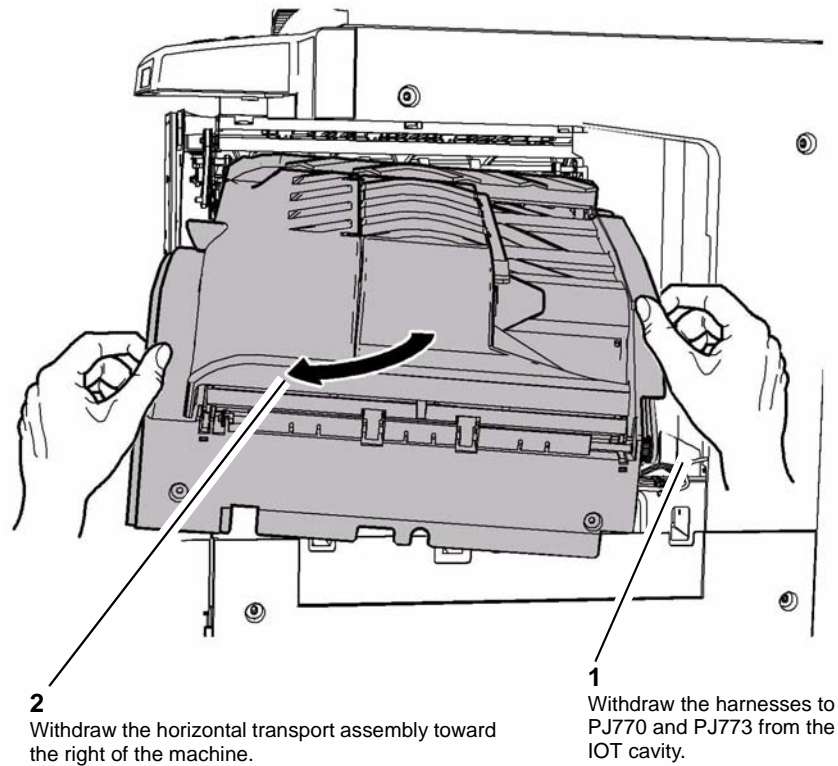
W-1-1318-A

9. Remove the horizontal transport assembly, [Figure 3](#).

Figure 3 Horizontal transport removal

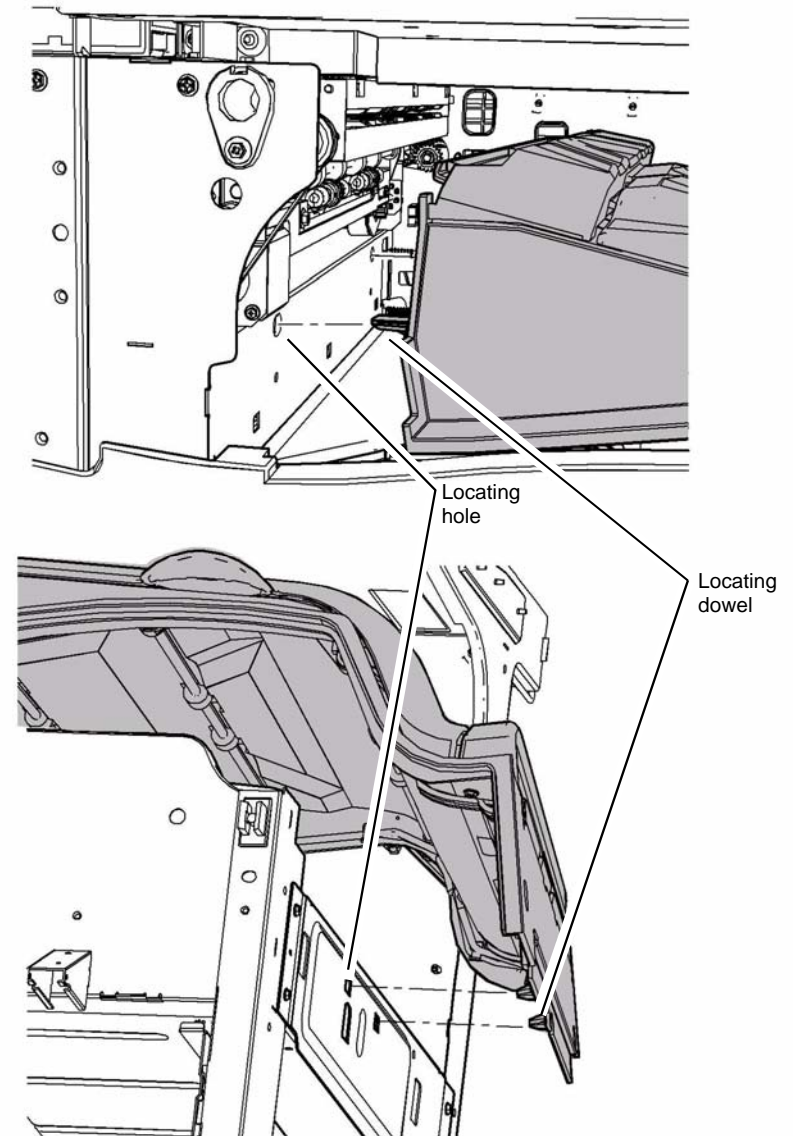
W-1-1097-A

2. Ensure that the dowels on the horizontal transport assembly align with the holes in the frame, [Figure 4](#).

Figure 4 Transport replacement

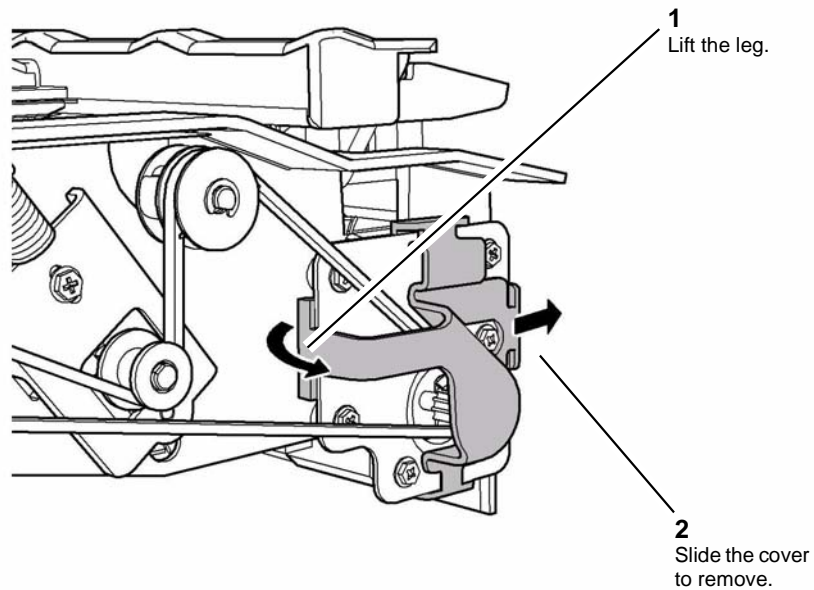
W-1-1406-B

1. Remove the horizontal transport assembly, [REP 10.6](#).
2. Remove the pulley cover, [Figure 1](#).

Figure 1 Pulley cover removal

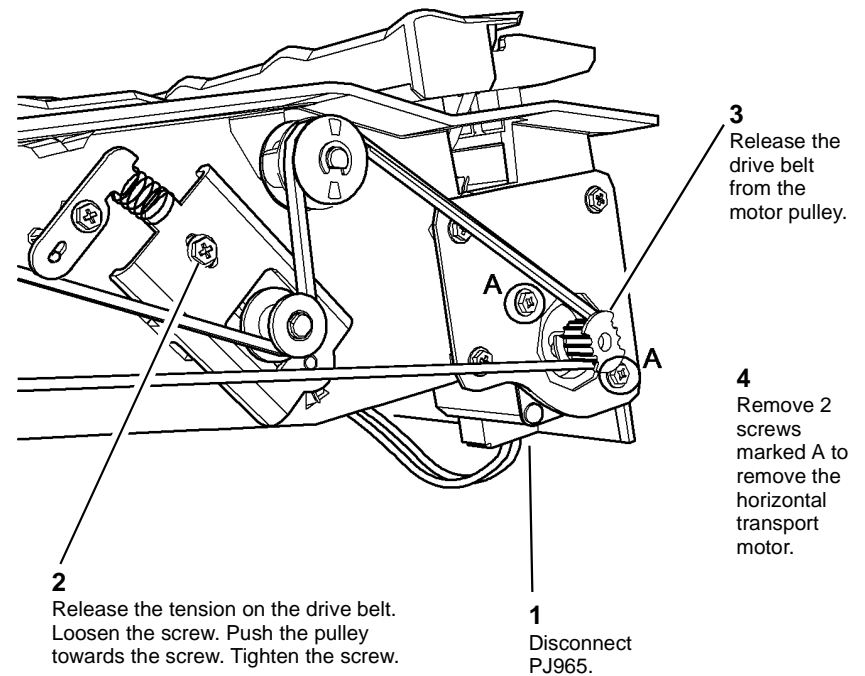
W-1-1096-A

3. Remove the horizontal transport motor or horizontal transport drive belt, as necessary, [Figure 2](#).

NOTE: If removing only the drive belt, perform steps 2 and 3 only in [Figure 2](#).

Figure 2 Motor or belt removal

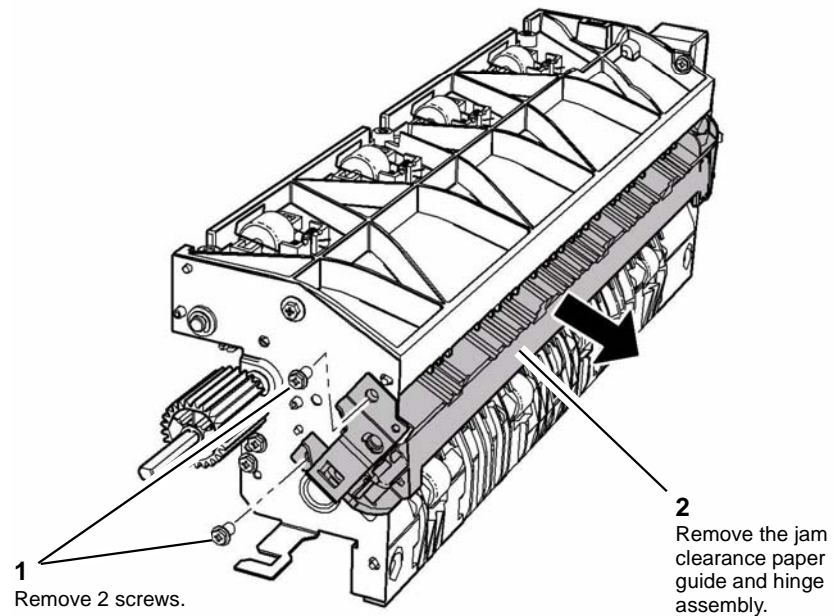
W-1-1452-A

1. Remove the Inverter Assembly, [REP 10.1](#).
2. Remove the jam clearance paper guide & hinge assembly, [Figure 1](#).

Figure 1 Assembly removal

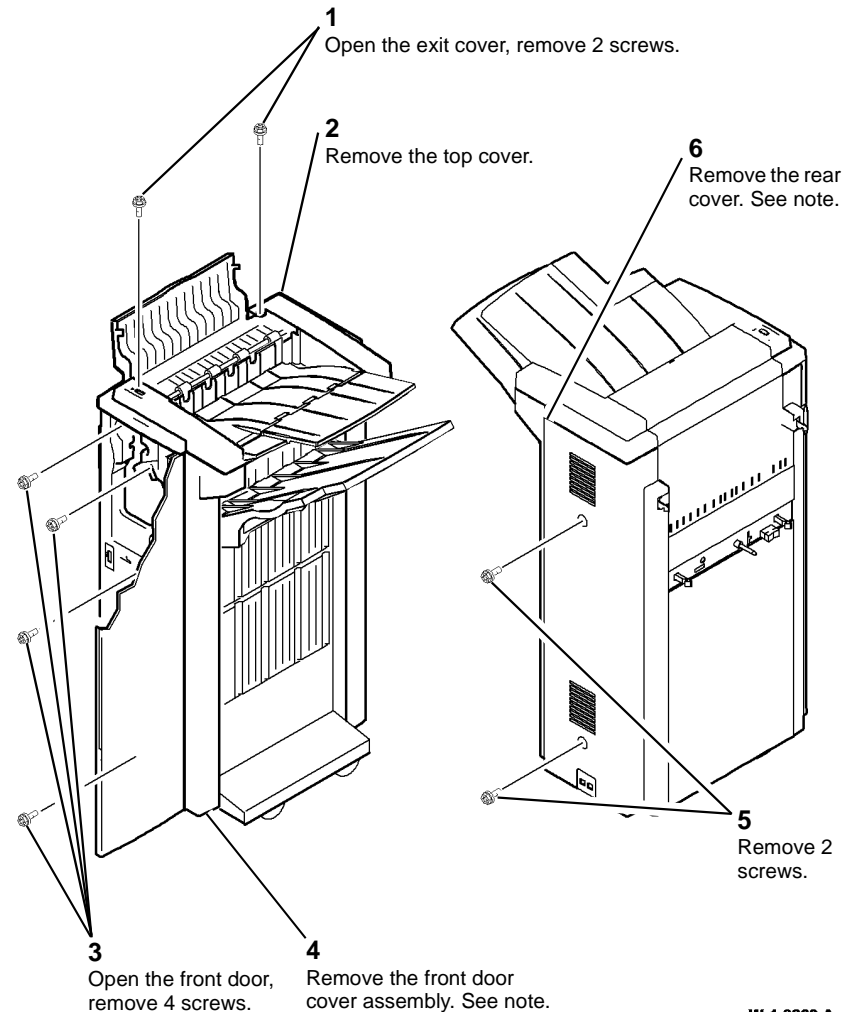
W-1-0263-A

NOTE: Later versions of the 2K LCSS rear cover and front door cover assembly may be additionally retained by protrusions that locate in holes in the frame edges. These protrusions are best released by pulling on the bottom section of the covers.

Remove the covers, Figure 1.

Figure 1 Covers removal

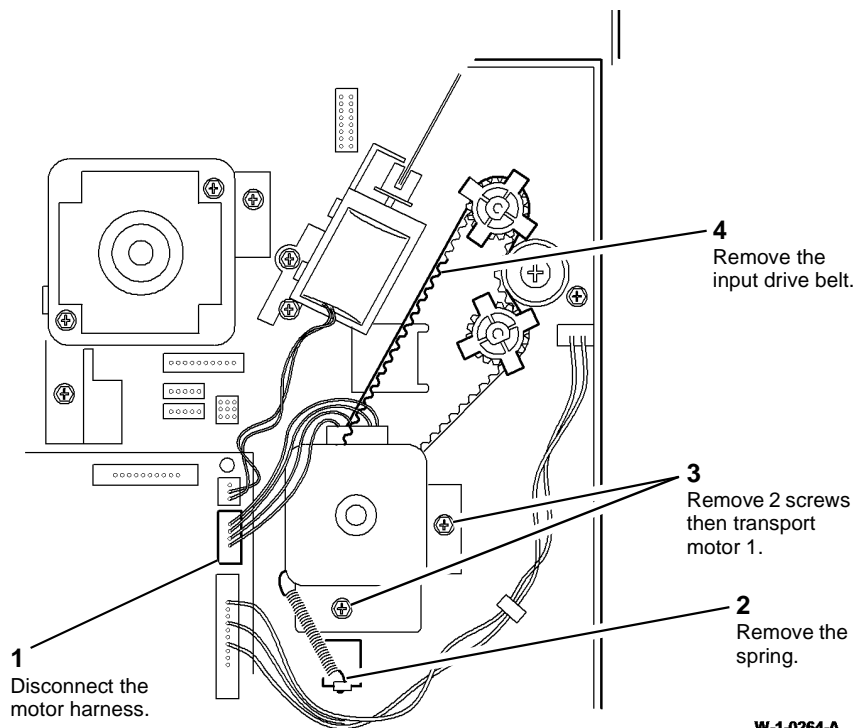
1. Place the input drive belt around the pulleys.
2. Install the motor screws, but do not tighten.
3. Install the spring
4. Rotate the shaft by hand to ensure the belt runs smoothly over the pulleys and allows the spring to tension the belt, [ADJ 12.4-110](#).
5. Tighten the motor screws and re-connect the harness.
6. Install the 2K LCSS top cover and rear cover, [REP 12.1-110](#).

Figure 1 Component removal

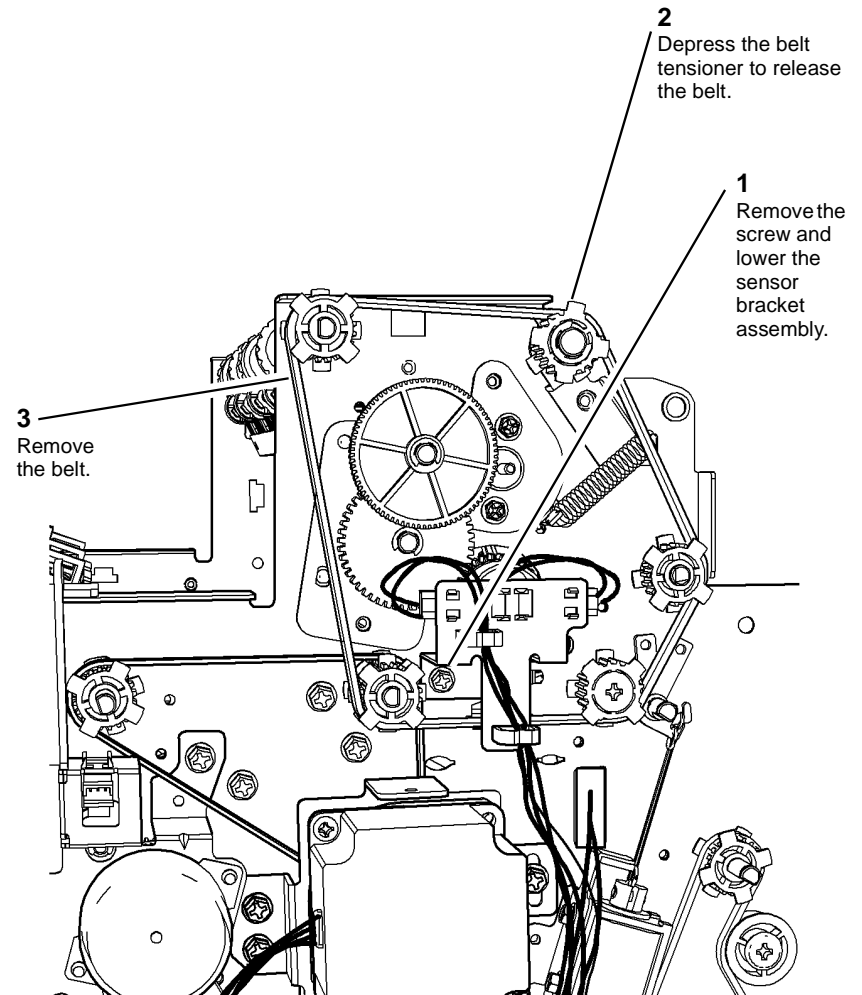
W-1-0265-A

1. Remove the 2K LCSS top cover and rear cover, [REP 12.1-110](#).
2. Remove the intermediate paper drive belt, [Figure 1](#).

Figure 1 Belt removal

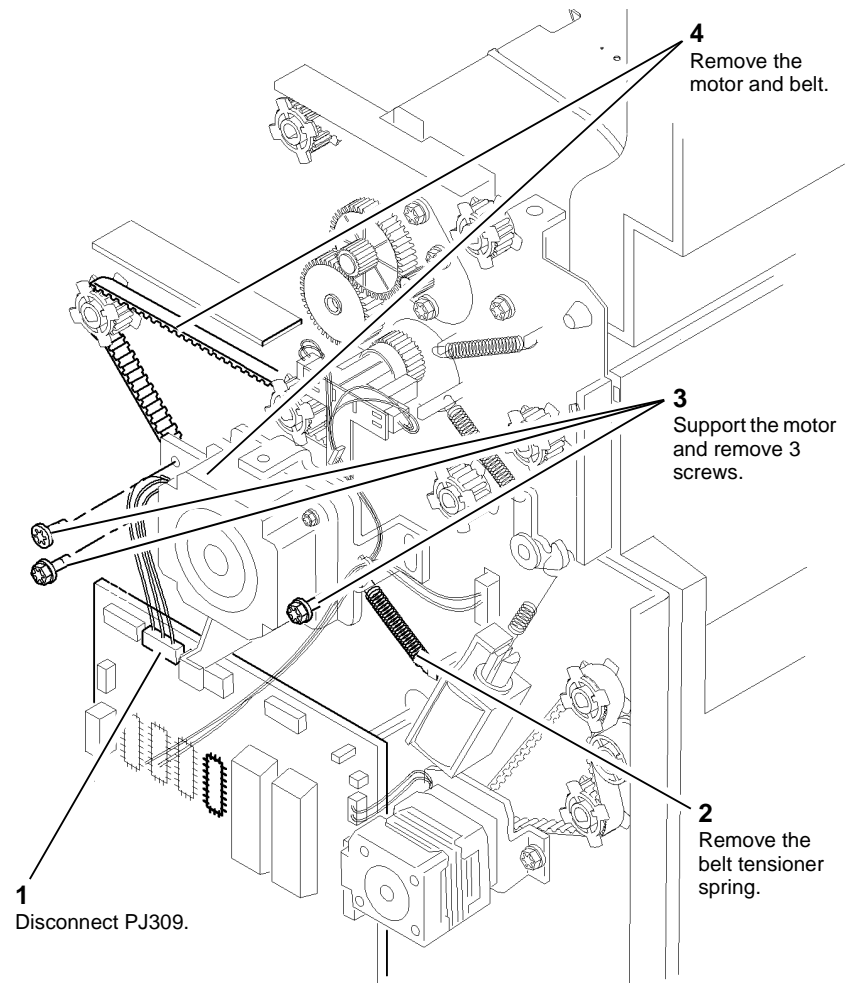
1. Remove the 2K LCSS top cover and rear cover, [REP 12.1-110](#).
2. Remove the intermediate paper drive belt, [REP 12.3-110](#).
3. Remove the paper output drive belt and transport motor 2, [Figure 1](#).

Figure 1 Component removal

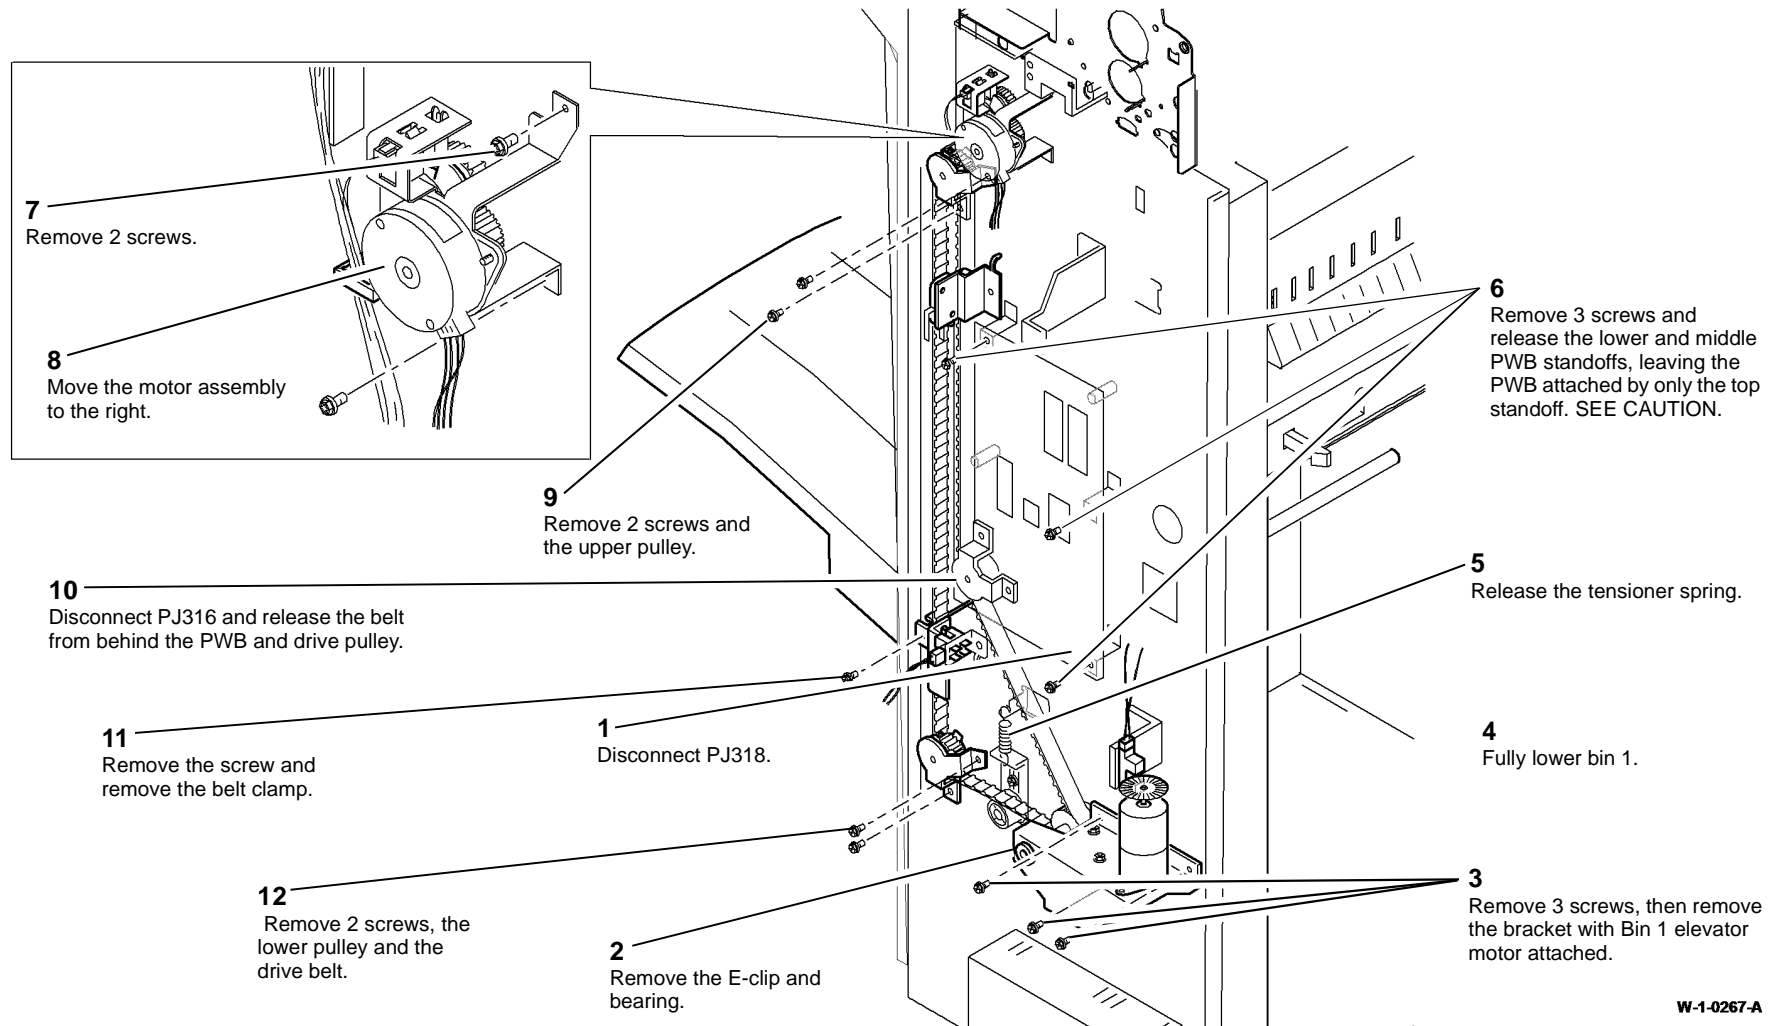
W-1-0267-A

2. Remove the bin 1 drive belt (rear) [Figure 1](#).

NOTE: Keep all of the rear components removed as a set. The set of rear frame components are different from the front frame set.

Figure 1 Rear belt removal

Ensure that ESD procedures are observed during step 6 of [Figure 1](#).

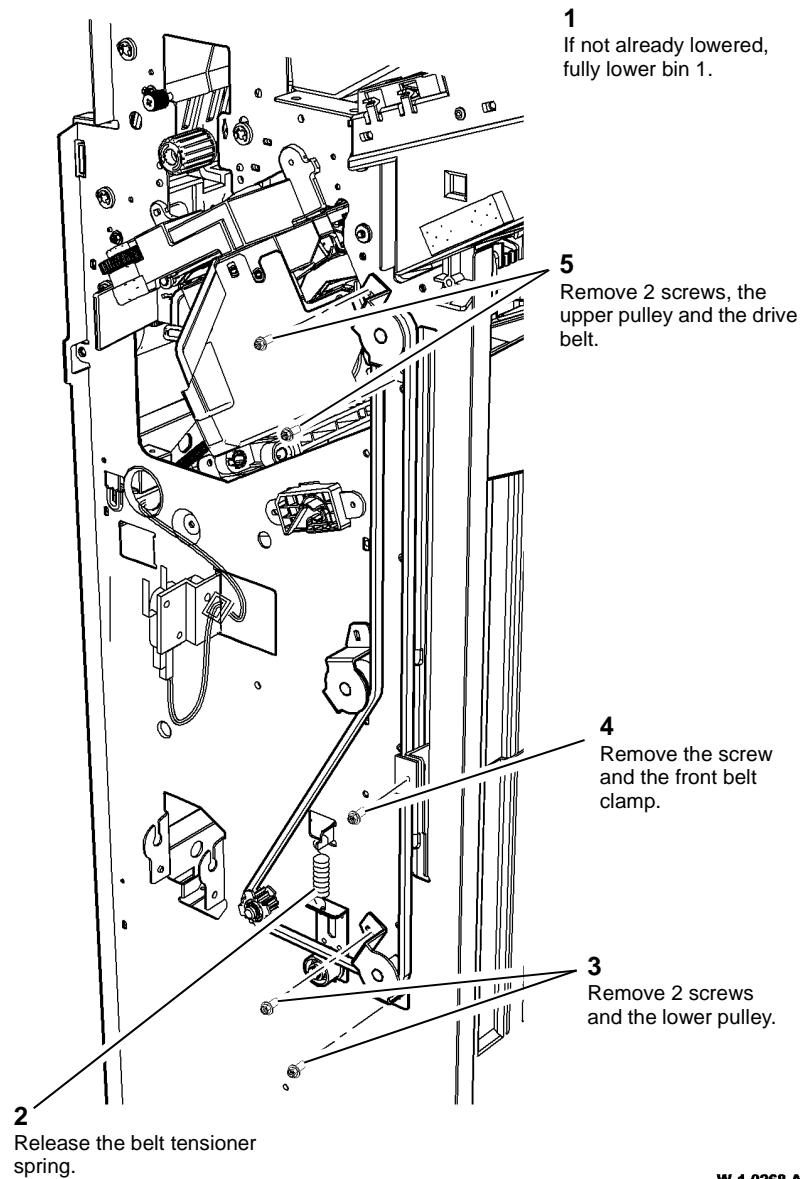
W-1-0268-A

3. Remove the bin 1 drive belt (front) [Figure 2](#).

NOTE: Keep all of the front components removed as a set. The set of front frame components are different from the rear frame set.

Figure 2 Front belt removal

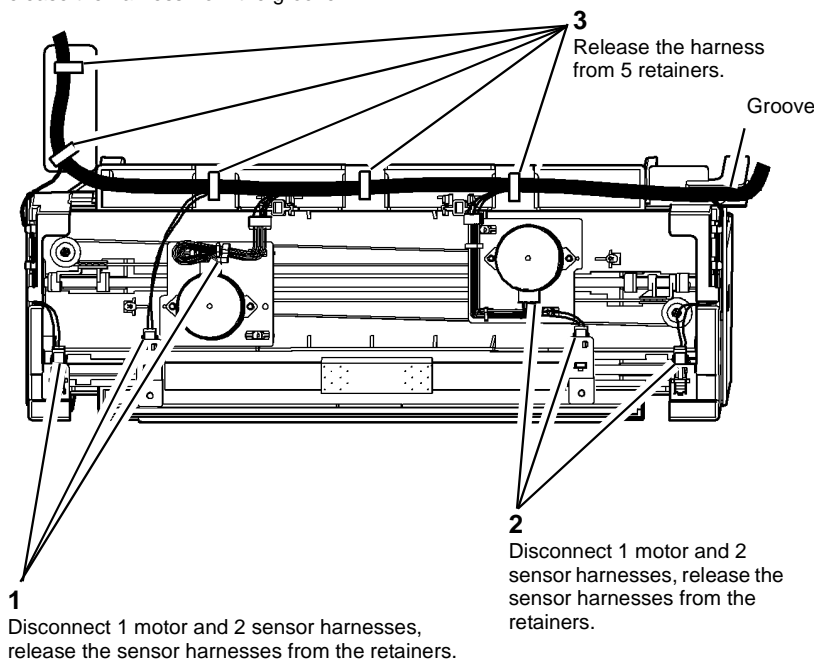
W-1-0269-A

1. Remove the 2K LCSS covers, [REP 12.1-110](#).
2. Prepare to remove the tamper assembly, [Figure 1](#).

4. Release the harness from the groove.

Figure 1 Preparation

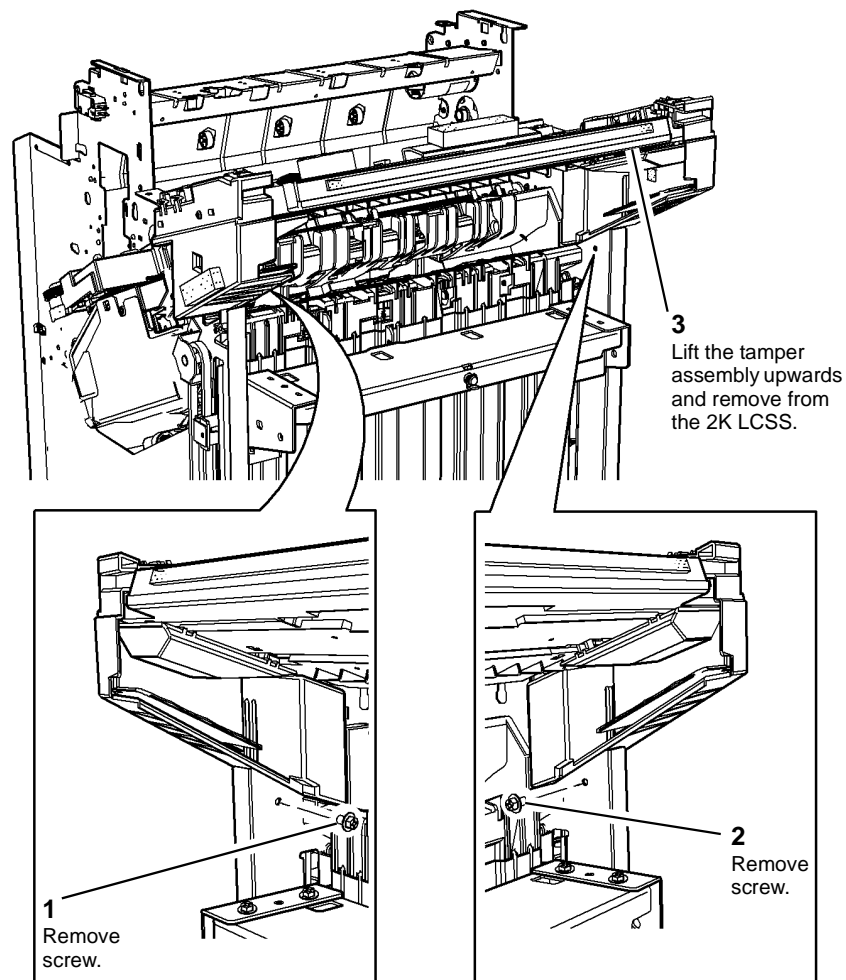
3. Remove the tamper assembly, [Figure 2](#).

NOTE: For clarity, bin 1, [PL 12.10 Item 10](#) has been omitted from [Figure 2](#).

Figure 2 Tamper assembly removal

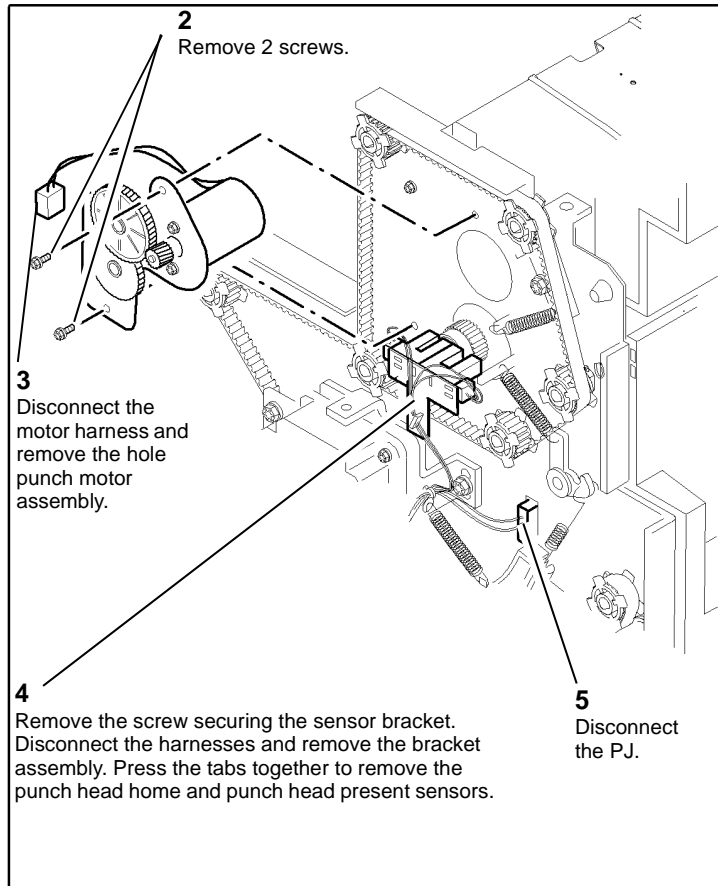
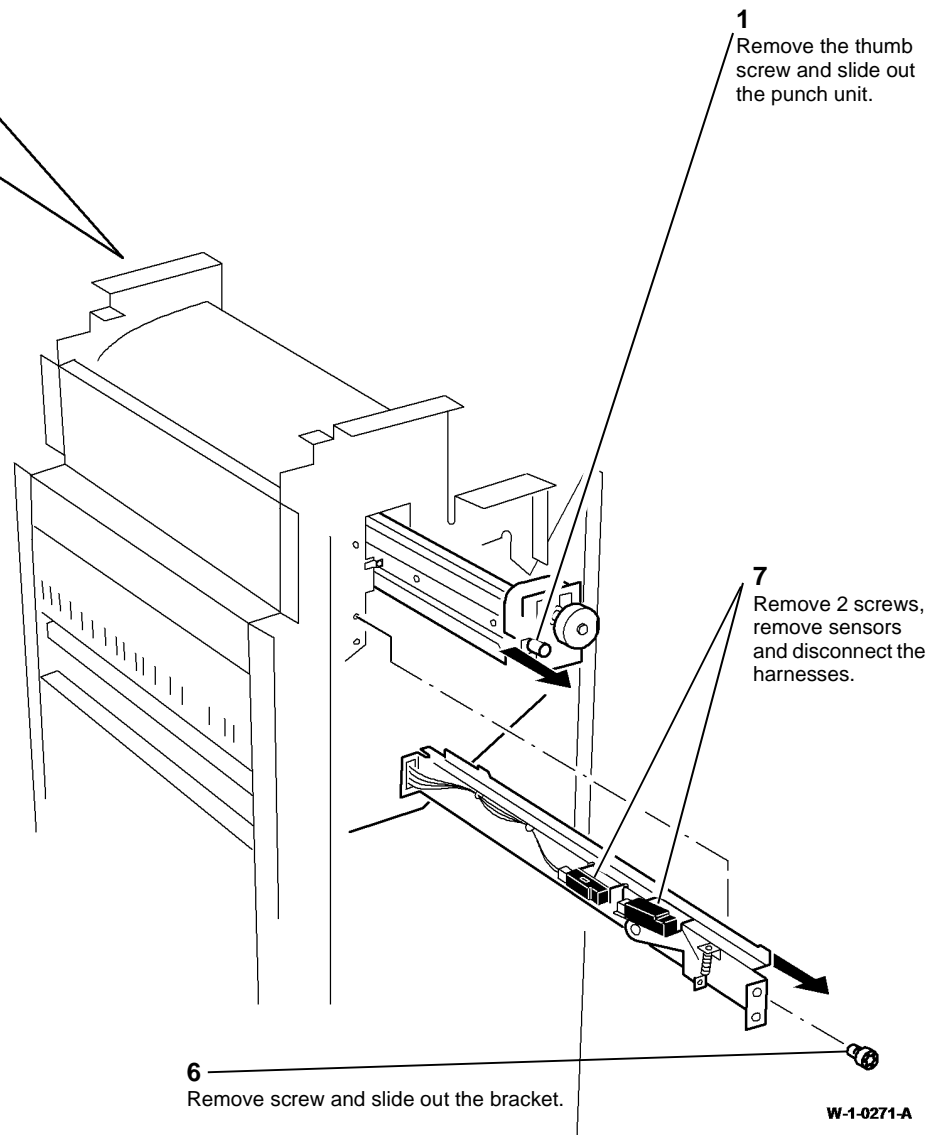
1. Remove the 2K LCSS covers, [REP 12.1-110](#).
2. Remove and empty the chad bin, [PL 12.20 Item 4](#).
3. Remove the hole punch unit, motor assembly and sensors, [Figure 1](#).

Figure 1 Component removal

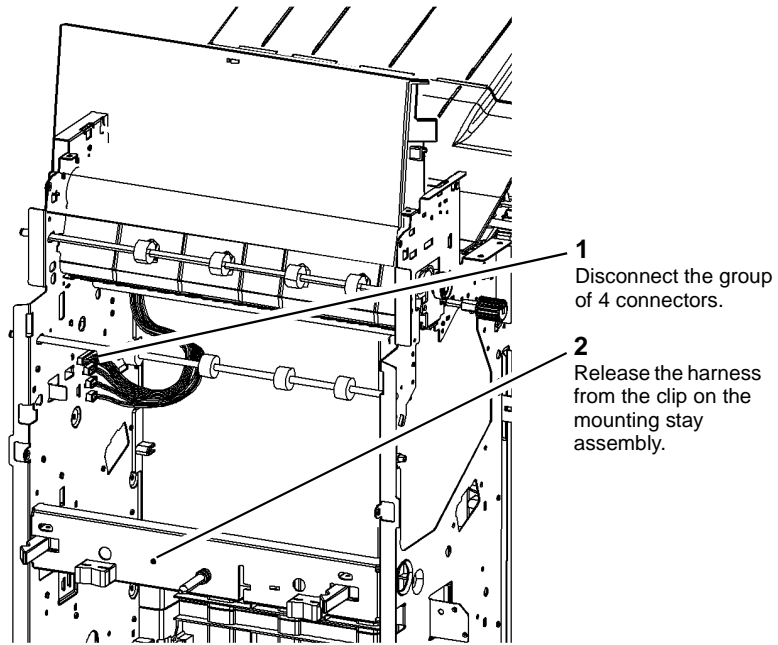
W-1-0272-A

5. Disconnect the harness, [Figure 1](#).

Figure 1 Harness disconnection

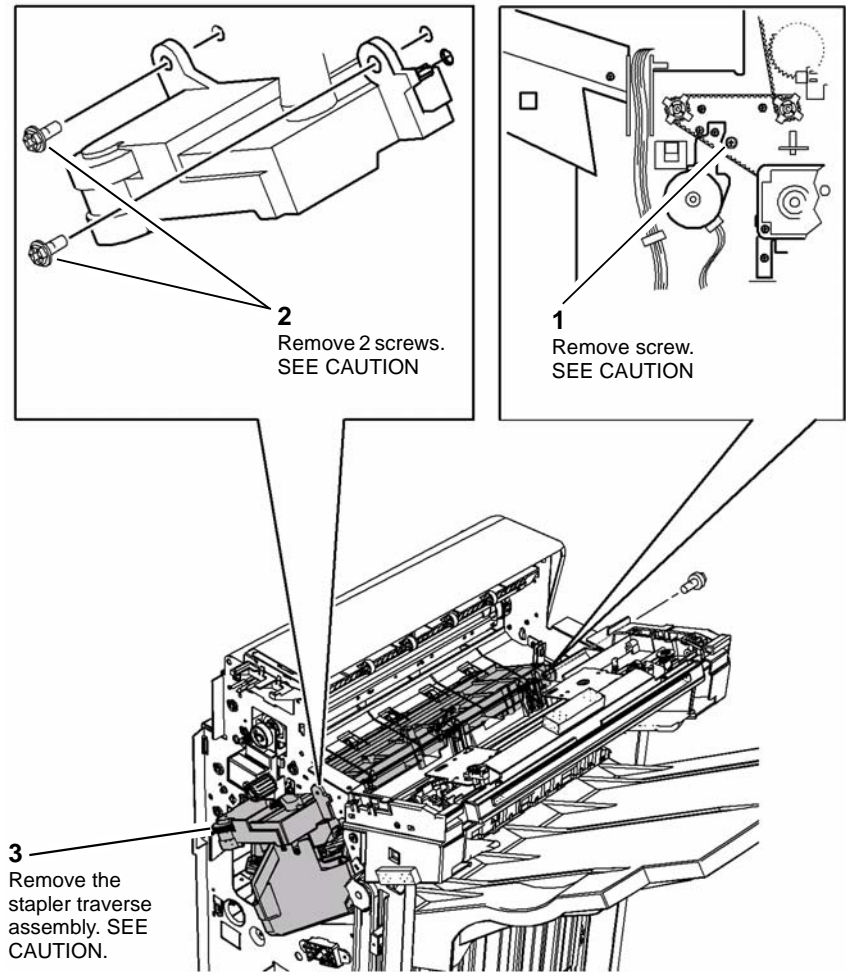
W-1-0273-A

When removing and replacing the stapler traverse assembly, support the weight of the assembly underneath the stapler and take care not to damage the wiring.

6. Remove the stapler traverse assembly, [Figure 2](#).

Figure 2 Traverse assembly removal

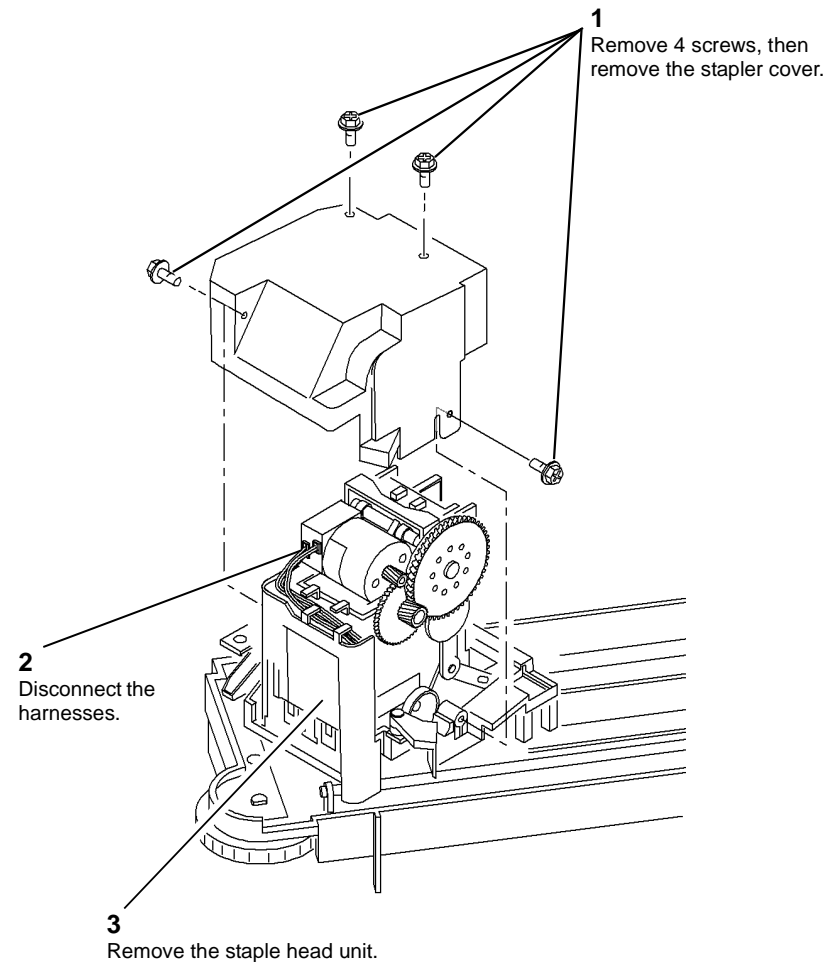
W-1-0274-A

1. Remove the stapler traverse assembly, [REP 12.8-110](#).
2. Place the stapler traverse unit upside-down.
3. Remove the staple head unit from the stapler traverse assembly [Figure 1](#).

Figure 1 Staple head unit removal

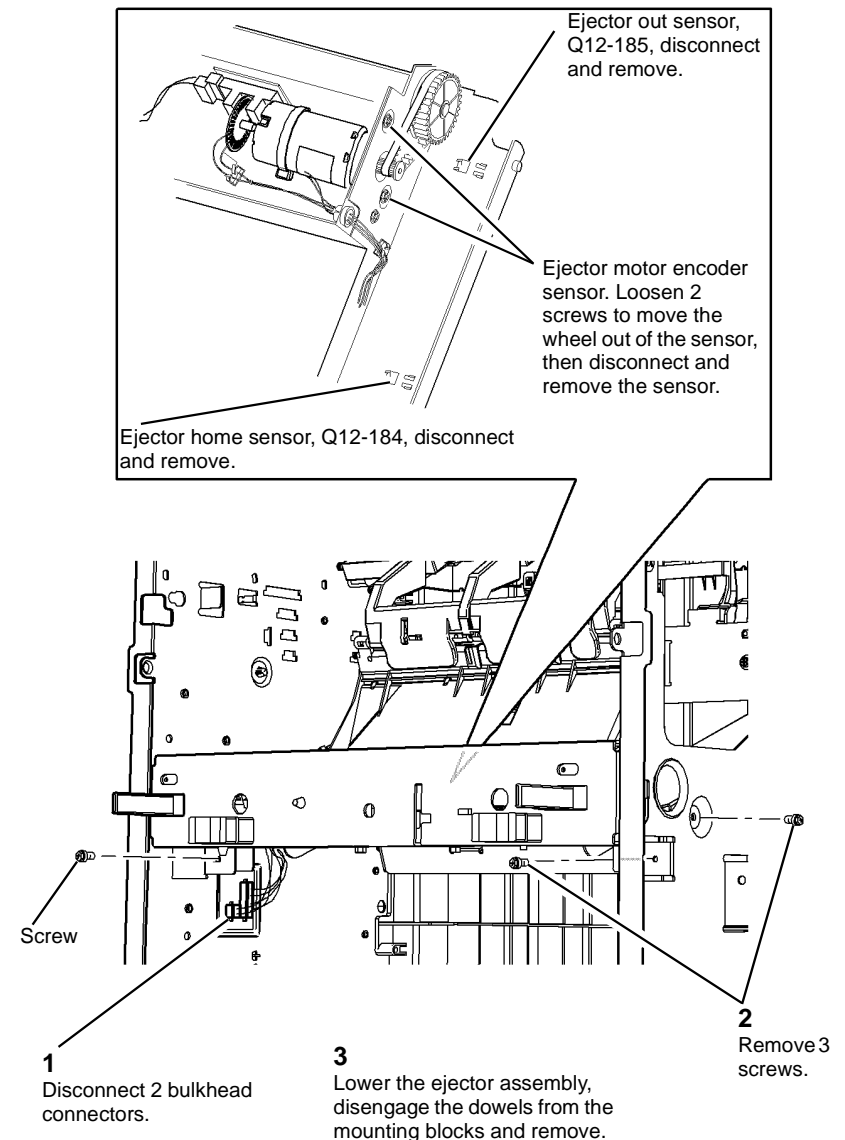
W-1-0275-A

NOTE: The home position of the stapling unit is when the staple head unit is at the corner stapling position (fully to the front of the 2K LCSS and rotated through 45 degrees).

1. Disconnect the 2 harnesses between the 2K LCSS and the machine.
2. Un-dock the 2K LCSS, REP 12.13-110 and move it away from the machine.
3. Remove the top cover and front door cover assembly, REP 12.1-110.
4. Ensure the stapling unit is at the home position.
5. If necessary, manually move the ejector to the home (left) position.
6. Figure 1, remove the ejector assembly.

Figure 1 Ejector assembly removal

When installing the ejector assembly onto the 2K LCSS, ensure that the ejector fingers do not damage the wiring to the staple head unit.

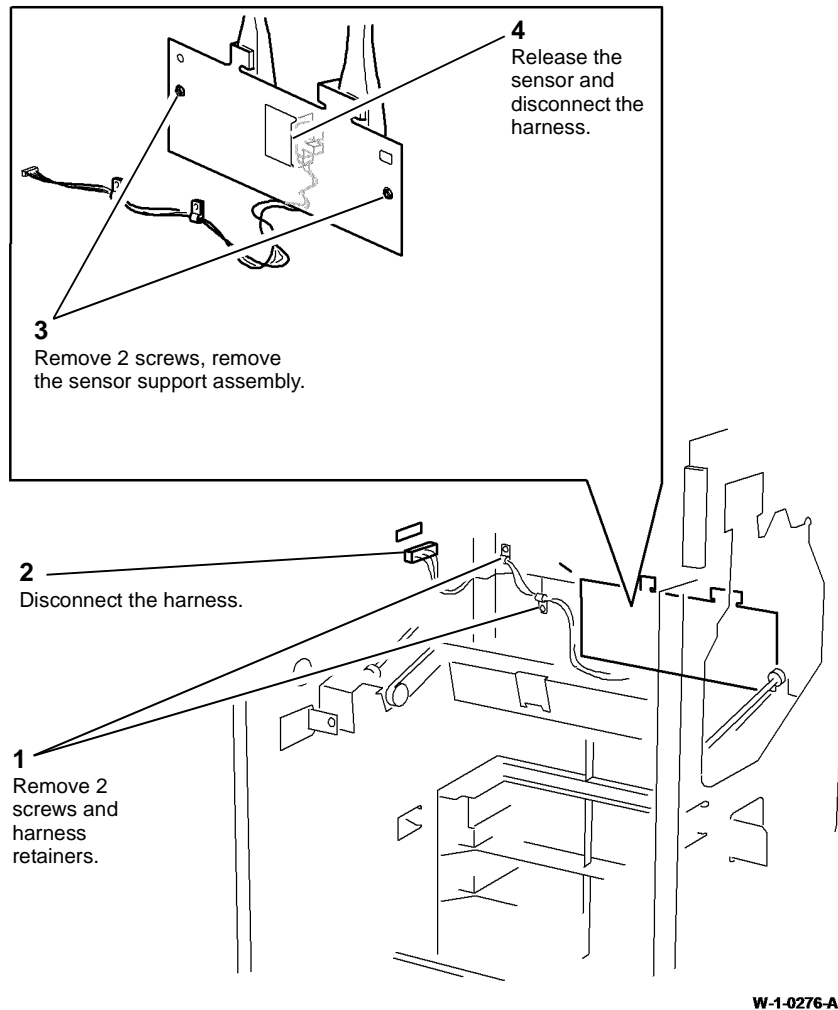
2. Remove the bin 1 upper level sensor, [Figure 1](#).

Figure 1 Removal

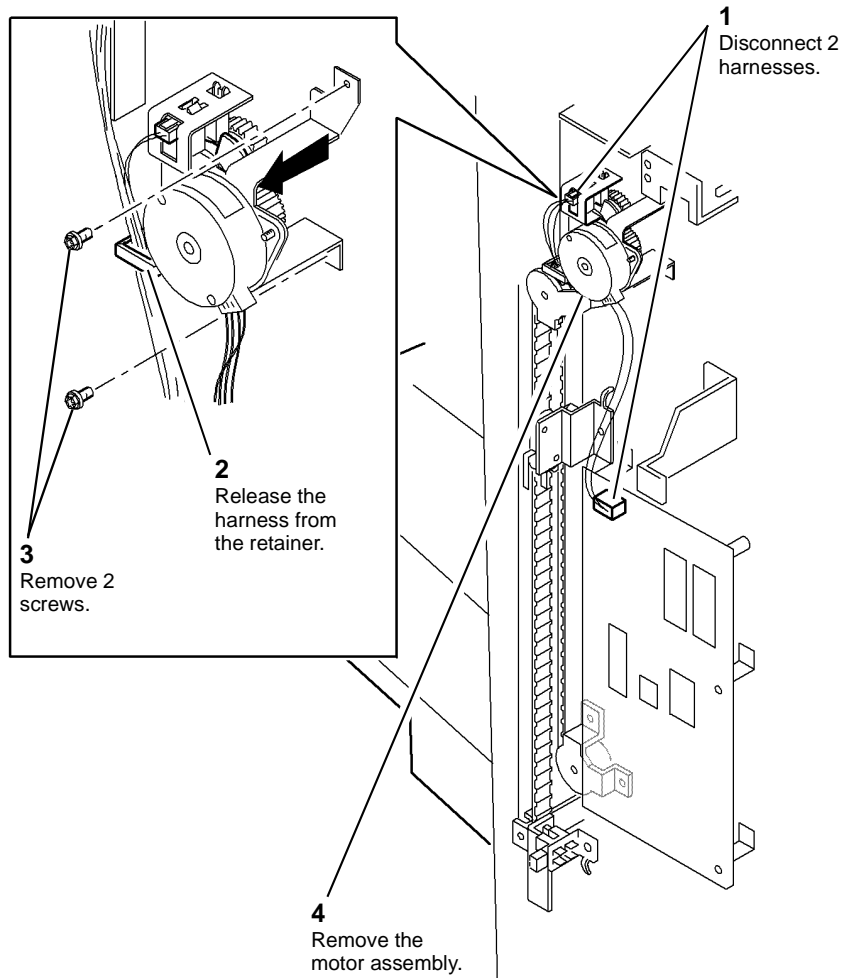
W-1-0277-A

3. Remove the paddle motor assembly, **Figure 1**.

Figure 1 Paddle motor removal

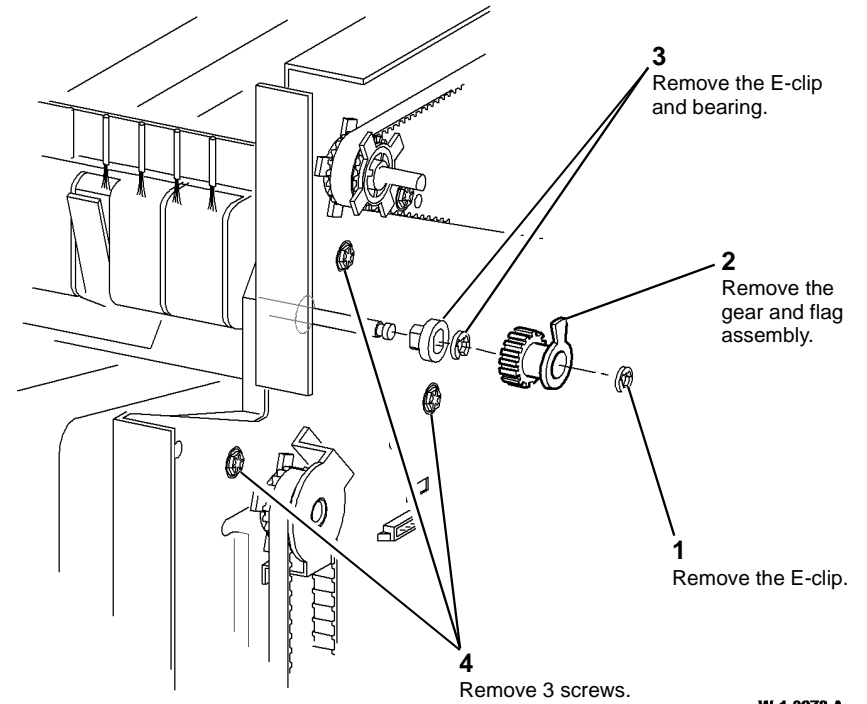
W-1-0278-A

4. Prepare to remove the rear components, **Figure 2**.

Figure 2 Rear preparation

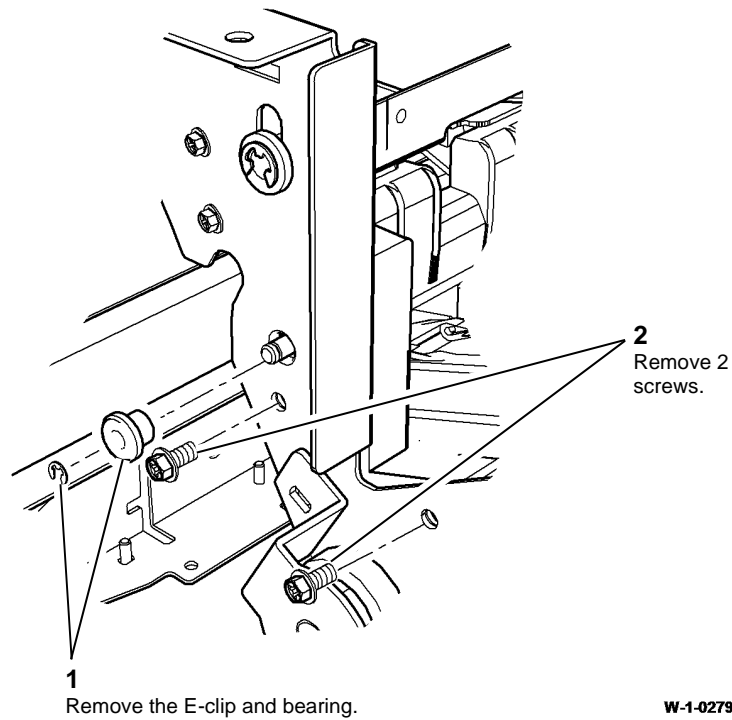
Figure 3 Front preparation

5. Prepare to remove the front components, [Figure 3](#).

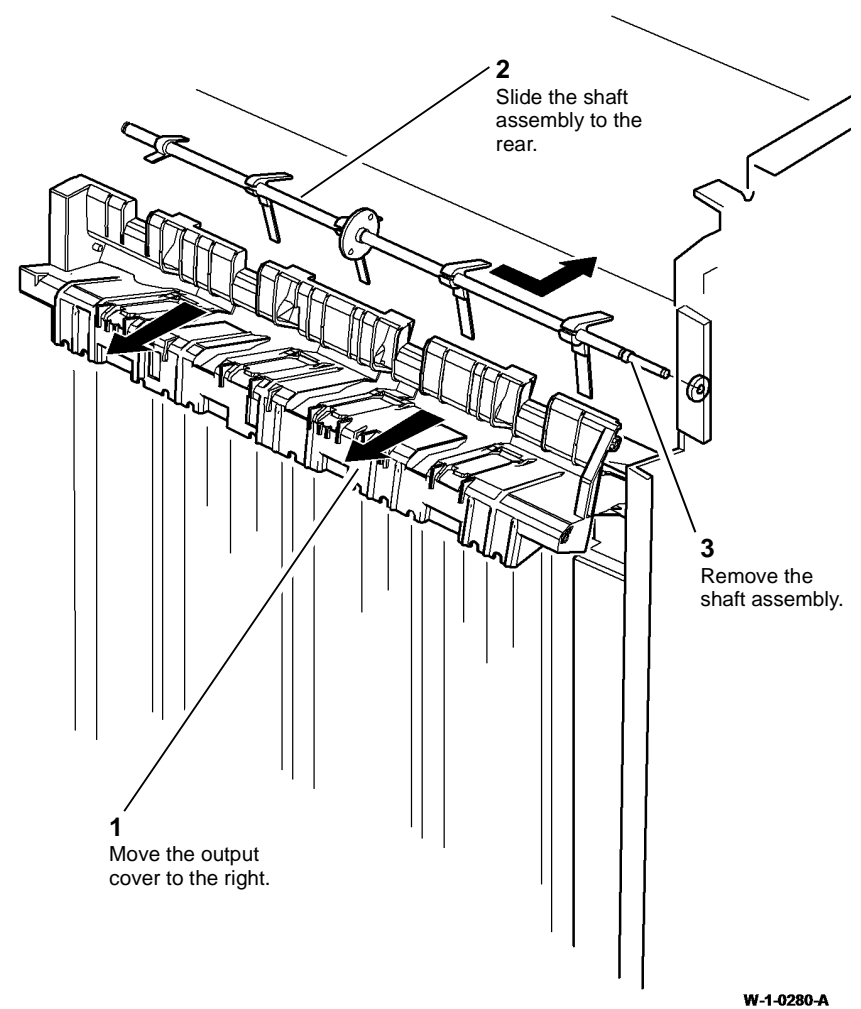
Figure 4 Paddle shaft removal

7. Remove the paddle shaft assembly, [Figure 4](#).

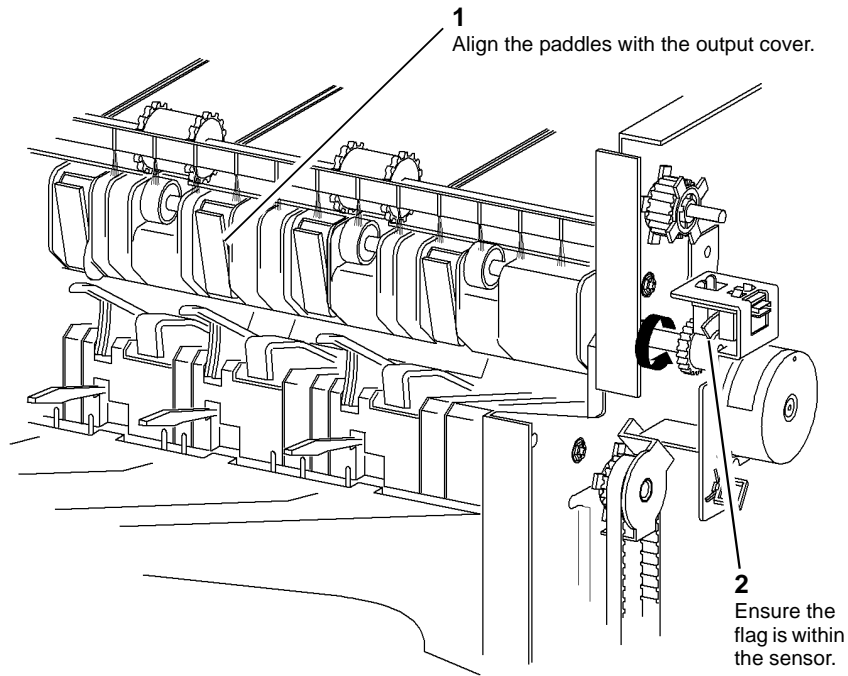
Figure 5 Paddle alignment

6. Ensure the paddles and flag are correctly aligned, [Figure 5](#).
