708P91139
February 2016

Xerox® WorkCentre® 5945 Family Multifunction Printer Service Manual

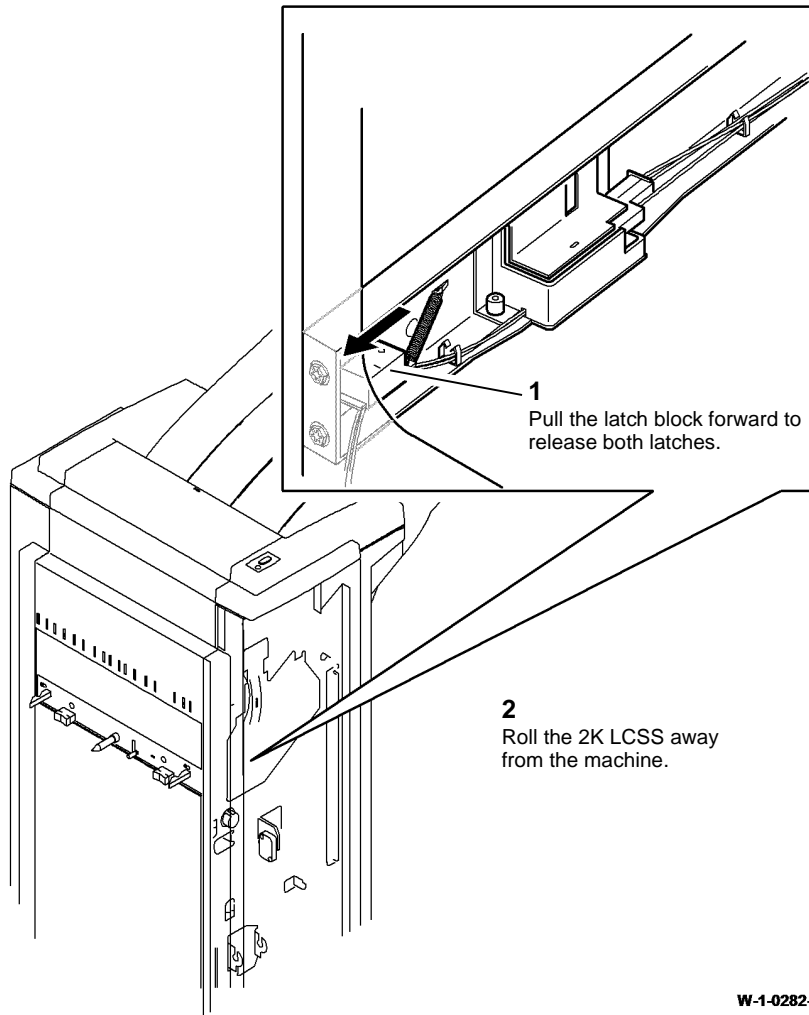
Figure 1 Docking latch assembly

3. Release the 2K LCSS docking latch assembly, [Figure 1](#).

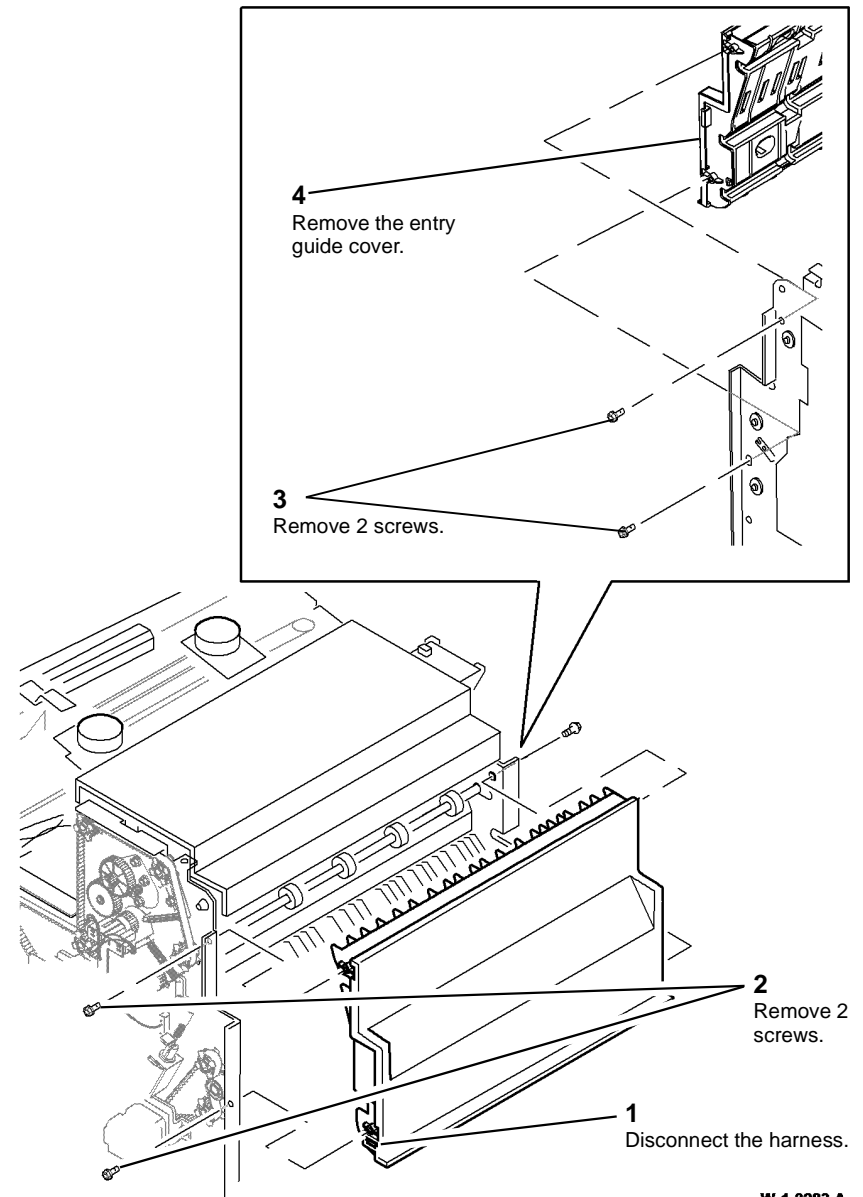
Figure 1 Entry guide cover removal

1. Un-dock the 2K LCSS, [REP 12.13-110](#) and move it away from the machine.
2. Remove the 2K LCSS covers, [REP 12.1-110](#).
3. Remove the entry guide cover, [Figure 1](#).

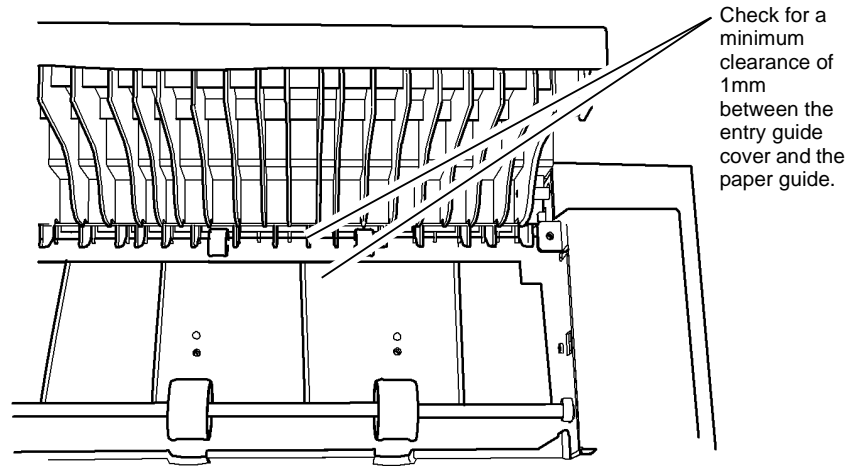
Figure 2 Entry guide cover clearance

1. Bias the entry guide cover away from the paper guide when you tighten the screws.
2. The clearance between the entry guide cover and the paper guide must be a minimum of 1 mm. Refer to [Figure 2](#).

NOTE: If the clearance is less than 1 mm, then install a new entry guide cover.

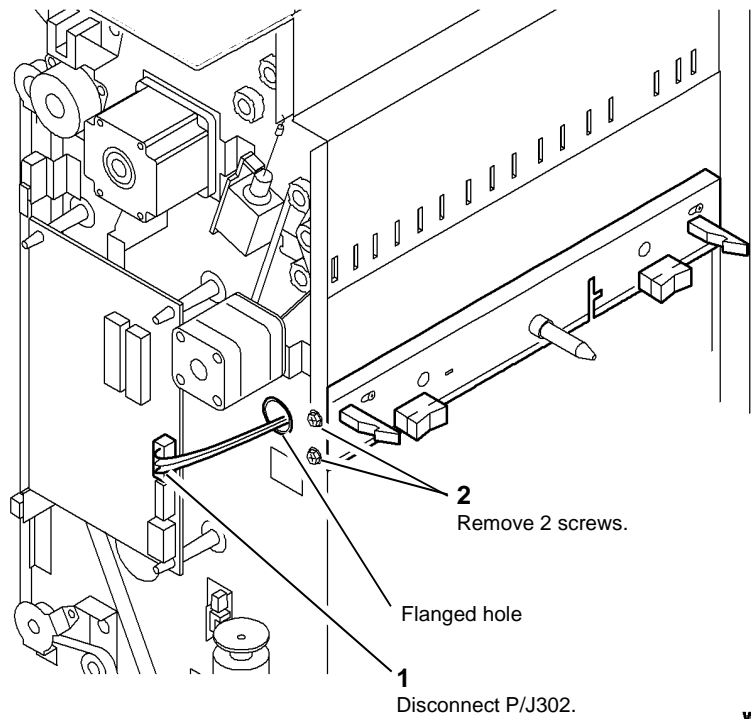
Figure 1 Preparation

3. Prepare to remove the docking latch assembly, [Figure 1](#).

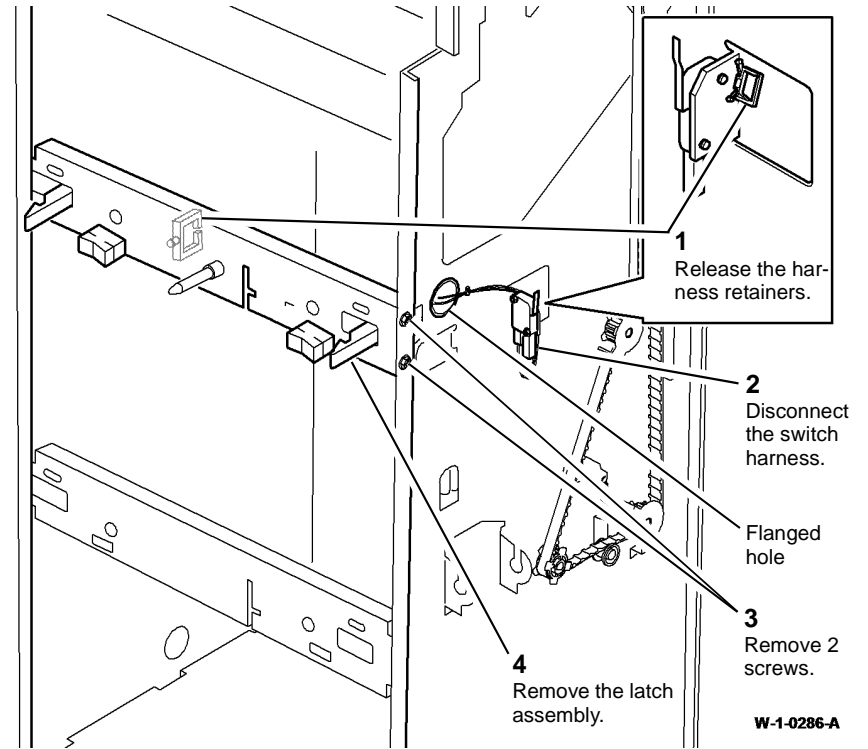
Figure 2 Latch assembly removal.

4. Remove the docking latch assembly, [Figure 2](#).

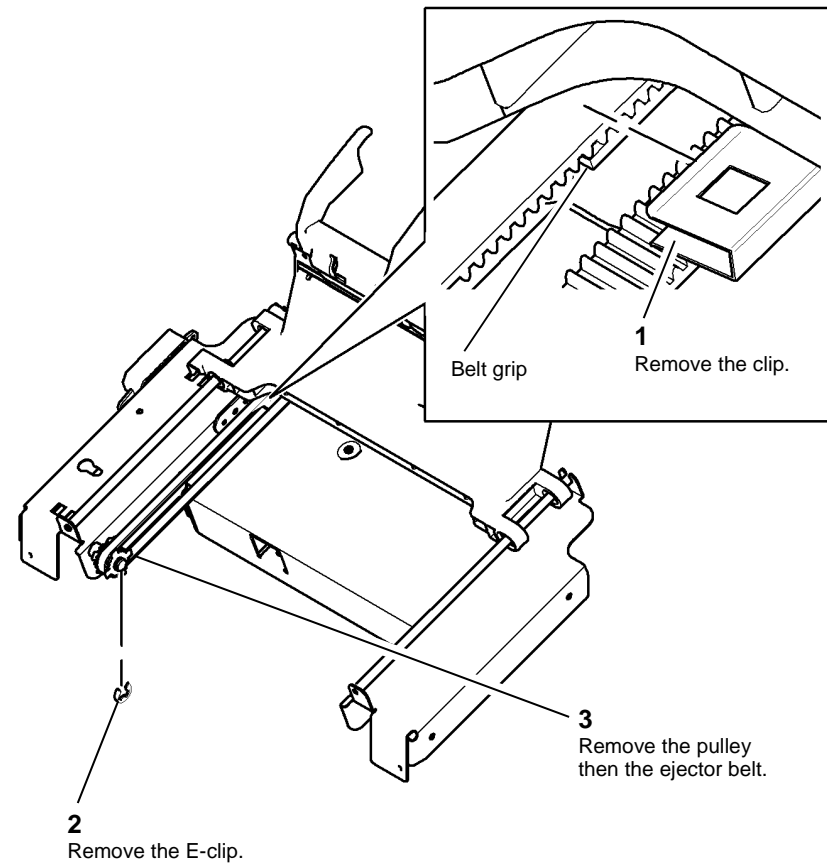
Figure 1 Ejector belt removal

1. Remove the ejector assembly, refer to [REP 12.10-110](#).
2. Remove the ejector belt, [Figure 1](#).

The replacement is the reverse of the removal procedure. Ensure that the ejector belt is correctly engaged with the belt grip on the ejector assembly before the clip is re-installed. Refer to [Figure 1](#).

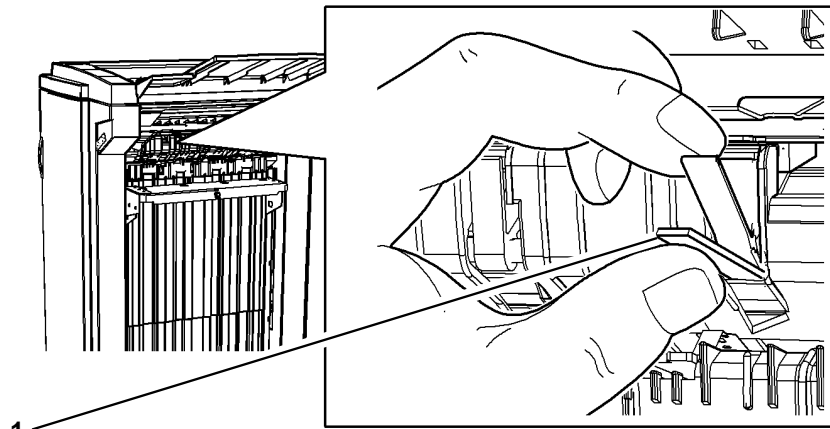
4. Remove the paddles, [Figure 1](#).

1 Squeeze the rubber blades together and pull the paddle from the shaft

To ensure that the correct home position of the paddle shaft assembly is maintained, remove the old paddles and install the new paddles one at a time.

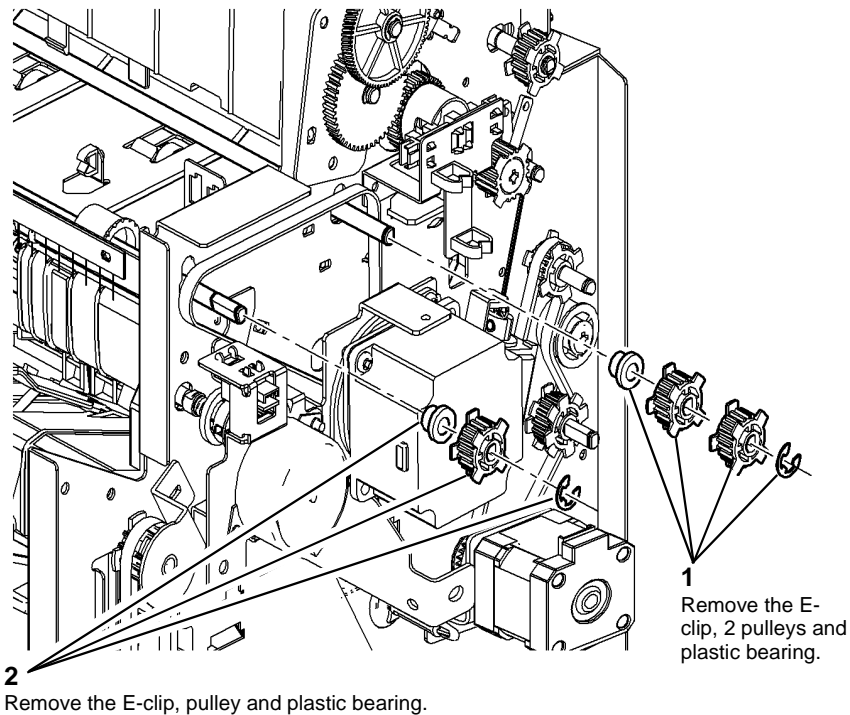
Figure 1 Preparation

1. Remove the 2K LCSS covers, [REP 12.1-110](#).
2. Remove the tamper assembly, [REP 12.6-110](#).
3. Remove the paper output drive belt, [REP 12.4-110](#).
4. Loosen the fixing screws on transport motor 2, [PL 12.60 Item 5](#).
5. Prepare to remove the drive shafts [Figure 1](#).

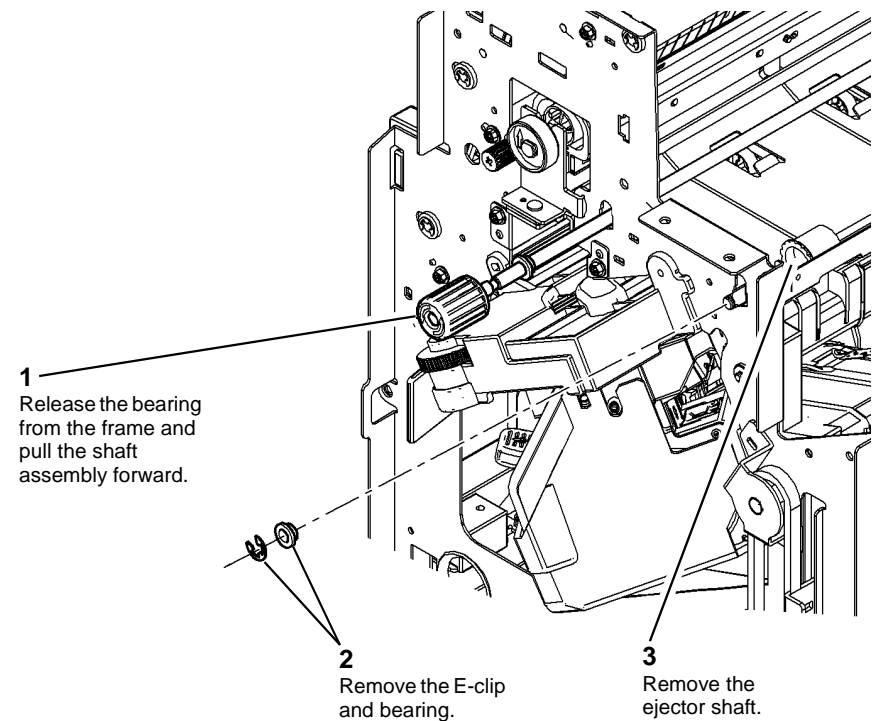
Figure 2 Ejector shaft removal

6. Remove the ejector drive shaft, [Figure 2](#).

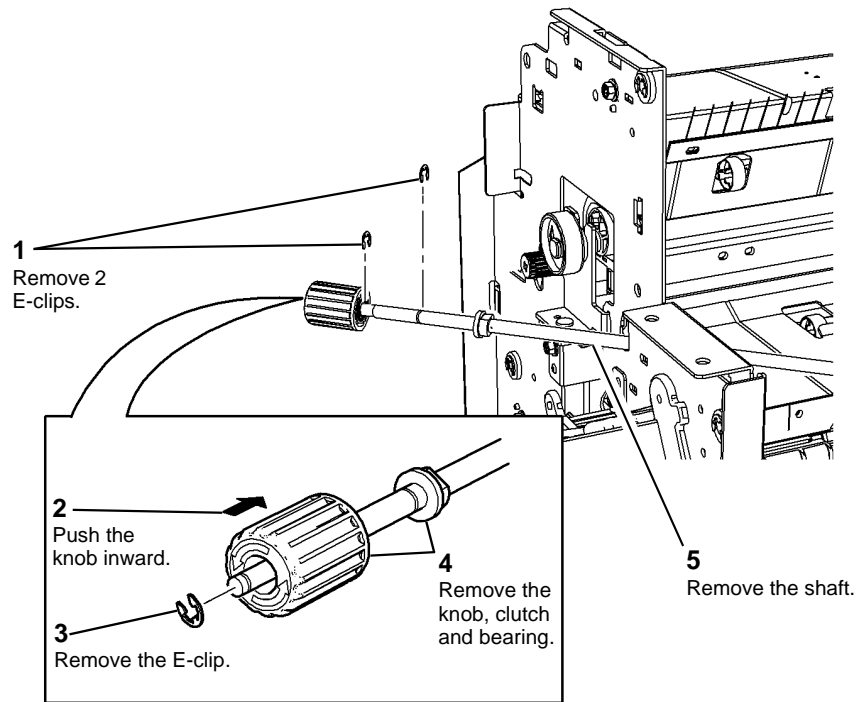
Figure 3 Drive shaft removal

7. Remove the drive shaft, [Figure 3](#).

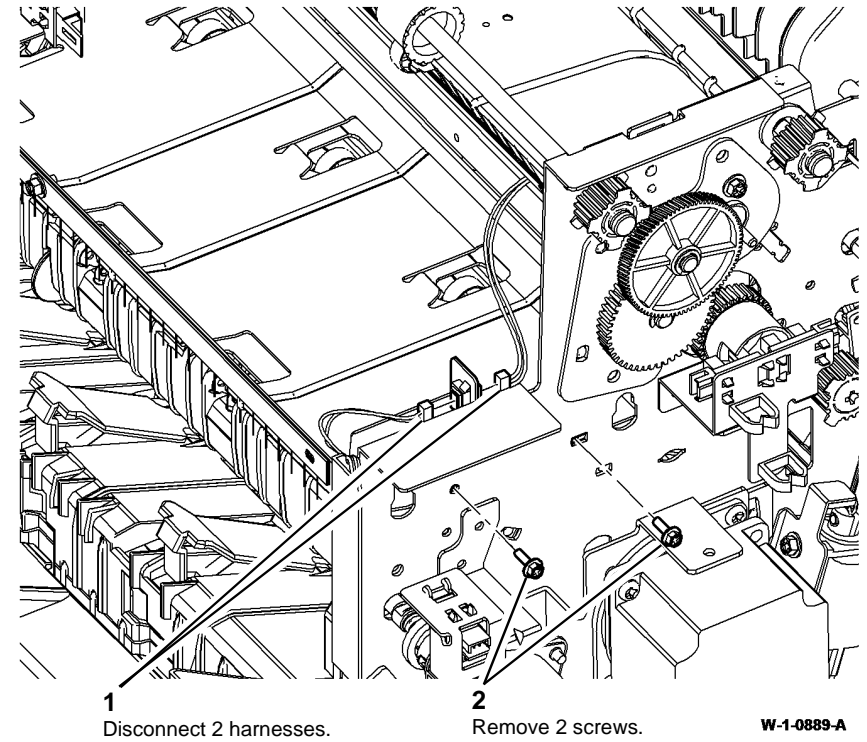
Figure 4 Preparation

8. Prepare to remove the upper right paper guide, [Figure 4](#).

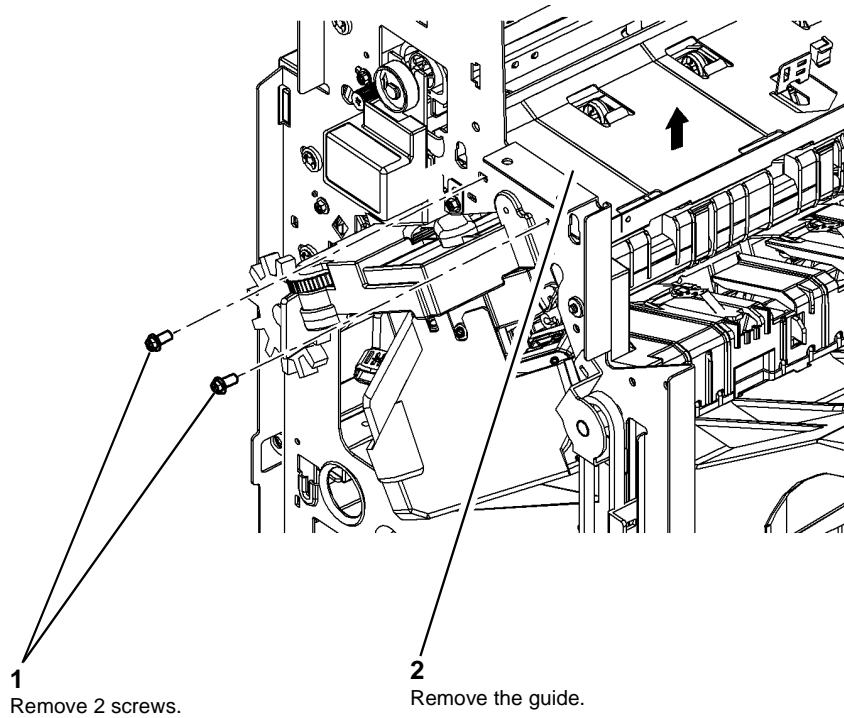
Figure 5 Upper right guide removal

9. Remove the upper right paper guide, [Figure 5](#).

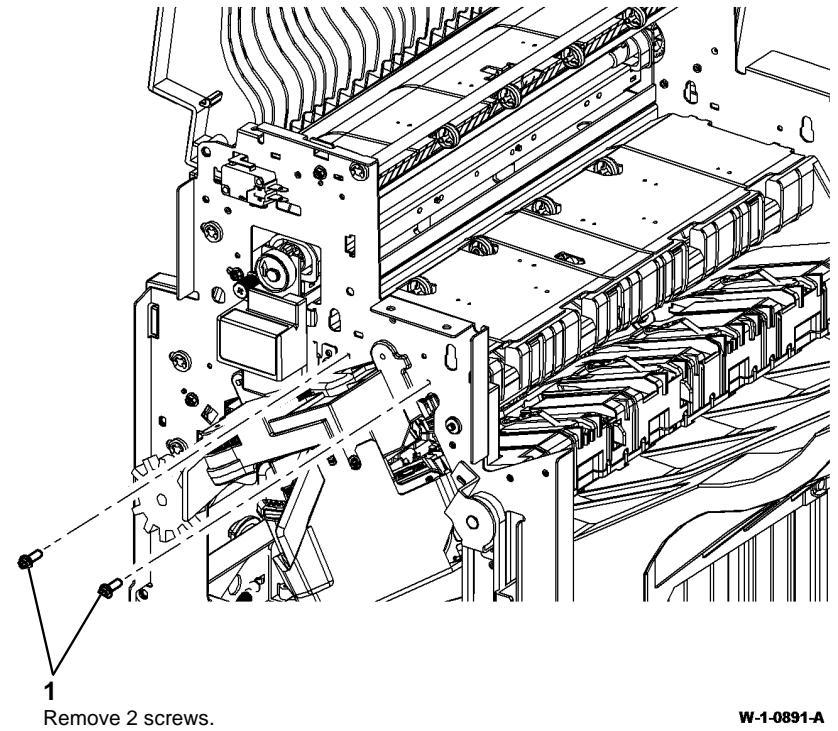
Figure 6 Preparation

10. Prepare to remove the lower right paper guide, [Figure 6](#).

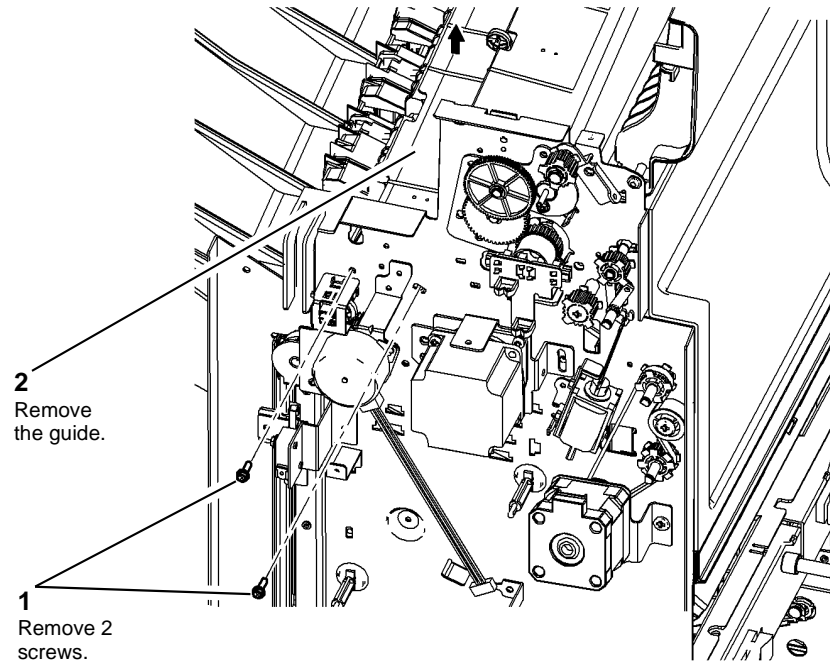
Figure 7 Lower right guide removal

11. Remove the lower right paper guide, [Figure 7](#).

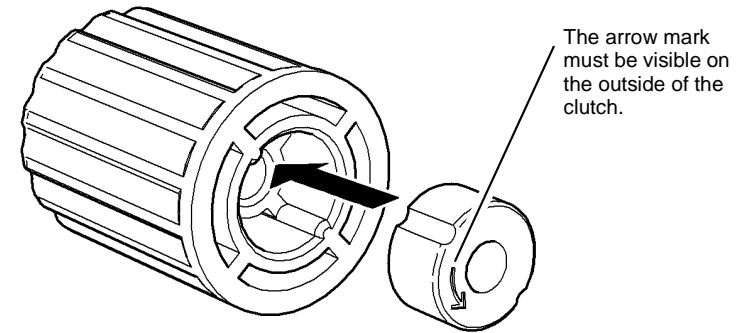
Figure 8 Clutch orientation

1. The replacement is the reverse of the removal procedure.
2. Ensure that the one-way-clutch inside the knob is installed correctly, [Figure 8](#).

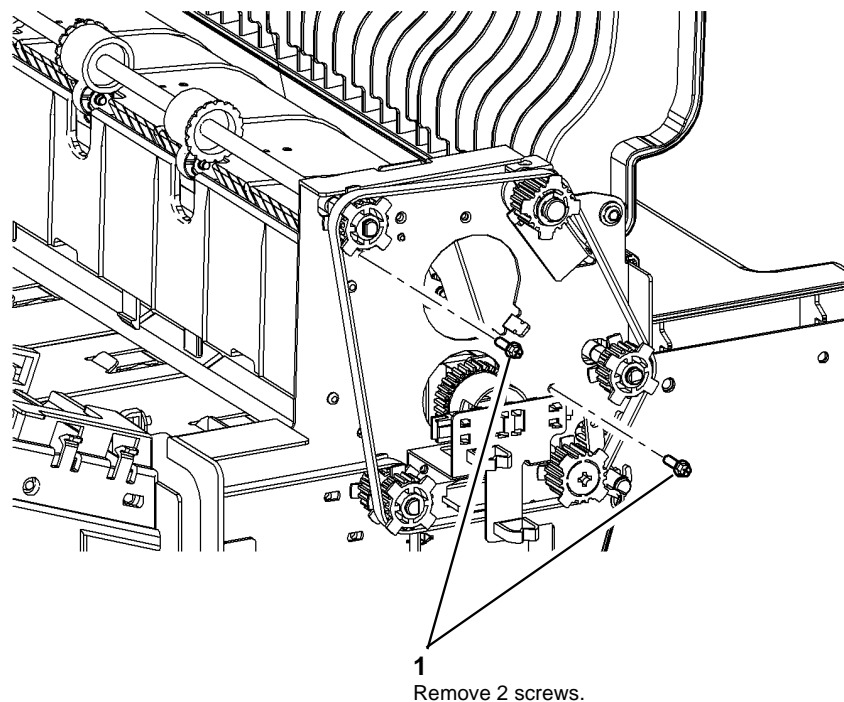
Figure 1 Preparation

1. Remove the 2K LCSS covers, REP 12.1-110.
2. Remove the hole punch motor assembly, REP 12.7-110.
3. Prepare to remove the paper guide, Figure 1.

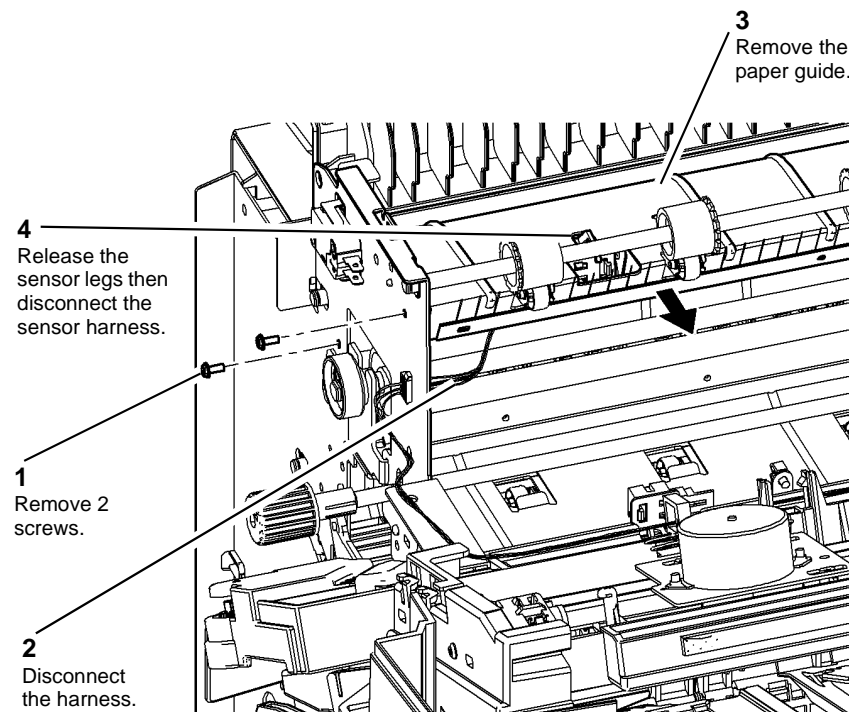
Figure 2 Guide and sensor removal

4. Remove the paper guide and top tray exit sensor, Q12-107, Figure 2.

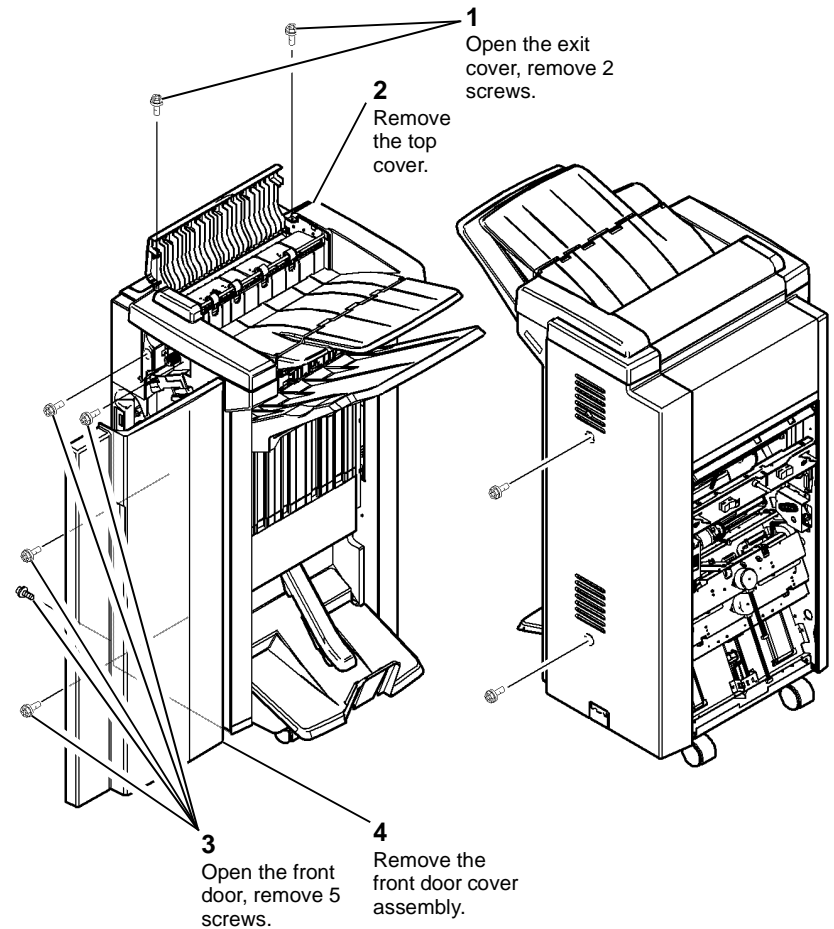
Figure 1 Covers removal 1 of 2

1. Un-dock the LVF BM, [REP 12.13-150](#).
2. Remove the covers, [Figure 1](#) and [Figure 2](#).

NOTE: The front and rear covers are additionally retained by protrusions that locate in holes in the frame edges. These protrusions are best released by pulling on the bottom section of the covers.

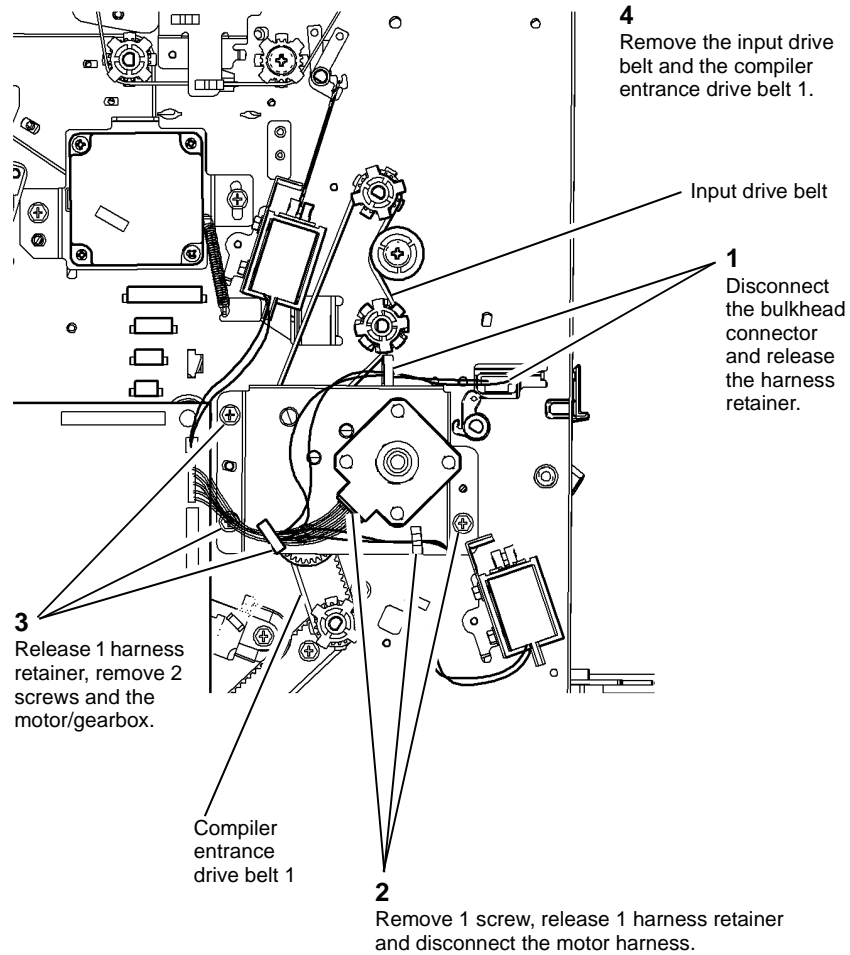
Figure 1 Motor and drive belt removal

2. Remove the motor and drive belt, [Figure 1](#).

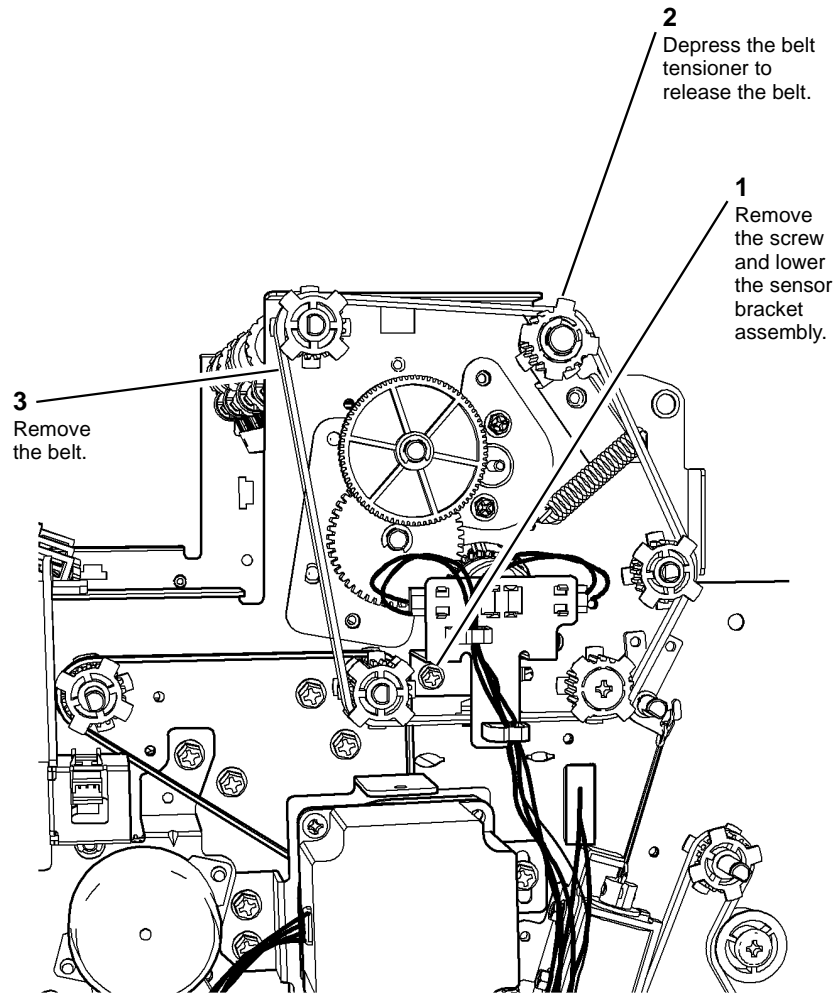
Figure 1 Belt removal

2. Remove the intermediate paper drive belt, [Figure 1](#).

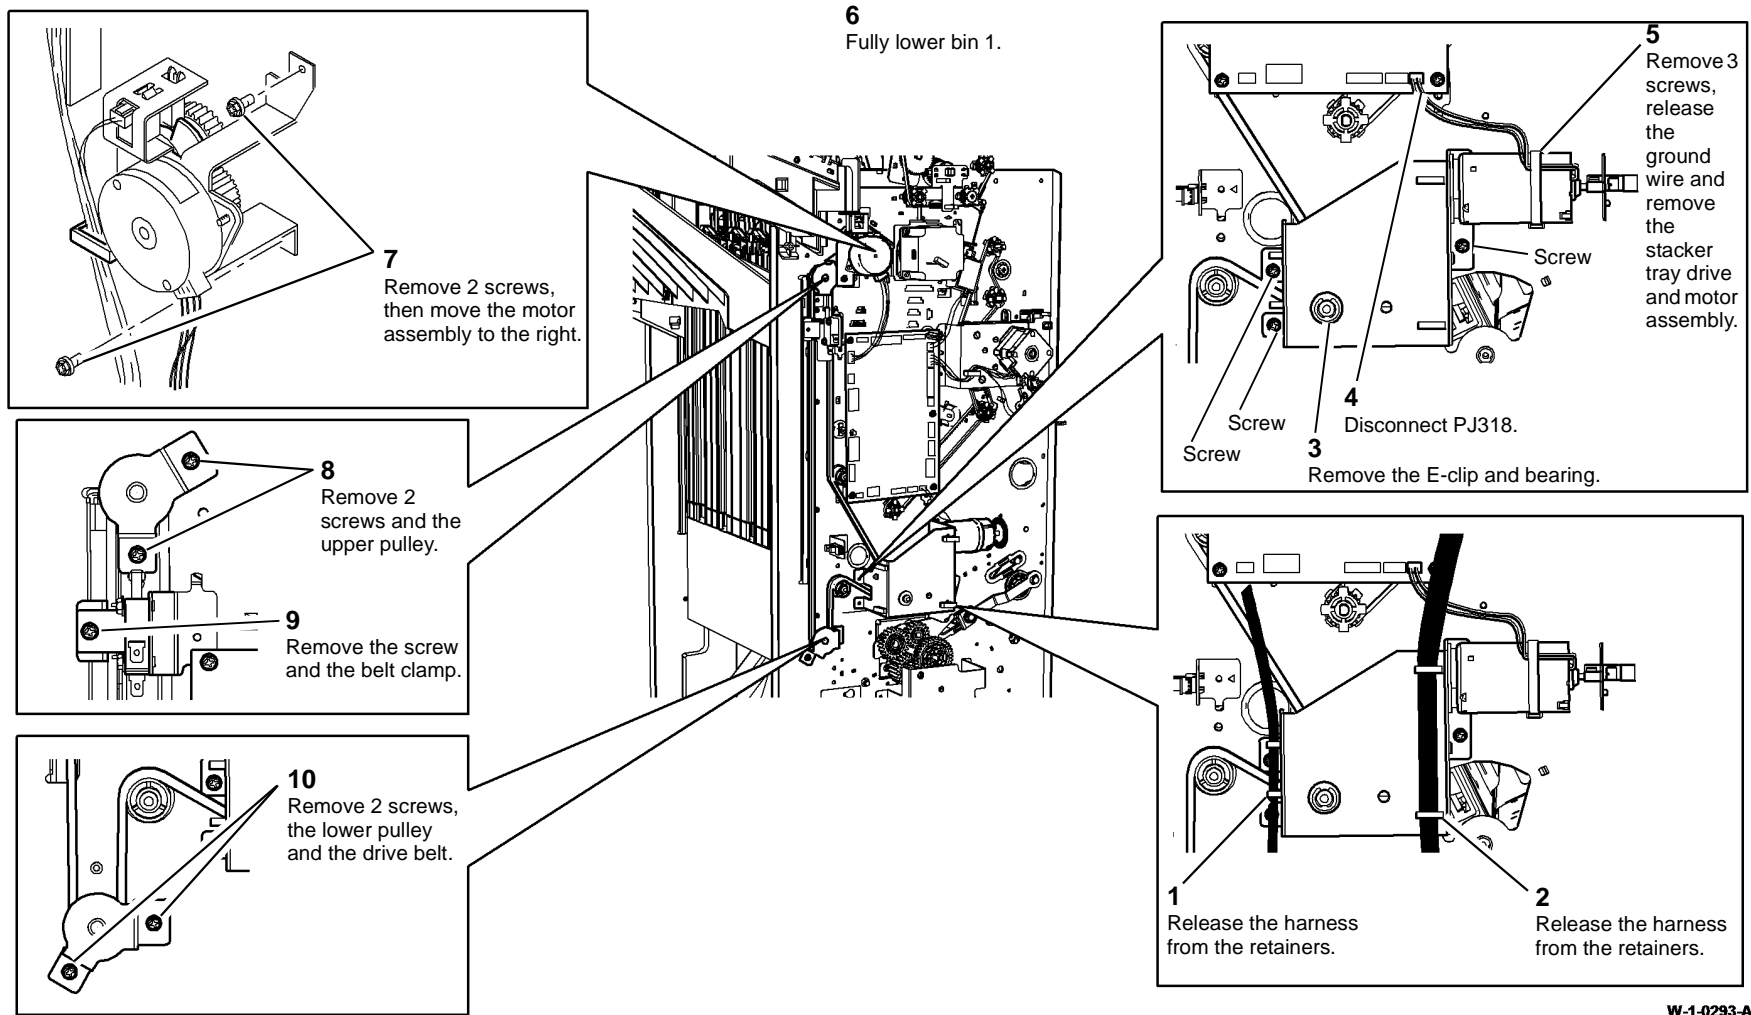
Figure 1 Bin 1 drive belt (rear)

1. Remove the LVF BM front door cover assembly and rear cover, [REP 12.1-150](#).
2. Remove the bin 1 drive belt (rear), [Figure 1](#).

NOTE: Keep all of the components removed as a set. The set of rear frame components are different from the front frame set.

1. Check that bores of the pulleys and idlers are adequately greased, if necessary perform the LVF BM Bin 1 Drive Belt Pulleys and Idlers procedure of [ADJ 40.1](#).
2. The replacement is the reverse of the removal procedure.

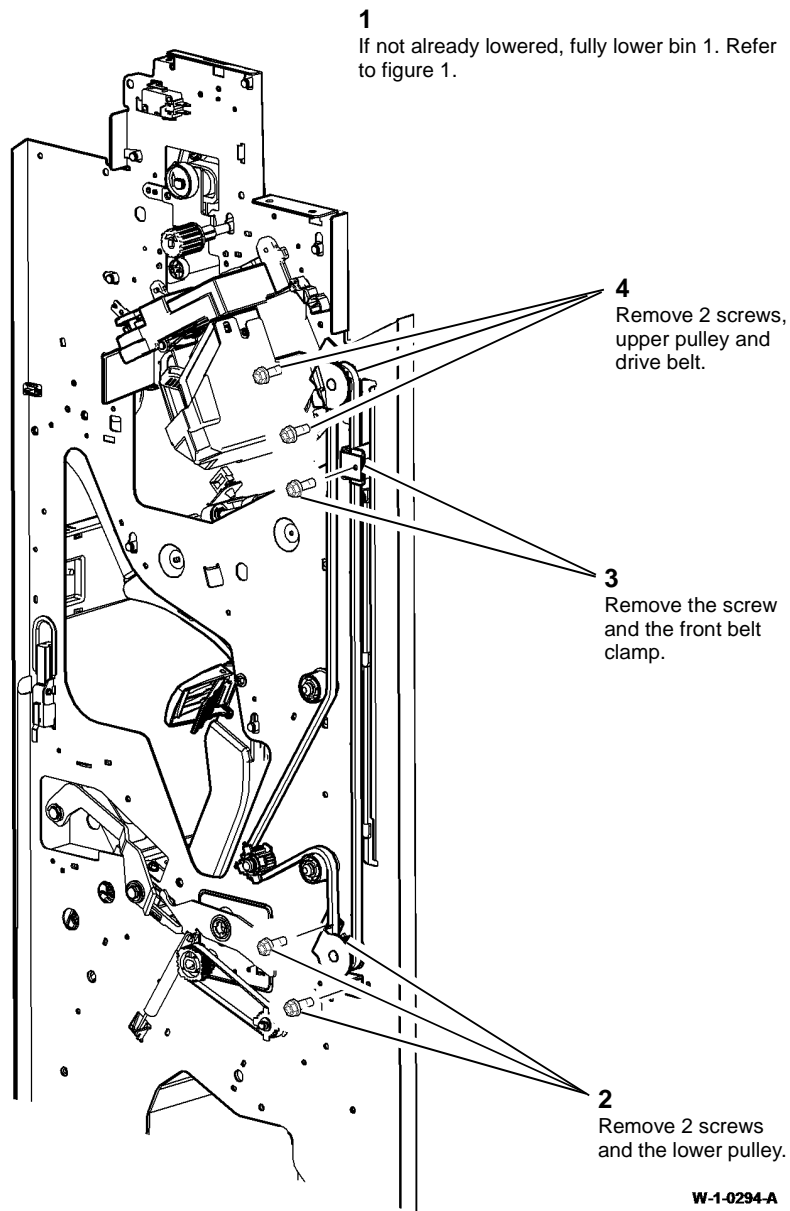
Figure 2 Bin 1 drive belt (front)

3. Remove the bin 1 drive belt (front) [Figure 2](#).

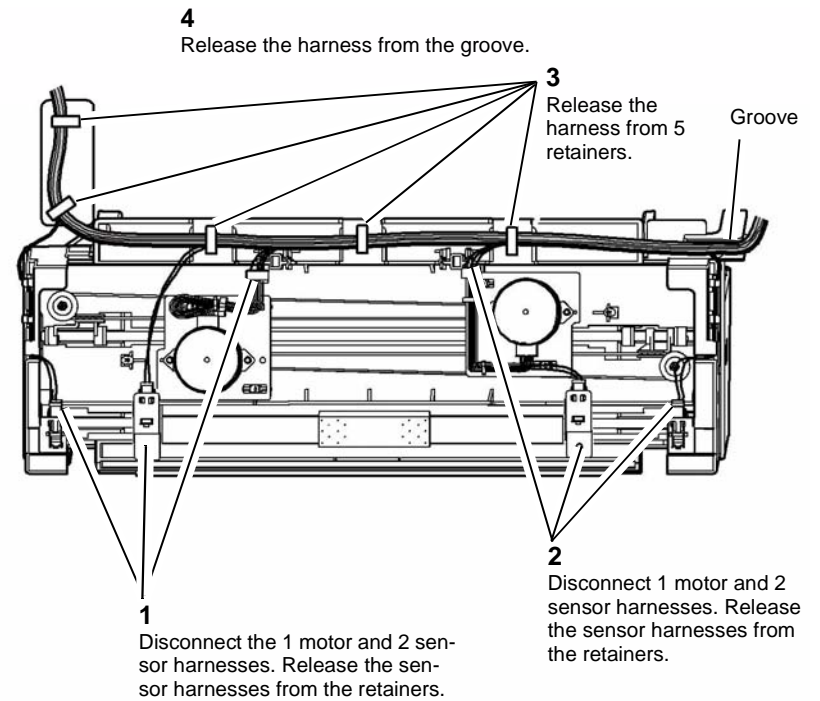
Figure 1 Preparation

3. Prepare to remove the tamper assembly [Figure 1](#).

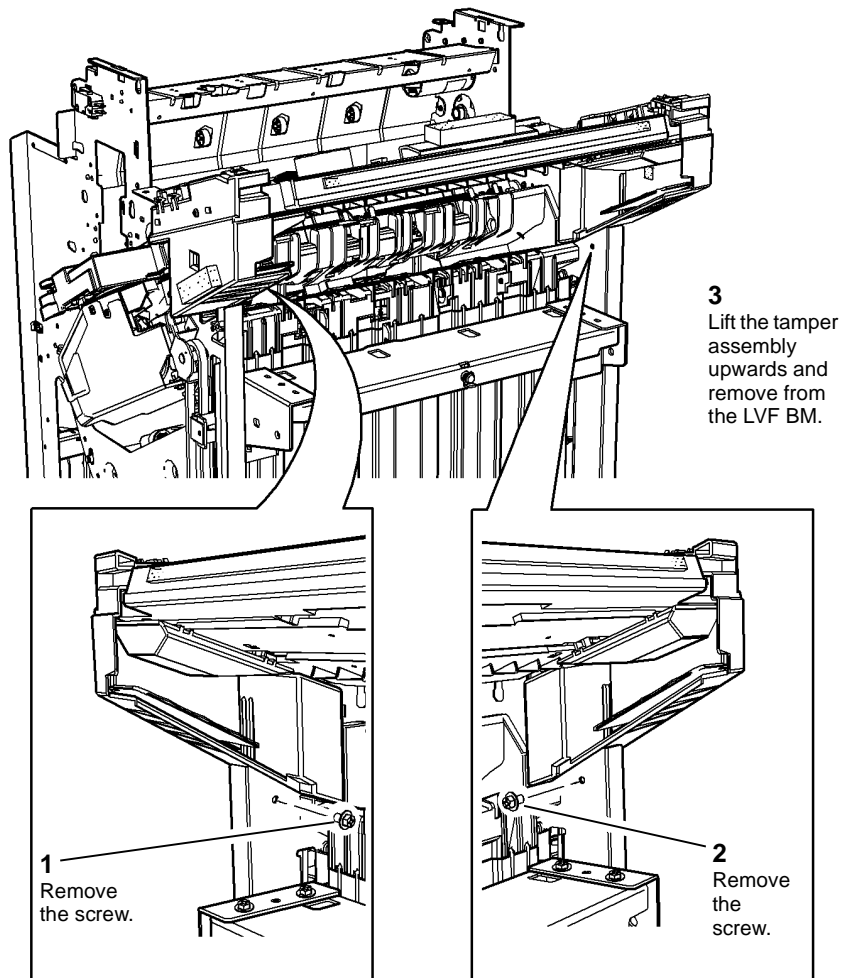
Figure 2 Removing the tamper assembly

4. Remove the tamper assembly, [Figure 2](#).

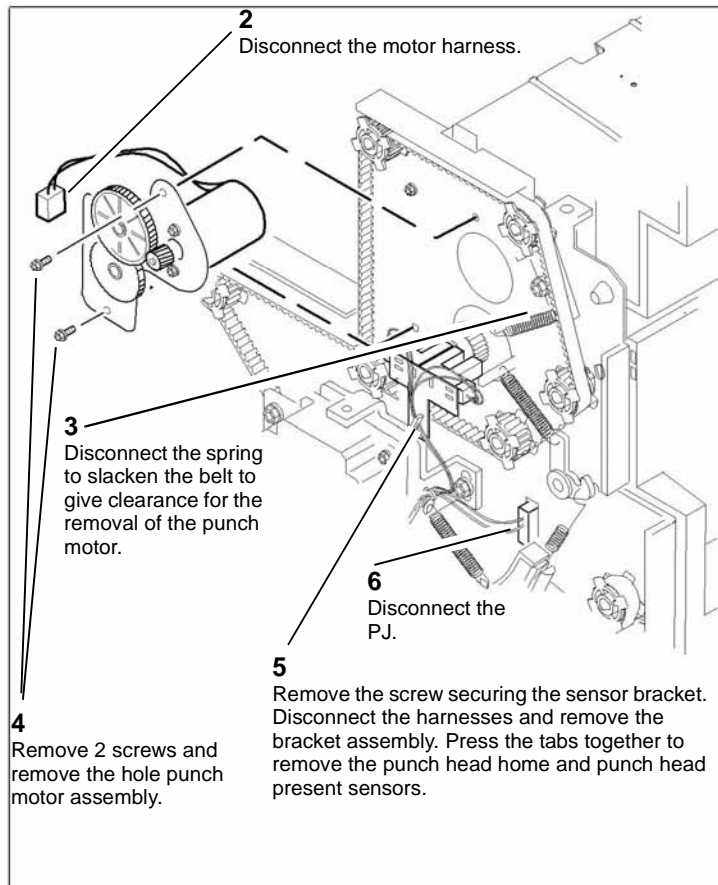
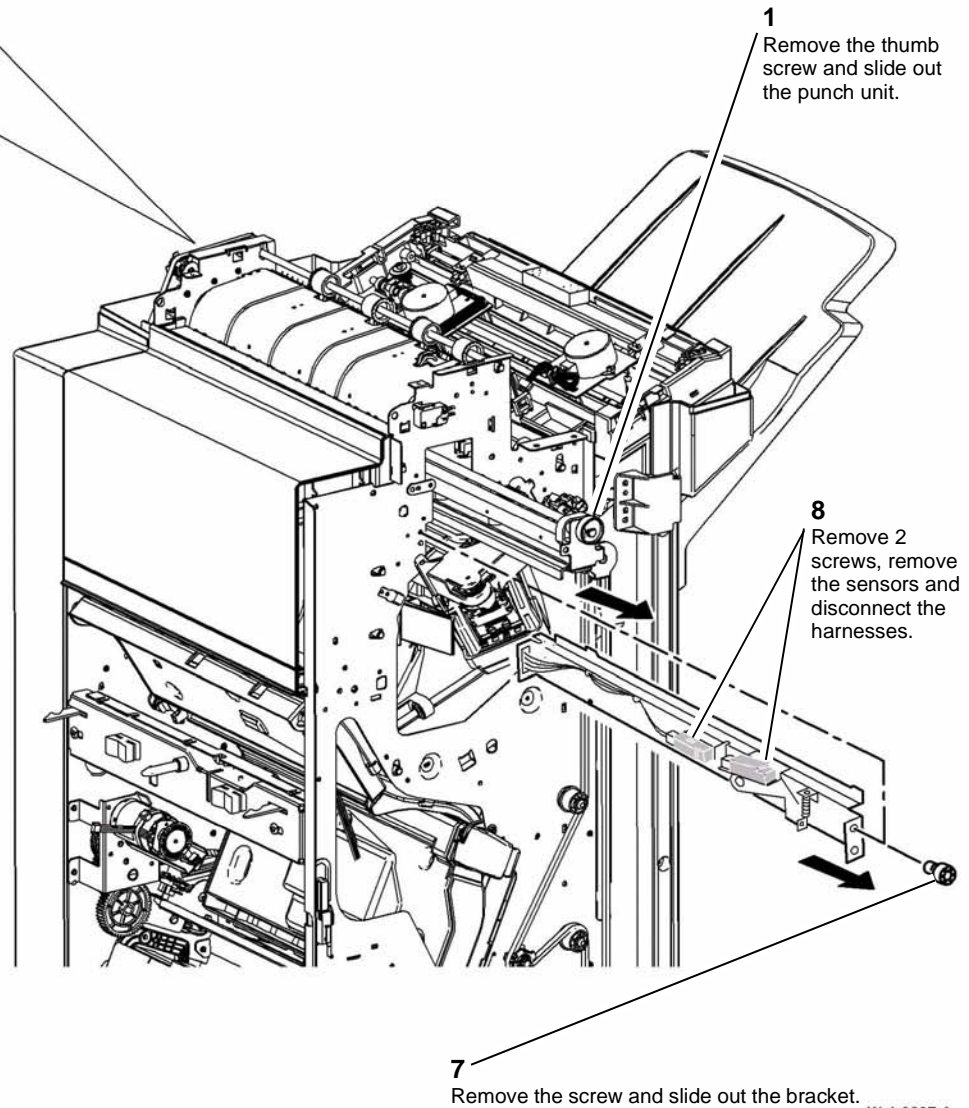
Figure 1 Removal

1. Remove the LVF BM covers, [REP 12.1-150](#).
2. Remove and empty the chad bin, [PL 12.330 Item 4](#).
3. Remove the hole punch unit, motor assembly and sensors, [Figure 1](#).

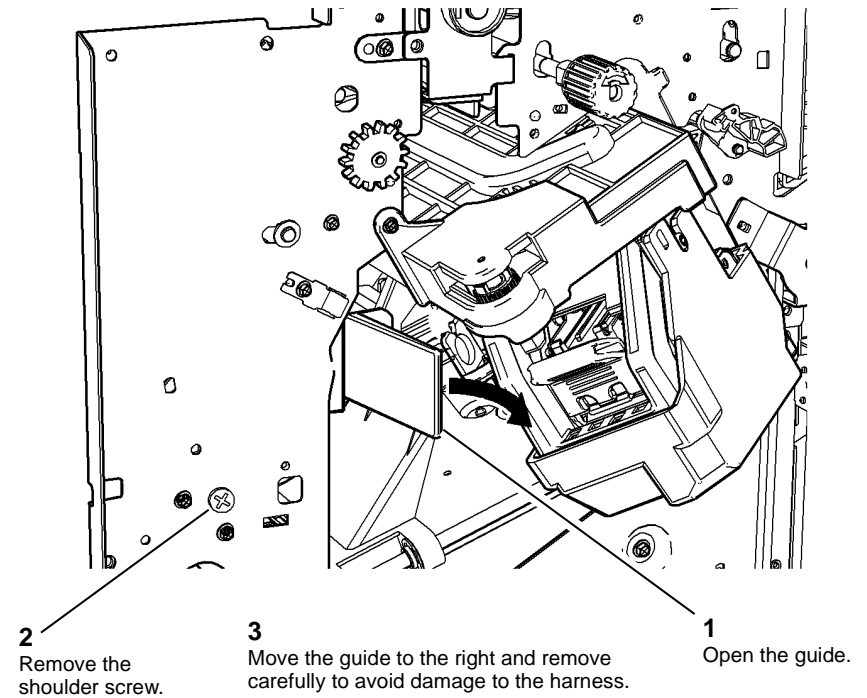
Figure 1 Paper entry guide removal

1. Un-dock the LVF BM, [REP 12.13-150](#).
2. Remove the rear cover and front door cover assembly, [REP 12.1-150](#).
3. Remove the entry guide cover assembly, [REP 12.15-150](#).
4. Remove the paper entry guide assembly, [Figure 1](#).

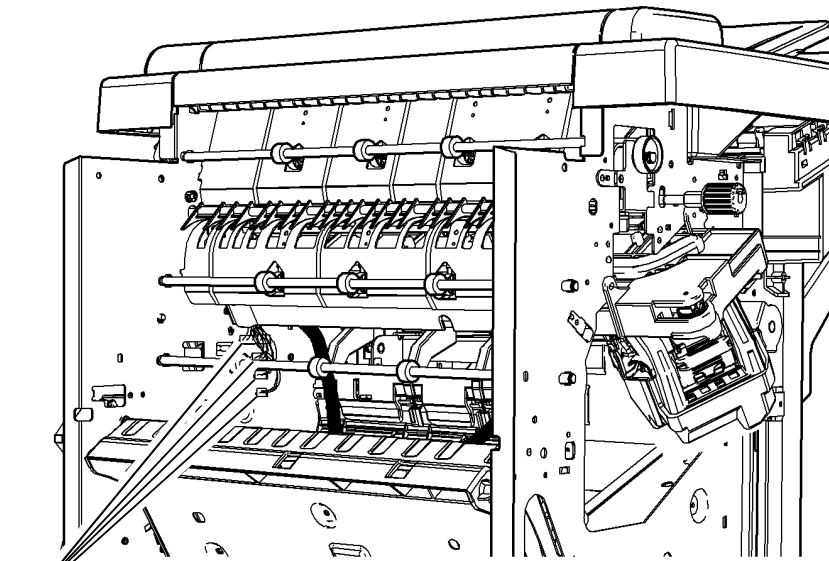
Figure 2 Harness disconnection

6. Disconnect the harness, **Figure 2**.

1
Disconnect the group of 4 connectors.

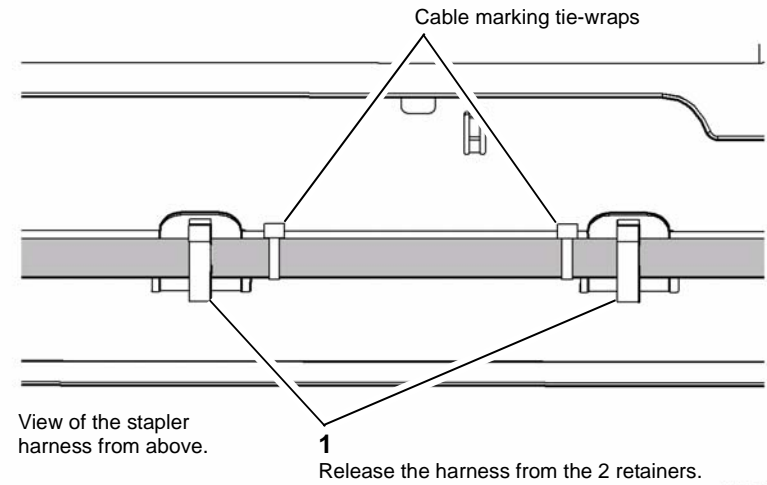
Figure 3 Harness release

7. Release the stapler harness, **Figure 3**.

1. Refer to [GP 6](#) before re-fitting screws into plastic components.
2. When installing the stapler harness, ensure that the cable marking tie-wraps are positioned between the 2 harness retainers, [Figure 3](#).
3. Ensure that the stapling traverse assembly is engaged on the front and rear locating dowels.
4. Ensure that the stapler harness does not interfere with the paper entry guide assembly, [Figure 1](#).
5. Reverse the removal procedure to replace the stapling unit.

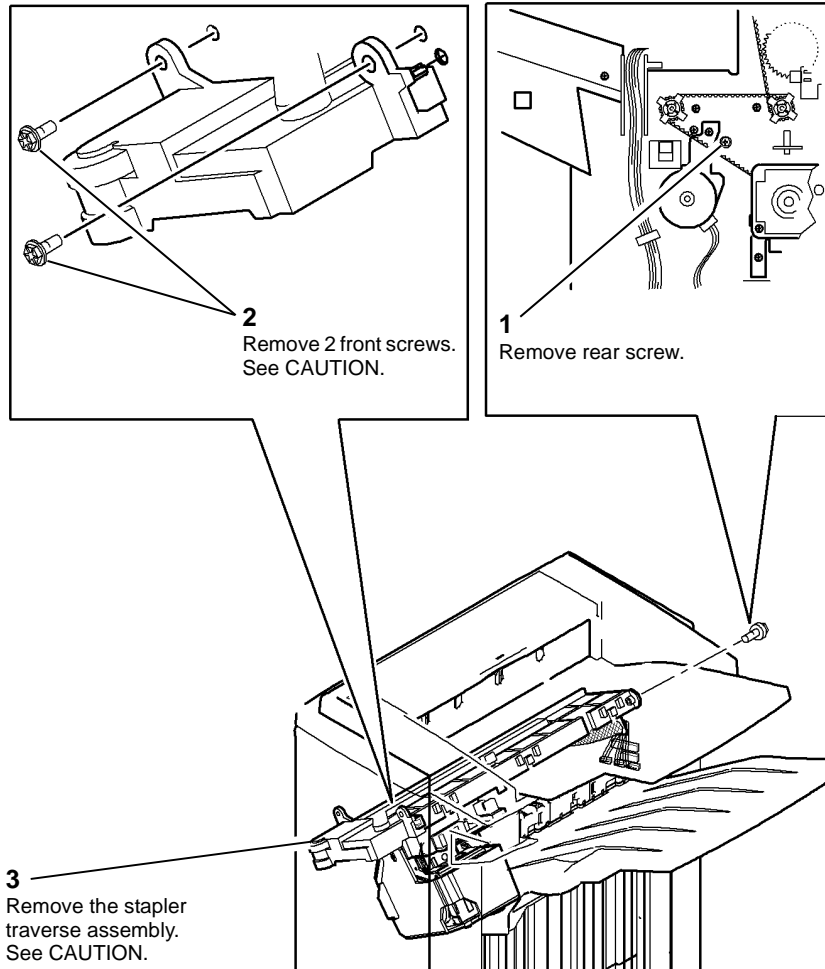
Figure 4 Traverse assembly removal

When removing and replacing the stapler traverse assembly, support the weight of the assembly underneath the stapler and take care not to damage wiring.

8. Remove the stapler traverse assembly, [Figure 4](#).

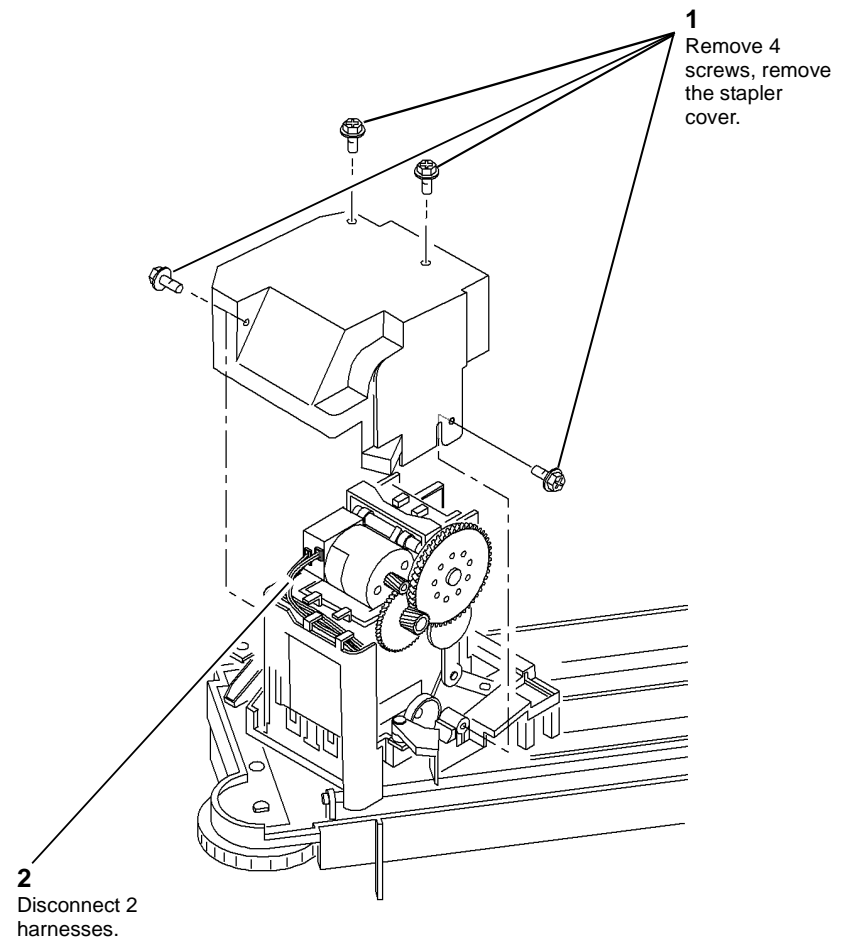
Figure 1 Staple head unit removal

1. Remove the stapler traverse assembly, [REP 12.8-150](#).
2. Place the stapler traverse unit upside-down.
3. Remove the staple head unit from the stapling unit, [Figure 1](#).
