708P91139
February 2016

Xerox® WorkCentre® 5945 Family Multifunction Printer Service Manual

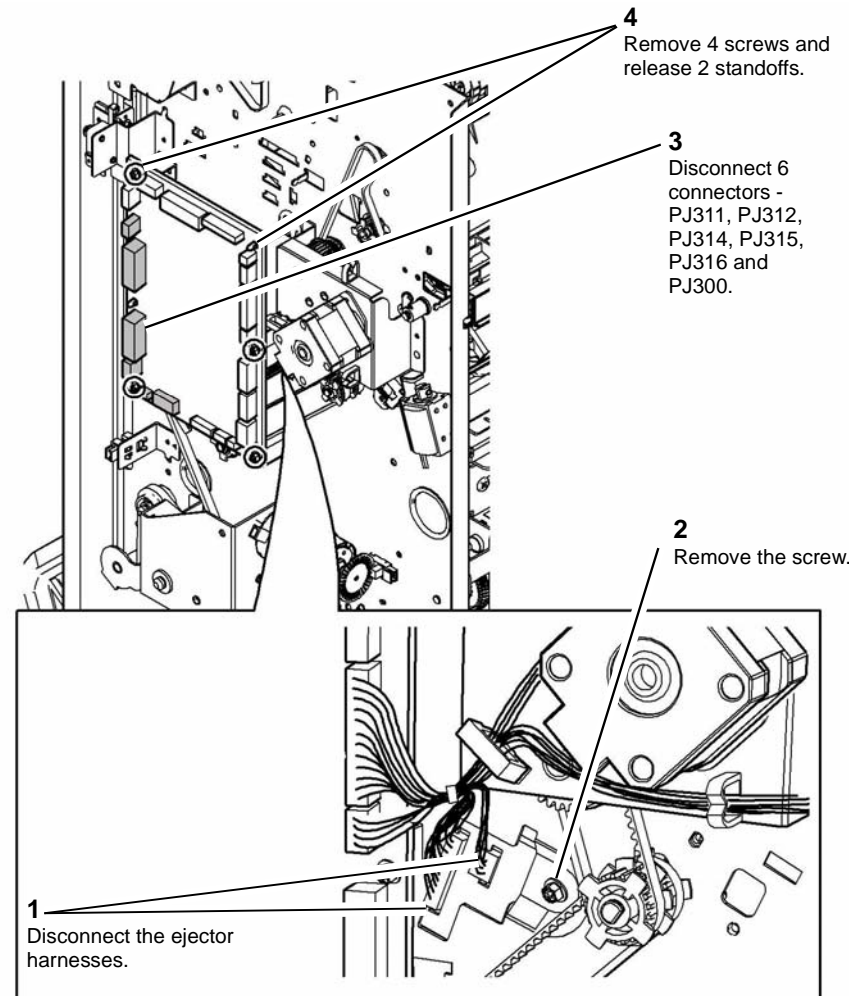
Figure 2 Preparation 1

4. Prepare to remove the ejector assembly, [Figure 2](#) and [Figure 3](#).

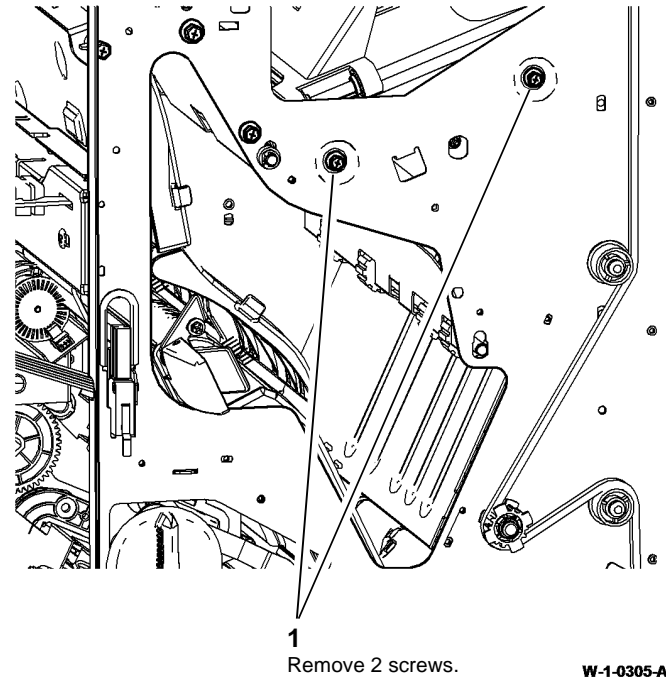
Figure 4 Front fixings removal

5. Remove the front fixings, [Figure 4](#).

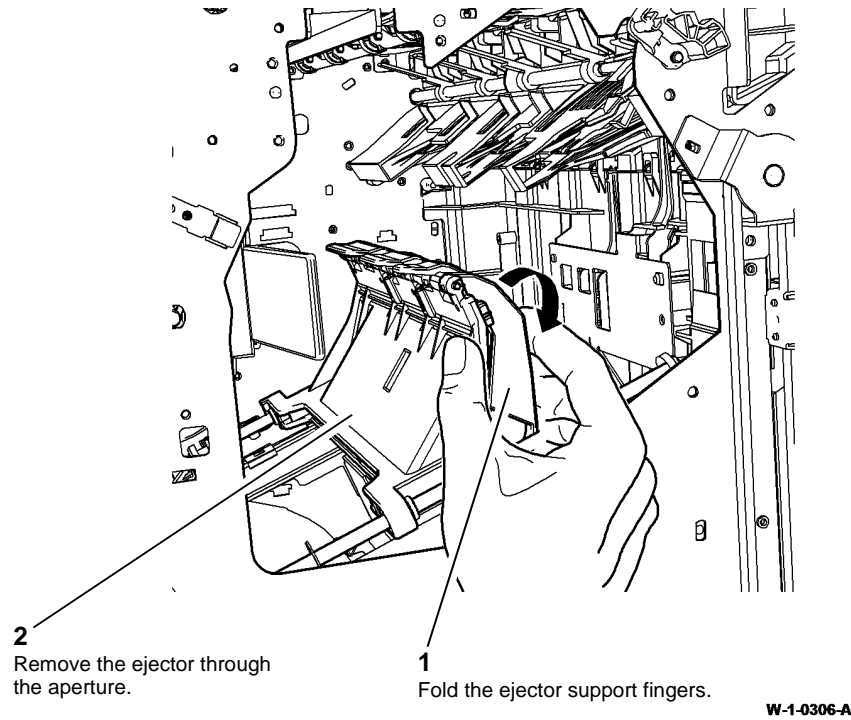
Figure 5 Ejector assembly removal

6. Remove the ejector assembly, [Figure 5](#).

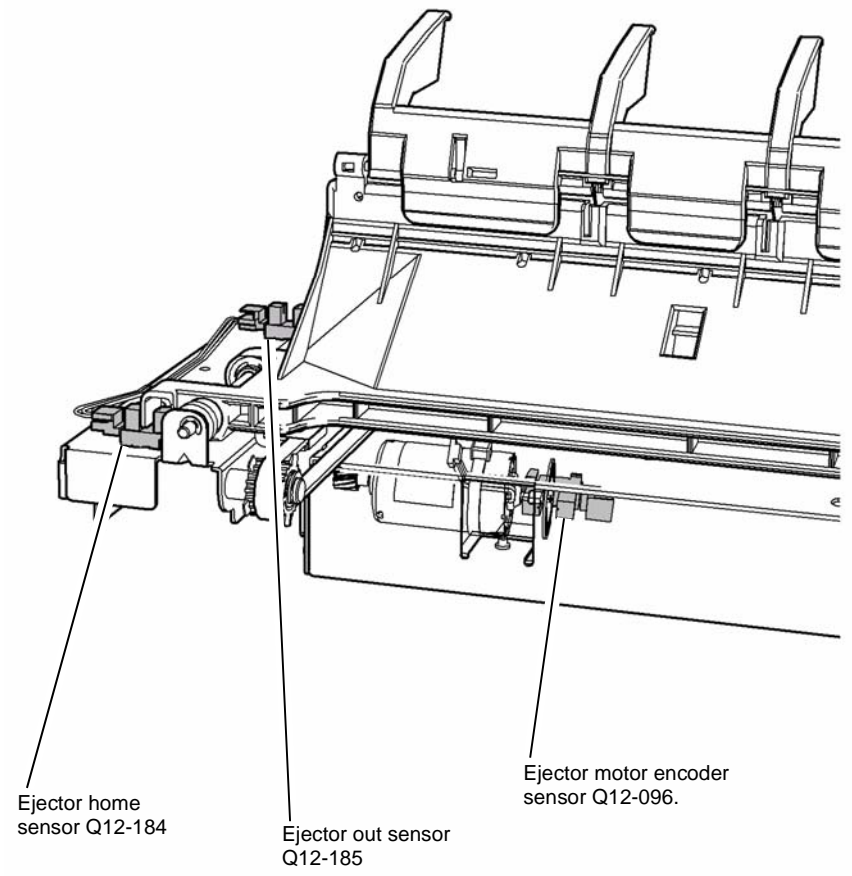
Figure 6 Sensor removal

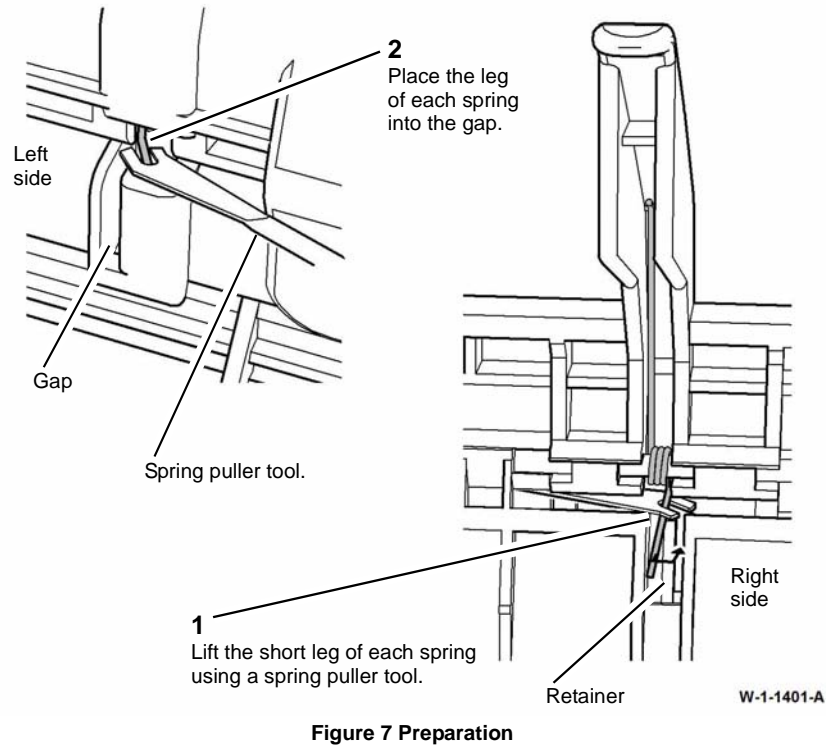
8. If required, prepare to remove the support finger, [Figure 7](#).

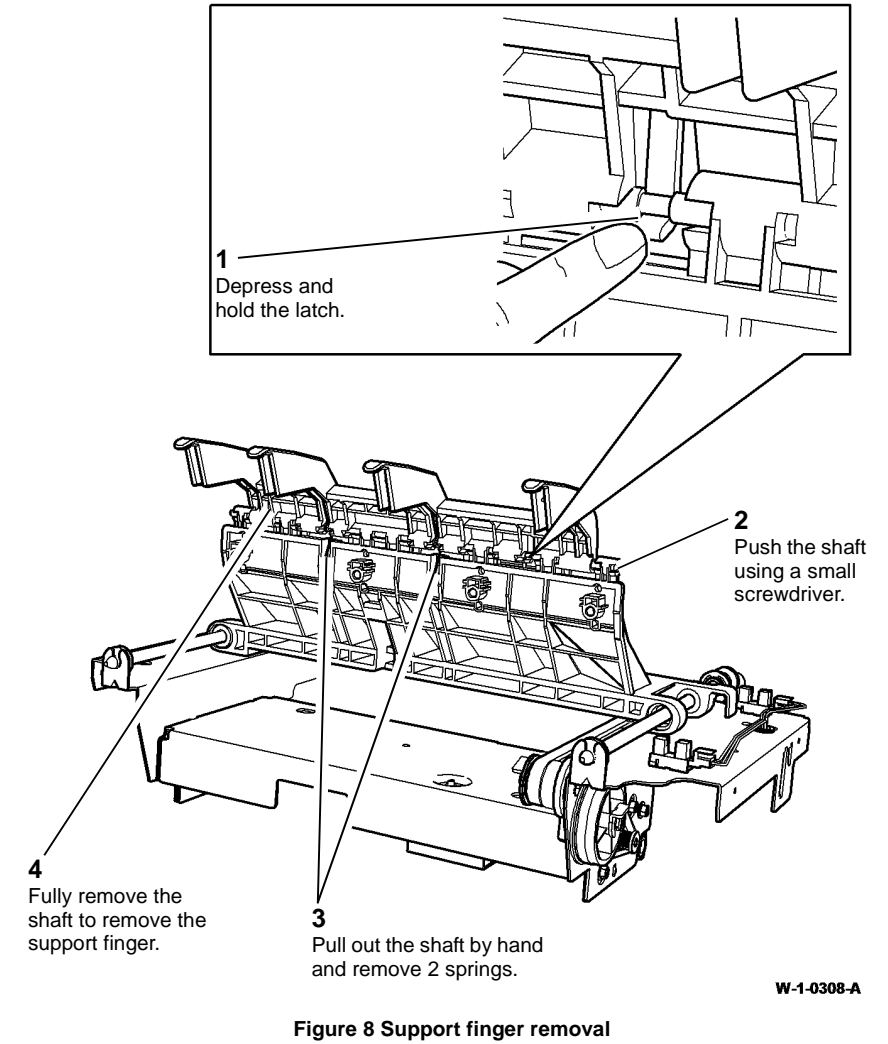
9. Remove the support finger, [Figure 8](#).

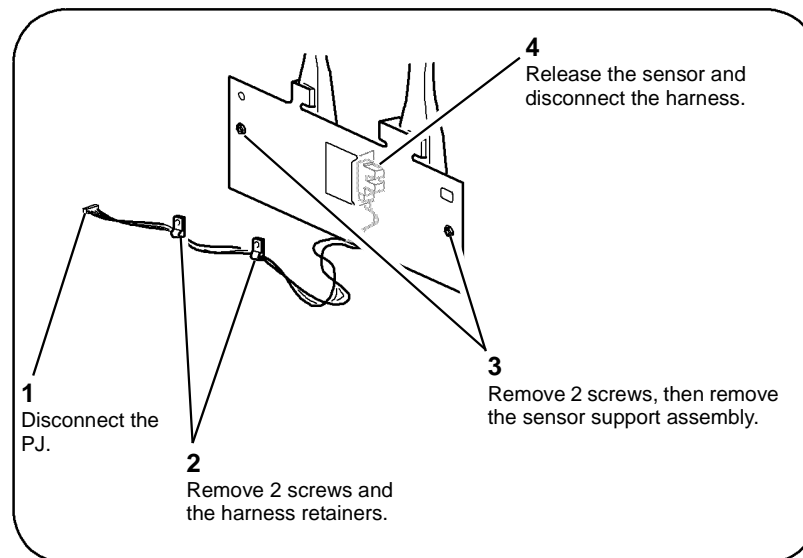
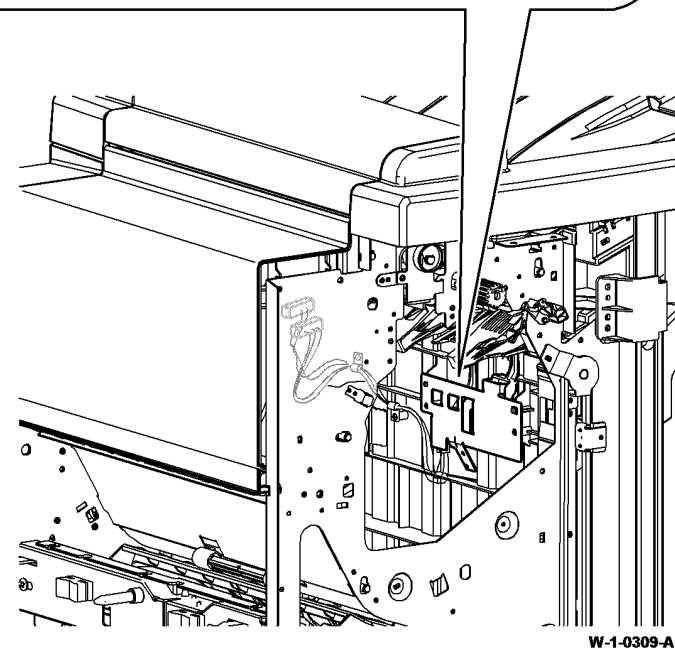
1. Remove the ejector assembly. Refer to [REP 12.10-150](#).
2. Remove the bin 1 upper level sensor [Figure 1](#).

Figure 1 Bin 1 level sensors removal

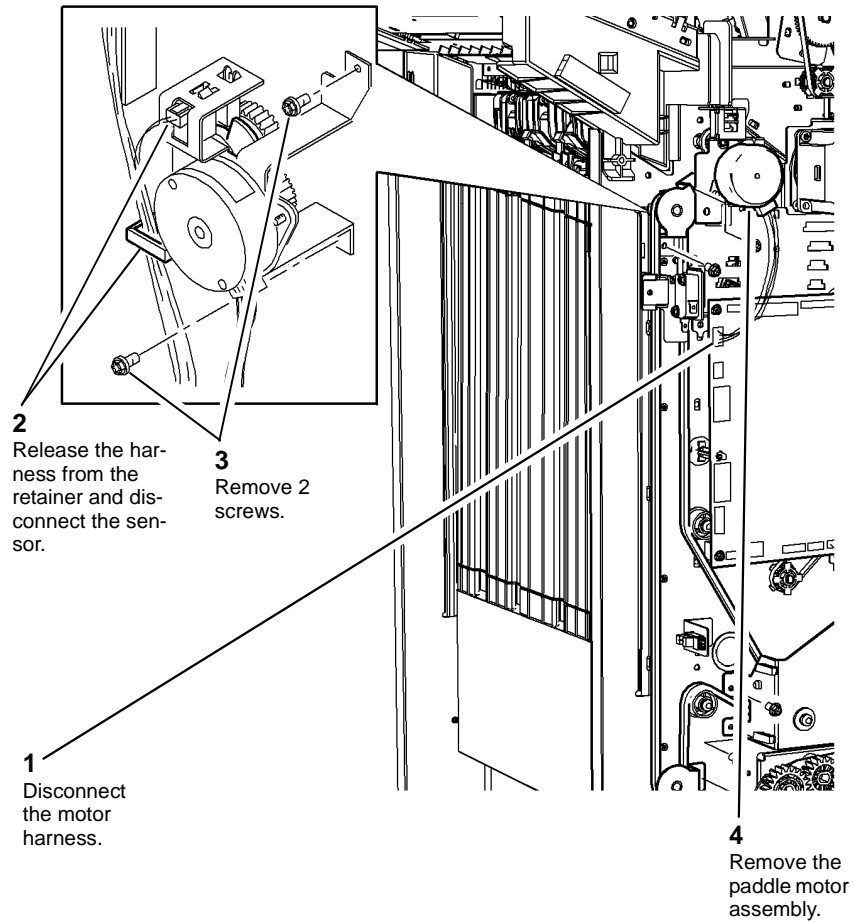
W-1-0310-A

3. Remove the paddle motor assembly, **Figure 1**.

Figure 1 Paddle motor assembly

1. Refer to [GP 6](#) before refitting the screws.
2. Install the paddle shaft. Install the front E-clip.
3. Install the output cover, [Figure 4](#).
4. Install the rear bearing and E-clip.
5. Install the gear and flag assembly with the E-clip. Ensure that it locates onto the "D" flat, [Figure 2](#).
6. Install the motor assembly, [Figure 1](#).
7. Install the tamper assembly and bin 1.

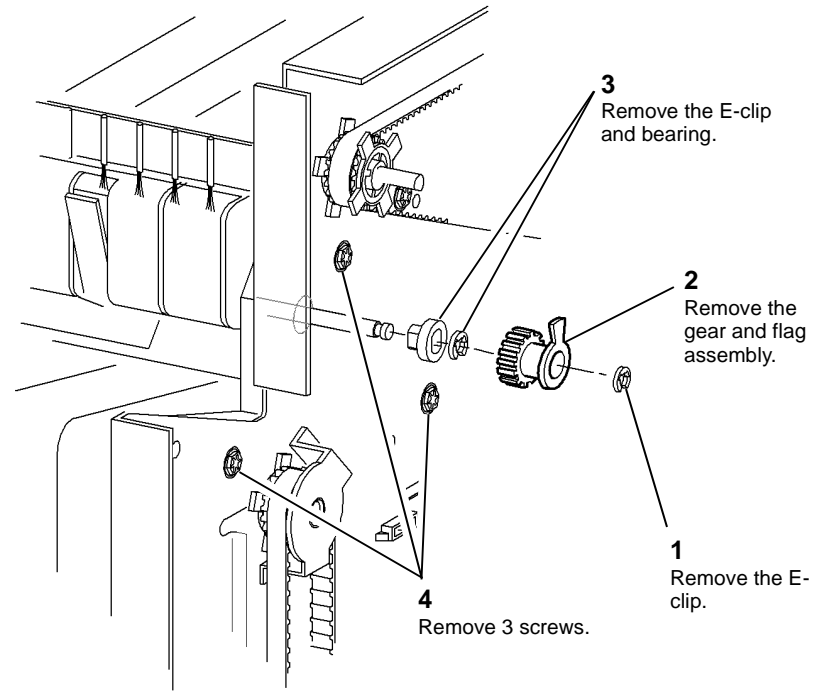
W-1-0311-A

4. Prepare to remove the rear components, **Figure 2**.

Figure 2 Rear preparation

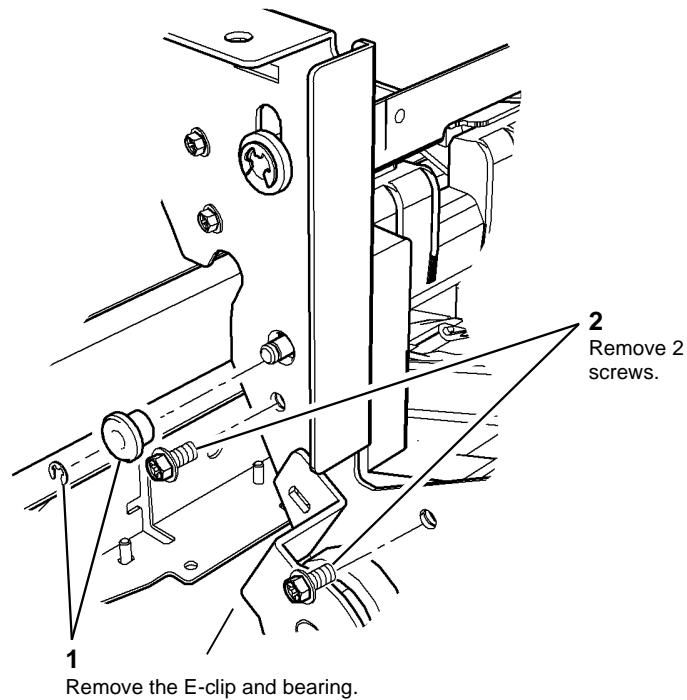
W-1-0312-A

5. Prepare to remove the front components, [Figure 3](#).

Figure 3 Front preparation

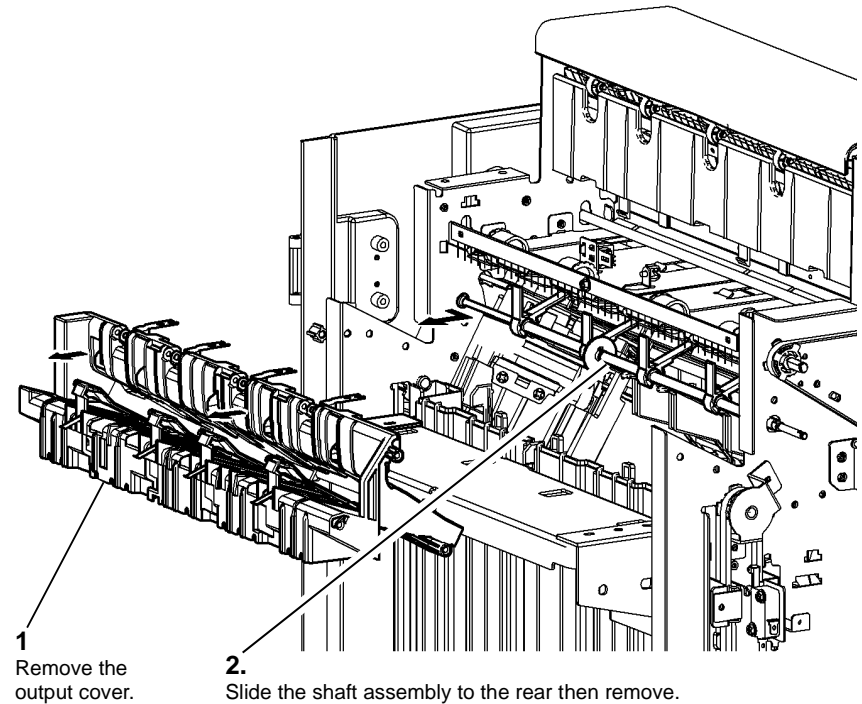
W-1-0313-A

6. Remove the paddle shaft assembly, [Figure 4](#).

Figure 4 Paddle shaft removal

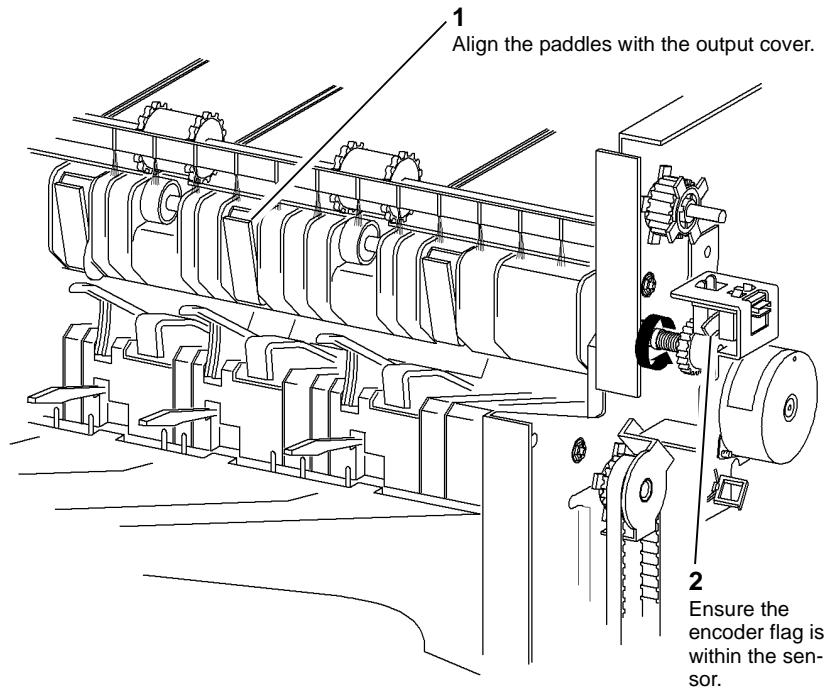
W-1-0314-A

8. Ensure that the paddles and flag are correctly aligned [Figure 5](#).

Figure 5 Paddle alignment

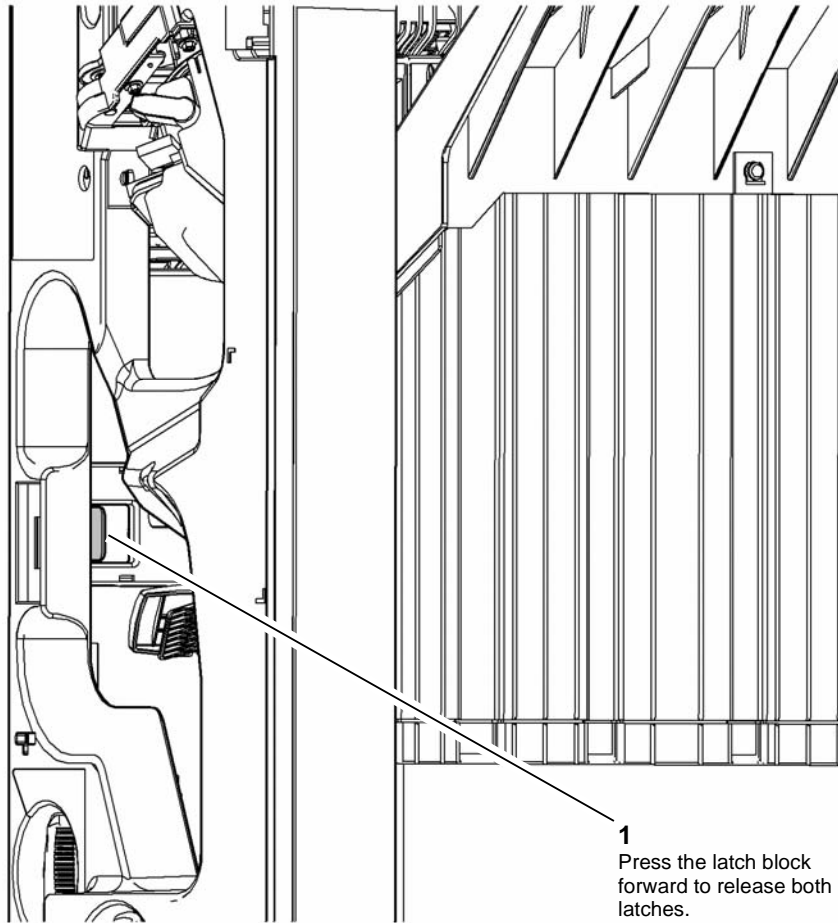
W-1-0315-A

- Release the LVF BM link bracket assembly, [Figure 1](#).

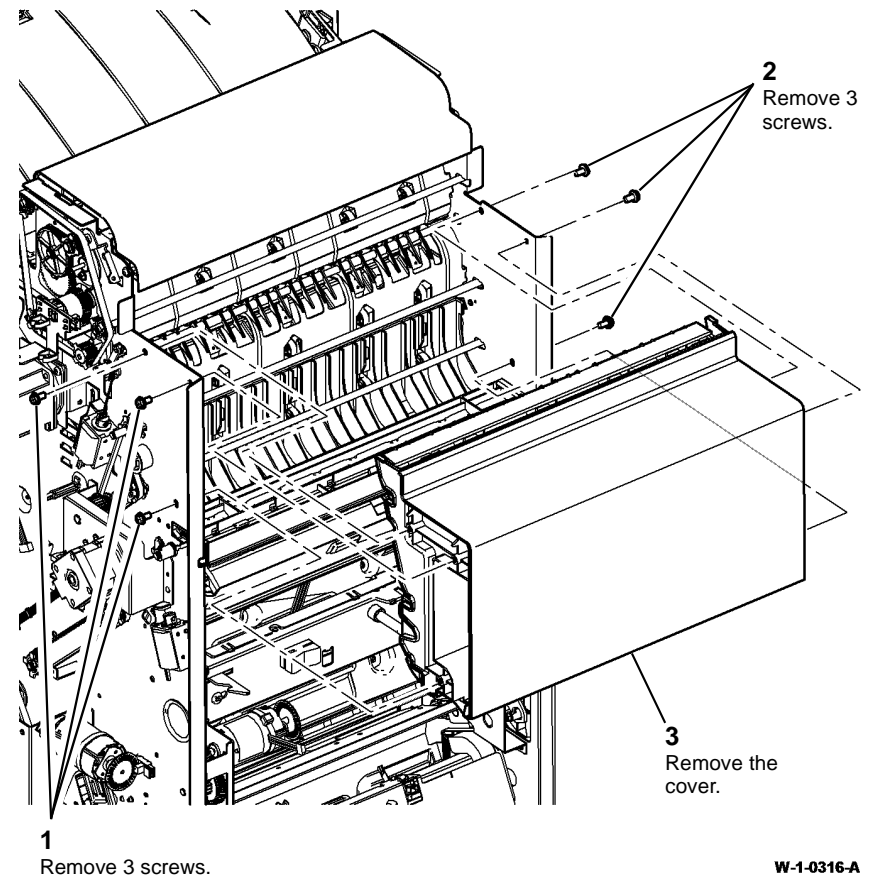
W-1-0316-A

4. Remove the entry guide cover, [Figure 1](#).

Figure 1 Entry guide cover removal

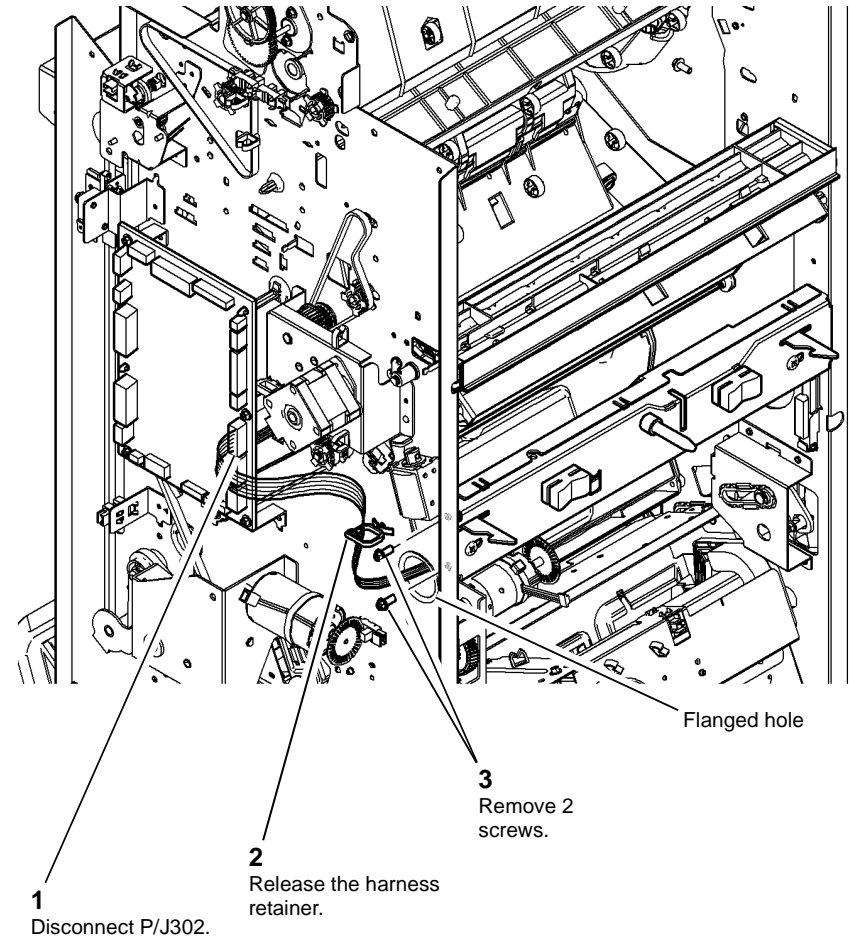
W-1-0317-A

3. Prepare to remove the docking latch assembly, [Figure 1](#).

Figure 1 Prepare to remove the latch

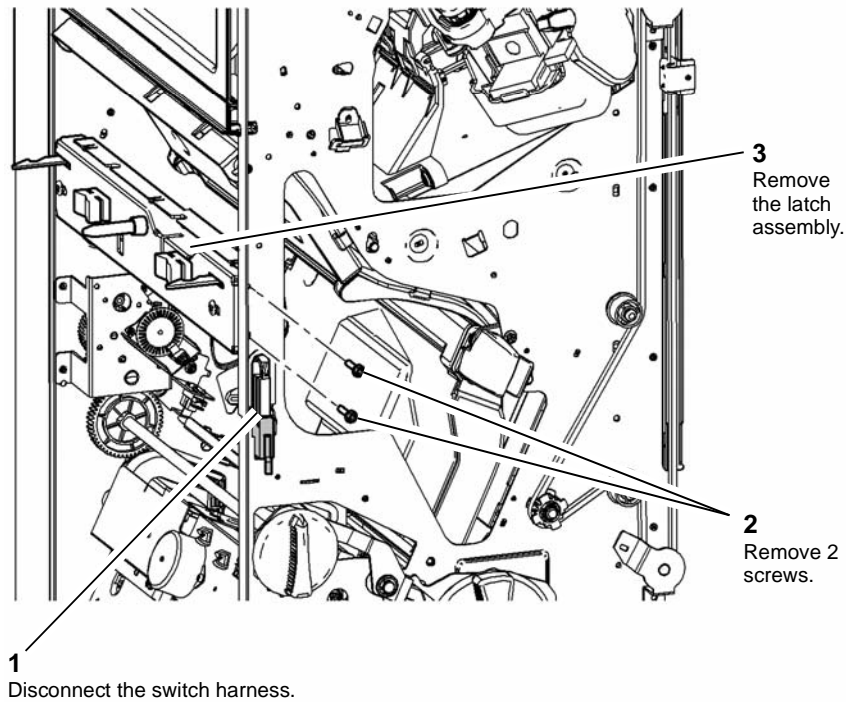
W-1-0318-A

4. Remove the docking latch assembly, [Figure 2](#).

Figure 2 Latch assembly removal

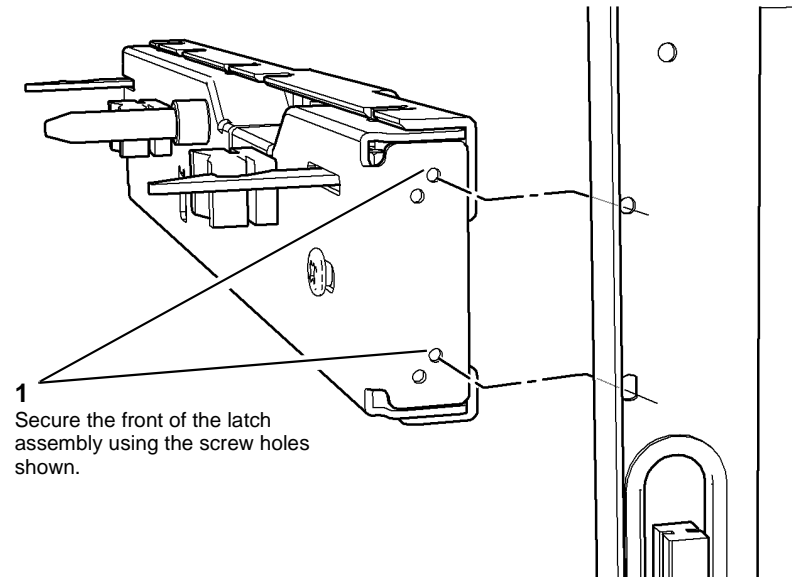
W-1-1322-A

1. The replacement is the reverse of the removal procedure.
2. Ensure the 2 screws at the front locate in the correct holes, [Figure 3](#).

Figure 3 Latch assembly front screw holes

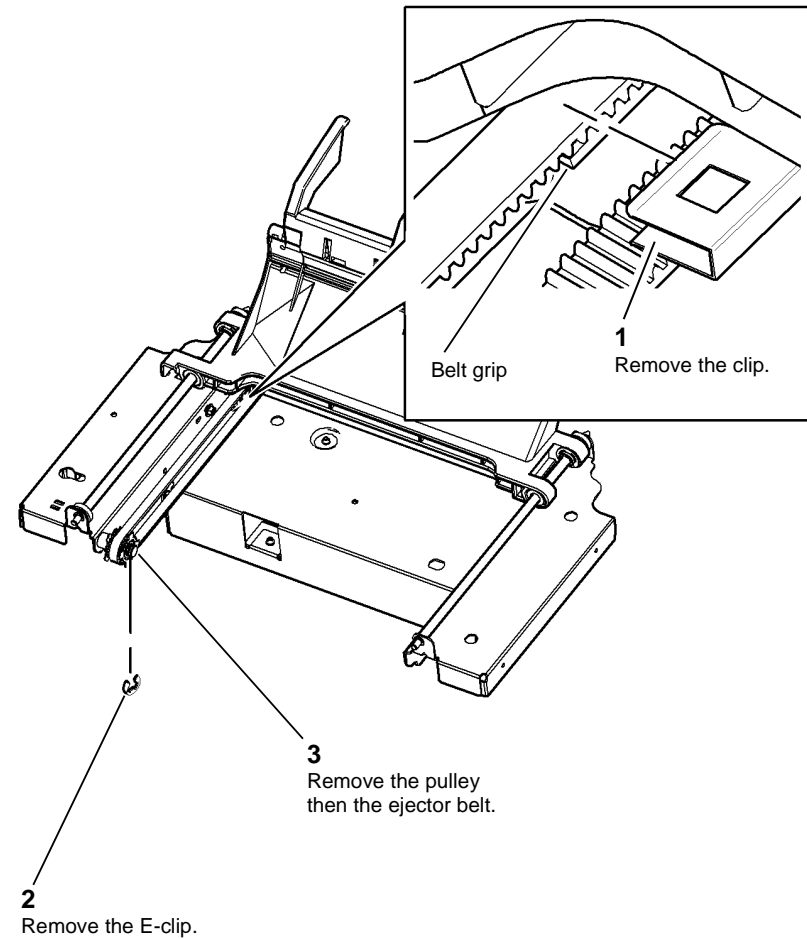
W-1-0319-A

1. Remove the ejector assembly. Refer to [REP 12.10-150](#).
2. Remove the ejector belt, [Figure 1](#).

Figure 1 Remove the ejector belt

1. The replacement is the reverse of the removal procedure.
2. Ensure that the ejector belt is correctly engaged with the belt grip on the ejector assembly before the clip is re-installed. Refer to [Figure 1](#).

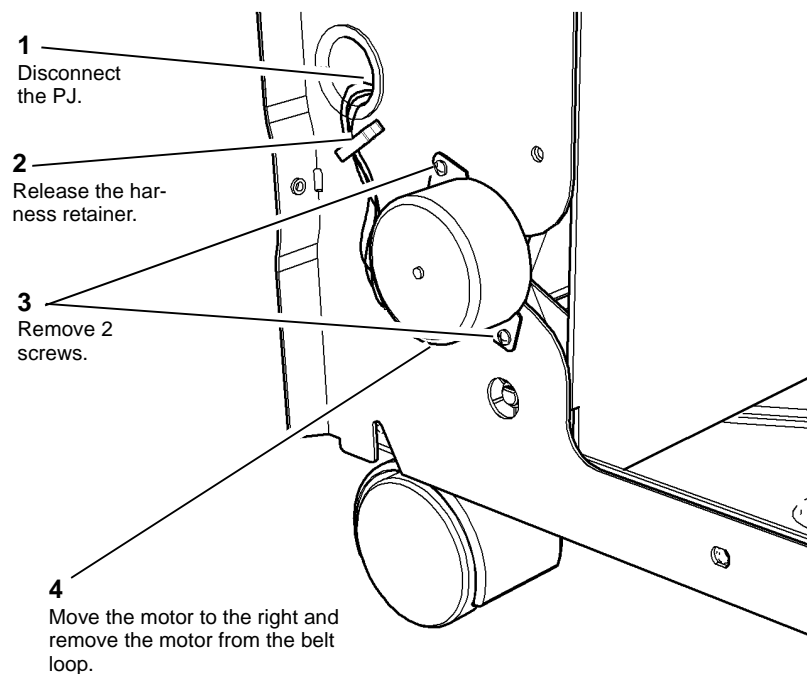
W-1-0320-A

1. Un-dock the LVF BM, [REP 12.13-150](#).
2. Remove the LVF BM front door cover assembly, [REP 12.1-150](#).
3. Remove the back stop motor, [Figure 1](#).

Figure 1 Back stop motor removal

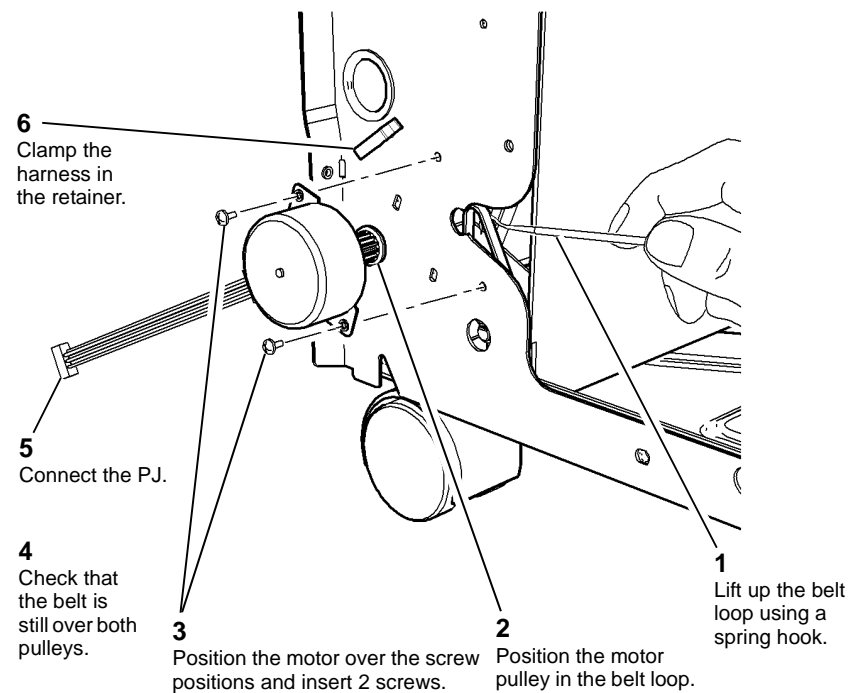
W-1-0321-A

1. Install the back stop motor, [Figure 2](#).

Figure 2 Back stop motor installation

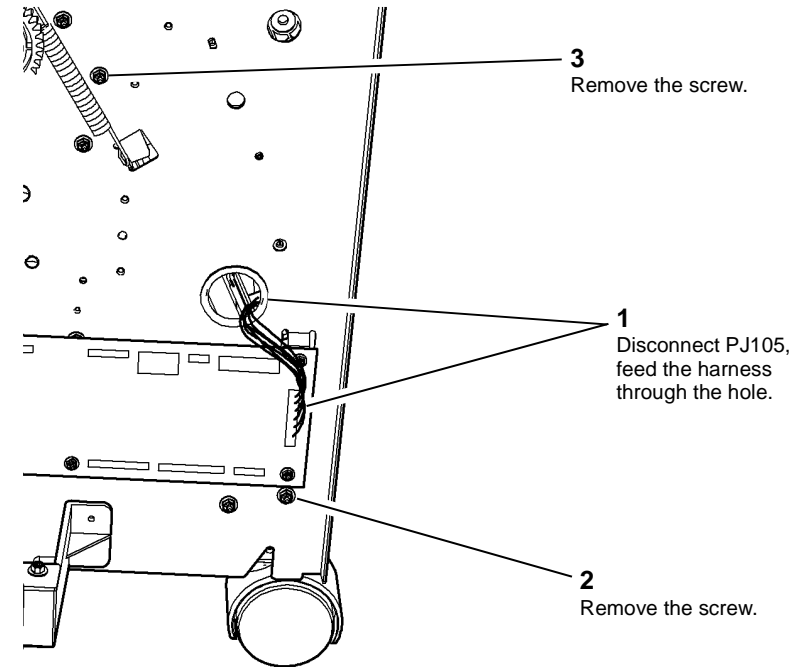
W-1-0322-A

6. Prepare to remove the left guide assembly, [Figure 1](#).

Figure 1 Preparation

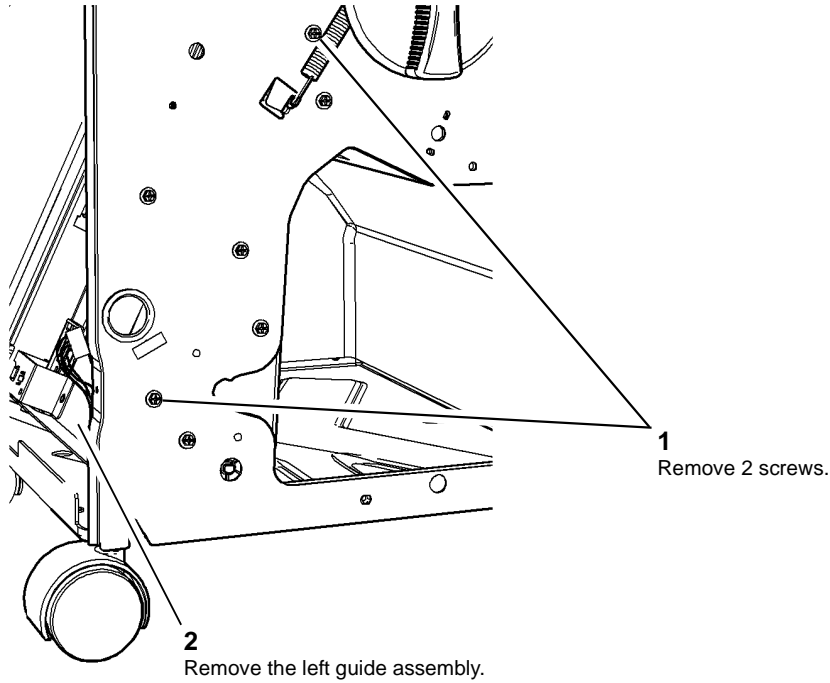
W-1-0323-A

7. Remove the left guide assembly, [Figure 2](#).

Figure 2 Left guide assembly removal

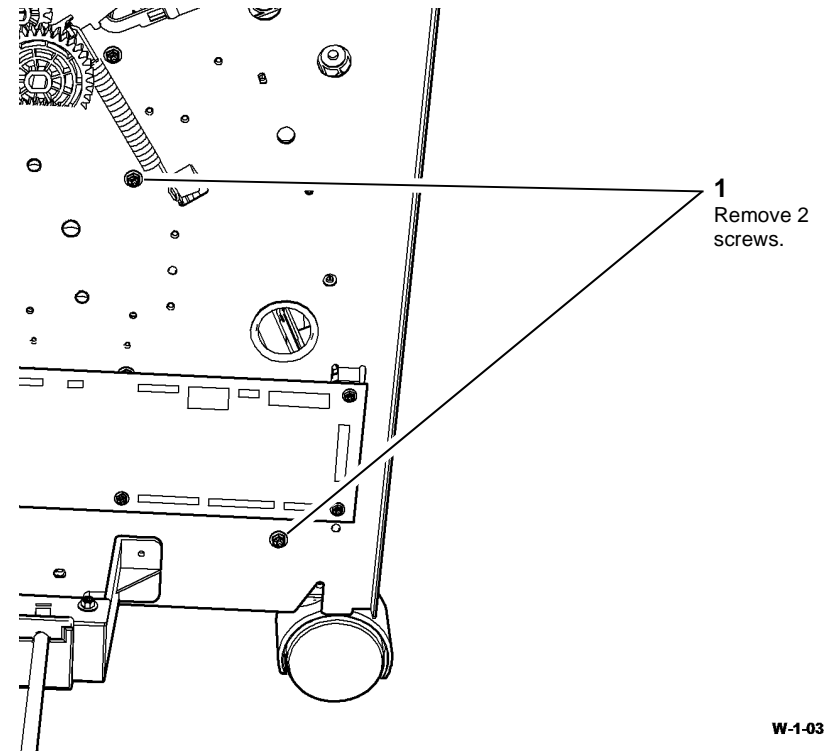
W-1-0324-A

9. Prepare to remove the right guide assembly, [Figure 3](#).

Figure 3 Preparation

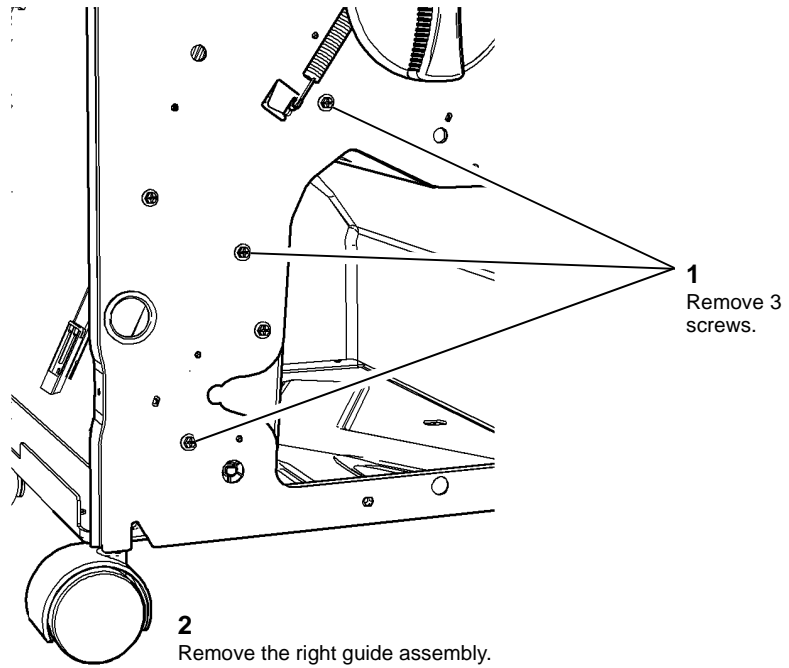
W-1-0325-A

10. Remove the right guide assembly, [Figure 4](#).

Figure 4 Right guide assembly removal

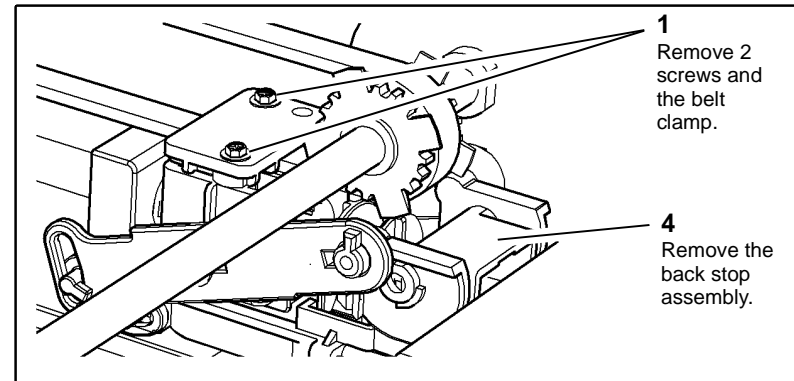
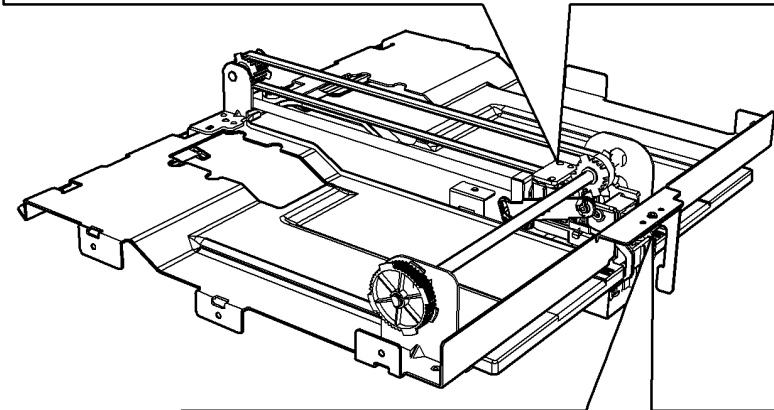
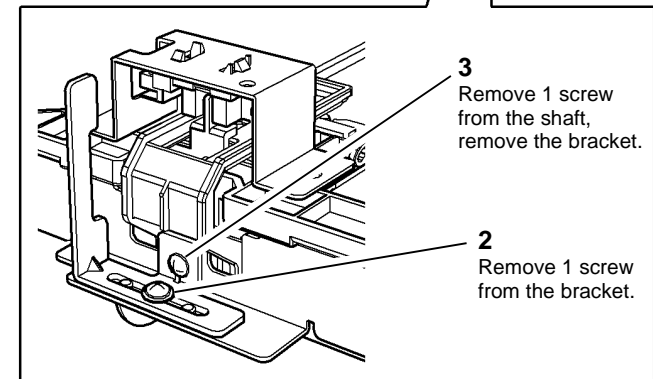
W-1-0326-A

11. Remove the back stop assembly, [Figure 5](#).

Figure 5 Back stop assembly removal

1. Refer to [GP 6](#) before refitting the screws.
2. Install the back stop assembly by reversing the steps in [Figure 5](#). Ensure that the back stop is correctly located, [Figure 6](#). Ensure that the belt clamp is correctly located, [Figure 7](#).

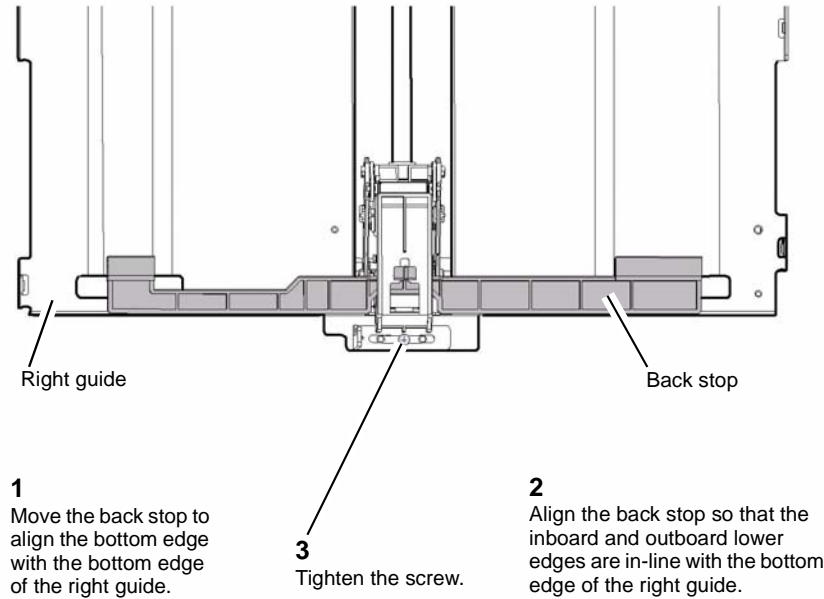
W-1-0327-A

Figure 6 Bracket location

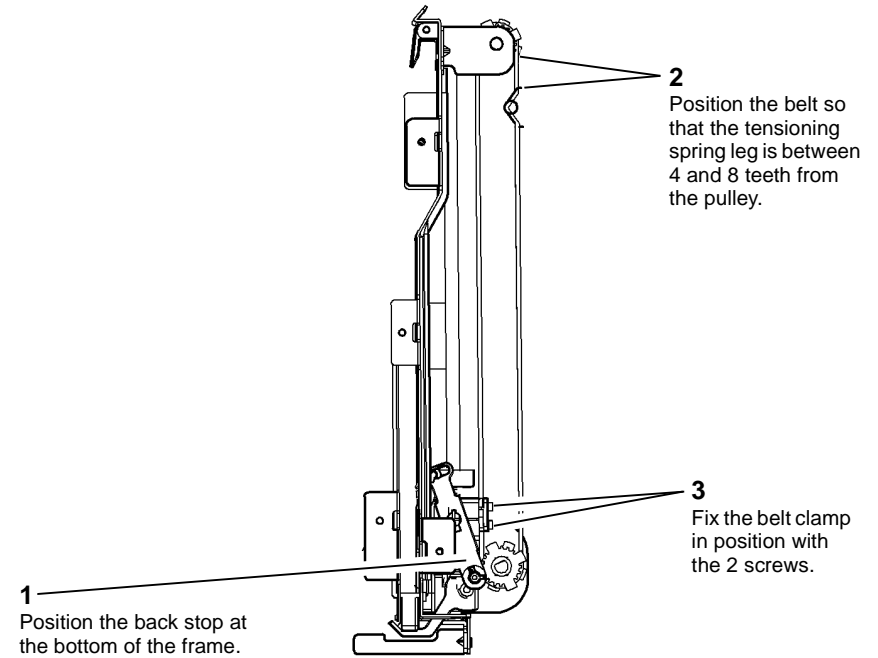
W-1-0328-A

Figure 7 Belt clamp location

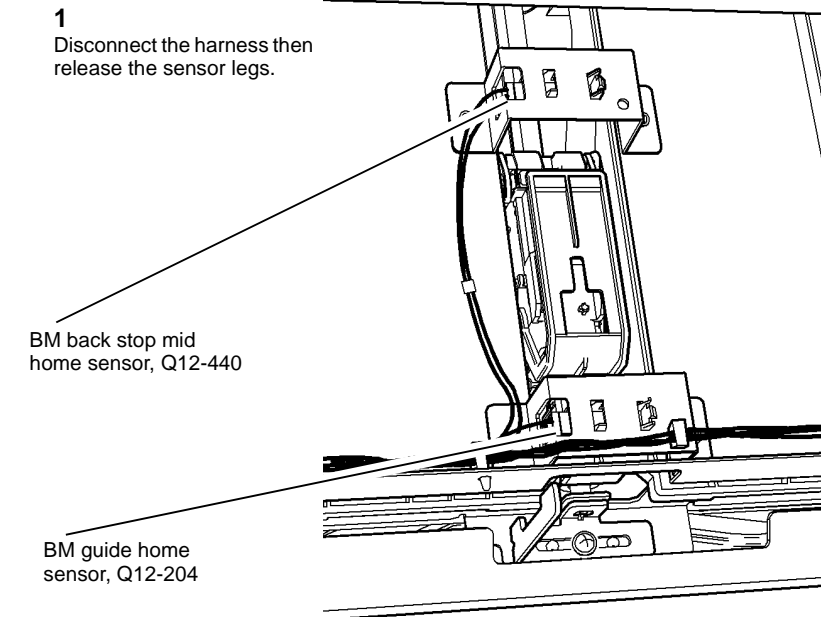
1. Un-dock the LVF BM, [REP 12.13-150](#).
2. Remove the LVF BM back stop cover, [REP 12.1-150](#).
3. Remove the sensors, [Figure 1](#).

Figure 1 Sensors removal

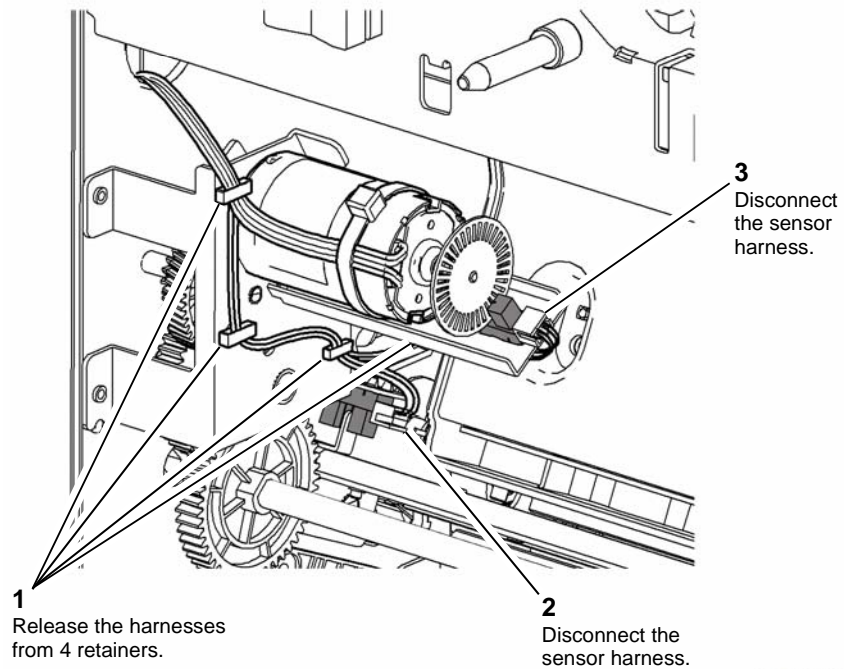
W-1-0330-A

3. Prepare to remove the crease blade motor and gearbox, [Figure 1](#).

Figure 1 Preparation

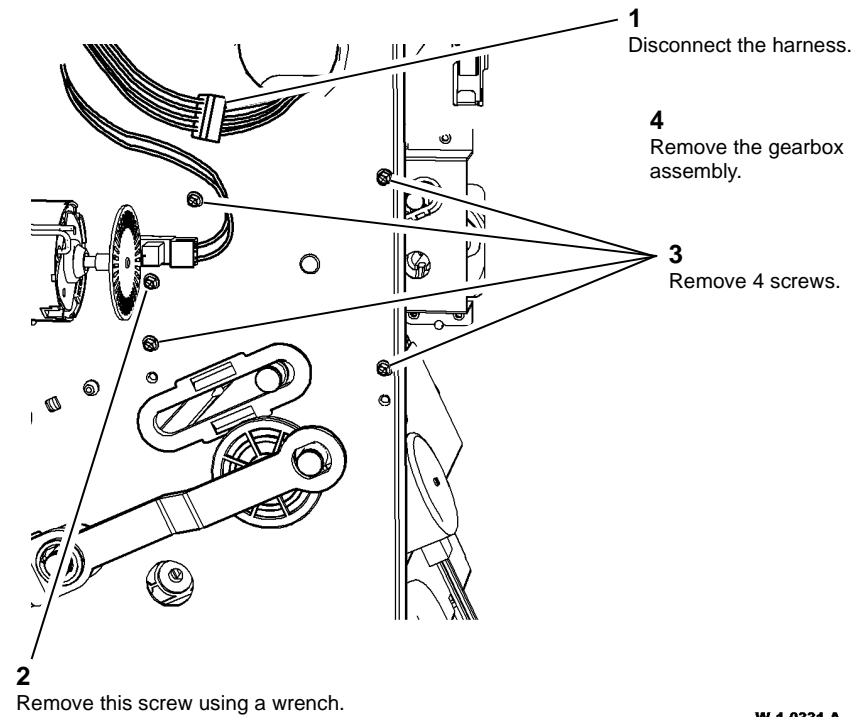
W-1-0331-A

4. Remove the crease blade gearbox assembly, [Figure 2](#).

Figure 2 Gearbox assembly removal

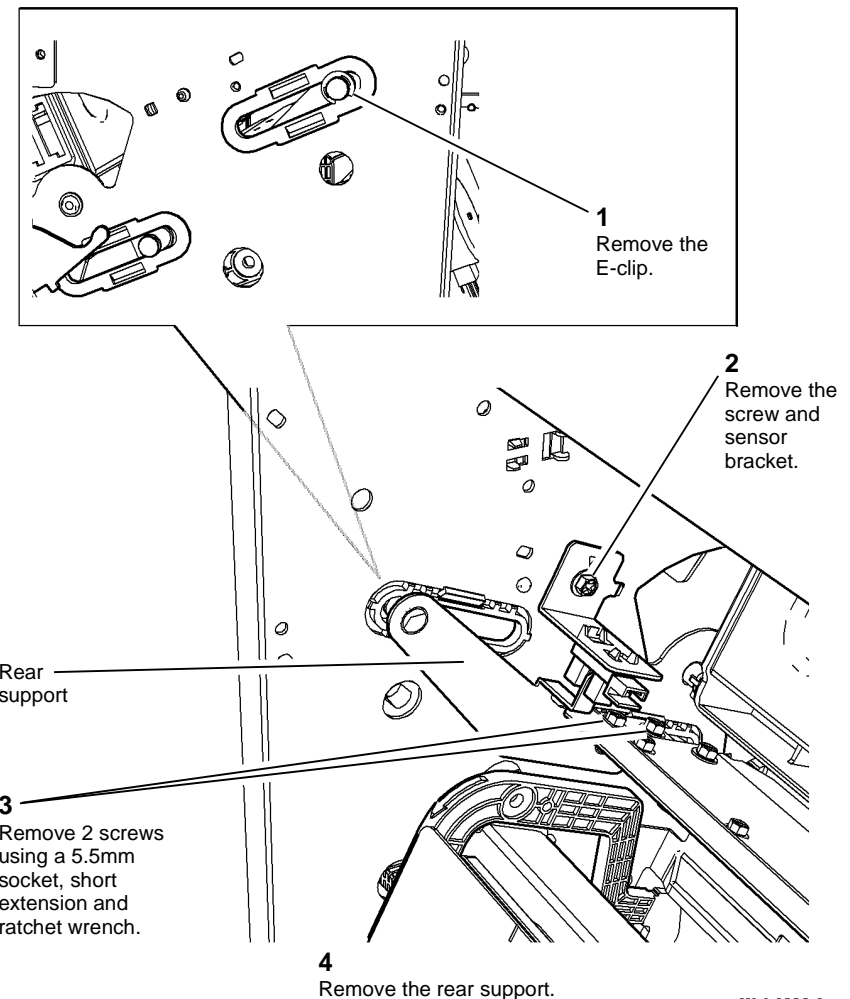
W-1-0332-A

1. Un-dock the LVF BM, [REP 12.13-150](#).
2. Remove the LVF BM front door cover assembly and rear cover, [REP 12.1-150](#).
3. Remove the crease blade gearbox assembly, [REP 12.21-150](#).
4. Remove the crease blade cranks, bearings, drive gear and handle, [REP 12.23-150](#).
5. Prepare to remove the crease blade assembly, [Figure 1](#).

Figure 1 Preparation

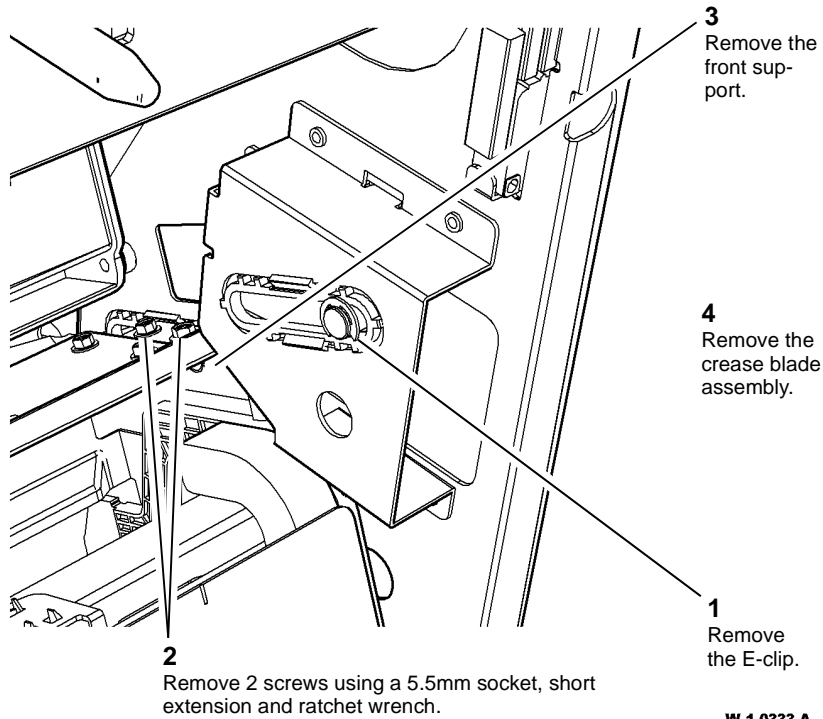
6. Remove the crease blade assembly, [Figure 2](#).

Figure 2 Crease blade assembly removal

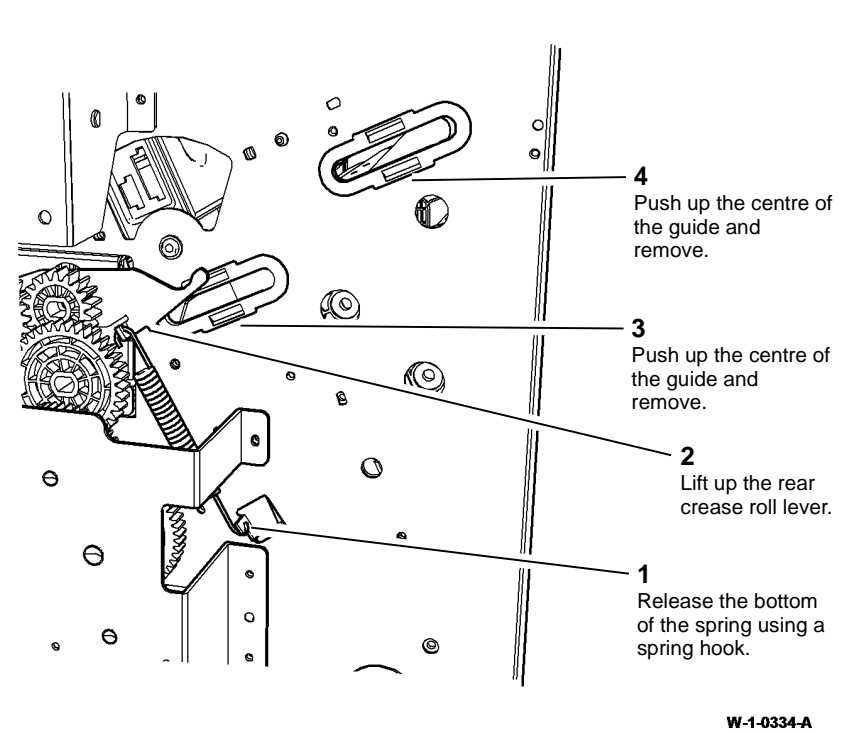
7. Remove the rear crease blade guides, [Figure 3](#).

Figure 3 Rear guides removal

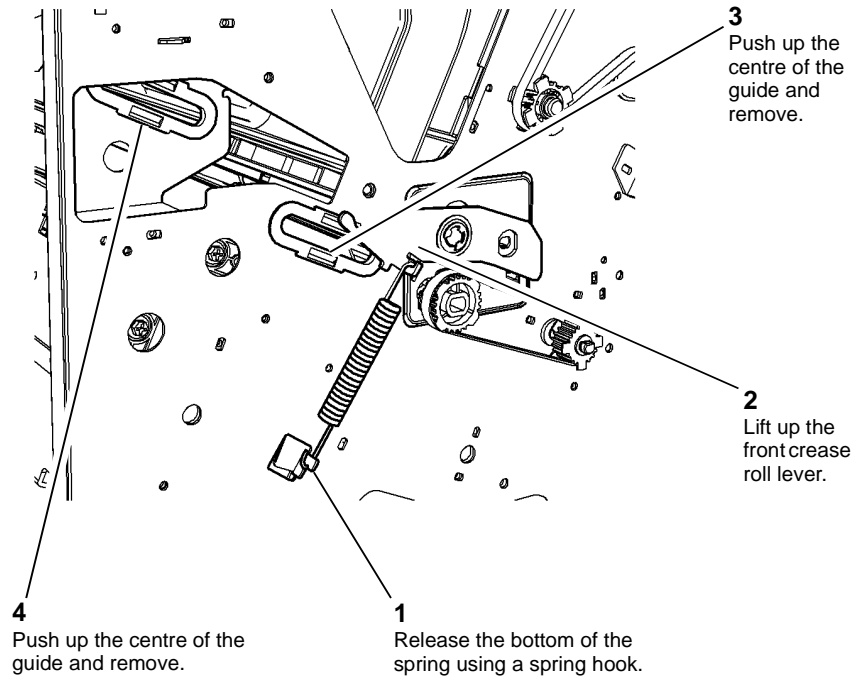
8. Remove the front crease blade guides, [Figure 4](#).

Figure 4 Front guides removal
