708P91139
February 2016

Xerox® WorkCentre® 5945 Family Multifunction Printer Service Manual

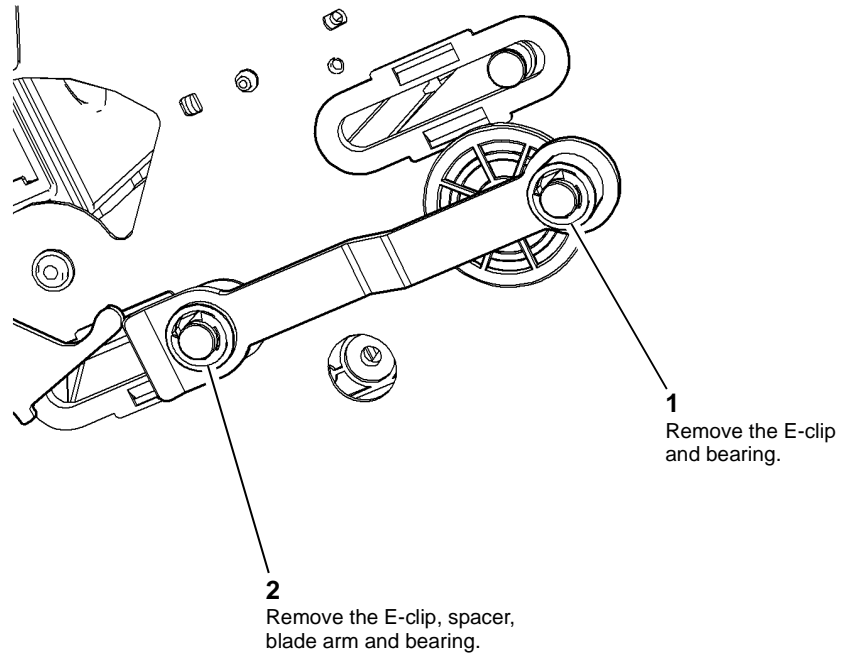
W-1-0336-A

4. Remove the rear blade arm, [Figure 1](#).

Figure 1 Rear blade arm removal

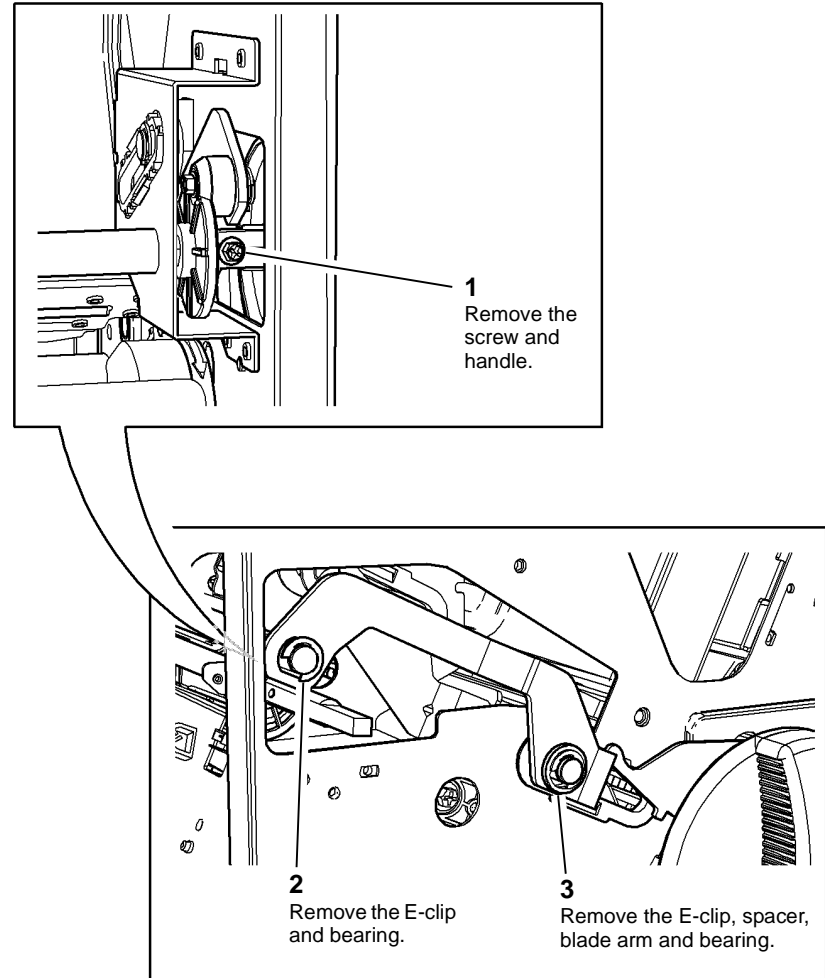
W-1-0337-A

5. Remove the front blade arm, [Figure 2](#).

Figure 2 Front blade arm removal

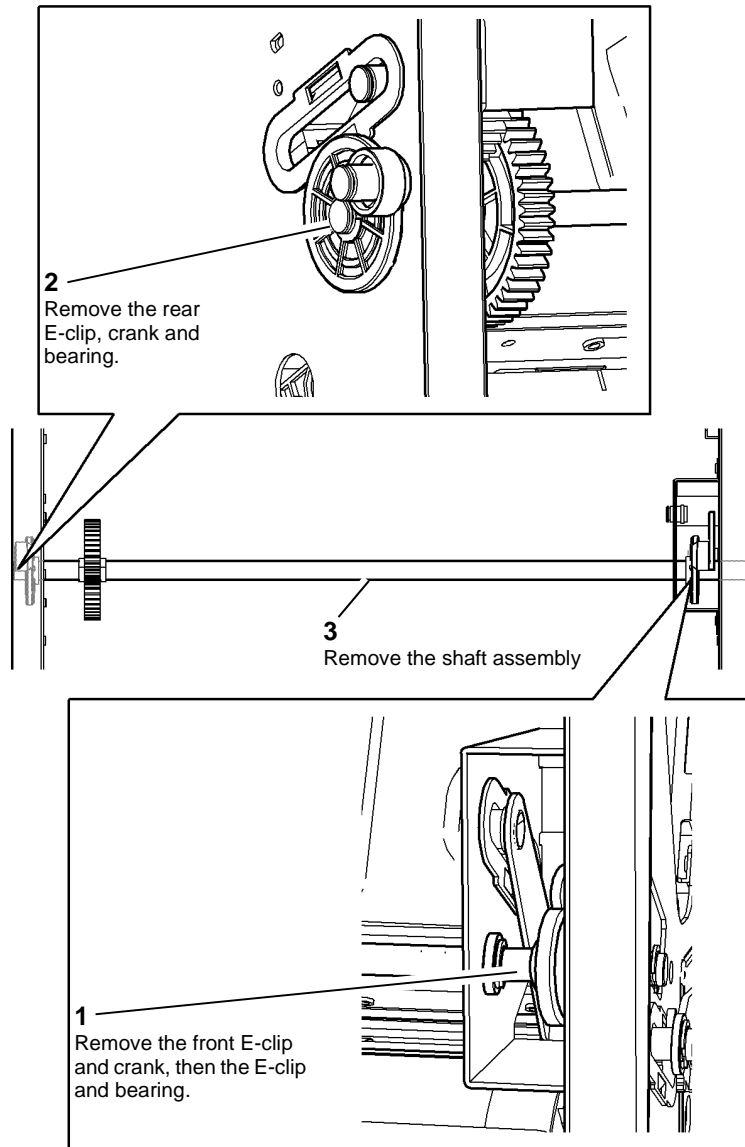
W-1-0338-A

6. Remove the crease blade shaft assembly, [Figure 3](#).

Figure 3 Crease blade shaft removal

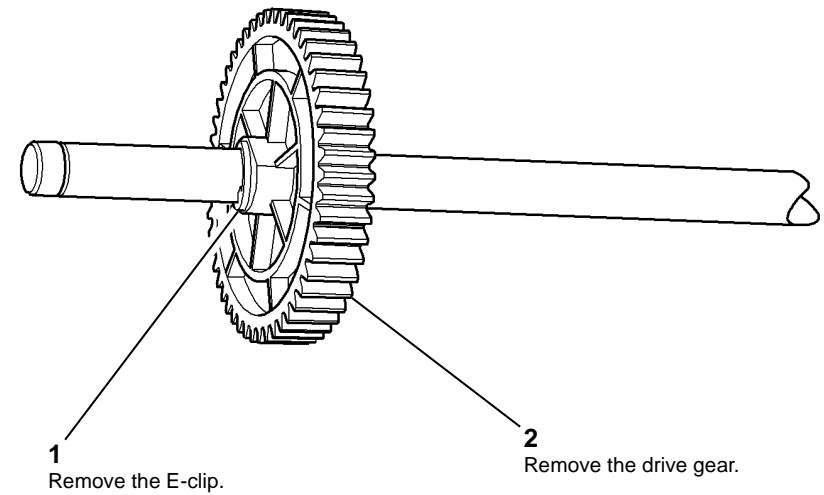
W-1-0339-A

7. Remove the crease blade drive gear, [Figure 4](#).

Figure 4 Drive gear removal

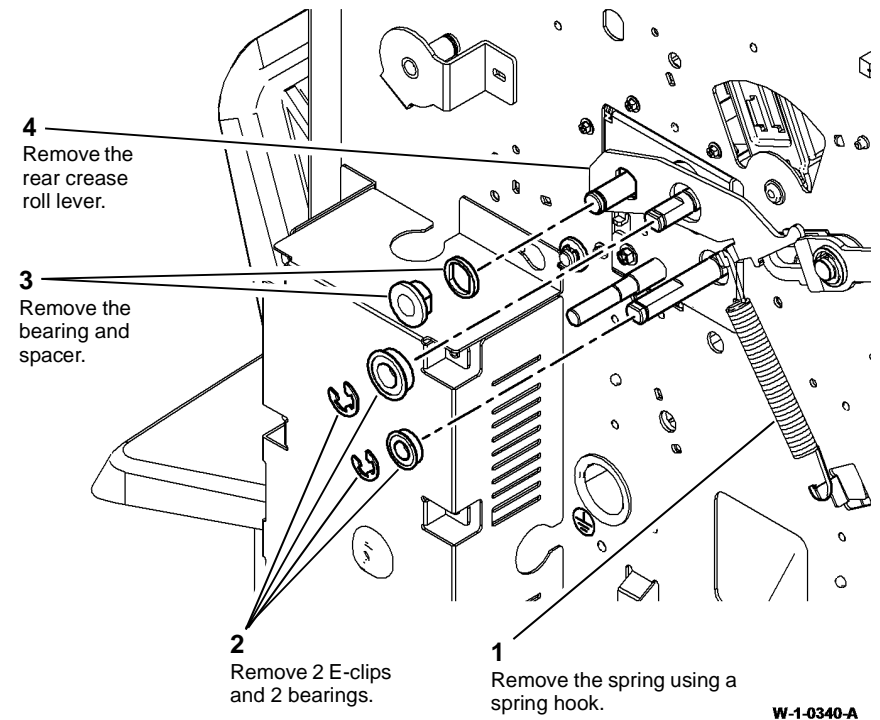
5. Remove the rear crease roll lever, Figure 1.

Figure 1 Rear lever removal

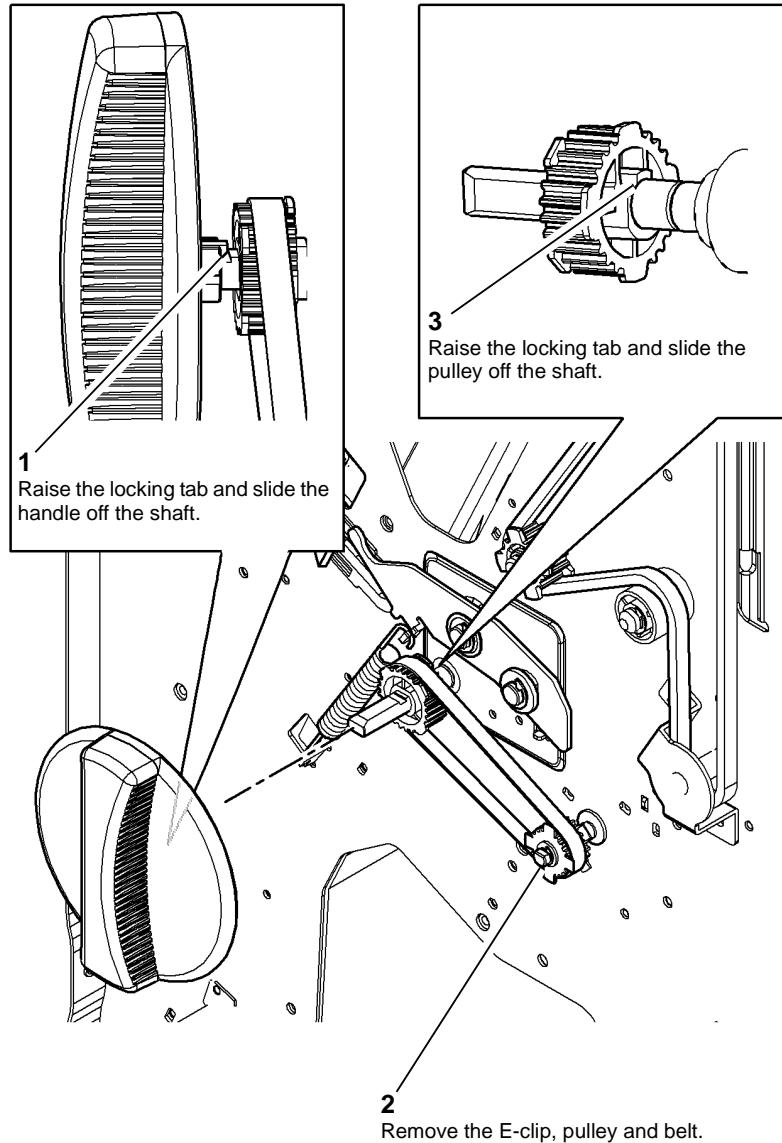
6. Remove the exit roll belt components, [Figure 2](#).

Figure 2 Exit roll belt removal

1. The replacement is the reverse of the removal procedure.
2. When replacing the exit roll belt components, ensure the one-way clutch on the pulley is on the inside. Refer to [Figure 2](#).

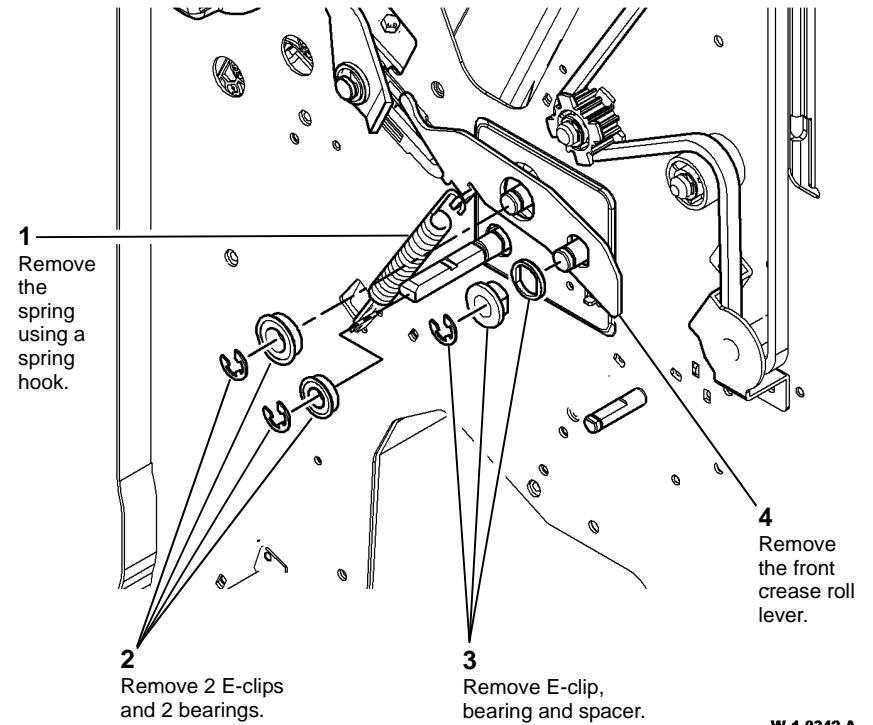
7. Remove the front crease roll lever, [Figure 3](#).

Figure 3 Front lever removal

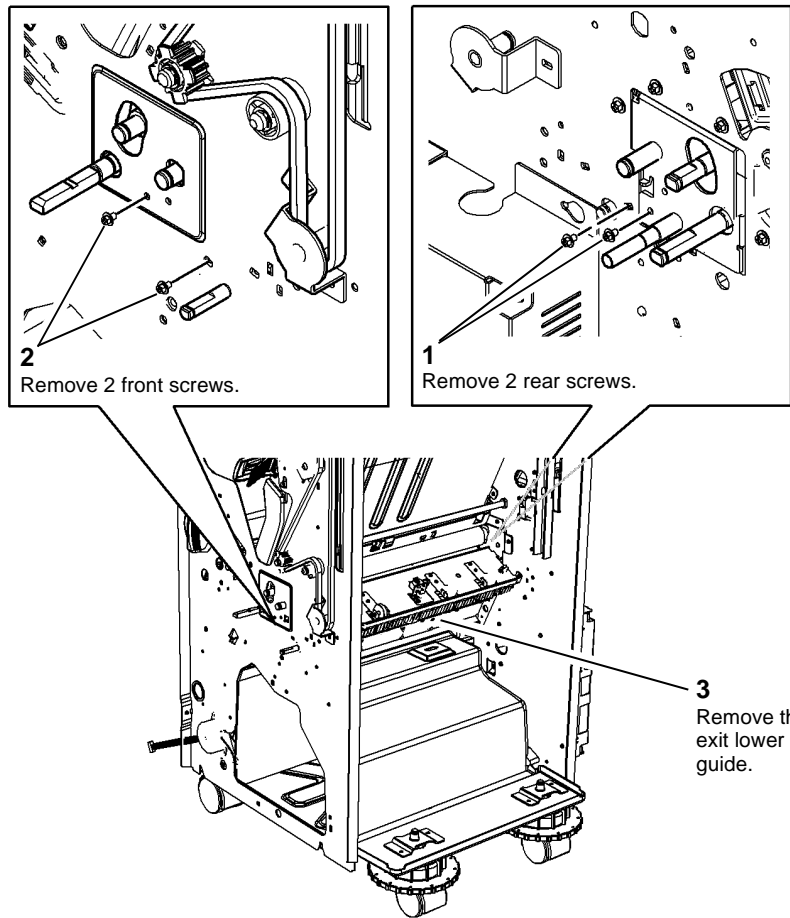
W-1-0343-A

12. Remove the exit lower guide, [Figure 4](#).

Figure 4 Exit lower guide removal

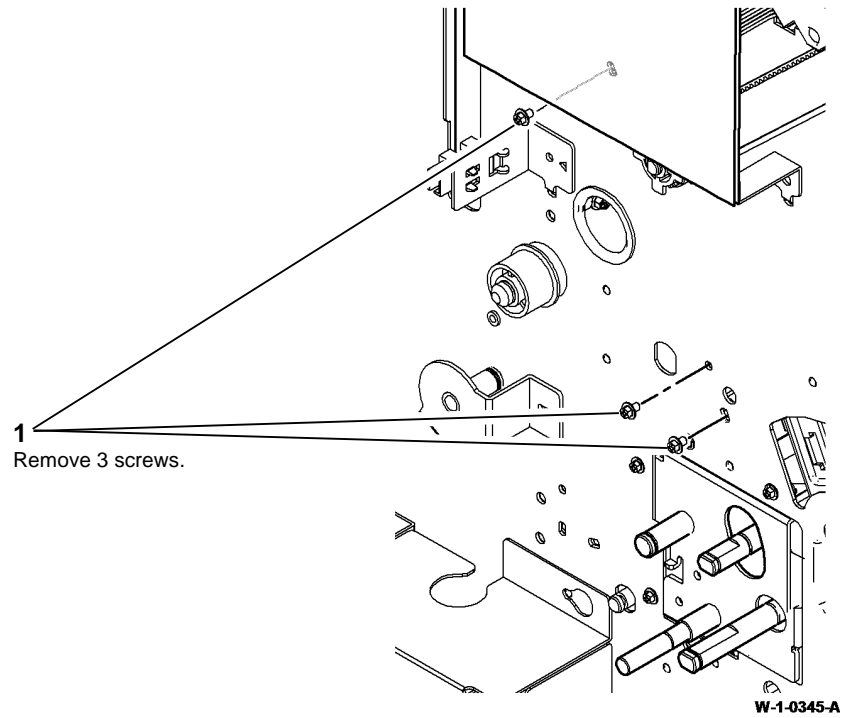
15. Release the booklet compiler tray, [Figure 6](#).

Figure 6 Tray release

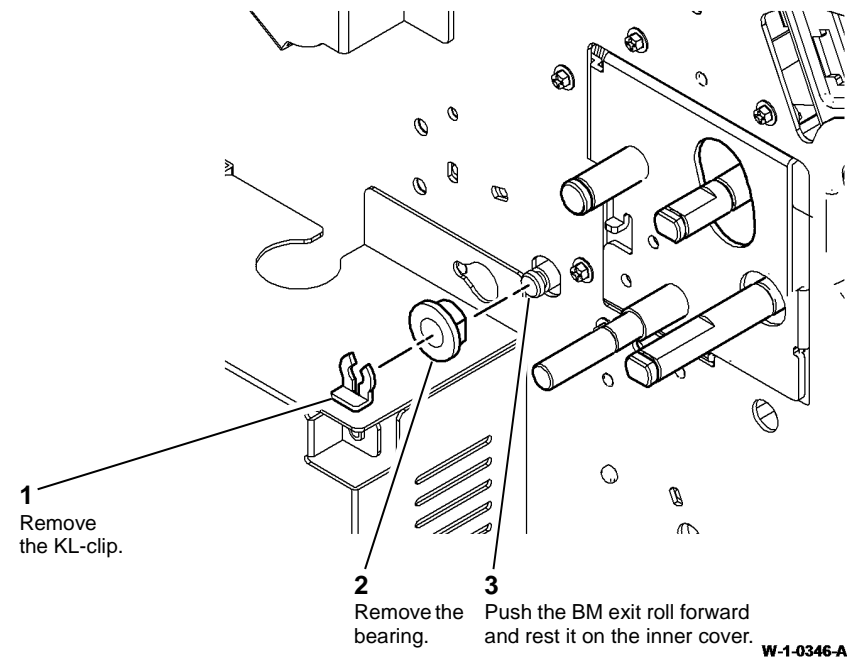
16. Release the rear of the BM exit roll assembly, [Figure 7](#).

Figure 7 BM exit roll release

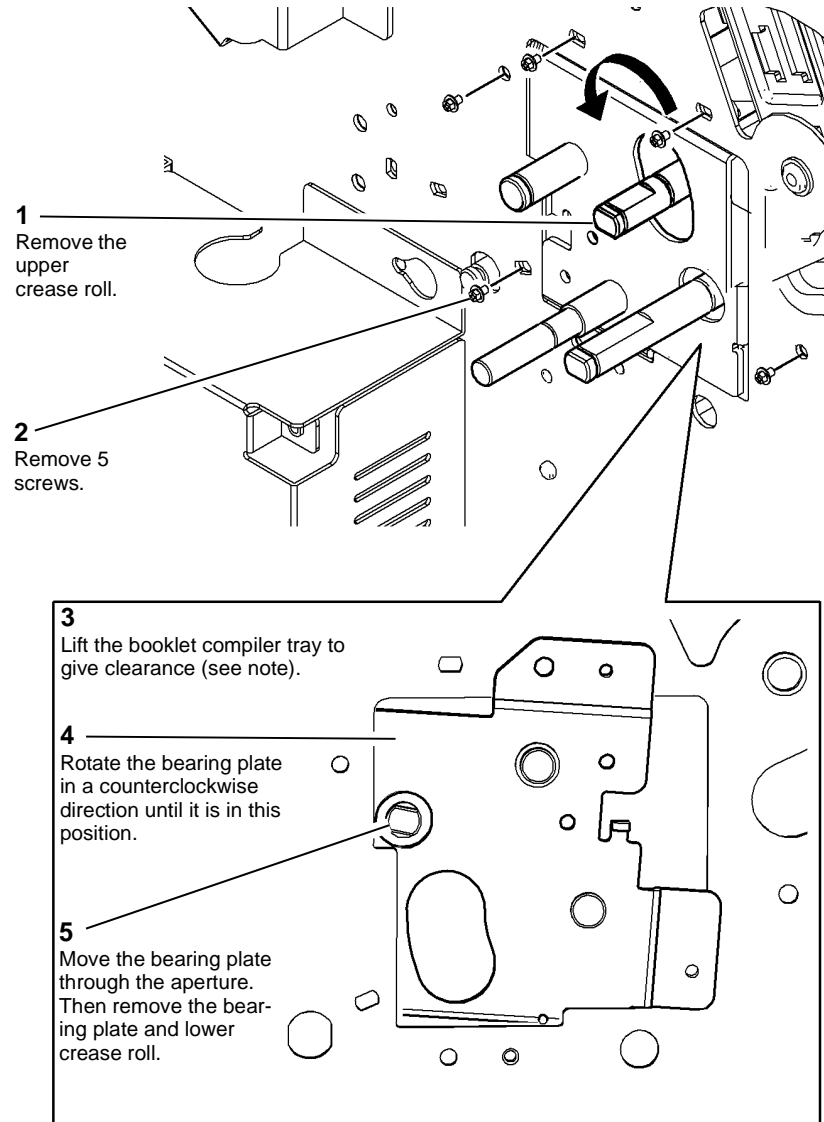
17. Remove the upper and lower crease roll, [Figure 8](#).

NOTE: The lifted booklet compiler tray can be temporarily supported by loosely holding it in place with a screw. Lift the tray as high as it can be raised. Align the lower screw hole with a suitable hole in the finisher frame.

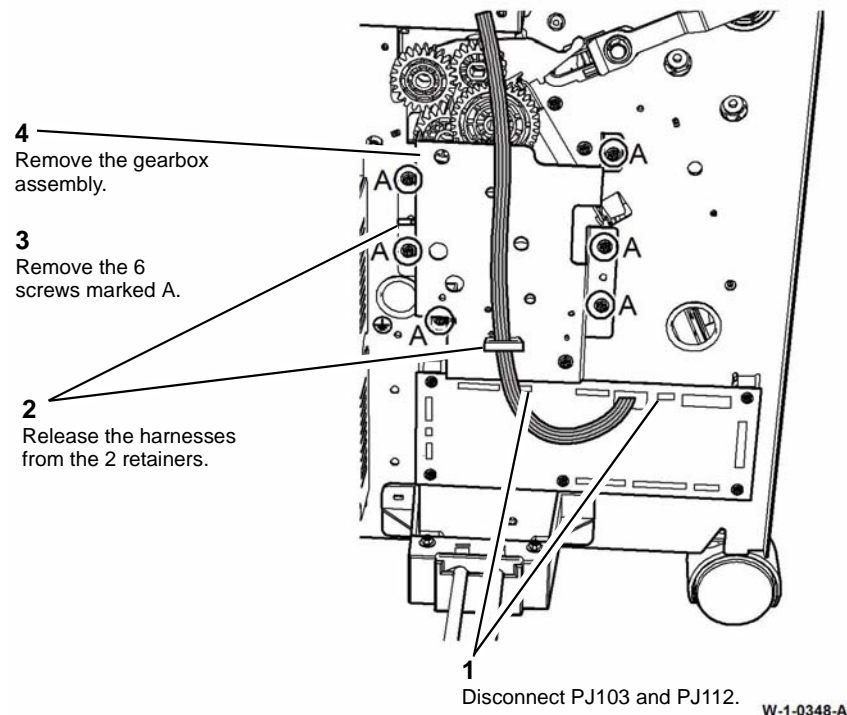
1. Remove the LVF BM top and rear covers, [REP 12.1-150](#).
2. Remove the crease roll gearbox assembly, [Figure 1](#).

Figure 1 Gearbox removal

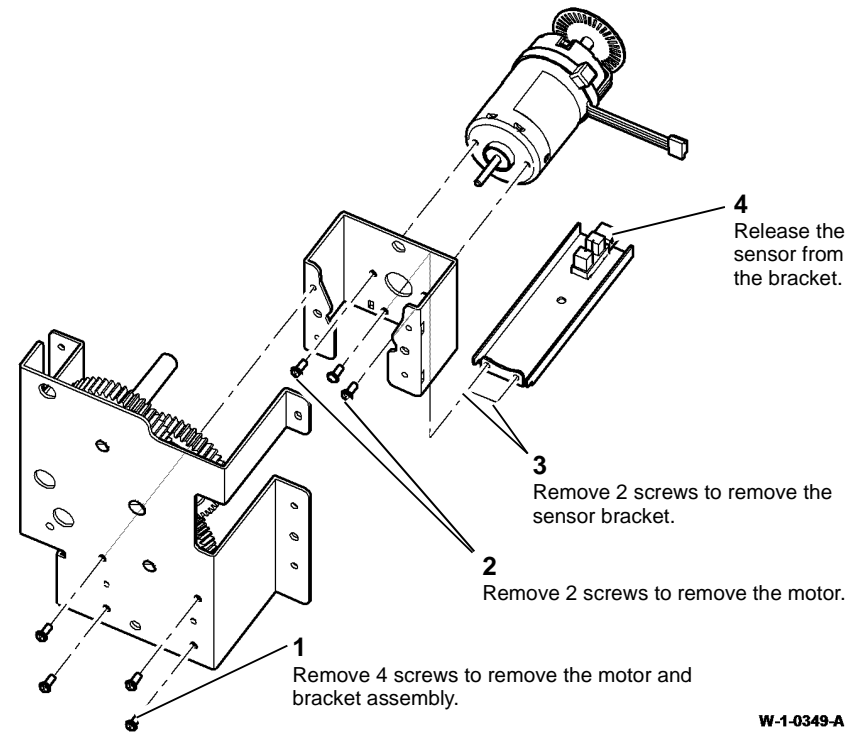
3. Remove the crease roll motor and sensor, [Figure 2](#).

Figure 2 Crease roll motor removal

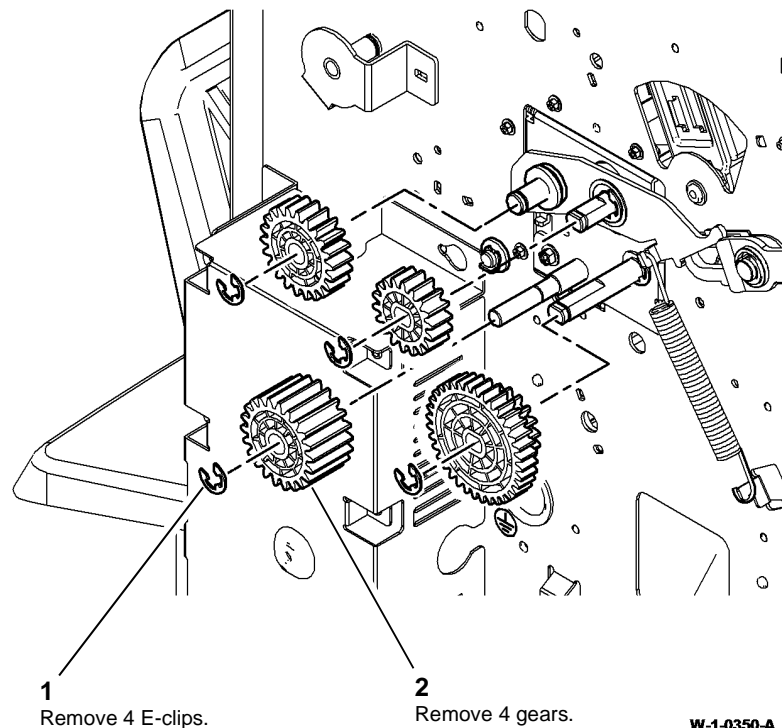
1. Remove the crease roll motor and gearbox, [REP 12.25-150](#).
2. Remove the crease roll gears, [Figure 1](#).

Figure 1 Gears removal

1. Ensure the gears are located in their correct positions. Refer to [Figure 1](#).
2. Reverse the removal procedure to replace the remainder of the components.

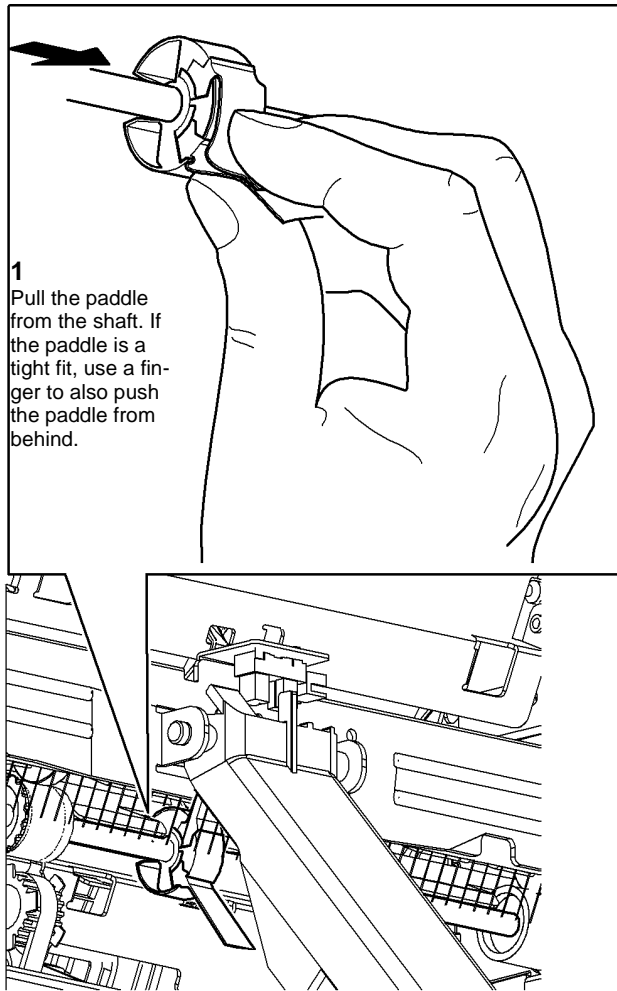
W-1-0351-A

3. Remove the exit roll paddle, [Figure 1](#).

Figure 1 Exit roll paddle removal

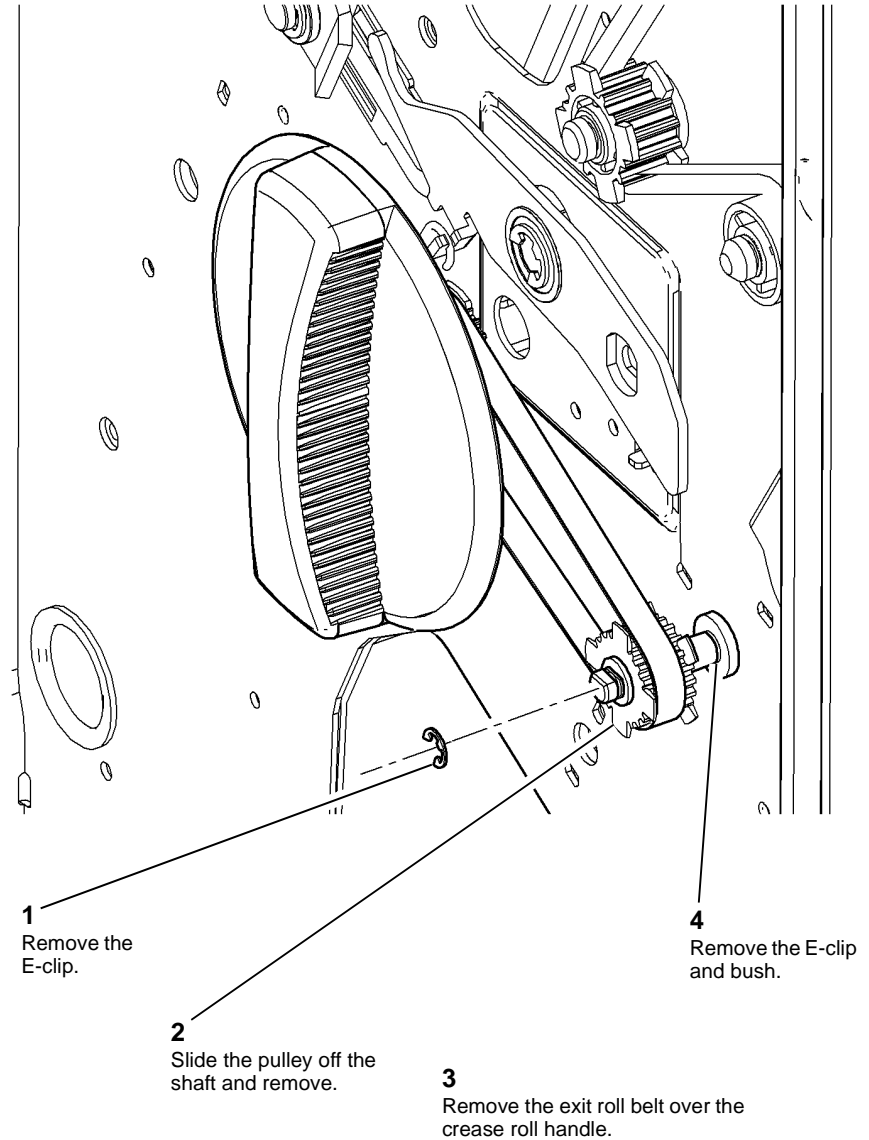
W-1-0352-A

4. Remove the belt pulley and bush, **Figure 2**.

Figure 2 Belt pulley and bush removal

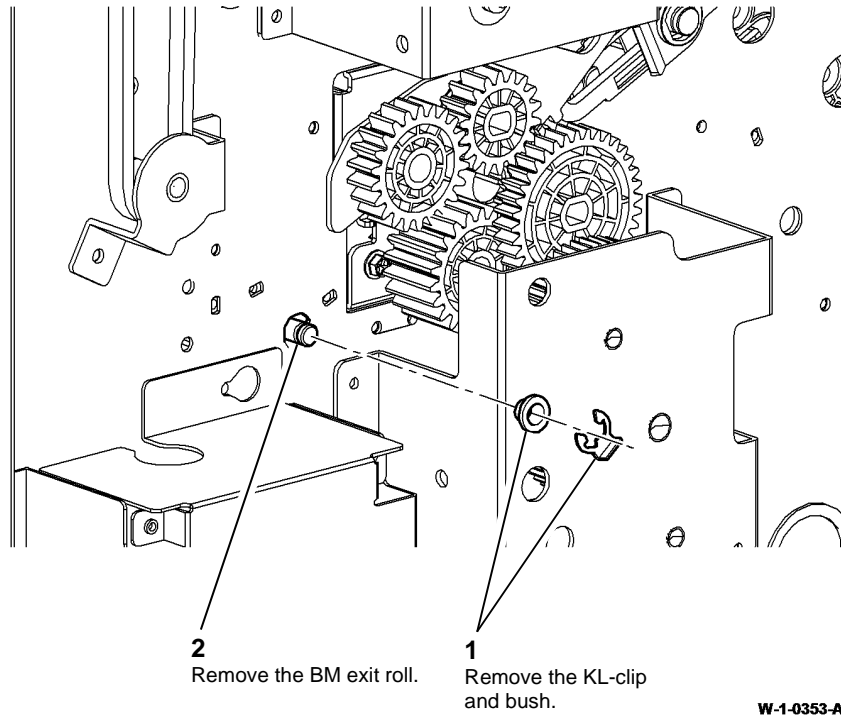
- Remove the BM exit roll, [Figure 3](#).

Figure 3 BM exit roll removal

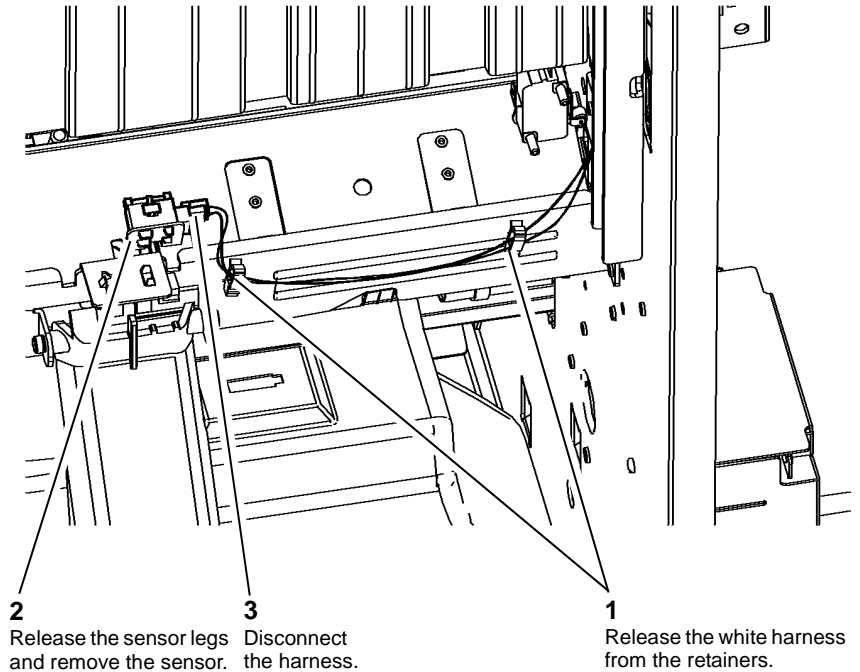
- Remove the lower right cover, [REP 12.45-150](#).
- Remove the BM exit sensor, [Figure 1](#).

Figure 1 BM exit sensor removal

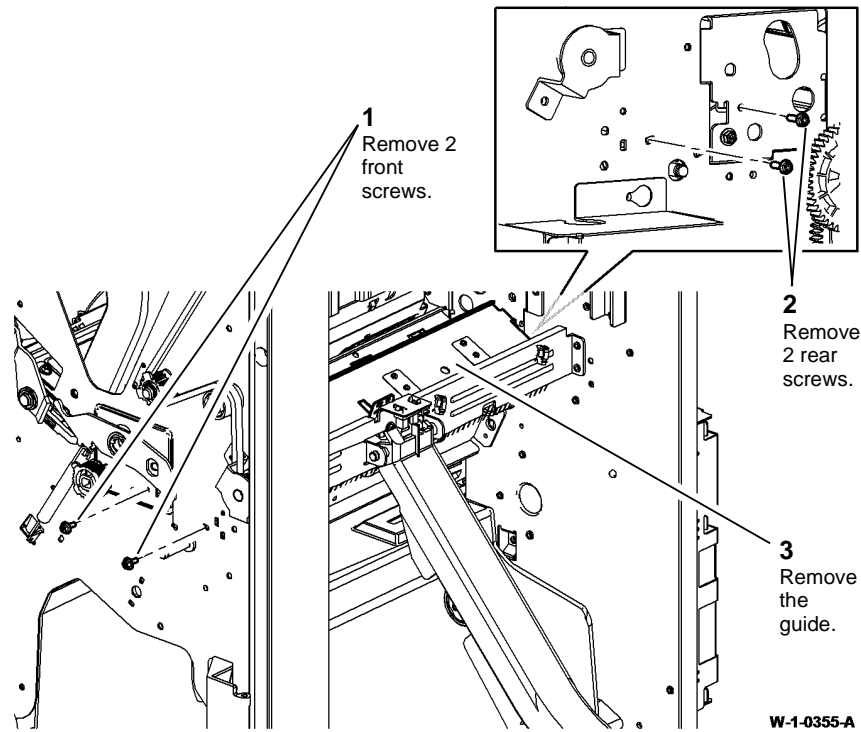
- Remove the BM exit upper guide assembly, [Figure 2](#).

Figure 2 Upper guide removal

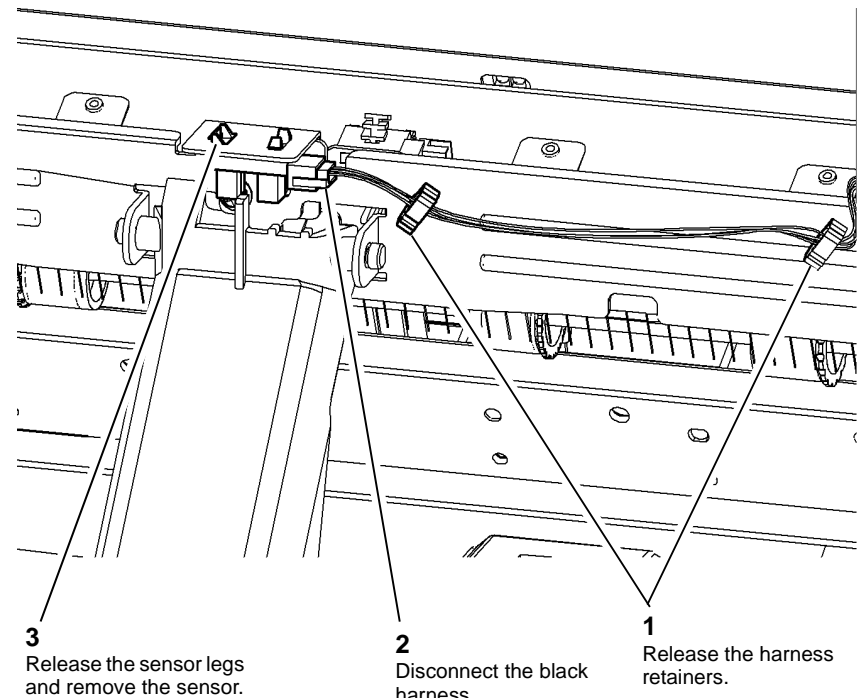
- Remove the lower right cover, [REP 12.45-150](#).
- Remove the bin 2 90% full sensor, [Figure 1](#).

Figure 1 Sensor removal

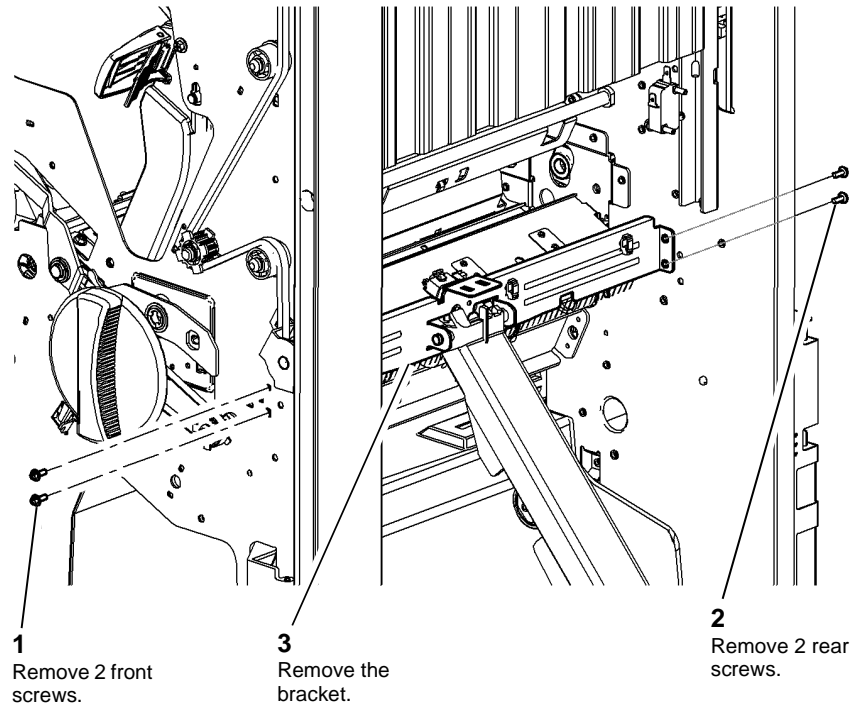
W-1-0357-A

3. Remove the bail arm support bracket and bail arm, [Figure 2](#).

Figure 2 Support bracket removal

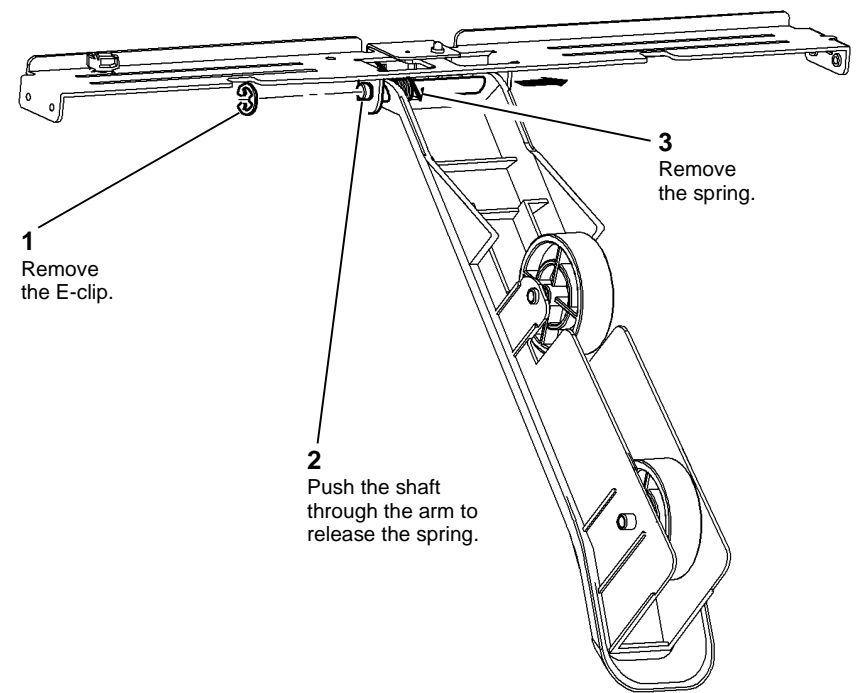
W-1-0358-A

4. Remove the bail arm spring, [Figure 3](#).

Figure 3 Bail arm spring removal

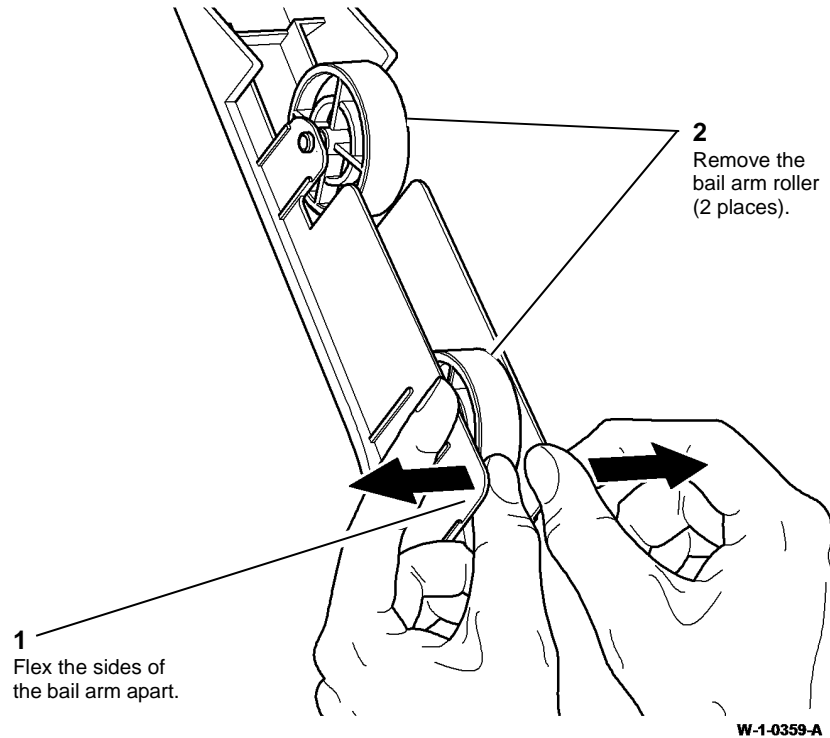
NOTE: The bail arm rollers can be removed with the bail arm installed on the LVF BM.

5. Remove the bail arm roller, [Figure 4](#).

Figure 4 Bail arm roller removal

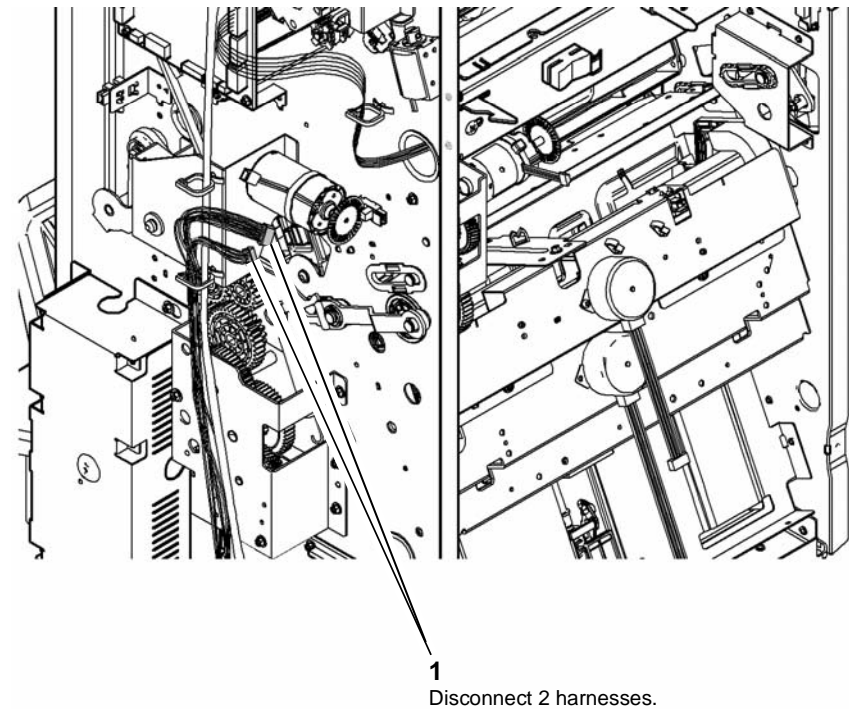
1. Un-dock the LVF BM, [REP 12.13-150](#).
2. Remove the LVF BM front door cover assembly, rear cover and LVF BM back stop cover, [REP 12.1-150](#).
3. Disconnect the harnesses, [Figure 1](#).

Figure 1 Disconnecting harnesses

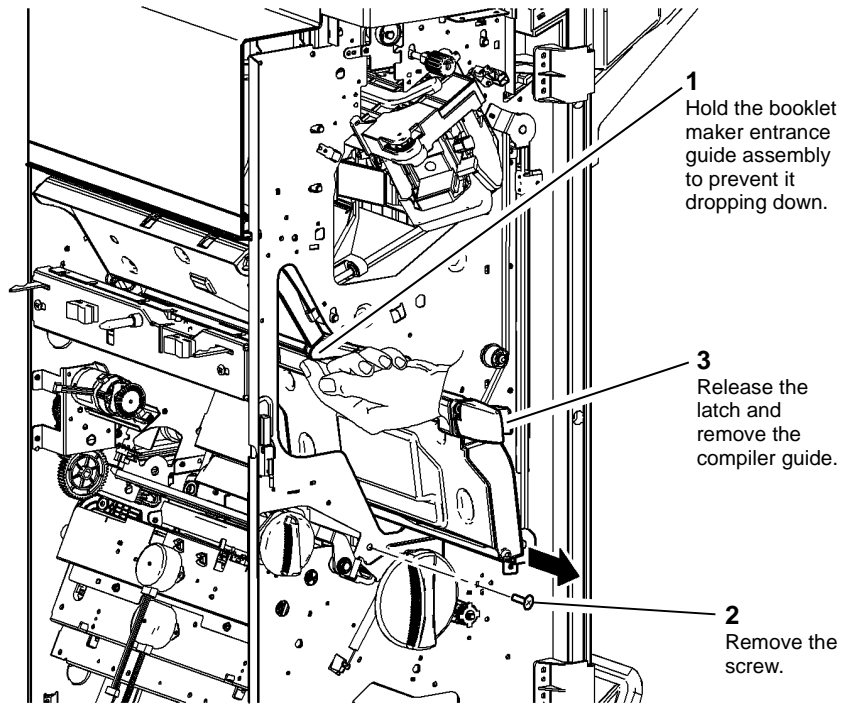
W-1-0361-A

4. Remove the BM compiler guide assembly, [Figure 2](#).

Figure 2 Compiler guide removal

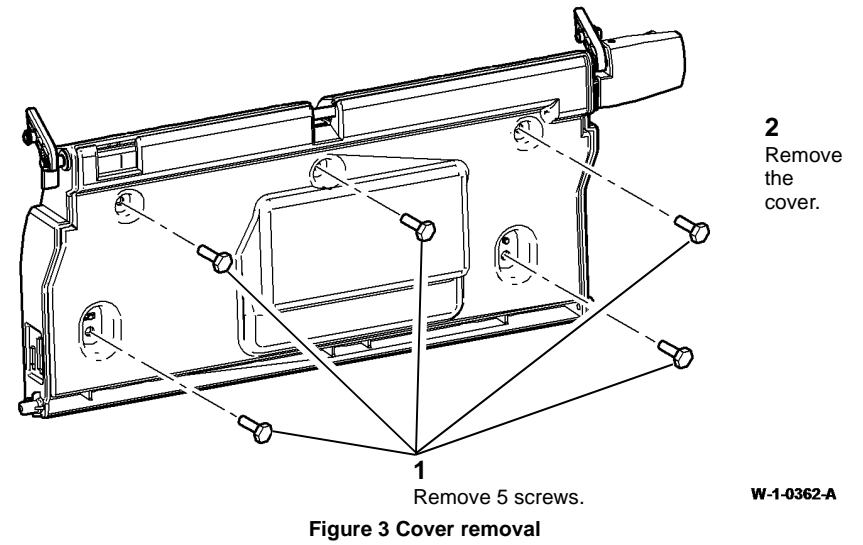
W-1-0362-A

5. Remove the BM compiler guide assembly cover, [Figure 3](#).

Figure 3 Cover removal

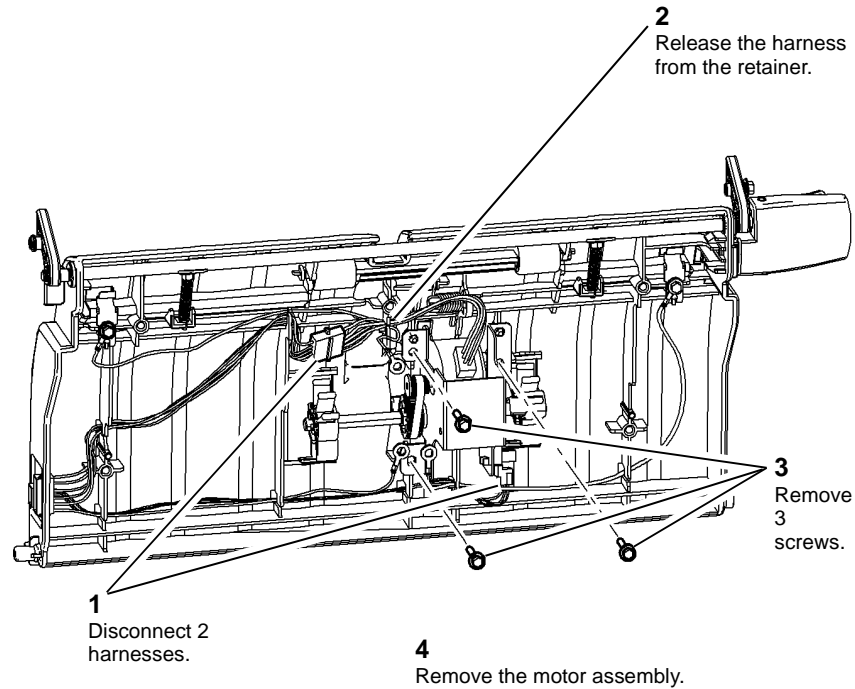
6. Remove the BM flapper motor assembly, [Figure 4](#).

Figure 4 Motor assembly removal

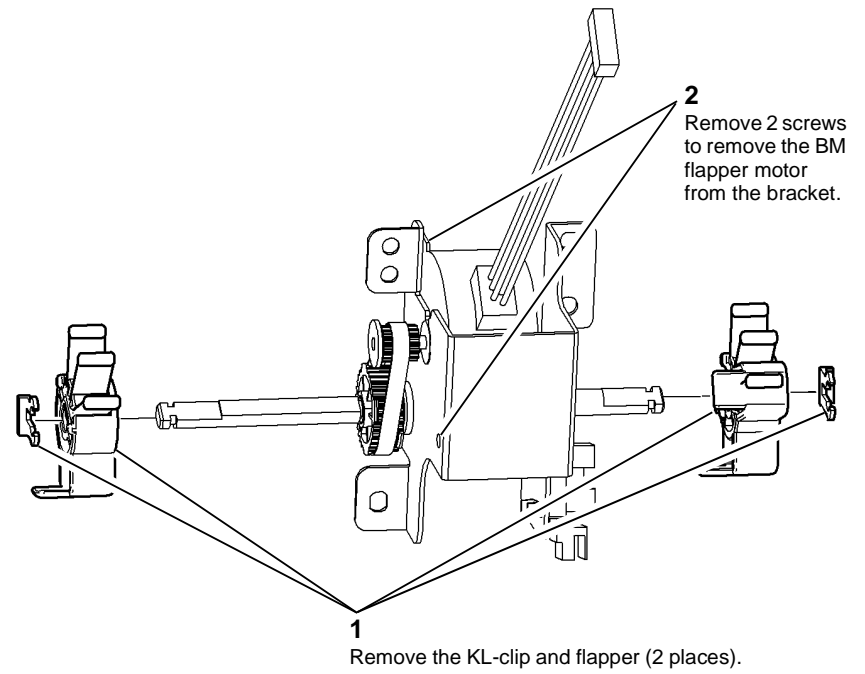
7. Remove the BM compiler flappers, [Figure 5](#).

Figure 5 BM compiler flapper removal

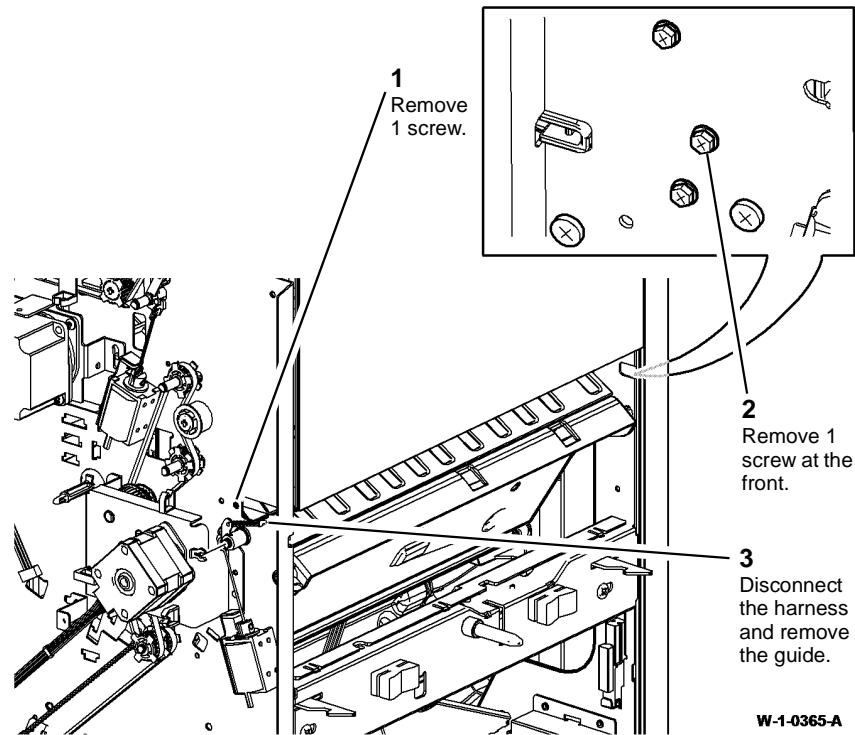
Figure 1 Upper entrance guide removal

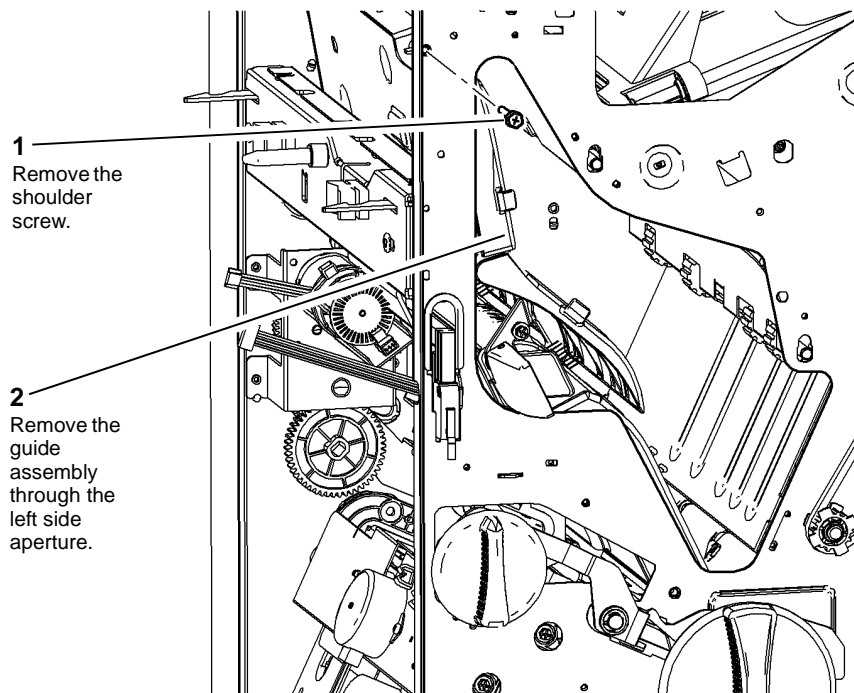
W-1-0366-A

1. Un-dock the LVF BM, [REP 12.13-150](#).
2. Remove the LVF BM front door cover assembly and rear cover, [REP 12.1-150](#).
3. Remove the BM entrance guide assembly, [Figure 1](#).

Figure 1 Entrance guide removal

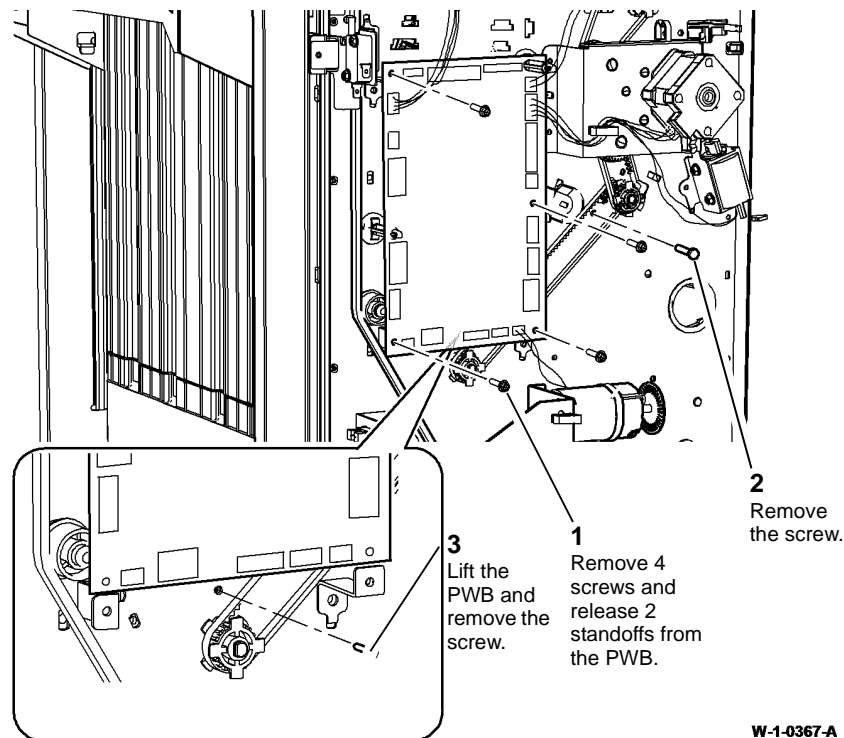
W-1-0367-A

4. Remove the BM compiler guide assembly, [REP 12.30-150](#).
5. Prepare to remove the BM lower guide, [Figure 2](#).

Figure 2 Preparation

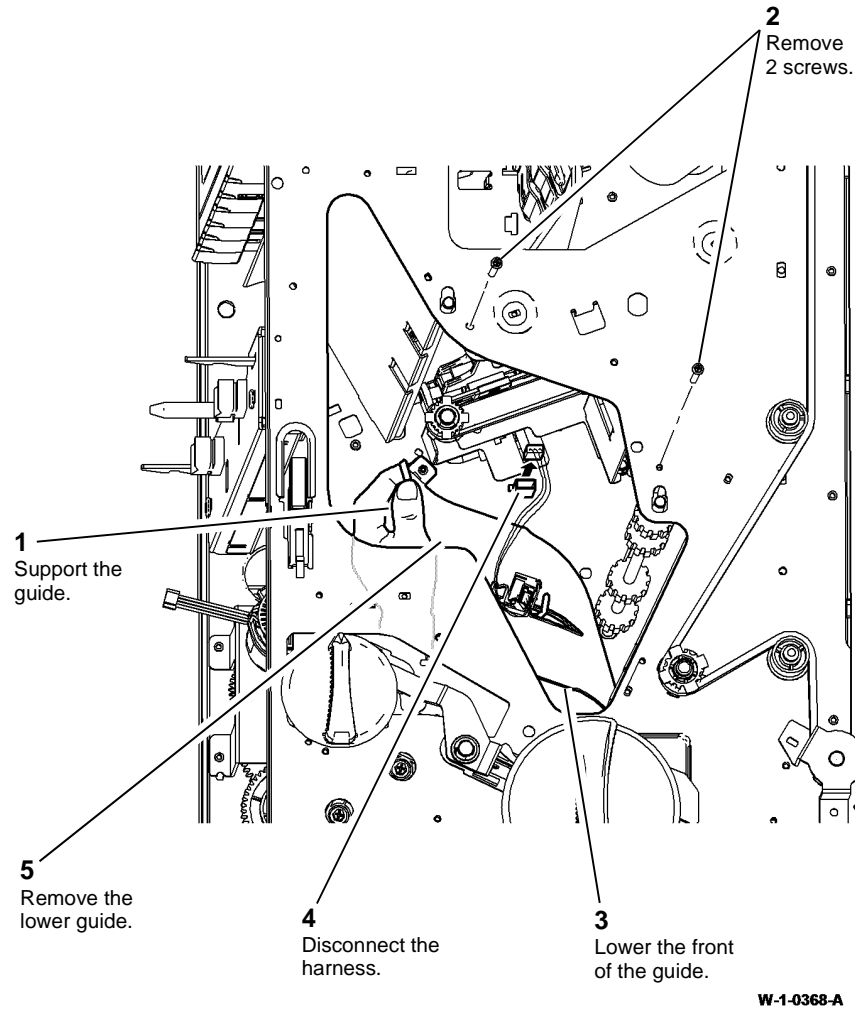
- Remove the BM lower guide, [Figure 3](#).

Figure 3 BM lower guide removal

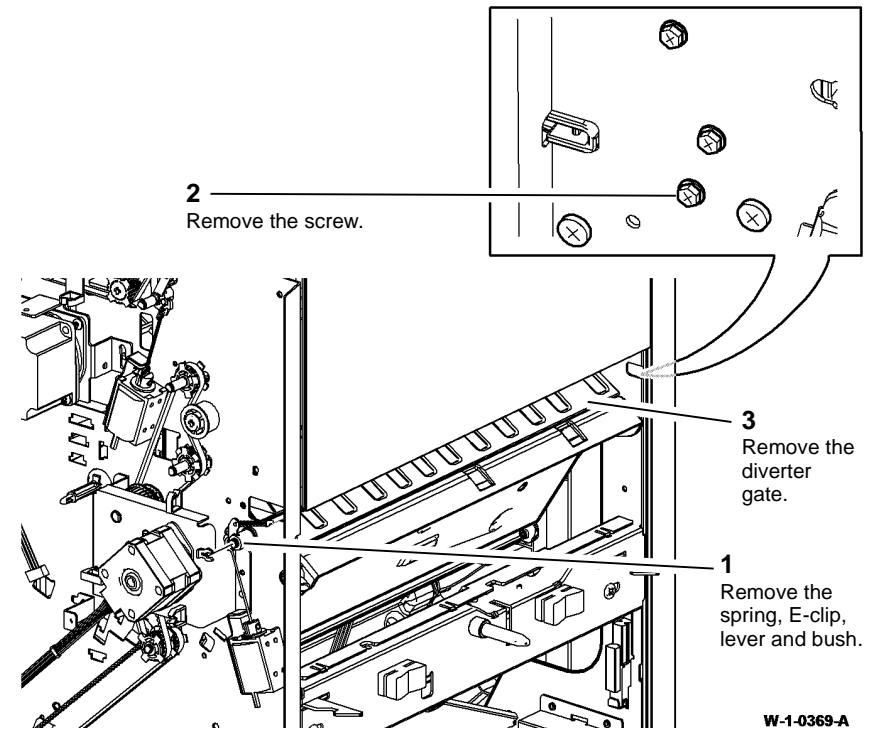
- Un-dock the LVF BM, [REP 12.13-150](#).
- Remove the LVF BM front door cover assembly and rear cover, [REP 12.1-150](#).
- Remove the upper entrance guide, [REP 12.31-150](#).
- Remove the booklet diverter gate, [Figure 1](#).

Figure 1 Diverter gate removal
