708P91139
February 2016

Xerox® WorkCentre® 5945 Family Multifunction Printer Service Manual

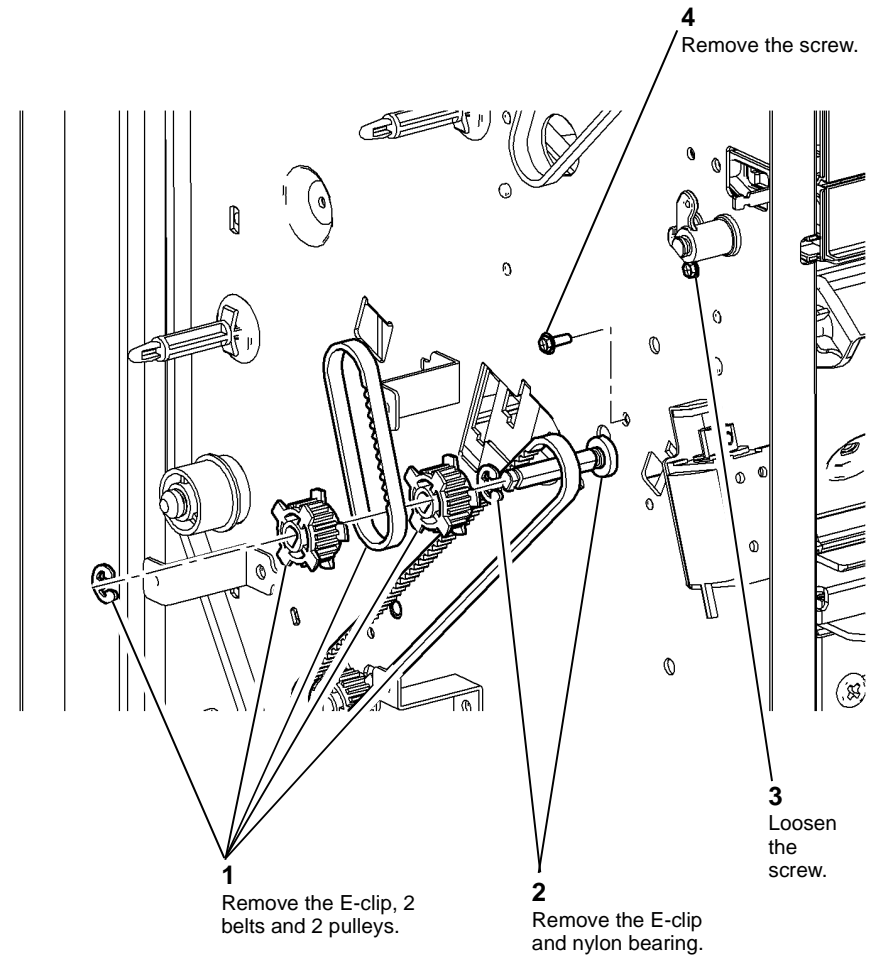
W-1-0370-A

1. Un-dock the LVF BM, [REP 12.13-150](#).
2. Remove the LVF BM front door cover assembly and rear cover, [REP 12.1-150](#).
3. Remove the transport motor 1 and gearbox assembly, [REP 12.2-150](#).
4. Remove the rear components, [Figure 1](#).

Figure 1 Rear components removal

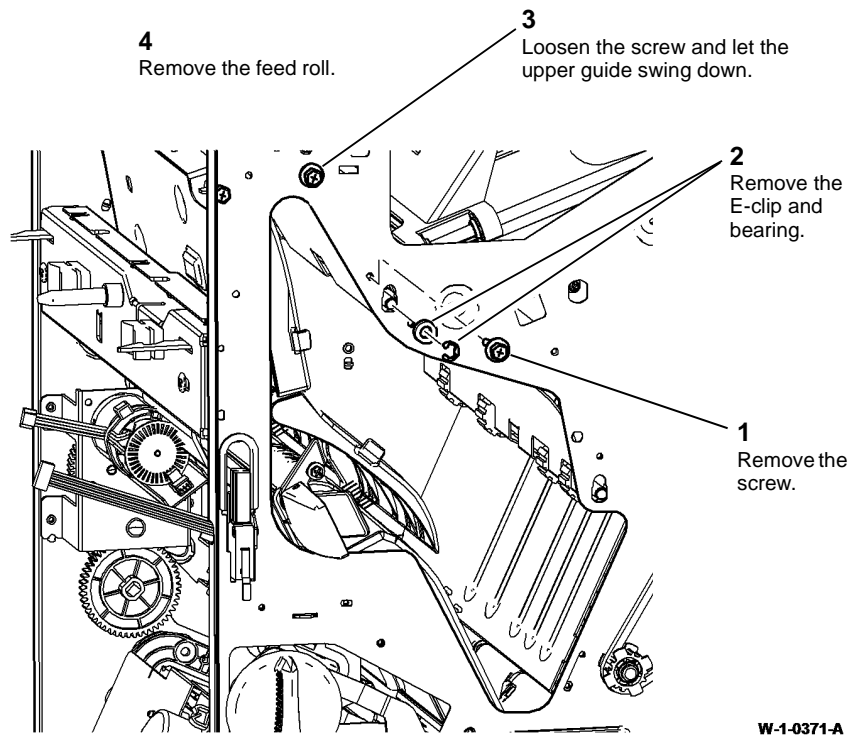
6. Remove the BM 1st feed roll assembly, [Figure 2](#).

Figure 2 1st feed roll removal

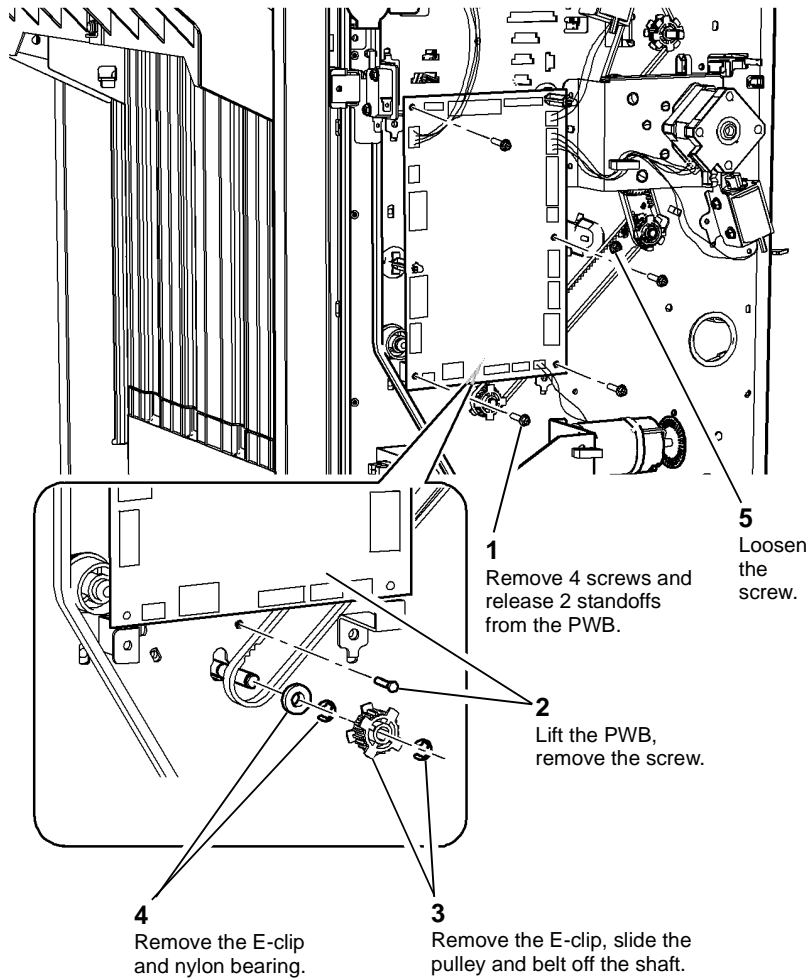
W-1-0371-A

1. Un-dock the LVF BM, [REP 12.13-150](#).
2. Remove the LVF BM front door cover assembly and rear cover, [REP 12.1-150](#).
3. Remove the rear components, [Figure 1](#).

Figure 1 Rear components removal

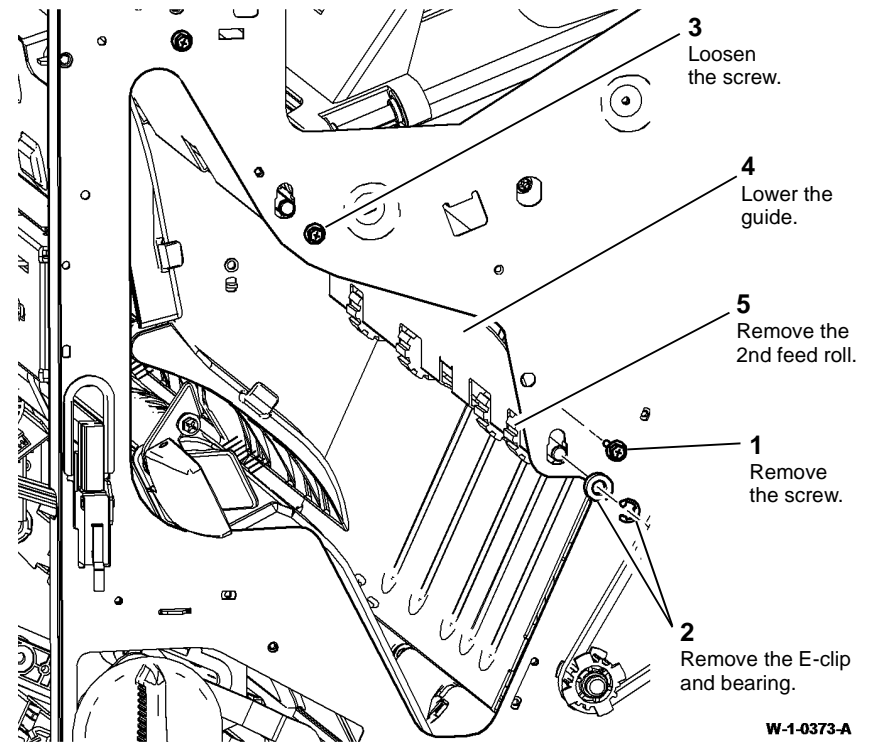
W-1-0373-A

5. Remove the BM 2nd feed roll assembly, [Figure 2](#).

NOTE: Take care when lowering the guide in [Figure 2](#), so that the harness to the BM entry sensor does not become disconnected.

Figure 2 2nd feed roll removal

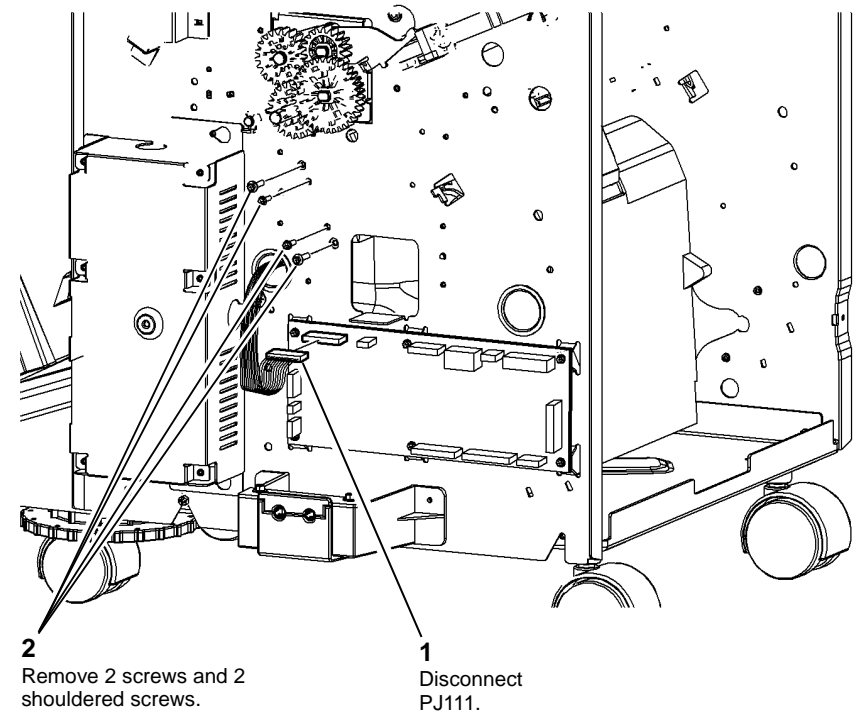
W-1-0374-A

1. Remove the right guide assembly. Refer to [REP 12.19-150](#).
2. Prepare to remove the BM staple cartridge assembly, [Figure 1](#).

Figure 1 Preparation

1. Insert and tighten the 4 shouldered screws, [Figure 1](#) and [Figure 2](#).
2. The remainder of the replacement is the reverse of the removal procedure.

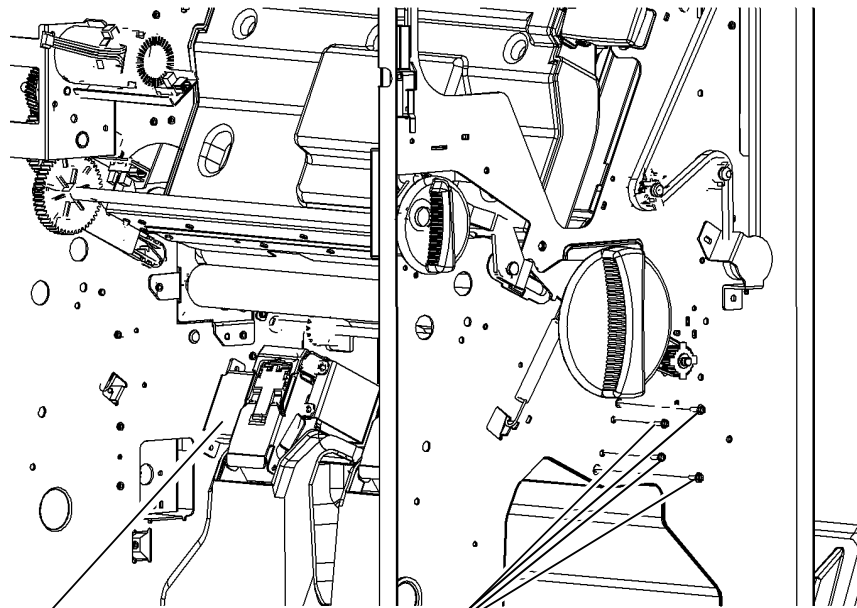
3. Remove the BM staple cartridge assembly, [Figure 2](#).

2
Remove the staple cartridge assembly.

1
Remove 2 screws and 2 shouldered screws.

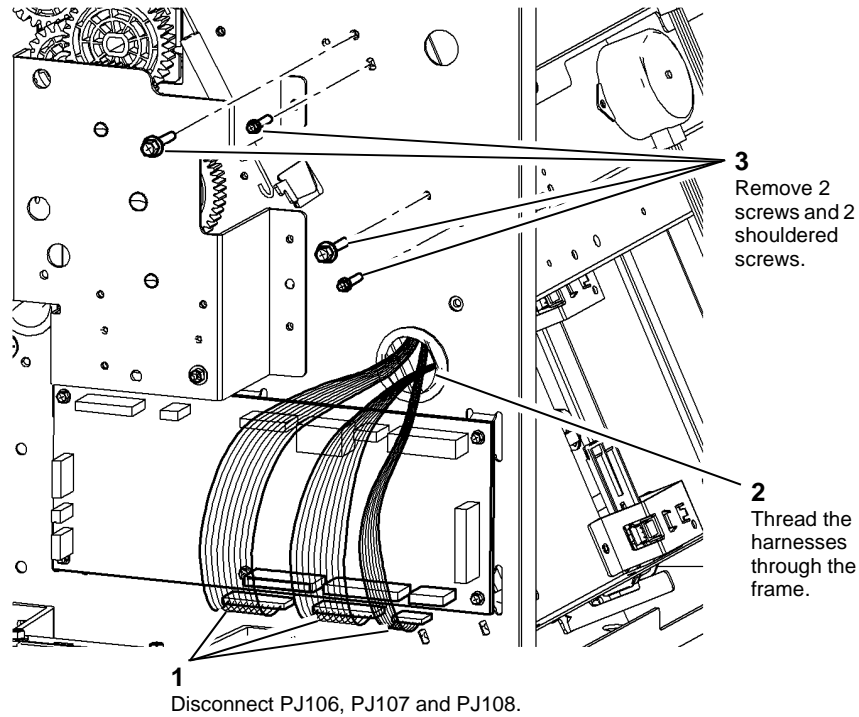
3. Prepare to remove the BM stapler assembly and booklet tamper assembly, [Figure 1](#).

Figure 1 Preparation

1. The replacement is the reverse of the removal procedure.
2. When installing the BM stapler assembly and booklet tamper assembly, first insert and tighten the 4 shouldered screws, [Figure 1](#) and [Figure 2](#), then continue with the remainder of the installation.
3. Perform [ADJ 12.6-150](#) Booklet Staple Position.

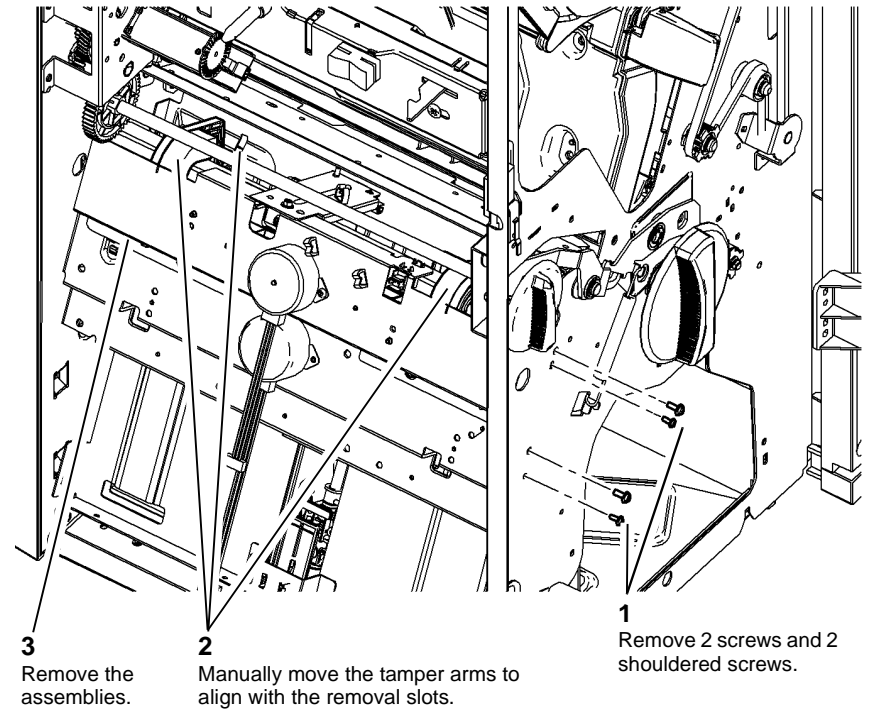
4. Remove the BM stapler assembly and booklet tamper assembly, [Figure 2](#).

Figure 2 Assemblies removal

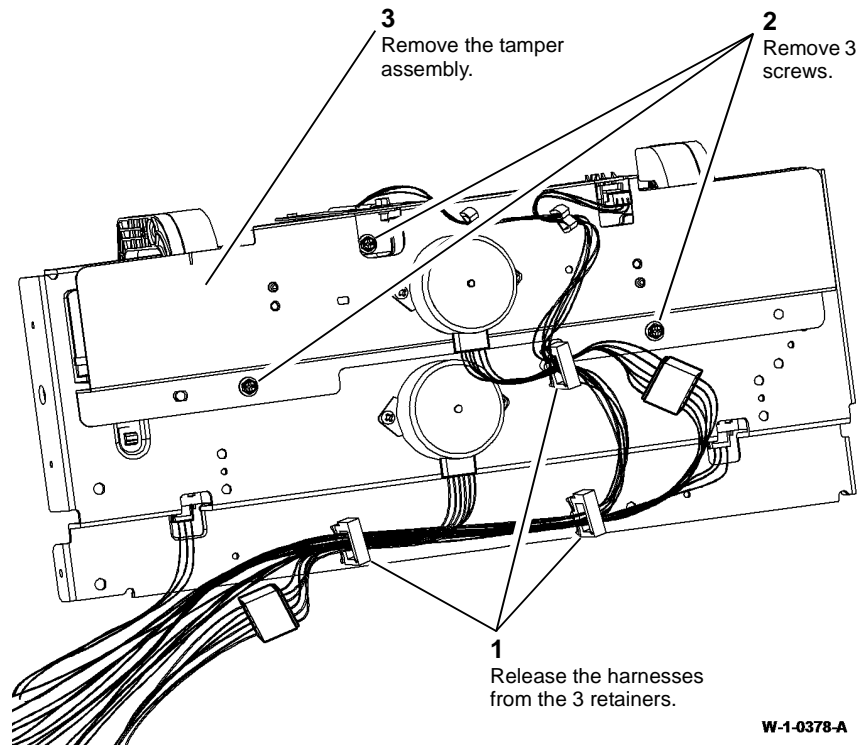
5. Separate the BM stapler assembly from the booklet tamper assembly, [Figure 3](#).

Figure 3 Stapler assembly removal

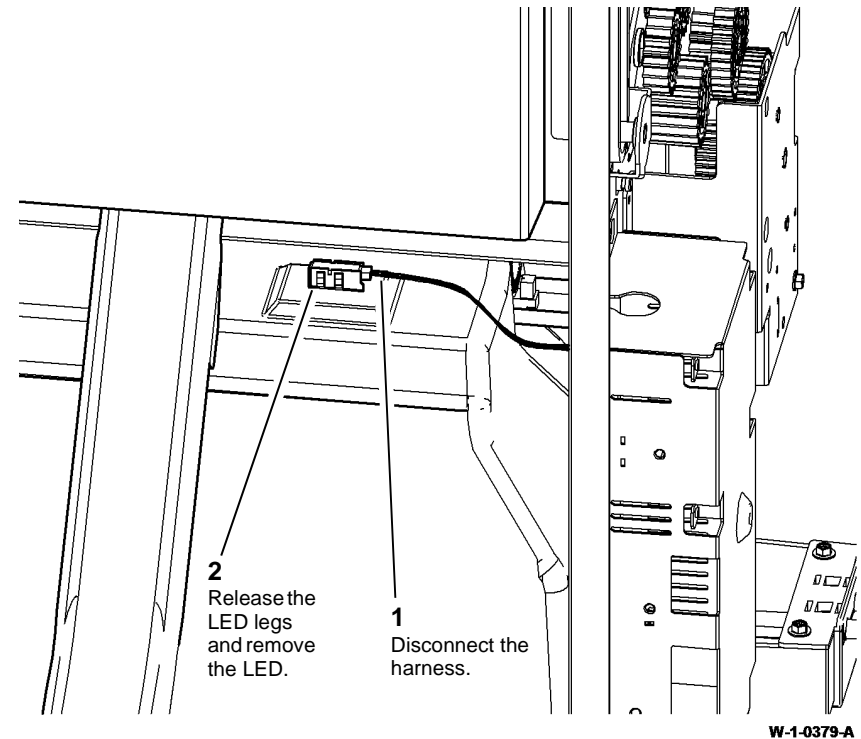
1. Remove the bin 2 support, [REP 12.44-150](#).
2. Remove the BM staple cartridge LED, [Figure 1](#).

Figure 1 Staple cartridge LED removal

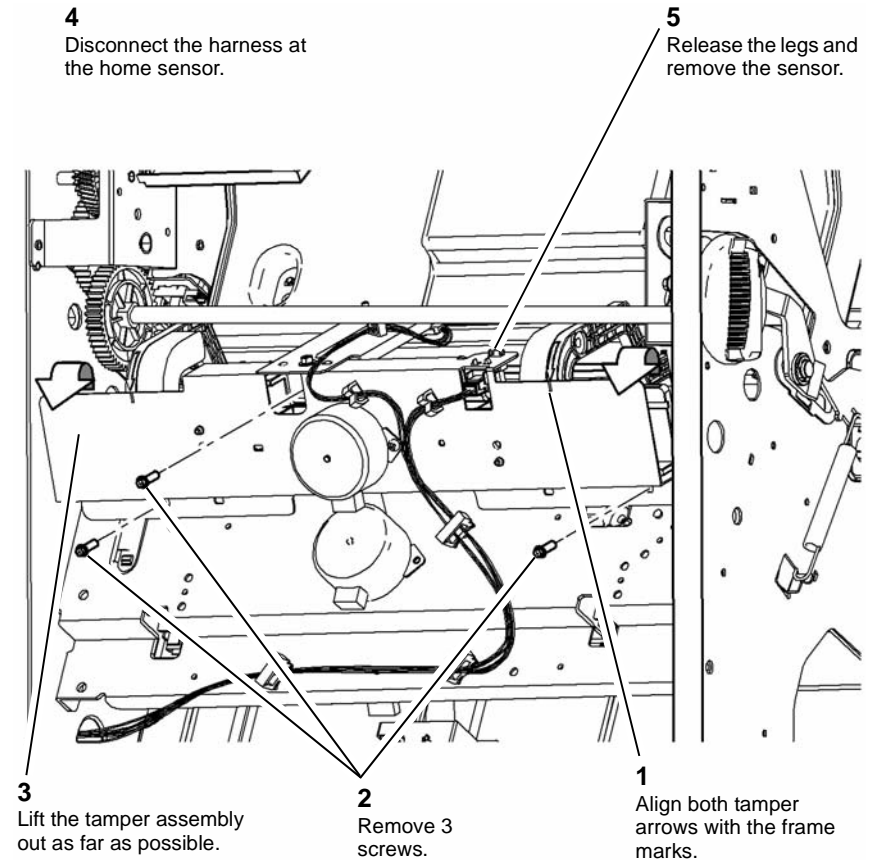
W-1-0380-A

1. Un-dock the LVF BM, [REP 12.13-150](#).
2. Remove the LVF BM LVF BM back stop cover, [REP 12.1-150](#).
3. Remove the BM tamper 1 home sensor, [Figure 1](#).

Figure 1 Home sensor removal

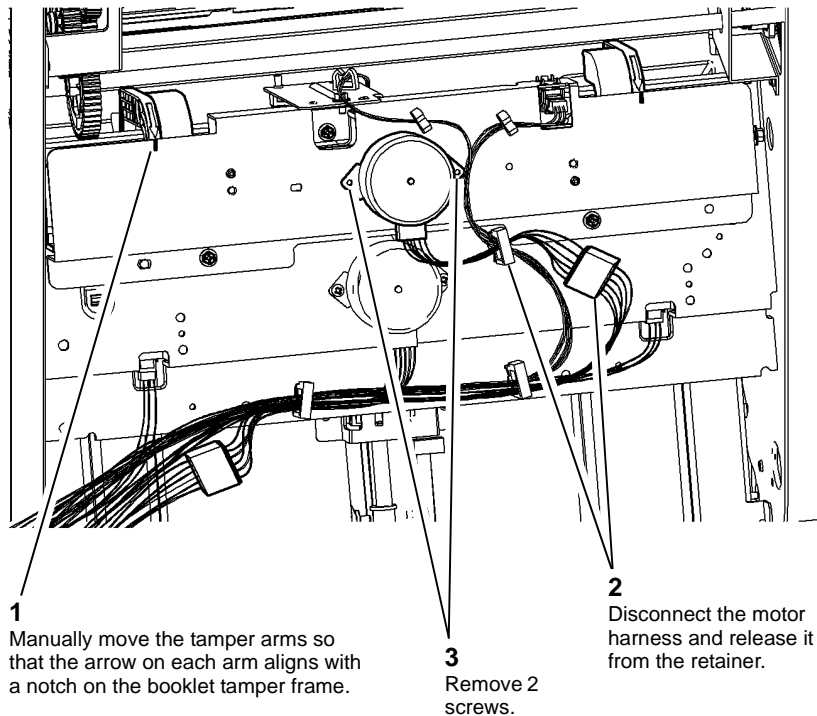
W-1-0381-A

1. Un-dock the LVF BM, [REP 12.13-150](#).
2. Remove the LVF BM LVF BM back stop cover, [REP 12.1-150](#).
3. Prepare to remove the booklet tamper motor, [Figure 1](#).

Figure 1 Preparation

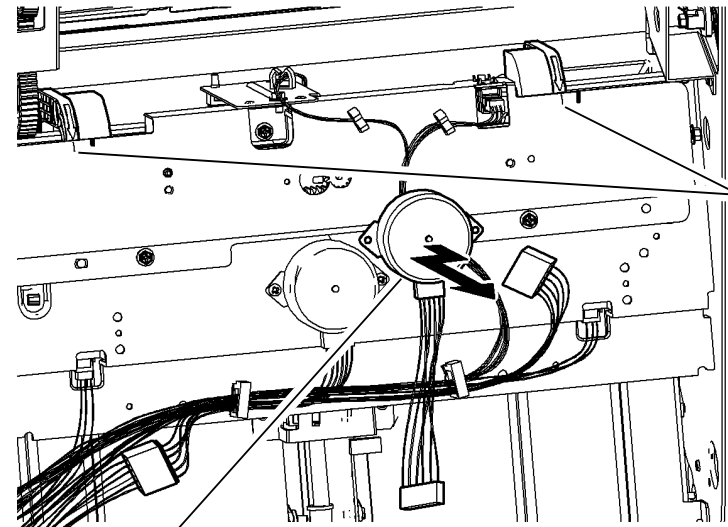
4. Remove the booklet tamper motor, [Figure 2](#).

1. Pull the motor out by approximately 1mm (0.04 inch), slide the motor approximately 12mm (0.5 inch) to the rear, pull the motor out to remove.

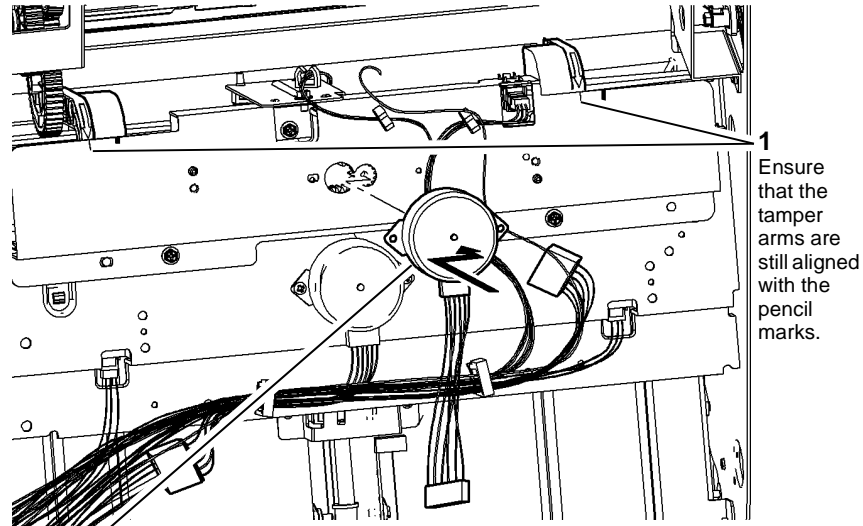
Figure 3 Preparation

1. Prepare to install the booklet tamper motor, [Figure 3](#).

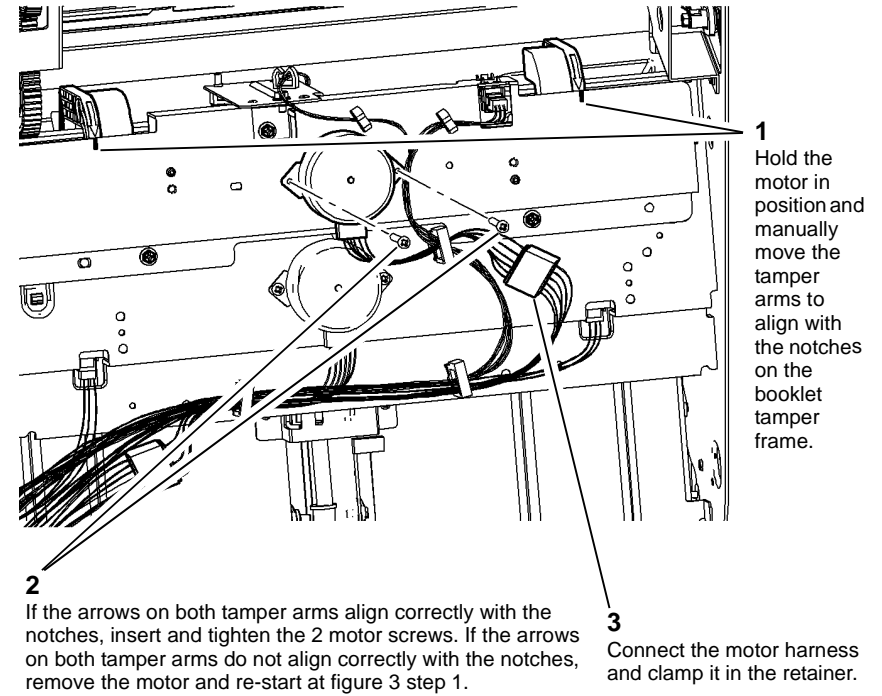
Figure 4 Tamper motor installation

2. Install the booklet tamper motor, [Figure 4](#).

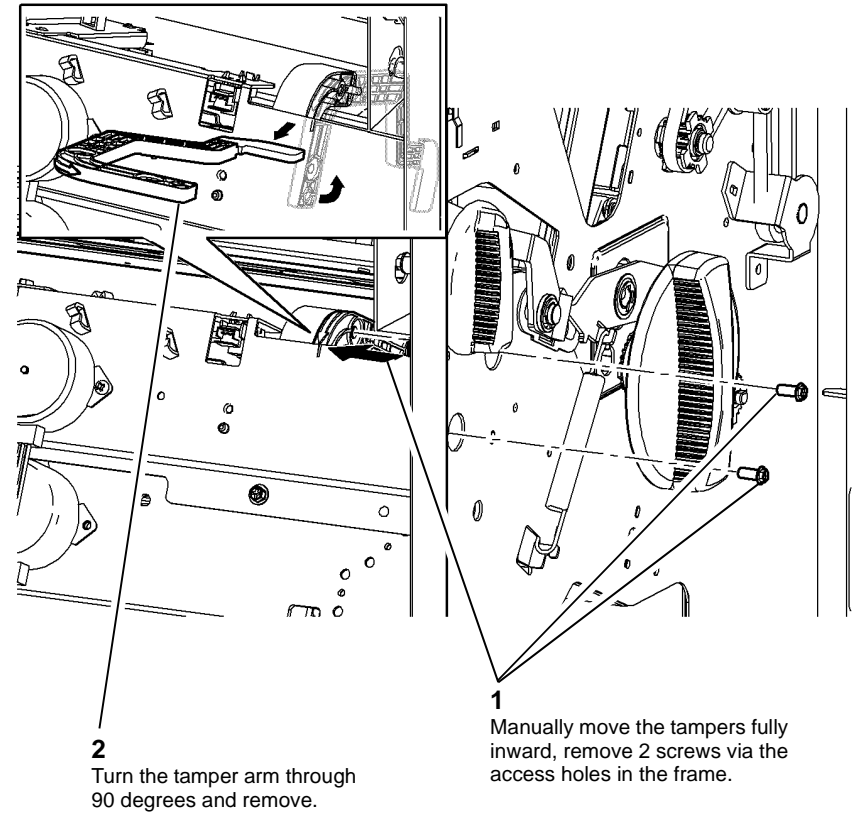
Figure 1 Front tamper arm removal

1. Un-dock the LVF BM, [REP 12.13-150](#).
2. Remove the LVF BM front door cover assembly and rear cover, [REP 12.1-150](#).
3. Remove the front booklet tamper arm, [Figure 1](#).

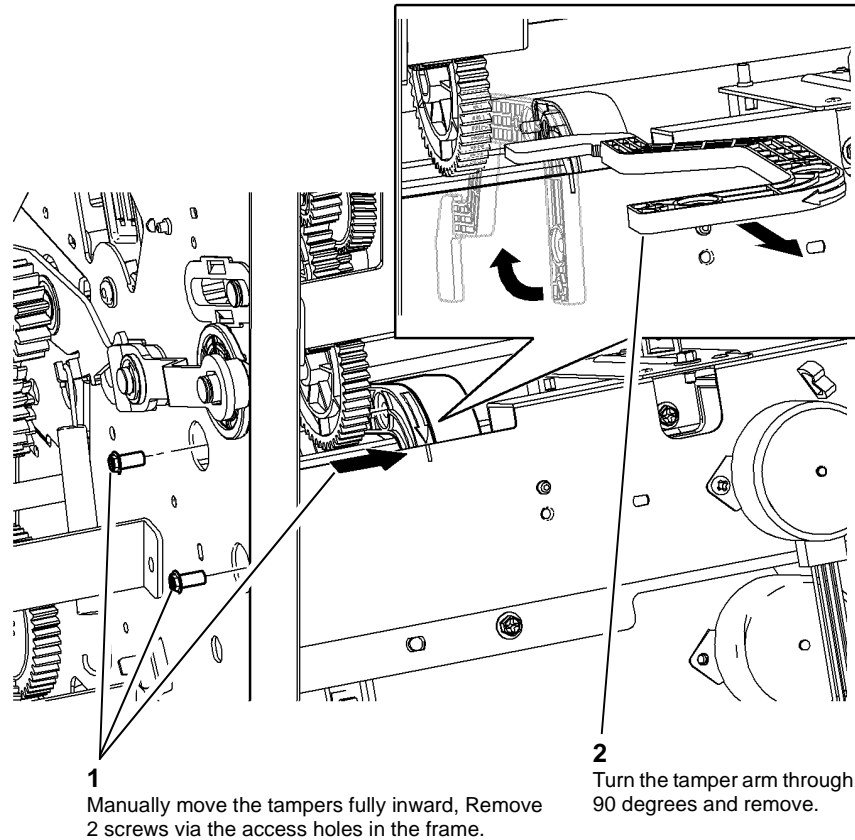
- Remove the rear booklet tamper arm, [Figure 2](#).

- Manually move the tampers fully inward, Remove 2 screws via the access holes in the frame.
- Turn the tamper arm through 90 degrees and remove.

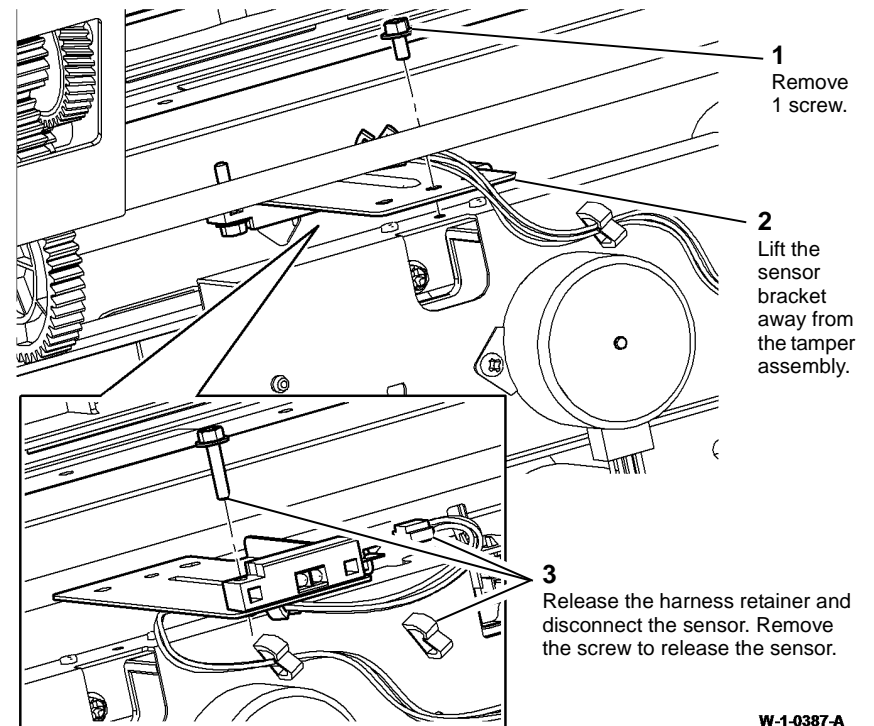
- Un-dock the LVF BM, [REP 12.13-150](#).
- Remove the sensor bracket, [Figure 1](#).

- Remove 1 screw.

- Lift the sensor bracket away from the tamper assembly.

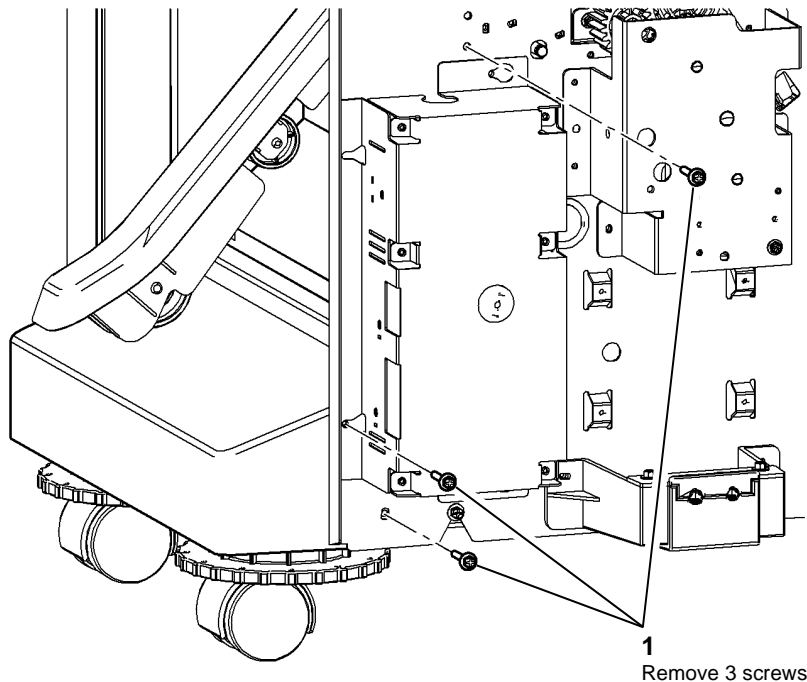
Figure 1 Preparation

1. Un-dock the LVF BM, [REP 12.13-150](#).
2. Remove the LVF BM front door cover assembly and rear cover, [REP 12.1-150](#).
3. Remove bin 2, [PL 12.320 Item 18](#).
4. Prepare to remove the bin 2 support, [Figure 1](#).

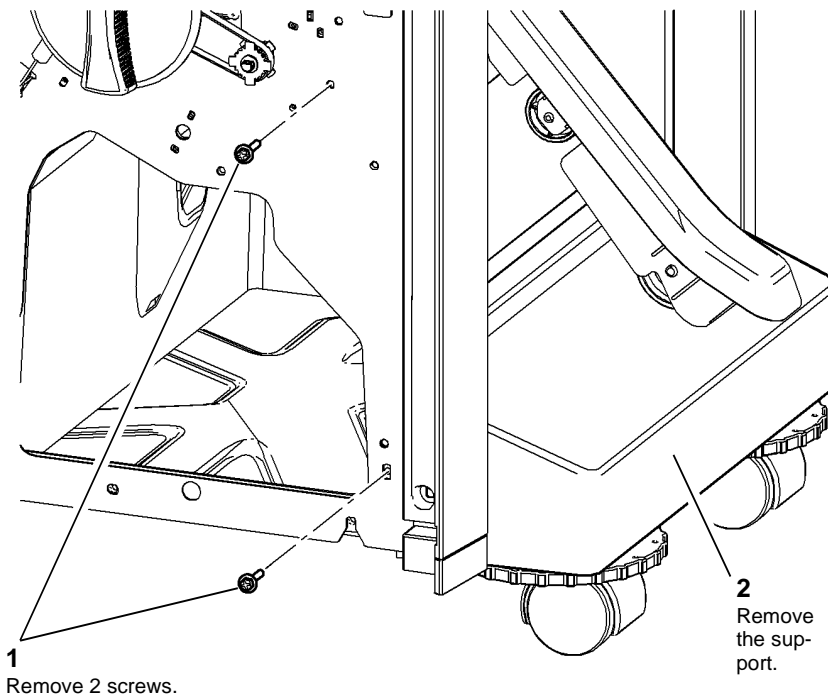
Figure 2 Bin 2 support removal

5. Remove the bin 2 support, [Figure 2](#).

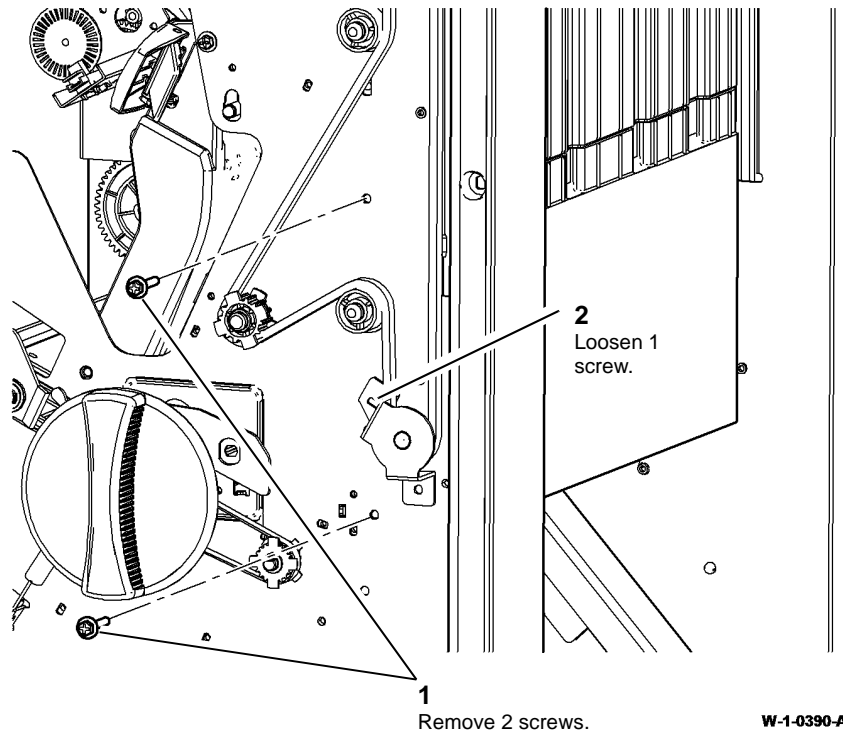
Figure 1 Preparation

1. Remove the bin 2 support, [REP 12.44-150](#).
2. Prepare to remove the lower right cover, [Figure 1](#).

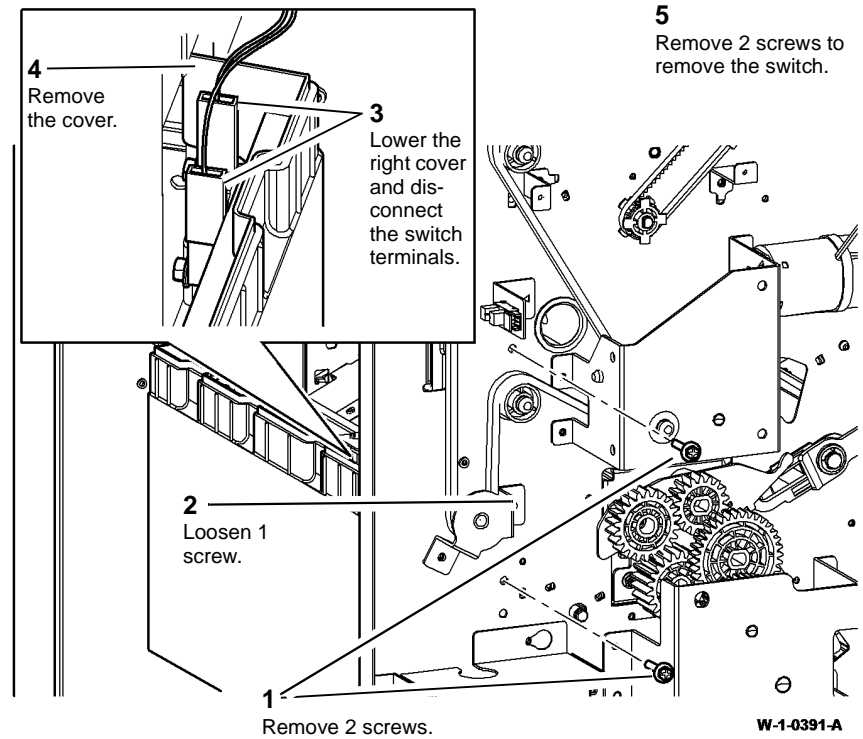
Figure 2 Cover and switch removal

3. Remove the lower right cover and bin 1 lower limit switch, [Figure 2](#).

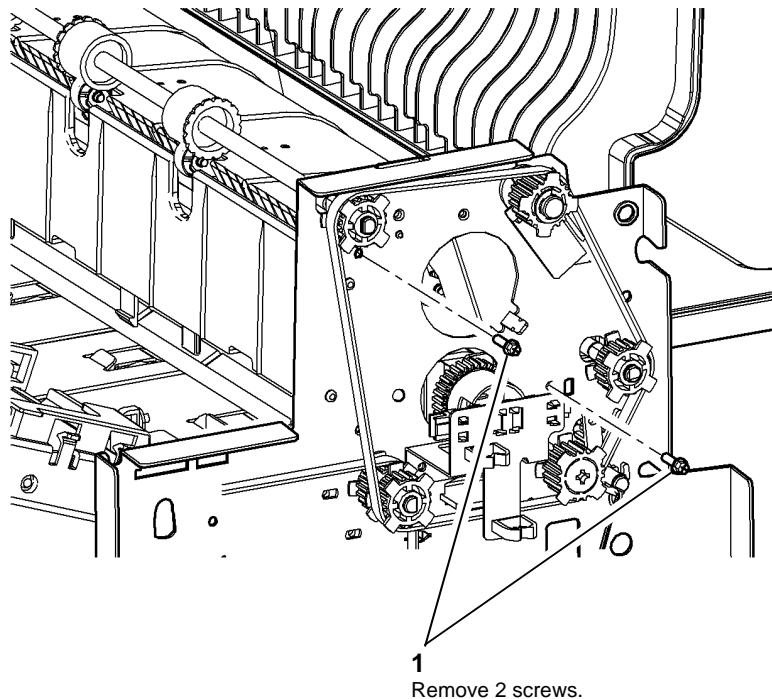
Figure 1 Preparation

1. Un-dock the LVF BM, [REP 12.13-150](#).
2. Remove the LVF BM front door cover assembly, rear cover and top cover, [REP 12.1-150](#).
3. Remove the hole punch motor assembly, [REP 12.7-150](#).
4. Prepare to remove the paper guide [Figure 1](#).

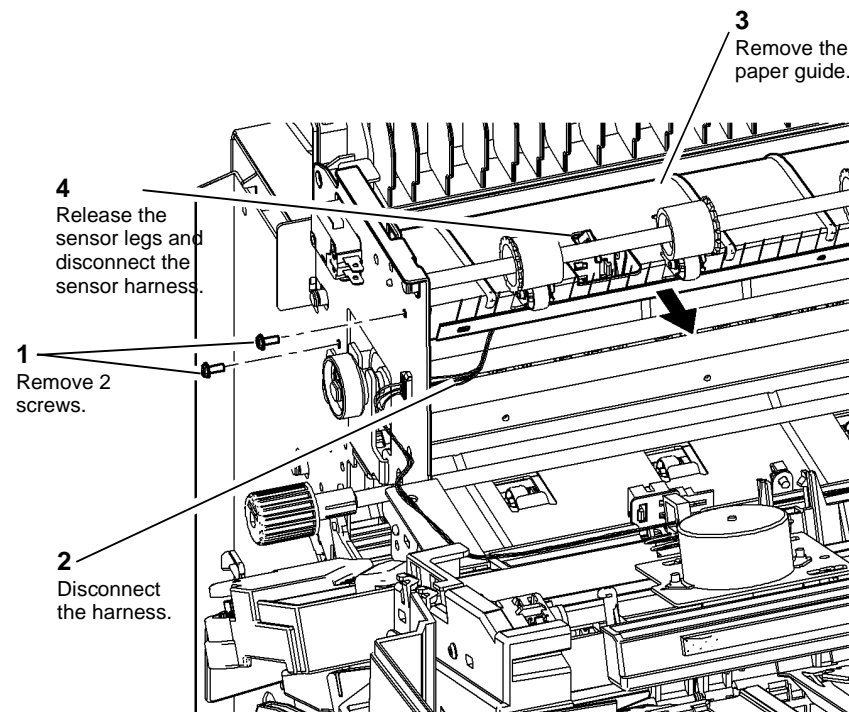
Figure 2 Guide and sensor removal

5. Remove the paper guide and top tray exit sensor, Q12-107, [Figure 2](#).

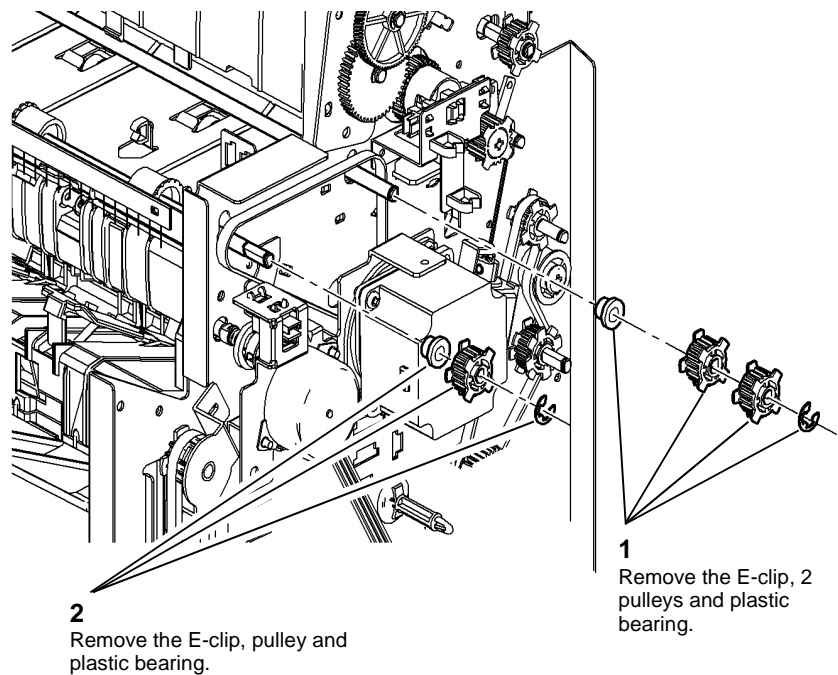
Figure 1 Preparation

1. Un-dock the LVF BM, [REP 12.13-150](#).
2. Remove the LVFBM top cover, rear cover and front door cover assembly, [REP 12.1-150](#).
3. Remove the tamper assembly, [REP 12.6-150](#).
4. Remove the paper output drive belt, [REP 12.4-150](#).
5. Prepare to remove the drive shafts [Figure 1](#).

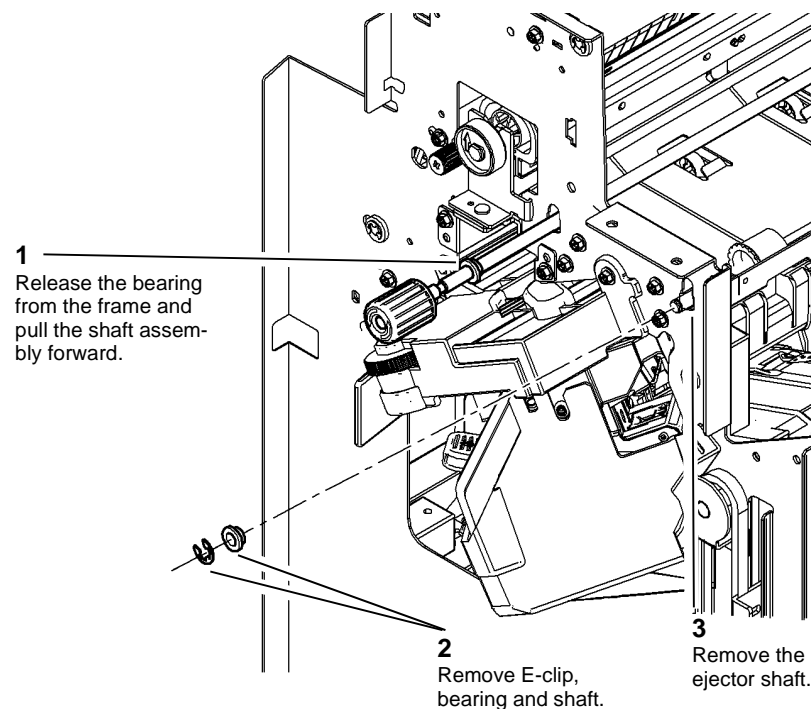
Figure 2 Ejector shaft removal

6. Remove the ejector drive shaft, [Figure 2](#).

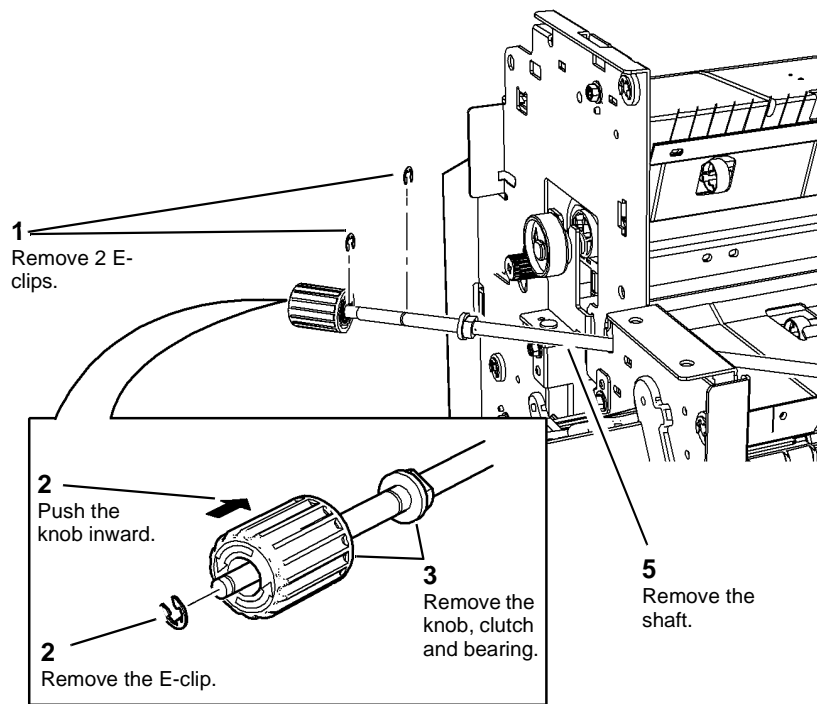
Figure 3 Drive shaft removal

7. Remove the drive shaft, [Figure 3](#).

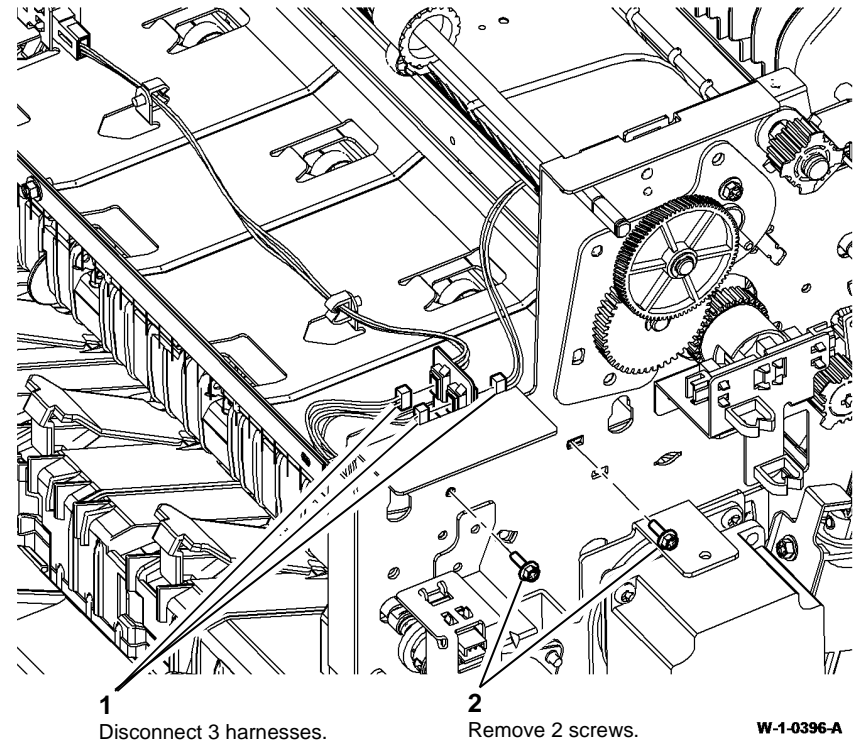
Figure 4 Preparation

8. Prepare to remove the upper right paper guide, [Figure 4](#).

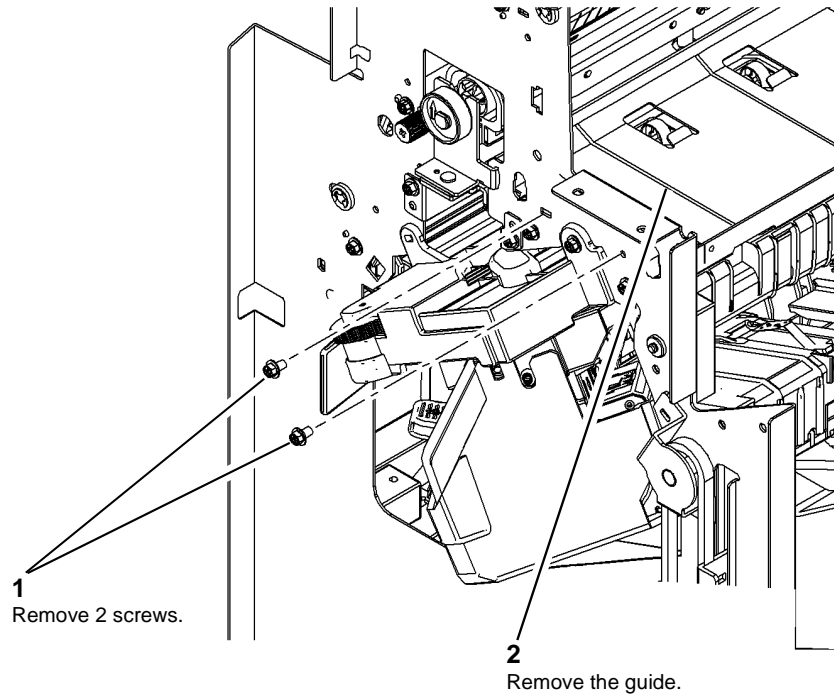
Figure 5 Upper right guide removal

9. Remove the upper right paper guide, [Figure 5](#).

1
Remove 2 screws.

2
Remove the guide.

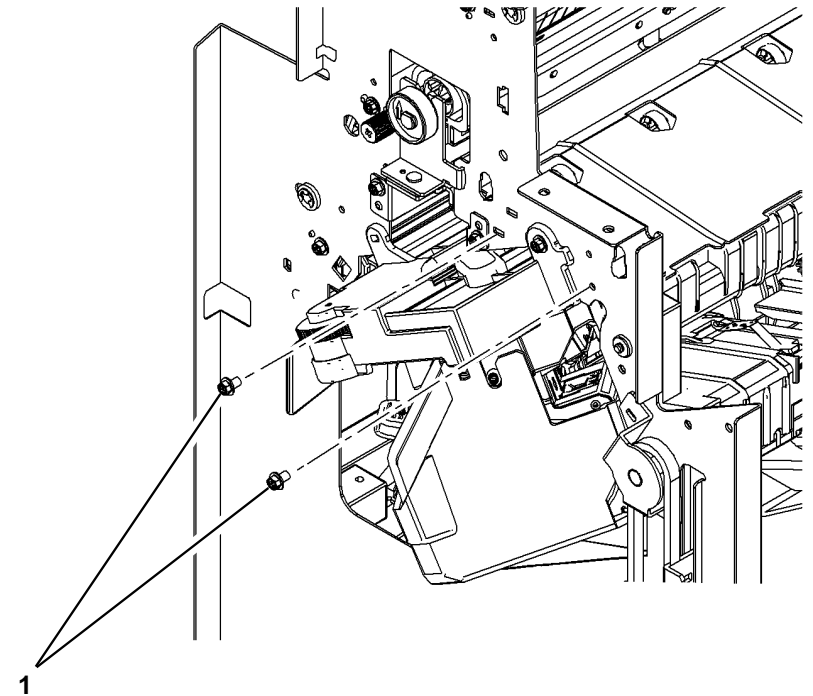
Figure 6 Preparation

10. Prepare to remove the lower right paper guide, [Figure 6](#).

1
Remove 2 screws.

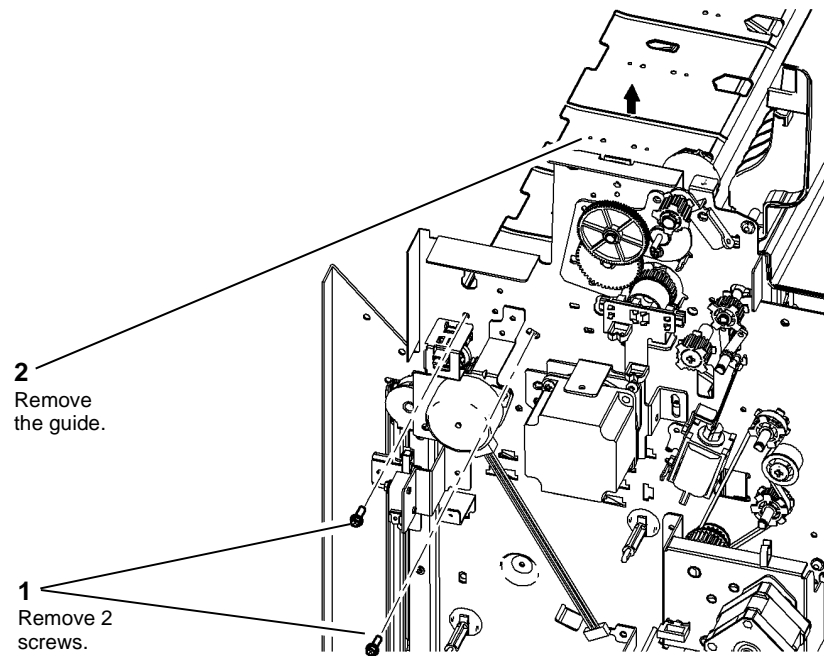
Figure 7 Lower right guide removal

11. Remove the lower right paper guide, [Figure 7](#).

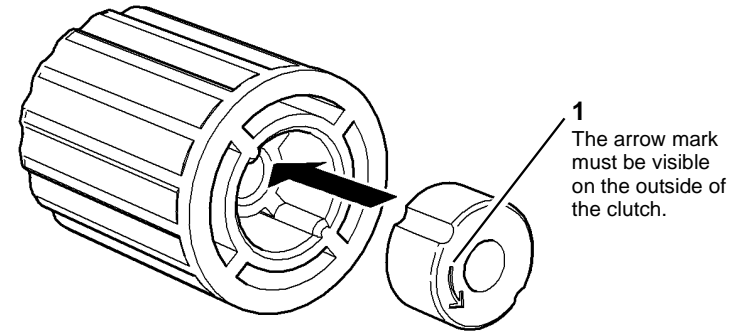
Figure 8 Clutch orientation

1. The replacement is the reverse of the removal procedure.
2. When replacing the jam clearance knob, ensure the one-way clutch is installed in the correct orientation, [Figure 8](#).

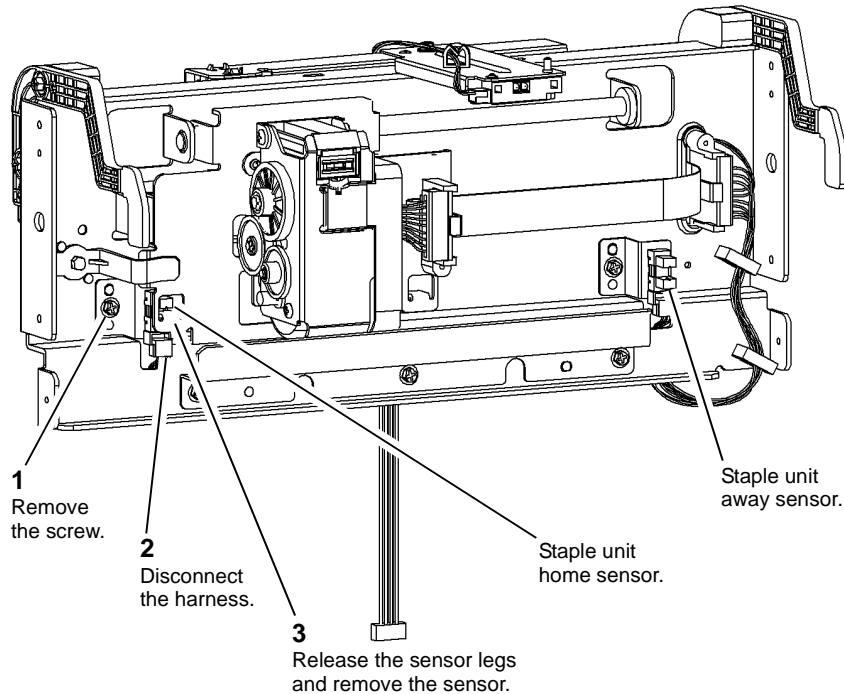
Figure 1 Sensor removal

1. Remove the BM stapler assembly and booklet tamper assembly, [REP 12.38-150](#).
2. If required, remove the BM staple unit home sensor, Q12-438 or staple unit away sensor, Q12-439, [Figure 1](#).

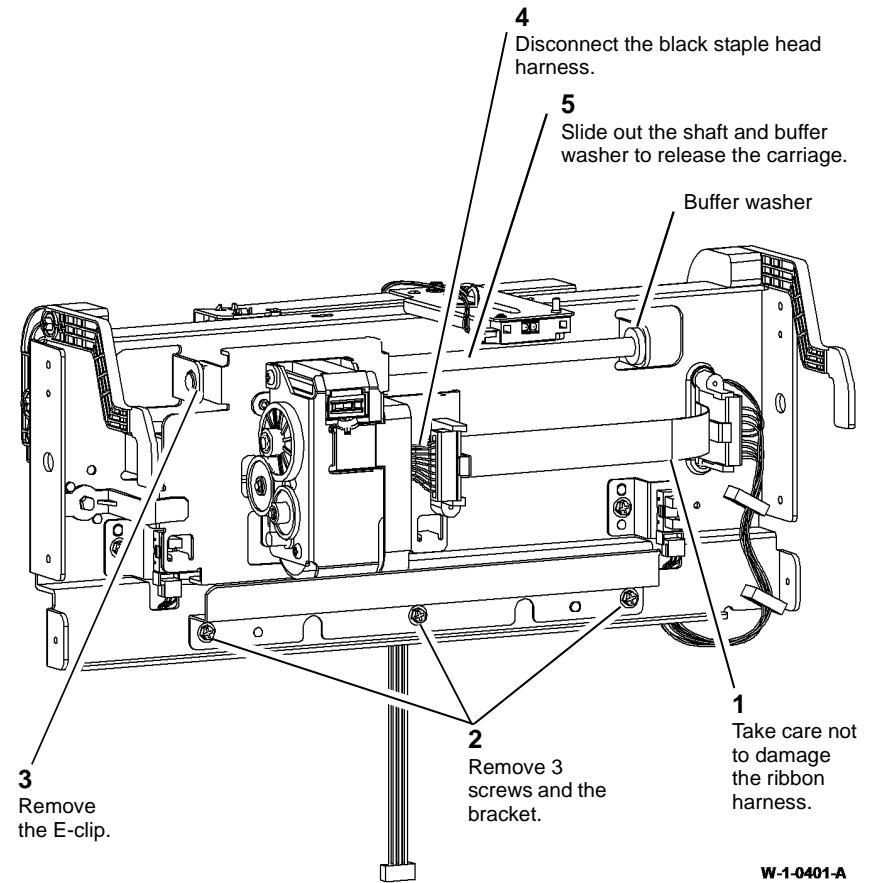
Figure 2 Preparation

3. Prepare to remove the stapler carriage assembly, [Figure 2](#).

1. Refer to [GP 6](#) before refitting the screws.
2. Ensure that the buffer washer is installed in the correct position, refer to [Figure 2](#).
3. The replacement is the reverse of the removal procedure.
4. Perform the adjustments that follow:
 - [ADJ 12.7-150](#) Booklet Stapler Anvil Position - Front
 - [ADJ 12.8-150](#) Booklet Stapler Anvil Position - Rear.

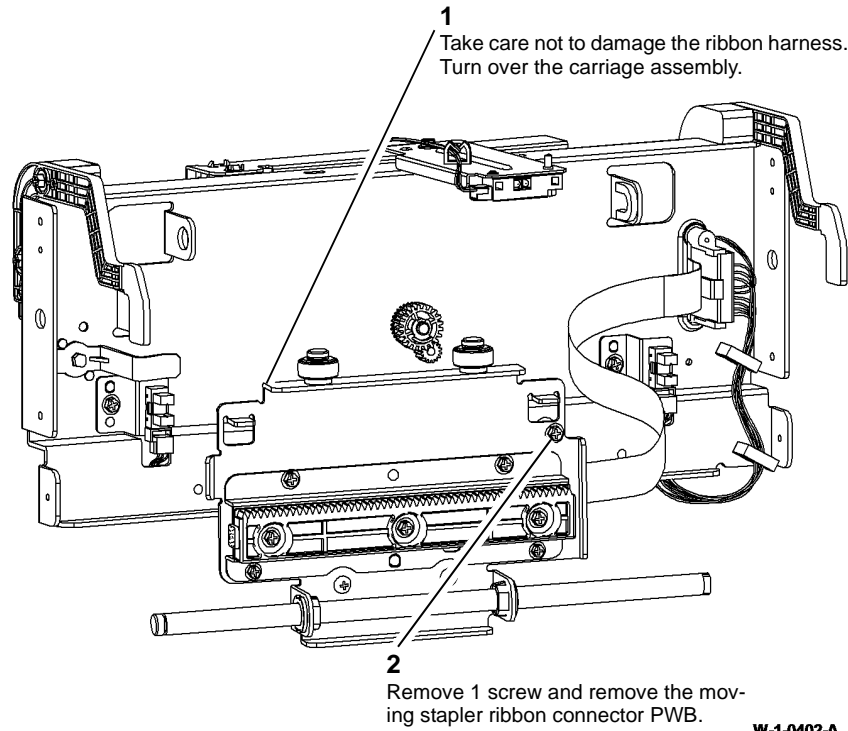
Figure 3 Carriage removal

4. Remove the stapler carriage assembly, **Figure 3**.
