708P91139
February 2016

Xerox® WorkCentre® 5945 Family Multifunction Printer Service Manual

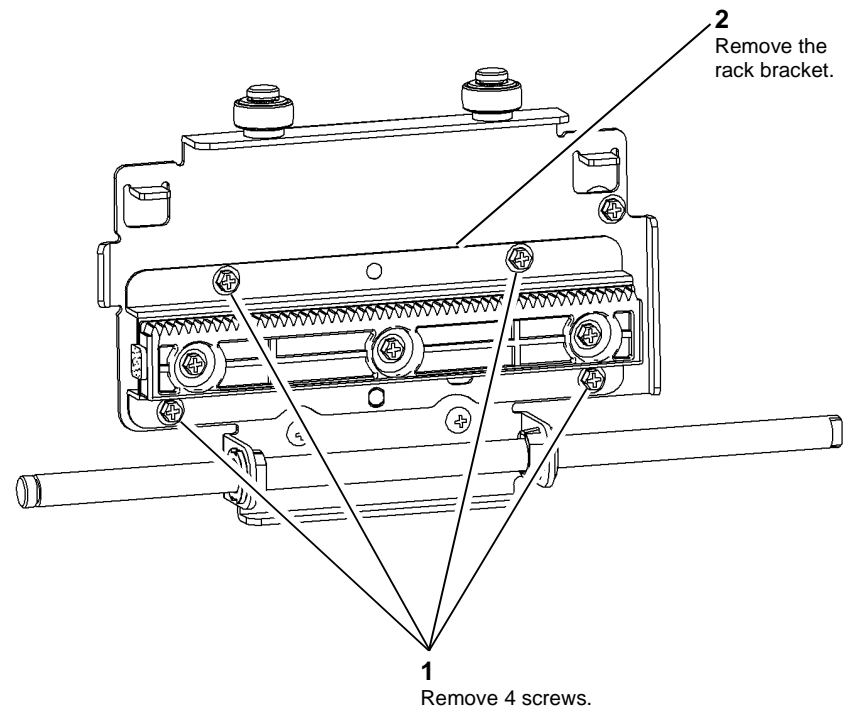
Figure 4 Rack bracket removal

5. Remove the rack bracket, **Figure 4**.

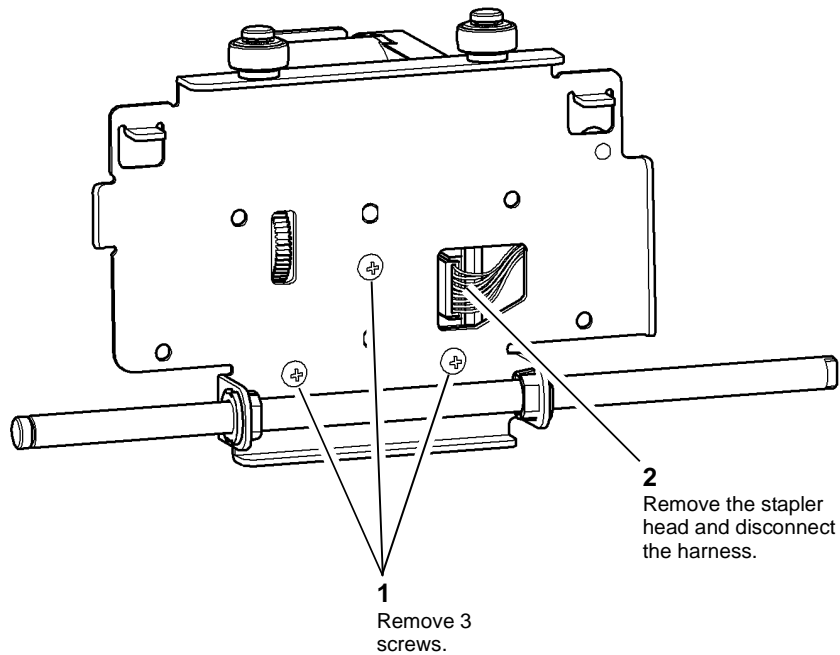
Figure 5 Head assembly removal

6. Remove the BM stapler head assembly, [Figure 5](#).

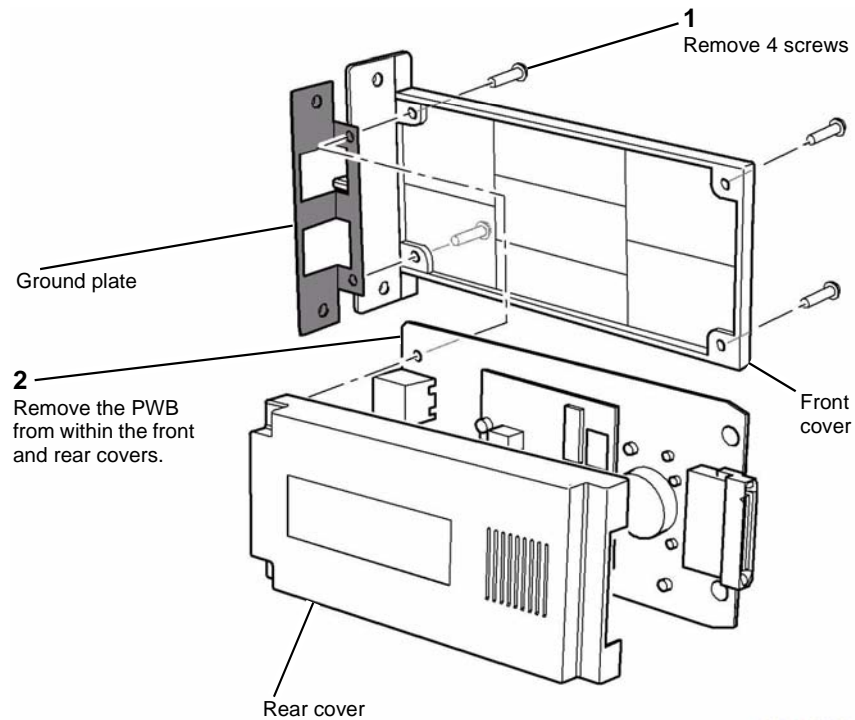
Figure 1 Fax PWB removal

1. Switch off the machine, [GP 14](#).
2. Disconnect the telephone cable(s), [PL 20.05 Item 3](#).
3. Remove the fax module (2 thumb screws).
4. [Figure 1](#), remove the fax PWB.

Ensure that the ground plate is located between the Fax PWB and the front cover. The ground plate provides a ground path for lightning strikes. Electricity can cause death or injury.

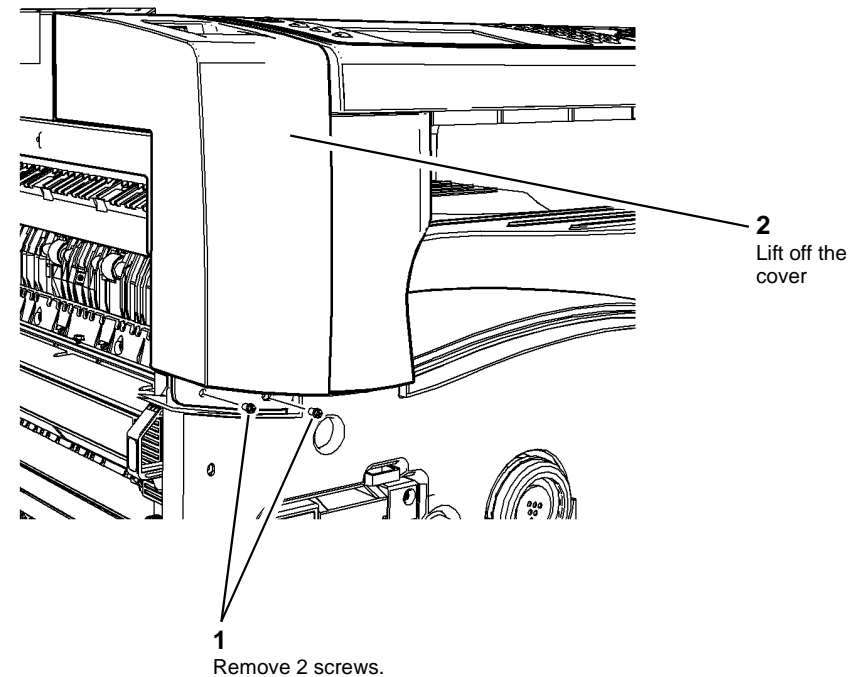
Figure 1 Preparation

1. Open the front door.
2. Open the left door.
3. Raise the SPDH, [PL 5.10 Item 9](#).
4. Prepare to remove the left frame cover, [Figure 1](#).

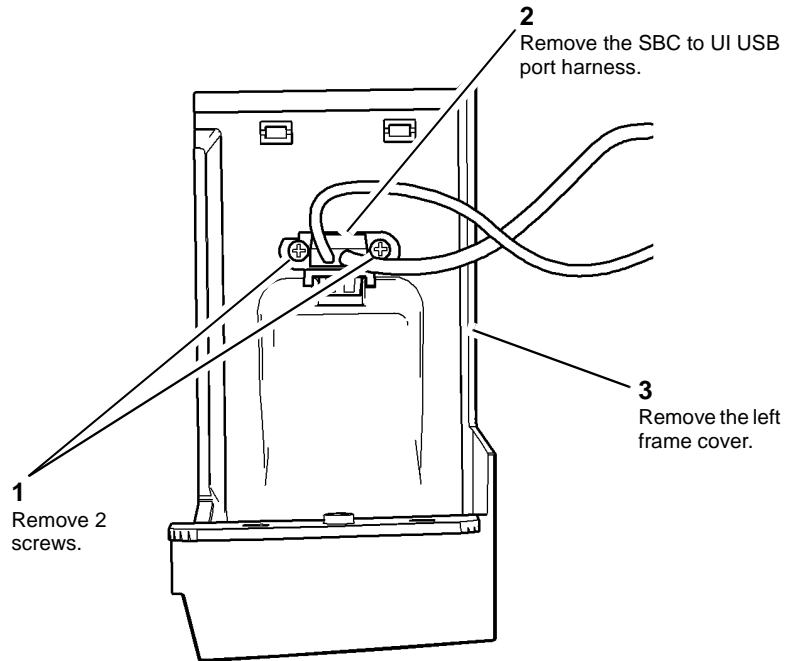
Figure 2 Left frame cover removal

- Remove the left frame cover, [Figure 2](#).

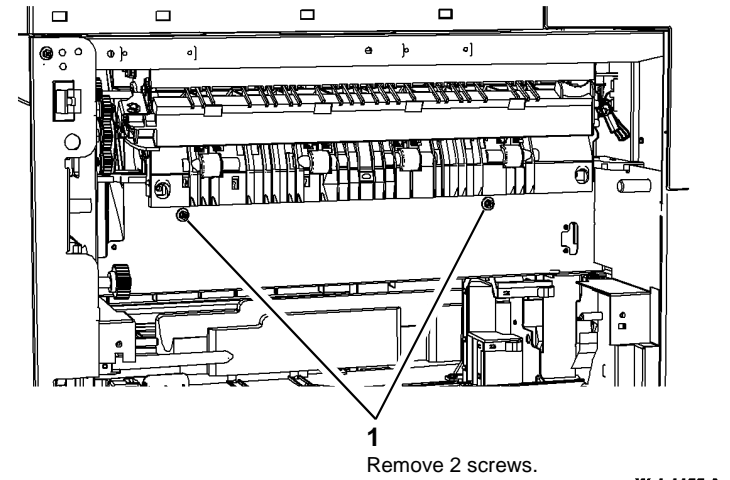
Figure 3 Preparation

- Prepare to remove the centre output tray, [Figure 3](#).

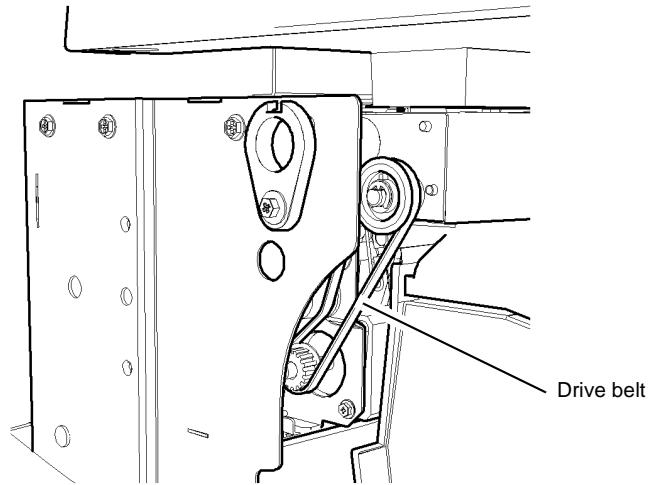
Figure 4 Drive belt

3. When reinstalling the centre exit cover, take care not to disengage the drive belt, [Figure 4](#).

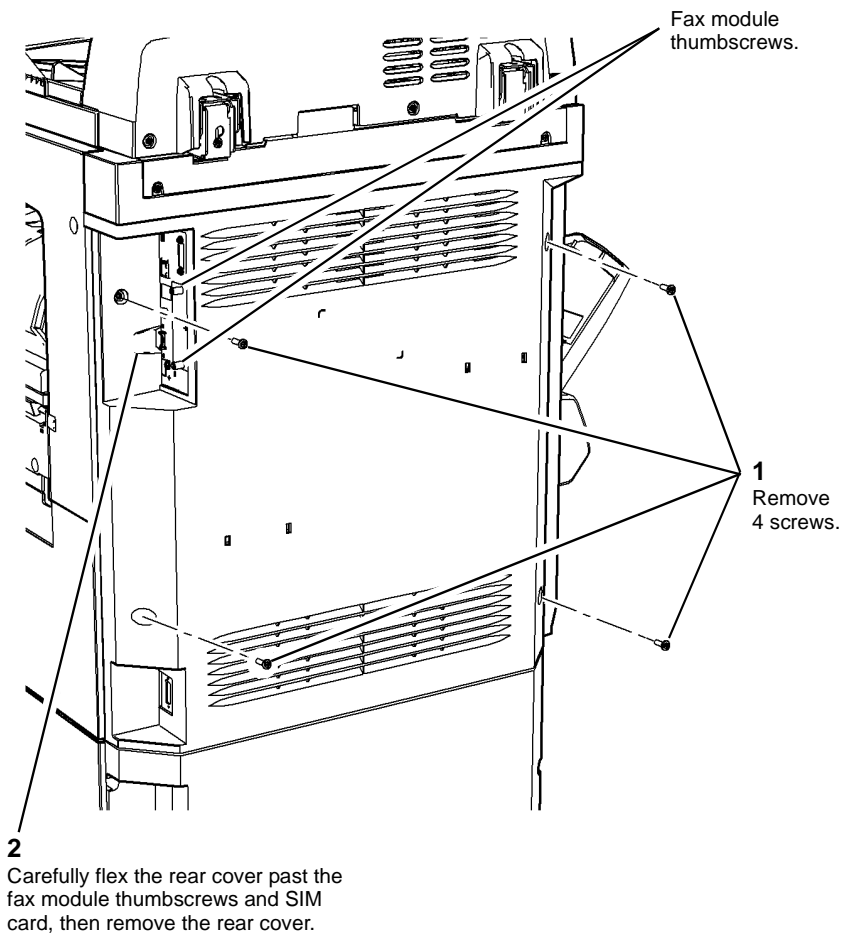
Figure 1 Removal

1. Disconnect the components that follow, as necessary:
 - Network cable.
 - Wireless network adaptor, [PL 3.22 Item 20](#).
 - Telephone cable.
 - FDI harness.
 - Finisher communication harness.
2. Remove the rear cover, [Figure 1](#).

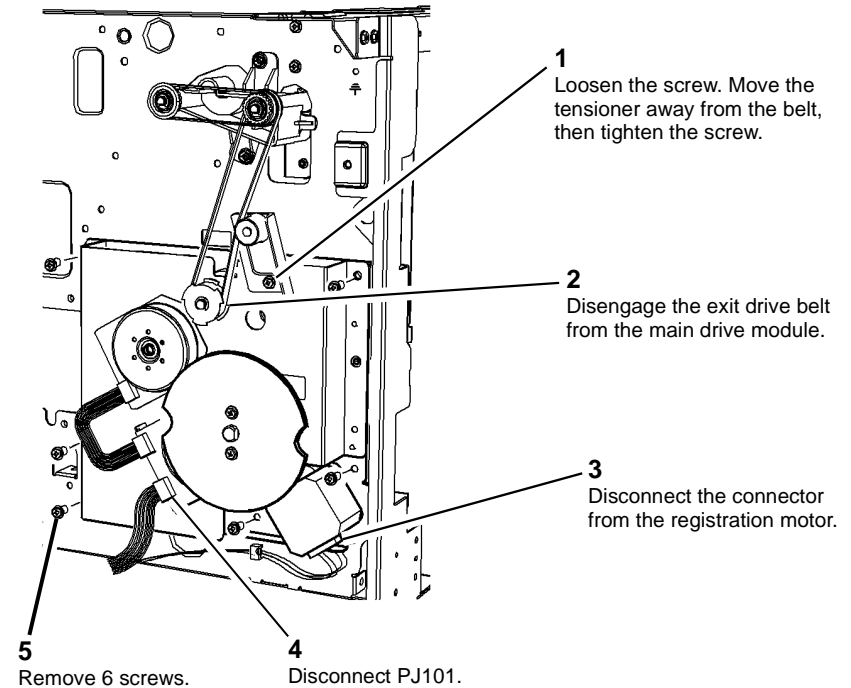
Figure 1 Preparation

1. Remove the fuser, [PL 10.8 Item 1](#).
2. Remove the print cartridge, [PL 90.17 Item 9](#), then place in a black bag.
3. Remove the rear cover, [REP 28.2](#).
4. Prepare to remove the main drive module, [Figure 1](#).

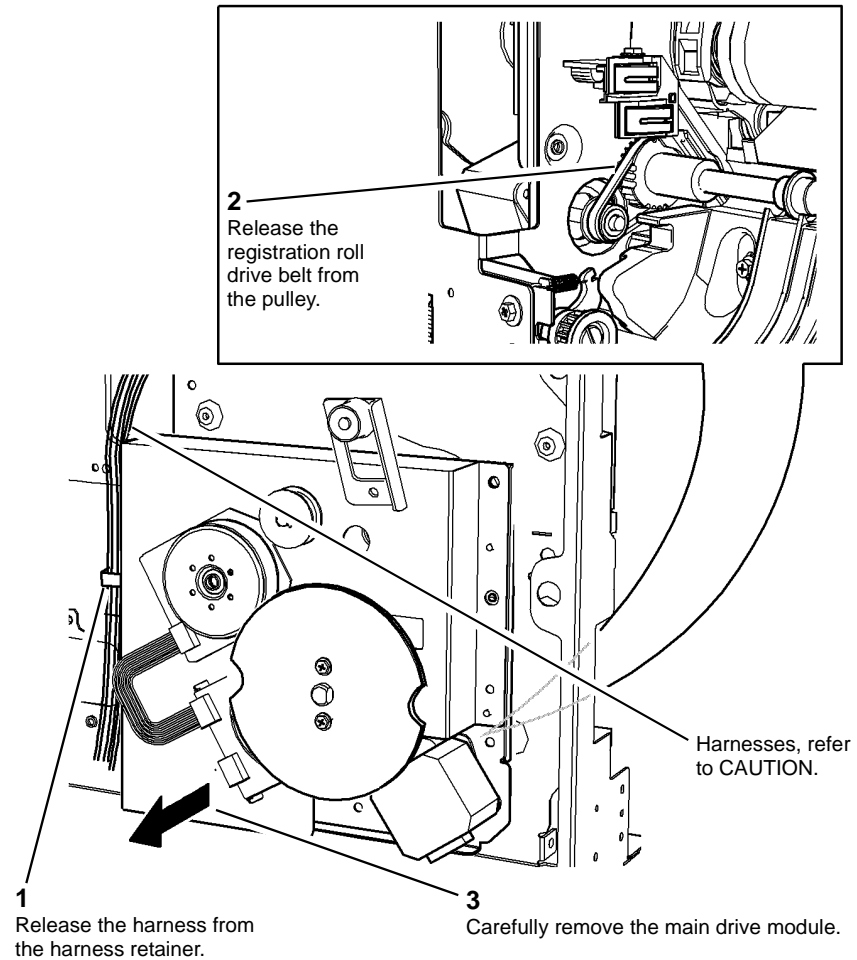
Figure 2 Removal

Take care not to damage harnesses when removing the main drive module.

5. Remove the main drive module. Refer to **Figure 2**.

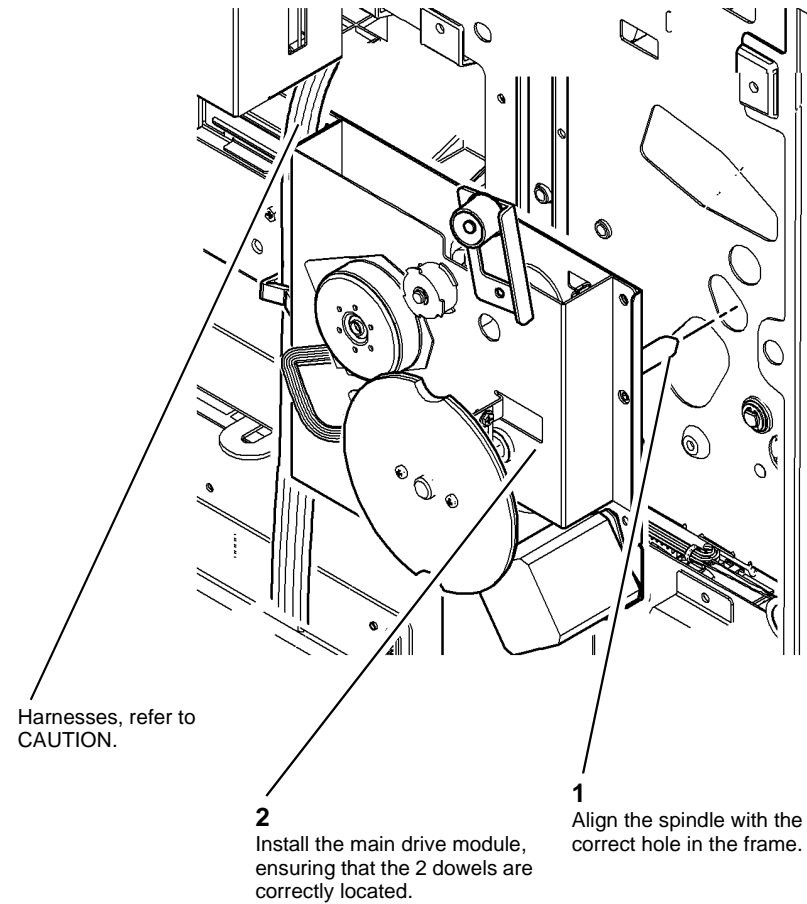
Figure 3 Replacement

1. Check that the gears are adequately greased, if necessary perform the Main Drive Module procedure of **ADJ 40.1**.
2. Install the main drive module, **Figure 3**.

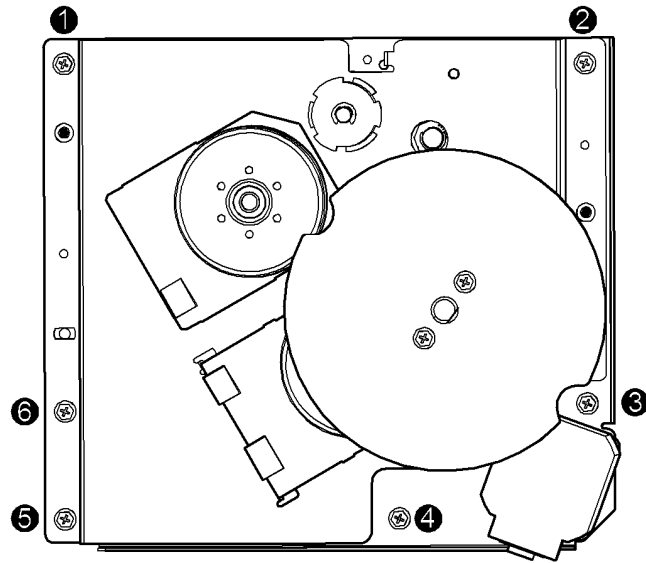
To ensure optimum image quality, ensure that the securing screws are tightened in the order given in Figure 4.

3. Figure 4, secure the drives module to the machine frame.

1
Loosely insert 6 screws.

2
Tighten the 6 securing screws in the order shown. See Caution.

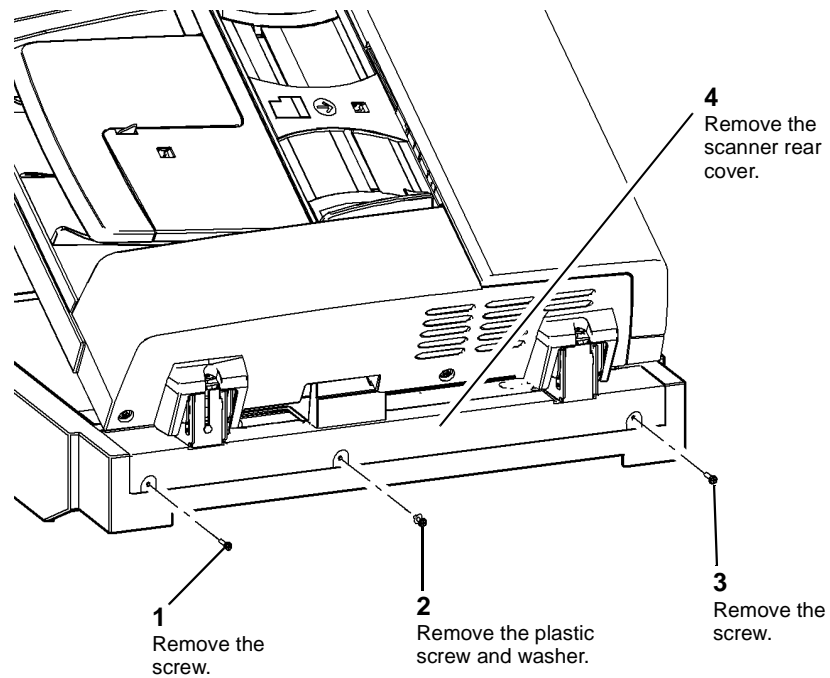
Figure 1 Scanner rear cover

1. Raise the SPDH, [PL 5.10 Item 9](#).
2. Remove the scanner rear cover, [Figure 1](#).

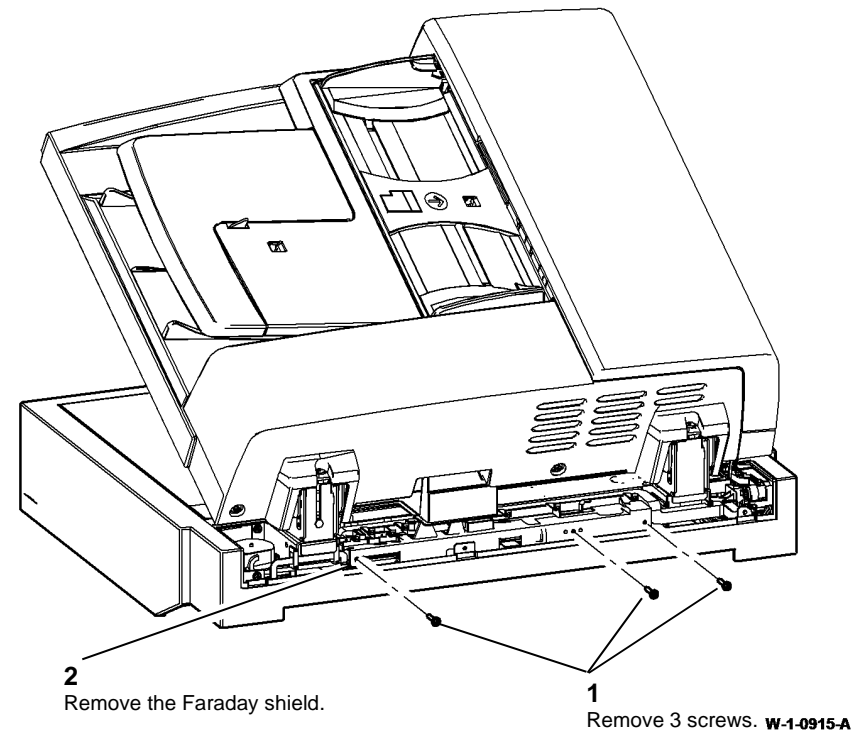
Figure 2 Faraday shield removal

3. Remove the Faraday shield, [Figure 2](#).

1. The replacement is the reverse of the removal procedure.
2. Ensure the Faraday shield is positioned under the 4 hooks formed in the scanner PWB cover, [PL 60.20 Item 6](#).

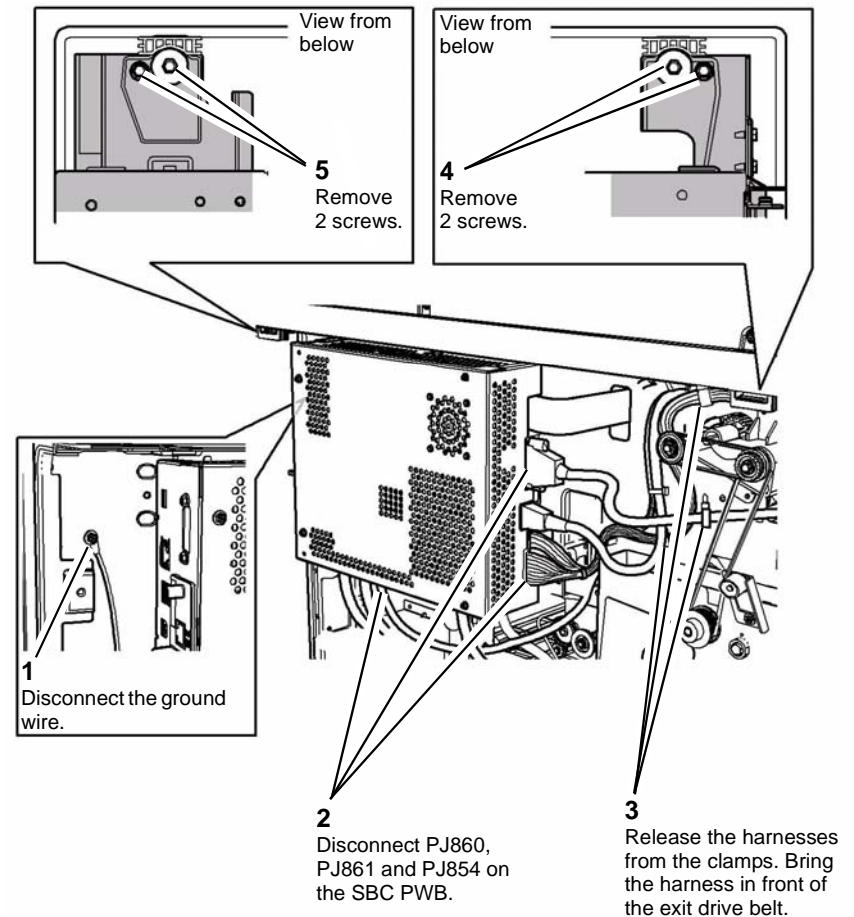
Figure 1 Scanner removal preparation

1. If a finisher is installed, un-dock the finisher. Refer to:
 - [REP 12.13-110 LCSS Un-Docking](#).
 - [REP 12.13-150 LVF BM Un-Docking](#).
2. Position the machine to allow for the minimum safety work space [GP 21](#).
3. Ensure both of the front castors are locked, [PL 70.26 Item 3](#).
4. Remove the SPDH, [REP 5.19](#).
5. Remove the upper right cover, [PL 28.10 Item 3](#).
6. Remove the rear cover, [REP 28.2](#).
7. Remove the 2 securing screws from the left frame cover, [PL 28.10 Item 6](#). Allow the cover to hang from the harness.
8. Prepare to remove the scanner module, [Figure 1](#).

- Ensure the shouldered screws are inserted into the blue grommets. Refer to [Figure 1](#).
- Ensure the scan carriage is unlocked. Refer to [Figure 2](#).
- Ensure the ground wire is connected correctly. Refer to [Figure 1](#).
- Re-connect the harnesses to the SBC PWB. Ensure that the harnesses are positioned and secured correctly, refer to [Figure 1](#).
- Re-attach the left frame cover to the machine.
- The remainder of the replacement procedure is the reverse of the removal procedure.
- Perform [ADJ 60.3](#) IIT Registration, Magnification and Calibration.
- Ensure that the machine serial number in [dC132](#) is correct. If necessary, enter the correct serial number.

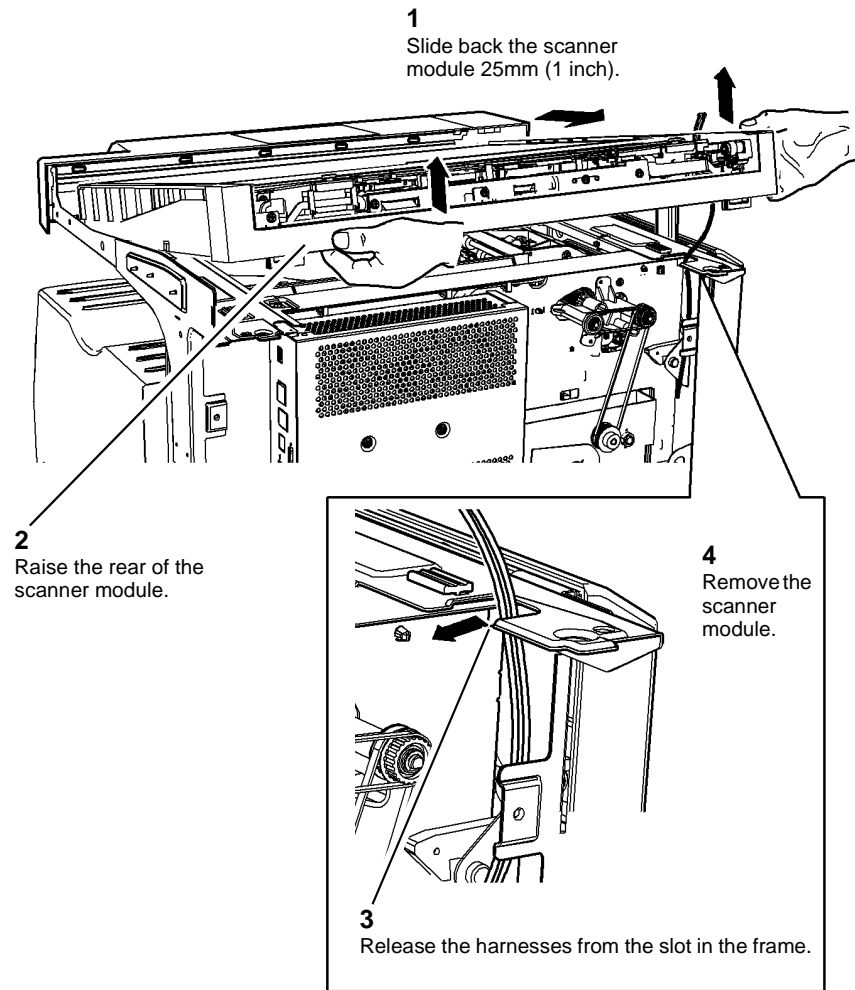
Figure 2 Scanner removal

Take care not to damage the scanner harnesses when removing the scanner.

10. Remove the scanner module, Figure 2.

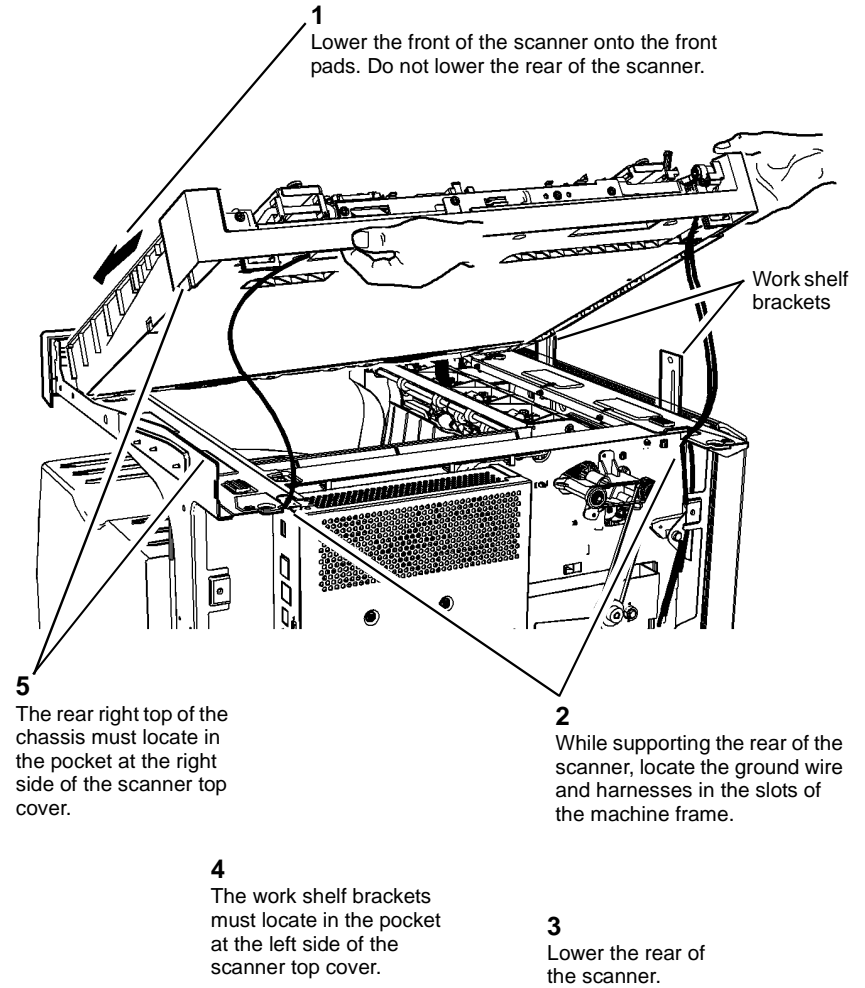
W-1-1035-A

1. Holding the scanner as shown, replace the scanner, Figure 3.

Figure 3 Scanner replacement

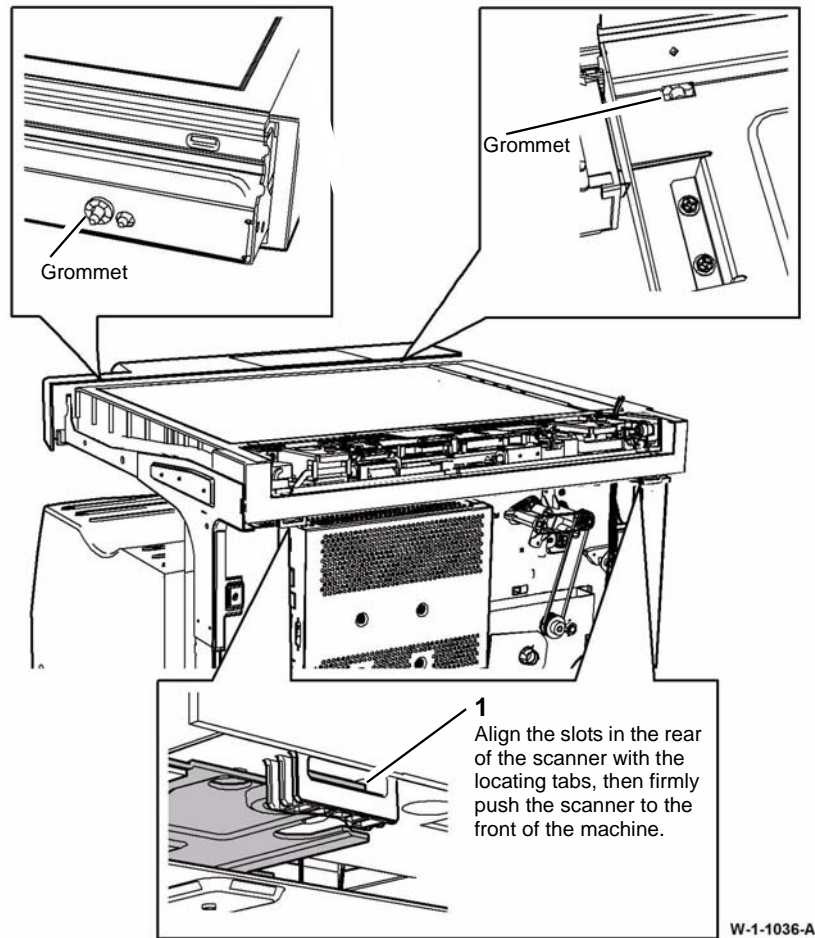
Ensure the front location pins are located correctly and have not pushed the grommets out of position.

Figure 4 Scanner replacement

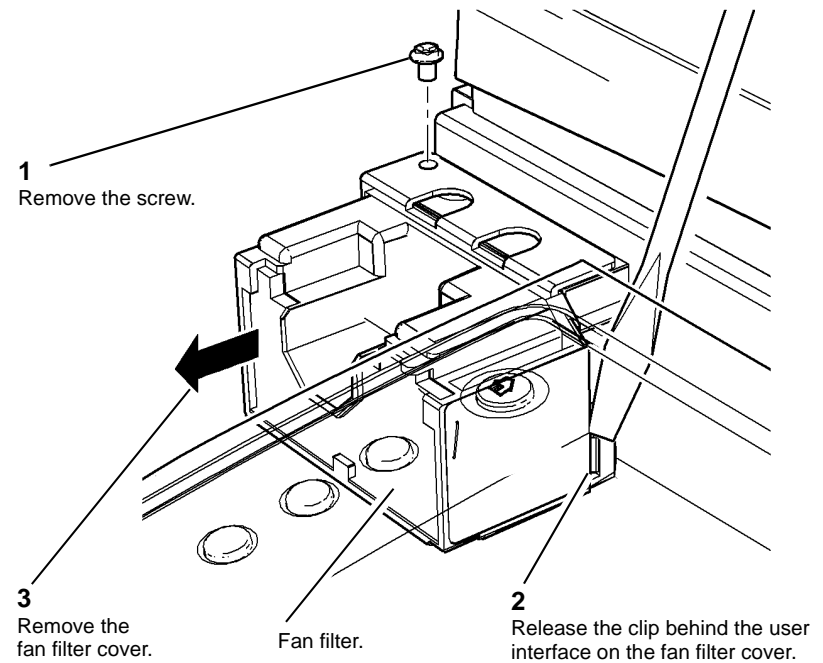
W-1-1245-A

Figure 1 Fan filter cover assembly

1. Remove the SPDH, [REP 5.19](#).
2. Remove the left frame cover, [REP 28.1](#).
3. Remove the left frame cover support bracket, (2 screws).
4. Remove the upper right cover, [PL 28.10 Item 3](#).
5. Remove the 4 screws securing the scanner. Refer to [REP 60.2](#).
6. Slide the scanner back approximately 25mm (1 inch) to allow access to the 7 fixing screws on the front of the top cover assembly, [Figure 2](#).
7. If only the fan filter, [Figure 1](#) is being repaired, remove the wire retainer, [PL 60.15 Item 11](#) and fan filter, then go to Replacement step 1.
8. Remove the fan filter cover, [Figure 1](#).

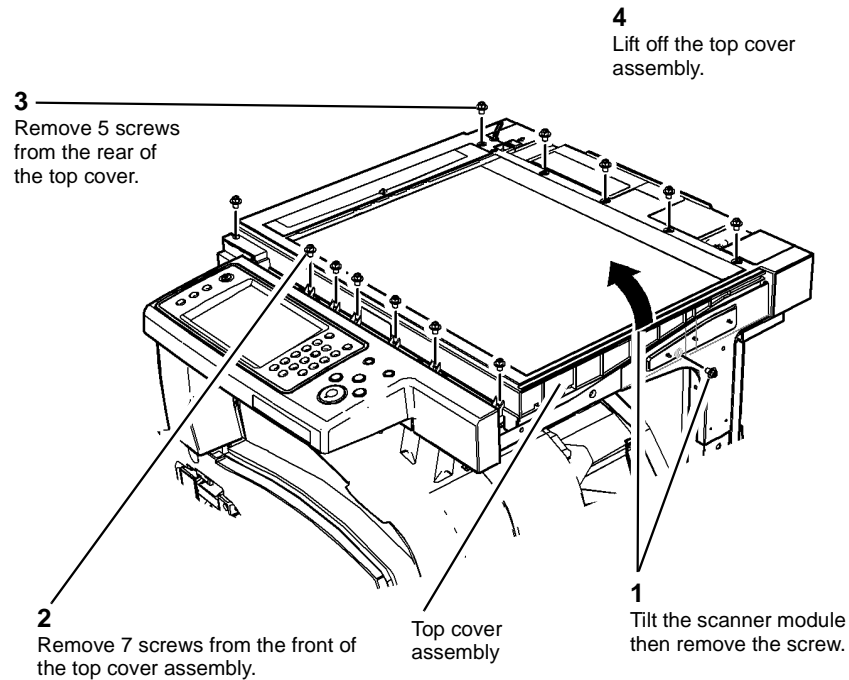
W-1-0920-A

- Remove the top cover assembly, [Figure 2](#).

Figure 2 Top cover assembly

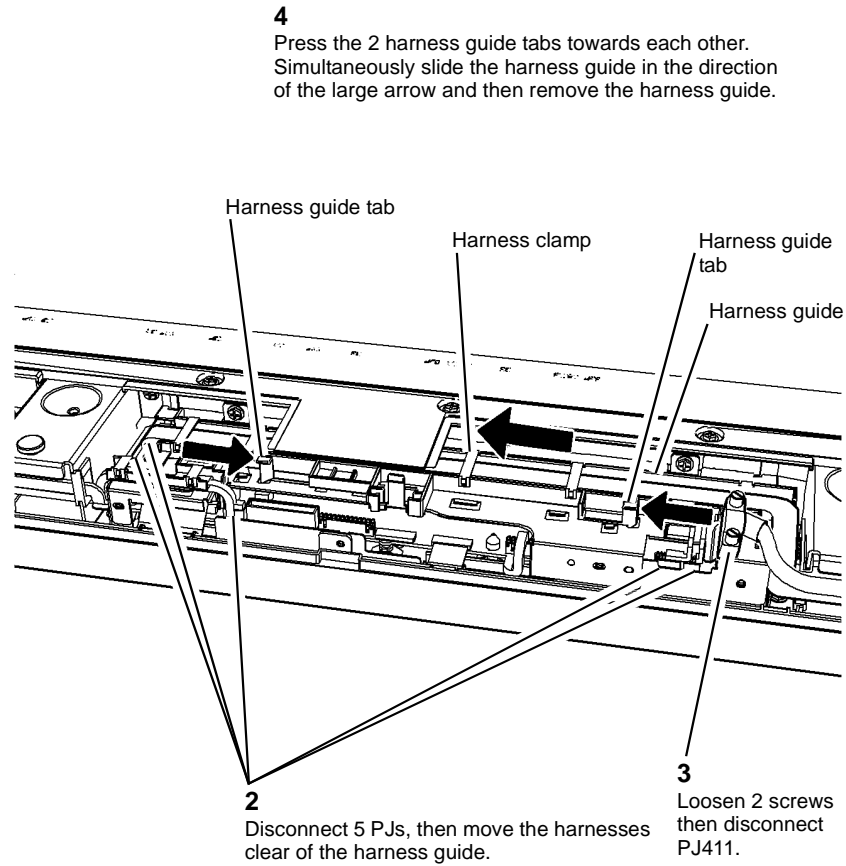
W-1-0921-A

2. Remove the harness guide, [Figure 1](#).

Figure 1 Scanner harness guide

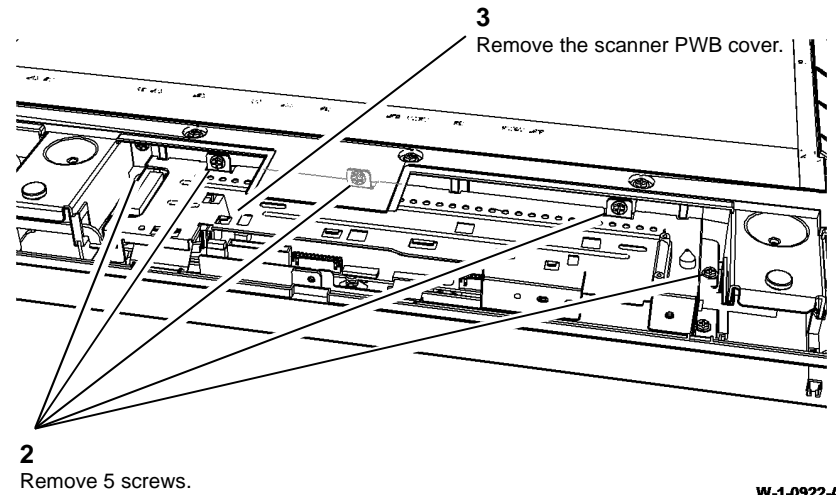
W-1-0922-A

3. Remove the scanner PWB cover, [Figure 2](#).

Figure 2 Scanner PWB cover

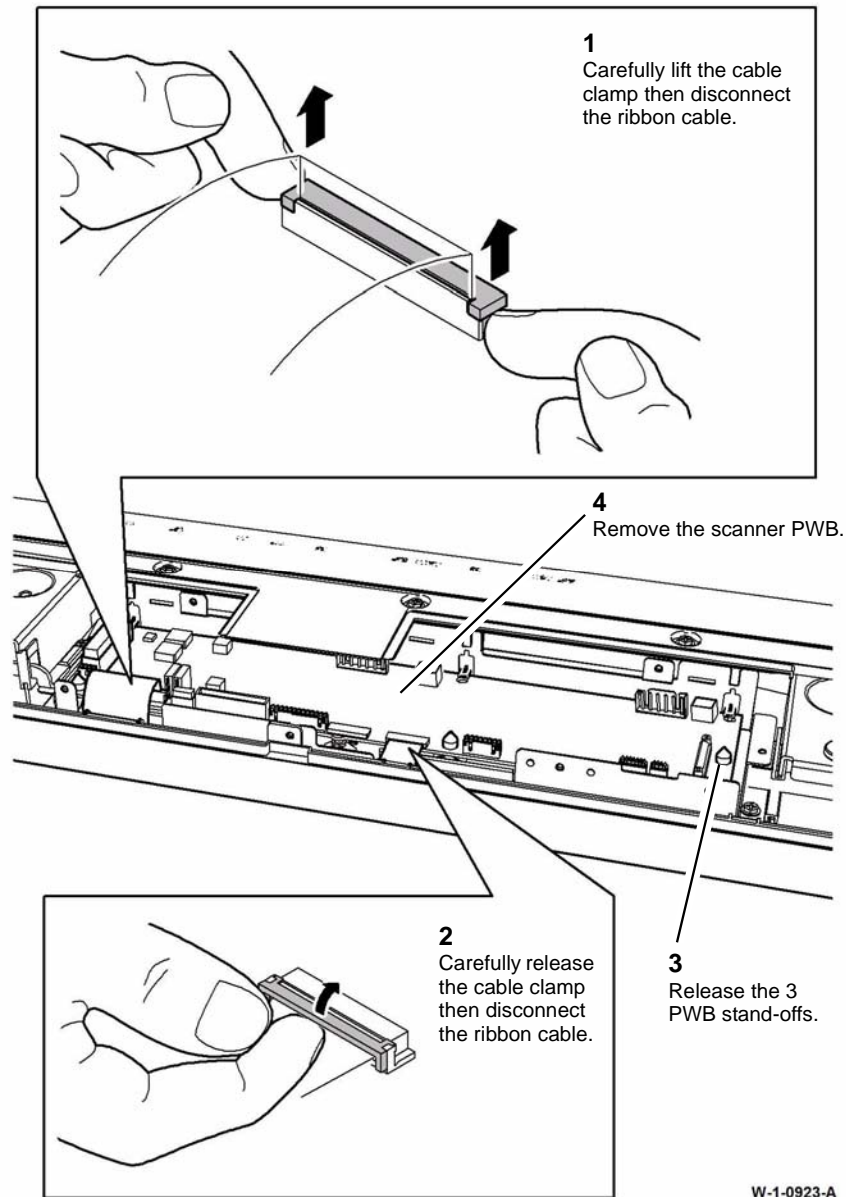
4. Remove the scanner PWB, [Figure 3](#).

Figure 3 Scanner PWB

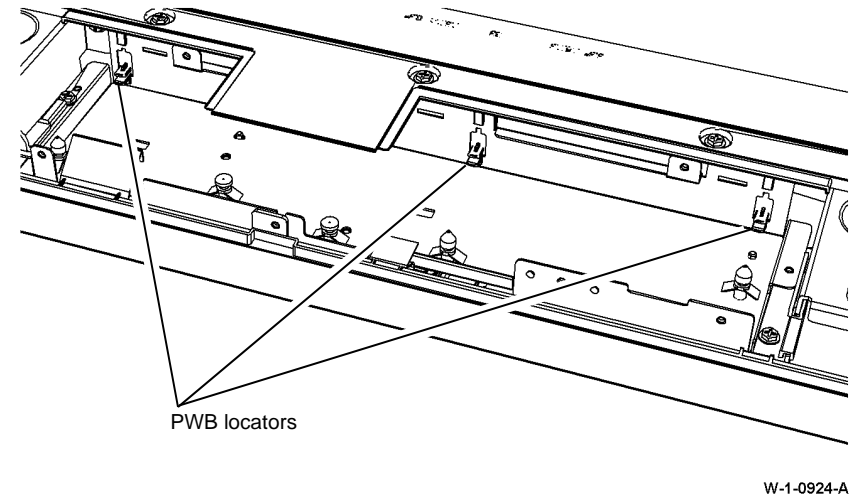
1. The replacement is the reverse of the removal procedure.
2. Ensure the scanner PWB engages with the 3 PWB locators on the rear of the scanner PWB support, [Figure 4](#).

Figure 4 Scanner PWB locators

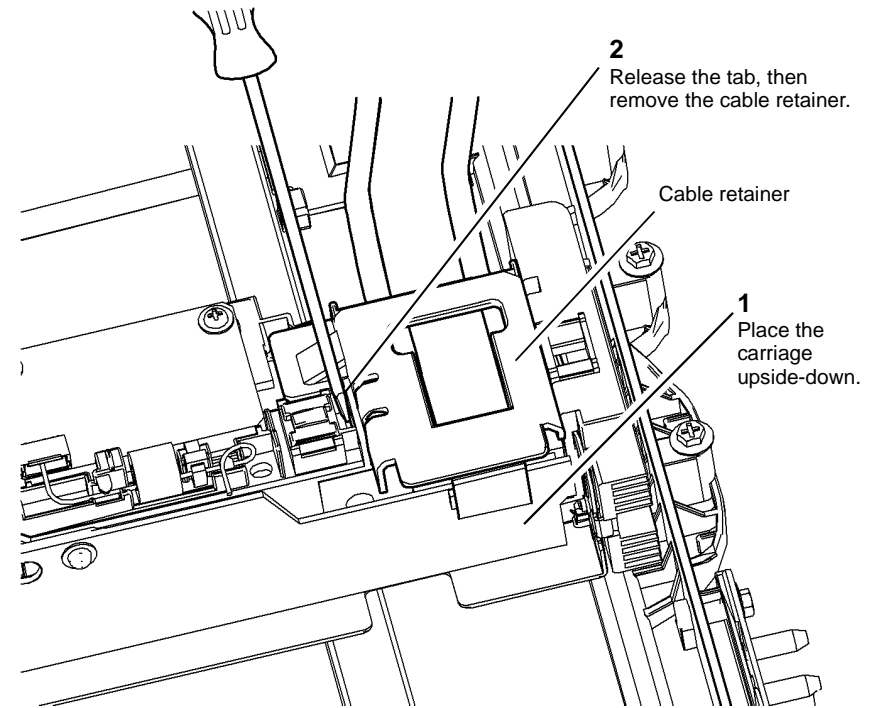
W-1-0925-A

3. Remove the ribbon cable retainer, [Figure 1](#).

Figure 1 Cable retainer removal

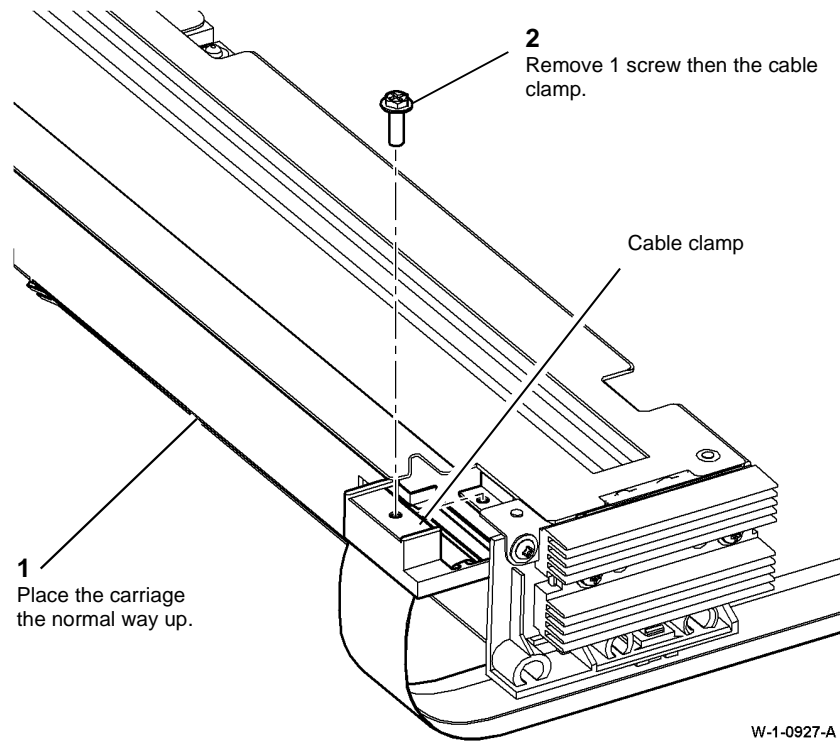
4. Remove the cable clamp, [Figure 2](#).

Figure 2 Cable clamp removal

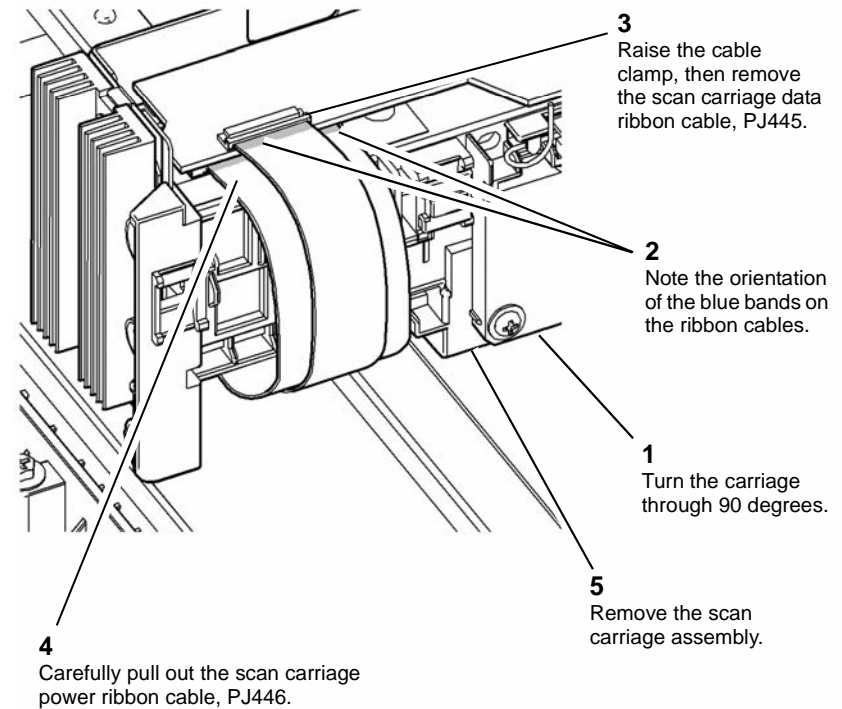
5. Remove the scan carriage, [Figure 3](#).

Figure 3 Scan carriage removal

1. The replacement is the reverse of the removal procedure.
2. When re-connecting the ribbon cables, the blue band printed on the cables must be orientated as shown in [Figure 3](#).
3. Perform [ADJ 60.1](#) Scanner Cleaning Procedure.
4. Perform [ADJ 60.3](#) IIT Registration, Magnification and Calibration.

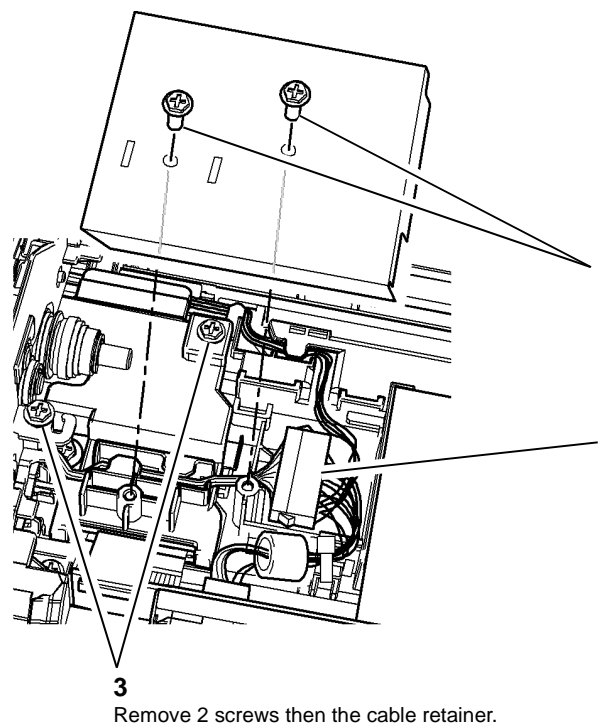
W-1-0928-A

1. Remove the takeaway roll assembly, [REP 5.5](#).
2. Prepare to remove the side 2 scan assembly, [Figure 1](#).

Figure 1 Scan assembly harnesses

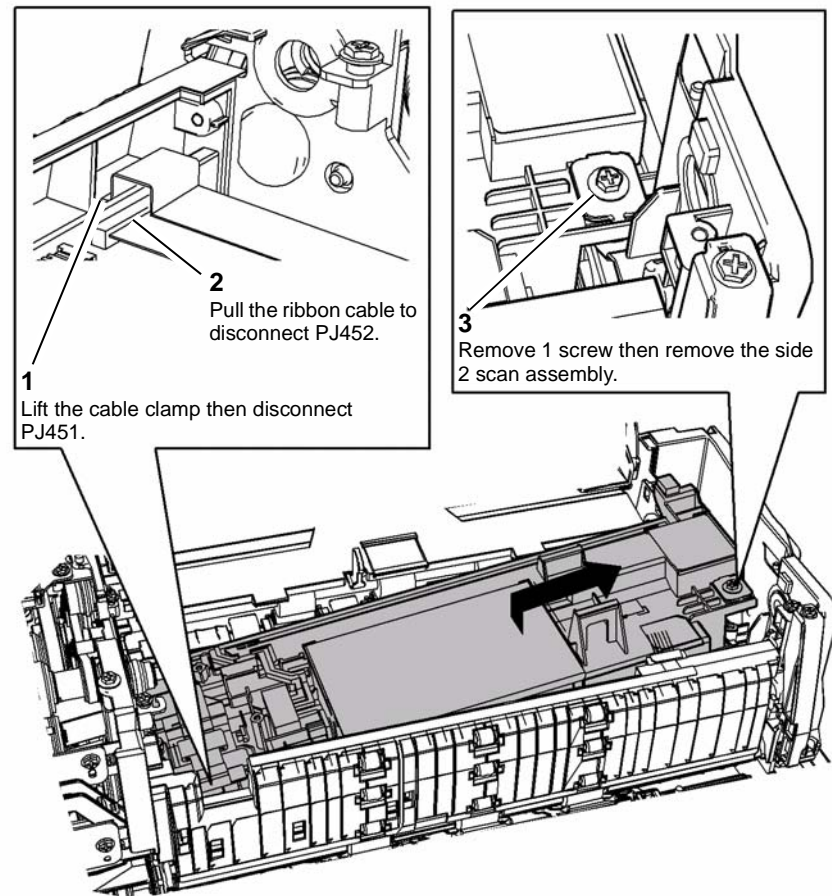
W-1-0929-A

3. Remove the side 2 scan assembly, [Figure 2](#).

Figure 2 Side 2 scan assembly

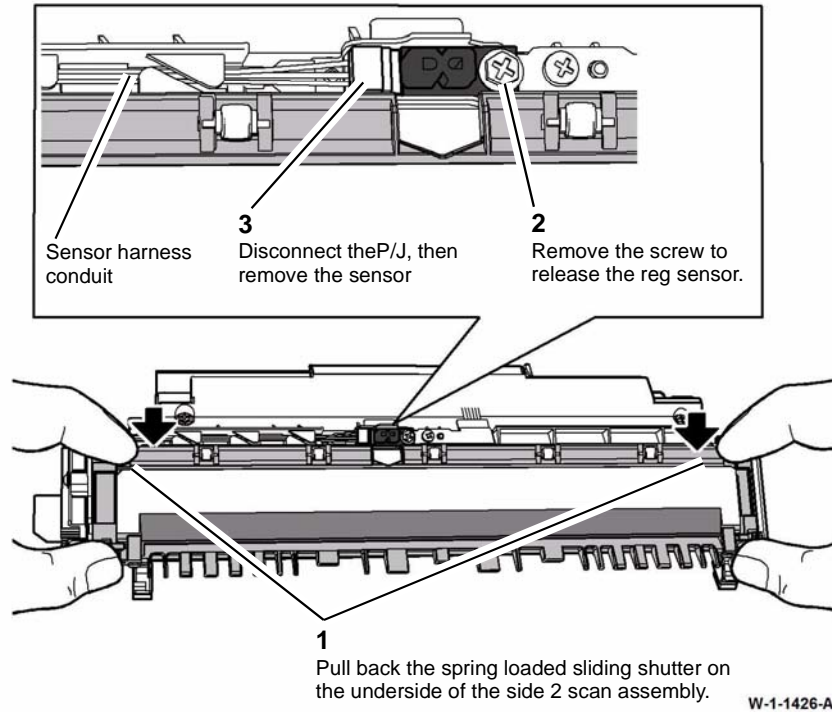
4. If required, remove the side 2 reg sensor, [Figure 3](#).

Figure 3 Sensor removal

1. The replacement is the reverse of the removal procedure.
2. If the side 2 reg sensor was removed, ensure that the sensor harness is routed correctly within the harness conduit when the sensor is replaced, [Figure 3](#).
3. Perform [ADJ 60.2](#) Side 2 Scan Assembly Cleaning Procedure.
4. Perform [ADJ 60.3](#) IIT Registration, Magnification and Calibration.

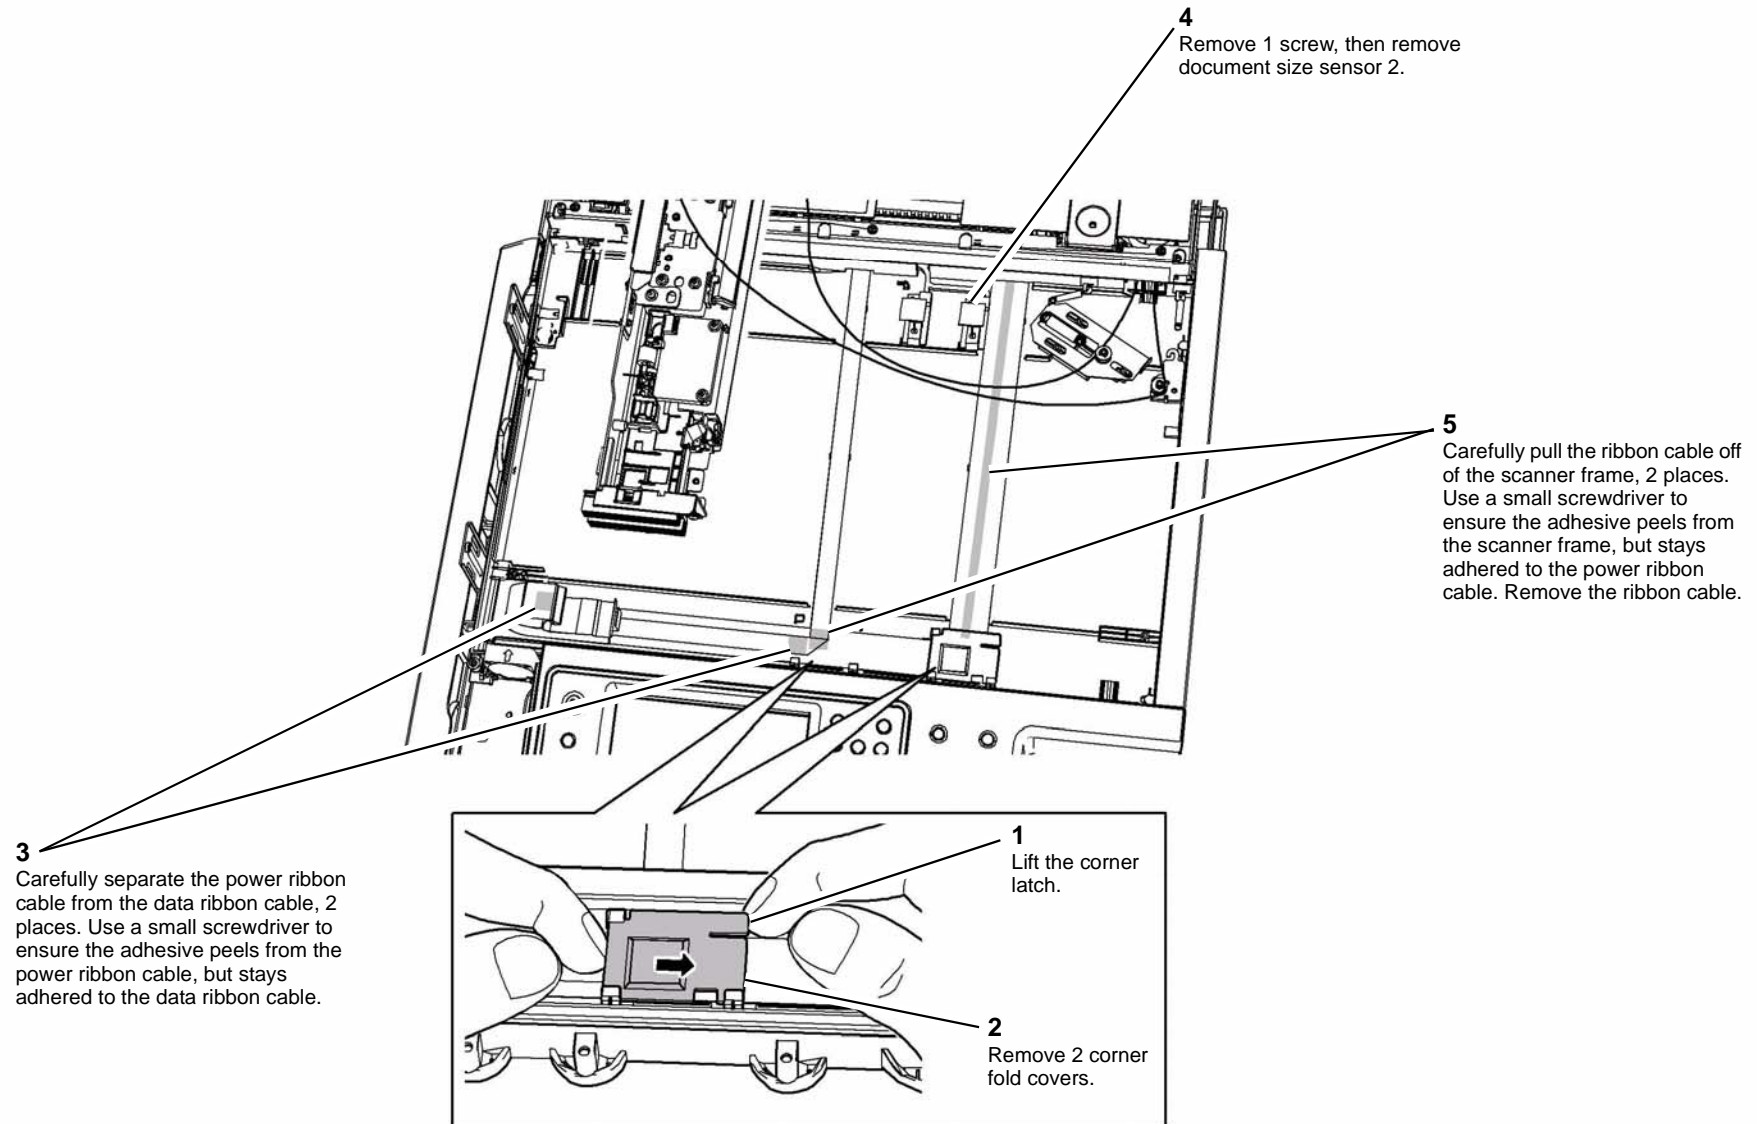
W-1-0930-A

5. Remove the ribbon cable, [Figure 1](#).

Figure 1 Ribbon cable removal

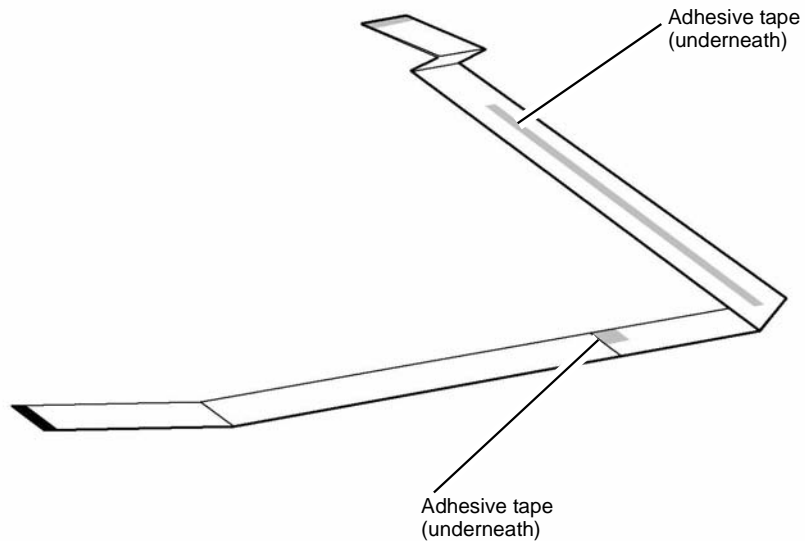
W-1-0931-A

1. A new pre-folded ribbon cable is supplied with double sided tape attached. [Figure 2](#) shows the positions of the double sided tape.

Figure 2 Ribbon cable adhesive
