708P91139
February 2016

Xerox® WorkCentre® 5945 Family Multifunction Printer Service Manual

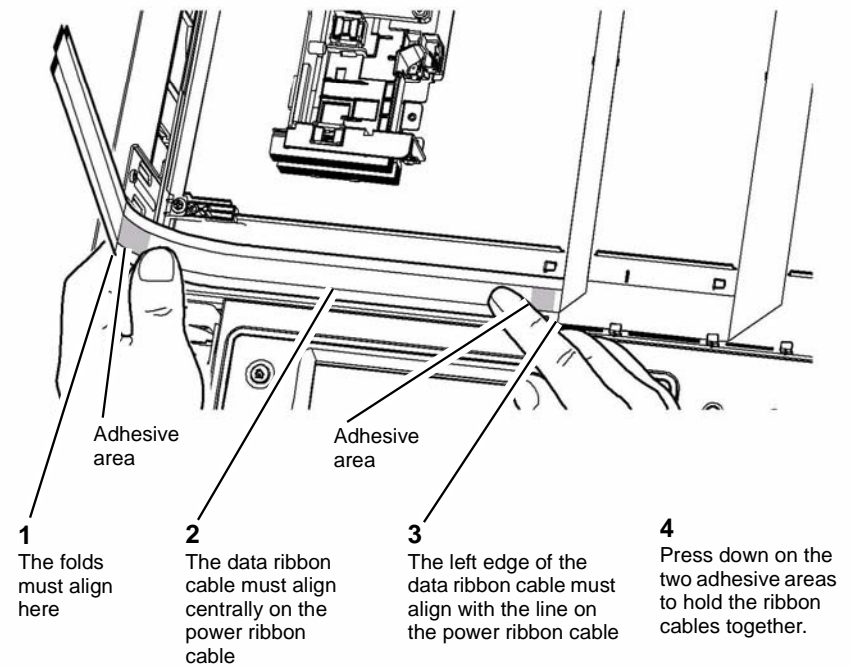
W-1-1375-A

2. Align the ribbon cable, [Figure 3](#).

Figure 3 Ribbon cable alignment

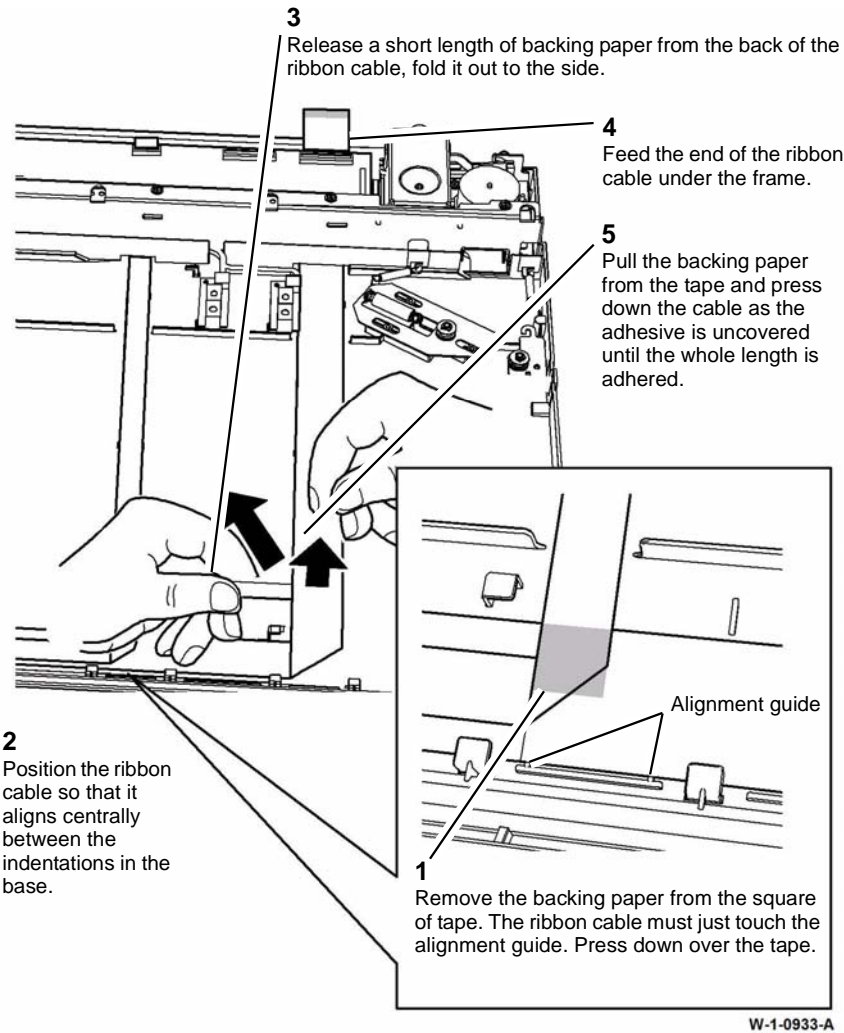
3. Install the ribbon cable, [Figure 4](#).

Figure 4 Ribbon cable placement

4. The remainder of the replacement procedure is the reverse of the removal procedure.
NOTE: Add folds to the ends of the new ribbon cable to copy the shape of the old ribbon cable. This will aid in the ease of connection to the ribbon cable connectors.
5. Perform [ADJ 60.1](#) Scanner Cleaning Procedure.
6. Perform [ADJ 60.3](#) IIT Registration, Magnification and Calibration.

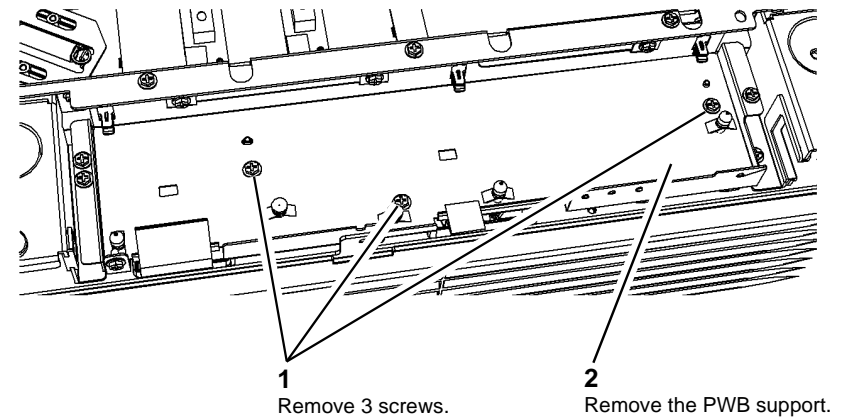
W-1-0932-A

1. Remove the top cover assembly, [REP 60.3](#).
2. Remove the scanner PWB, [REP 60.4](#).
3. Remove the scanner PWB support, [Figure 1](#).

- 1 Remove 3 screws.
- 2 Remove the PWB support.

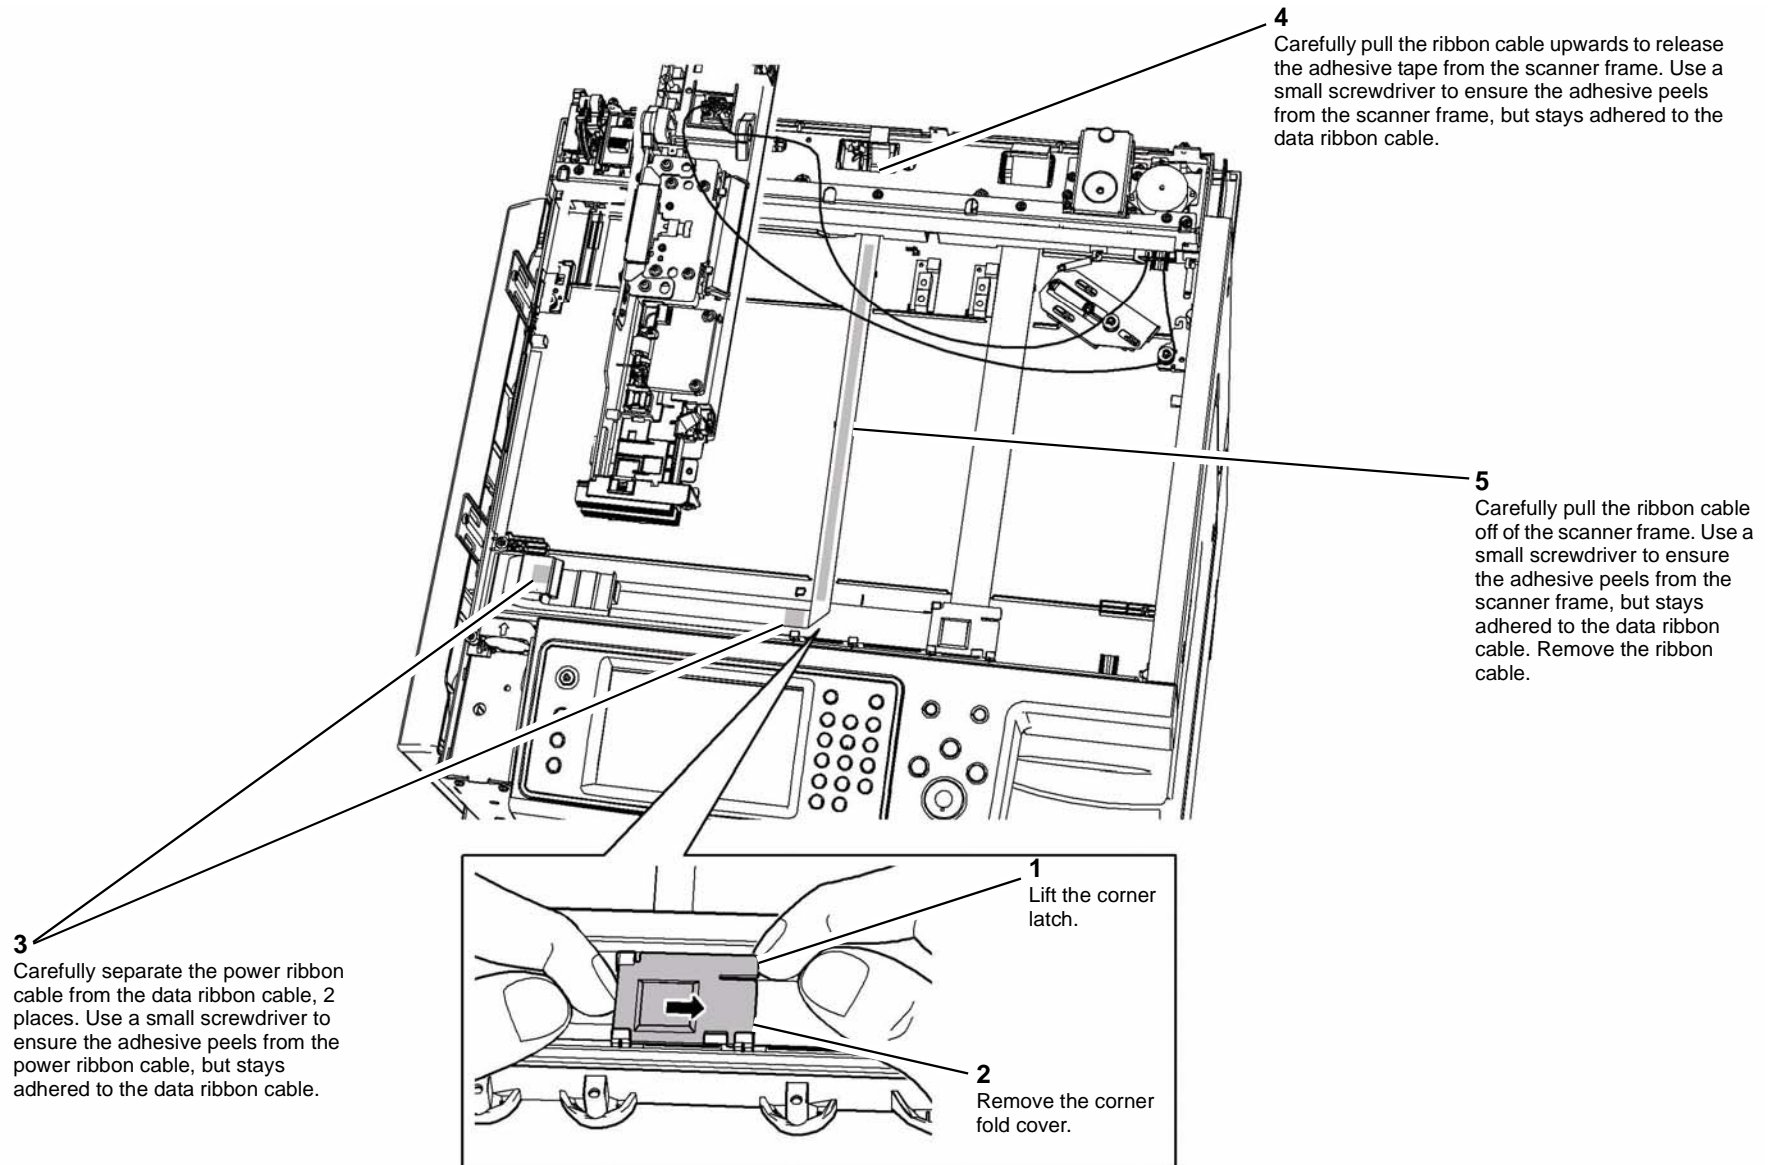
5. Remove the scan carriage support rail from the front of the scanner base, by removing 1 screw from the right end and 2 screws from the left end.
6. Remove the ribbon cable, [Figure 2](#).

Figure 2 Ribbon cable removal

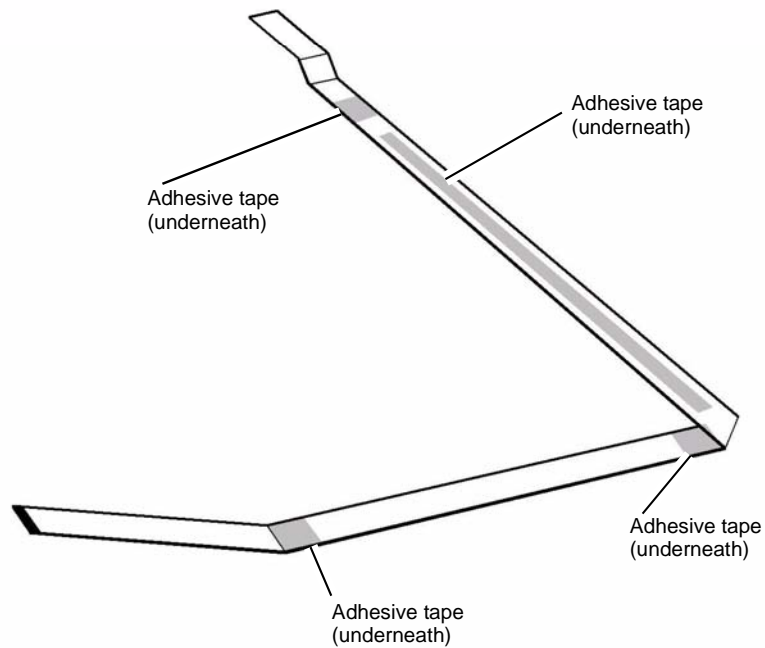
W-1-0935-A

1. A new pre-folded ribbon cable is supplied with double sided tape attached. [Figure 3](#) shows the positions of the double sided tape.

Figure 3 Ribbon cable adhesive

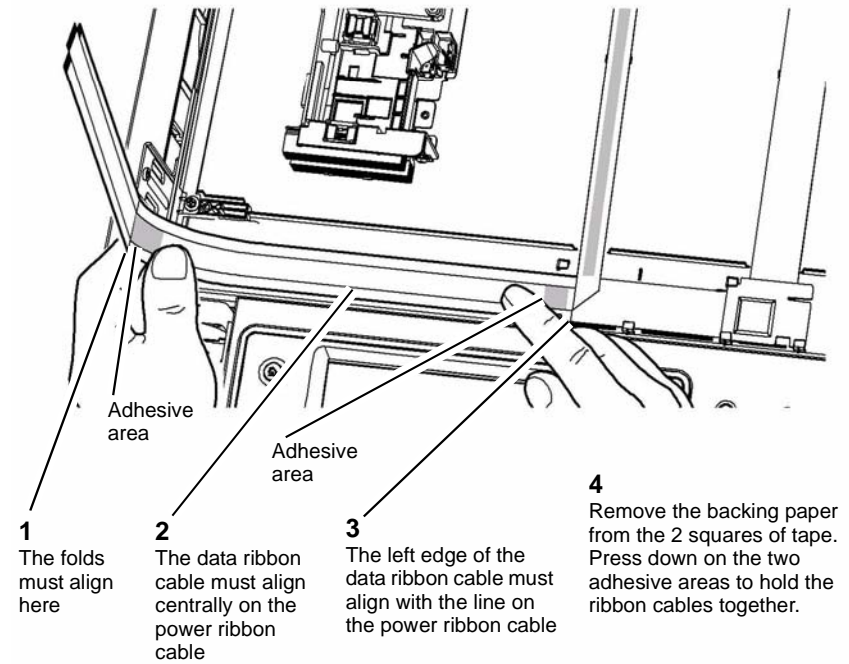
W-1-0936-A

2. Align the ribbon cable, [Figure 4](#).

Figure 4 Ribbon cable alignment

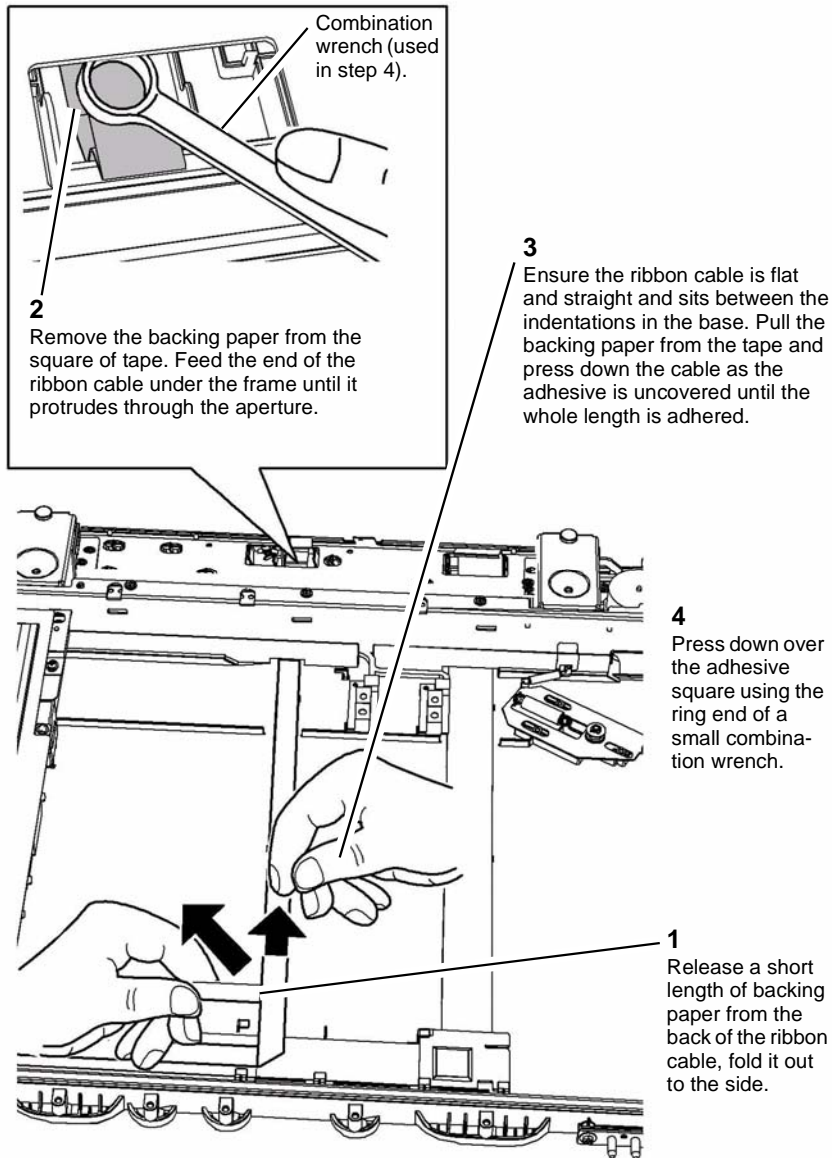
W-1-0937-A

3. Install the ribbon cable, [Figure 5](#).

Figure 5 Ribbon cable placement

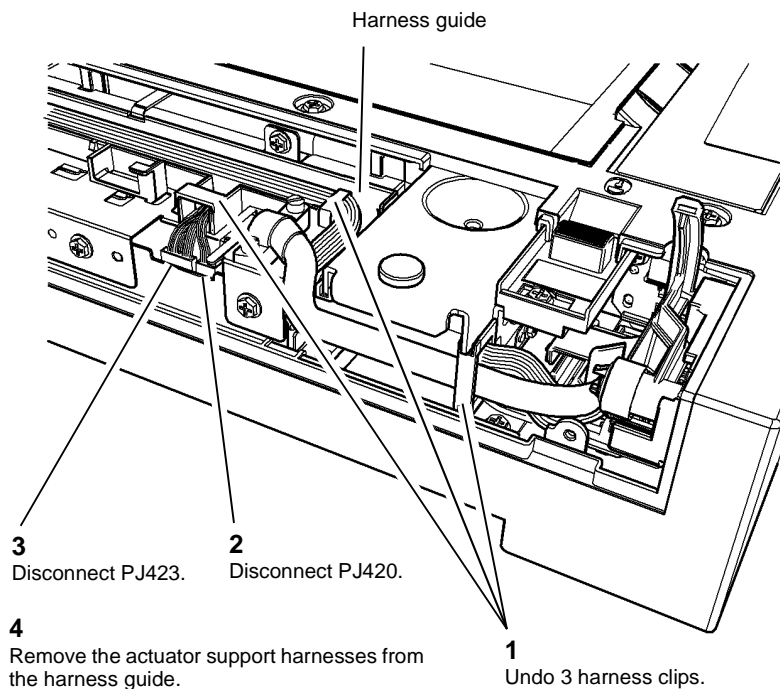
W-1-0938-A

1. Remove the SPDH. [REP 5.19](#).
2. Disconnect the actuator support harnesses, [Figure 1](#).

Figure 1 Harness connections

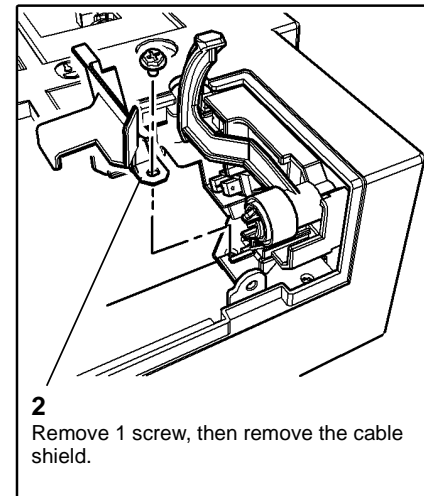
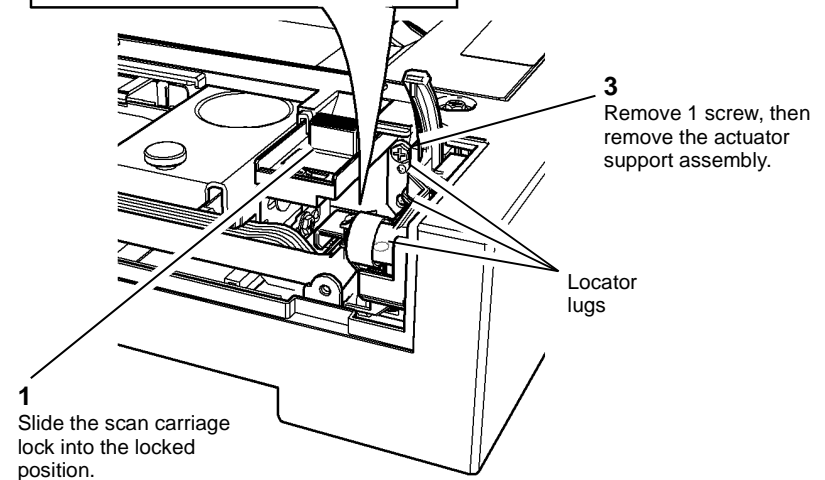
W-1-0939-A

3. Remove the actuator support assembly, [Figure 2](#).

Figure 2 Actuator support assembly

1. The replacement is the reverse of the removal procedure.
2. When replacing the actuator support assembly, ensure that the 3 locator lugs of the scanner frame are located into the actuator support assembly before tightening the screw.

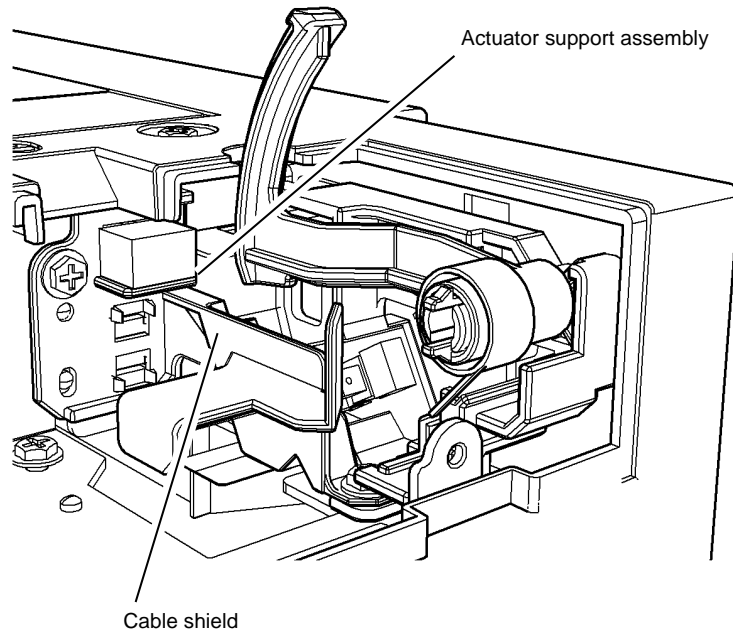
W-1-0940-A

- When replacing the cable shield, ensure the tip of the cable shield is positioned under the actuator support assembly, [Figure 3](#).

NOTE: The scanner lock has been removed from this illustration for clarity.

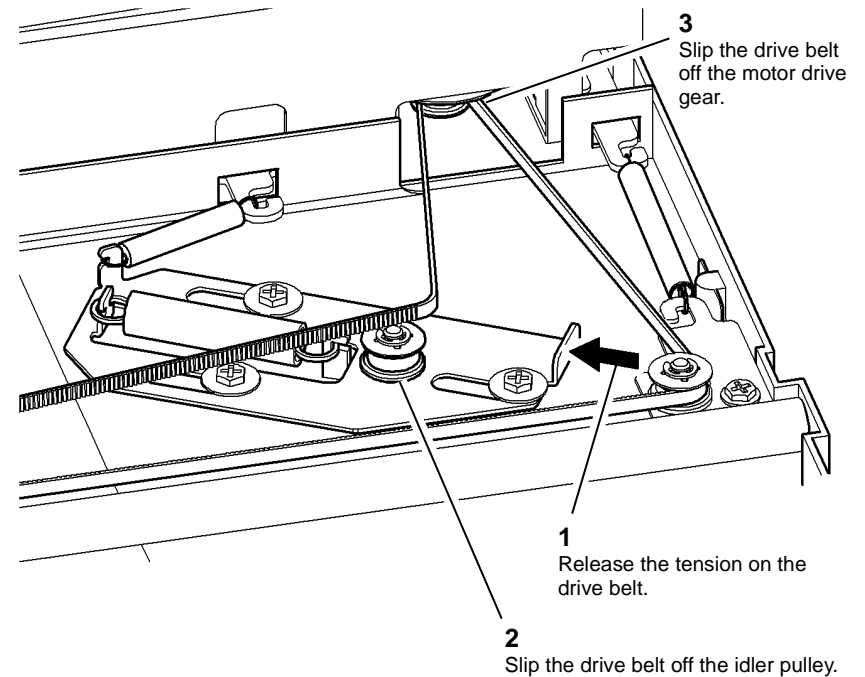
W-1-0941-A

- Remove the top cover assembly, [REP 60.3](#).
- Remove the scan carriage drive belt from the motor drive gear, [Figure 1](#).

Figure 1 Release the drive belt

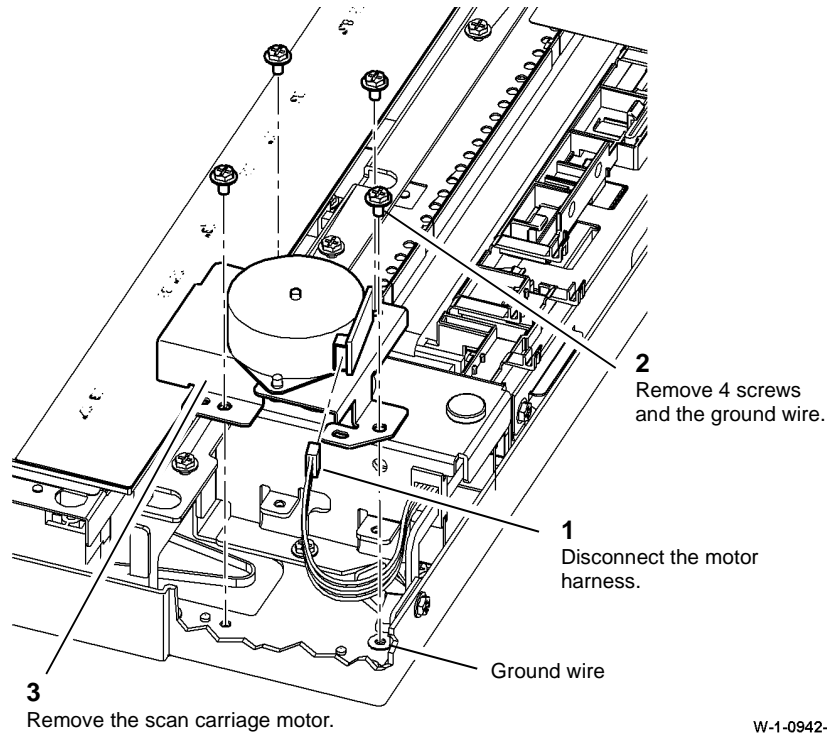
W-1-0942-A

- Remove the scan carriage motor, [Figure 2](#).

Figure 2 Scan carriage motor

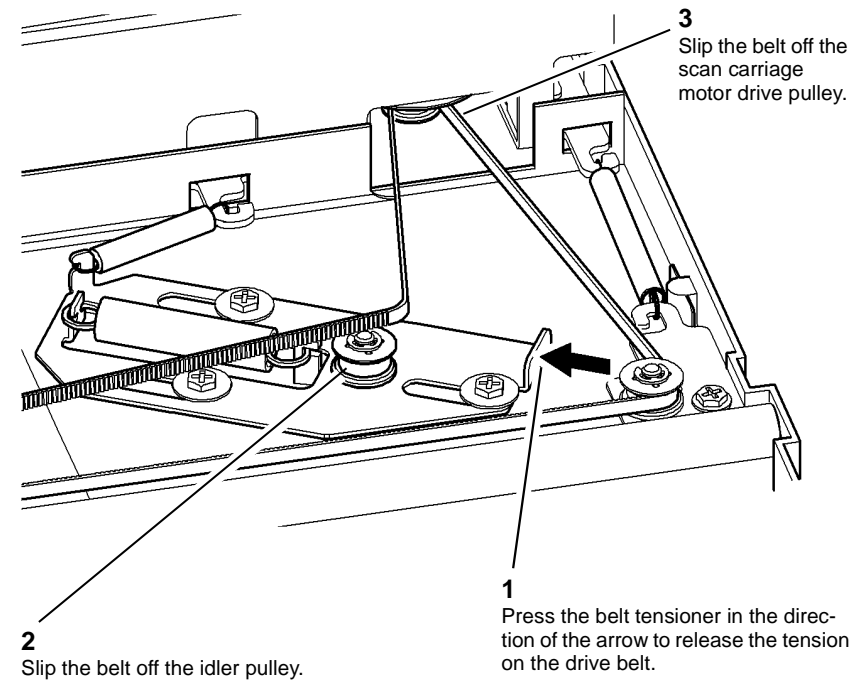
W-1-0943-A

- Remove the top cover assembly, [REP 60.3](#).
- Remove the scan carriage drive belt from the scan carriage motor assembly, [Figure 1](#).

Figure 1 Release the drive belt

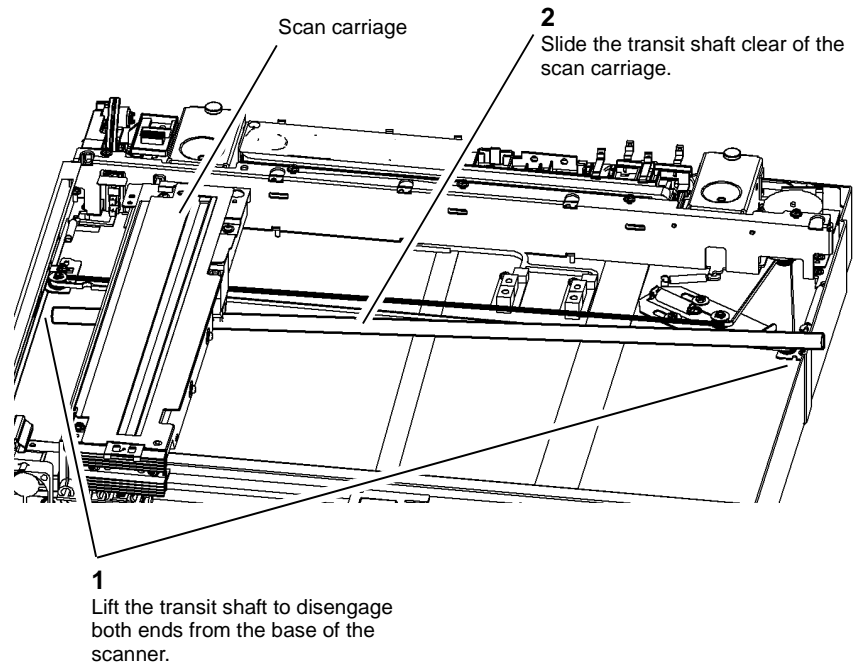
W-1-0944-A

3. Remove scan carriage transit shaft, [Figure 2](#).

Figure 2 Release the transit shaft

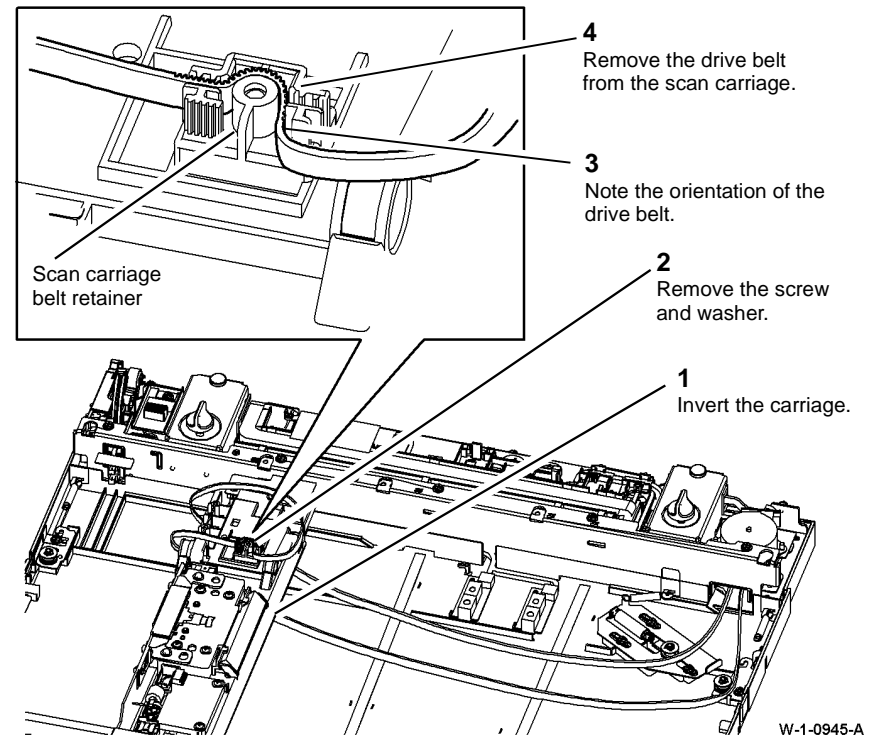
W-1-0945-A

4. Detach the scan carriage drive belt, [Figure 3](#).

Figure 3 Drive belt retaining screw

1. The replacement is the reverse of the removal procedure.
2. Ensure the scan carriage drive belt is installed correctly in the scan carriage belt retainer, [Figure 3](#).
3. Ensure the scan carriage drive belt is installed correctly on all 3 idler pulleys and the scan carriage motor drive gear.
4. Perform [ADJ 60.1](#) Scanner Cleaning Procedure.
5. Perform [ADJ 60.3](#) IIT Registration, Magnification and Calibration.

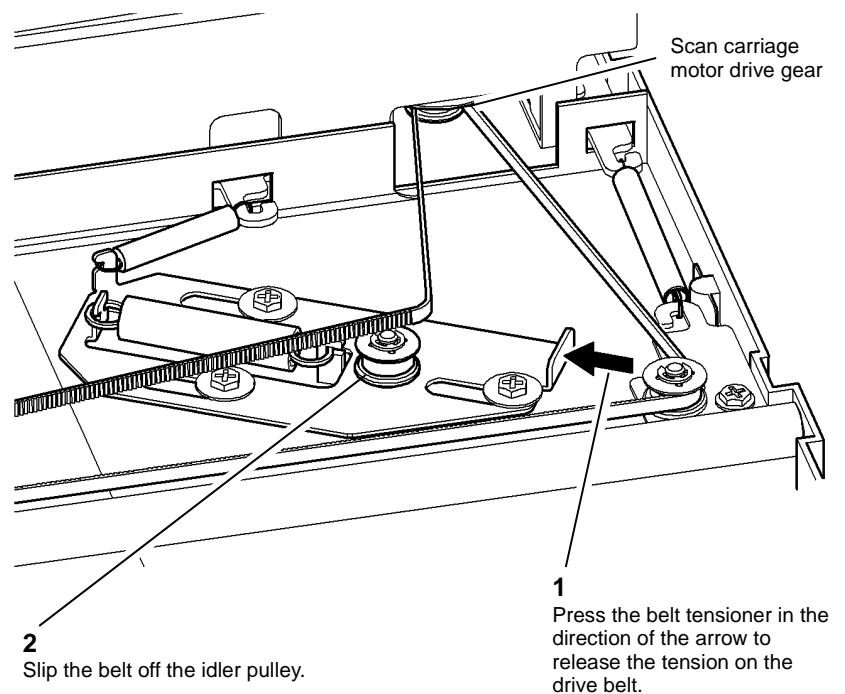
W-1-0946-A

1. Remove the scanner top cover, [REP 60.3](#).
2. Remove the scan carriage drive belt from the idler pulley of the belt tensioner, [Figure 1](#).

Figure 1 Release the drive belt

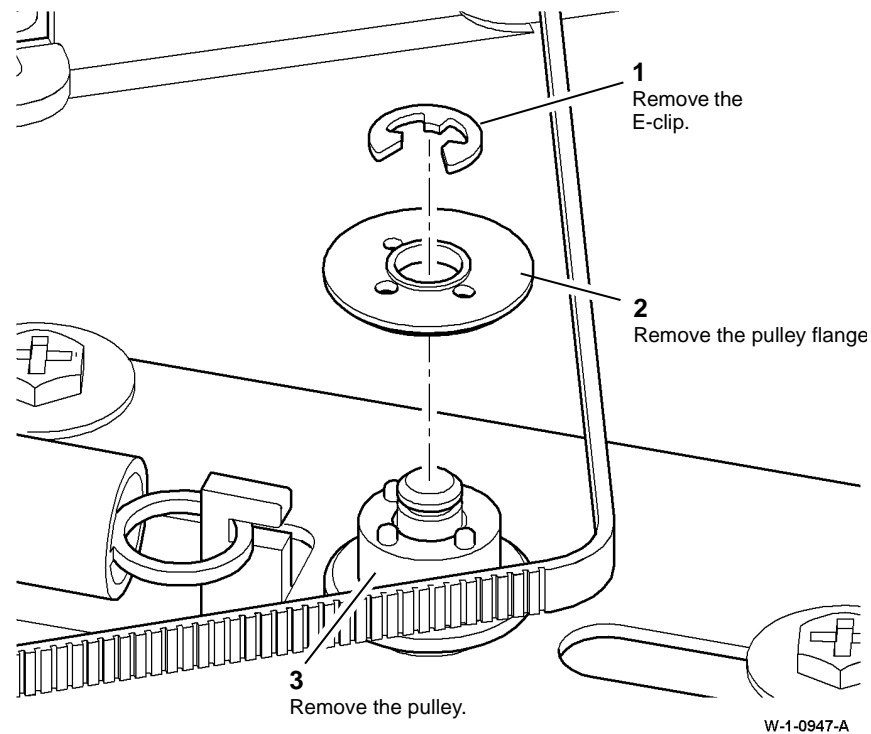
3. Remove the scan idler pulley, [Figure 2](#).

NOTE: [Figure 2](#) shows the idler pulley of the belt tensioner. However, the removal procedure for all 3 idler pulleys is identical.

Figure 2 Scan idler pulley removal

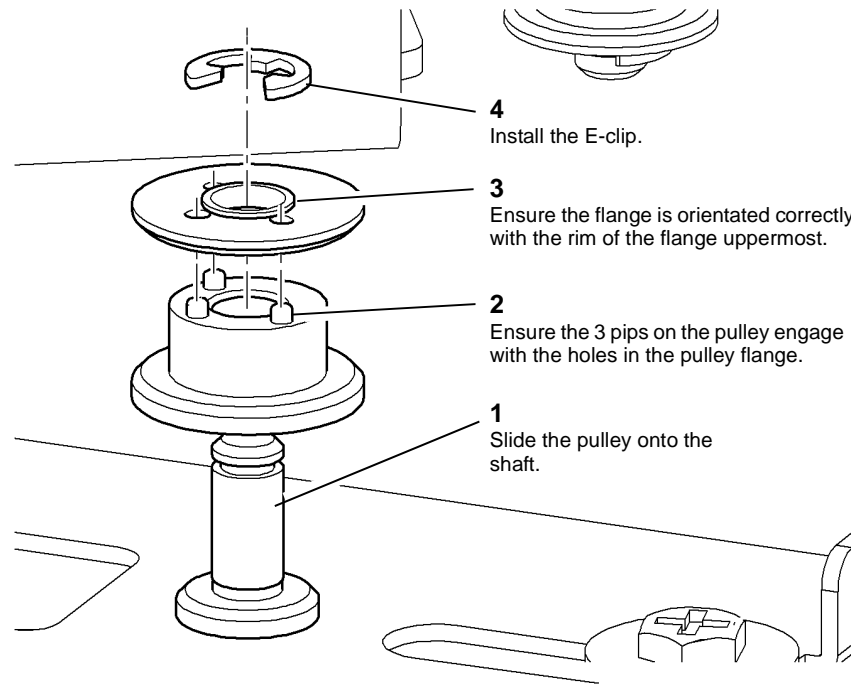
W-1-0948-A

1. The replacement is the reverse of the removal procedure.
2. Ensure the scan idler pulleys are installed correctly, [Figure 3](#).

Figure 3 Idler pulley replacement

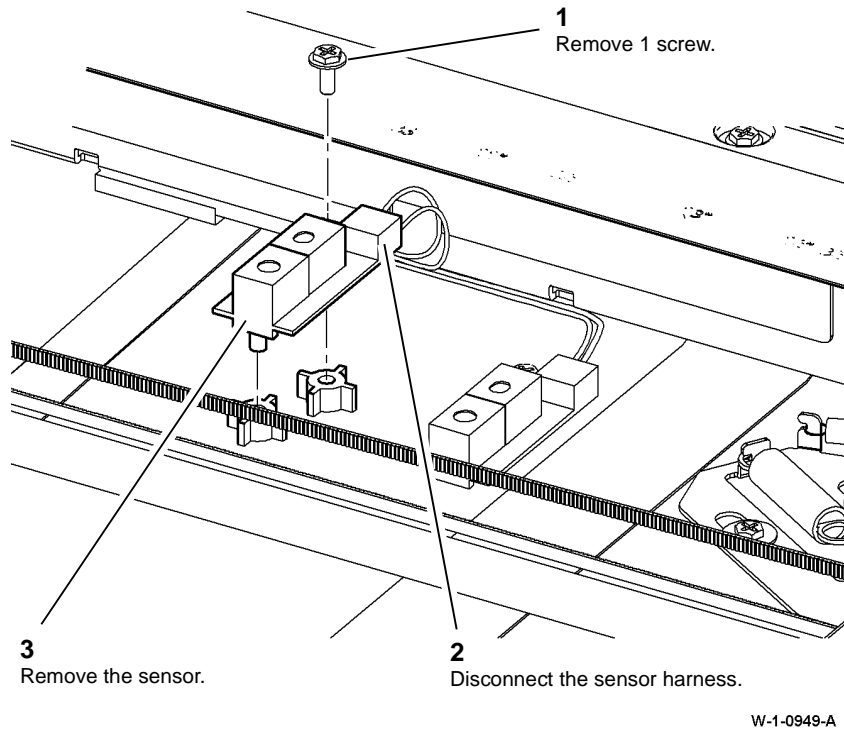
1. Remove the top cover assembly, [REP 60.3](#).
2. Remove document size sensor 1 (Q62-251) or document size sensor 2 (Q62-253), [Figure 1](#).

NOTE: The removal procedure of document size sensor 1 and document size sensor 2 is identical.

Figure 1 Document size sensor removal

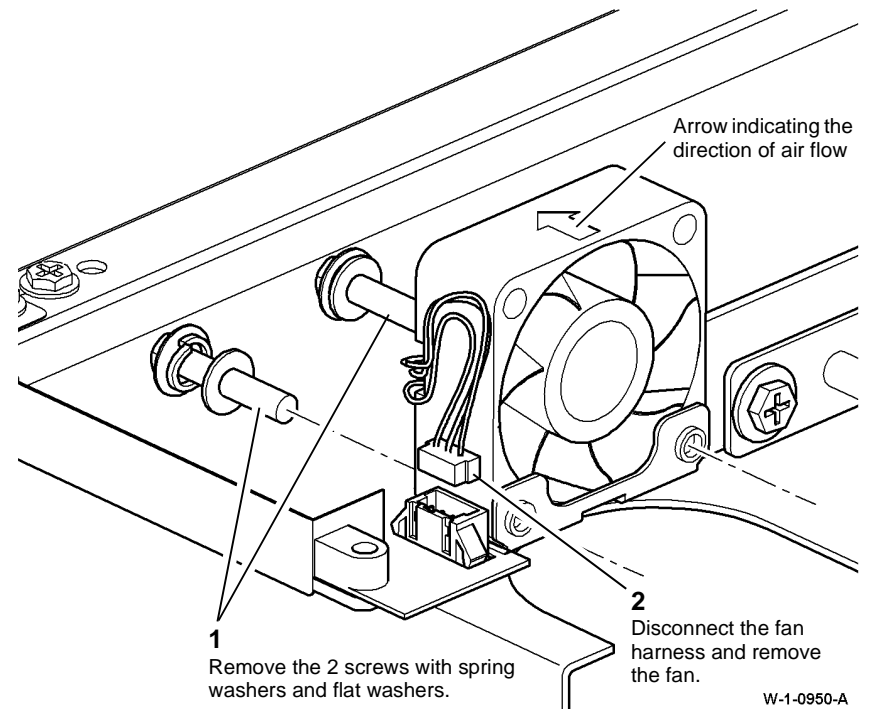
1. Remove the top cover assembly, [REP 60.3](#).
2. Remove the cooling fan, [Figure 1](#).

Figure 1 Cooling fan removal

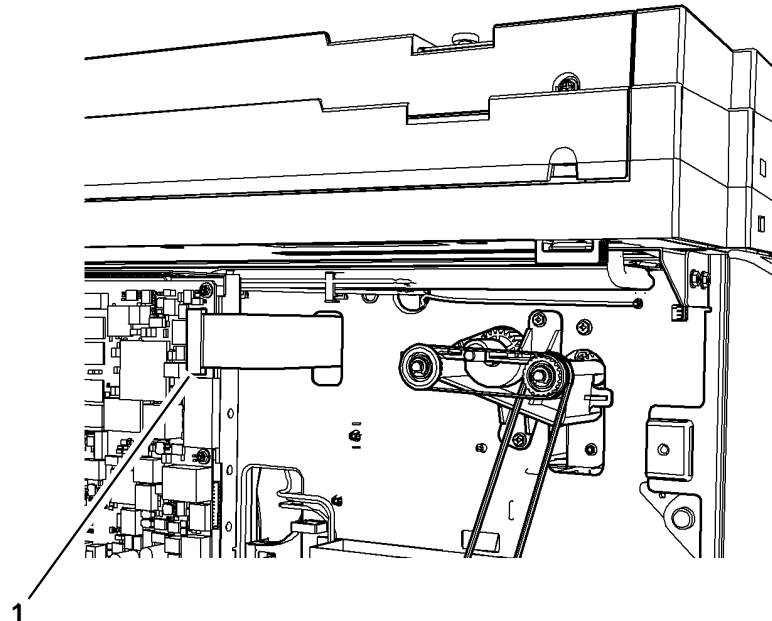
W-1-1037-A

3. Disconnect the LED print head module ribbon cable, [Figure 1](#).

1. Disconnect the LPH ribbon cable from PJ851 on the SBC PWB.

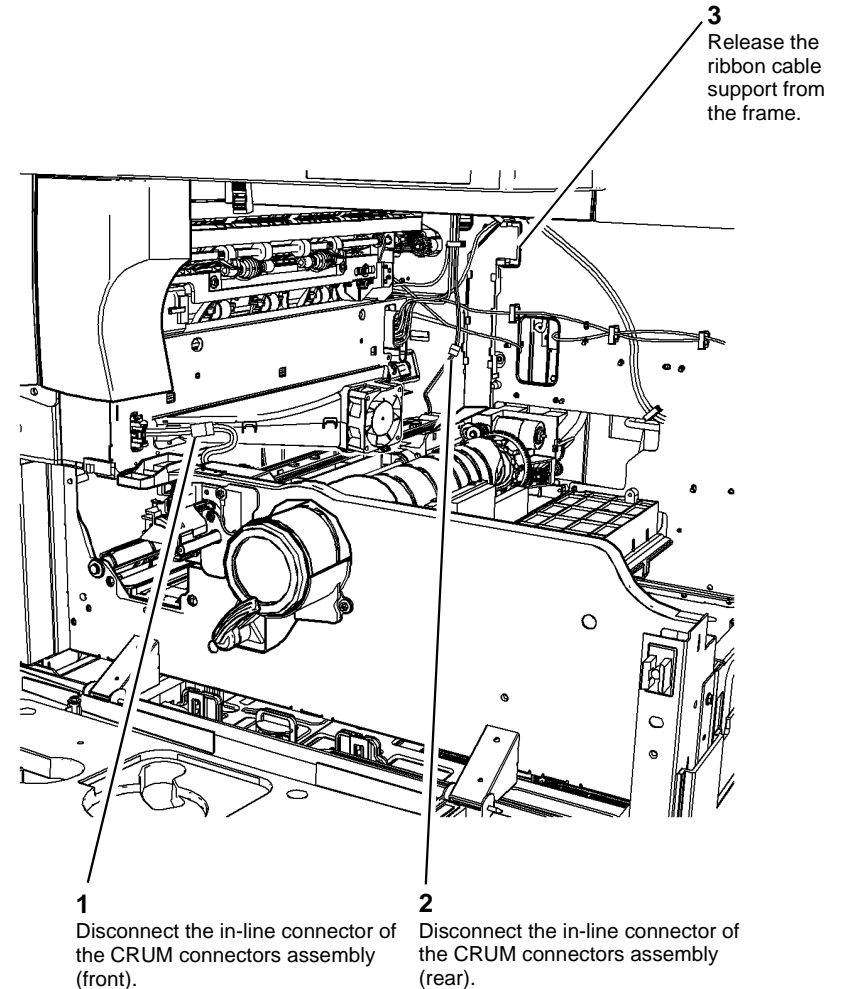
W-1-1244-A

9. Prepare to remove the LED print head module, [Figure 2](#).

1. Disconnect the in-line connector of the CRUM connectors assembly (front).
2. Disconnect the in-line connector of the CRUM connectors assembly (rear).
3. Release the ribbon cable support from the frame.

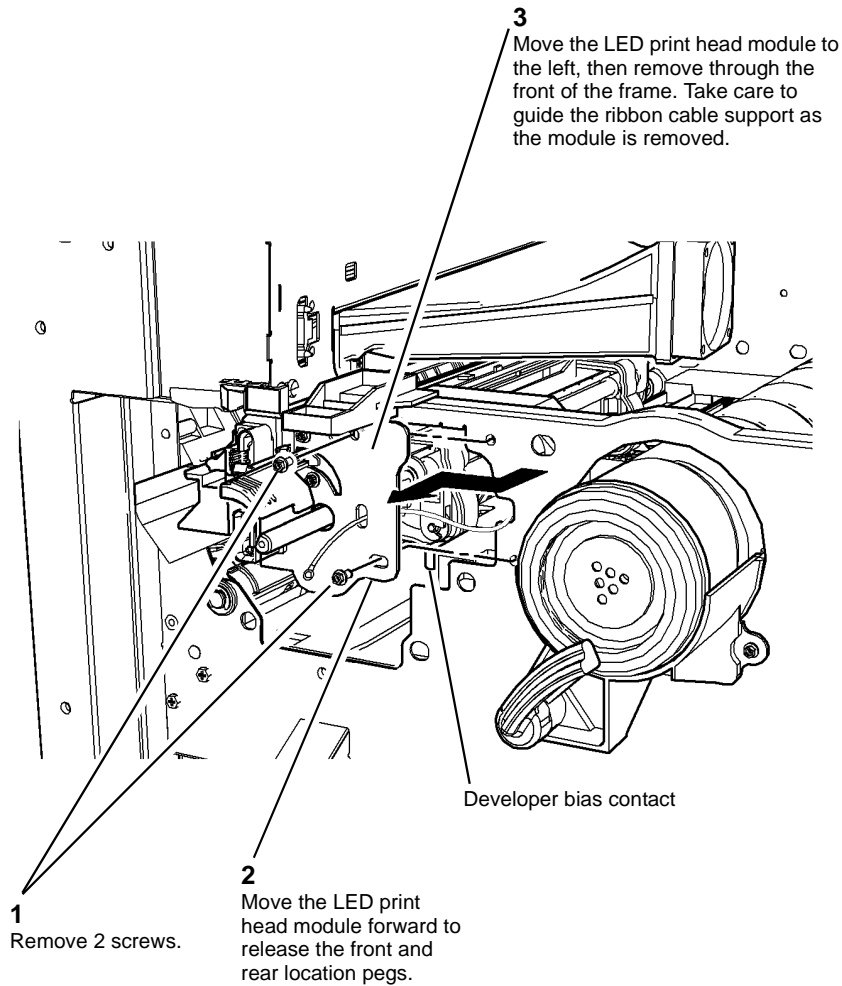
10. Remove the LED print head module, [Figure 3](#).

Figure 3 LPH removal

Take care not to damage the developer bias contact when removing the LED print head module. Also, avoid touching the LED lamp when handling the LED print head module.

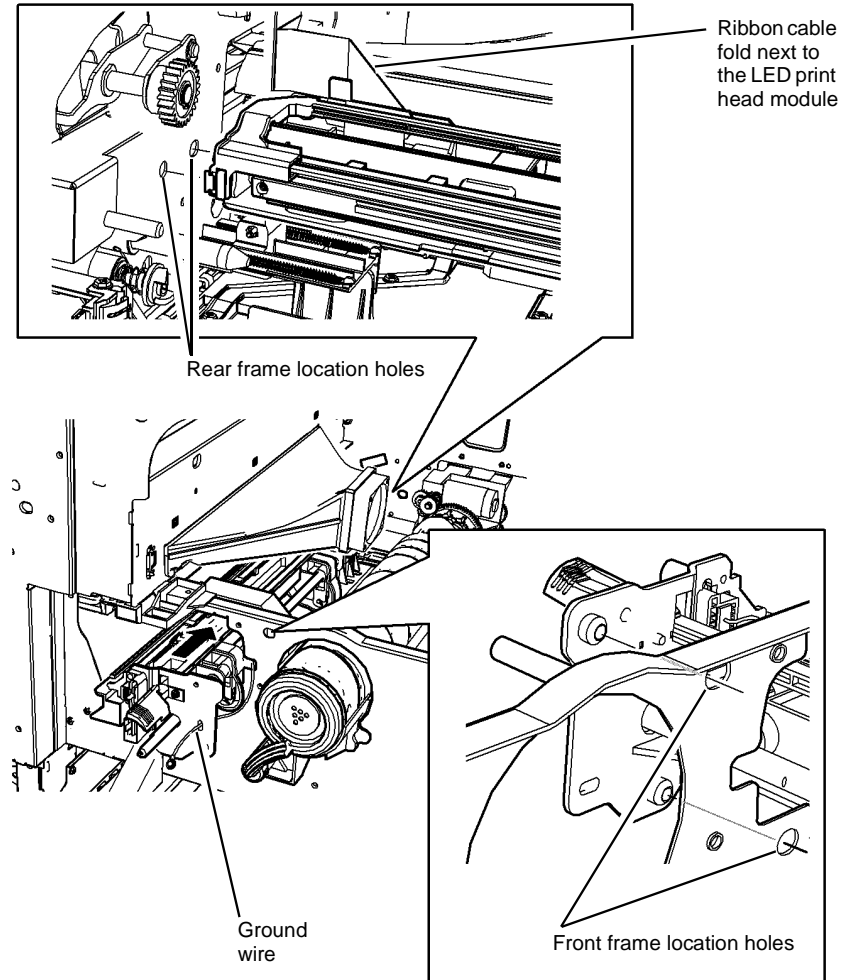
Figure 4 Replacement

3. Ensure the front and rear location pegs on the LPH are aligned with the holes in the frame, **Figure 4**.

4. Ensure that any slack in the ground wire is positioned behind the machine frame, not in front, **Figure 4**.
5. Ensure that the ribbon cable fold next to the LED print head module is formed as shown in **Figure 4**.
6. Ensure the ribbon cable is correctly connected to PJ851 on the SBC PWB. The printed blue band should face away from the PWB.
7. Perform **ADJ 60.4** LED Print Head Cleaning Procedure.

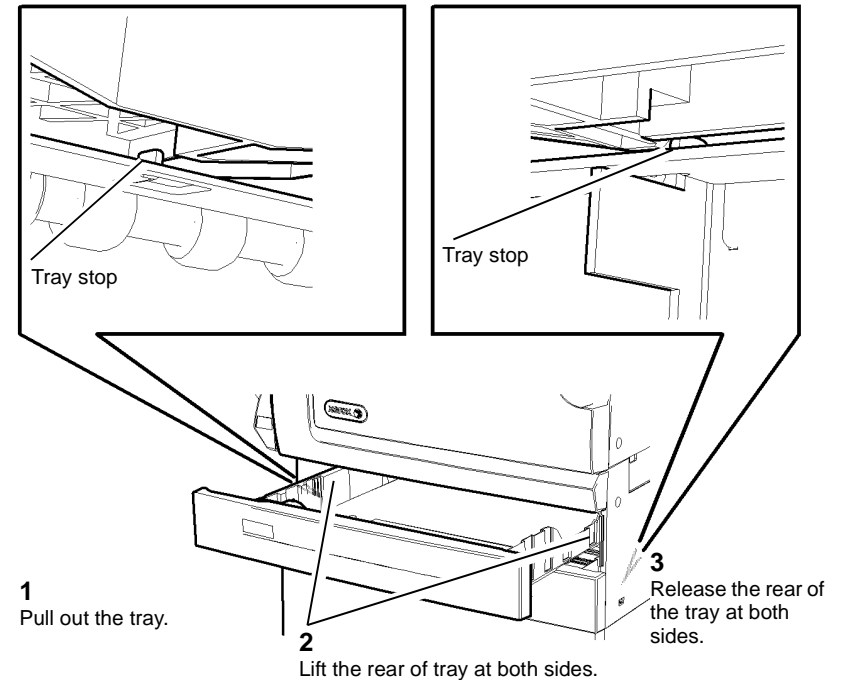
Figure 1 Tray 1 and tray 2 removal

1. Remove tray 1 or tray 2, [Figure 1](#).

1. The replacement is the reverse of the removal procedure. Lift the rear of the tray over the tray stops and push the tray in. Refer to [Figure 1](#).
2. If the trays do not slide easily, go to [ADJ 40.1](#) and perform the Tray 1 and 2 Slide Pads procedure.

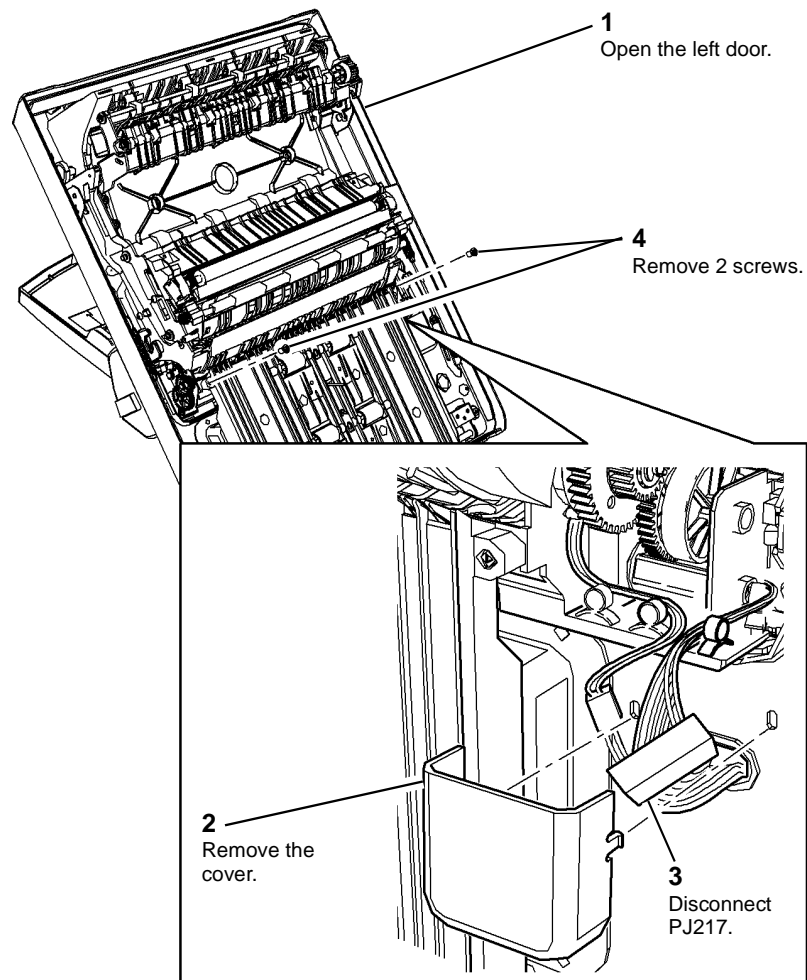
Figure 1 Preparation

1. Remove the print cartridge, [PL 90.17 Item 9](#), then place in a black bag.
2. Prepare to remove the bypass tray assembly, [Figure 1](#).

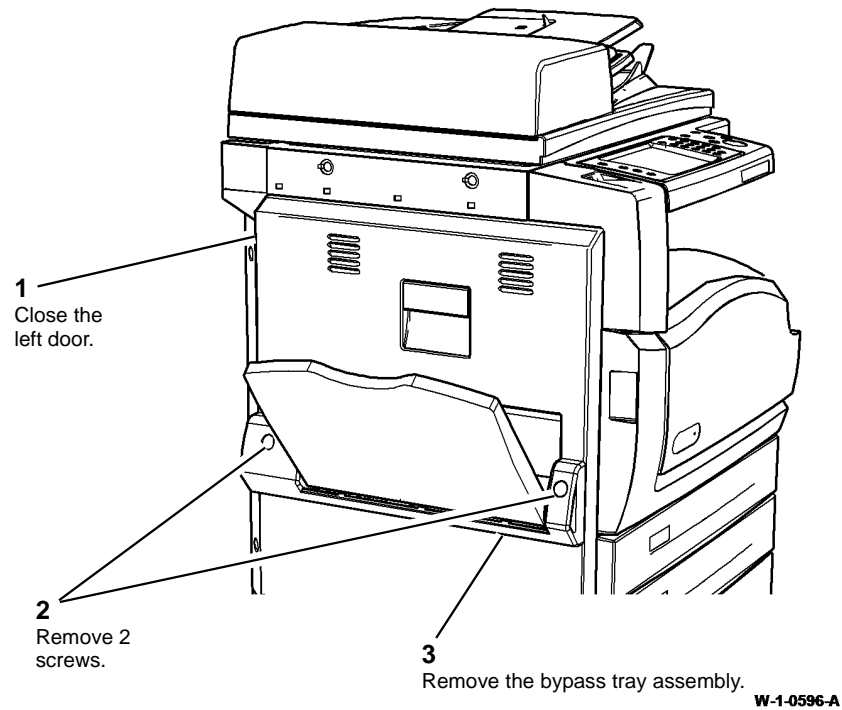
Figure 2 Bypass tray removal

3. Remove the bypass tray assembly, [Figure 2](#).

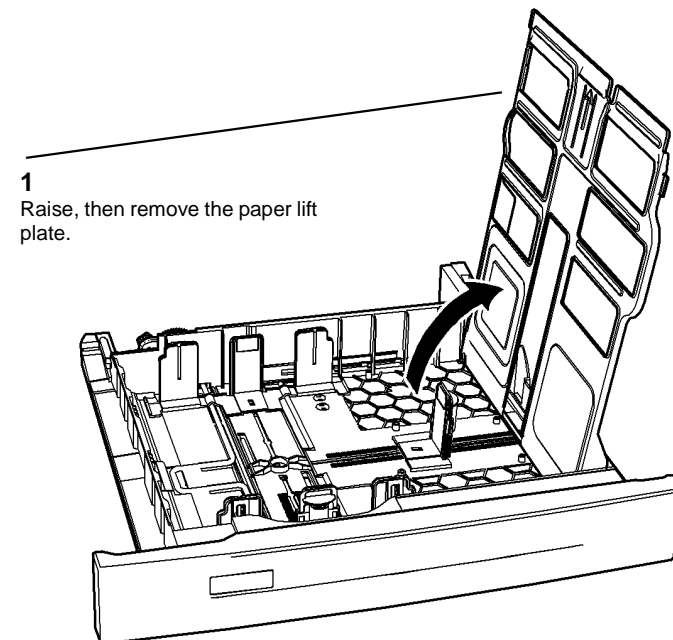
Figure 1 Paper lift plate removal

1. Remove the paper from the tray.
2. Remove the tray, [REP 70.1](#).
3. Remove the paper lift plate, [Figure 1](#).

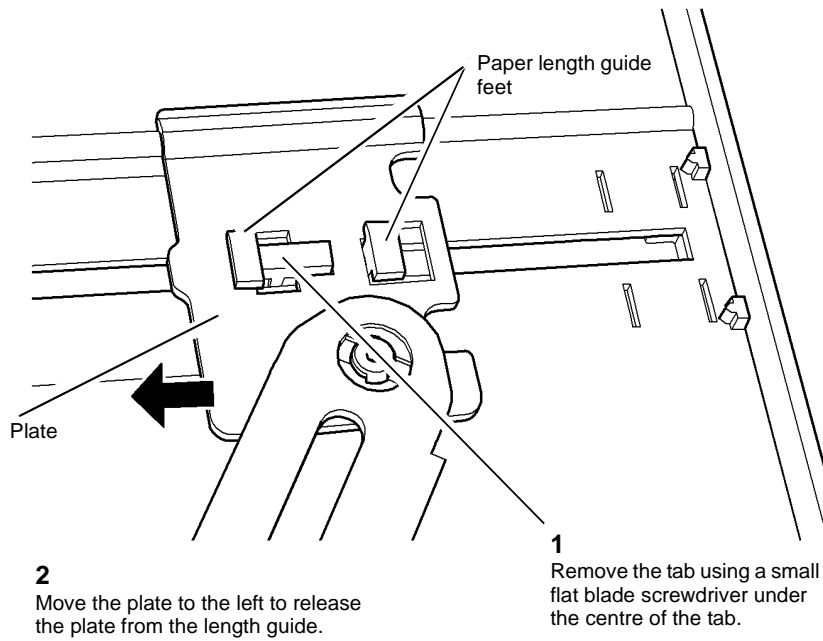
Figure 2 Preparation

4. Prepare to remove the paper length guide, [Figure 2](#).

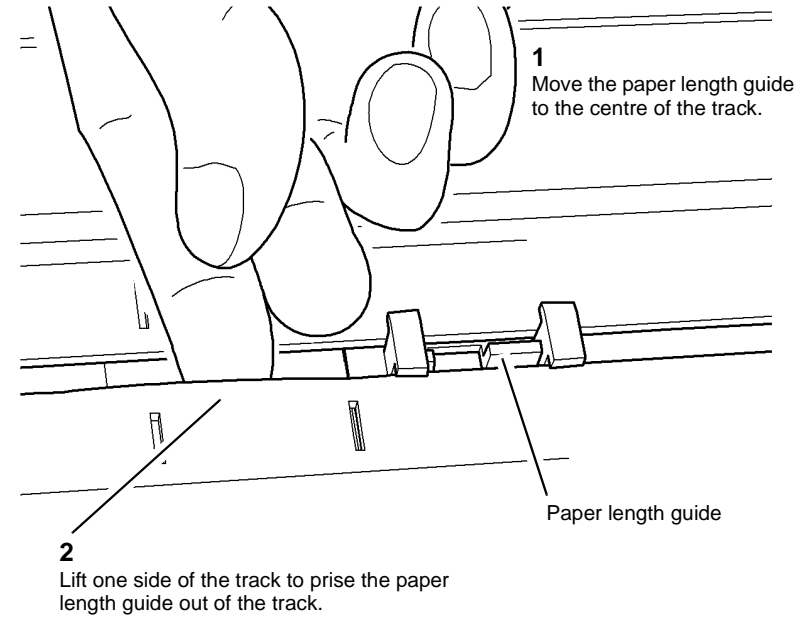
Figure 3 Paper length guide removal

5. Remove the paper length guide, [Figure 3](#).

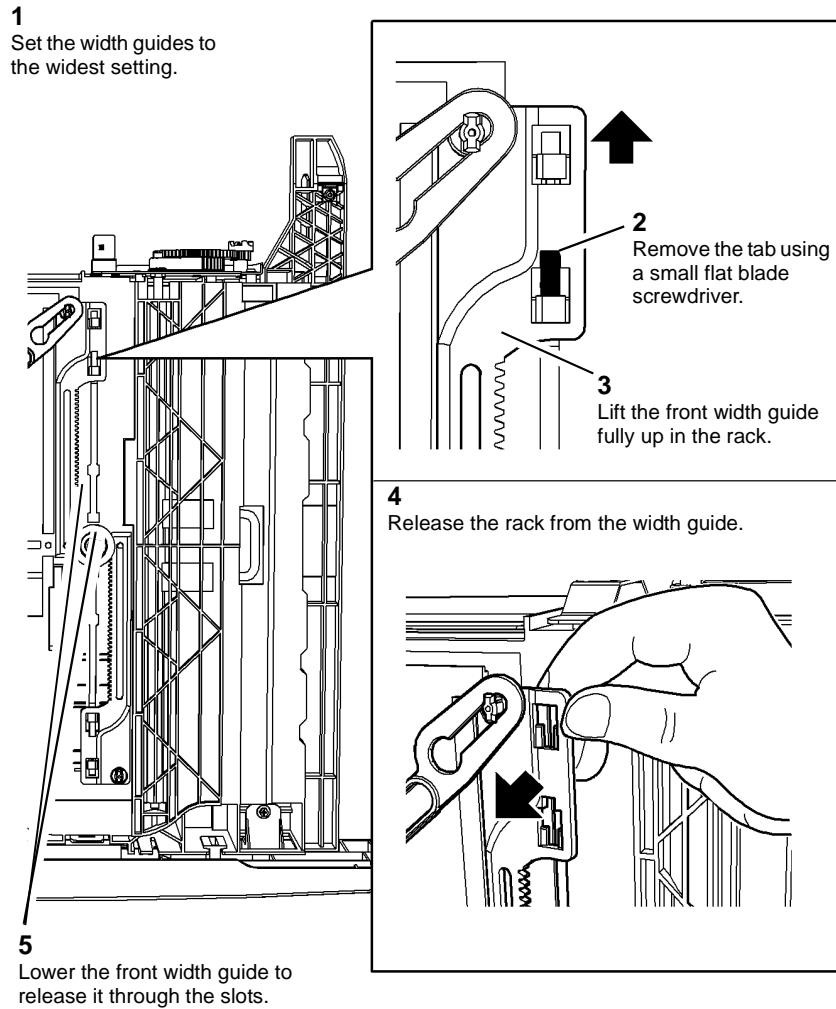
Figure 4 Front width guide removal

6. Remove the front paper width guide, [Figure 4](#).
