708P91139
February 2016

Xerox® WorkCentre® 5945 Family Multifunction Printer Service Manual

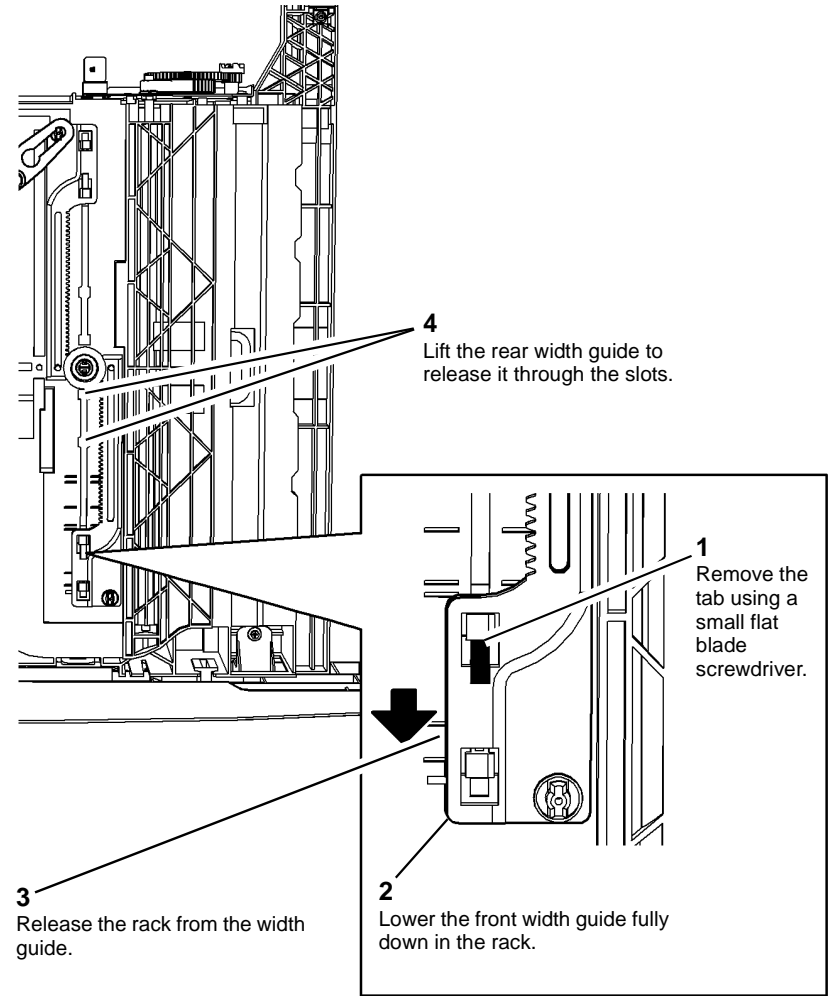
Figure 5 Rear width guide removal

7. Remove the rear paper width guide, [Figure 5](#).

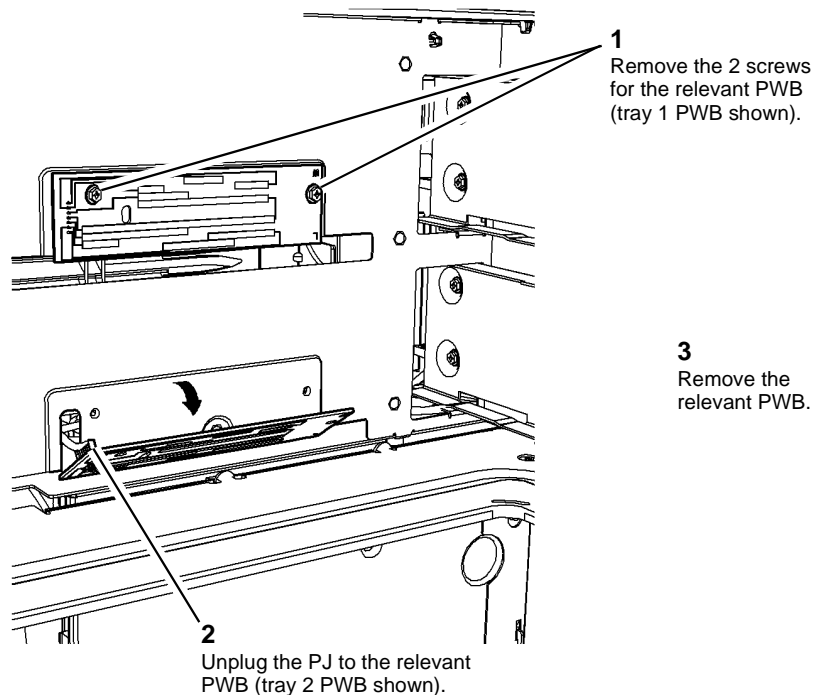
Figure 1 PWB removal

1. Remove tray 1 and tray 2, [REP 70.1](#).
2. Remove the relevant tray size sensing PWB, [Figure 1](#).

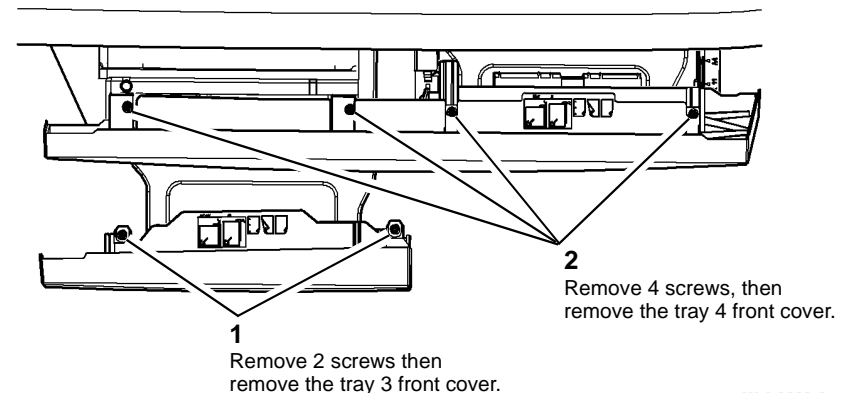
Figure 1 Tray front covers removal

1. Remove the paper from tray 3.
2. Remove the tray 3 and tray 4 front covers, [Figure 1](#).

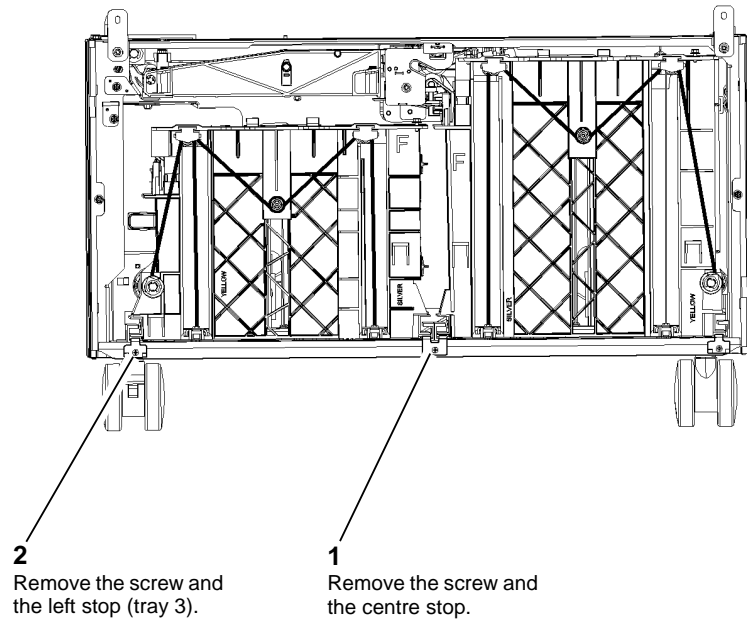
Figure 2 Tray 3 rail stops

3. Remove the stops, [Figure 2](#).

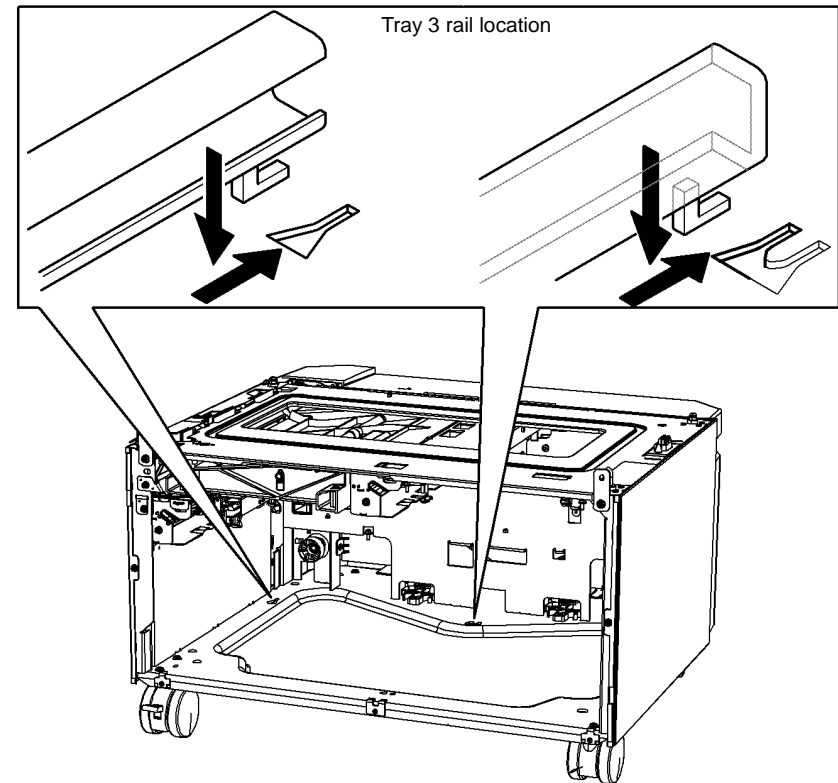
Figure 3 Location of the tray rails

NOTE: When installing tray 3 ensure that the tray rails are located correctly in the base of the machine, [Figure 3](#).

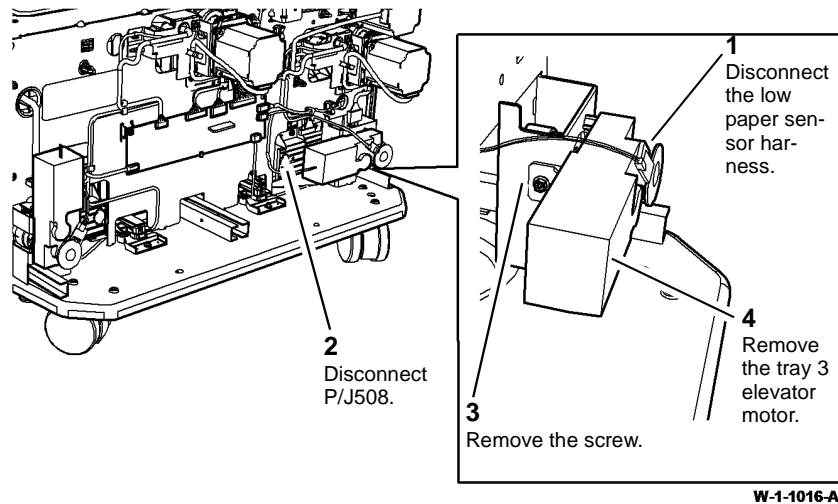
Figure 1 Elevator motor removal

1. Pull out tray 3.
2. Remove the lower rear cover, [PL 70.26 Item 1](#).
3. Remove the tray 3 elevator motor, [Figure 1](#).

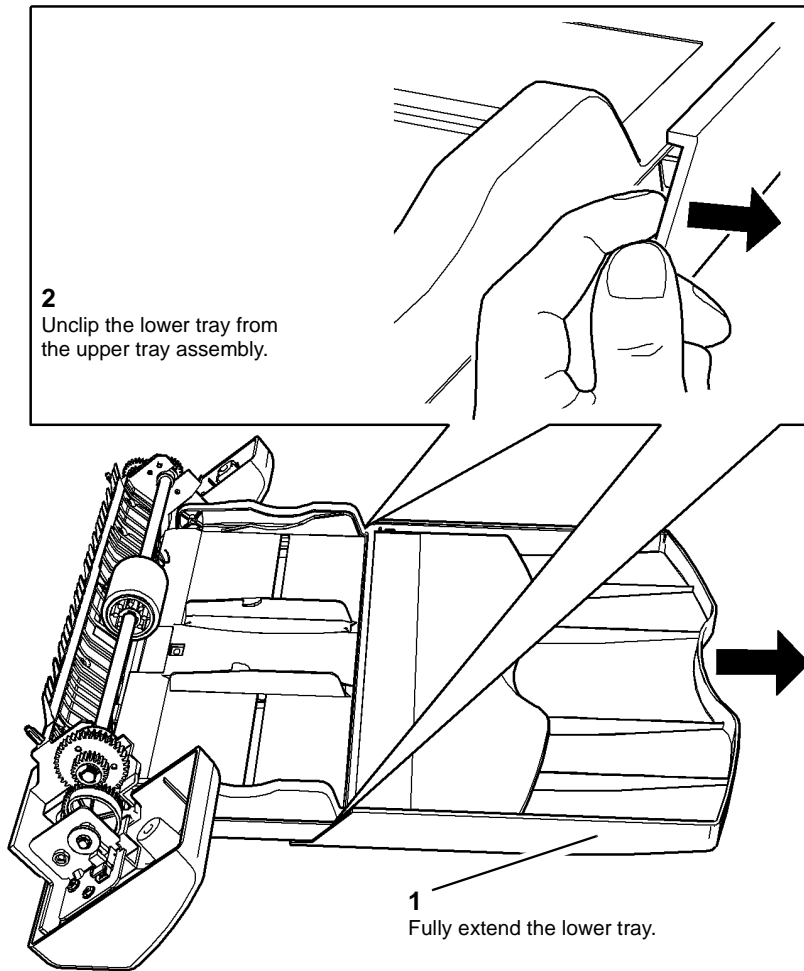
Figure 1 Lower tray removal

1. Remove the bypass tray, [REP 70.2](#).
2. Remove the lower tray, [Figure 1](#).

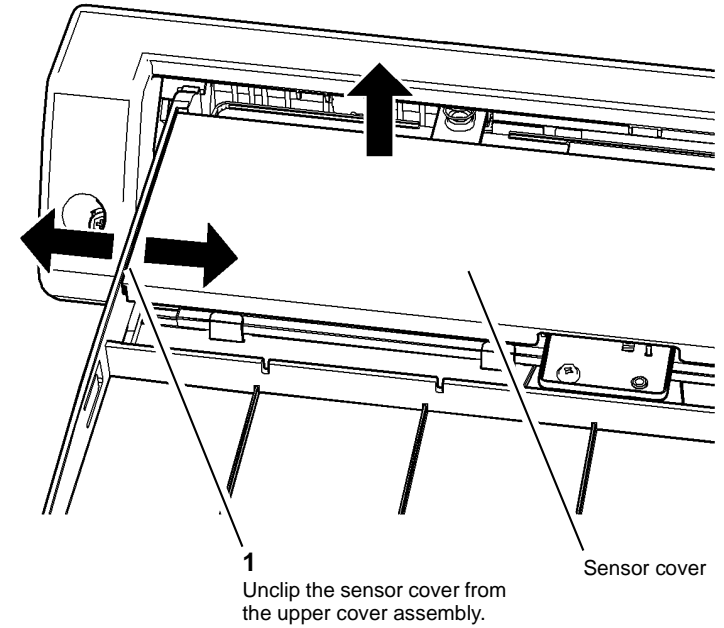
Figure 2 Width sensor cover removal

3. Remove the width sensor cover, [Figure 2](#).

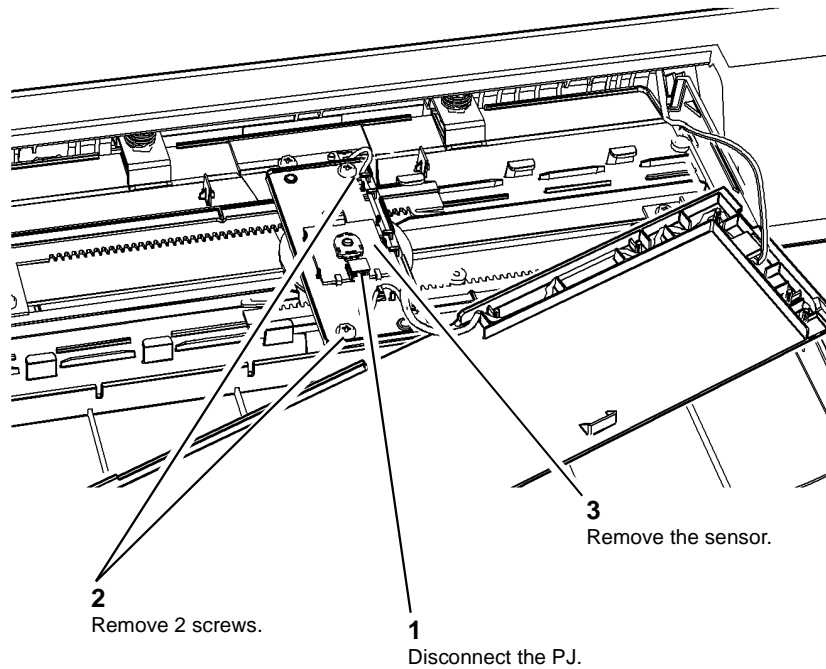
Figure 3 Width sensor removal

4. Remove the width sensor, [Figure 3](#).

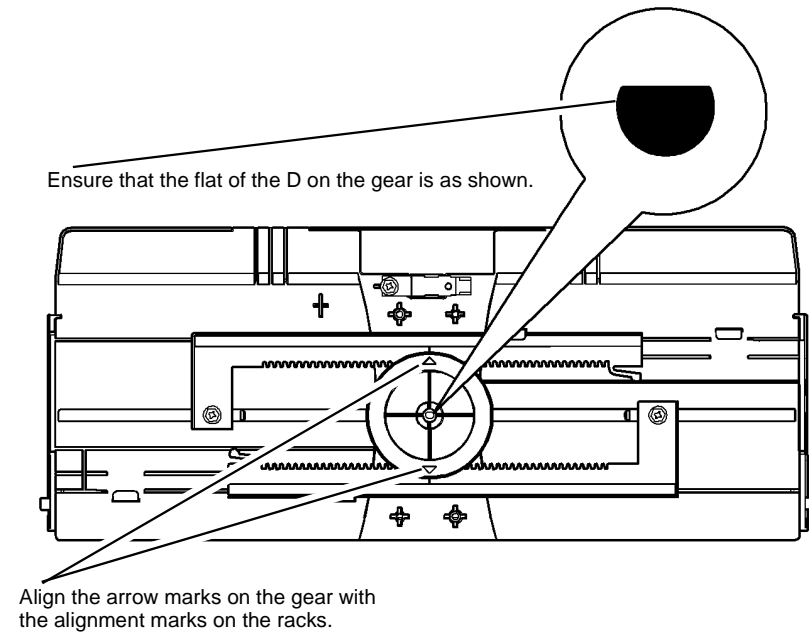
Figure 4 Correct alignment

1. The replacement is the reverse of the removal procedure. Refer to [GP 6](#) when refitting the screws securing the sensor.
2. Ensure the potentiometer and gear are correctly aligned with the racks on the size guides, [Figure 4](#).

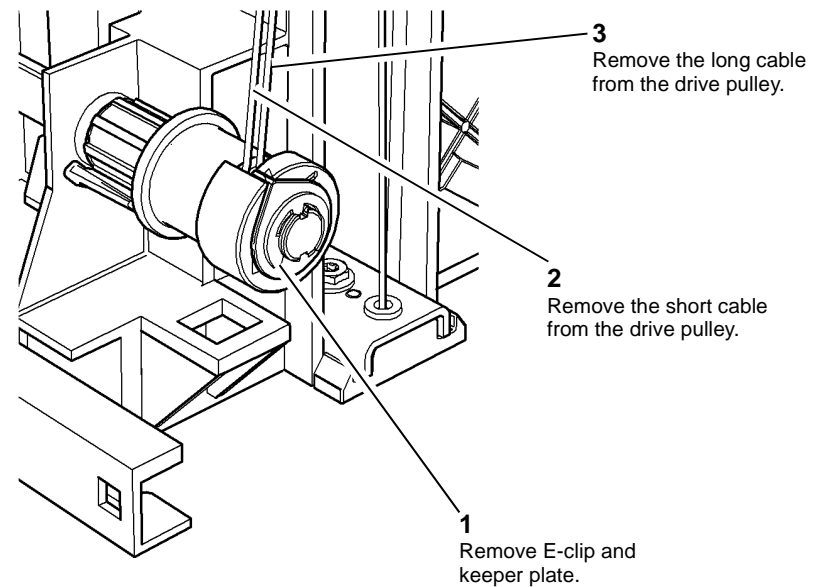
Figure 1 Front cables release

2. Release the cables from the appropriate front drive pulley, [Figure 1](#).

This illustration shows tray 3 front.

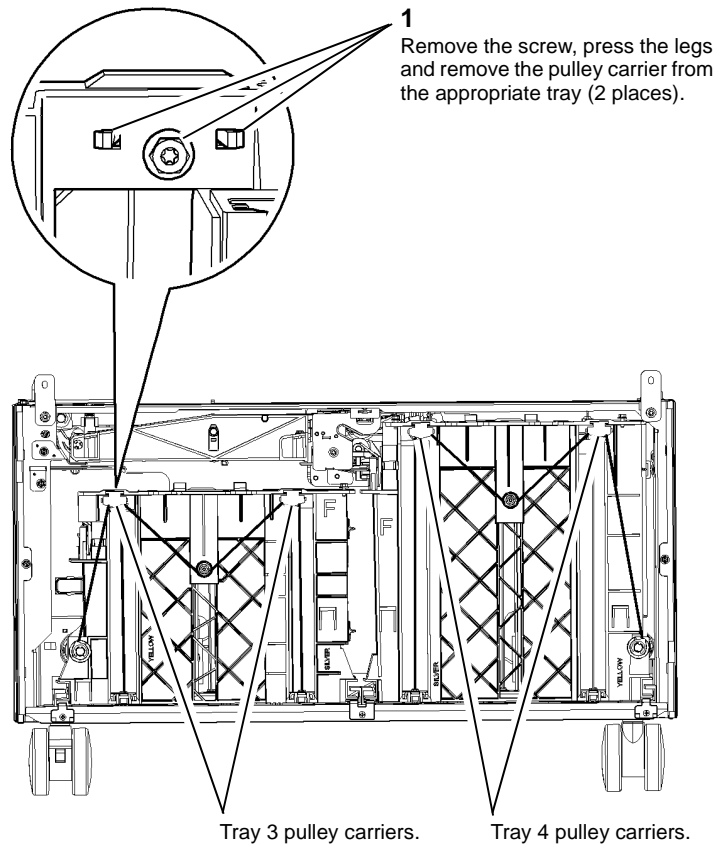
Figure 2 Front cables removal

- Remove the appropriate front elevator cables, [Figure 2](#).

NOTE: The short cable is located over the outer pulley and the long cable is located over the inner pulley.

1. The replacement is the reverse of the removal procedure.
2. For the tray 3 front cables:
 - a. Thread the long cable over the inner groove on the pulley.
 - b. Thread the short cable over the outer groove on the pulley.
3. For the tray 3 rear cable, thread the medium length cable over the outer groove on the pulley.
4. For the tray 4 front cables:
 - a. Thread the short cable over the inner groove on the pulley.
 - b. Thread the long cable over the outer groove on the pulley.
5. For the tray 4 rear cable, thread the medium length cable over the inner groove on the pulley.

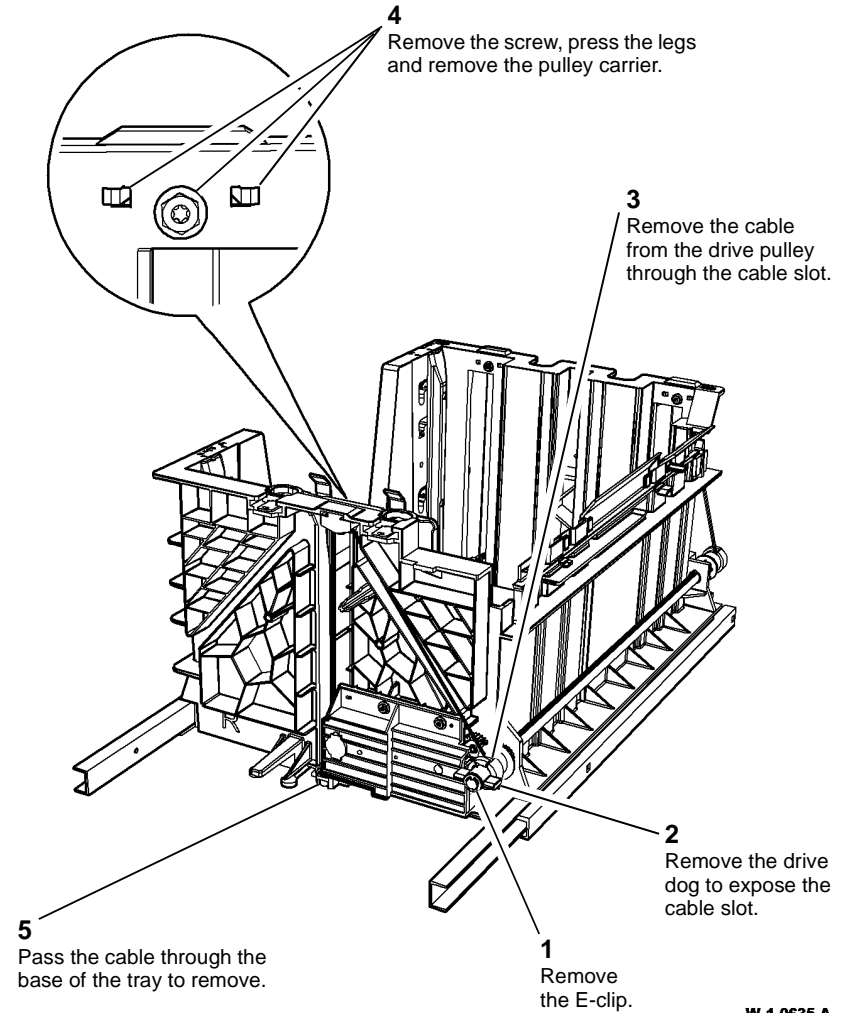
Figure 3 Tray 3 rear cable removal

- Release the appropriate rear paper tray guide, refer to [ADJ 70.1](#).
- Remove the appropriate rear elevator cable:
 - Tray 3, [Figure 3](#).
 - Tray 4, [Figure 4](#).

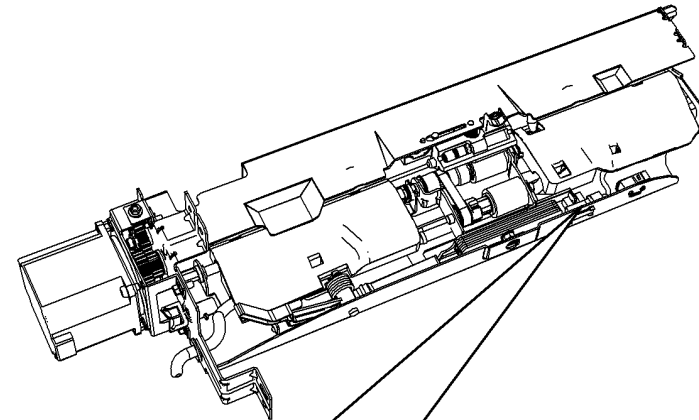
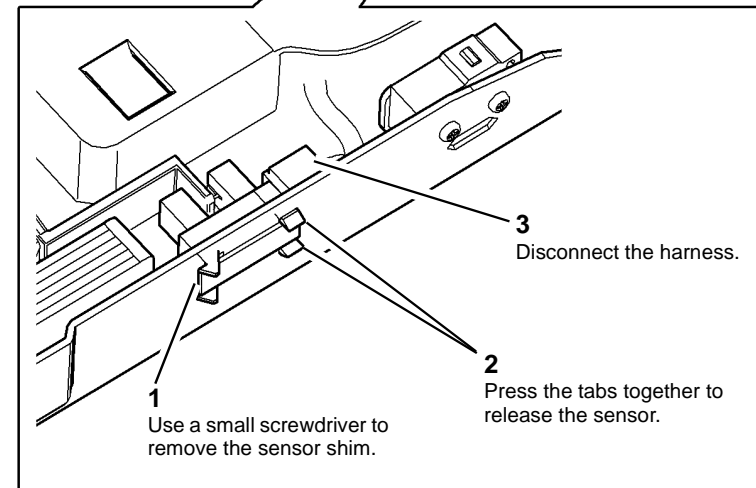
Figure 1 Stack height sensor removal

1. Remove the required paper feed assembly:
 - Tray 3 paper feed assembly, [REP 80.20](#).
 - Tray 4 paper feed assembly, [REP 80.21](#).
2. Remove the stack height sensor, [Figure 1](#).

The replacement is the reverse of the removal procedure. Install a new sensor shim to lock the sensor in place.

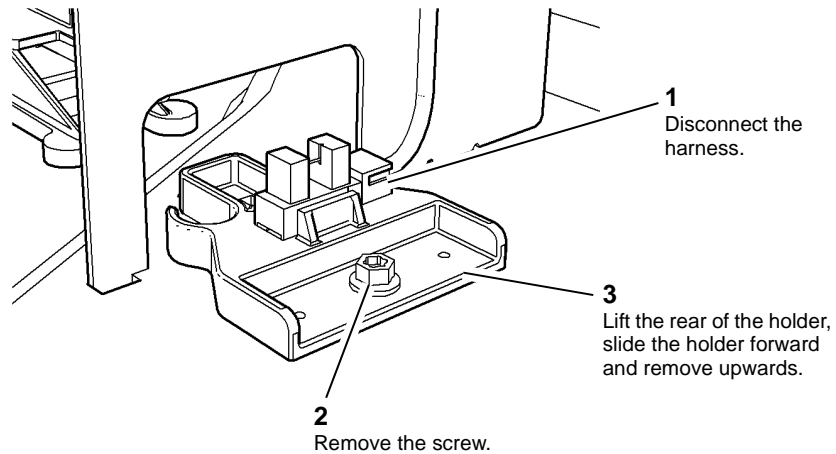
Figure 1 Tray home switch and holder

1. Pull out tray 3 or tray 4 by approximately 50mm (2 inches).
2. Remove the lower rear cover, [PL 70.26 Item 1](#).
3. If removing the tray 4 home sensor, remove the LVPS, [REP 1.1](#).
4. Remove the tray home sensor and holder, [Figure 1](#).

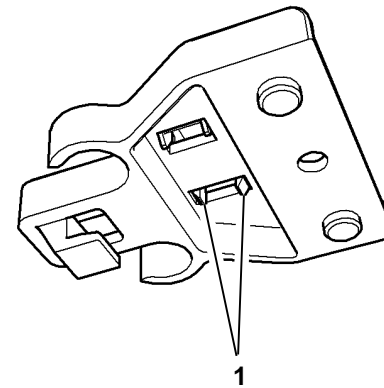
5. Remove the tray home sensor, [Figure 2](#).

1 Press the tabs to release the sensor.

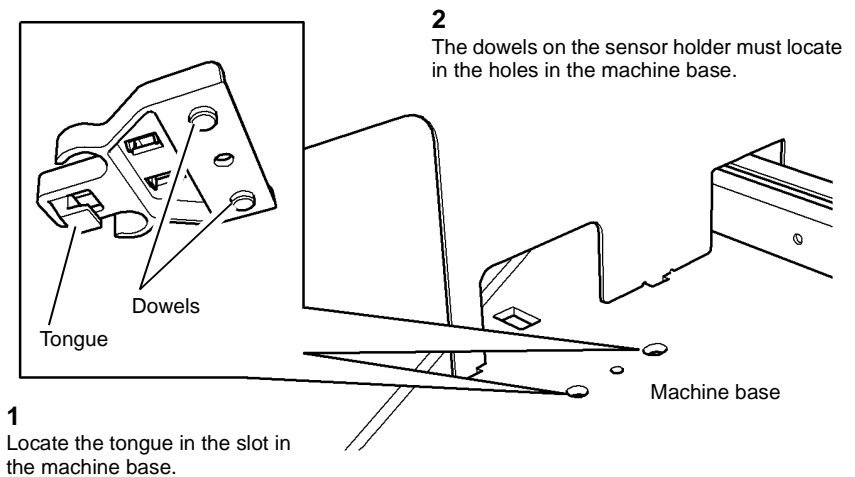
Figure 3 Holder location

Replacement is the reverse of the removal procedure. Correctly locate the sensor holder, [Figure 3](#).

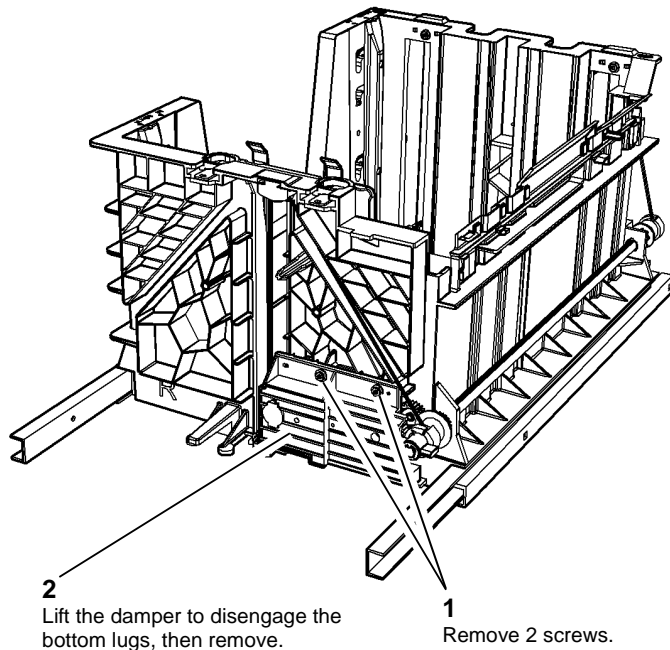
Figure 1 Tray 3 damper removal

1. Remove the required paper tray:
 - Tray 3, [REP 70.5](#).
 - Tray 4, [REP 70.14](#).
2. Remove the damper from tray 3, [Figure 1](#).

2 Lift the damper to disengage the bottom lugs, then remove.

1 Remove 2 screws.

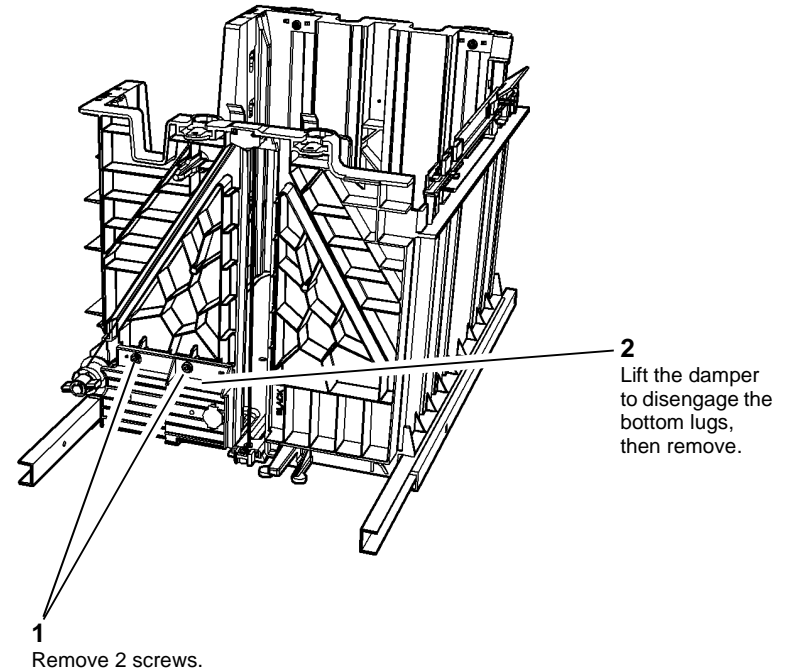
3. Remove the damper from tray 4, [Figure 2](#).

1 Remove 2 screws.

2 Lift the damper to disengage the bottom lugs, then remove.

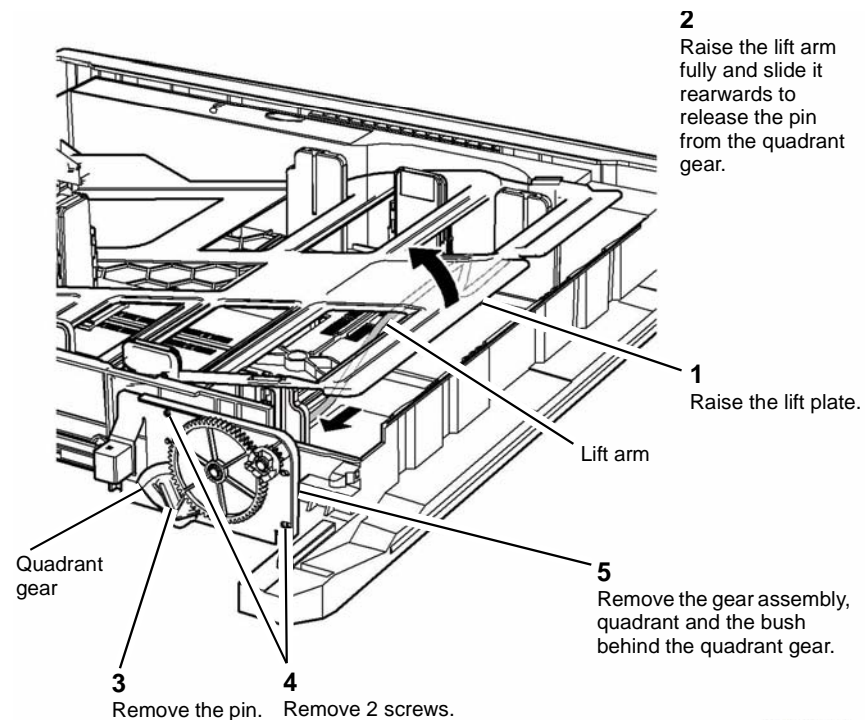
Figure 1 Lift gear removal

NOTE: Make a note of the position of the 2 screws on the gear assembly, for replacement purposes.

2. Remove the lift gear assembly, [Figure 1](#).

1. Engage the lift gear assembly with the spigots on the rear of the tray. The remainder of the replacement procedure is the reverse of the removal procedure.

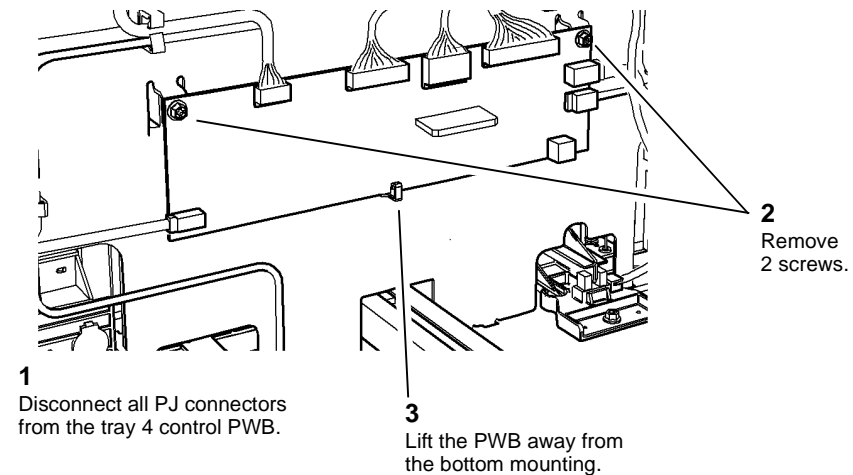
Figure 1 HCF control PWB removal

1. Remove the lower rear cover, [PL 70.26](#) Item 1.
2. Remove the LVPS, [REP 1.1](#).
3. Remove the tray 4 control PWB, [Figure 1](#).

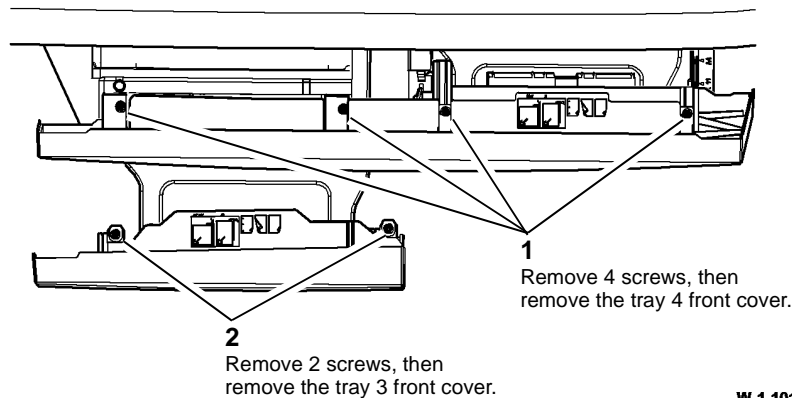
Figure 1 Front covers removal

1. Remove the paper from the tray.
2. Remove the tray 3 and tray 4 front covers, [Figure 1](#).

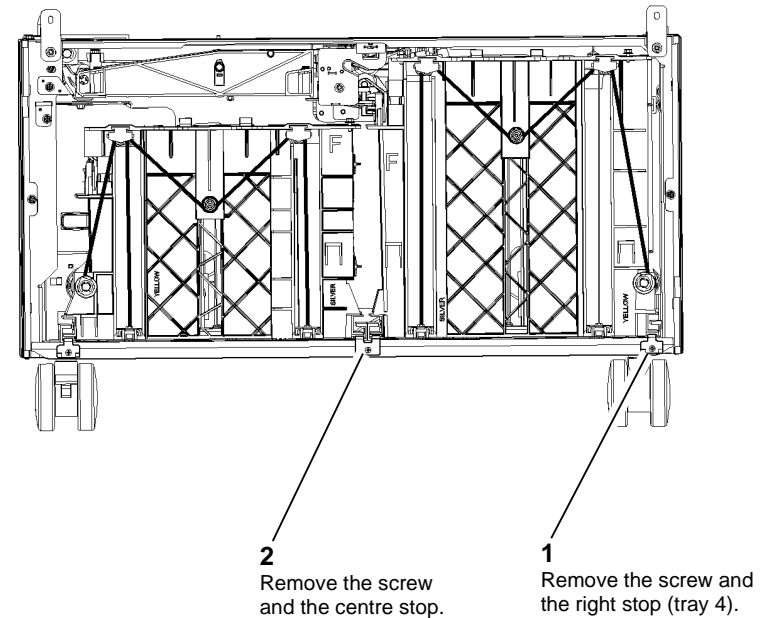
Figure 2 Tray 4 rail stops

3. Remove the stops, [Figure 2](#).

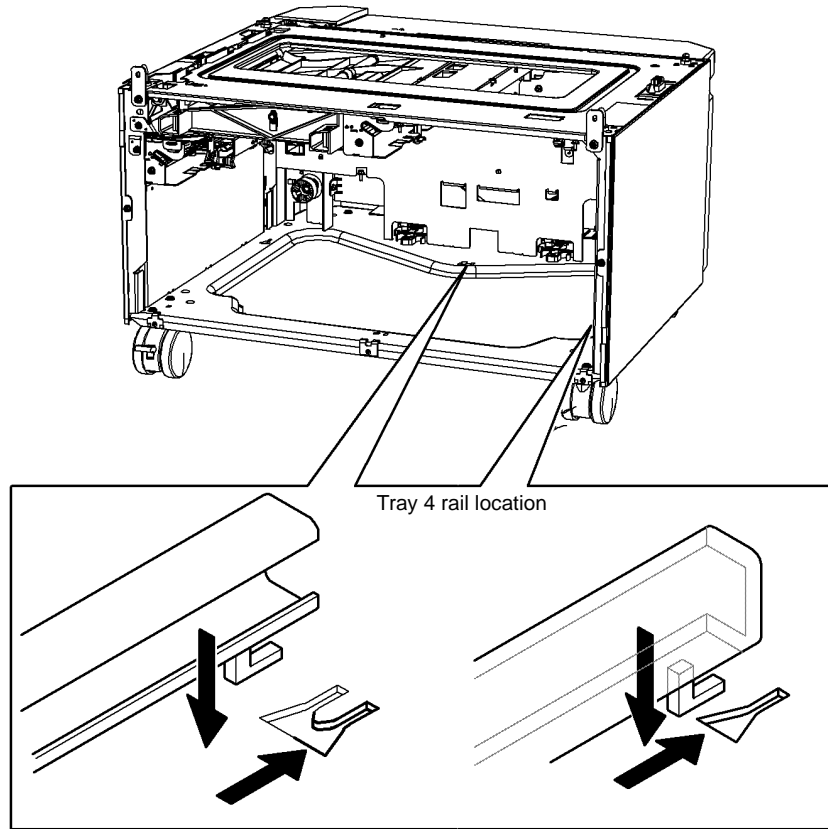
Figure 3 Location of the tray rails

NOTE: When installing tray 4 ensure that the tray rails are located correctly in the base of the machine, [Figure 3](#).

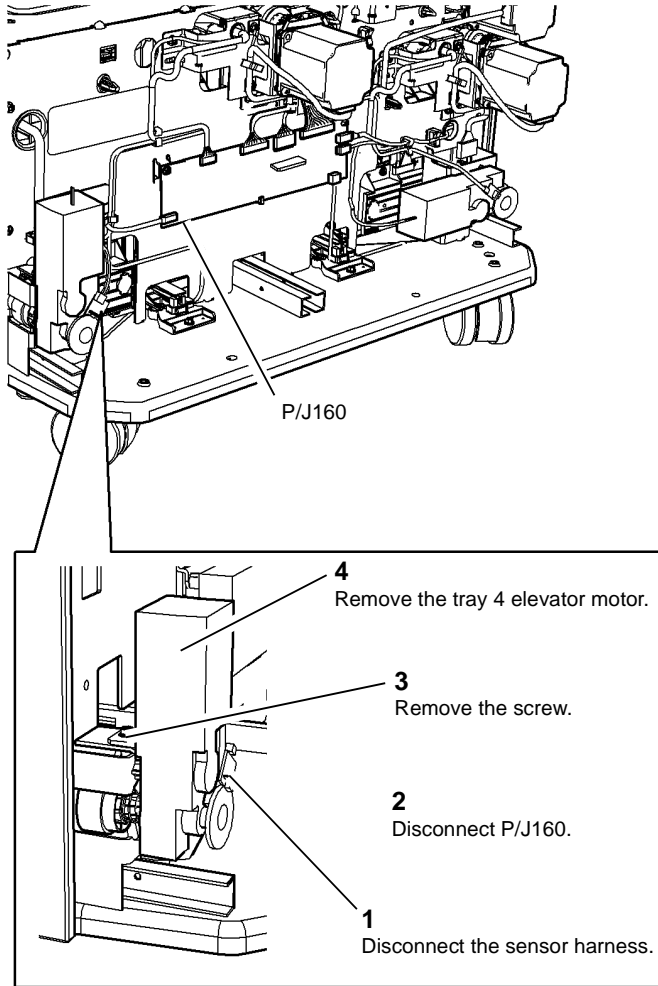
Figure 1 Elevator motor removal

- Remove the tray 4 elevator motor, [Figure 1](#).

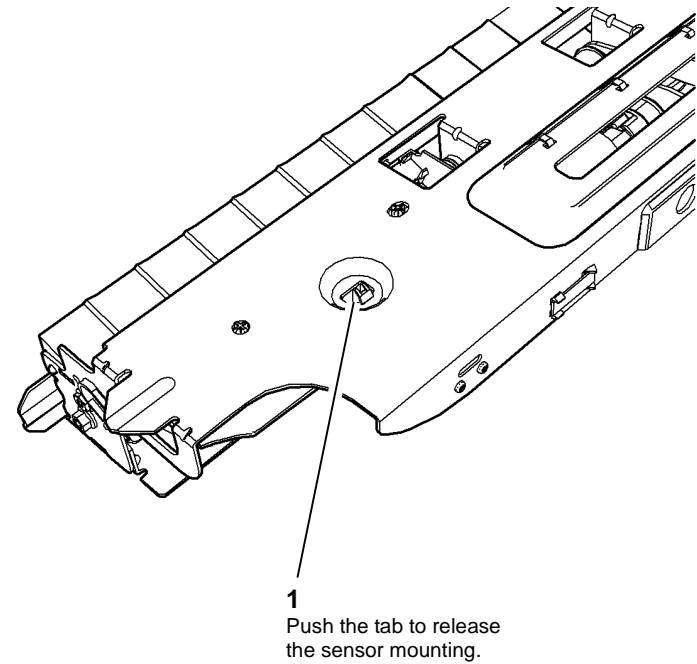
Figure 1 Sensor mounting release

- Remove the tray 3 paper feed assembly, [REP 80.20](#).
- Release the sensor mounting, [Figure 1](#).

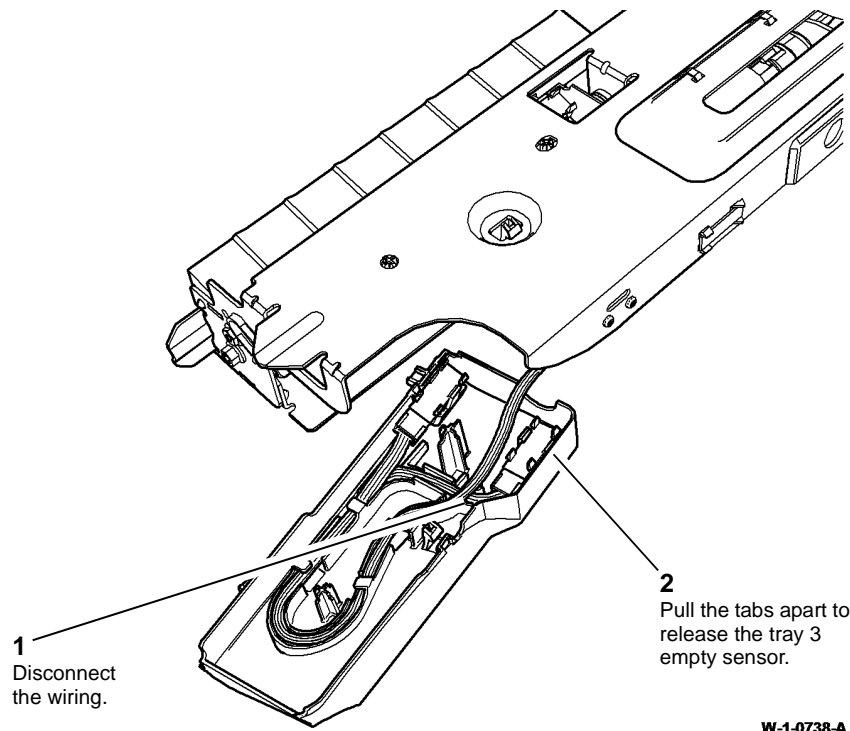
3. Remove the tray 3 empty sensor, [Figure 2](#).

1
Disconnect
the wiring.

2
Pull the tabs apart to
release the tray 3
empty sensor.

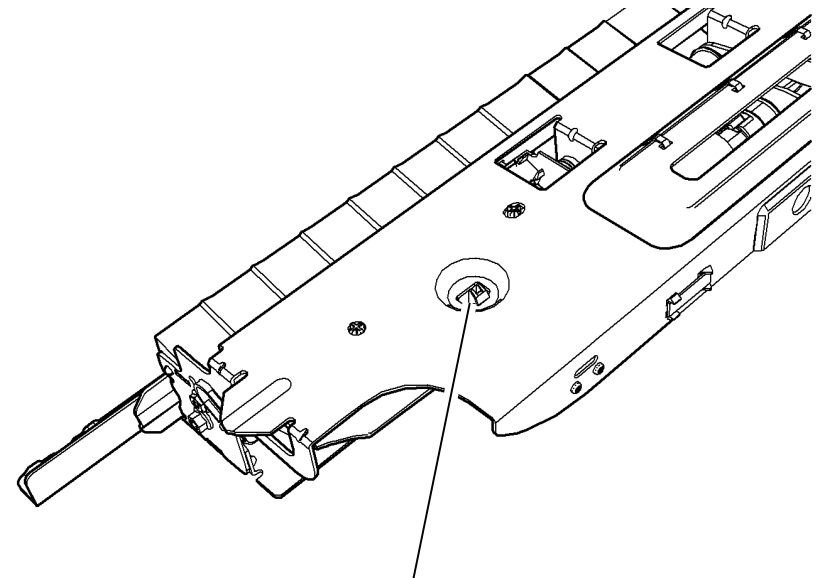
Figure 1 Sensor mounting release

1. Remove the tray 4 paper feed assembly, [REP 80.21](#).
2. Release the sensor mounting, [Figure 1](#).

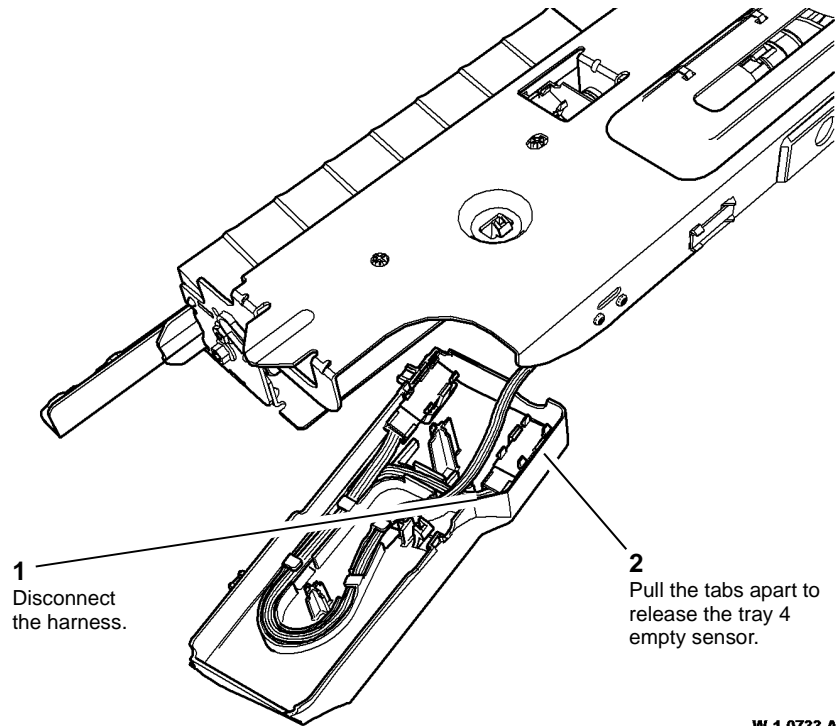
Figure 2 Sensor removal

3. Remove the tray 4 empty sensor, [Figure 2](#).

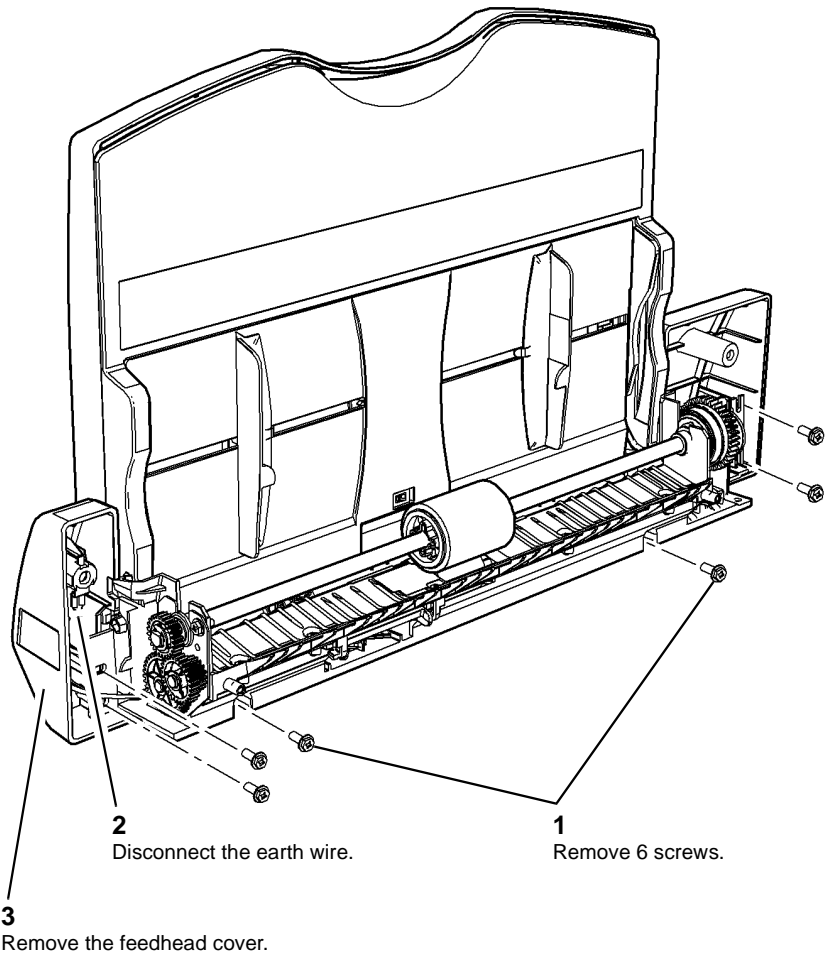
Figure 1 Cover removal

2. Remove the feedhead cover, [Figure 1](#).

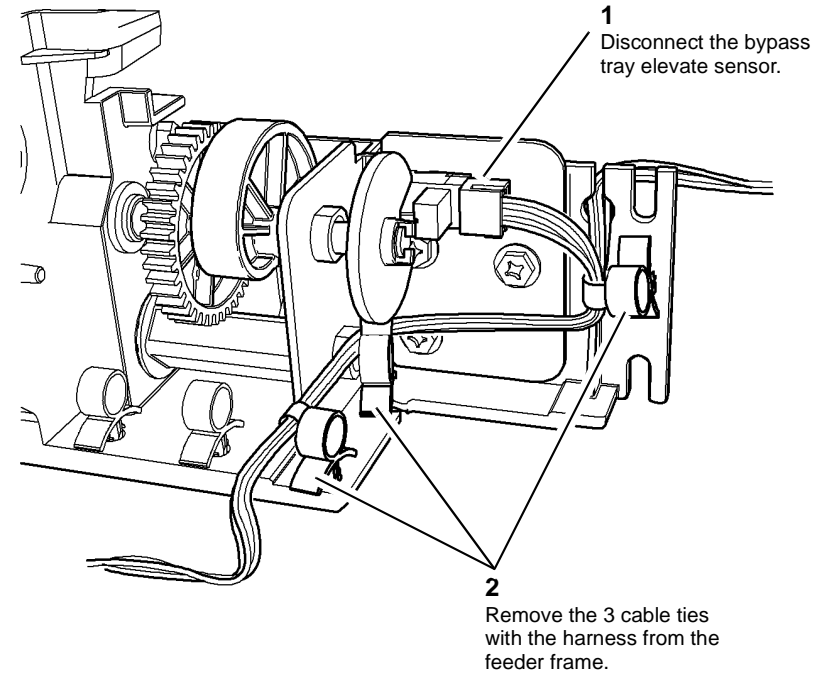
W-1-1420-A

- Release the bypass tray harness, [Figure 2](#).

Figure 2 Sensor and cable ties

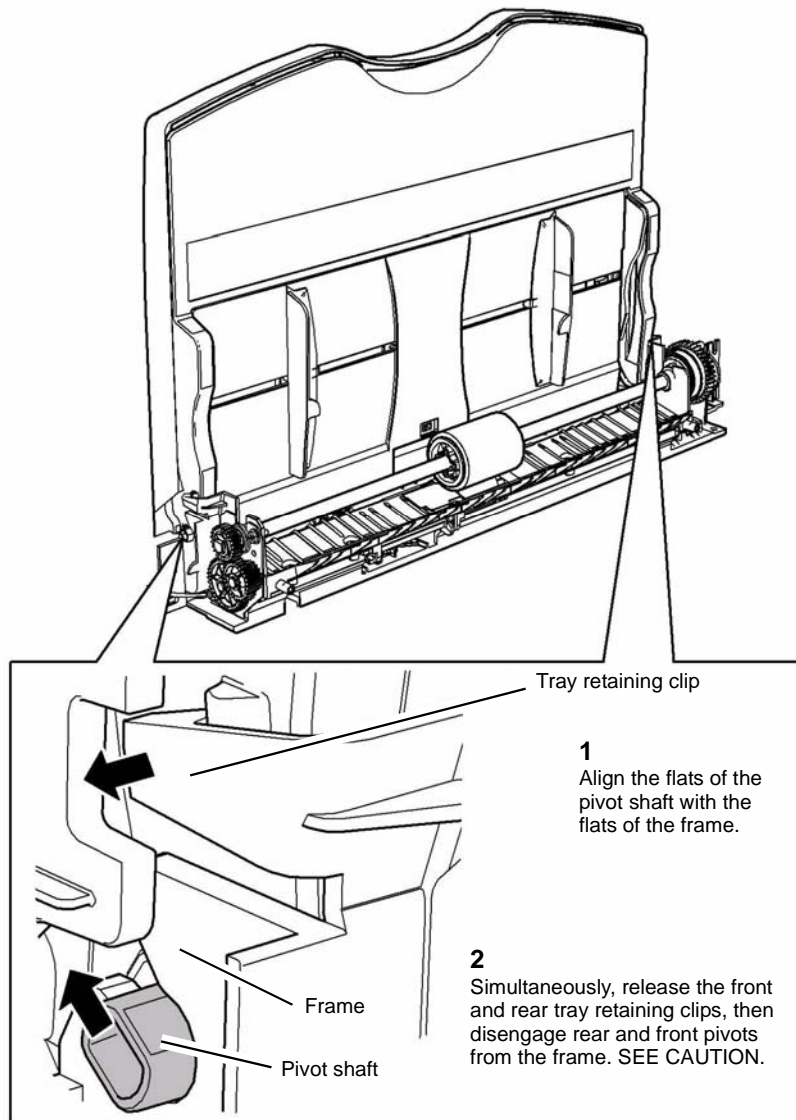
W-1-1428-A

4. Release the tray assembly, [Figure 3](#).

Figure 3 Tray assembly release

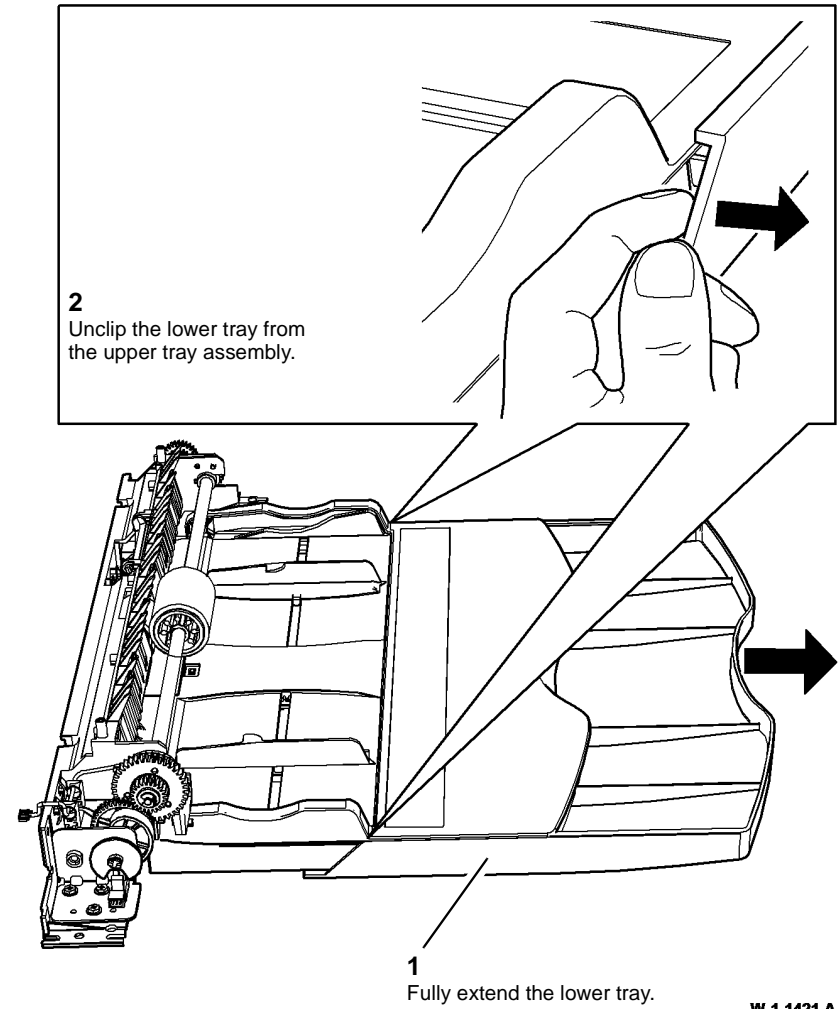
W-1-1421-A

5. Remove the lower tray, [Figure 4](#).

Figure 4 Lower tray removal

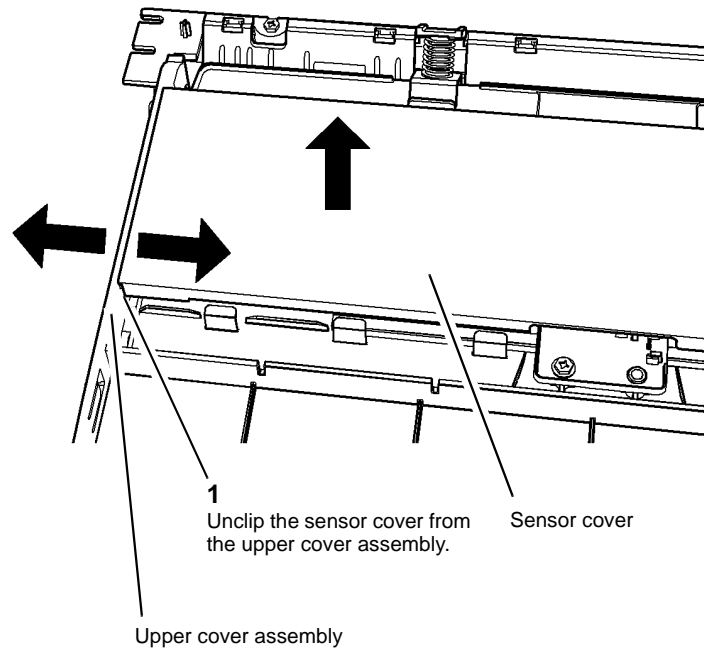
W-1-1422-A

6. Release the sensor cover, [Figure 5](#).

Figure 5 Unclip the sensor cover

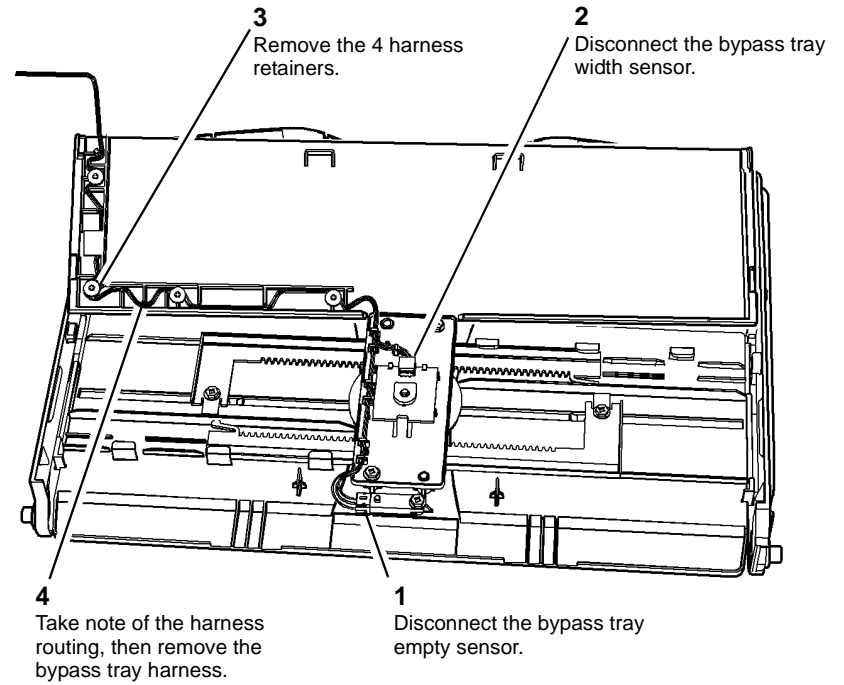
W-1-1419-A

7. Disconnect the sensors and release the bypass tray harness, [Figure 6](#).

Figure 6 Harness routing

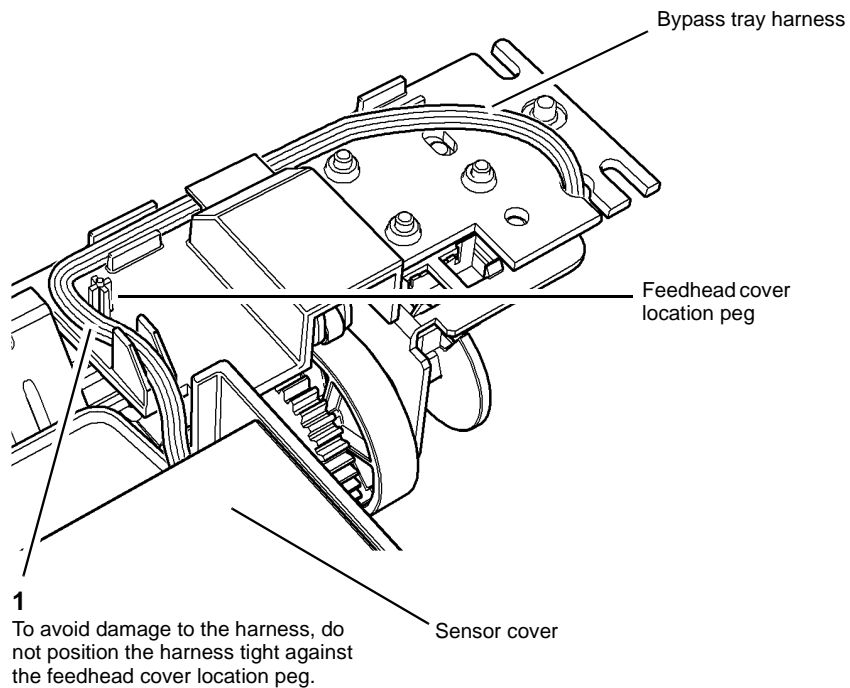
W-1-1418-A

- Ensure the bypass tray harness does not get crushed when the feedhead cover is positioned on the location peg, [Figure 7](#).

Figure 7 Harness routing on the feeder frame

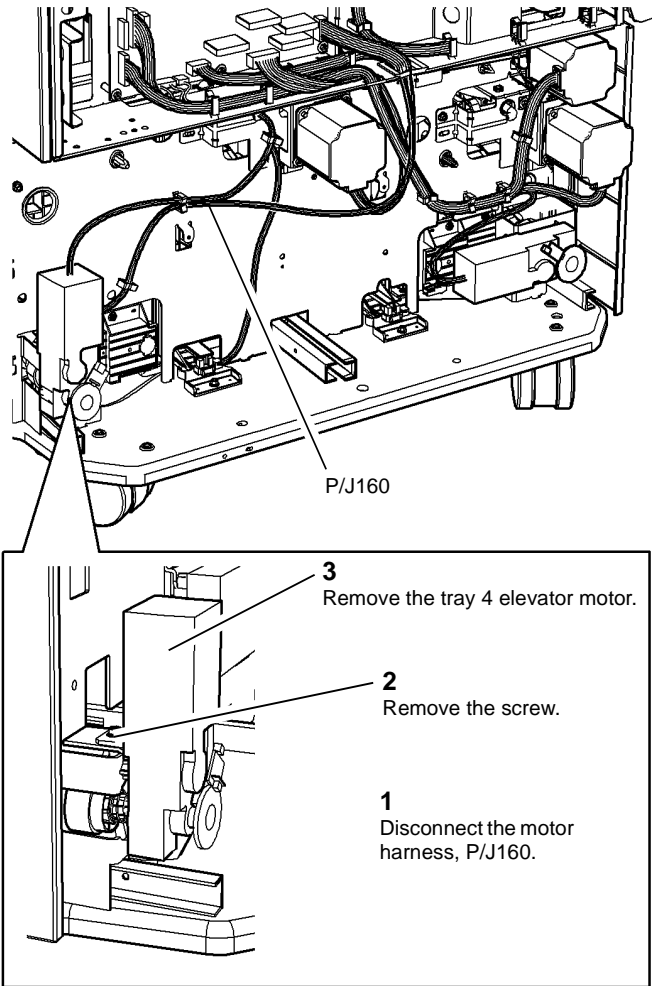
W-1-1431-A

1. Pull out tray 4.
2. Remove the lower rear cover, [PL 70.26 Item 1](#).
3. Remove the LVPS, [REP 1.1](#).
4. Remove the tray 4 elevator motor, [Figure 1](#).

Figure 1 Elevator motor removal

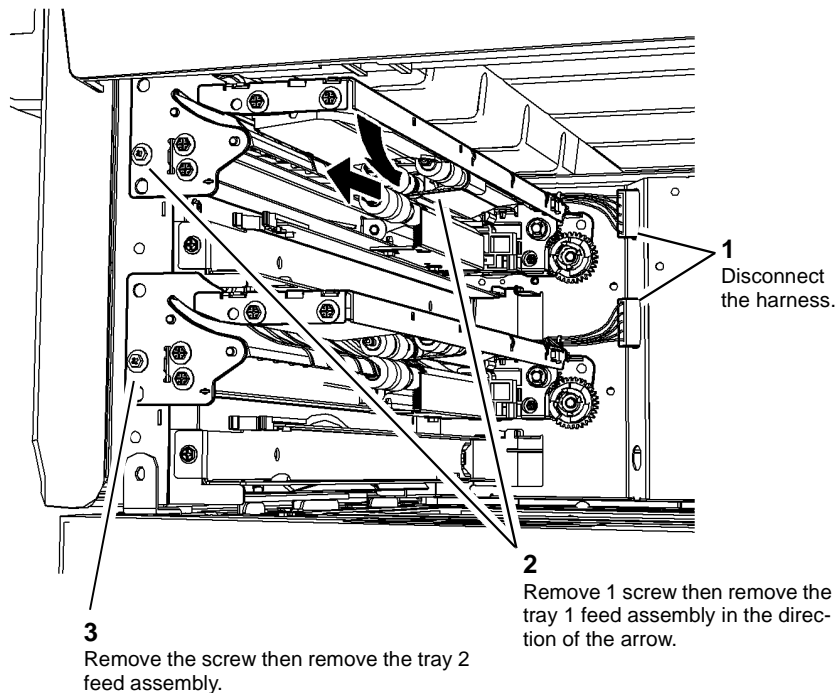
W-1-0643-A

1. Remove tray 1 or tray 2 as required, [REP 70.1](#).
2. Remove the tray 1 or tray 2 feed assembly, [Figure 1](#).

Figure 1 Paper feed assembly removal
