708P91139
February 2016

Xerox® WorkCentre® 5945 Family Multifunction Printer Service Manual

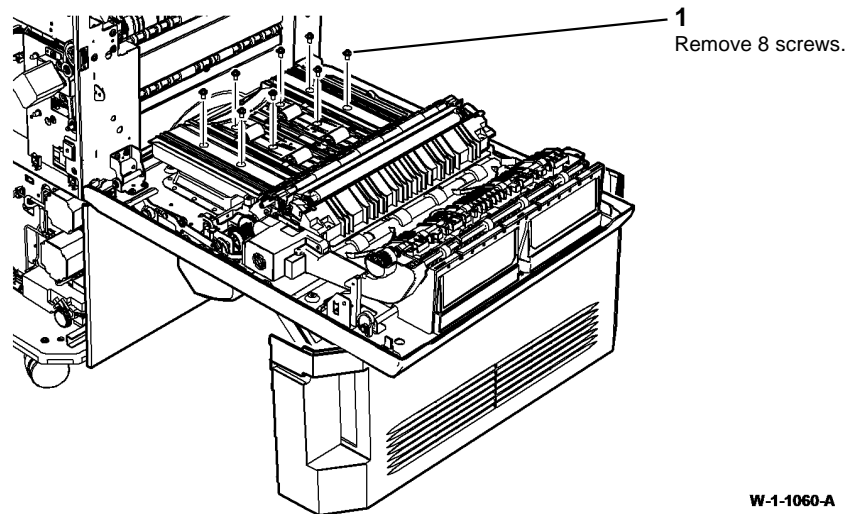
W-1-1060-A

1. Open the left door into the service position, [GP 37](#).
2. Prepare to remove the lower left door paper guide, [Figure 1](#).

Figure 1 Preparation

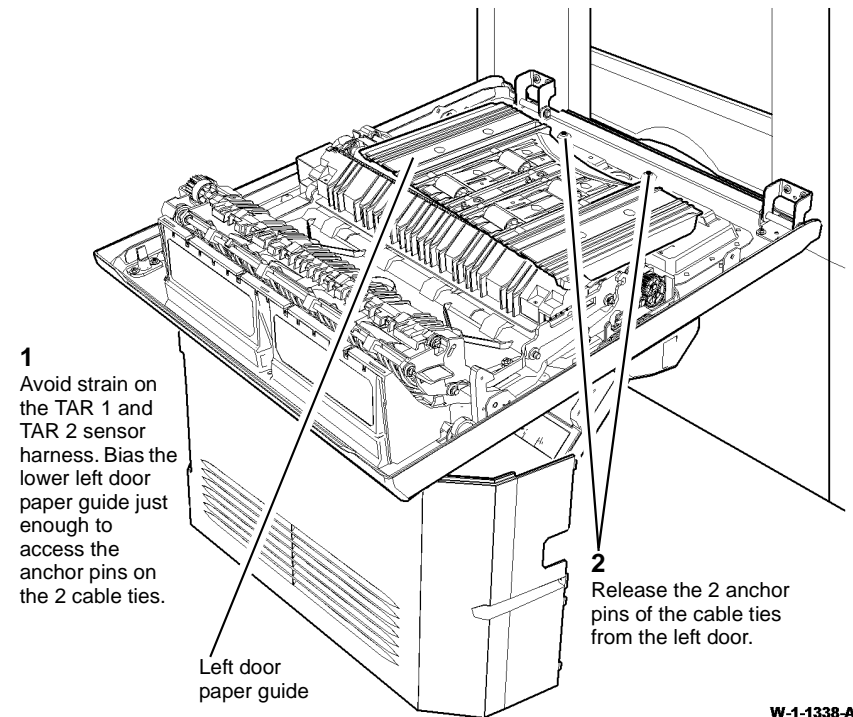
W-1-1338-A

3. Release the TAR 1 and TAR 2 sensor harness cable ties (2 places) [Figure 2](#).

Figure 2 TAR 1 and TAR 2 sensor harness fixings

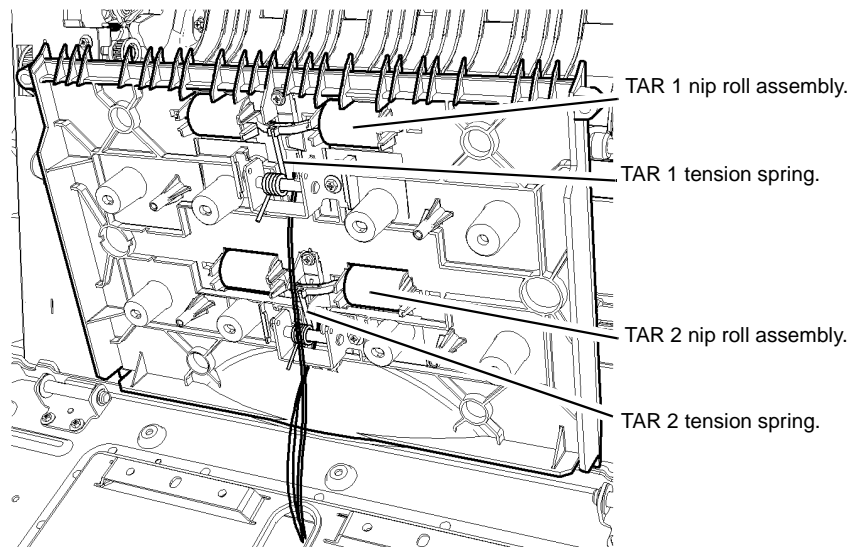
W-1-1339-A

4. Prepare to disconnect the TAR 1 or TAR 2 sensors, [Figure 3](#).

- 1 Release the appropriate tension spring.
- 2 Remove the appropriate nip roll assembly.

Figure 3 Lower left door nip rolls

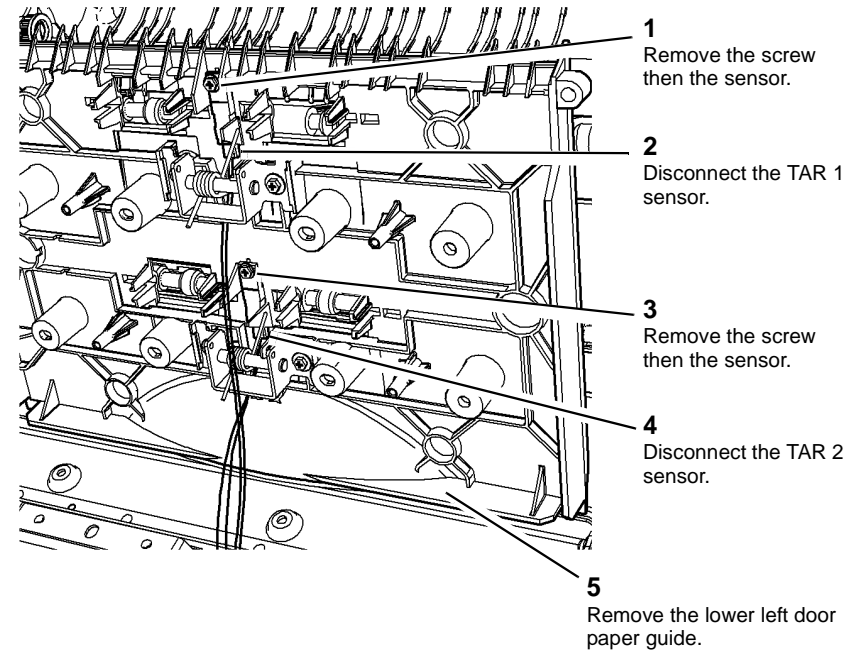
W-1-1061-A

5. Remove the lower left door paper guide, [Figure 4](#).

Figure 4 Sensor and guide removal

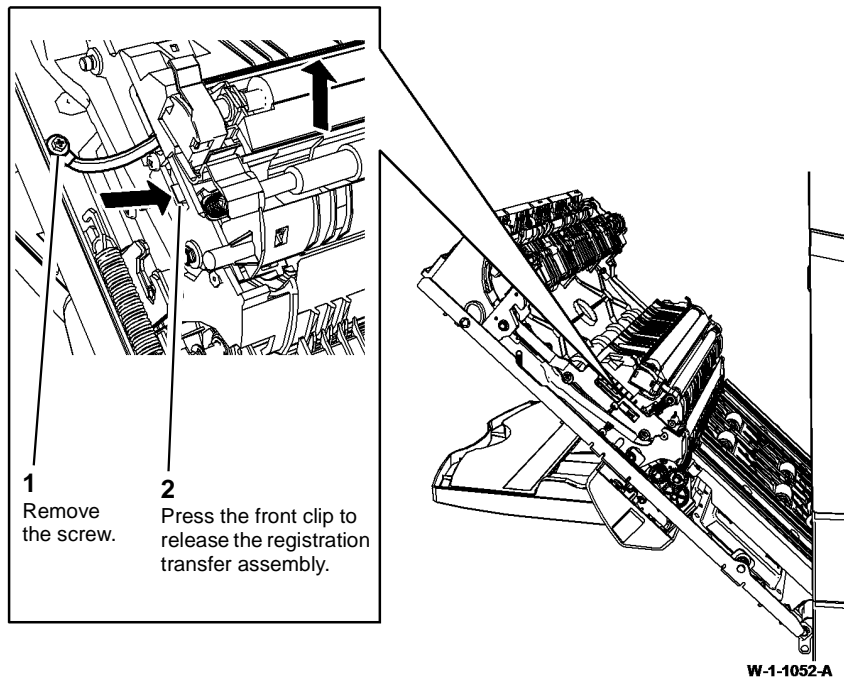
1. Open the left door, [PL 80.10 Item 1](#).
2. Remove the print cartridge, [PL 90.17 Item 9](#), then place in a black bag.
3. Remove the registration transfer assembly, [Figure 1](#).

Figure 1 Registration transfer assembly removal

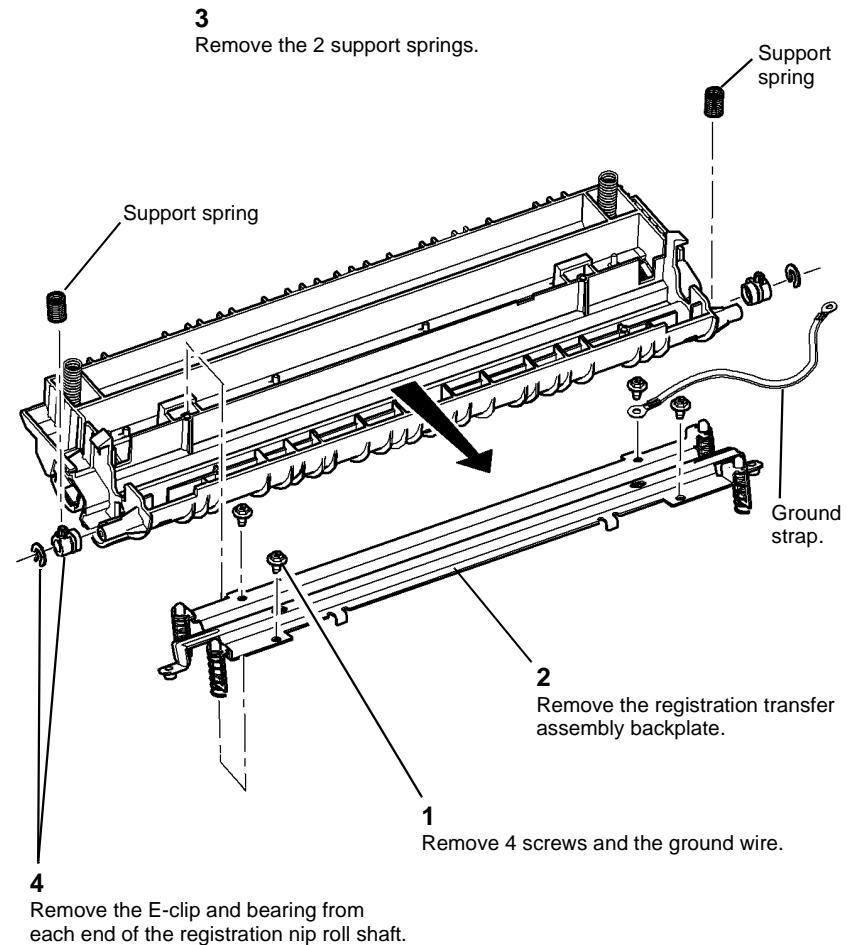
4. Prepare to remove the registration nip roll, [Figure 2](#).

Figure 2 Registration backplate assembly

1. Replacement is the reverse of the removal procedure. Refer to [GP 6](#) before refitting the screws.
2. Ensure the ground strap is installed, [Figure 2](#).
3. Perform the [dC604](#) Registration Setup procedure.

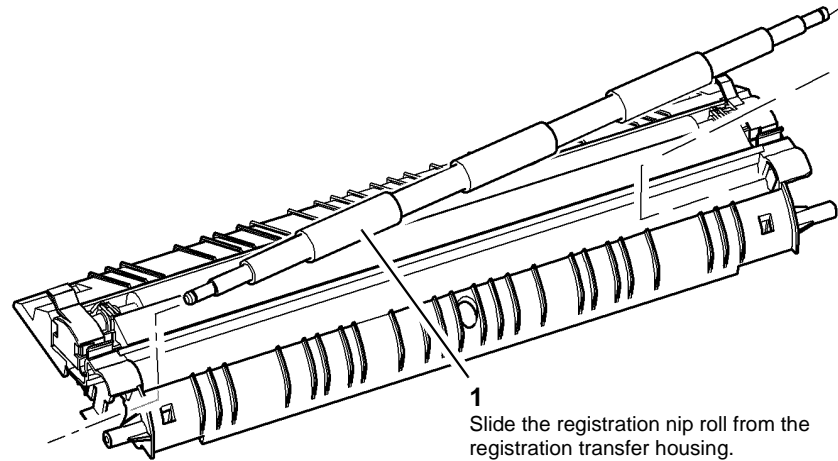
W-1-1054-A

5. Remove the registration nip roll, [Figure 3](#).

Figure 3 Registration nip roll removal

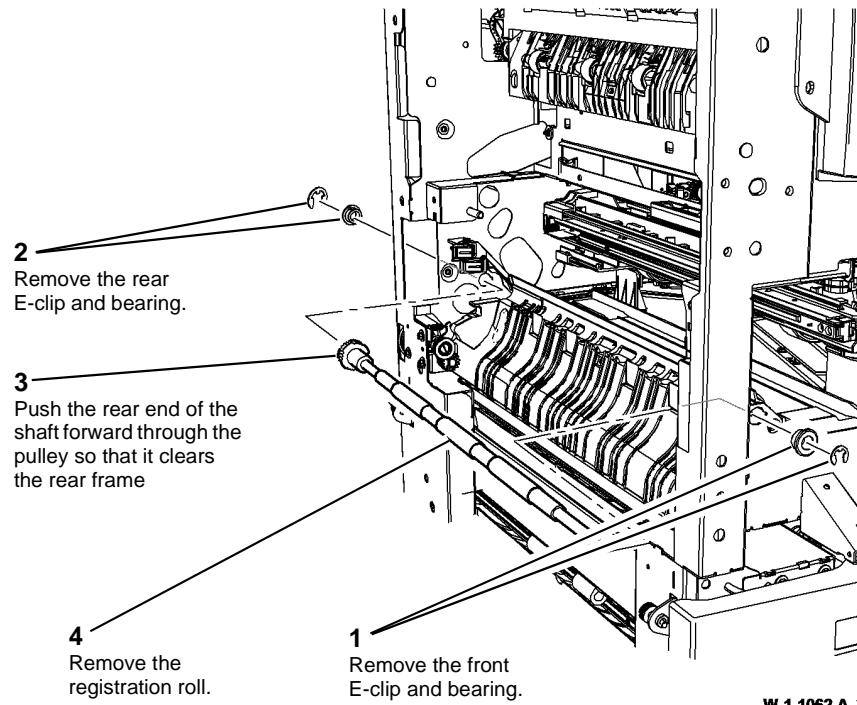
7. Remove the registration roll, [Figure 1](#).

Figure 1 Registration roll removal

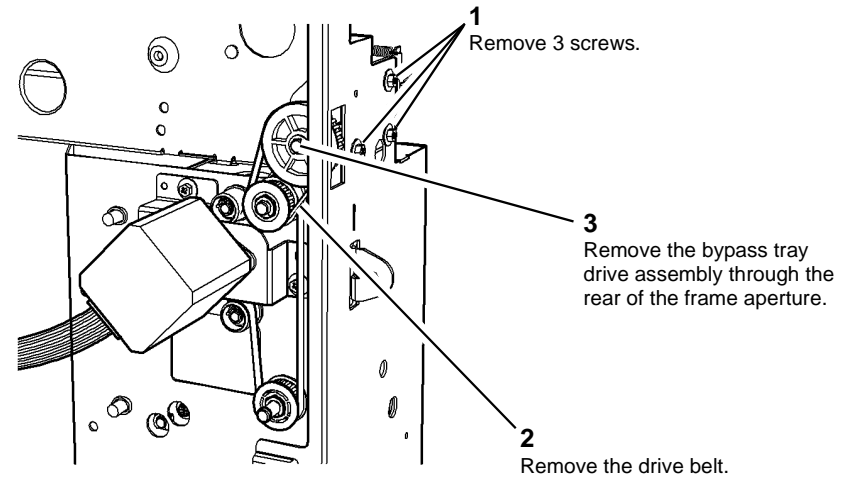
8. Remove the bypass tray drive assembly, [Figure 2](#).

Figure 2 Bypass tray drive assembly removal

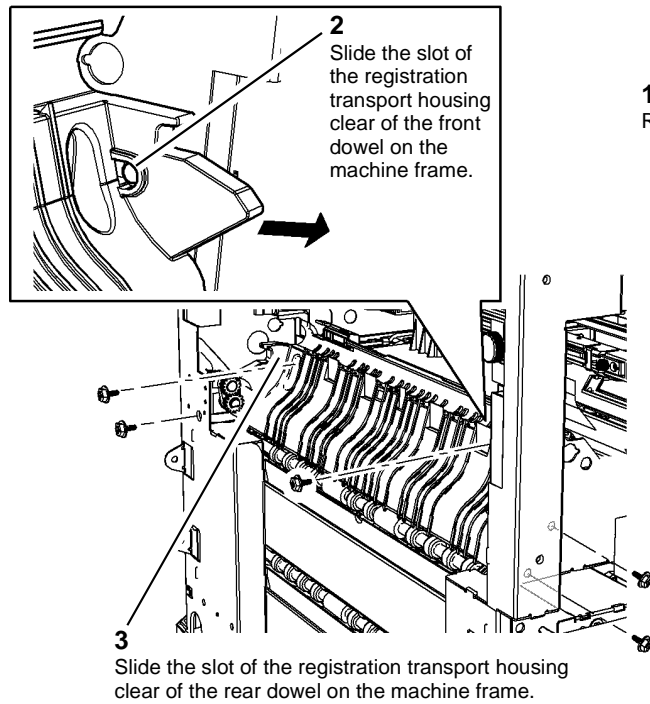
W-1-1064-A

9. Prepare to remove the registration transport housing, [Figure 3](#).

Figure 3 Preparation

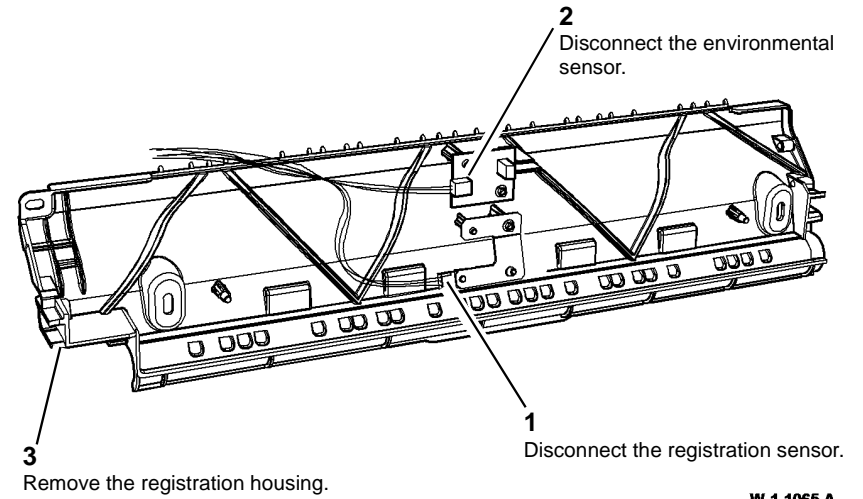
W-1-1065-A

10. Remove the registration transport housing, [Figure 4](#).

Figure 4 Housing removal

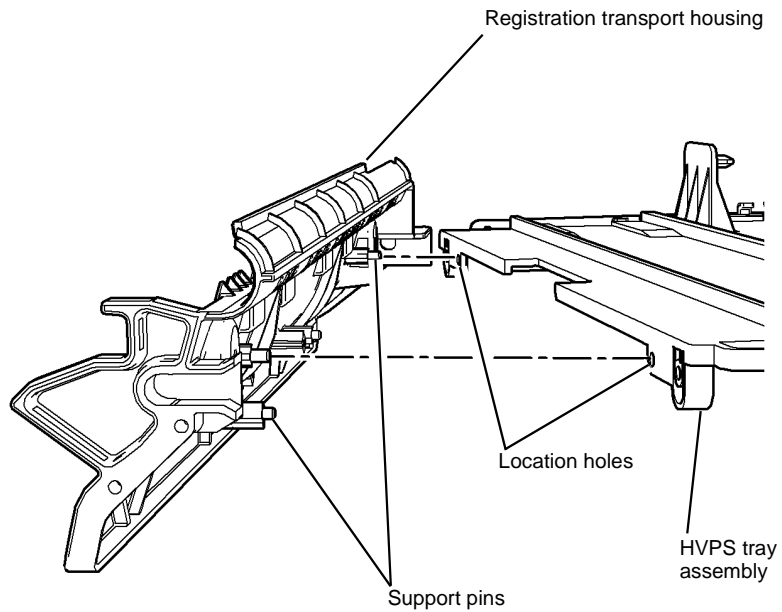
W-1-1294-A

1. Replacement is the reverse of the removal procedure. Refer to GP 6 before refitting the screws
2. Ensure the 2 support pins on the registration transport housing engage into the 2 location holes of the HVPS tray assembly, Figure 5.

Figure 5 Housing replacement

If the registration transport housing is not located correctly rotation of the registration roll will be impaired.

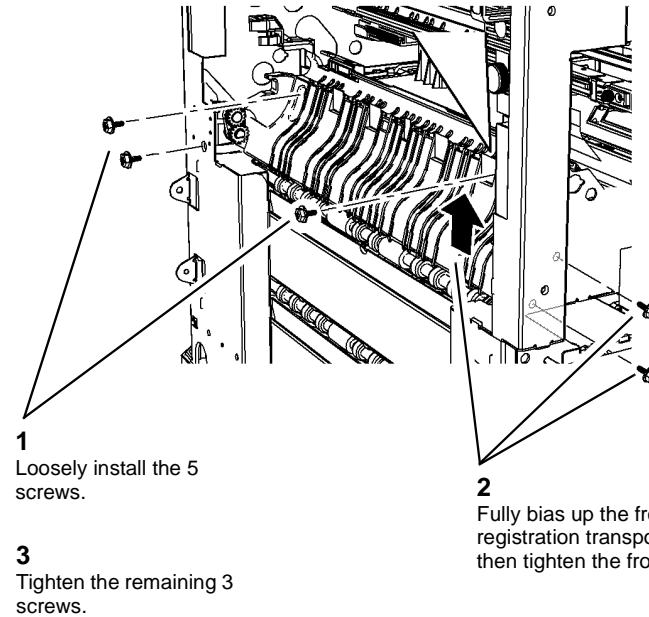
W-1-1416-A

Ensure the front of the registration transport housing is biased fully up before tightening the screws.

3. Secure the registration transport housing, Figure 6.

Figure 6 Housing biasing

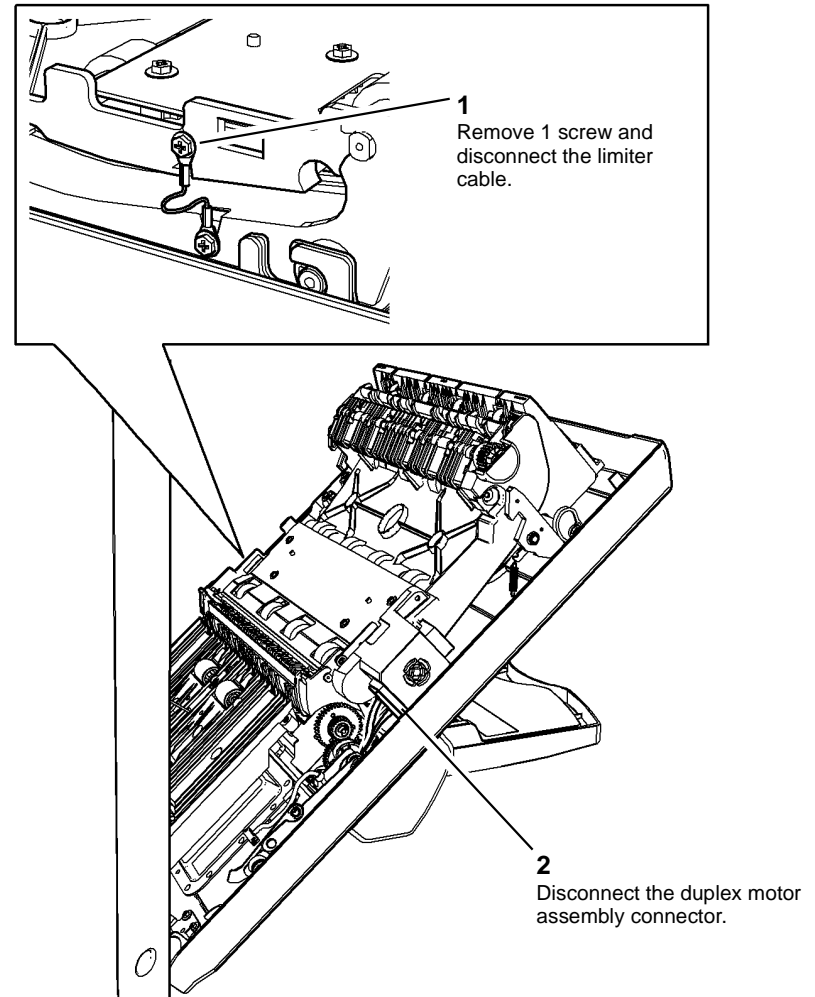
W-1-1055-A

1. Open the left door, [PL 80.10 Item 1](#).
2. Remove the print cartridge, [PL 90.17 Item 9](#), then place in a black bag.
3. Remove the registration transfer assembly, [REP 80.3](#).
4. Prepare to remove the duplex transport assembly, [Figure 1](#).

Figure 1 Preparation

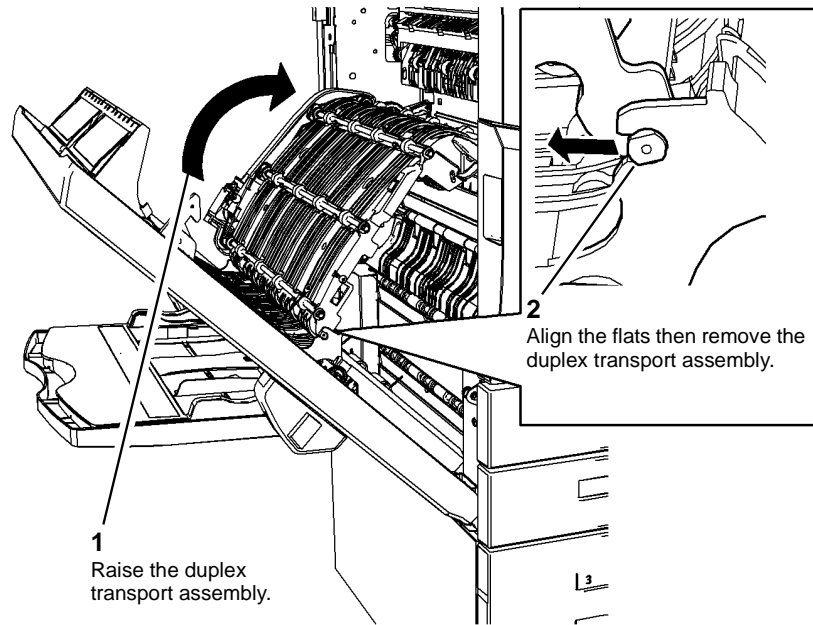
W-1-1056-A

6. Remove the duplex transport assembly, [Figure 2](#).

Figure 2 Removal

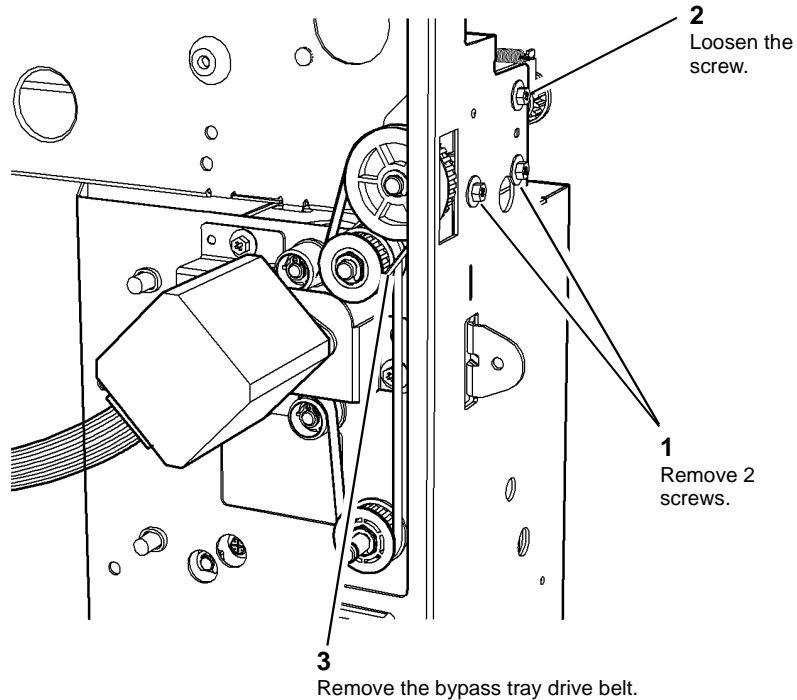
4. Remove the bypass tray drive belt, [Figure 1](#).

Figure 1 Drive Belt Removal

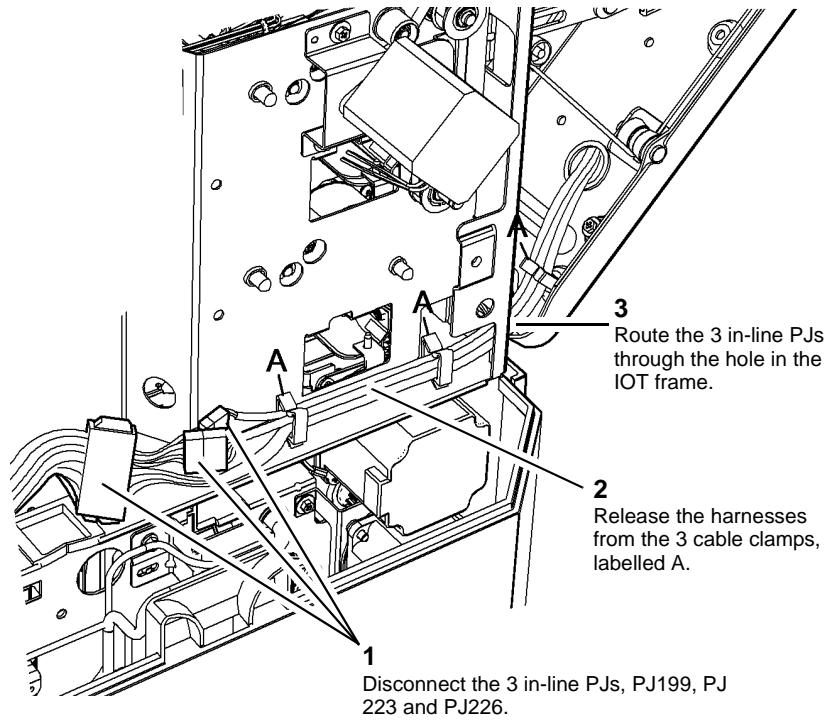
W-1-1342-A

4. Disconnect the harnesses between the IOT and the left door assembly, [Figure 1](#).

Figure 1 Left door harness connections

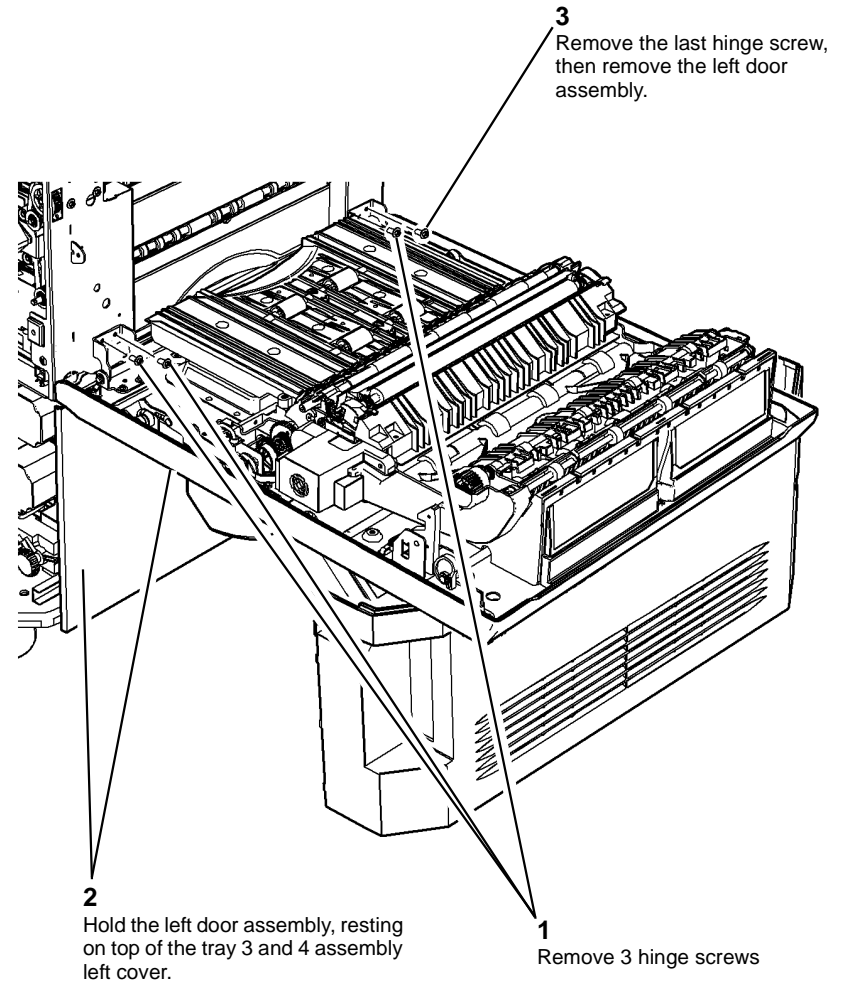
W-1-1372-A

6. Remove the left door assembly, [Figure 2](#).

Figure 2 Left door removal

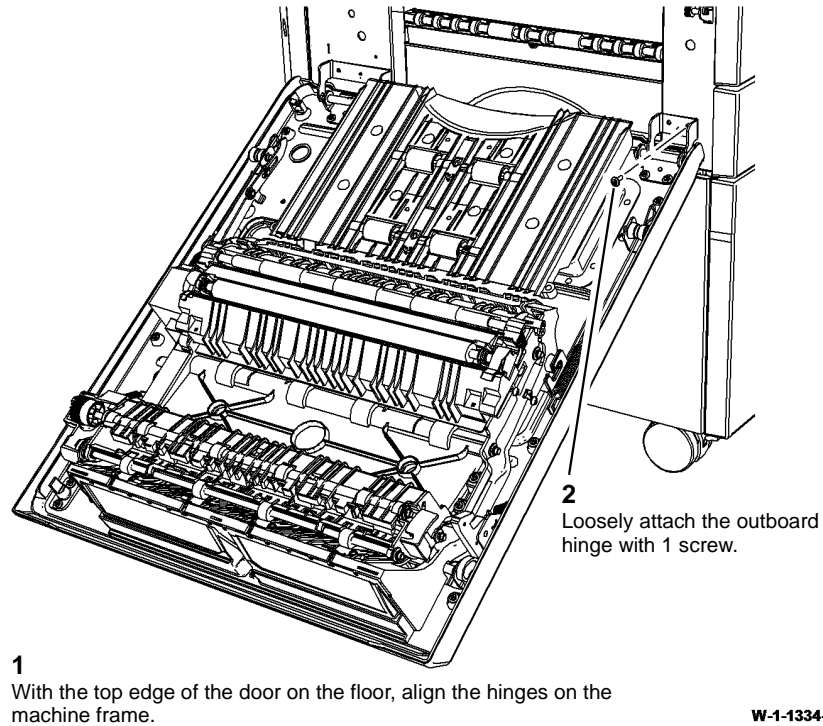
W-1-1334-A

1. Prepare to install the left door assembly, Figure 3.

Figure 3 Temporary alignment

Ensure the left door assembly is supported and finally fixed into place when in the service position (horizontal), GP 37. Incorrect positioning of the left door assembly when installing the 4 fixing screws may cause the left door cover to collide with the IOT to HCF inboard fixing bolt, when the door is closed.

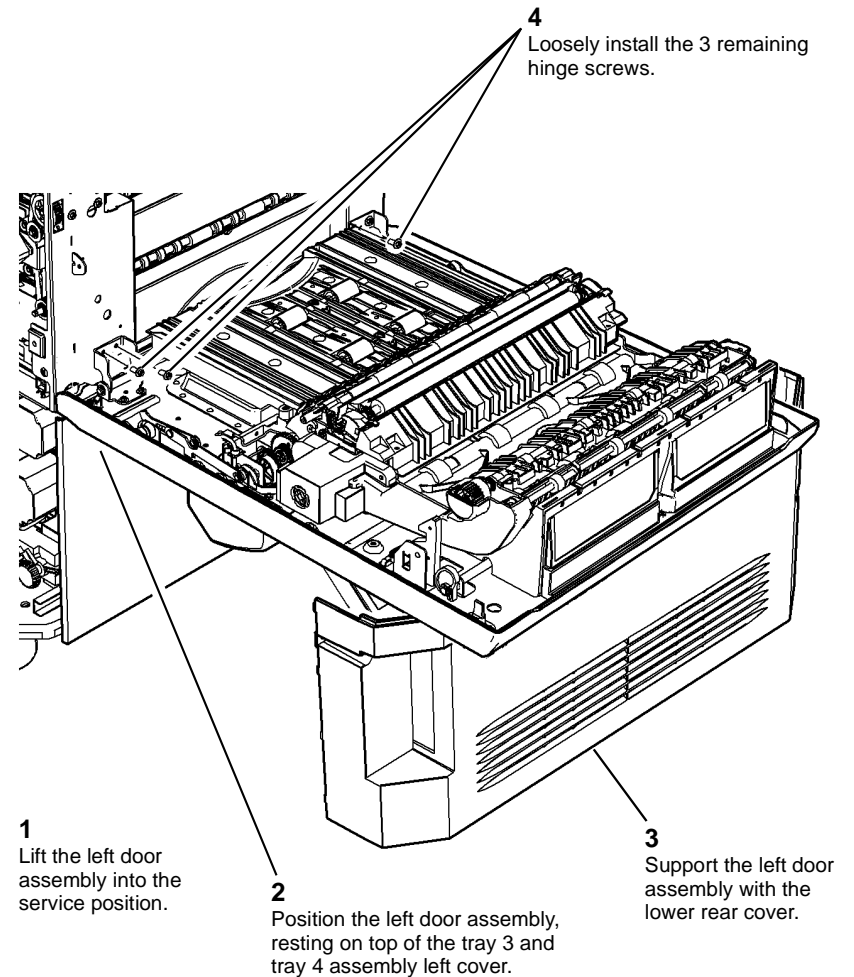
W-1-1373-A

2. Install the left door assembly, Figure 4.

Figure 4 Left door assembly Installation

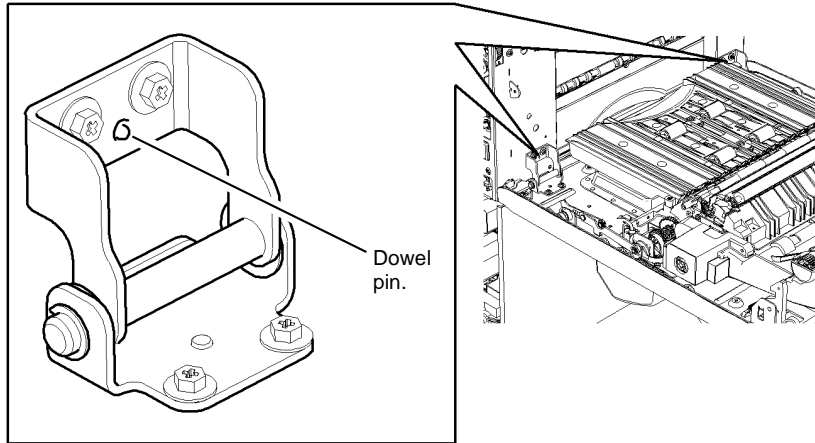
W-1-1374-A

Figure 5 Hinge location

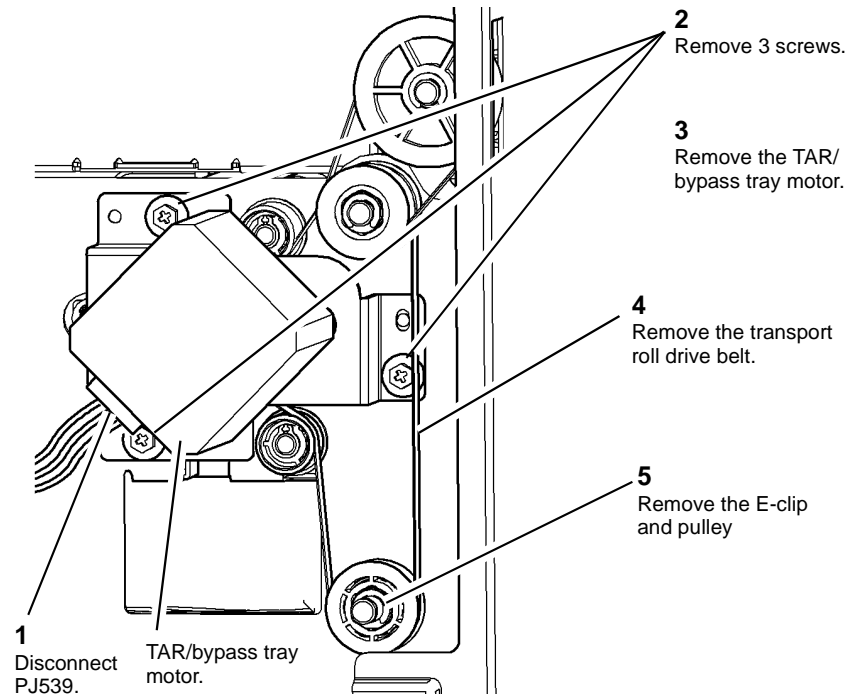
1. Remove the bypass tray drive belt, [REP 80.6](#).
2. Remove the TAR/Bypass tray motor, [Figure 1](#).

Figure 1 TAR/Bypass tray motor

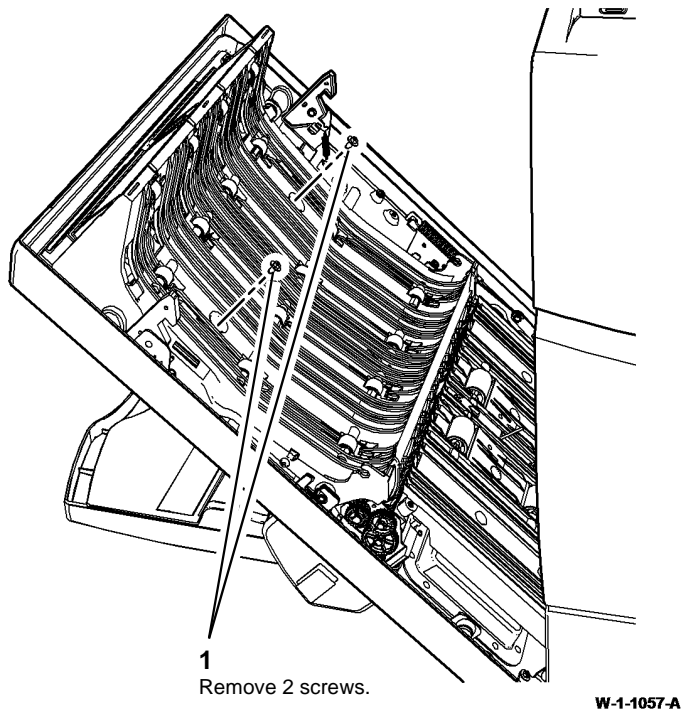
1. Open the left door, [PL 80.10 Item 1](#).
2. Remove the print cartridge, [PL 90.17 Item 9](#), then place in a black bag.
3. Remove the left door fan cover, [PL 80.10 Item 4](#).
4. Remove the duplex transport assembly, [REP 80.5](#).
5. Prepare to remove the duplex outer guide assembly, [Figure 1](#).

Figure 1 Preparation

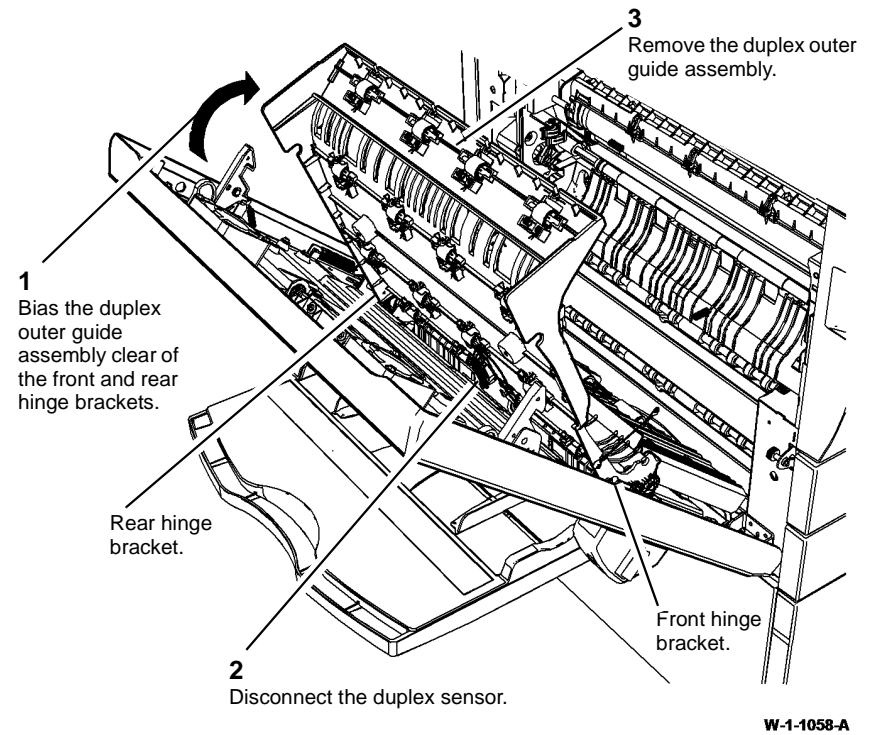
6. Remove the duplex outer guide assembly, [Figure 2](#).

Figure 2 Removal

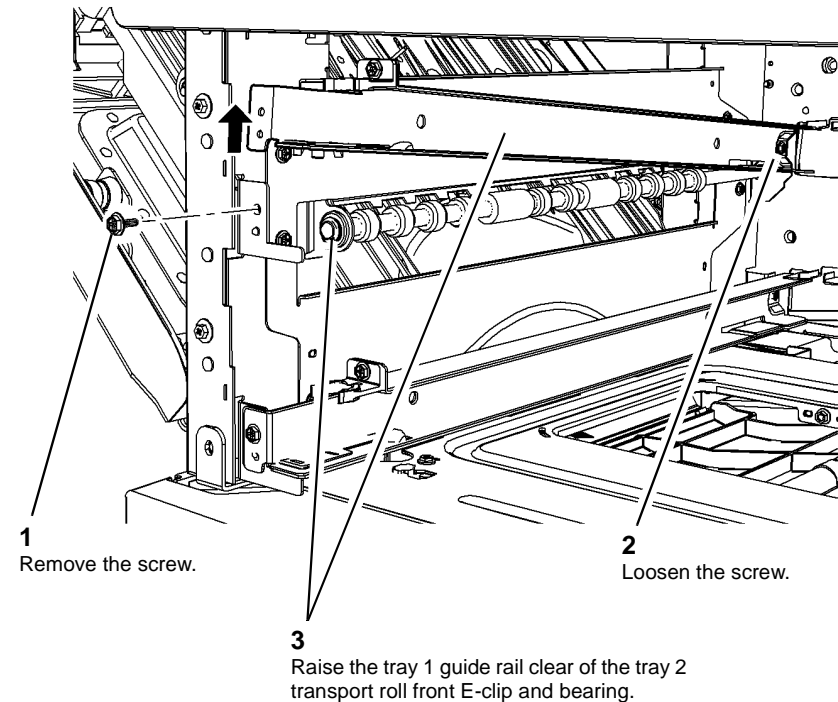
W-1-1331-A

6. Raise the tray 1 guide rail to increase access to the tray 2 transport roll front E-clip and bearing, [Figure 1](#).

Figure 1 Front E-clip access

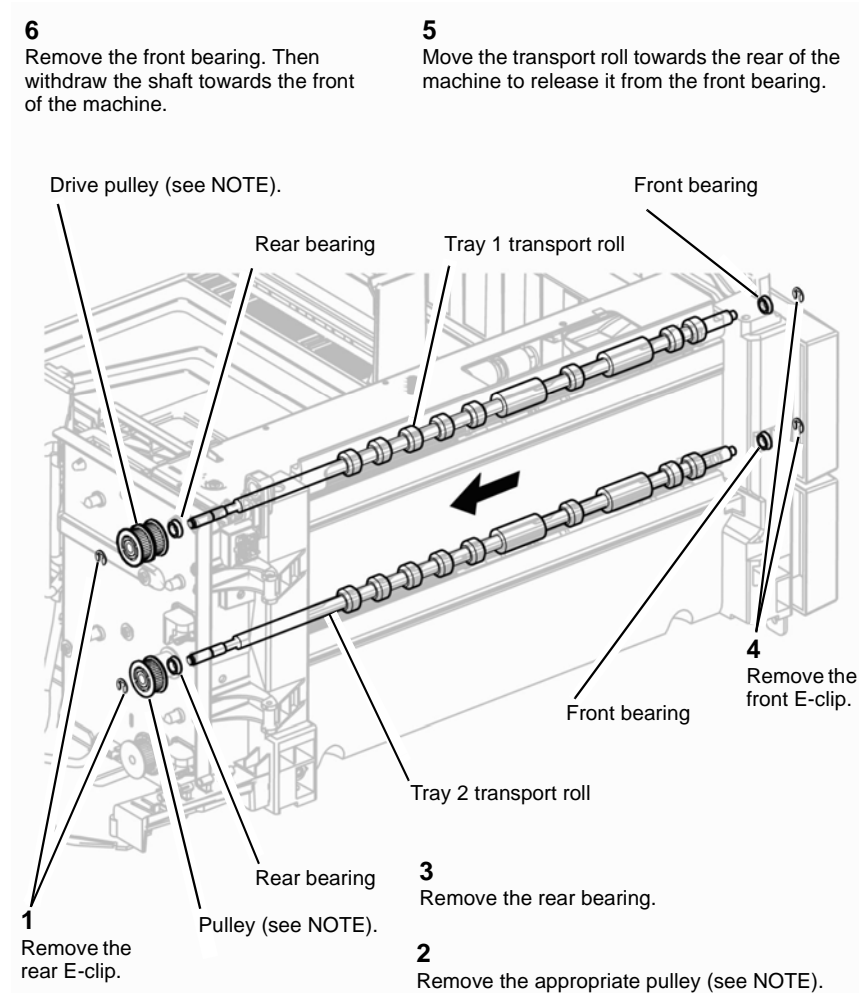
W-1-0663-A

7. Remove the transport roll and transport roll bearings, [Figure 2](#).

Figure 2 Transport roll removal

NOTE: The drive pulley, [PL 80.25 Item 3](#) and pulley, [PL 80.25 Item 4](#) both have a built-in one-way clutch. The transport roll rotates when the pulleys are turned in a counter-clockwise direction. Before removal of the pulleys, mark the pulleys to indicate their correctly installed position.

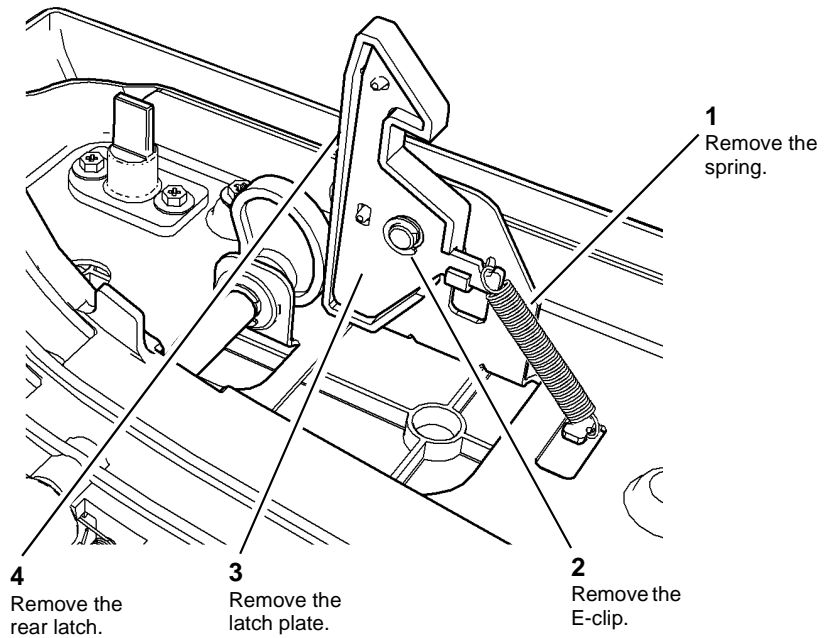
W-1-1059-A

1. Open the left door, [PL 80.10](#) Item 1.
2. Remove the print cartridge, [PL 90.17](#) Item 9, then place in a black bag.
3. Raise the duplex transport assembly, [PL 80.22](#) Item 1.
4. Remove the rear latch assembly, [Figure 1](#).

Figure 1 Removal

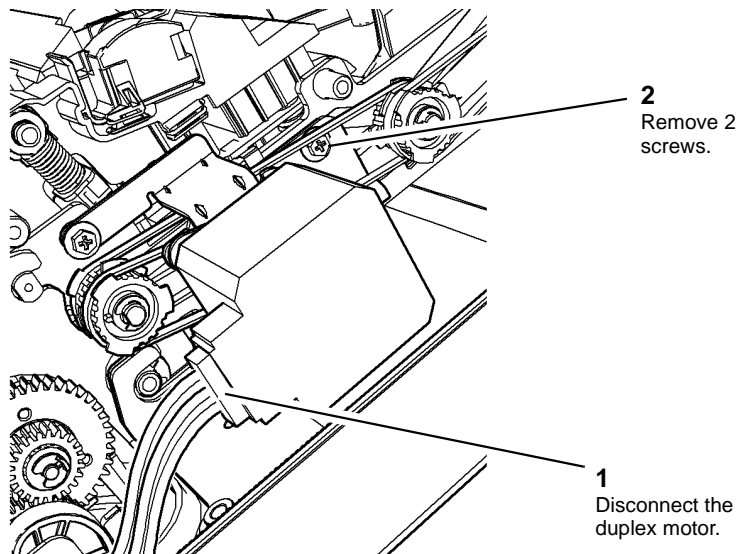
W-1-1332-A

1. Open the left door, [PL 80.10 Item 1](#).
2. Remove the print cartridge, [PL 90.17 Item 9](#), then place in a black bag.
3. Remove 2 screws, then remove the duplex drives cover, [PL 80.22 Item 21](#).
4. Prepare to remove the duplex motor assembly, [Figure 1](#).

Figure 1 Preparation

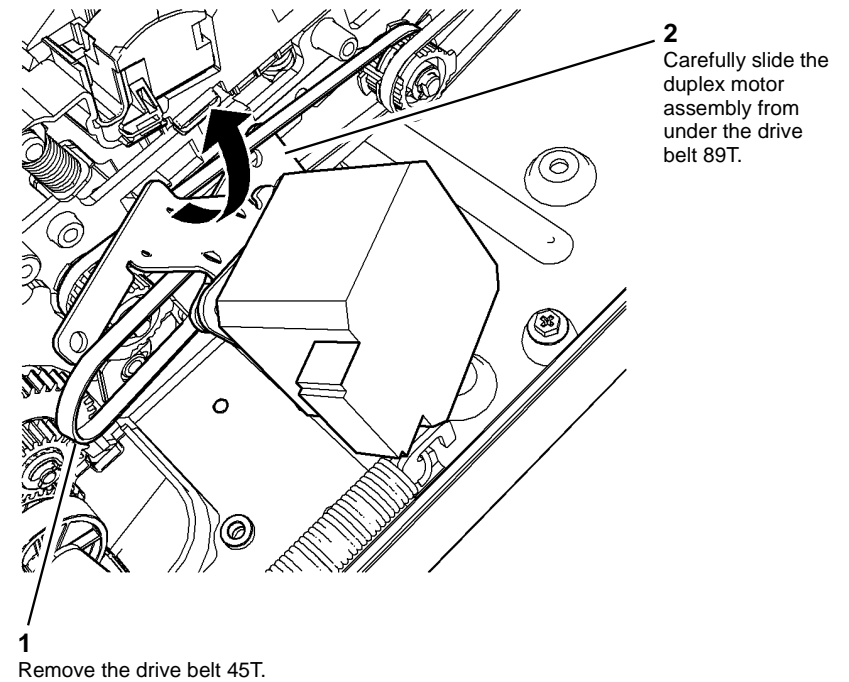
W-1-1333-A

5. Remove the duplex motor assembly, [Figure 2](#).

Figure 2 Remove the assembly

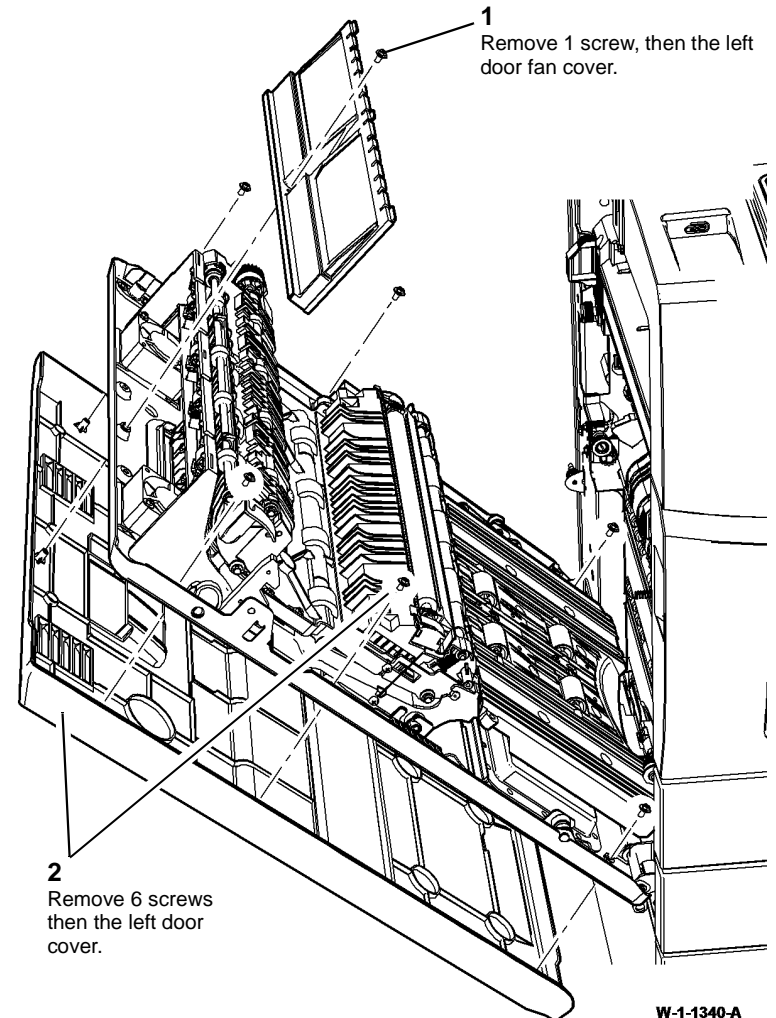
1. Remove the bypass tray assembly, [REP 70.2](#).
2. Remove the left door cover, [Figure 1](#).

Figure 1 Cover removal

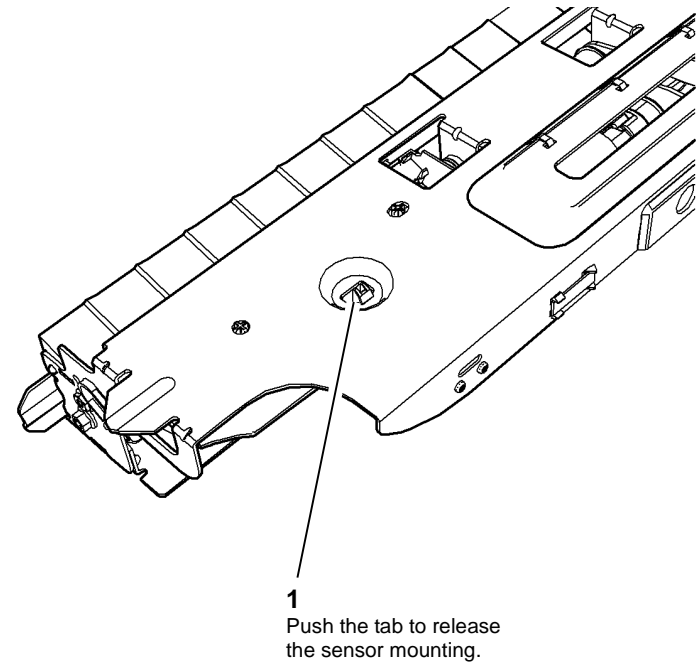
W-1-0739-A

1. Remove the tray 4 paper feed assembly, [REP 80.21](#).
2. Release the sensor mounting, [Figure 1](#).

Figure 1 Sensor mounting release

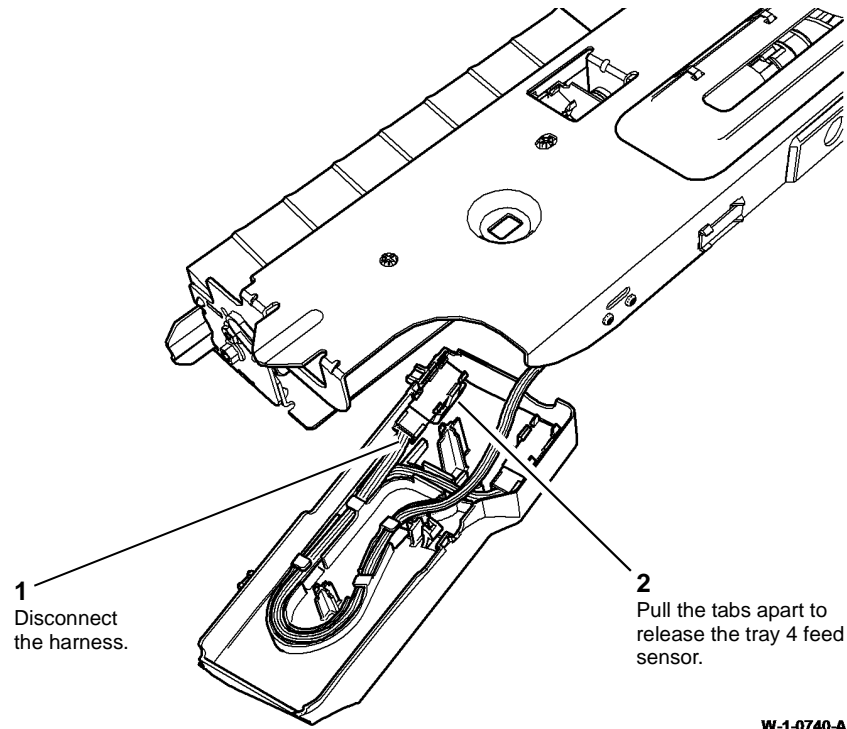
- Remove the tray 4 feed sensor, [Figure 2](#).

1
Disconnect
the harness.

2
Pull the tabs apart to
release the tray 4 feed
sensor.

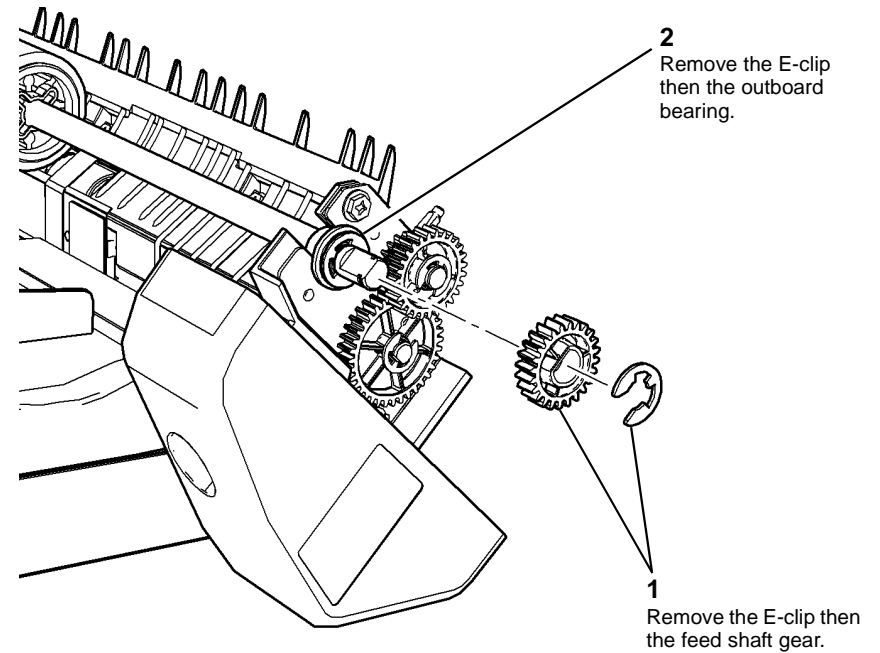
2
Remove the E-clip
then the outboard
bearing.

1
Remove the E-clip then
the feed shaft gear.

Figure 1 Feed roll front fixings

- Remove the bypass tray assembly, [REP 70.2](#).
- Prepare to remove the feed roll assembly, [Figure 1](#).

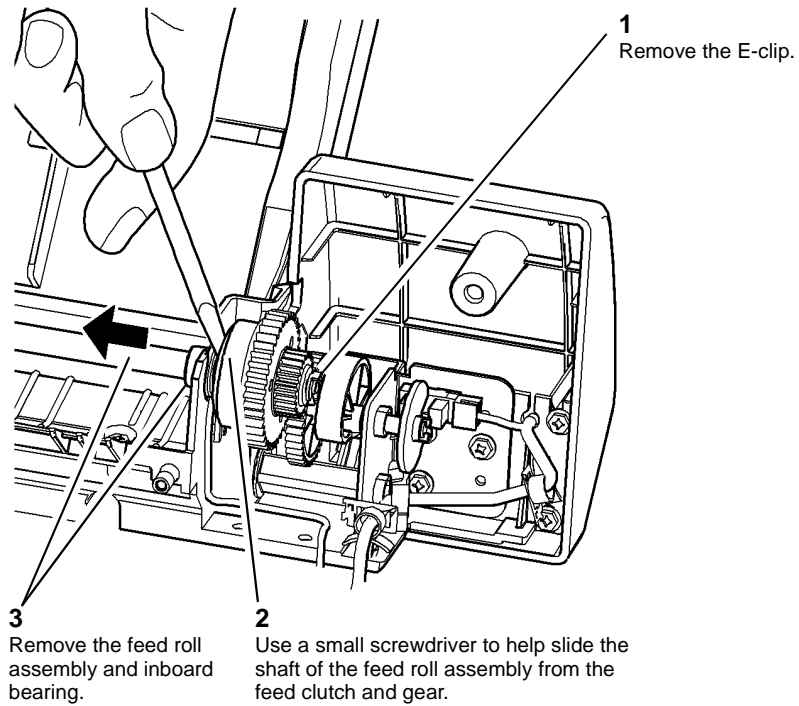
Figure 2 Feed roll and clutch assemblies

3. Remove the feed clutch and feed roll assembly, [Figure 2](#).

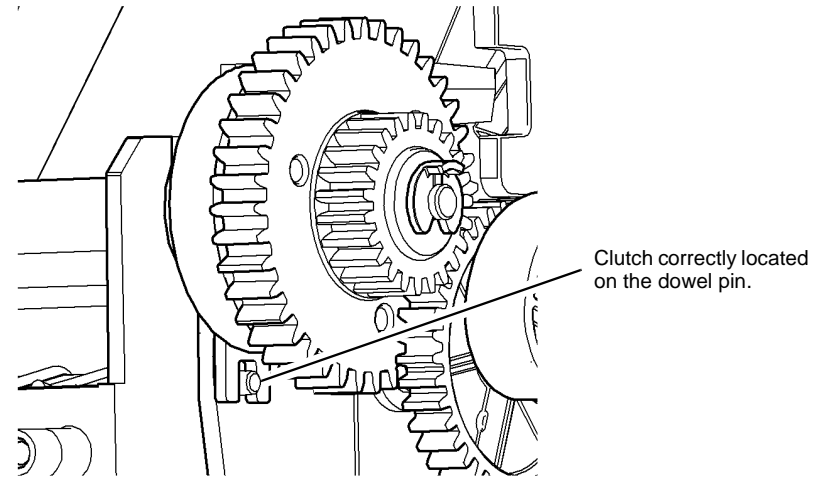
Figure 3 Dowel pin

1. Replacement is the reverse of the removal procedure.
2. Ensure the clutch locates with the dowel pin on the feeder frame, [Figure 3](#).

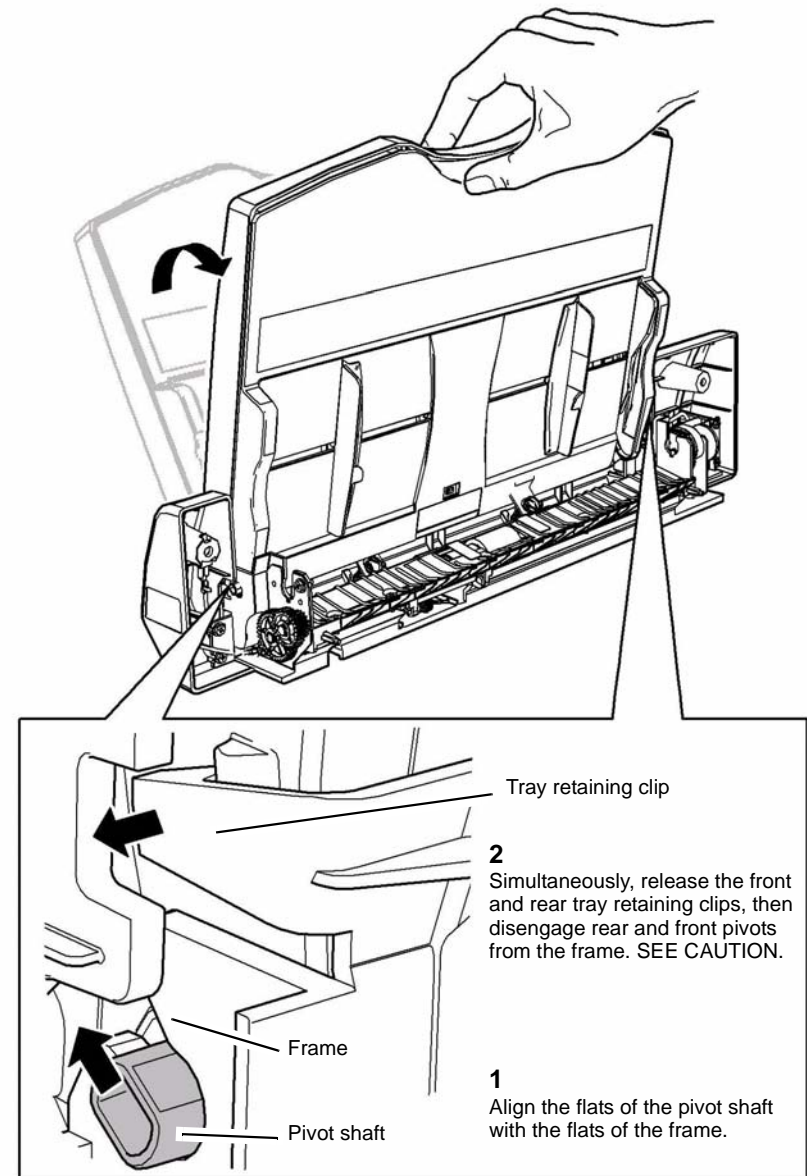
Figure 1 Bypass tray release

2. Release the tray assembly, [Figure 1](#).

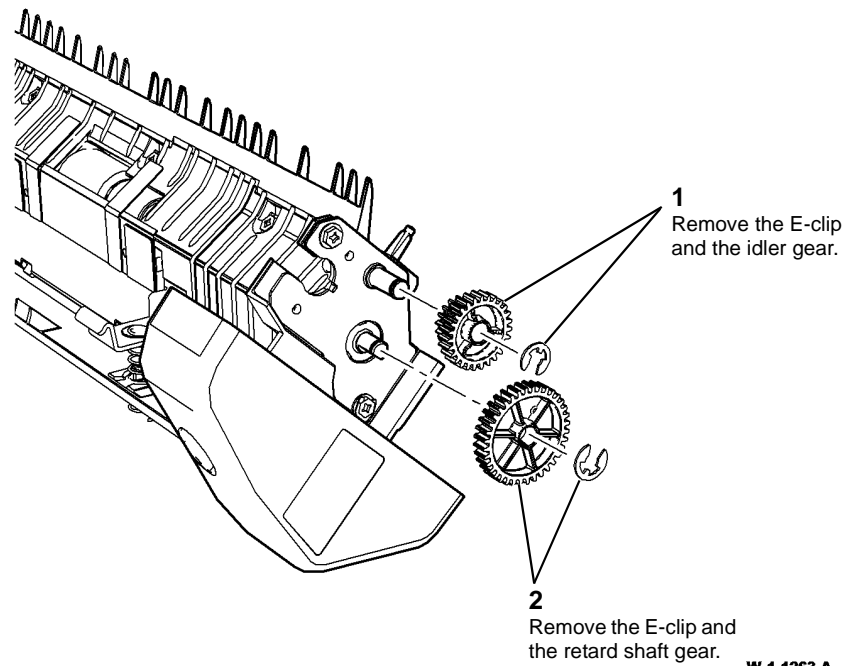
Figure 2 Gears removal

3. Remove the front gears, [Figure 2](#).
