708P91139
February 2016

Xerox® WorkCentre® 5945 Family Multifunction Printer Service Manual

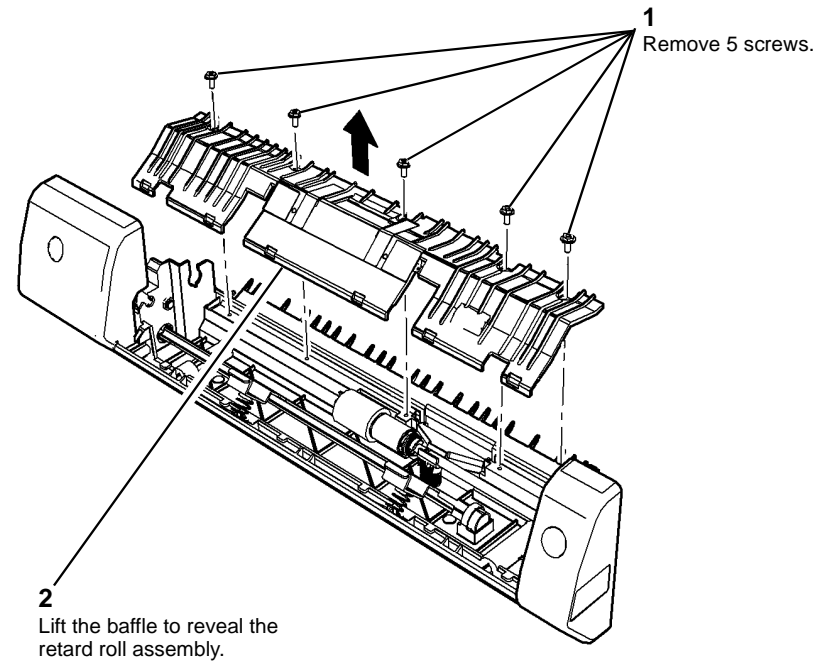
Figure 3 Baffle release

4. Release the baffle, [Figure 3](#).

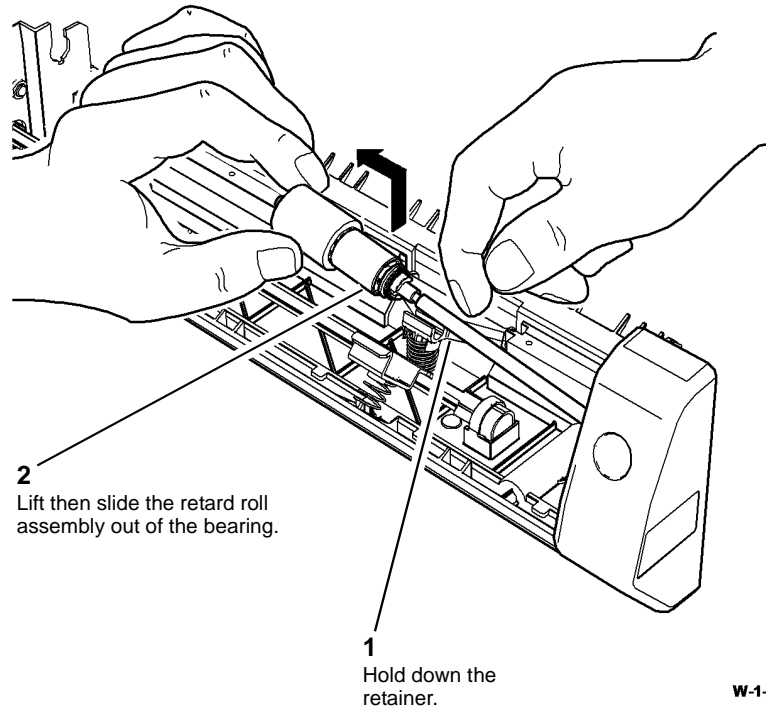
2
Lift then slide the retard roll assembly out of the bearing.

1
Hold down the retainer.

5. Remove the retard roll assembly, [Figure 4](#).

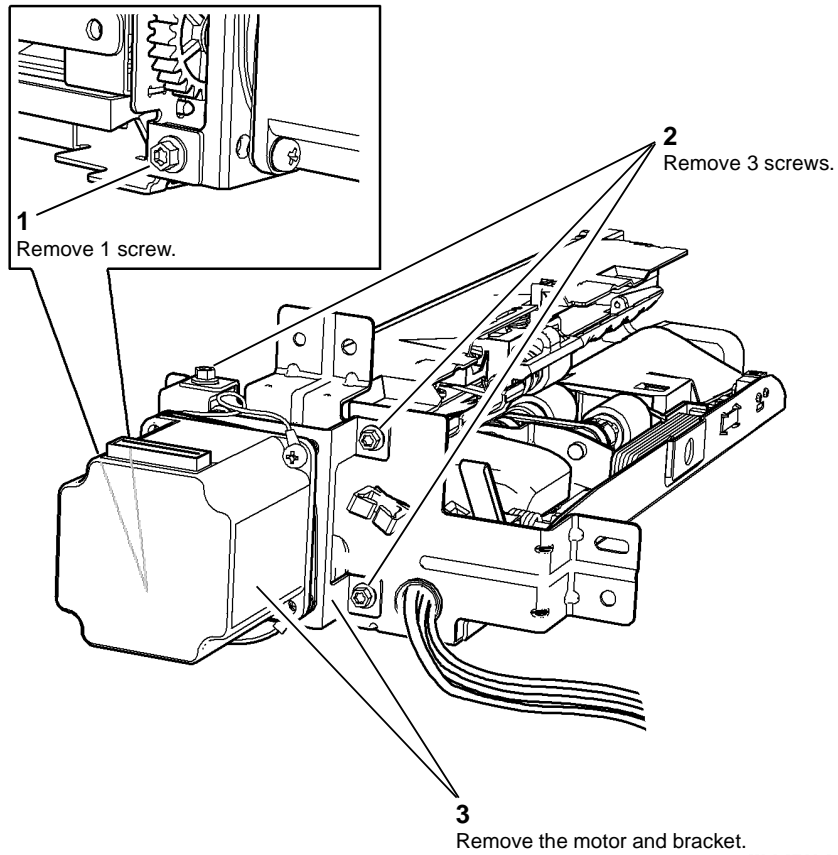
Figure 1 Motor and bracket removal

3. Remove the feed motor with the bracket, [Figure 1](#).

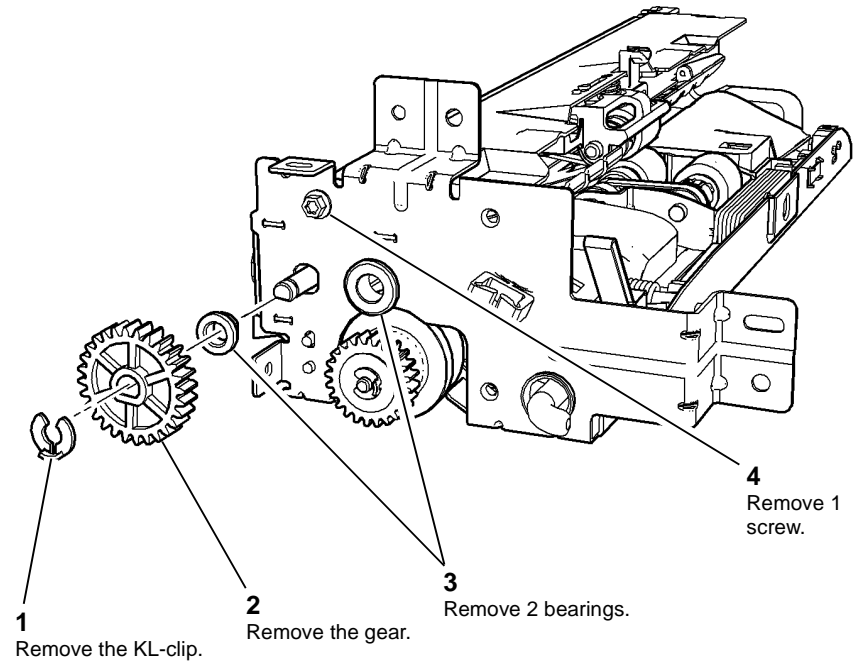
Figure 2 Rear fixings

4. Release the rear fixings, [Figure 2](#).

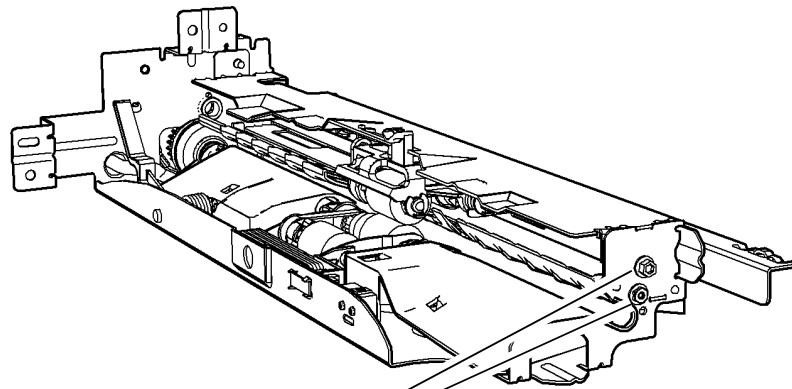
1
Remove 2 screws.

Figure 3 Front fixings

5. Release the front fixings, [Figure 3](#).

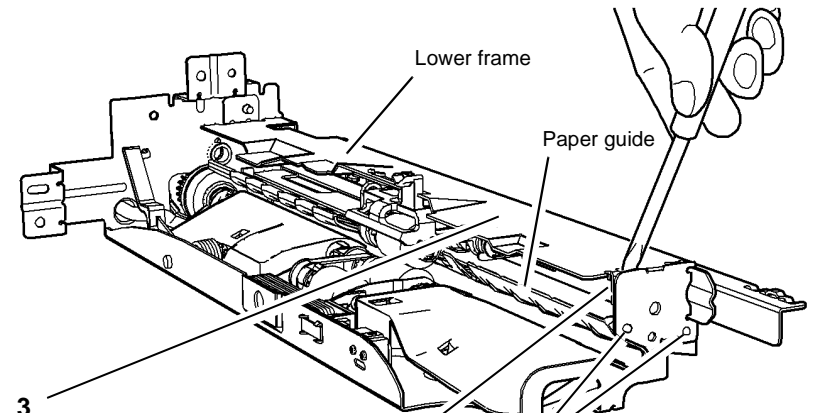
3
Remove the lower frame
and paper guide.

2
Ensure the plastic pins of the paper
guide are disengaged from the
holes in the lower frame.

6. Separate the upper and lower frames, [Figure 4](#).

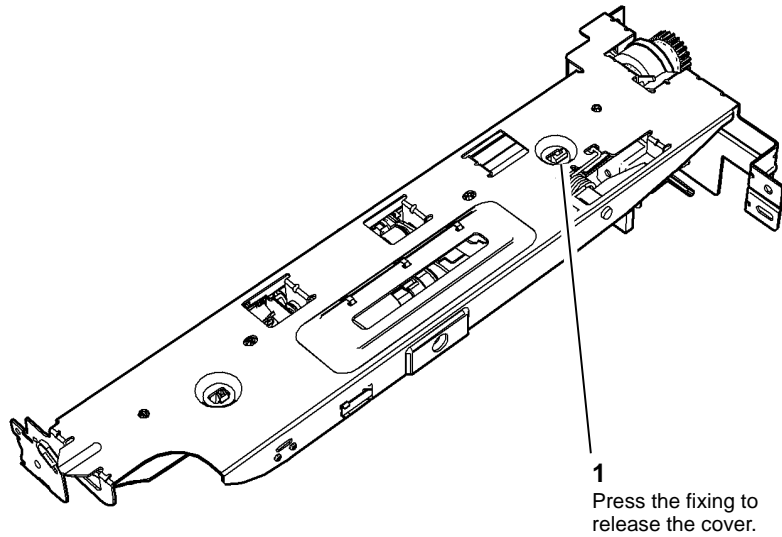
Figure 5 Cover removal

7. Remove the plastic cover, [Figure 5](#).

5. Fasten the plastic cover into position ensuring that the wiring is not trapped, refer to [Figure 5](#).

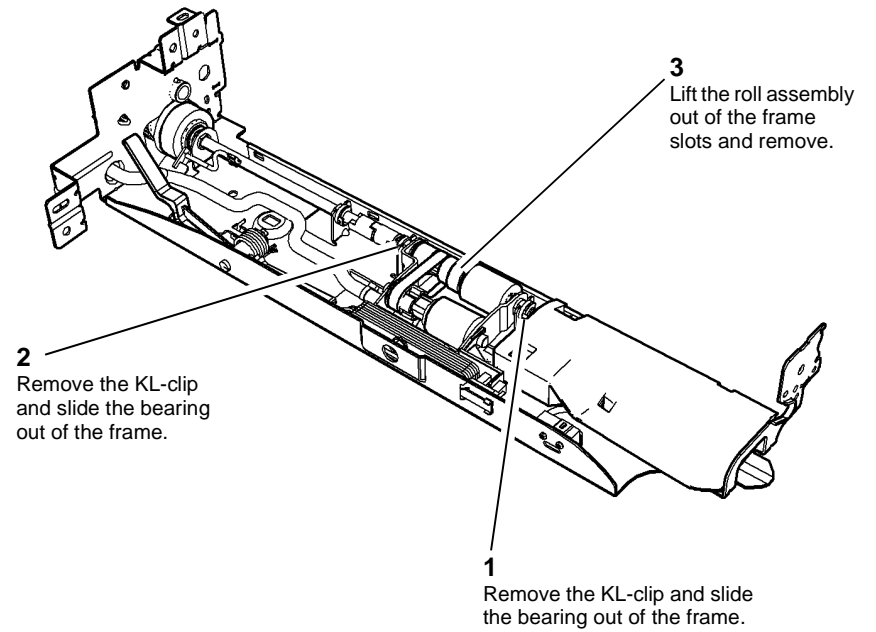
Figure 6 Nudger and feed roll removal

8. Remove the nudger roll and feed roll assembly, [Figure 6](#).

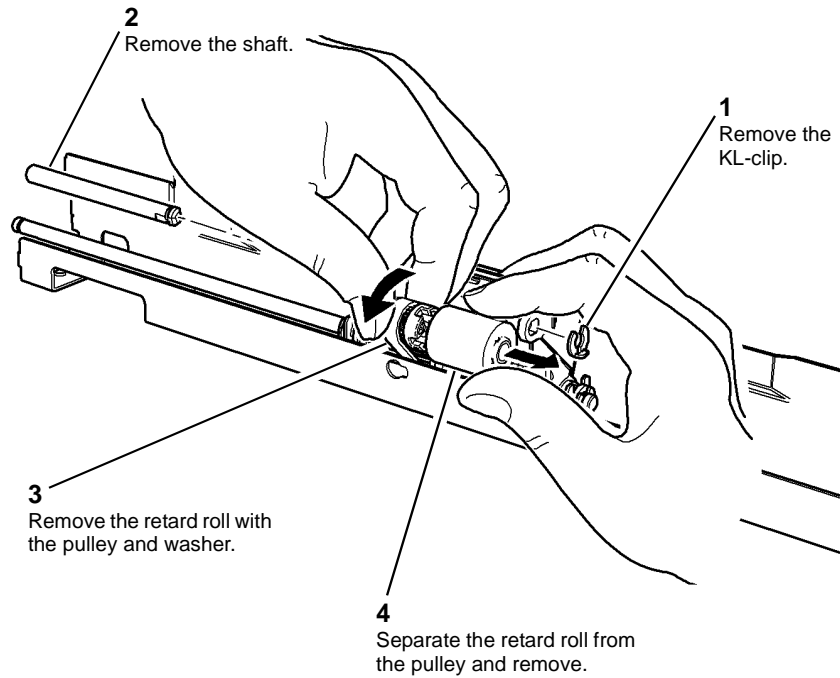
Figure 7 Retard roll removal

9. Remove the retard roller, [Figure 7](#).

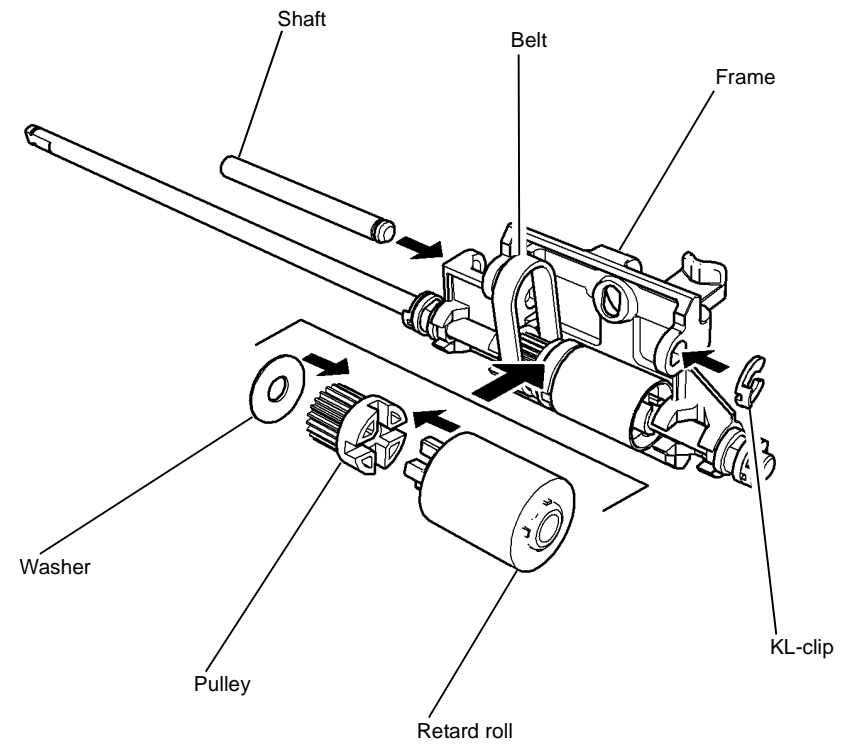
Figure 8 Exploded view of the retard assembly

1. Install the retard roll by reversing the steps in [Figure 7](#).
2. If necessary refer to [Figure 8](#) for the correct assembly of the retard roll components.

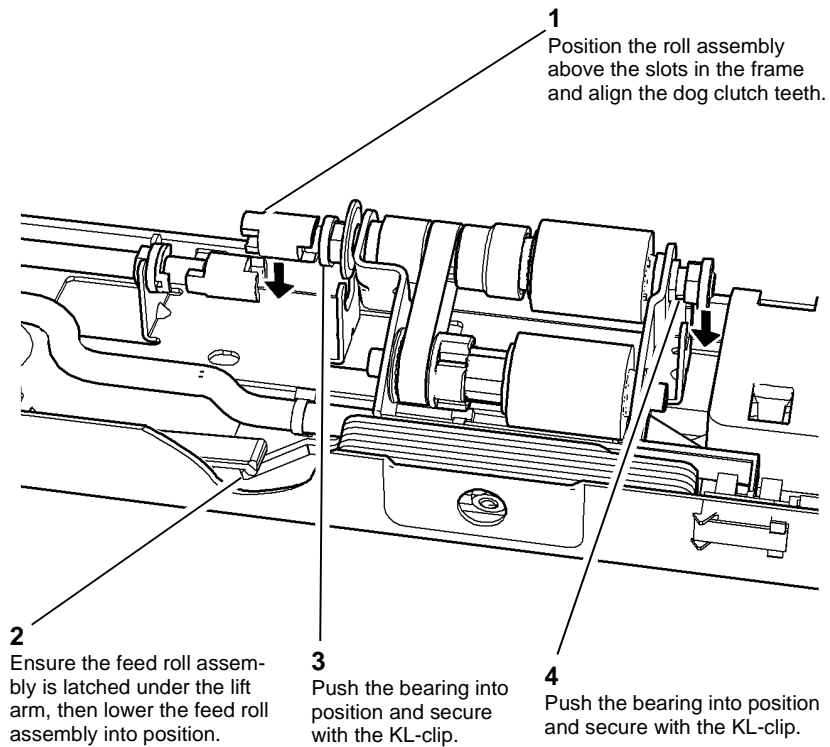
Figure 9 Nudger and feed roll install

4. Install the nudger roll and feed roll assembly, [Figure 9](#).

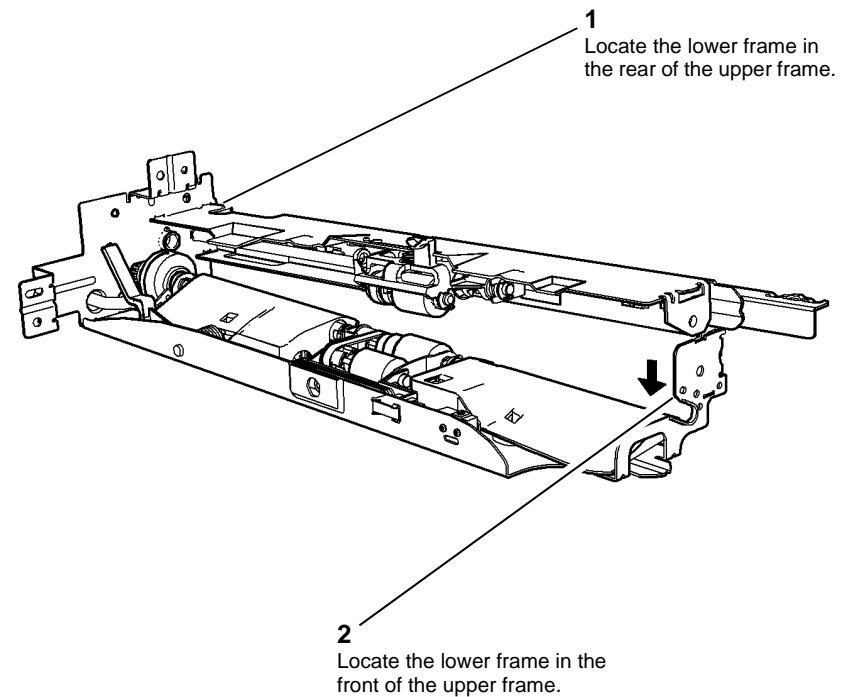
Figure 10 Frame assembly

6. Assemble the upper and lower frames, [Figure 10](#).

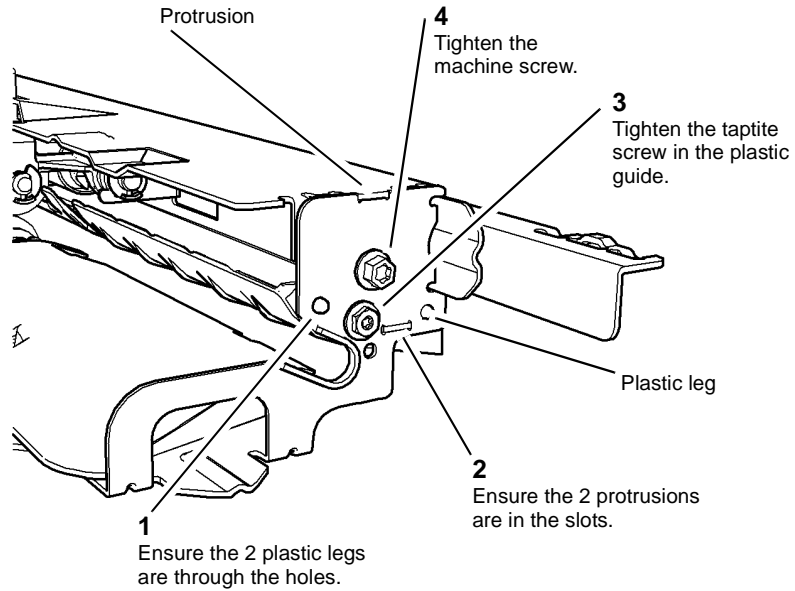
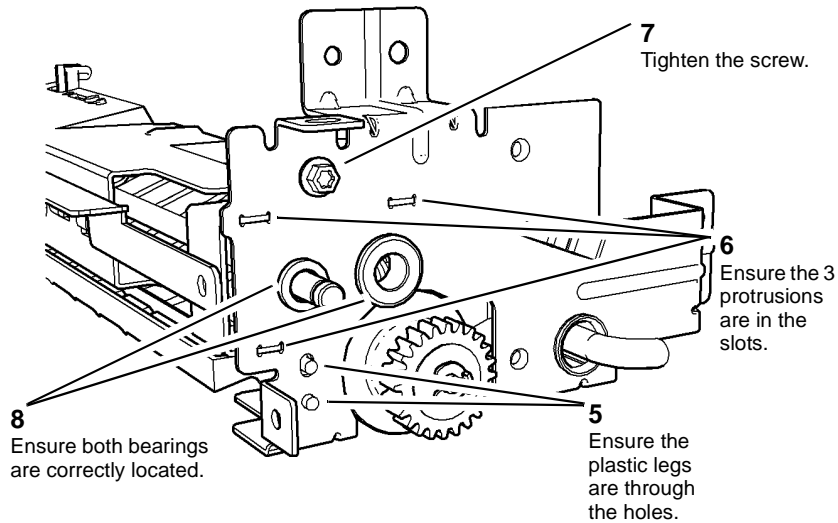
Figure 11 Final assembly

9. Align and secure the upper and lower frames, [Figure 11](#).

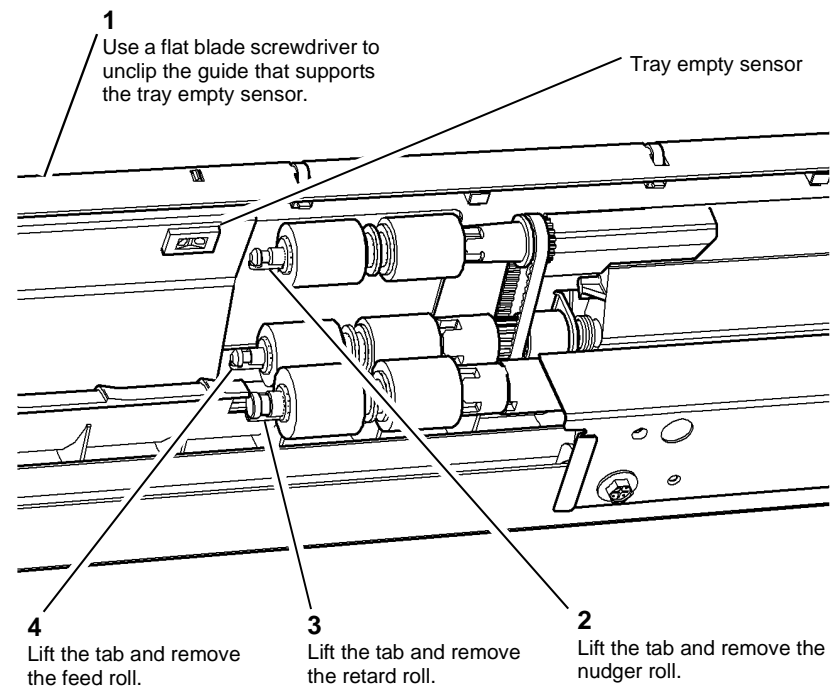
NOTE: The removal procedure is the same for the tray 1 and tray 2 feed, nudger and retard rolls. The feed and nudger rolls are the same diameter, but the retard roll has a larger diameter.

Figure 1 Feed rolls removal

1. Remove tray 1 or tray 2 as required, [REP 70.1](#).
2. Remove tray 1 or tray 2 paper feed assembly as required, [REP 80.1](#).
3. Remove tray 1 or tray 2 feed rolls, [Figure 1](#).

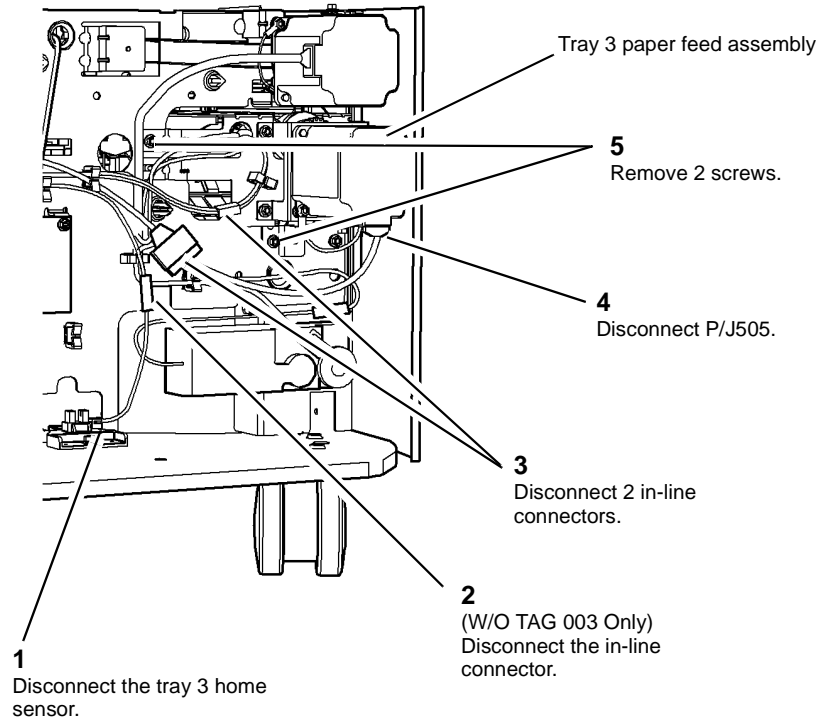
Carefully slide out the tray 3 paper feed assembly, ensuring that harnesses are not damaged.

Ensure the harnesses of the tray 3 paper feed assembly are released from their cable ties.

Figure 1 Feed assembly removal

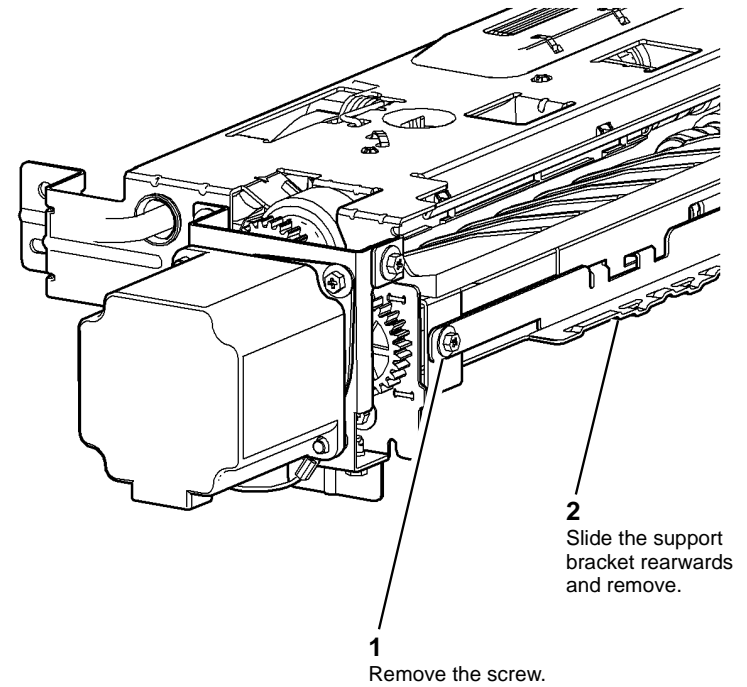
Figure 2 Support bracket removal

- Remove the support bracket, [Figure 2](#).

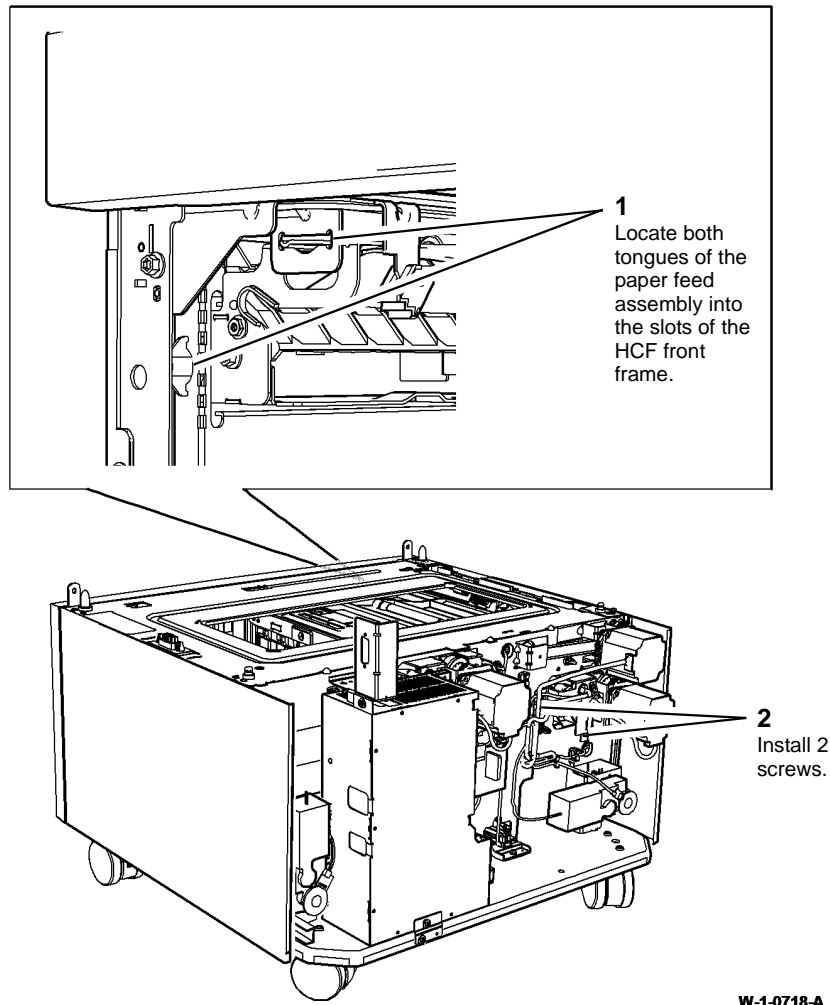
Figure 3 Feed assembly installation

5. Install the paper feed assembly, [Figure 3](#).

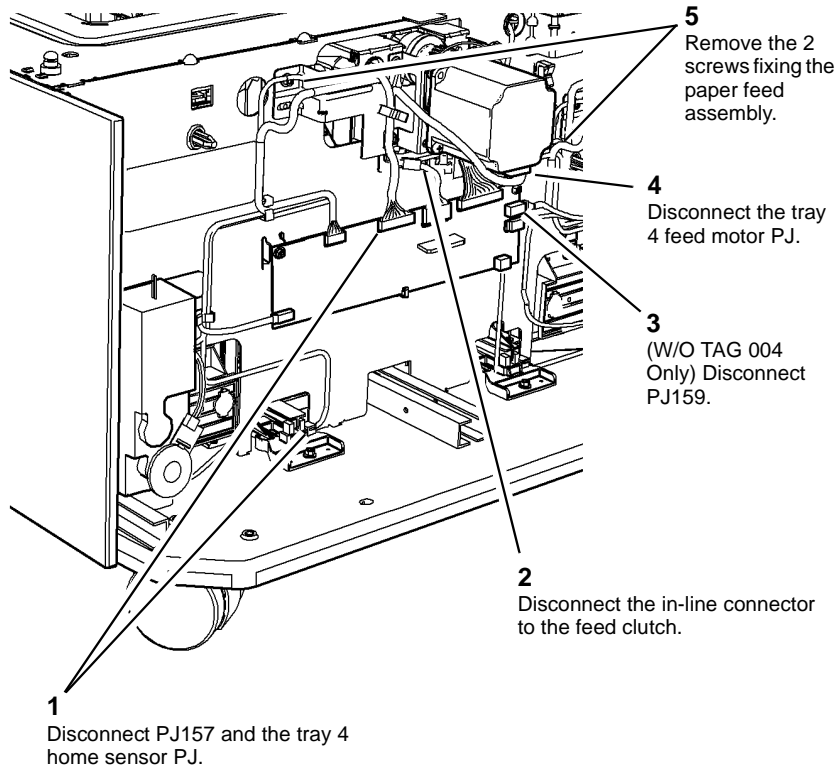
7
Carefully remove the paper feed assembly, from the rear of the machine.

6
Ensure the harnesses of the tray 4 paper feed assembly are released from their cable ties.

Figure 1 Feed assembly removal (W/OTAG 009)

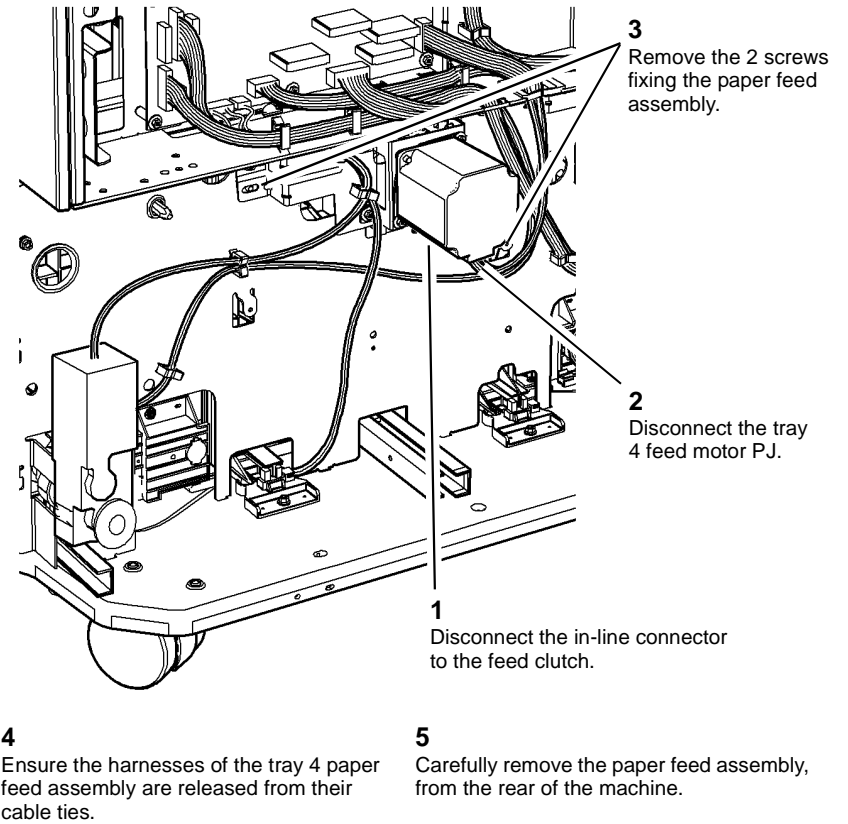
Figure 2 Feed assembly removal (W/TAG 009)

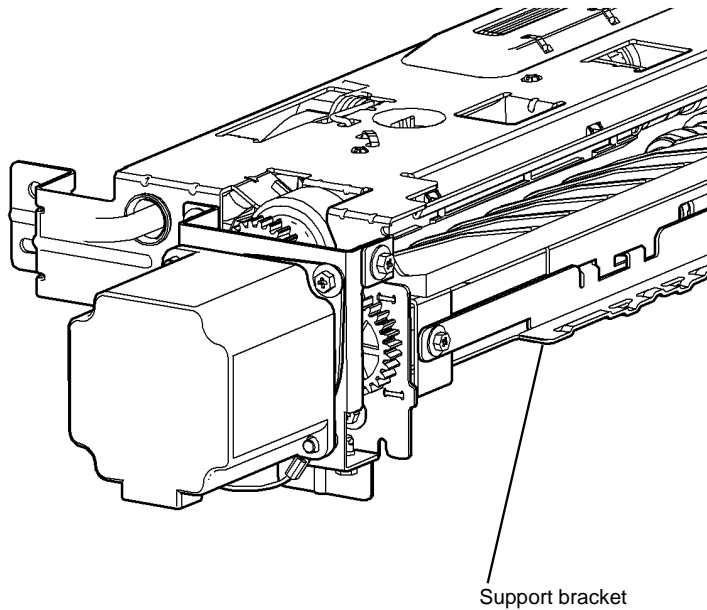
Figure 3 Support bracket

1. Ensure the support bracket is present on the tray 4 paper feed assembly, [Figure 3](#).

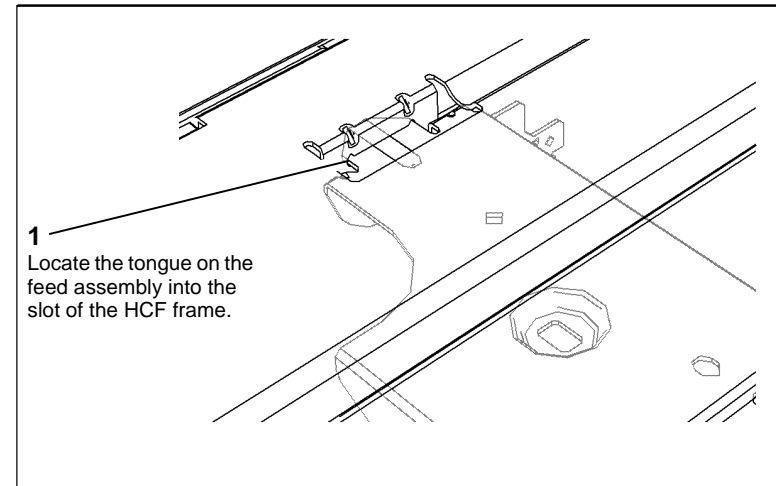
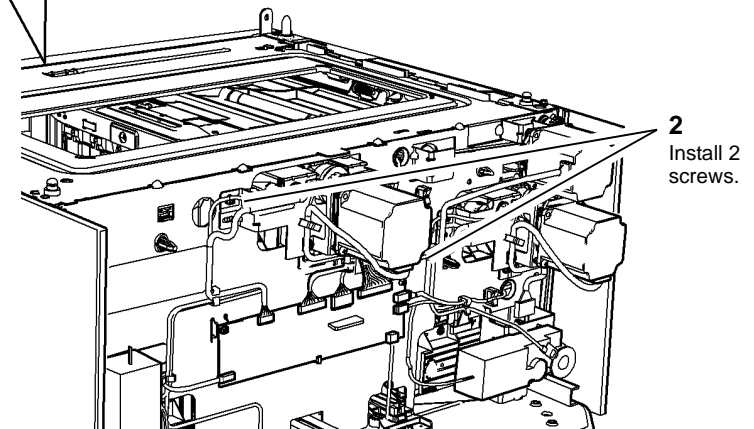
Figure 4 Feed assembly installation (W/O TAG 009)

2. Install the paper feed assembly:
 - W/O TAG 009 machines, [Figure 4](#).
 - W/TAG 009 machines, [Figure 5](#).

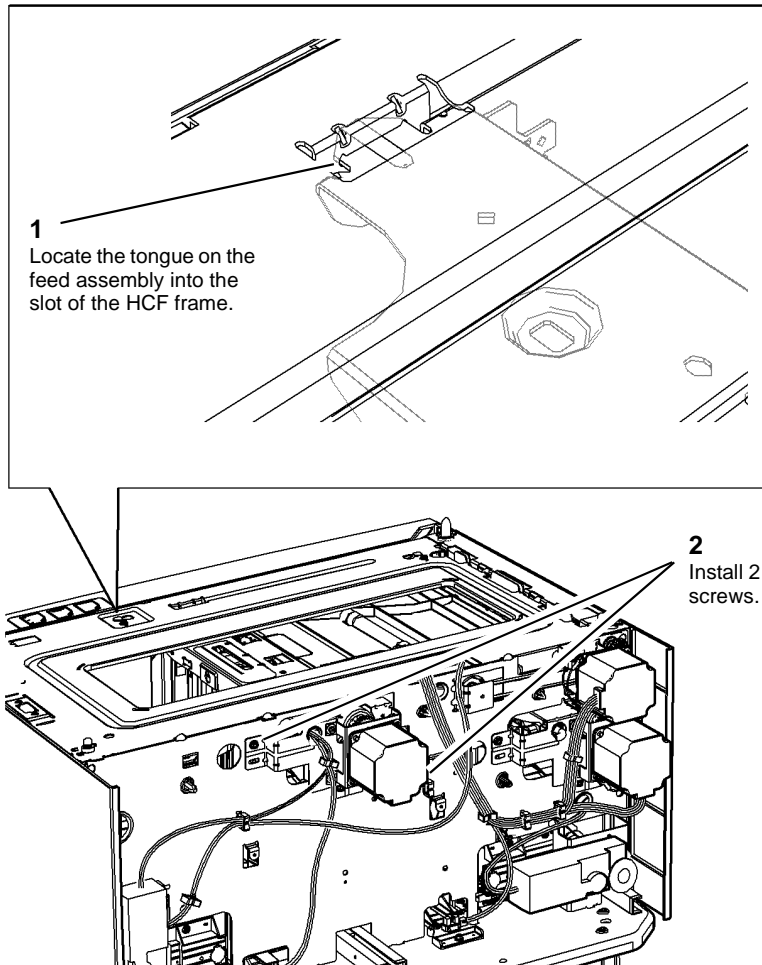
Figure 5 Feed assembly installation (W/TAG 009)

3. Ensure that the tray slide, at the rear right of the tray 4 transport assembly, straddles the support bracket when the paper feed assembly is replaced.
4. Push tray 4 in slowly and check that the tray does not foul the paper feed assembly.
5. Connect the PJs, refer to [Figure 1](#) (W/O TAG 009) or [Figure 2](#) (W/TAG 009).
6. The remainder of the replacement is the reverse of the removal procedure. Refer to [GP 6](#) before refitting the screws.
7. If a new paper feed assembly has been installed, reset the tray 4 feed roll HFSI count. Refer to [dC135](#) CRU/HFSI Status.

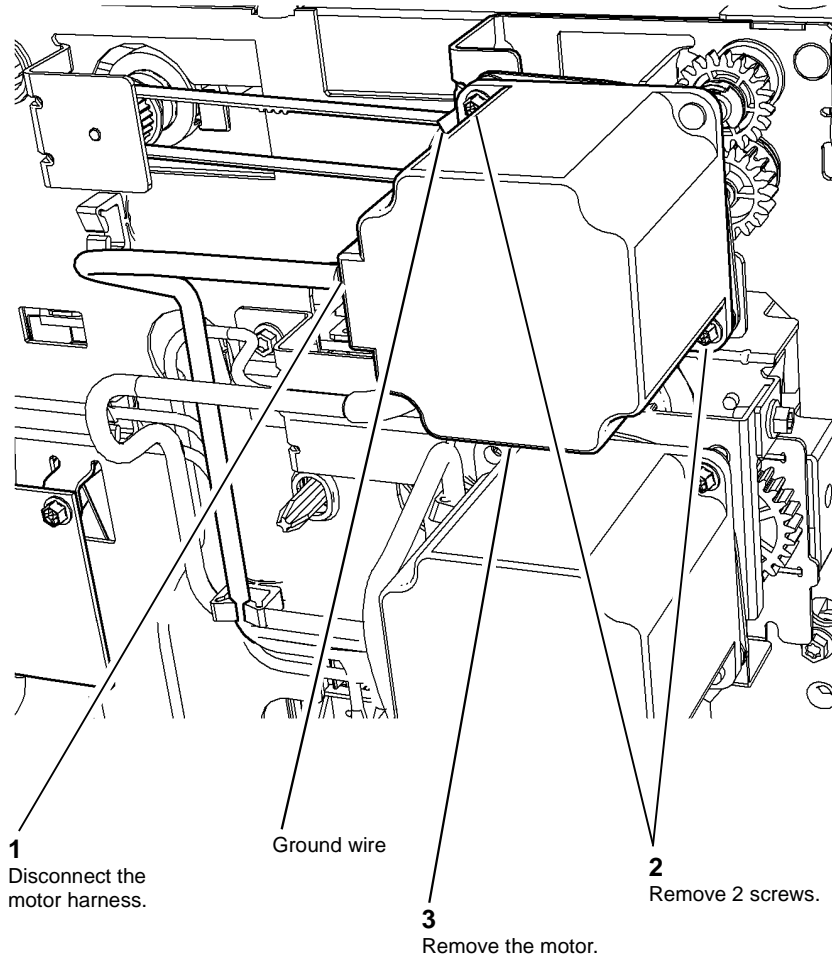
1
Disconnect the motor harness.

Ground wire

- Remove the HCF transport motor, [Figure 1](#).

- Replacement is the reverse of the removal procedure. Ensure that the ground wire is installed between the motor and the frame, [Figure 1](#).

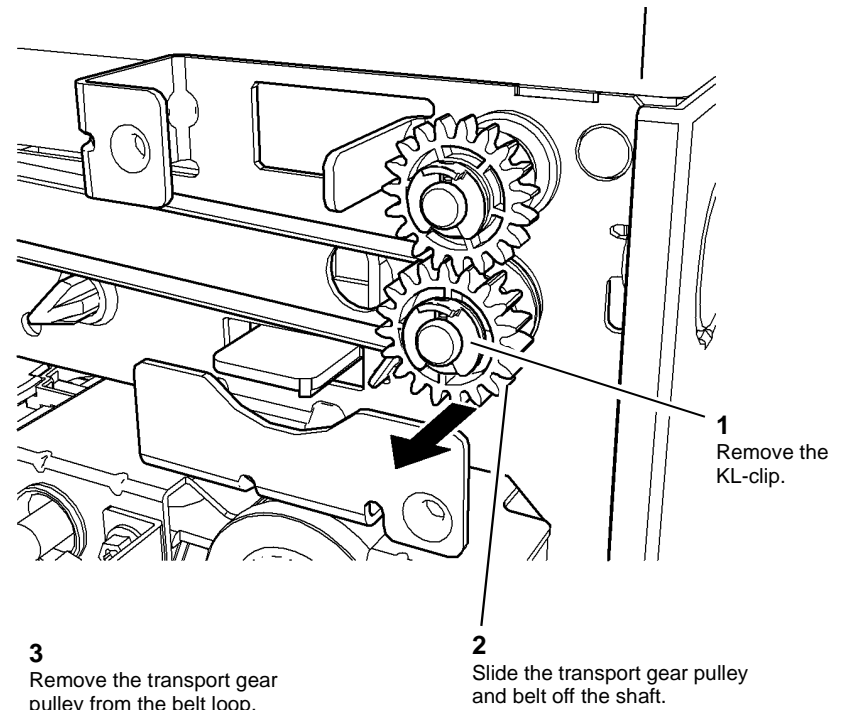
1
Remove the KL-clip.

2
Slide the transport gear pulley and belt off the shaft.

- Remove the lower rear cover, [PL 70.26 Item 1](#).
- Remove the HCF transport motor, [REP 80.22](#).
- Remove the transport gear pulley, [Figure 1](#).

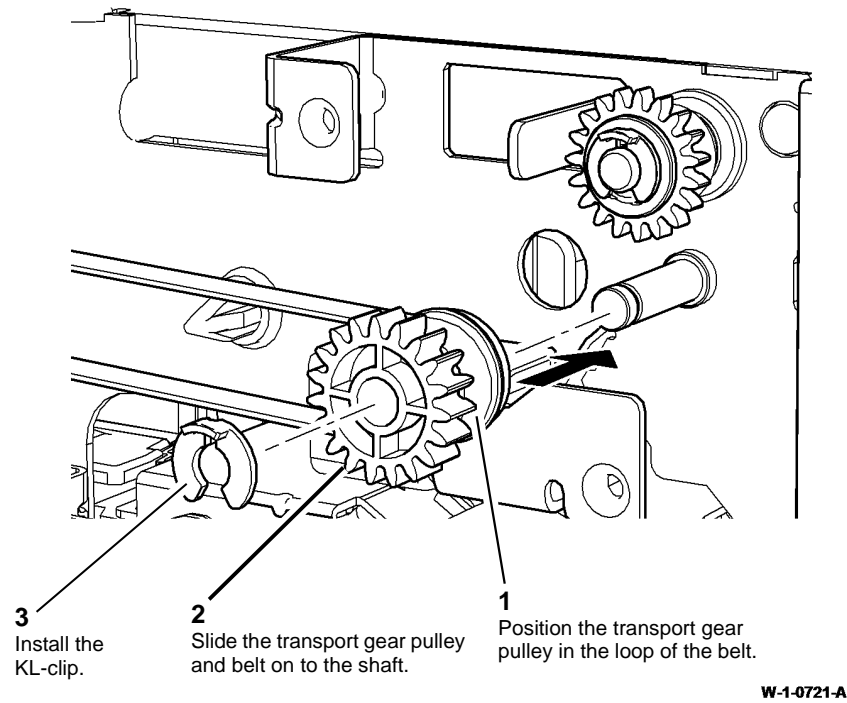
Figure 2 Drive belt installation

1. Install the transport gear pulley, [Figure 2](#).

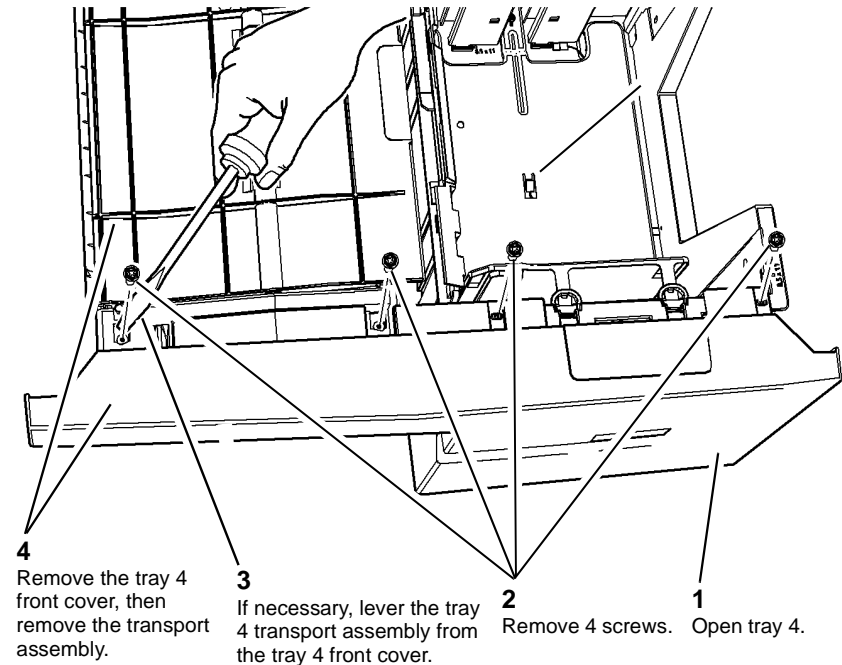
Figure 1 Transport assembly removal

1. Remove the tray 4 transport assembly, [Figure 1](#).

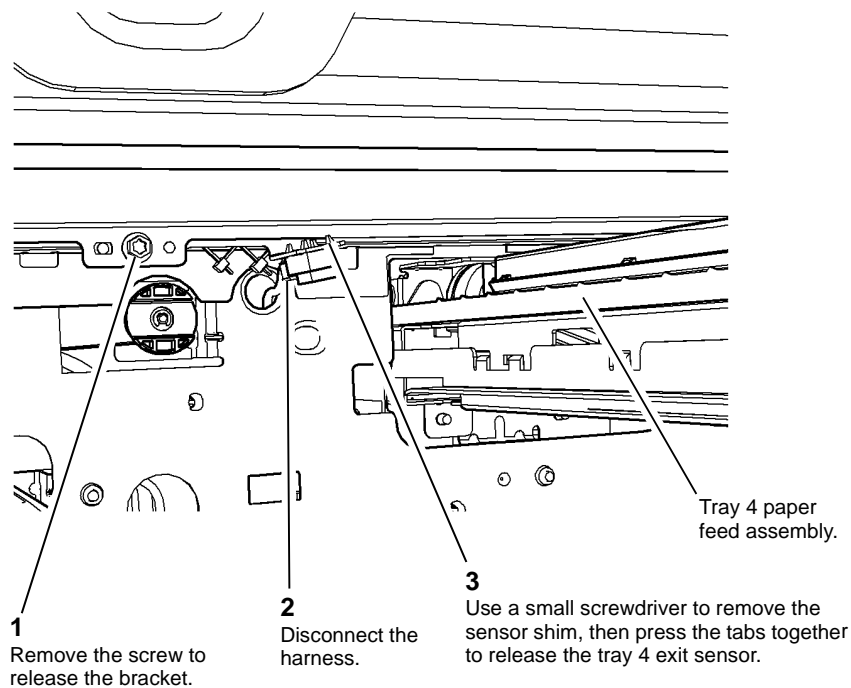
Figure 1 Tray 4 exit sensor removal

1. Remove the tray 3 assembly, [REP 70.5](#).
2. Remove the tray 4 assembly, [REP 70.14](#).
3. Remove the tray 4 exit sensor, [Figure 1](#).

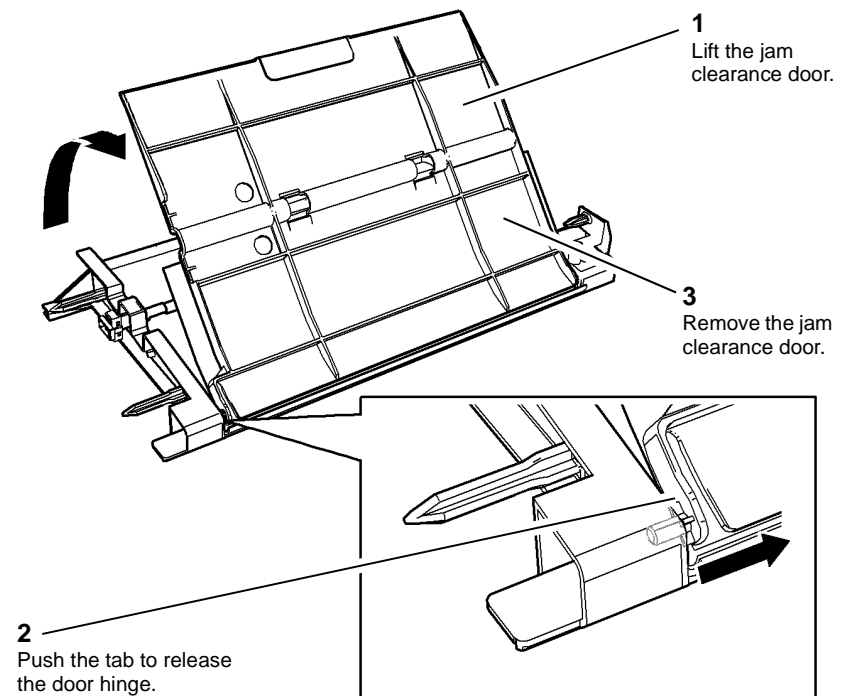
Figure 1 Jam clearance door removal

1. Remove the tray 4 transport assembly, [REP 80.24](#).
2. Remove the jam clearance door, [Figure 1](#).

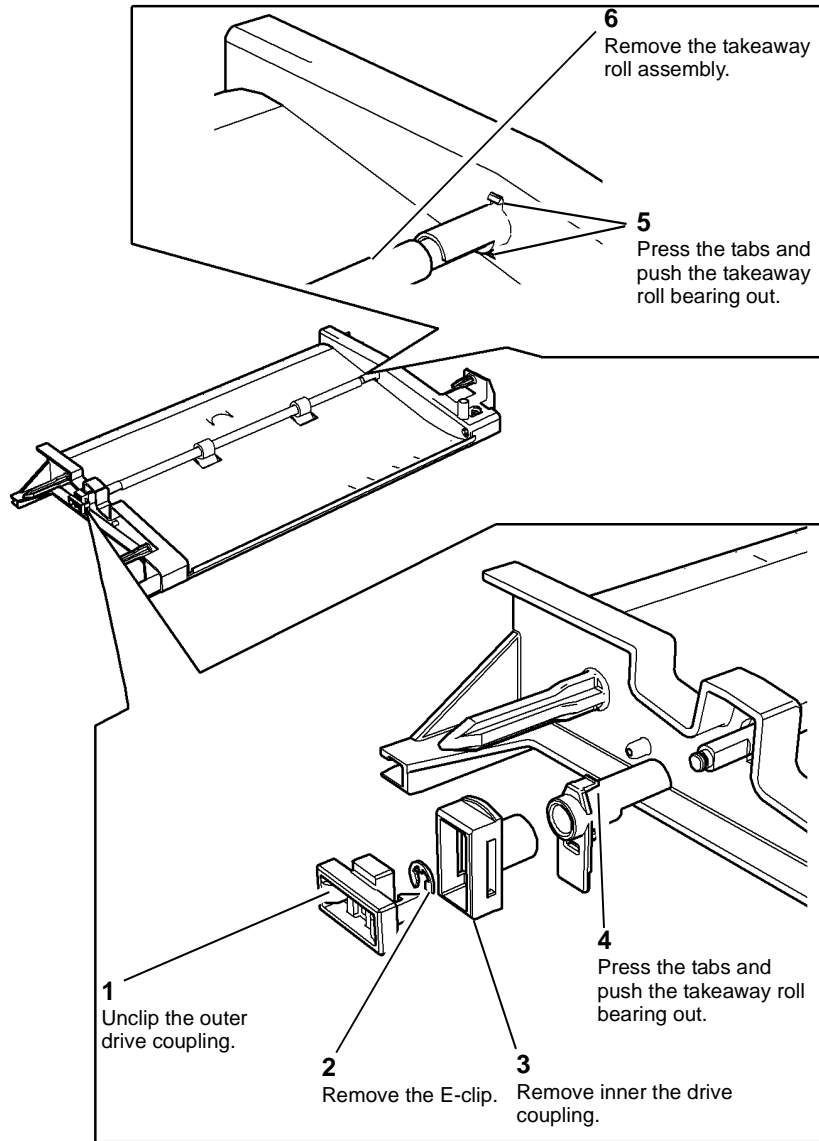
Figure 2 Takeaway roll removal

3. Remove the takeaway roll assembly, [Figure 2](#).

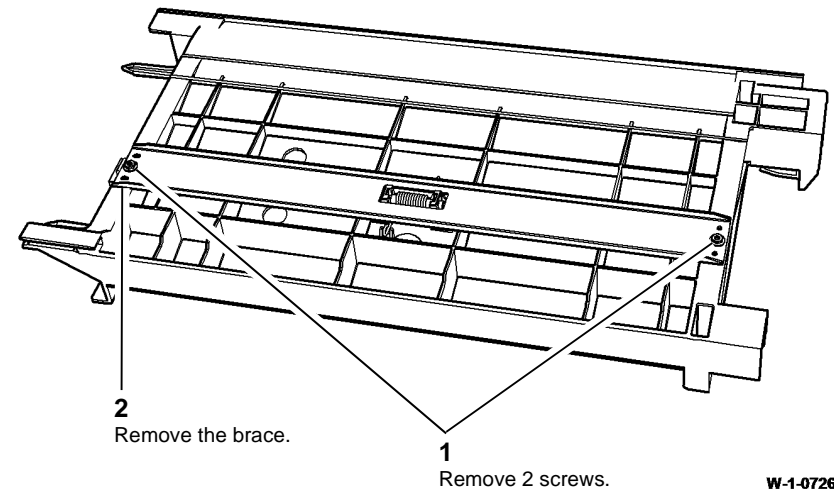
Figure 3 Brace removal

4. If necessary, remove the tray 4 transport brace, [Figure 3](#), and the idler roll assembly, [Figure 4](#).

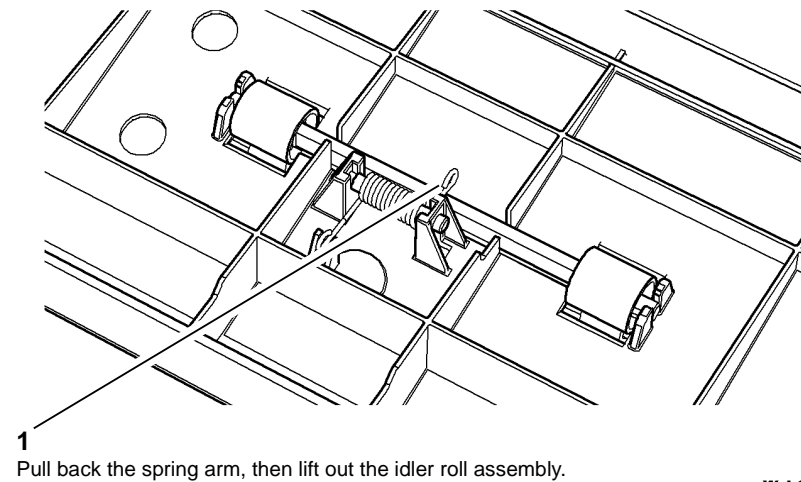
Figure 4 Idler rolls removal

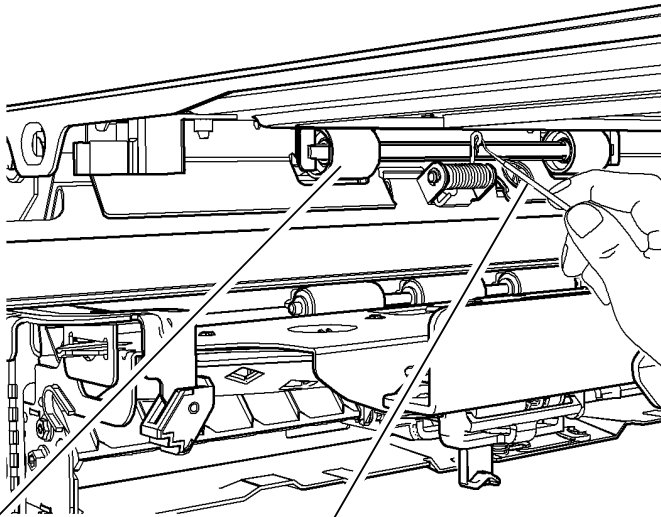
2
Remove the idler roll assembly.

1
Use a spring hook to pull the spring leg away from the idler roll assembly.

Figure 1 Idler shaft removal

1. Remove the lower left cover, [PL 70.26 Item 7](#).
2. Remove the tray 3 assembly, [REP 70.5](#).
3. Remove the tray 4 transport assembly, [REP 80.24](#).
4. Remove the idler roll assembly, [Figure 1](#).

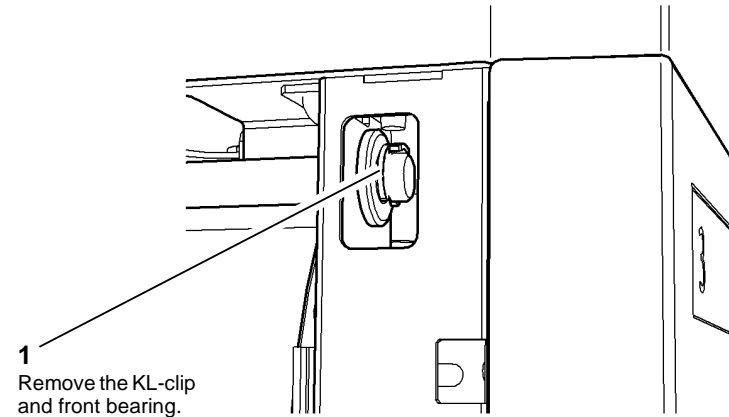
1
Remove the KL-clip and front bearing.

5. Remove the HCF transport motor, [REP 80.22](#).
6. Prepare to remove the HCF transport roll, [Figure 2](#).

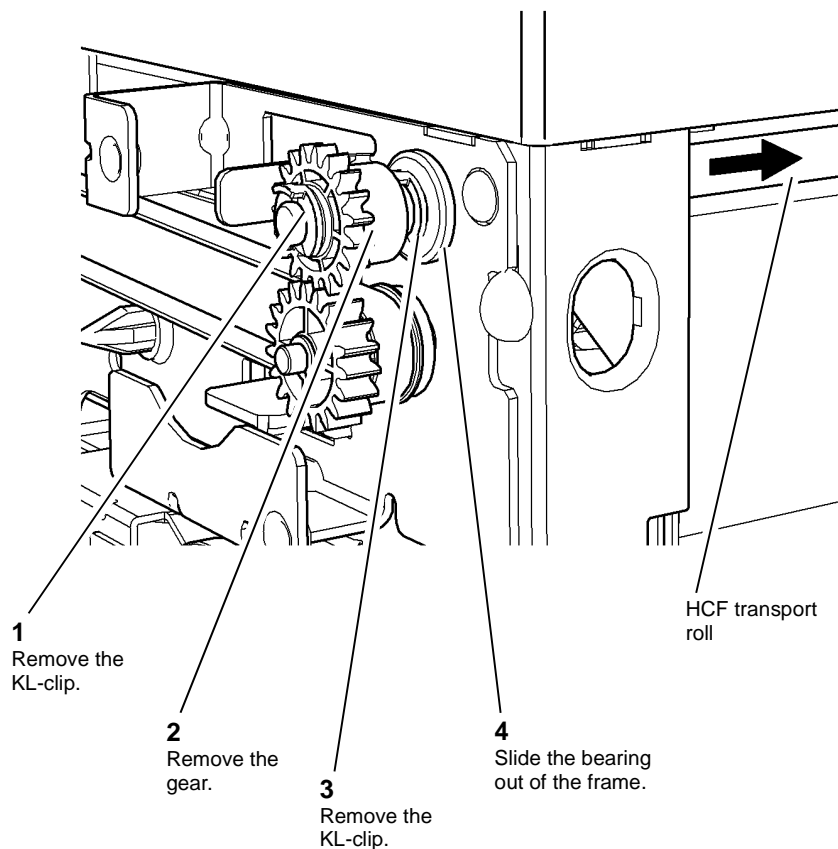
6
Slide the HCF transport roll to the front and remove.

5
Slide the HCF transport roll to the rear to release the roll from the front of the frame.

Figure 3 Transport roll removal

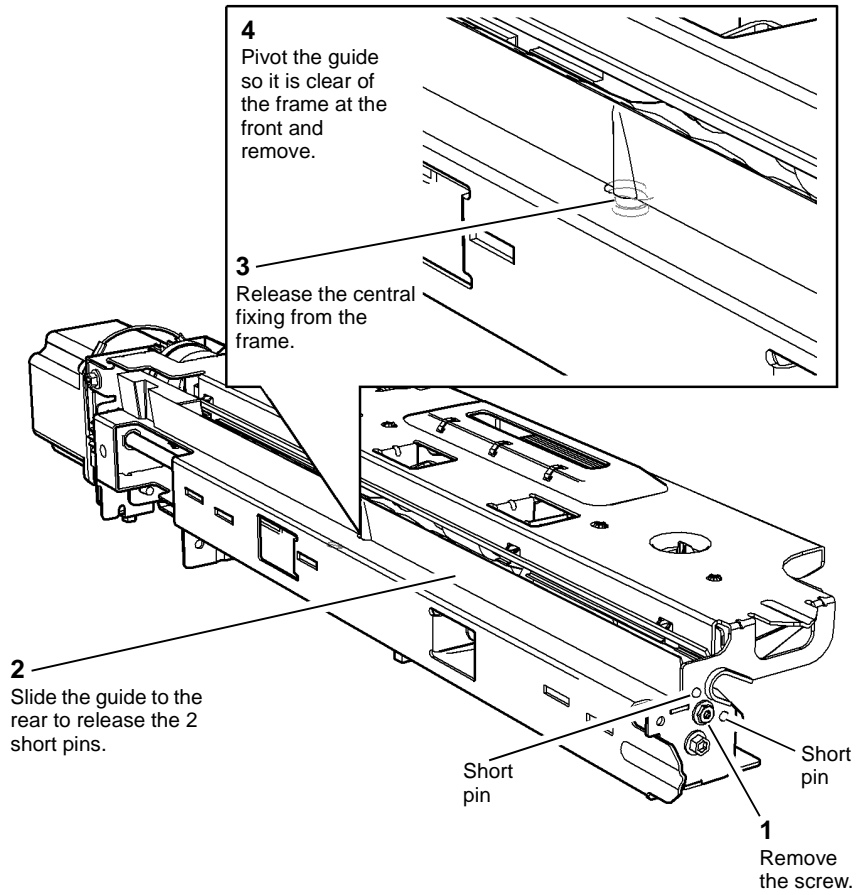
W-1-0754-A

Figure 1 Paper guide removal

1. Remove the tray 3 paper feed assembly, [REP 80.20](#).
2. Remove the tray 3 paper guide, [Figure 1](#).

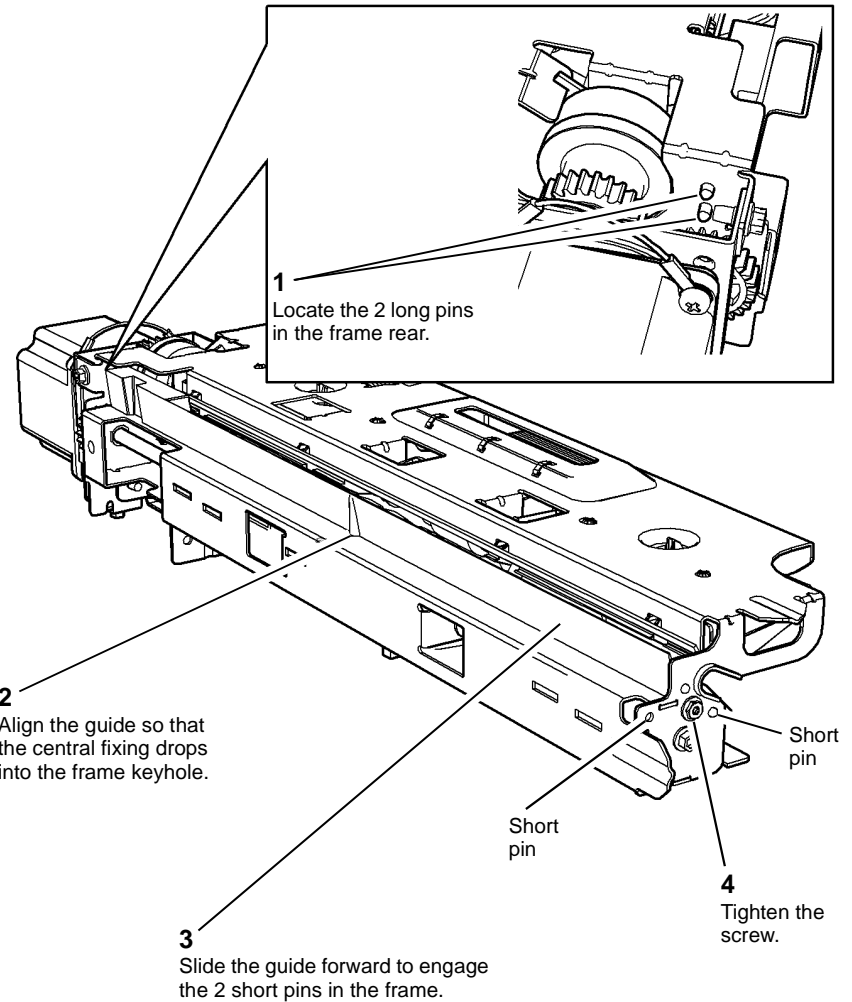
W-1-0755-A

Figure 2 Paper guide replacement

1. Install the tray 3 paper guide, [Figure 2](#).
