708P91139
February 2016

Xerox® WorkCentre® 5945 Family Multifunction Printer Service Manual

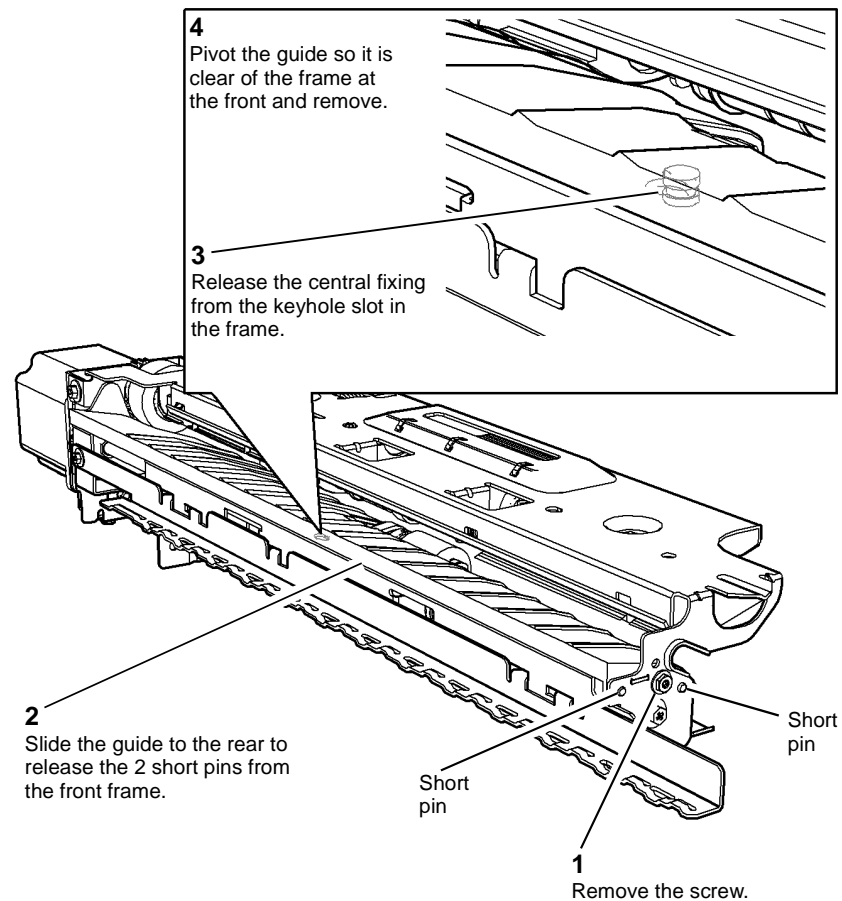
W-1-0752-A

Figure 1 Paper guide removal

1. Remove the tray 4 paper feed assembly, [REP 80.21](#).
2. Remove the tray 4 paper guide, [Figure 1](#).

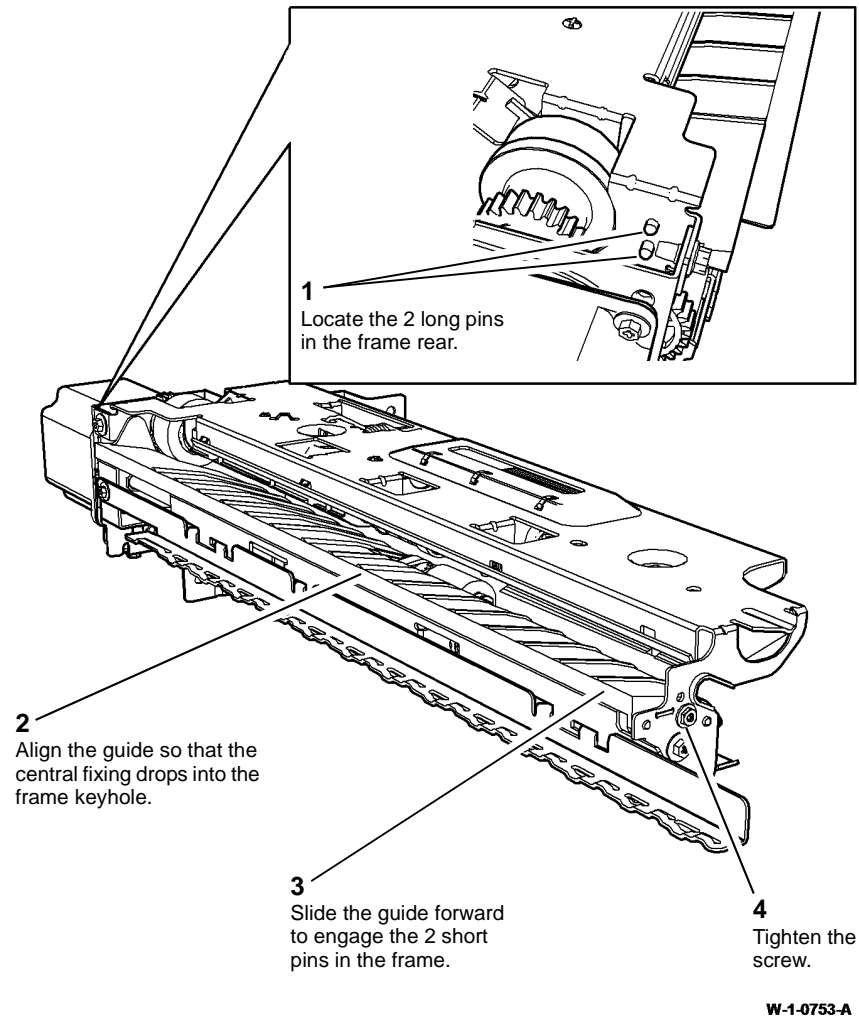
Figure 2 Paper guide replacement

1. Install the tray 4 paper guide, [Figure 2](#).

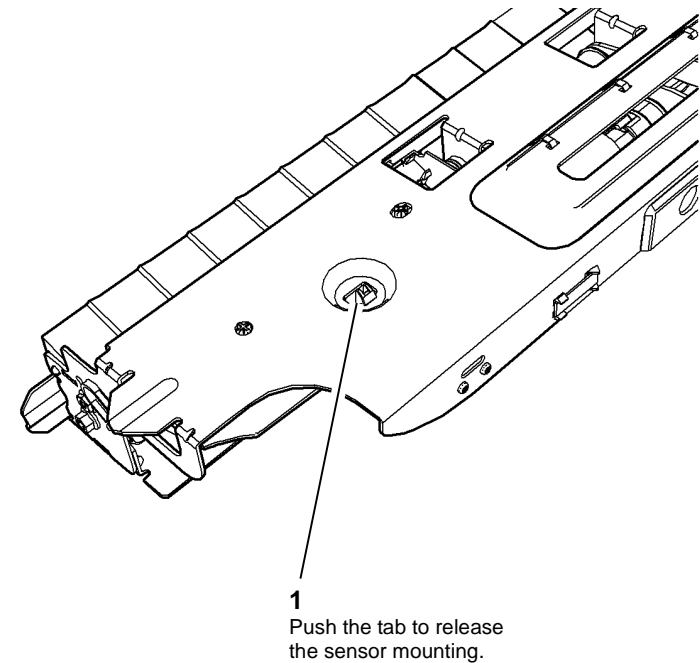
Figure 1 Sensor mounting release

1. Remove the tray 3 paper feed assembly, [REP 80.20](#).
2. Release the sensor mounting, [Figure 1](#).

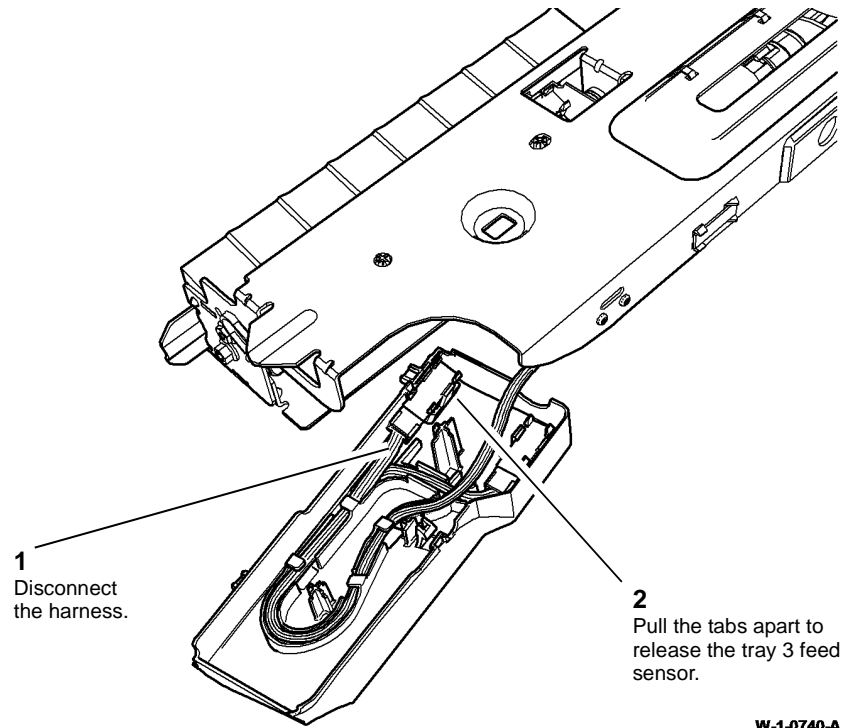
1
Disconnect
the harness.

2
Pull the tabs apart to
release the tray 3 feed
sensor.

3. Remove the tray 3 feed sensor, [Figure 2](#).

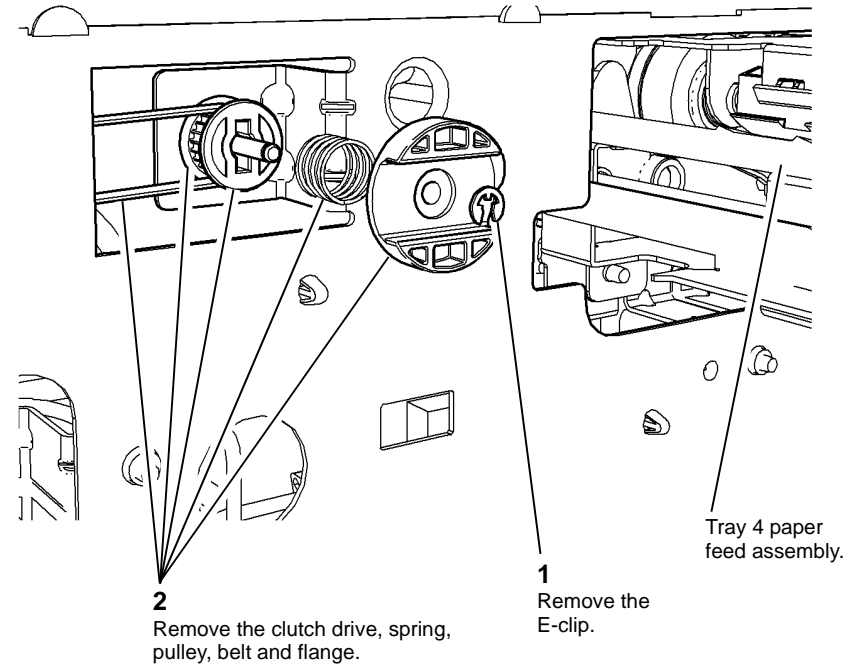
2
Remove the clutch drive, spring,
pulley, belt and flange.

1
Remove the
E-clip.

1. Remove tray 1 and 2, [REP 70.1](#).
2. Remove the tray 4 transport assembly, [REP 80.24](#).
3. Remove tray 3 [REP 70.5](#).
4. Remove the tray 4 transport gear pulley, [REP 80.23](#).
5. Remove the tray 4 transport clutch drive assembly, [Figure 1](#).

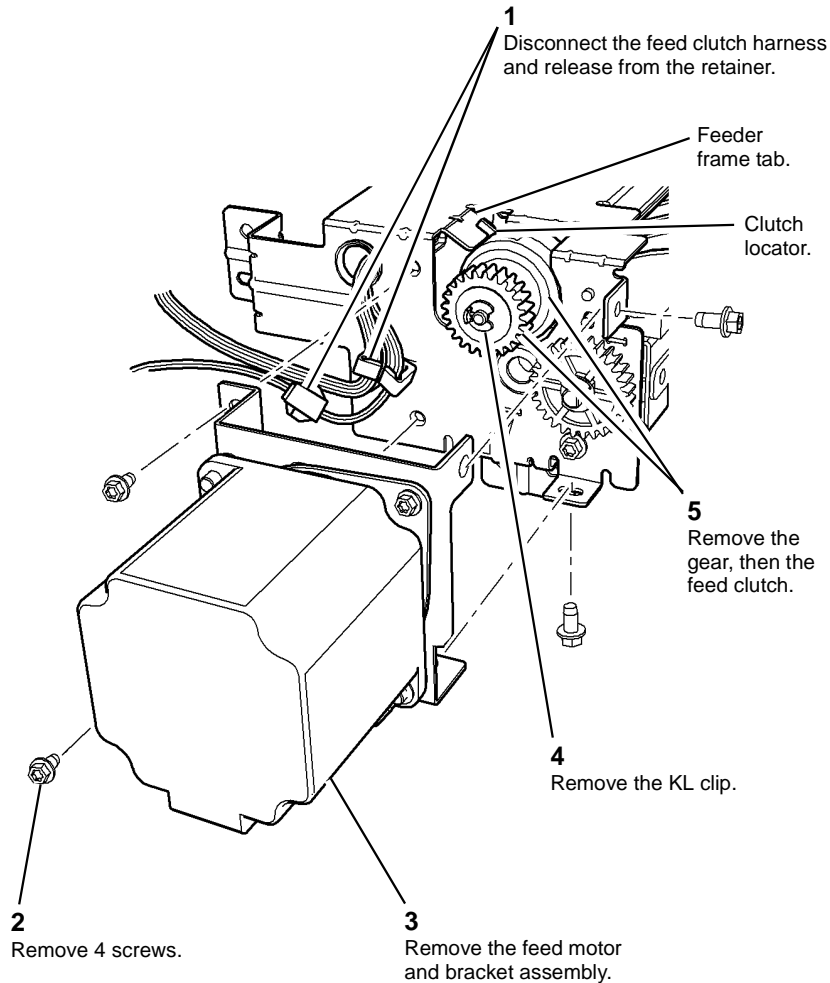
W-1-1425-A

Figure 1 Feed clutch removal

1. Remove the appropriate paper feed assembly:
 - [REP 80.20](#) for tray 3.
 - [REP 80.21](#) for tray 4.
2. Remove the feed clutch, [Figure 1](#).

1. Replacement is the reverse of the removal procedure.
2. Ensure that the clutch locator is engaged with the feeder frame tab, [Figure 1](#).

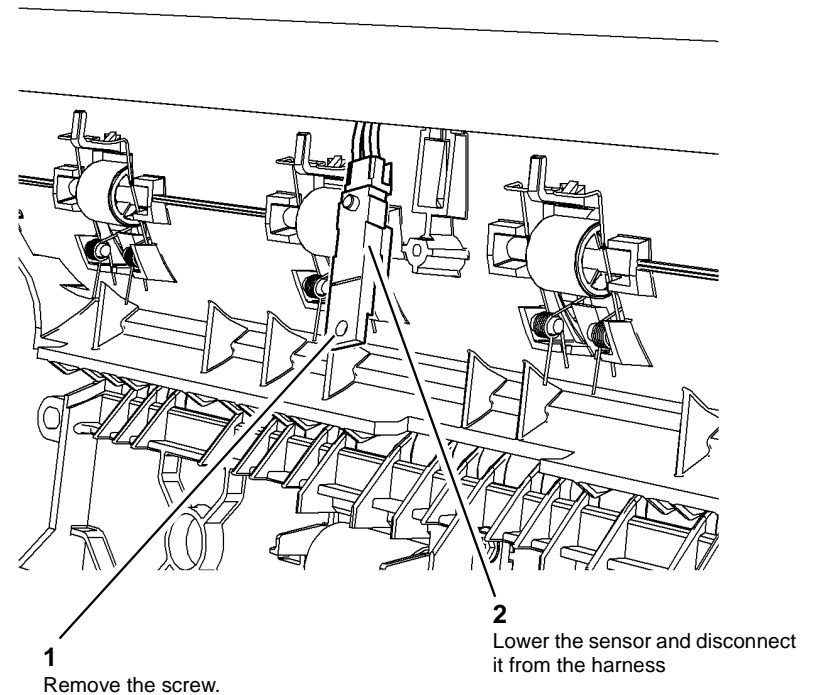
W-1-1430-A

Figure 1 Duplex sensor disconnection

- Perform [REP 80.2](#) Tray 1 and Tray 2 TAR Sensors and Lower Left Door Paper Guide to release the left door sensor and fan harness from the tray 1 and tray 2 tar sensors.
- Remove the left door cover, [REP 80.13](#).
- Close the left door. Disconnect the harness from the duplex sensor, [Figure 1](#).

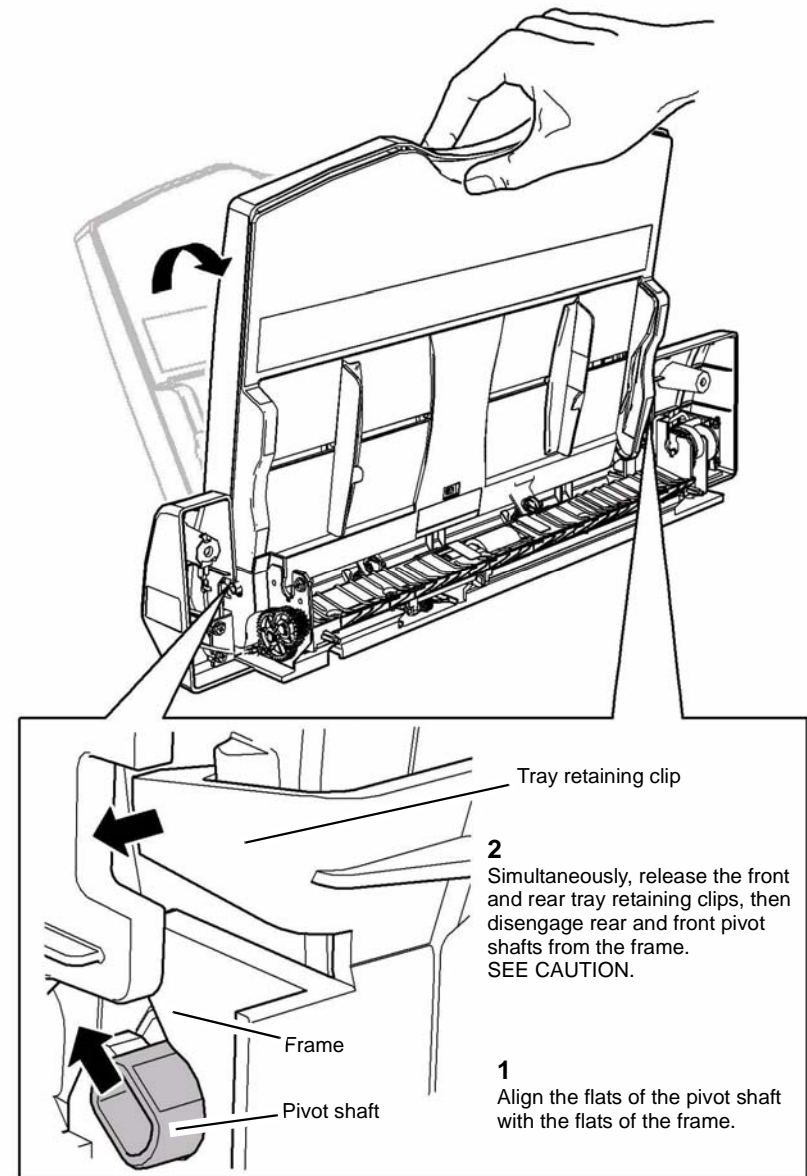
W-1-1462-A

Figure 1 Access the retard shield

1. Remove the bypass tray assembly, REP 70.2.
2. Release the bypass elevate tray assembly to gain access to the mylar retard shield, Figure 1.

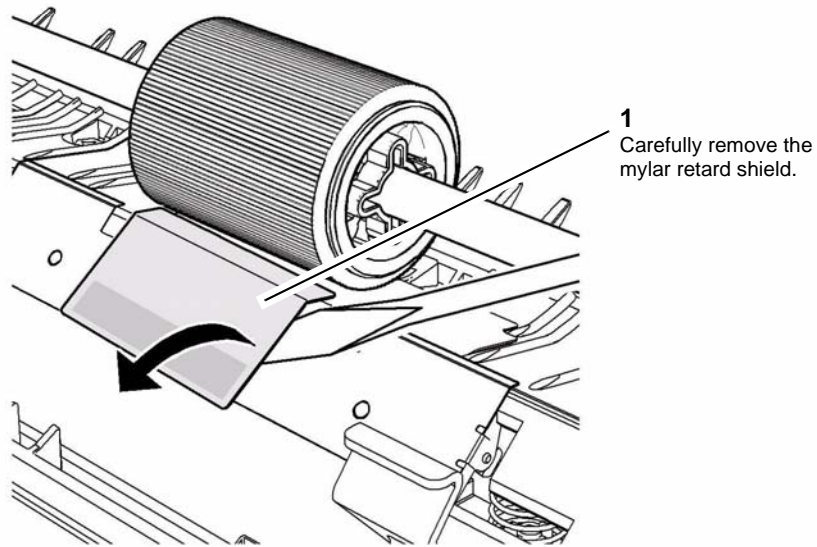
W-1-1463-A

Figure 2 Retard shield removal

3. Remove the mylar retard shield, [Figure 2](#).

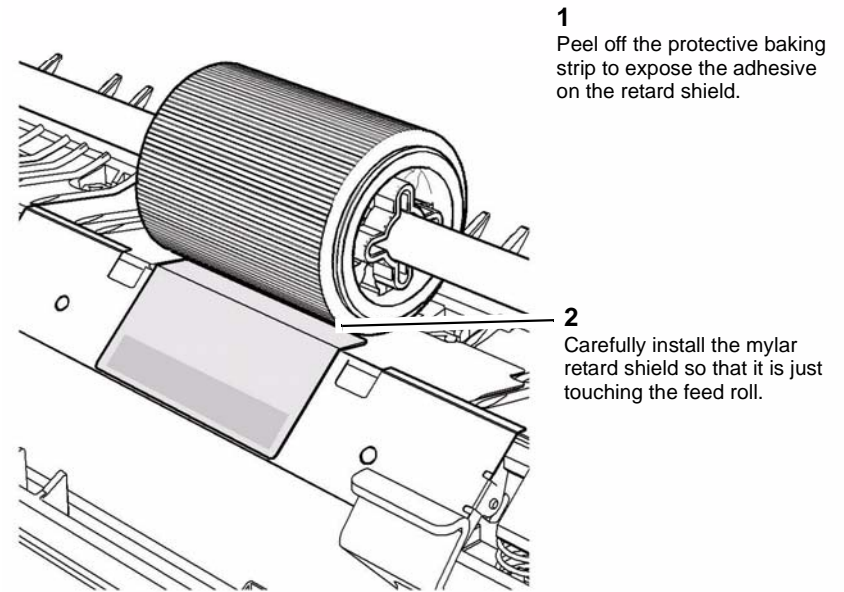
W-1-1464-A

Figure 3 Retard shield installation

1. Install the mylar retard shield, [Figure 3](#).

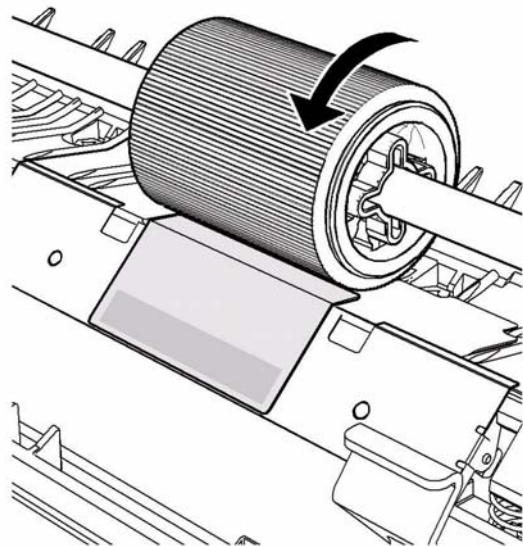
2. Ensure that the mylar retard shield is making contact with the feed roll

1
Manually turn the feed roll in the feed direction, you should hear the mylar retard shield rubbing on the feed roll.

2
If necessary remove then reinstall the mylar retard shield a little closer to the feed roll.

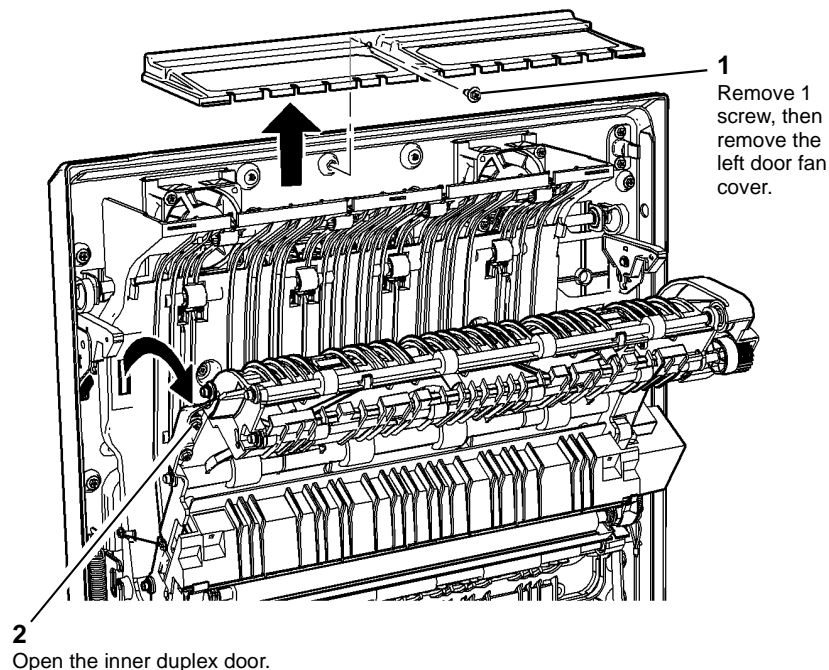
W-1-1448-A

Figure 1 Preparation

1. Open the left door.
2. [Figure 1](#), prepare to remove the left door fans.

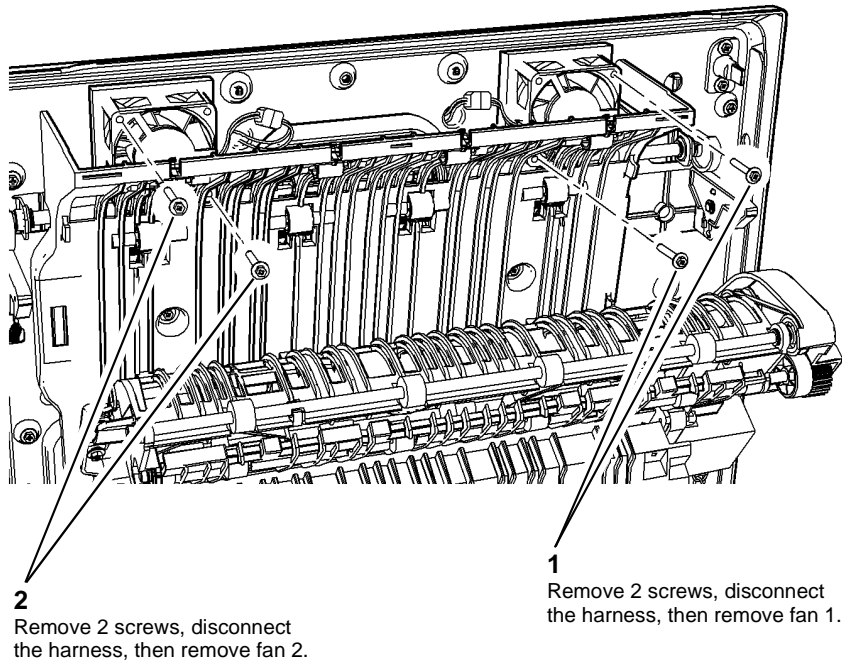
W-1-1449-A

Figure 2 Left door fans removal

3. **Figure 2**, remove the left door fans.

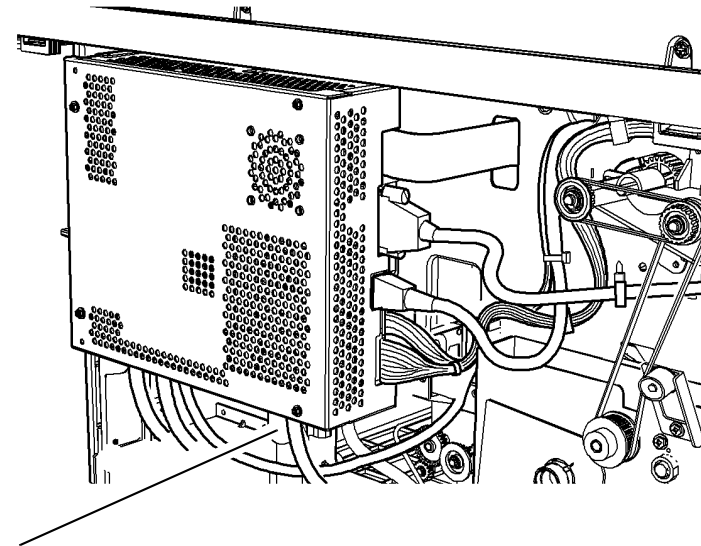
W-1-1315-A

1
Disconnect PJ850.

1. Remove the toner cartridge, [PL 90.17 Item 2](#).
2. Remove the print cartridge, [PL 90.17 Item 9](#), then place in a lightproof bag.
3. Remove the rear cover, [REP 28.2](#).
4. Remove the relevant component:
 - Centre output tray, [REP 28.1](#).
 - Horizontal transport, [REP 10.6](#).
5. Disconnect PJ850 from the [SBC PWB](#), [Figure 1](#).

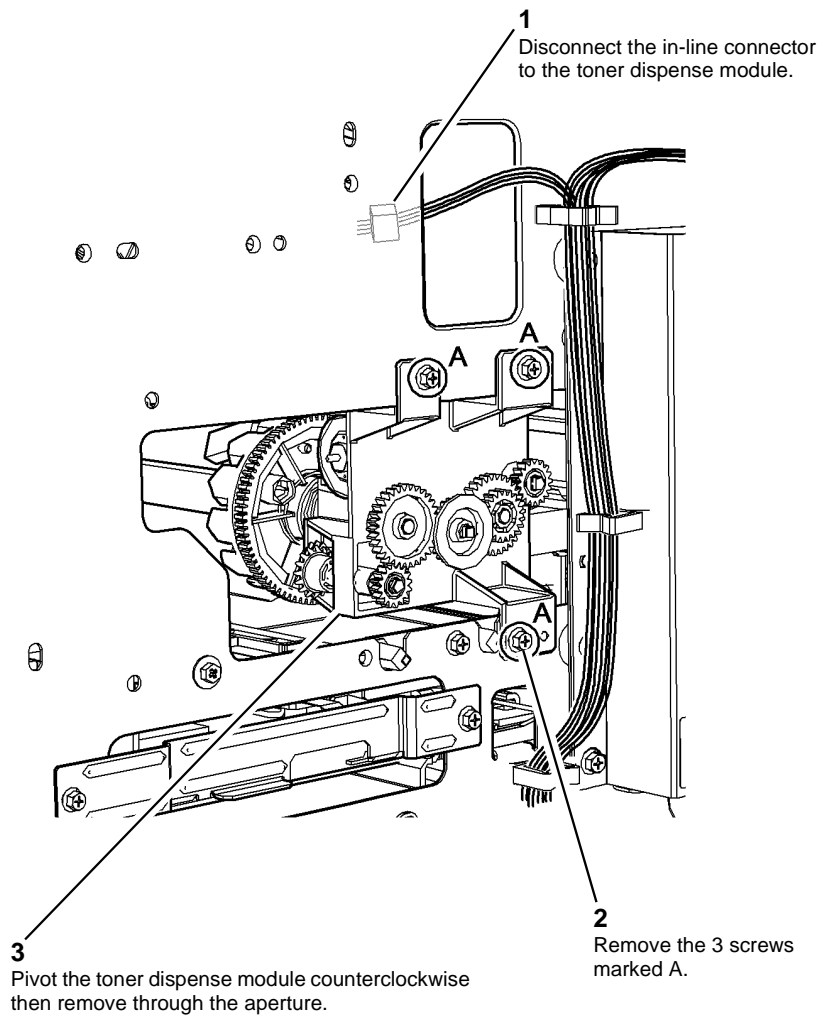
W-1-112-A

NOTE: For clarity, the SBC module is not shown in [Figure 2](#).

Figure 2 Module removal

- Remove the toner dispense module, [Figure 2](#).

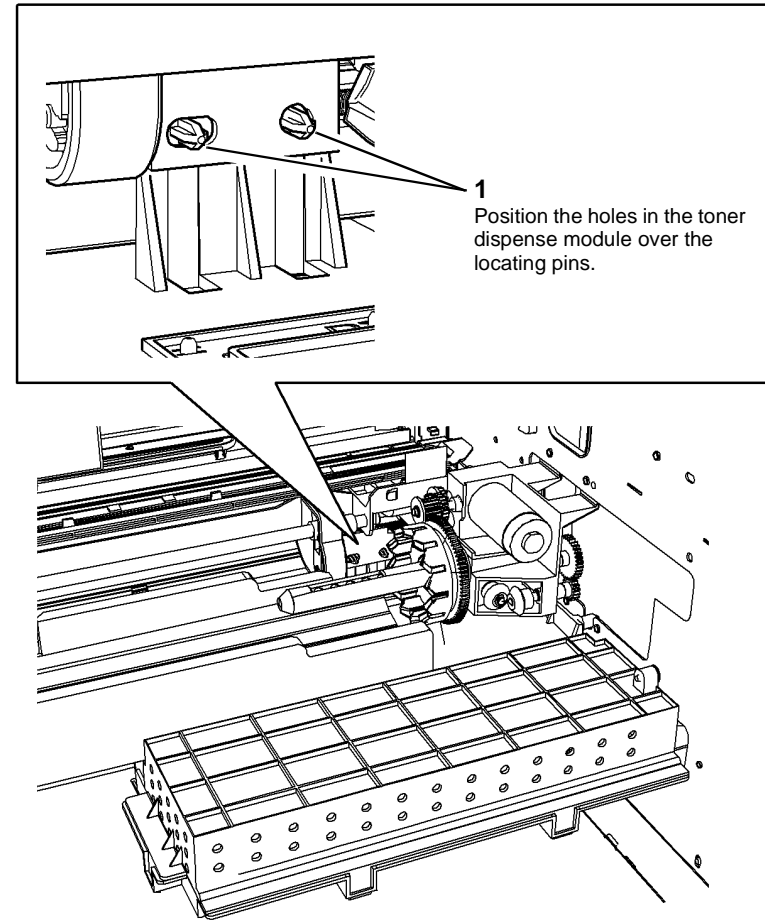
W-1-1113-A

- The replacement is the reverse of the removal procedure.
- When installing the toner dispense module, ensure the locating pins on the HVPS tray assembly are inserted in the holes in the toner dispense module, [Figure 3](#).

Figure 3 Installation

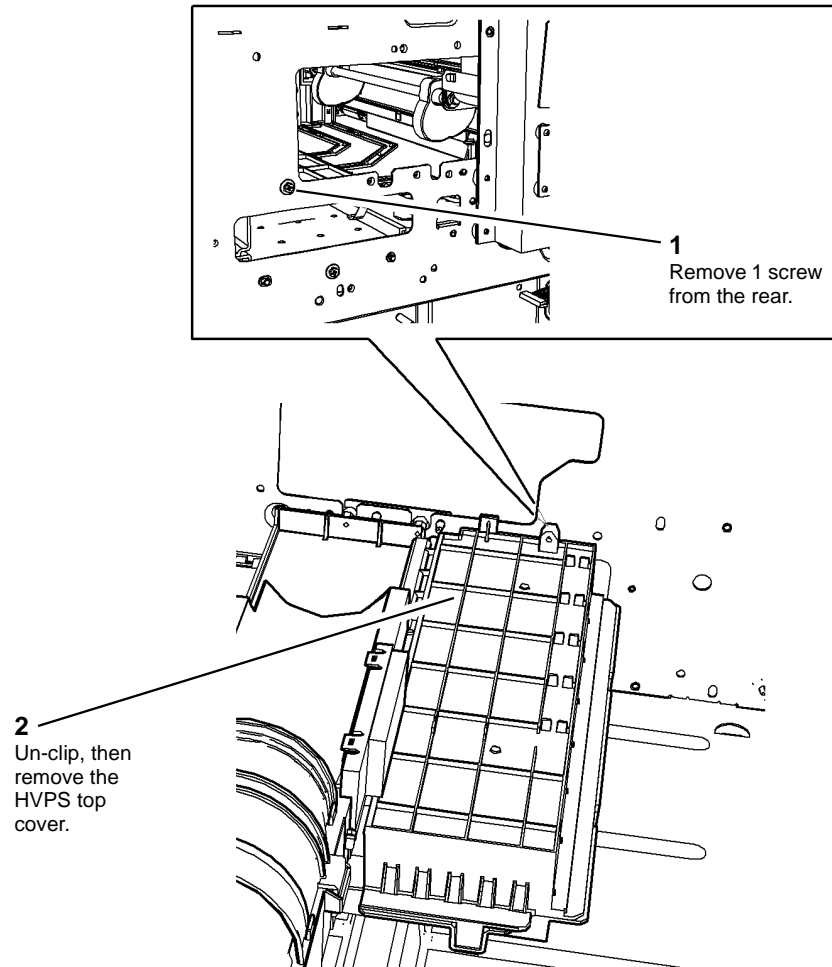
W-1-1107-A

Figure 1 HVPS top cover removal

7. Remove the HVPS top cover, [Figure 1](#).

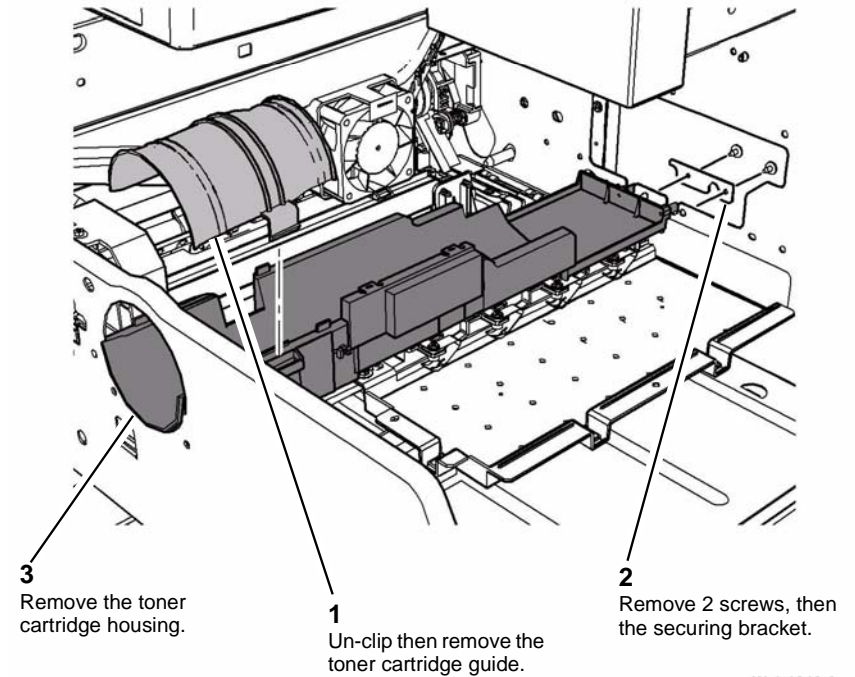
W-1-1246-A

Figure 2 Toner cartridge removal

8. Remove the toner cartridge housing, [Figure 2](#).

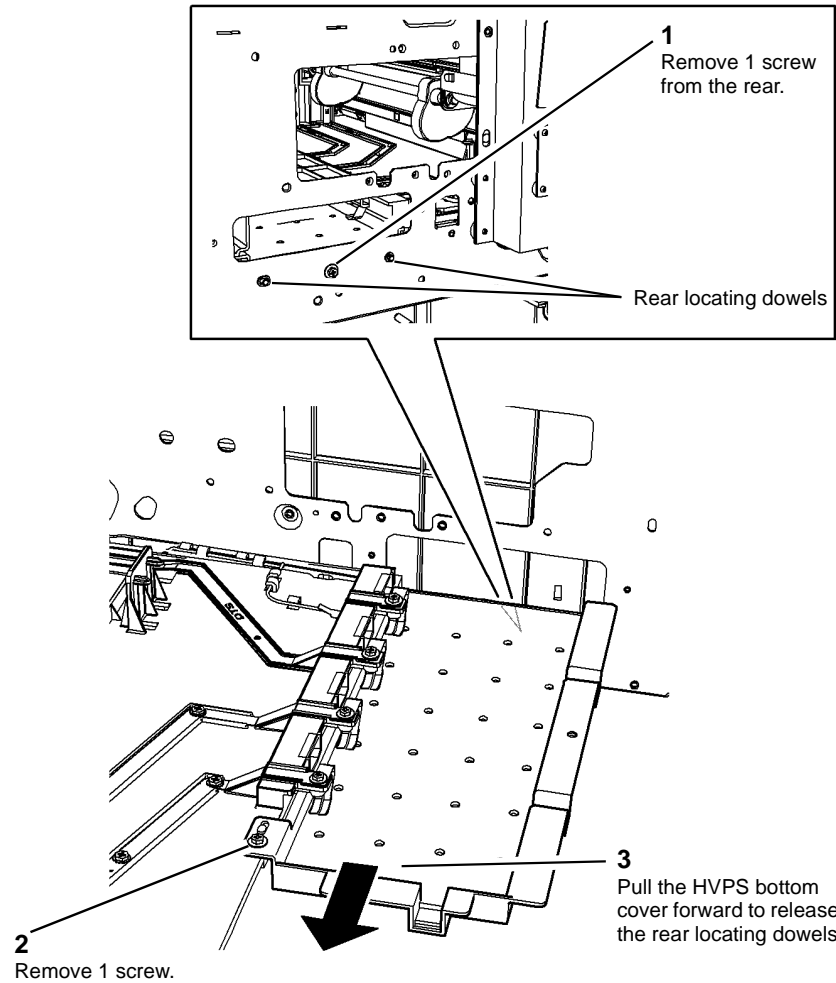
W-1-1247-A

Figure 3 Preparation

9. Prepare to remove the HVPS tray assembly, [Figure 3](#).

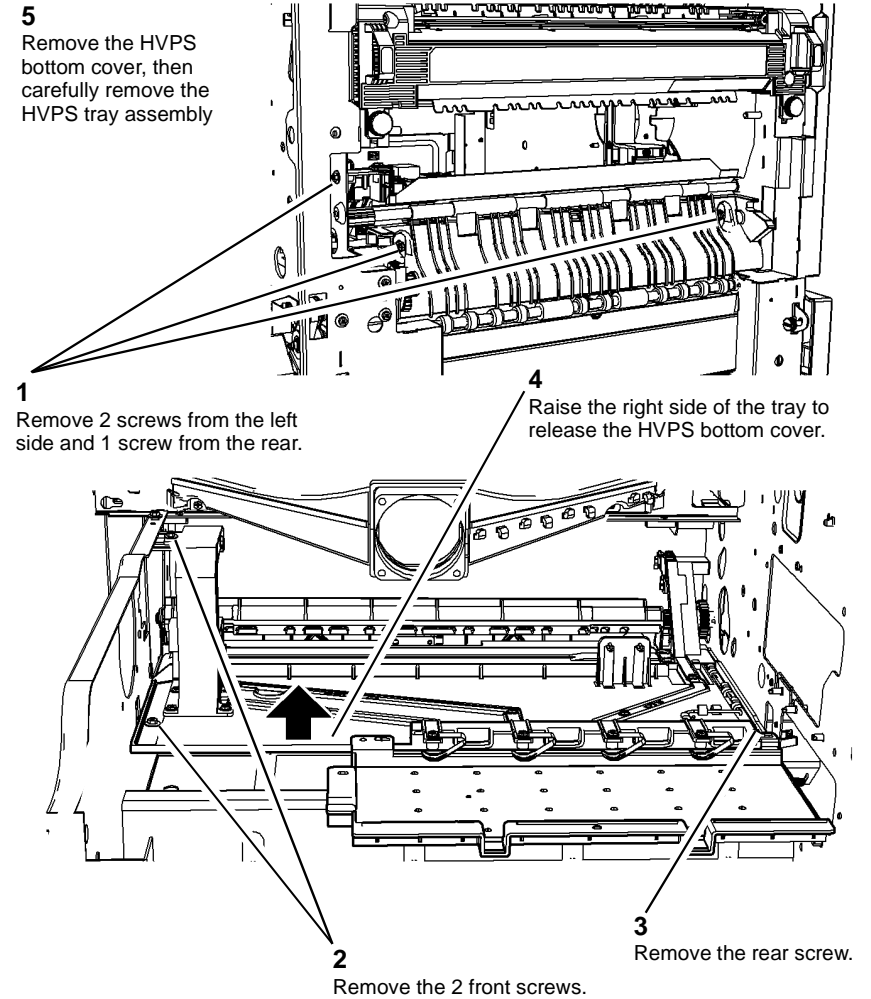
W-1-1108-A

Figure 4 Removal

10. Remove HVPS bottom cover and the HVPS tray assembly, [Figure 4](#).

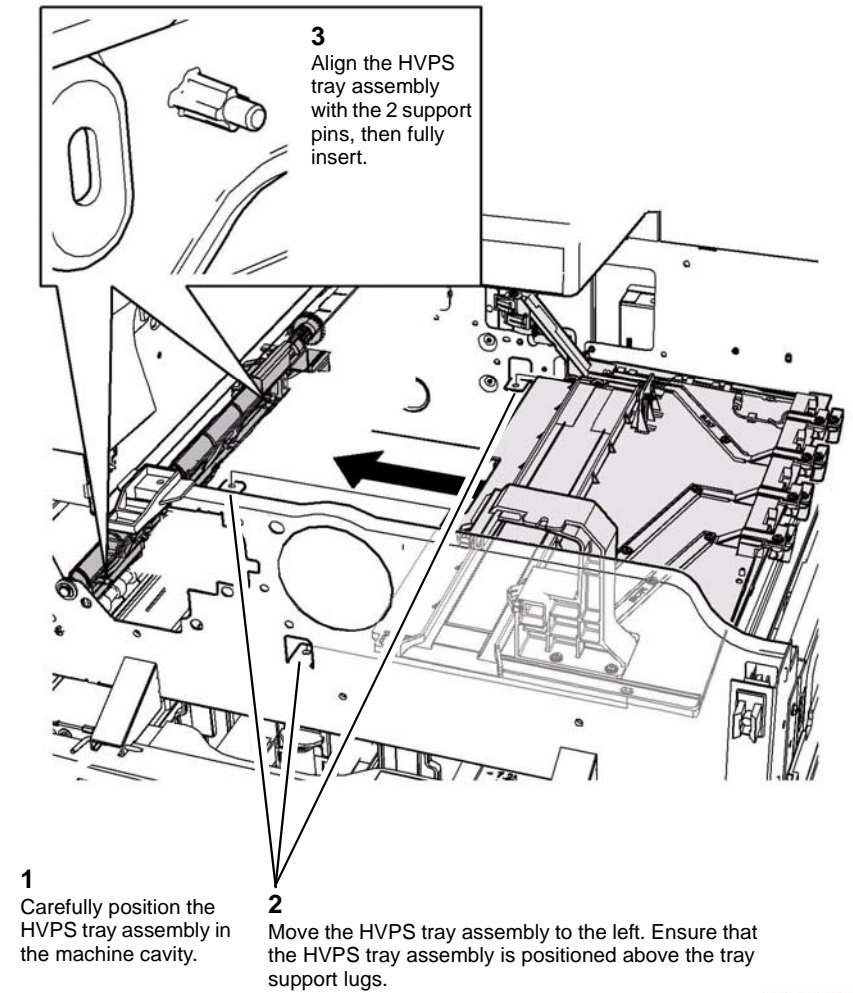
W-1-1110-A

NOTE: For clarity, the print cartridge fan duct is not shown in [Figure 5](#).

Figure 5 HVPS tray assembly installation

1. Install the HVPS tray assembly, [Figure 5](#).

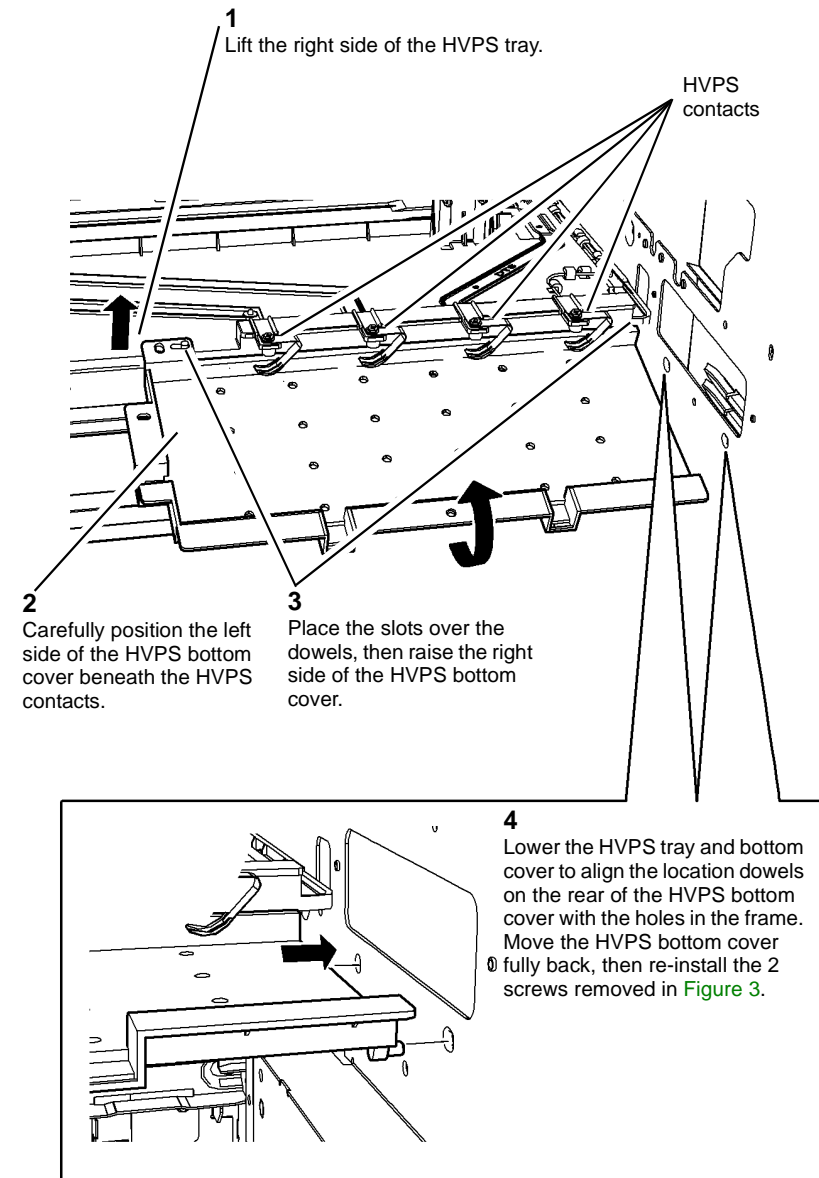
W-1-1109-A

Figure 6 Bottom cover install

2. Install the HVPS bottom cover, [Figure 6](#).

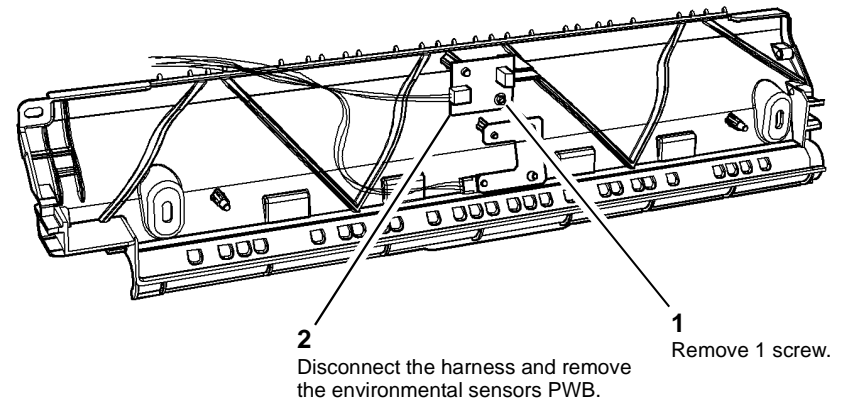
W-1-1111-A

Figure 1 Removal

1. Remove the registration transport assembly, **REP 80.4**.
2. Remove the environmental sensors PWB, **Figure 1**.

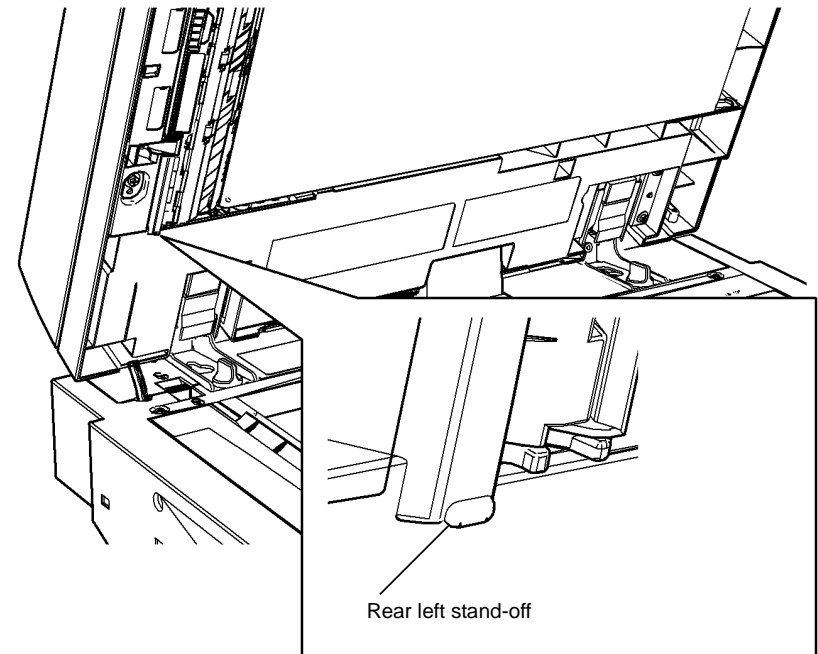
W-1-0757-A

Figure 1 Rear left stand-off location

1. Check the gap between the rear left stand-off, [Figure 1](#), and the CVT glass. Also check the gap between the front left stand-off, [Figure 2](#), and the CVT glass.

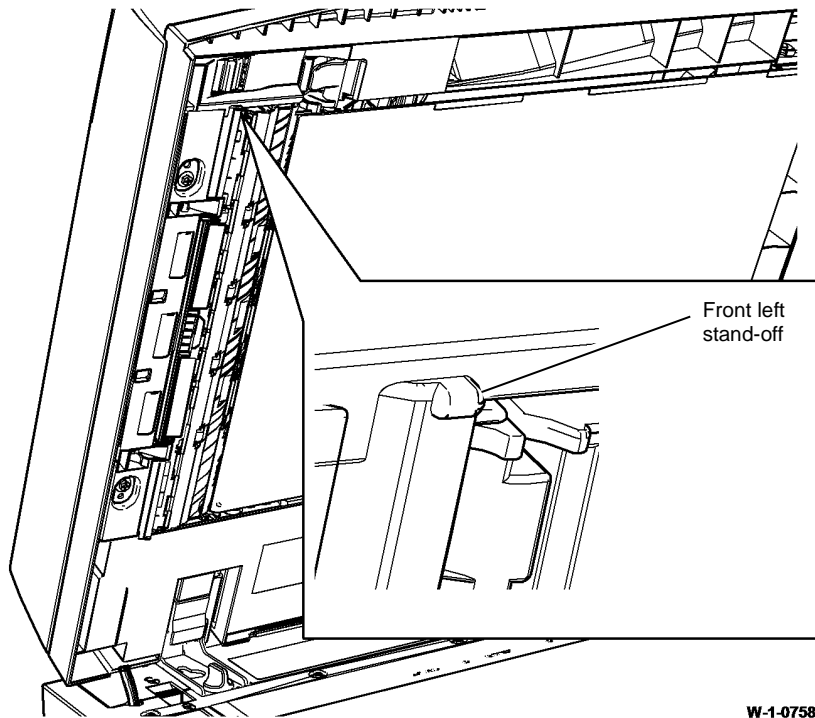
W-1-0758-A

Figure 2 Front left stand-off location

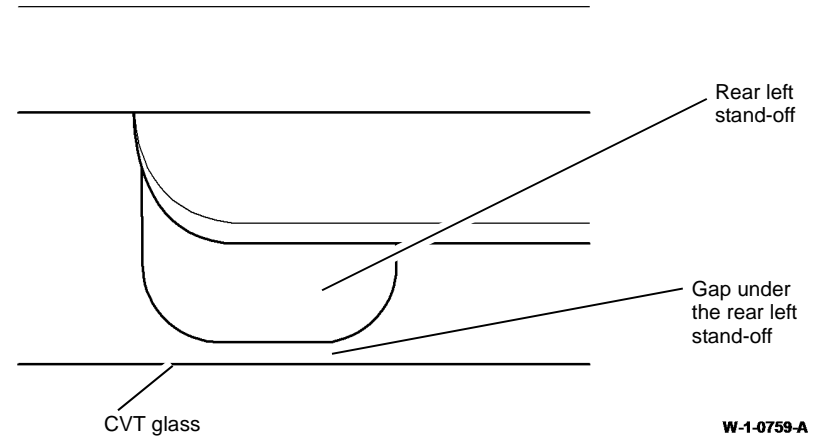
W-1-0759-A

Figure 3 Rear left stand-off gap

2. Switch the machine on, [GP 14](#).
3. Lift the SPDH then lower it back down so that the scanner module lamp illuminates. View the rear left stand-off gap, [Figure 3](#), in the space between the SPDH and the scanner module. The rear left stand-off must just touch the CVT glass.

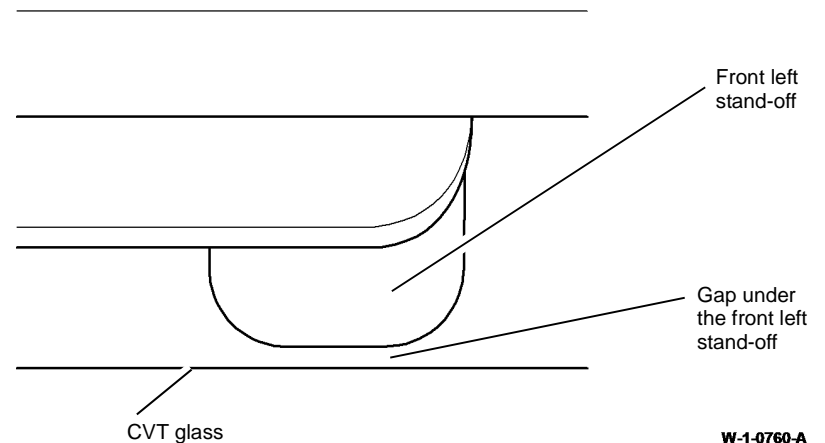
W-1-0760-A

Figure 4 Front left stand-off gap

4. View the front left stand-off gap, [Figure 4](#), in the space between the SPDH and the scanner module. The front left stand-off must just touch the CVT glass.

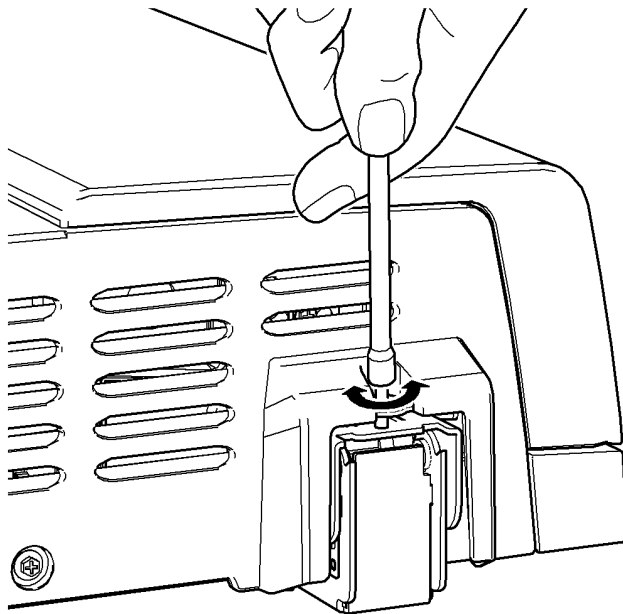
NOTE: If the rear of the SPDH is lowered too far then it will start to lift the front off the CVT glass.

NOTE: If the front of the SPDH is lowered too far then it will start to lift the rear off the CVT glass.

Turn the screw clockwise to raise the rear and lower the front of the SPDH.

Turn the screw counterclockwise to lower the rear and raise the front of the SPDH.

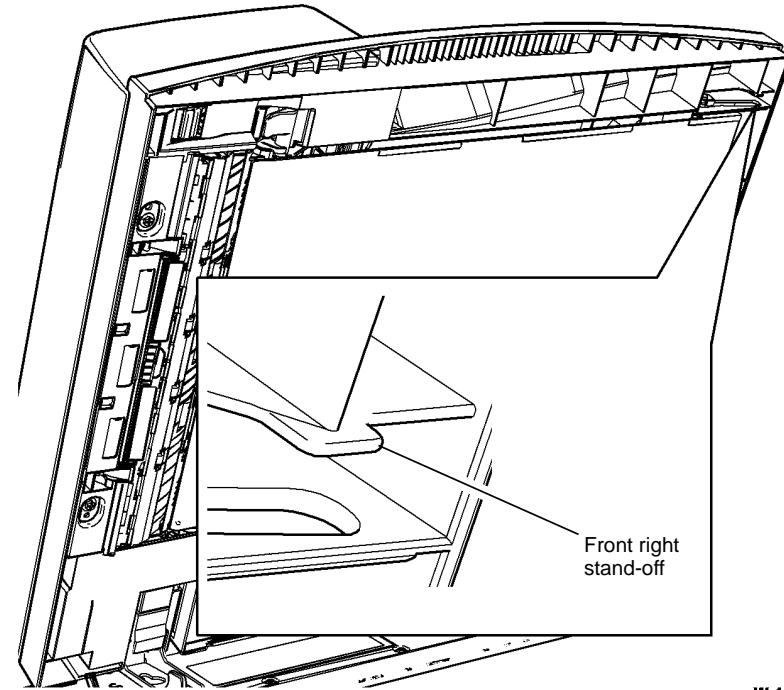
W-1-0762-A

Figure 6 Front right stand-off location

1. Check the gap between the front right stand-off, [Figure 6](#), and the document glass.

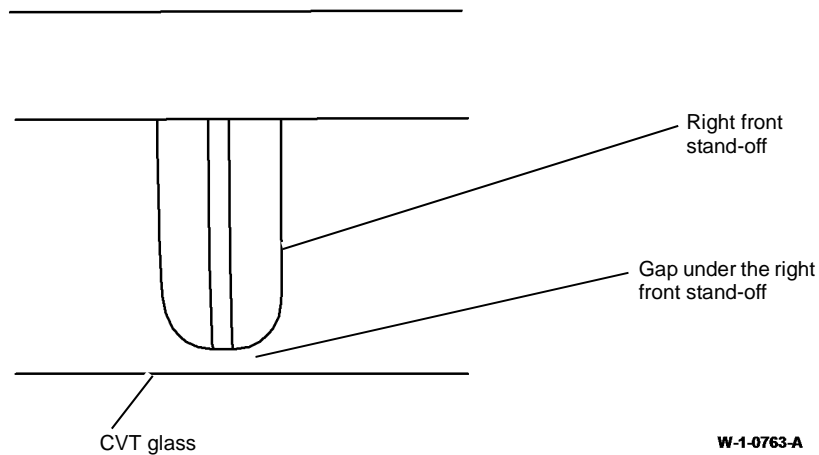
Figure 7 Front right stand-off gap

- View the front right stand-off gap, [Figure 7](#), in the space between the SPDH and the scanner module. The front right stand-off must just touch the document glass.

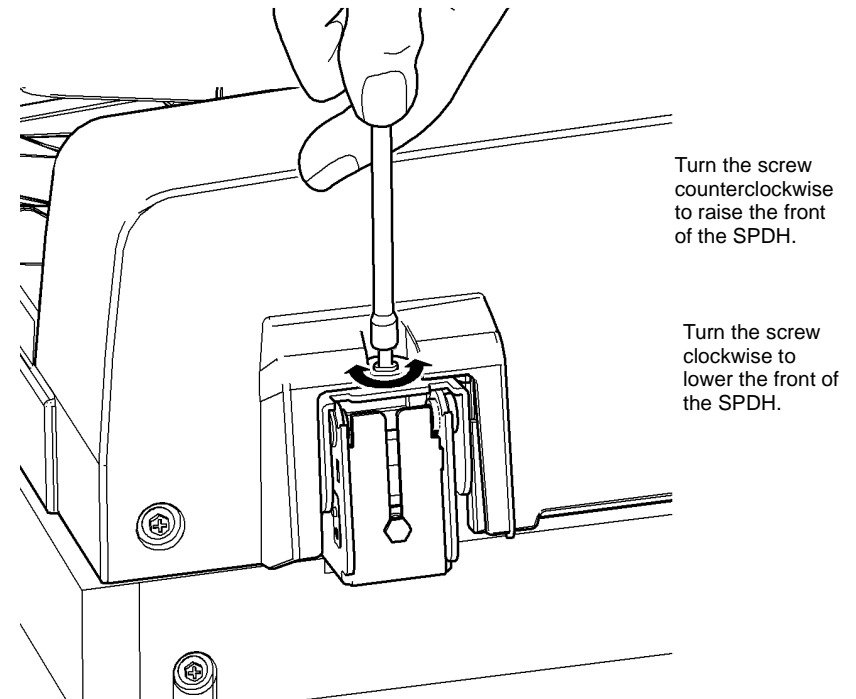
NOTE: It should only be necessary to adjust the height by approximately 1 turn of the adjustment screw. Observe the stand-off whilst adjusting the screw. Stop when the front right stand-off is in contact with the document glass.

Figure 8 Right side adjustment

- [Figure 8](#), adjust the right counterbalance.

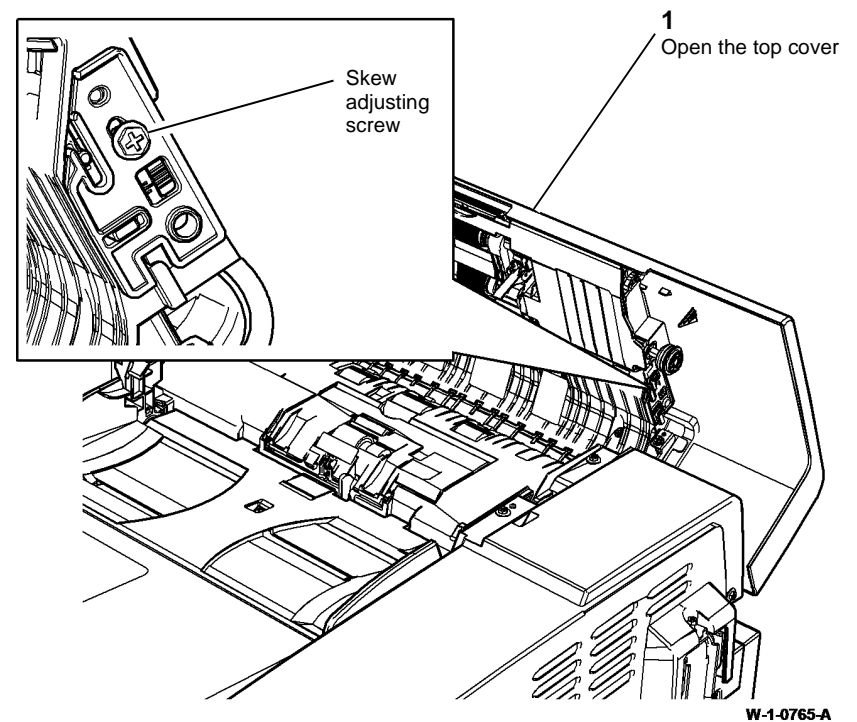
Figure 1 Adjusting screw location

1. From the rear of the SPDH locate the skew adjusting screw, [Figure 1](#).

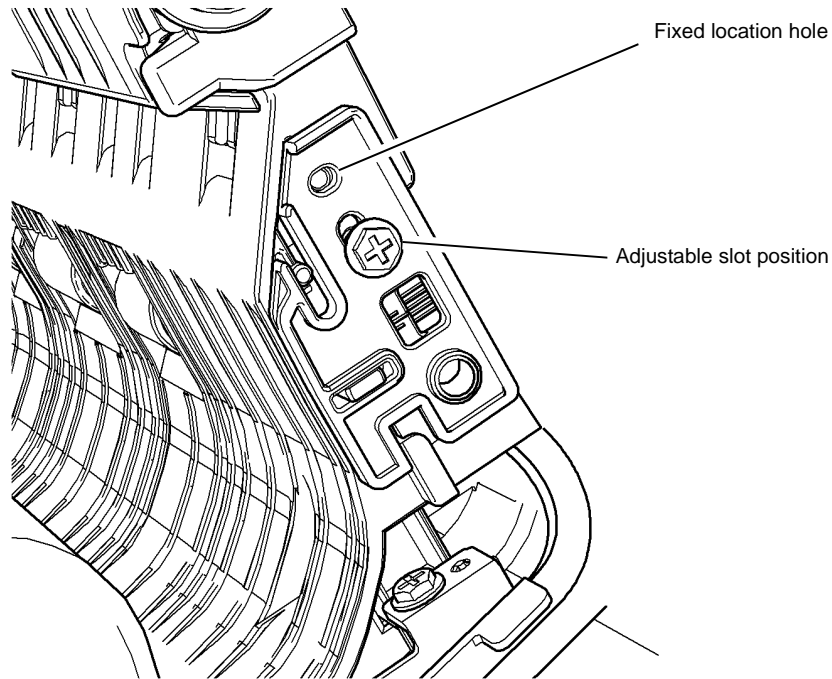
W-1-0766-A

Figure 2 Adjusting screw position

2. If the SPDH did not need adjustment during build, the adjustment screw will be in the fixed location hole. If necessary move the screw to the adjustable slot position, [Figure 2](#).

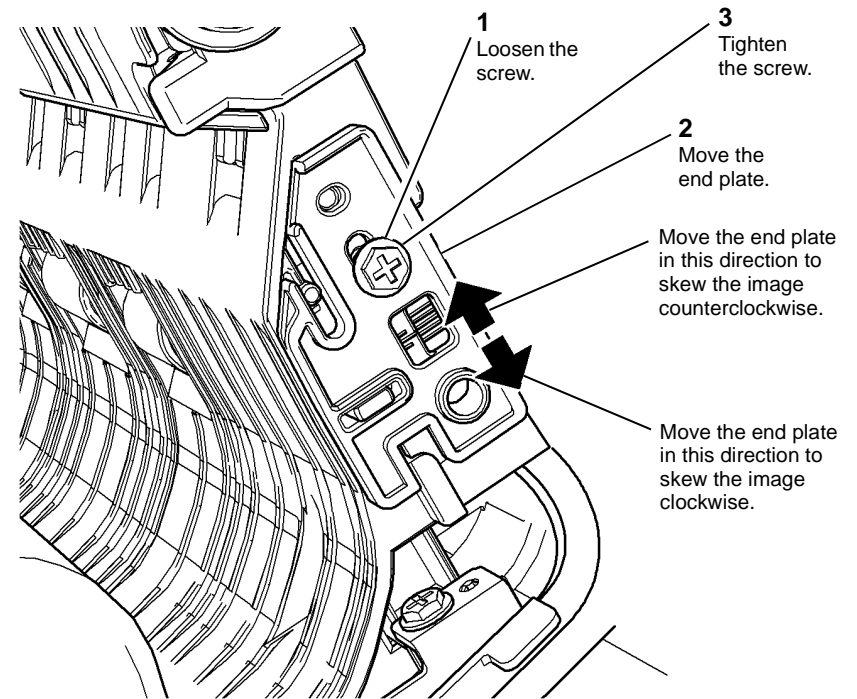
W-1-0767-A

Figure 3 Side 2 skew adjustment

3. Adjust the side 2 skew, [Figure 3](#).

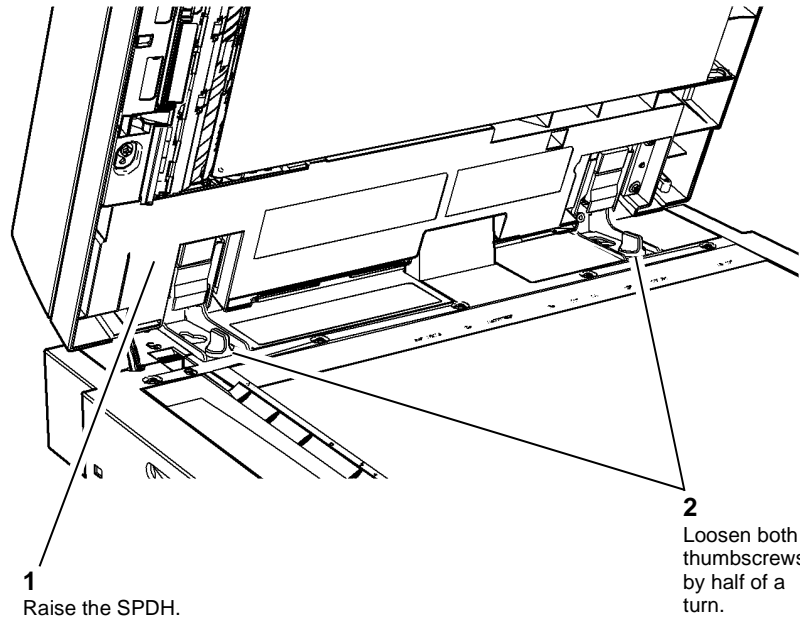
W-1-0768-A

Figure 4 Preparation

1. Prepare to adjust the side 1 skew, [Figure 4](#).
