708P91139
February 2016

Xerox® WorkCentre® 5945 Family Multifunction Printer Service Manual

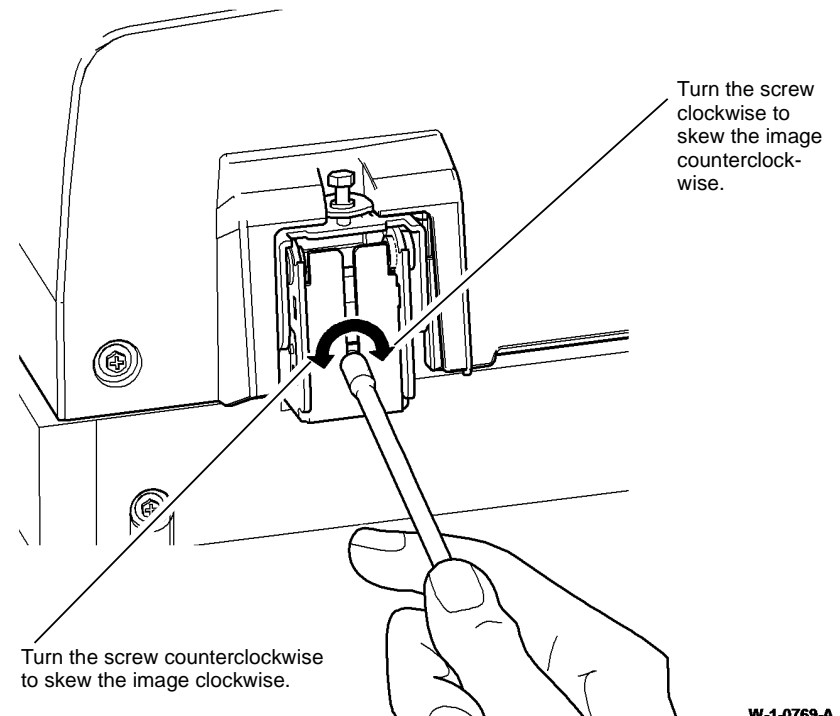
W-1-0769-A

NOTE: Approximately 3 turns of the adjustment screw will move the skew by 1mm.

Figure 5 Side 1 skew adjustment

2. Adjust the side 1 skew, [Figure 5](#).

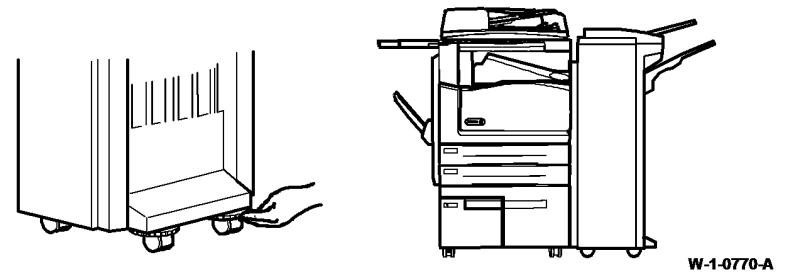
- Turn both hand wheels in the same direction to adjust the vertical alignment between the 2K LCSS and the machine. The 2K LCSS should be in vertical alignment with the machine, viewed from the front and rear, [Figure 1](#).

Figure 1 Machine to 2K LCSS alignment

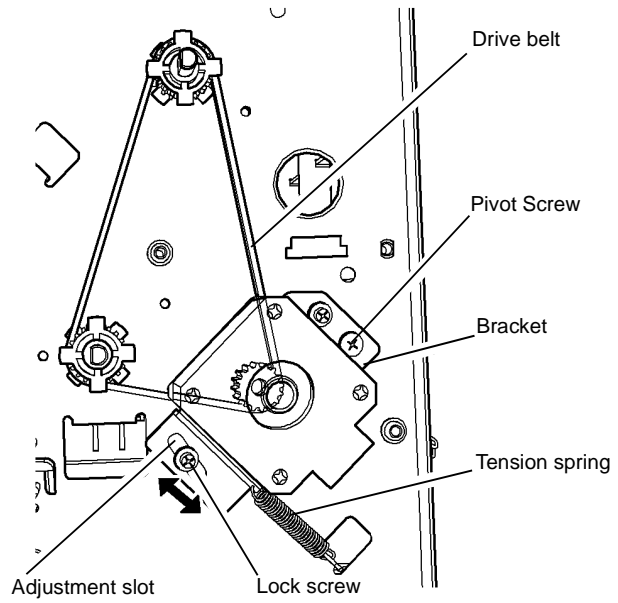
W-1-0773-A

1. **Figure 1** shows a typical arrangement. Press the belt midway between pulleys and check that the bracket moves to stretch the spring. Slacken the bracket screws if necessary. Allow the spring to pull the bracket and tension the drive belt, then tighten bracket screws.

Typical spring tensioning arrangement

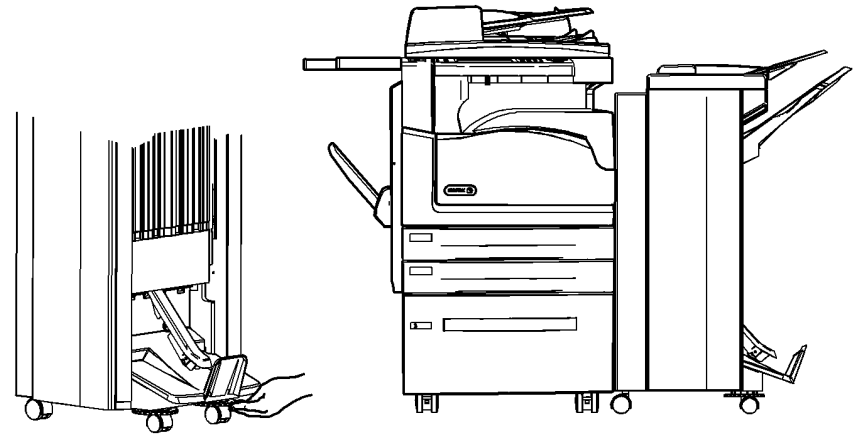
W-1-0774-A

1. [Figure 1](#), turn both right hand wheels in the same direction to adjust the vertical alignment between the LVF BM and the machine viewed from the front or rear.

Figure 1 Machine to LVF BM alignment

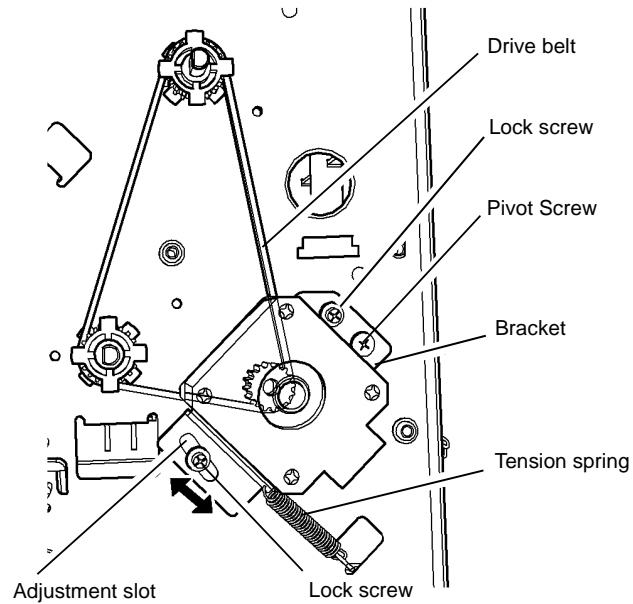
W-1-0777-A

1. **Figure 1** shows a typical arrangement. Slacken the bracket lock screws. Press the belt midway between pulleys and check that the bracket moves and returns by the spring pull.
2. Release the belt and allow the spring to pull the bracket and tension the drive belt then tighten the lock screws.

Typical spring tensioning arrangement.

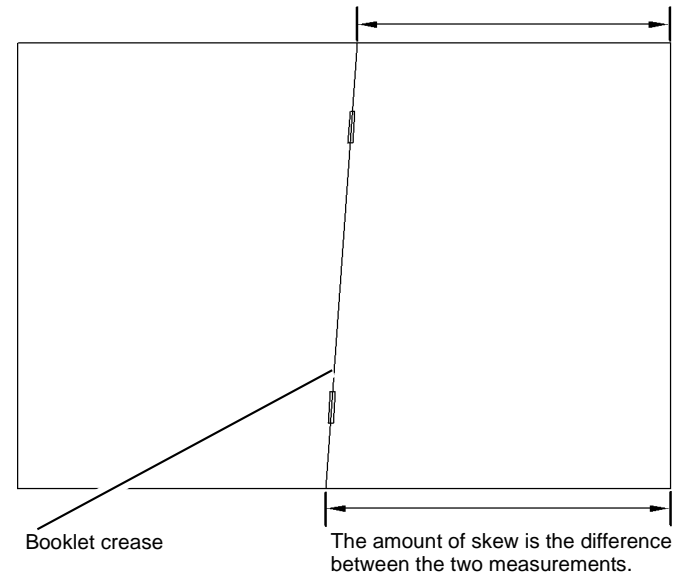
W-1-1412-A

1. Run a copy job of 3 stapled 4 sheet booklets.
2. Open out the booklet at the centre page and press it onto a flat surface. Measure the misalignment of the open side edges of the booklet, **Figure 1**.

Figure 1 Booklet skew

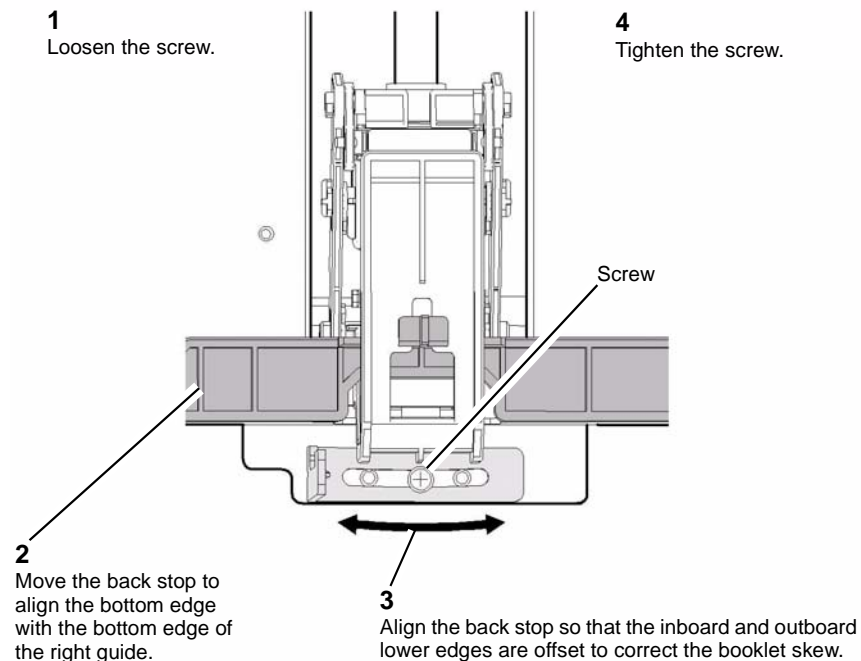
W-1-1413-A

1. Perform [REP 12.19-150](#) steps 1 to 7 to uncover the back stop right guide assembly.
2. [Figure 2](#), adjust the position of the back stop.

Figure 2 Back stop adjustment

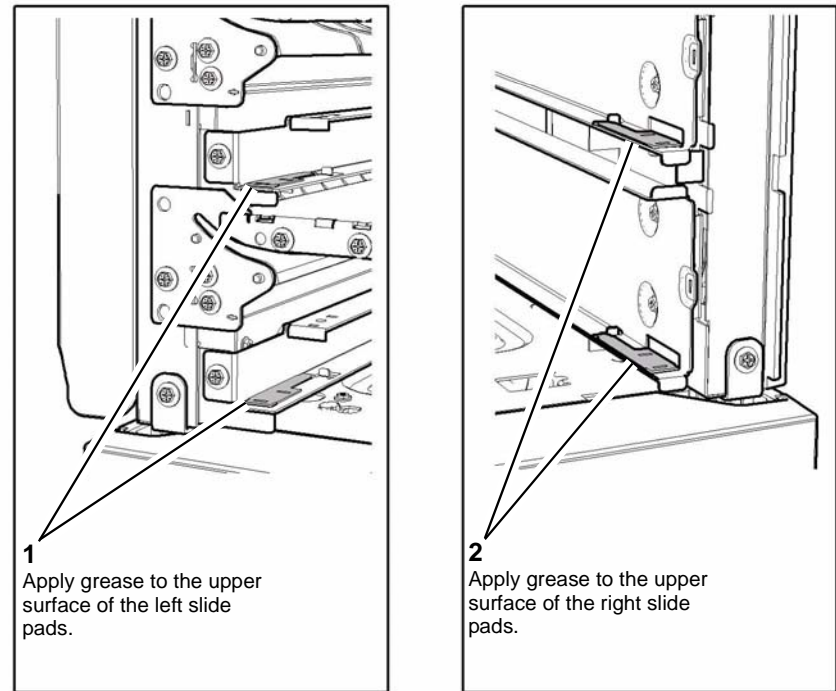
W-1-1207-A

1. Remove tray 1 and 2, [REP 70.1](#).
2. If the trays do not slide easily, apply plastislip grease, [PL 26.10 Item 8](#), to lubricate the slide pads, [Figure 1](#).

Figure 1 Tray 1 and 2 slide pads

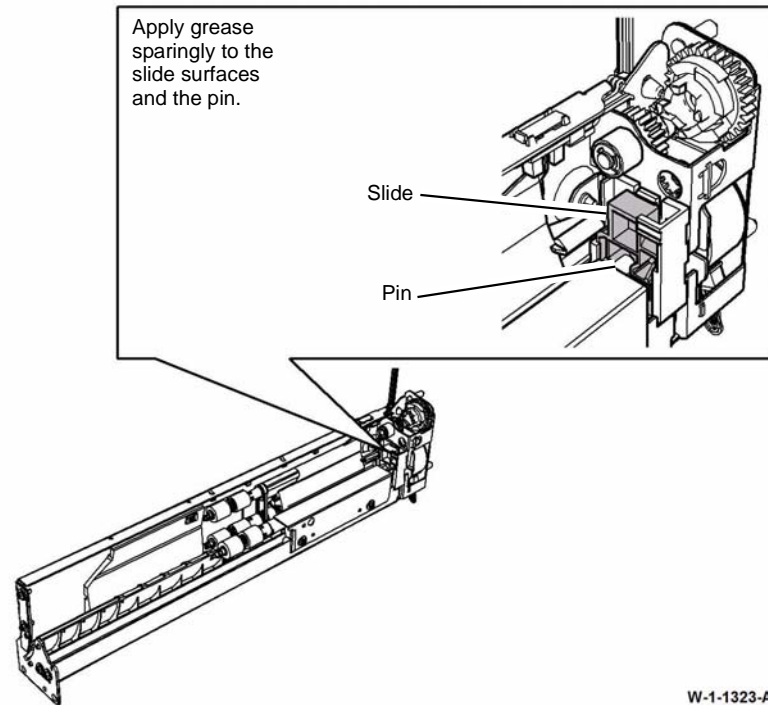
1. Remove tray 1 and 2, [REP 70.1](#).
2. Remove the tray 1 and tray 2 paper feed assemblies, [REP 80.1](#).
3. Check that the actuator mechanism operates smoothly, if necessary apply plastislip grease, [PL 26.10 Item 8](#), to lubricate the actuator, [Figure 2](#).

Figure 2 Actuator lubrication

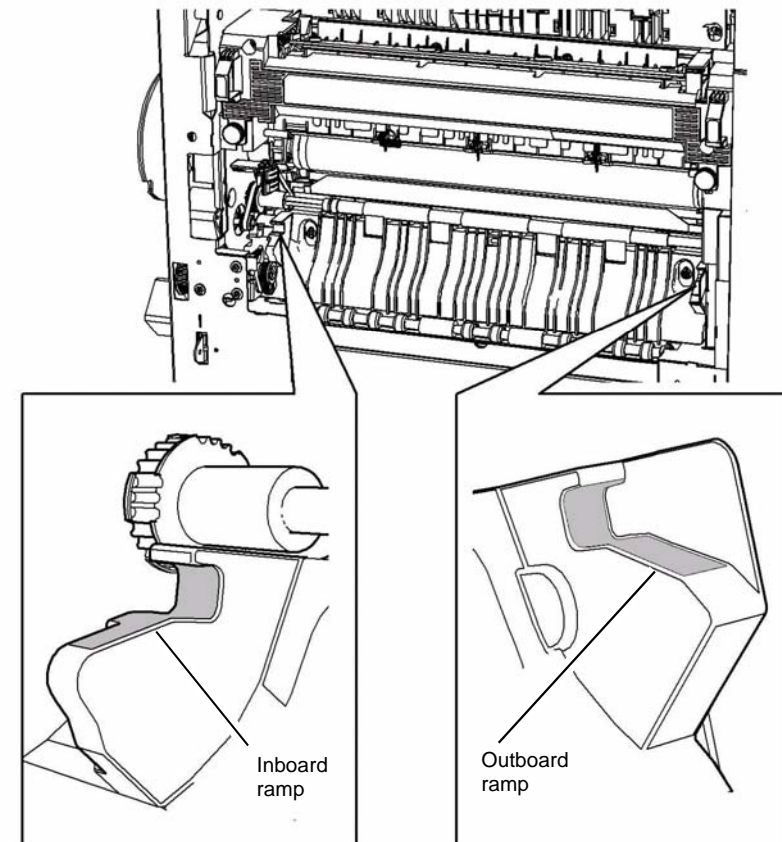
1. Open the left door.
2. Lubricate the registration transport location ramps with plastislip grease, [PL 26.10 Item 8](#), [Figure 3](#).

1
Clean any residual lubricant or contamination from the two areas.

2
Apply plastislip grease very sparingly to the two areas.

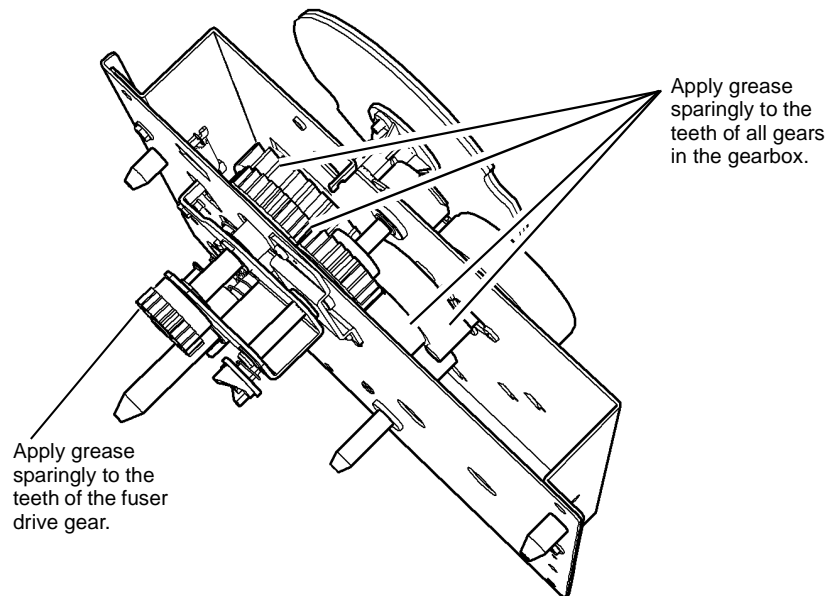
1. Remove the main drive module, [REP 40.1](#).
2. Check that the gears are adequately lubricated, if necessary apply plastislip grease, [PL 26.10 Item 8](#), to lubricate the main drive module, [Figure 4](#).

Figure 4 Main drive module

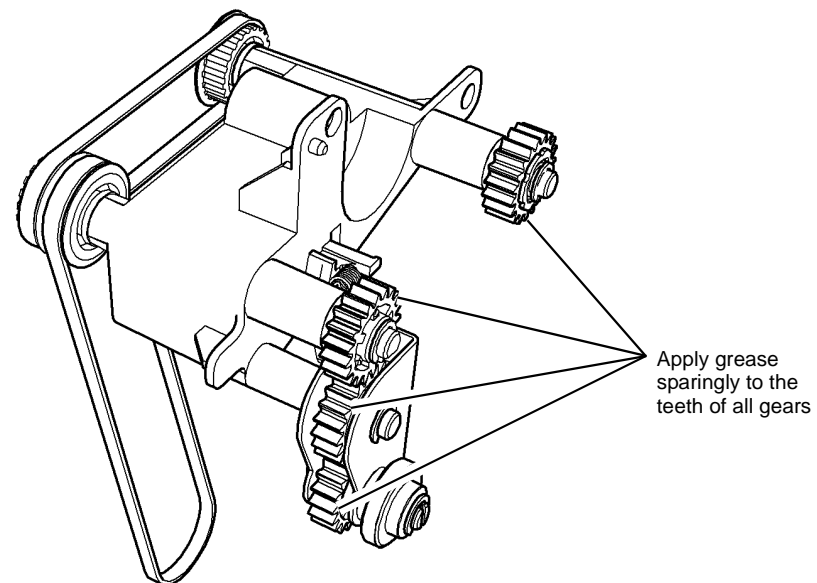
W-1-1326-A

1. Remove the exit drive assembly, [REP 10.2](#).
2. Check that the gears are adequately lubricated, if necessary apply plastislip grease, [PL 26.10 Item 8](#), to lubricate the exit drive assembly gears, [Figure 5](#).

Figure 5 Exit drive assembly

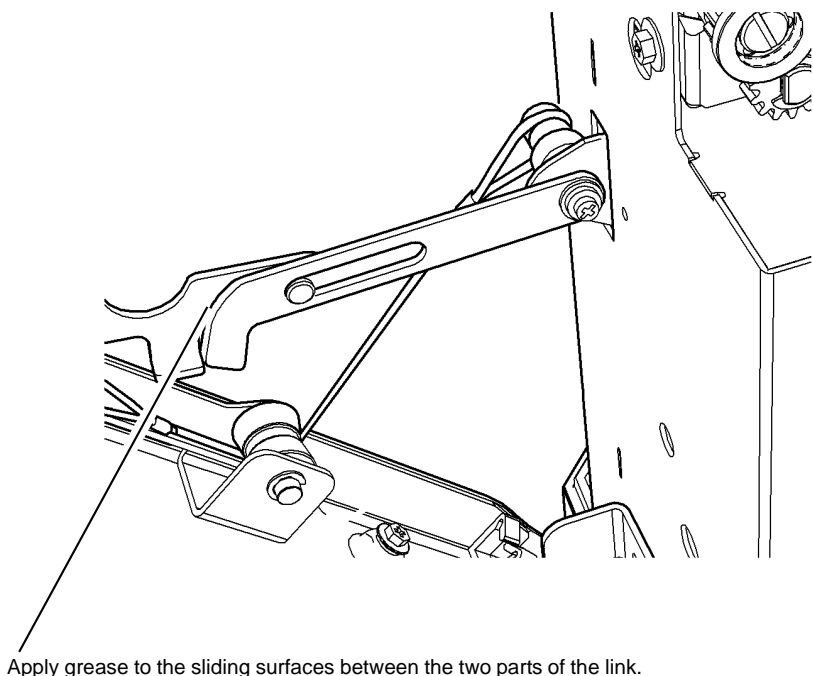
W-1-1411-A

1. Open the left door.
2. **Figure 6**, check that the link assembly is adequately lubricated, if necessary apply plastislip grease, **PL 26.10 Item 8**.

Figure 6 Door link lubrication

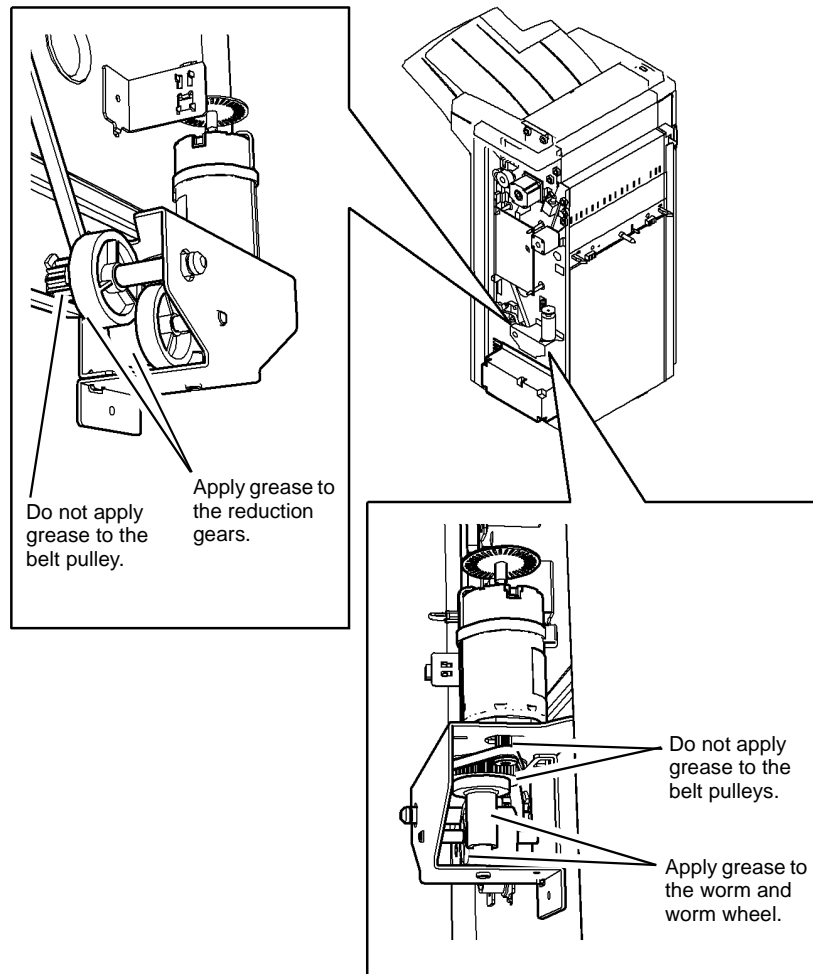
W-1-1319-A

1. Remove the 2K LCSS top cover and rear cover, [REP 12.1-110](#).
2. Check that the worm, worm wheel and reduction gears are adequately lubricated, if necessary use plastislip grease, [PL 26.10 Item 8](#), to lubricate the components, [Figure 7](#).

Figure 7 Worm and gears

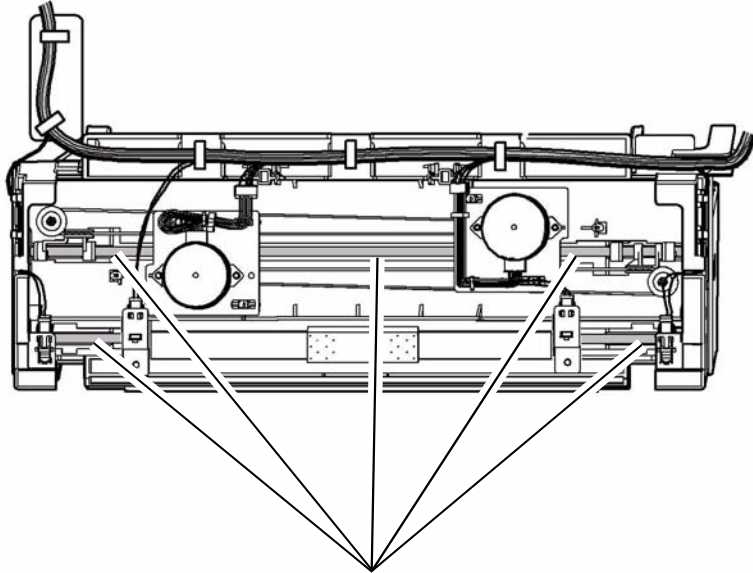
W-1-1321-A

1. Remove the 2K LCSS top cover, [REP 12.1-110](#) or LVF BM top cover, [REP 12.1-150](#).
2. Check that the two tamper shafts are adequately lubricated, if necessary use plastislip grease, [PL 26.10 Item 8](#), to lubricate the tamper assembly, [Figure 8](#).

Apply grease sparingly to the shafts.

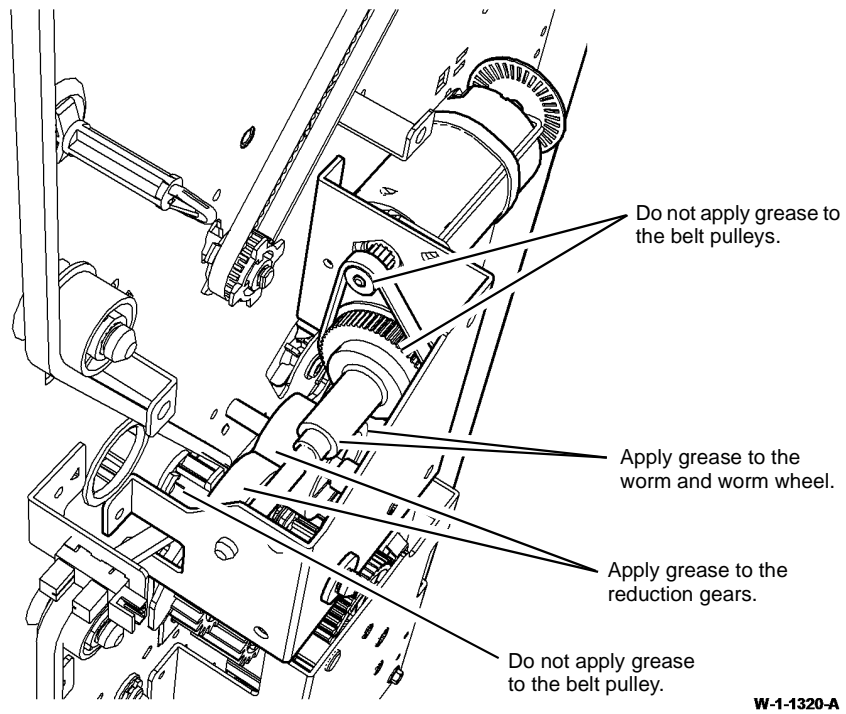
1. Remove the LVF BM top cover and rear cover, [REP 12.1-150](#).
2. Check that the worm, worm wheel and reduction gears are adequately lubricated, if necessary use plastislip grease, [PL 26.10 Item 8](#), to lubricate the components, [Figure 9](#).

Figure 9 Worm and gears

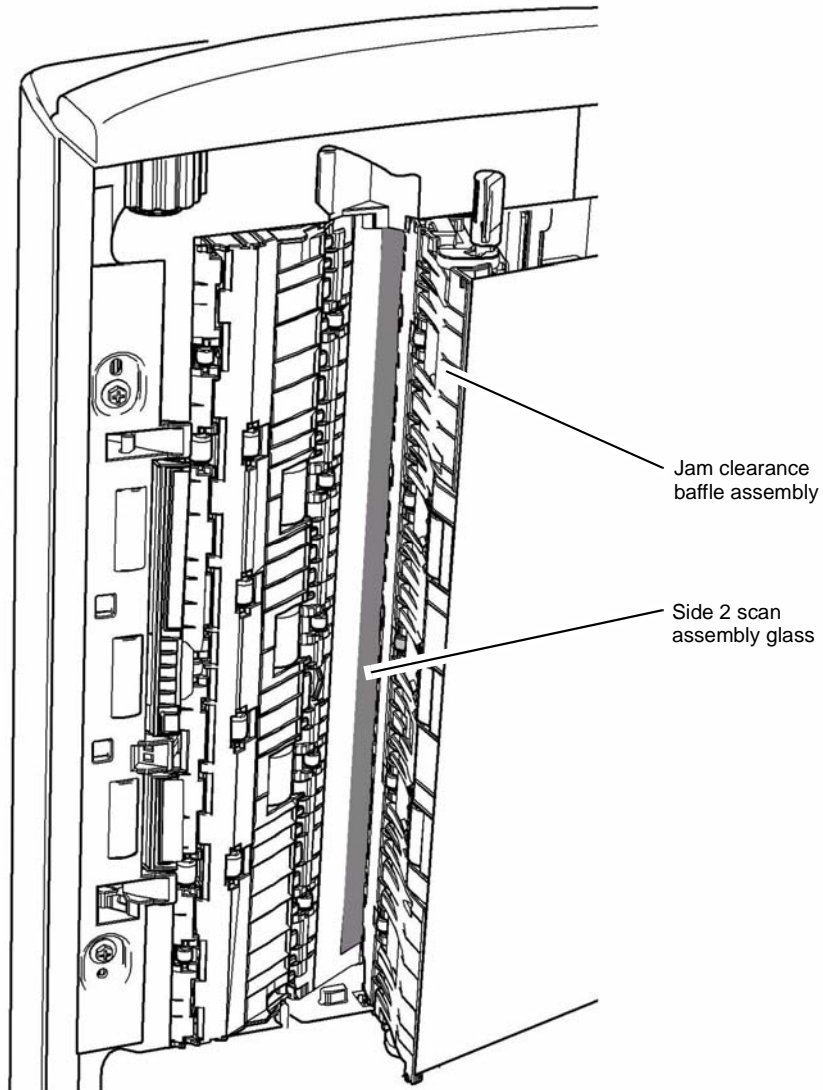
W-1-1203-A

2. Lower the jam clearance baffle assembly, [Figure 1](#).

Figure 1 Component location

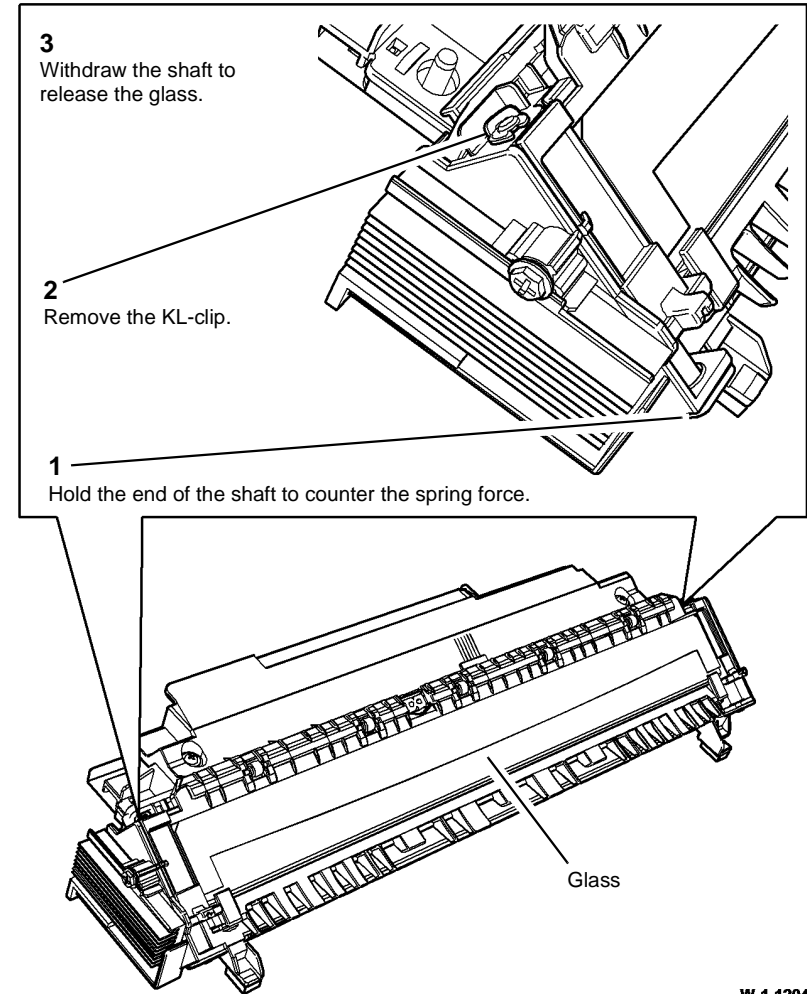
W-1-1204-A

1. Remove the side 2 scan assembly, [REP 60.6](#).
2. Remove the side 2 scan assembly glass, [Figure 2](#).

Figure 2 Side 2 scan glass assembly removal

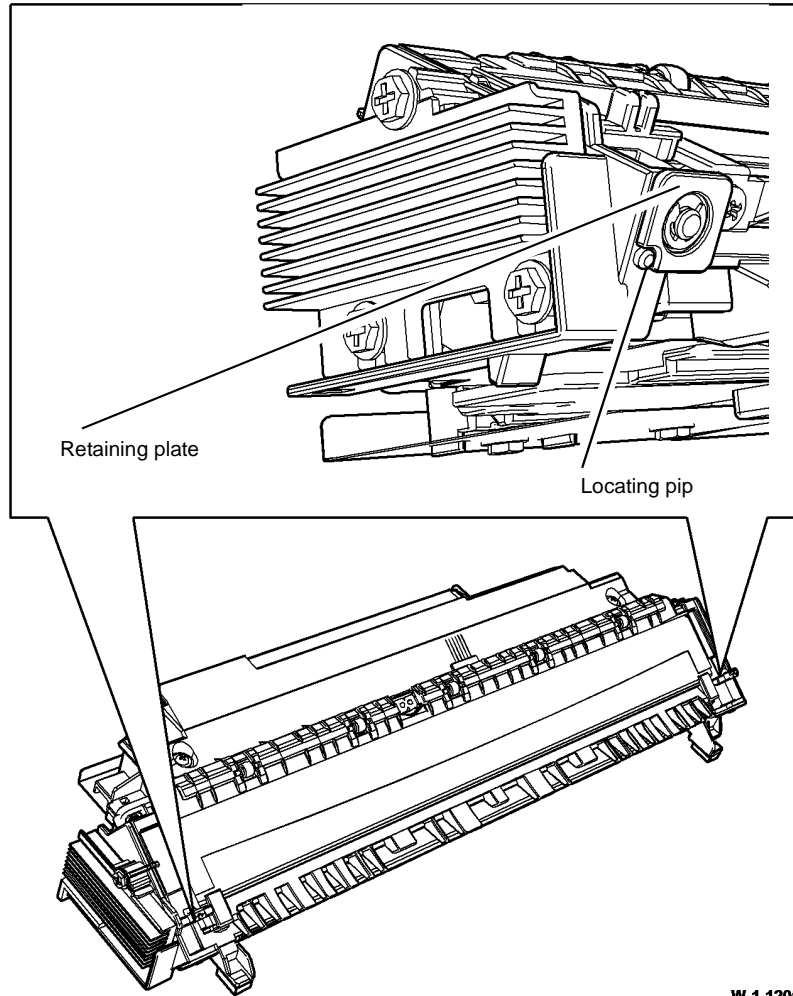
3. Use a microfiber wiper, [PL 26.10 Item 13](#), dampened with antistatic fluid, [PL 26.10 Item 19](#) to clean the inside surface of the side 2 scan assembly glass.
4. Use a microfiber wiper, [PL 26.10 Item 13](#), to polish the inside surface of the side 2 scan assembly glass.
5. Reverse the removal process in [Figure 2](#) to replace the side 2 scan assembly glass.
6. Ensure that the retaining plate on the end of each shaft is positioned correctly relative to the locating pips on the side 2 scan assembly, [Figure 3](#).

Figure 3 Replacement of the side 2 scan assembly glass

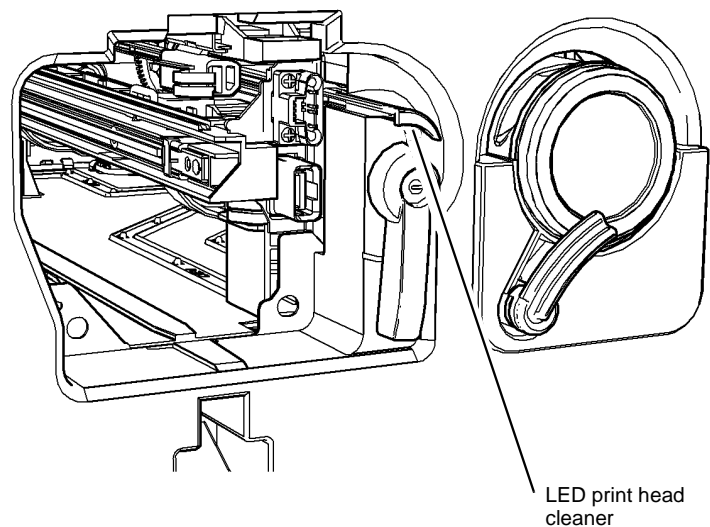
1. Open the front door assembly, [PL 28.10 Item 5](#).
2. Cam the LED print head away from the print cartridge.
3. Manually move the LED print head cleaner fully out, then in 3 times, [Figure 1](#).

Figure 1 Component location

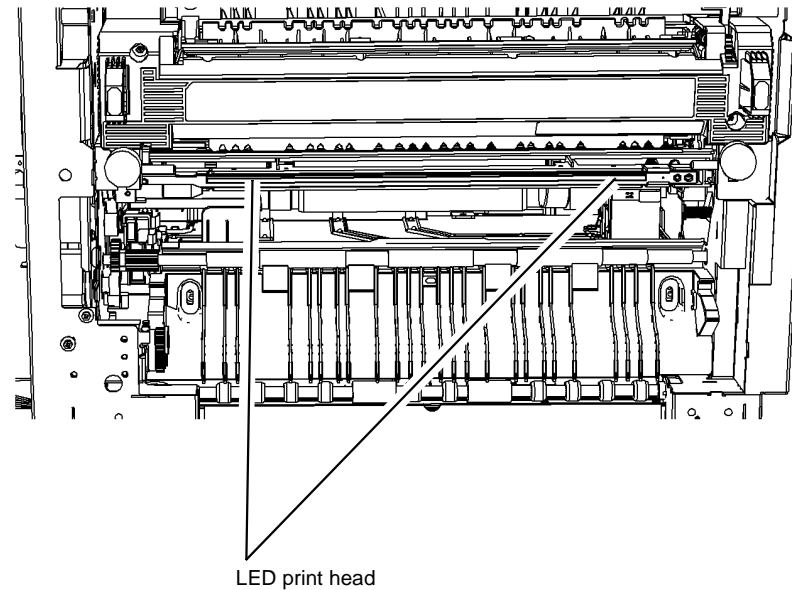
W-1-1219-A

- c. Use a lint free wiper, [PL 26.10 Item 13](#) dampened with cleaning fluid, [PL 26.10 Item 22](#) to clean the LED print head, [Figure 2](#).

Figure 2 Component location

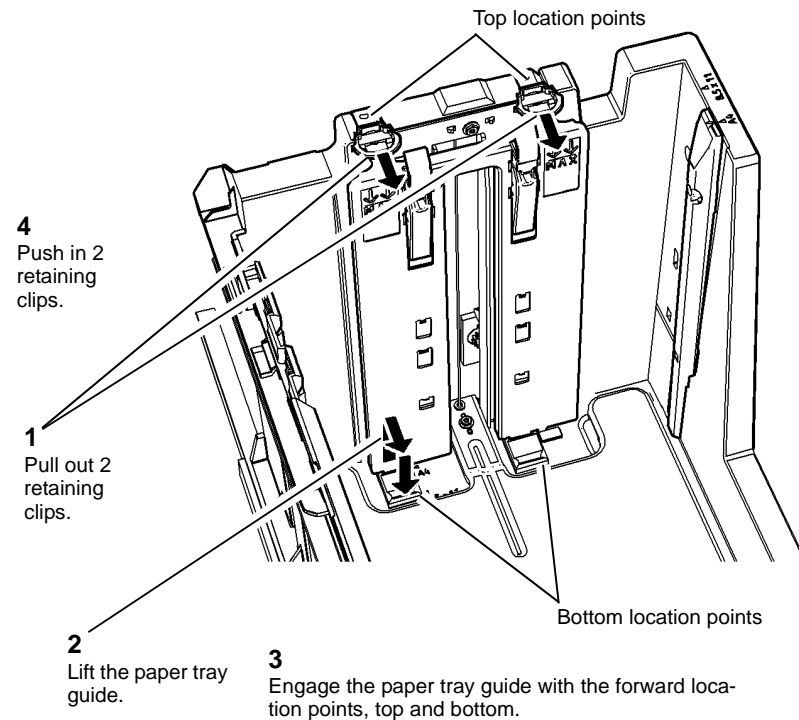
W-1-0795-A

Figure 1 Rear paper tray guide re-position

1. Pull out the tray to be adjusted. Remove the paper from the tray.
2. To reset the paper tray guides:
 - Refer to [Figure 1](#) and [Figure 2](#) to change the paper tray guides from A4 paper size to 8.5x11 inch paper size.
 - Refer to [Figure 3](#) to change the paper guides from A4 paper size to 8.5x11 inch paper size.
 - Refer to [Figure 4](#) and [Figure 5](#) to change the paper tray guides and paper guides from 8.5x11 inch paper size to A4 paper size.
 - Refer to [Figure 6](#) to change the paper guides from 8.5x11 inch paper size to A4 paper size.

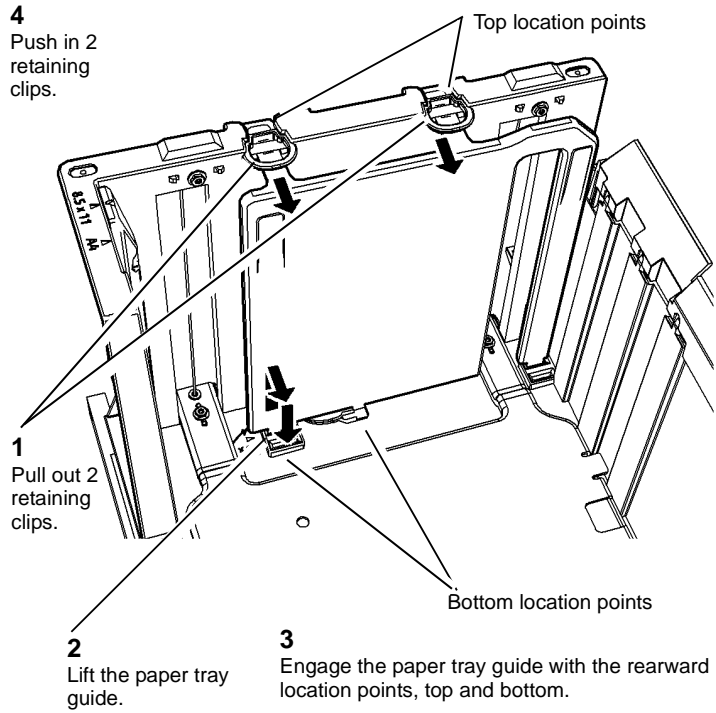
W-1-1011-A

Figure 2 Front paper tray guide re-position

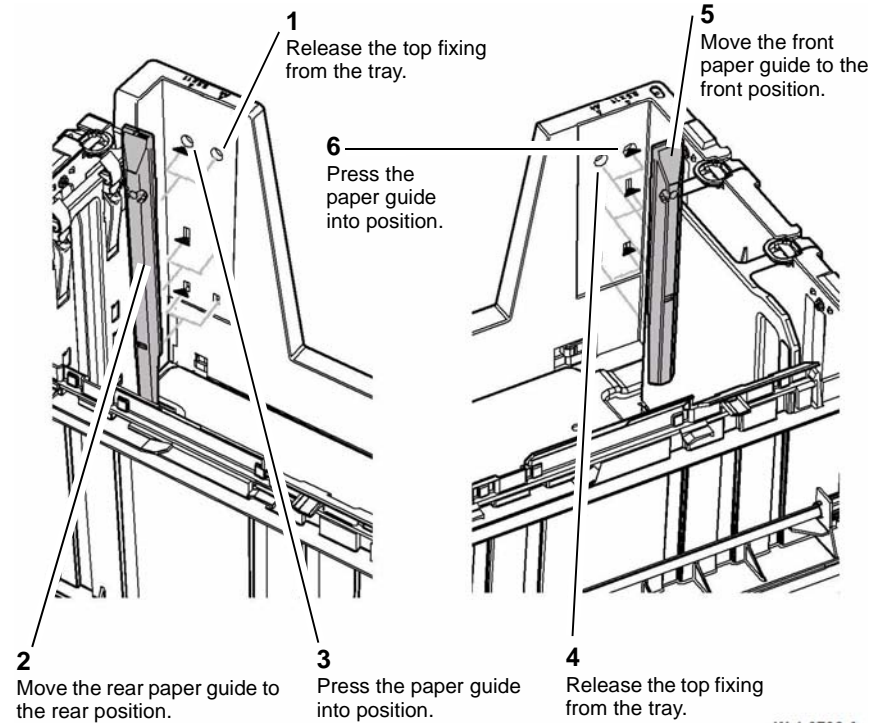
W-1-0796-A

Figure 3 Paper guides re-position

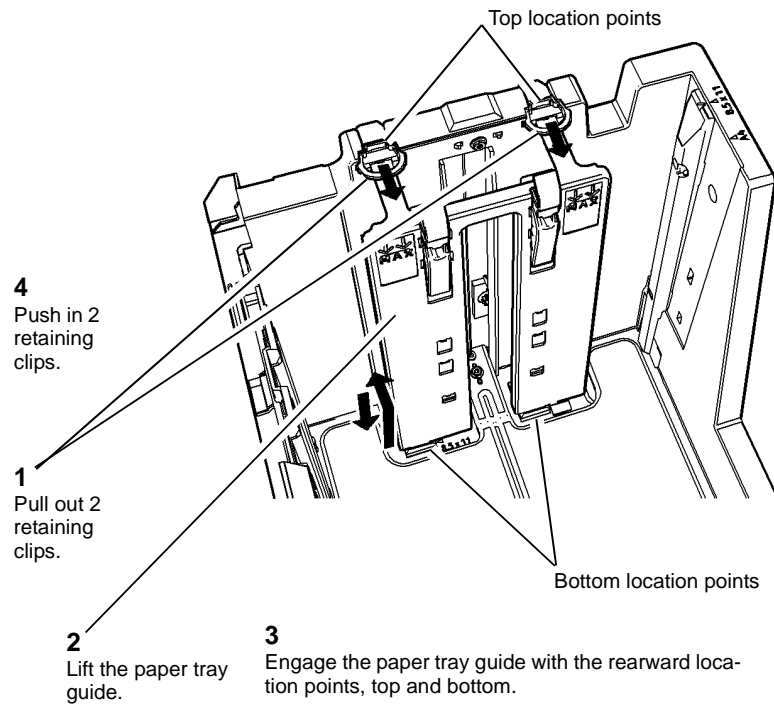
W-1-0797-A

Figure 4 Rear paper tray guide re-position

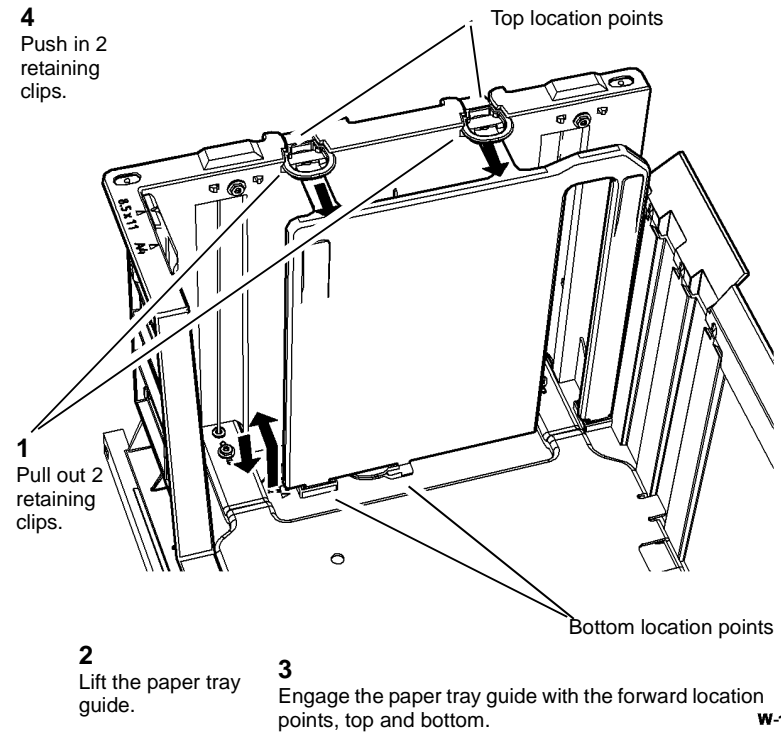
W-1-1012-A

Figure 5 Front paper tray guide re-position

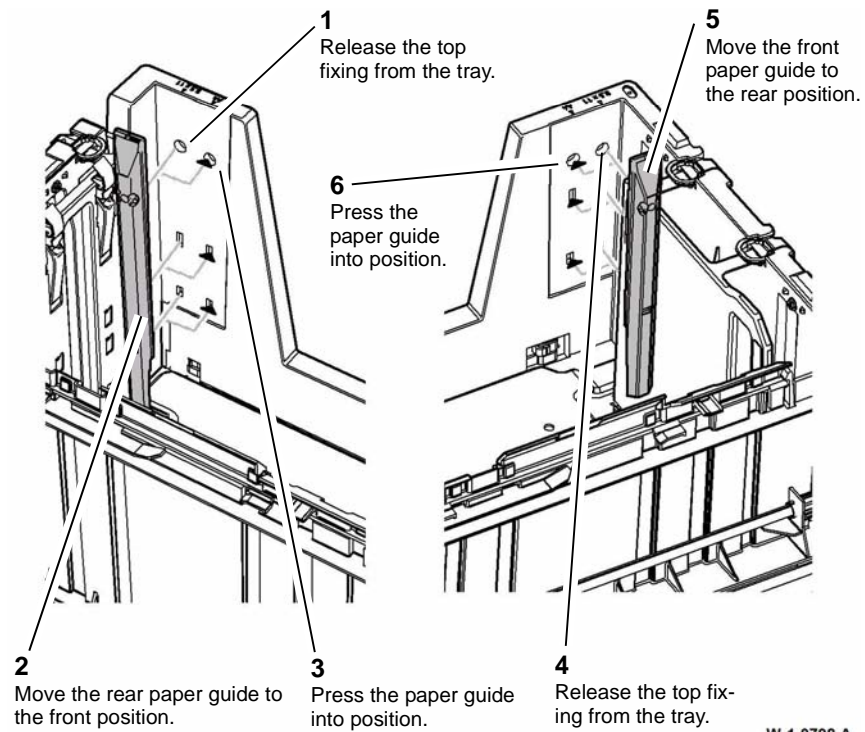
Figure 6 Paper guides re-position

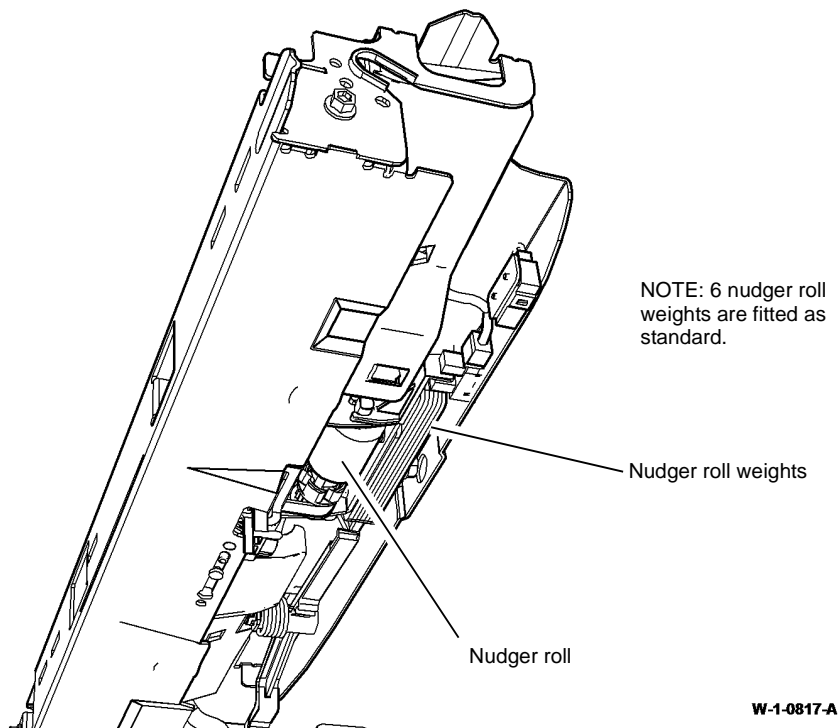
1. Remove the relevant paper feed assembly:
 - Tray 3, [REP 80.20](#).
 - Tray 4, [REP 80.21](#).
2. Check the number of nudger roll weights. Refer to [Figure 1](#).

Figure 1 Weights position

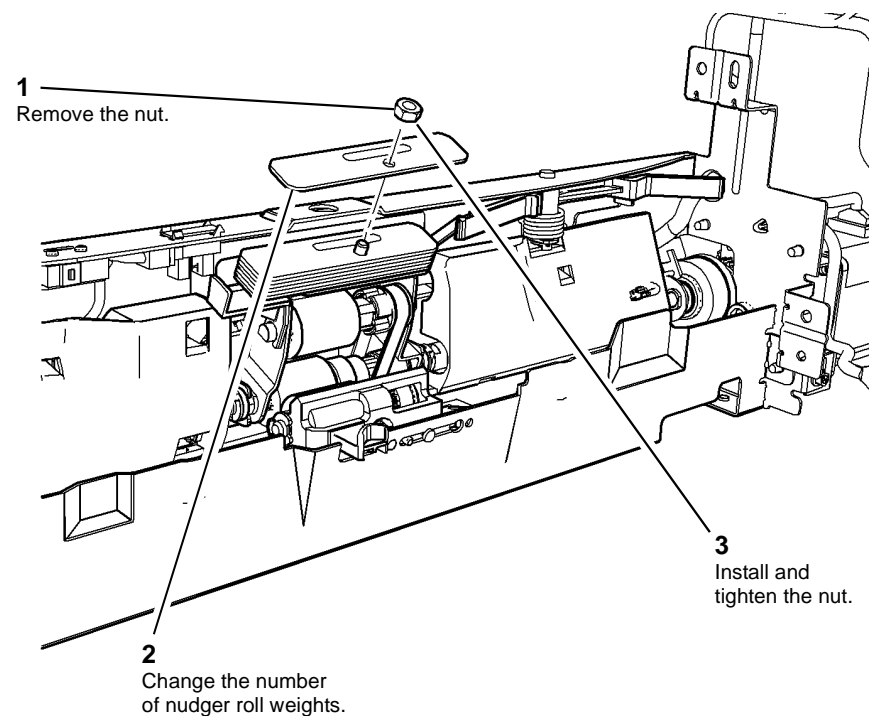
1. Change the number of nudger roll weights to adjust the downward pressure of the nudger roll, [Figure 2](#).

Figure 2 Spring seat adjustment

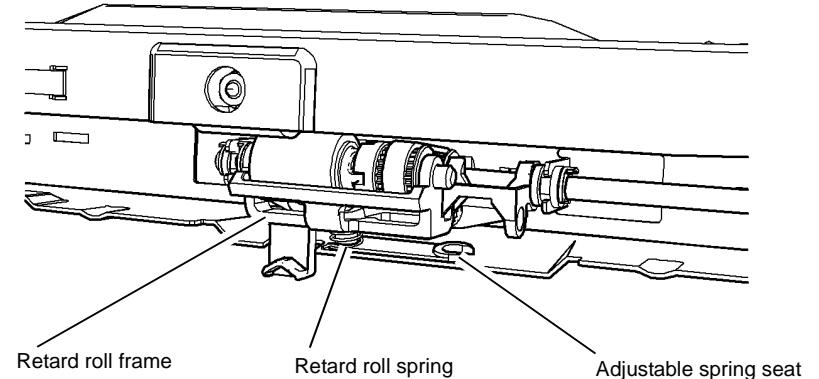
W-1-0815-A

1. Remove the relevant paper feed assembly:
 - Tray 3, [REP 80.20](#).
 - Tray 4, [REP 80.21](#).
2. Check the position of the spring seat. Refer to [Figure 1](#).

Figure 1 Spring seat position

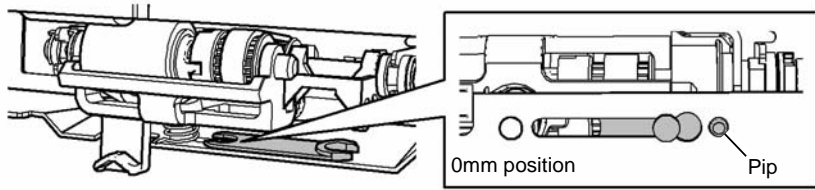
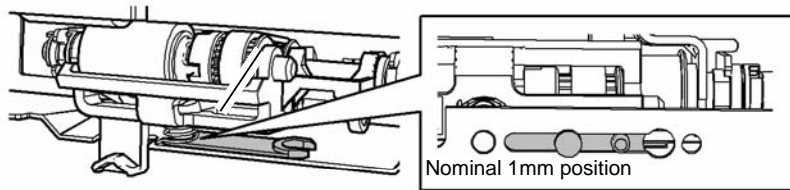
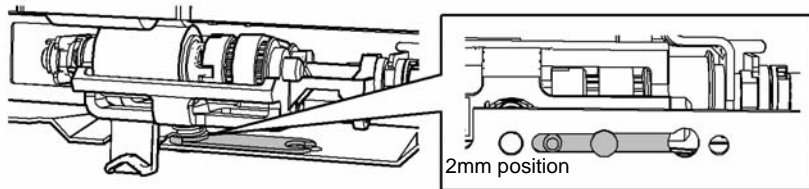
W-1-0816-A

1. Change the position of the spring seat to adjust the nip pressure of the retard roll, [Figure 2](#):
 - Change the spring seat to the 2mm position to increase the retard roll pressure.
 - Change the spring seat to the 0mm position to decrease the retard roll pressure.

To release the spring seat from this position, press down the pip then slide the spring seat away from the frame hole.
To locate the spring seat in this position, slide the spring seat along the slot until the pip drops into the frame hole.

To release the spring seat from this position, lift up the base of the spring then slide the spring seat away from the spring position.
To locate the spring seat in this position, lift the base of the spring then slide the spring seat along the slot until the thin end is located under the spring.

To release the spring seat from this position, lift up the base of the spring then slide the spring seat away from the spring position.
To locate the spring seat in this position, lift the base of the spring then slide the spring seat along the slot until the thick end is located under the spring.

NOTE: The feeders have the spring seat set in the nominal (1mm) position during manufacture, [Figure 2](#).

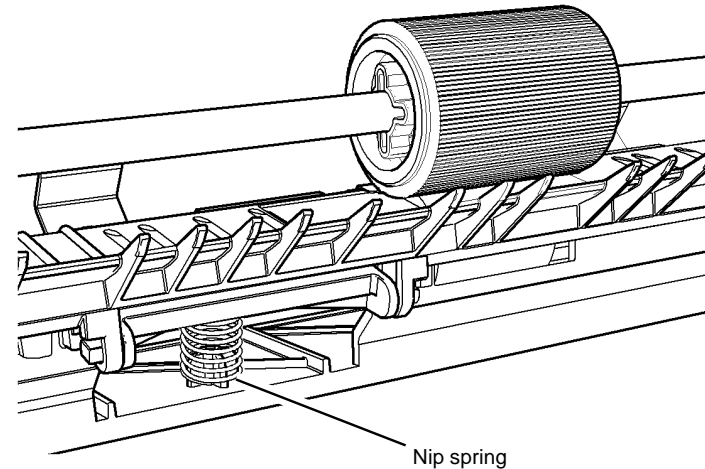
W-1-1466-A

1. Insert a M10 washer, thickness 1.8mm, outside diameter 19.0mm (part number 251W10855 or 651W10855 - See Note) underneath the retard force nip spring, refer to [PL 70.35 Item 18](#) and [Figure 1](#) and [Figure 2](#).

Figure 1 Retard force nip spring

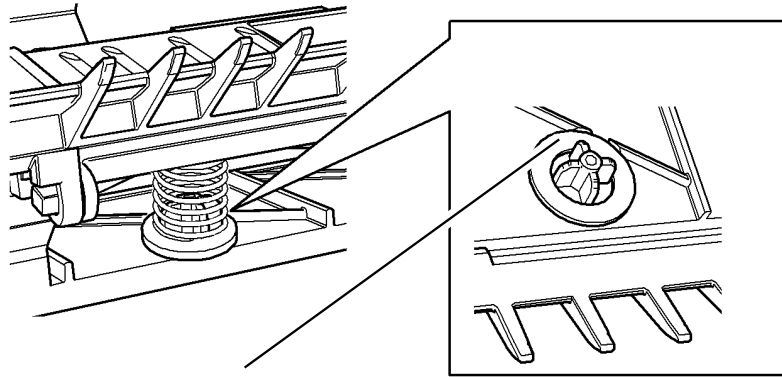
W-1-1467-A

1
Ensure the washer is flat against the base of the bypass tray feeder frame. It may be necessary to remove part of a rib in the base.

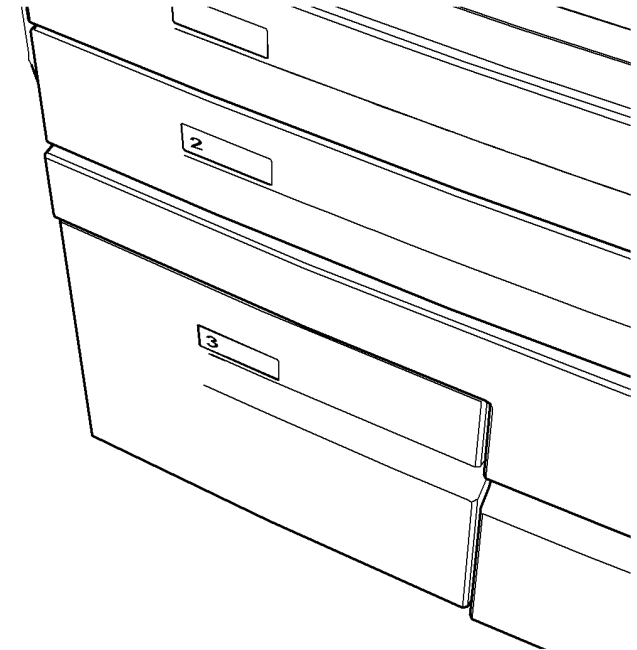
W-1-1453-A

Open and close tray 4 several times to check that the tray closes easily and fully. [Figure 1](#), shows a tray 4 that is not fully closed at the left side, the tray is closed enough to actuate the tray home sensor, but paper jams, mis-feeds and skew can occur. If tray 4 does not close easily and/or fully, perform the adjustment.

Figure 1 Tray 4 not fully closed

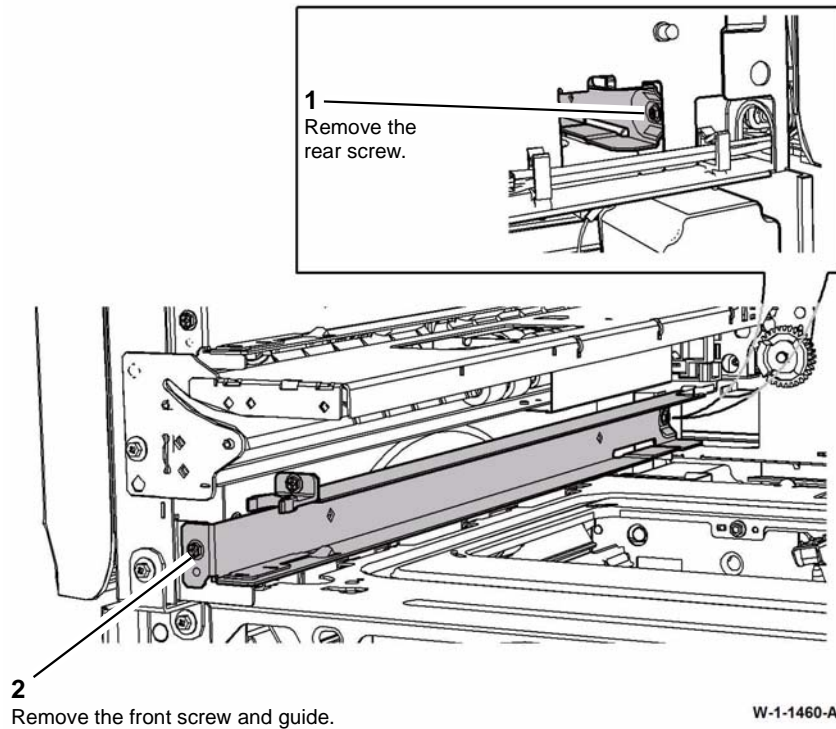
5. Figure 2, remove the tray 2 left guide.

Figure 2 Left guide removal

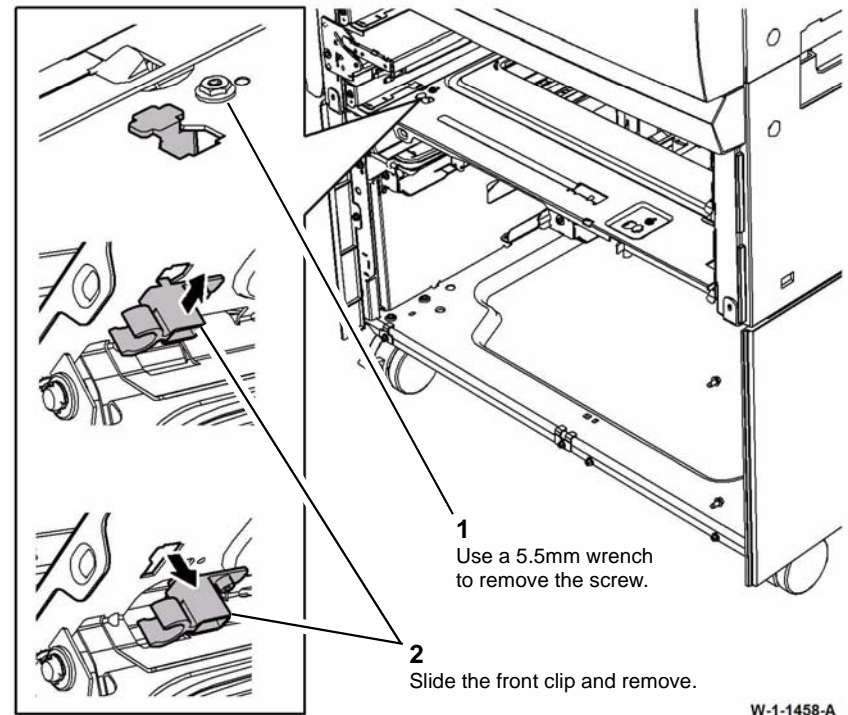
6. Figure 3, remove the front clip.

NOTE: For clarity, tray 3 is not shown in Figure 3.

Figure 3 Front clip removal

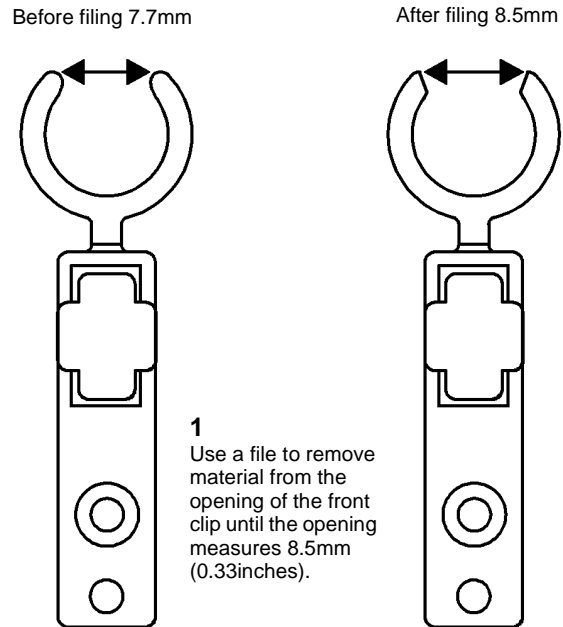
7. **Figure 4**, Adjust the opening of the front clip.

Figure 4 Front clip adjustment

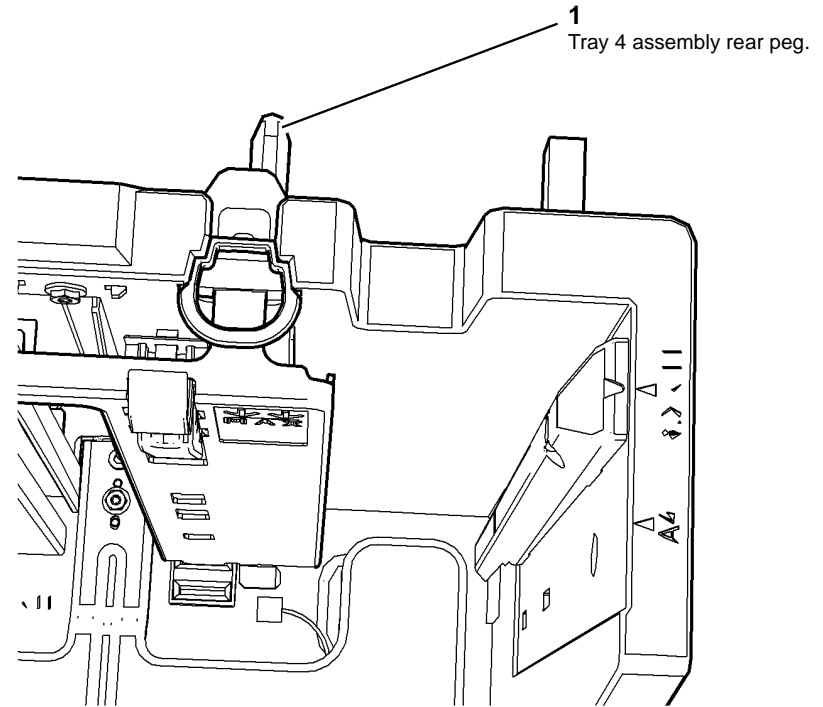
11. **Figure 5**, apply a thin coating of plastislip grease, **PL 26.10 Item 8** to the tray 4 assembly rear peg.

Figure 5 Tray 4 rear peg lubrication

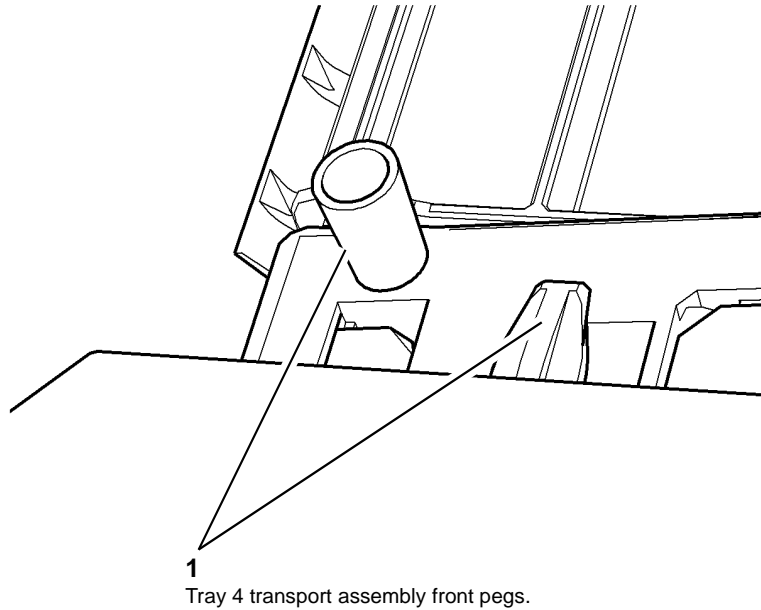
W-1-1455-A

13. **Figure 6**, apply a thin coating of plastislip grease, **PL 26.10 Item 8** to the tray 4 transport assembly front pegs.

Figure 6 Front pegs lubrication
