708P91139
February 2016

Xerox® WorkCentre® 5945 Family Multifunction Printer Service Manual

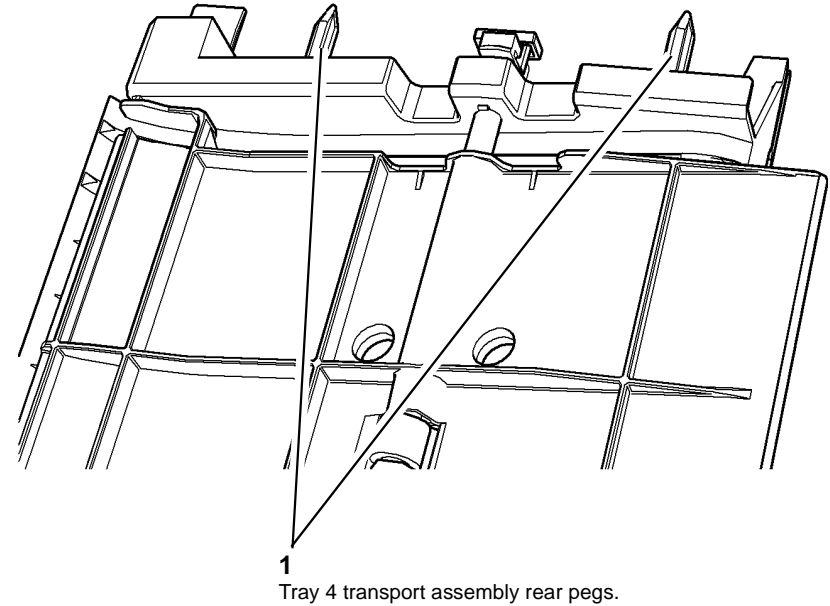
W-1-1456-A

14. **Figure 7**, apply a thin coating of plastislip grease, **PL 26.10 Item 8** to the tray 4 transport assembly rear pegs.

Figure 7 Rear pegs lubrication

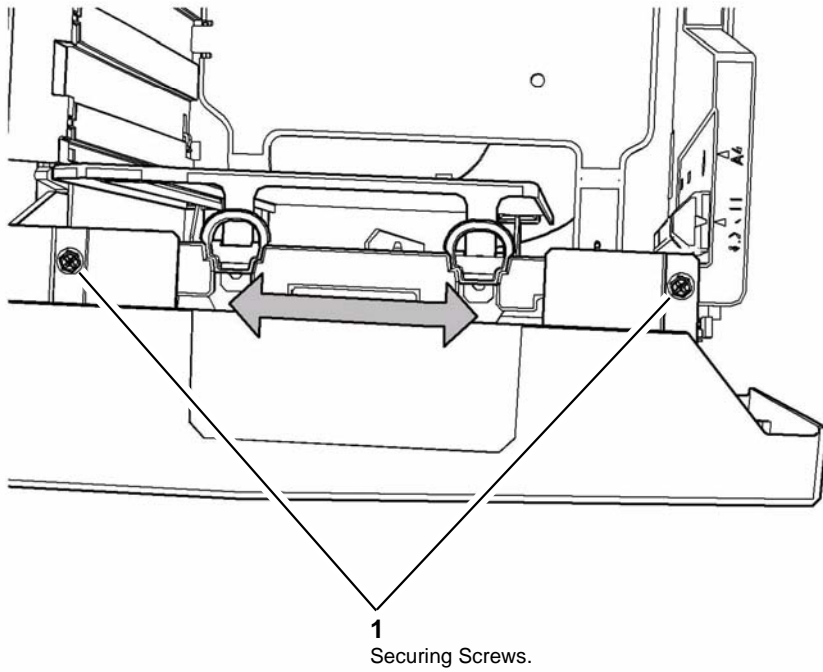
Figure 8 Cover left/right movement

15. Apply a thin coating of plastislip grease, **PL 26.10 Item 8** at the 2 fixing screw boss areas on the inside of the front cover and around the screw boss areas on the top of the tray 4 assembly, refer to **Figure 8**.
16. Re-install the tray 4 front cover, but do not overtighten the screws, refer to GP 6 Screw Usage.

17. **Figure 8**, check that the tray 4 front cover will move to the left and right to allow the tray 4 transport assembly location pegs to align with the frame holes when the tray is closed. If necessary slightly loosen the two screws securing the tray 4 front cover to the tray 4 assembly until the front cover is free to move.

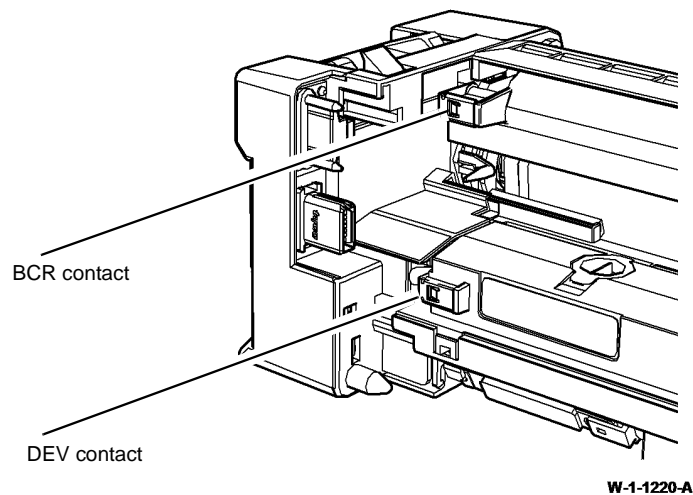
Figure 1 DEV and BCR contacts

1. Remove the print cartridge, [PL 90.17 Item 9](#), then place in a black bag.
2. Use a lint free wiper, [PL 26.10 Item 13](#) dampened with cleaning fluid, [PL 26.10 Item 22](#) to clean the DEV and BCR contacts on the print cartridge, [Figure 1](#).

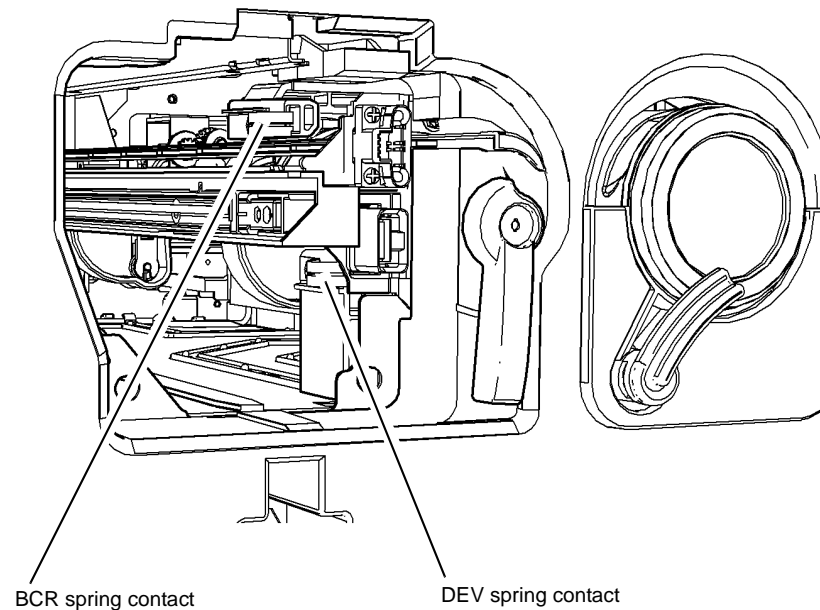
Figure 2 DEV and BCR spring contacts

3. Use a lint free wiper, [PL 26.10 Item 13](#) dampened with cleaning fluid, [PL 26.10 Item 22](#) to clean the DEV and BCR spring contacts, [Figure 2](#).

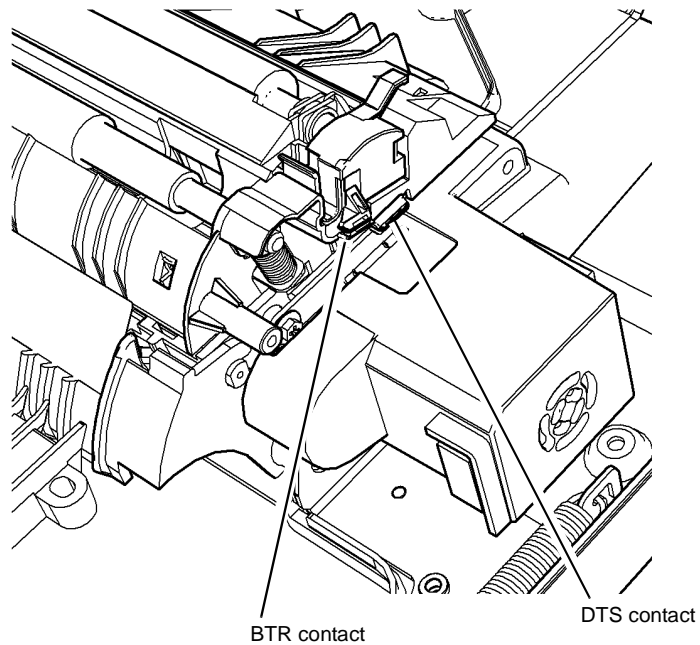
Figure 3 DTS and BTR contacts

9. Use a lint free wiper, [PL 26.10 Item 13](#) dampened with cleaning fluid, [PL 26.10 Item 22](#) to clean the DTS and BTR contacts on the registration transfer assembly, [Figure 3](#).

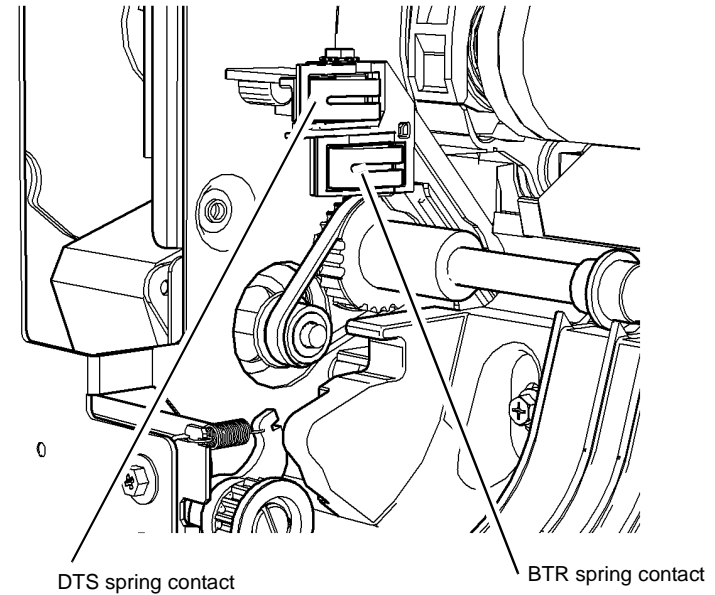
Figure 4 DTS and BTR spring contacts

10. Use a lint free wiper, [PL 26.10 Item 13](#) dampened with cleaning fluid, [PL 26.10 Item 22](#) to clean the DTS and BTR spring contacts, [Figure 4](#).

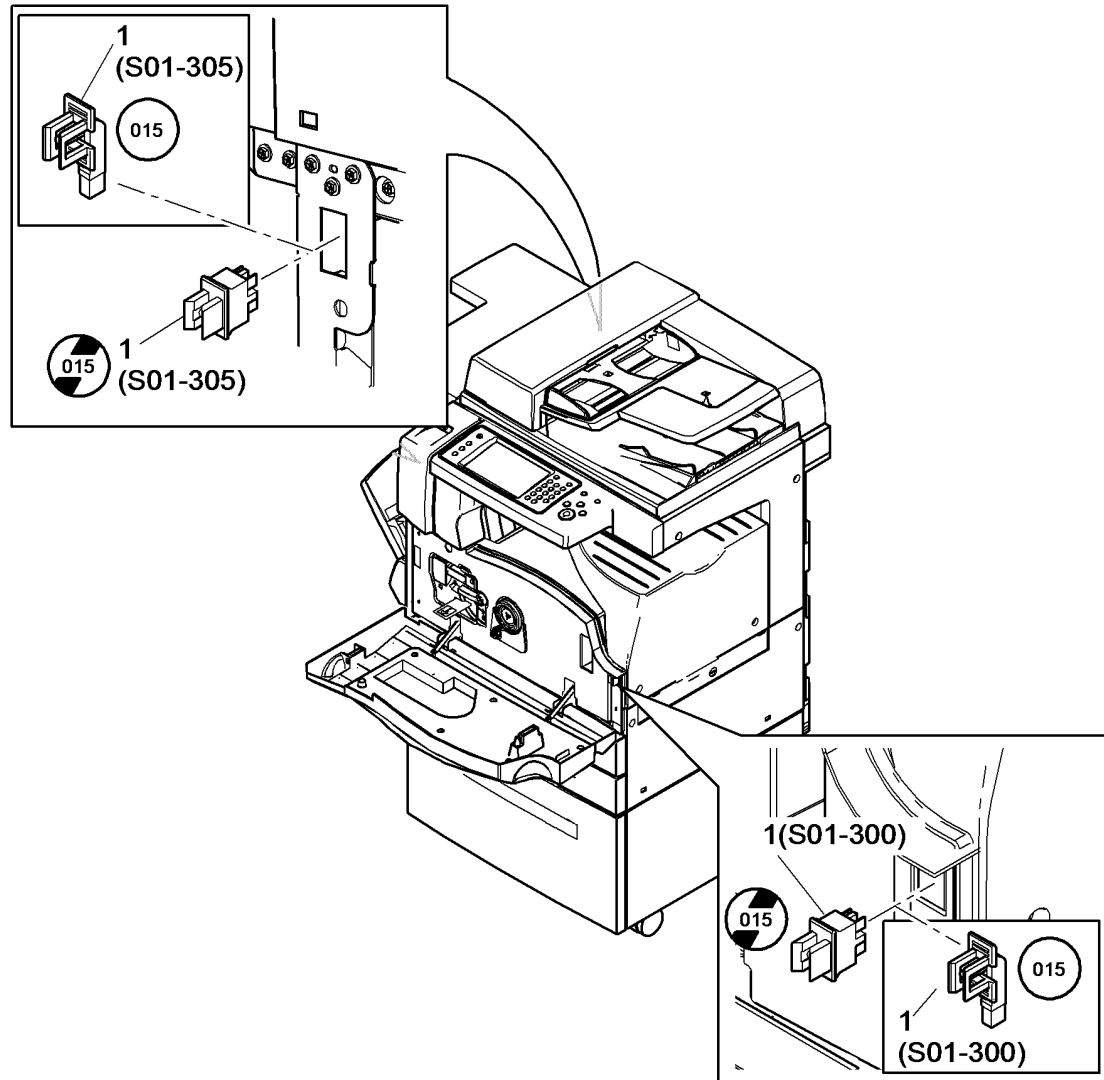
PL 1.12 Interlock Switches

Item	Part	Description
1	110E21780	Front door interlock switch (S01-300) (REP 1.8)/ Left door interlock switch (S01-305) (REP 1.9) (W/O TAG 015)
-	110K21900	Front door interlock switch (S01-300) (REP 1.12)/ Left door interlock switch (S01-305) (REP 1.13) (W/TAG 015)

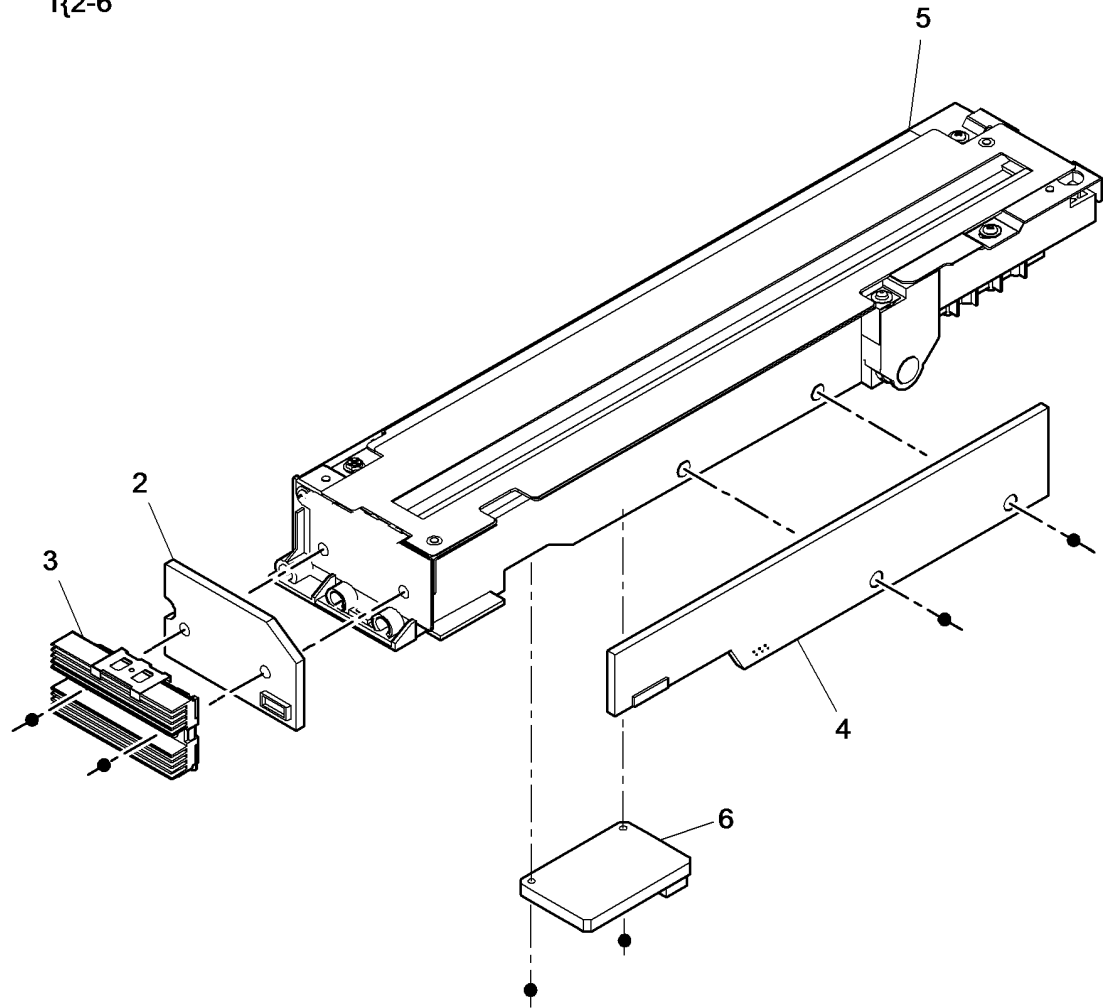
PL 60.30 Side 2 Scan Assembly

Item	Part	Description
1	041K06851	Side 2 scan assembly (REP 60.6)
2	-	Side 2 LED lamp PWB (P/O PL 60.30 Item 1)
3	-	Side 2 LED lamp assembly (P/O PL 60.30 Item 1)
4	-	Side 2 CCD PWB (P/O PL 60.30 Item 1)
5	-	Harness cover (P/O PL 60.30 Item 1)
6	-	Not used
7	-	Scan carriage unit (P/O PL 60.30 Item 1)
8	130E19060	Side 2 reg sensor (Q05-343) (REP 60.6)

NOTE: Refer to ADJ 60.2 for the side 2 scan assembly cleaning procedure.

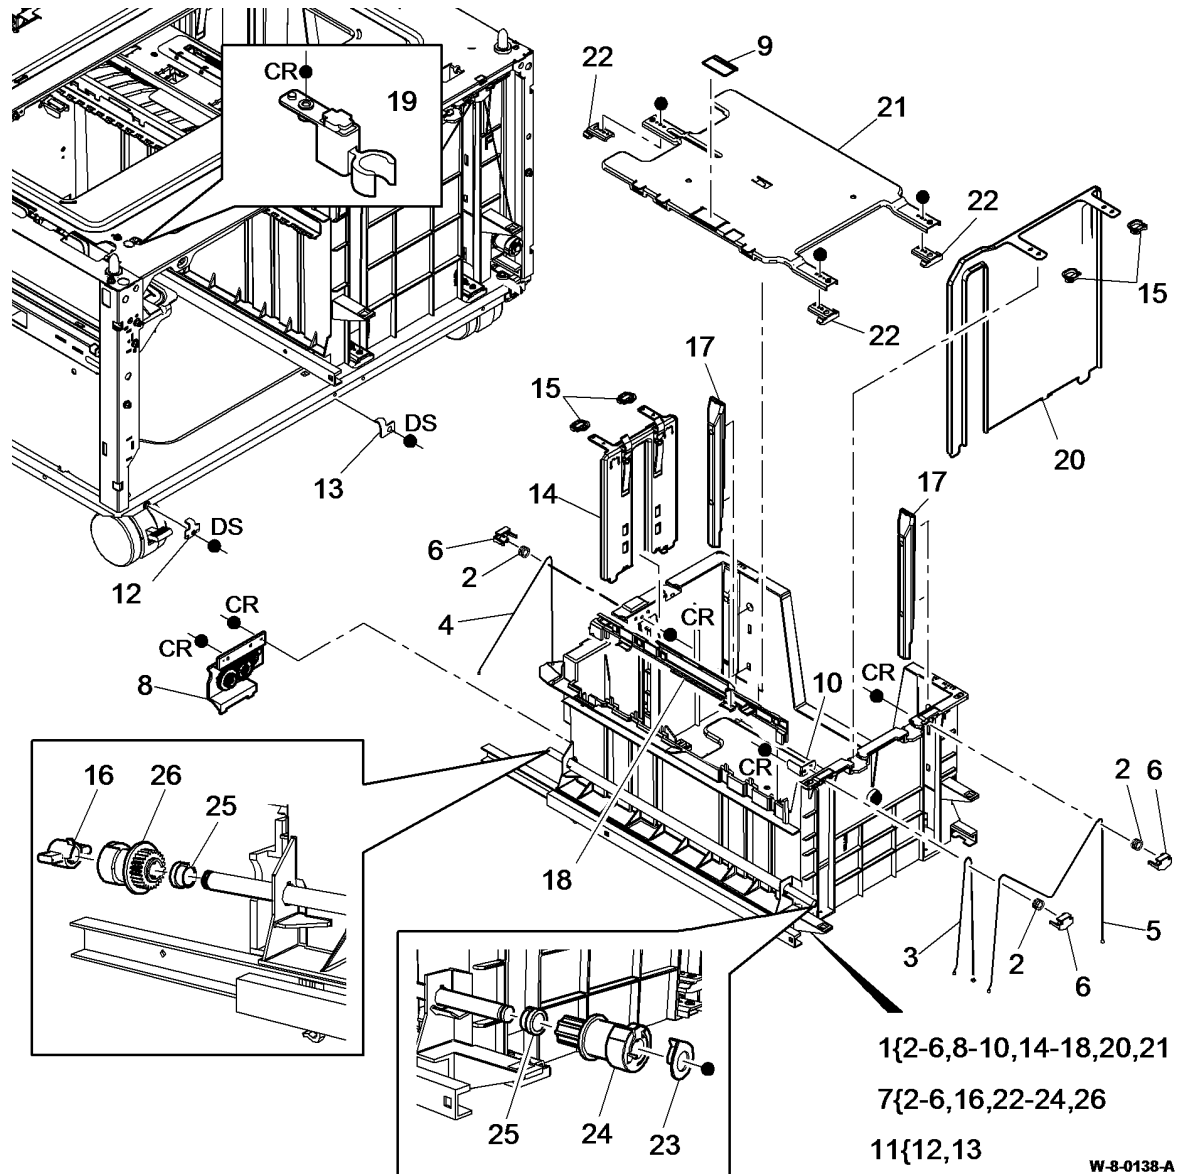
PL 70.19 Tray 4 Assembly

Item	Part	Description
1	050K74923	Tray 4 assembly (REP 70.14)
2	-	Tray hoist pulley (P/O PL 70.19 Item 7)
3	-	Front short elevator cable (P/O PL 70.19 Item 7)
4	-	Rear elevator cable (P/O PL 70.19 Item 7)
5	-	Front long elevator cable (P/O PL 70.19 Item 7)
6	-	Pulley carrier (P/O PL 70.19 Item 7)
7	604K84081	Tray 4 elevator cable kit (REP 70.8)
8	004K07870	Tray 4 elevate damper assembly (REP 70.11)
9	-	Retard pad (Not Spared)
10	-	Tray 4 skew bracket (P/O PL 31.14 Item 4)
11	604K83671	Tray 3 and 4 clamp kit
12	-	Side clamp (2 off) (P/O PL 70.19 Item 11)
13	-	Centre clamp (P/O PL 70.19 Item 11)
14	-	Rear paper guide (P/O PL 70.19 Item 1) (ADJ 70.1)
15	019E74532	Retaining clips
16	-	Elevator drives gear coupling (P/O PL 70.19 Item 7)
17	-	Tray 4 paper guide (P/O PL 70.19 Item 1)
18	815E92301	Separation strip
19	-	Not used
20	-	Front paper guide (P/O PL 70.19 Item 1) (ADJ 70.1)
21	-	Lift plate (P/O PL 70.19 Item 1)

22	-	Guide plate (P/O PL 70.19 Item 7)
23	-	Spacer (P/O PL 70.19 Item 7)
24	-	Elevator pulley (P/O PL 70.19 Item 7)
25	-	Bearing (Not Spared)
26	-	Elevator gear (P/O PL 70.19 Item 7)

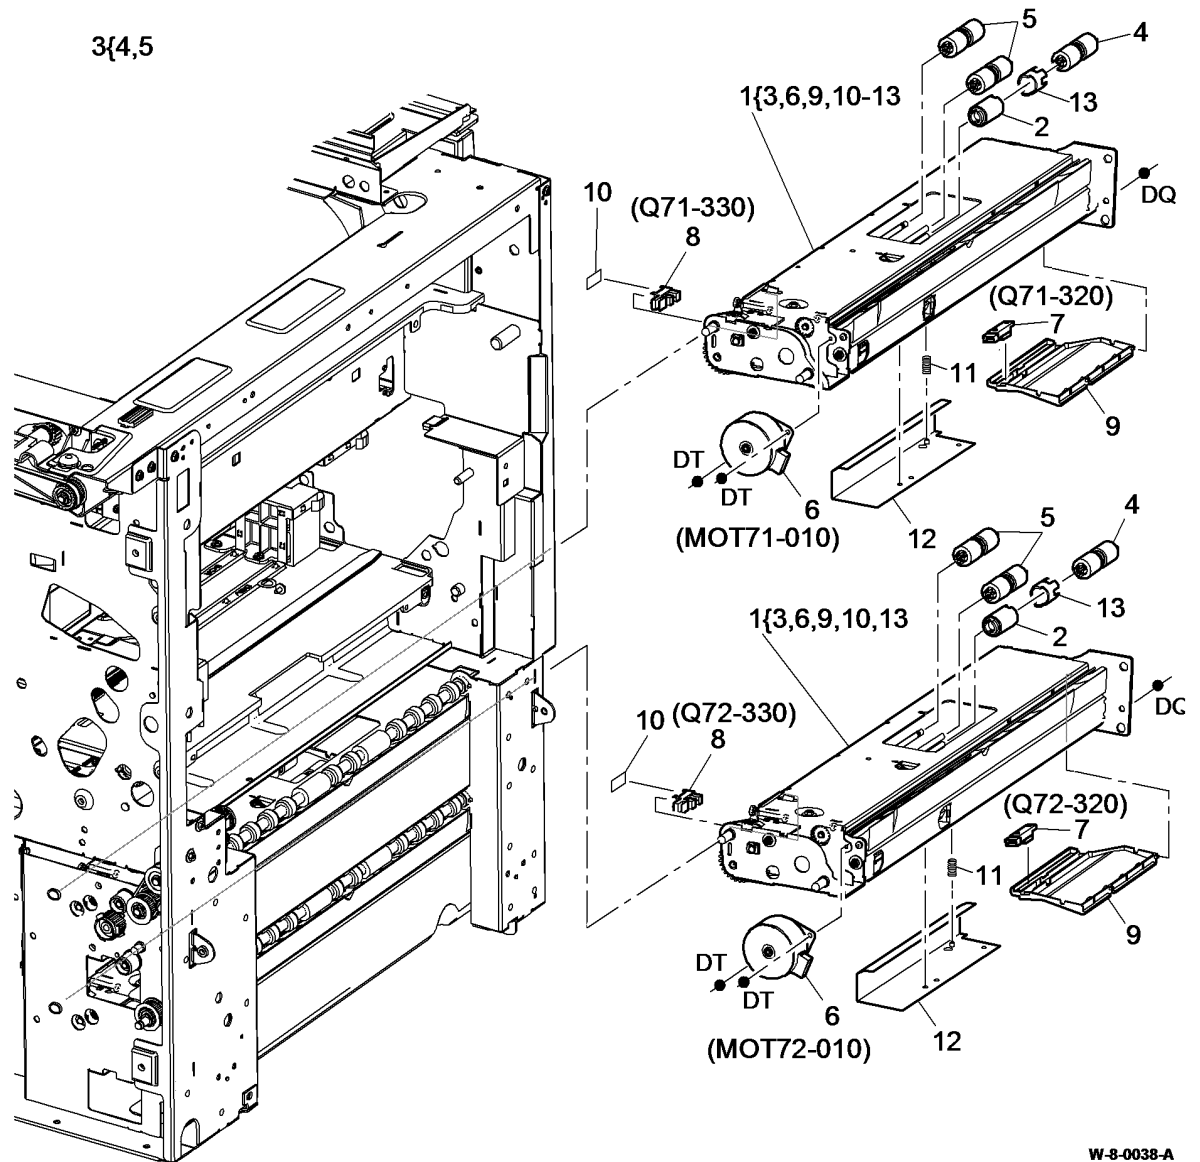
PL 80.32 Tray 3 Paper Feed Assembly

16	-	Shim (P/O PL 31.12 Item 16)
17	-	Nudger roll weight (P/O PL 80.32 Item 9) (ADJ 80.1)
18	-	Gull wing cover (P/O PL 31.14 Item 4)
19	121E27552	Feed clutch (REP 80.32)
20	-	Bracket (P/O PL 80.32 Item 1)

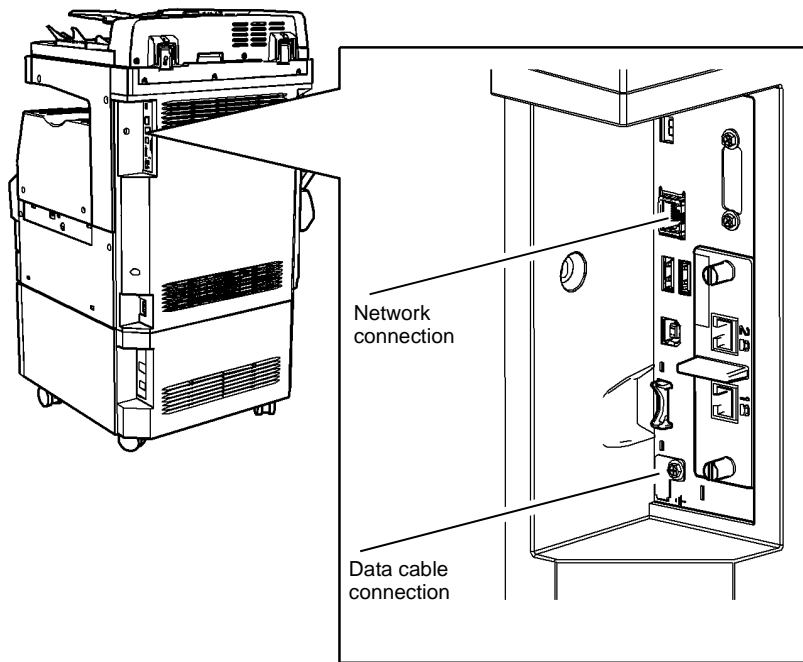
Figure 1 Data cable connection

NOTE: When connecting the data cable, ensure that the ground connector (marked GND) is aligned with ground symbol on the SBC module. Also, ensure that the data cable terminals are not misaligned with the PJ44 pins.
7. Start the PWS AltBoot tool.
8. Browse to and highlight the folder that contains the upgrade files, [Figure 2](#). Select OK.
9. If a **Connection Failed** window appears, Perform the steps that follow:
 - a. Open the PWS Control Panel window.
 - b. Select System Security, then System, then Device Manager.
 - c. In the Device Manager window select Ports (COM and LPT1). Note the USB serial port (COM#) number displayed.

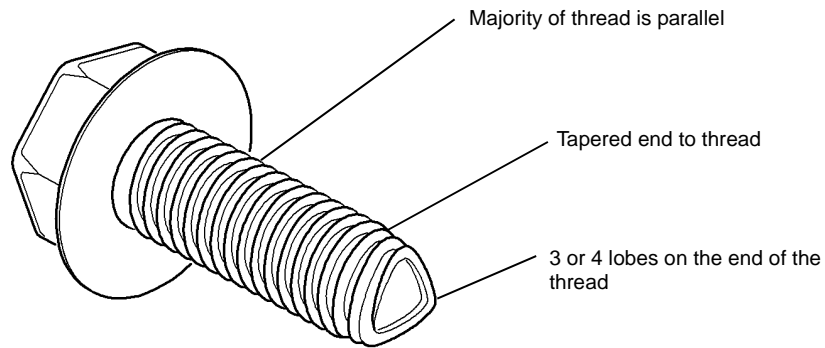
Figure 1 Thread forming screw

1. Ensure that the screw is a thread forming screw, refer to [Figure 1](#).

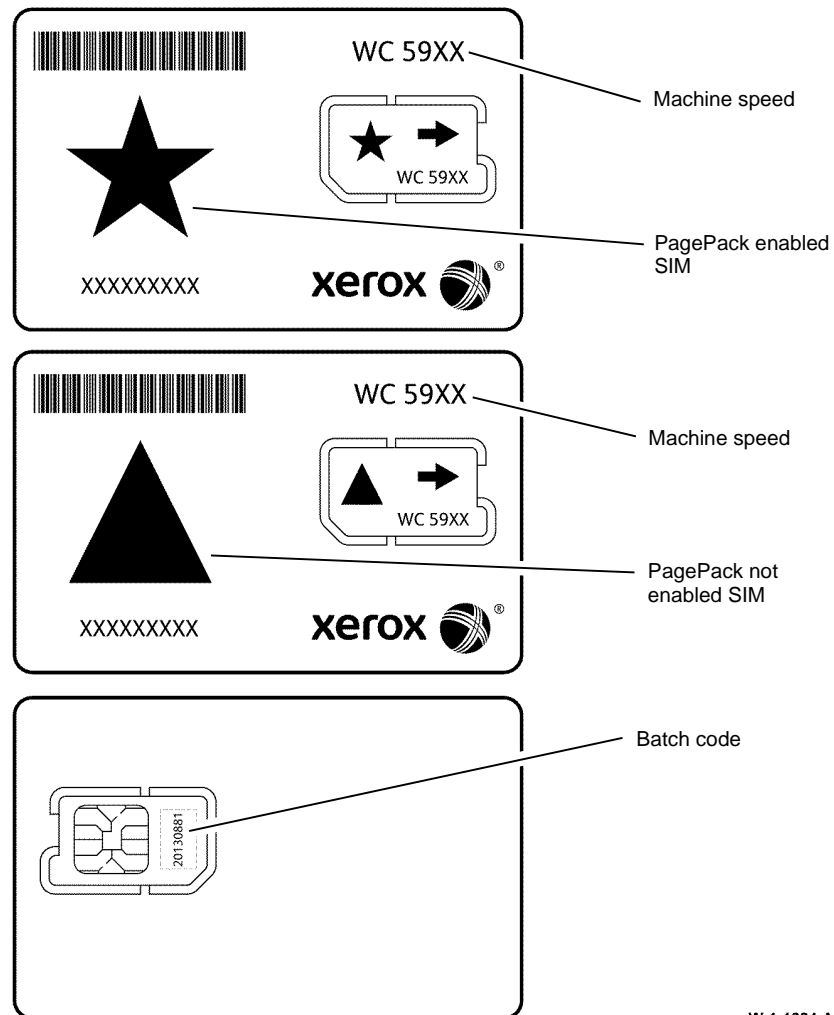
Figure 1 SIM card matrix

- The PagePack function is enabled in all XE installations. Depending on the customer's full service maintenance agreement, the PagePack function may need to be enabled when a USSG/XCL machine is installed in an XE region.
- A new SIM is pre-programmed with the machine speed and either PagePack enabled or not enabled. When the SIM is installed, the machine serial number is permanently written to the SIM. The SIM can not be reused in another machine.
- On the reverse of each SIM card is printed the batch code.

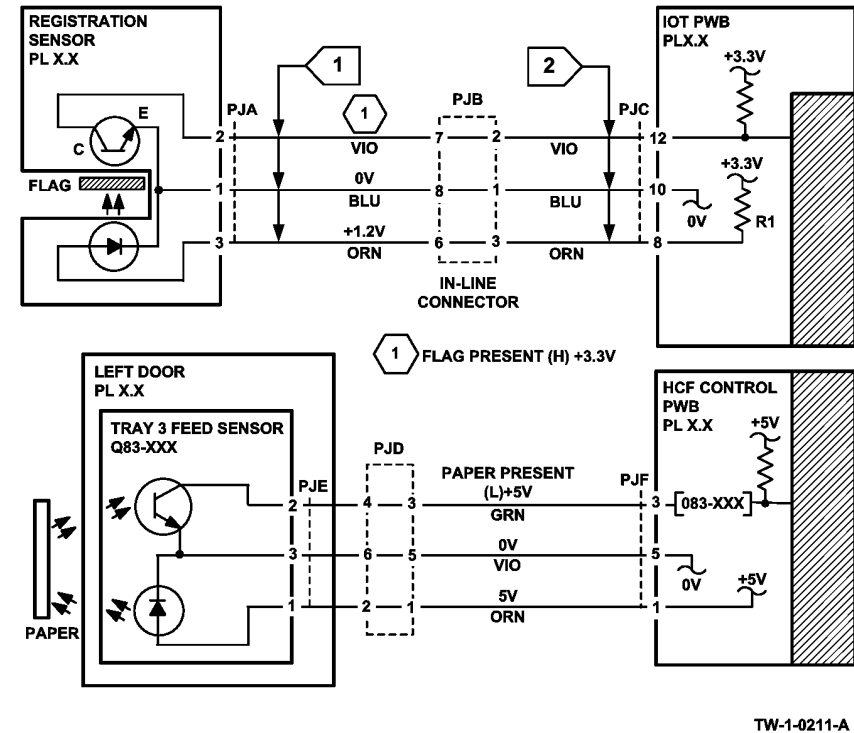
Figure 1 Circuit diagram

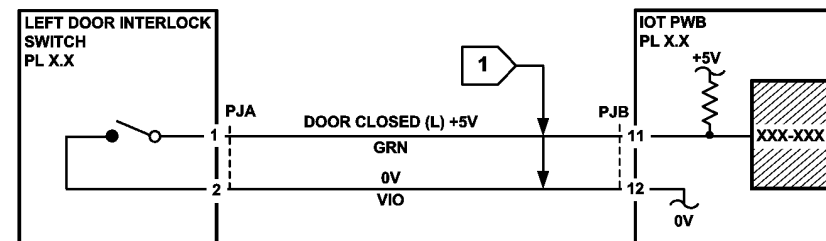
Figure 1 Circuit diagram

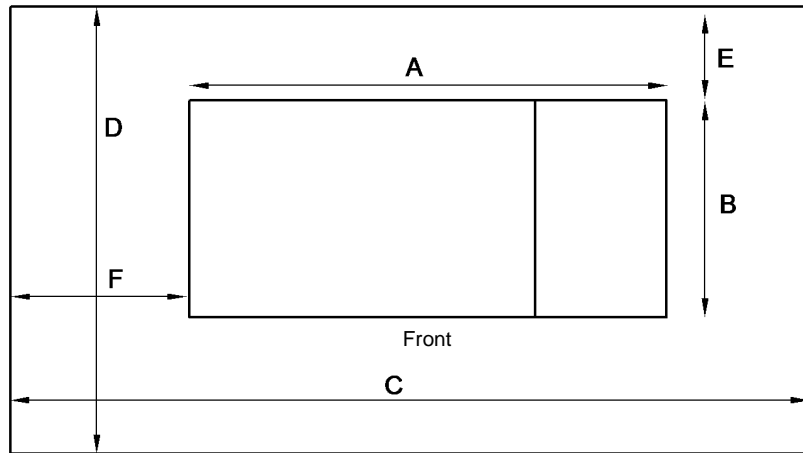
Figure 1 Installation plan

Configuration	Machine Width (A) mm/inches	Machine Depth (B) mm/inches	Install Width Required (C) mm/inches		Install Depth Required (D) mm/inches		Install Airflow/Service Work Space (E) mm/inches		Left Door Access Space (F) mm/inches
			Moveable	Fixed	Moveable	Fixed	Moveable	Fixed	
Basic machine without finisher	850 / 33.5	665 / 26.2	2043 / 80.4	3043 / 119.8	1665 / 65.5	2665 / 105	100 / 4	1000 / 39.4	440 / 17
Basic machine with 2K LCSS	1470 / 57.8	665 / 26.2	2663 / 104.8	3663 / 144.2	1665 / 65.5	2665 / 105	100 / 4	1000 / 39.4	440 / 17
Basic machine with LVF BM	1530 / 60.2	665 / 26.2	2723 / 107.2	3723 / 146.6	1665 / 65.5	2665 / 105	100 / 4	1000 / 39.4	440 / 17

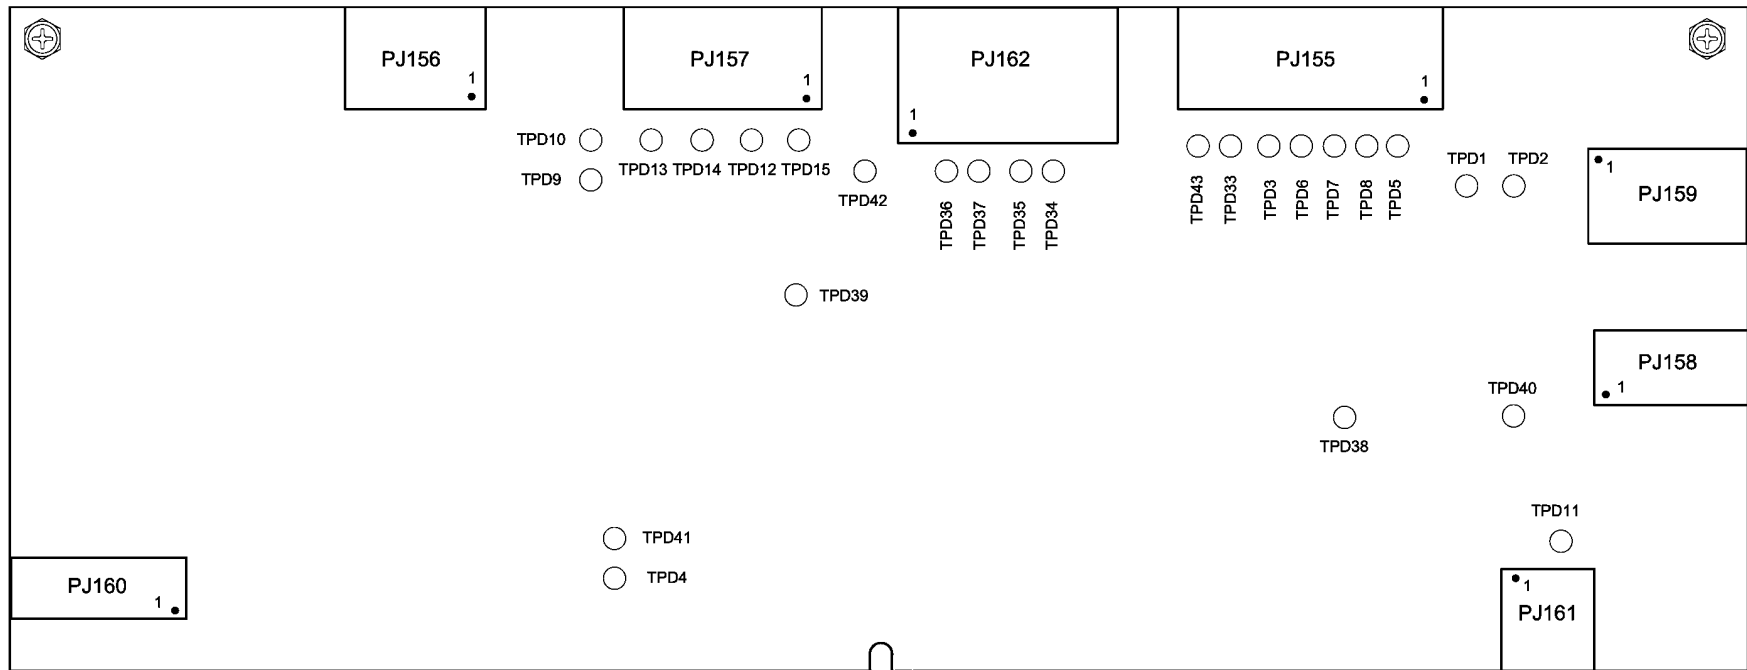
Figure 1 Tray 4 control PWB test points

Test Point	PJ	Pin	Component	Measure
TPD1	N/A	N/A	Do not use	N/A
TPD2	159	1	Tray 4 over elevate switch Tray 4 elevate motor, MOT74-010, return	Limit reached (H) +24V Motor on (L) +24V
TPD3	155	11	Tray 4 elevate motor, MOT74-010, enable	Elevate enabled (H) +5V
TPD4	159 160	3 1	Tray 4 over elevate switch supply Tray 4 elevate motor, MOT74-010, supply	+24V
TPD5	155	7	Tray 4 feed motor, MOT81-040, hold	N/A
TPD6	155	10	Tray 4 feed motor, MOT81-040, enable	Feed enabled (L) +5V
TPD7	155	9	Tray 4 feed motor, MOT81-040, clock	N/A
TPD8	155	8	Tray 4 feed clutch, CL81-043, enable	Clutch energised (H) +5V
TPD9	156	4	Tray 4 level encoder sensor, Q74-340, supply	+1.1V
TPD10	156	6	Tray 4 level encoder sensor, Q74-340	Pulses (L) +3.3V
TPD11	161	2	Tray 4 exit sensor, Q81-150	Paper present (L) +3.3V
TPD12	157	5	Tray 4 feed sensor, Q81-104	Paper sensed (L) +3.3V
TPD13	157	11	Tray 4 home sensor, Q74-300	Tray home (L) +3.3V

TPD14	157	8	Tray 4 empty sensor, Q74-320	Tray empty (H) +3.3V
TPD15	157	2	Tray 4 stack height sensor, Q74-330	Stack up (H) +3.3V
TPD33	155	12 13	+5V supply to tray 4 control PWB	+5V
TPD34	162	6	Tray 4 feed motor, MOT81-040, A+	Pulses (L)
TPD35	162	5	Tray 4 feed motor, MOT81-040, A-	Pulses (L)
TPD36	162	4	Tray 4 feed motor, MOT81-040, B+	Pulses (L)
TPD37	162	3	Tray 4 feed motor, MOT81-040, B-	Pulses (L)
TPD38	158	1	Power ground	Ground
TPD39	N/A	N/A	Do not use	N/A
TPD40	158	2	24V from LVPS	+24V
TPD41	160 162	2 1	Tray 4 feed clutch, CL81-043, 24V supply Tray 4 elevate motor, MOT74-010, 24V supply	+24V
TPD42	162	1	Tray 4 feed clutch, CL81-043, enable	Energised (L) +24V
TPD43	N/A	N/A	Tray 4 control PWB ground	Ground

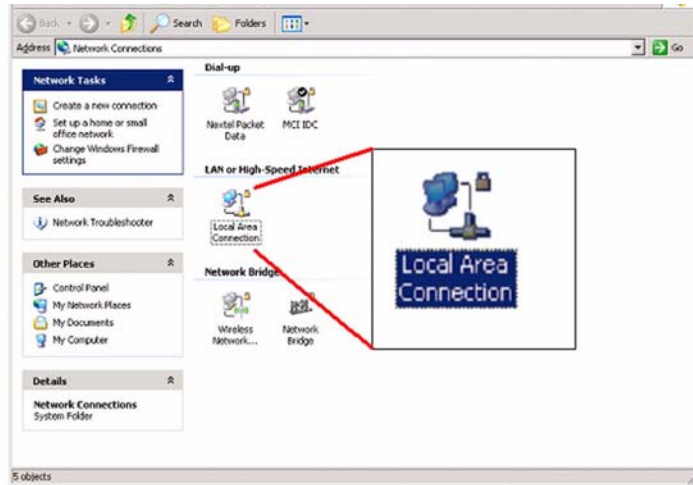
1. On the PWS, right-click on the My Network Places desktop icon or select Start / My Network Places. Select Properties from the menu. The Network and Dial-up Connections window will open.
2. Check if the firewall is enabled or disabled. If the Local Area Connection icon has a padlock symbol, the firewall is enabled, [Figure 2](#). If the firewall is enabled, continue with this procedure.

Figure 2 Padlock symbol

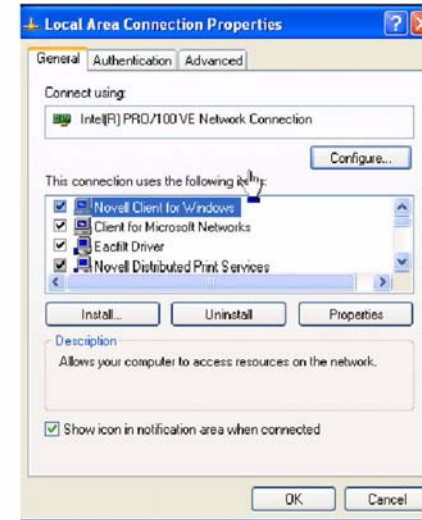
3. Right-click on Local Area Connection icon, then select Properties. The Local Area Connection Properties window will open, [Figure 3](#).

Figure 3 Properties window

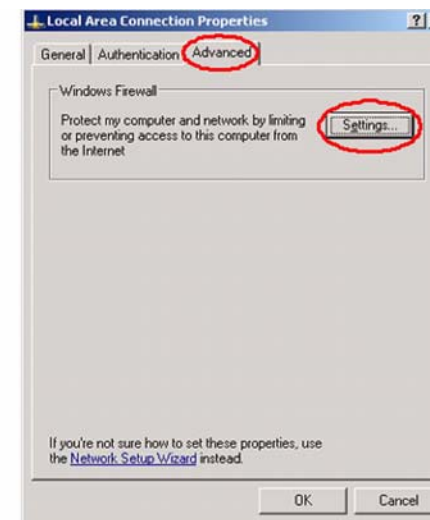
4. Select the Advanced tab, then the Settings button, [Figure 4](#). If available, uncheck Protect my computer and network by limiting or preventing access to the computer from the Internet. Select OK. The Windows Firewall window will open.

Figure 4 Settings button

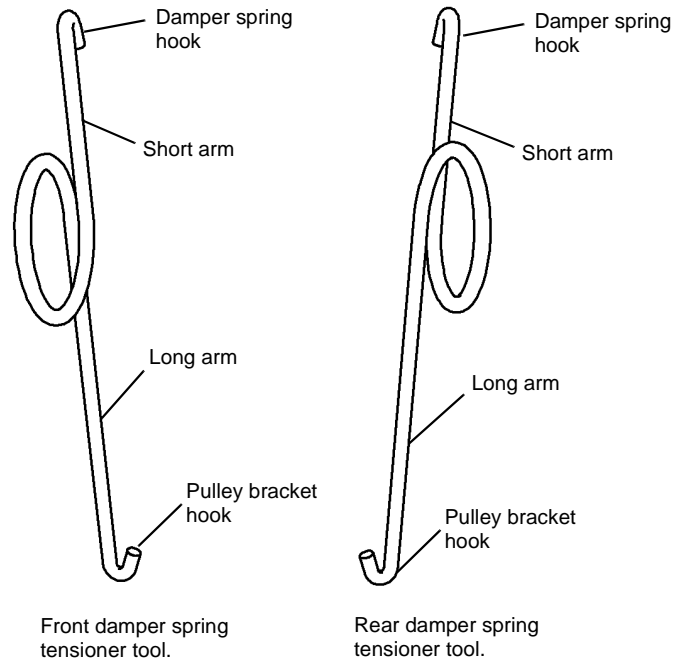
6. Identify the front and rear spring tensioner tools, [Figure 1](#).

Figure 1 Tool identification

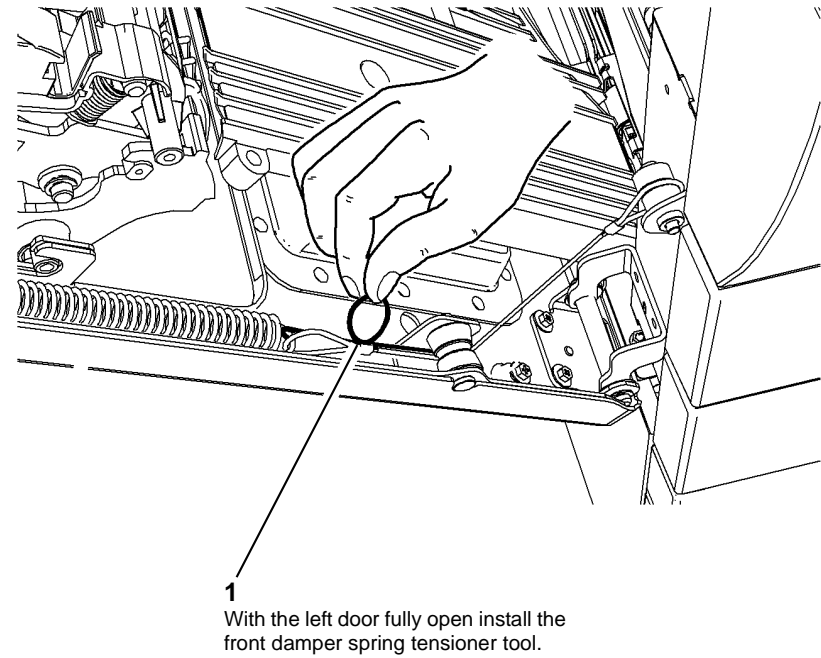
7. Install the front and rear damper spring tensioner tools. Hook the short arm of each tool to the bottom loop of the respective damper spring, then hook the long arm to the inner side of the pulley bracket, [Figure 2](#) and [Figure 3](#).

Figure 2 Front damper spring tensioner tool

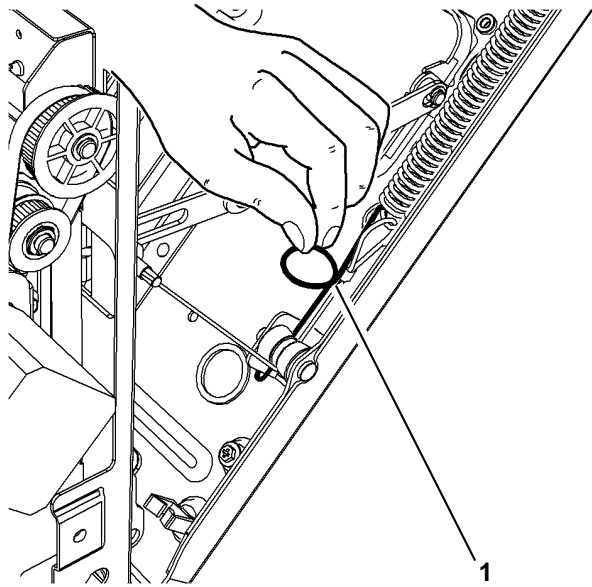
1
With the left door fully open install the rear damper spring tensioner tool.

Figure 3 Rear damper spring tensioner tool

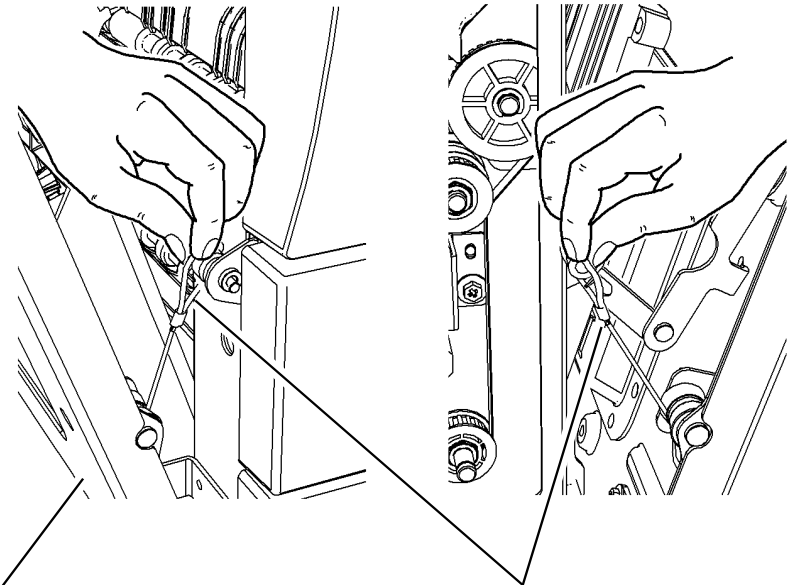
8. Release the front and rear damper cables, Figure 4.

1
Partially close the left door, leaving just sufficient access to the looped ends of the front and rear damper cables.

2
Pull the damper cables off the front and rear anchor pulleys.

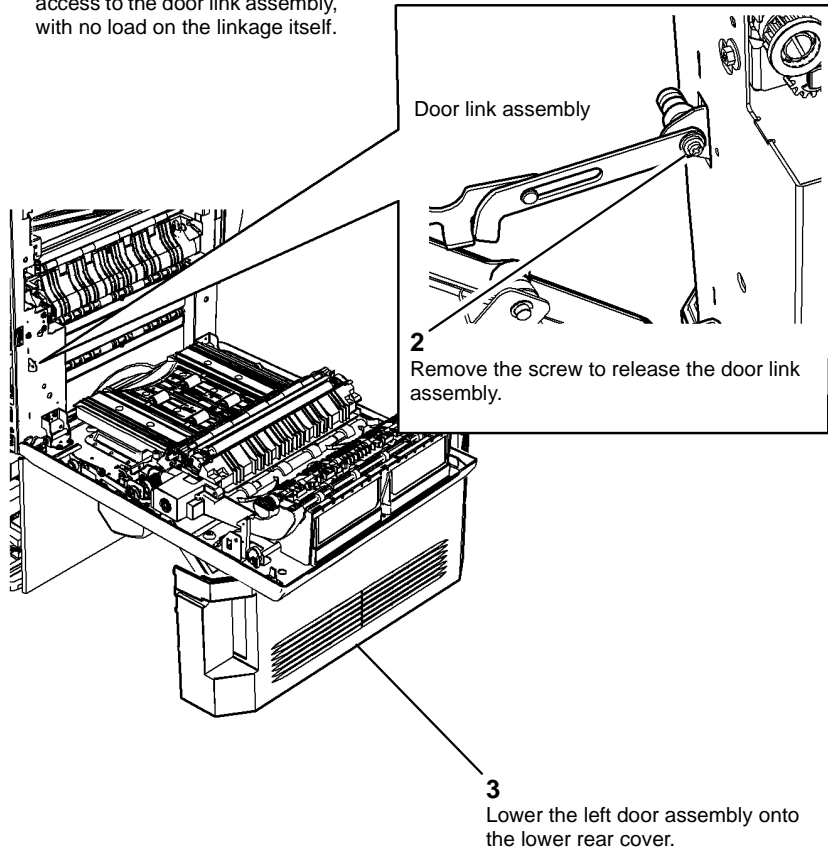
Lower, then hold the left door assembly in a position to allow access to the door link assembly, with no load on the linkage itself.

Figure 5 Left door service position

Do not lower the left door assembly further than the authorized service position, GP 37. Lowering of the left door assembly beyond the service position will cause the left door cover to collide with the IOT to HCF inboard fixing bolt.

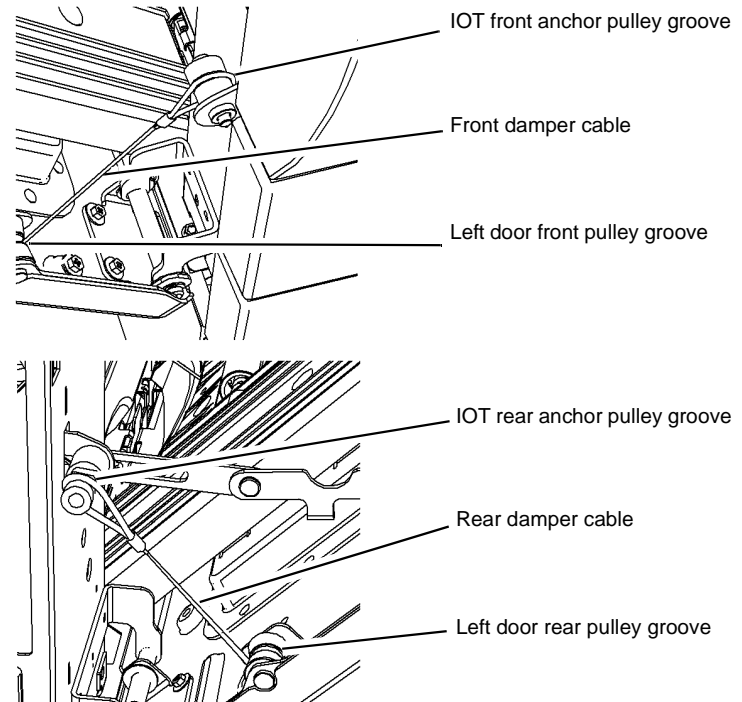
- The replacement is the reverse of the removal procedure.
- Ensure the front and rear damper cables are located in the grooves of their pulleys, [Figure 6](#).

Figure 6 Pulley grooves

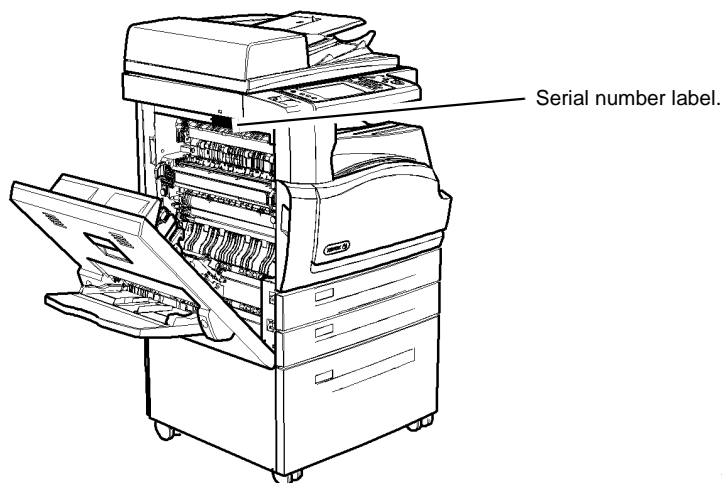
1. Enter service mode, [GP 1](#).
2. Select the Maintenance tab.
3. Select dC132 Machine Serial Number.
4. The machine identifier code (serial number) or '#####' is displayed.
5. If the displayed serial number does not match the number on the serial number label ([Figure 1](#)) or '#####' is displayed, the serial number is corrupt. Perform [Serial Number Restore](#).

Figure 1 Label location

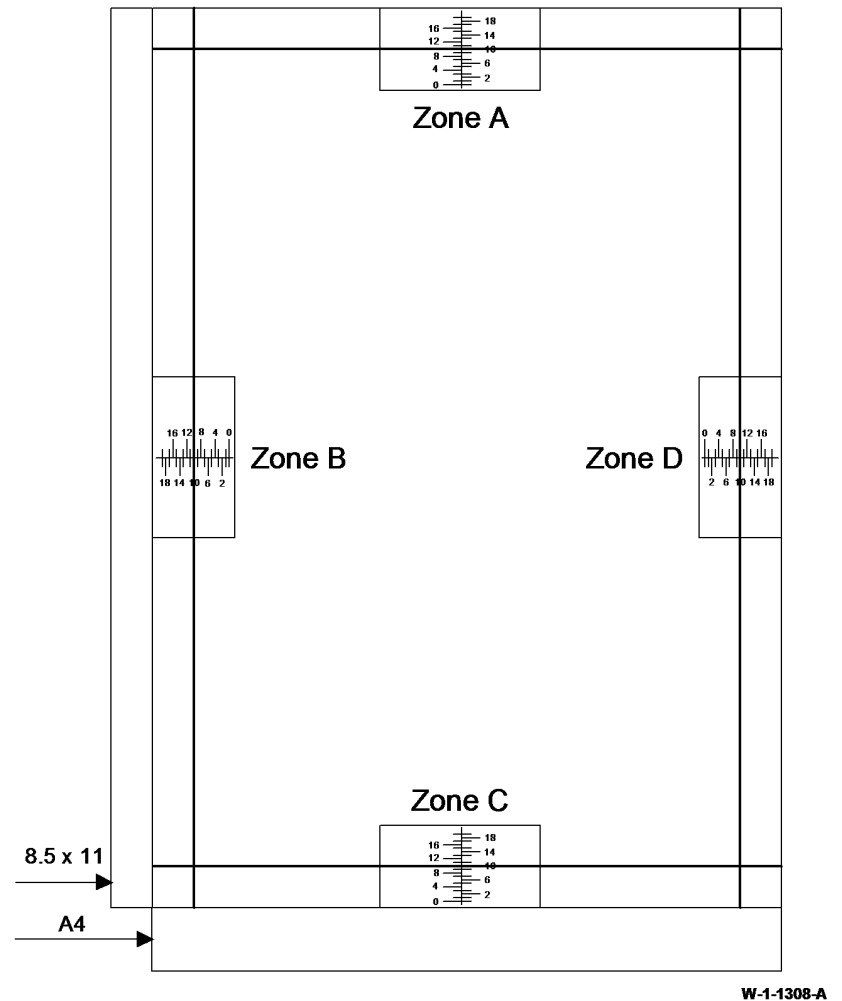
Figure 1 Registration test pattern

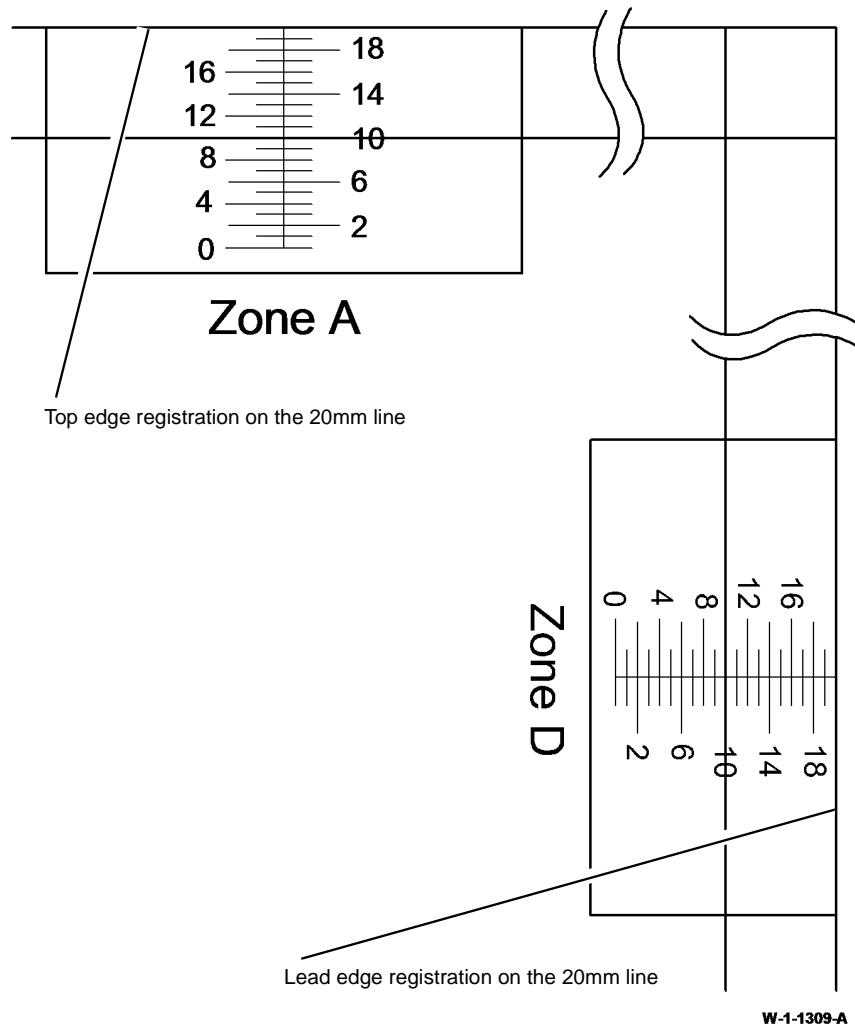
Figure 2 IOT registration

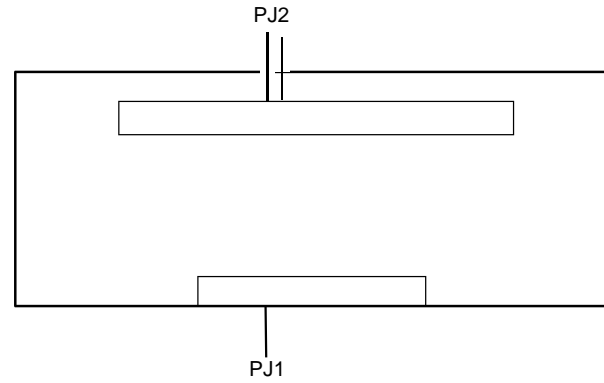
Location: PL 20.05 Item 2

Figure 2 Fax connector PWB

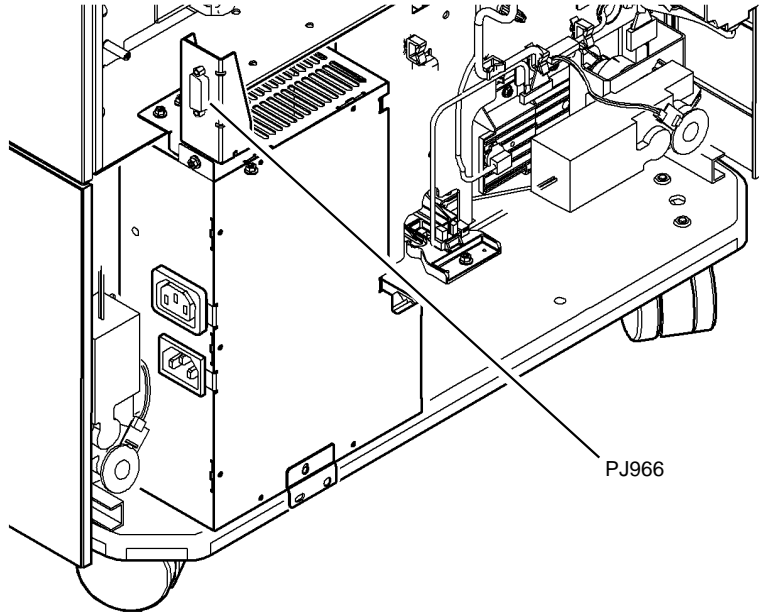
Finisher Communications Connector PJ966

Figure 3 Finisher connector

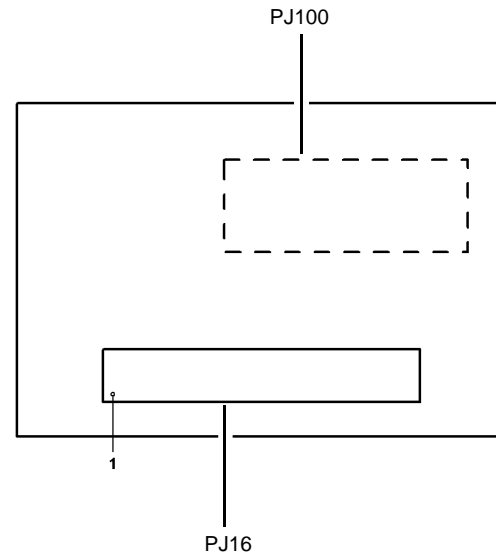
Location: [PL 3.22 Item 18](#)

Figure 4 Foreign device interface PWB

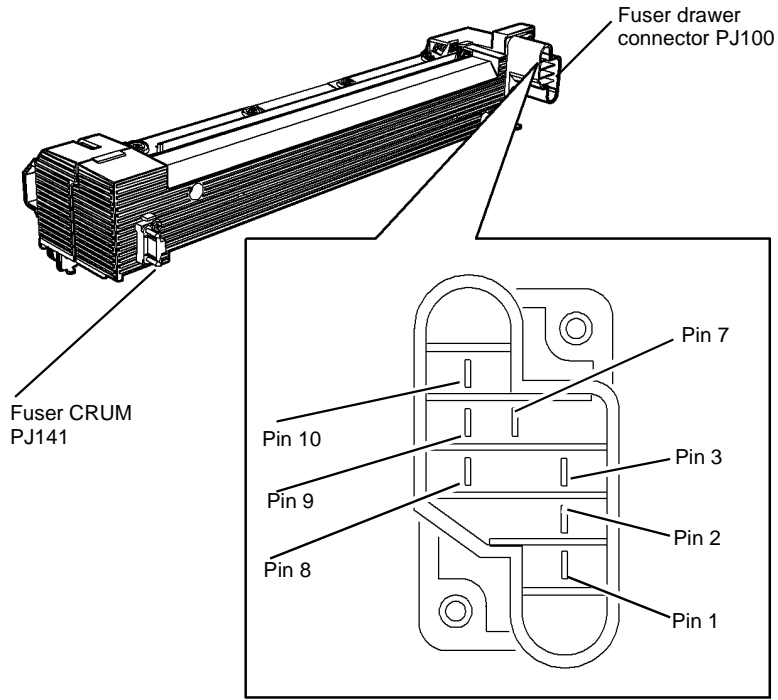
Location: PL 10.10 Item 1

Figure 5 Fuser module

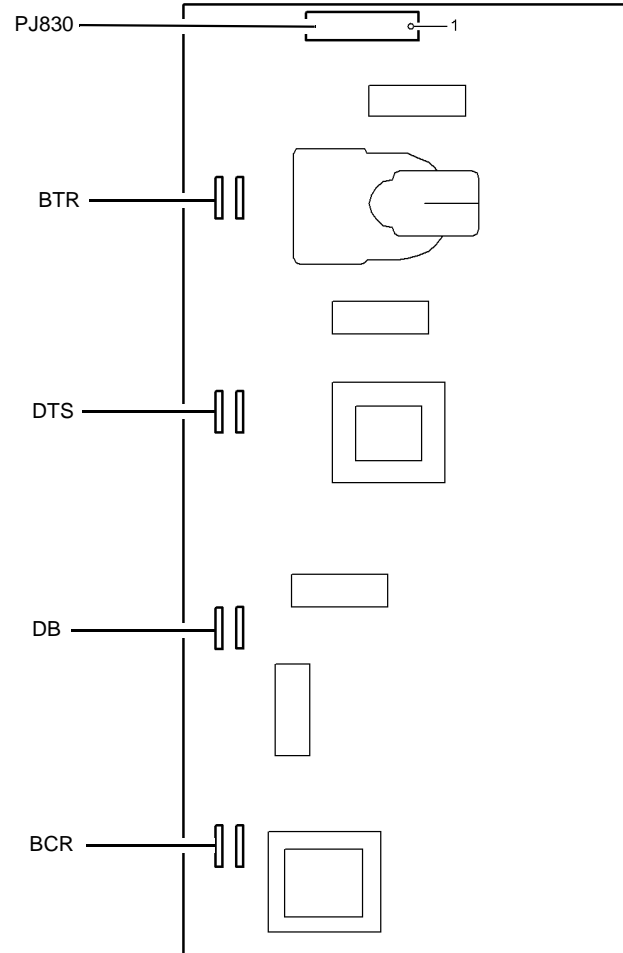
Location: PL 1.10 Item 5

Figure 6 HVPS
