708P91139
February 2016

Xerox® WorkCentre® 5945 Family Multifunction Printer Service Manual

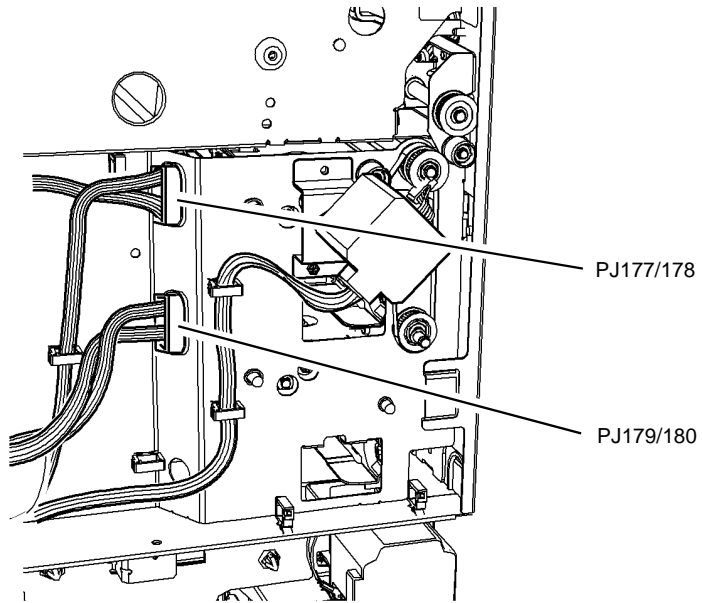
In-line Connectors PJ177/178 and PJ179/180

Figure 7 In-line connectors

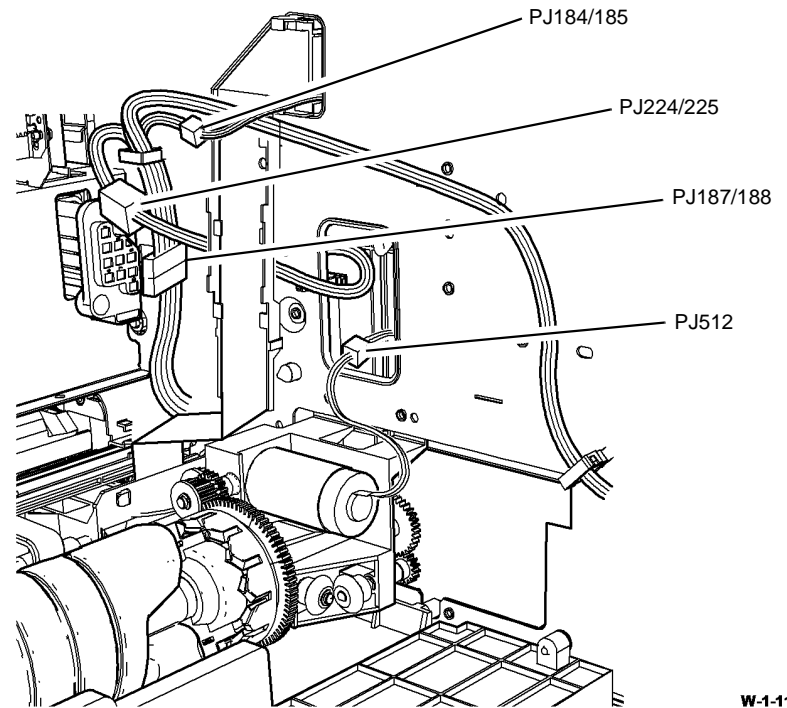
In-line Connectors PJ184/185, 187/188, PJ224/225 and PJ512

Figure 8 In-line connectors

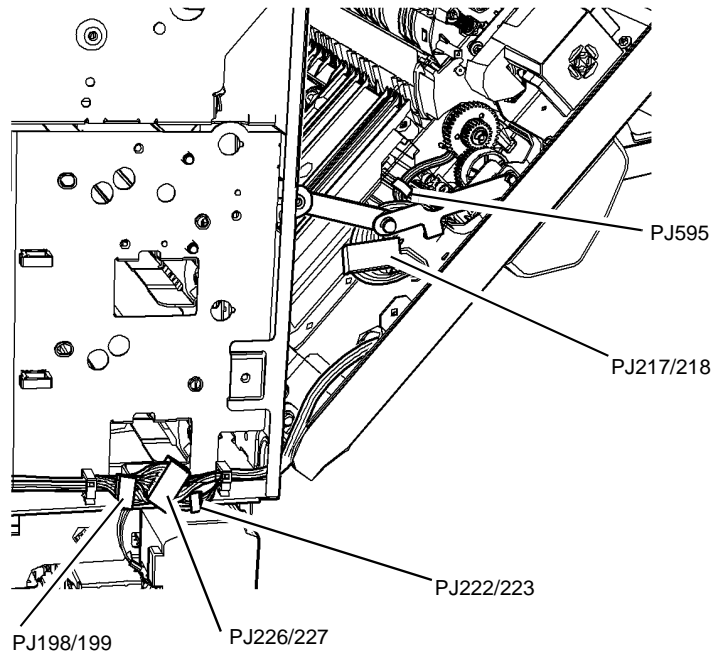
NOTE: For clarity, the connector cover, [PL 80.11 Item 22](#) is not shown in [Figure 9](#).

Figure 9 In-line connectors

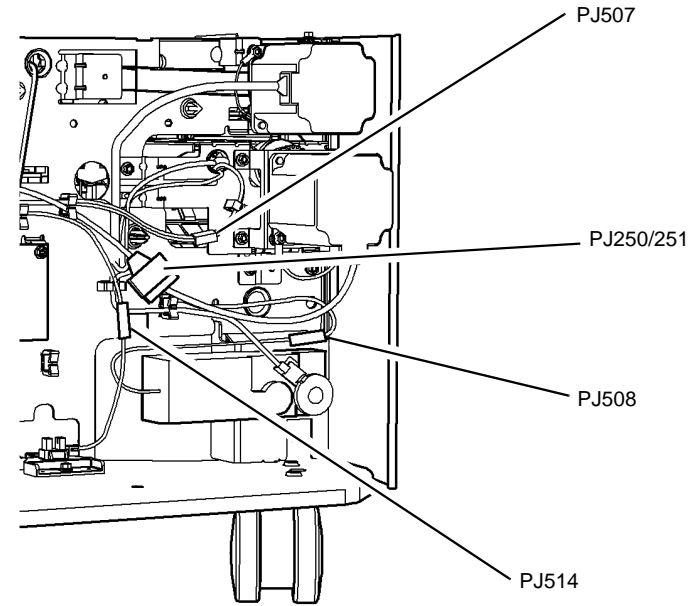
In-line Connectors PJ250/251, PJ507, PJ508 and PJ514

Figure 10 In-line connectors

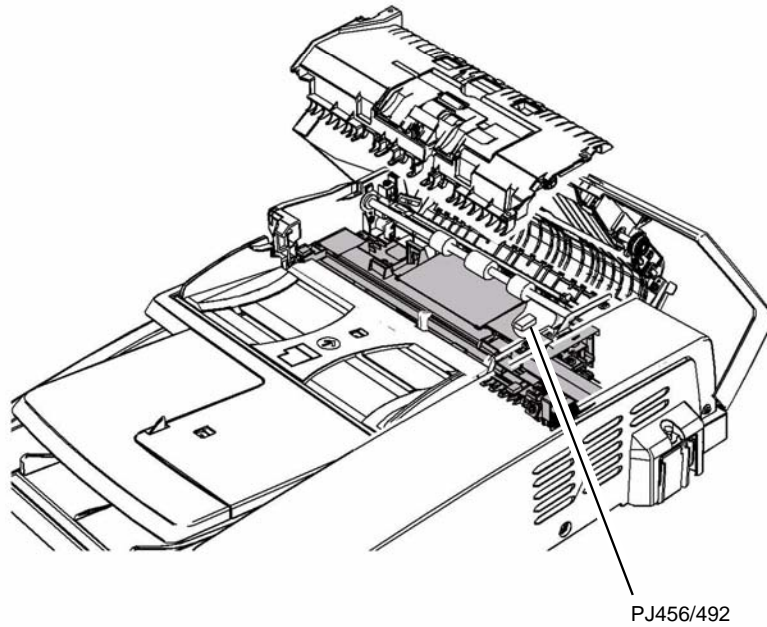
In-line Connector PJ456/492

Figure 11 In-line connector

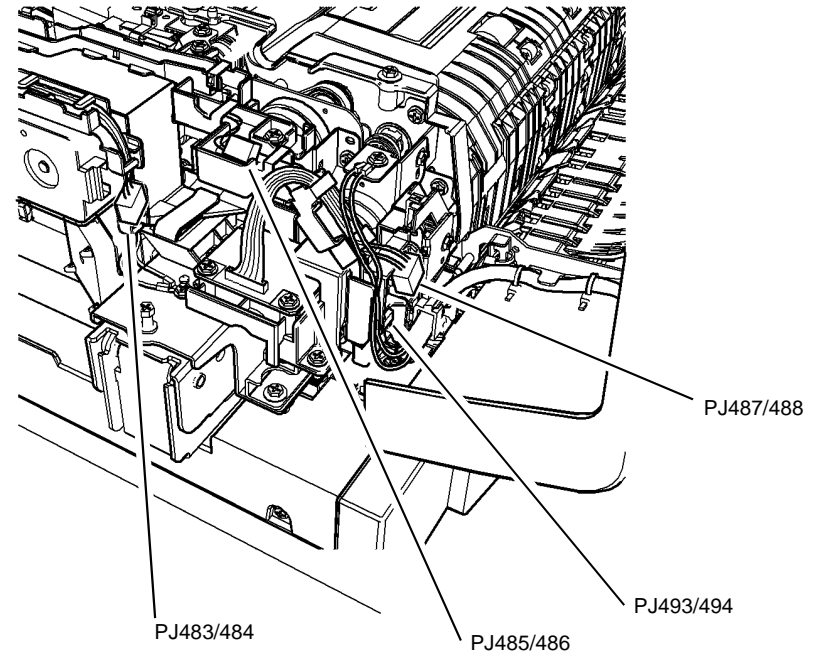
In-line Connectors PJ483/484, PJ485/486, PJ487/488 and PJ493/494

Figure 12 In-line connector

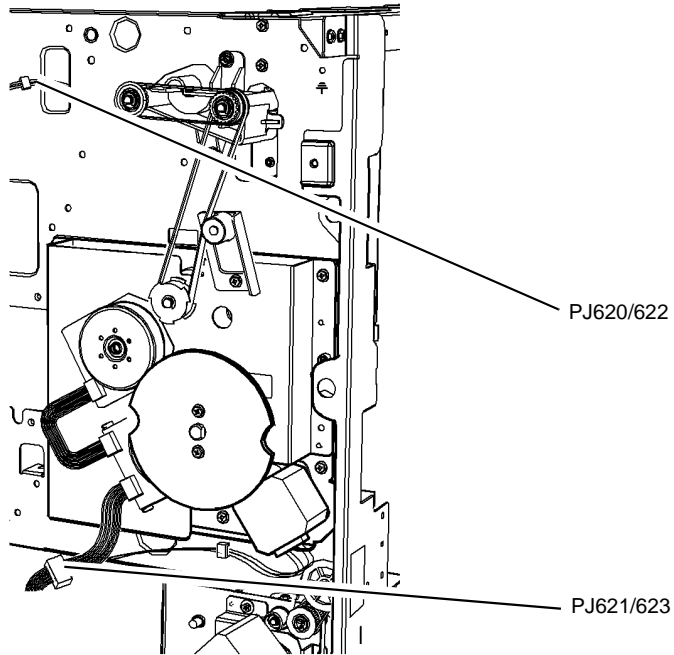
In-line Connectors PJ620/622 and PJ621/623

Figure 13 In-line connector

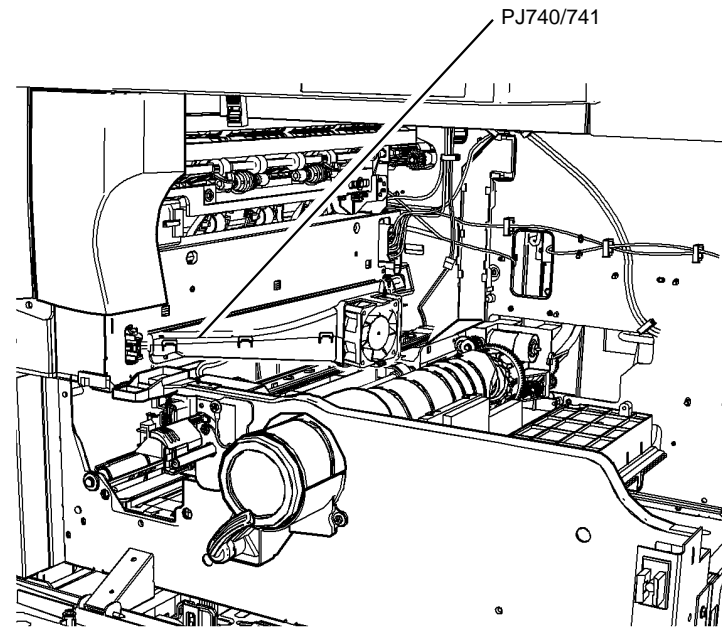
In-line Connector PJ740/741

Figure 14 In-line connector

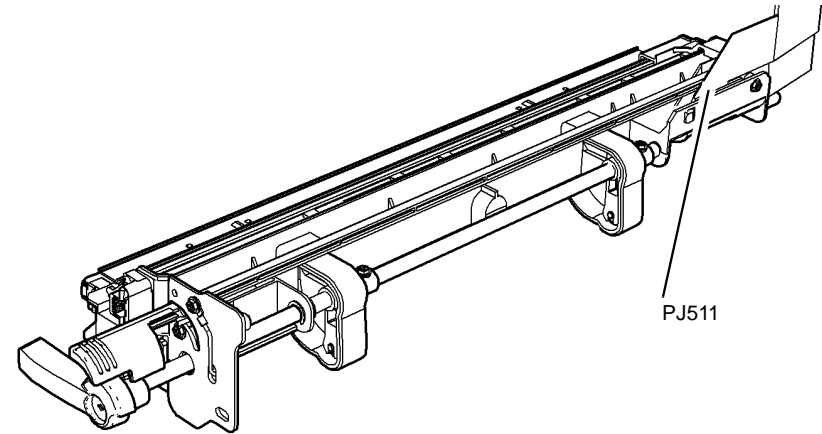
Location: PL 60.35 Item 1

Figure 16 LED print head module

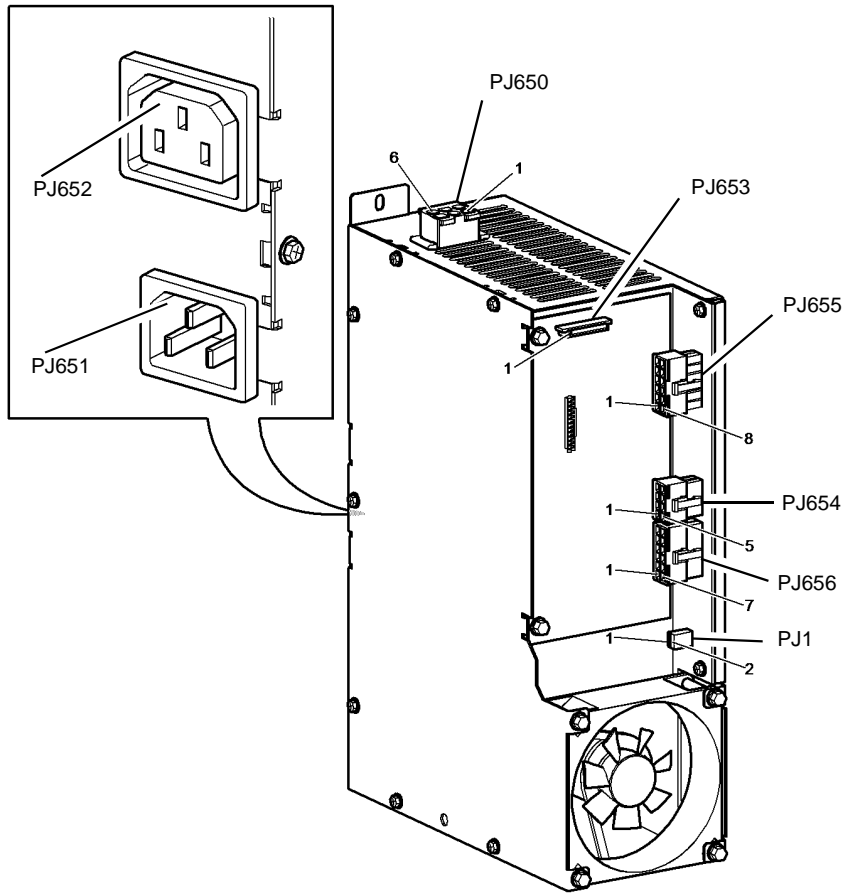
Location: PL 1.10 Item 3

Figure 19 LVPS

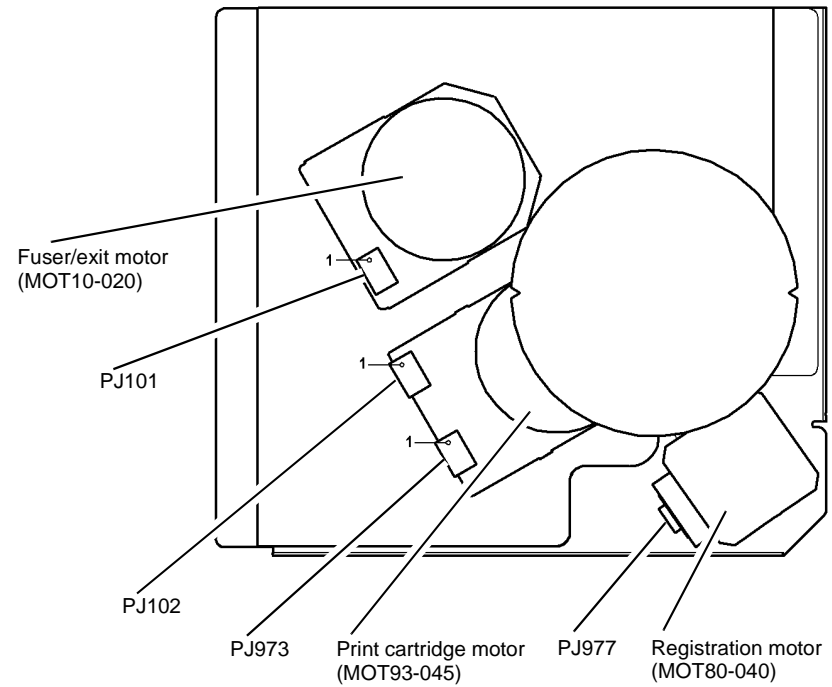
Location: PL 40.15 Item 1

Figure 20 Main drive module

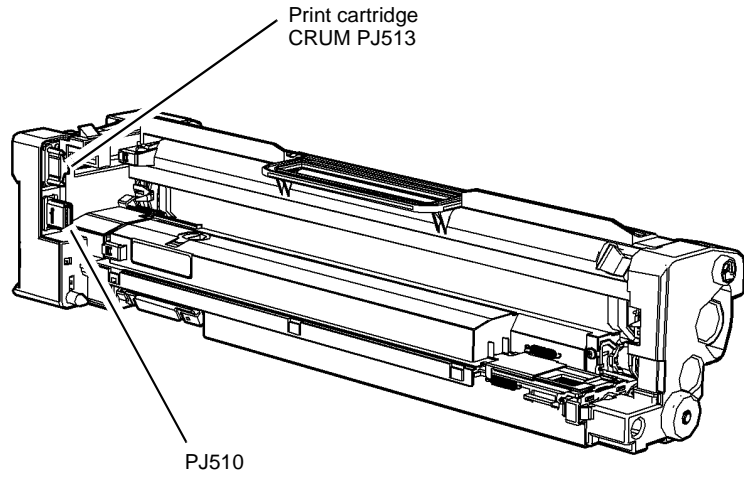
Location: [PL 90.17 Item 9](#)

Figure 21 Print cartridge

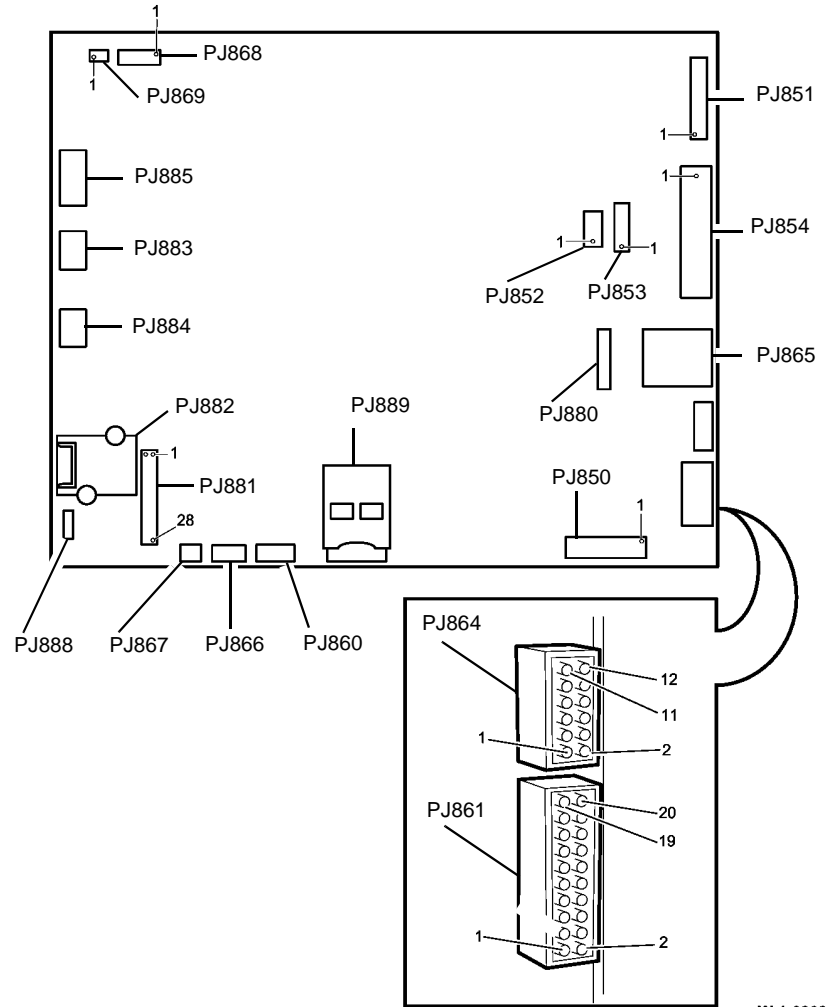
Location: [PL 3.22 Item 3](#)

Figure 22 SBC PWB

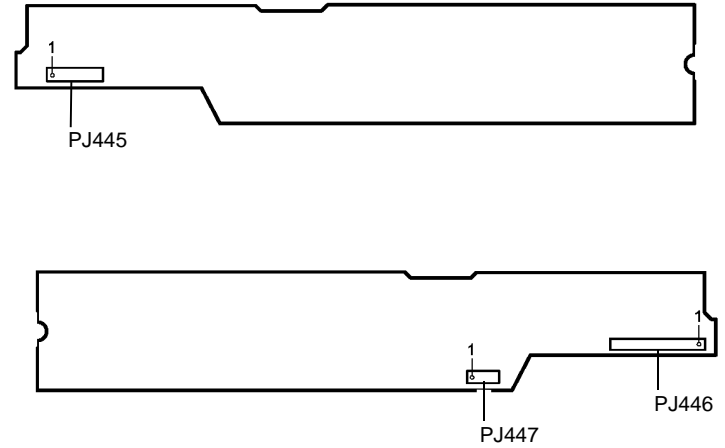
Location: PL 60.25 Item 4

Figure 24 Scanner CCD PWB

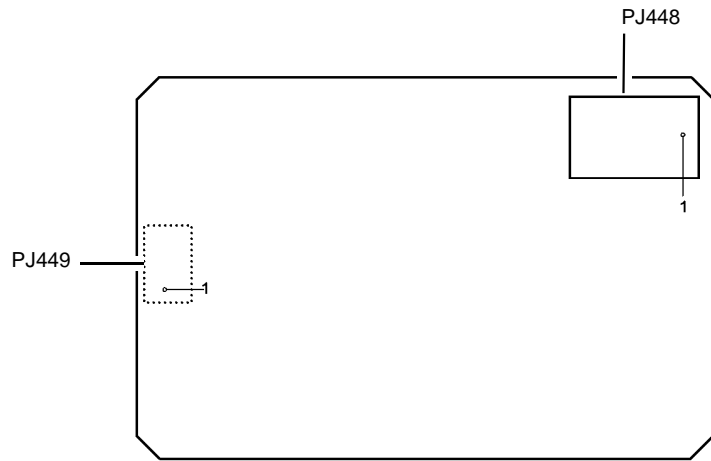
Scanner LED Drive PWB

Location: PL 60.25 Item 6

446	Figure 24	Scanner CCD PWB	WD 16
447	Figure 24	Scanner CCD PWB	WD 16
448	Figure 25	Scanner LED drive PWB	WD 16
449	Figure 25	Scanner LED drive PWB	WD 16
450	Figure 26	Scanner LED lamp PWB	WD 16

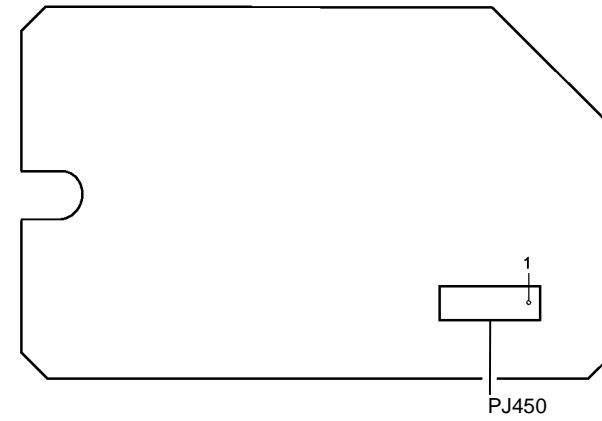
Figure 26 Scanner LED lamp PWB

Scanner LED Lamp PWB

Location: PL 60.25 Item 2

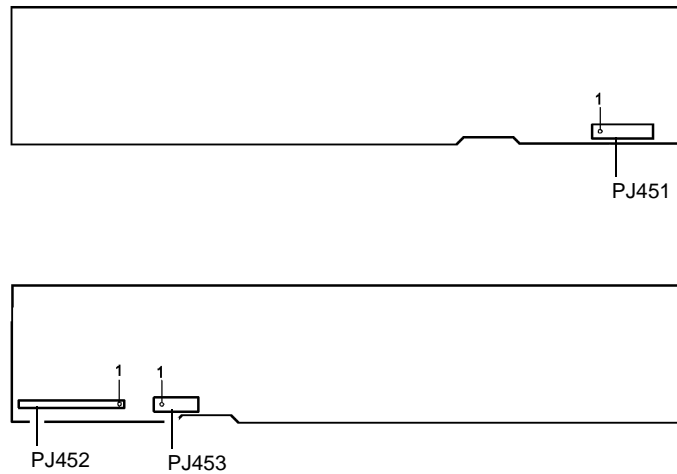
Side 2 CCD PWB

Location: PL 60.30 Item 4

PJ Number	Figure No.	PJ Location	Wiring Diagram
451	Figure 27	Side 2 CCD PWB	WD 16

PJ Number	Figure No.	PJ Location	Wiring Diagram
452	Figure 27	Side 2 CCD PWB	WD 13
453	Figure 27	Side 2 CCD PWB	WD 13
454	Figure 28	Side 2 LED drive PWB	WD 14
455	Figure 29	Side 2 LED lamp PWB	WD 15
456	Figure 11	In-line connector side 2 PWB	WD 13, WD 14
458	Figure 30	SPDH PWB	WD 13
459	Figure 30	SPDH PWB	WD 13
460	Figure 30	SPDH PWB	WD 13
461	Figure 30	SPDH PWB	WD 13
462	Figure 30	SPDH PWB	WD 13
463	Figure 30	SPDH PWB	WD 13
464	Figure 30	SPDH PWB	WD 14
465	Figure 30	SPDH PWB	WD 14
466	Figure 30	SPDH PWB	WD 14
467	Figure 30	SPDH PWB	WD 14
468	Figure 30	SPDH PWB	WD 14
469	Figure 30	SPDH PWB	WD 15
470	Figure 30	SPDH PWB	WD 15
471	Figure 30	SPDH PWB	WD 15
472	Figure 30	SPDH PWB	WD 15
473	Figure 30	SPDH PWB	WD 15
474	Figure 30	SPDH PWB	WD 15
475	Figure 30	SPDH PWB	WD 15
483	Figure 12	In-line connector SPDH PWB side	WD 15
484	Figure 12	In-line connector fan side	WD 15
485	Figure 12	In-line connector SPDH PWB side	WD 15

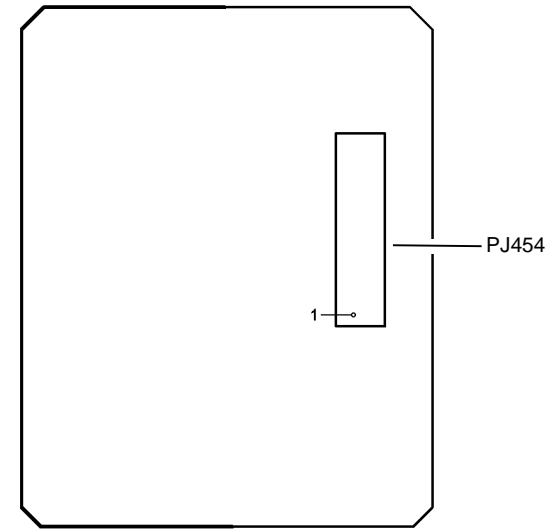
Figure 28 Side 2 LED drive PWB

Side 2 LED Drive PWB

Location: PL 60.30

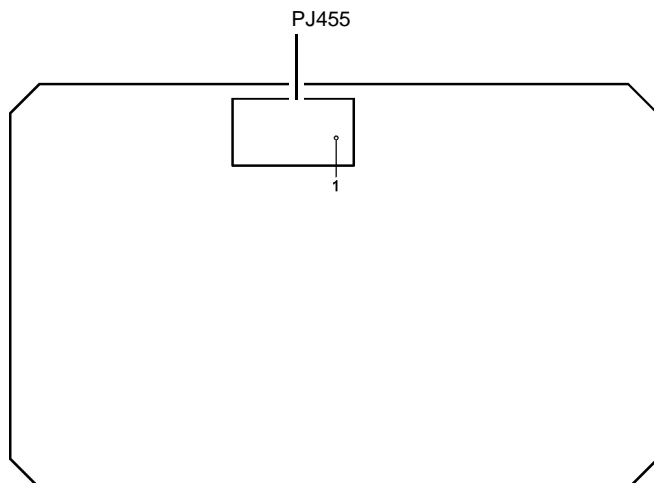
Figure 29 Side 2 LED lamp PWB

Side 2 LED Lamp PWB

Location: PL 60.30 Item 2

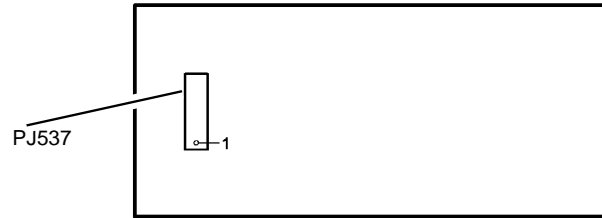
Tray 1 Paper Size Sensing PWB

Location: [PL 70.10 Item 18](#)

PJ Number	Figure No.	PJ Location	Wiring Diagram
512	Figure 8	In-line connector	WD 9
513	Figure 21	Print cartridge	WD 9
514	Figure 10	In-line connector tray 3 over elevate switch	WD 7
537	Figure 31	Tray 1 paper size sensing PWB	WD 5
544	Figure 32	Tray 2 paper size sensing PWB	WD 5
595	Figure 9	In-line connector bypass tray clutch	WD 7
620	Figure 13	In-line connector IOT PWB side	WD 9
621	Figure 13	In-line connector LVPS side	WD 1
622	Figure 13	In-line connector fuser side	WD 9
623	Figure 13	In-line connector main drive module side	WD 1
650	Figure 19	LVPS	WD 9
651	Figure 19	LVPS	WD 1
652	Figure 19	LVPS	WD 1
653	Figure 19	LVPS	WD 9
654	Figure 19	LVPS	WD 1
655	Figure 19	LVPS	WD 2
656	Figure 19	LVPS	WD 1
740	Figure 14	In-line connector print cartridge side	WD 9
741	Figure 14	In-line connector fuser side	WD 9
750	Figure 15	IOT PWB	WD 5
751	Figure 15	IOT PWB	WD 5
752	Figure 15	IOT PWB	WD 6
754	Figure 15	IOT PWB	WD 6
755	Figure 15	IOT PWB	WD 6

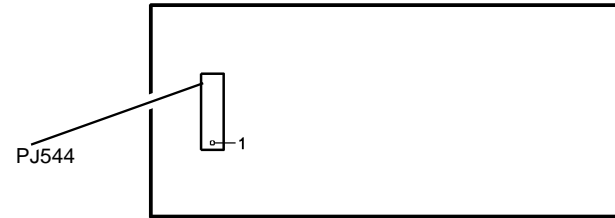
Figure 32 Tray 2 paper size sensing PWB

Tray 2 Paper Size Sensing PWB

Location: [PL 70.10 Item 18](#)

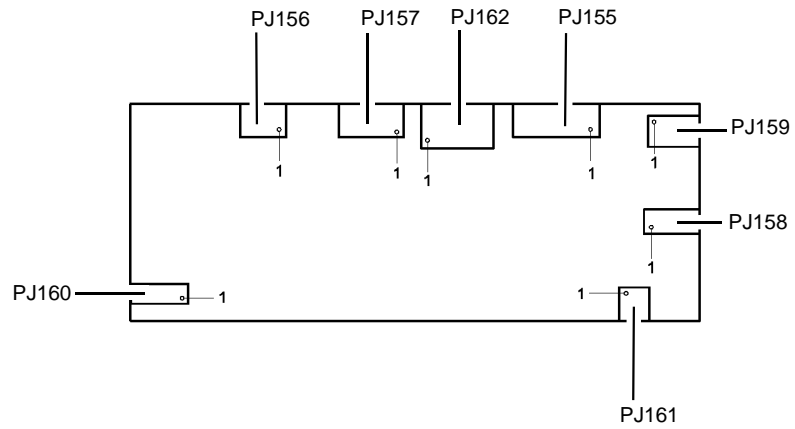
Figure 33 Tray 4 Control PWB

Tray 4 Control PWB

Location: PL 70.21 Item 2

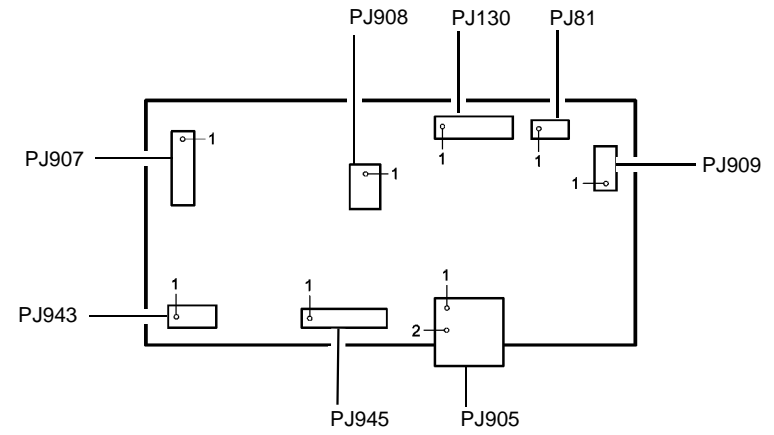
UI Control PWB

Location: PL 2.10 Item 6

PJ Number	Figure No.	PJ location	Wiring Diagram
1	Figure 2	Fax connector PWB	WD 4
1	Figure 19	LVPS	WD 1
2	Figure 2	Fax connector PWB	WD 4
16	Figure 4	Foreign device interface PWB	WD 4
81	Figure 34	UI control PWB	WD 4

PJ Number	Figure No.	PJ Location	Wiring Diagram
107	Figure 18	LVF BM PWB	WD 28
108	Figure 18	LVF BM PWB	WD 28
109	Figure 18	LVF BM PWB	WD 28
110	Figure 18	LVF BM PWB	WD 29
111	Figure 18	LVF BM PWB	WD 29
112	Figure 18	LVF BM PWB	WD 29
113	Figure 18	LVF BM PWB	WD 29
130	Figure 34	UI control PWB	WD 4
141	Figure 5	Fuser module	WD 9
155	Figure 33	Tray 4 control PWB	WD 18
156	Figure 33	Tray 4 control PWB	WD 18
157	Figure 33	Tray 4 control PWB	WD 18
158	Figure 33	Tray 4 control PWB	WD 18
159	Figure 33	Tray 4 control PWB	WD 18
160	Figure 33	Tray 4 Control PWB	WD 18
161	Figure 33	Tray 4 control PWB	WD 18
162	Figure 33	Tray 4 control PWB	WD 18
177	Figure 7	In-line connector IOT PWB side	WD 5, WD 6
178	Figure 7	In-line connector component side	WD 5, WD 6
179	Figure 7	In-line connector component side	WD 5, WD 6
180	Figure 7	In-line connector IOT PWB side	WD 5, WD 6
184	Figure 8	In-line connector IOT PWB side	WD 7
185	Figure 8	In-line connector component side	WD 7

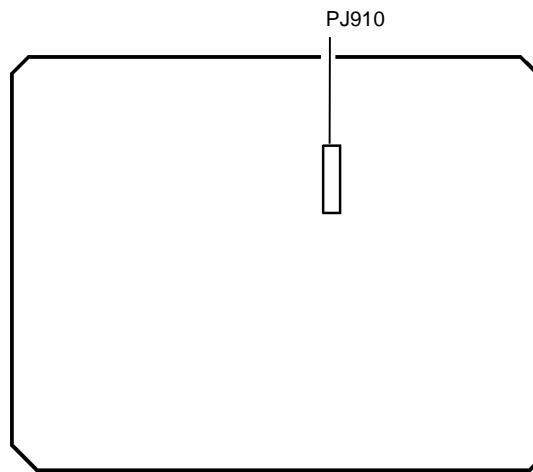
Figure 35 UI keyboard PWB

UI Keyboard PWB

Location: [PL 2.10 Item 9](#)

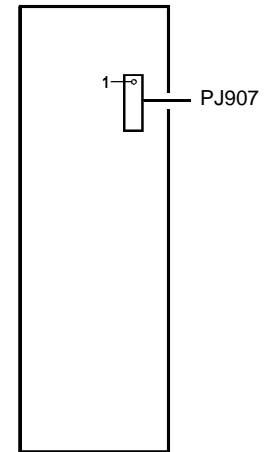
Figure 36 UI status PWB

UI Status PWB

Location: [PL 2.10 Item 7](#)
