708P91370 June 2018

Xerox® VersaLink® B7025/B7030/B7035 Multifunction Printer Service Manual

Xerox® VersaLink® B7035 Family Multifunction Printer

Service Documentation

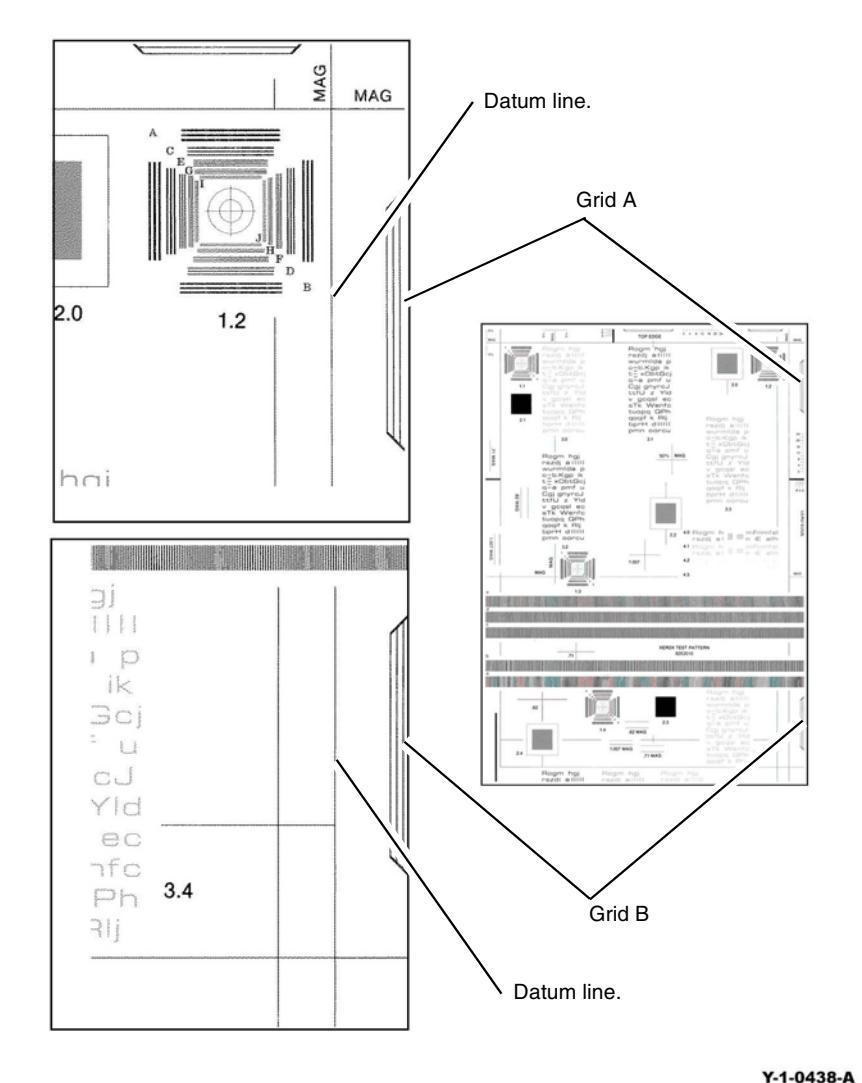
Figure 1 Copy and scan skew measurement

3. If skew is not within specification, perform the IQ26 DADF, Document Glass and Scanner RAP.

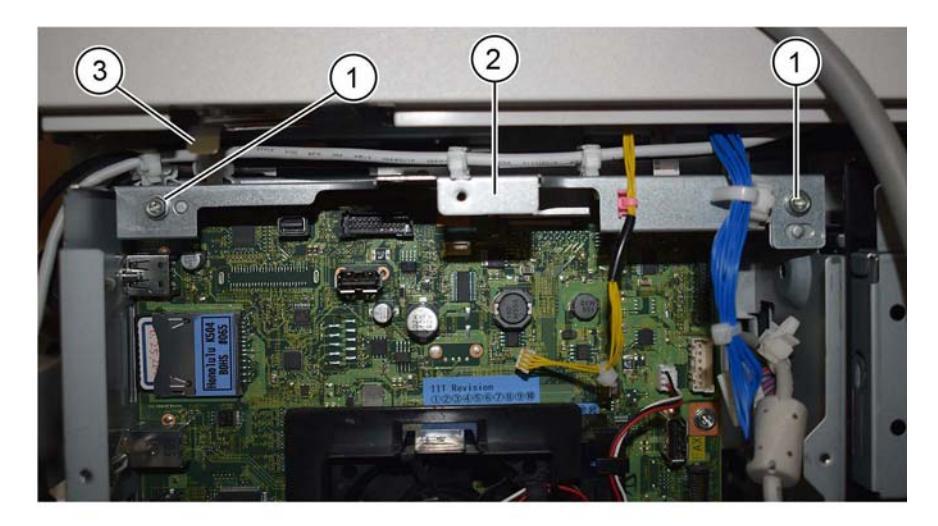
- 10. Remove the ESS upper panel, Figure 9.
 - a. Remove both screws (1).
 - b. Remove the ESS upper panel (2).
 - c. Release all remaining harness clamps from the ESS upper panel.

Figure 9 ESS upper panel removal

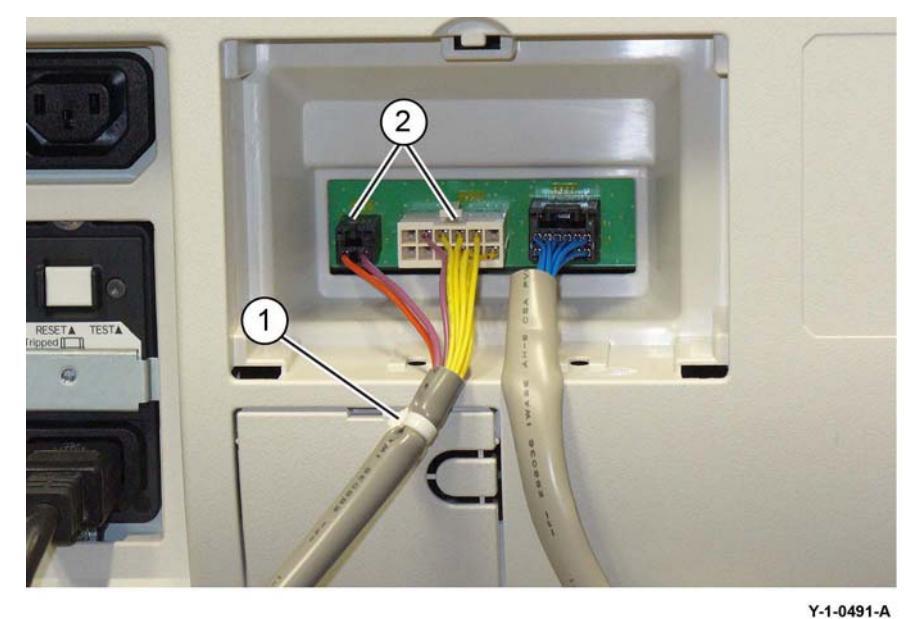
- 1. Remove the STM cover, PL 28.06 Item 1.
- 2. Disconnect the integrated office finisher harnesses, Figure 1:
 - a. Release the cable clamp (1).
 - b. Disconnect two connectors (2).

Figure 1 Connectors

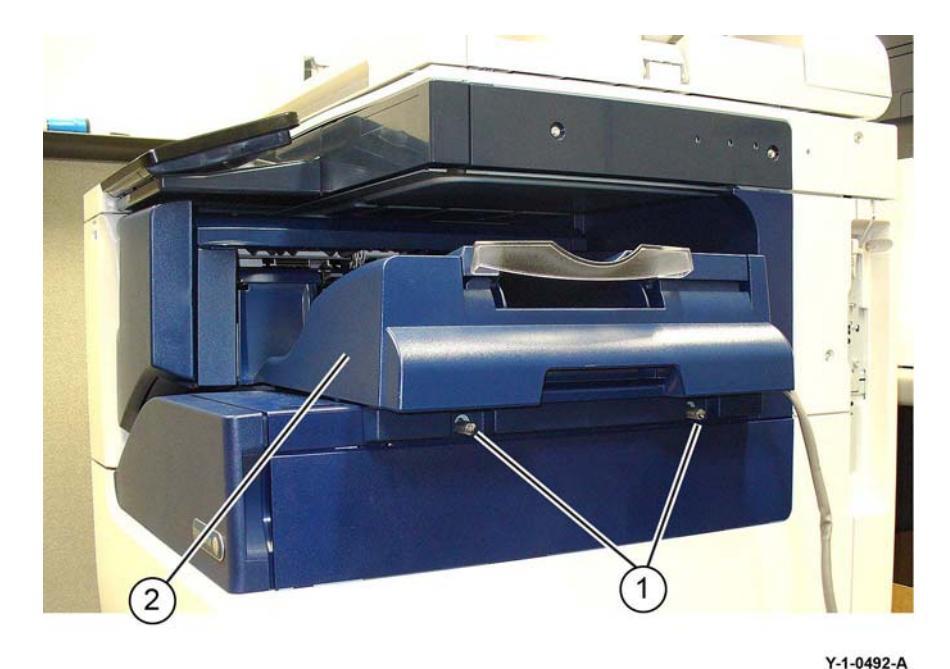
- 3. Remove the integrated office finisher, Figure 2:
 - a. Remove two thumbscrews (1).
 - b. Remove the integrated office finisher (2) towards the front of the machine.

Figure 2 Finisher removal

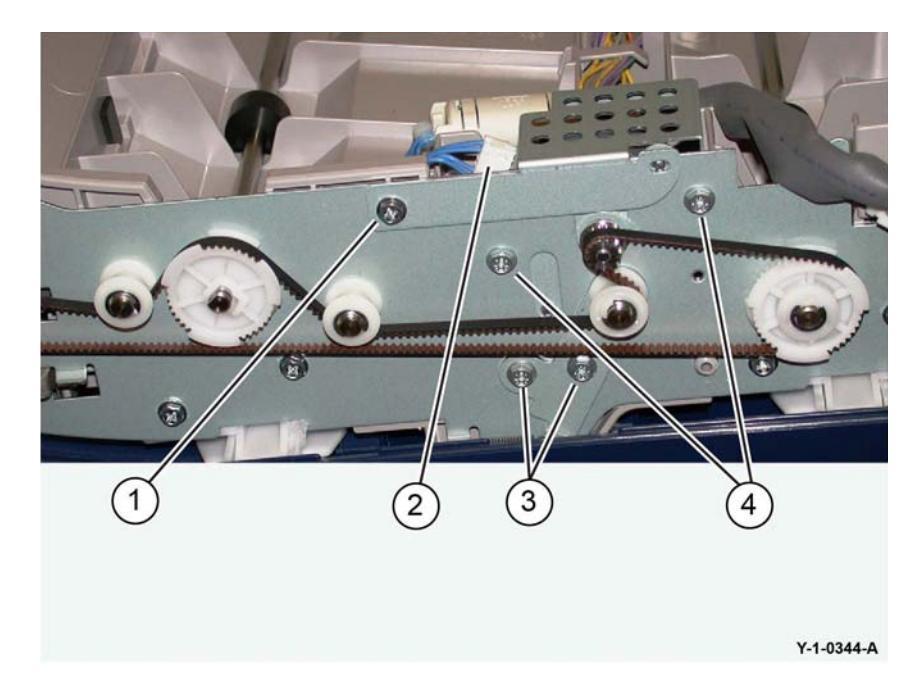
- 1. Remove the H-transport assembly, REP 13.1.
- 2. Remove the H-transport rear cover, PL 13.06 Item 9.
- 3. Place the H-transport top down on a work surface.
- 4. Remove the H-transport motor, Figure 1:
 - a. Remove the screw, then the shield (1).
 - b. Disconnect the connector (2).
 - c. Loosen two screws to release the belt tension (3).
 - d. Remove two screws (3), then remove the H-transport motor.

Figure 1 H-transport motor removal

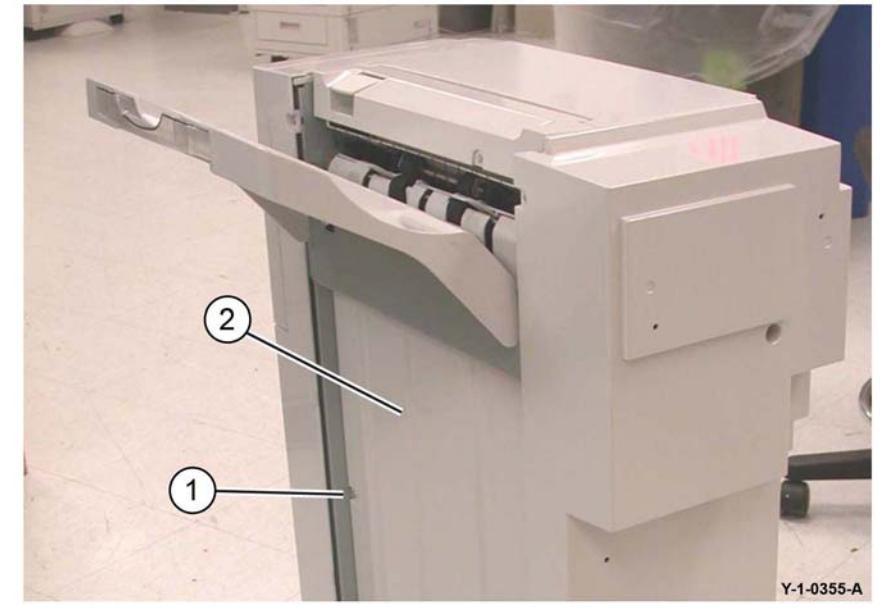
- 1. Remove the stacker tray, REP 13.20.
- 2. Remove the stacker lower cover, REP 13.11.
- 3. Remove six screws (1), then the stacker upper cover (2), Figure 1.

Figure 1 Stacker upper cover removal

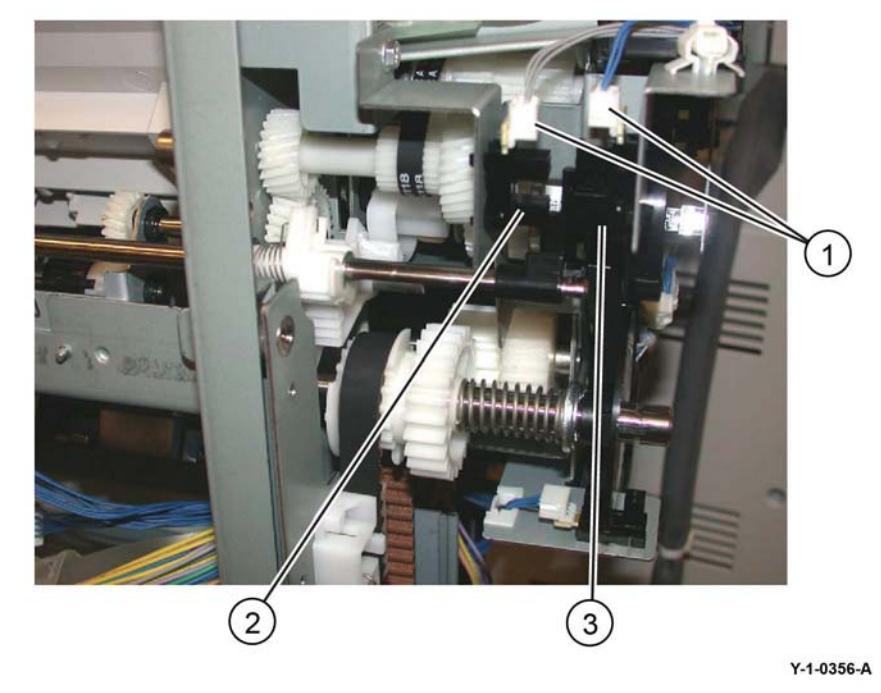
- 1. Remove the rear upper cover, REP 13.7.
- 2. Remove the relevant stack height sensor, Figure 1:
 - a. Disconnect the relevant connector (1).
 - b. Remove either stack height sensor 1 (2) or stack height sensor 2 (3).

Figure 1 Sensor removal

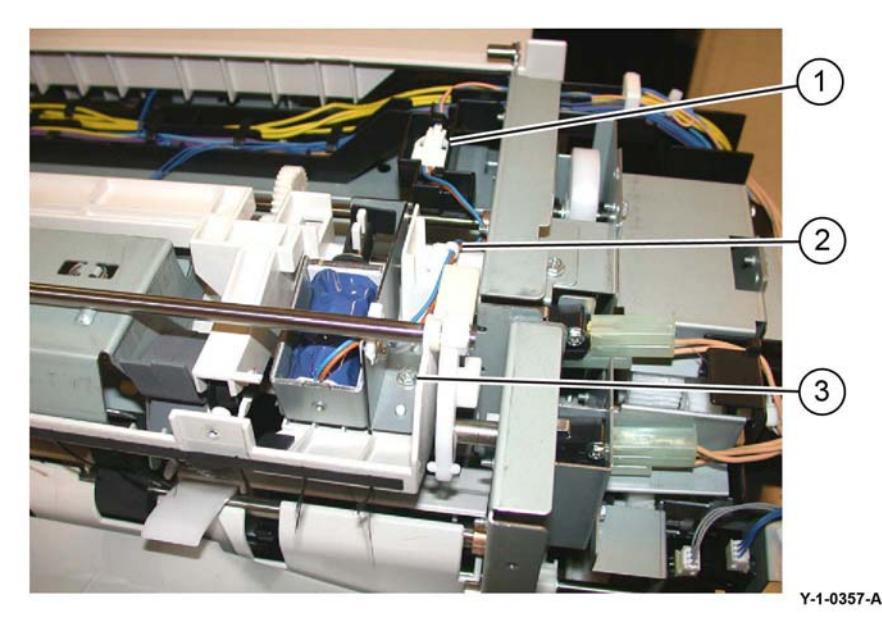
- 1. Remove the eject cover, REP 13.9.
- 2. Remove the sub paddle solenoid assembly, Figure 1:
 - a. Disconnect the connector (1).
 - b. Release the harness from the clamps (2).
 - c. Remove the screw (3), then the sub paddle solenoid assembly.

Figure 1 Sub paddle solenoid assembly removal

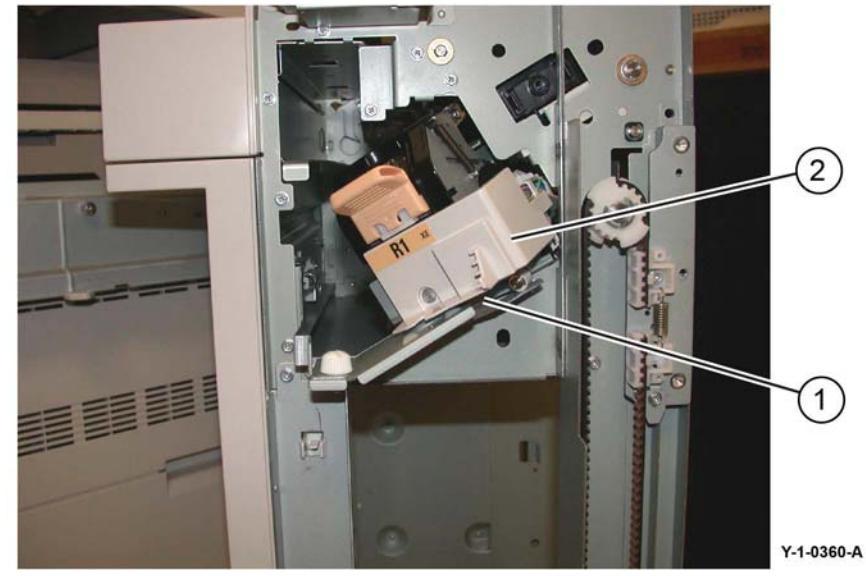
- 1. Remove the creaser knife assembly, REP 13.18.
- 2. Remove the front cover assembly, REP 13.6.
- 3. Remove the stapler cover, Figure 1:
 - a. Remove the screw (1).
 - b. Remove the stapler cover (2).

Figure 1 Stapler cover removal

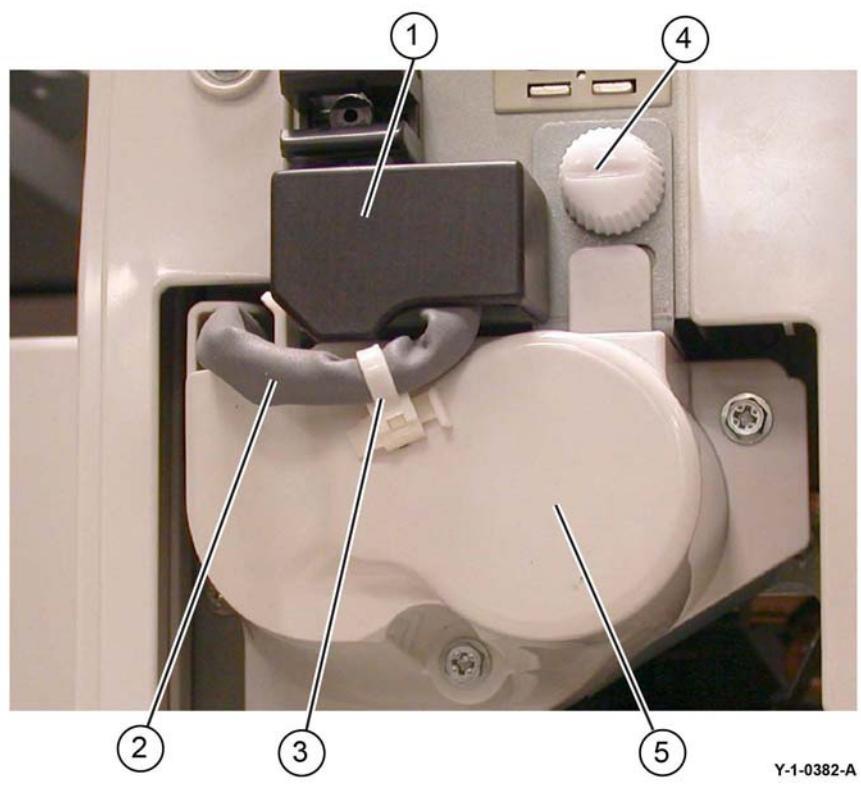
- d. Remove the thumbscrew (4).
- e. Pull out the crease assembly (5).

Figure 1 Crease assembly removal

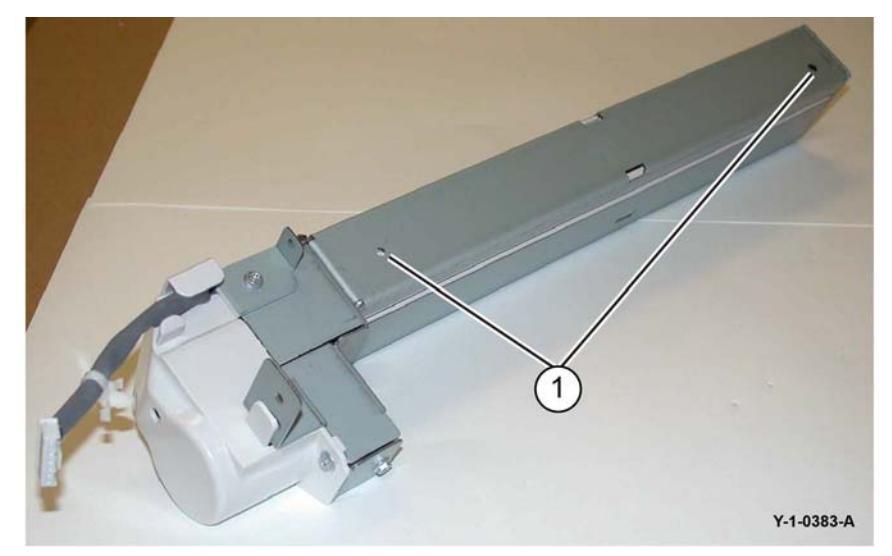
- 1. The replacement is the reverse of the removal procedure.
- 2. Ensure the locating pins (1) are correctly engaged, Figure 2.

Figure 2 Crease assembly

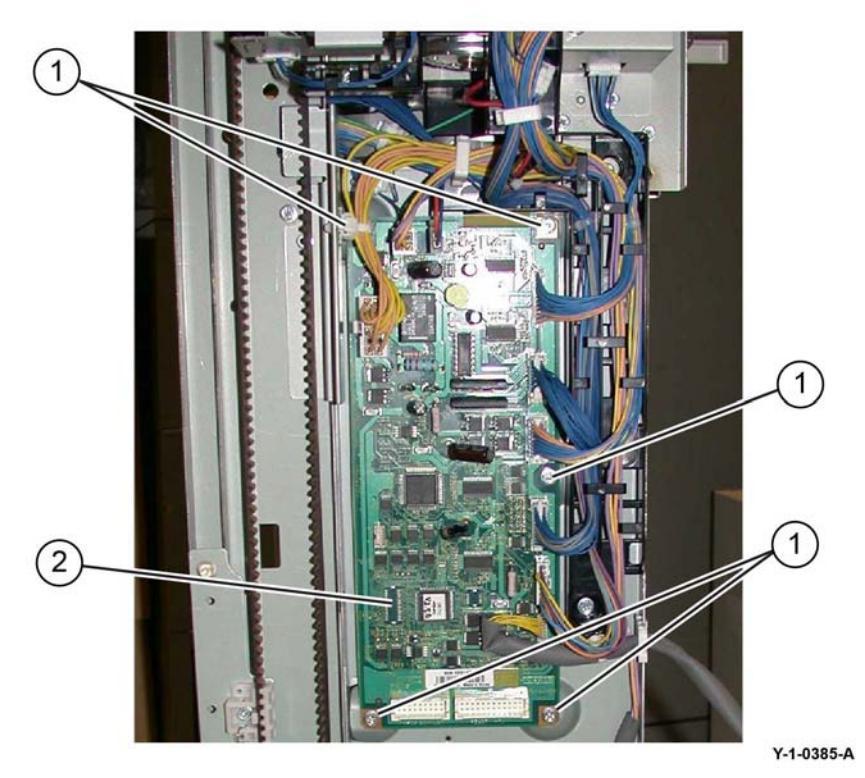
- 1. If possible, record the current software level by either:
 - Printing the configuration report, GP 14.
 - From the user interface Home screen, touch Device, then About. Scroll down to view the Software Version.
- 2. Remove the rear upper cover, REP 13.7.
- 3. Remove the finisher PWB, Figure 1:
 - a. Disconnect the all connectors from the finisher PWB.
 - b. Remove the five screws (1).
 - c. Remove the finisher PWB (2).

Figure 1 Finisher PWB removal

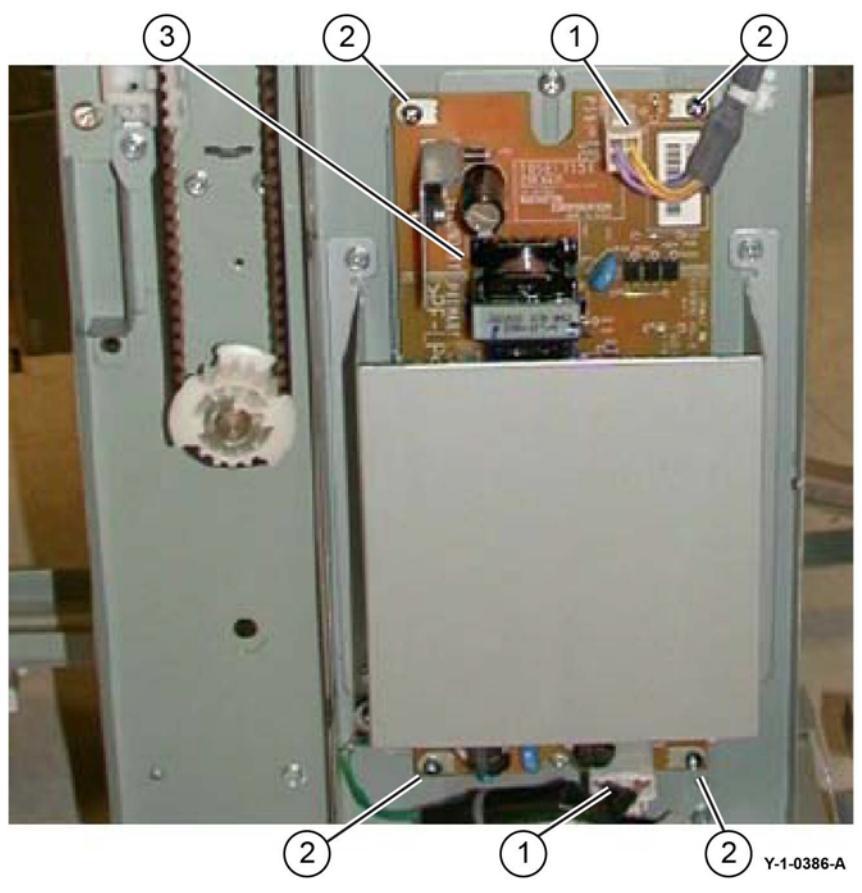
- 1. Remove the rear lower cover, REP 13.8.
- 2. Remove the finisher LVPS, Figure 1:
 - a. Disconnect both Connectors (1).
 - b. Remove four screws (2).
 - c. Remove the finisher LVPS (3).

Figure 1 Finisher LVPS removal

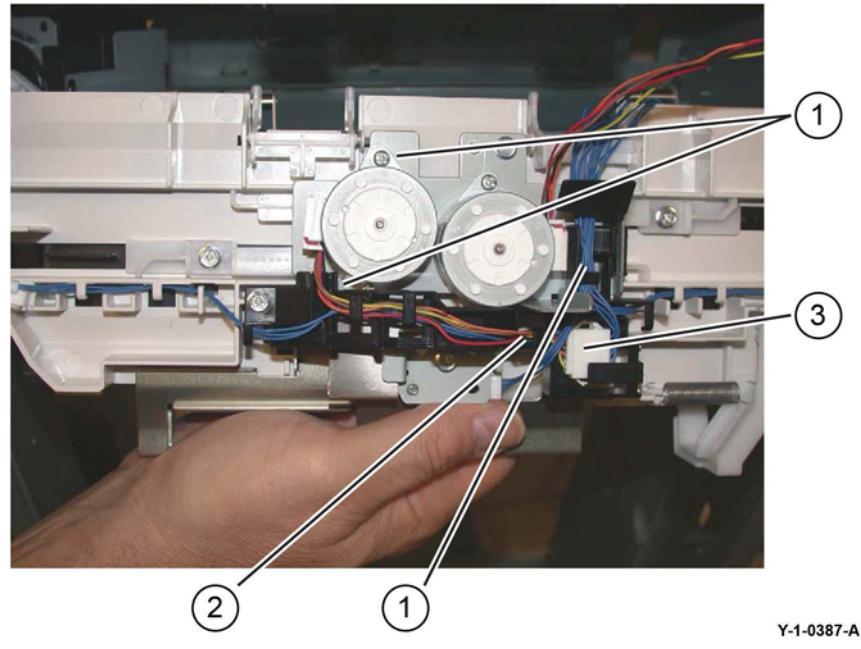
- 1. Remove the compiler tray, REP 13.17.
- 2. Place the compiler tray upside down on a work surface.
- 3. Remove the tamper motor, Figure 1:
 - a. Release the harness (1) from the harness guide.
 - b. Remove the screw (2), then the harness guide.
 - c. Disconnect the tamper motor connector (3).
 - d. Remove both screws, then the relevant tamper motor (4).

Figure 1 Tamper motor removal

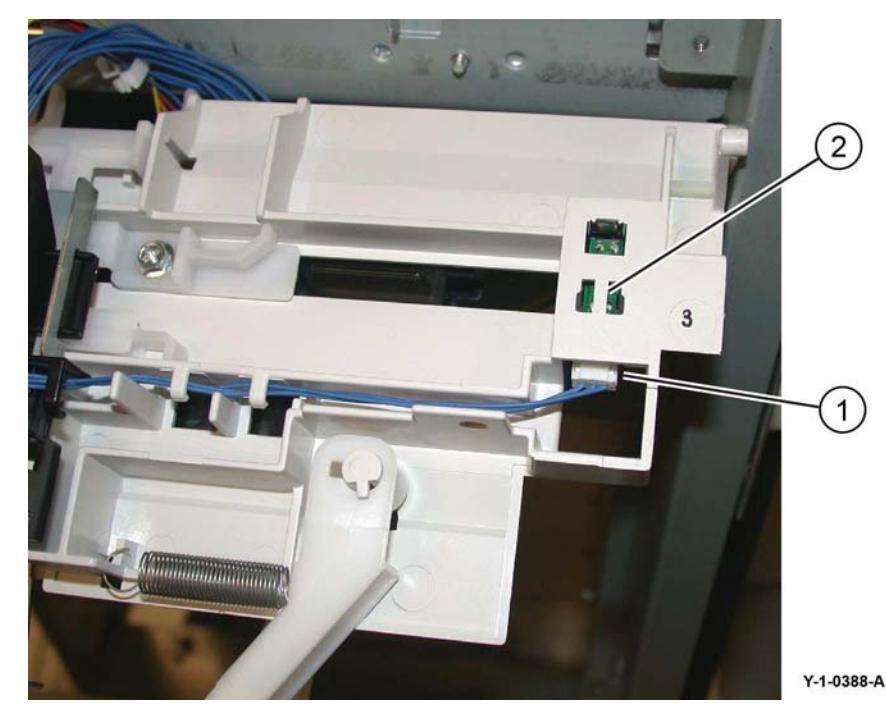
NOTE: The removal of the rear tamper home sensor is shown in Figure 1.

Figure 1 Tamper home sensor removal

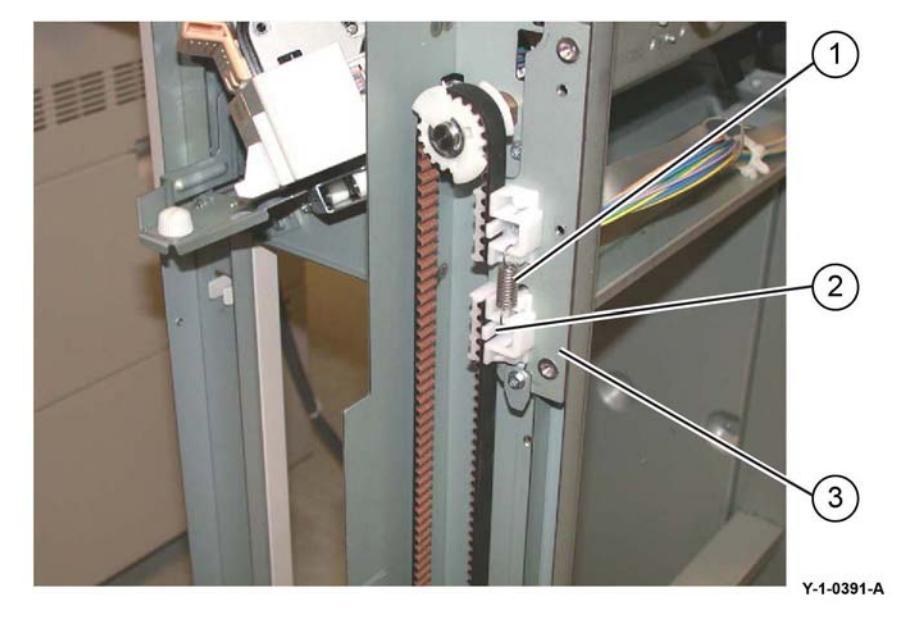
NOTE: The carriage bearings (2 each assembly) are not fastened to the shafts. Ensure the bearings are retained when the carriage assembly is removed.

Figure 1 Carriage assembly removal

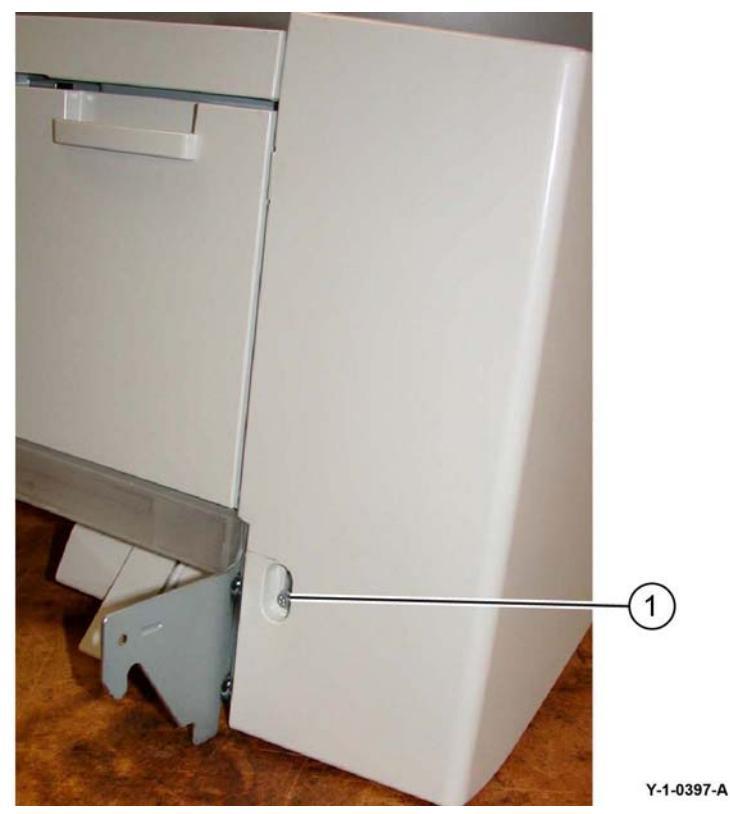
- Remove the booklet maker assembly from the finisher, REP 13.31. 1.
- 2. Remove the screw (1), Figure 1.

Figure 1 Screw removal

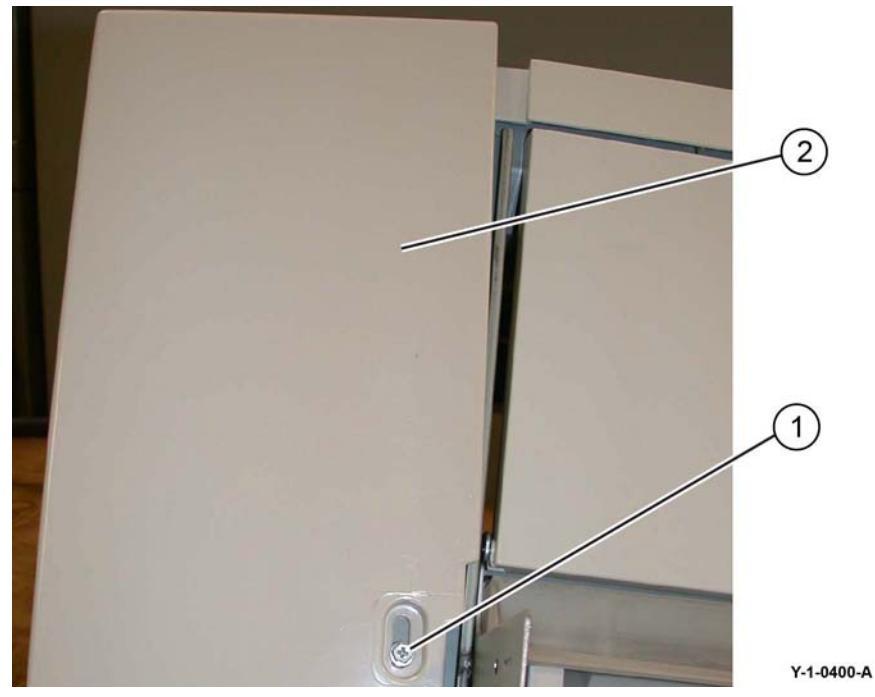
4. Remove the screw (1), then the booklet rear cover (2), Figure 2.

Figure 2 Booklet rear cover removal

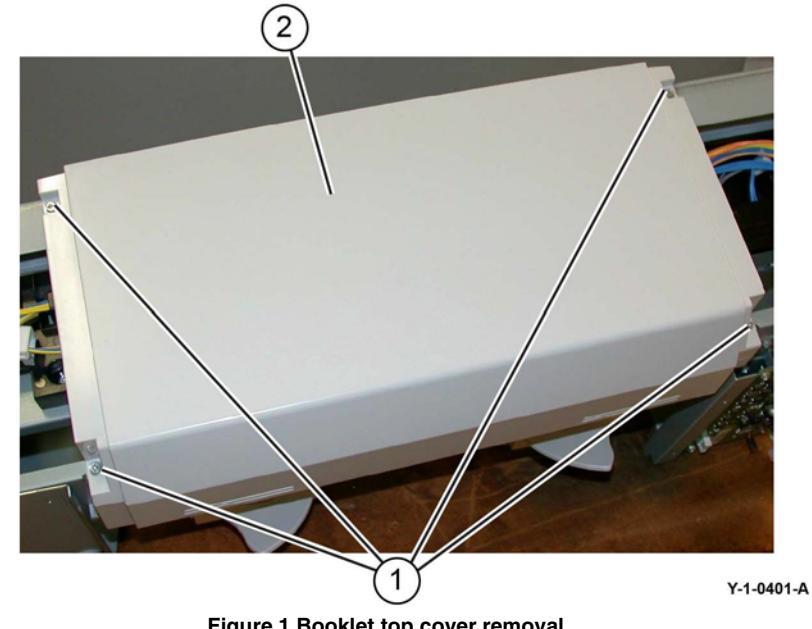
- Remove the booklet front cover, REP 13.32. 1.
- 2. Remove the booklet rear cover, REP 13.33.
- 3. Remove the booklet top cover, Figure 1:
 - Remove four screws (1). a.
 - b. Remove the booklet top cover (2).

Figure 1 Booklet top cover removal

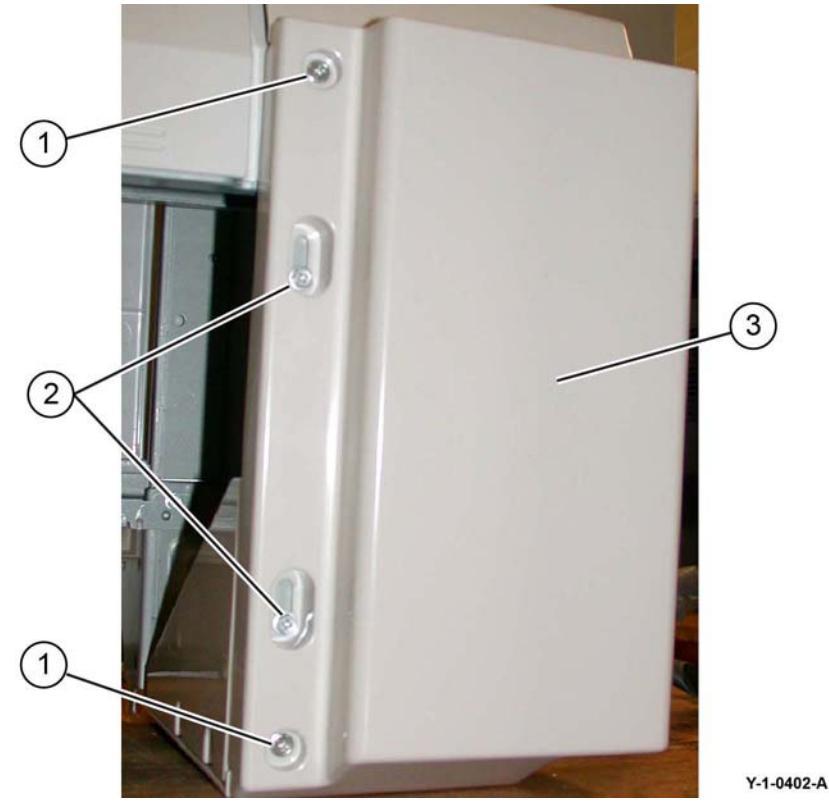
- 1. Remove the booklet PWB cover, Figure 1:
 - a. Remove both self-tapping screws (1).
 - b. Remove both screws (2).
 - c. Remove the booklet PWB cover (3).

Figure 1 Booklet PWB cover removal

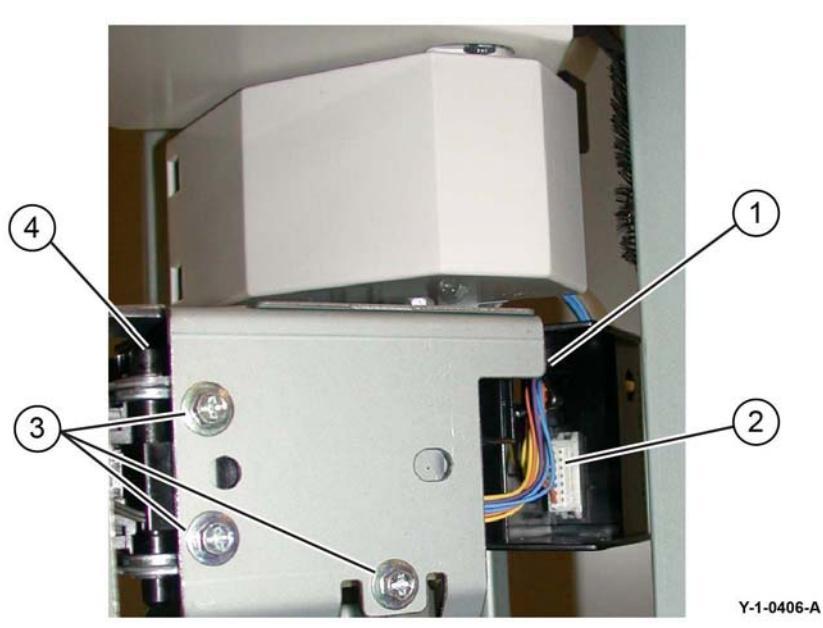
- 5. Remove the stapler, Figure 4:
 - a. Release the harness from the clamp (1).
 - b. Disconnect the connector (2).
 - c. Remove three screws (3).
 - d. Remove the stapler (4).

Figure 4 Stapler removal

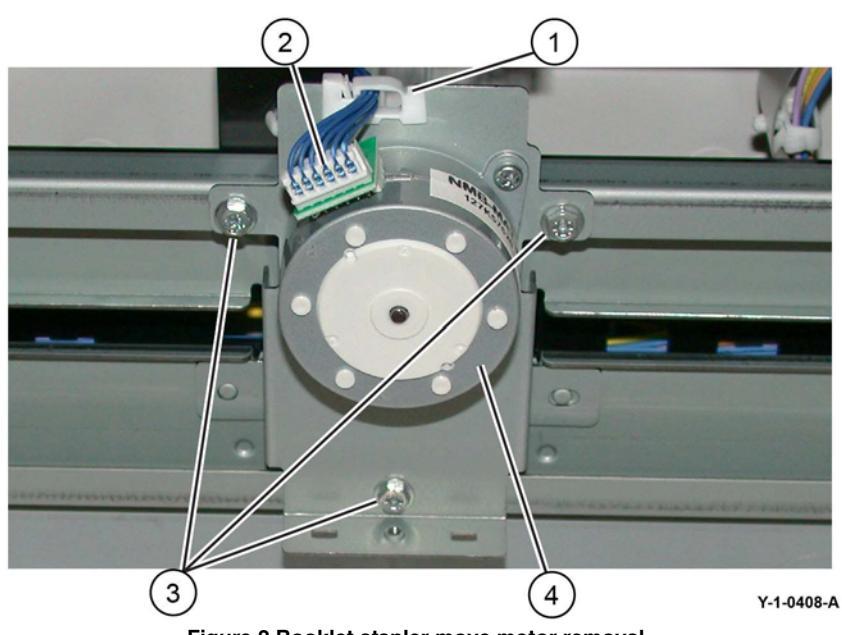
- 3. Remove the booklet stapler move motor, Figure 2:
 - a. Release the harness from the clamp (1).
 - b. Disconnect the connector (2).
 - c. Remove three screws (3).
 - d. Remove the booklet stapler move motor (4).

Figure 2 Booklet stapler move motor removal

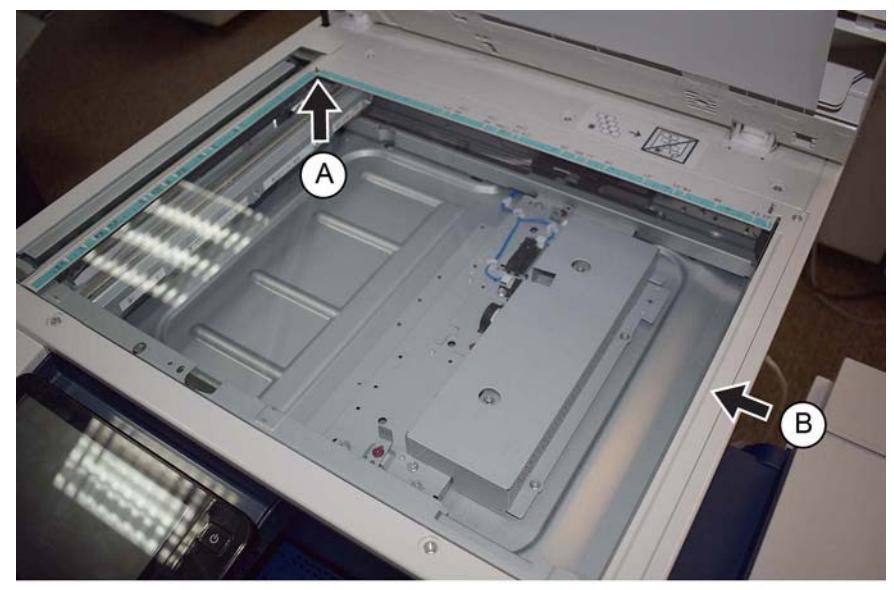
- 1. The replacement is the reverse of the removal procedure.
- 2. Before tightening the two screws, align the document glass in the direction of arrow A and the right plate in the direction of arrow B, Figure 1.

Figure 1 Alignment

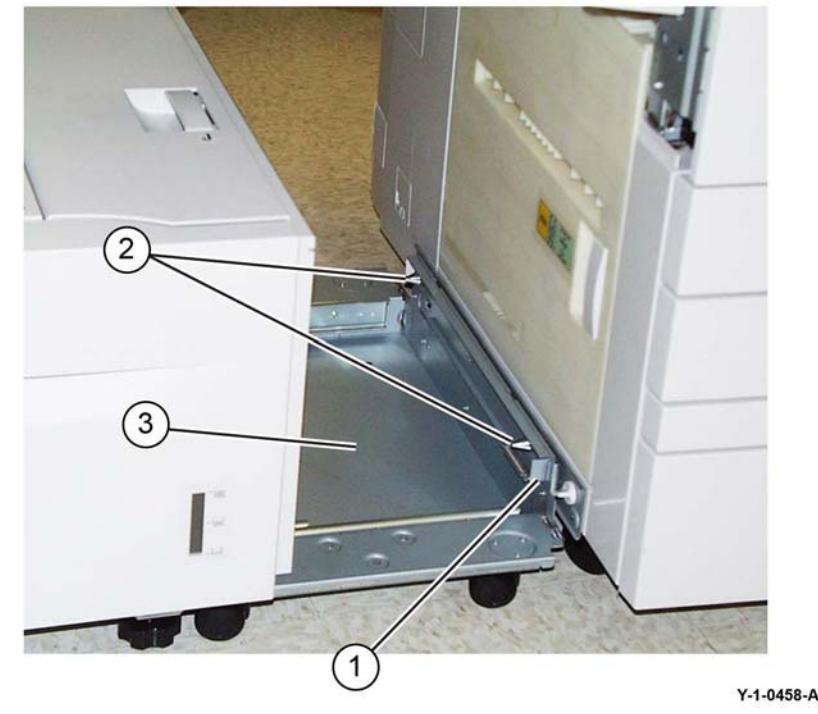
- 1. Disconnect the HCF power cable from the machine.
- 2. Pull the HCF away from the machine.
- 3. Release the docking latch spring lever (1) on the right side of the docking base, Figure 1.

Figure 1 Docking base

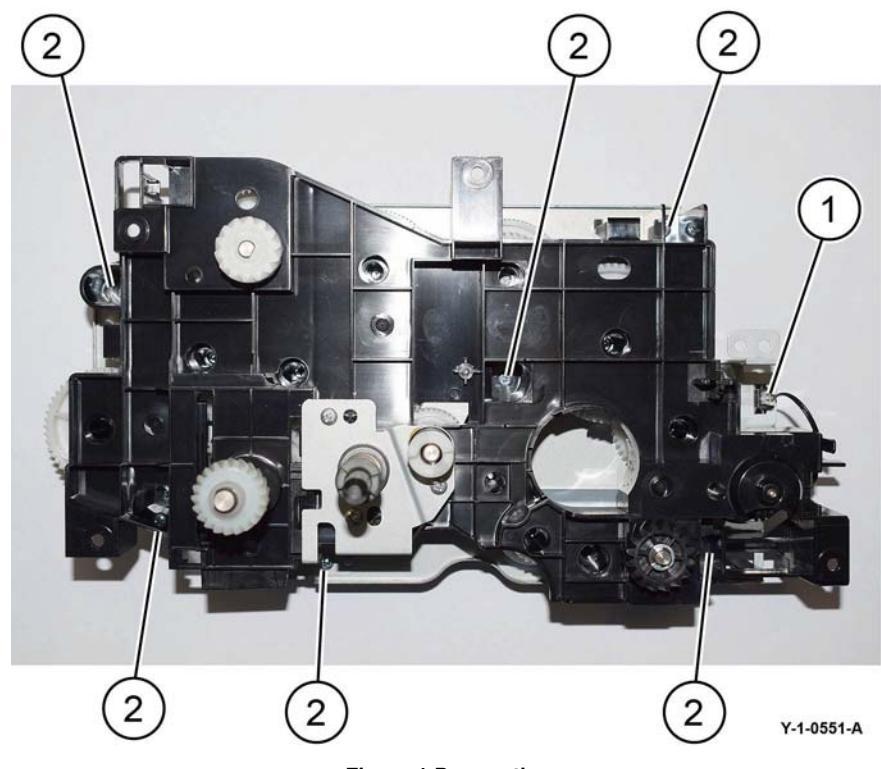
- 1. Remove the drive assembly, REP 40.1.
- 2. Prepare to split the drive assembly, Figure 1:
 - a. Disconnect the inline connector (1).
 - b. Remove six screws (2).

Figure 1 Preparation

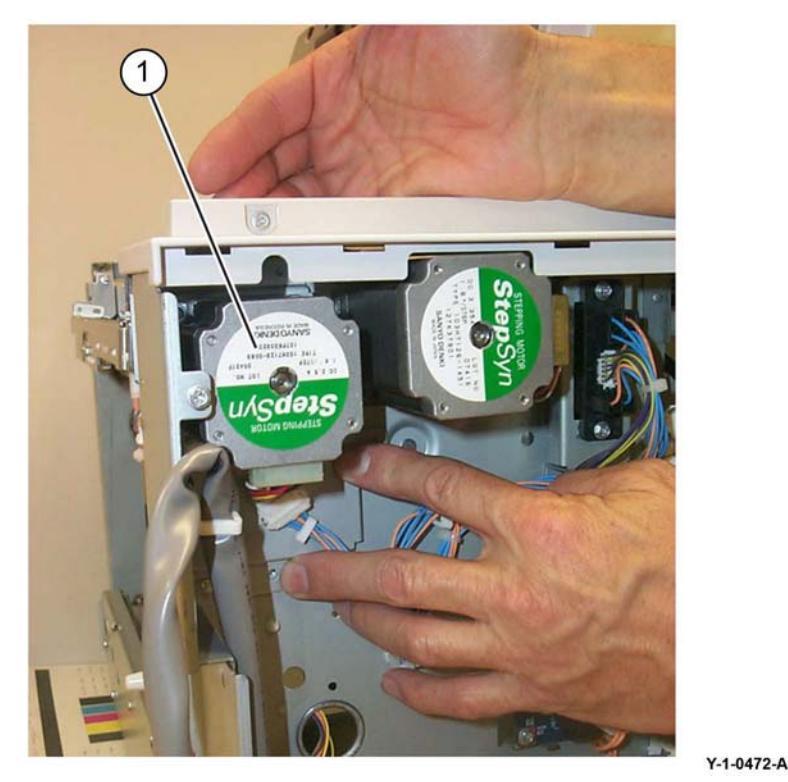
4. While supporting the motor with one hand, remove two screws then the HCF feed/lift motor (1), Figure 1.

Figure 1 HCF feed/lift motor removal

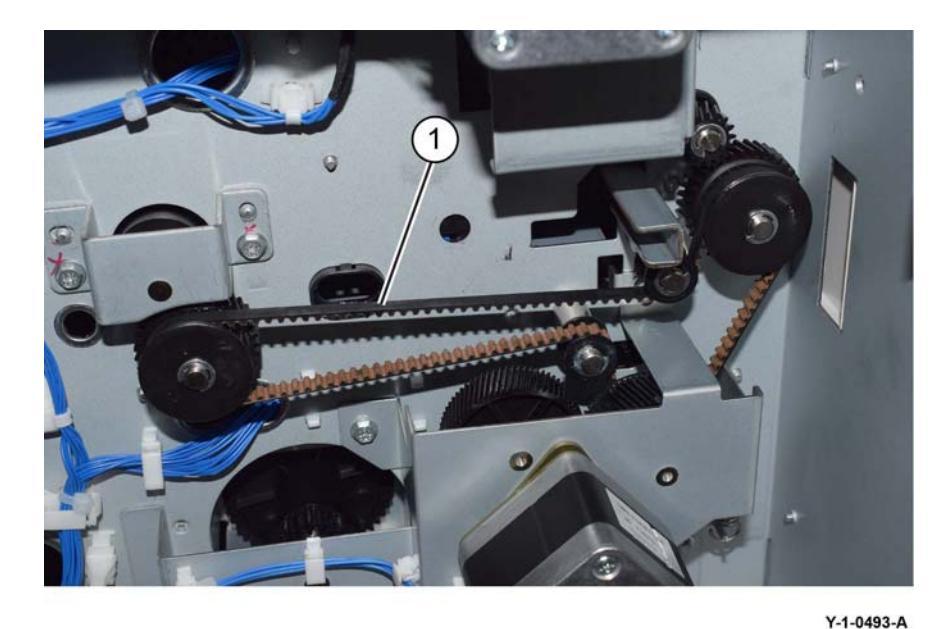
- 1. The replacement is the reverse of the removal procedure.
- 2. Ensure that the drive belt (1) is installed as shown in Figure 1.

Figure 1 Belt installation

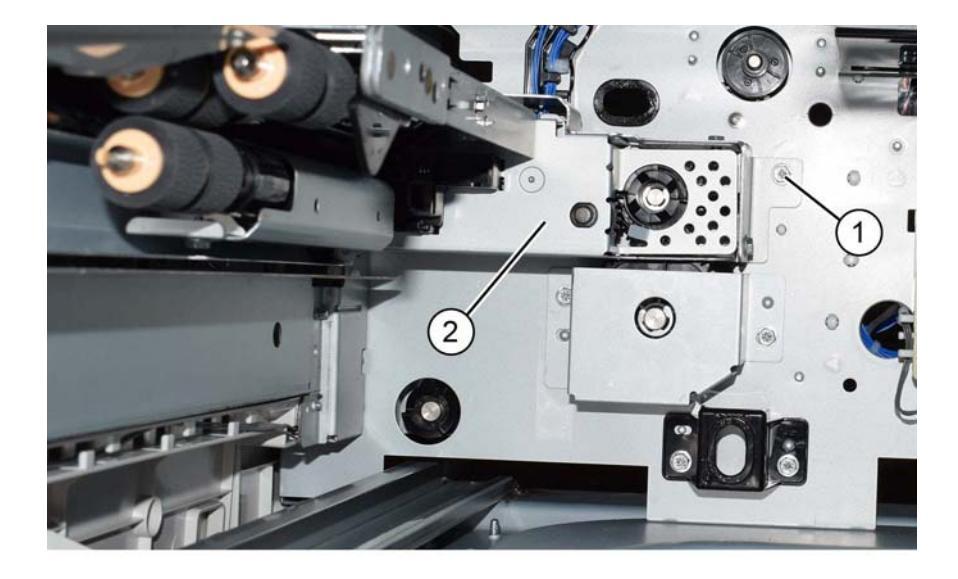
- 8. Remove the complete tray 3 feeder assembly including bracket, Figure 5.
 - a. Remove the screw (1).
 - b. Remove the tray 3 feeder assembly (2).

- Figure 5 Tray 3 feeder assembly removal
- Repairs and Adjustments **REP 80.34**

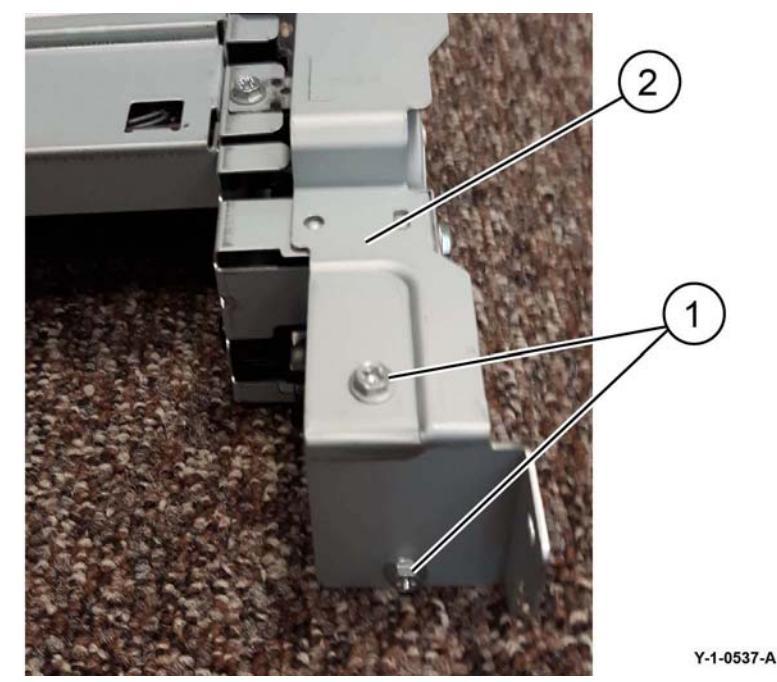
- 9. Remove the feeder cover from the tray 3 feeder assembly, Figure 6.
 - a. Remove two screws(1).
 - b. Remove the feeder cover (2). Retain the cover for installation onto the new tray 3 feeder assembly.

Figure 6 Feeder cover removal

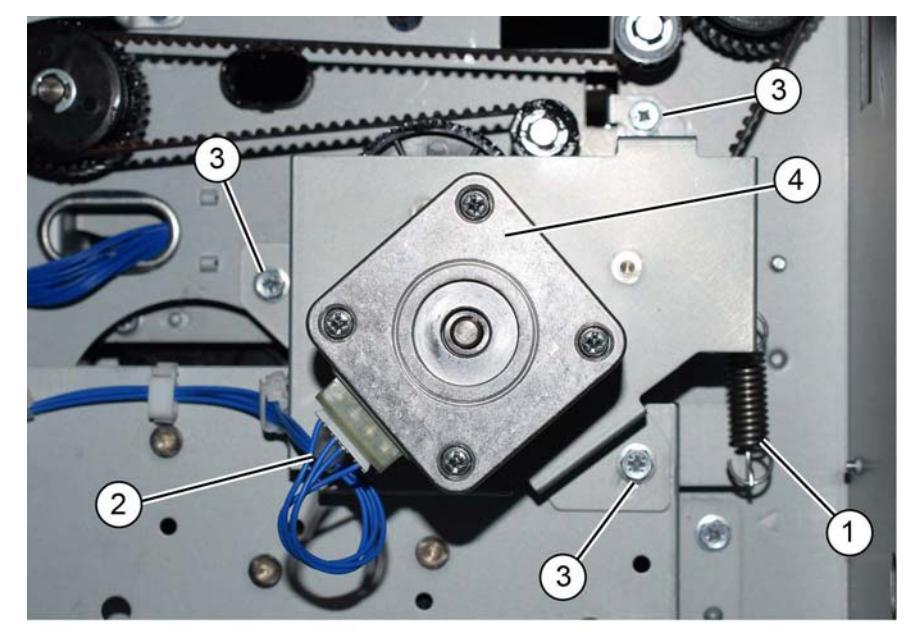
- 1. Remove the TTM rear cover, PL 70.95 Item 8.
- 2. Remove the takeaway motor 2 assembly, Figure 1:
 - a. Unhook the spring (1).
 - b. Disconnect the PJ and release the harness (2).
 - c. Remove three screws (3).
 - d. Remove the takeaway motor 2 assembly (4).

Figure 1 Motor assembly removal

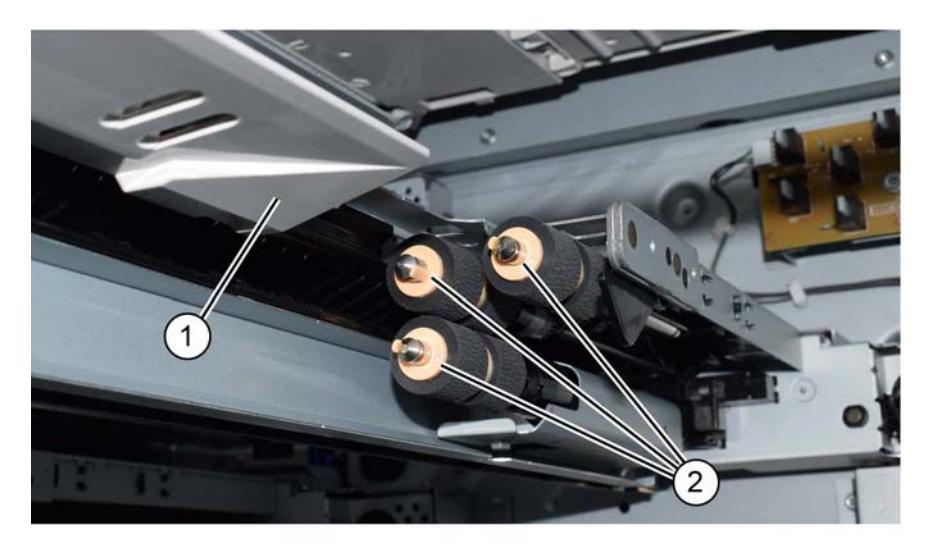
- 1. Pull out trays 2, 3 and 4. Remove the paper.
- 2. Remove trays 2, 3 and 4.
- 3. Open the left cover assembly, PL 70.70 Item 7.
- 4. Remove the tray 4 feed, retard and nudger rolls, Figure 1:
 - a. Slide the chute (1) forwards.
 - b. Release the clip, then remove the tray 4 feed, retard and nudger rolls (2).

Figure 1 Roll removal

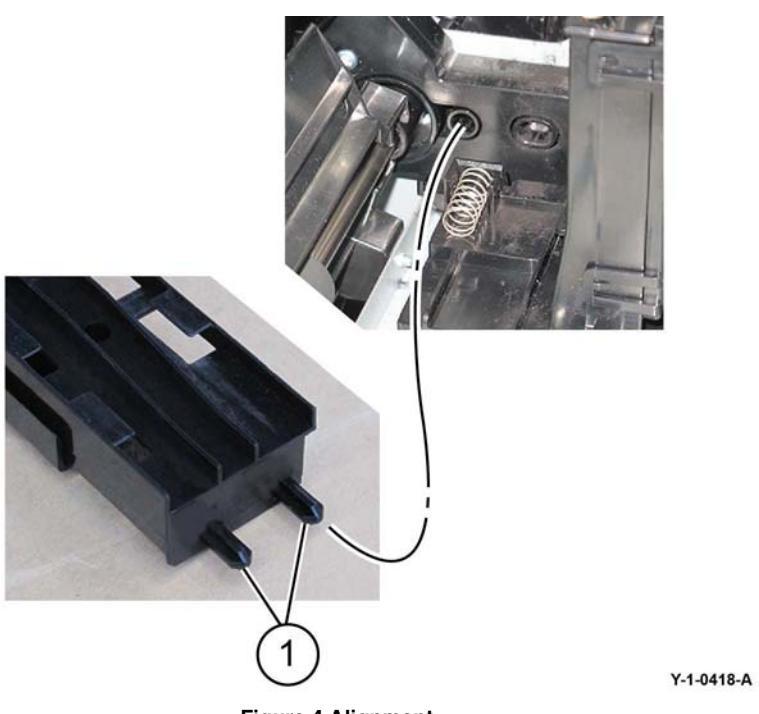
- 1. The replacement is the reverse of the removal procedure.
- 2. When installing the lower guide assembly, align the bosses (1) with the holes, Figure 4.

Figure 4 Alignment
