Control Panel Message: Jam in Output Bin
HP M452, M377MFP, and M477MFP

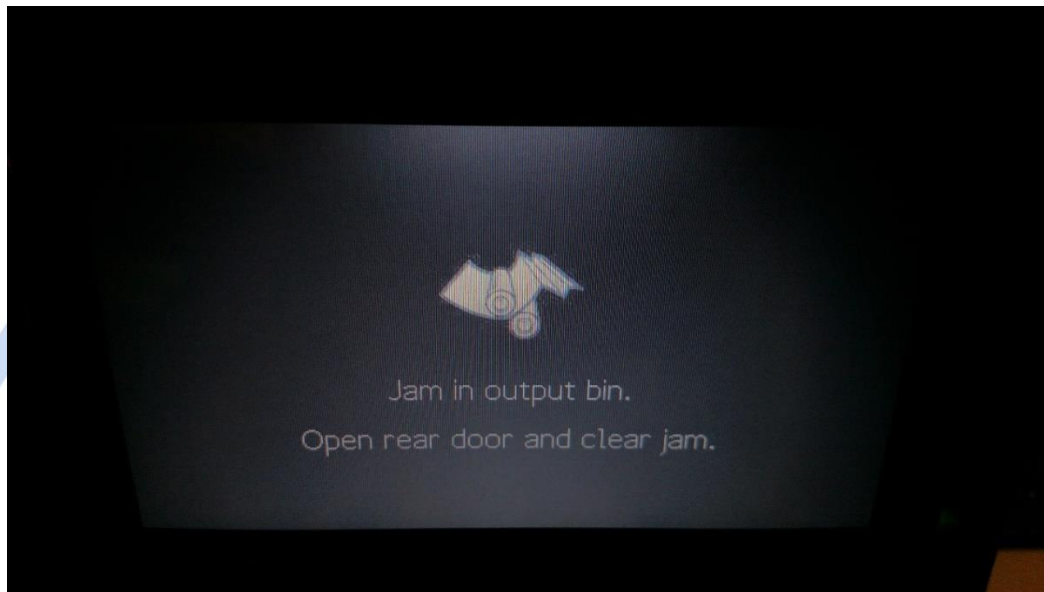
The Jam in output bin message has been a common occurrence for the above listed models. To troubleshoot, closely examine the paper exit area for any obstruction and open the rear door to inspect for obstruction.

If no paper or obstructions found, the fusing assembly RM2-6418 (duplex models) or RM2-6431 (simplex models) will need replacing.
