Fading Black Color in Lower Right Corner (Just in the First Page) HP CP4025, CP4525 and M651

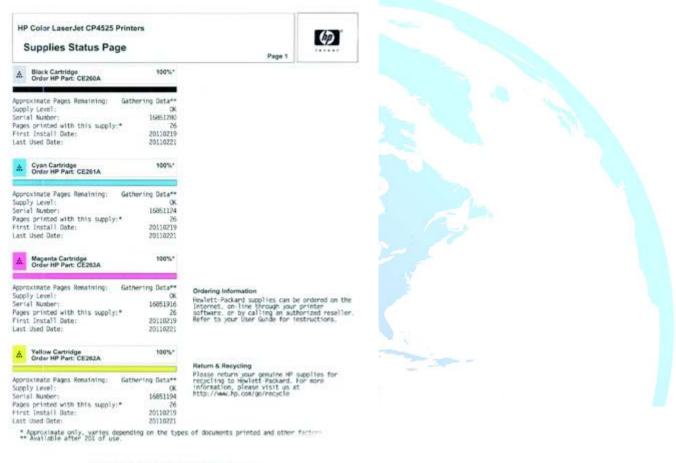
Print jobs are faded in the lower right corner just in black color. See the figure below for an example of this issue.

- 1. Check if the issue occurs right out of the box. Print a Demo Page to check this.
- 2. Make sure toner cartridges are HP genuine. Print a **Supply Status Page**. Also check for Print Quality Defect on Supplies Status Page.
- 3. Check if the issue occurs from **Multipurpose Tray** by printing a Demo page from tray 1. If the issue is also happening from tray 1, this could be a toner cartridge failure. Continue to next step.
- 4. Calibrate the printer, perform 3 Full Calibrations, and check if the issue persists.

Isolate the failure to a defective cartridge, perform Disable Cartridge Check, and block the black cartridge H.V. Contact (refer to the following document), swap the Black Cartridge with the magenta Cartridge and print a Demo Page. Is the lower right corner still fading? YES: Replace the Black cartridge CE260-67901 Black print cartridge.

2. Remove the block from the black cartridge; now block the H.V. contact for the magenta Cartridge while this is still in the black slot. Print the configuration pages. Is the issue now shown in magenta color?

YES: Replace DC Controller PCA Assembly CP4025, CP4525 - (HP Part #: RM1-5758) M651 - (HP Part #: RM2-0496)
NO: Call Laser Pros Technical Support
