## Swingplate (fuser drive) Failure

### HP LaserJet 4200/4240/4250/4300/4350/4345MFP/M4345MFP

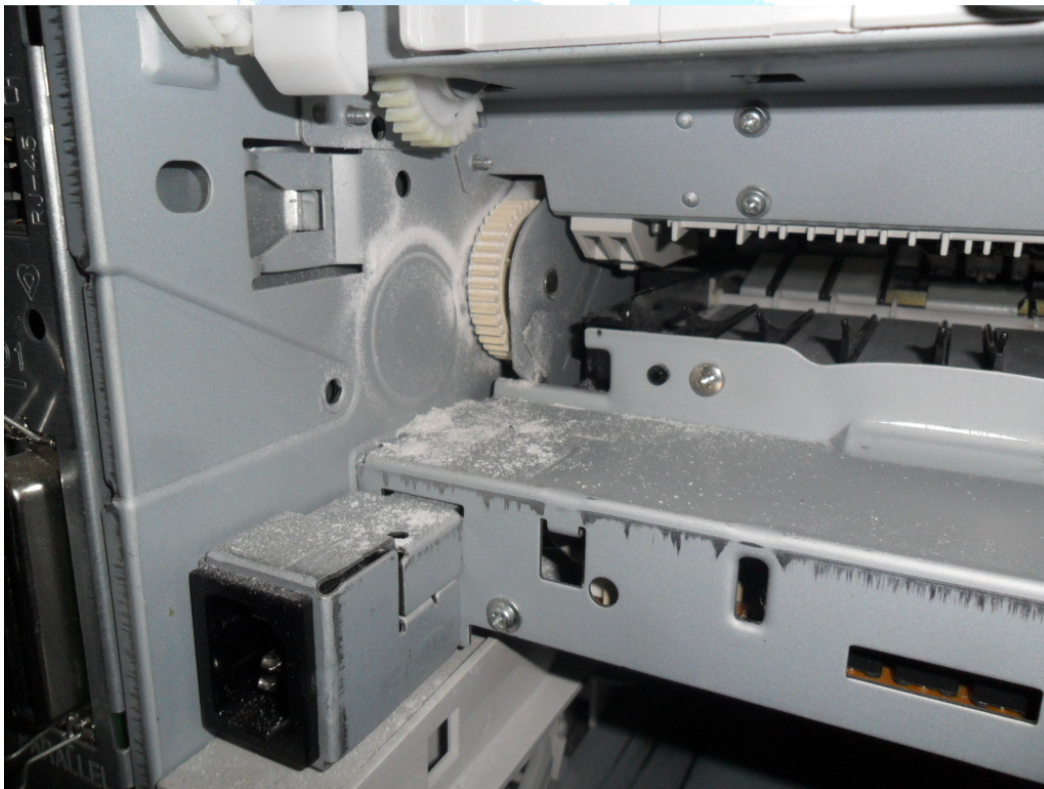
Below is a picture (fuser removed) of a worn swing plate gear. The gears will disintegrate into a dust/powder which will be apparent after removing the fuser. Some of the original gears are a cream color with the others being black.

The above HP printer series is well known to have the fuser and fuser drive gears wear out, causing a distinct “hum” or grinding noise – which can happen at a wide page count range due to duty use and printing environment. This typically requires the swing plate (fuser drive assembly) and fuser assembly to be replaced if the problem is not fixed in a timely manner. However if this is noted or made aware of before the gears deteriorate there is a kit available which includes the swing plate assembly and fuser drive gear # 5851-2766.
