Jam in Tray 3 (*clear jam and press ok message*)
**HP CP2025/CM2320MFP/M351/M451/
M375MFP/M475MFP/M476MFP**

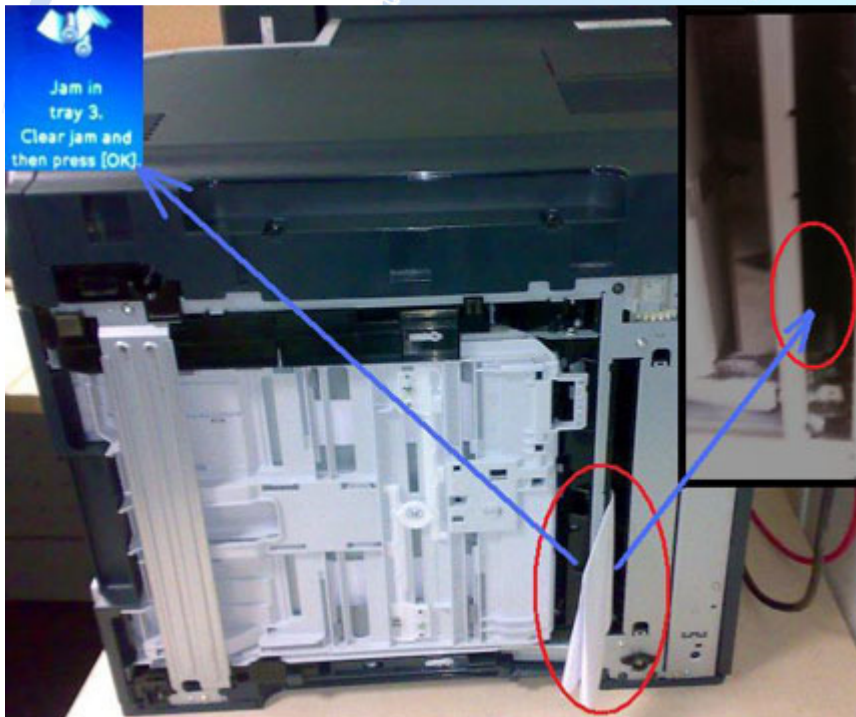
To resolve this issue, make sure the sensor flag shown in the following image is not dislocated, which can be checked by inserting a piece of paper. If yes, reseal or adjust the sensor flag to resolve this issue.
